96-104 Carlingford Road, Epping NSW 2121

Epping West Public School

DILAPIDATION REPORT

7<sup>th</sup> September 2021

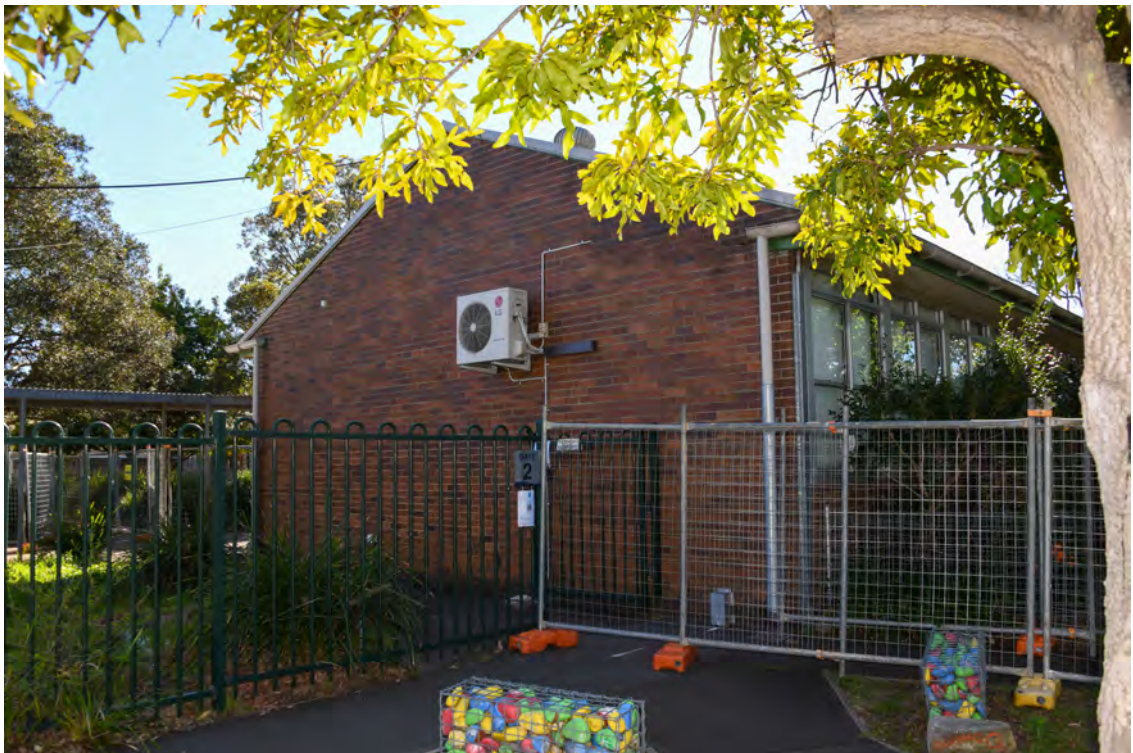
PRO\_1072.jpg

Block H. Western elevation.

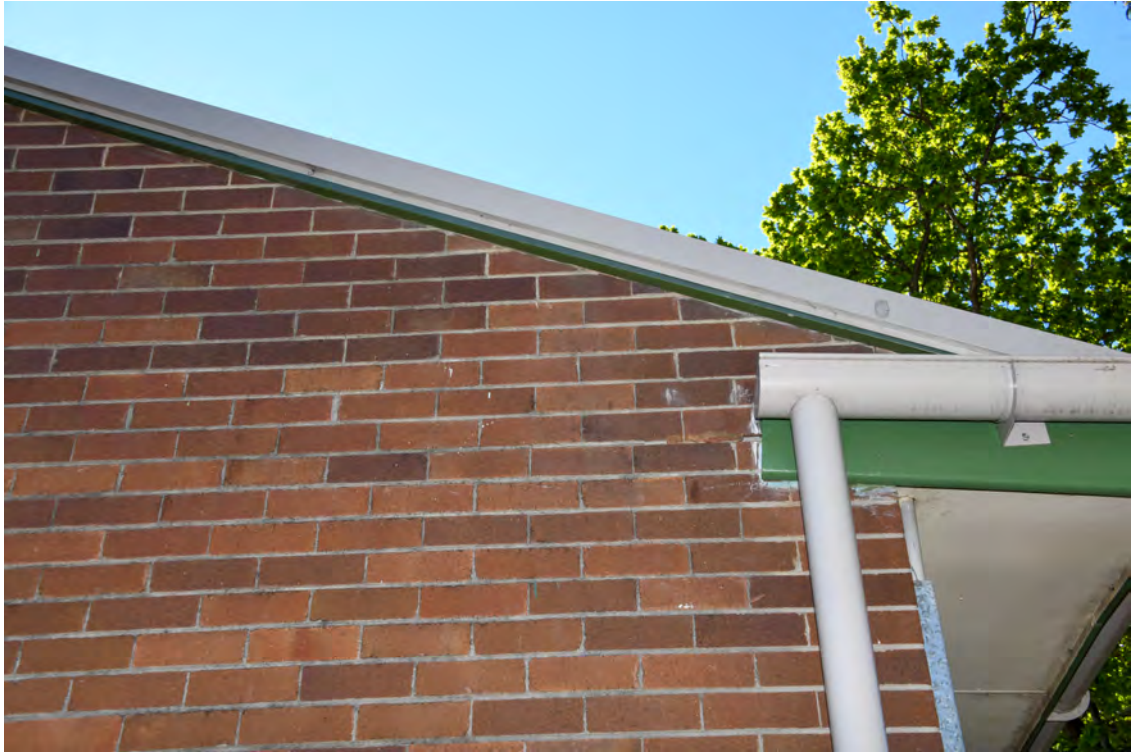
PRO\_1073.jpg

Block H. Western elevation. Southern end.

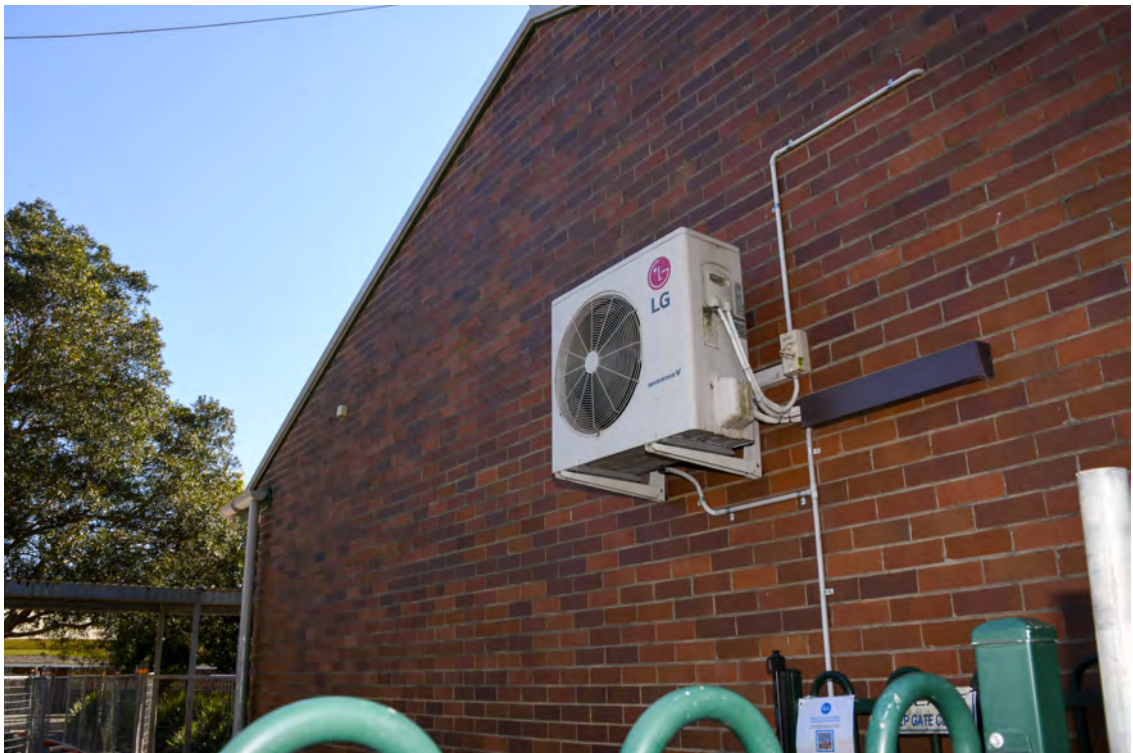
PRO\_1074.jpg

Block H. Western elevation.

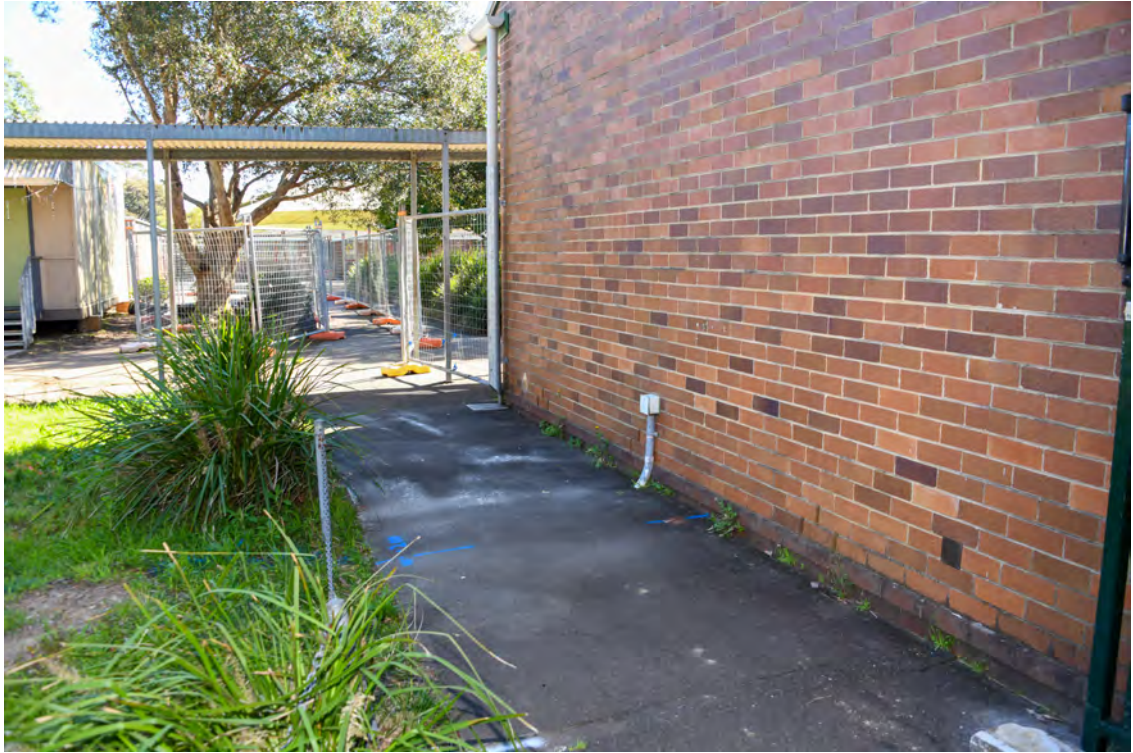
PRO\_1075.jpg

Block H. Western elevation.

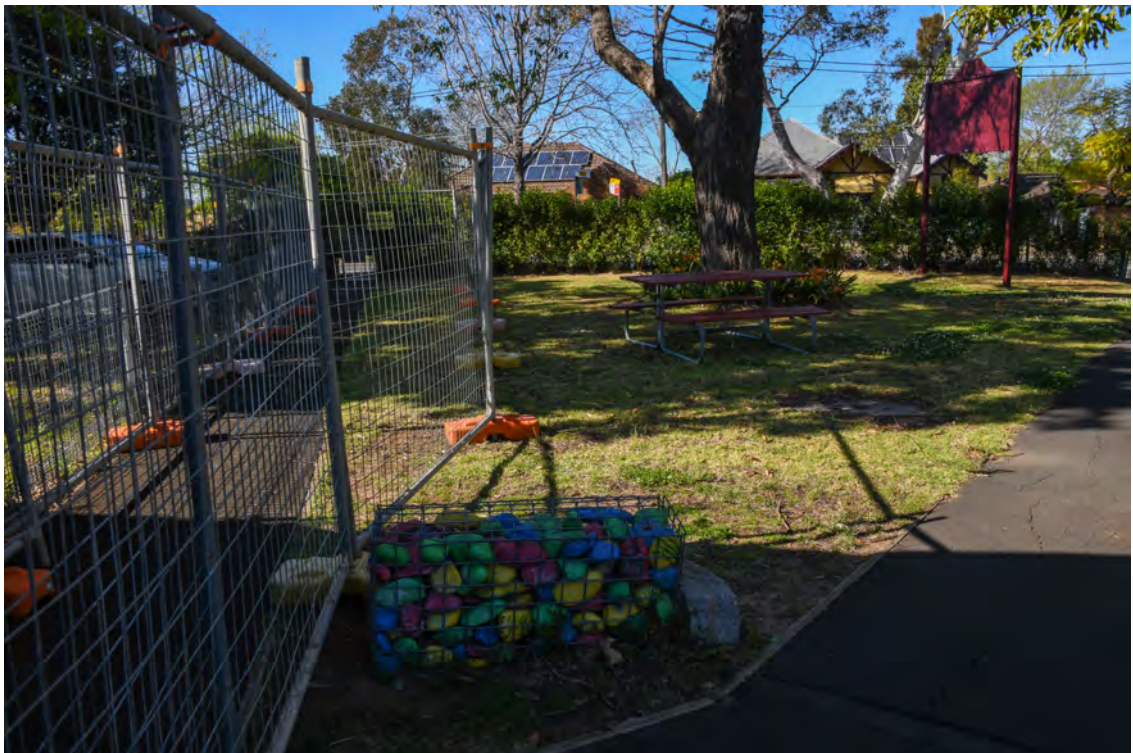
PRO\_1076.jpg

Block H. Western elevation. Facing south.

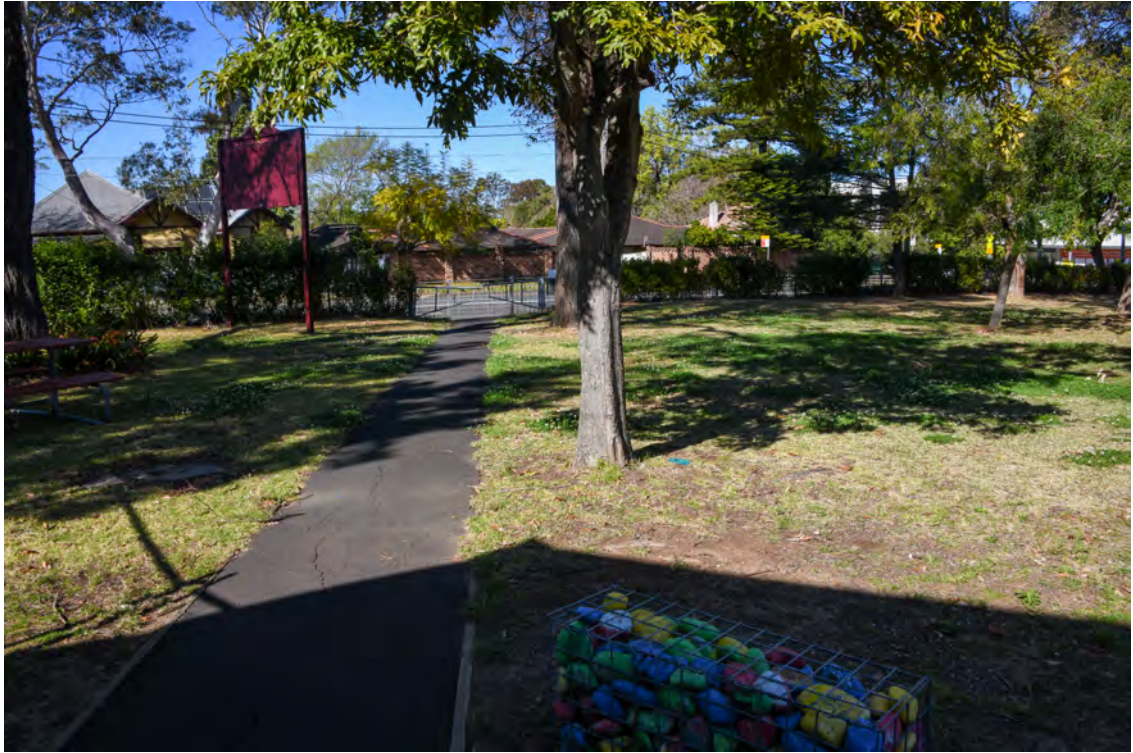
PRO\_1077.jpg

Block H. Western elevation. Facing south-west. Path to Carlingford Road.

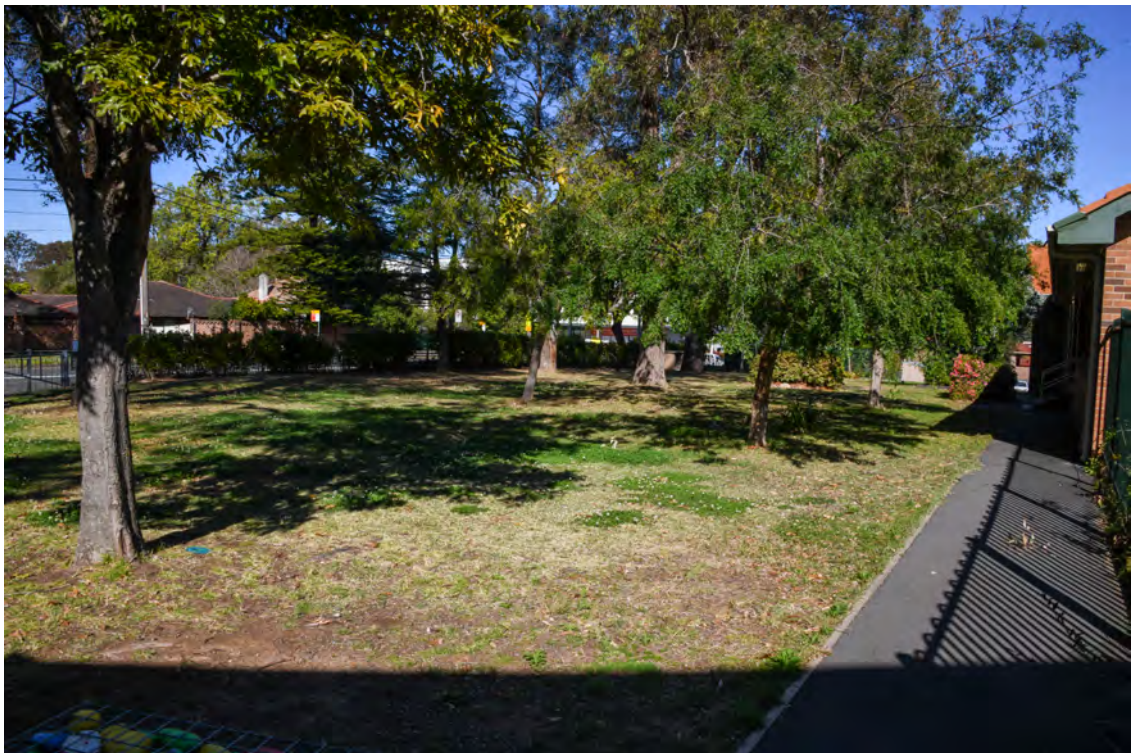
PRO\_1078.jpg

Block H. Western elevation. Facing west.

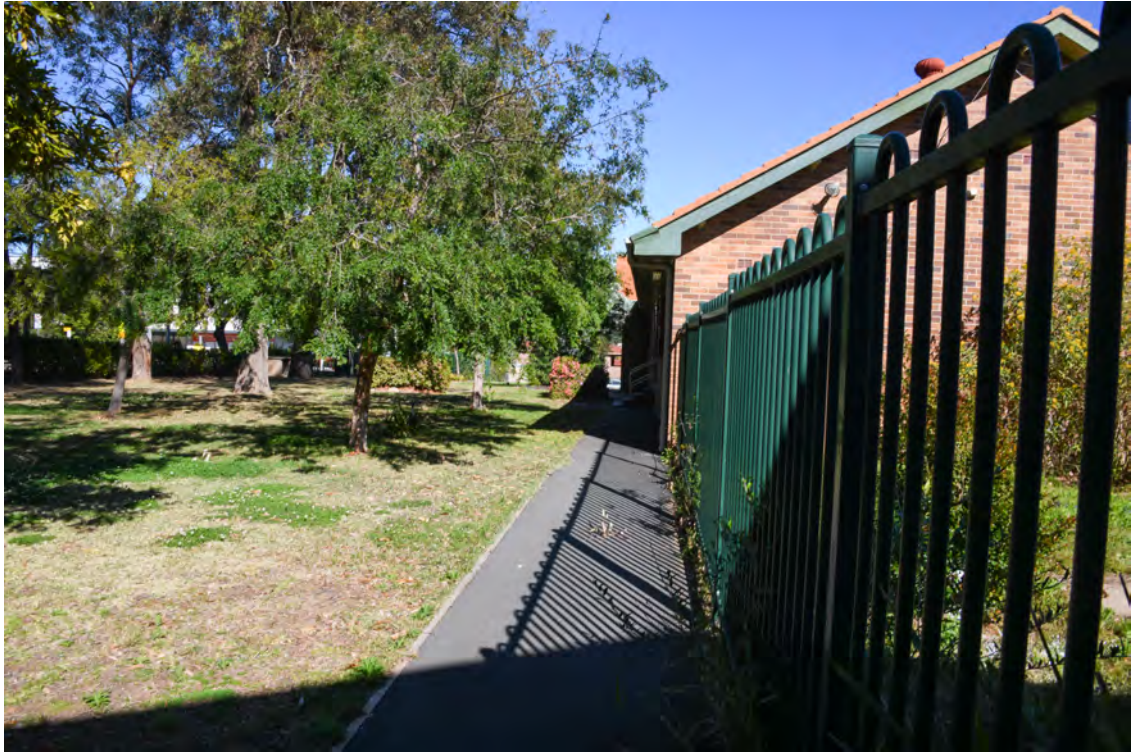
PRO\_1079.jpg

Block H. Western elevation. Facing west.

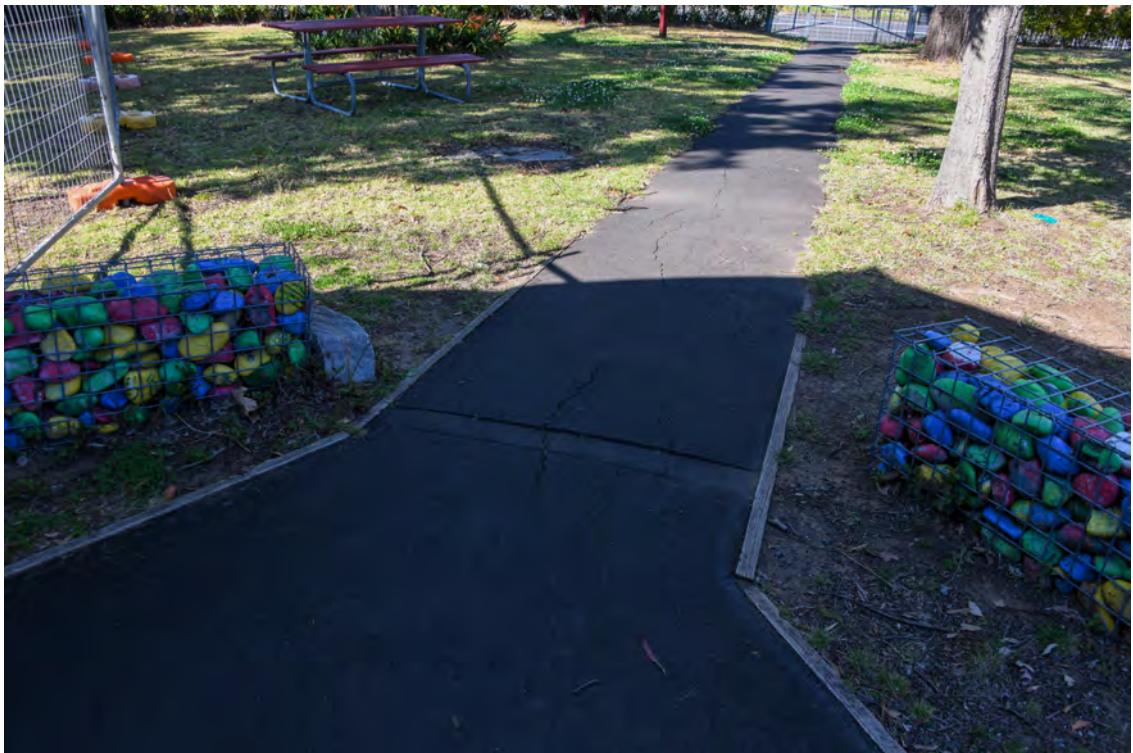
PRO\_1080.jpg

Block H. Western elevation. Facing south-west to the path leading to Carlingford Road.

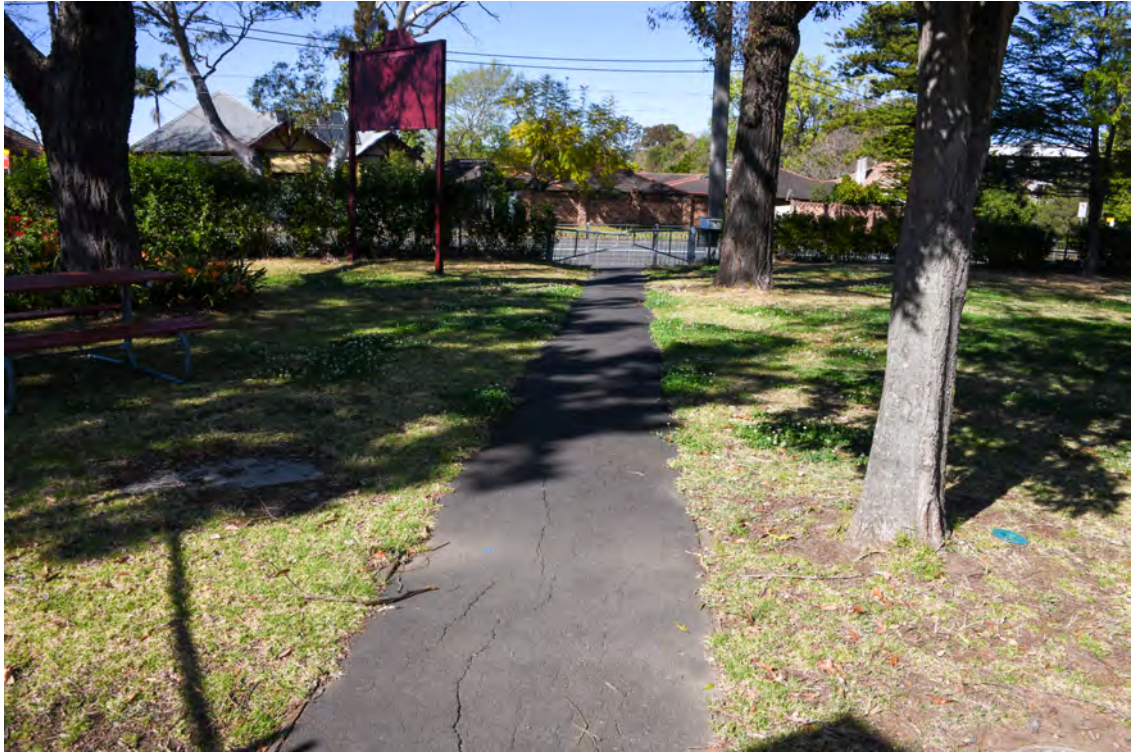
PRO\_1081.jpg

Block H. Western elevation. Facing south-west to the path leading to Carlingford Road.

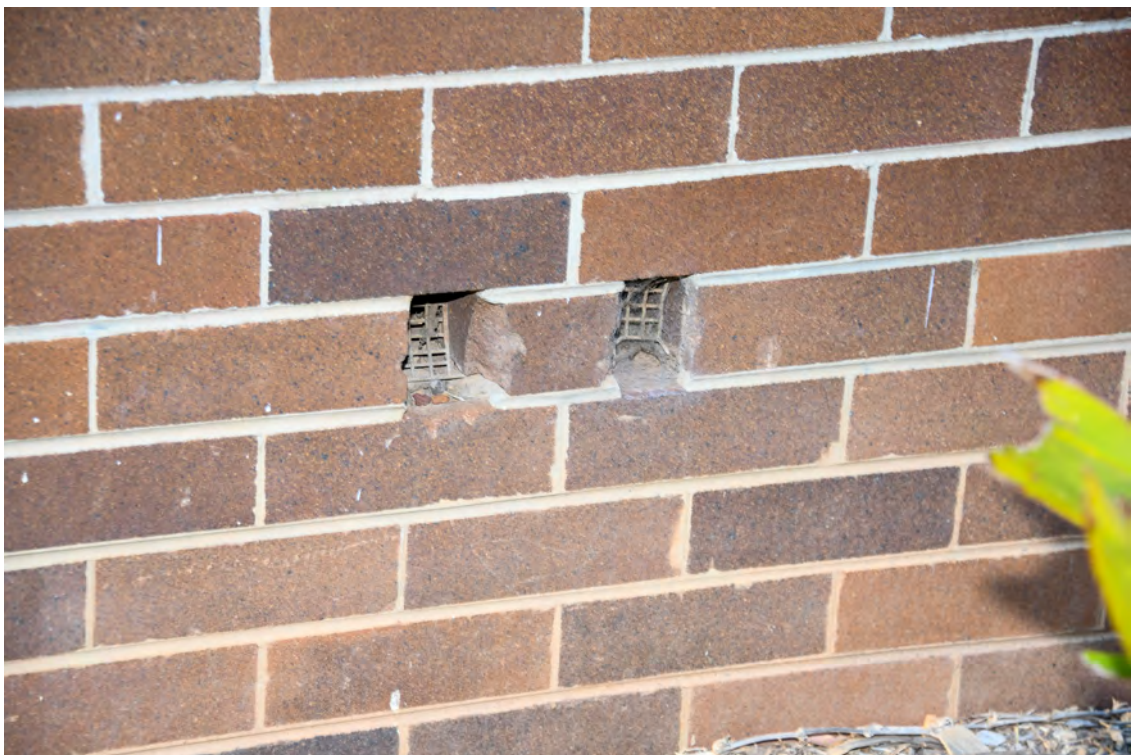
PRO\_0071.jpg

Block F. Northern elevation. Eastern end. Chipped brick edges at the wall vent.

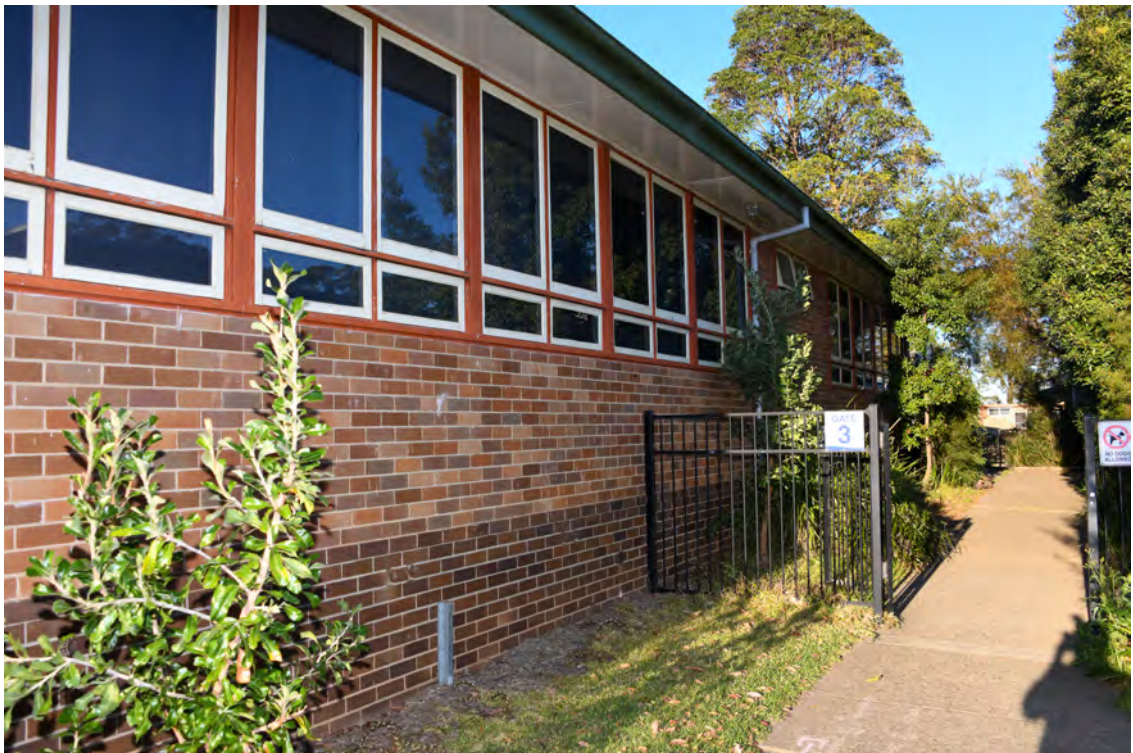
PRO\_0077.jpg

Block F. Northern elevation. Heading west. Chipped brick edges at the wall vent.

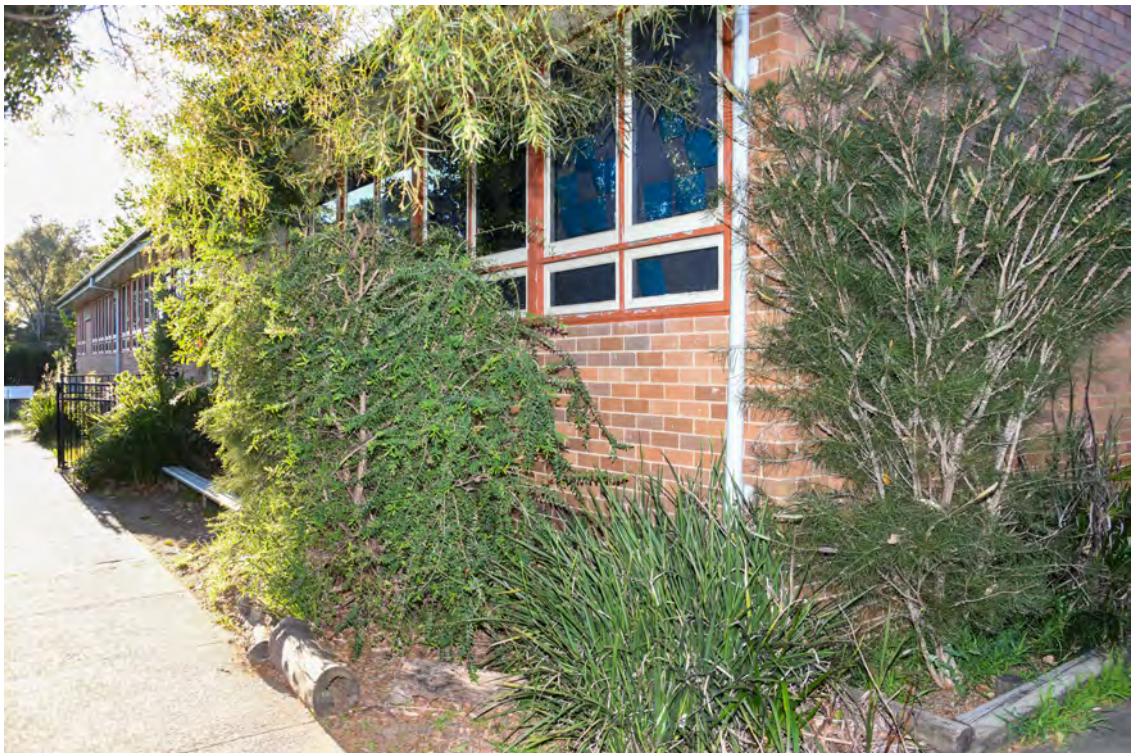
PRO\_0081.jpg

Block F. Northern elevation. Western end. Indentation in the roof gutter.

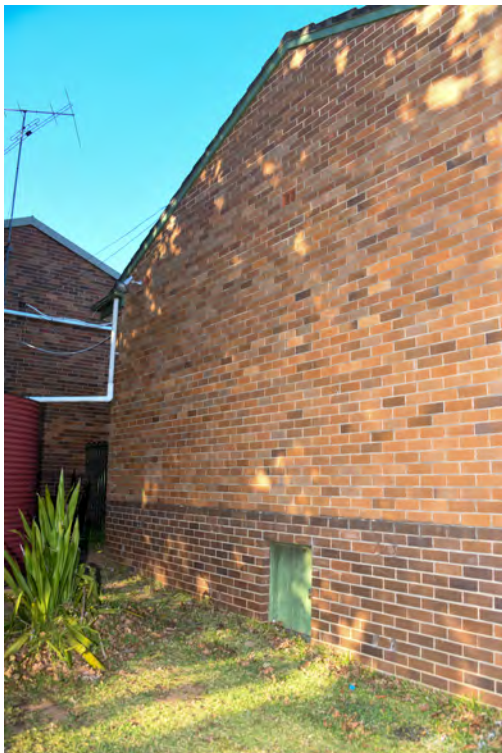
PRO\_0087.jpg

Block F. Eastern elevation. Northern end. Dislodged brick.

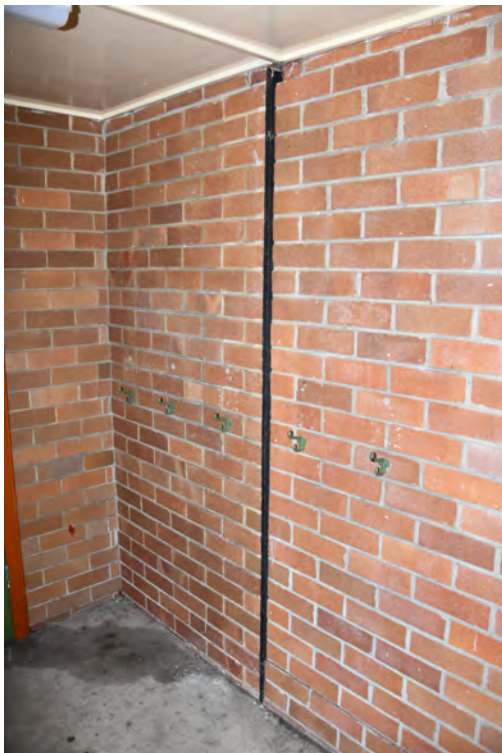
PRO\_0107.jpg

Block F. Southern elevation. Eastern end. Cracked concrete paving.

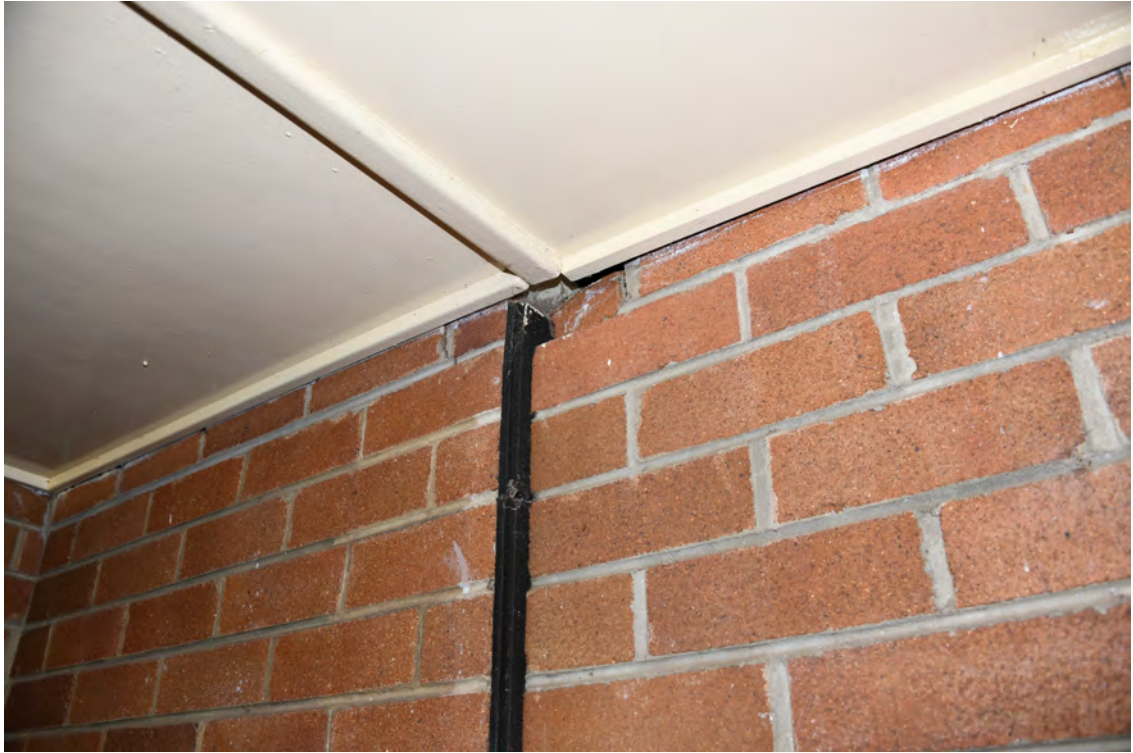
PRO\_0108.jpg

Block F. Southern elevation. Eastern end. Control joint in the brickwork. Loose brick.

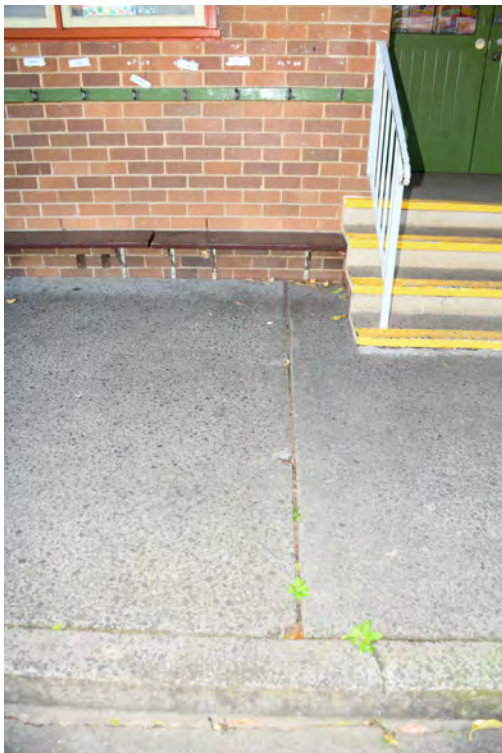
PRO\_0125.jpg

Block F. Southern elevation. Western end. Cracked kerb and gutter.

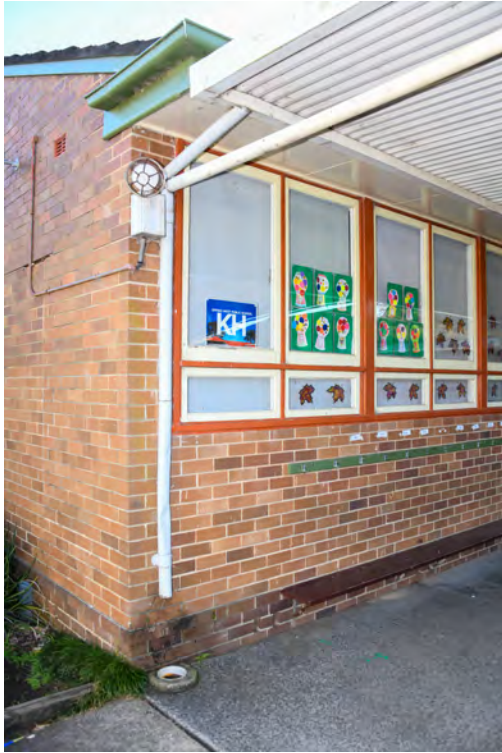
PRO\_0128.jpg

Block F. Southern elevation. Western end. Cracked kerb and gutter.

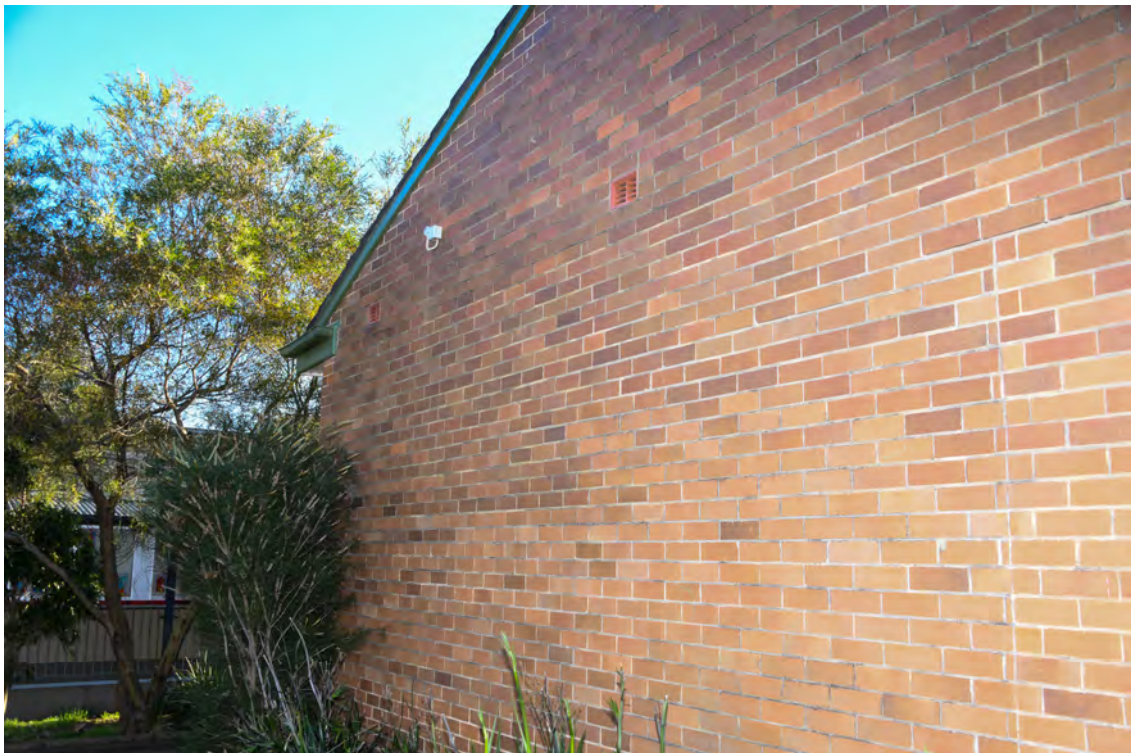
PRO\_0139.jpg

Block F. Western elevation. Southern end. Damaged wall vents.

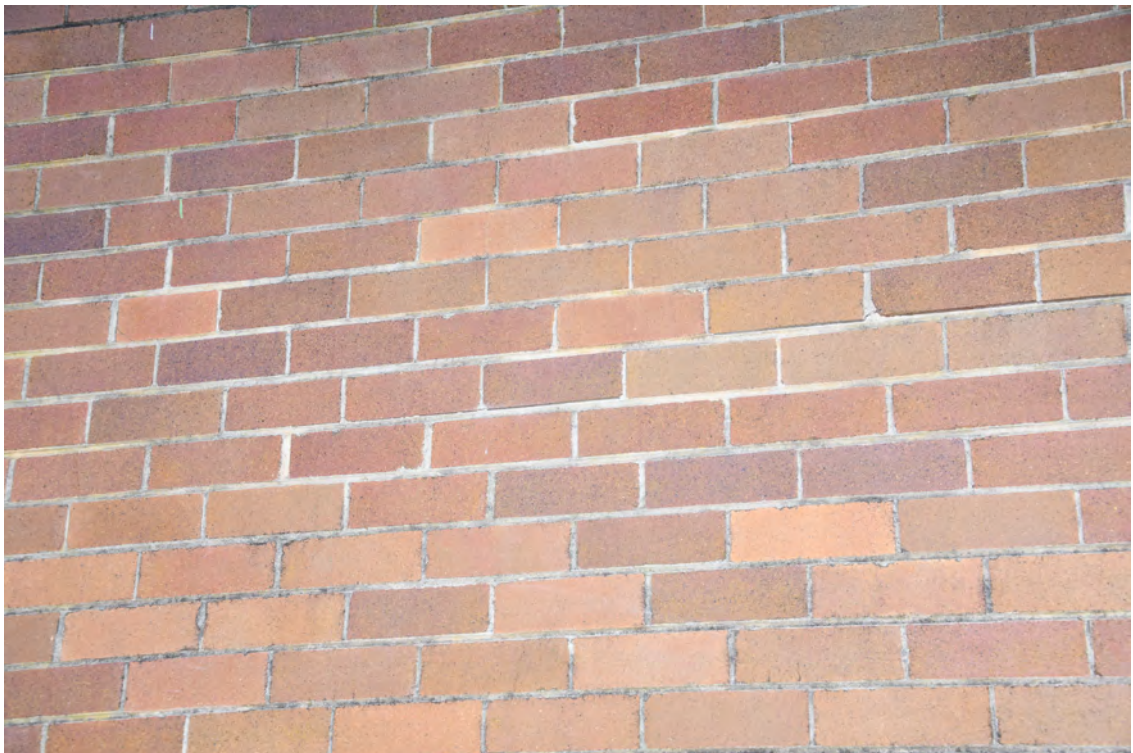
PRO\_0141.jpg

Block F. Western elevation. Northern end. Movement to the brickwork.

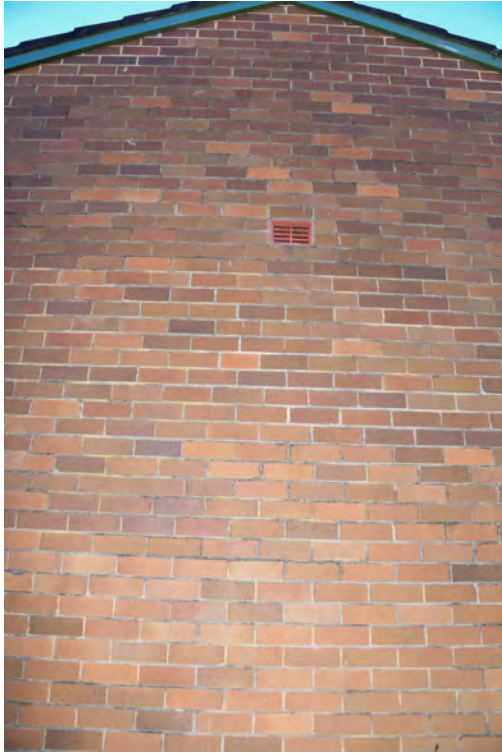
PRO\_0142.jpg

Block F. Western elevation. Northern end. Movement to the brickwork.

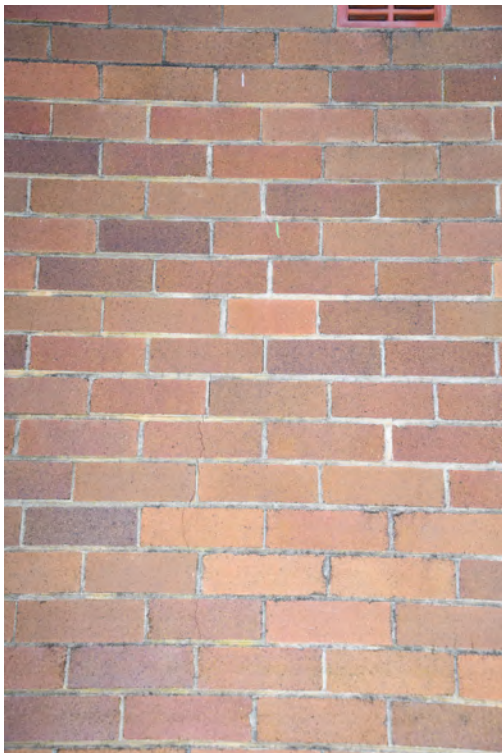
PRO\_0143.jpg

Block F. Western elevation. Movement to the brickwork.

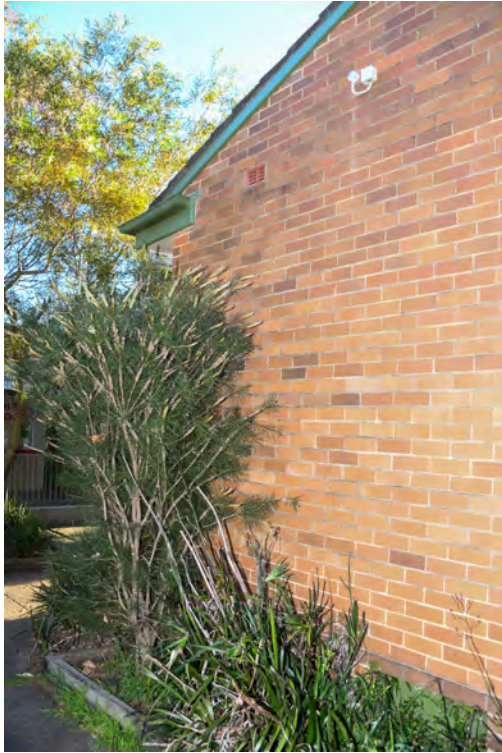
PRO\_0144.jpg

Block F. Western elevation. Cracked brickwork.

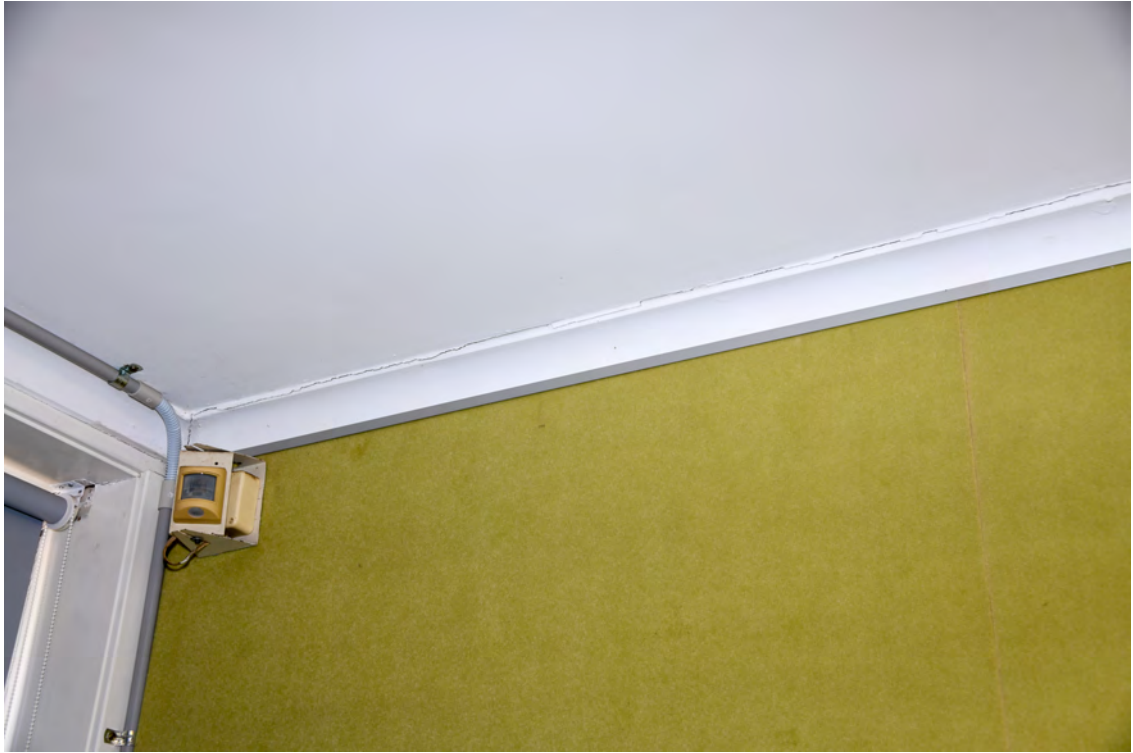
PRO\_0800.jpg

Block F. Interior. Eastern room. Eastern face. Movement to the cornice.

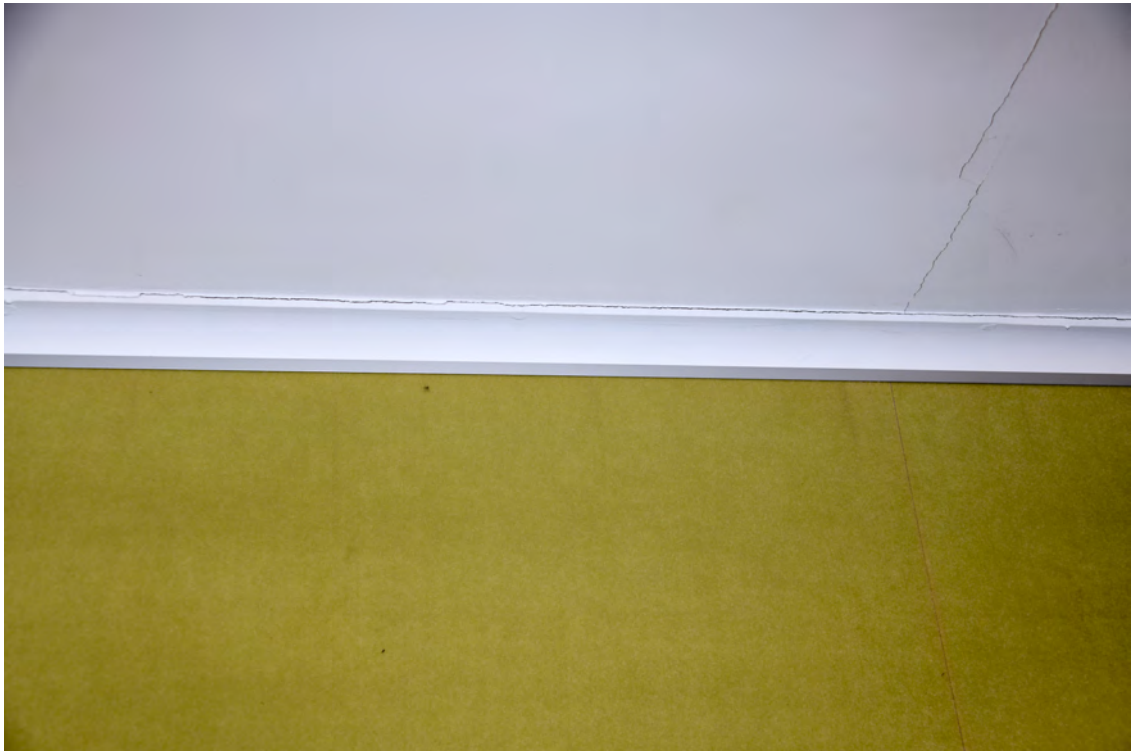
PRO\_0801.jpg

Block F. Interior. Eastern room. Eastern face. Movement to the cornice.

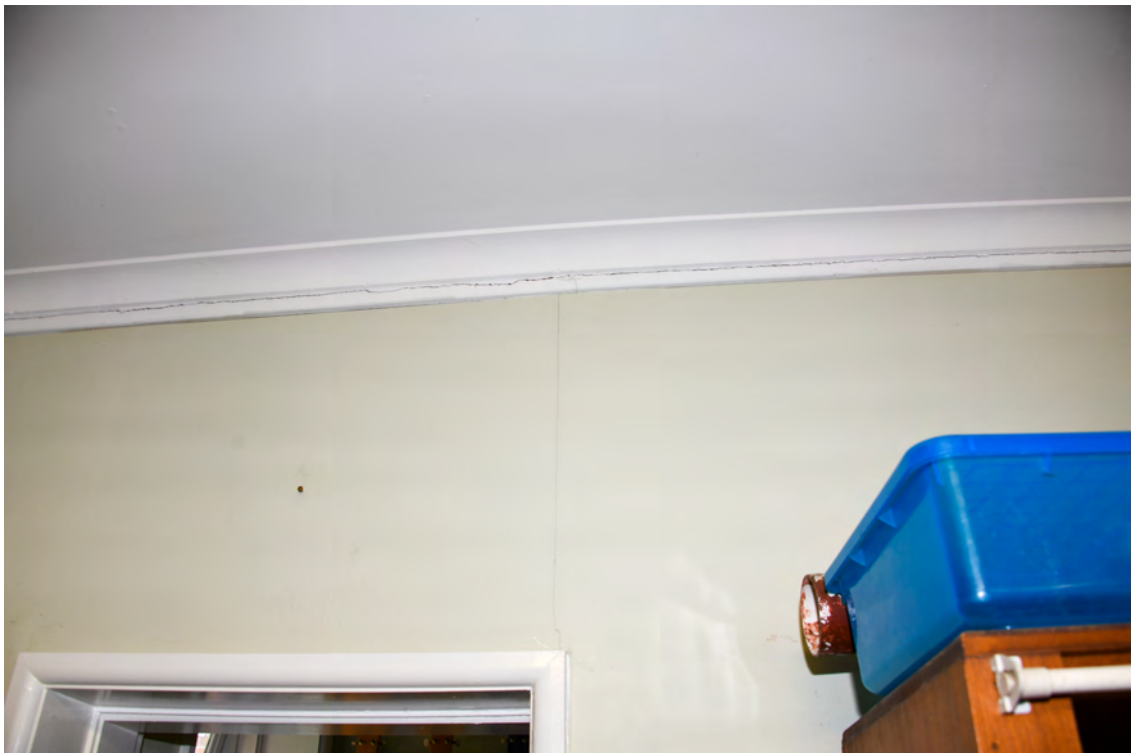
PRO\_0803.jpg

Block F. Interior. Eastern room. Southern face. Movement to the cornice.

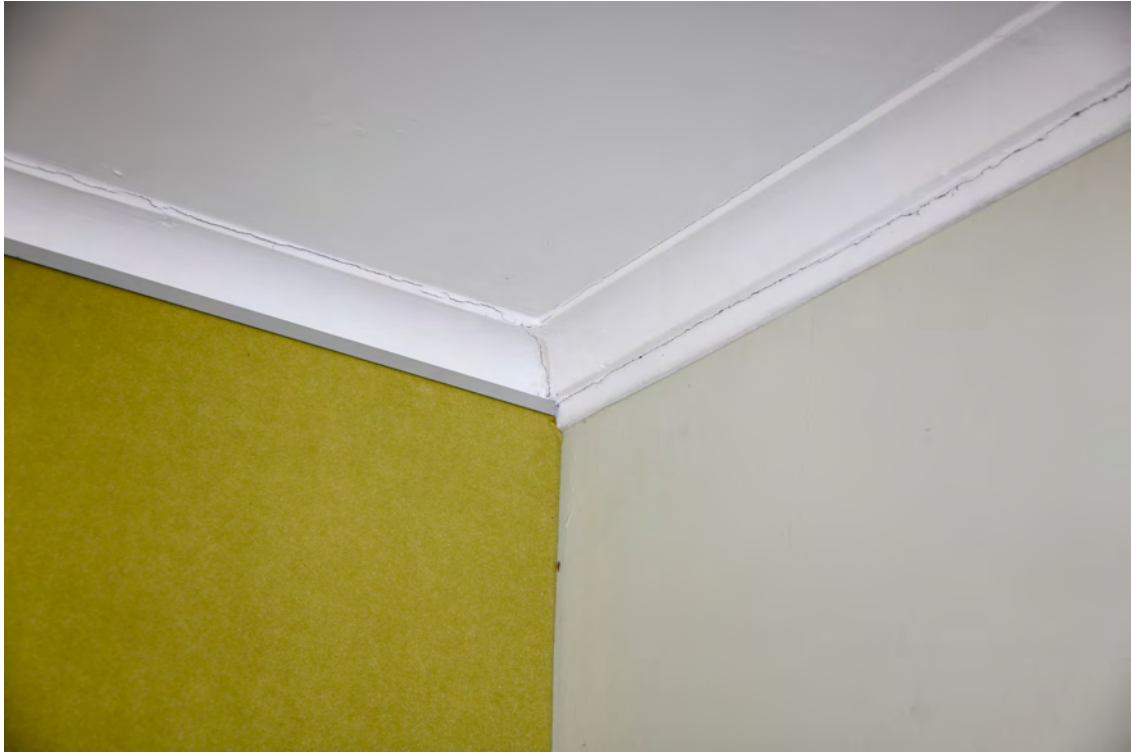
PRO\_0804.jpg

Block F. Interior. Eastern room. Southern face. Movement to the cornice.

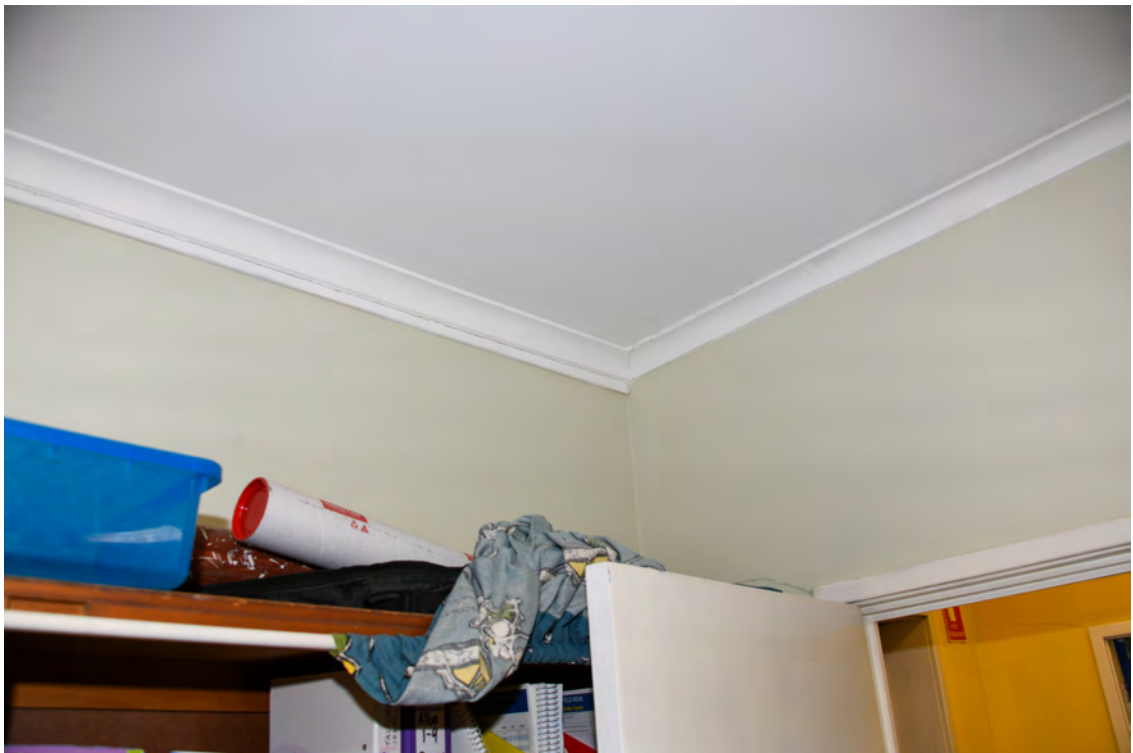
PRO\_0805.jpg

Block F. Interior. Eastern room. Southern face. Movement to the cornice.

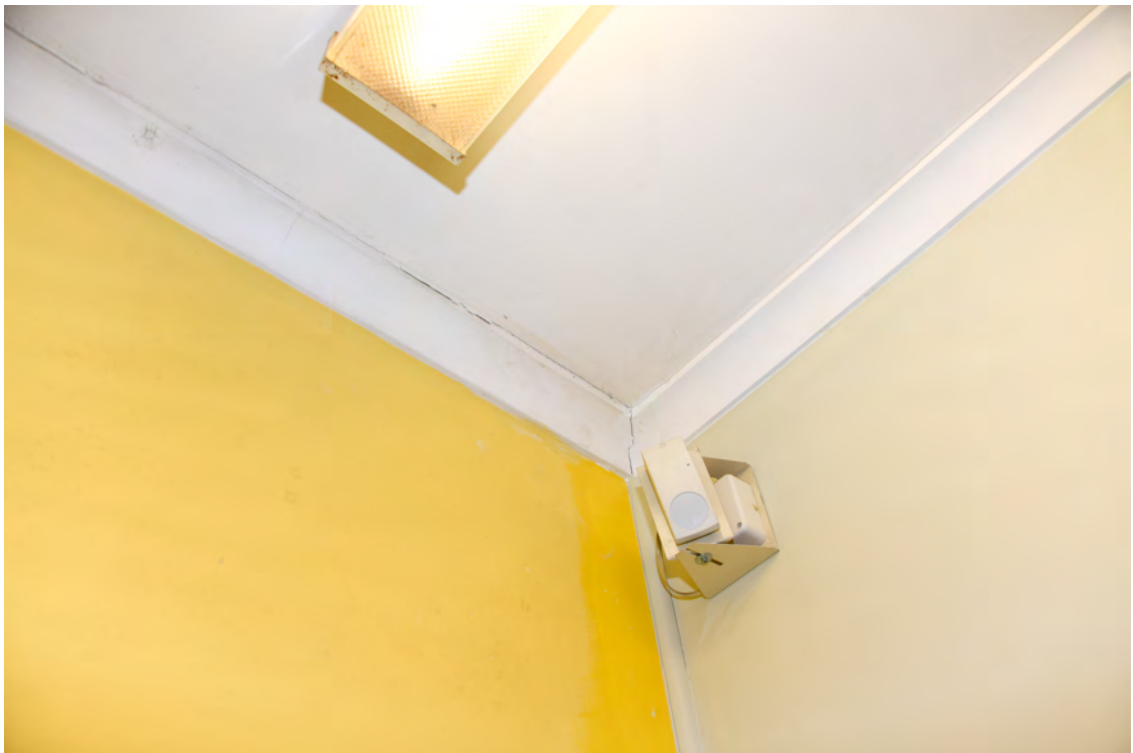
PRO\_0821.jpg

Block F. Interior. Entry Foyer (room 14). Northern face. Movement to the cornice.

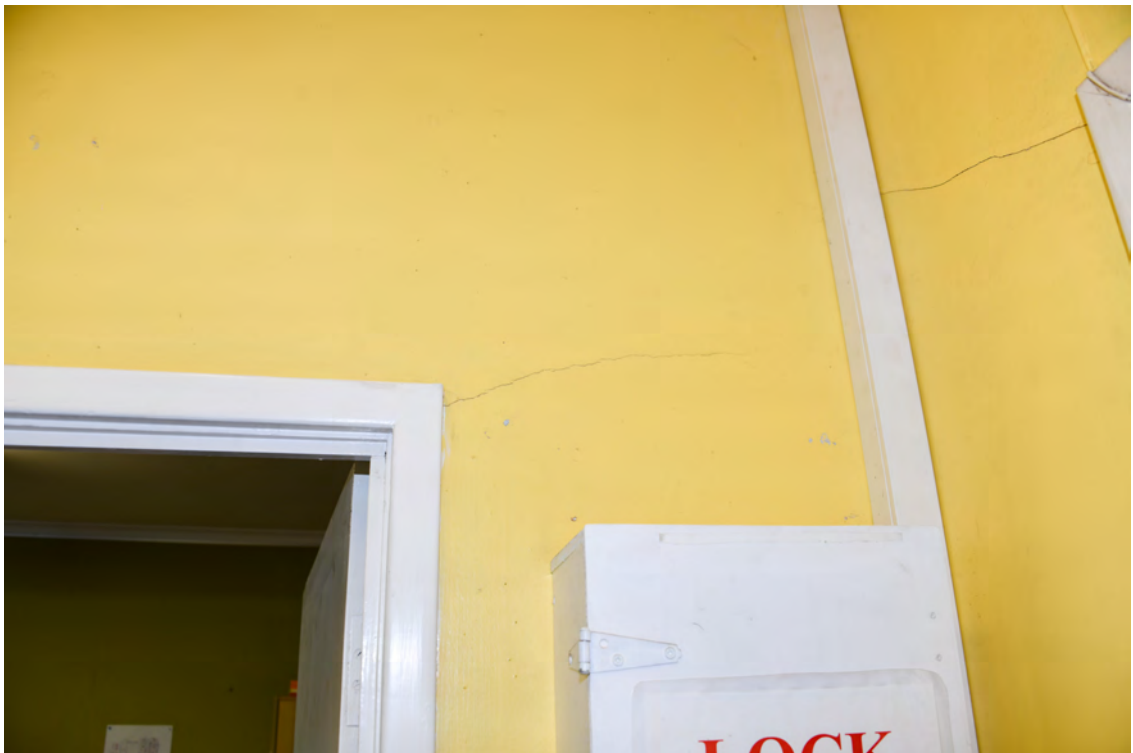
PRO\_0823.jpg

Block F. Interior. Entry Foyer (room 14). Eastern face. Cracked wall cladding.
