96-104 Carlingford Road, Epping NSW 2121

Epping West Public School

DILAPIDATION REPORT

7<sup>th</sup> September 2021

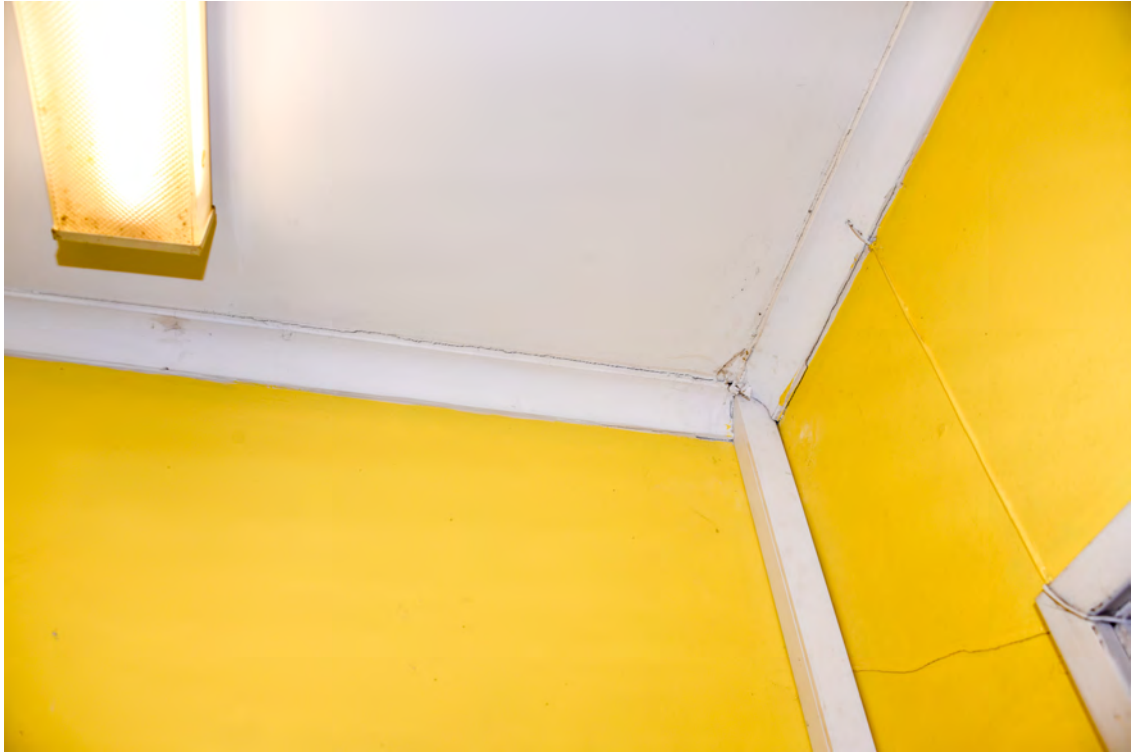
PRO\_0824.jpg

Block F. Interior. Entry Foyer (room 14). Eastern face. Cracked wall cladding and movement to the cornice.

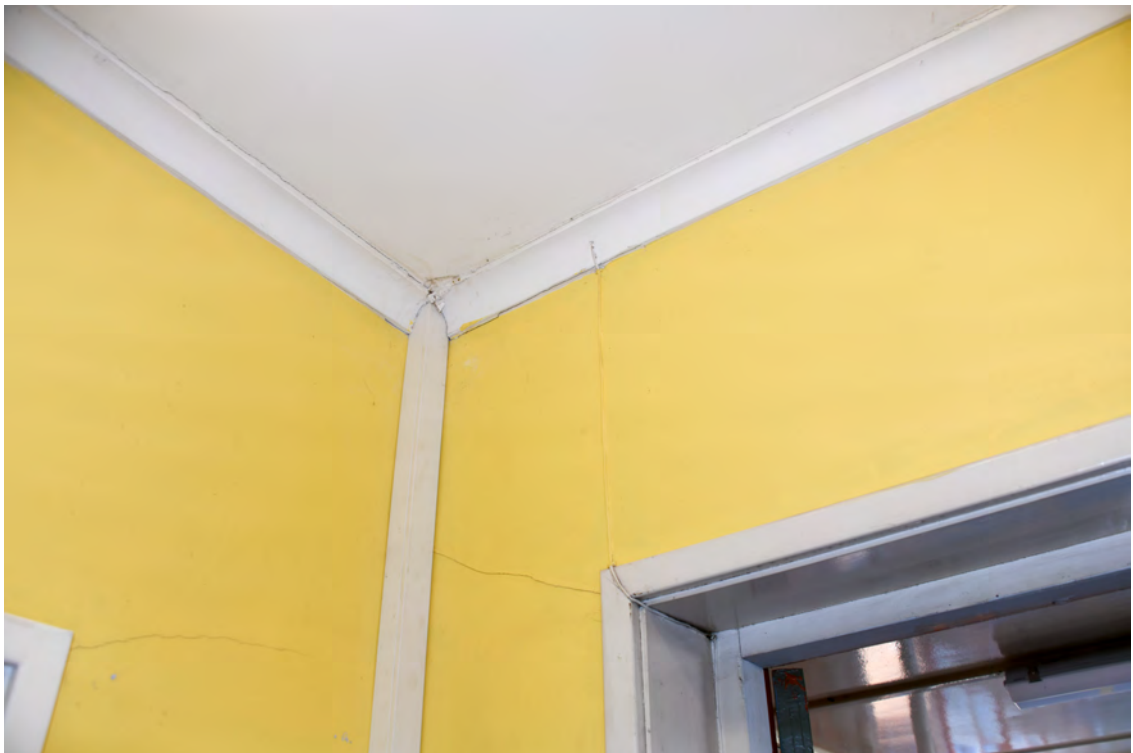
PRO\_0825.jpg

Block F. Interior. Entry Foyer (room 14). Southern face. Cracked wall cladding and movement to the cornice.

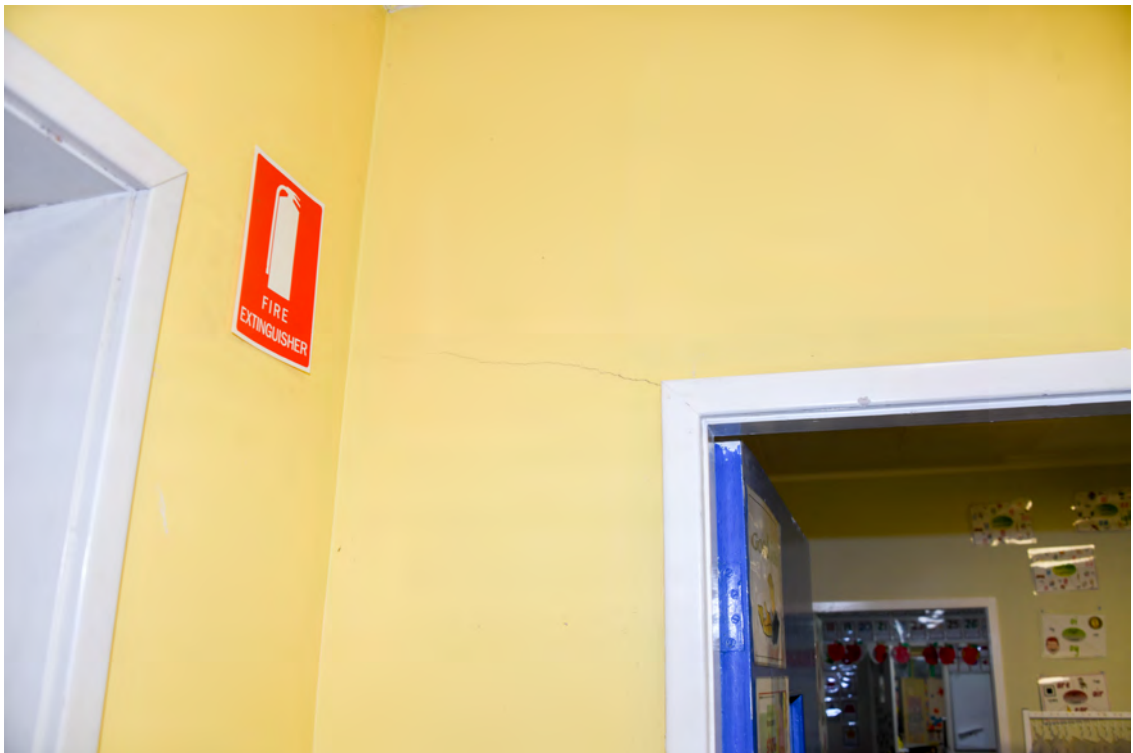
PRO\_0827.jpg

Block F. Interior. Entry Foyer (room 14). Western face. Cracked wall cladding.

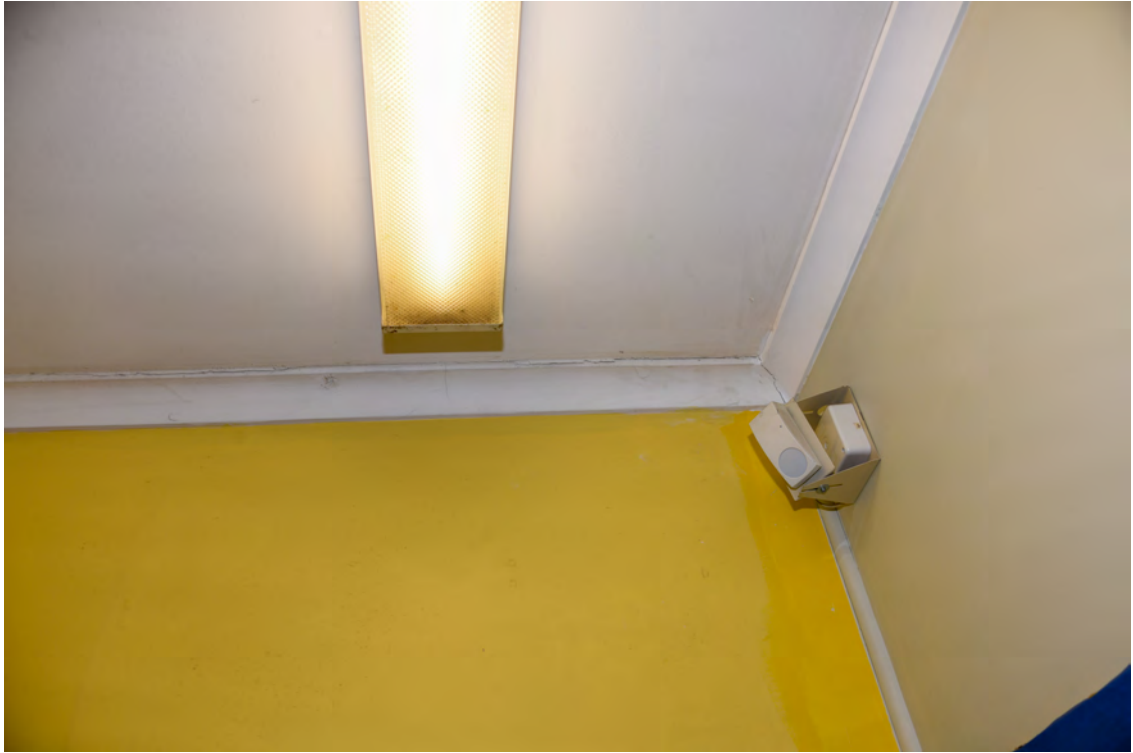
PRO\_0828.jpg

Block F. Interior. Entry Foyer (room 14). Western face. Movement to the cornice.

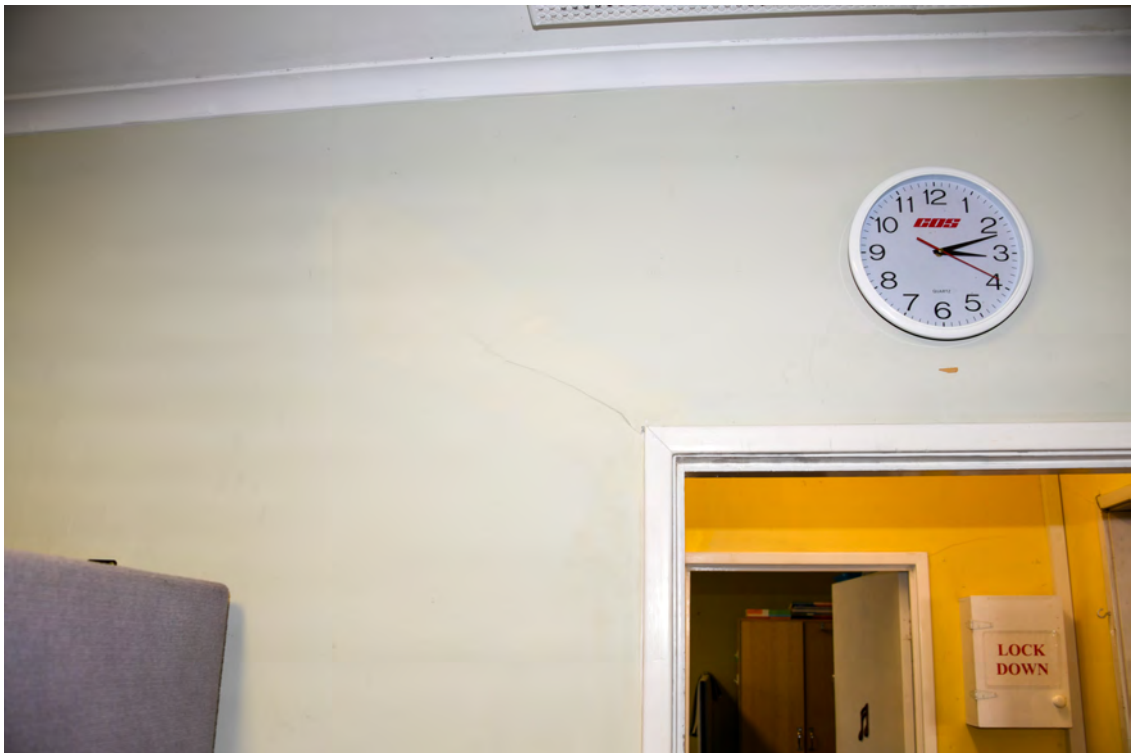
PRO\_0837.jpg

Block F. Interior. Second eastern room (Mrs Wiltshire). Eastern face. Cracked wall cladding.

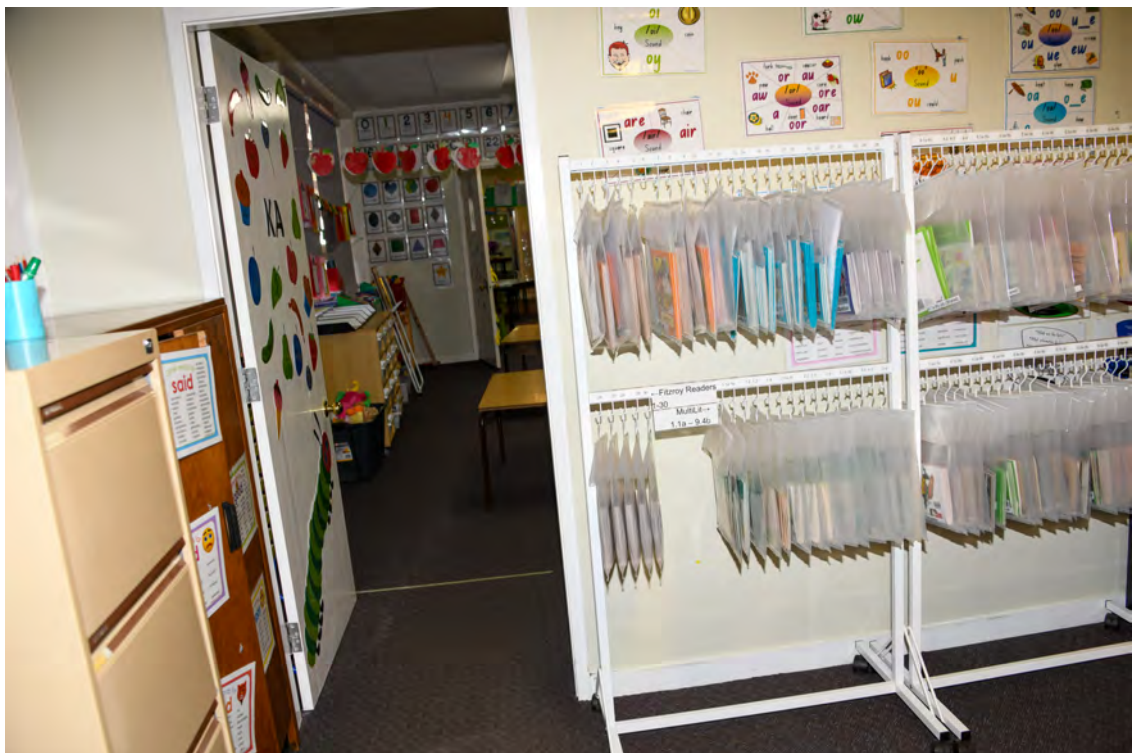
PRO\_0842.jpg

Block F. Interior. Second eastern room (Mrs Wiltshire). Western face.

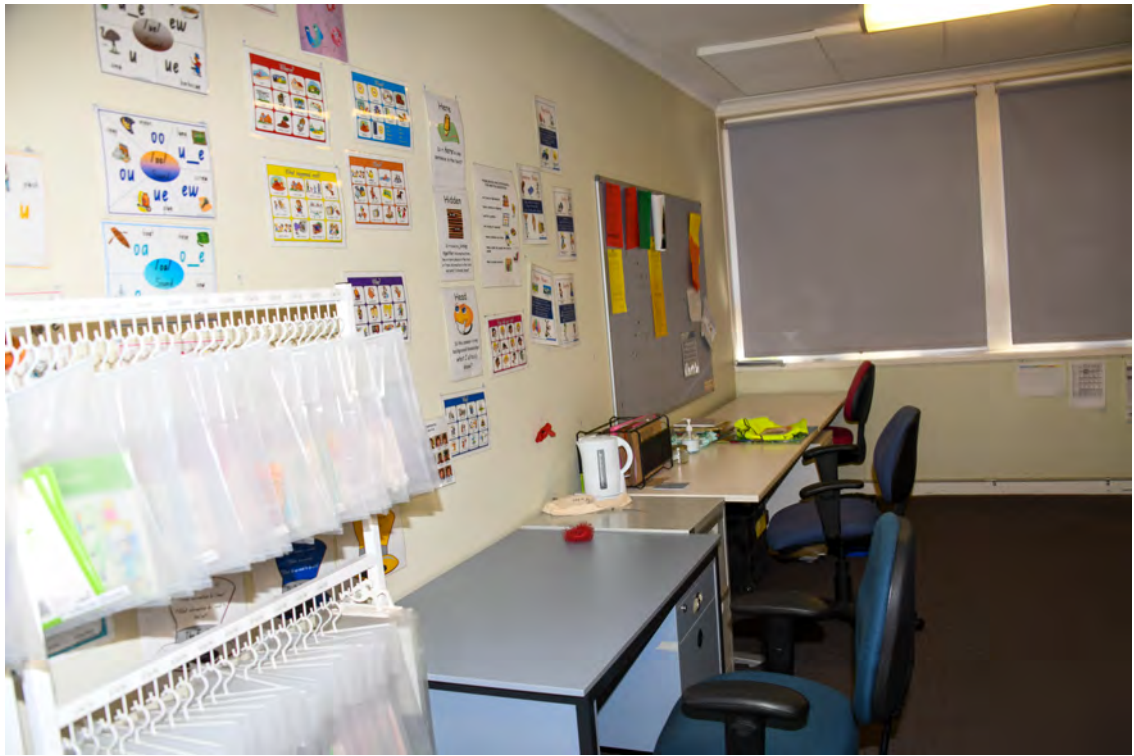
PRO\_0843.jpg

Block F. Interior. Second eastern room (Mrs Wiltshire). Western face.

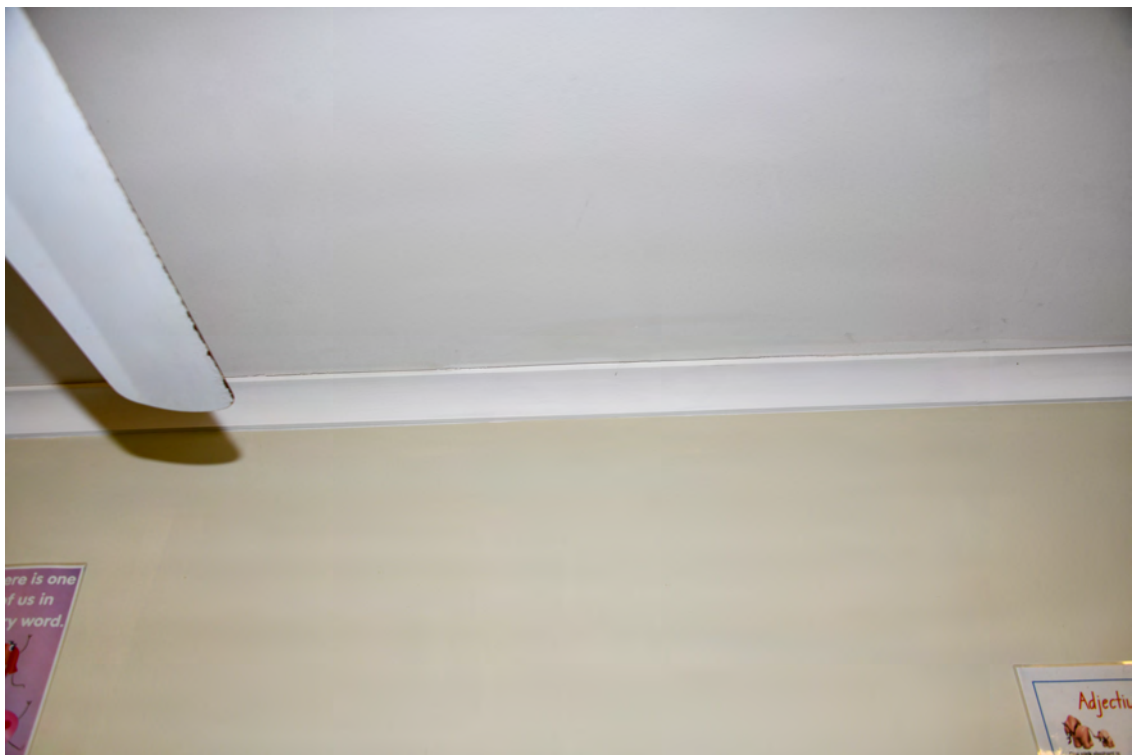
PRO\_0844.jpg

Block F. Interior. Second eastern room (Mrs Wiltshire). Western face.

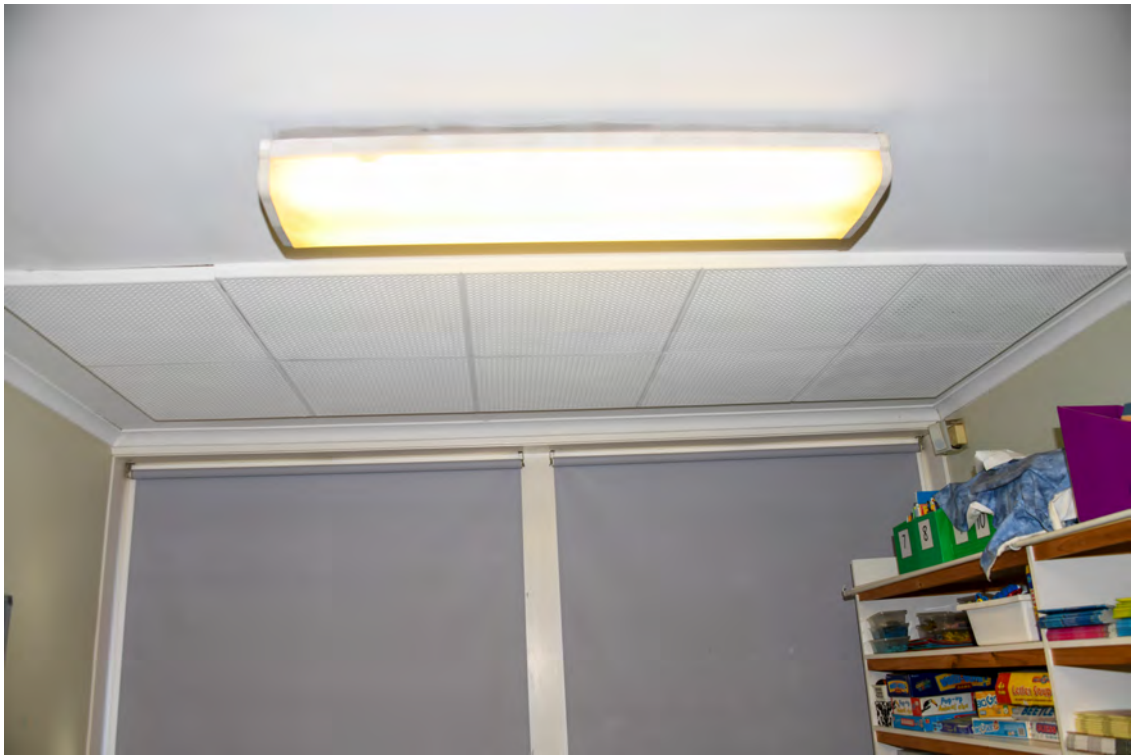
PRO\_0845.jpg

Block F. Interior. Second eastern room (Mrs Wiltshire). Ceiling.

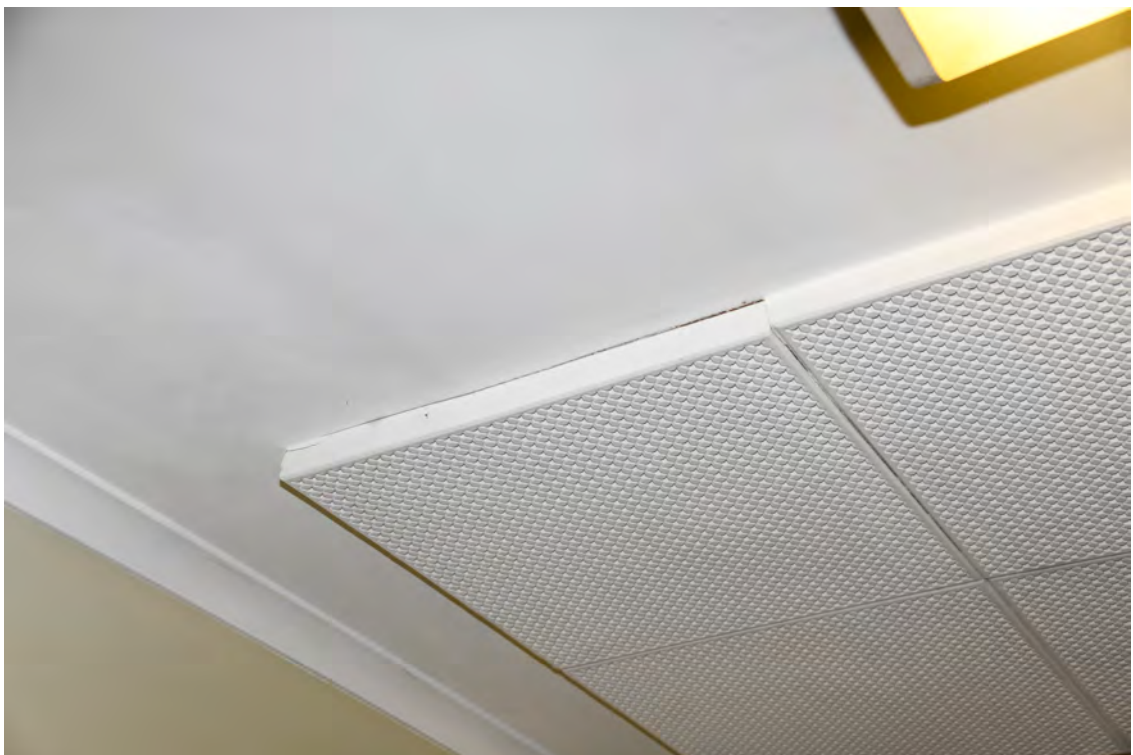
PRO\_0846.jpg

Block F. Interior. Second eastern room (Mrs Wiltshire). Ceiling.

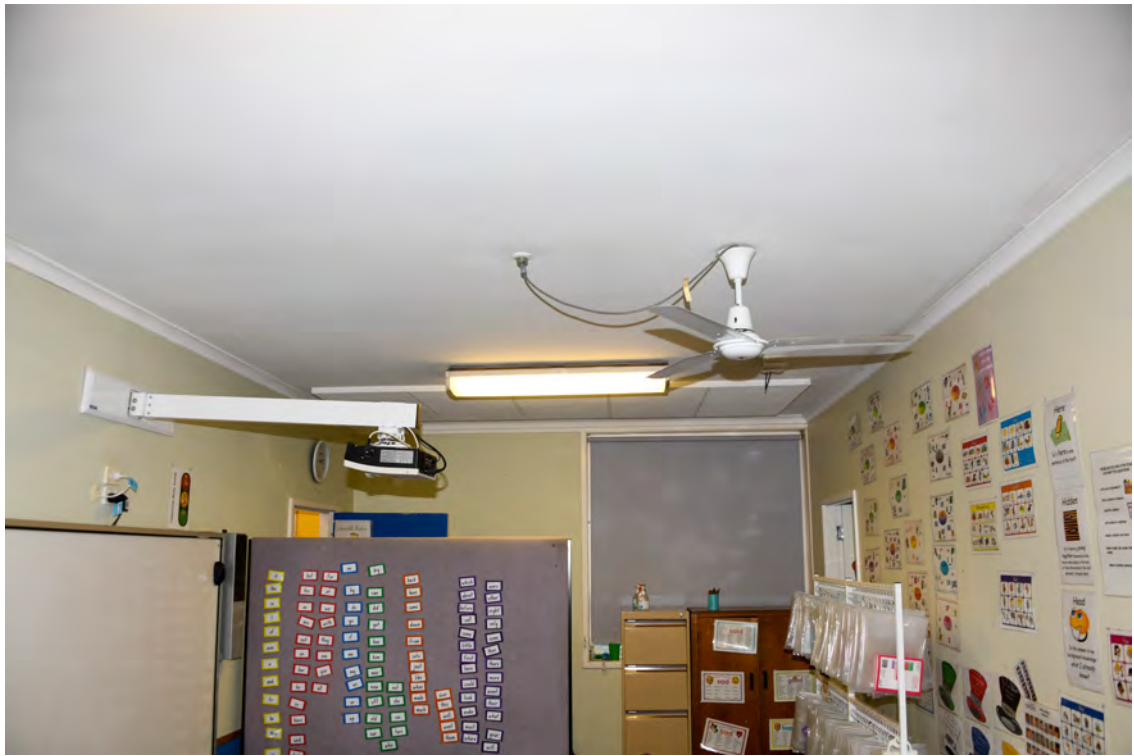
PRO\_0847.jpg

Block F. Interior. Second eastern room (Mrs Wiltshire). Ceiling.

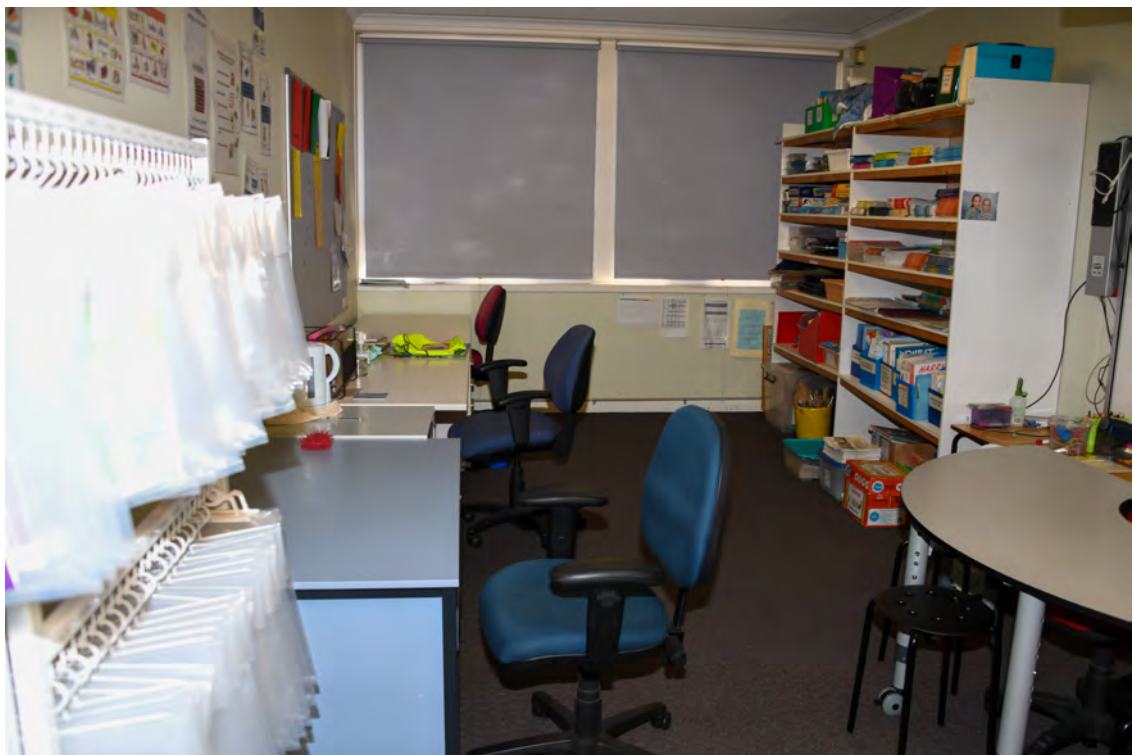
PRO\_0848.jpg

Block F. Interior. Second eastern room (Mrs Wiltshire). Overview of the room layout.

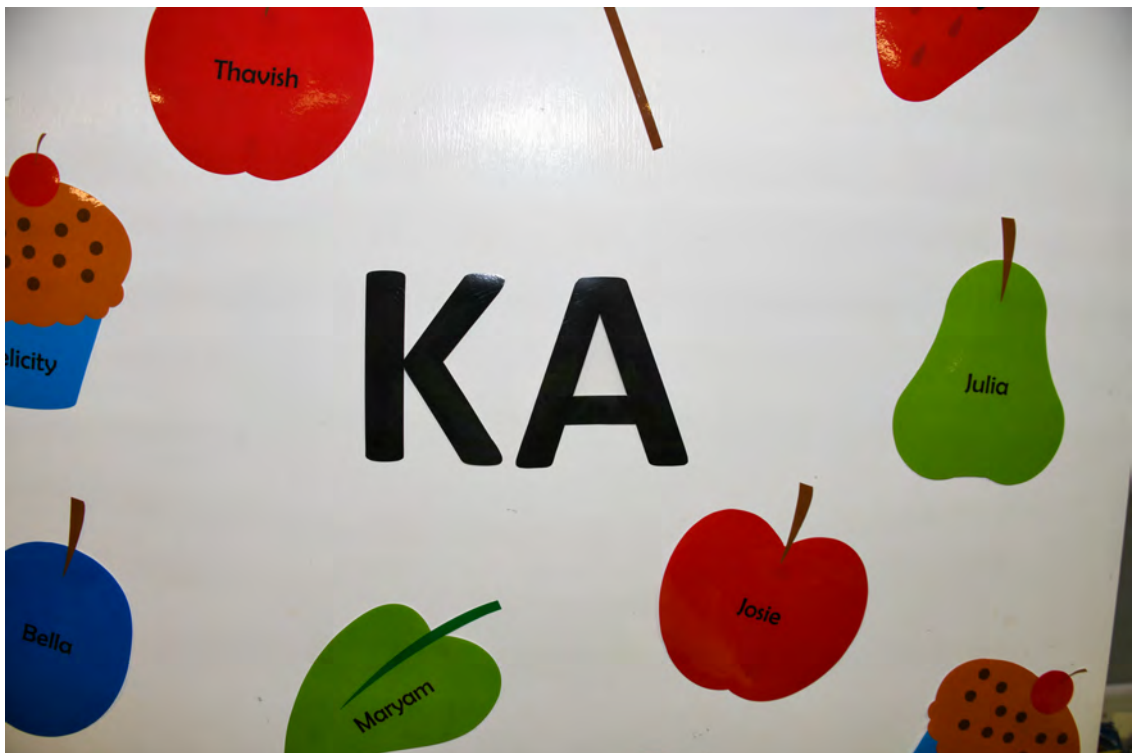
PRO\_0850.jpg

Block F. Interior. Room KA.

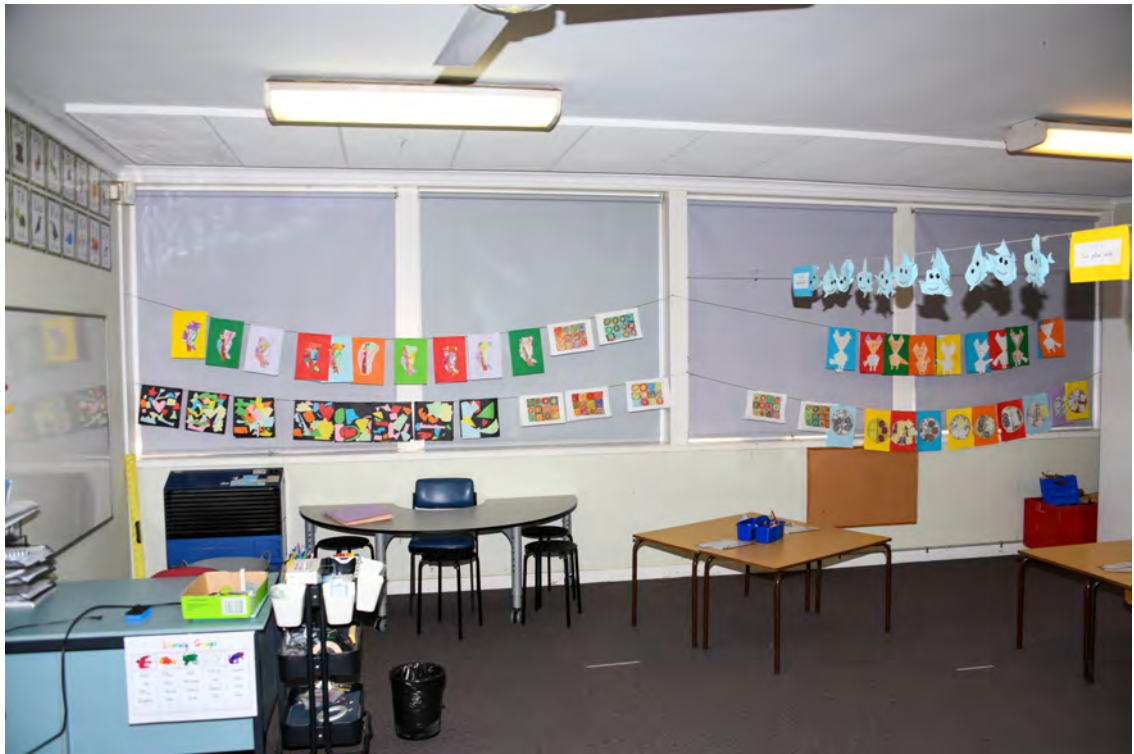
PRO\_0851.jpg

Block F. Interior. Room KA. Northern face.

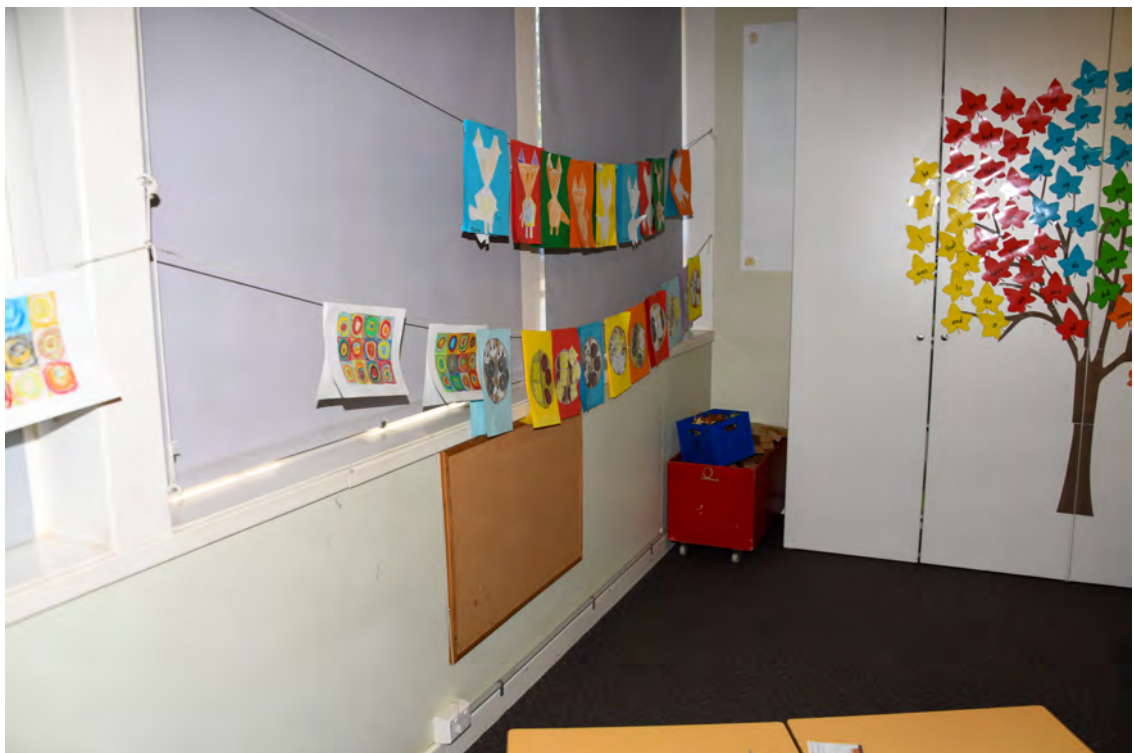
PRO\_0852.jpg

Block F. Interior. Room KA. Northern face.

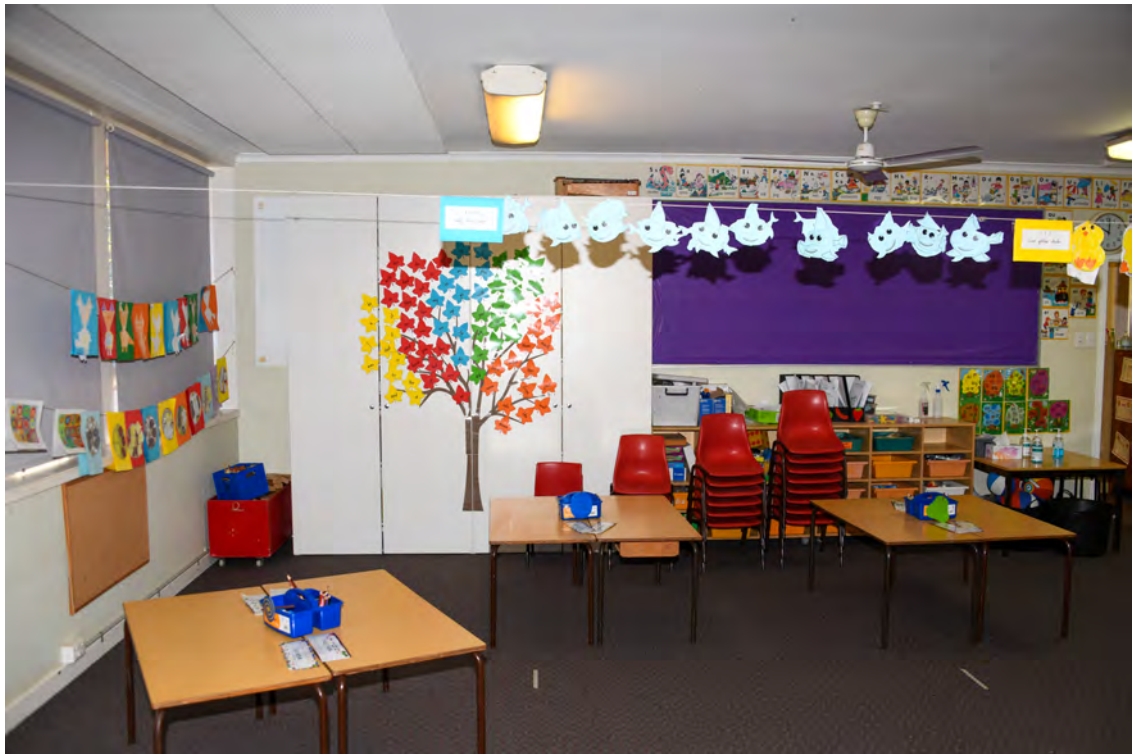
PRO\_0853.jpg

Block F. Interior. Room KA. Eastern face.

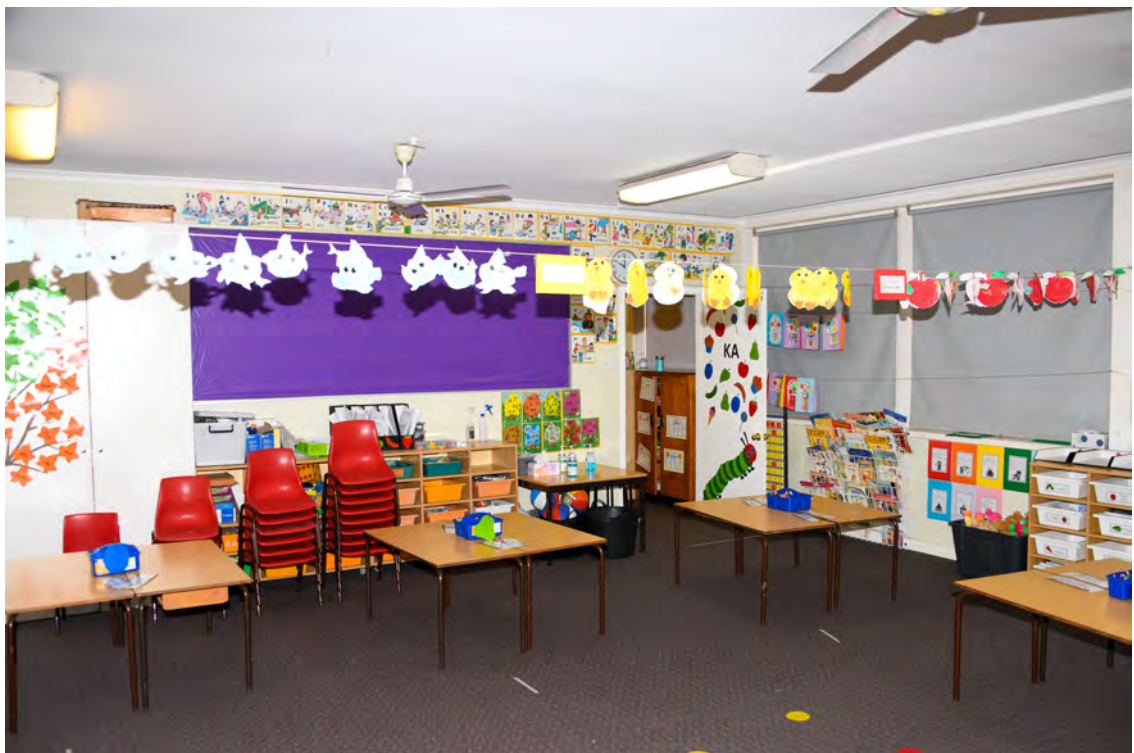
PRO\_0854.jpg

Block F. Interior. Room KA. Eastern face.

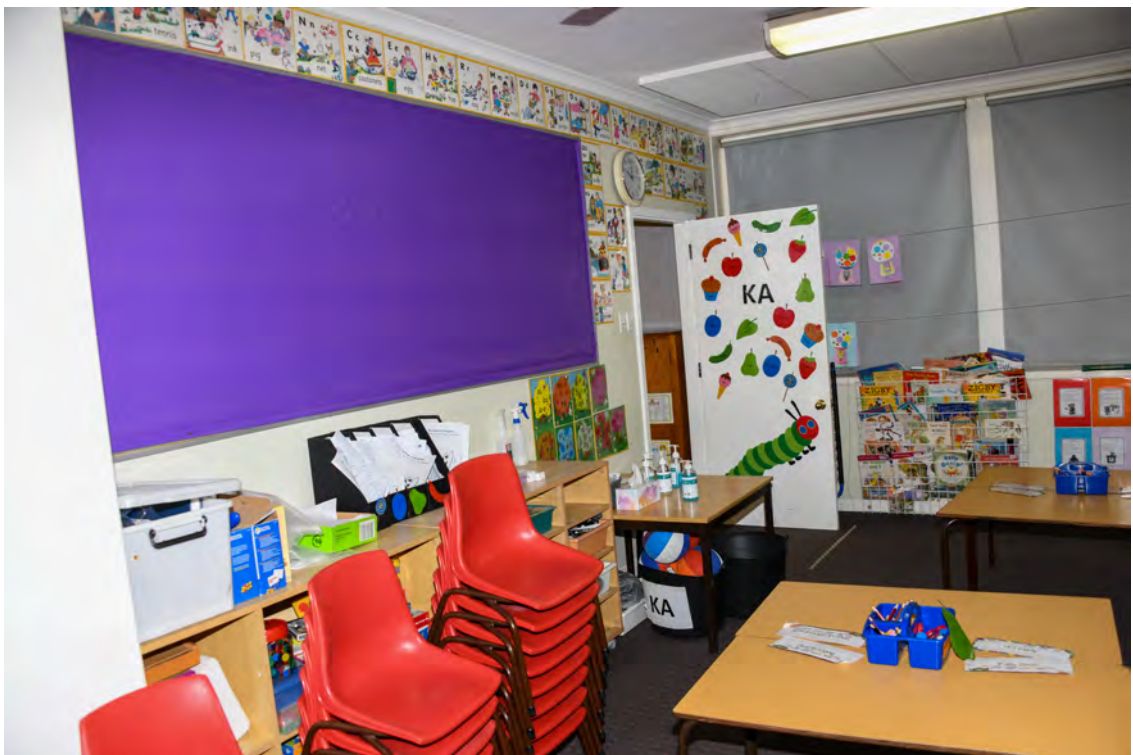
PRO\_0856.jpg

Block F. Interior. Room KA. Eastern face.

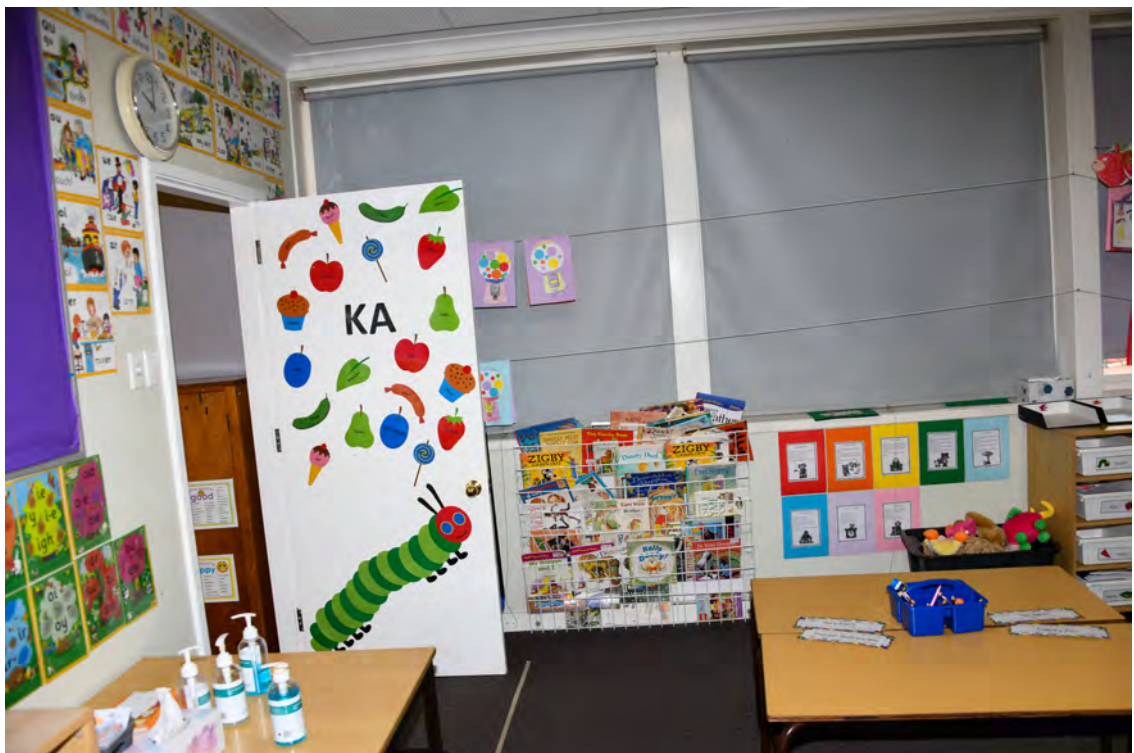
PRO\_0858.jpg

Block F. Interior. Room KA. South-eastern corner.

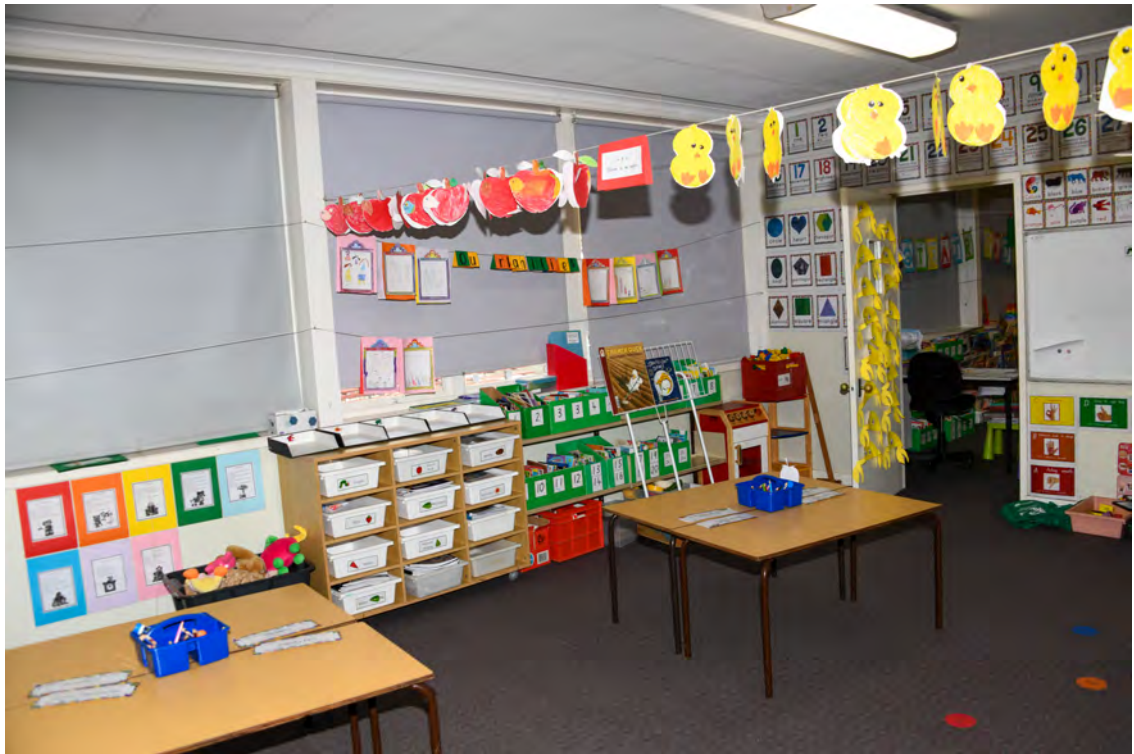
PRO\_0859.jpg

Block F. Interior. Room KA. Southern face.

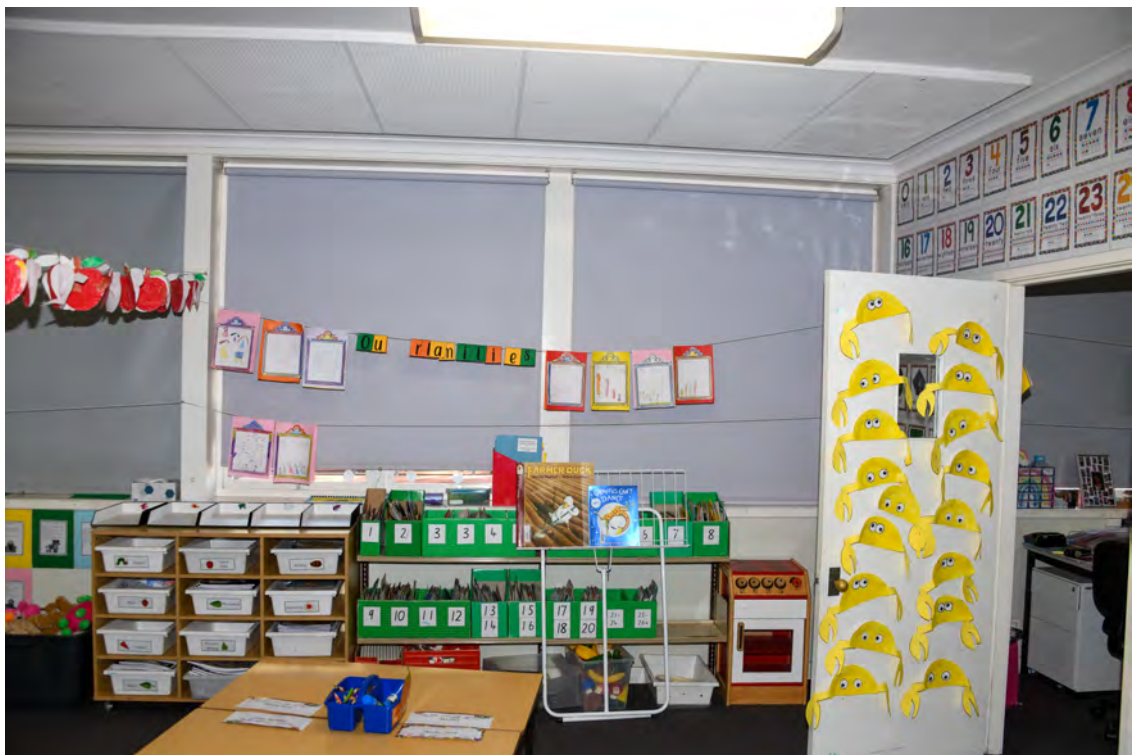
PRO\_0860.jpg

Block F. Interior. Room KA. Southern face.

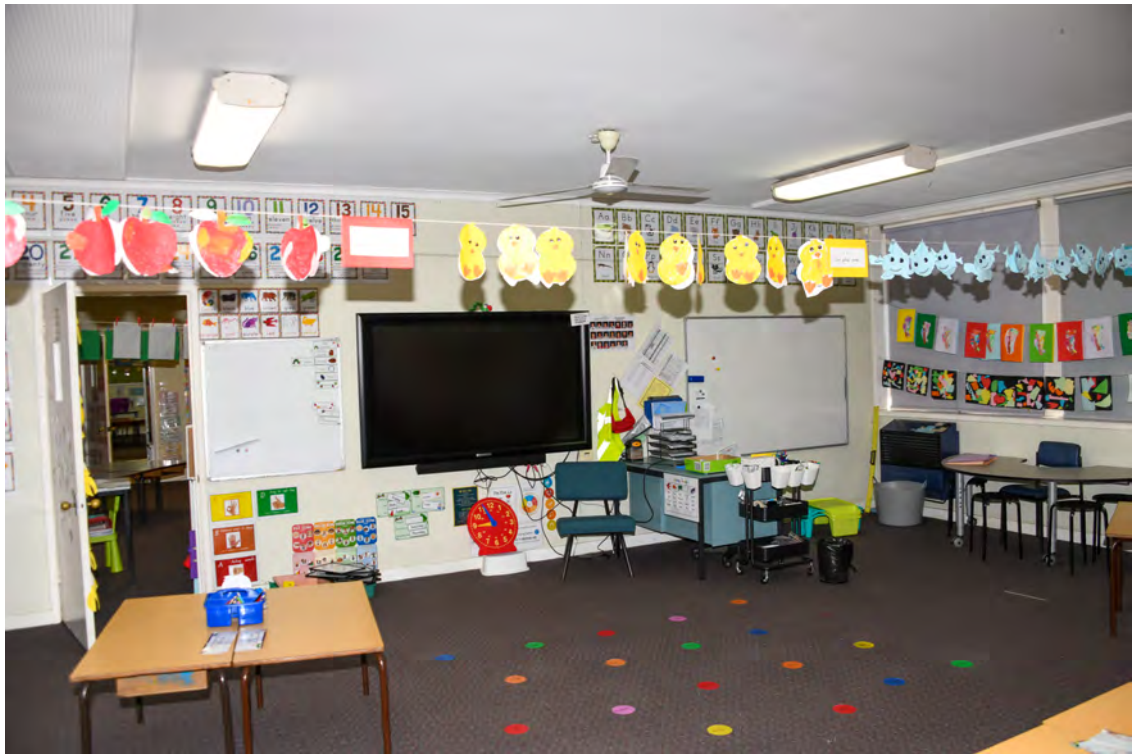
PRO\_0861.jpg

Block F. Interior. Room KA. Western face.

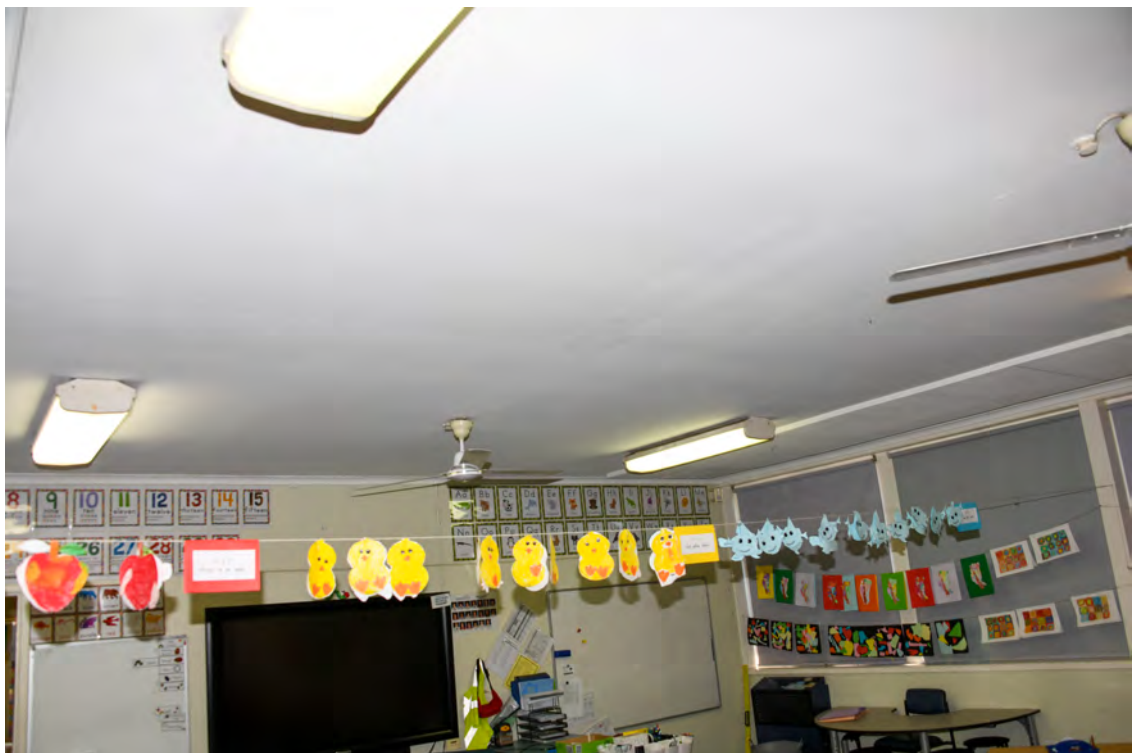
PRO\_0862.jpg

Block F. Interior. Room KA. Ceiling.

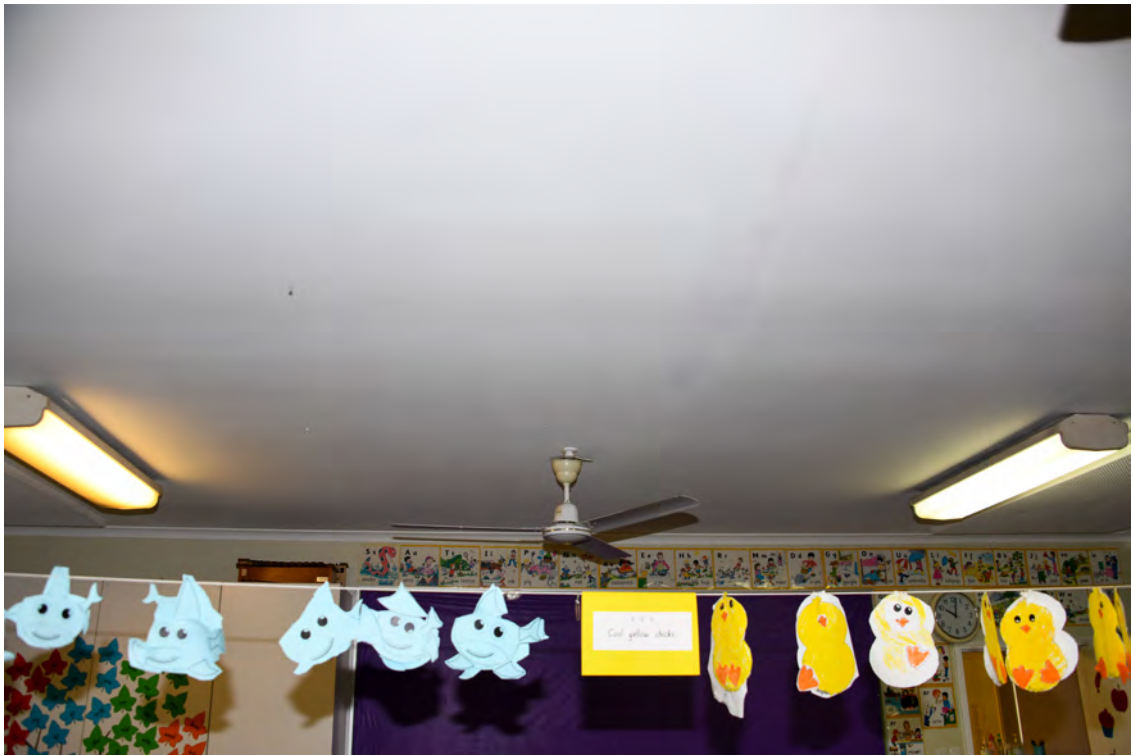
PRO\_0863.jpg

Block F. Interior. Room KA. Ceiling.

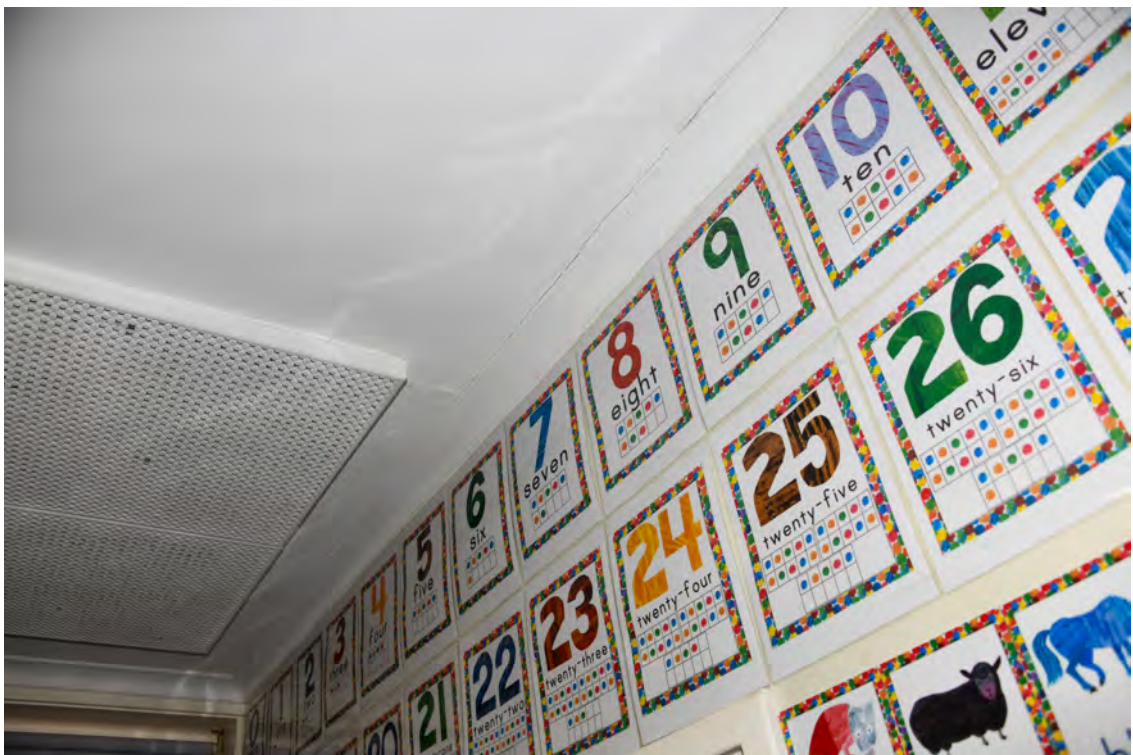
PRO\_0864.jpg

Block F. Interior. Room KA. Ceiling.

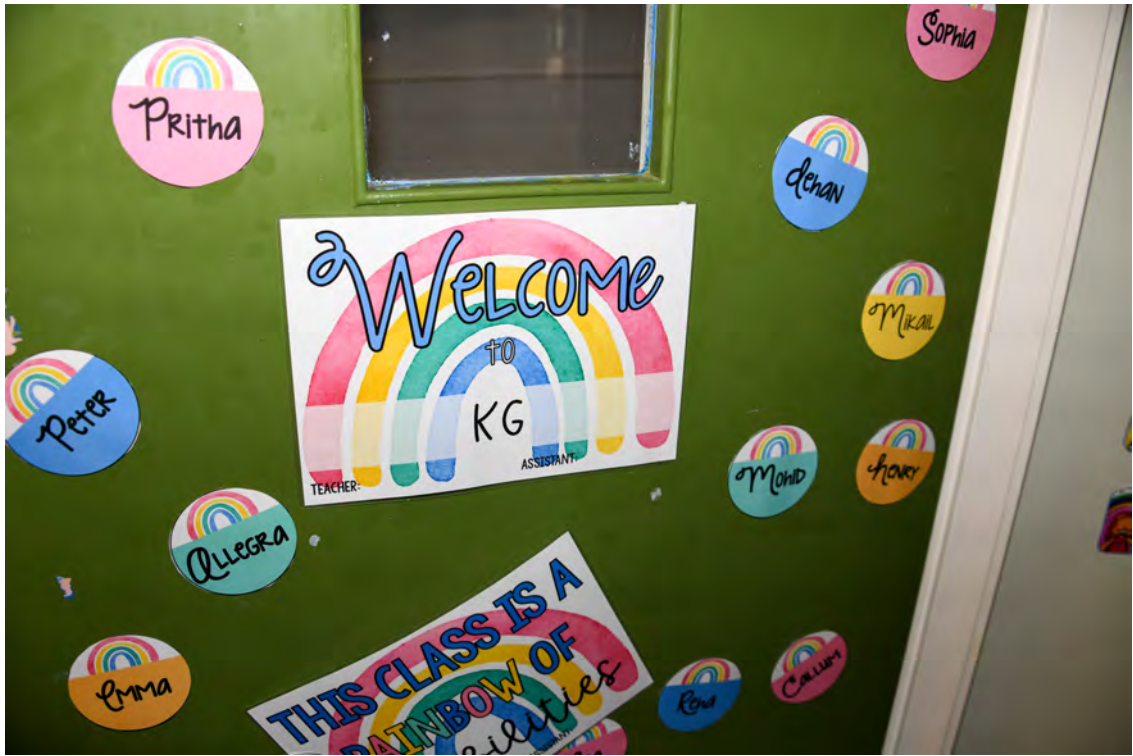
PRO\_0865.jpg

Block F. Interior. Room KG.
