96-104 Carlingford Road, Epping NSW 2121

Epping West Public School

DILAPIDATION REPORT

7<sup>th</sup> September 2021

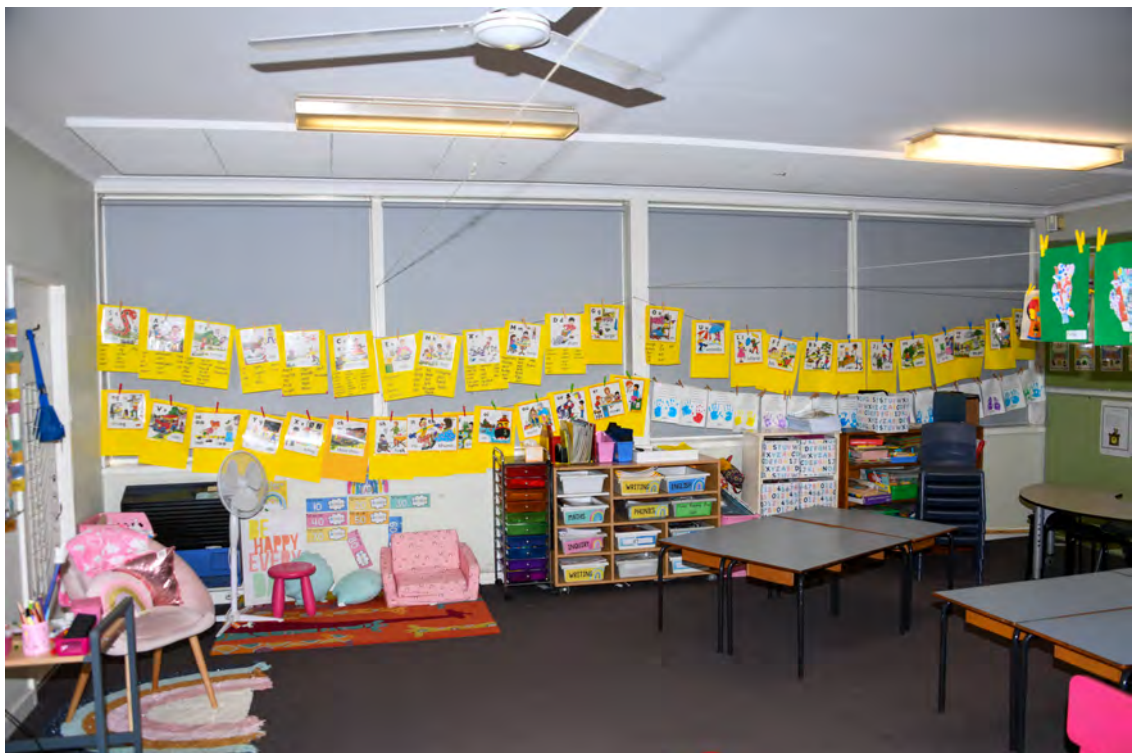
PRO\_0866.jpg

Block F. Interior. Room KG. Northern face.

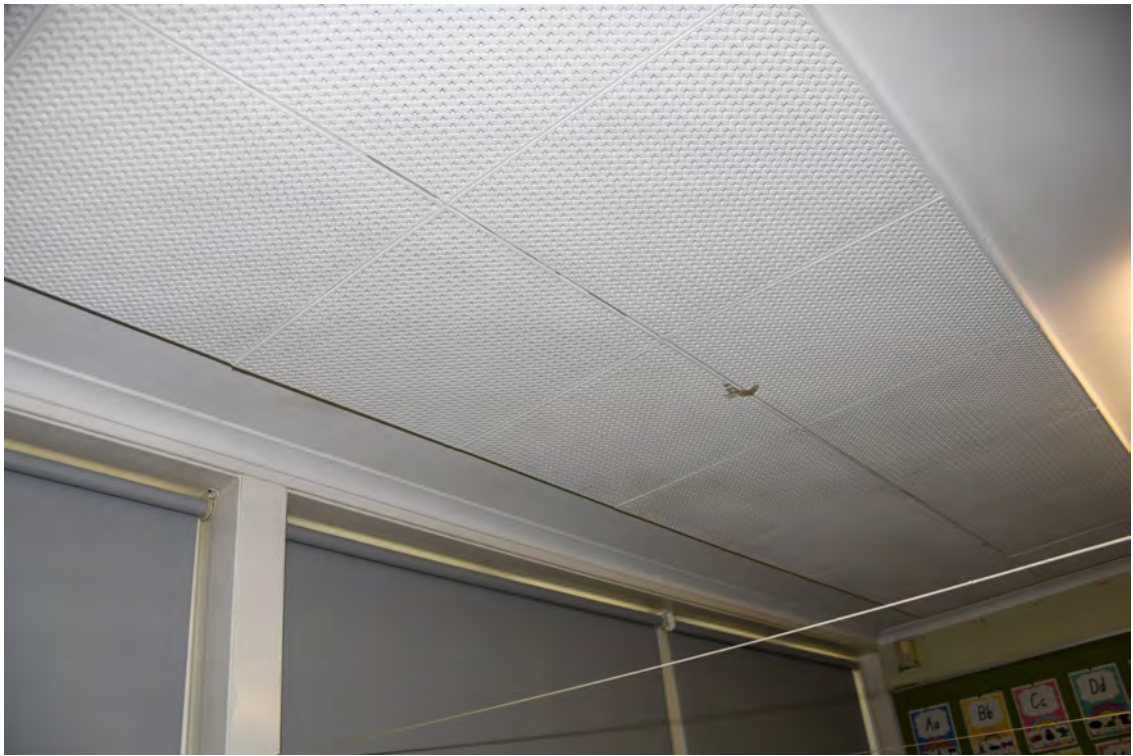
PRO\_0867.jpg

Block F. Interior. Room KG. Northern end of the ceiling.

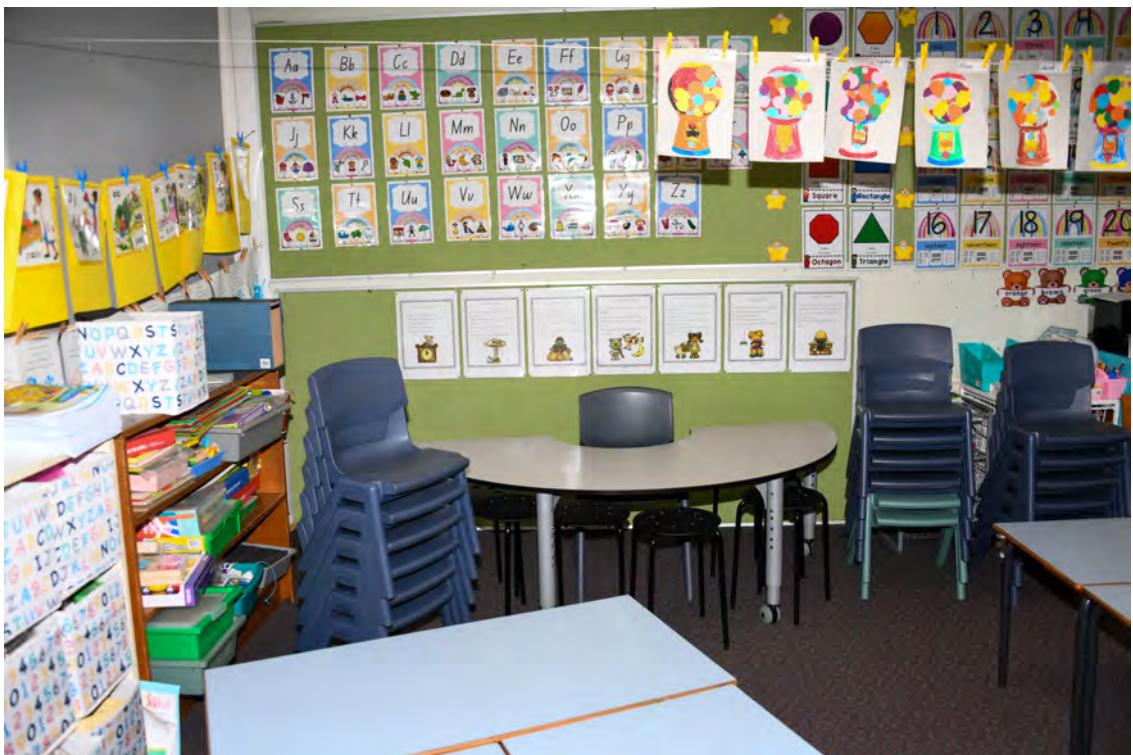
PRO\_0868.jpg

Block F. Interior. Room KG. Northern end of the eastern face.

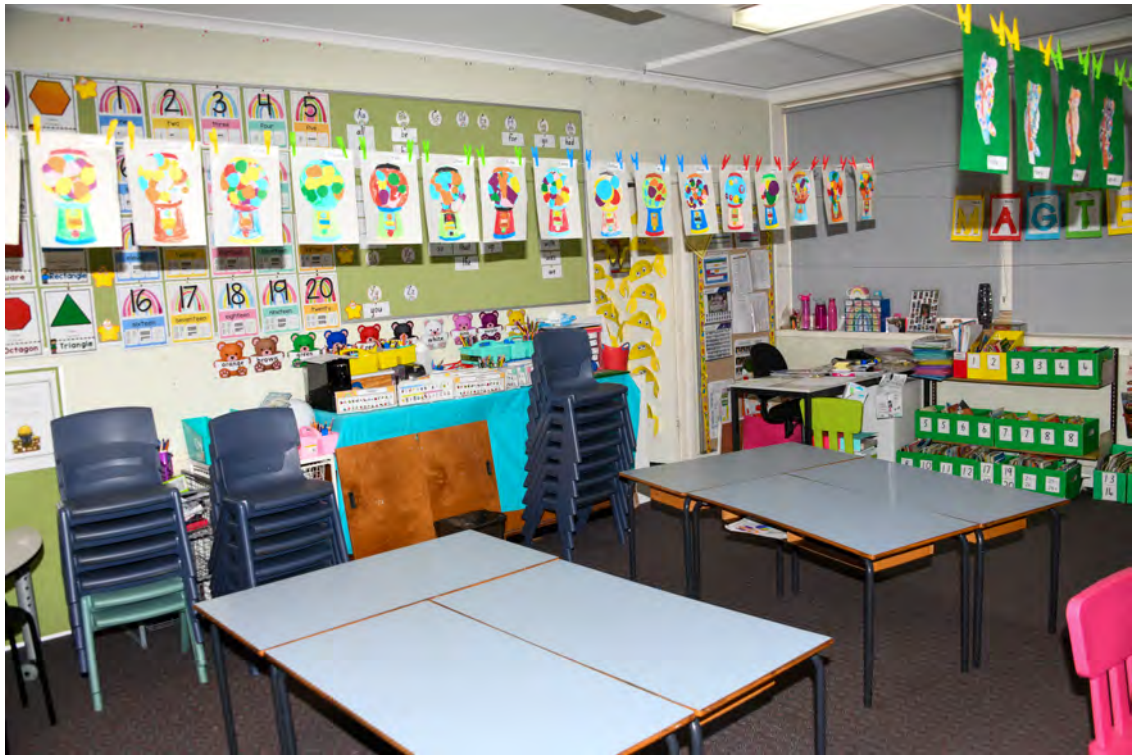
PRO\_0869.jpg

Block F. Interior. Room KG. Eastern face.

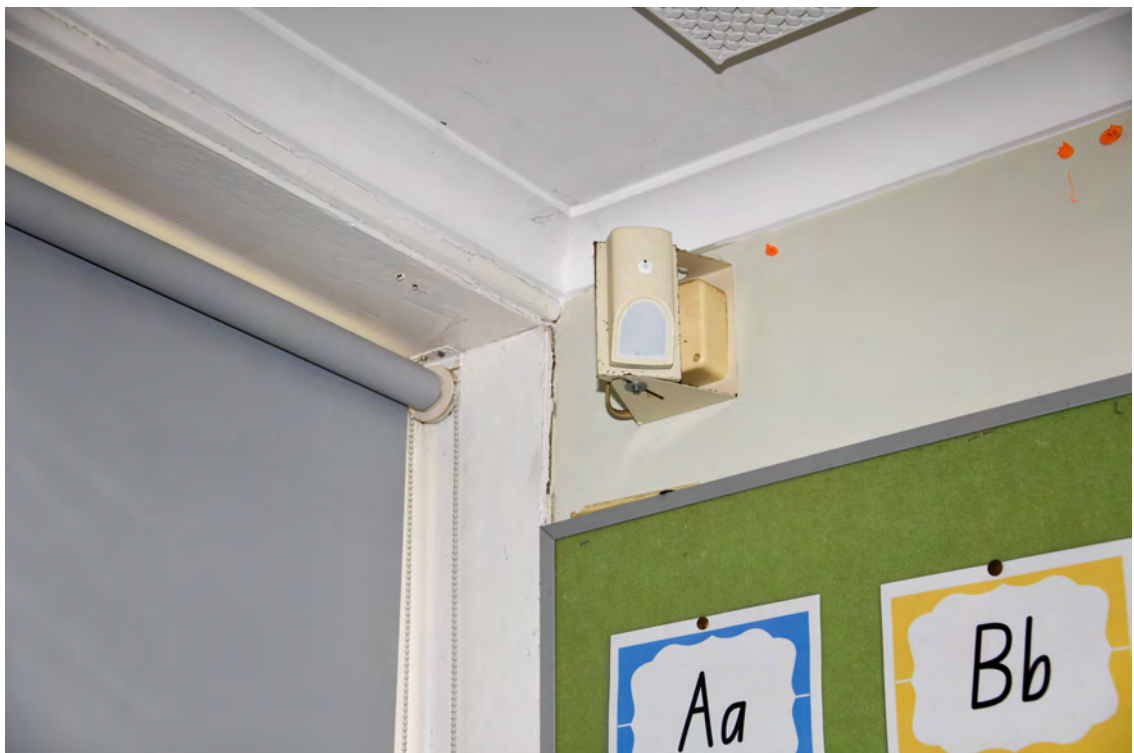
PRO\_0870.jpg

Block F. Interior. Room KG. North-eastern corner.

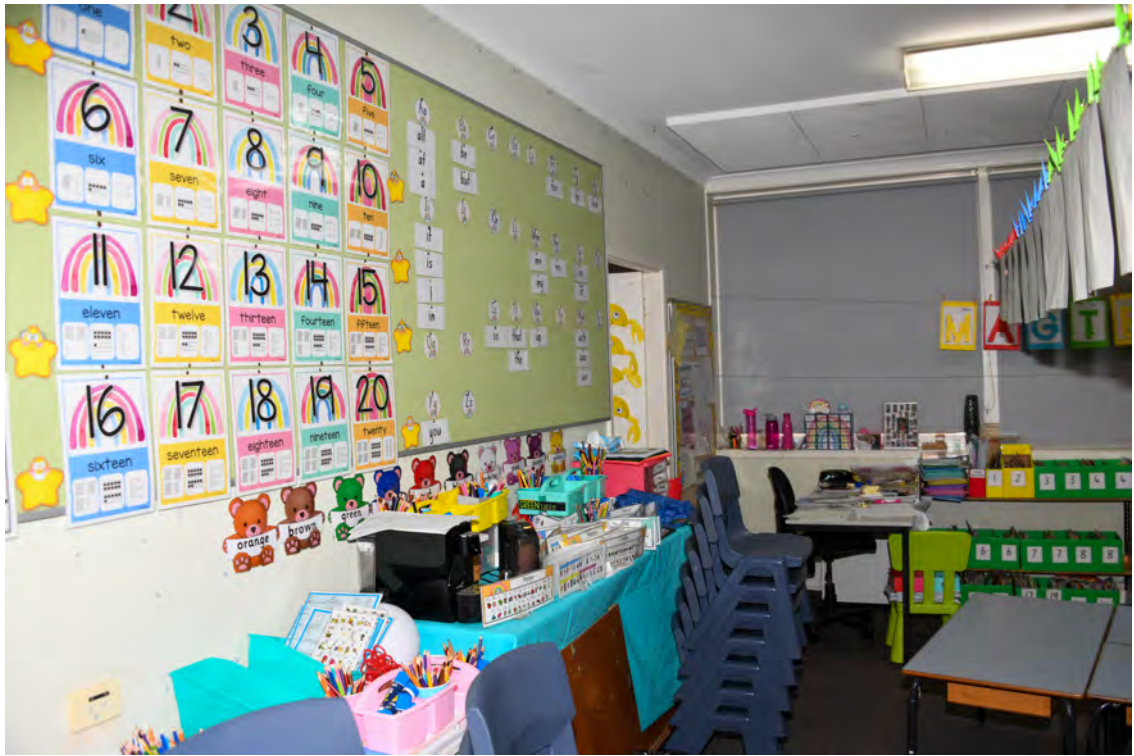
PRO\_0871.jpg

Block F. Interior. Room KG. Eastern face.

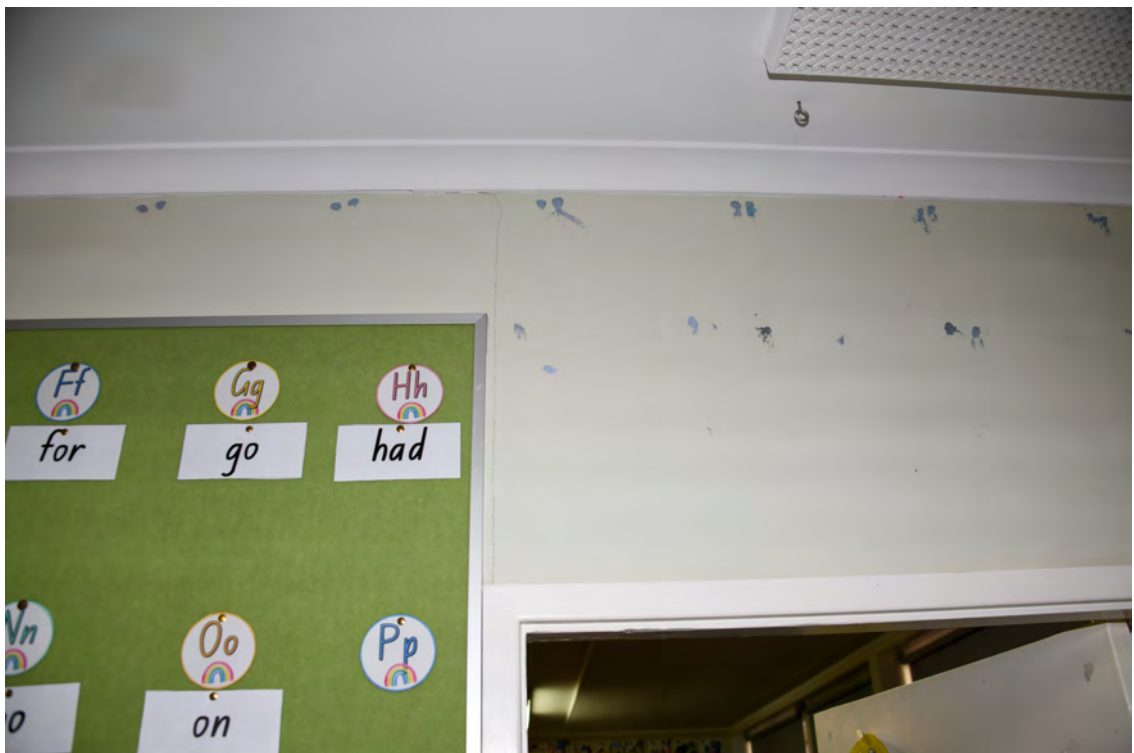
PRO\_0872.jpg

Block F. Interior. Room KG. Eastern face.

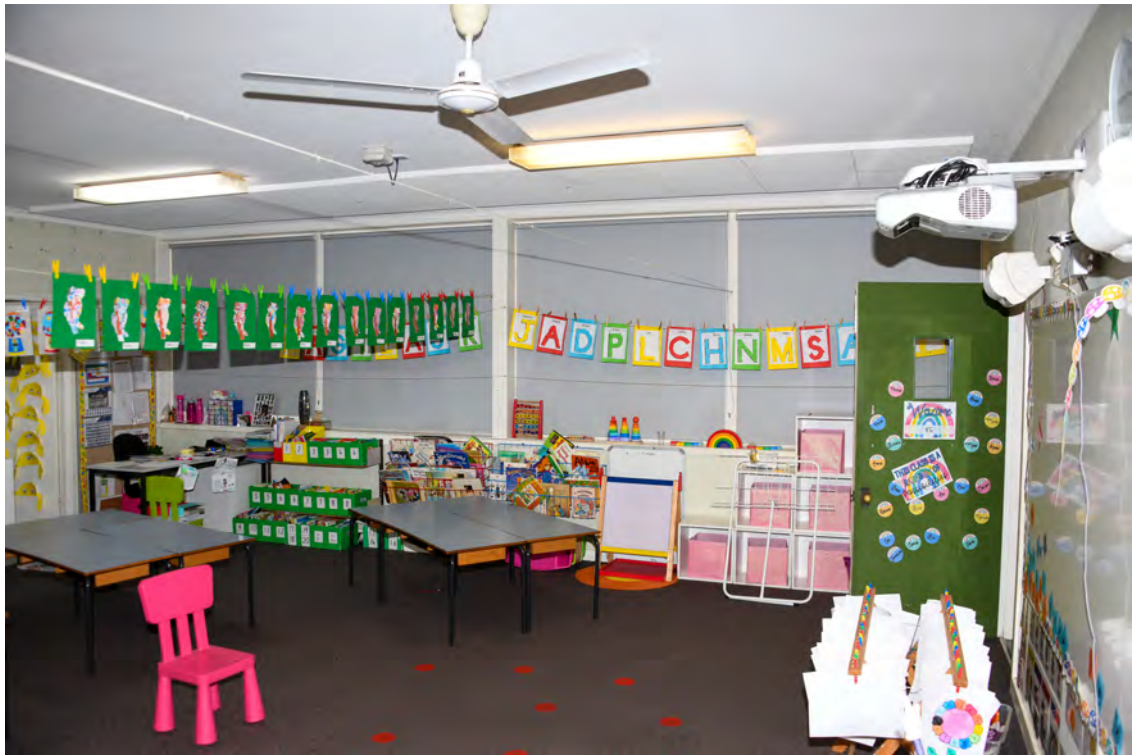
PRO\_0873.jpg

Block F. Interior. Room KG. Southern face.

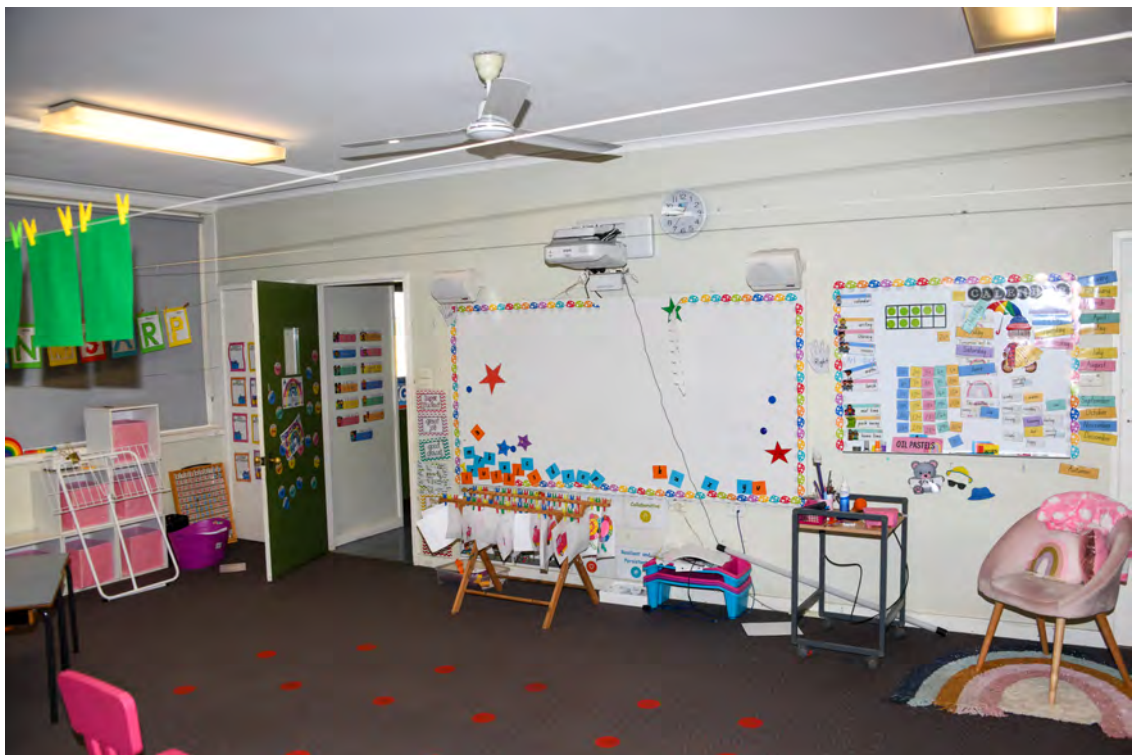
PRO\_0874.jpg

Block F. Interior. Room KG. Western face.

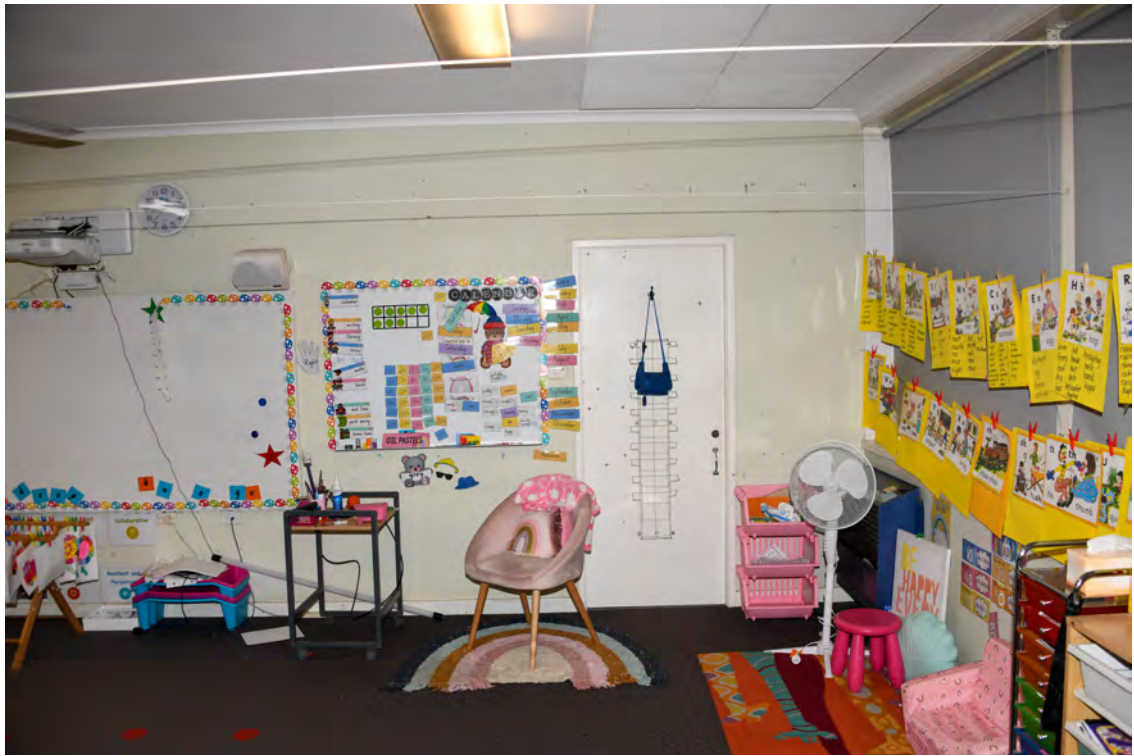
PRO\_0875.jpg

Block F. Interior. Room KG. Western face.

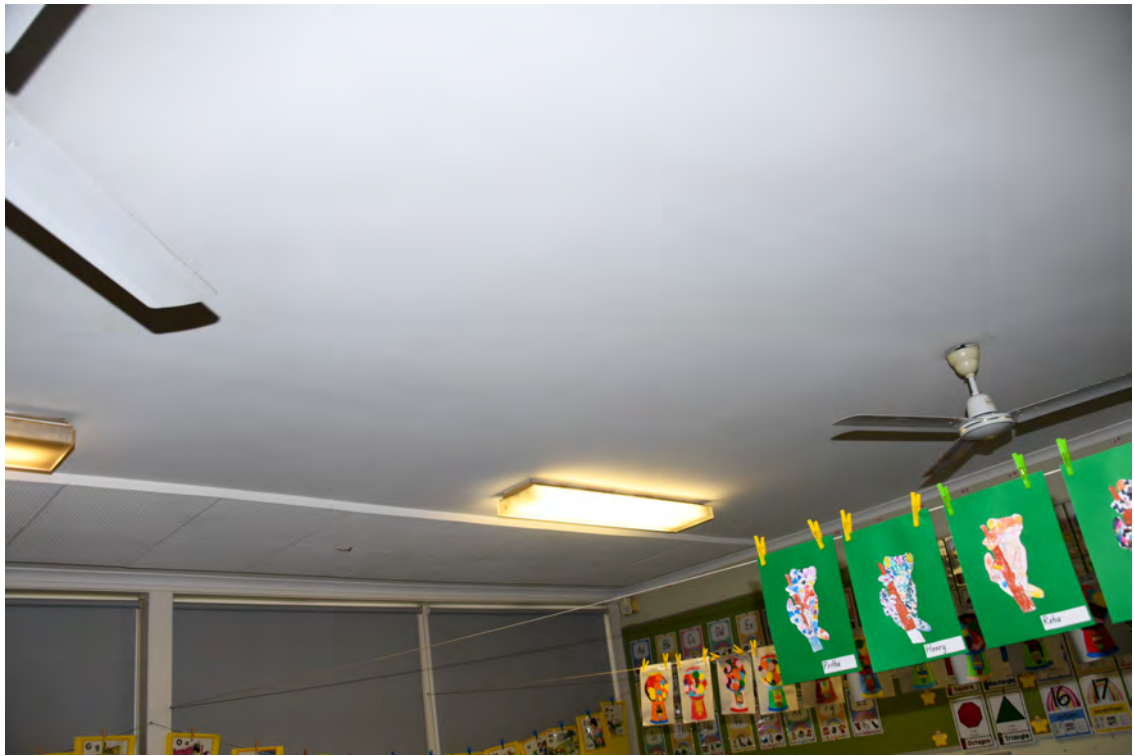
PRO\_0877.jpg

Block F. Interior. Room KG. Ceiling.

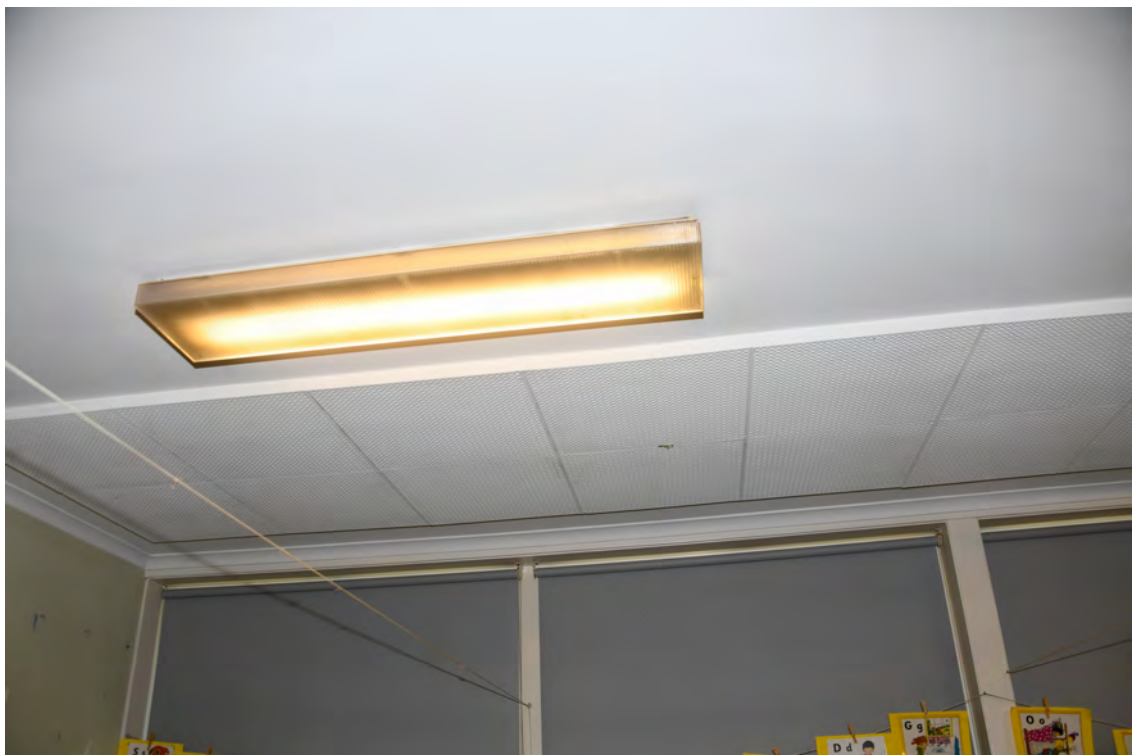
PRO\_0878.jpg

Block F. Interior. Room KG. Ceiling.

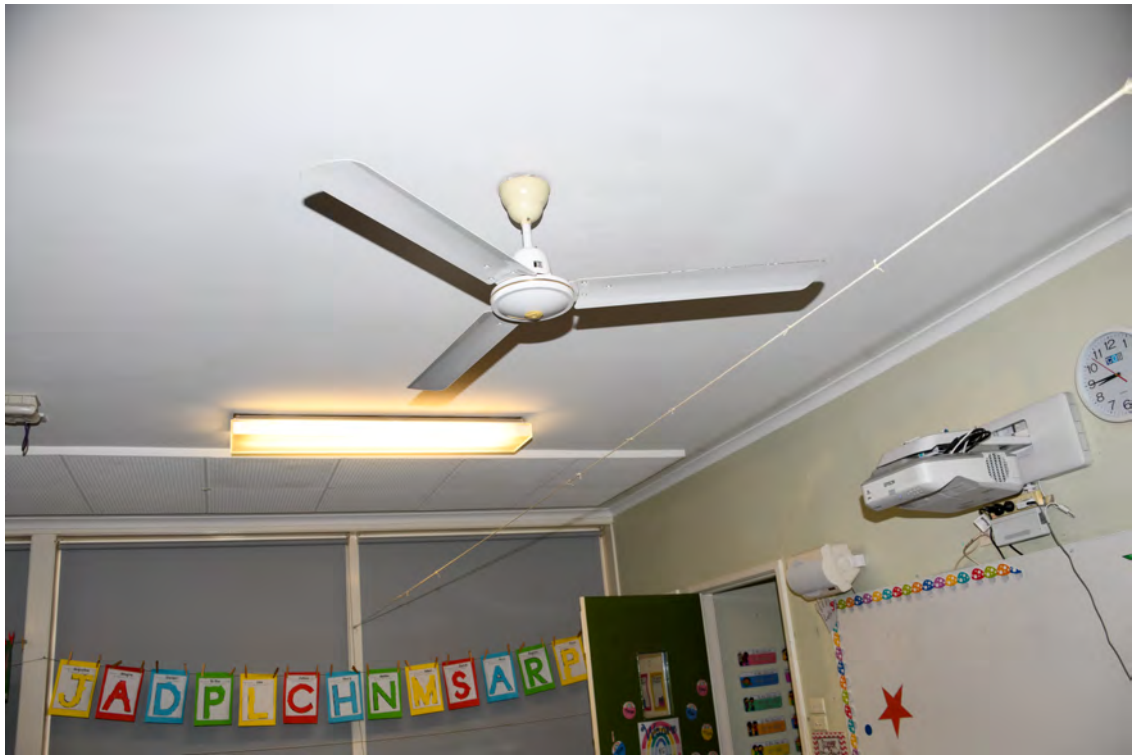
PRO\_0879.jpg

Block F. Interior. Room KG. Ceiling.

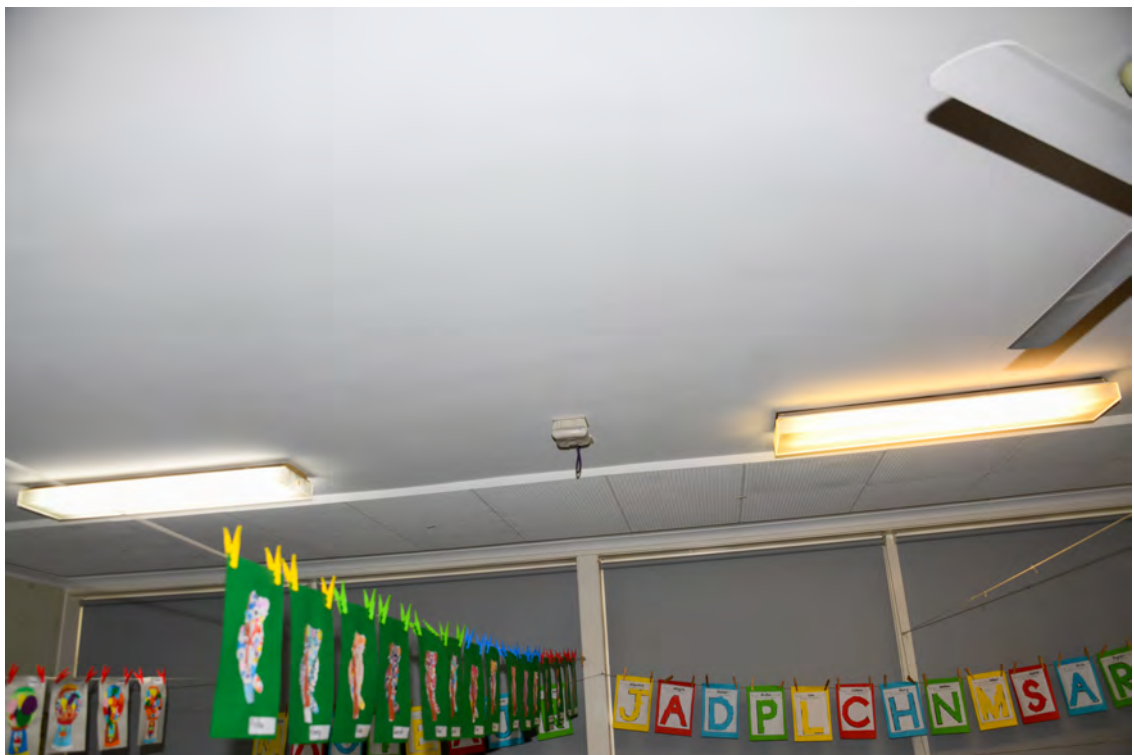
PRO\_0880.jpg

Block F. Interior. Room KG. Ceiling.

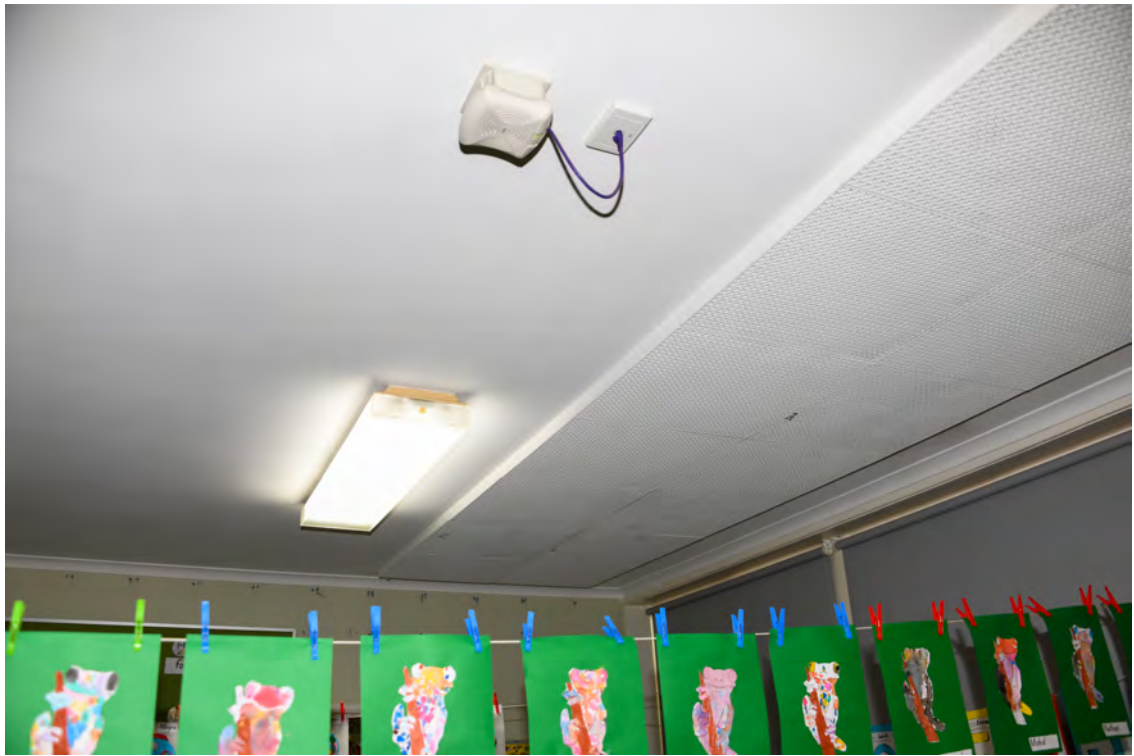
PRO\_0881.jpg

Block F. Interior. Room KG. Ceiling.

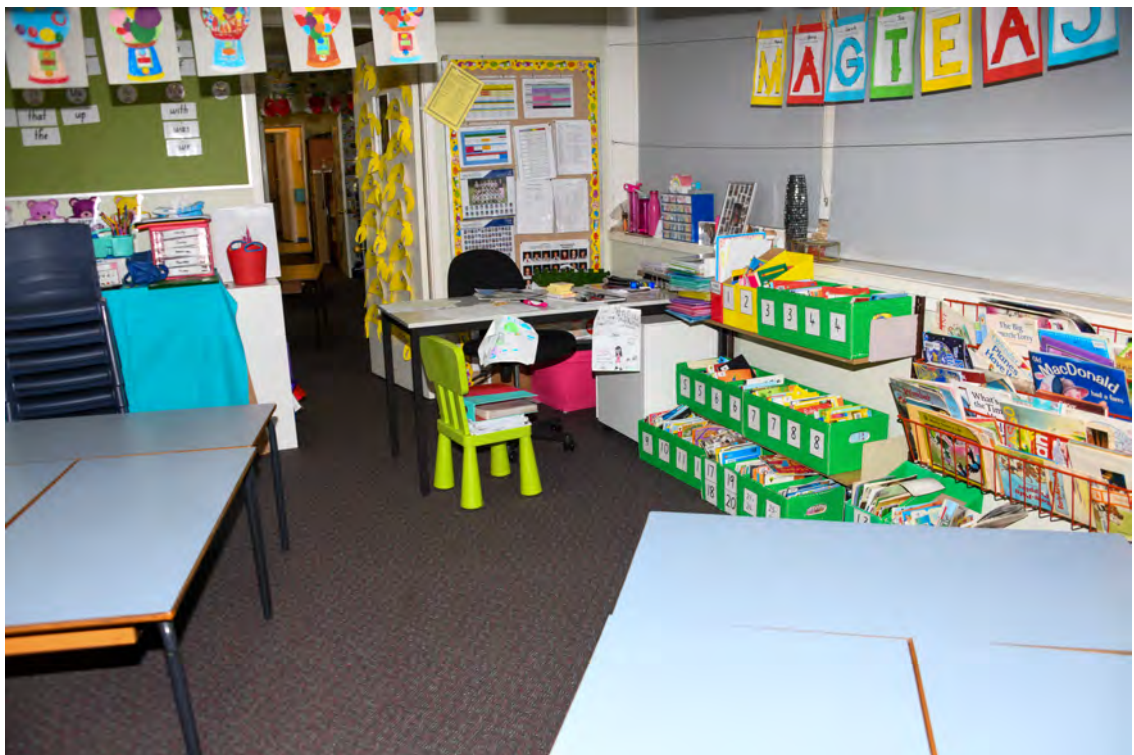
PRO\_0882.jpg

Block F. Interior. Room KG. General overview of the room.

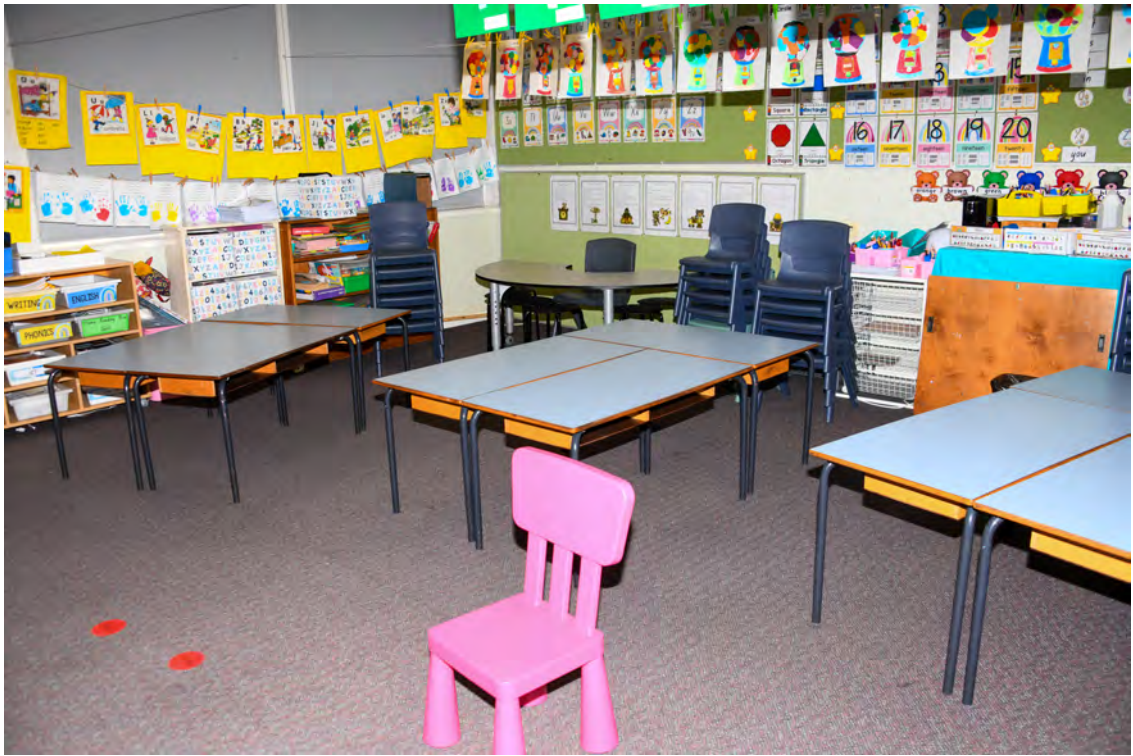
PRO\_0883.jpg

Block F. Interior. Room KG. General overview of the room.

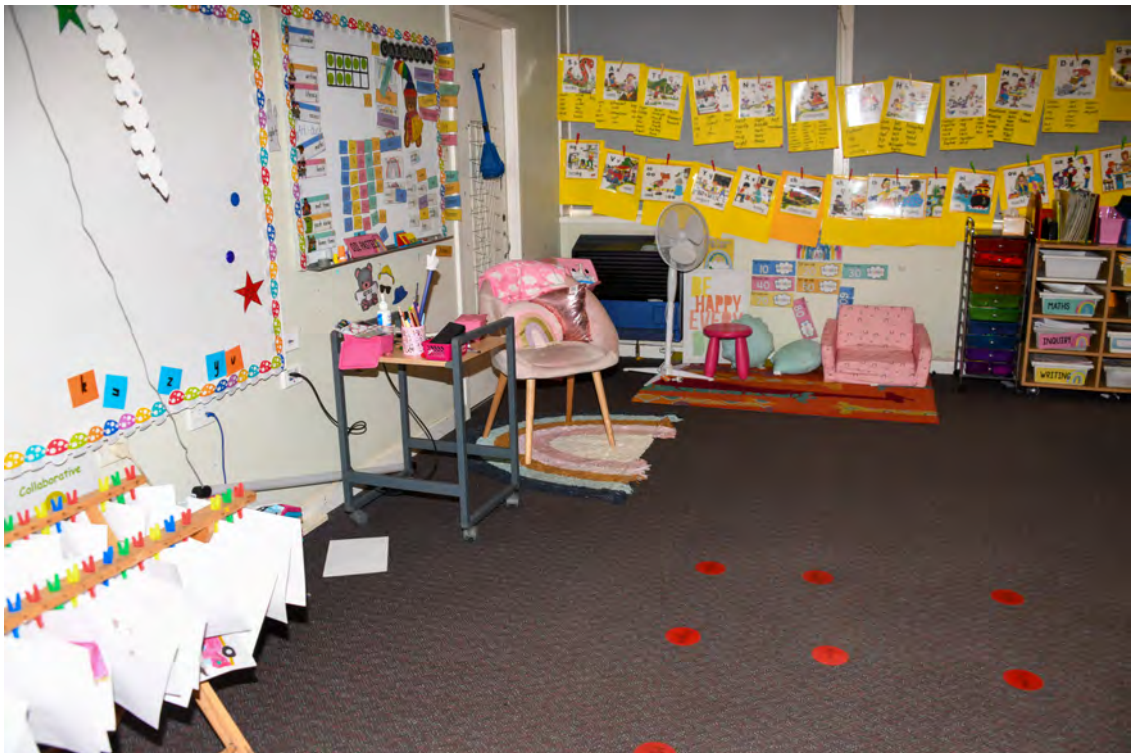
PRO\_0884.jpg

Block F. Interior. Room KG. General overview of the room.

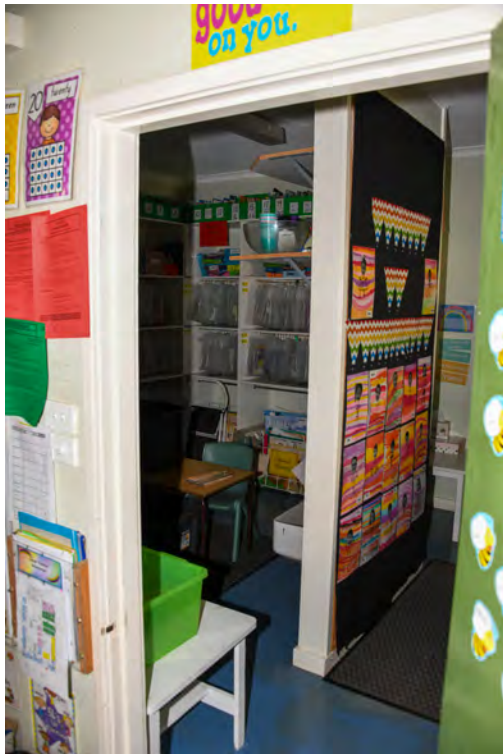
PRO\_0885.jpg

Block F. Interior. Foyer. Northern face.

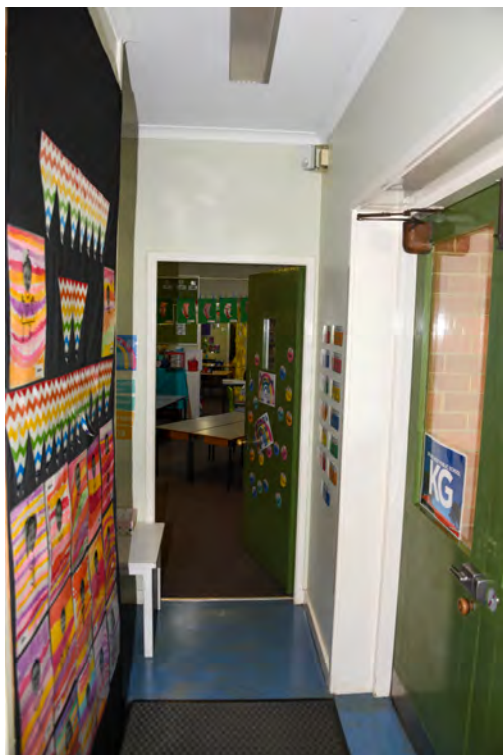
PRO\_0886.jpg

Block F. Interior. Foyer. Eastern face.

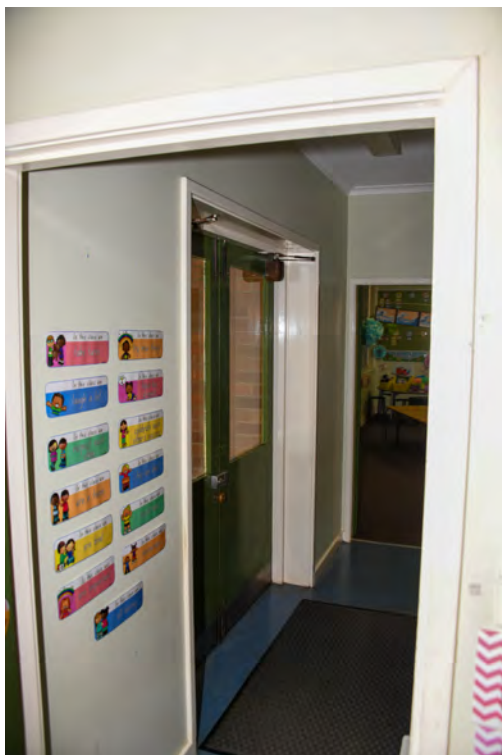
PRO\_0888.jpg

Block F. Interior. Foyer. Southern face.

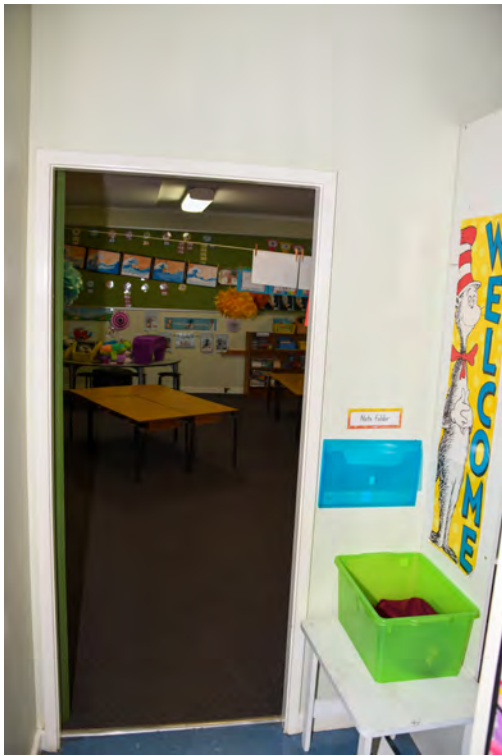
PRO\_0889.jpg

Block F. Interior. Foyer. Western face.

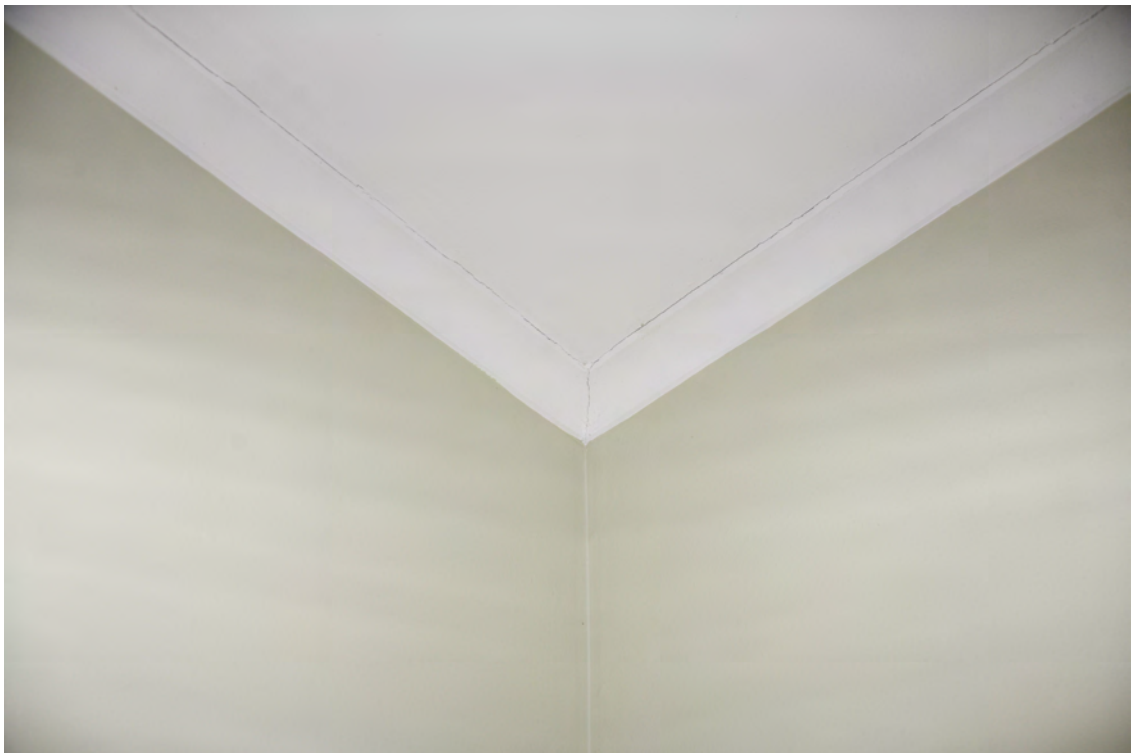
PRO\_0890.jpg

Block F. Interior. Foyer. Western face. Movement to the cornice.

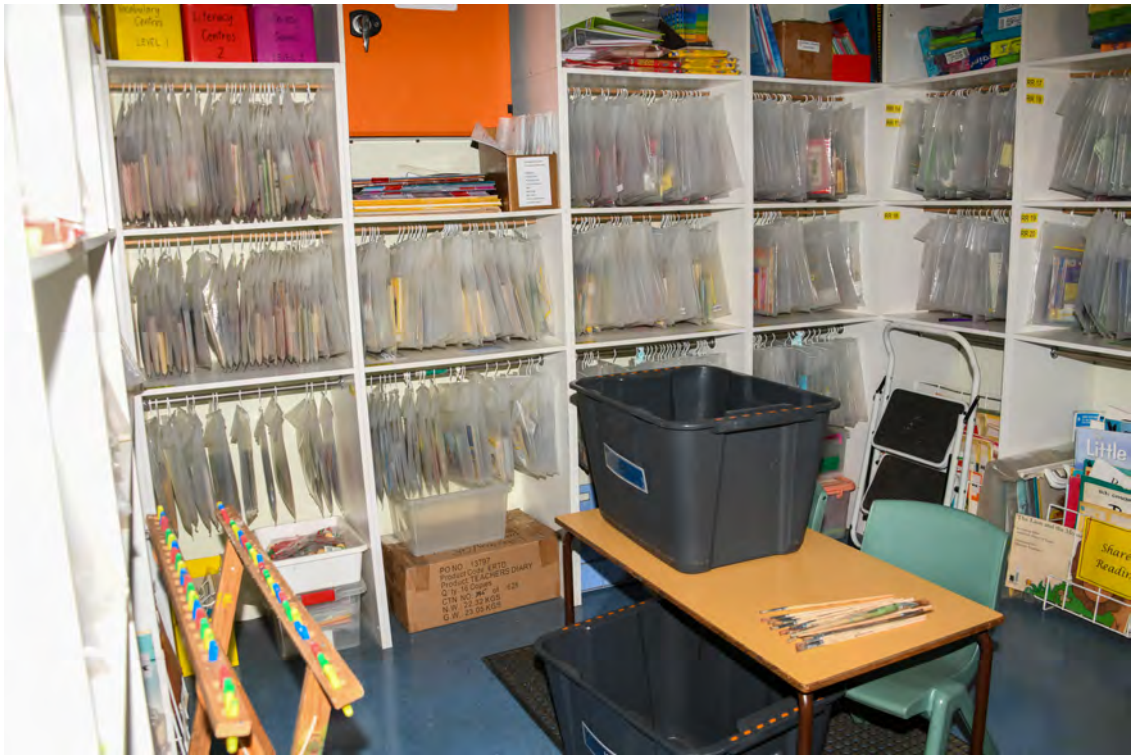
PRO\_0891.jpg

Block F. Interior. Foyer. Storeroom.

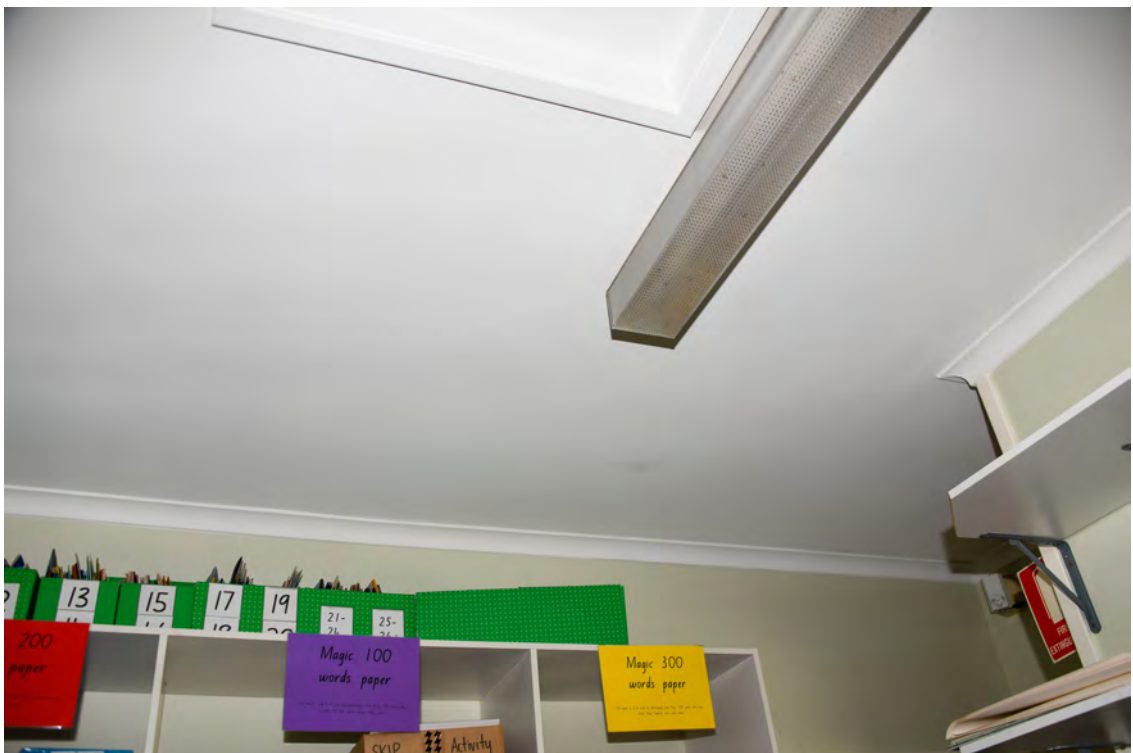
PRO\_0892.jpg

Block F. Interior. Foyer. Storeroom. Ceiling.

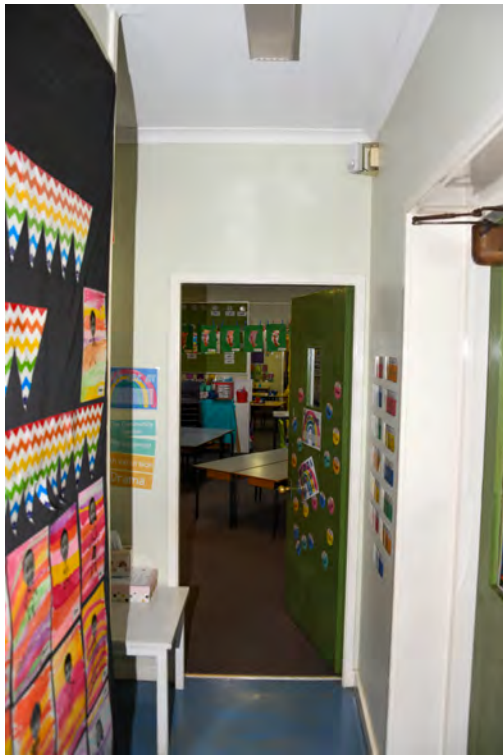
PRO\_0893.jpg

Block F. Interior. Foyer. Western face.

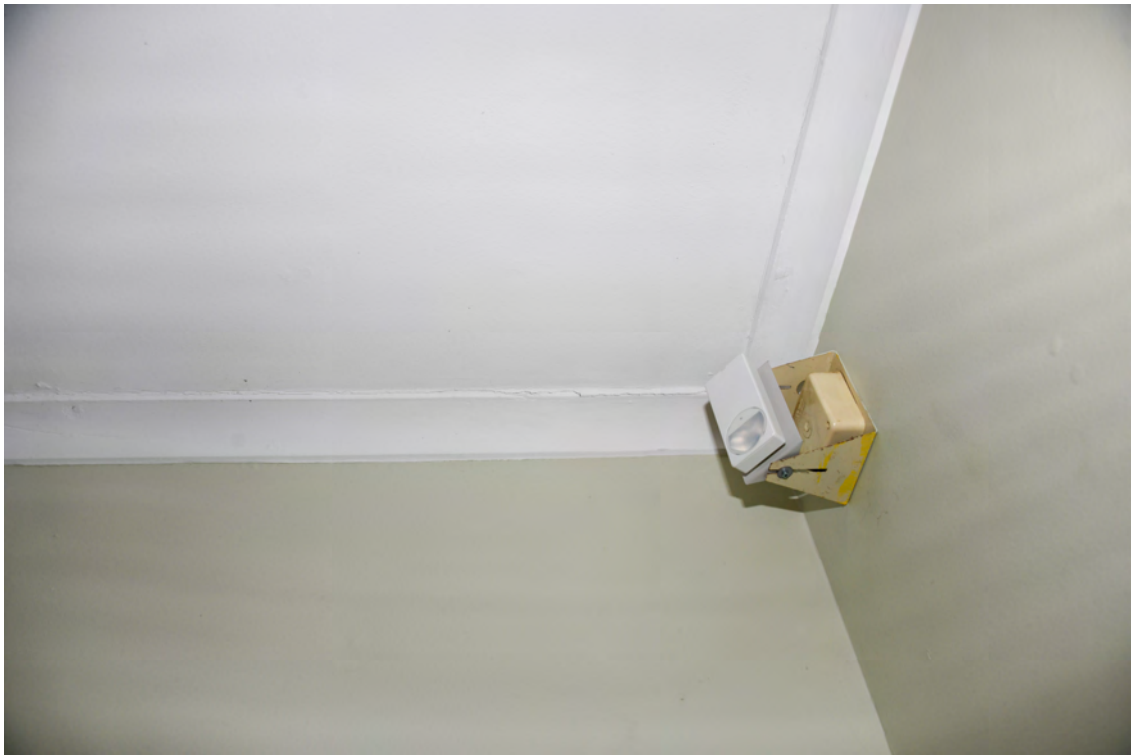
PRO\_0895.jpg

Block F. Interior. Foyer. Western face. Movement to the cornice.

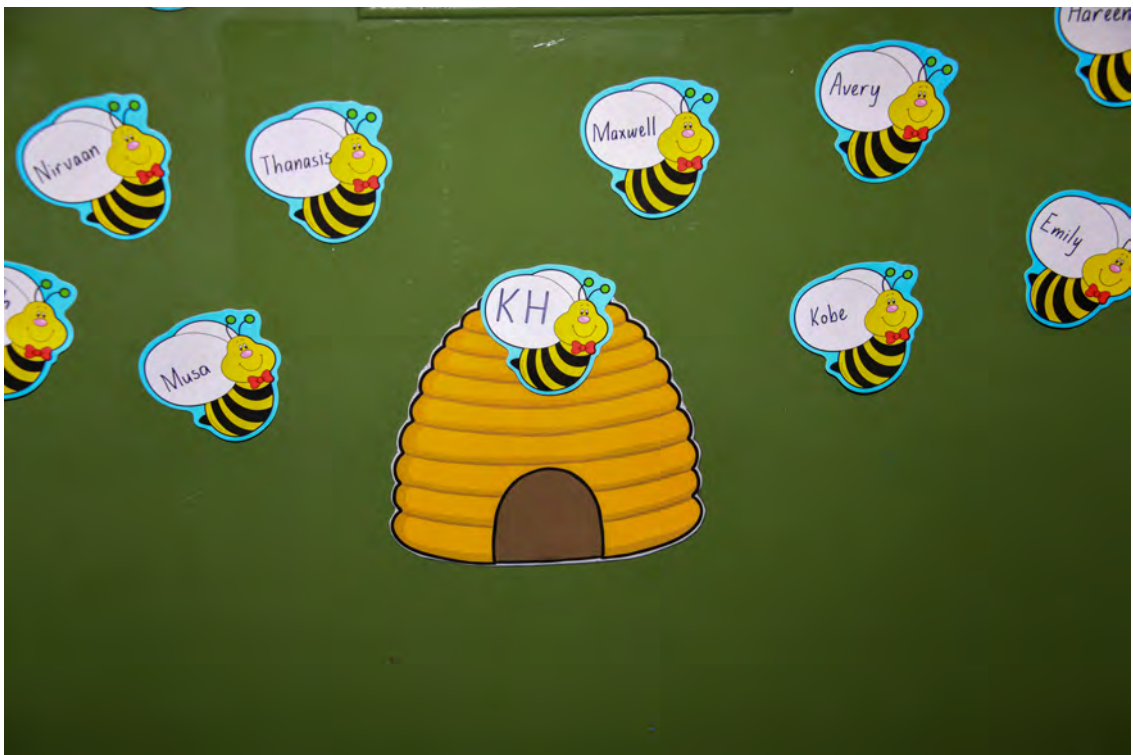
PRO\_0896.jpg

Block F. Interior. Room KH.

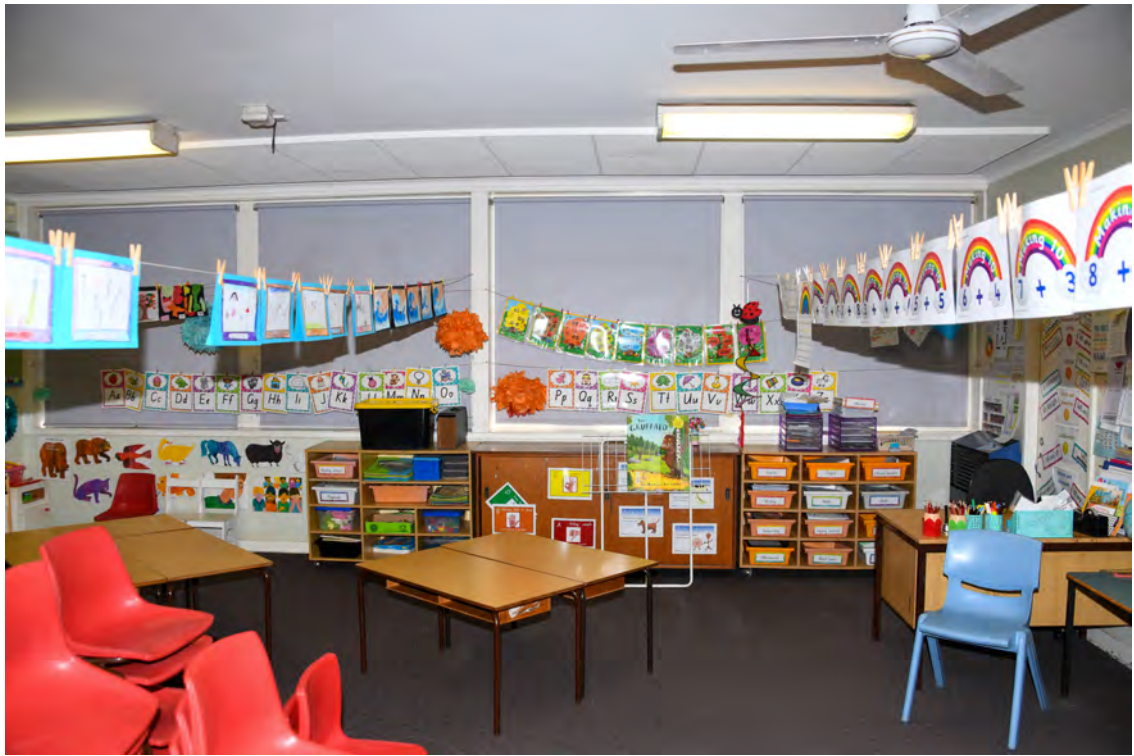
PRO\_0897.jpg

Block F. Interior. Room KH. Northern face.
