96-104 Carlingford Road, Epping NSW 2121

Epping West Public School

DILAPIDATION REPORT

7<sup>th</sup> September 2021

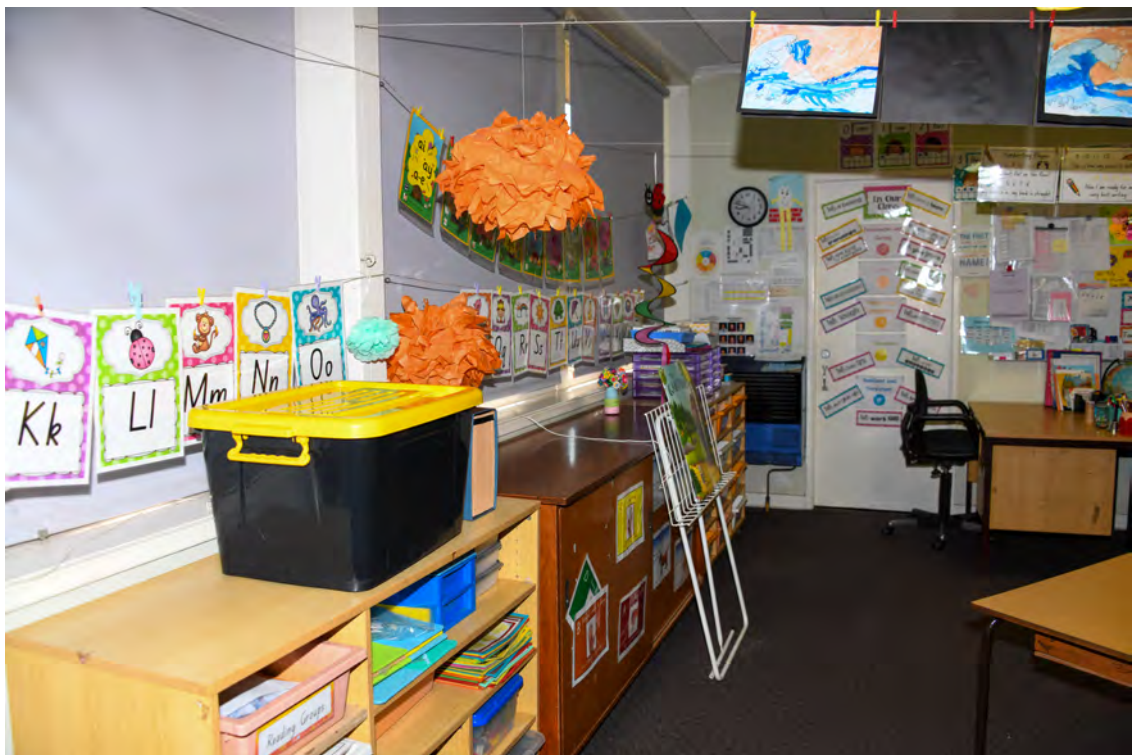
PRO\_0898.jpg

Block F. Interior. Room KH. Northern face.

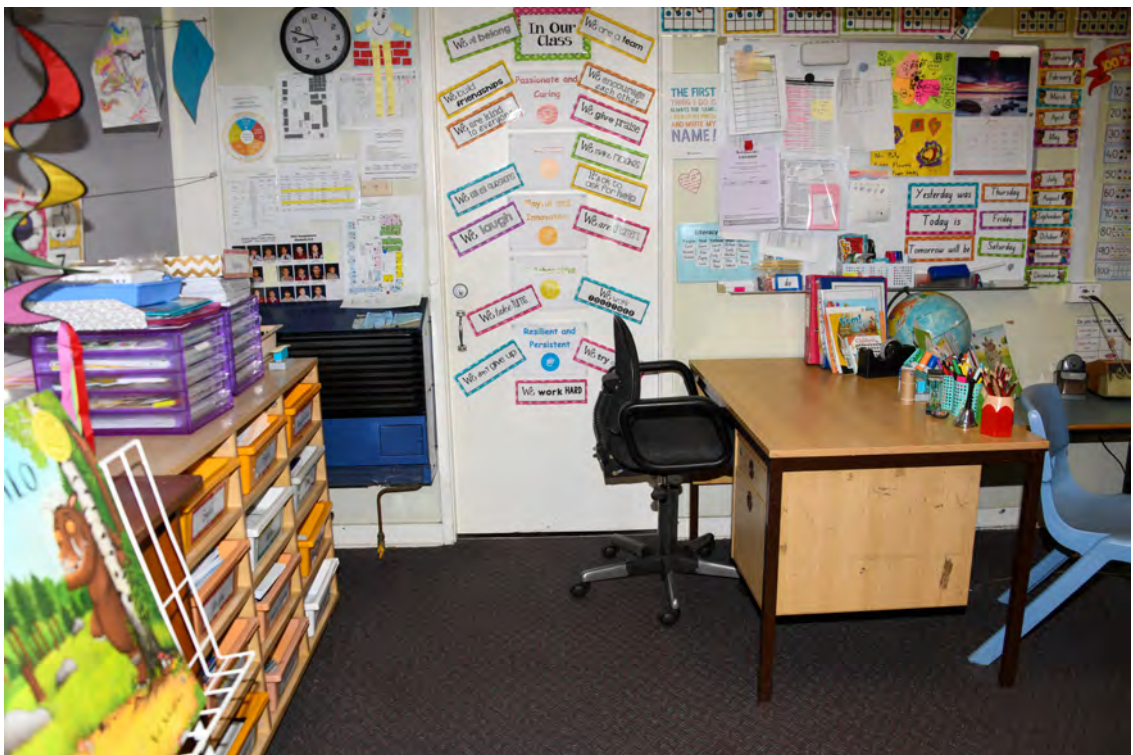
PRO\_0900.jpg

Block F. Interior. Room KH. Northern end of the eastern face.

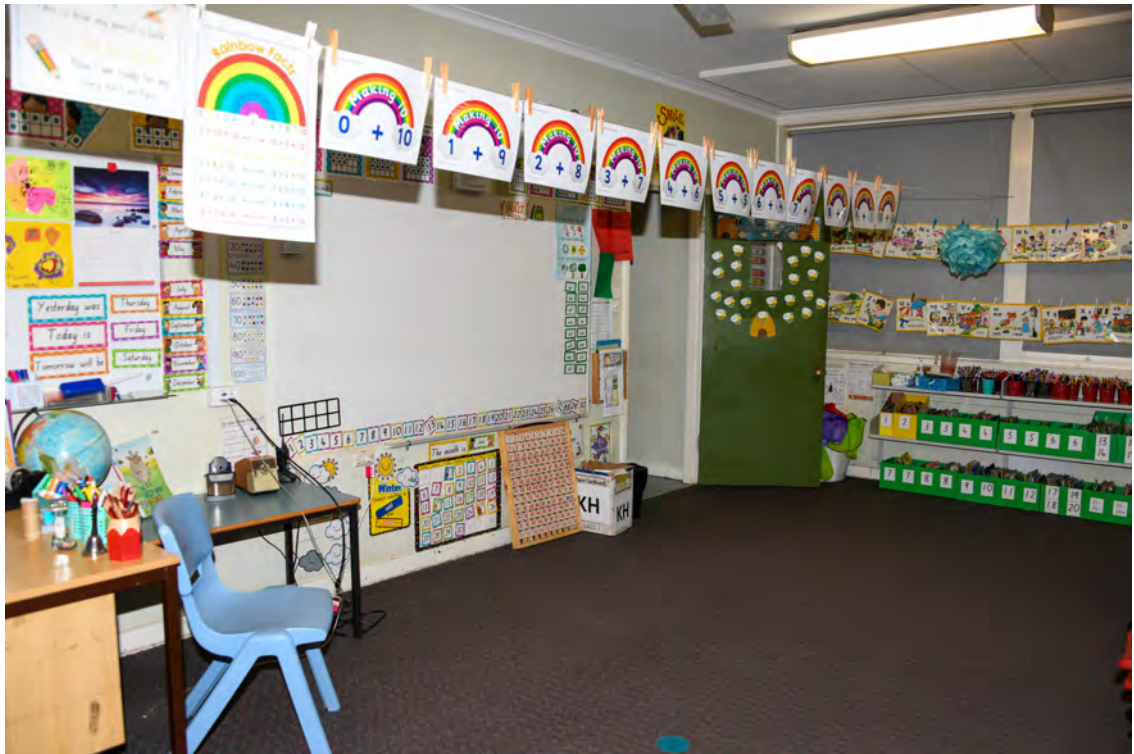
PRO\_0901.jpg

Block F. Interior. Room KH. Southern end of the eastern face.

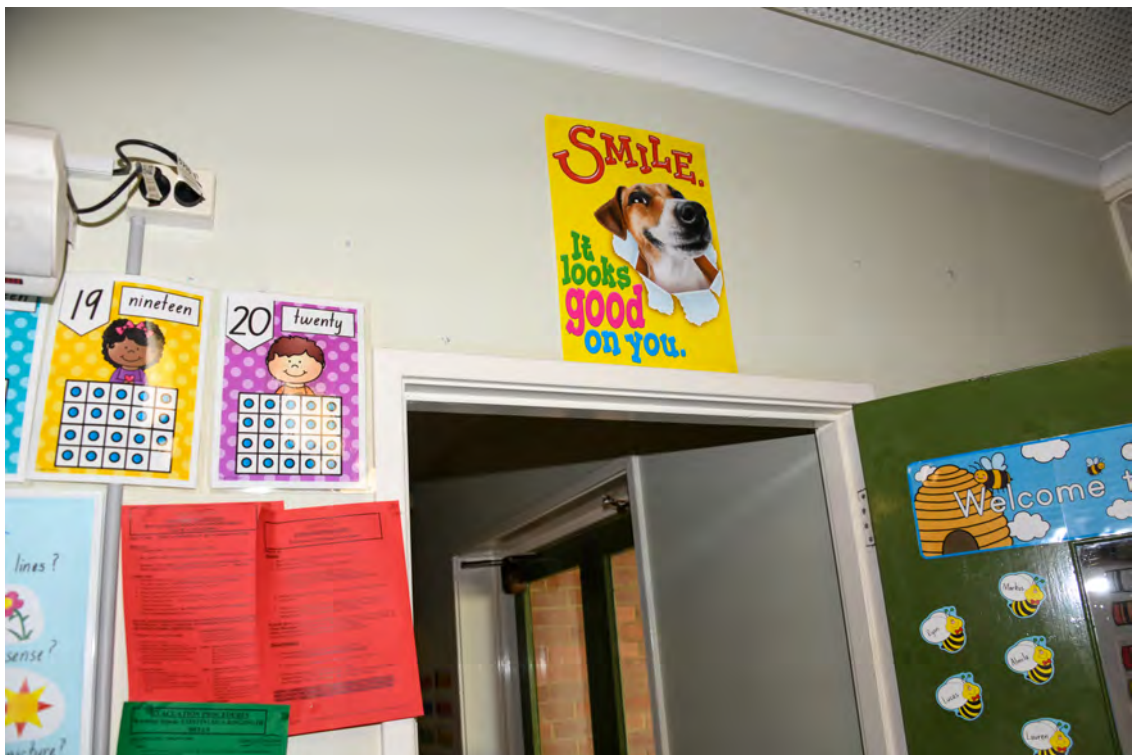
PRO\_0902.jpg

Block F. Interior. Room KH. Southern end of the eastern face.

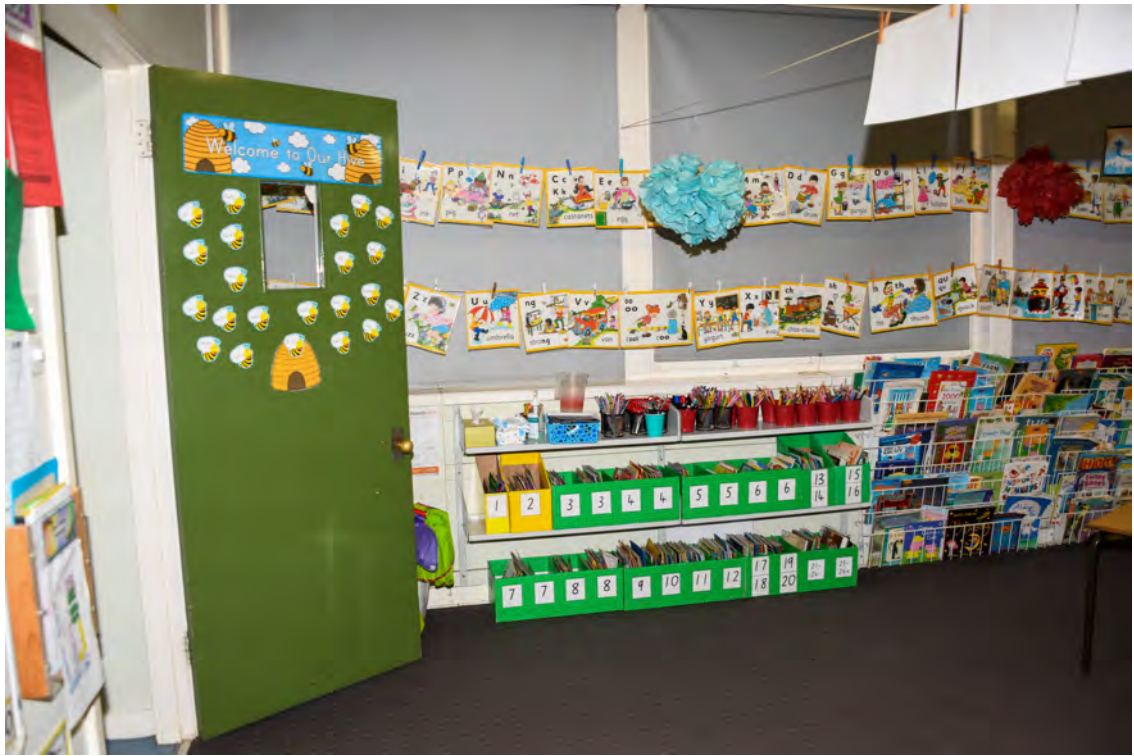
PRO\_0903.jpg

Block F. Interior. Room KH. Southern face.

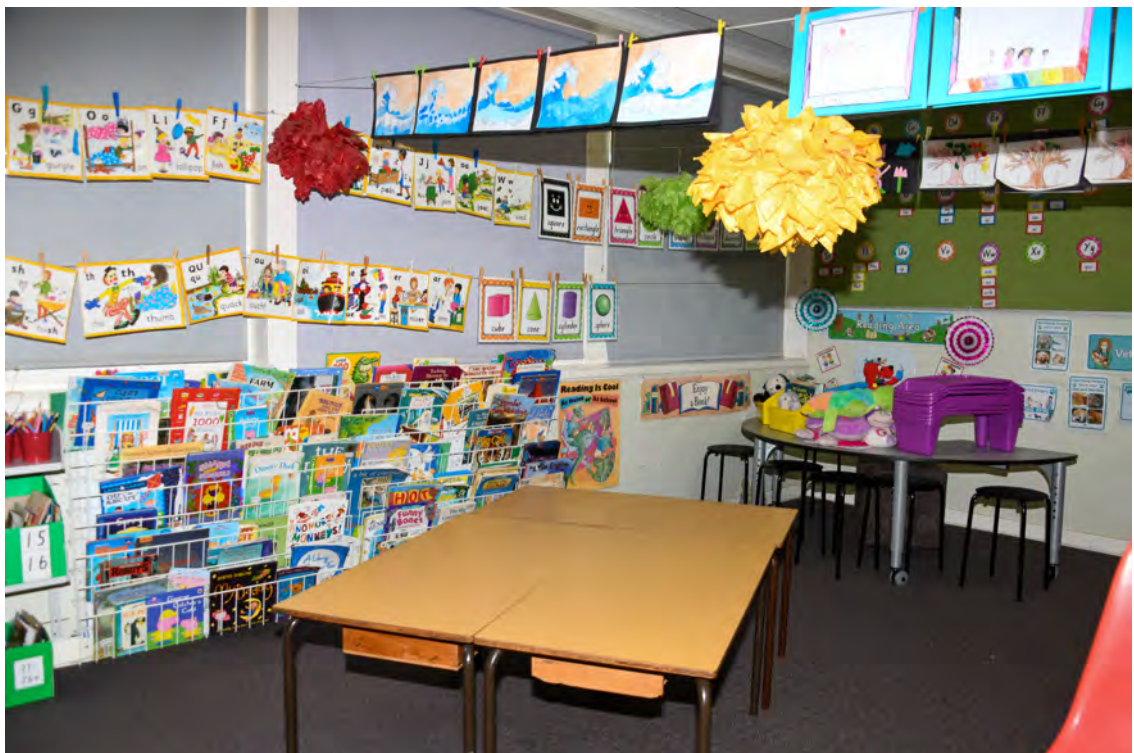
PRO\_0904.jpg

Block F. Interior. Room KH. Southern face.

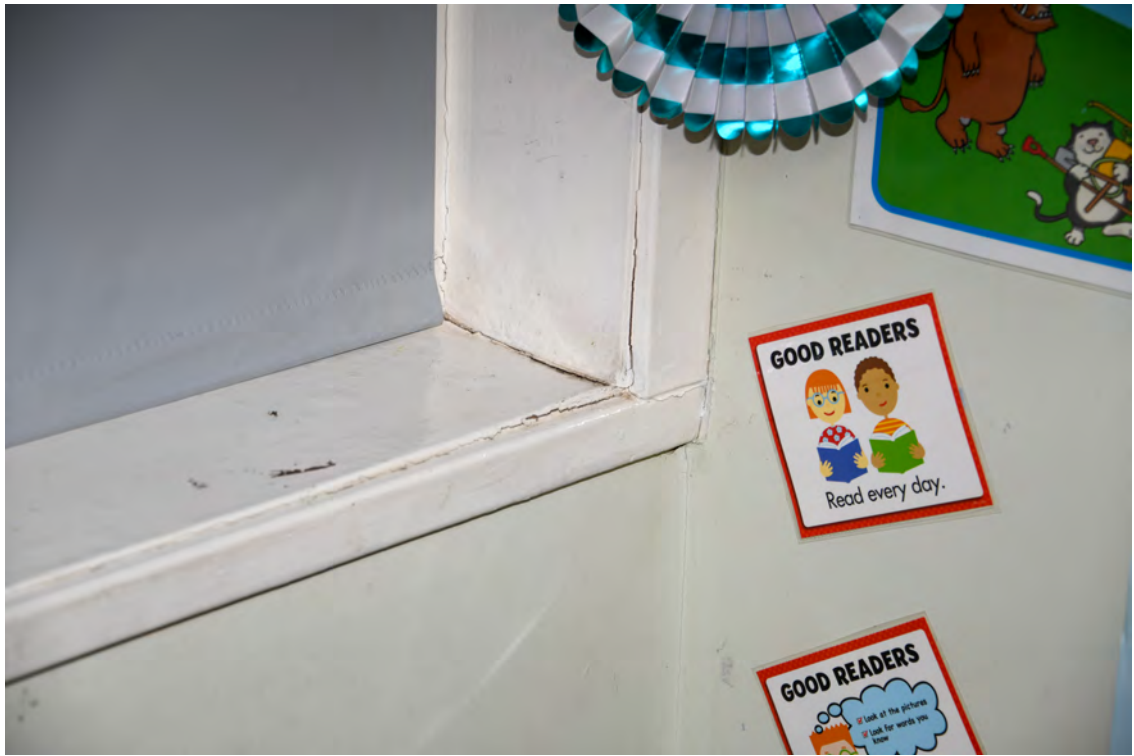
PRO\_0905.jpg

Block F. Interior. Room KH. South-western corner.

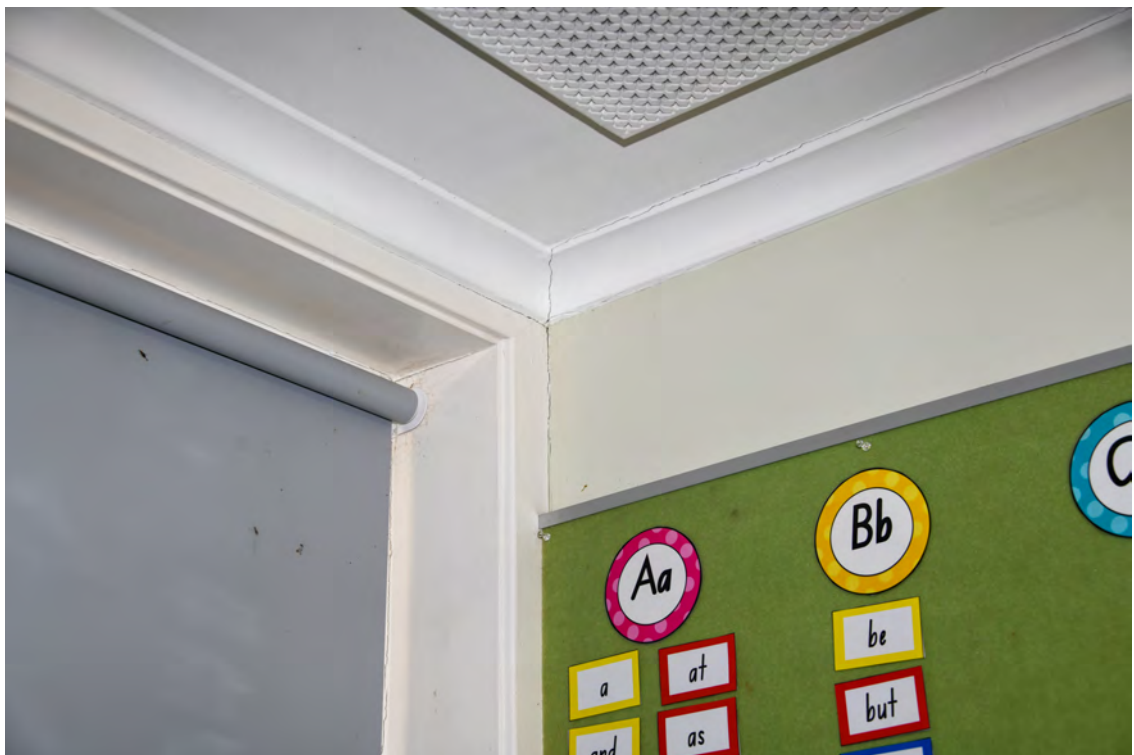
PRO\_0906.jpg

Block F. Interior. Room KH. South-western corner.

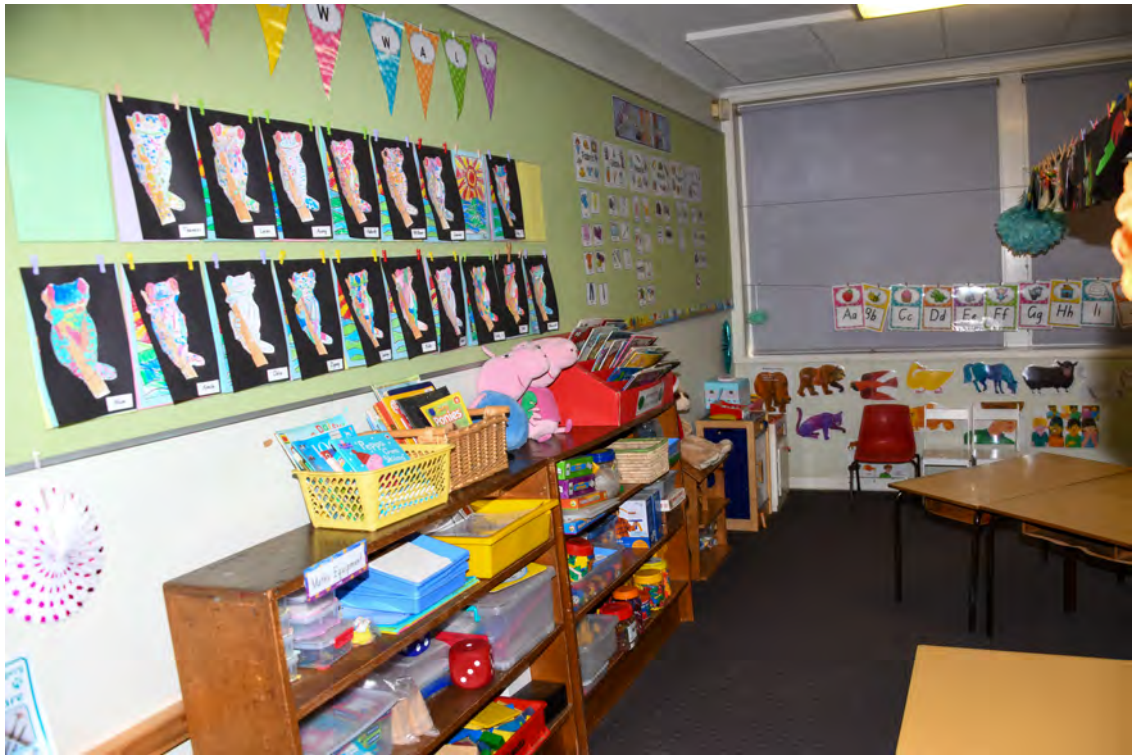
PRO\_0907.jpg

Block F. Interior. Room KH. Western face.

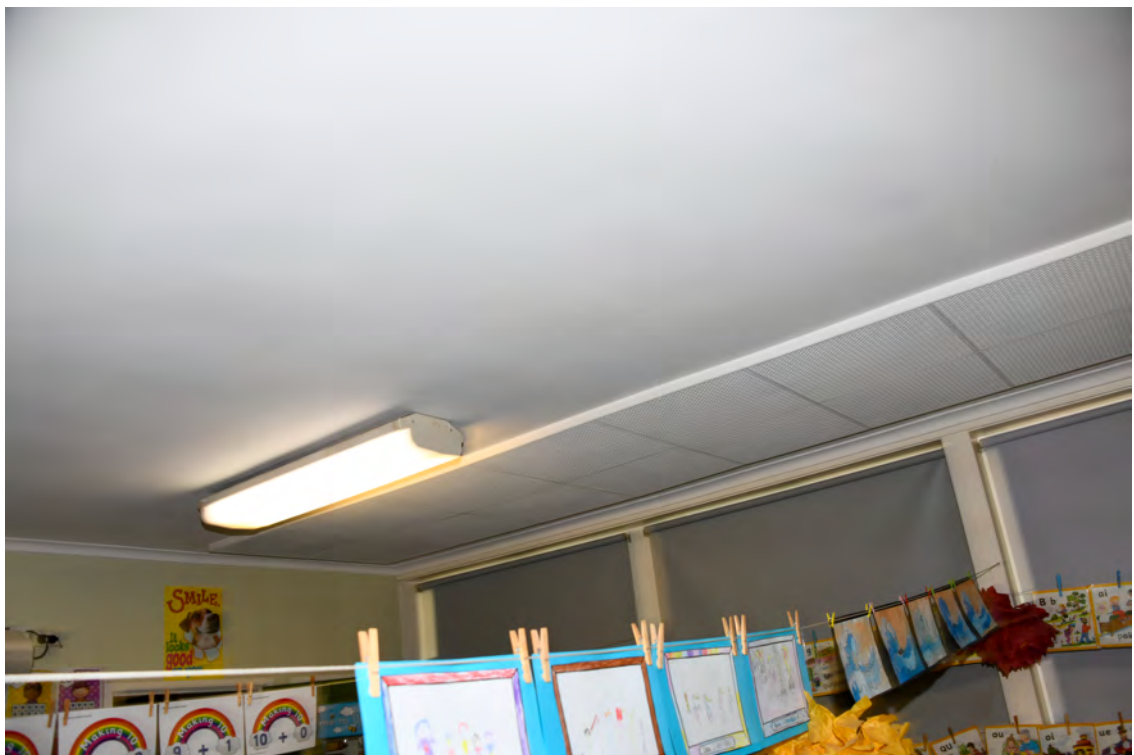
PRO\_0908.jpg

Block F. Interior. Room KH. Ceiling.

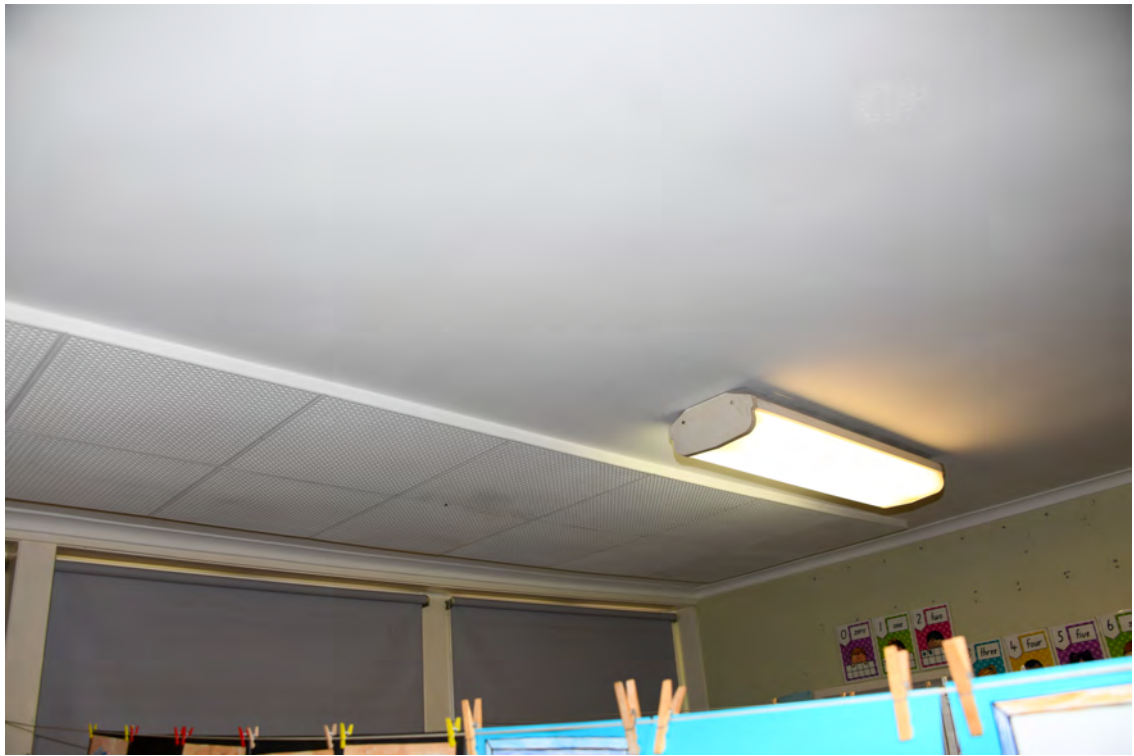
PRO\_0909.jpg

Block F. Interior. Room KH. Ceiling.

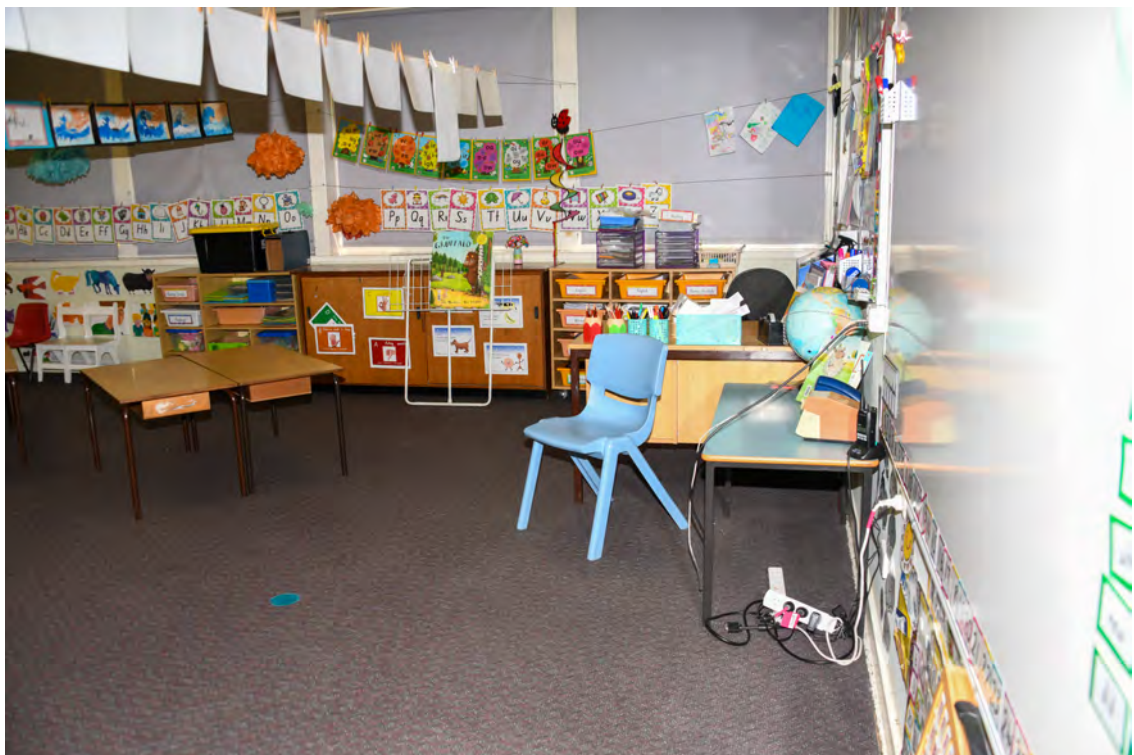
PRO\_0910.jpg

Block F. Interior. Room KH. General overview of the room.

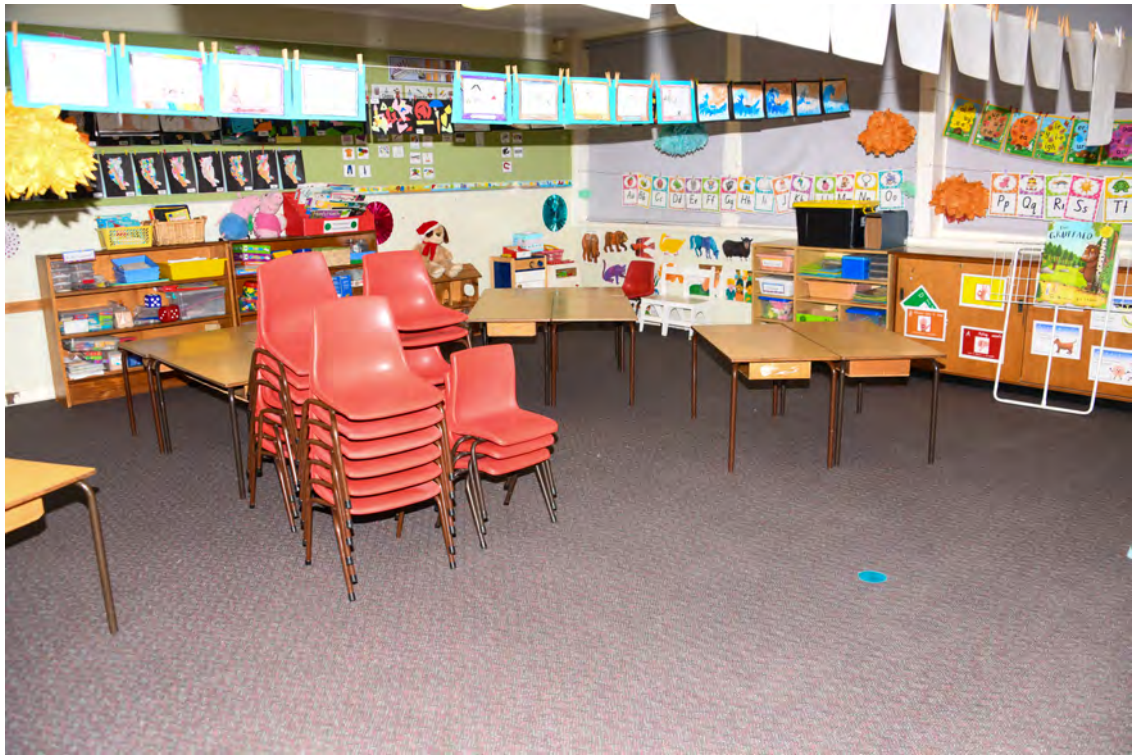
PRO\_0911.jpg

Block F. Interior. Room KH. General overview of the room.

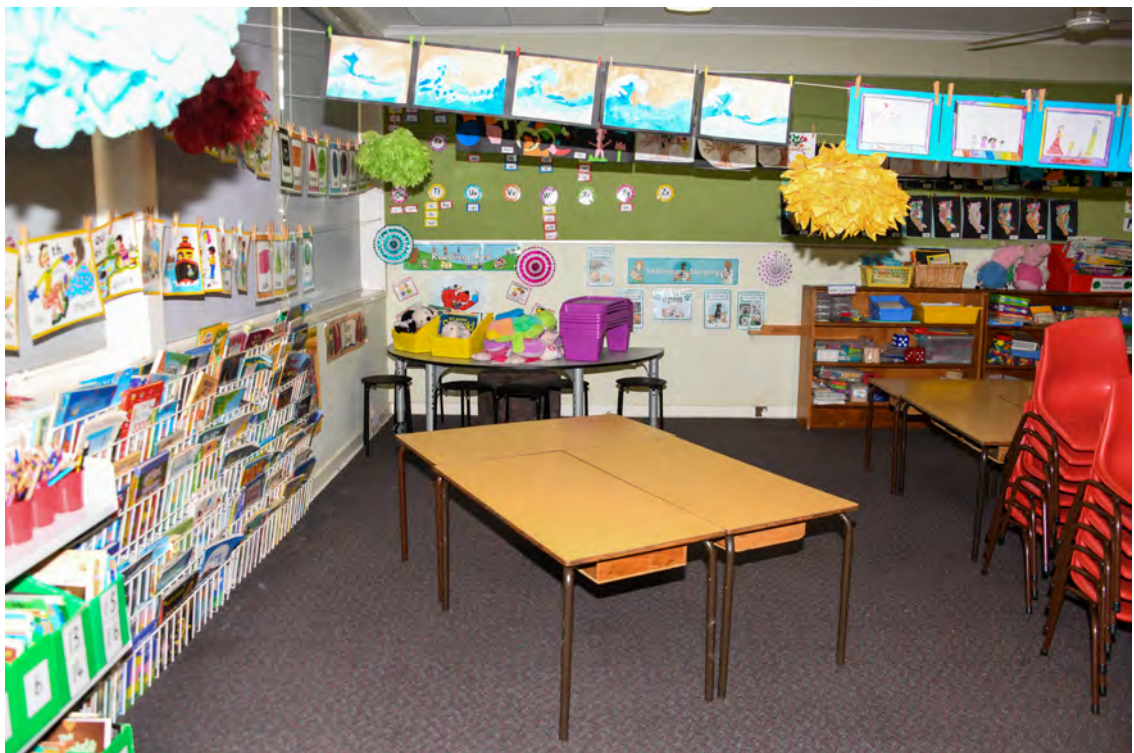
PRO\_0912.jpg

Block F. Interior. Room KH. General overview of the room.

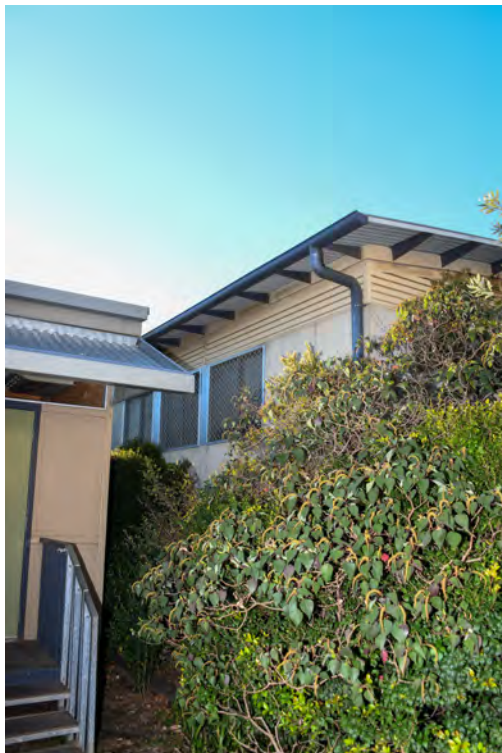
PRO\_0148.jpg

Block I. Northern elevation. Area obscured by vegetation.

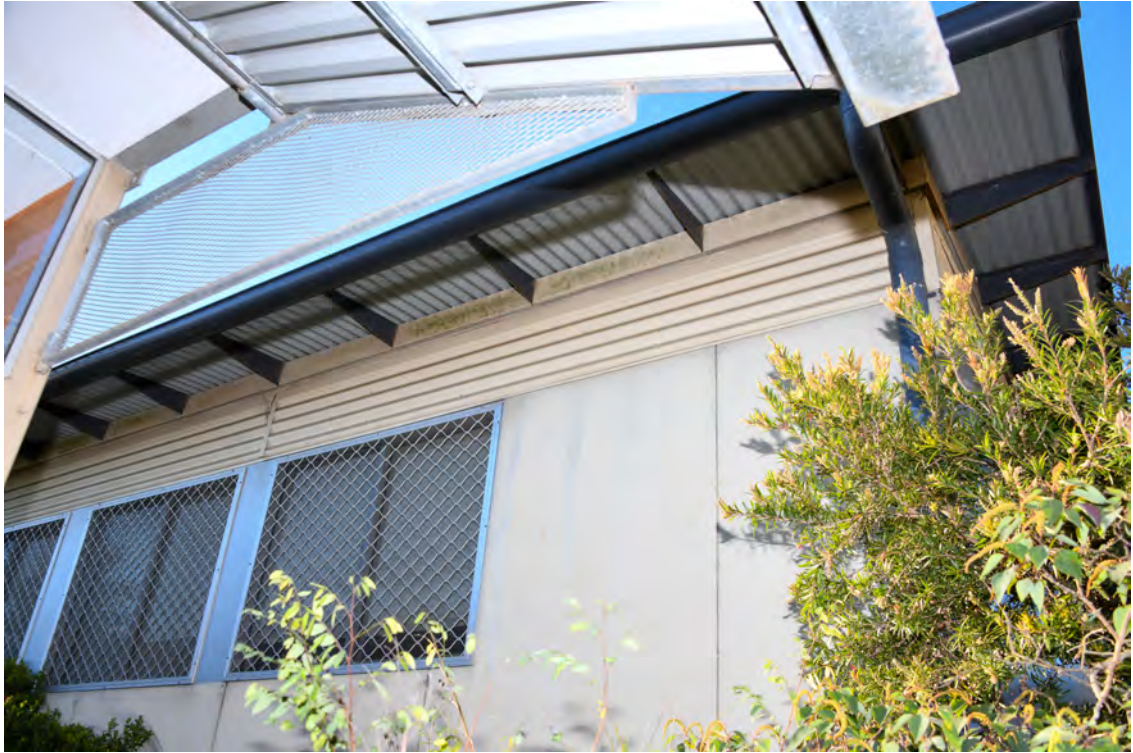
PRO\_0149.jpg

Block I. Northern elevation. Area obscured by vegetation.

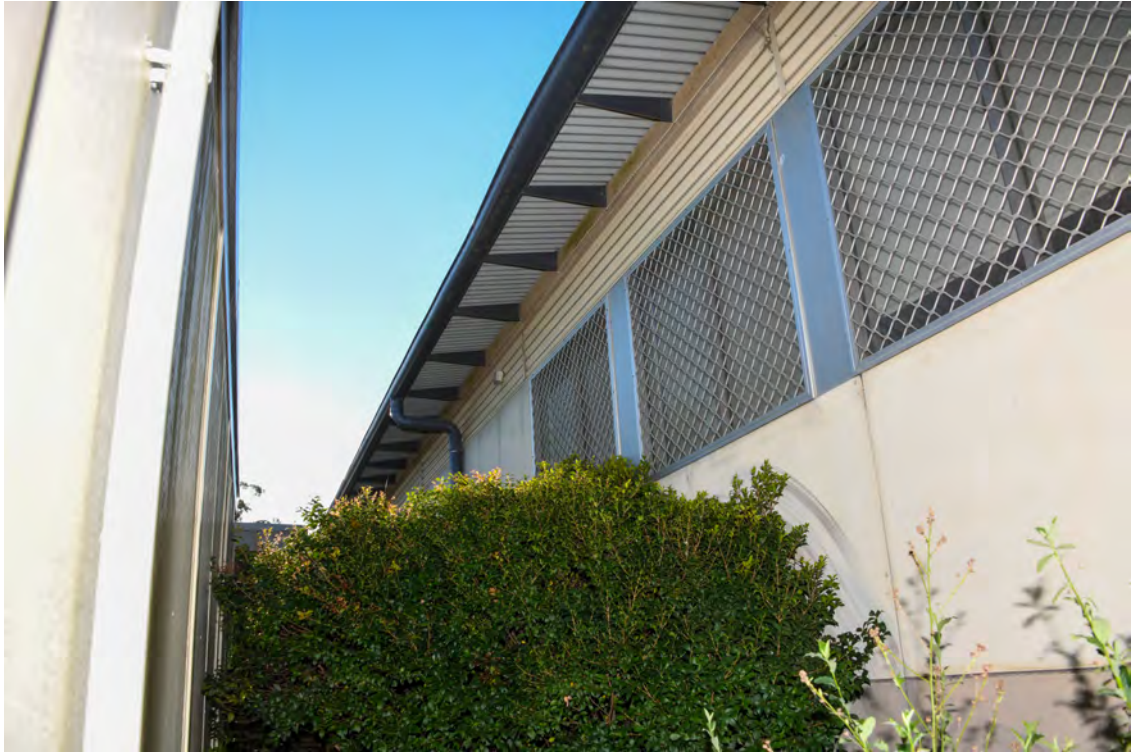
PRO\_0151.jpg

Block I. Northern elevation. Area obscured by vegetation.

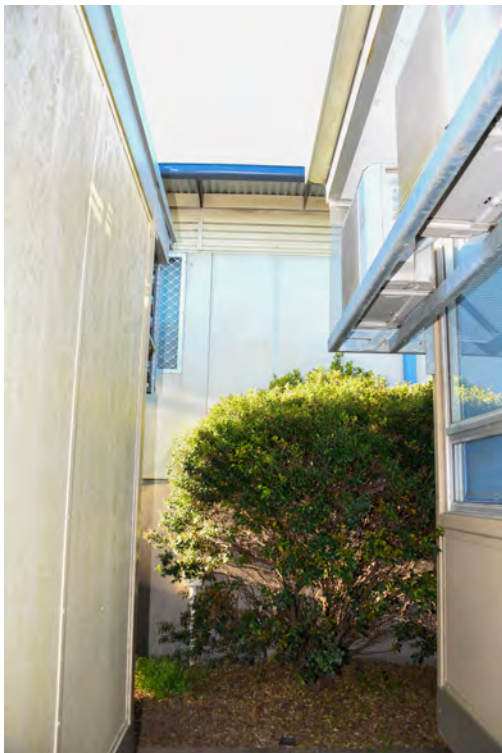
PRO\_0152.jpg

Block I. Northern elevation. Area obscured by vegetation.

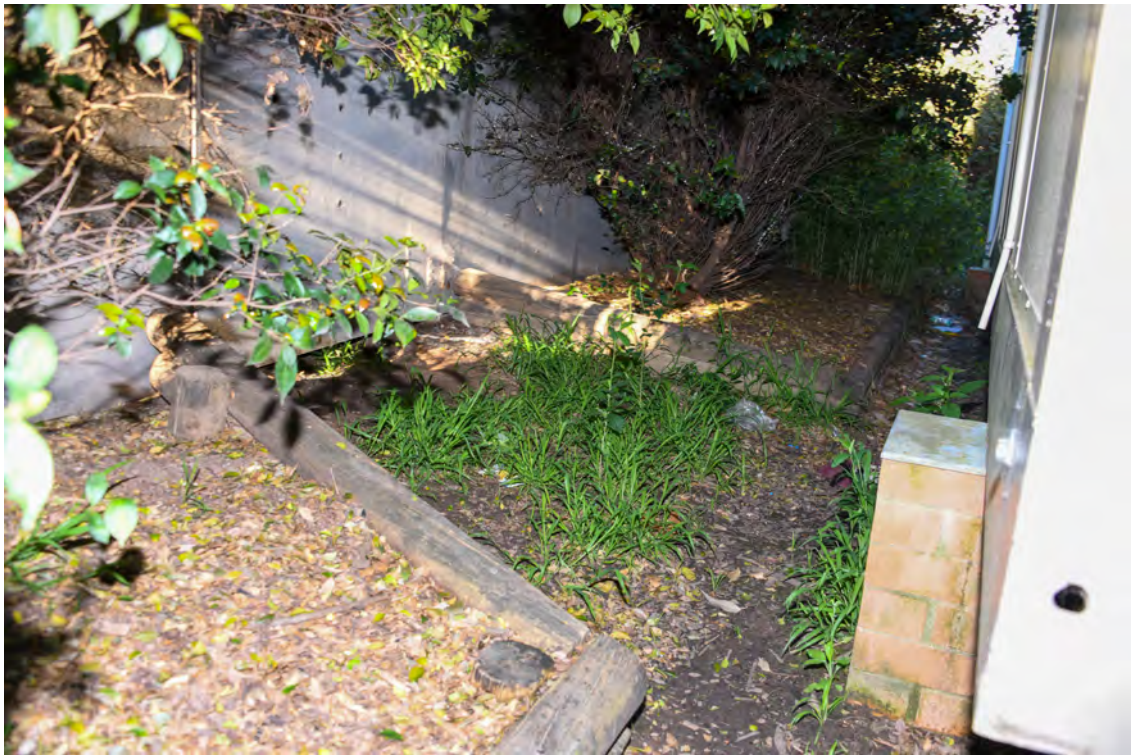
PRO\_0153.jpg

Block I. Northern elevation. Area obscured by vegetation.

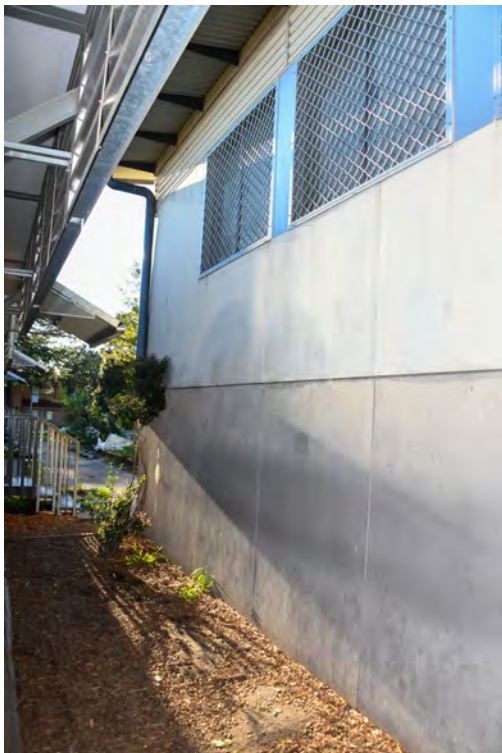
PRO\_0154.jpg

Block I. Northern elevation. Eastern end.

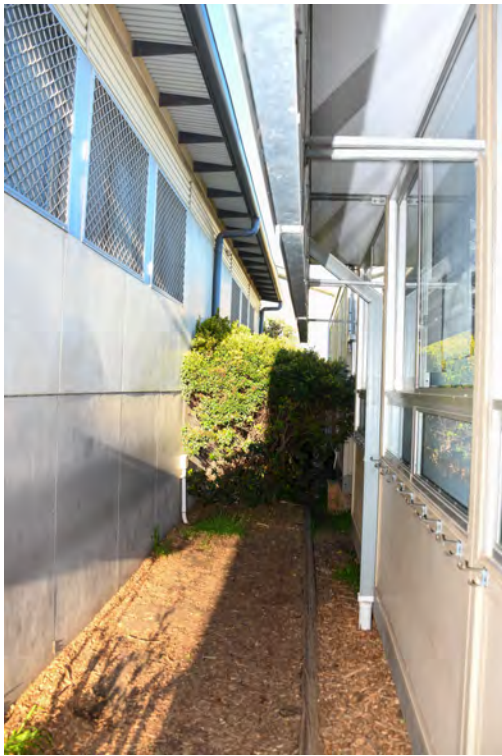
PRO\_0155.jpg

Block I. Northern elevation. Eastern end.

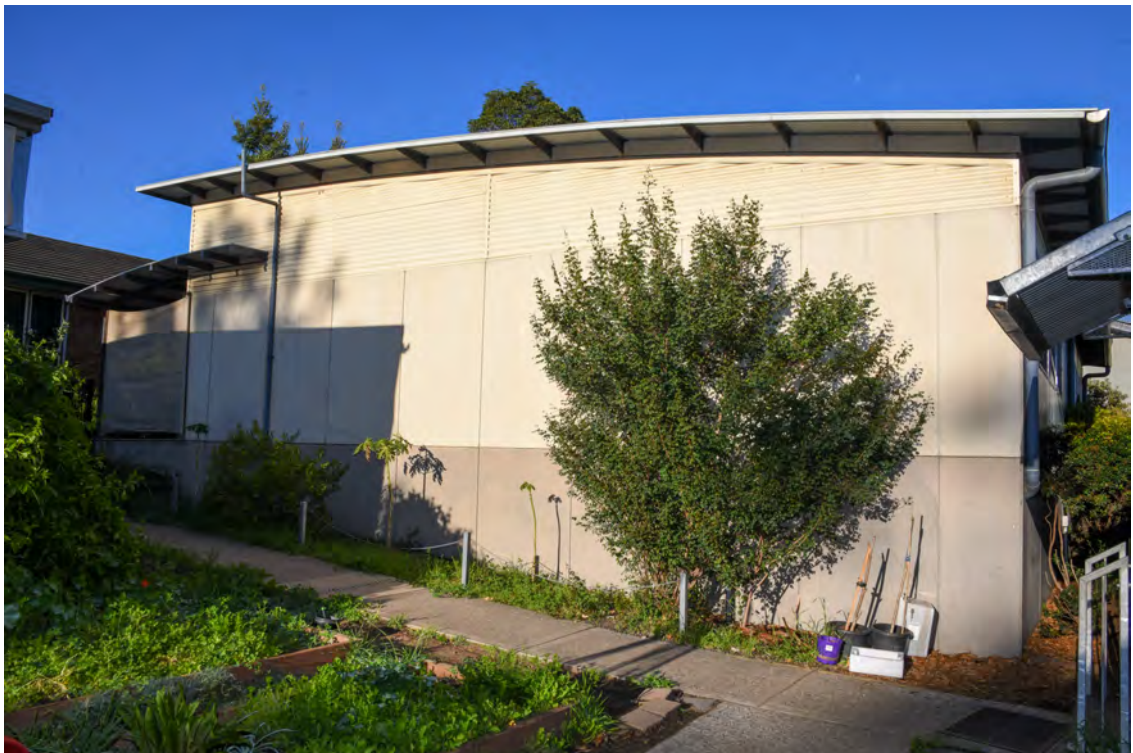
PRO\_0156.jpg

Block I. Eastern elevation.

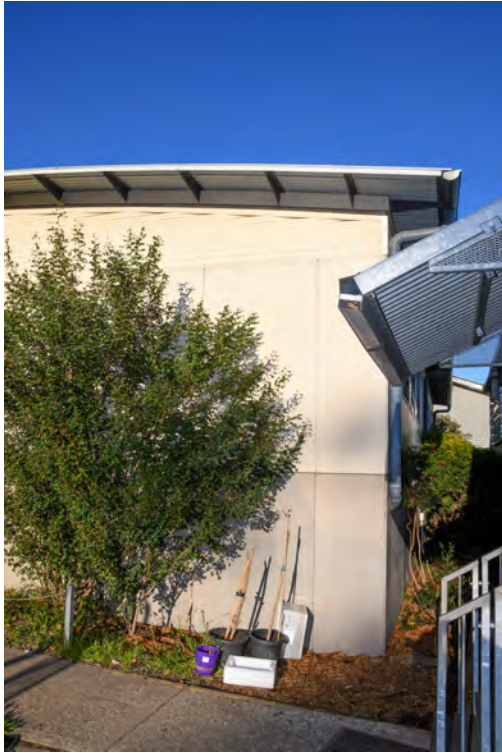
PRO\_0157.jpg

Block I. Eastern elevation. Northern end.

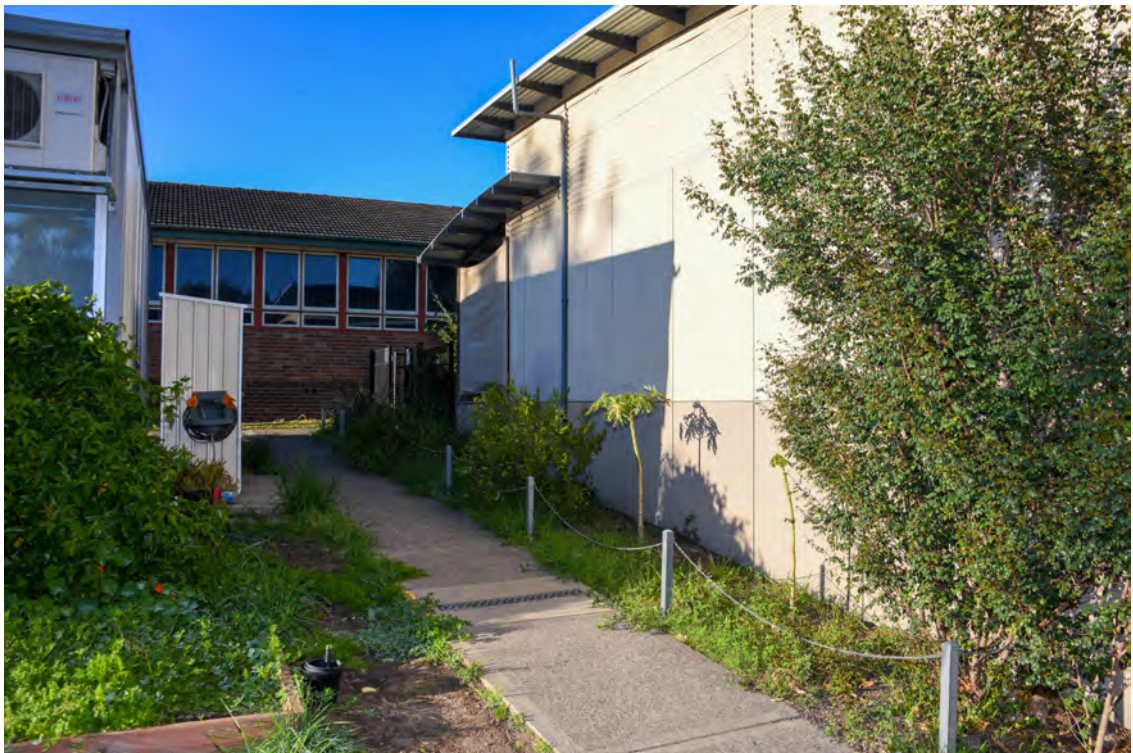
PRO\_0158.jpg

Block I. Eastern elevation.

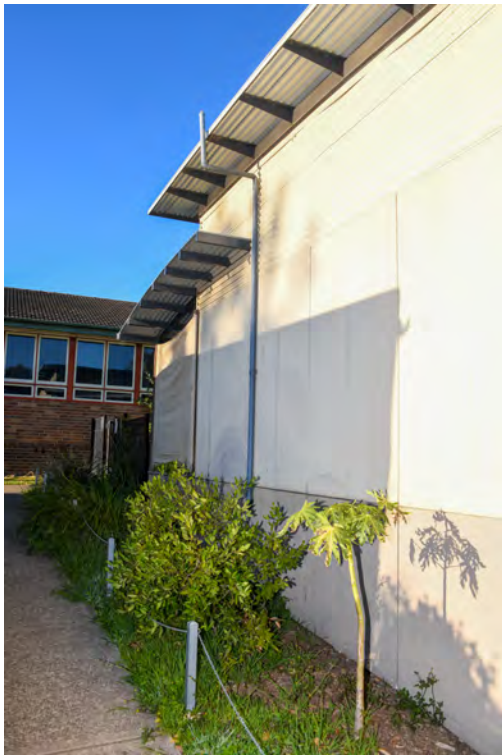
PRO\_0159.jpg

Block I. Eastern elevation. Southern end.

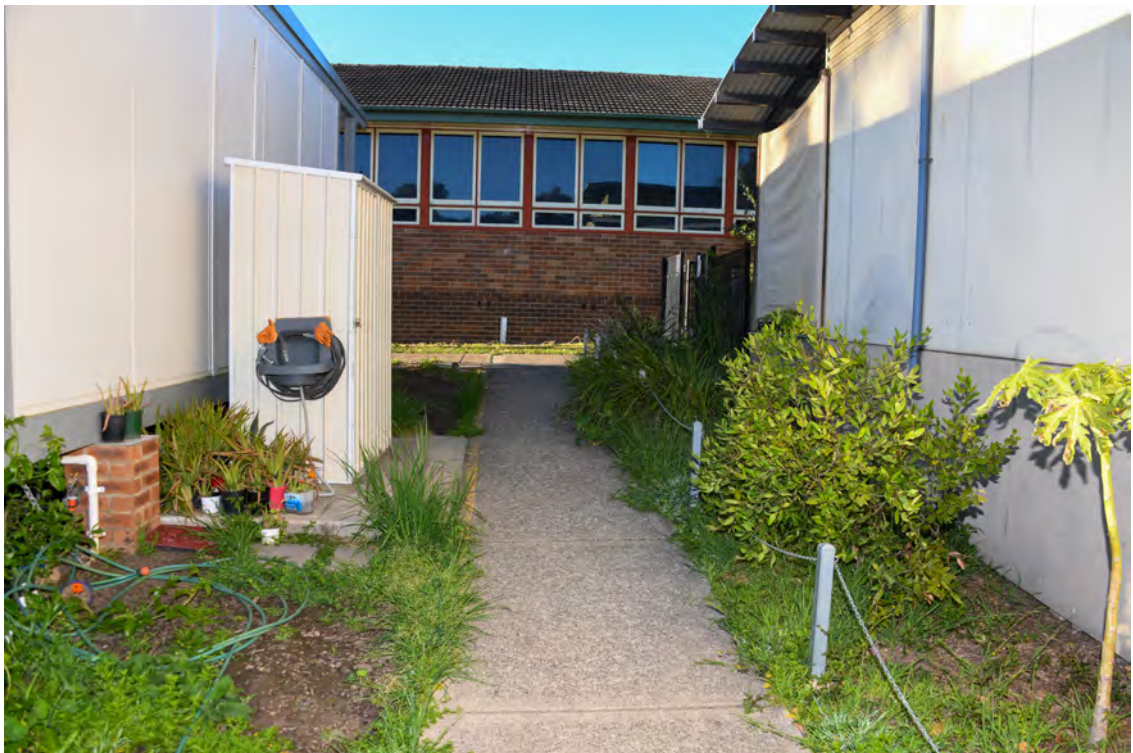
PRO\_0160.jpg

Block I. Eastern elevation. Adjacent path. Facing south.

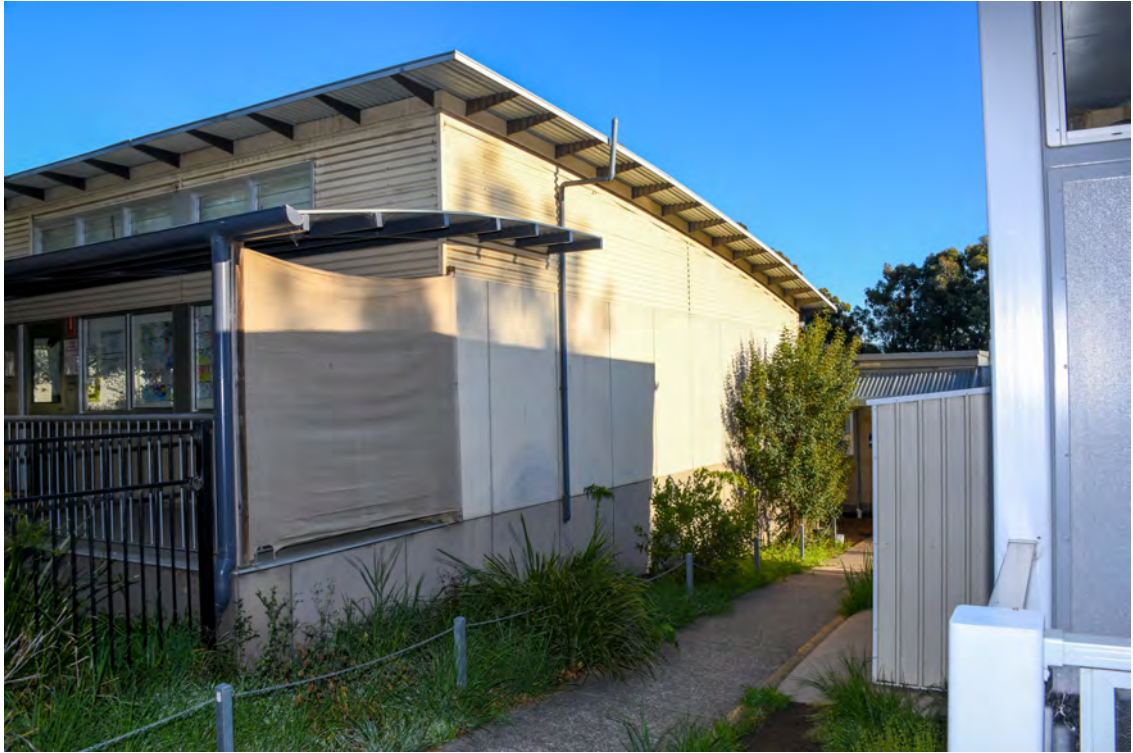
PRO\_0161.jpg

Block I. Eastern elevation. Facing north.

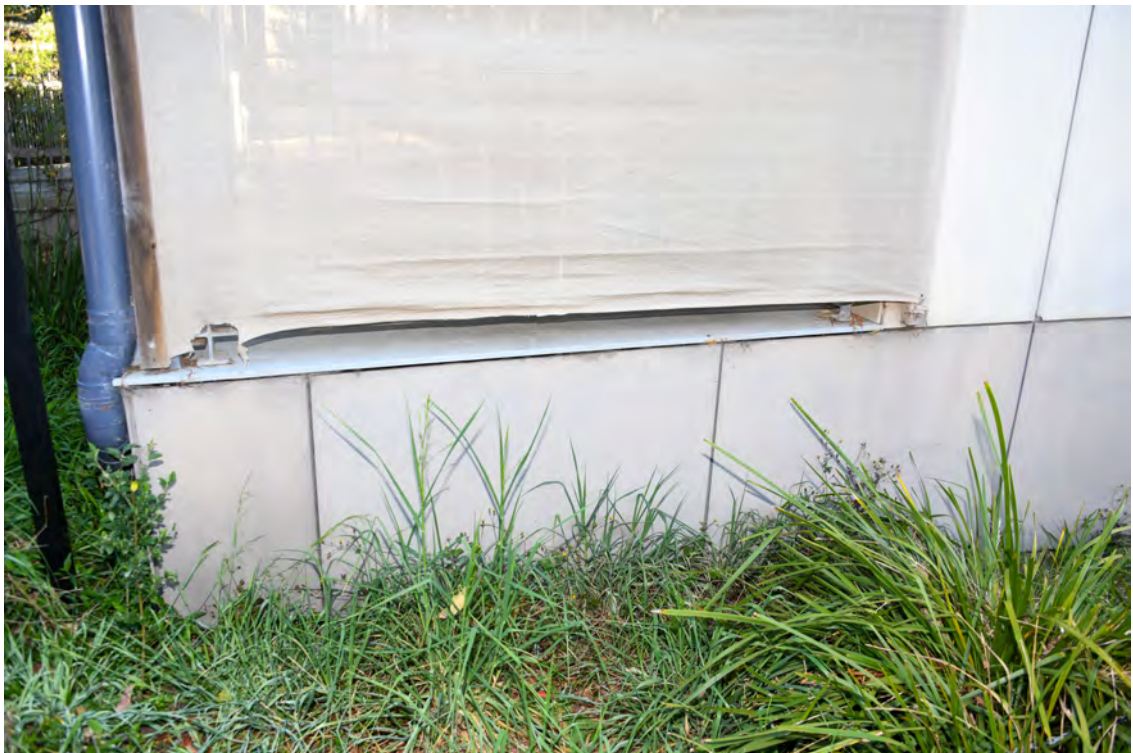
PRO\_0162.jpg

Block I. Eastern elevation. Southern end.

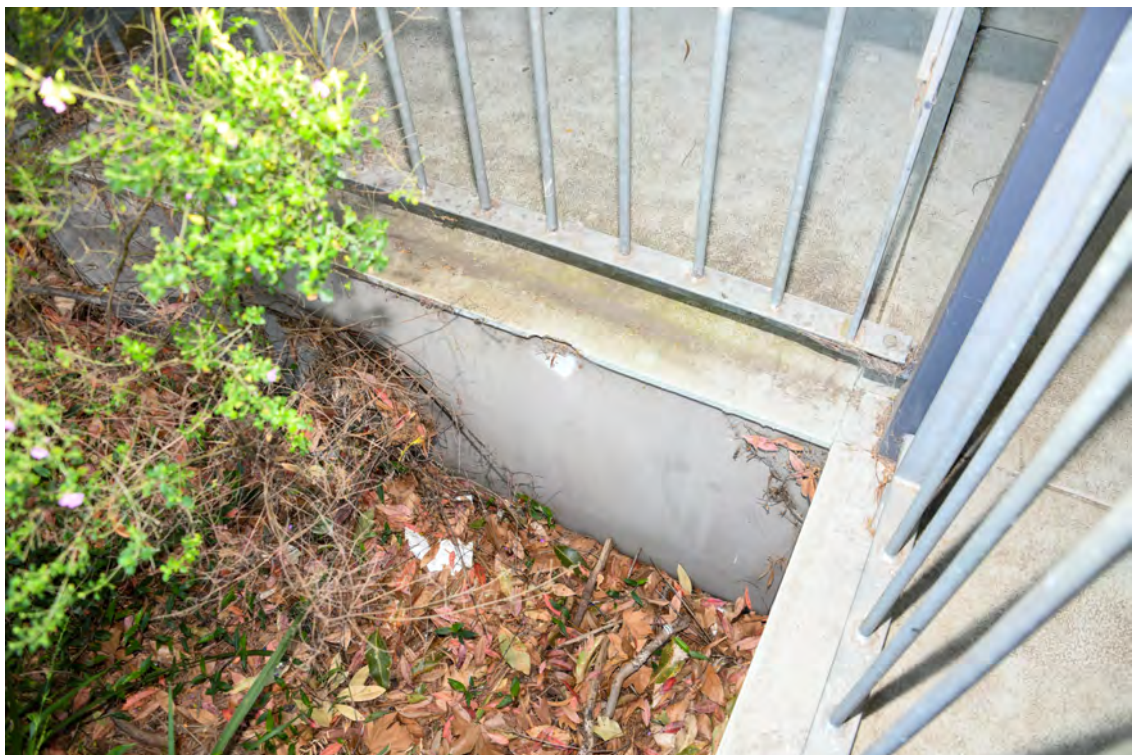
PRO\_0168.jpg

Block I. Southern elevation. Eastern end. Chipped edge of the flooring.

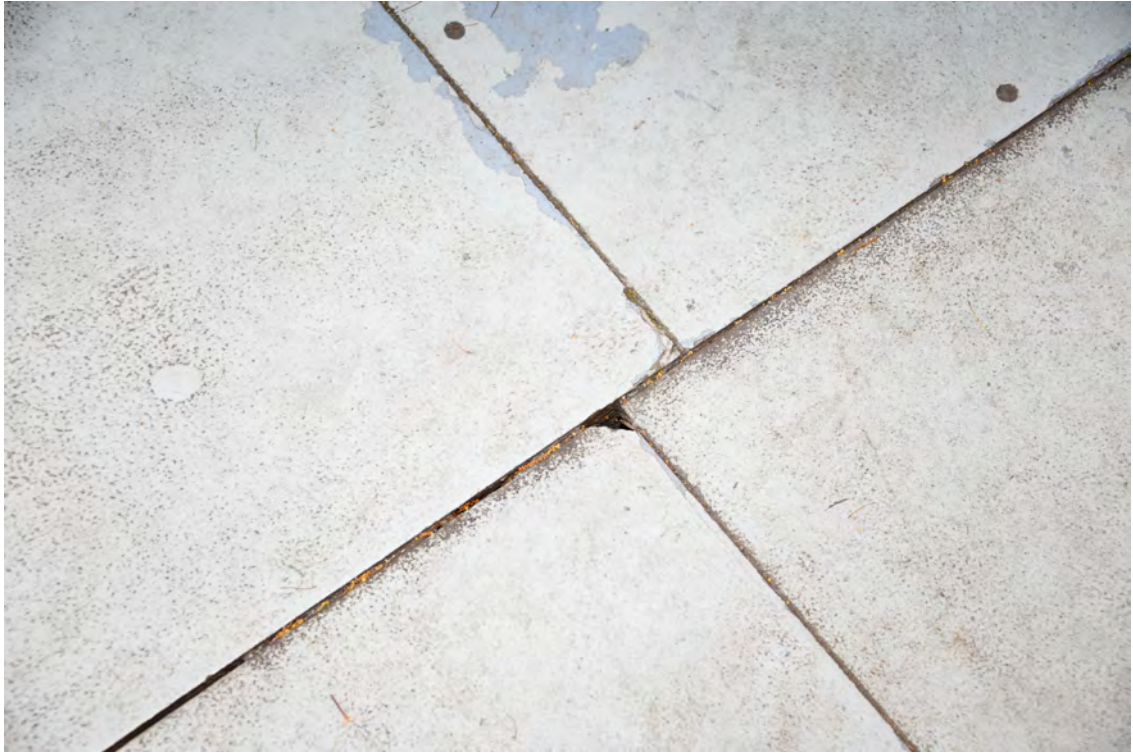
PRO\_0173.jpg

Block I. Southern side of the building. Access ramp. Chipped edges of the flooring.
