96-104 Carlingford Road, Epping NSW 2121

Epping West Public School

DILAPIDATION REPORT

7<sup>th</sup> September 2021

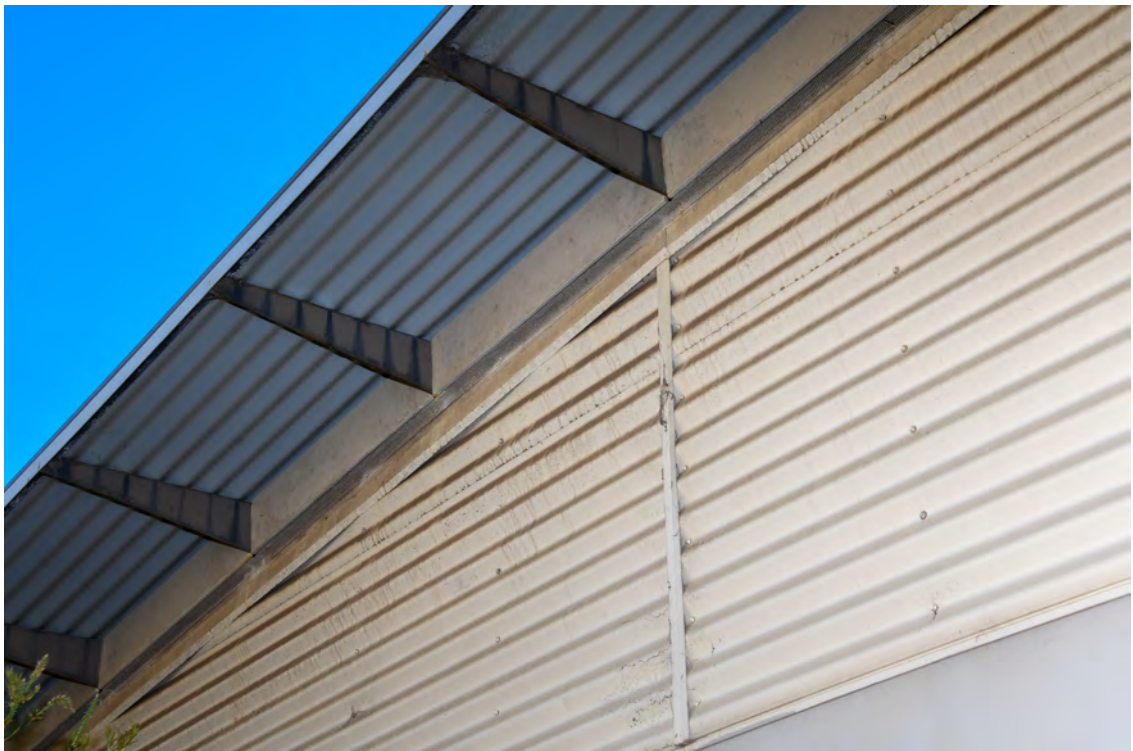
PRO\_0184.jpg

Block I. Western side of the building. Heading north. Noting the dirty state of the cladding.

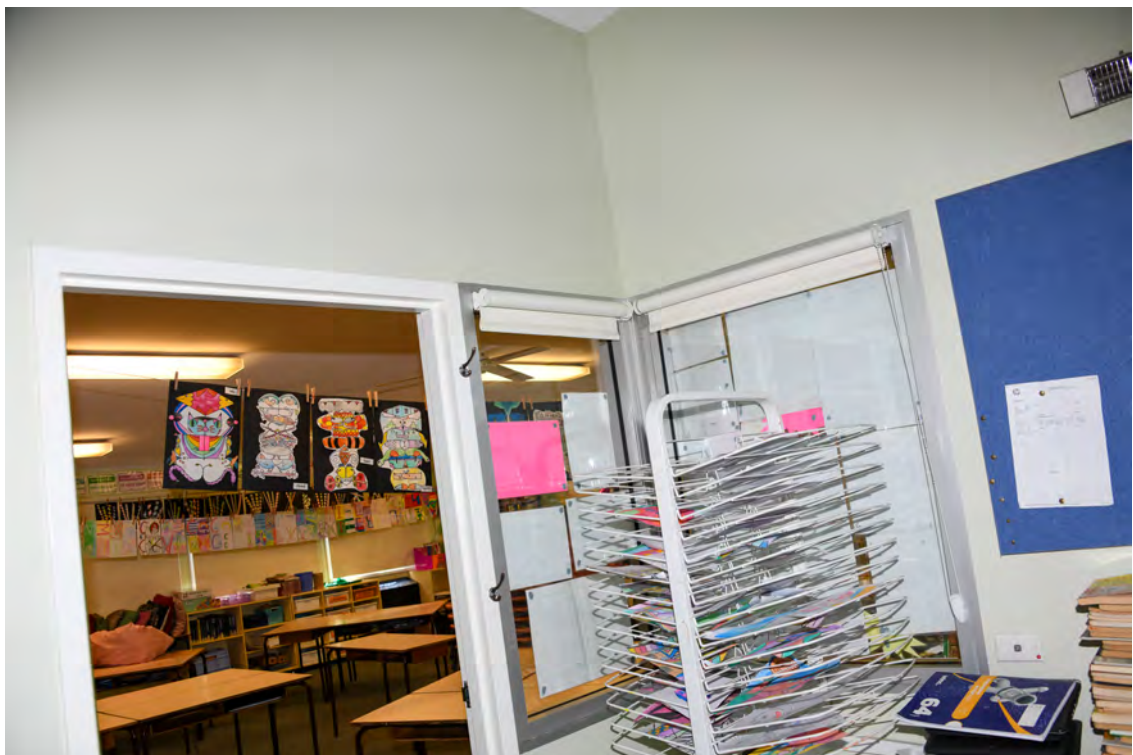
PRO\_0997.jpg

Block I. Second eastern room. Eastern face.

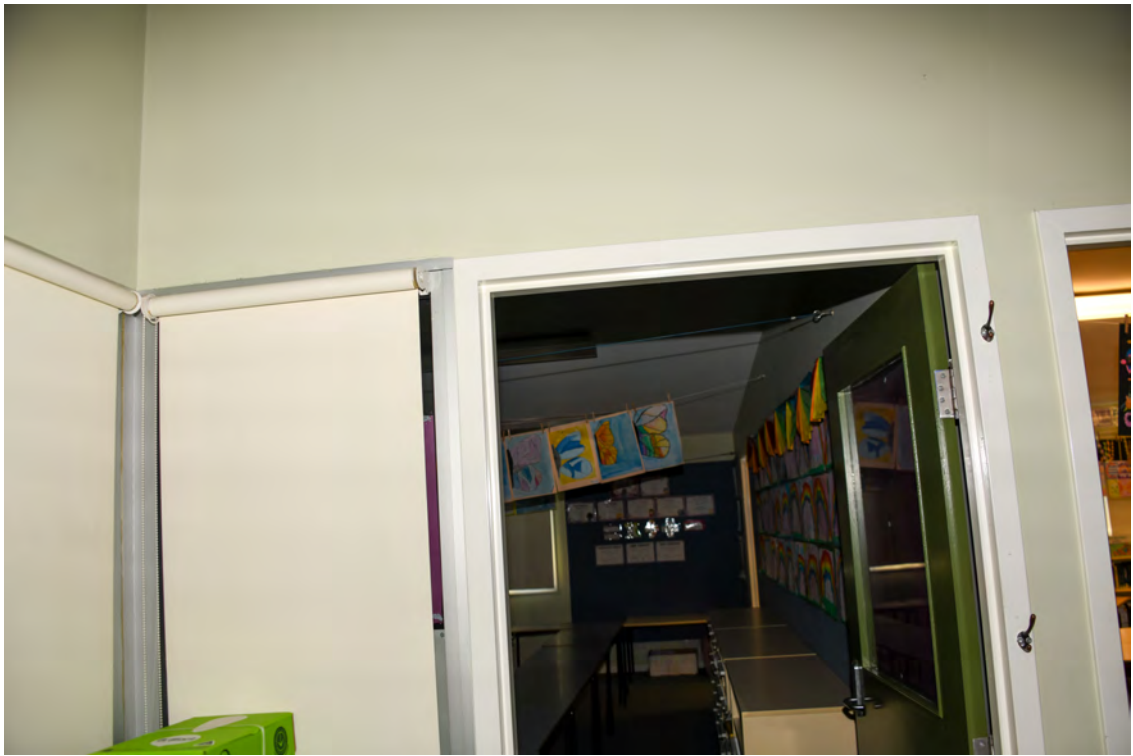
PRO\_0998.jpg

Block I. Second eastern room. Southern face.

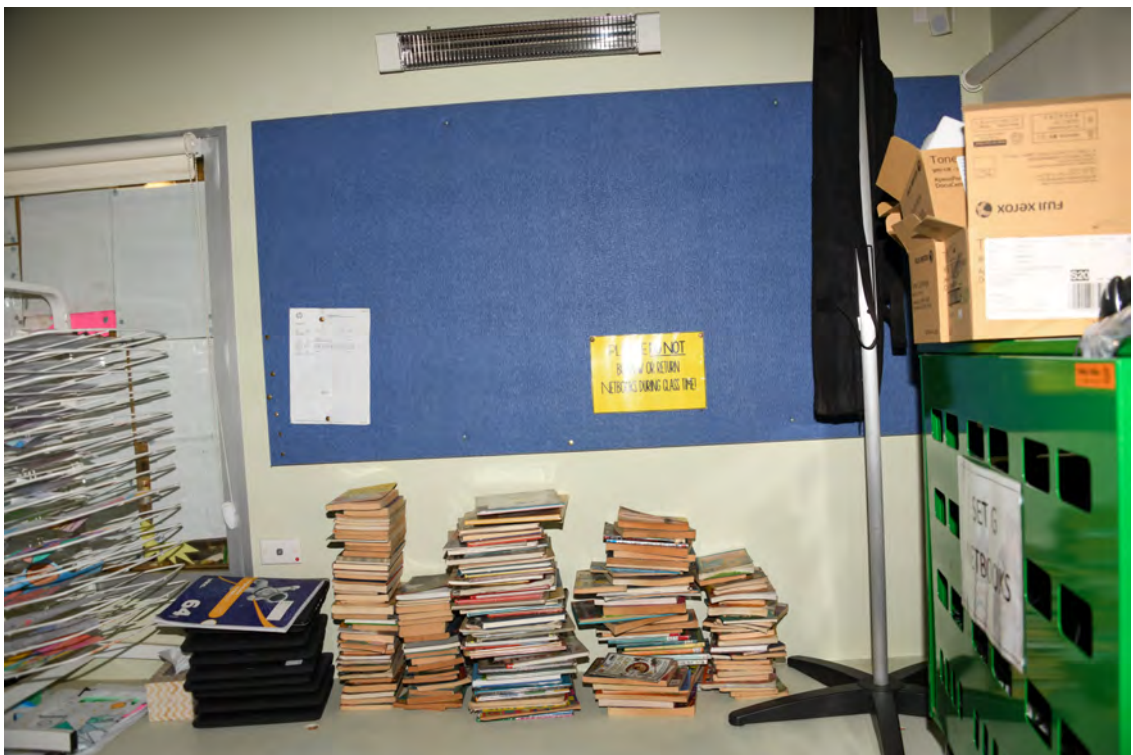
PRO\_0999.jpg

Block I. Second eastern room. Western face.

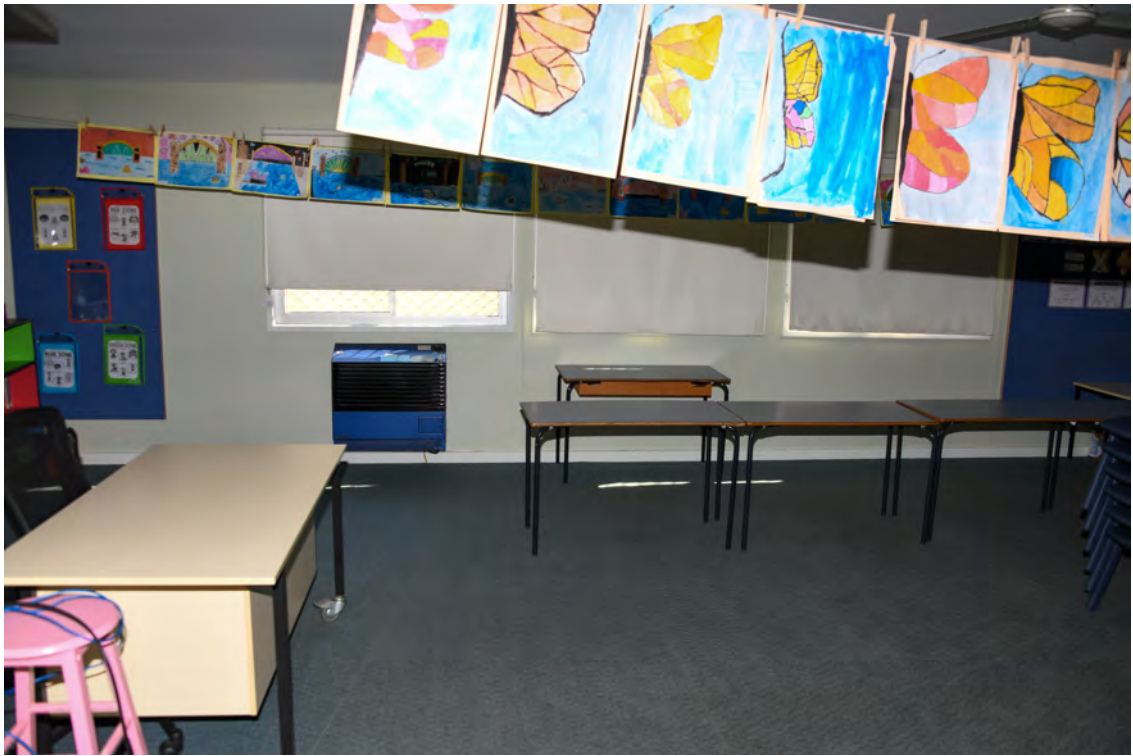
PRO\_1001.jpg

Block I. Western room. Northern face.

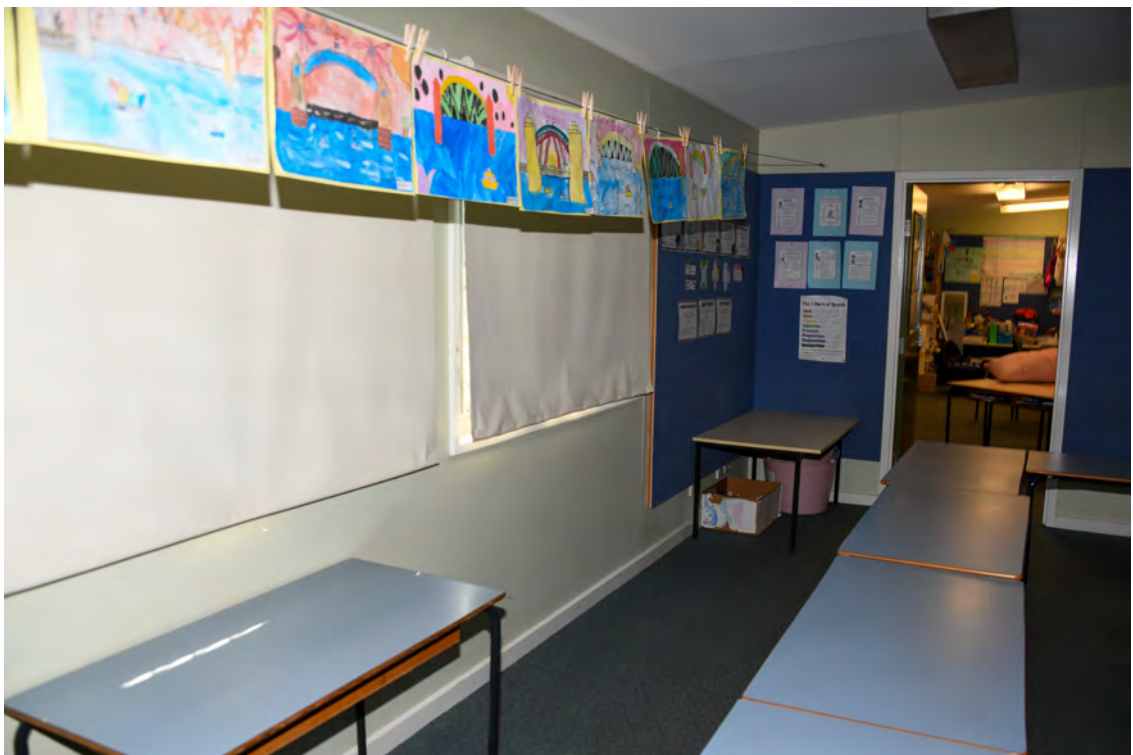
PRO\_1002.jpg

Block I. Western room. Northern face.

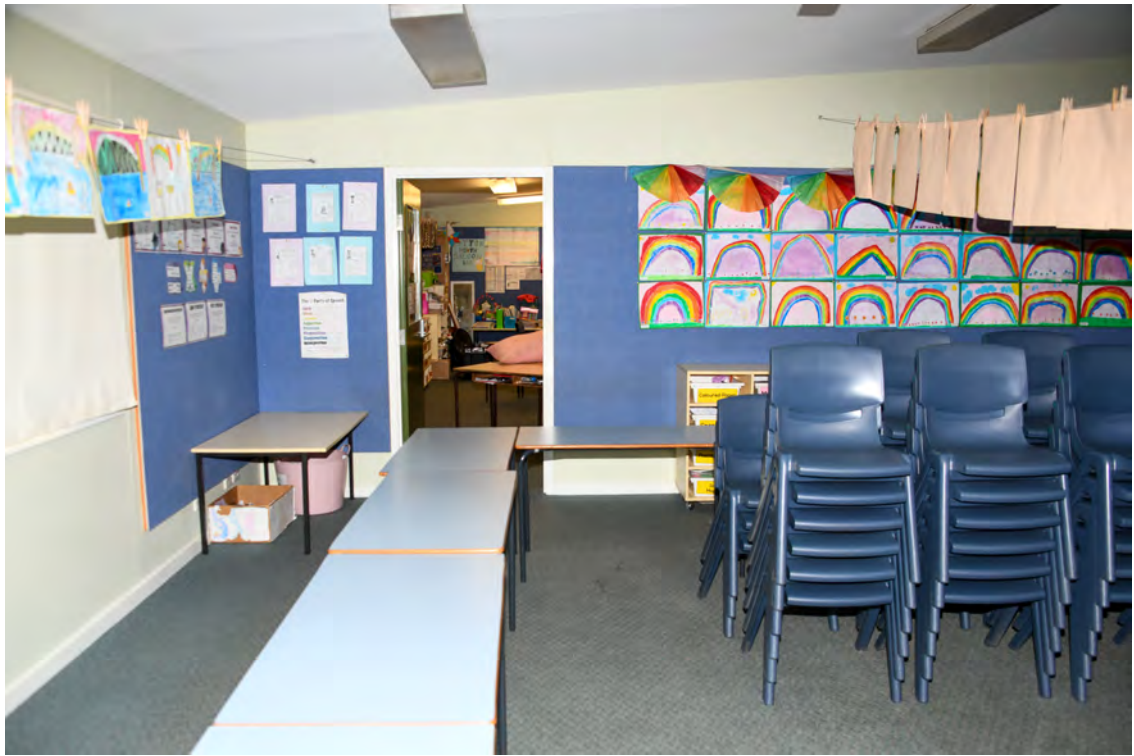
PRO\_1003.jpg

Block I. Western room. Eastern face.

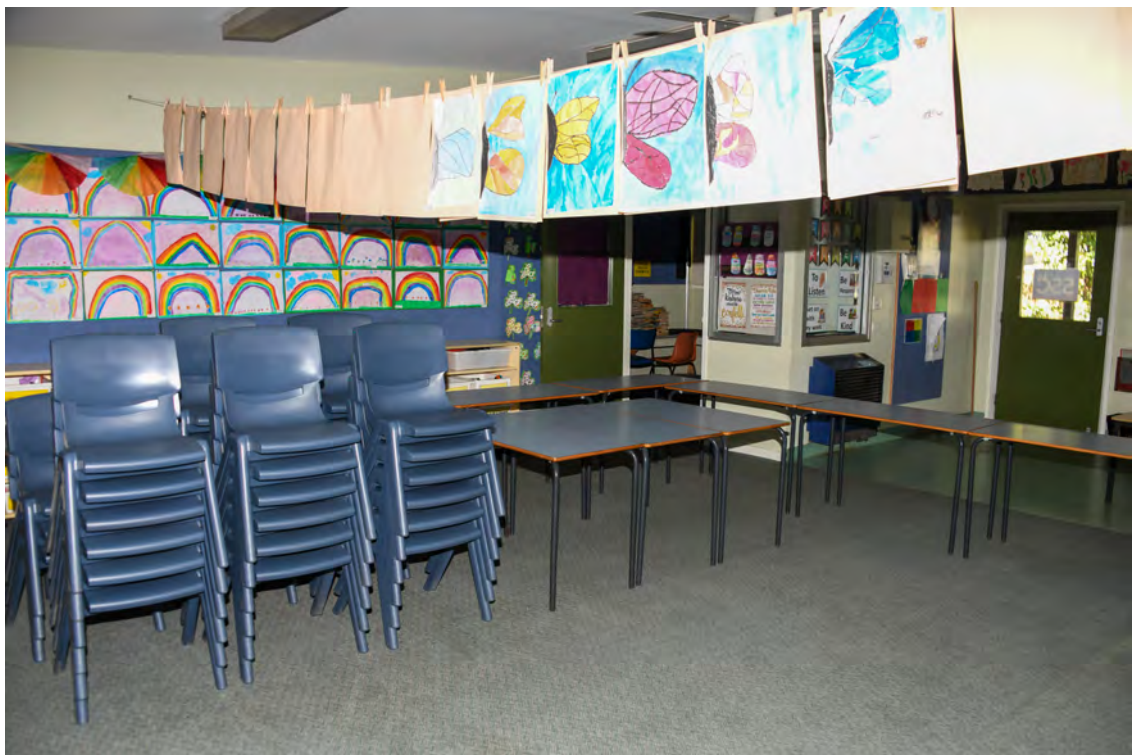
PRO\_1004.jpg

Block I. Western room. Eastern face.

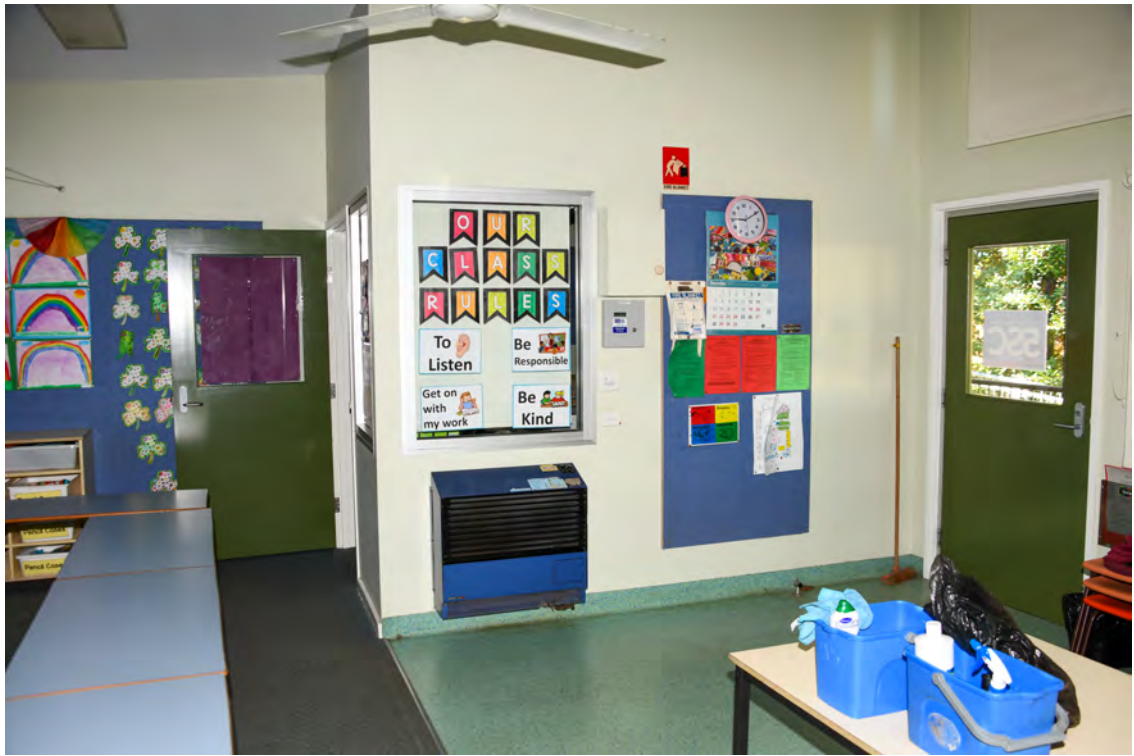
PRO\_1005.jpg

Block I. Western room. Eastern face.

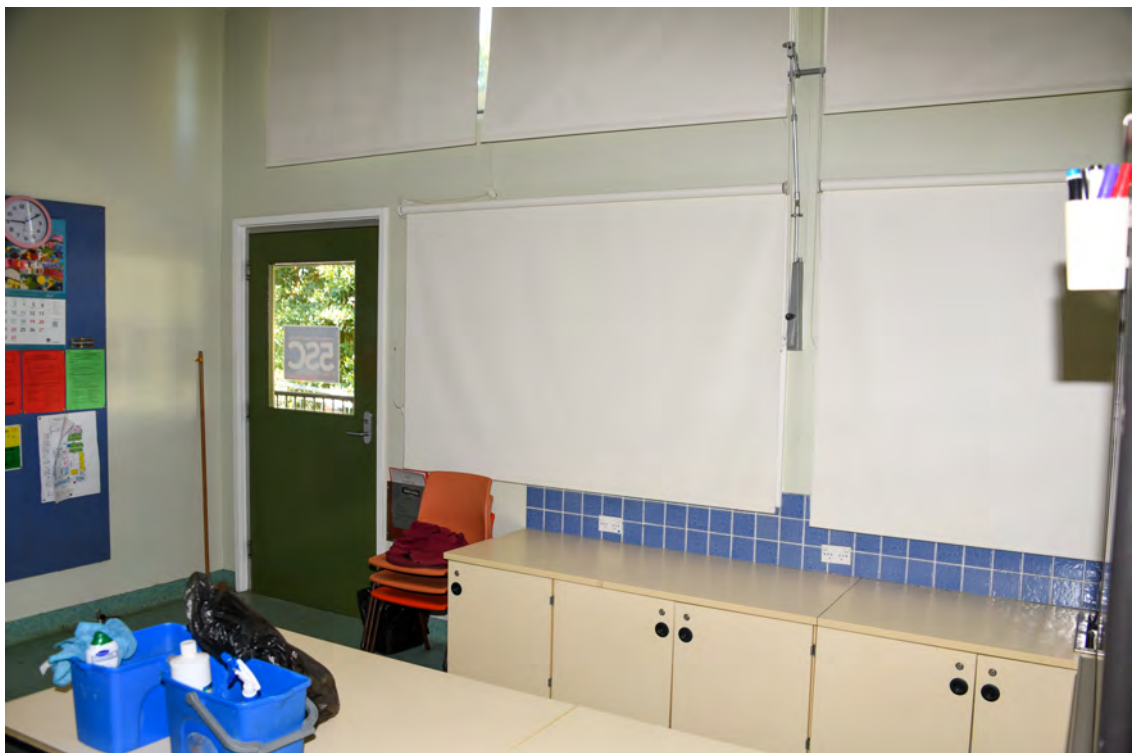
PRO\_1006.jpg

Block I. Western room. Southern face.

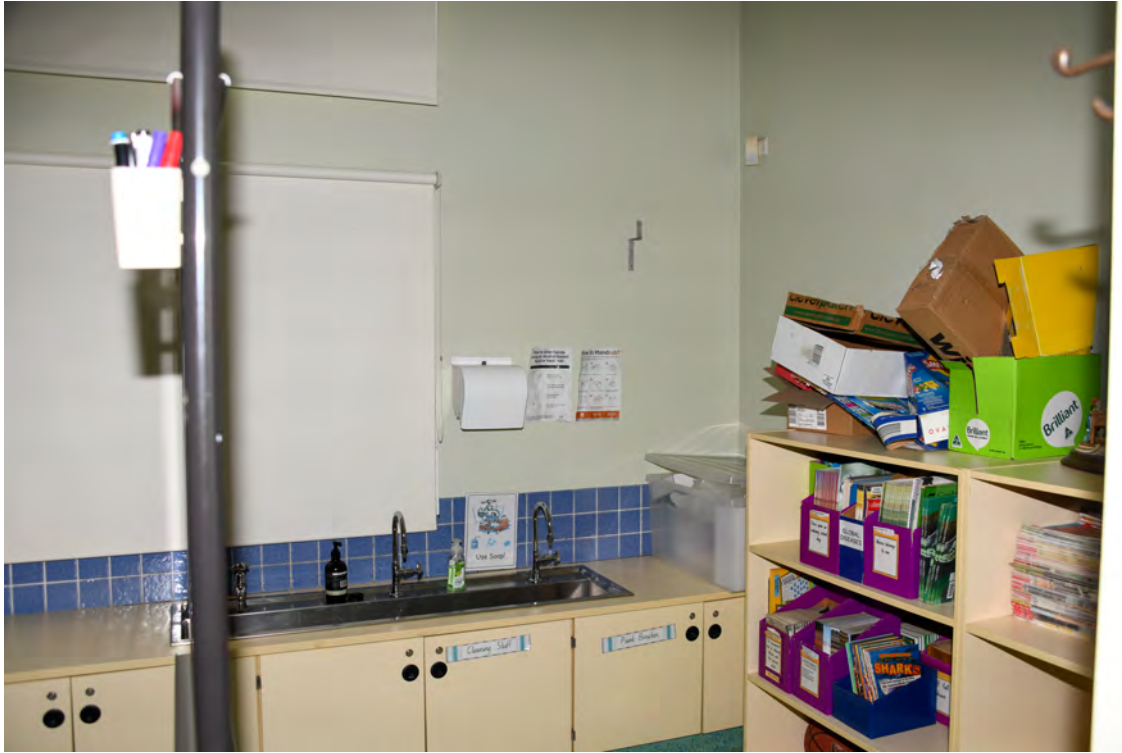
PRO\_1007.jpg

Block I. Western room. Southern face.

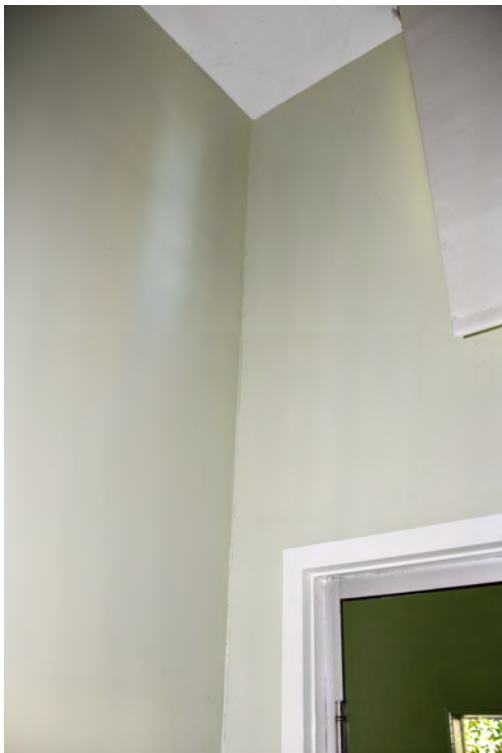
PRO\_1008.jpg

Block I. Western room. Southern face.

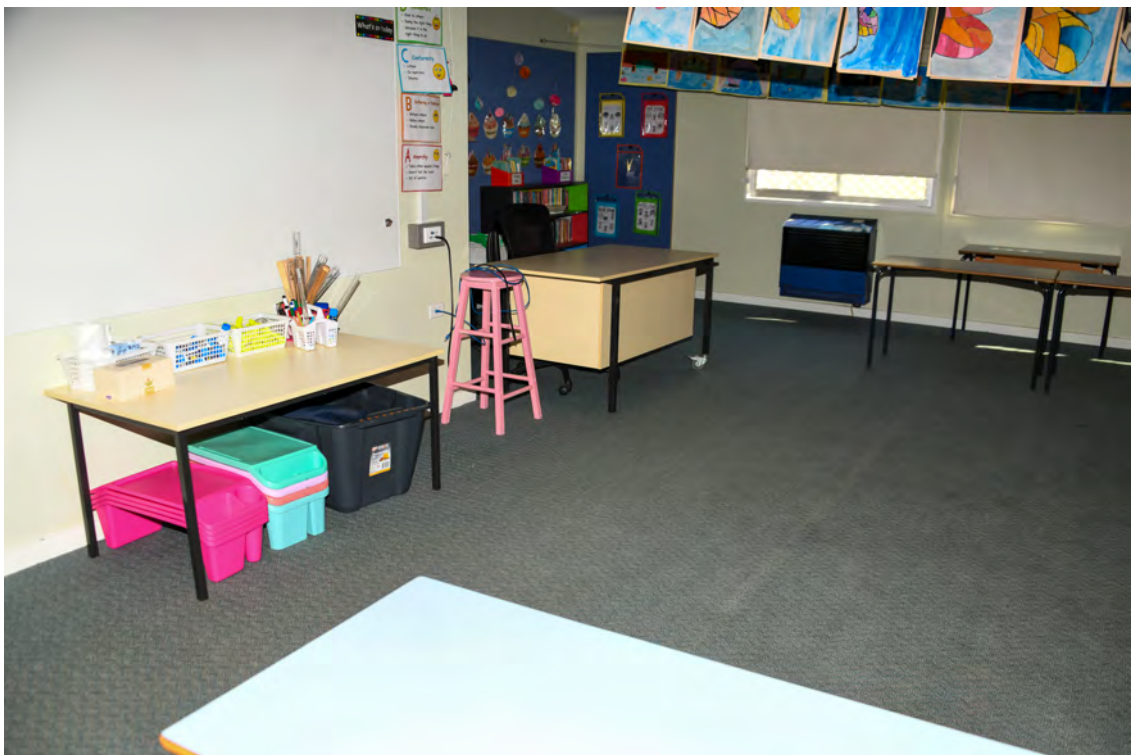
PRO\_1010.jpg

Block I. Western room. North-western corner of the room.

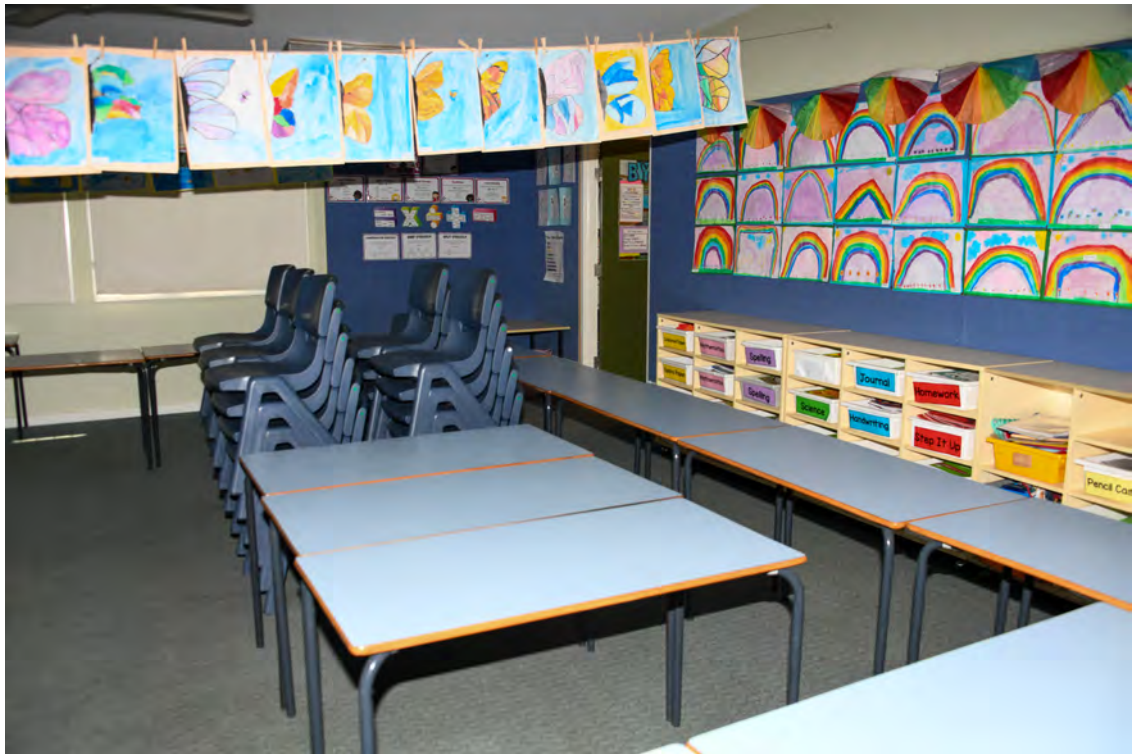
PRO\_1011.jpg

Block I. Western room. General overview of the room.

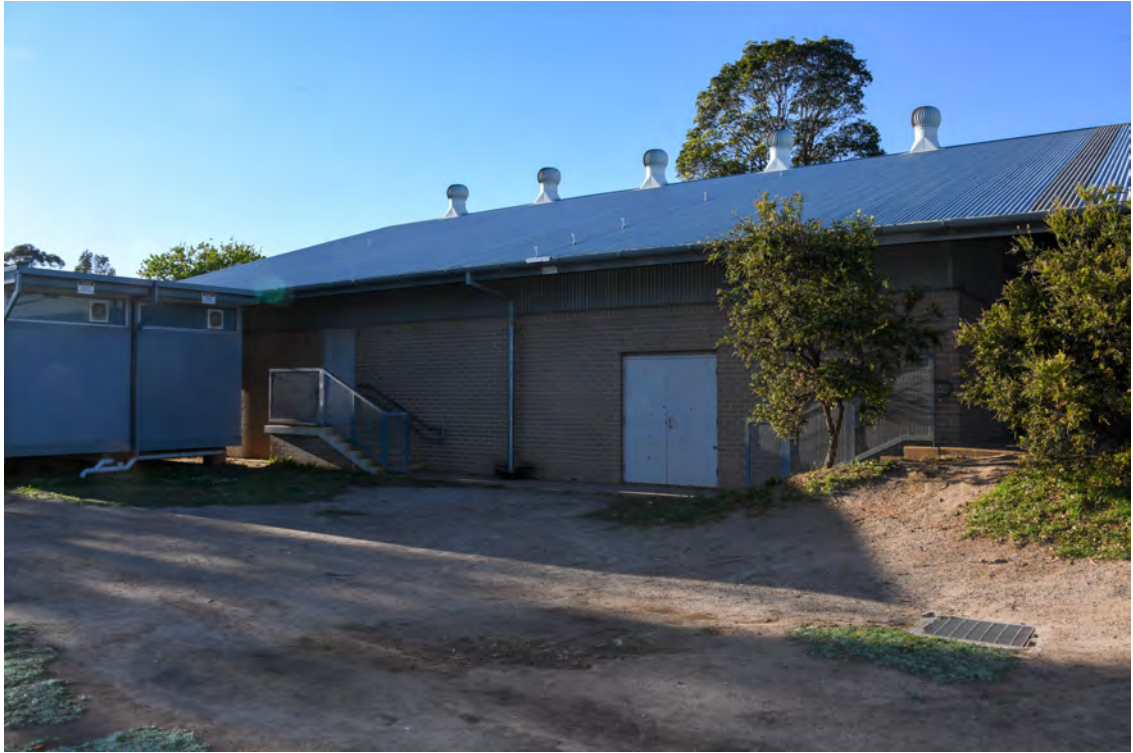
PRO\_0186.jpg

Block M / Hall / The Aurora Centre. Northern elevation.

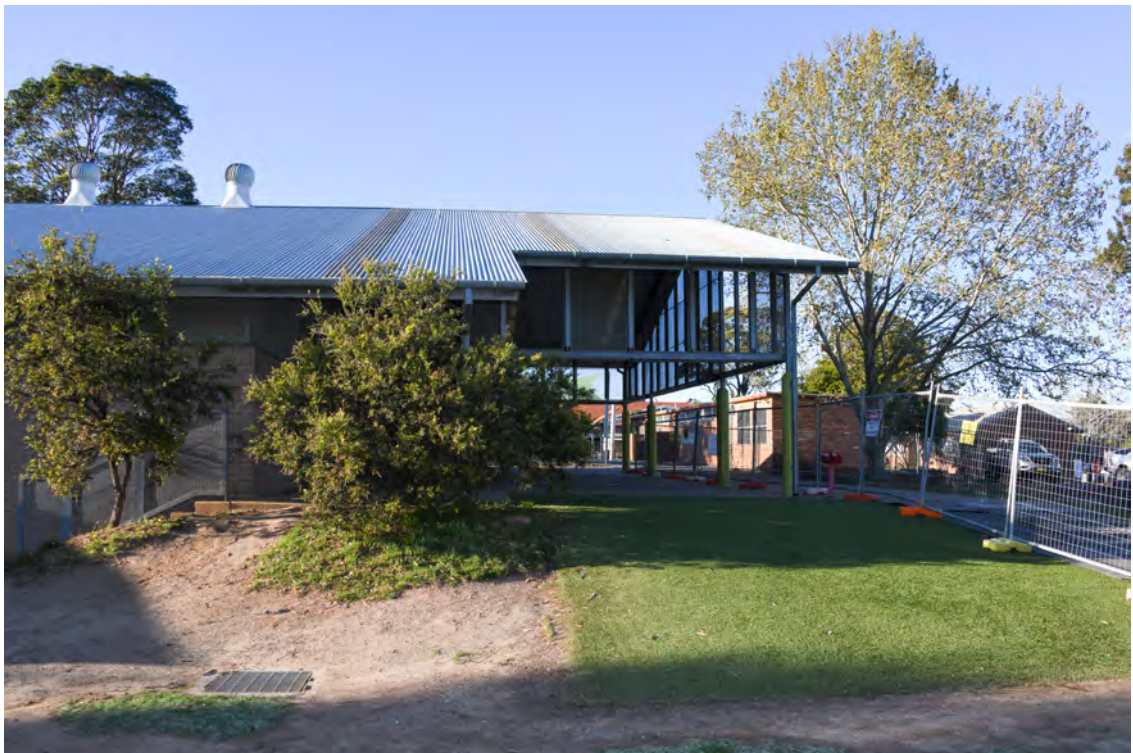
PRO\_0187.jpg

Block M / Hall / The Aurora Centre. Northern elevation. Western end.

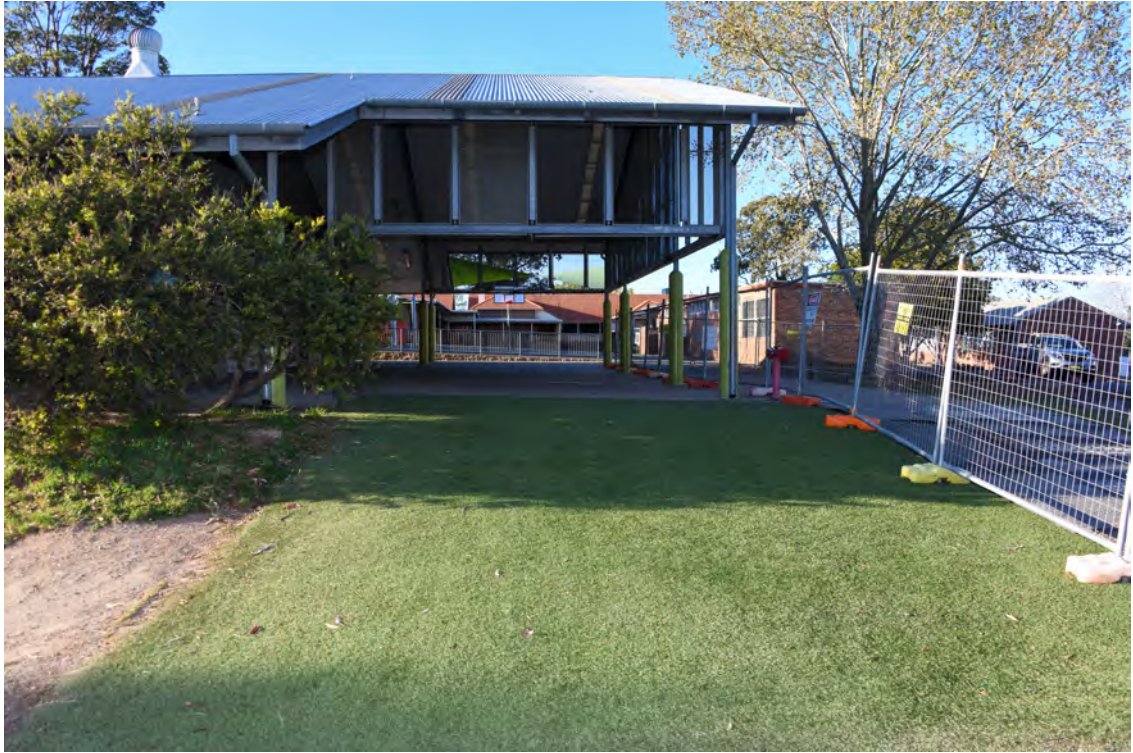
PRO\_0188.jpg

Block M / Hall / The Aurora Centre. Northern elevation. Western end.

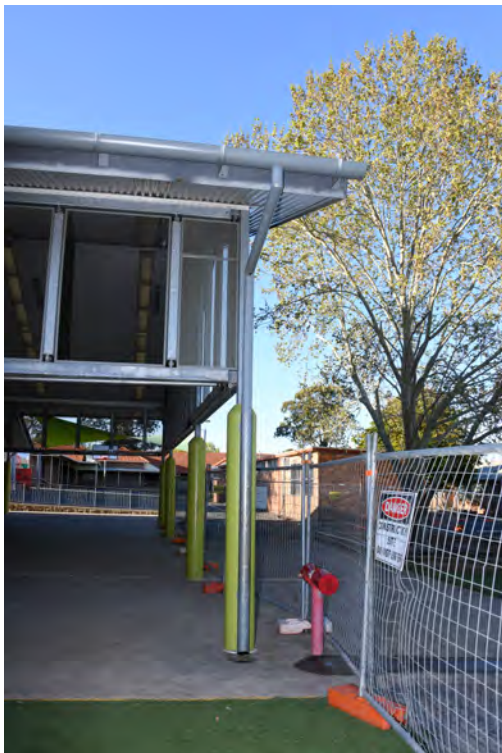
PRO\_0189.jpg

Block M / Hall / The Aurora Centre. Northern elevation. Western end.

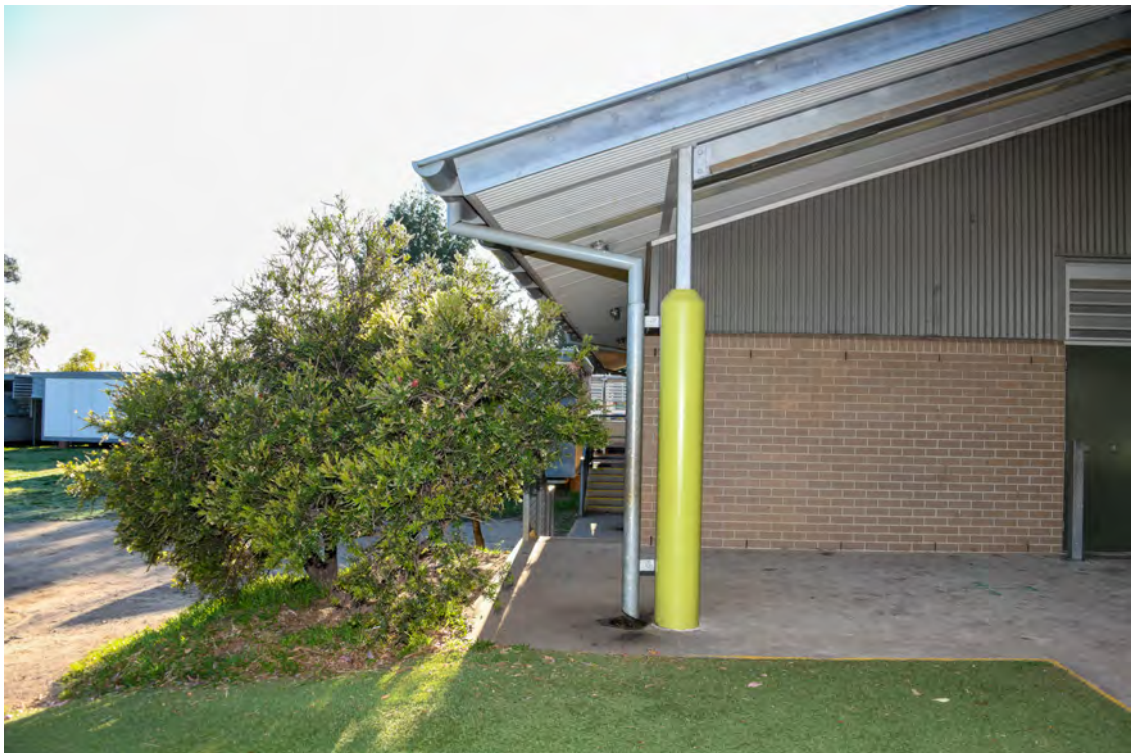
PRO\_0191.jpg

Block M / Hall / The Aurora Centre. North-western corner.

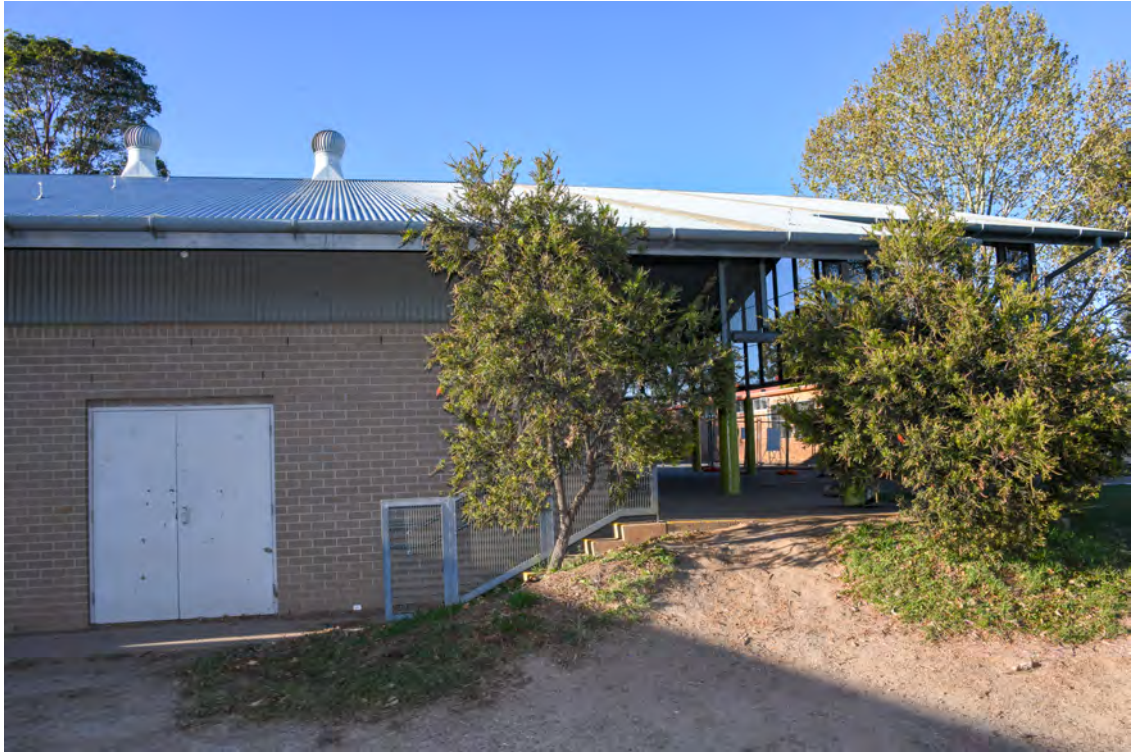
PRO\_0192.jpg

Block M / Hall / The Aurora Centre. Northern elevation.

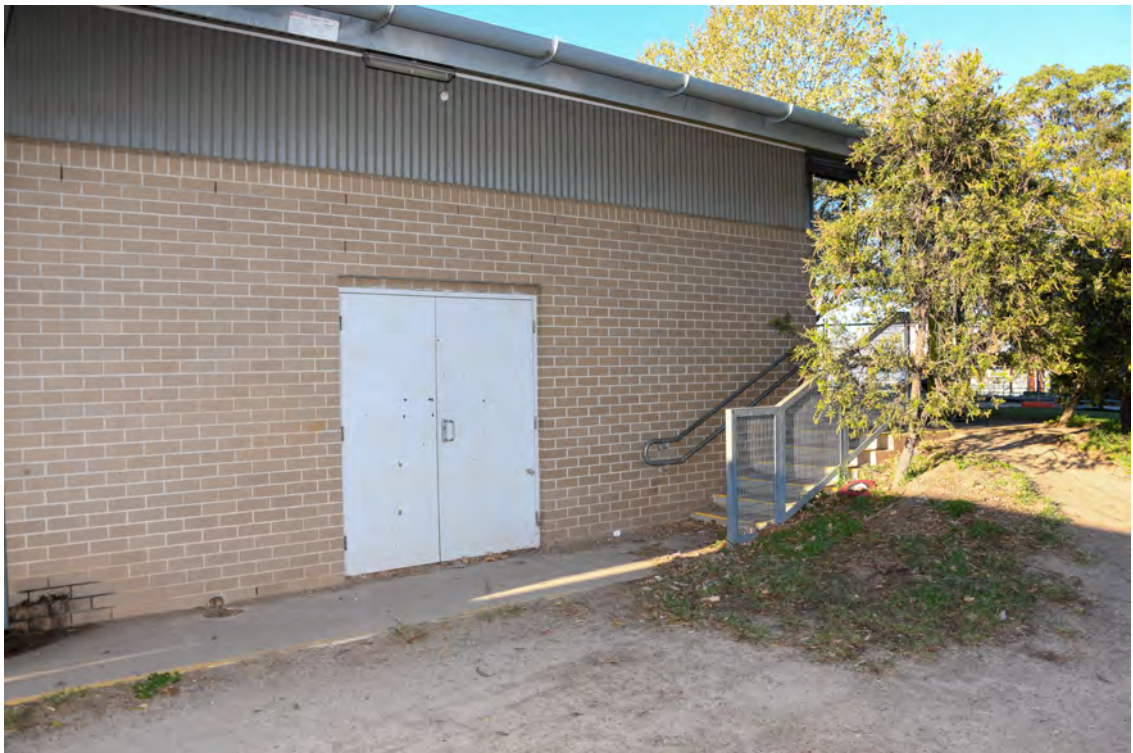
PRO\_0193.jpg

Block M / Hall / The Aurora Centre. Northern elevation. Western end.

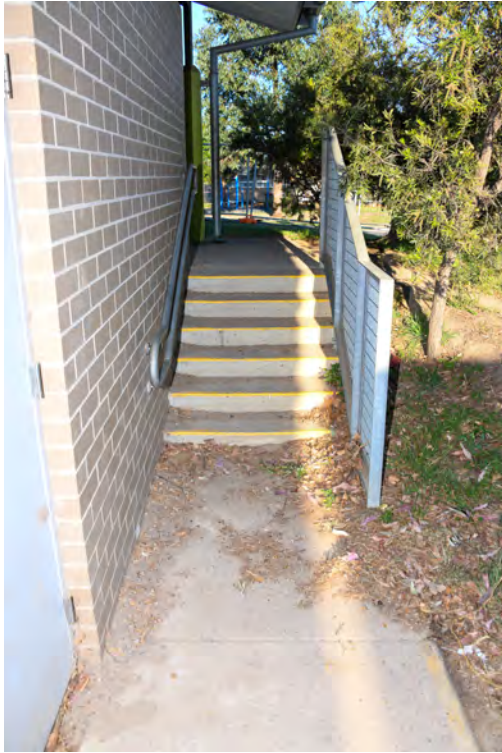
PRO\_0194.jpg

Block M / Hall / The Aurora Centre. Northern elevation. Western end.

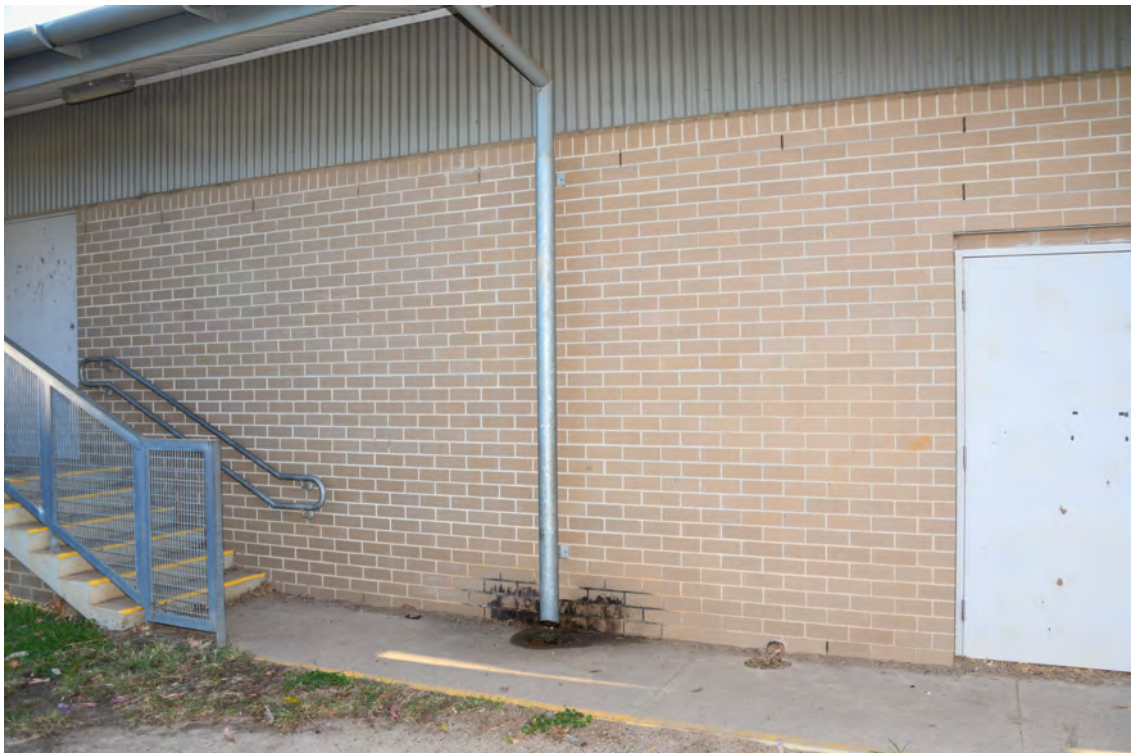
PRO\_0195.jpg

Block M / Hall / The Aurora Centre. Northern elevation. Western end.

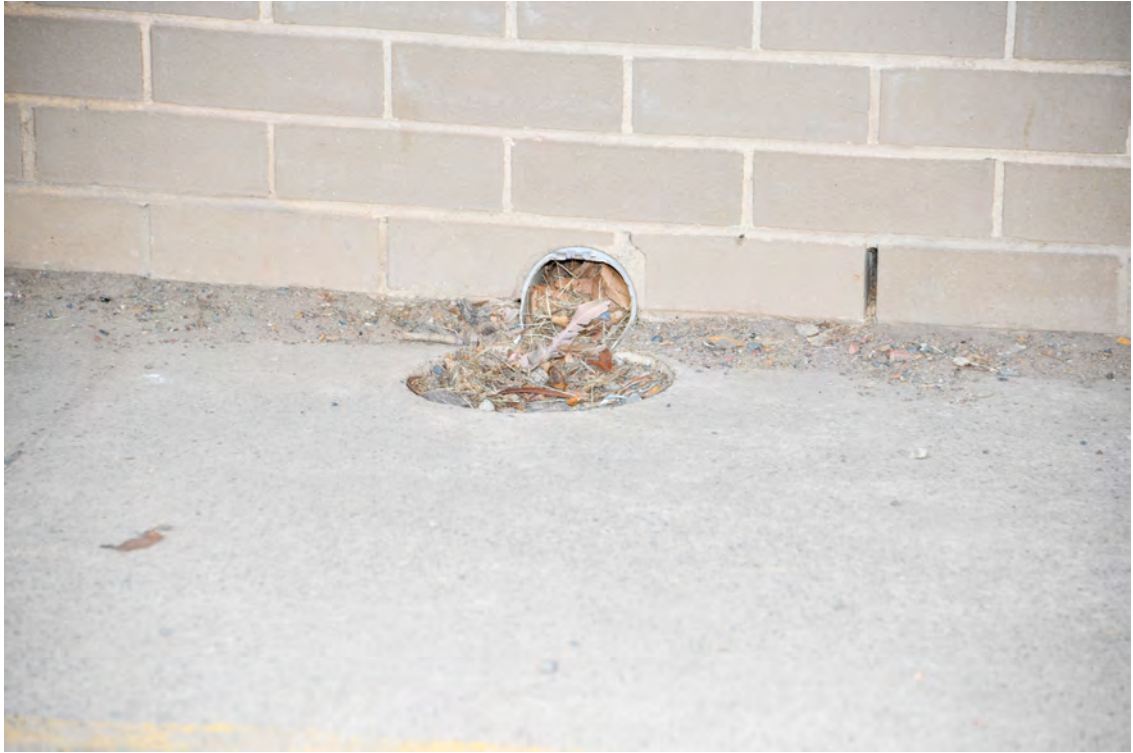
PRO\_0196.jpg

Block M / Hall / The Aurora Centre. Northern elevation. Western end.

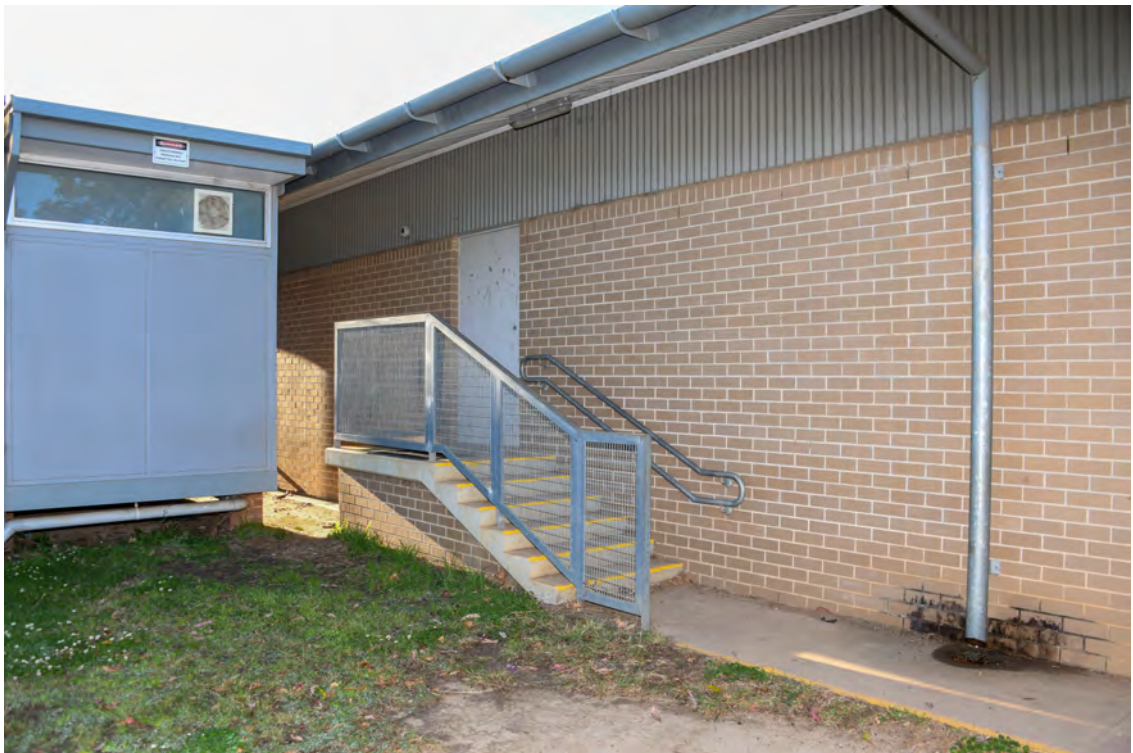
PRO\_0197.jpg

Block M / Hall / The Aurora Centre. Northern elevation. Heading east.

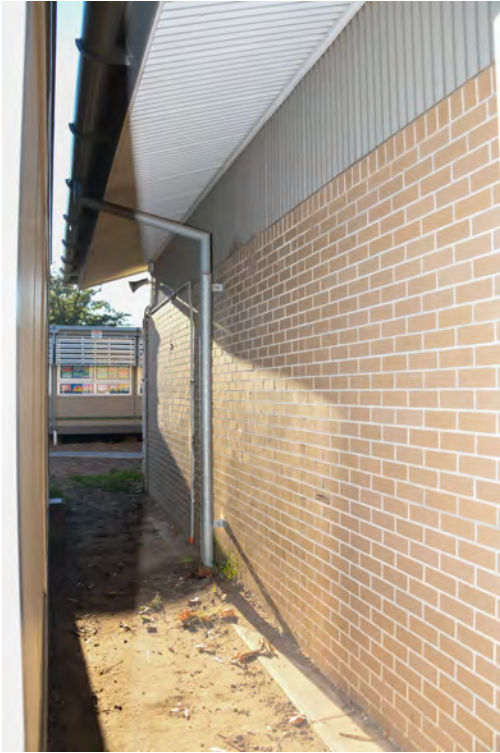
PRO\_0198.jpg

Block M / Hall / The Aurora Centre. Northern elevation. Heading east.

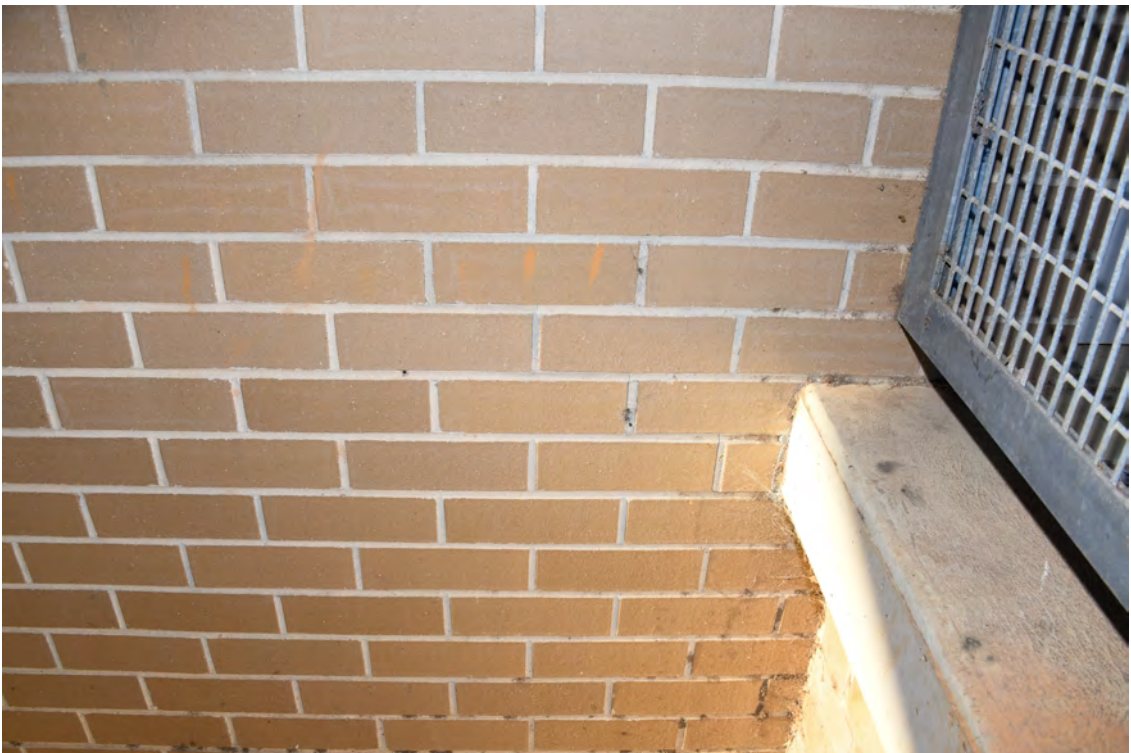
PRO\_0199.jpg

Block M / Hall / The Aurora Centre. Northern elevation. Heading east. Cracked mortar beds.

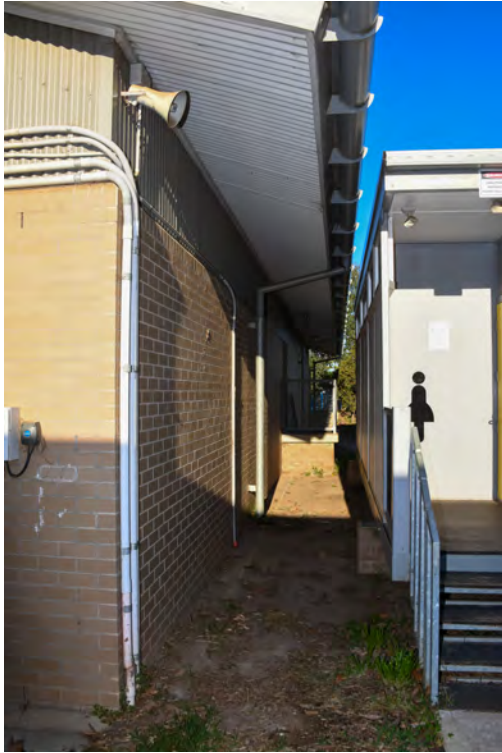
PRO\_0200.jpg

Block M / Hall / The Aurora Centre. Northern elevation. Heading west.

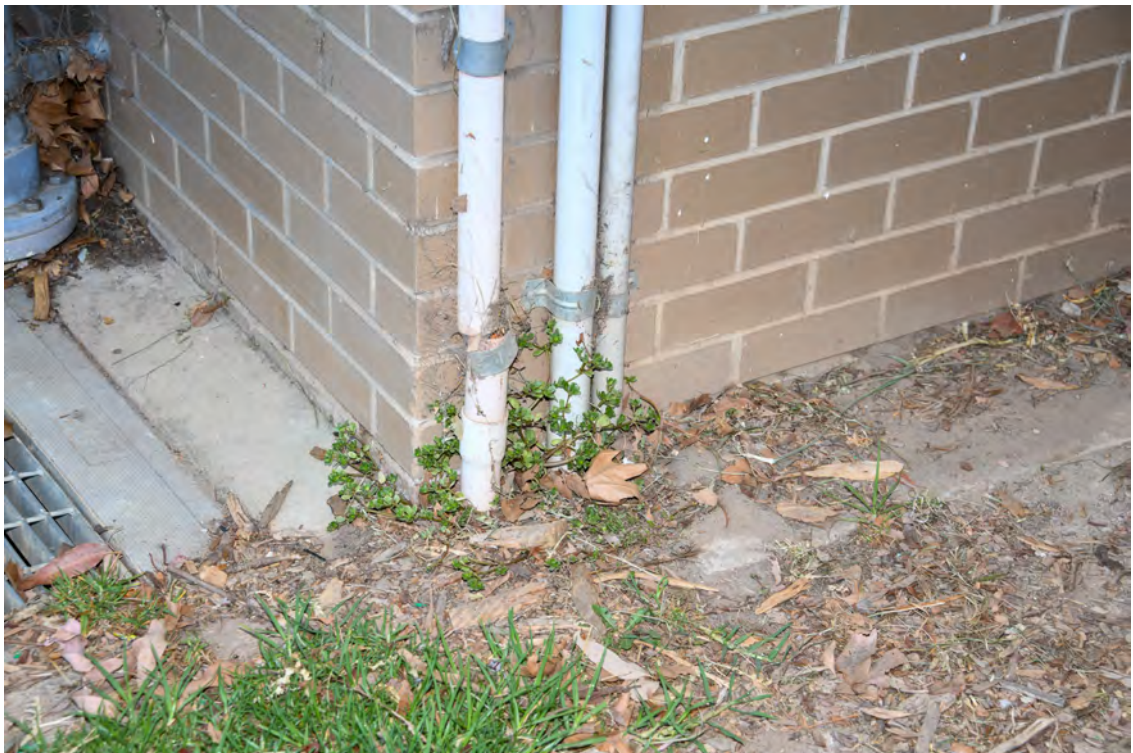
PRO\_0201.jpg

Block M / Hall / The Aurora Centre. North-western corner.
