96-104 Carlingford Road, Epping NSW 2121

Epping West Public School

DILAPIDATION REPORT

7<sup>th</sup> September 2021

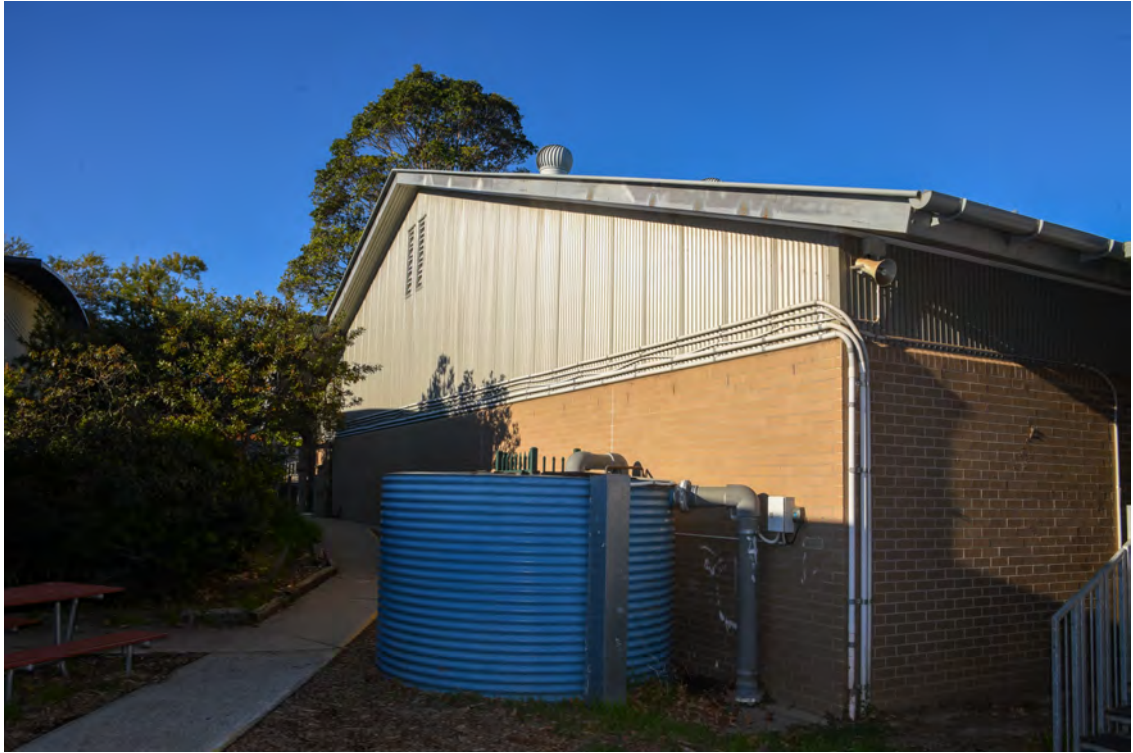
PRO\_0202.jpg

Block M / Hall / The Aurora Centre. Eastern elevation.

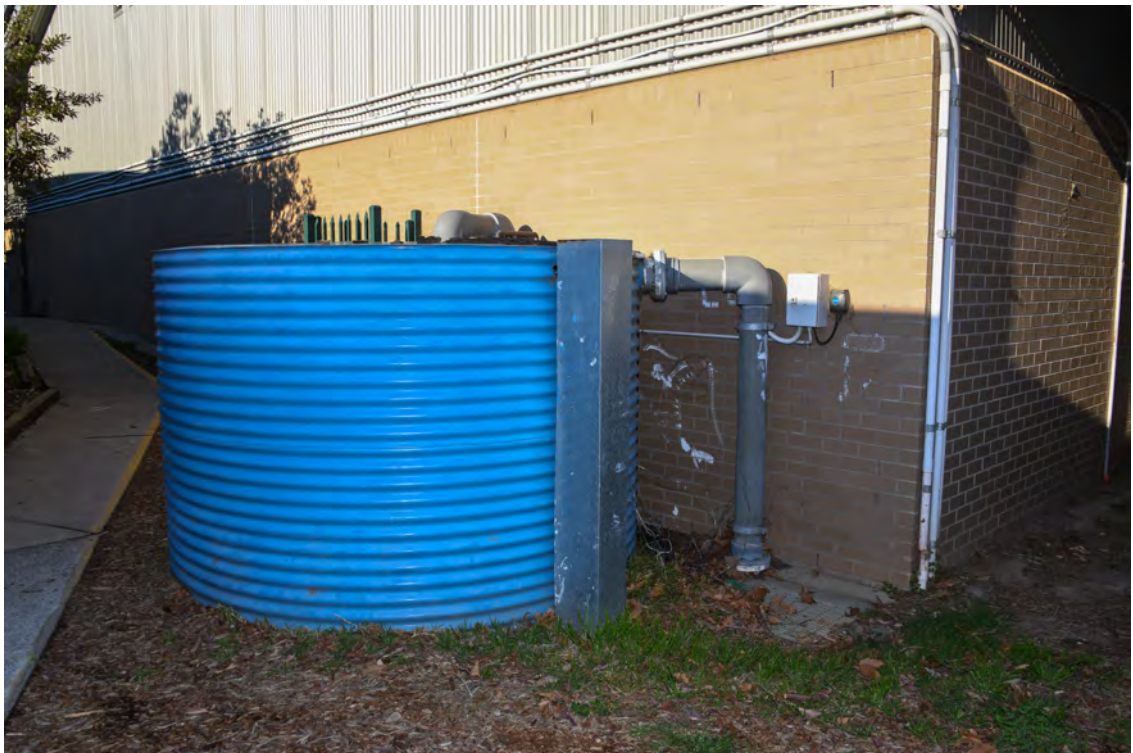
PRO\_0203.jpg

Block M / Hall / The Aurora Centre. Eastern elevation. Northern end. Water tank.

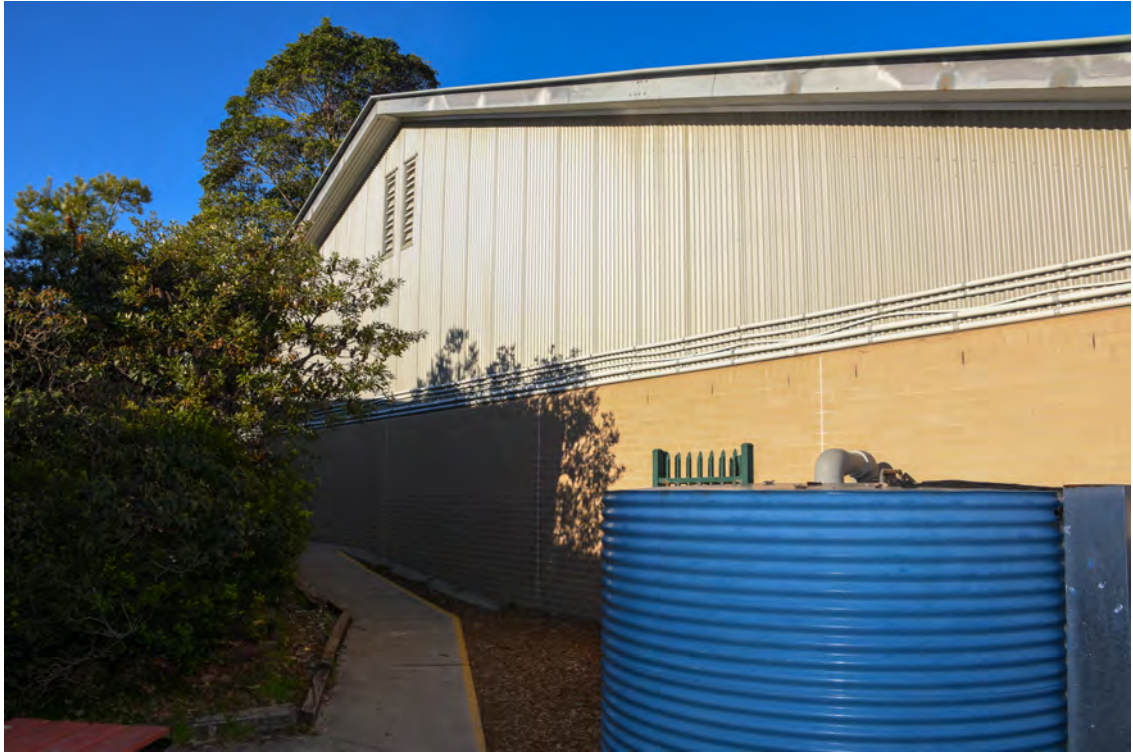
PRO\_0204.jpg

Block M / Hall / The Aurora Centre. Eastern elevation.

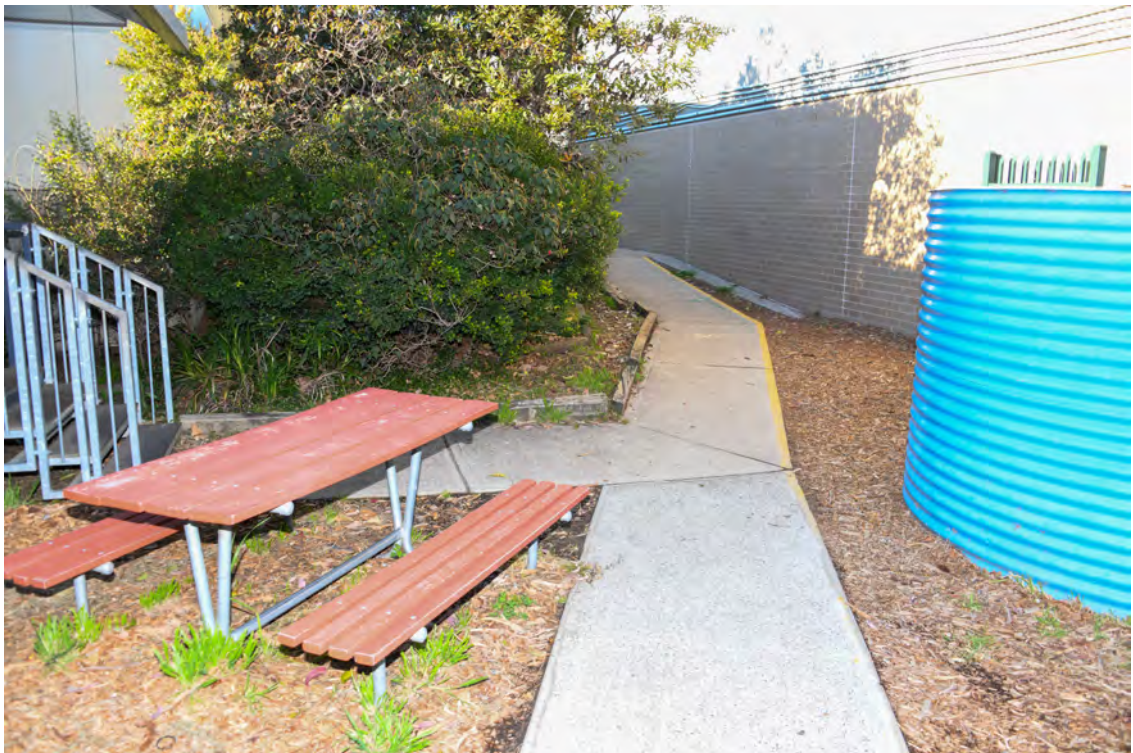
PRO\_0205.jpg

Block M / Hall / The Aurora Centre. Eastern elevation. Heading south.

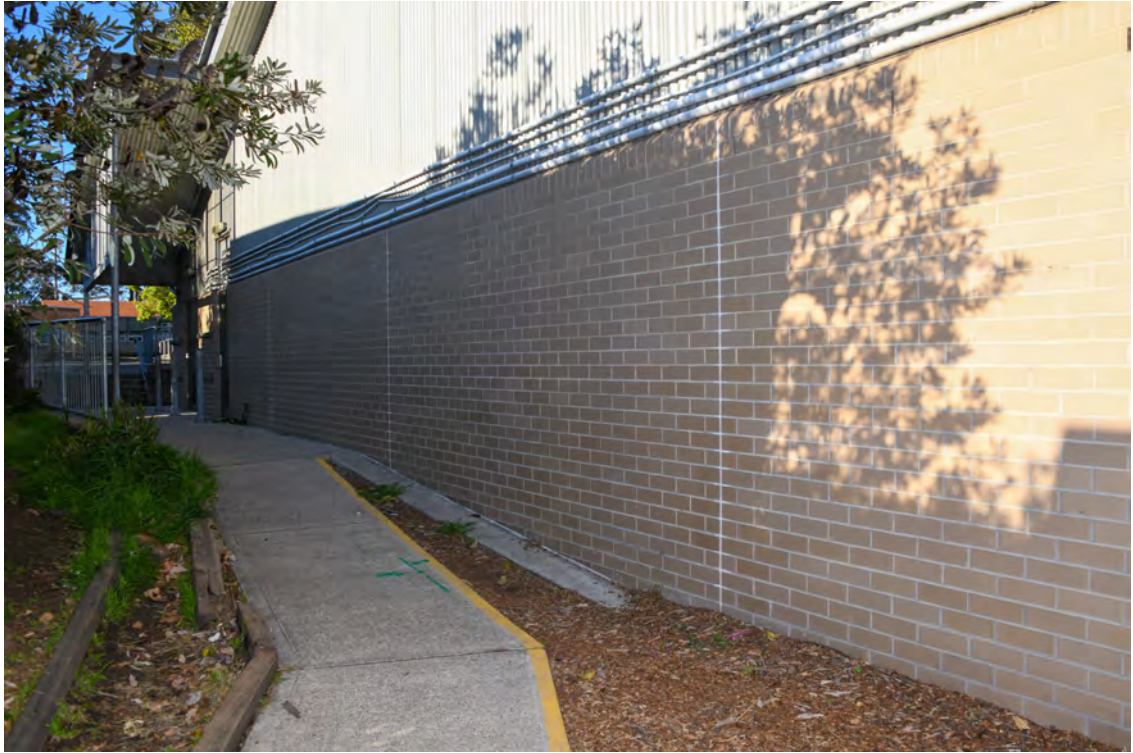
PRO\_0206.jpg

Block M / Hall / The Aurora Centre. Eastern elevation. Heading south.

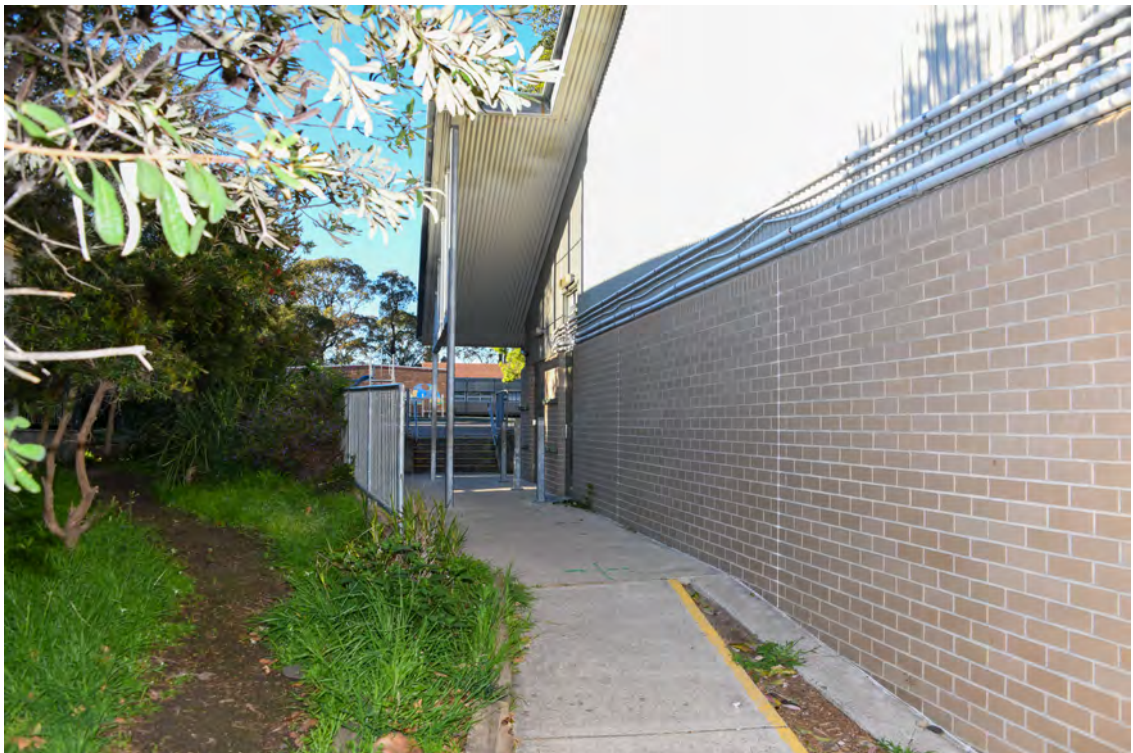
PRO\_0207.jpg

Block M / Hall / The Aurora Centre. Eastern elevation. Heading south.

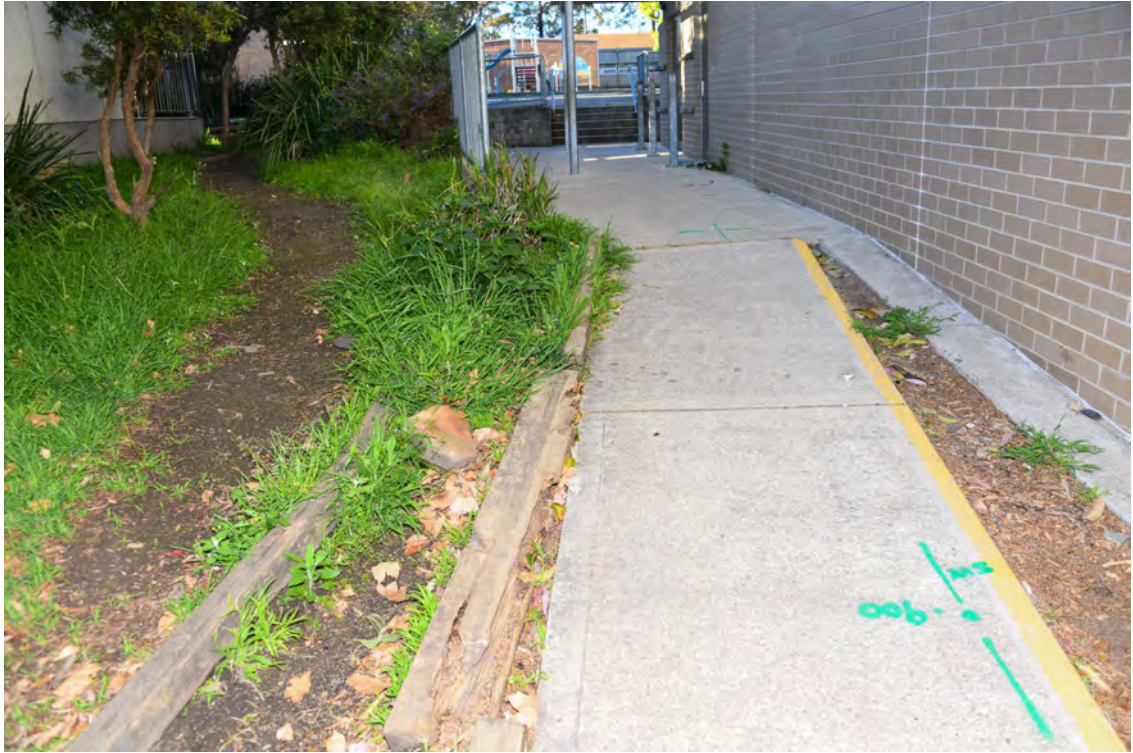
PRO\_0208.jpg

Block M / Hall / The Aurora Centre. Eastern elevation. Heading south.

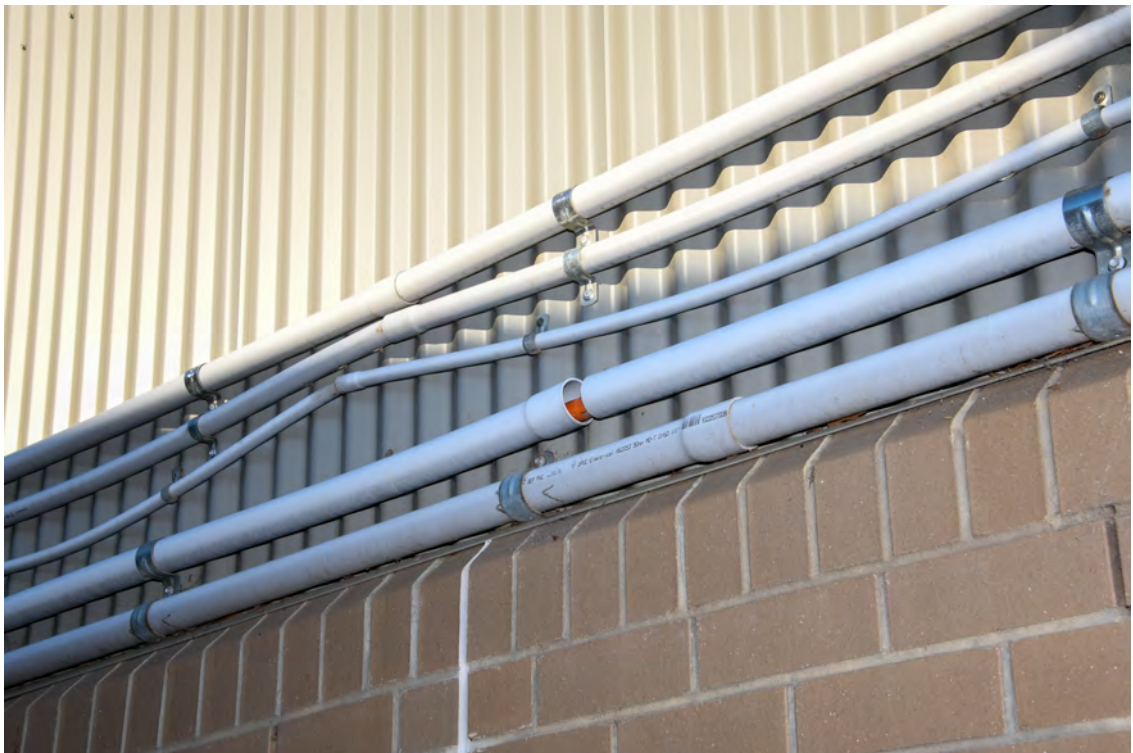
PRO\_0209.jpg

Block M / Hall / The Aurora Centre. Eastern elevation. Heading south. Gap in the electrical conduit.

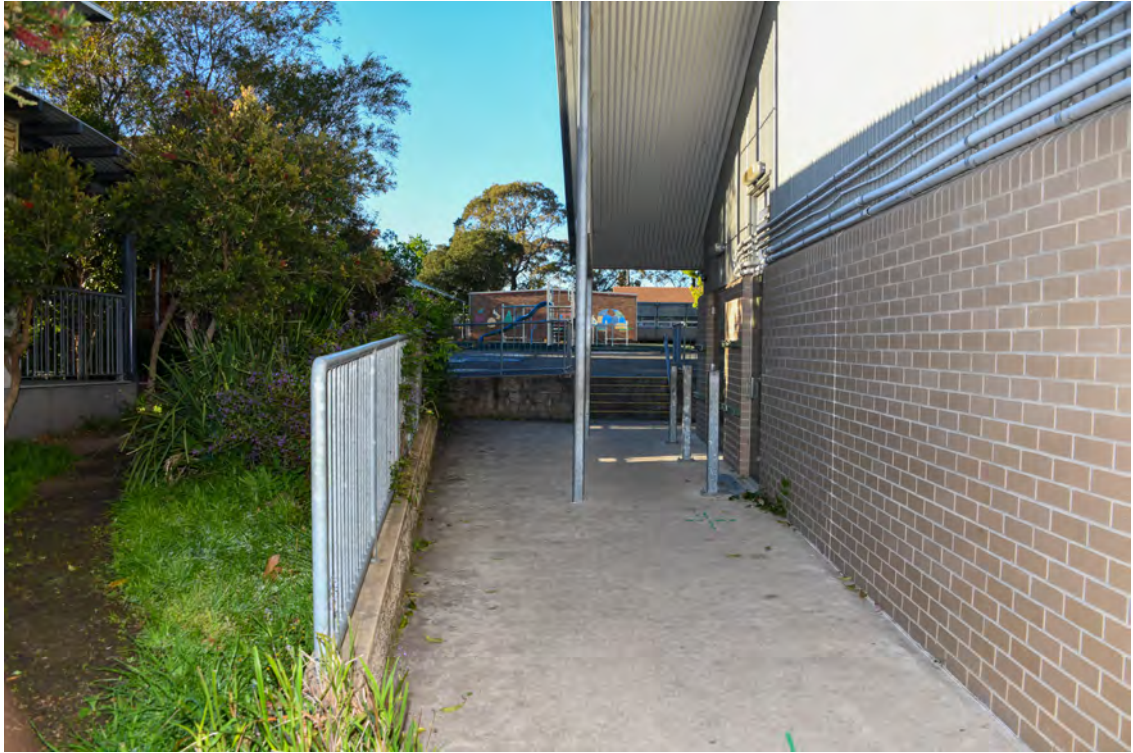
PRO\_0210.jpg

Block M / Hall / The Aurora Centre. Eastern elevation. Heading south.

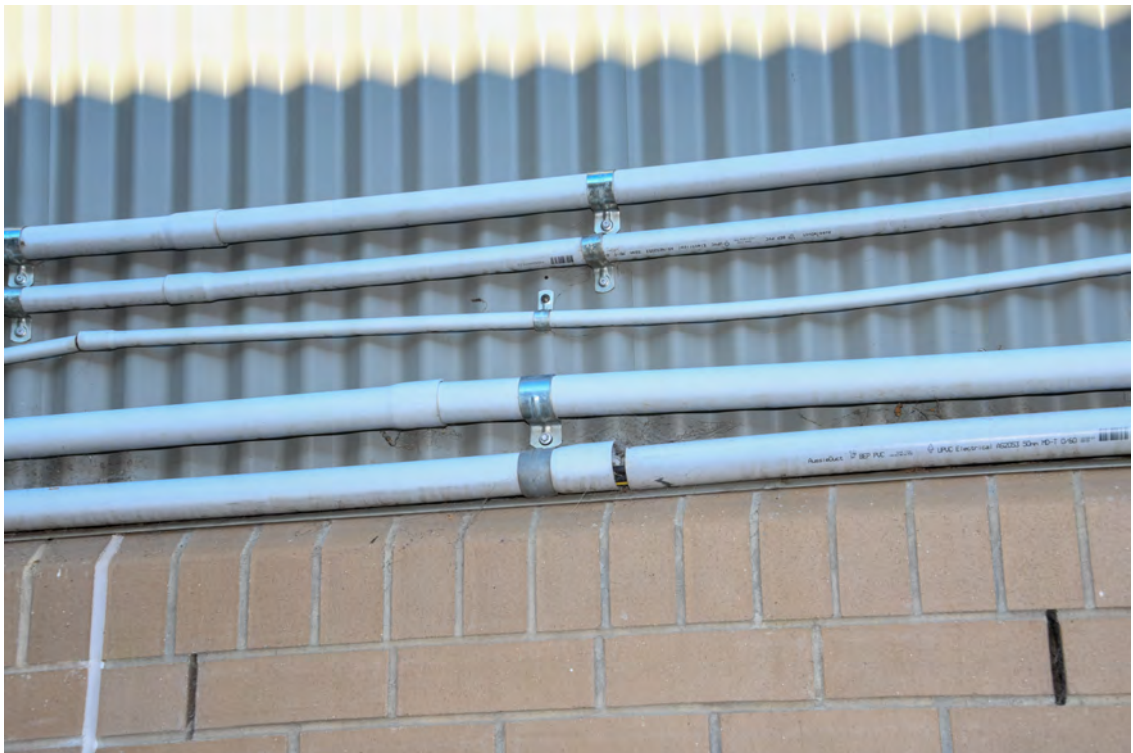
PRO\_0211.jpg

Block M / Hall / The Aurora Centre. Eastern elevation. Heading south. Gap in the electrical conduit.

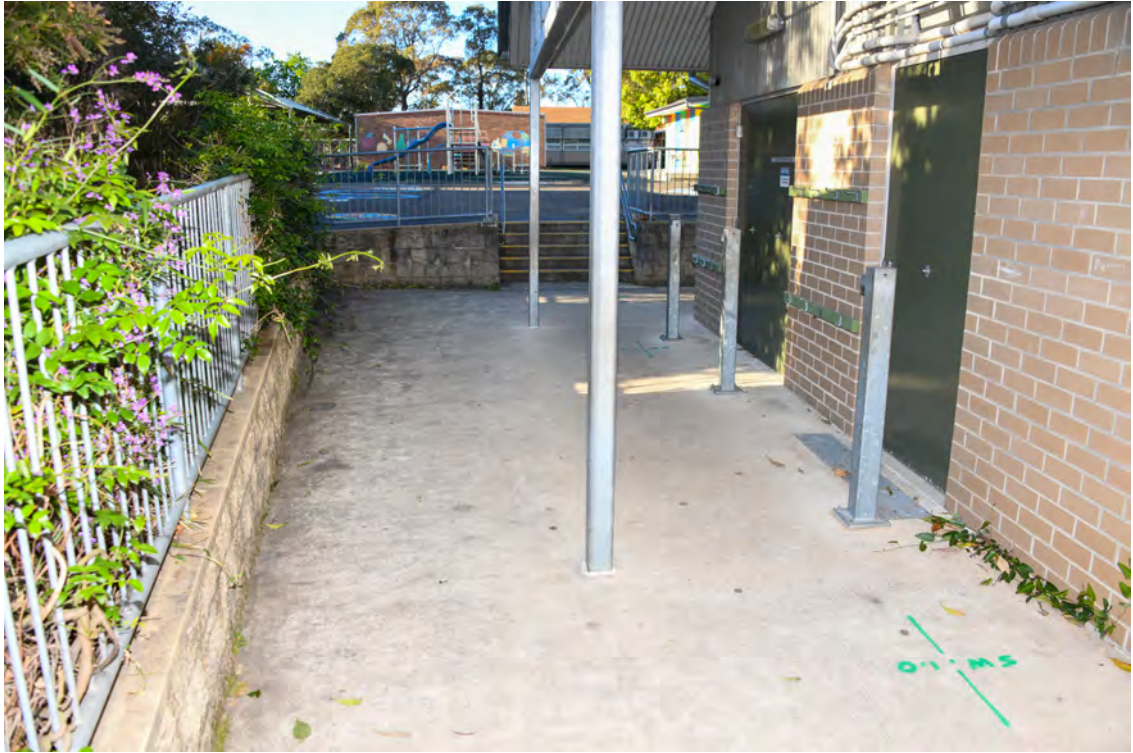
PRO\_0212.jpg

Block M / Hall / The Aurora Centre. Eastern elevation. Heading south.

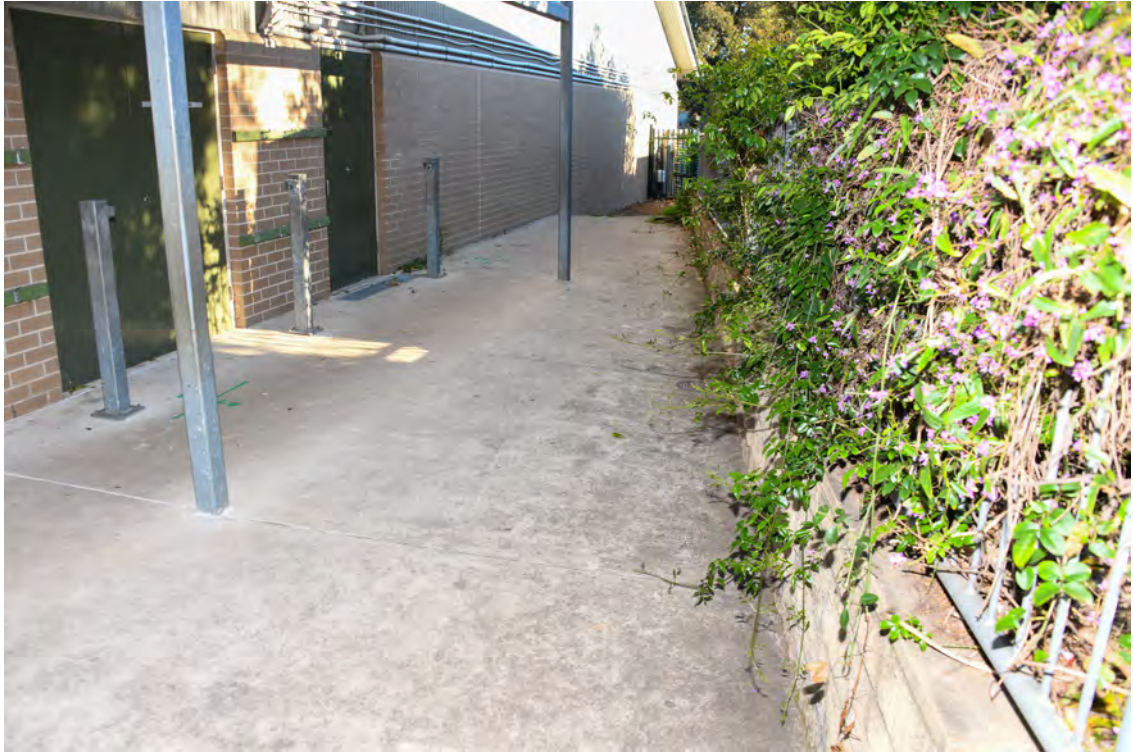
PRO\_0216.jpg

Block M / Hall / The Aurora Centre. Eastern elevation. Southern end. Adjacent concrete paving.

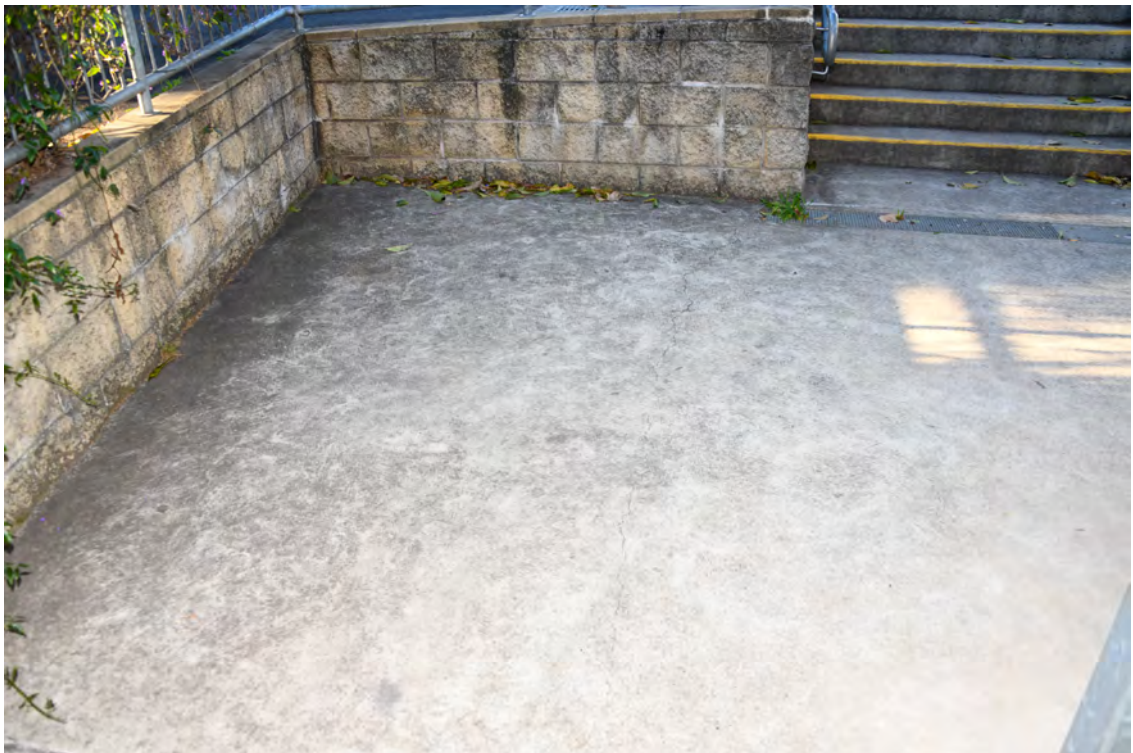
PRO\_0219.jpg

Block M / Hall / The Aurora Centre. Eastern elevation. Southern end. Adjacent concrete paving. Cracked paving.

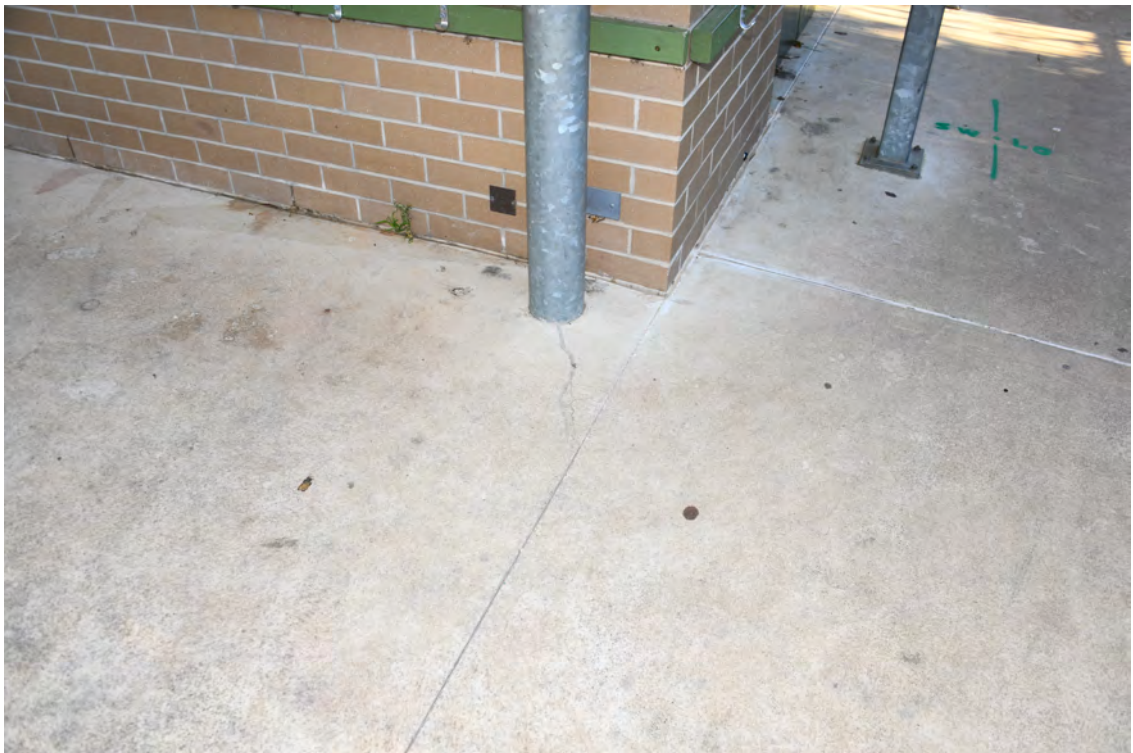
PRO\_0221.jpg

Block M / Hall / The Aurora Centre. Southern elevation. Eastern end. Cracked paving.

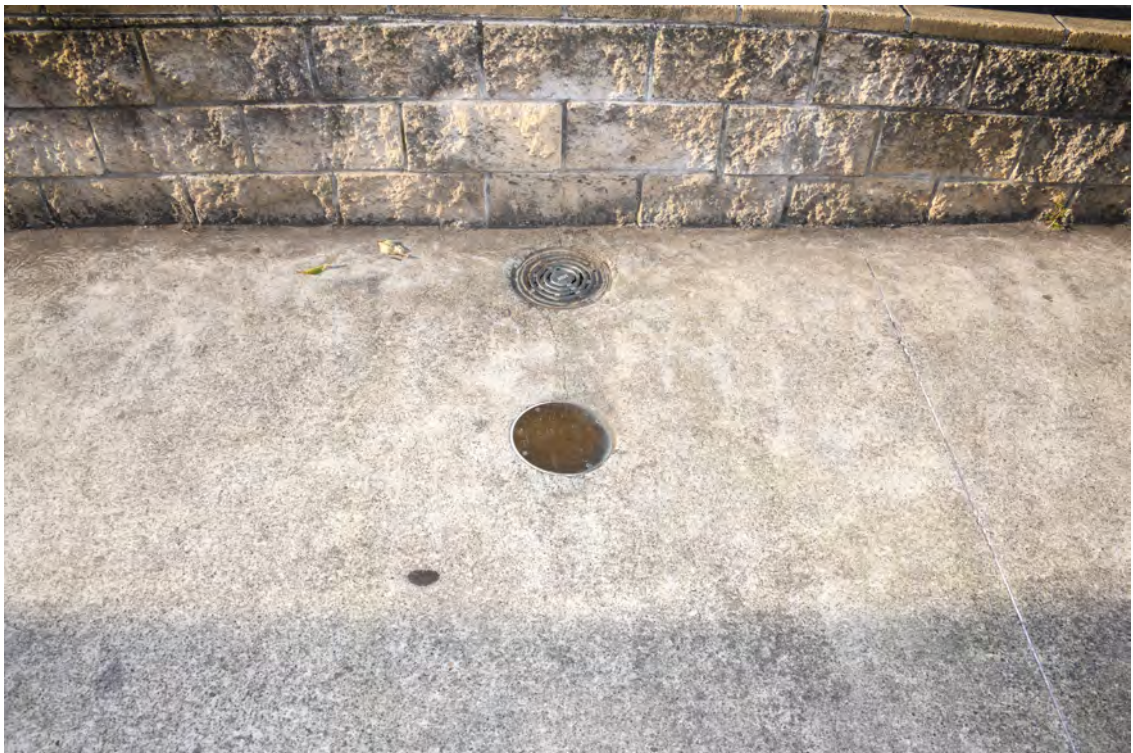
PRO\_0233.jpg

Block M / Hall / The Aurora Centre. Southern elevation. Facing east along the paving and retaining wall. Cracked paving.

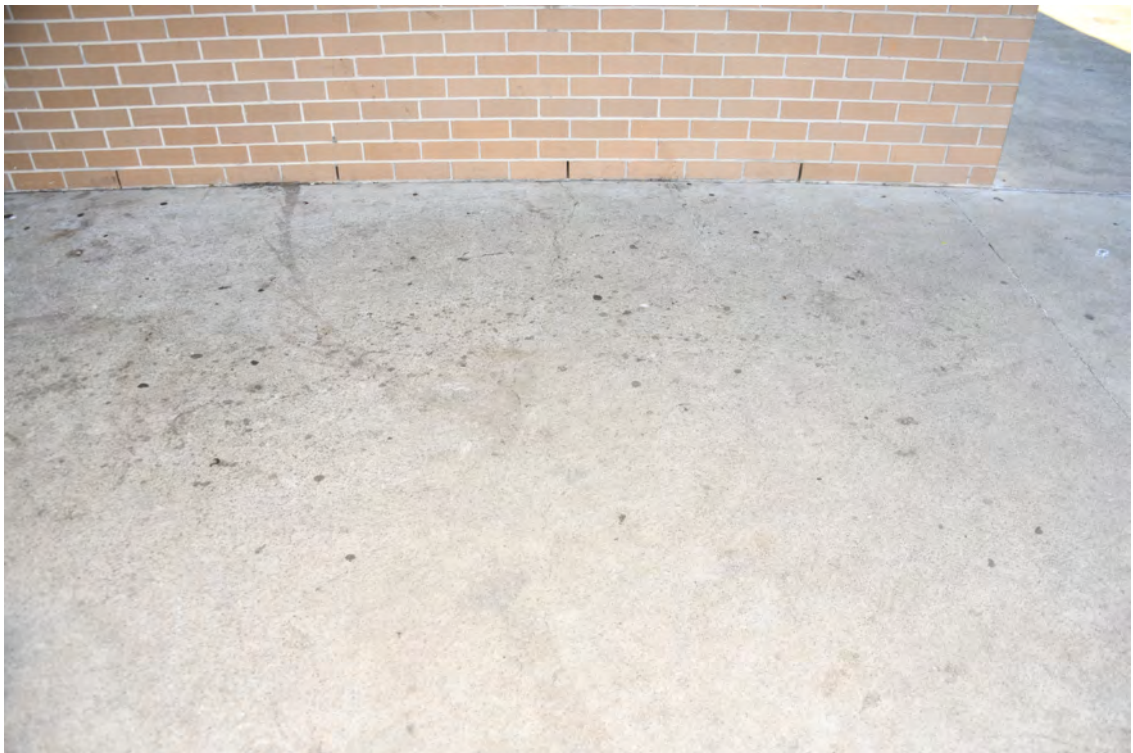
PRO\_0241.jpg

Block M / Hall / The Aurora Centre. Western elevation. COLA. Cracked paving.

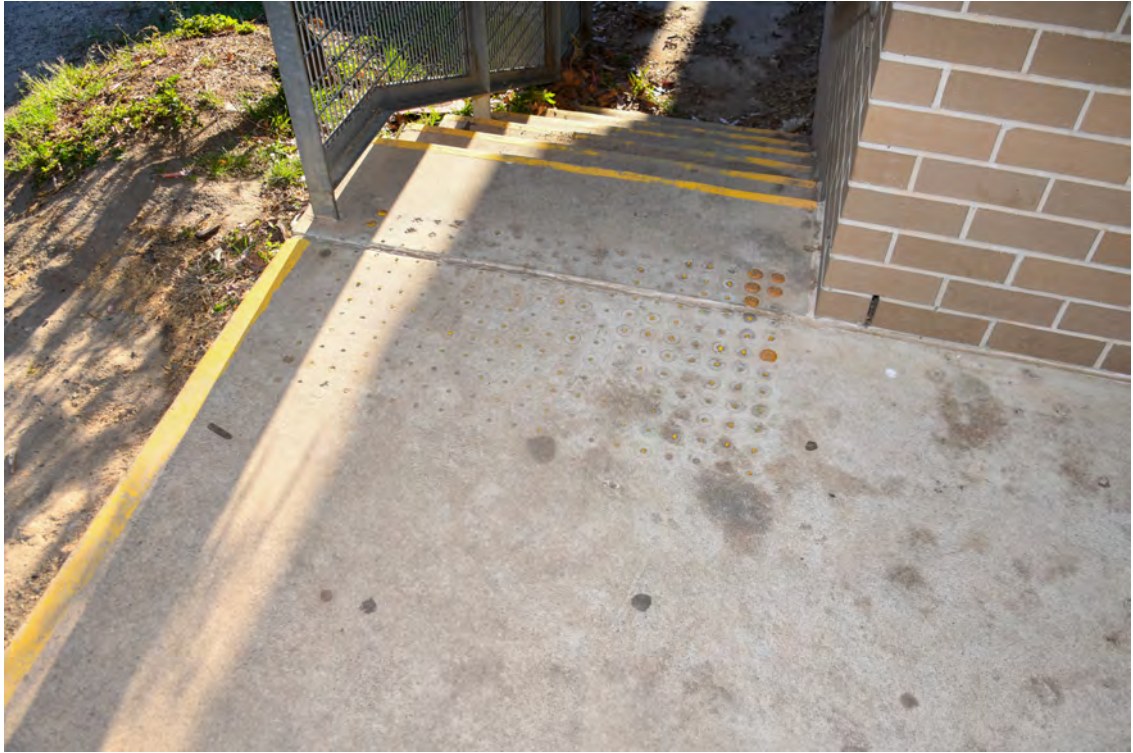
PRO\_0252.jpg

Block M / Hall / The Aurora Centre. Western elevation. COLA. Northern end. Dislodged 'tactiles'.

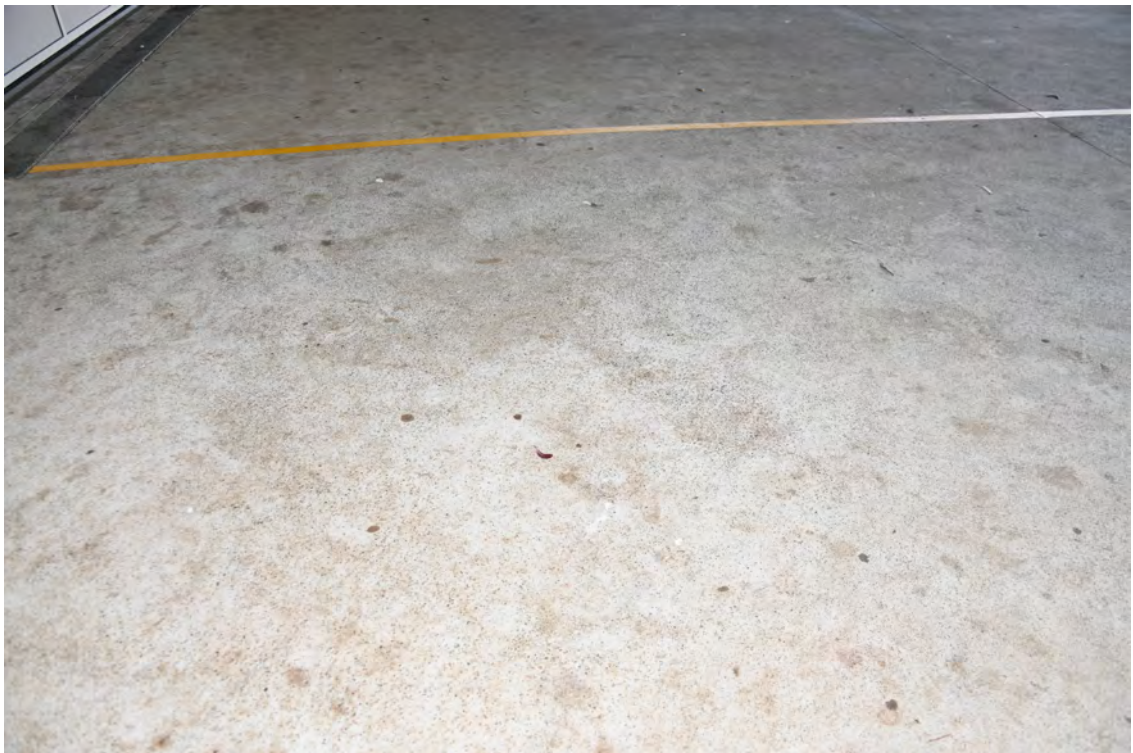
PRO\_0255.jpg

Block M / Hall / The Aurora Centre. COLA. Record of the concrete paving. Cracked paving.

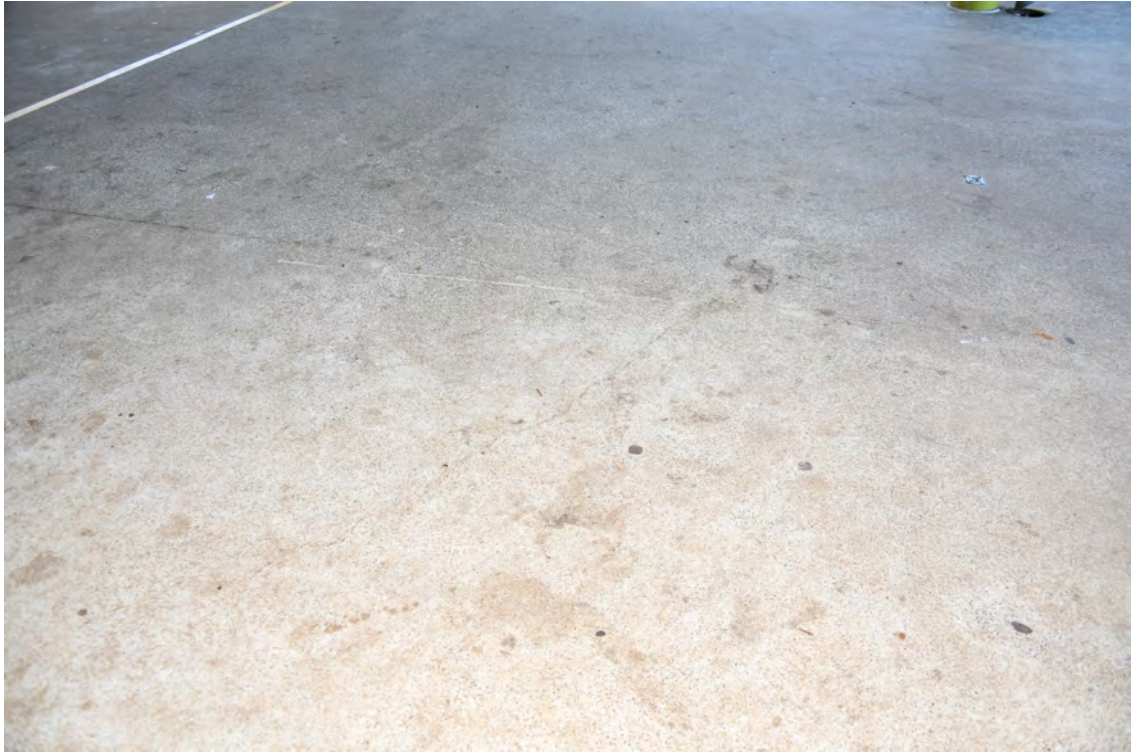
PRO\_0256.jpg

Block M / Hall / The Aurora Centre. COLA. Record of the concrete paving. Cracked paving.

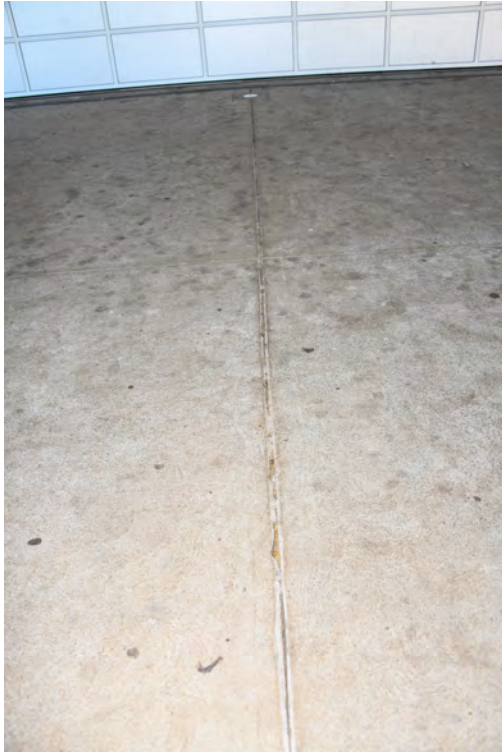
PRO\_0266.jpg

Block M / Hall / The Aurora Centre. COLA. Record of the concrete paving. Control joint in the paving.

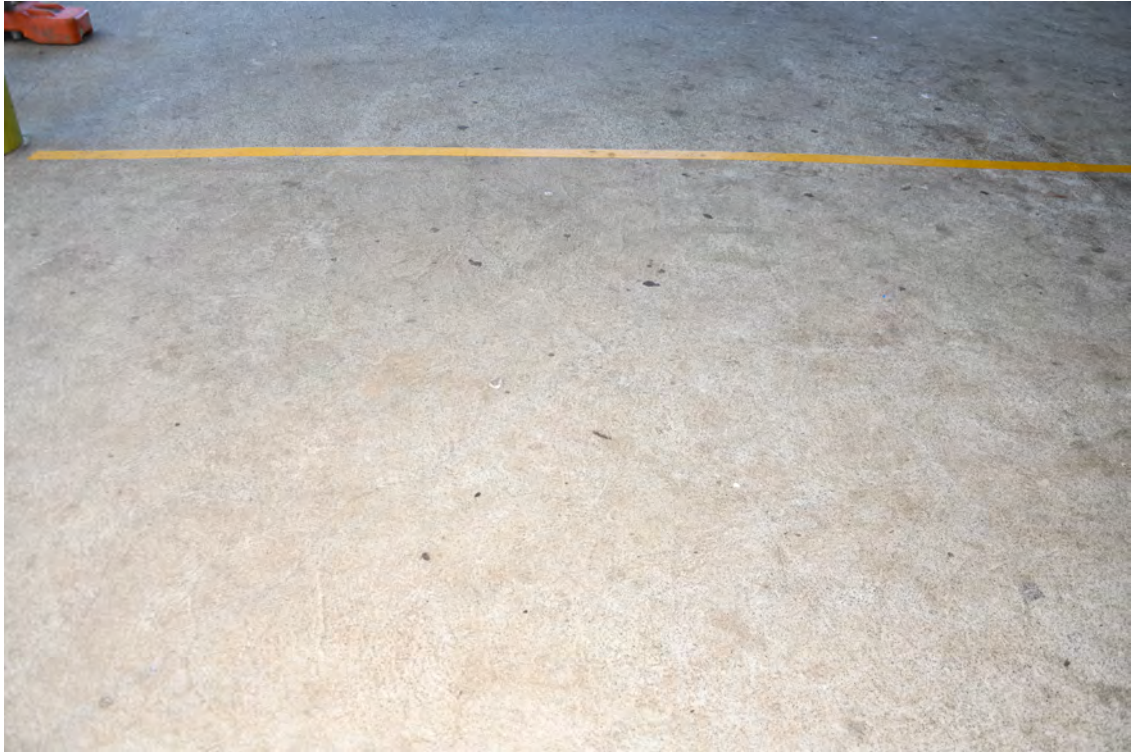
PRO\_0268.jpg

Block M / Hall / The Aurora Centre. COLA. Record of the concrete paving. Cracked paving.

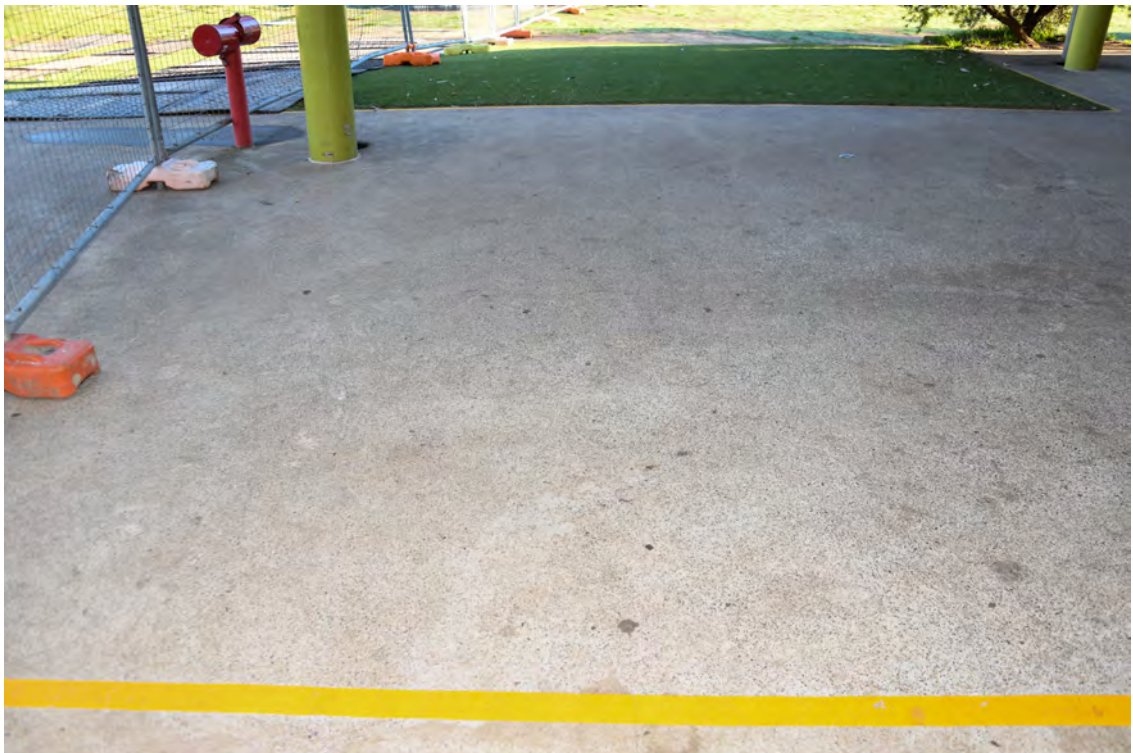
PRO\_0269.jpg

Block M / Hall / The Aurora Centre. COLA. Record of the concrete paving. Cracked paving.

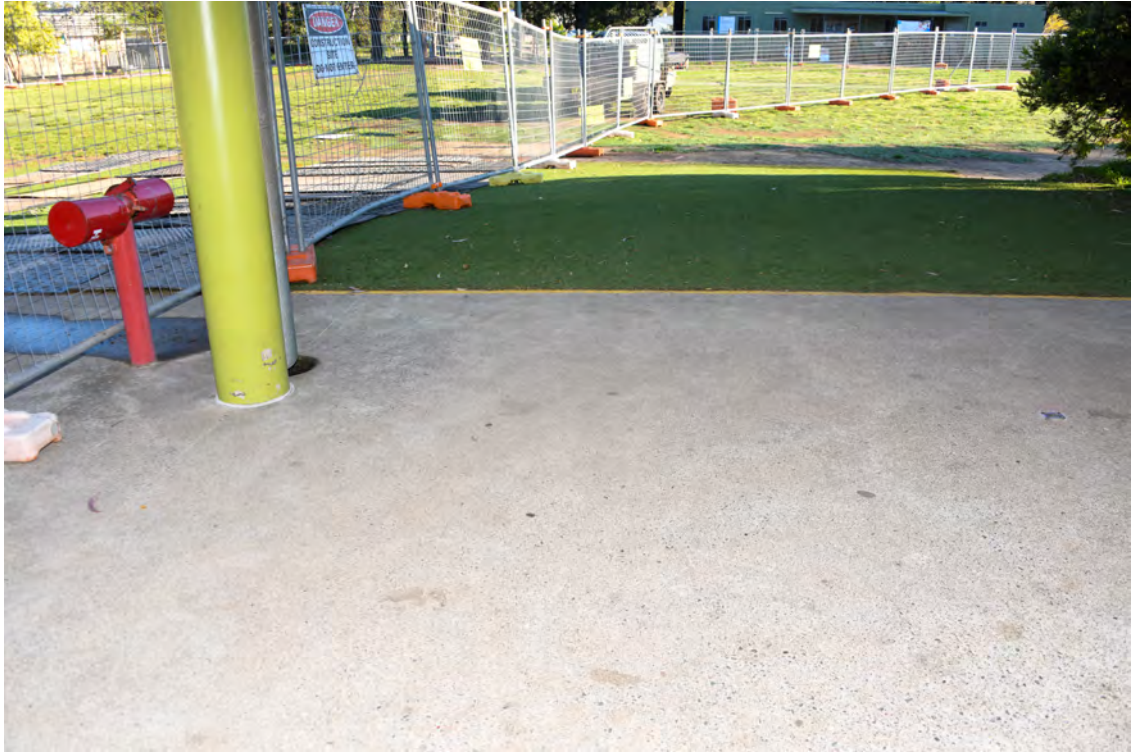
PRO\_0270.jpg

Block M / Hall / The Aurora Centre. COLA. Record of the concrete paving. Cracked paving.

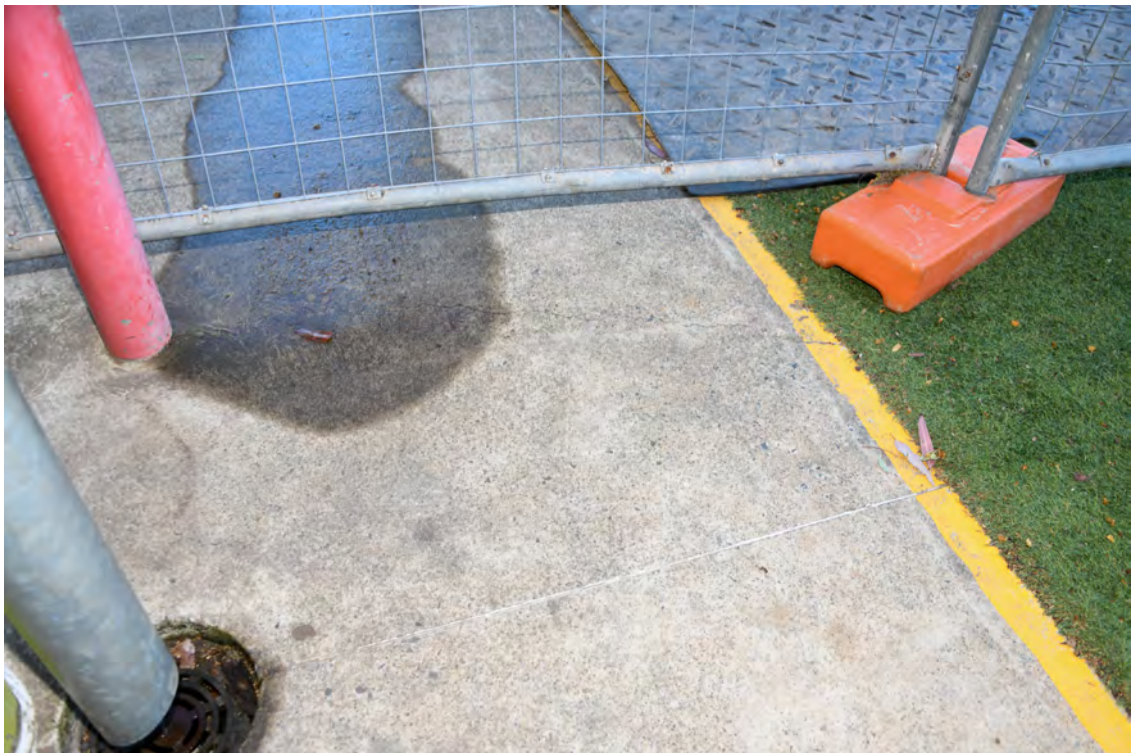
PRO\_0271.jpg

Block M / Hall / The Aurora Centre. COLA. Record of the concrete paving. Cracked paving.

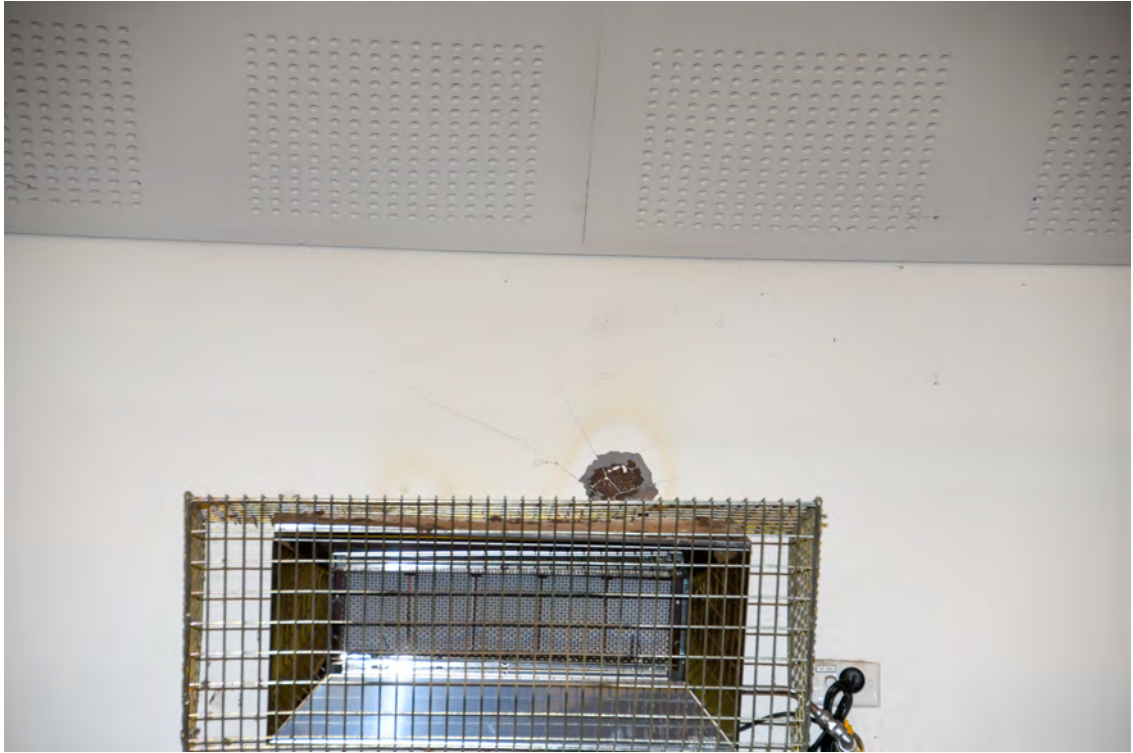
PRO\_0680.jpg

Block M / Hall / The Aurora Centre. Interior. Northern face. Damaged wall above the heater.

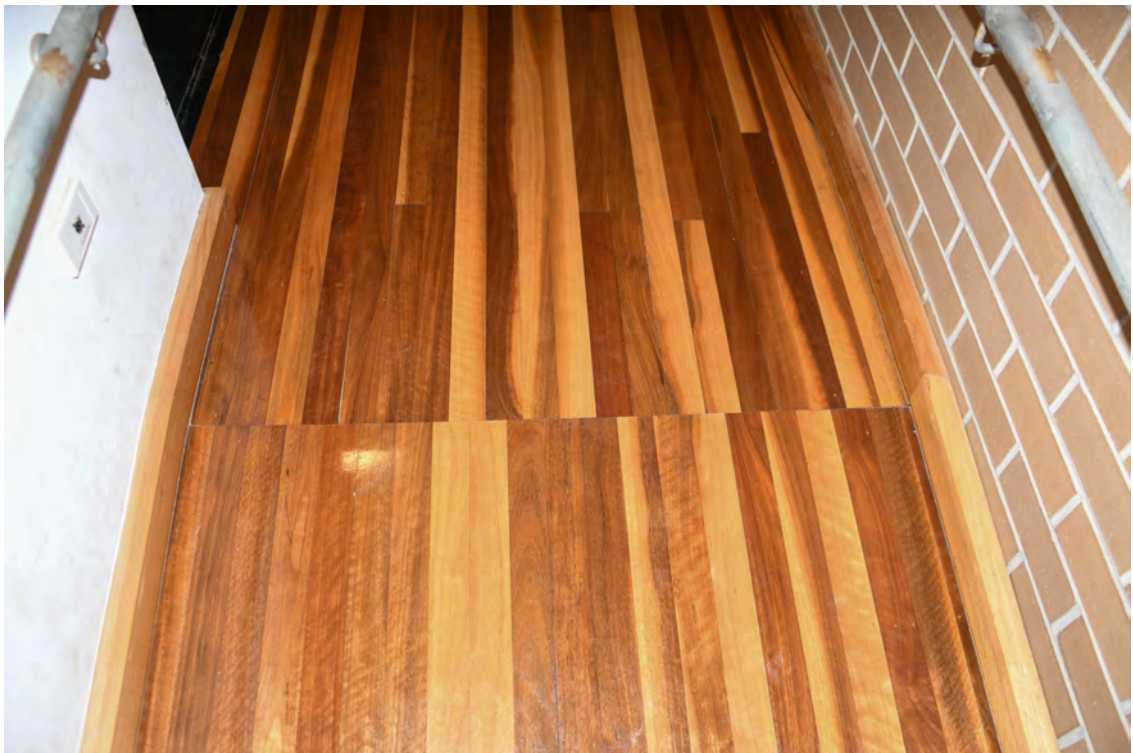
PRO\_0694.jpg

Block M / Hall / The Aurora Centre. Interior. Eastern face. Heading south. Movement at the join in the flooring.

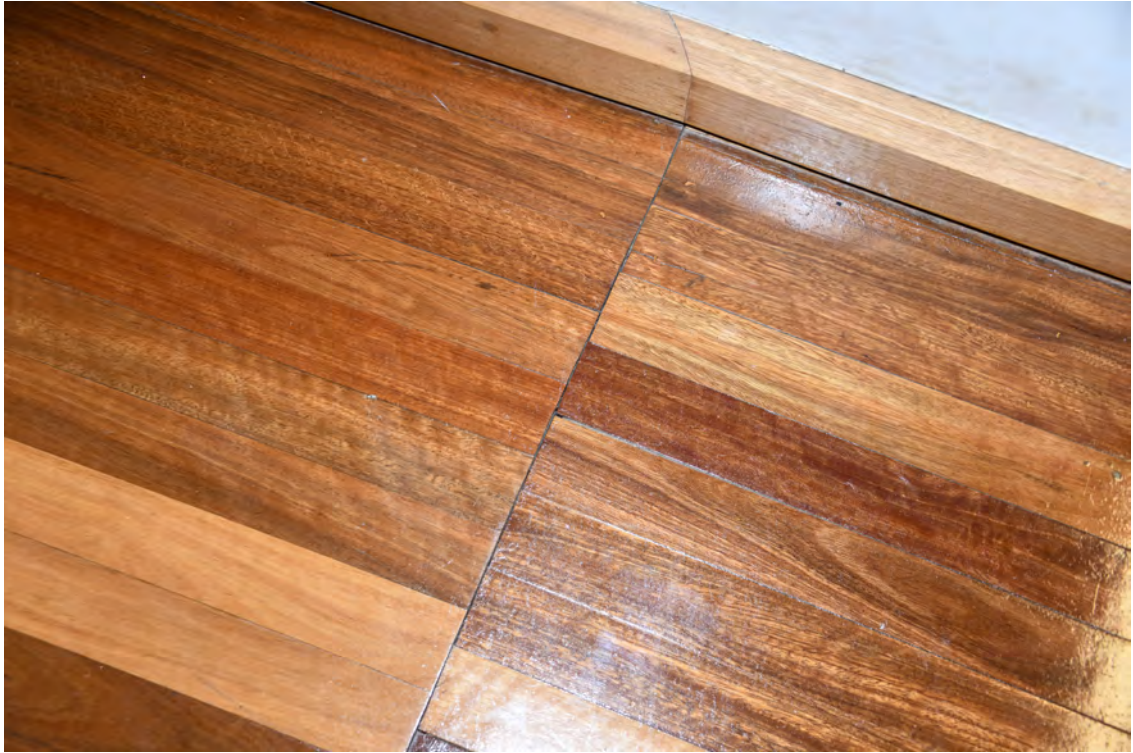
PRO\_0695.jpg

Block M / Hall / The Aurora Centre. Interior. Eastern face. Heading south. Movement at the join in the flooring.
