96-104 Carlingford Road, Epping NSW 2121

Epping West Public School

DILAPIDATION REPORT

7<sup>th</sup> September 2021

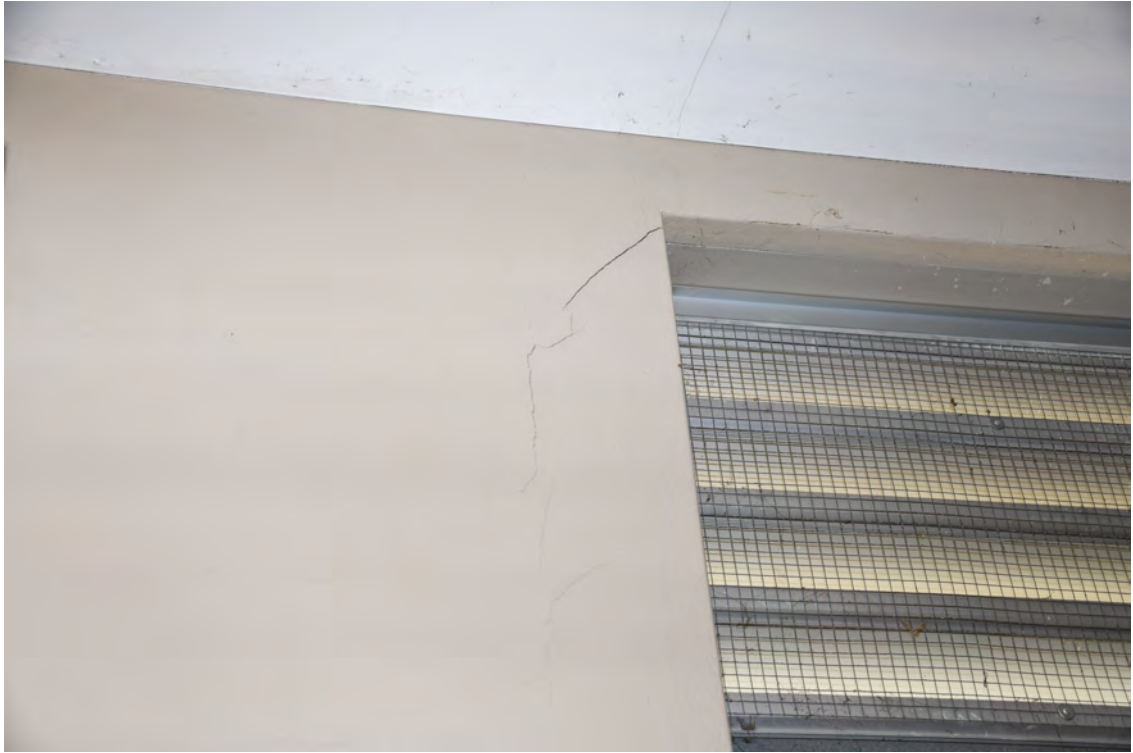
PRO\_0708.jpg

Block M / Hall / The Aurora Centre. Interior. Southern face. Boys Change Room.  
Cracked southern face.

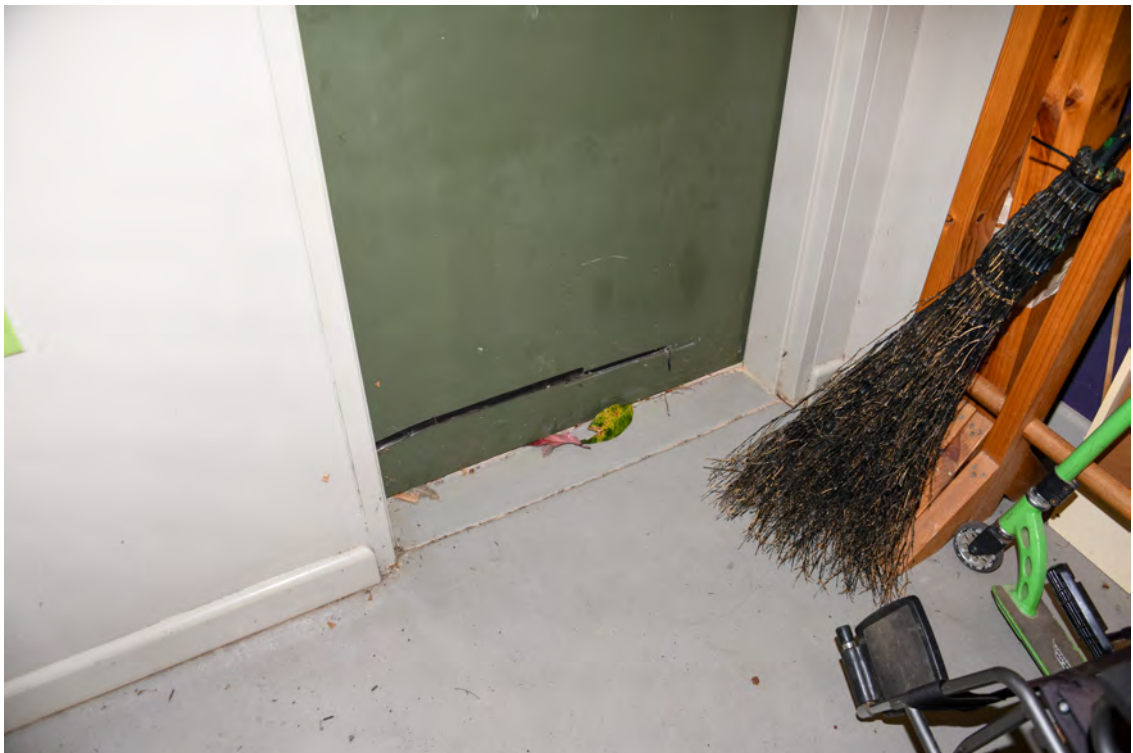
PRO\_0709.jpg

Block M / Hall / The Aurora Centre. Interior. Southern face. Boys Change Room.  
Southern face. Damage to the base of the door.

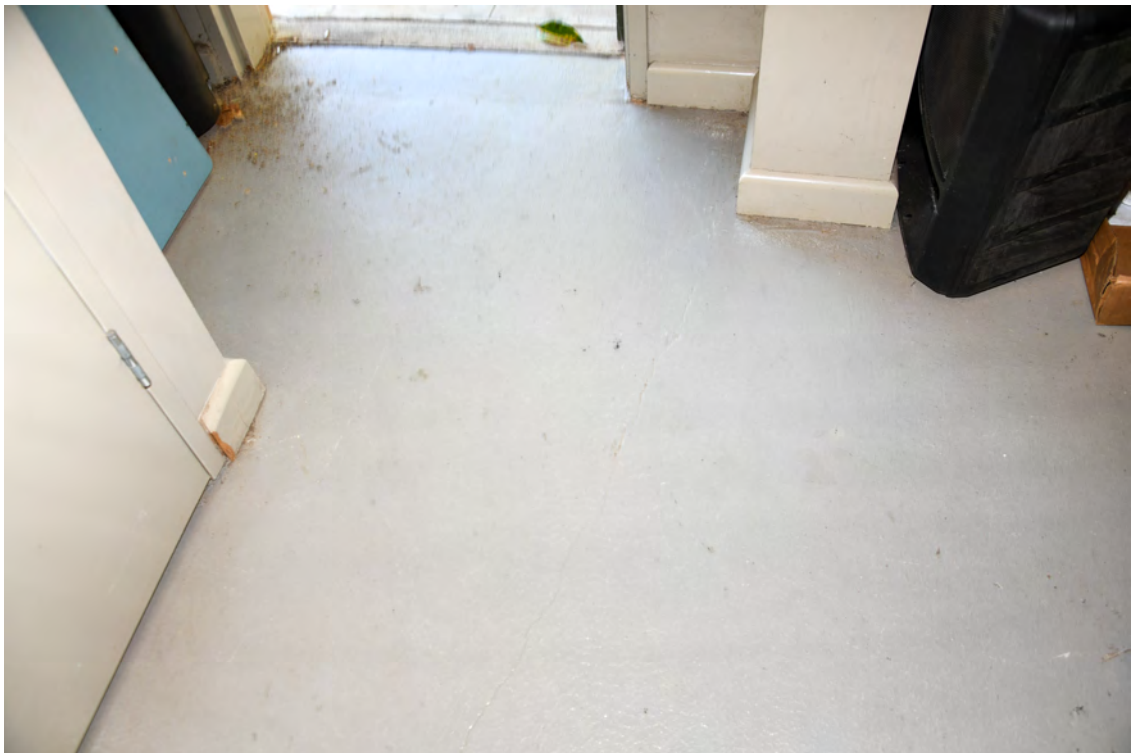
PRO\_0727.jpg

Block M / Hall / The Aurora Centre. Interior. Southern face. Girls Change Room.  
Cracked flooring.

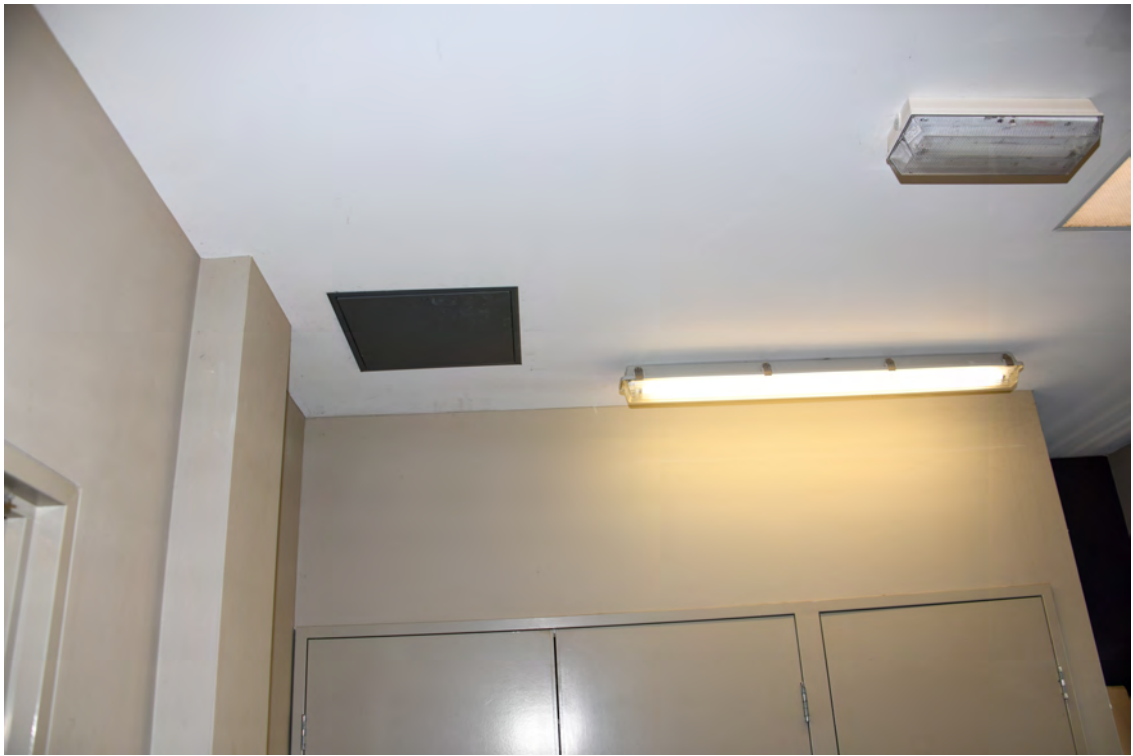
PRO\_0733.jpg

Block M / Hall / The Aurora Centre. Interior. Southern face. Girls Change Room. Ceiling.

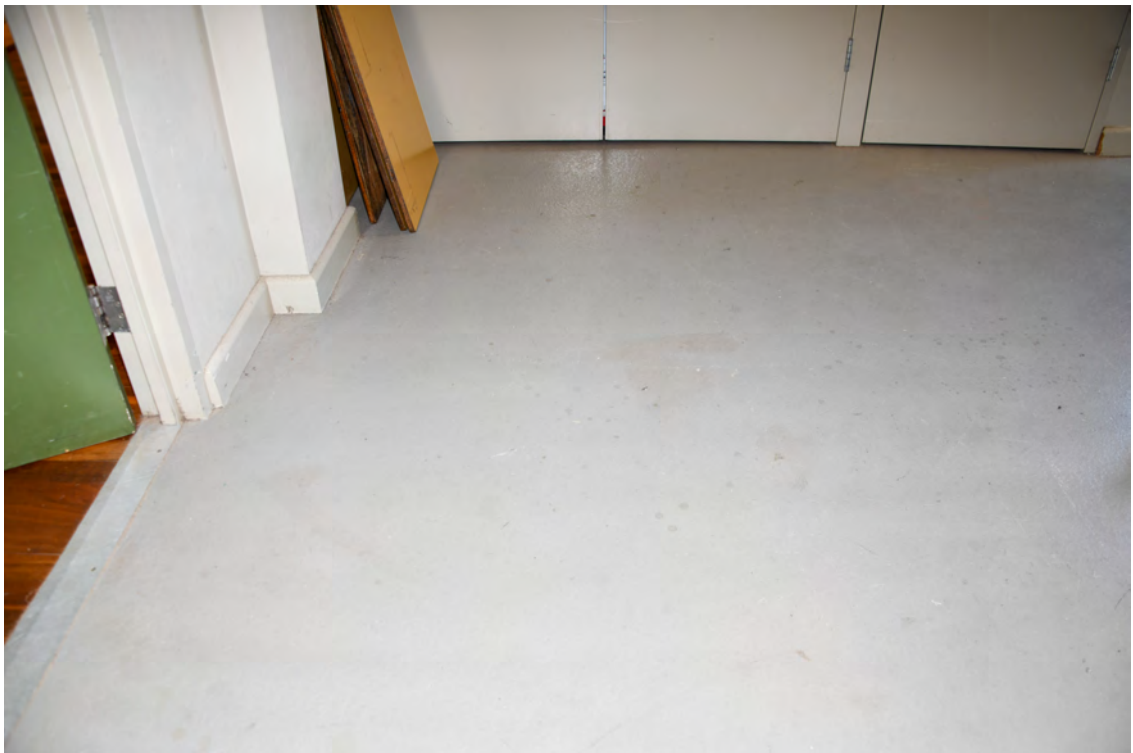
PRO\_0734.jpg

Block M / Hall / The Aurora Centre. Interior. Southern face. Girls Change Room. Flooring.

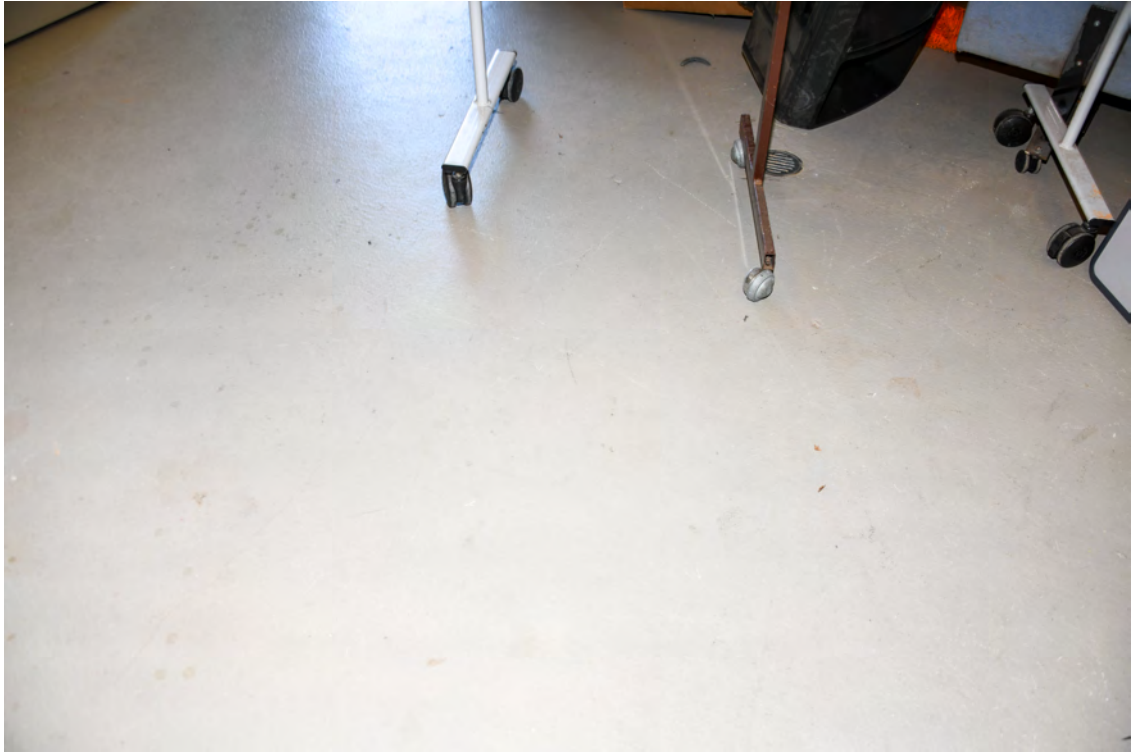
PRO\_0735.jpg

Block M / Hall / The Aurora Centre. Interior. Southern face. Girls Change Room.  
Cracked flooring.

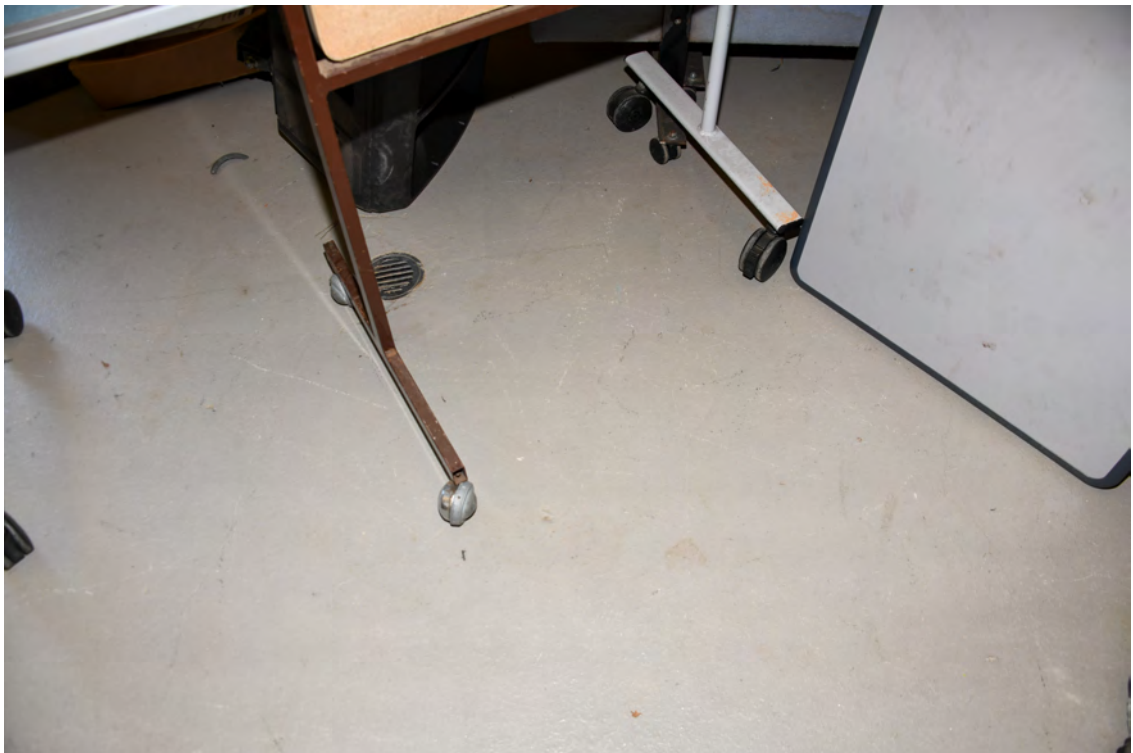
PRO\_0736.jpg

Block M / Hall / The Aurora Centre. Interior. Southern face. Girls Change Room.  
Cracked flooring.

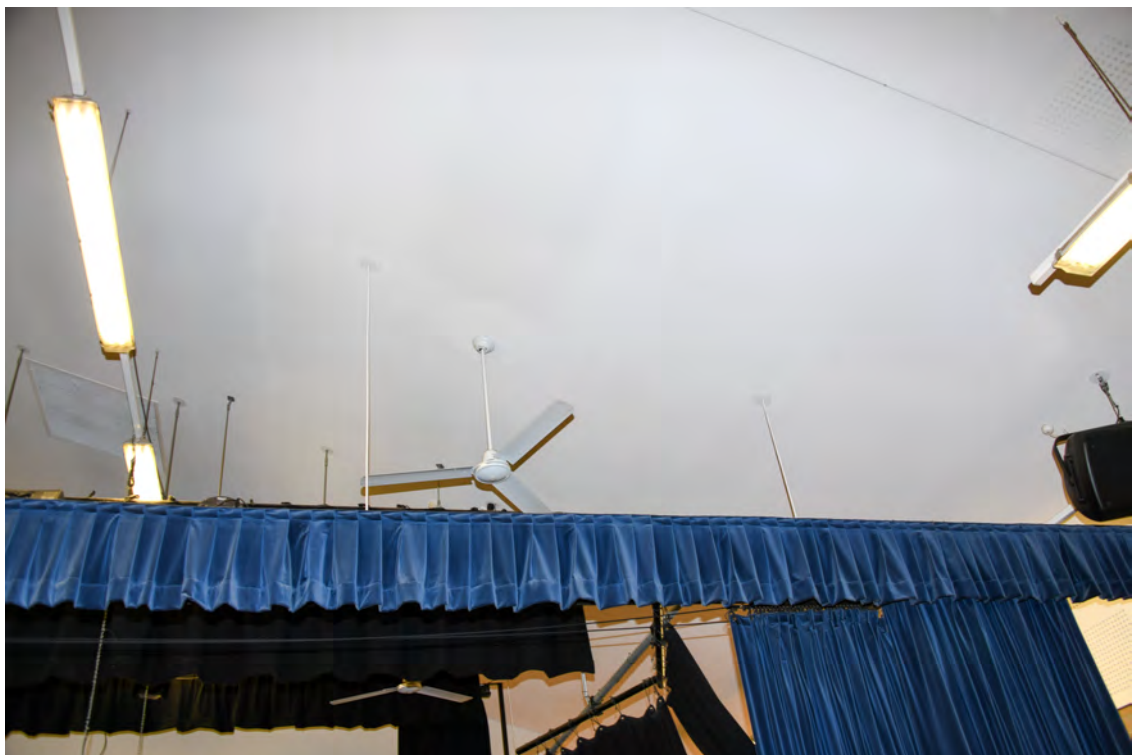
PRO\_0777.jpg

Block M / Hall / The Aurora Centre. Interior. Ceiling.

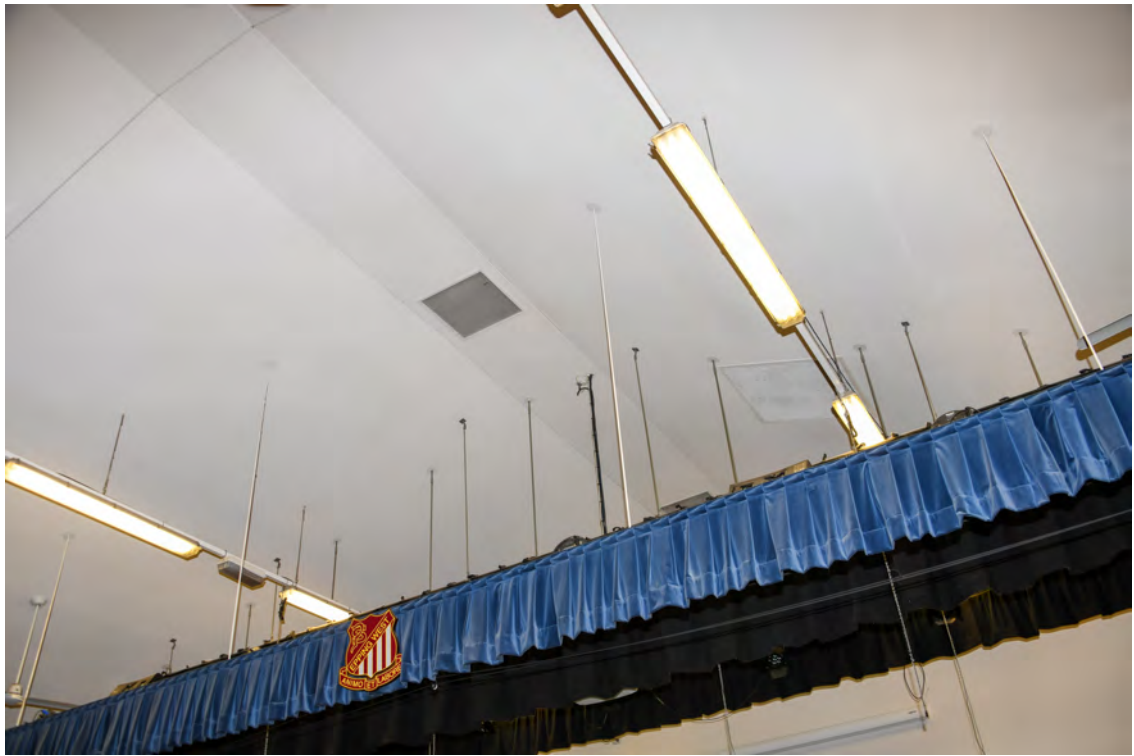
PRO\_0778.jpg

Block M / Hall / The Aurora Centre. Interior. Ceiling.

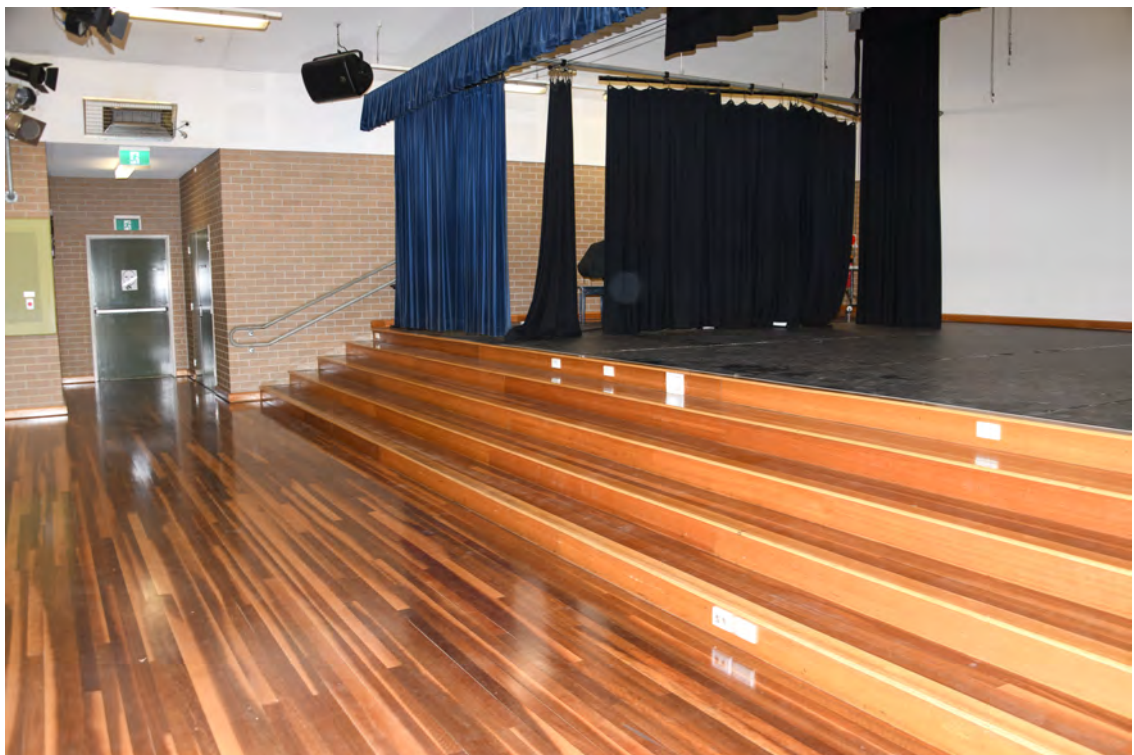
PRO\_0779.jpg

Block M / Hall / The Aurora Centre. Interior. Stage steps.

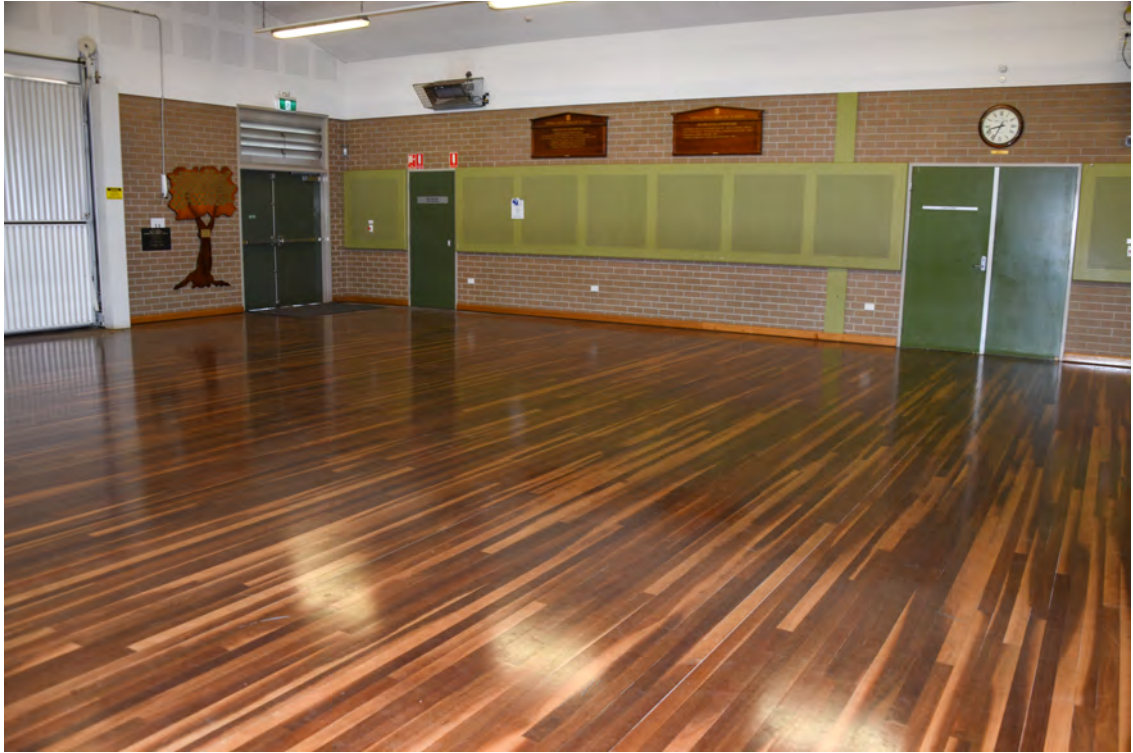
PRO\_0780.jpg

Block M / Hall / The Aurora Centre. Interior. Flooring.

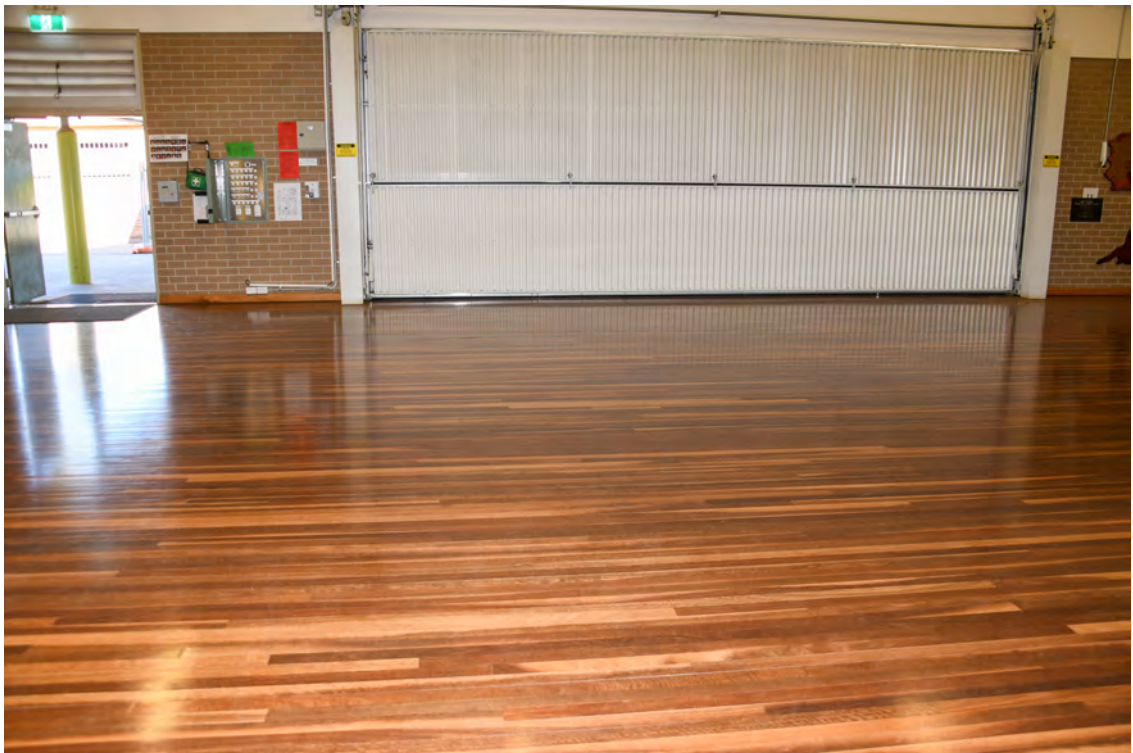
PRO\_0781.jpg

Block M / Hall / The Aurora Centre. Interior. Flooring.

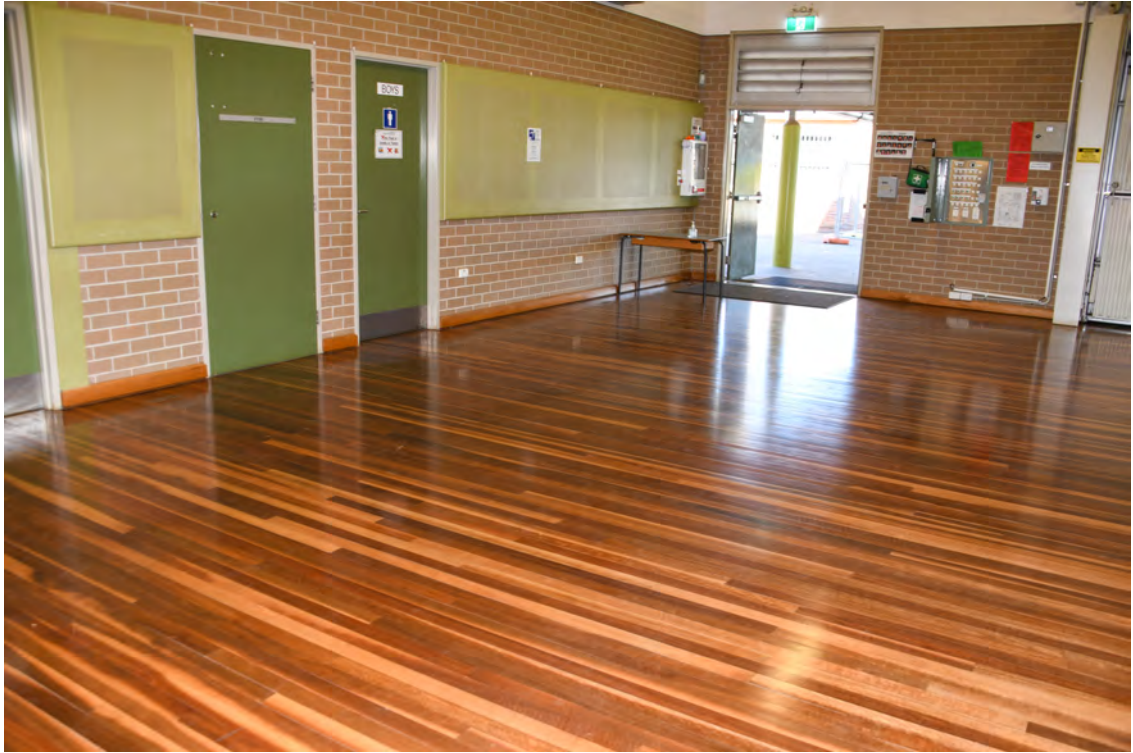
PRO\_0782.jpg

Block M / Hall / The Aurora Centre. Interior. Flooring.

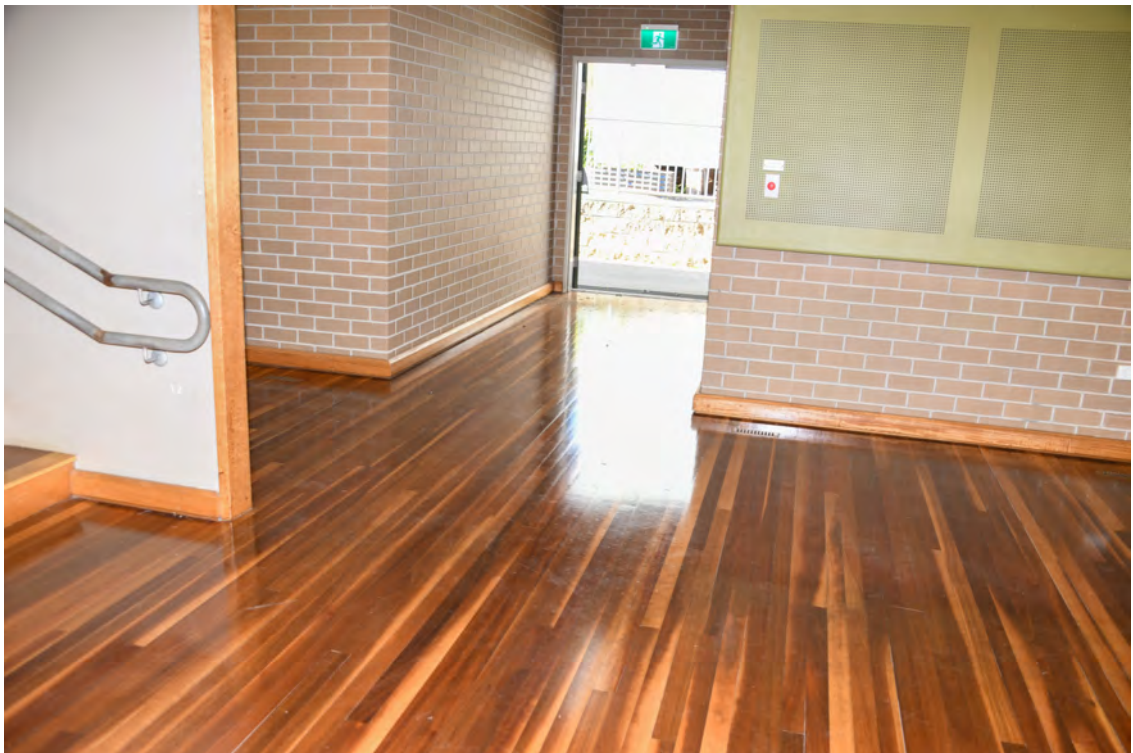
PRO\_0783.jpg

Block M / Hall / The Aurora Centre. Interior. Flooring.

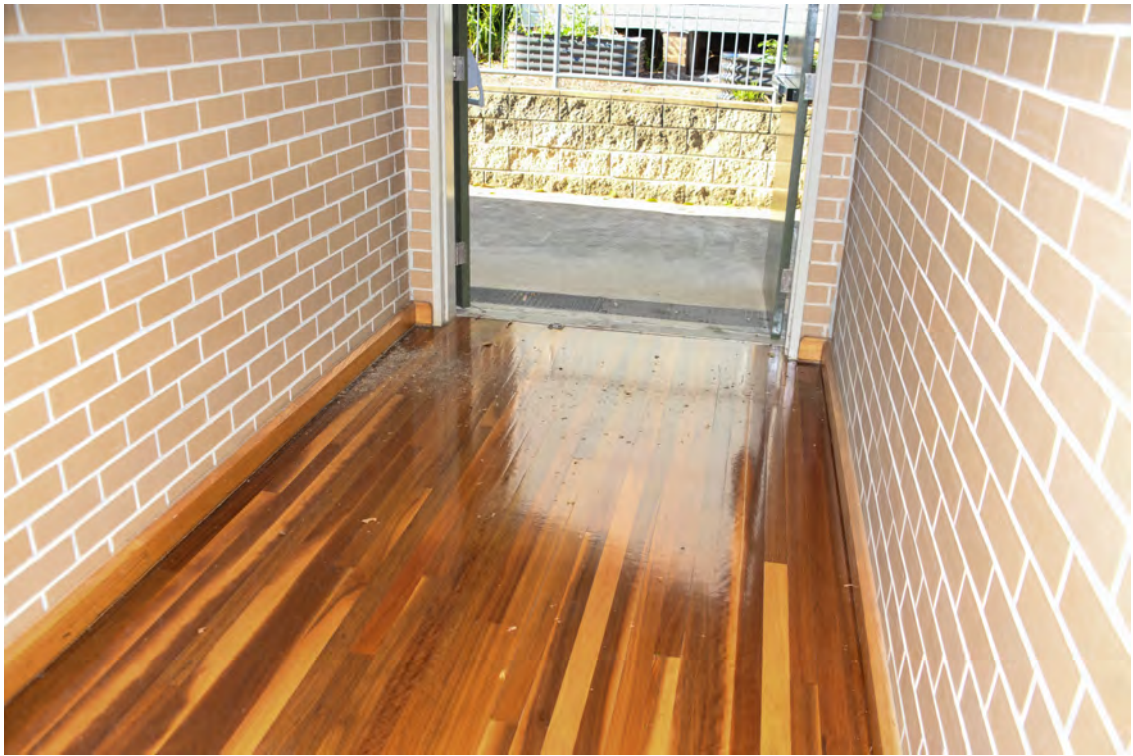
PRO\_0784.jpg

Block M / Hall / The Aurora Centre. Interior. Flooring.

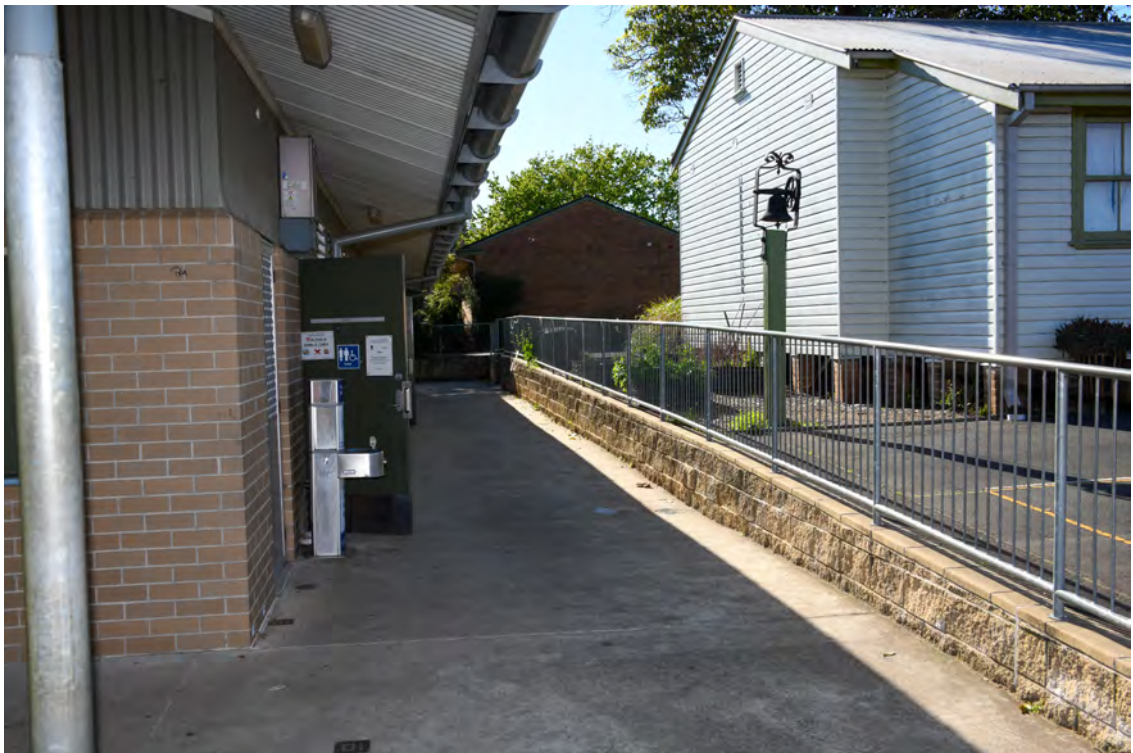
PRO\_0785.jpg

Block M / Hall / The Aurora Centre. Southern side. Facing east.

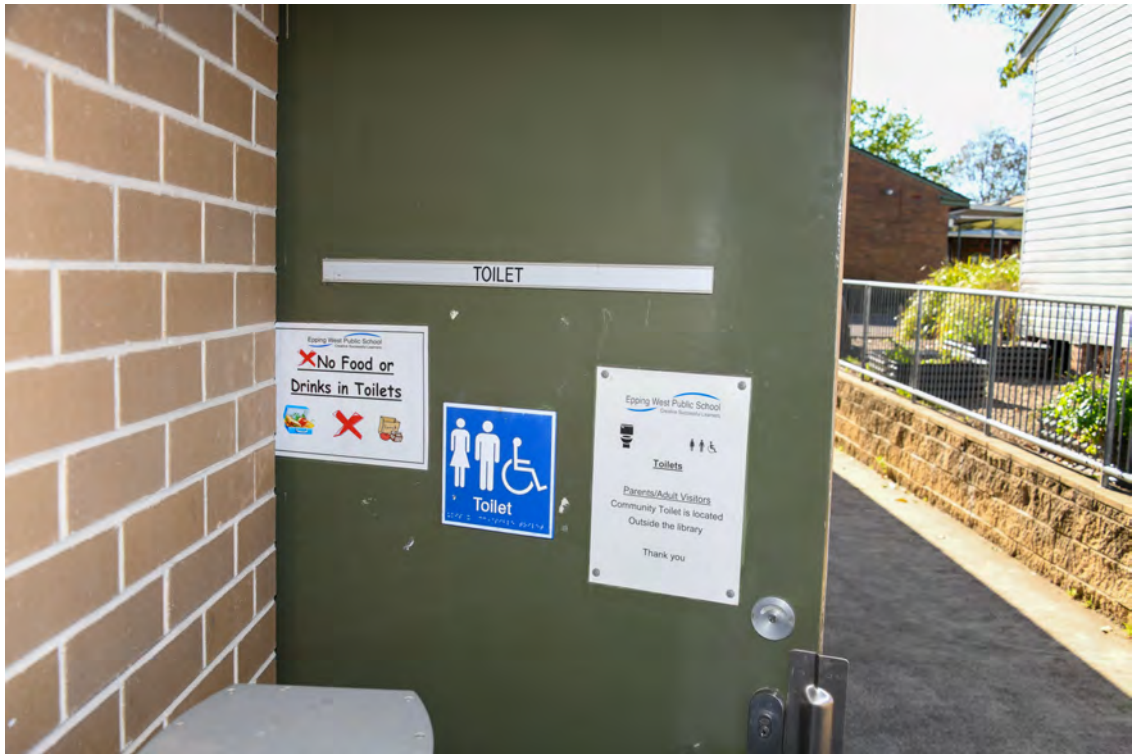
PRO\_0786.jpg

Block M / Hall / The Aurora Centre. Southern side. Accessible amenities.

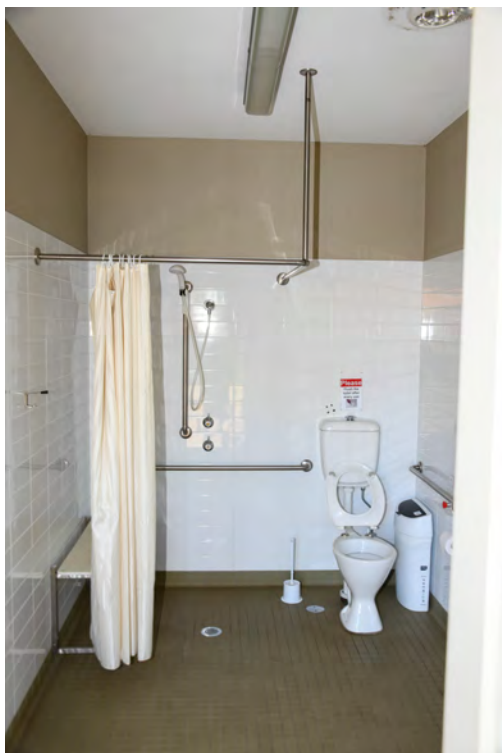
PRO\_0787.jpg

Block M / Hall / The Aurora Centre. Southern side. Accessible amenities.

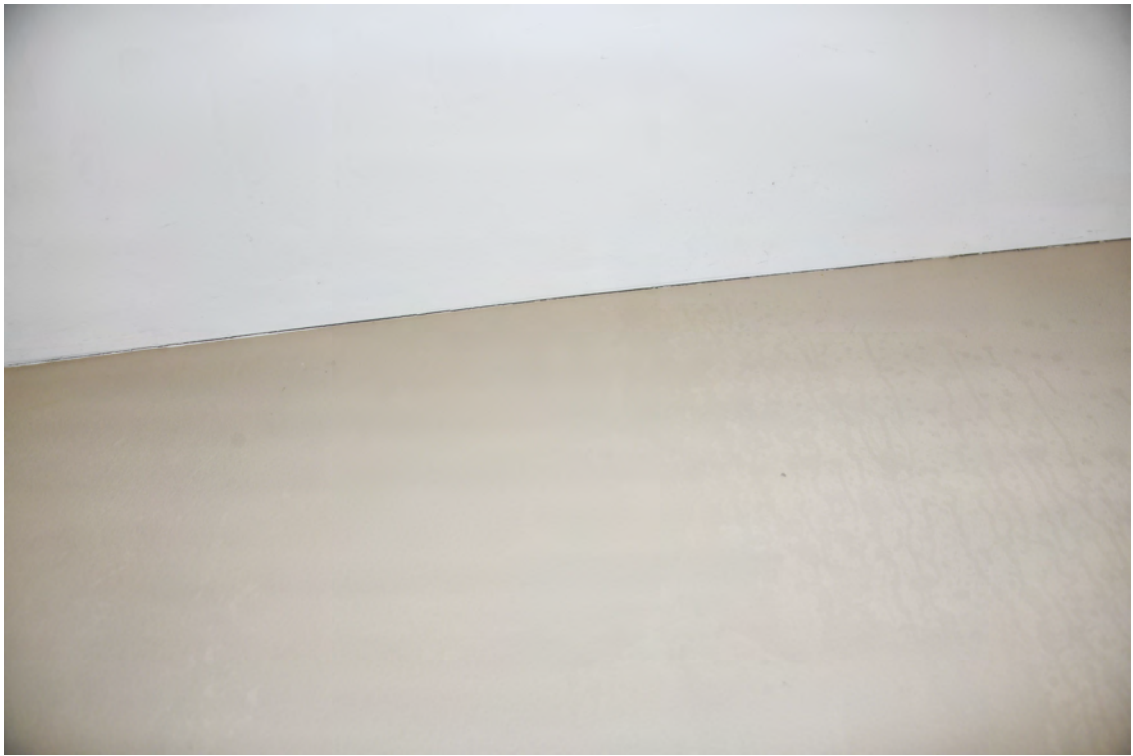
PRO\_0788.jpg

Block M / Hall / The Aurora Centre. Southern side. Accessible amenities.

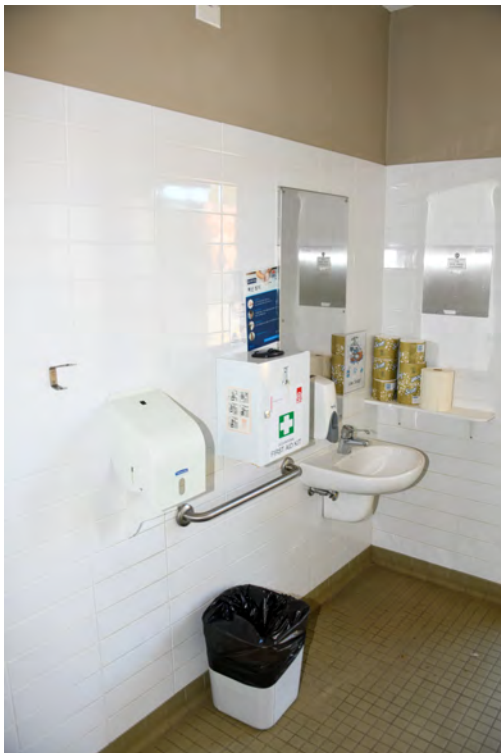
PRO\_0789.jpg

Block M / Hall / The Aurora Centre. Southern side. Accessible amenities.

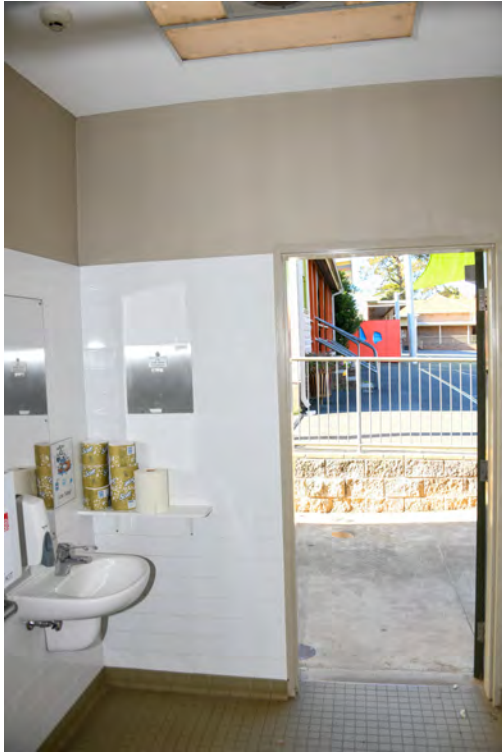
PRO\_0790.jpg

Block M / Hall / The Aurora Centre. Southern side. Accessible amenities.

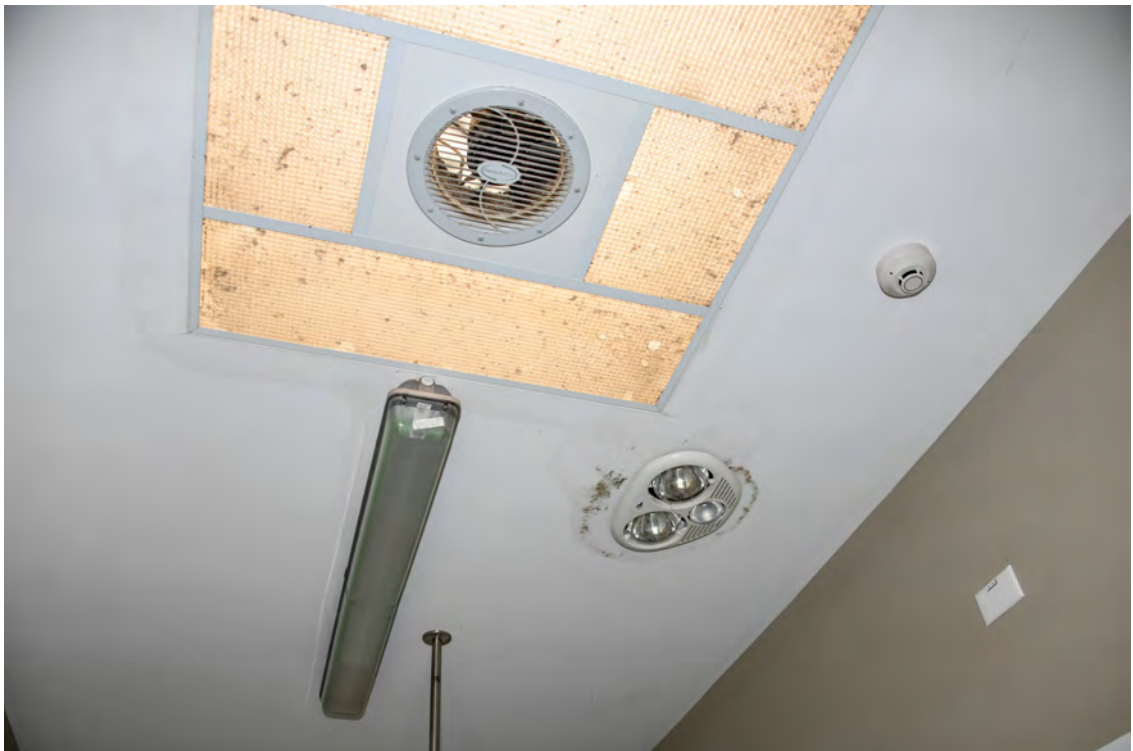
PRO\_0791.jpg

Block M / Hall / The Aurora Centre. Southern side. Accessible amenities. Ceiling.

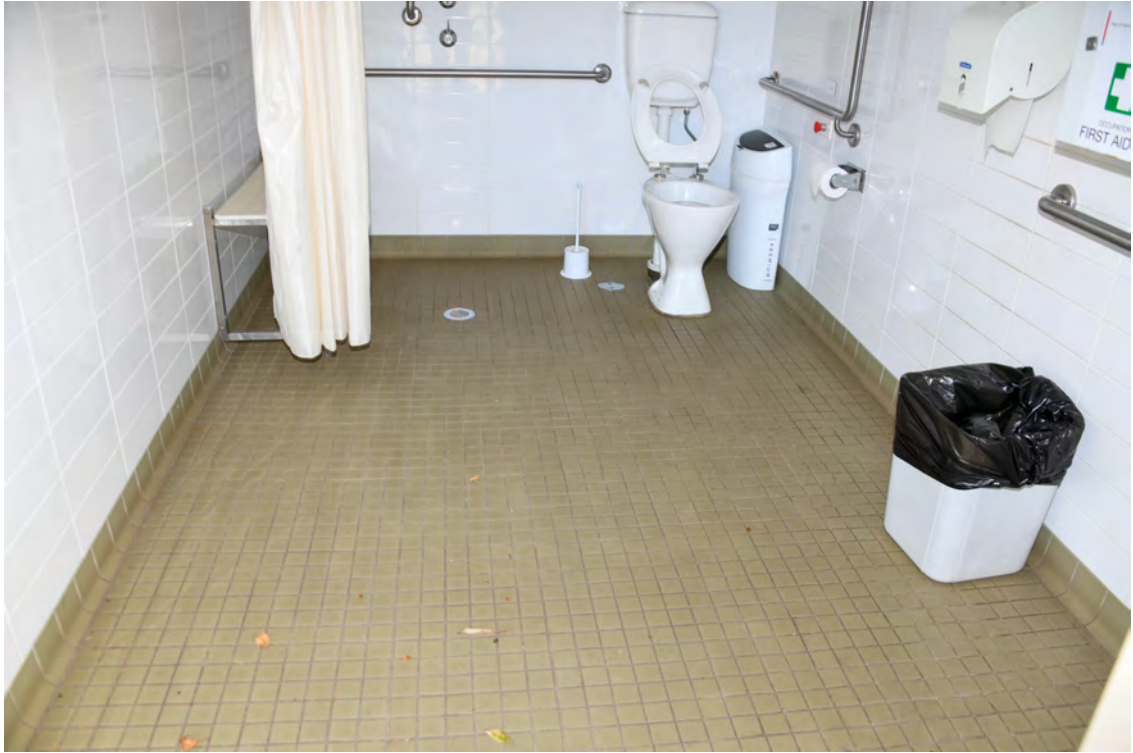
PRO\_0792.jpg

Block M / Hall / The Aurora Centre. Southern side. Accessible amenities.

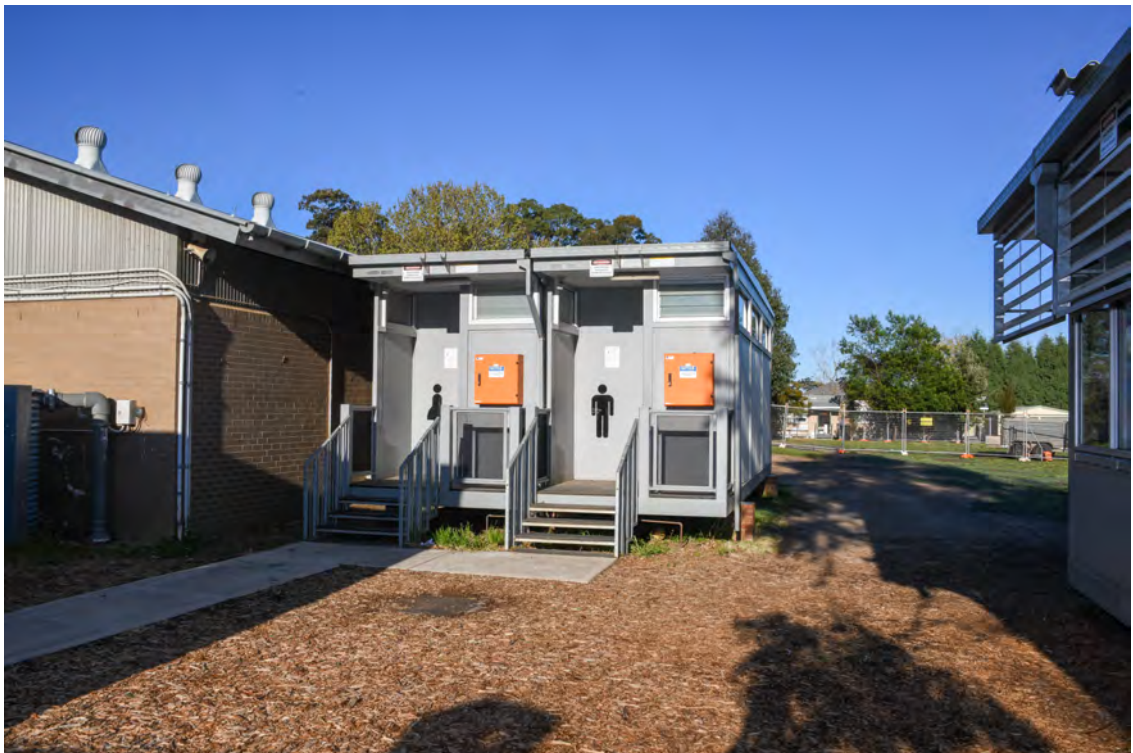
PRO\_0275.jpg

Amenities on the northern side of Block M / Hall / The Aurora Centre. Eastern elevation.

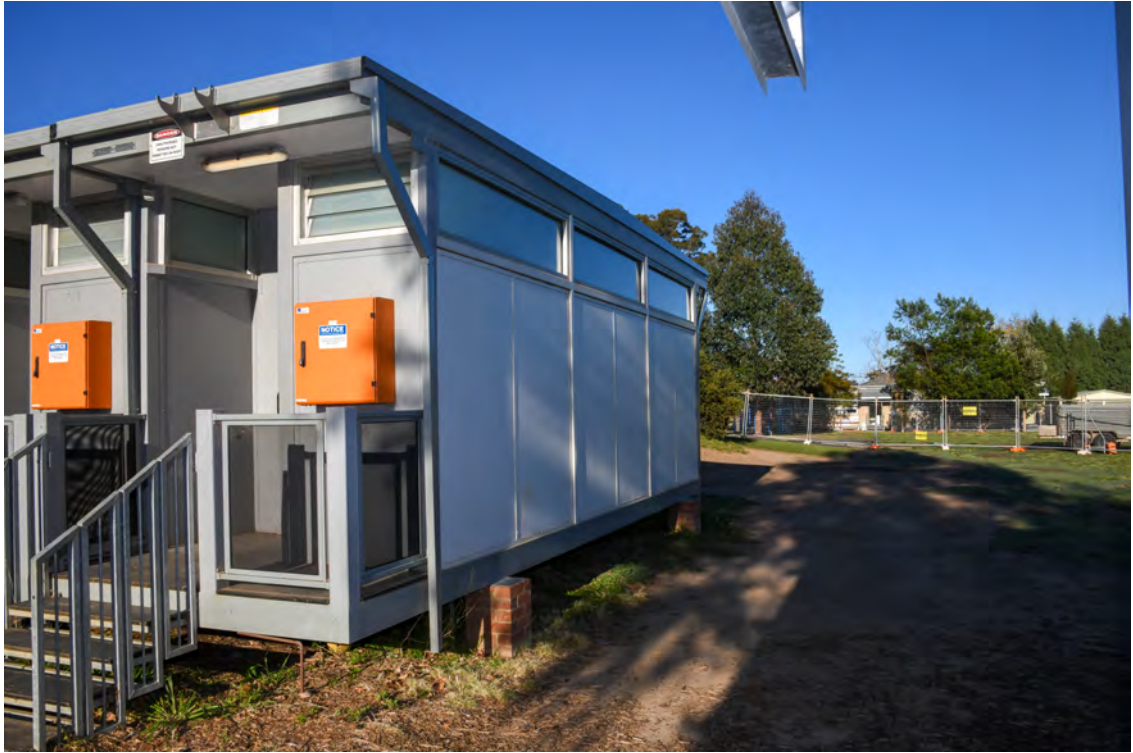
PRO\_0276.jpg

Amenities on the northern side of Block M / Hall / The Aurora Centre. Northern elevation.

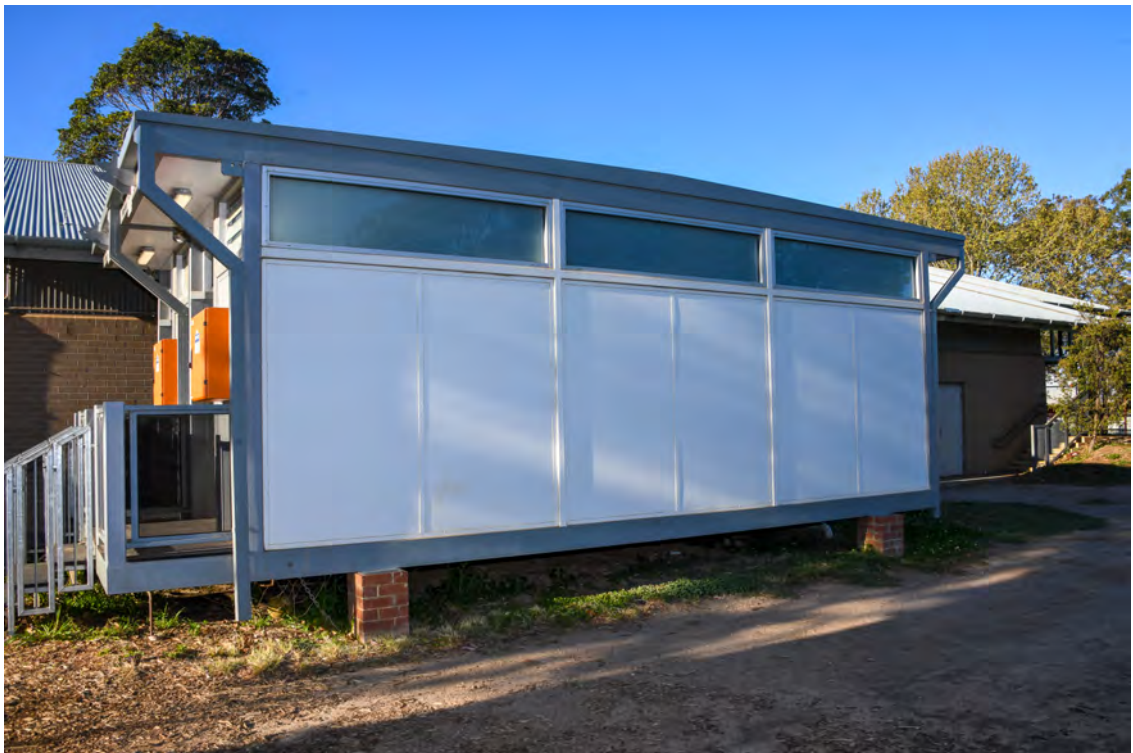
PRO\_0277.jpg

Amenities on the northern side of Block M / Hall / The Aurora Centre. Northern elevation.

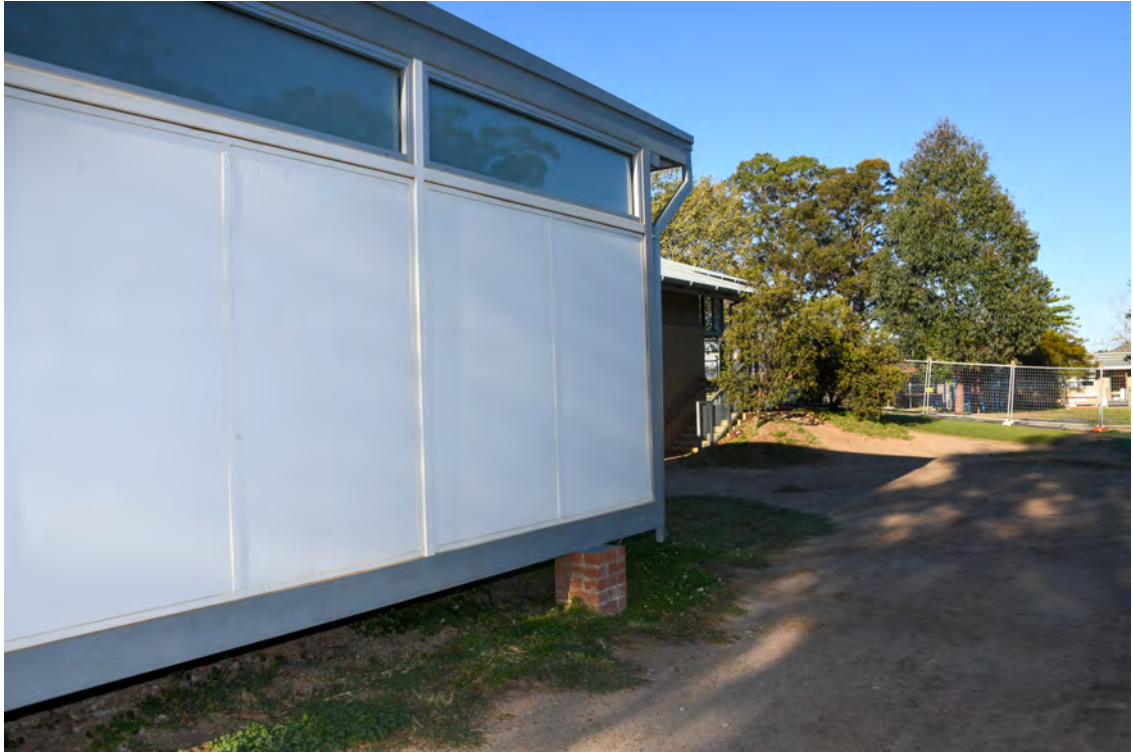
PRO\_0278.jpg

Amenities on the northern side of Block M / Hall / The Aurora Centre. Northern elevation.

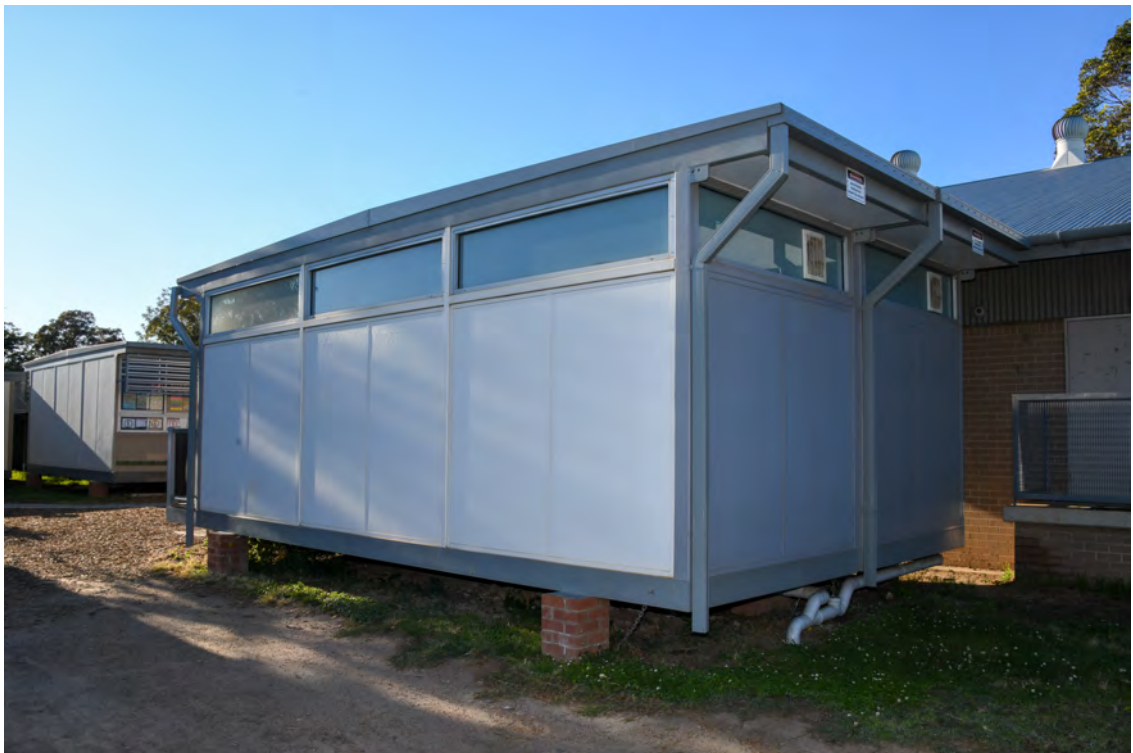
PRO\_0279.jpg

Amenities on the northern side of Block M / Hall / The Aurora Centre. Northern elevation.
