96-104 Carlingford Road, Epping NSW 2121

Epping West Public School

DILAPIDATION REPORT

7<sup>th</sup> September 2021

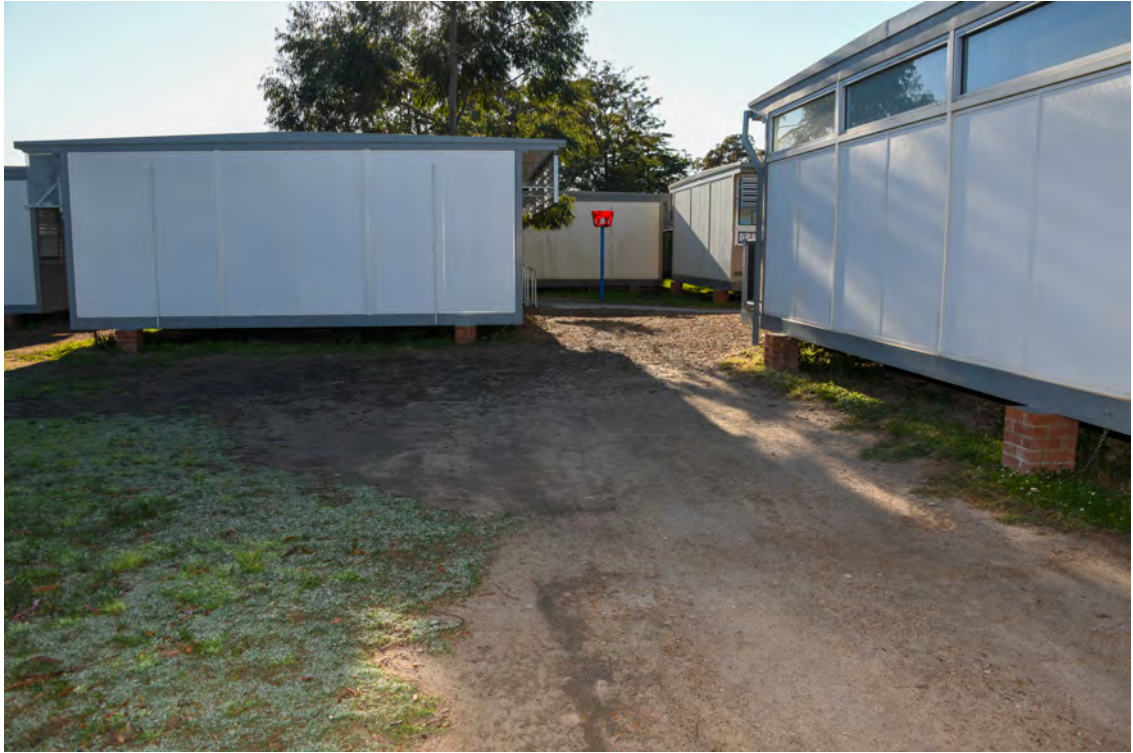
PRO\_0280.jpg

Amenities on the northern side of Block M / Hall / The Aurora Centre. Northern elevation.

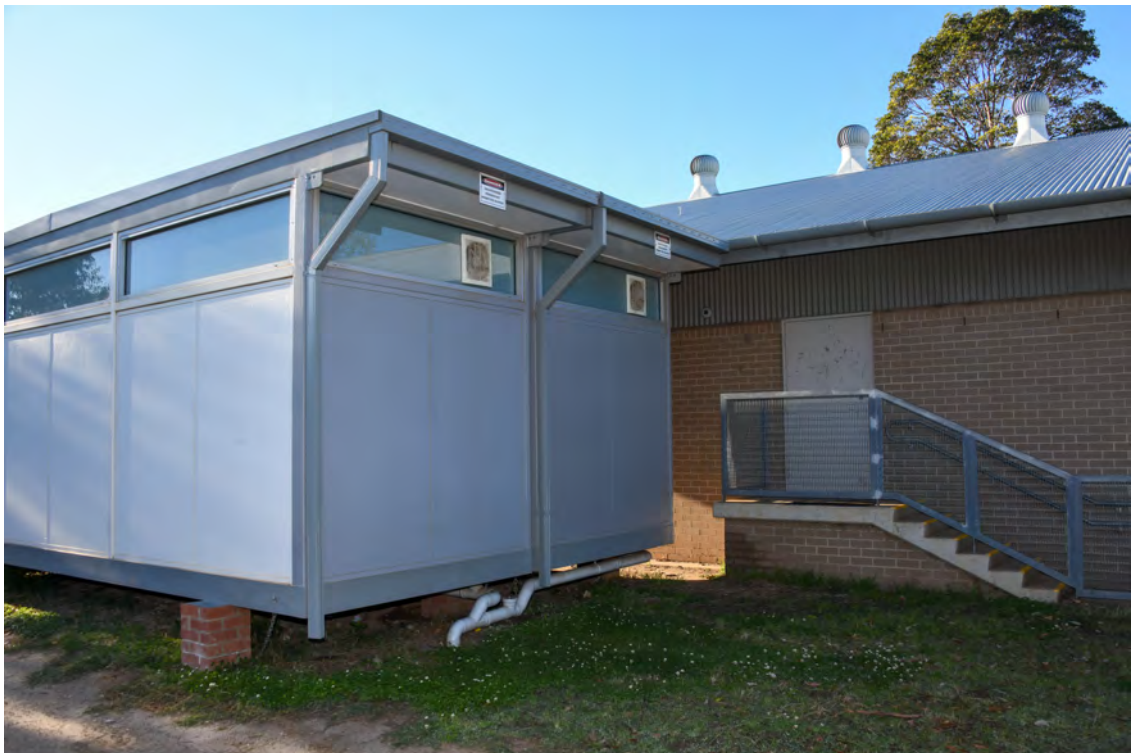
PRO\_0281.jpg

Amenities on the northern side of Block M / Hall / The Aurora Centre. Western elevation.

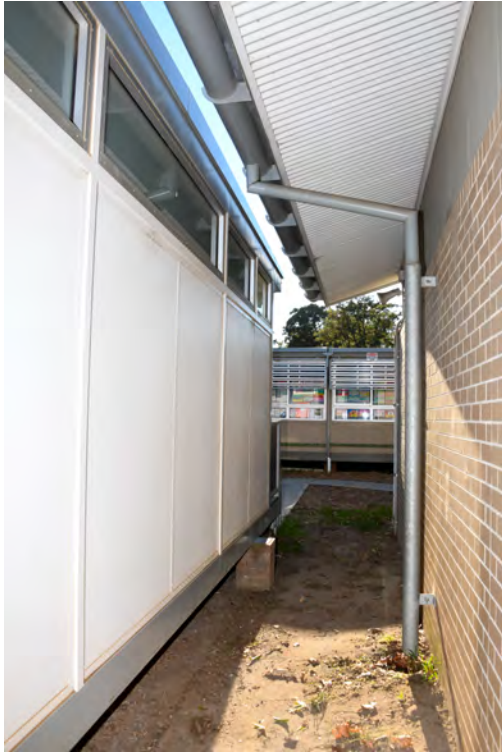
PRO\_0282.jpg

Amenities on the northern side of Block M / Hall / The Aurora Centre. Southern elevation.

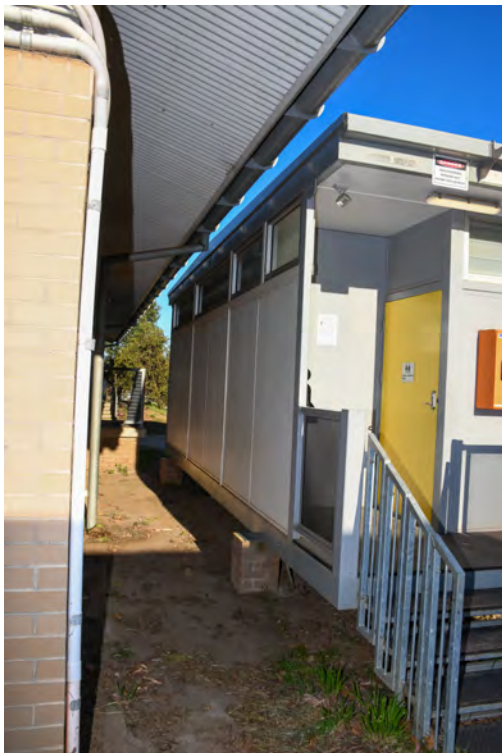
PRO\_0283.jpg

Amenities on the northern side of Block M / Hall / The Aurora Centre. Southern elevation.

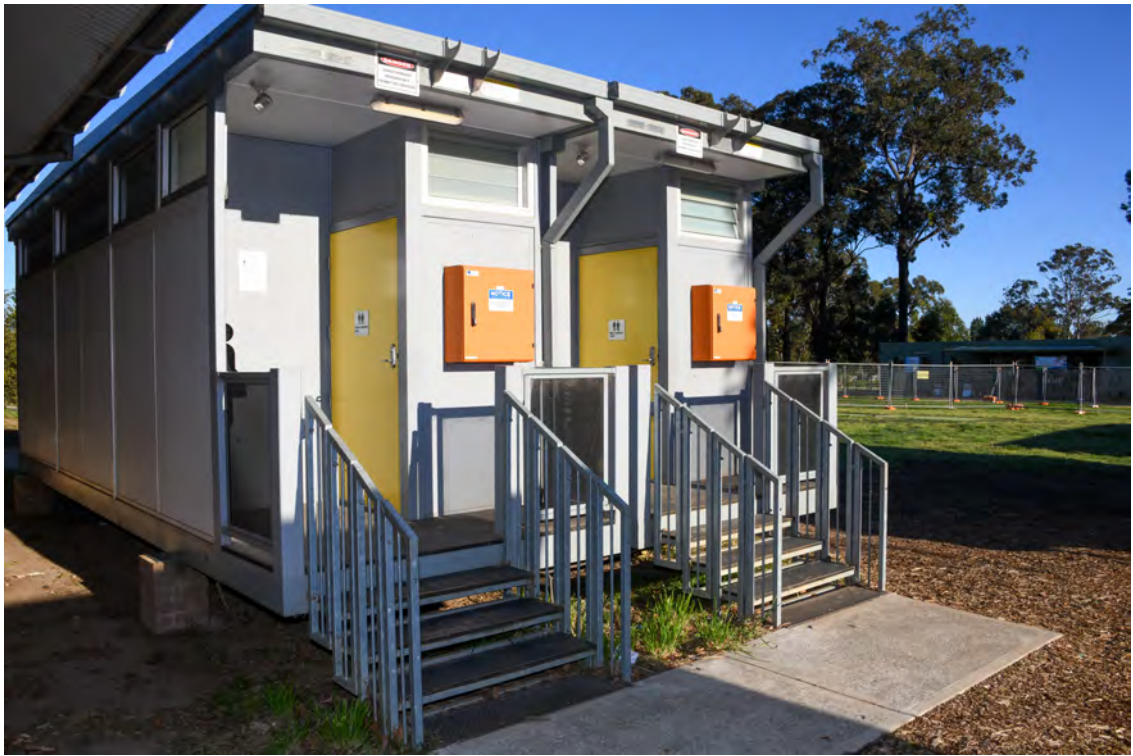
PRO\_0284.jpg

Amenities on the northern side of Block M / Hall / The Aurora Centre. Eastern elevation.

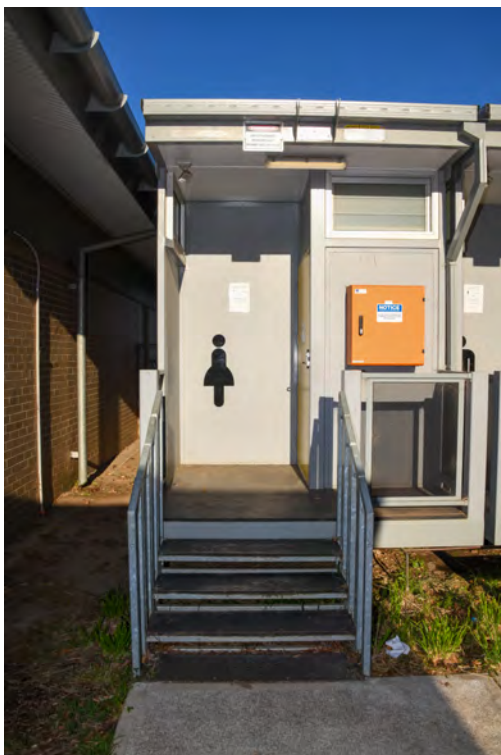
PRO\_0285.jpg

Amenities on the northern side of Block M / Hall / The Aurora Centre. Eastern elevation.

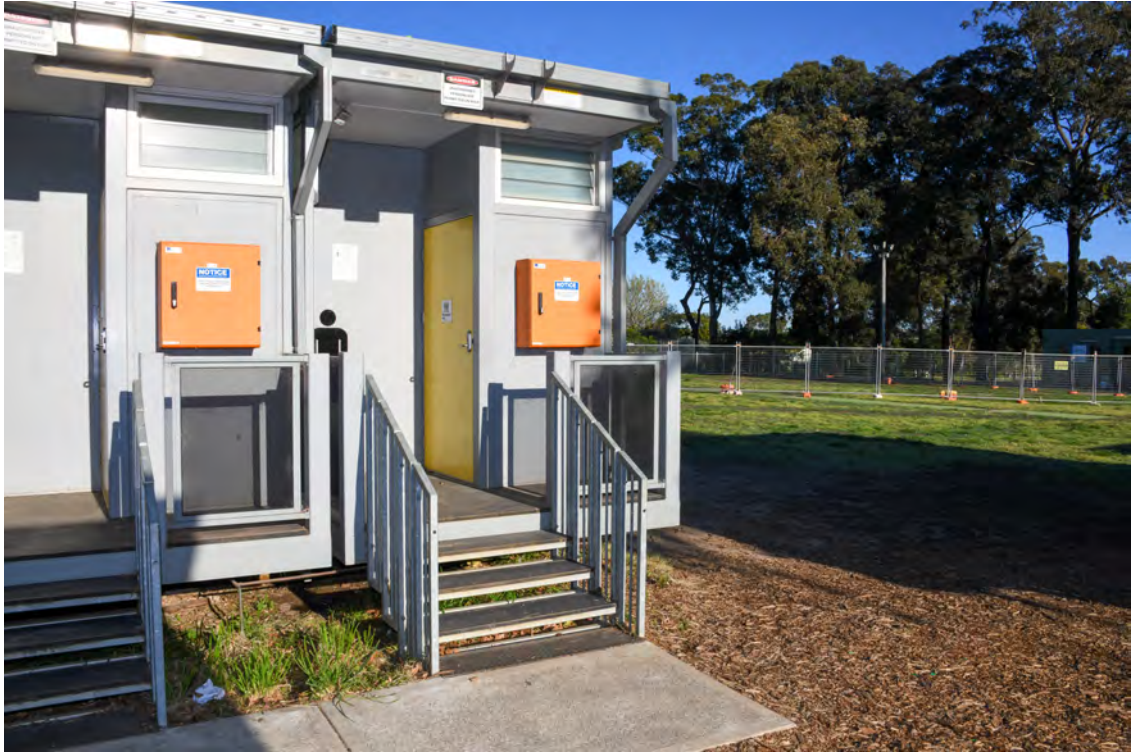
PRO\_0286.jpg

Amenities on the northern side of Block M / Hall / The Aurora Centre. Eastern elevation.

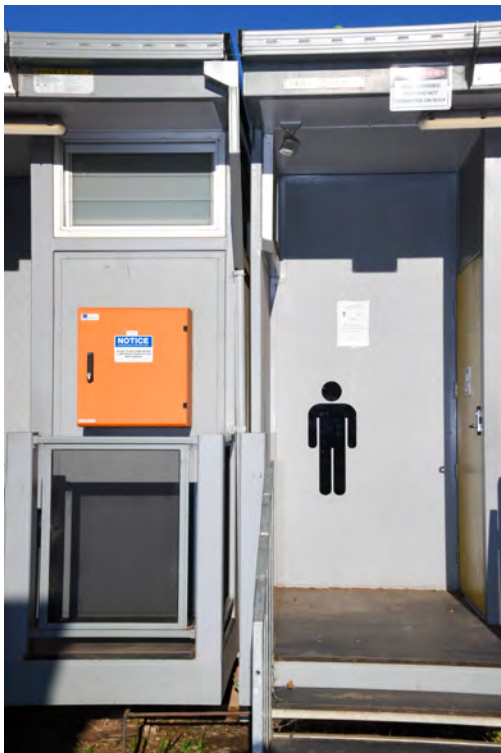
PRO\_0287.jpg

Amenities on the northern side of Block M / Hall / The Aurora Centre. Eastern elevation.

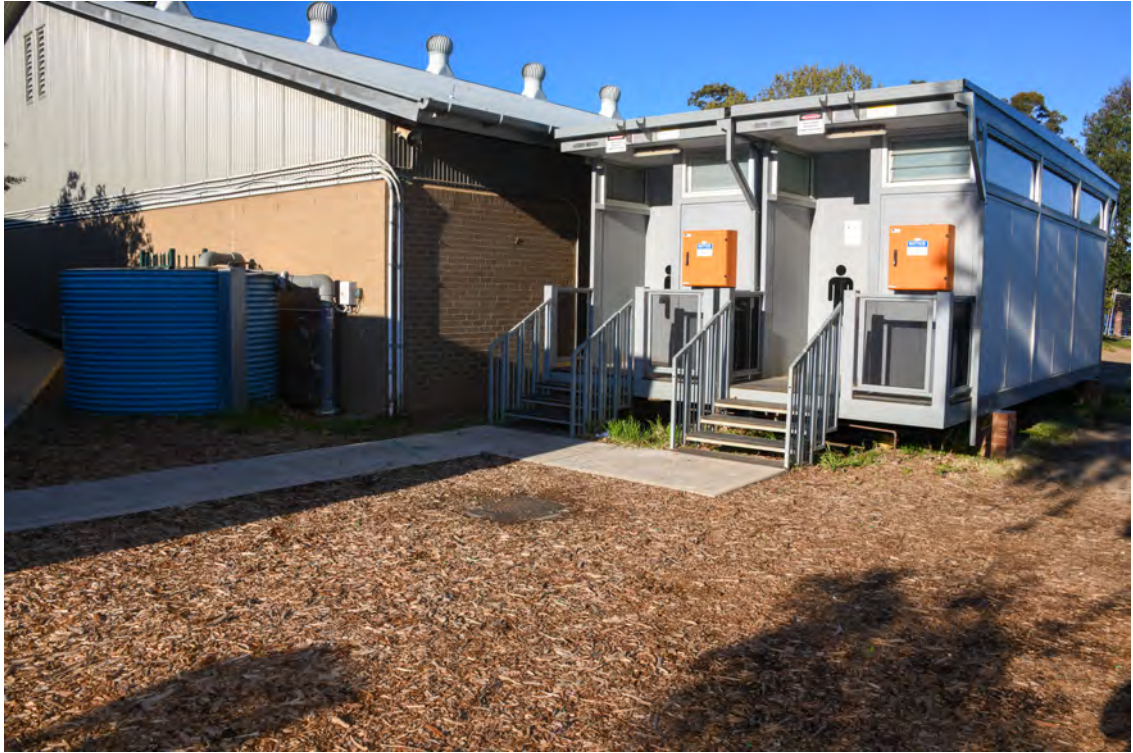
PRO\_0288.jpg

Amenities on the northern side of Block M / Hall / The Aurora Centre. Area on the eastern side of the block.

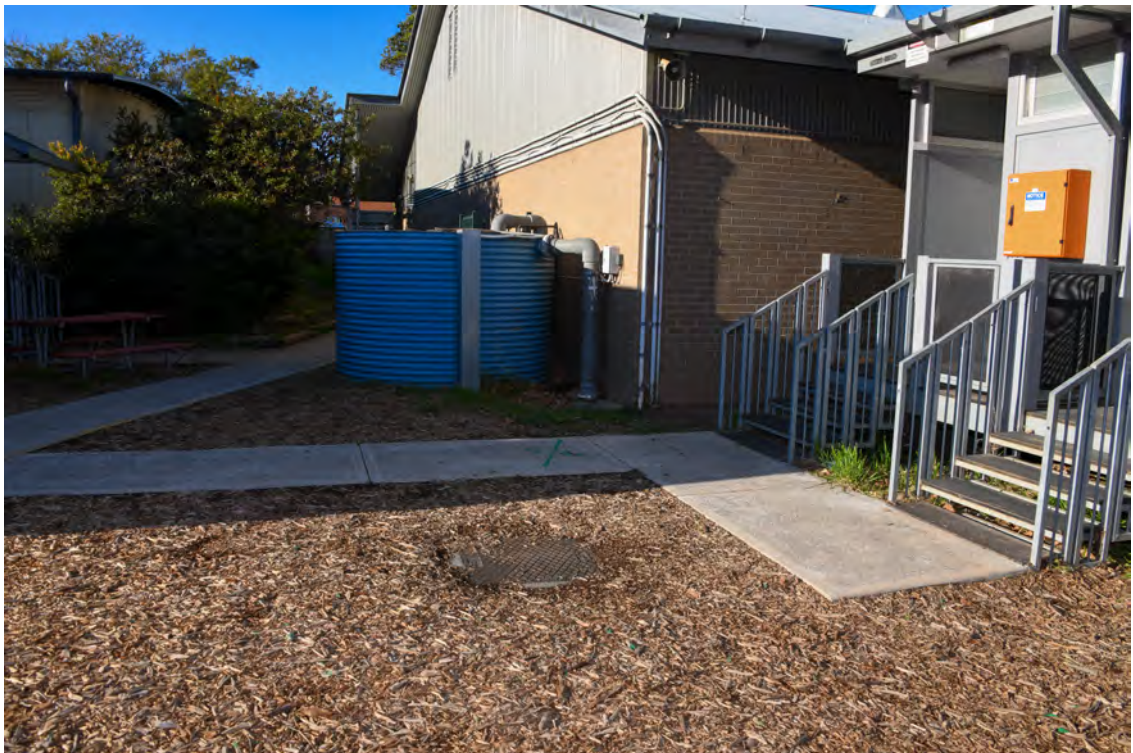
PRO\_0289.jpg

Amenities on the northern side of Block M / Hall / The Aurora Centre. Area on the eastern side of the block.

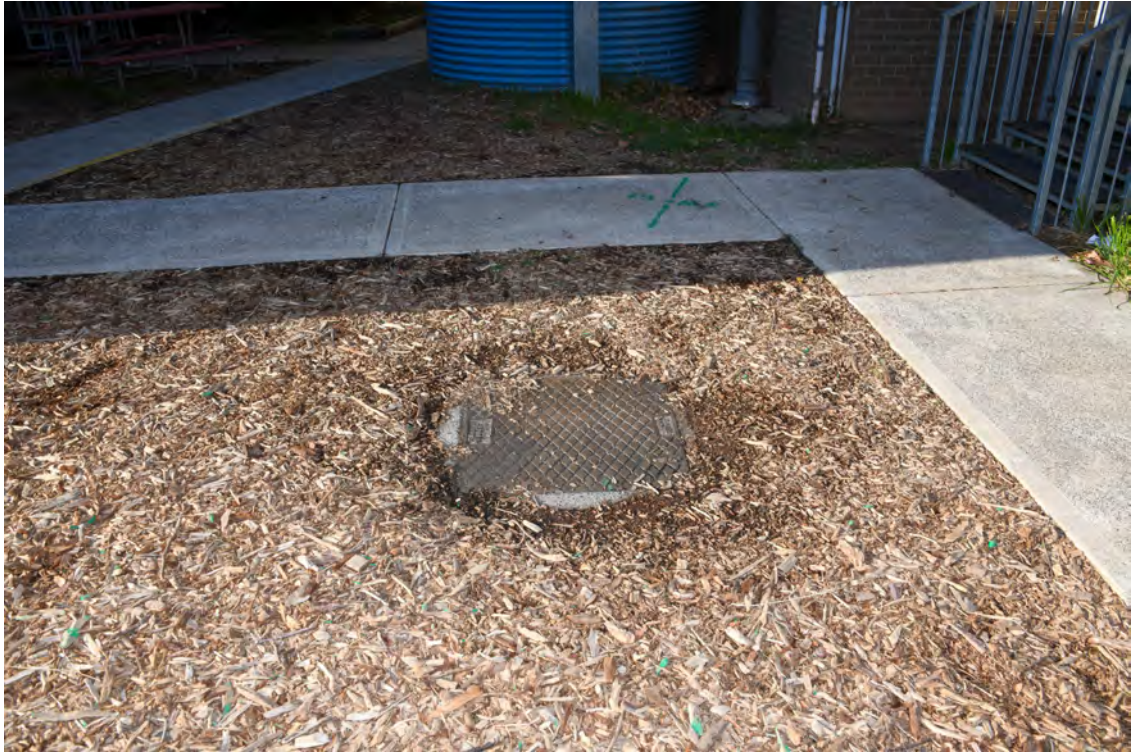
PRO\_0290.jpg

Amenities on the northern side of Block M / Hall / The Aurora Centre. Area on the eastern side of the block.

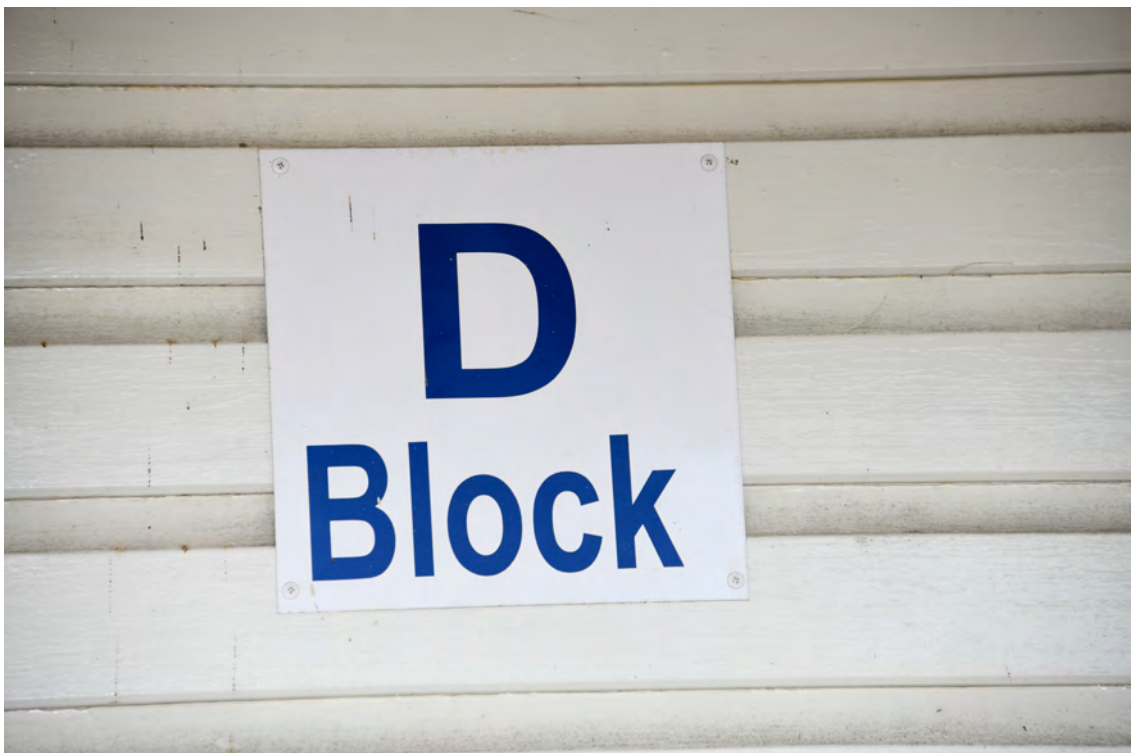
PRO\_0293.jpg

Block D. Refer to the following series of photographs for a record of the existing condition of the interior and exterior of the building.

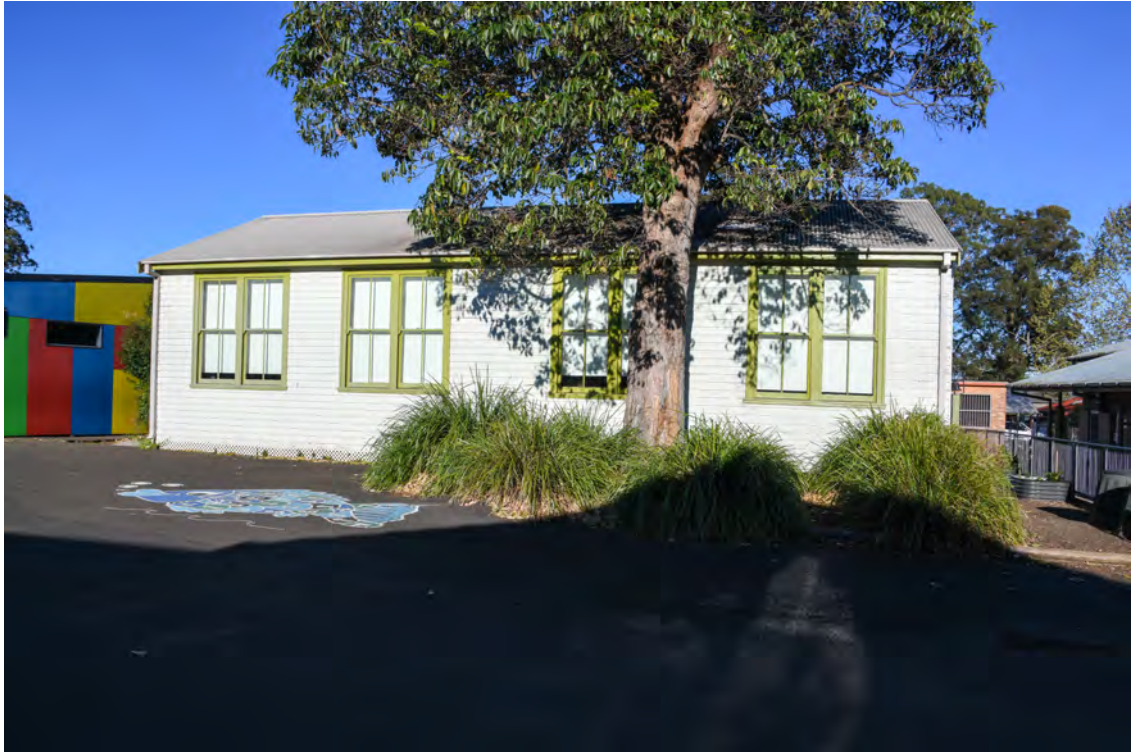
PRO\_0294.jpg

Block D. Eastern elevation. Refer to the following series of photographs for a record of the existing condition of the interior and exterior of the building.

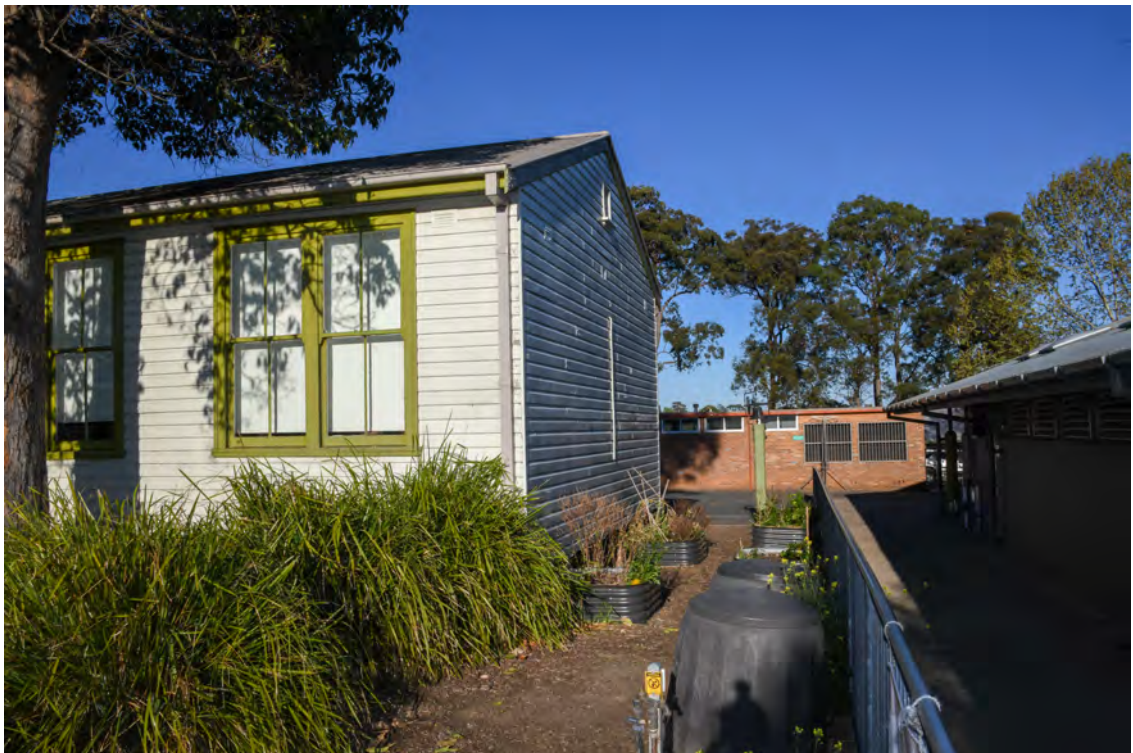
PRO\_0295.jpg

Block D. Northern elevation.

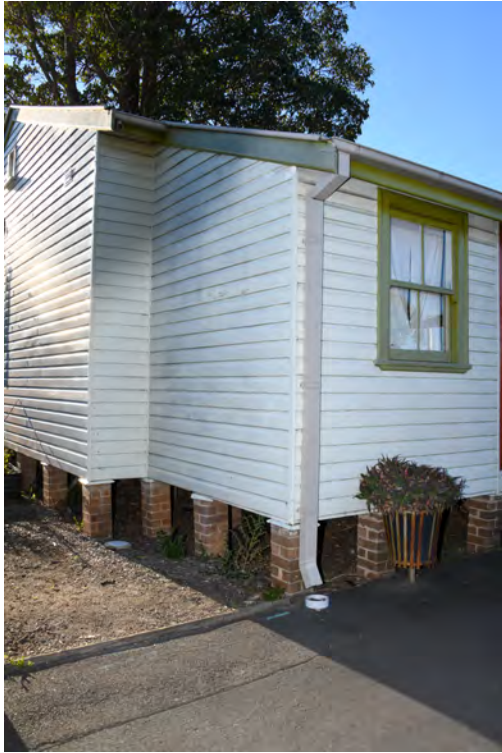
PRO\_0296.jpg

Block D. Northern elevation. Western end.

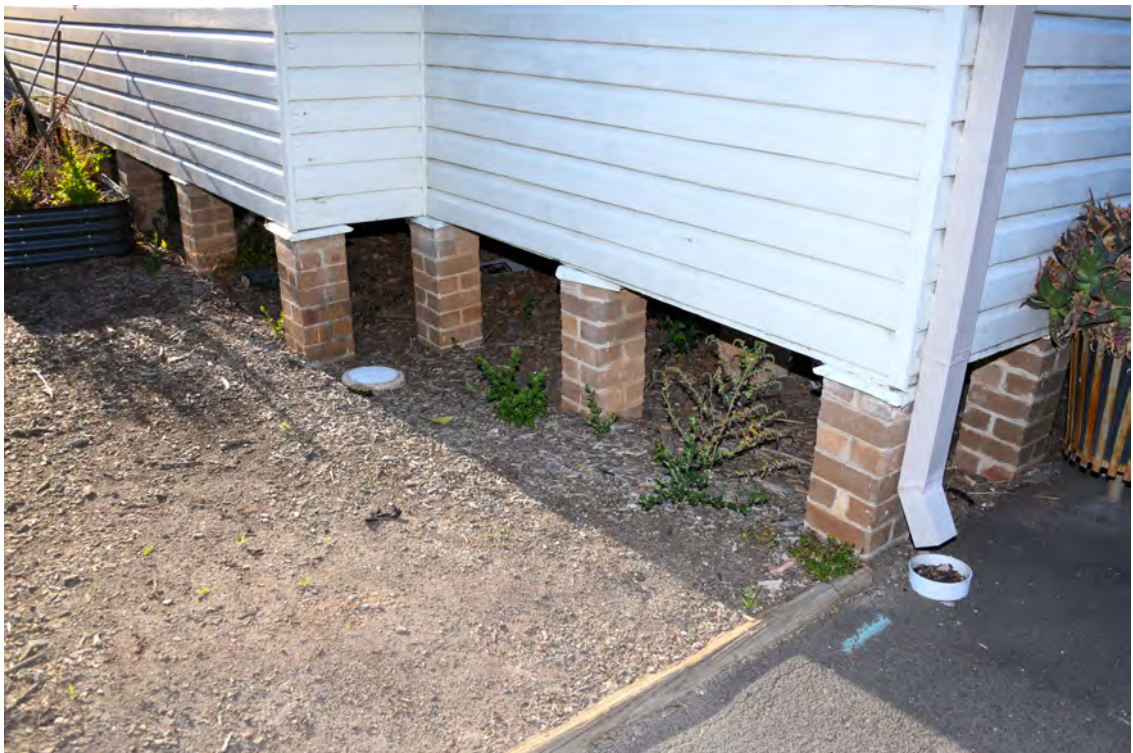
PRO\_0297.jpg

Block D. Northern elevation. Western end.

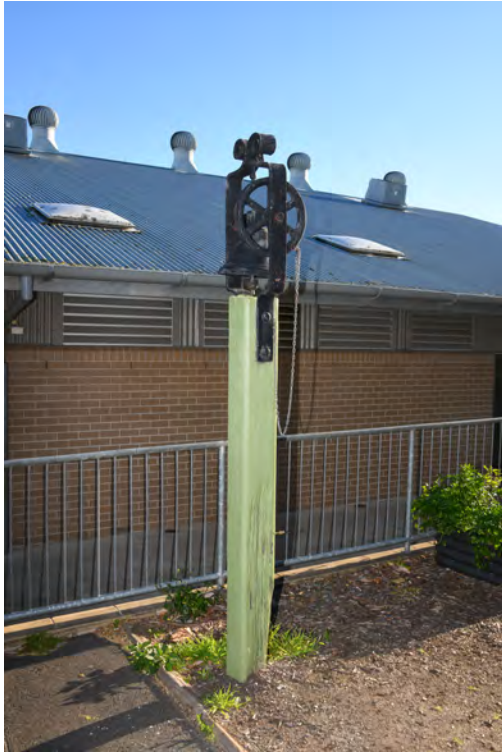
PRO\_0298.jpg

Block D. Northern elevation. Western end. Adjacent school bell.

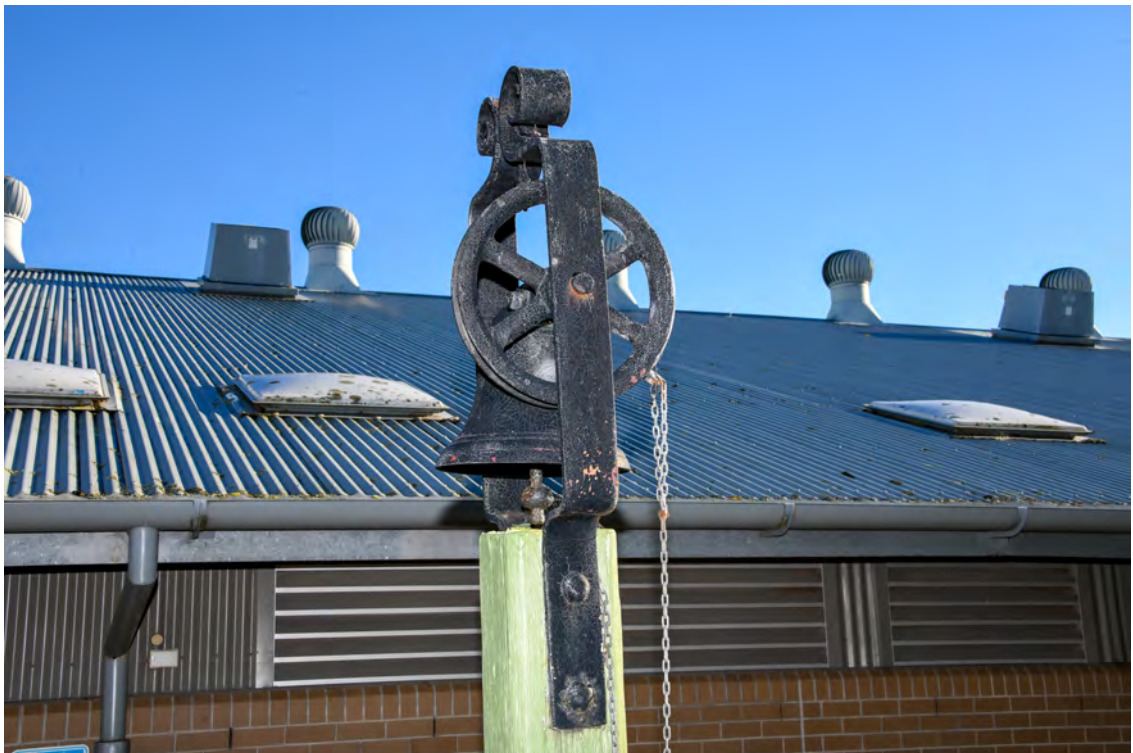
PRO\_0299.jpg

Block D. Northern elevation. Western end. Adjacent school bell.

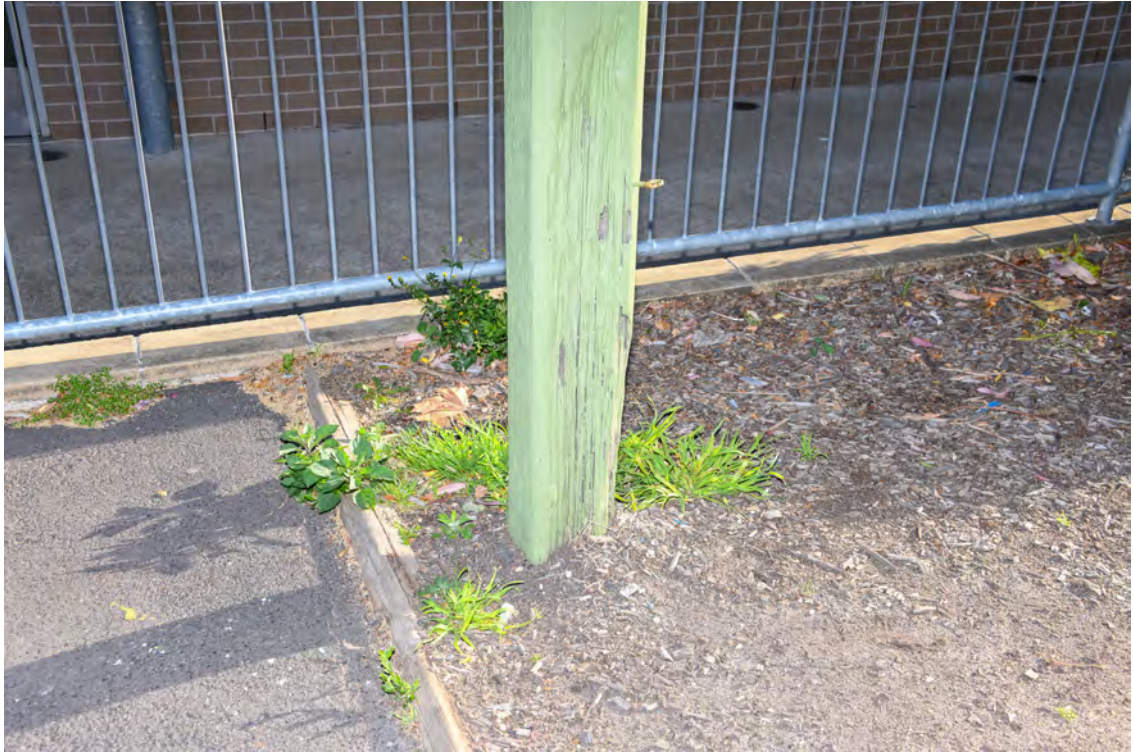
PRO\_0300.jpg

Block D. Northern elevation. Western end. Adjacent school bell.

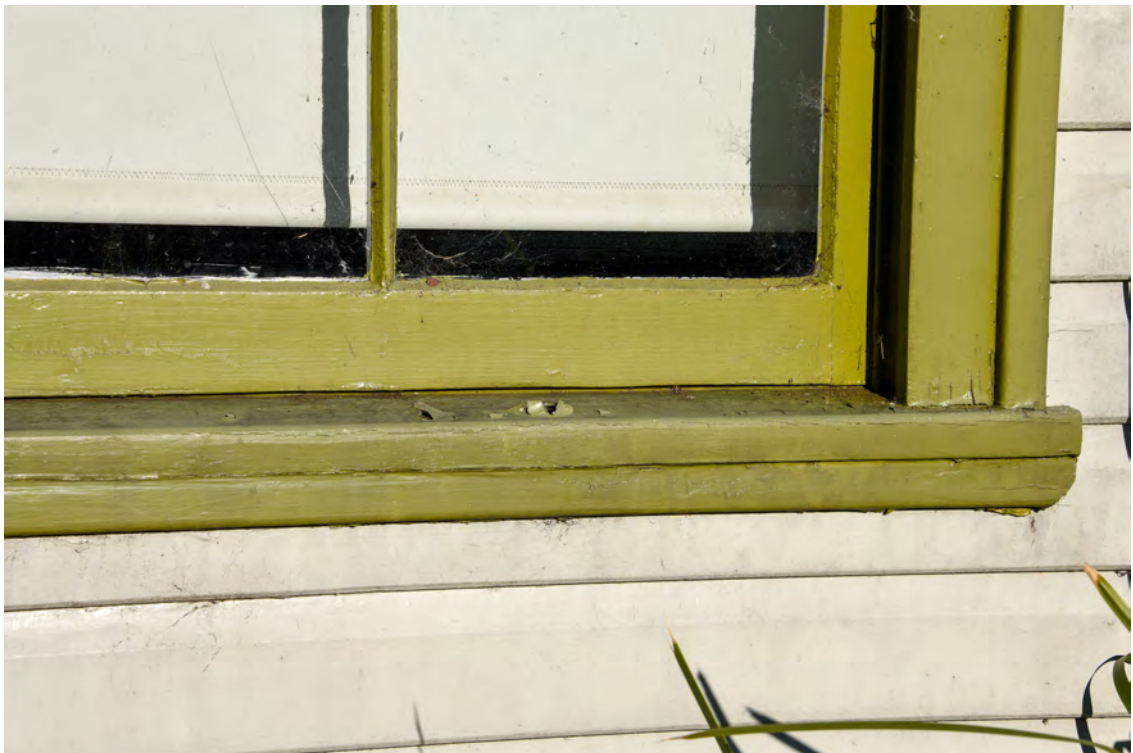
PRO\_0314.jpg

Block D. Eastern elevation. Northern end. Flaking paint finish.

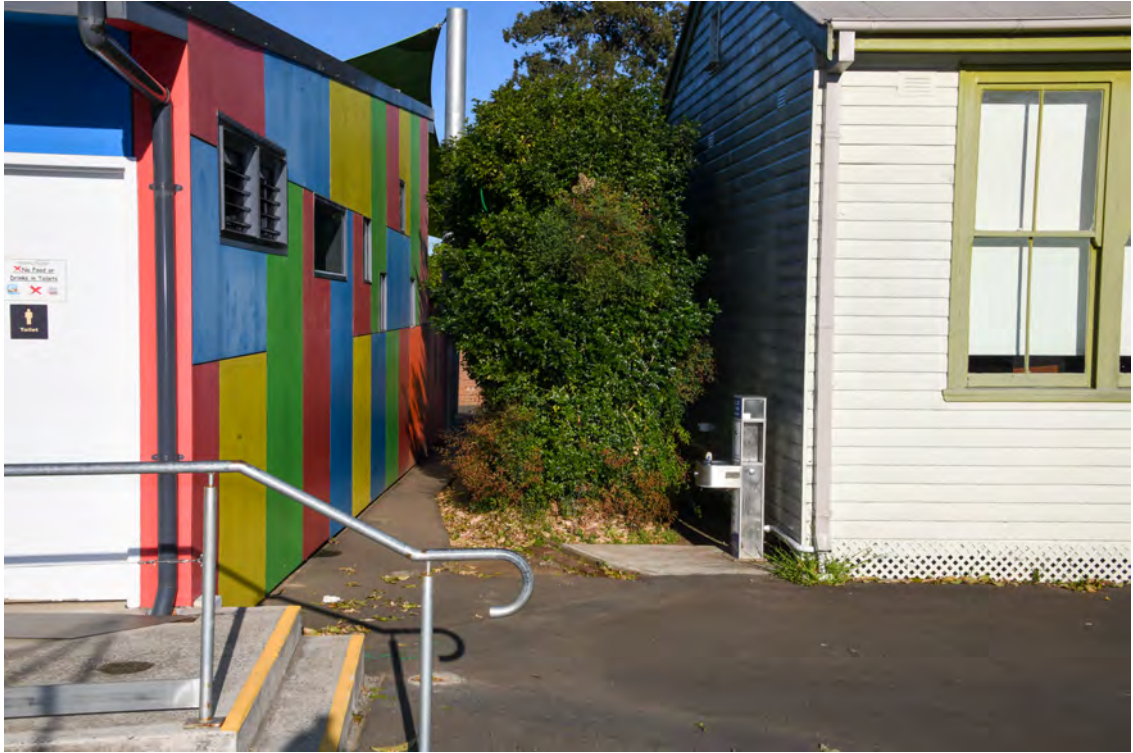
PRO\_0327.jpg

Block D. Southern elevation. Facing west. Area obscured by vegetation.

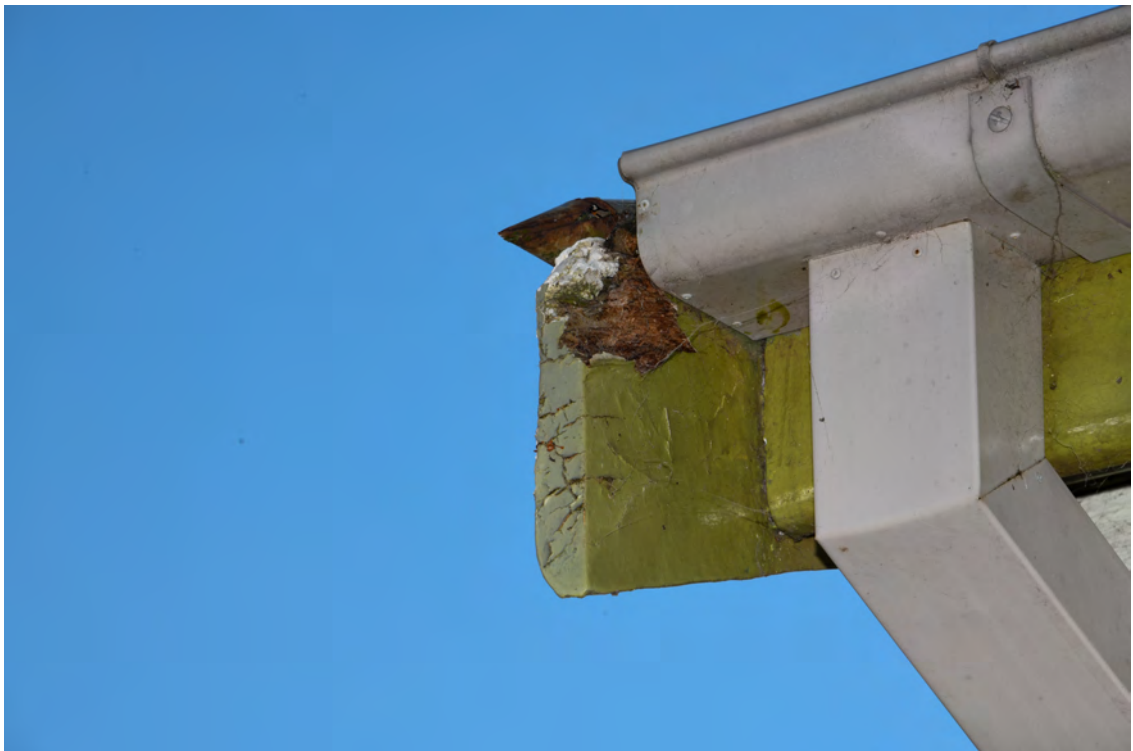
PRO\_0341.jpg

Block D. Western elevation. Northern end. Rotten fascia.

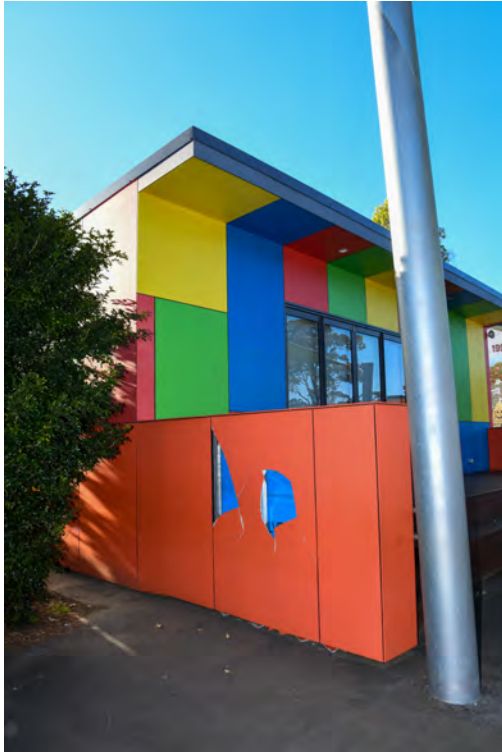
PRO\_0361.jpg

Block R. Northern elevation. Western end. Damaged cladding.

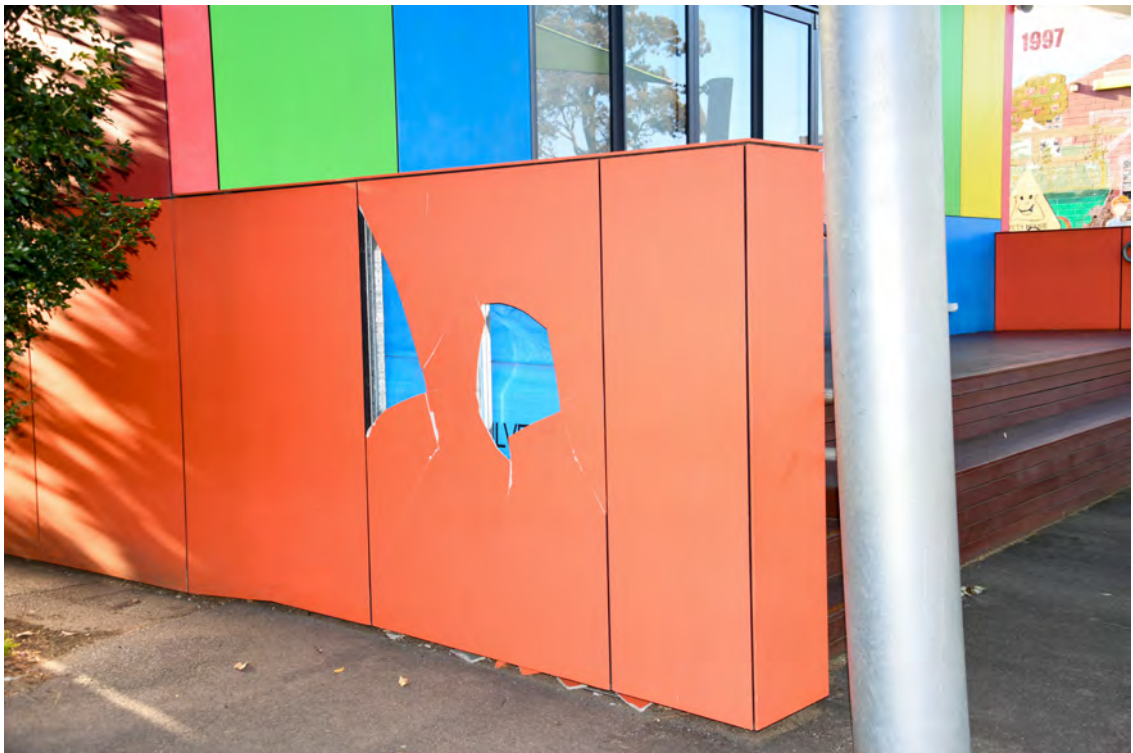
PRO\_0362.jpg

Block R. Northern elevation. Western end. Damaged cladding.

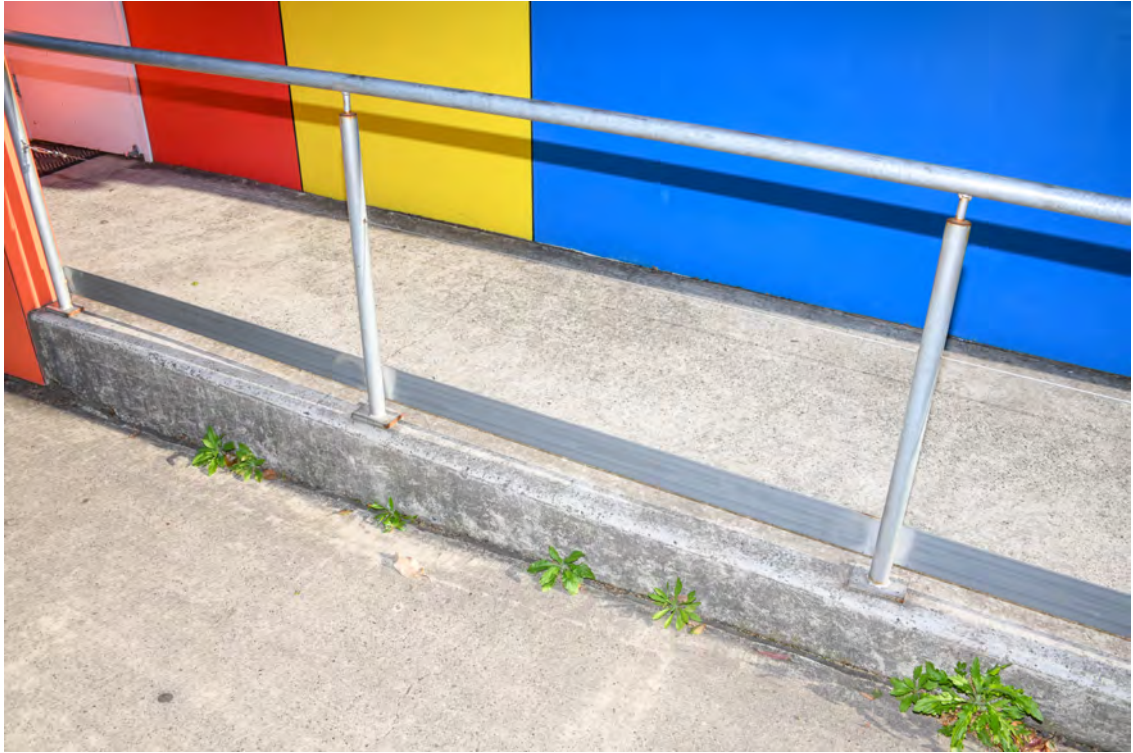
PRO\_0375.jpg

Block R. Southern side. Cracked adjacent paving.

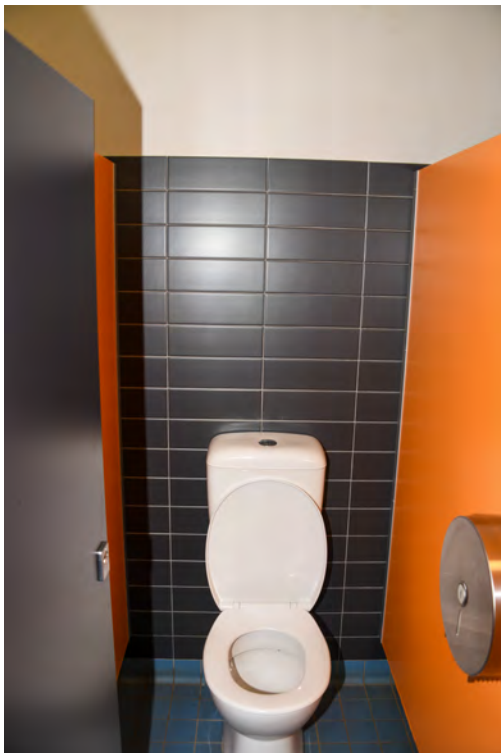
PRO\_0674.jpg

Block R. Eastern side. Male amenities.

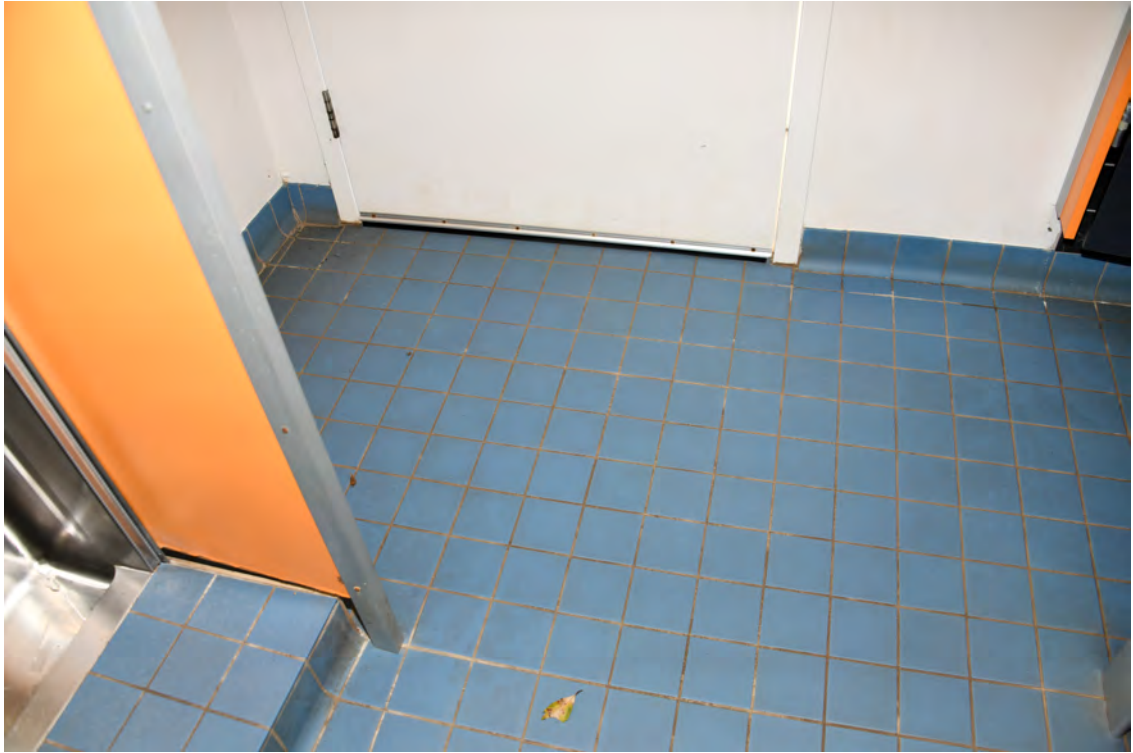
PRO\_0675.jpg

Block R. Eastern side. Male amenities.

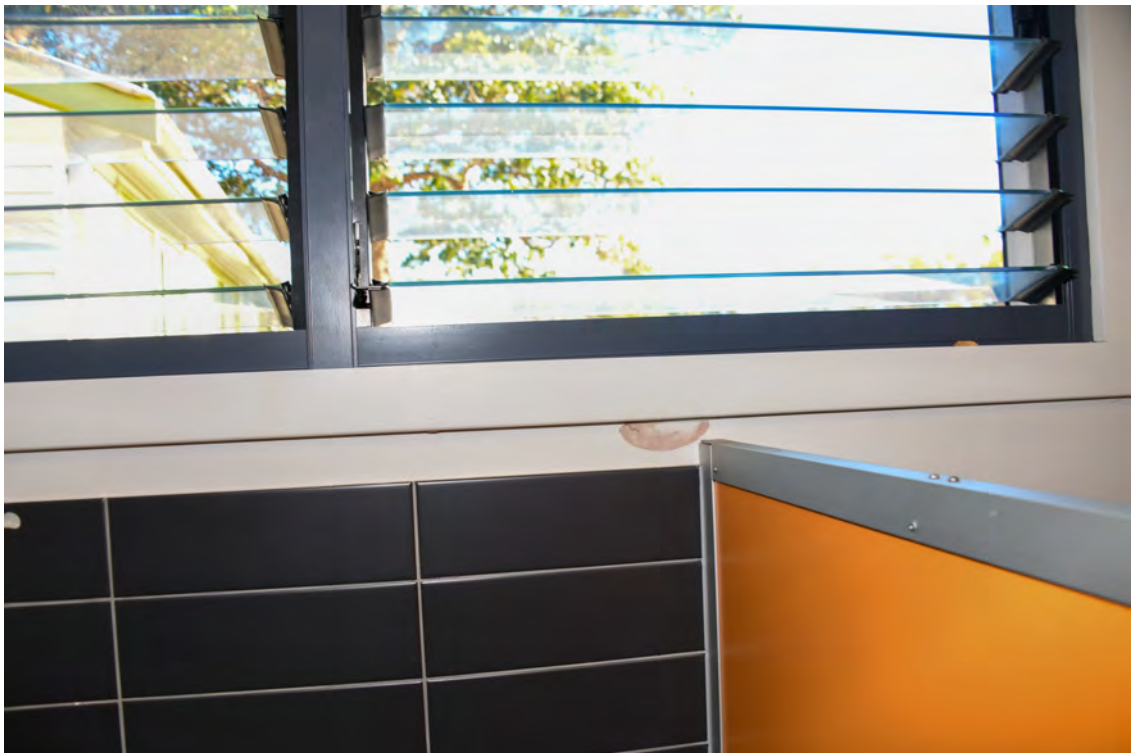
PRO\_0676.jpg

Block R. Eastern side. Male amenities.

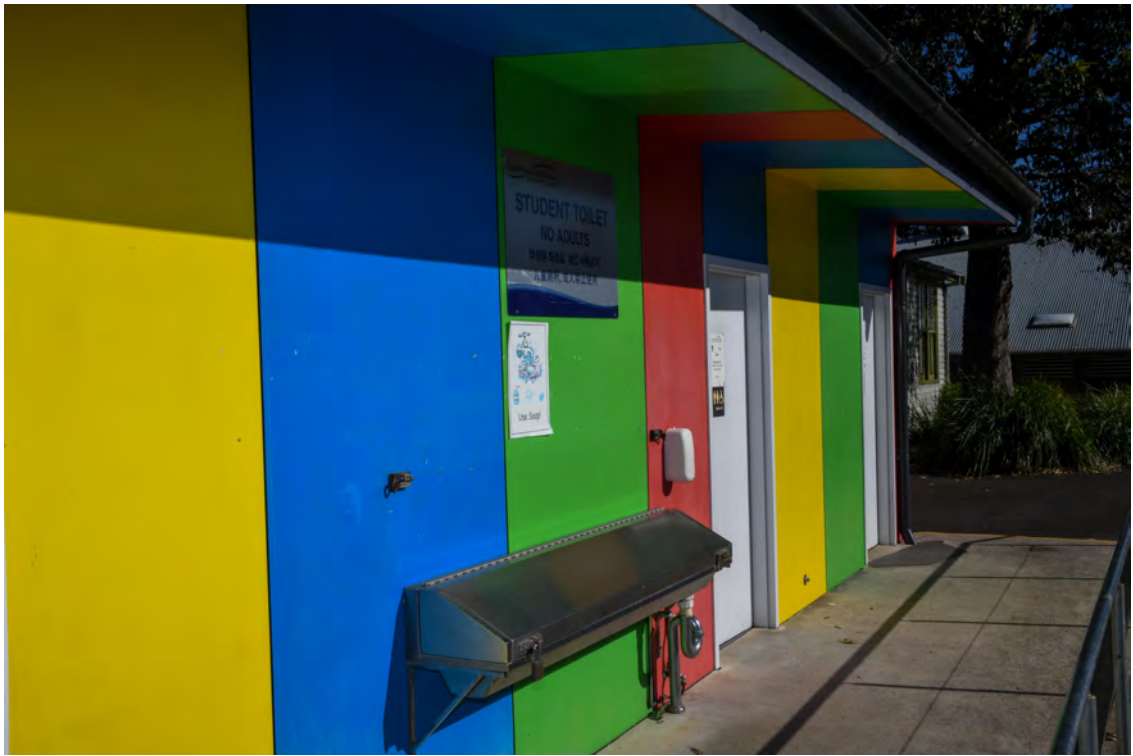
PRO\_0913.jpg

Block R. Eastern side.

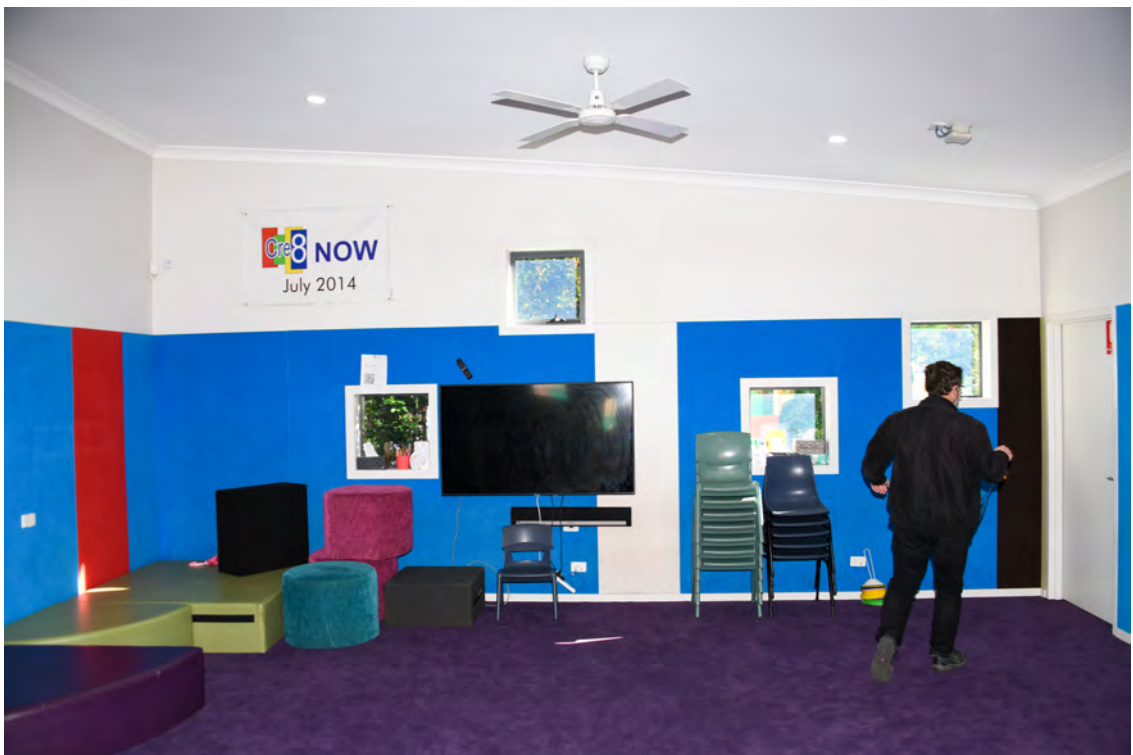
PRO\_0914.jpg

Block R. Interior. Western half. Northern face.
