96-104 Carlingford Road, Epping NSW 2121

Epping West Public School

DILAPIDATION REPORT

7<sup>th</sup> September 2021

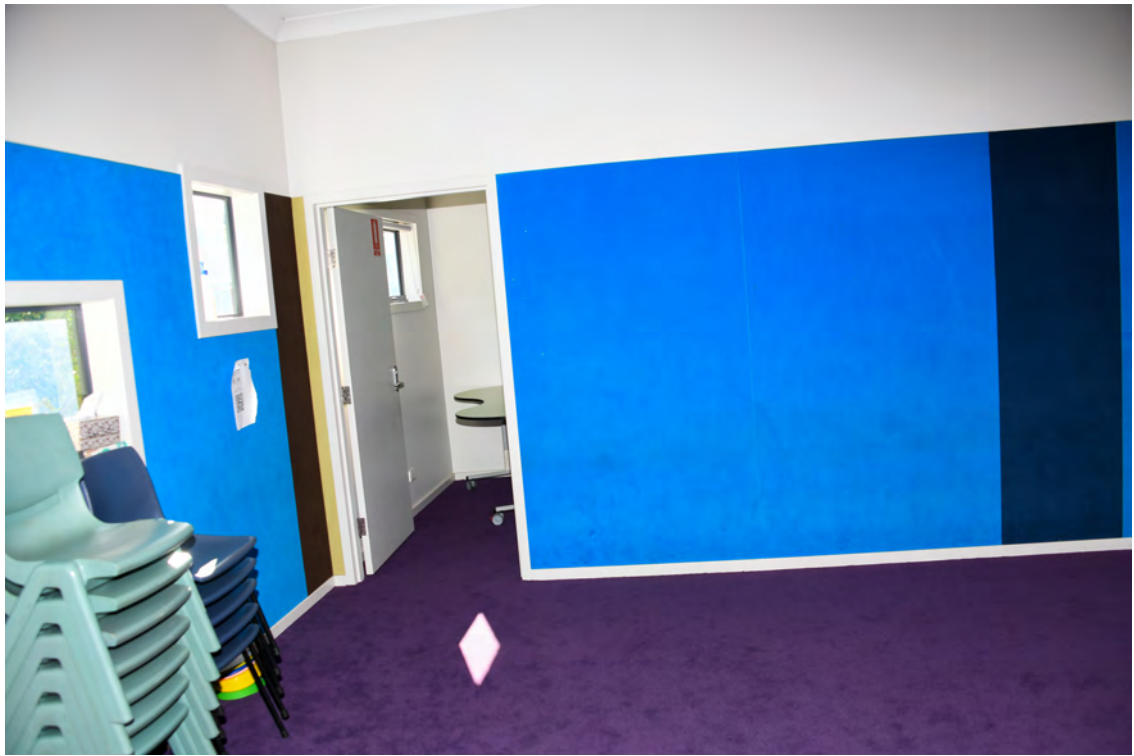
PRO\_0915.jpg

Block R. Interior. Western half. Northern face.

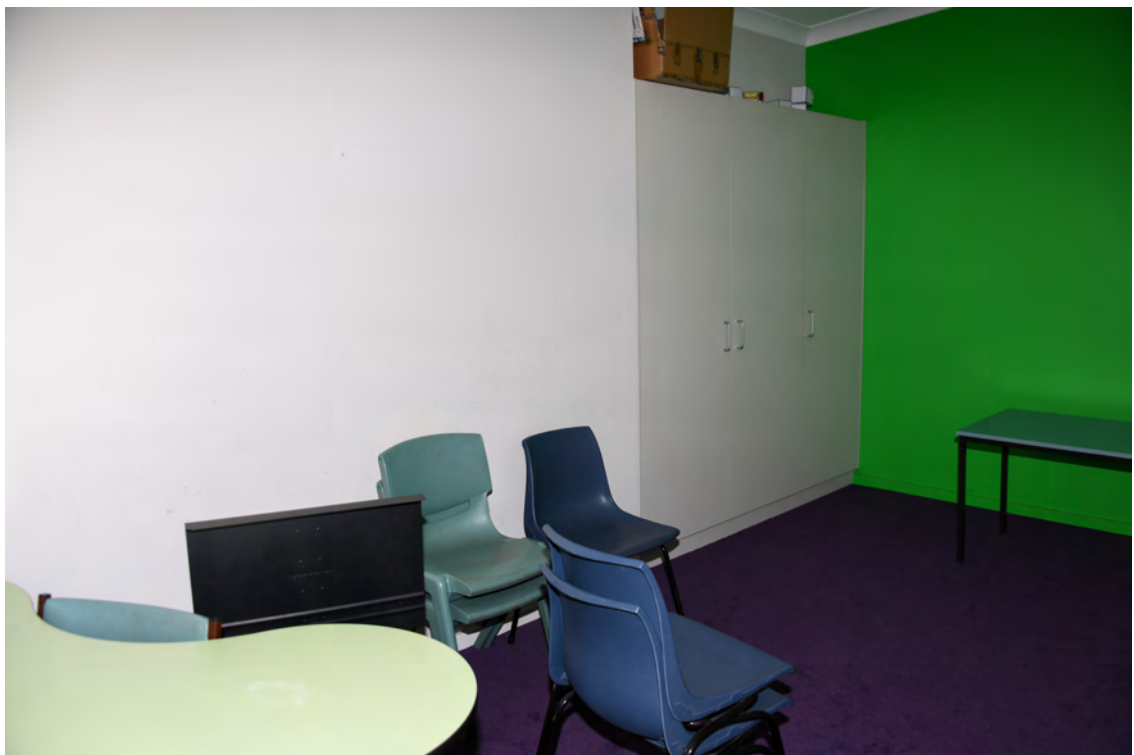
PRO\_0916.jpg

Block R. Interior. Western half. Northern face.

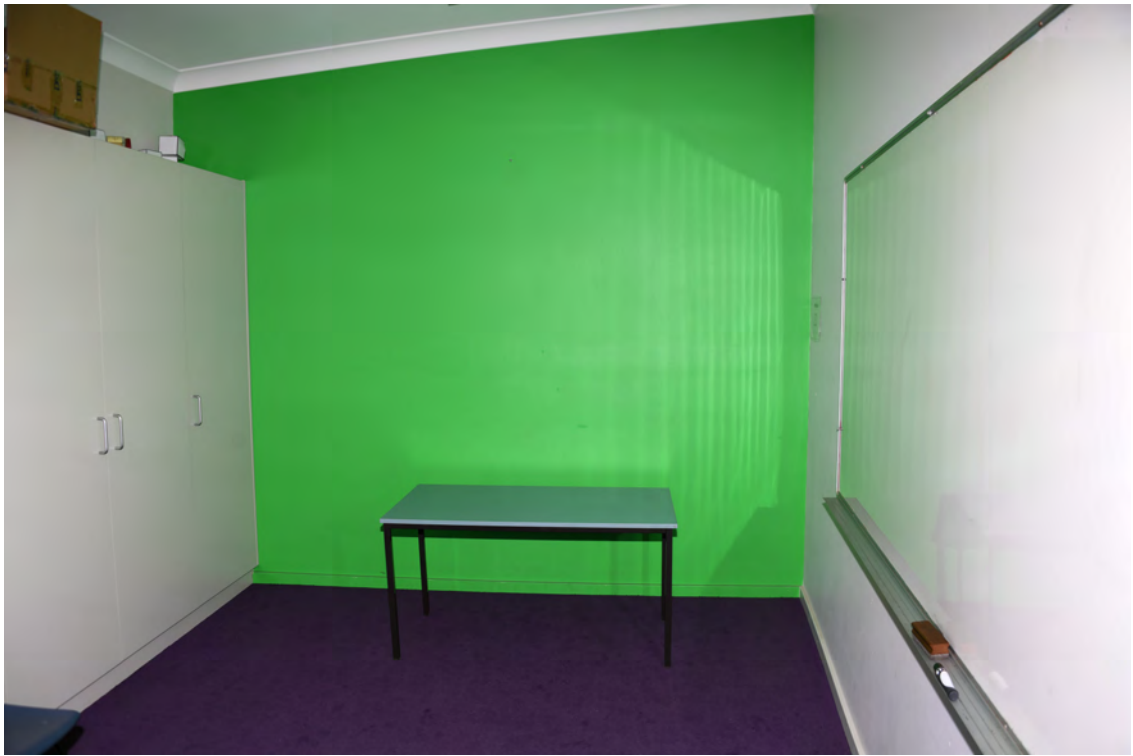
PRO\_0917.jpg

Block R. Interior. Western half. Eastern face.

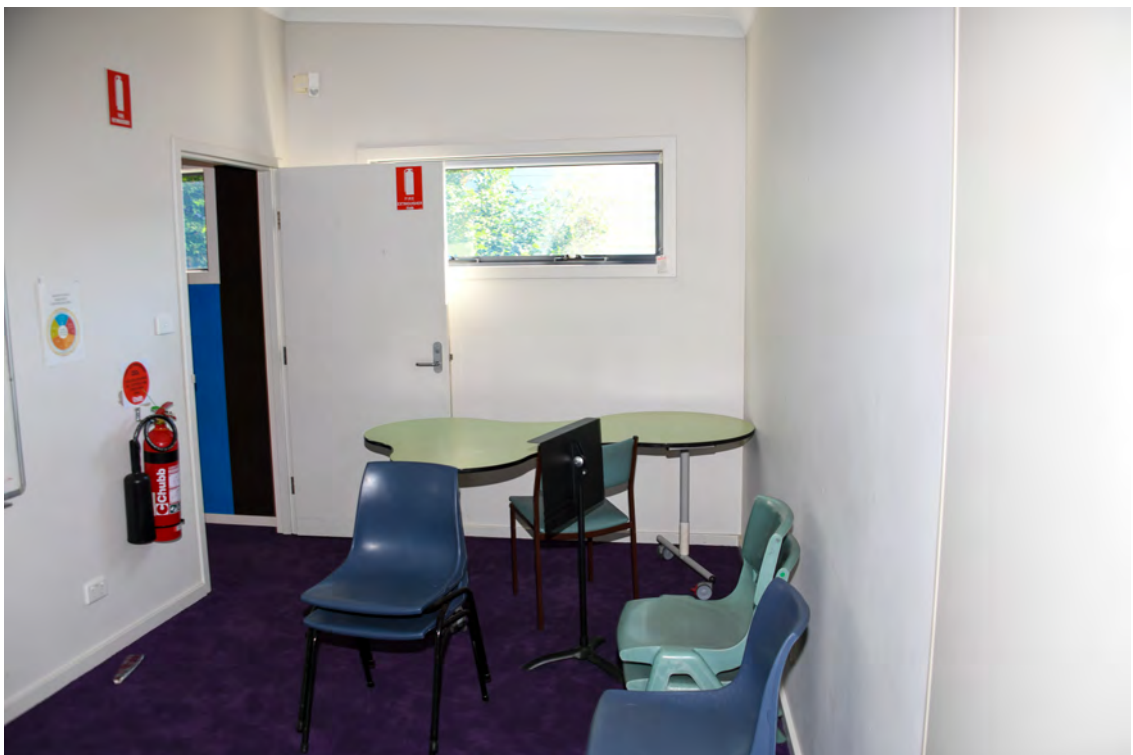
PRO\_0918.jpg

Block R. Interior. Western half. Western face.

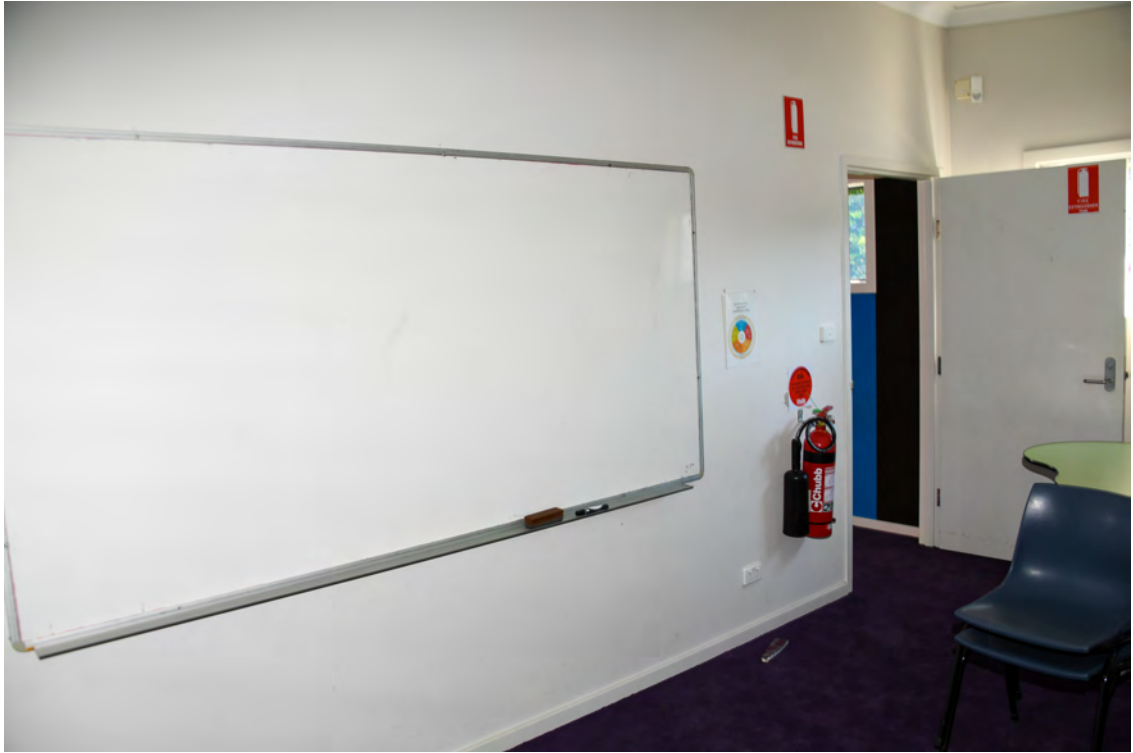
PRO\_0919.jpg

Block R. Interior. Western half. Southern face.

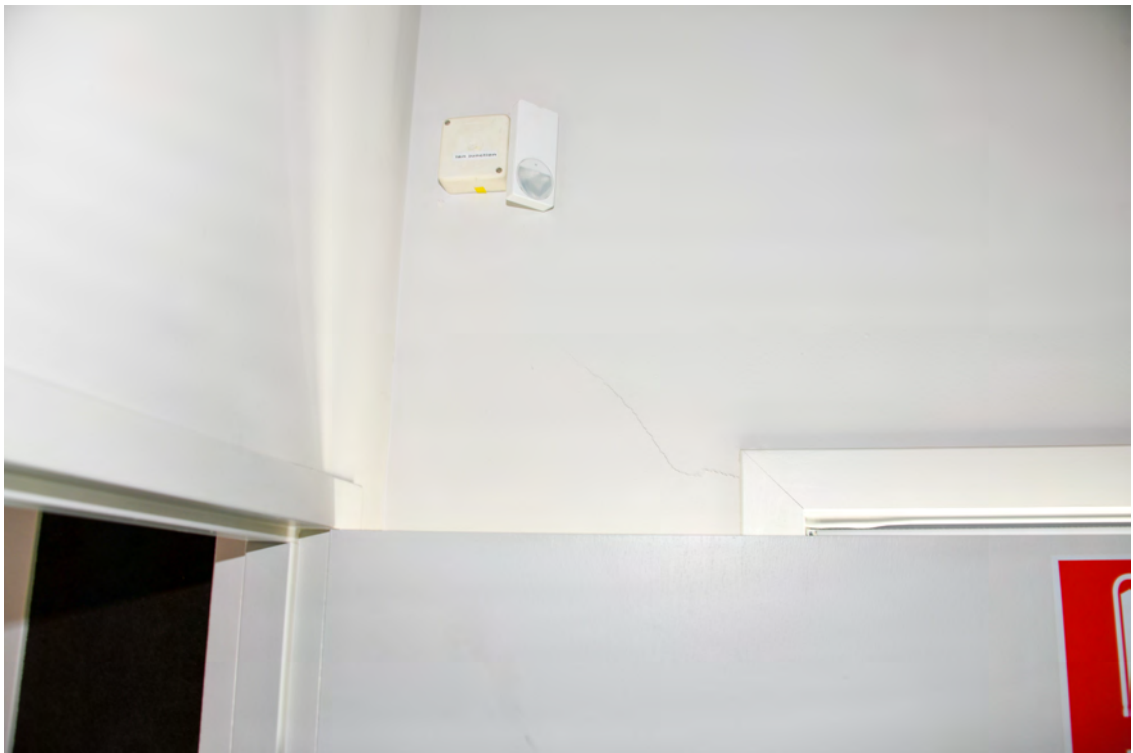
PRO\_0920.jpg

Block R. Interior. Western half. Western face. Crack in the wall lining.

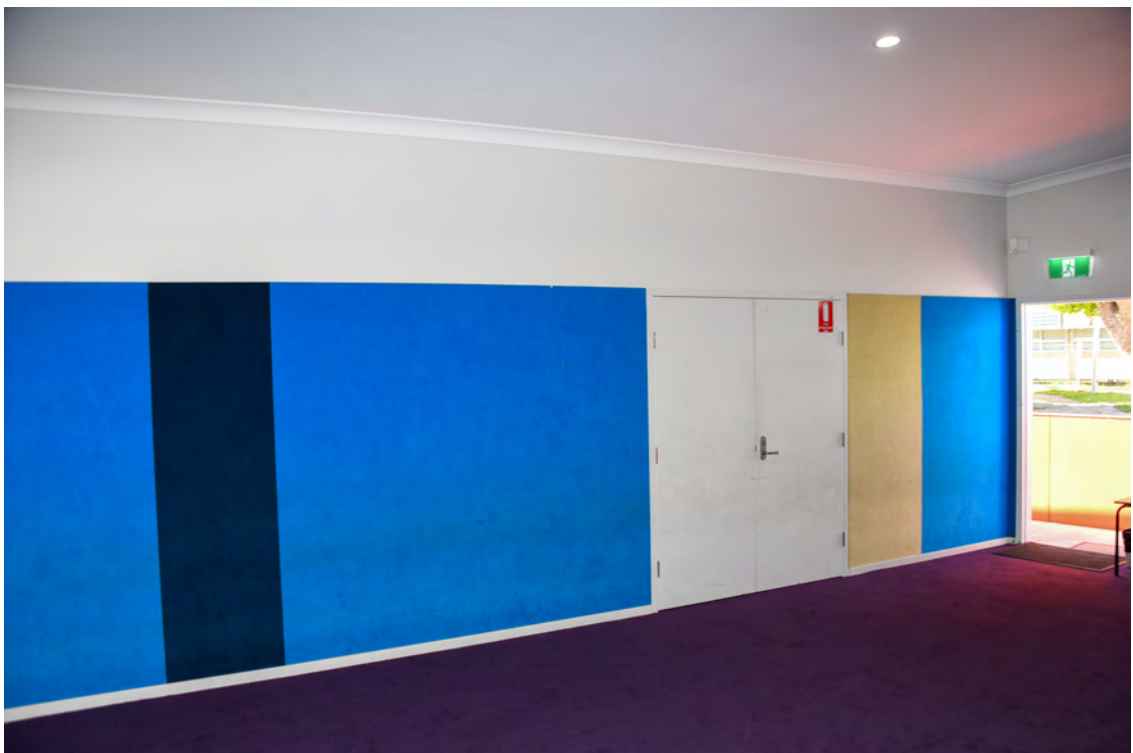
PRO\_0922.jpg

Block R. Interior. Western half. Southern face.

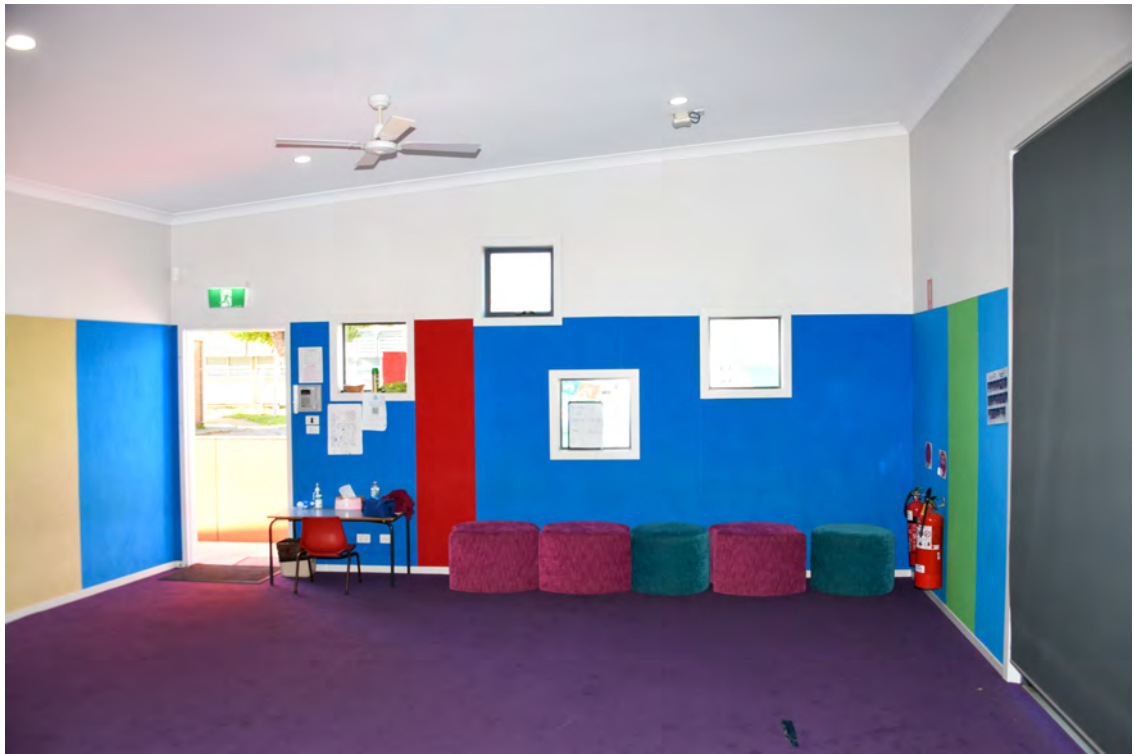
PRO\_0923.jpg

Block R. Interior. Western half. Western face.

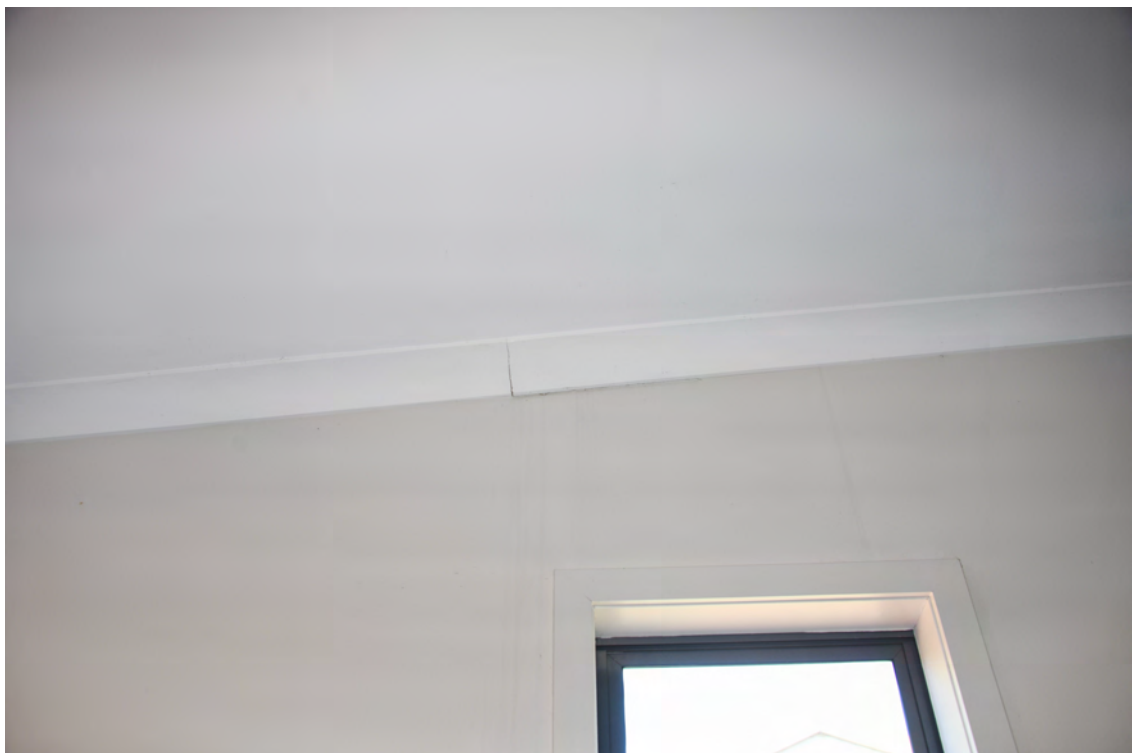
PRO\_0924.jpg

Block R. Interior. Western half. Western face.

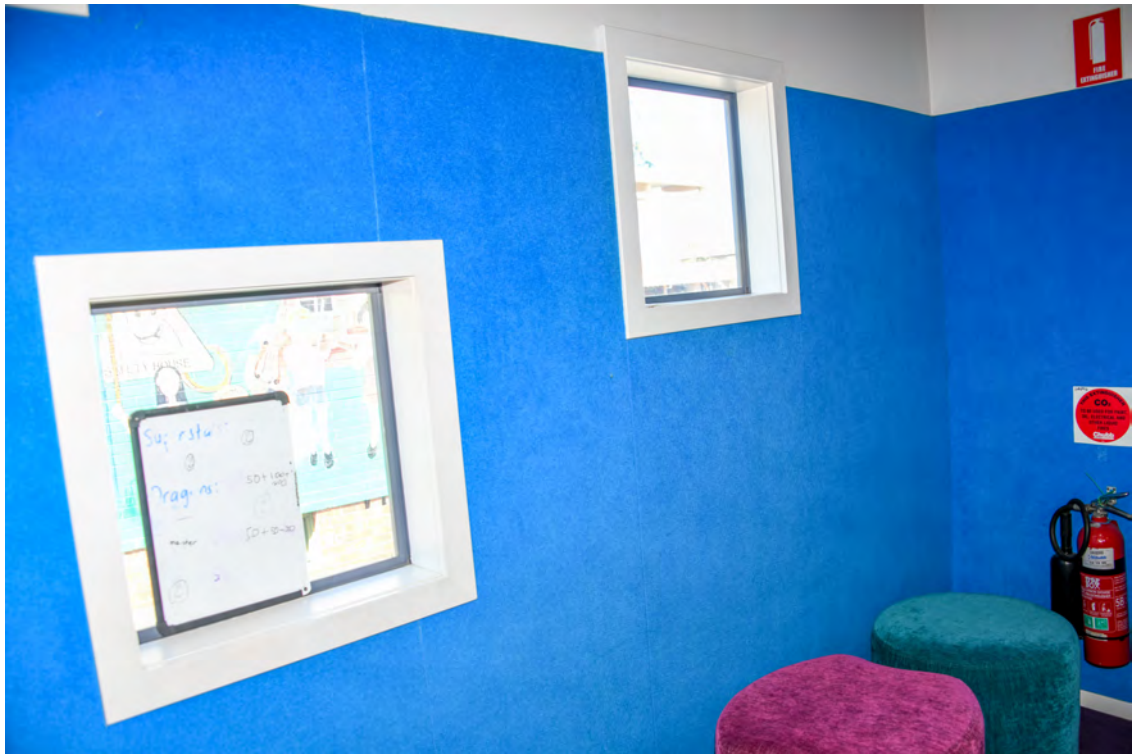
PRO\_0925.jpg

Block R. Interior. Western half. Western face.

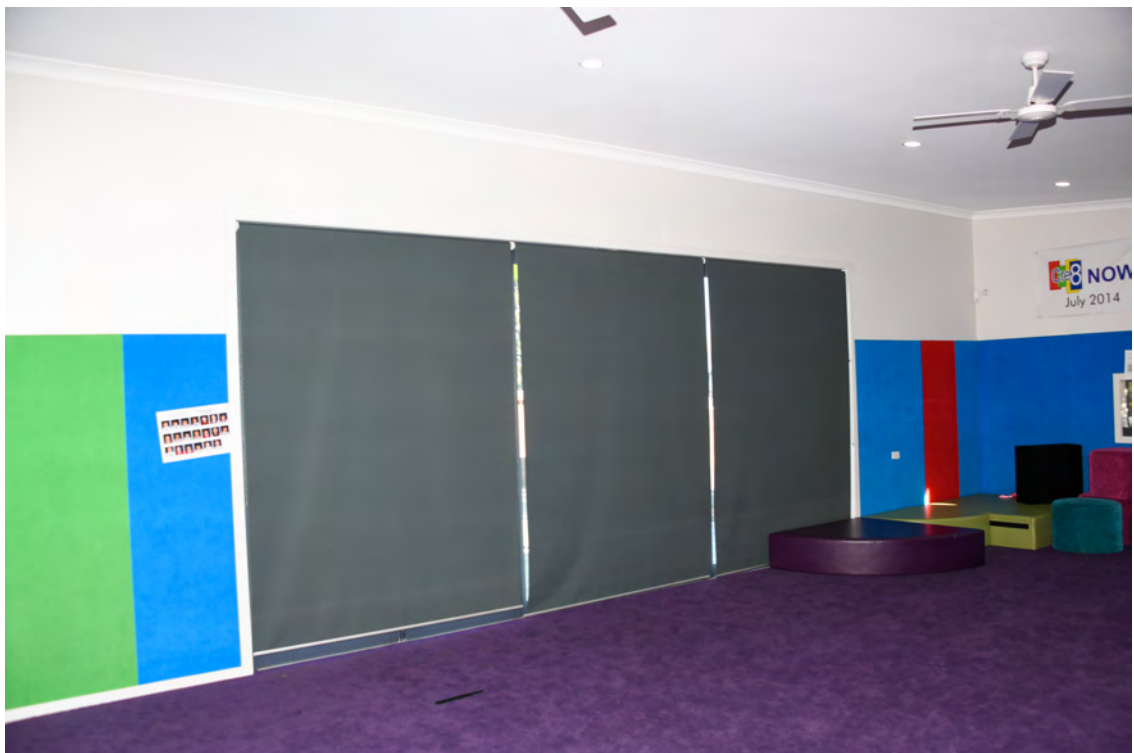
PRO\_0926.jpg

Block R. Interior. Western half. Northern face.

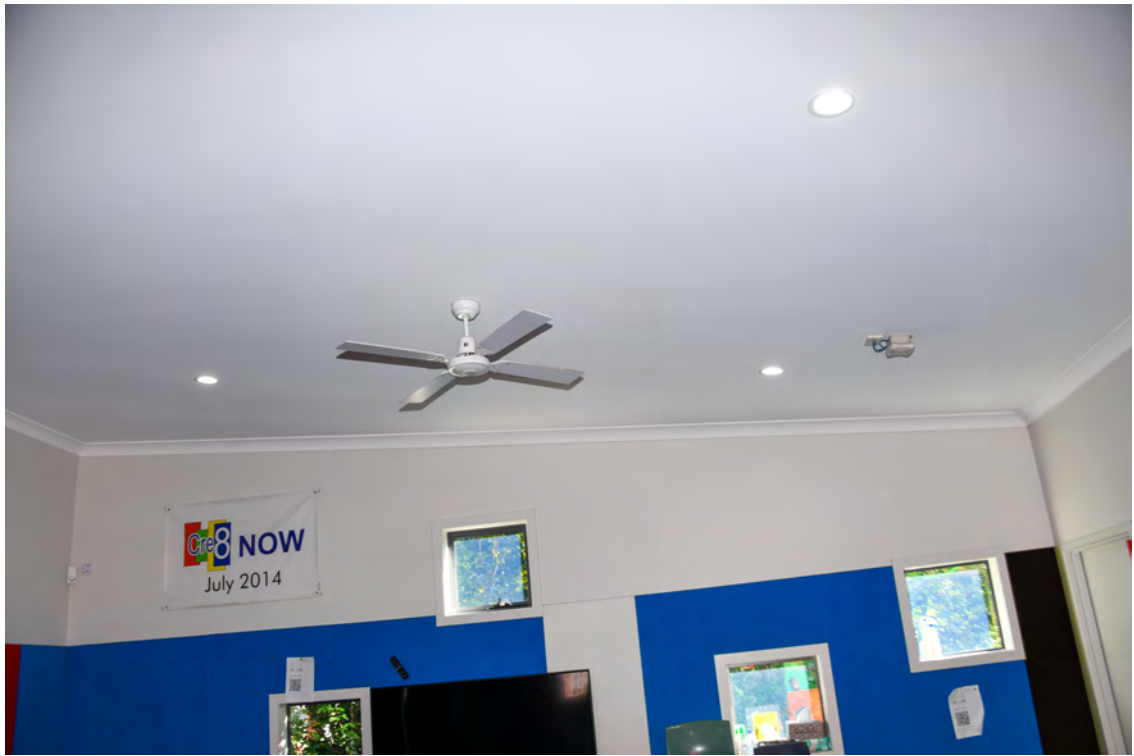
PRO\_0927.jpg

Block R. Interior. Western half. Ceiling.

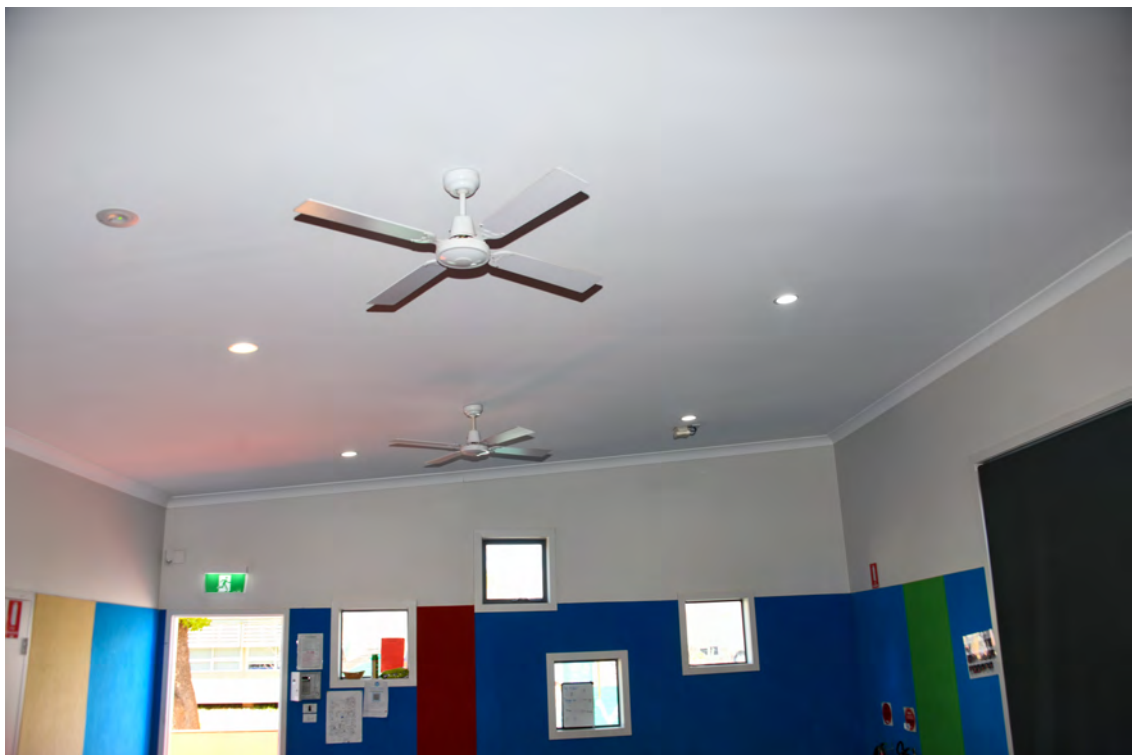
PRO\_0928.jpg

Block R. Interior. Western half. Ceiling.

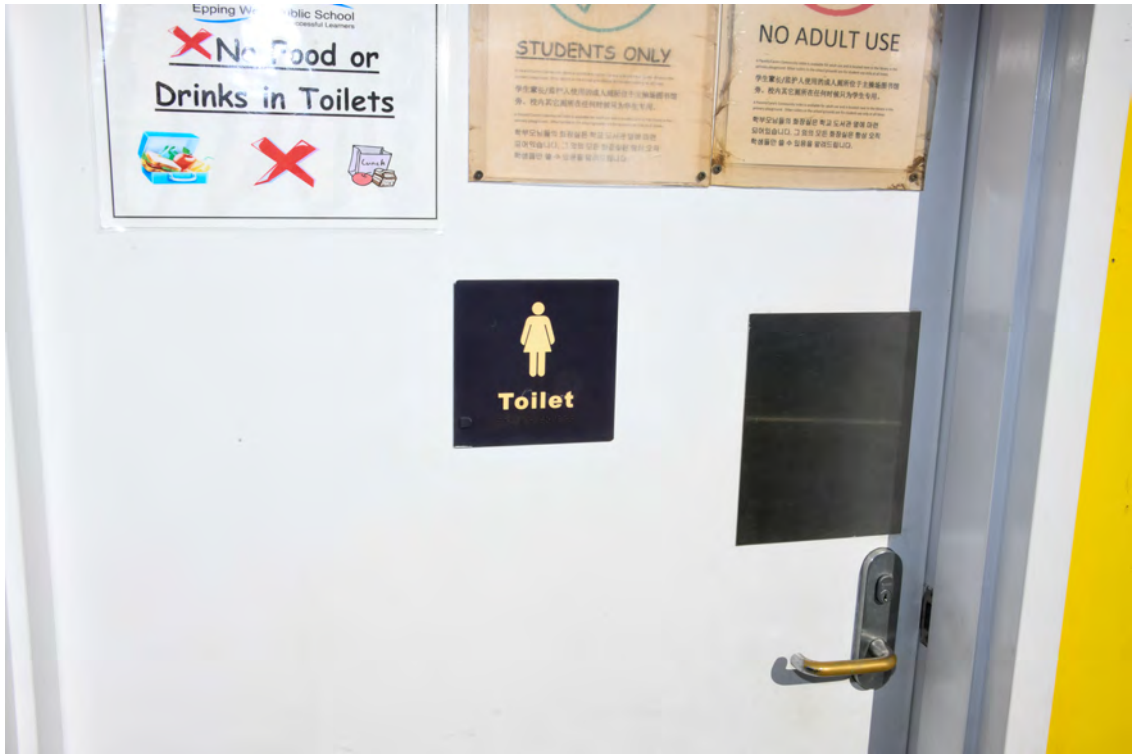
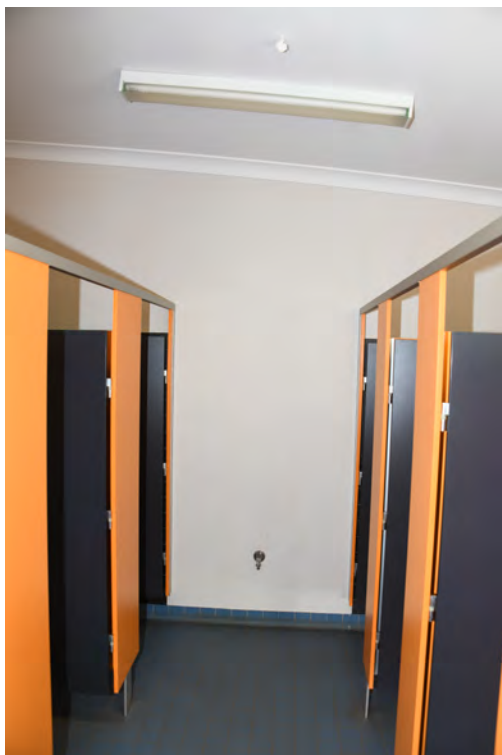
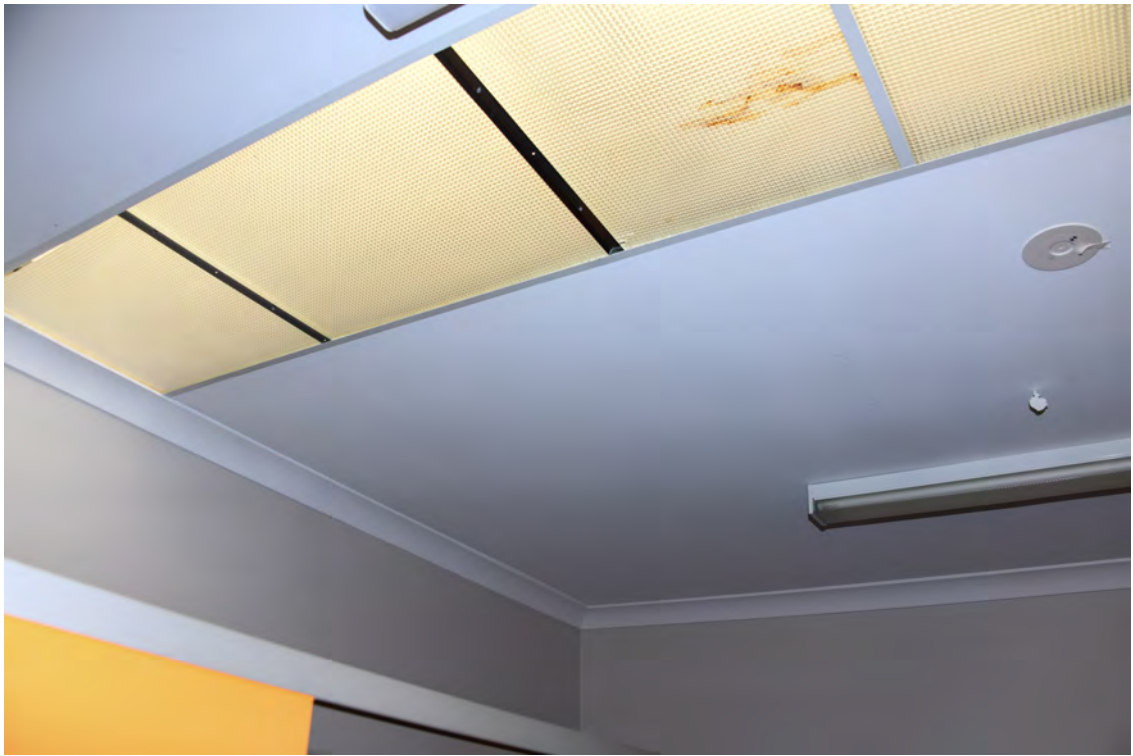
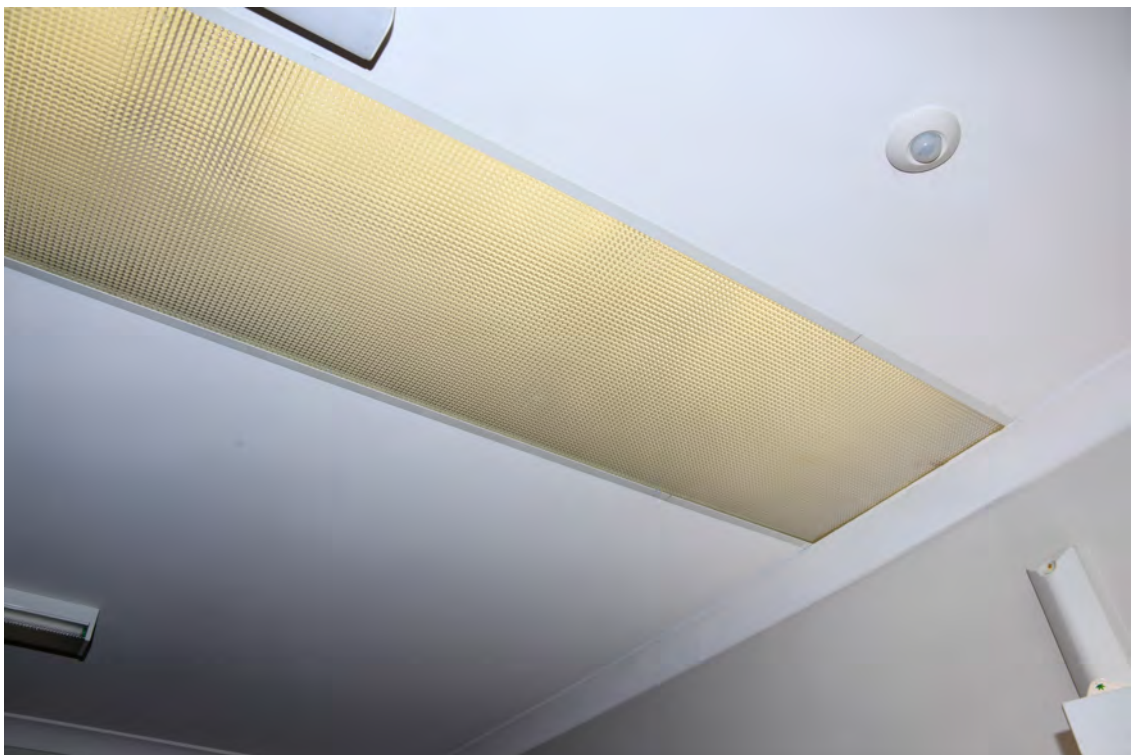
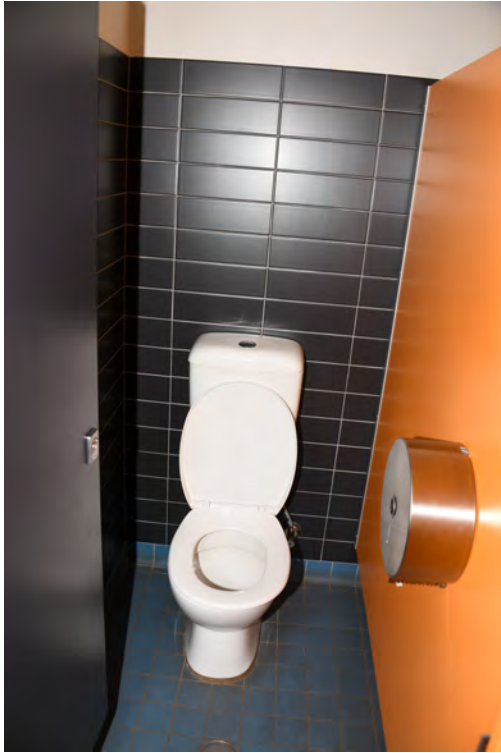
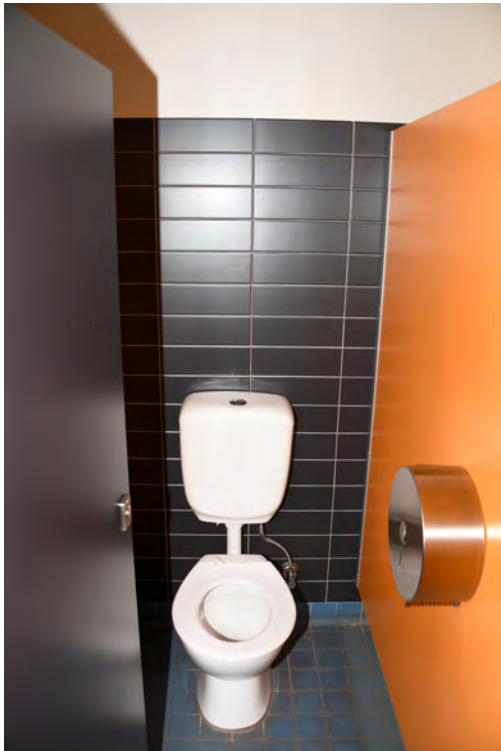
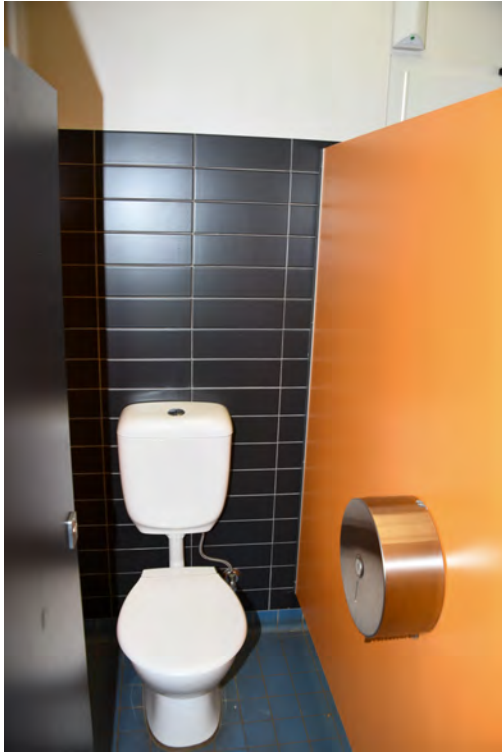
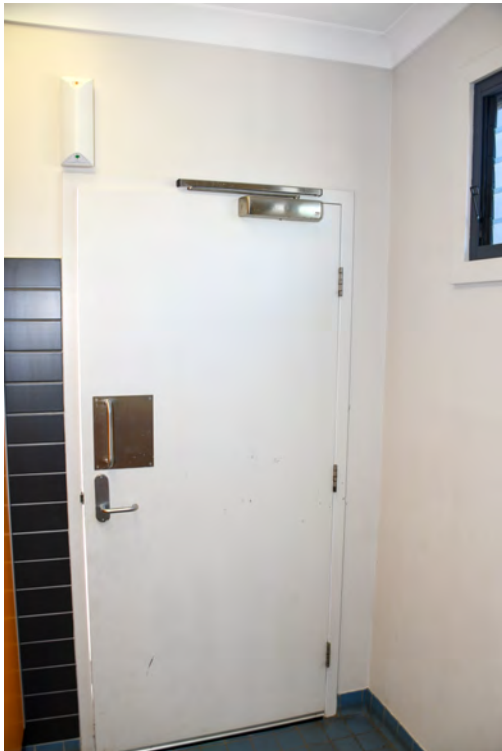
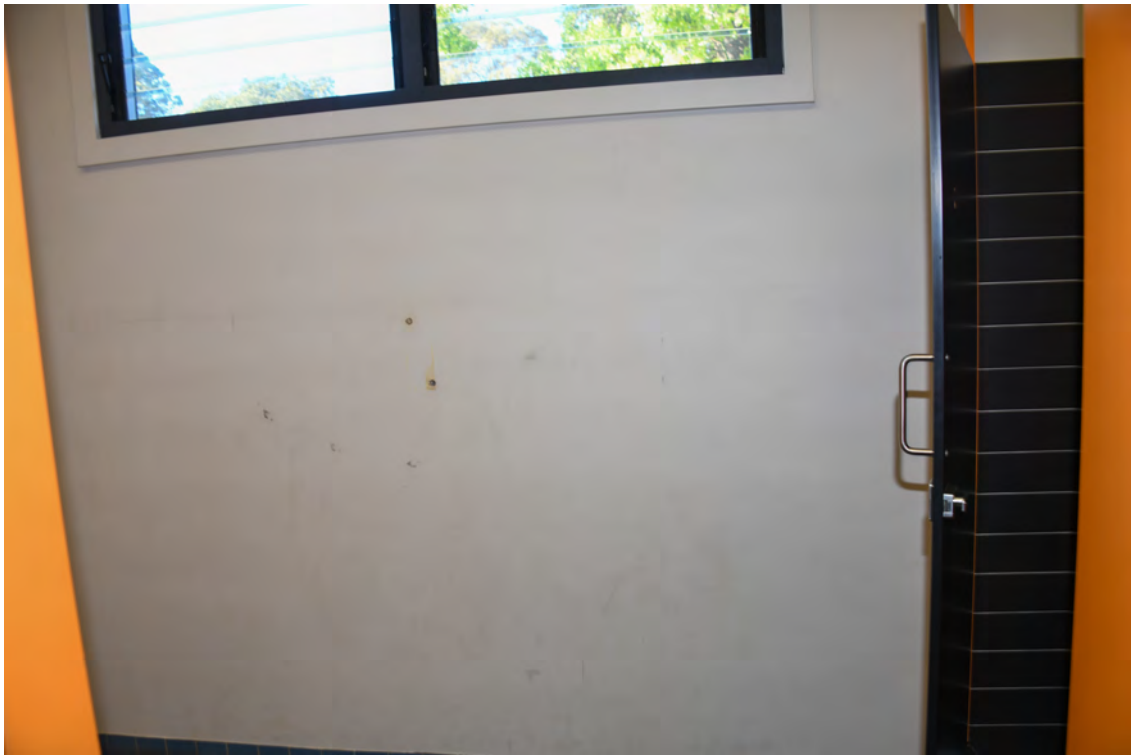
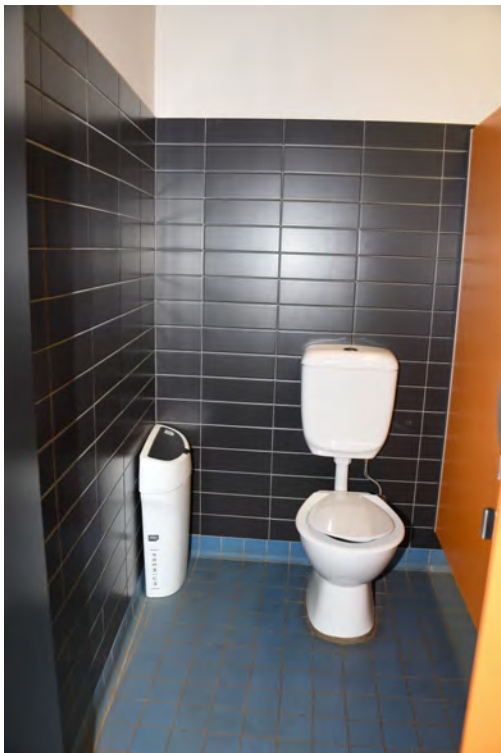
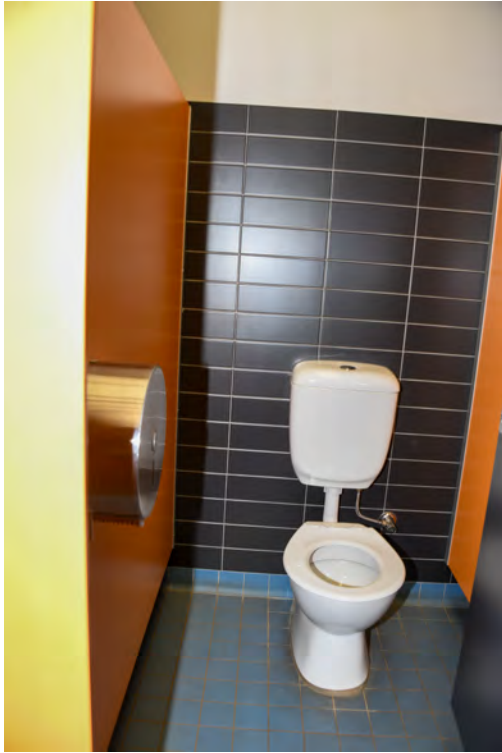
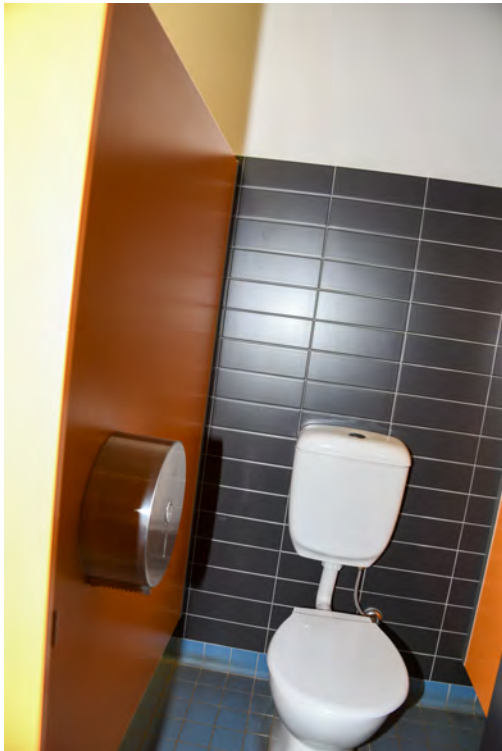
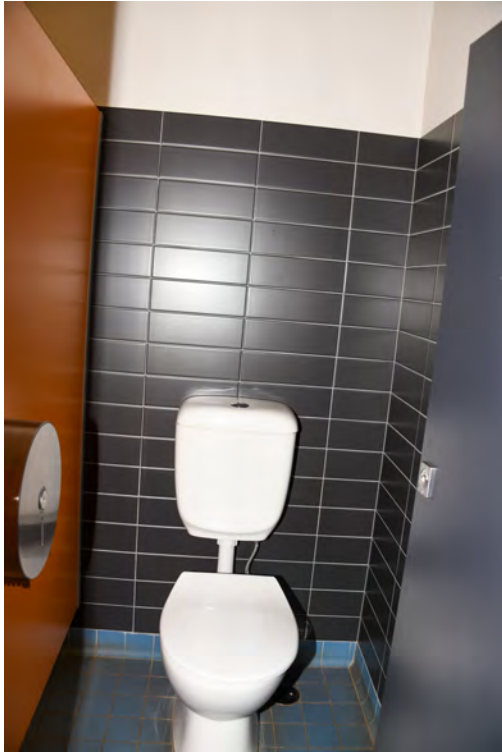
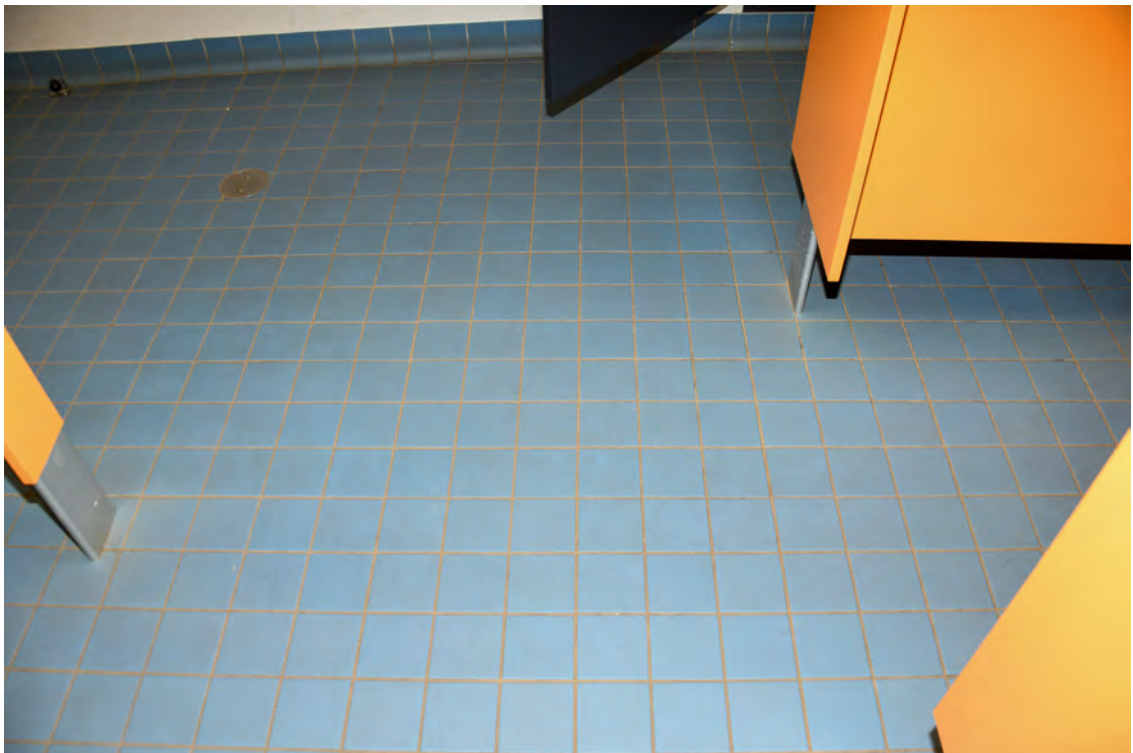
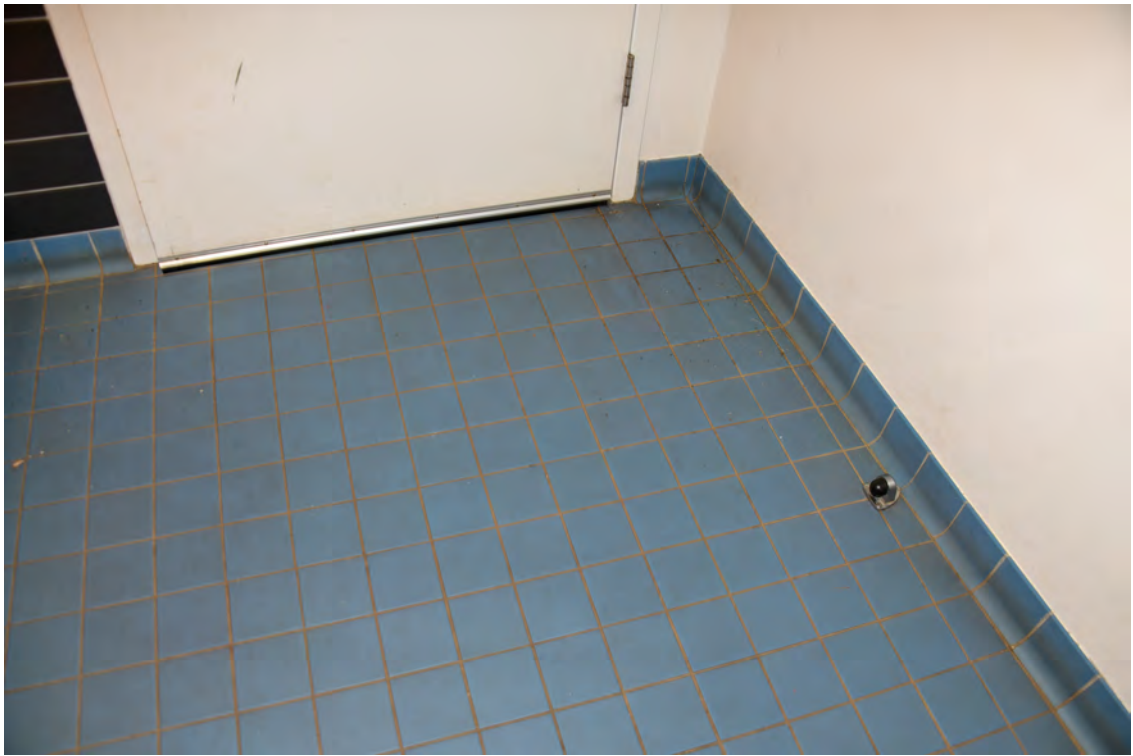
Block R. Interior. Female amenities.

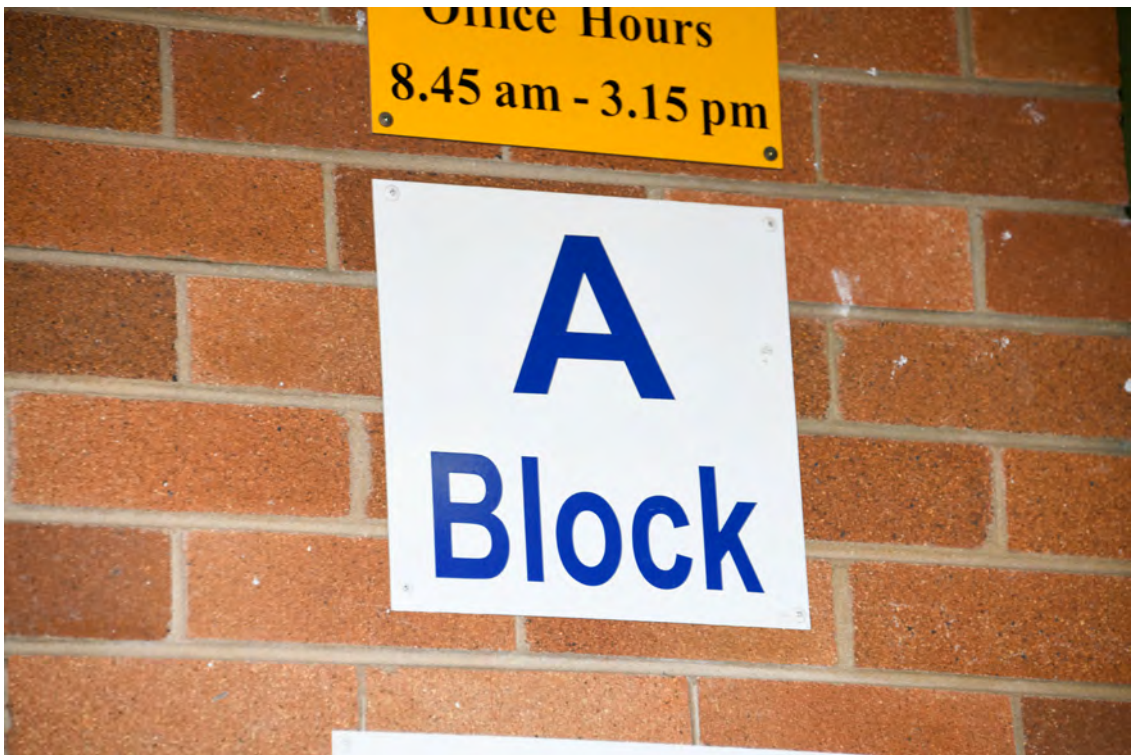
PRO\_0386.jpg

Block A. Refer to the following series of photographs for a record of the existing condition of the interior and exterior of the building.
