96-104 Carlingford Road, Epping NSW 2121

Epping West Public School

DILAPIDATION REPORT

7<sup>th</sup> September 2021

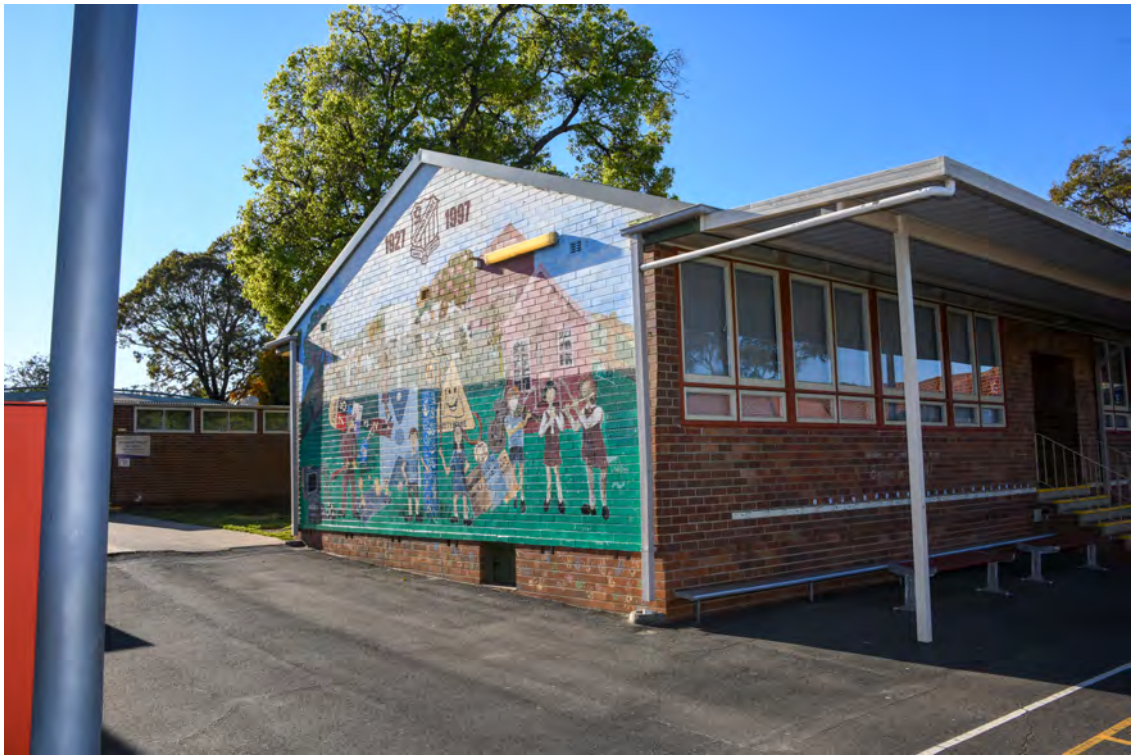
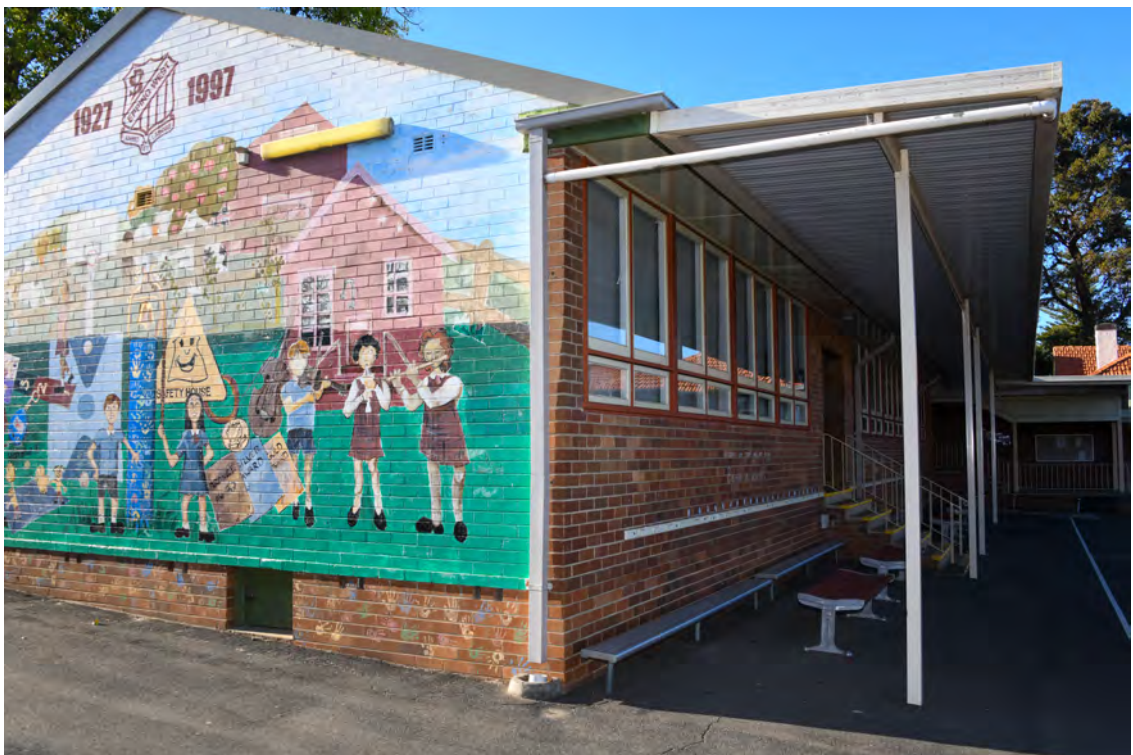
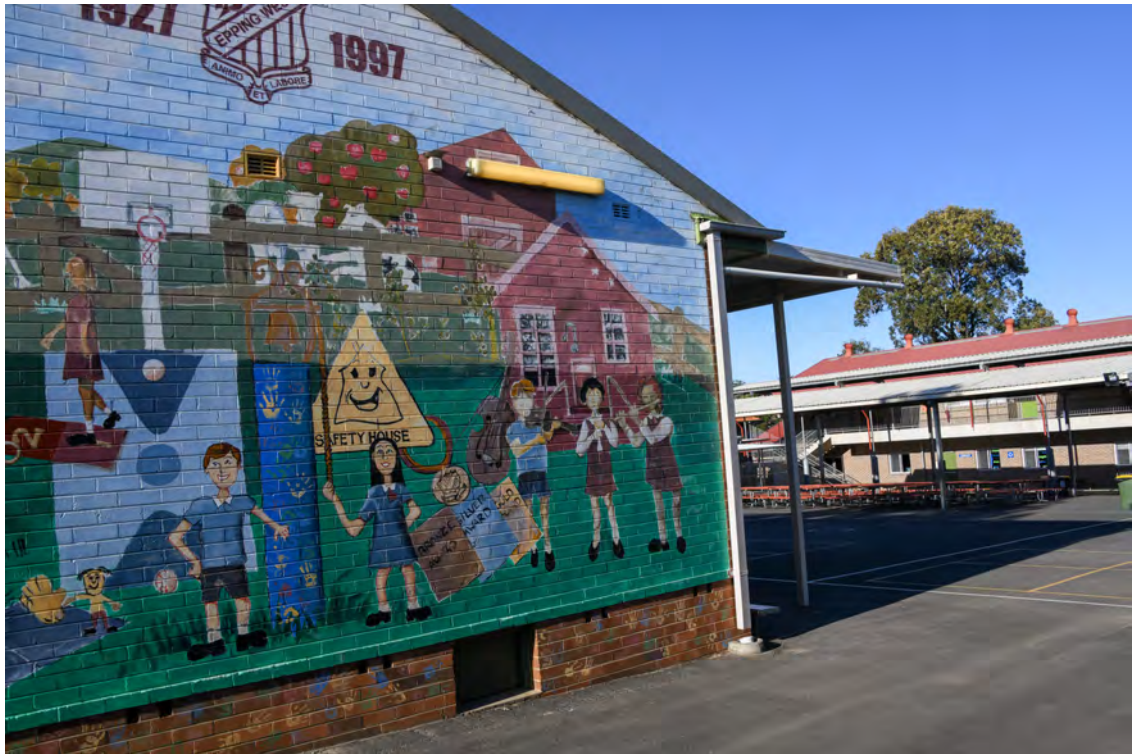
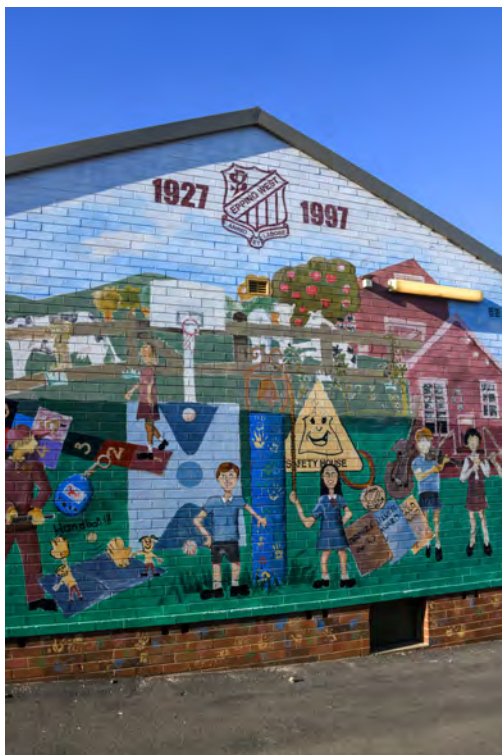
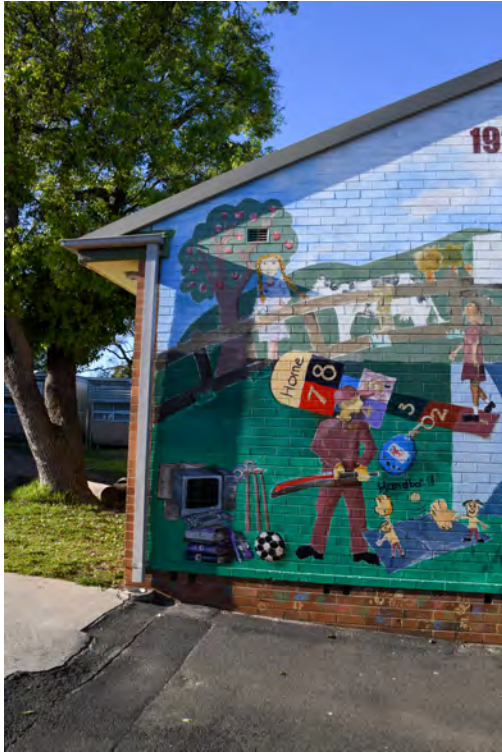
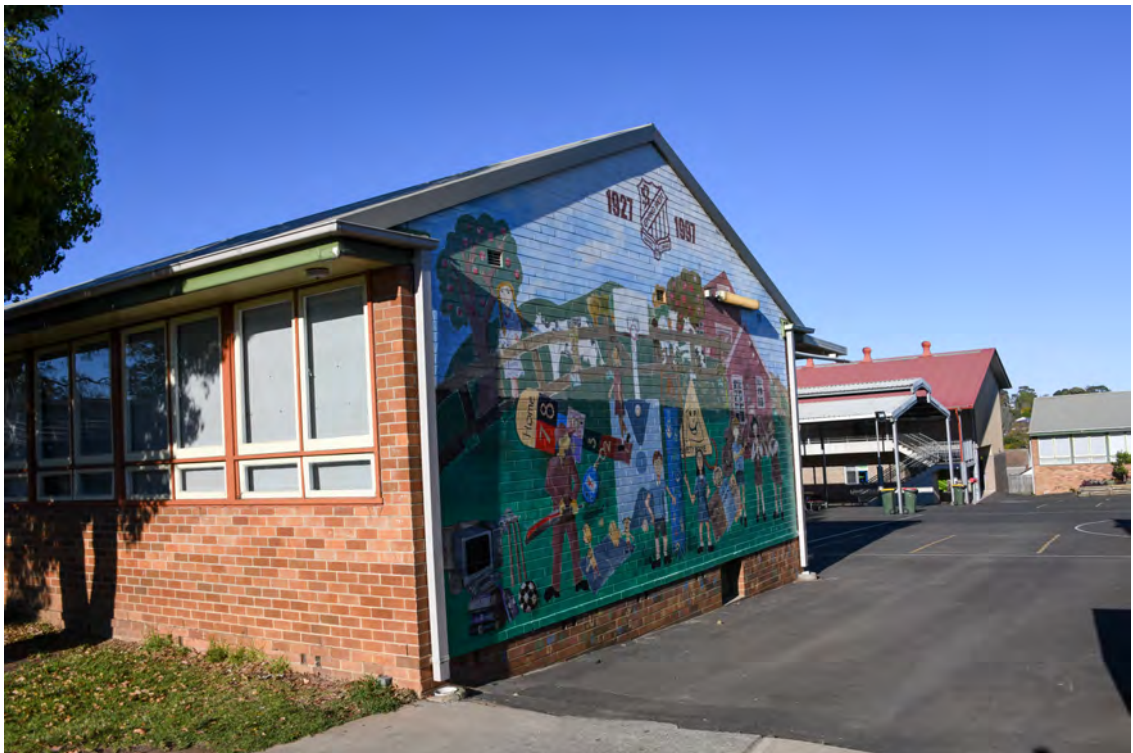
Block A. Northern elevation.

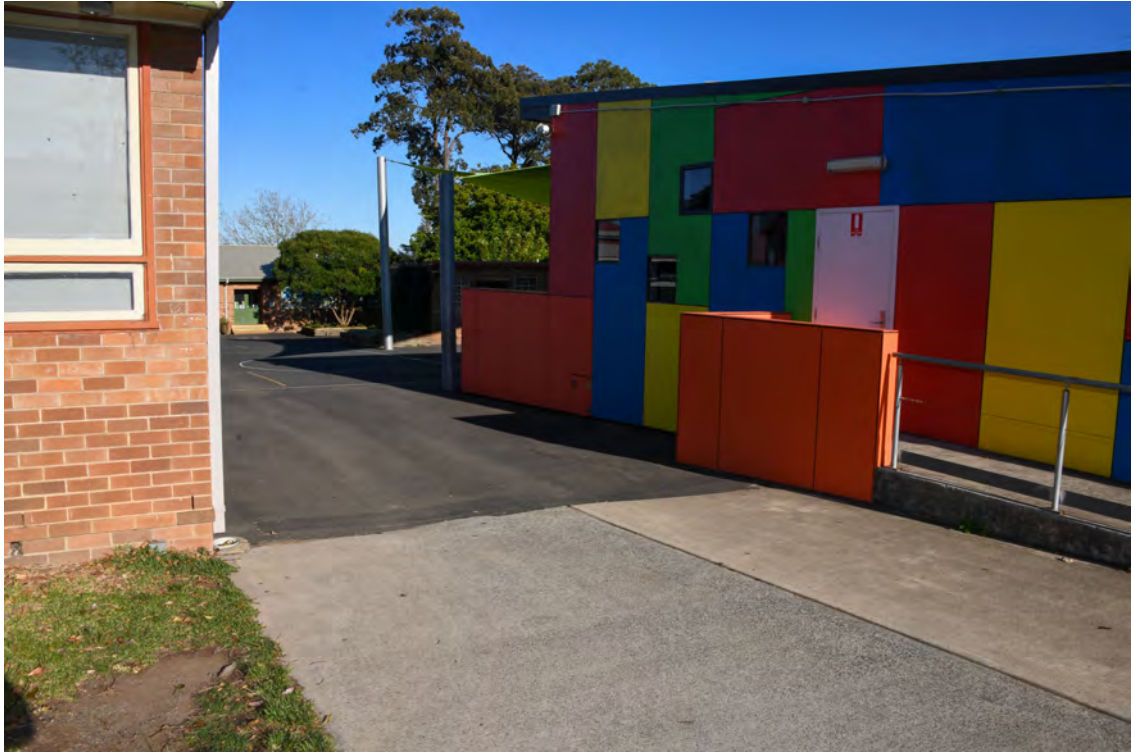
PRO\_0393.jpg

Block A. Northern elevation. Adjacent area.

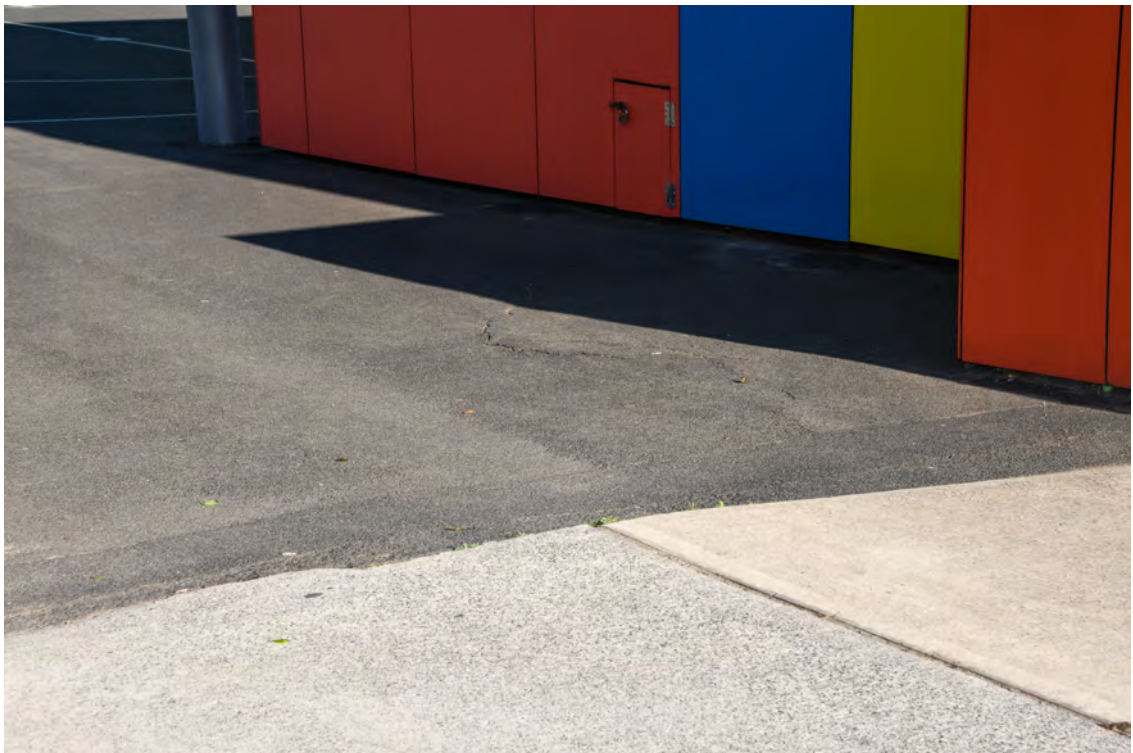
PRO\_0394.jpg

Block A. Northern elevation. Adjacent paving.

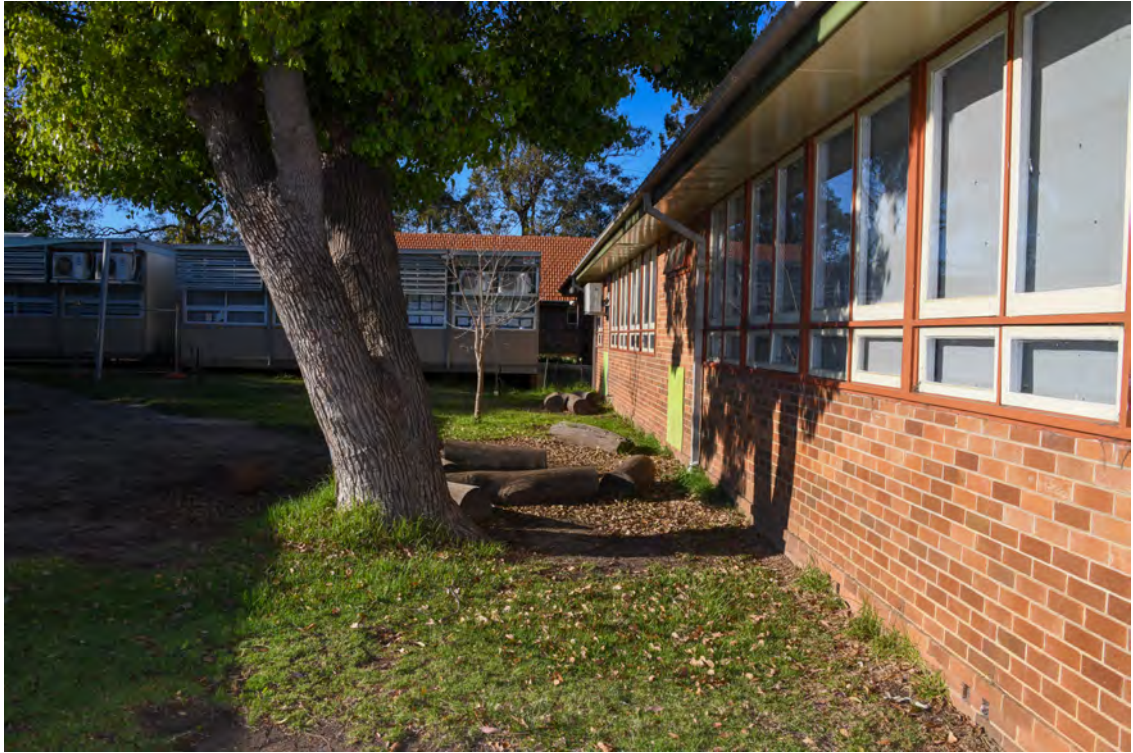
PRO\_0397.jpg

Block A. Eastern elevation. Facing south.

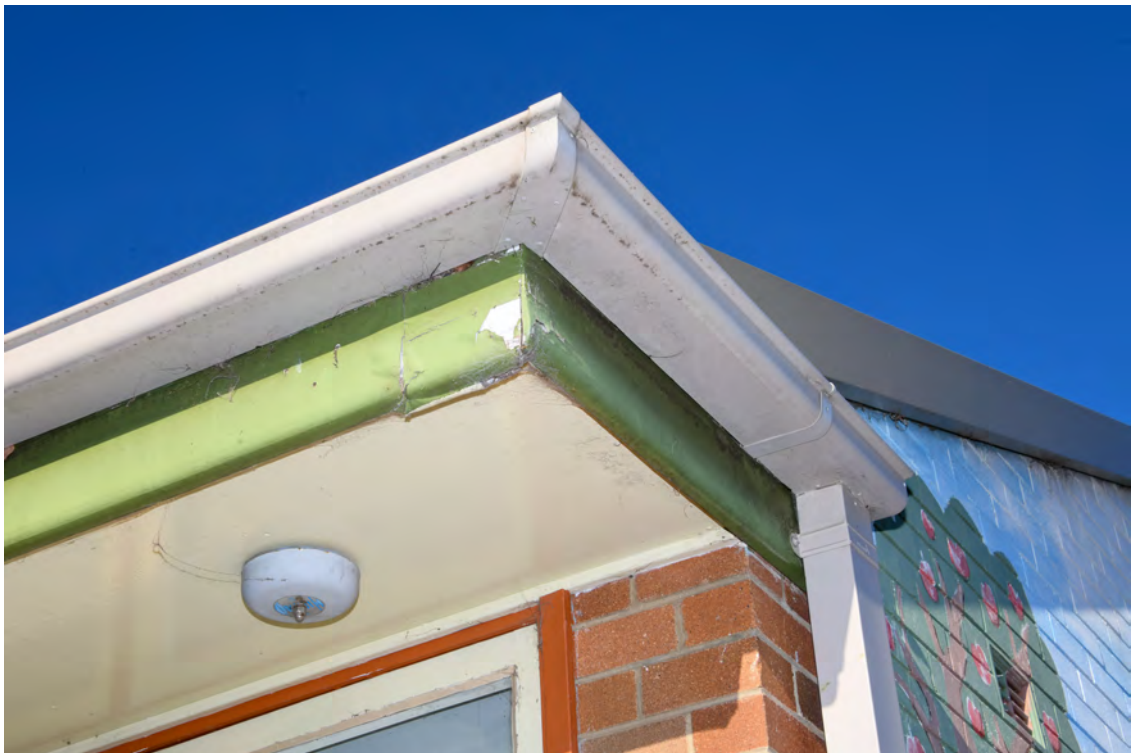
PRO\_0398.jpg

Block A. Eastern elevation. Northern end. Fascia.

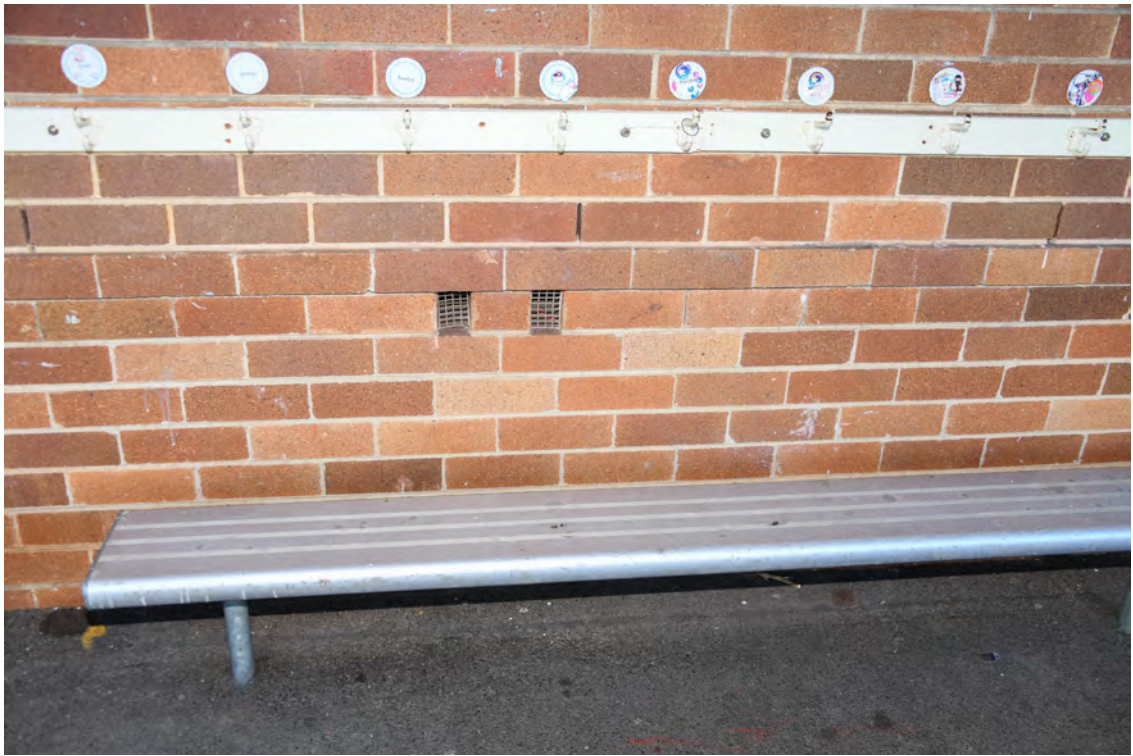
PRO\_0413.jpg

Block A. Western elevation. Heading south. Wall vents.

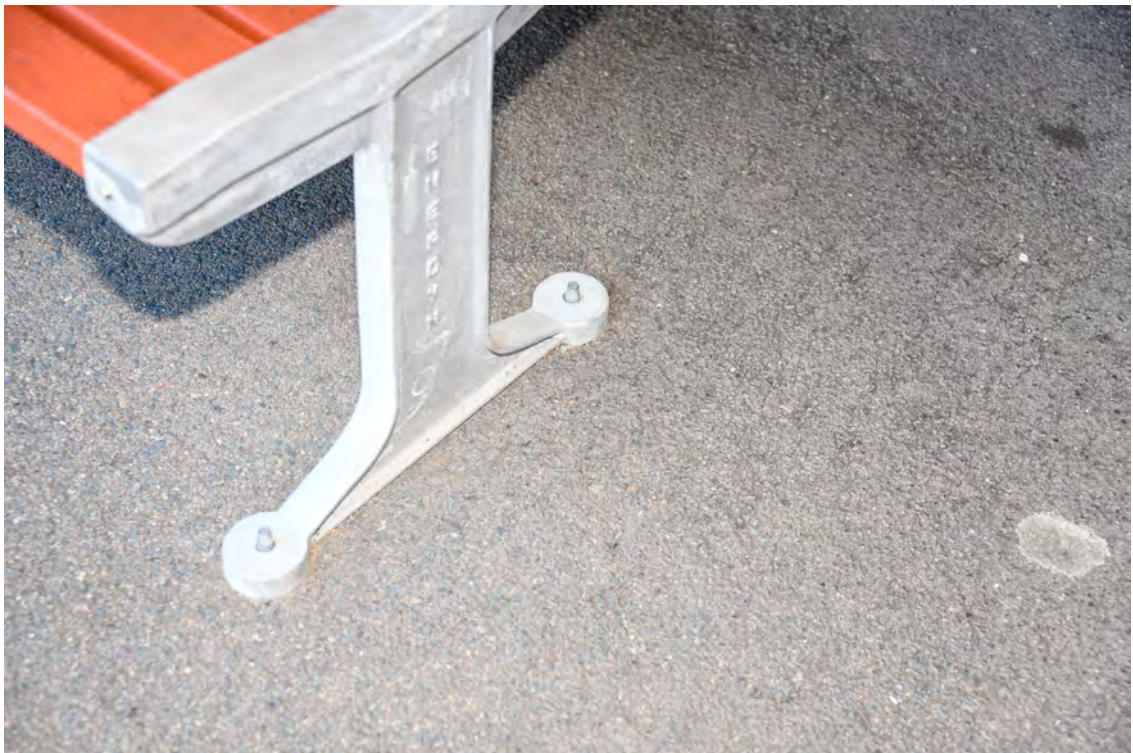
PRO\_0420.jpg

Block A. Western elevation. Heading south. Seats missing fixing nuts.

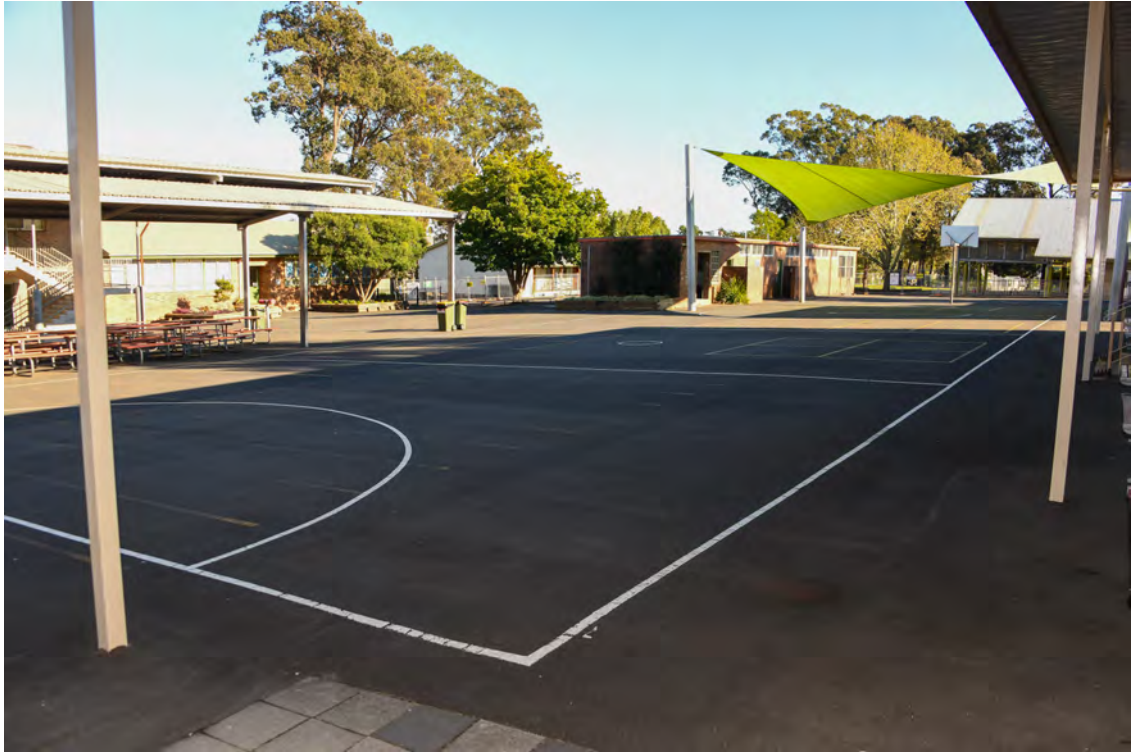
PRO\_0423.jpg

Block A. Western elevation. Adjacent asphalt paving.

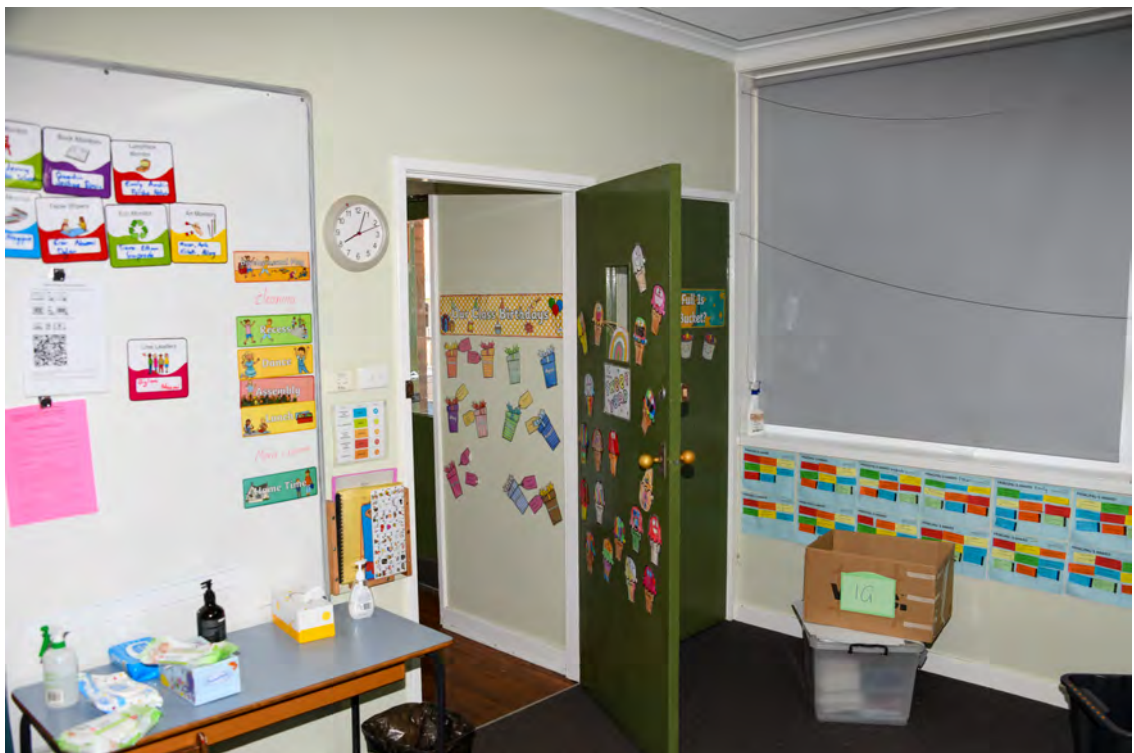
PRO\_0434.jpg

Block A. Room 1G. Southern face. Cracked wall cladding.

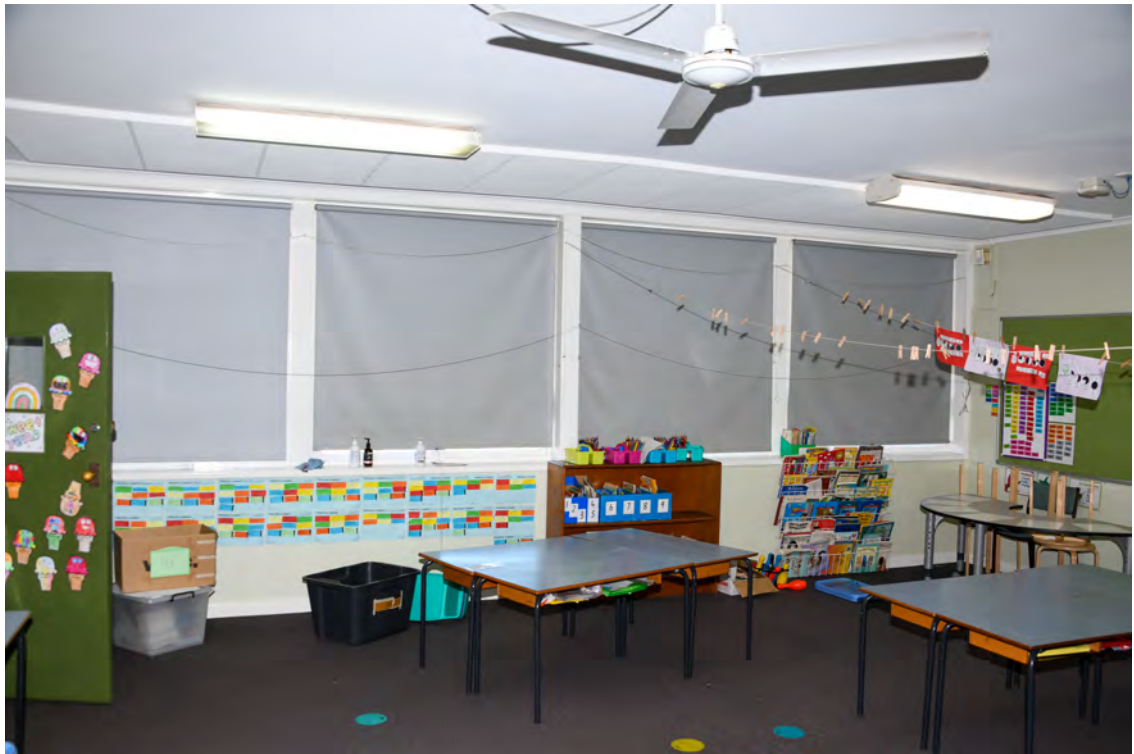
PRO\_0437.jpg

Block A. Room 1G. Southern face. Cracked wall cladding.

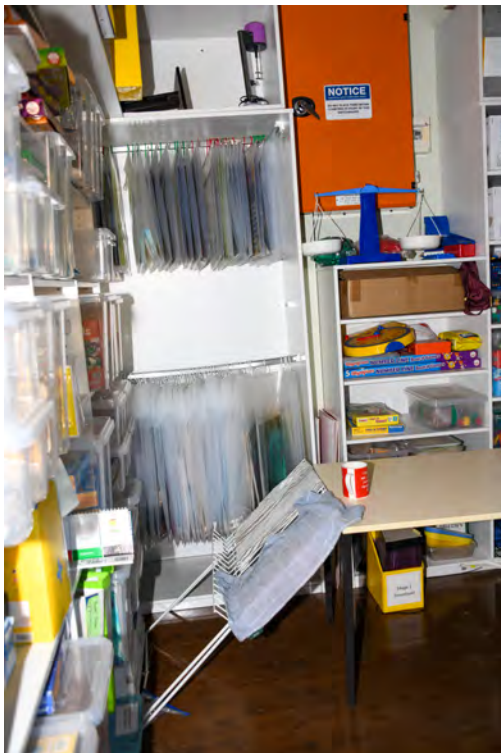
PRO\_0450.jpg

Block A. Building foyer. Northern face. Cracked wall cladding.

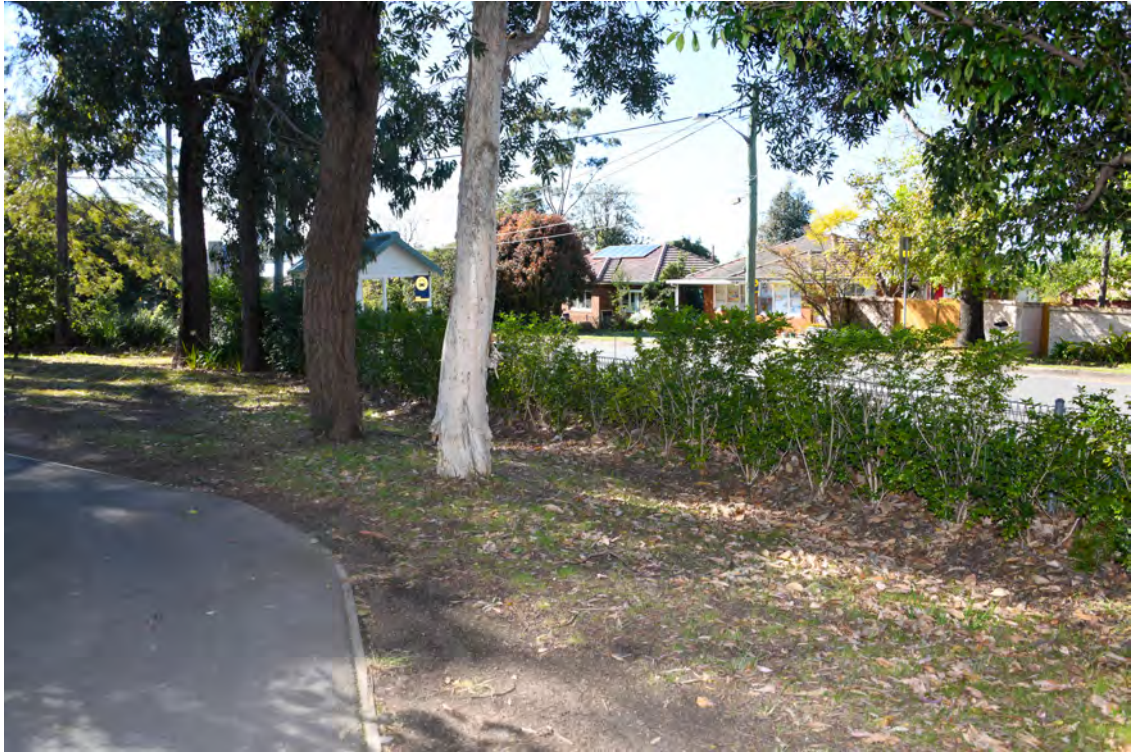
PRO\_1089.jpg

School boundaries. Eastern boundary fronting Ward Street. Area adjacent to Block H. Heading north.

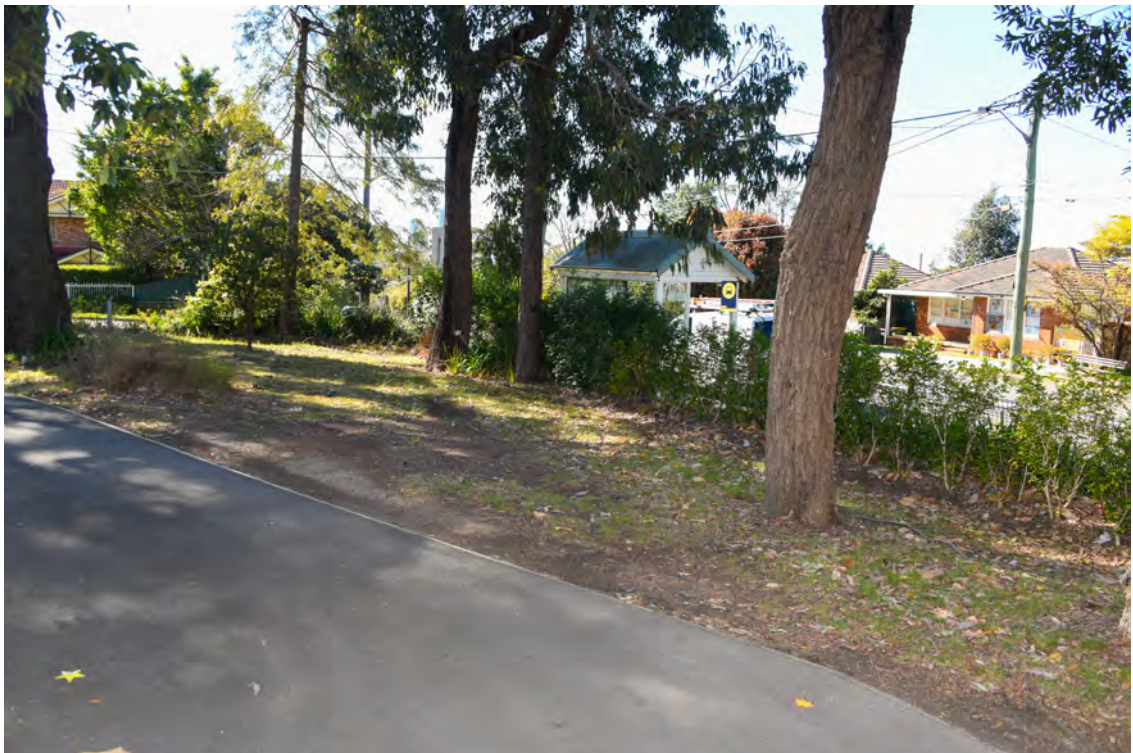
PRO\_1090.jpg

School boundaries. Southern boundary. Eastern end. Facing east.

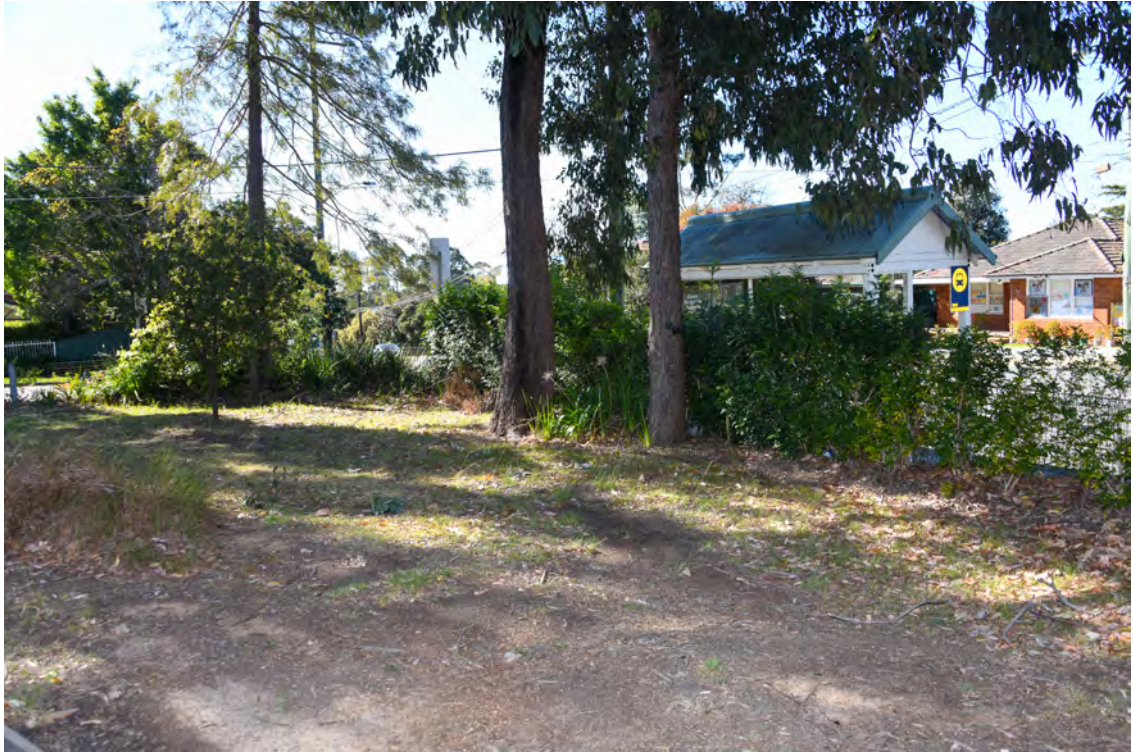
PRO\_1091.jpg

School boundaries. Southern boundary. Eastern end. Facing east.

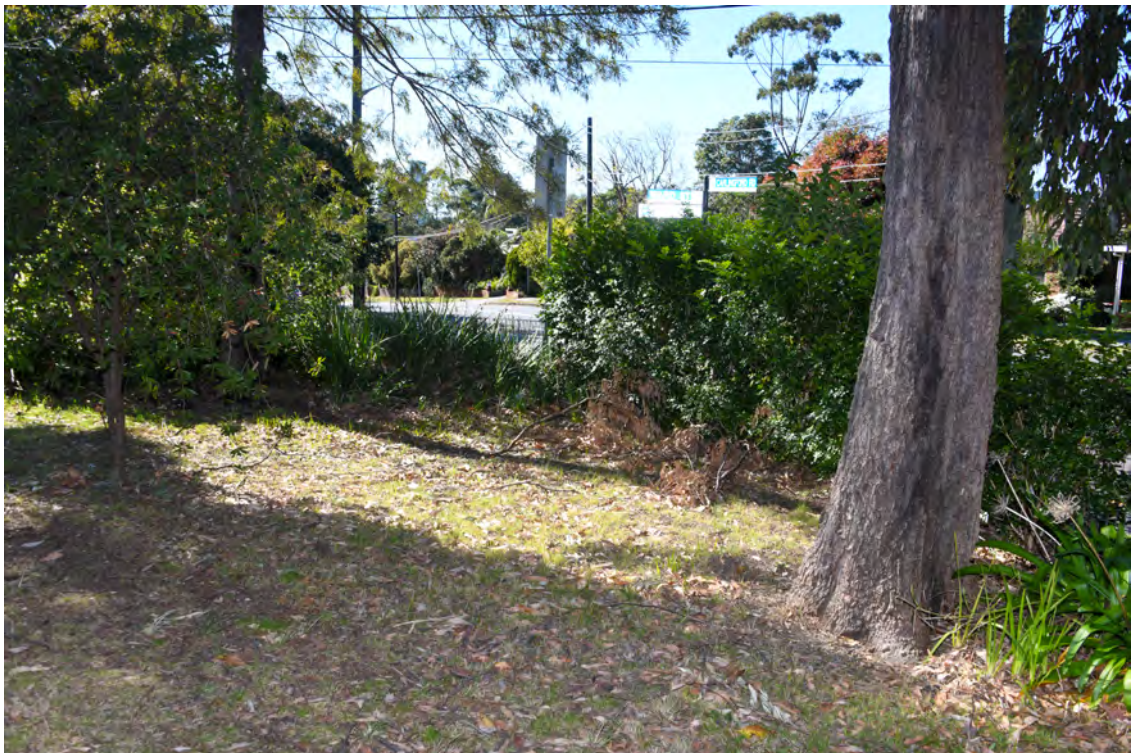
PRO\_1092.jpg

School boundaries. South-eastern corner.

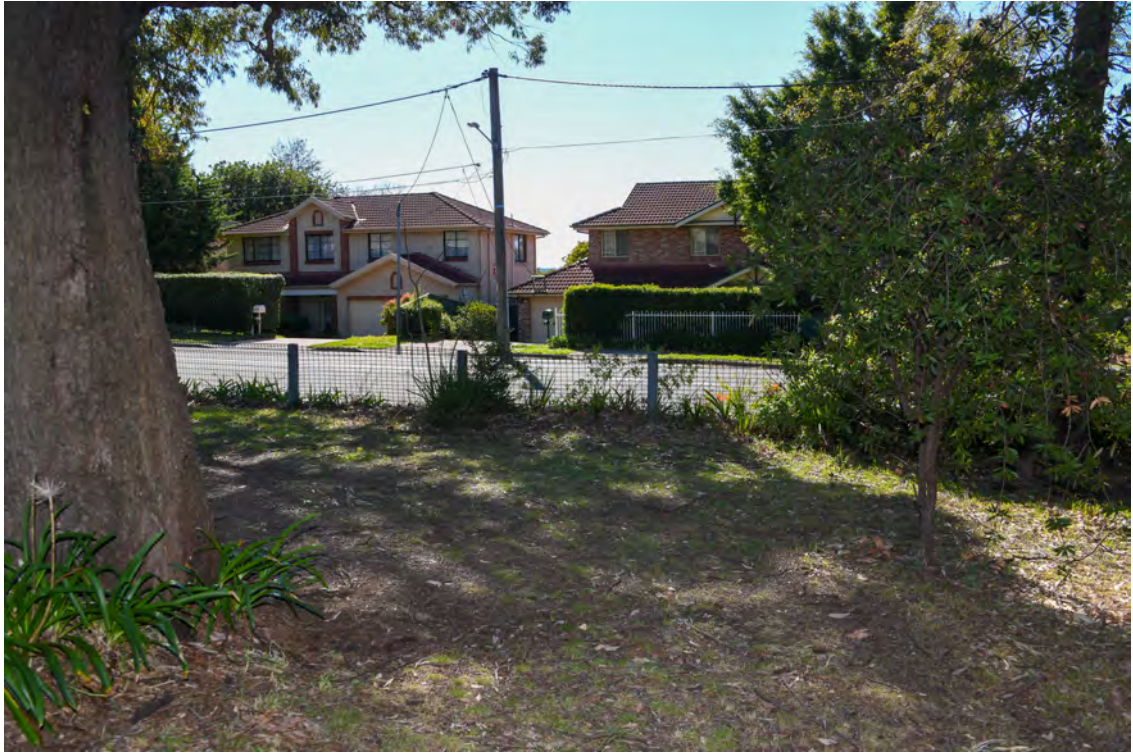
PRO\_1094.jpg

School boundaries. Eastern boundary fronting Ward Street. Area adjacent to Building H. Heading north.

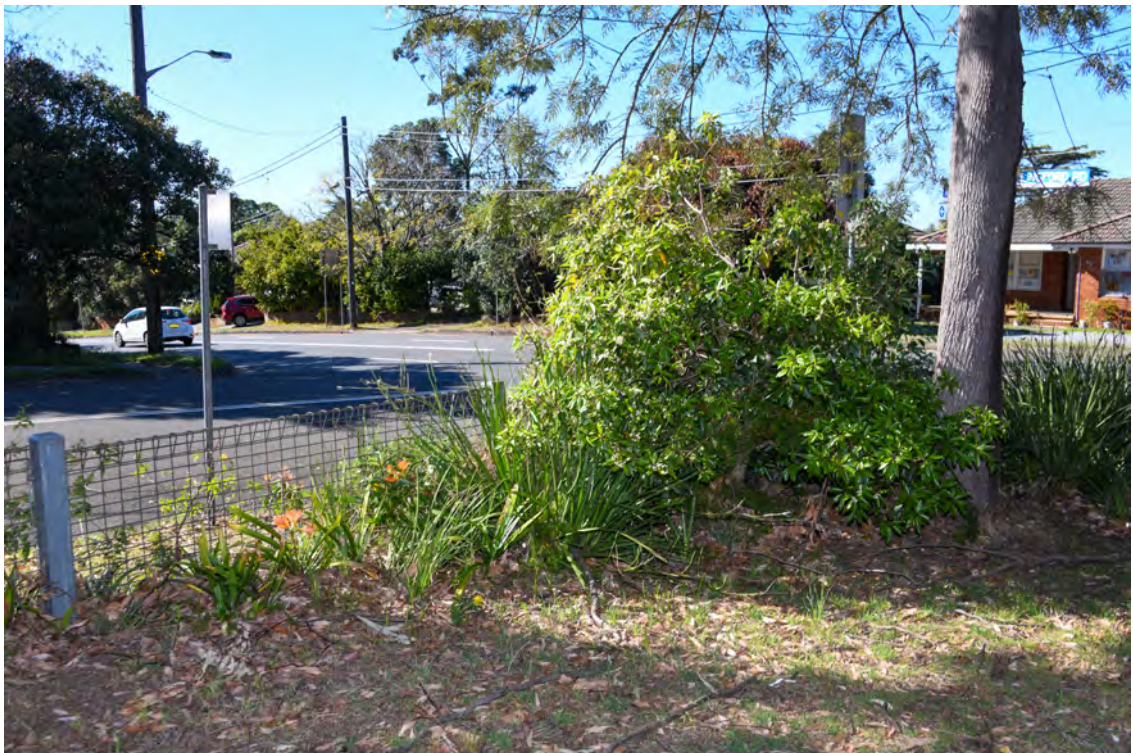
PRO\_1095.jpg

School boundaries. Eastern boundary fronting Ward Street. Area adjacent to Building H. Heading north.

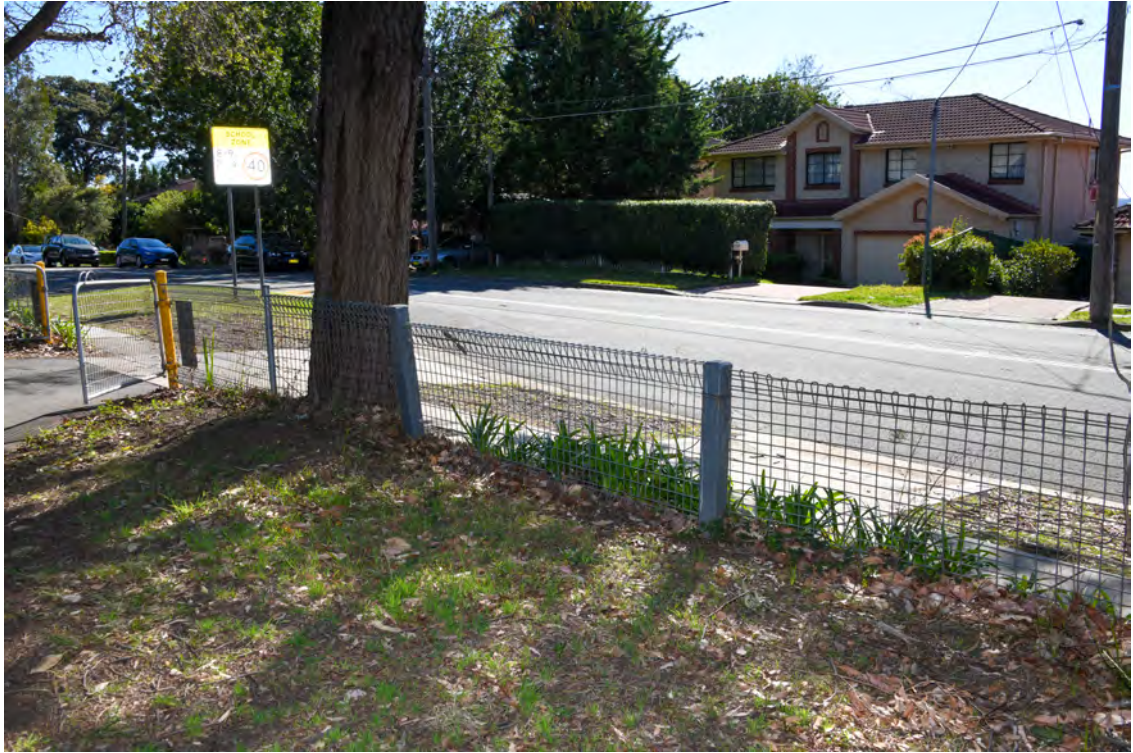
PRO\_1096.jpg

School boundaries. Eastern boundary fronting Ward Street. Area adjacent to Building H. Heading north.

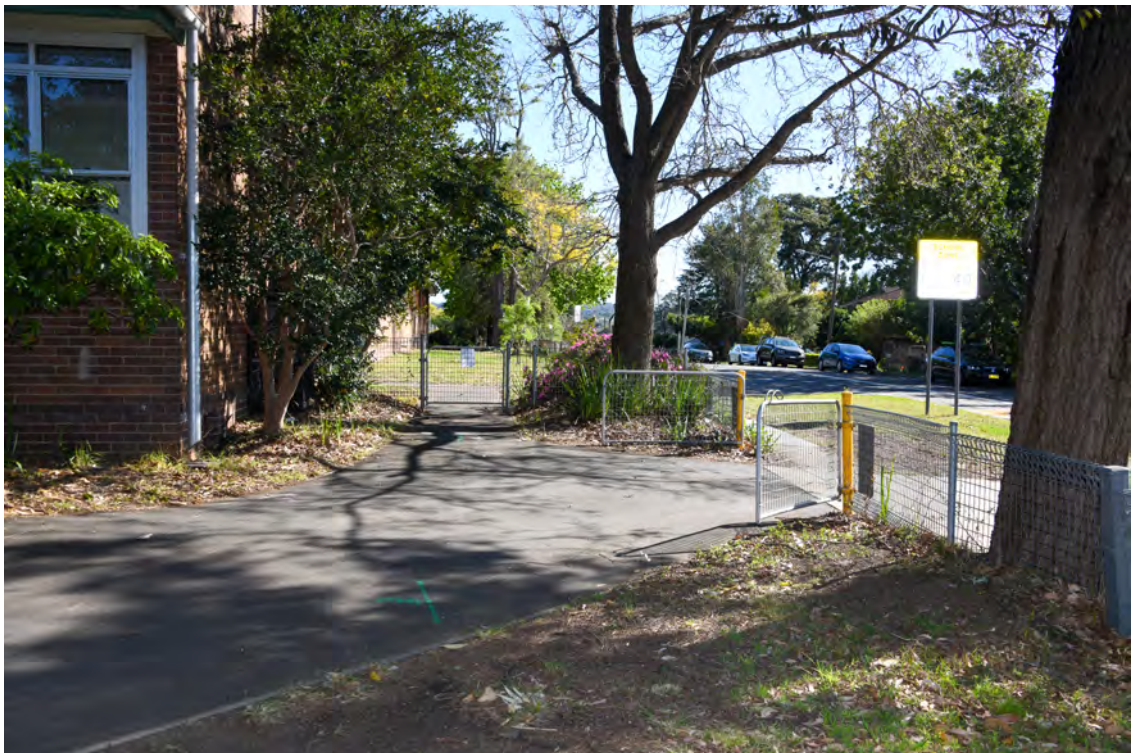
PRO\_1097.jpg

School boundaries. Eastern boundary fronting Ward Street. Area adjacent to Building H. Heading north.

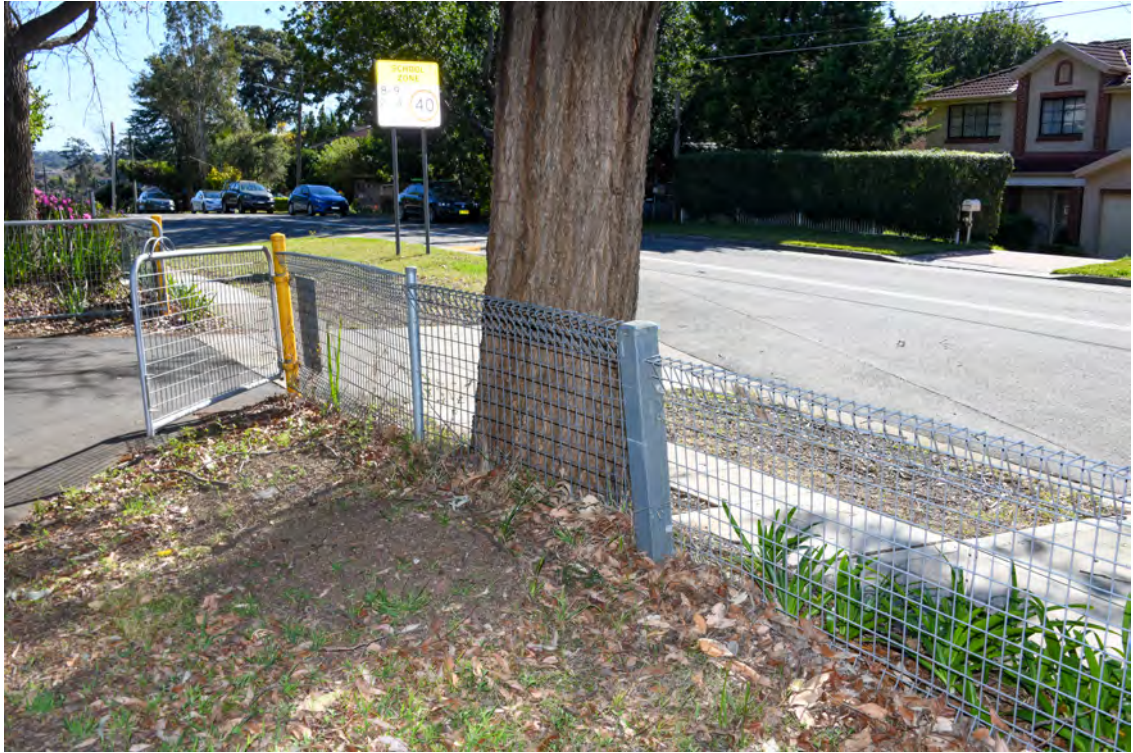
PRO\_1098.jpg

School boundaries. Eastern boundary fronting Ward Street. Area adjacent to Building H. Heading north.

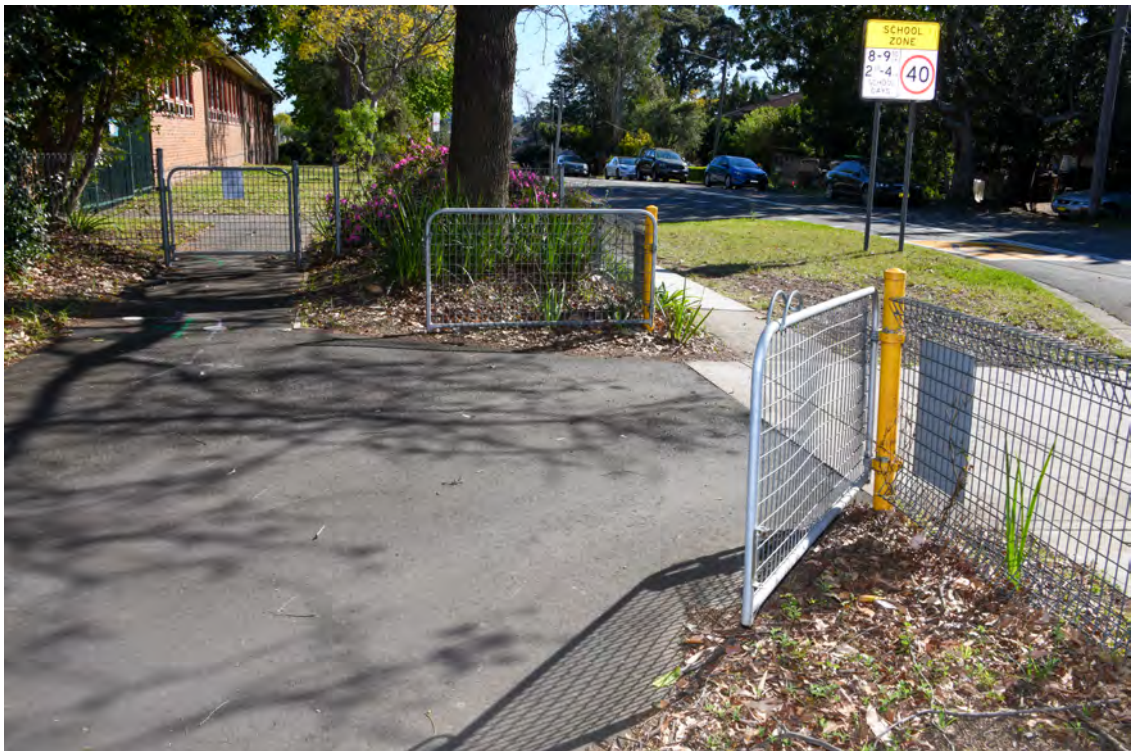
PRO\_1099.jpg

School boundaries. Eastern boundary fronting Ward Street. Area adjacent to Building H. Heading north.

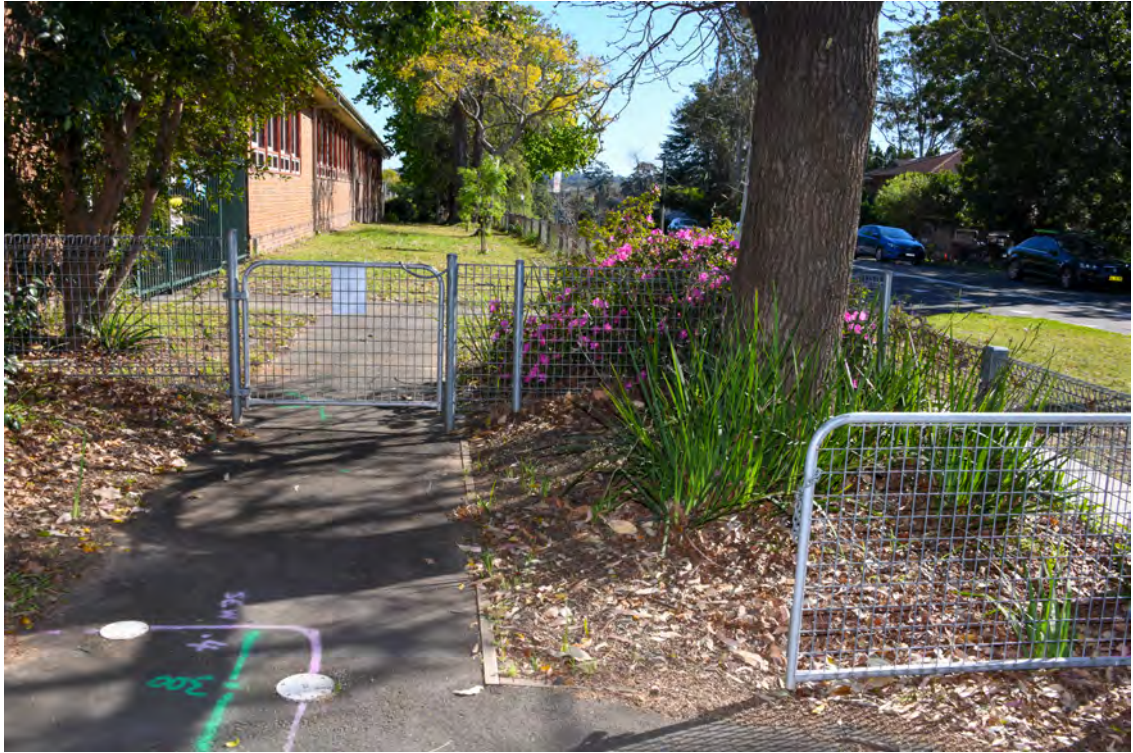
PRO\_1100.jpg

School boundaries. Eastern boundary fronting Ward Street. Area adjacent to Building H. Heading north.

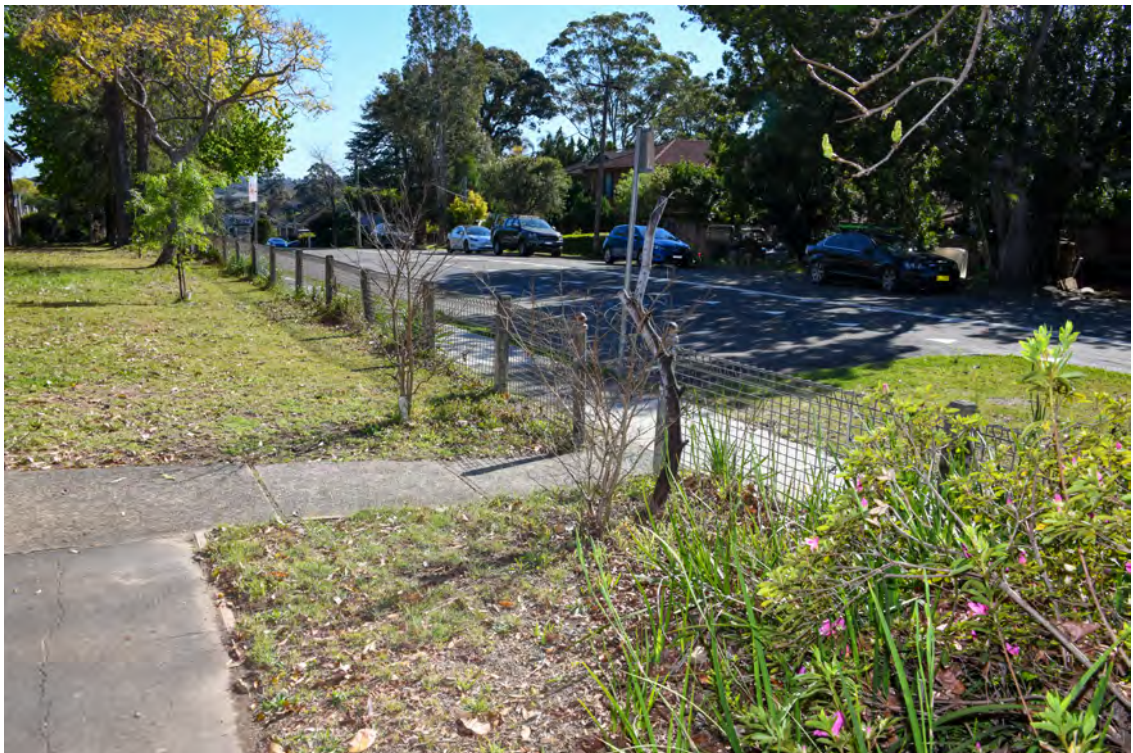
PRO\_1101.jpg

School boundaries. Eastern boundary fronting Ward Street. Area adjacent to Building H. Heading north.
