96-104 Carlingford Road, Epping NSW 2121

Epping West Public School

DILAPIDATION REPORT

7<sup>th</sup> September 2021

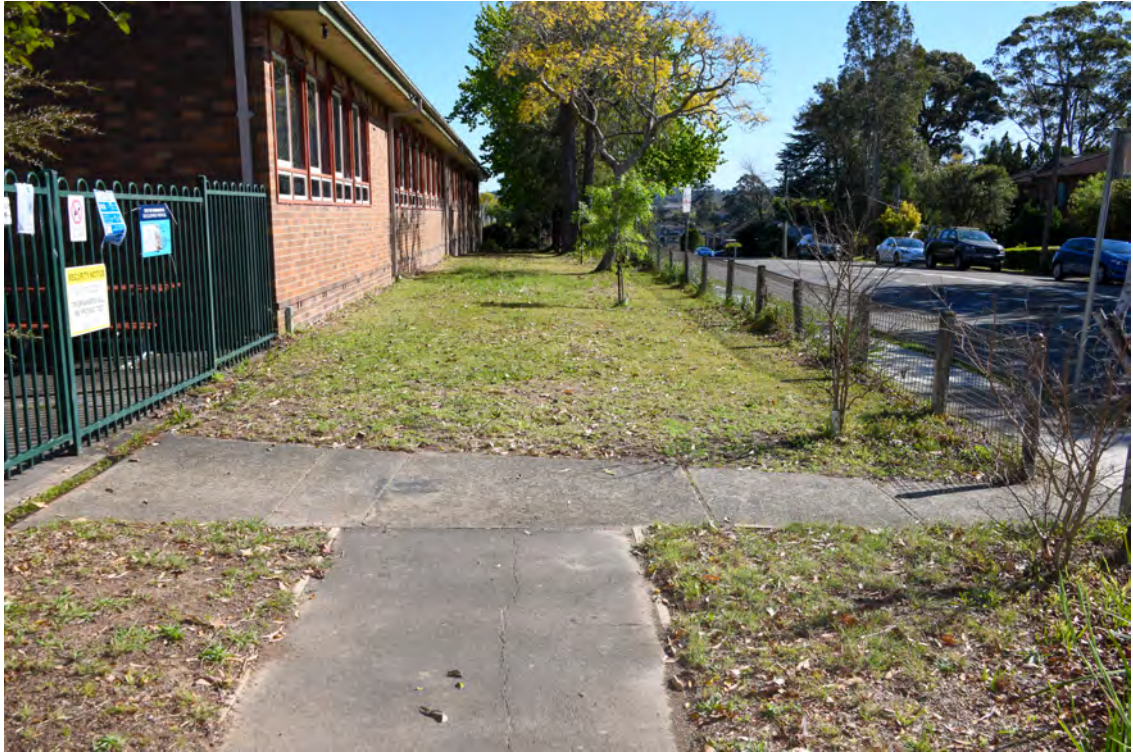
PRO\_1102.jpg

School boundaries. Eastern boundary fronting Ward Street. Area adjacent to Building H. Heading north.

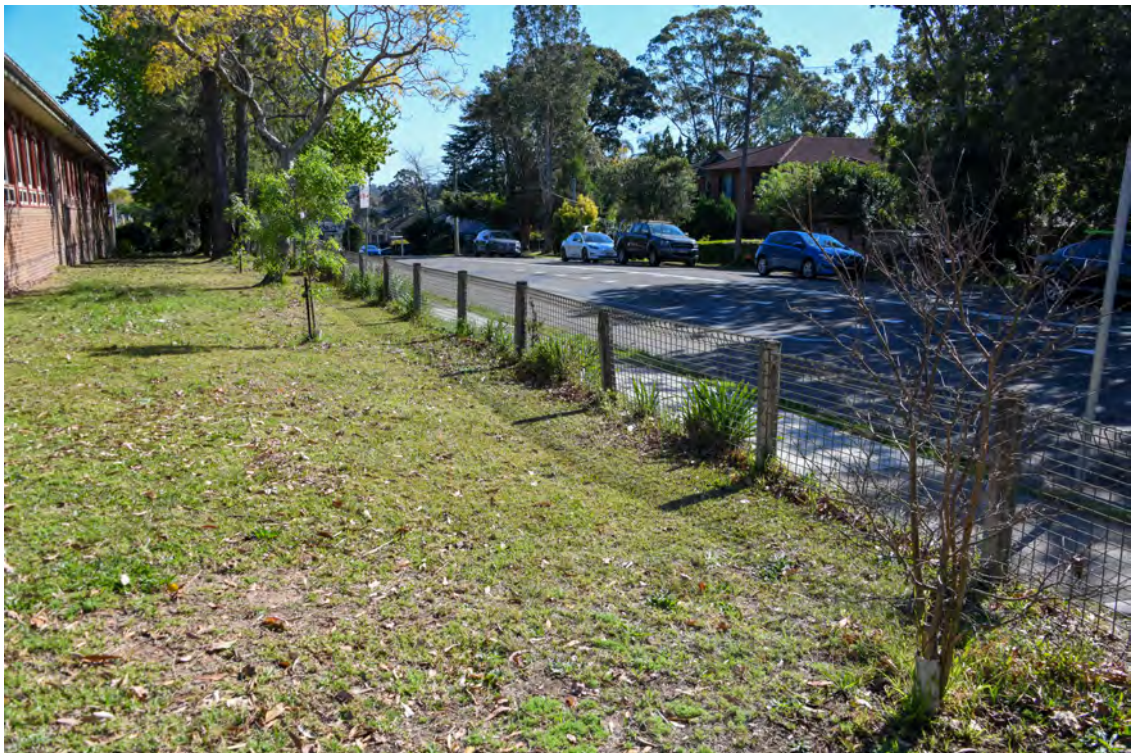
PRO\_1103.jpg

School boundaries. Eastern boundary fronting Ward Street. Area adjacent to Building H. Heading north.

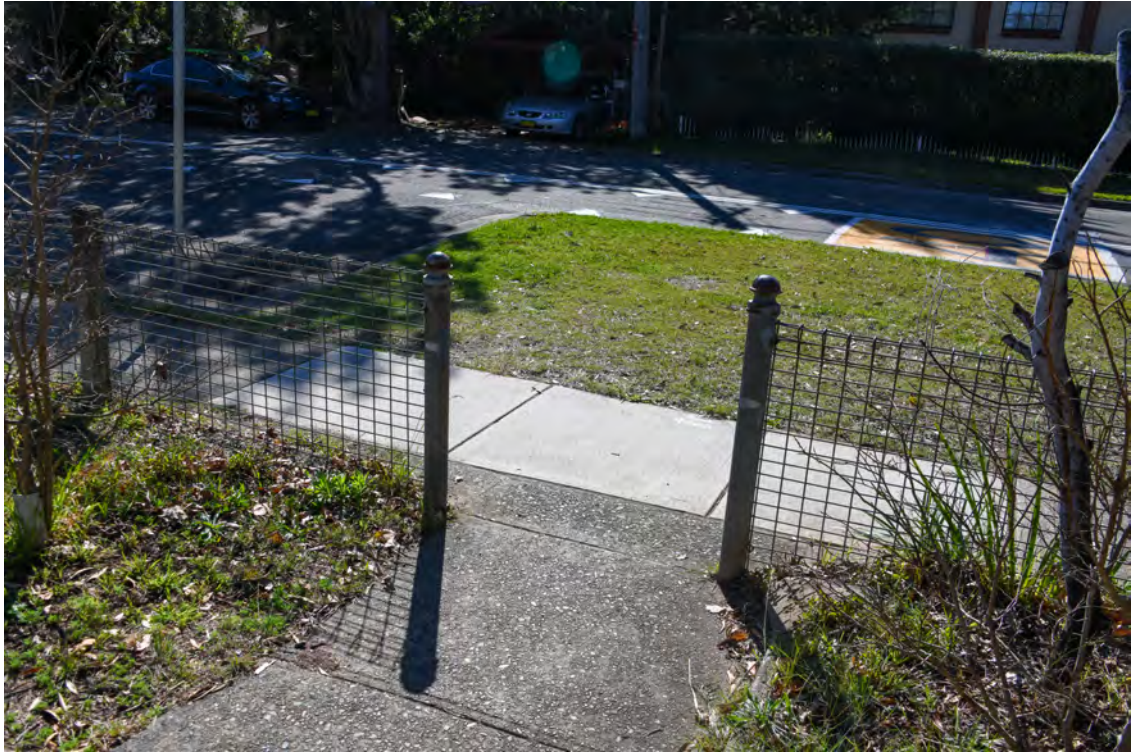
PRO\_1104.jpg

School boundaries. Eastern boundary fronting Ward Street. Area adjacent to Building H. Heading north.

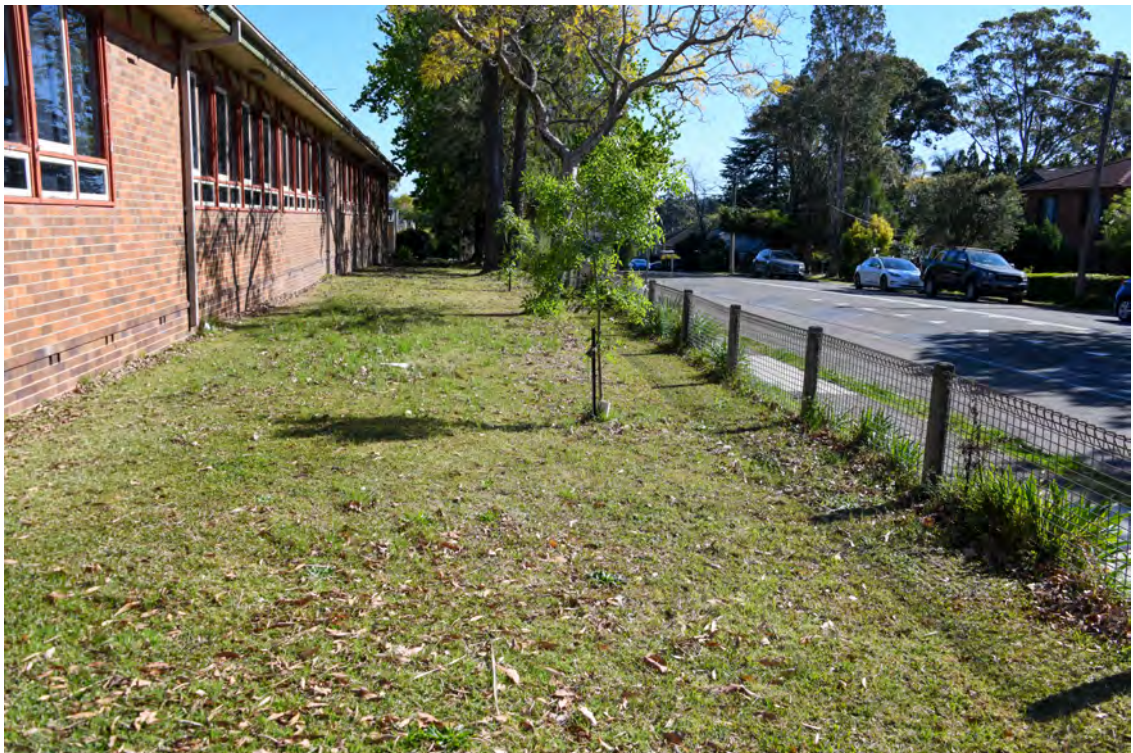
PRO\_1105.jpg

School boundaries. Eastern boundary fronting Ward Street. Area adjacent to Building G. Heading north.

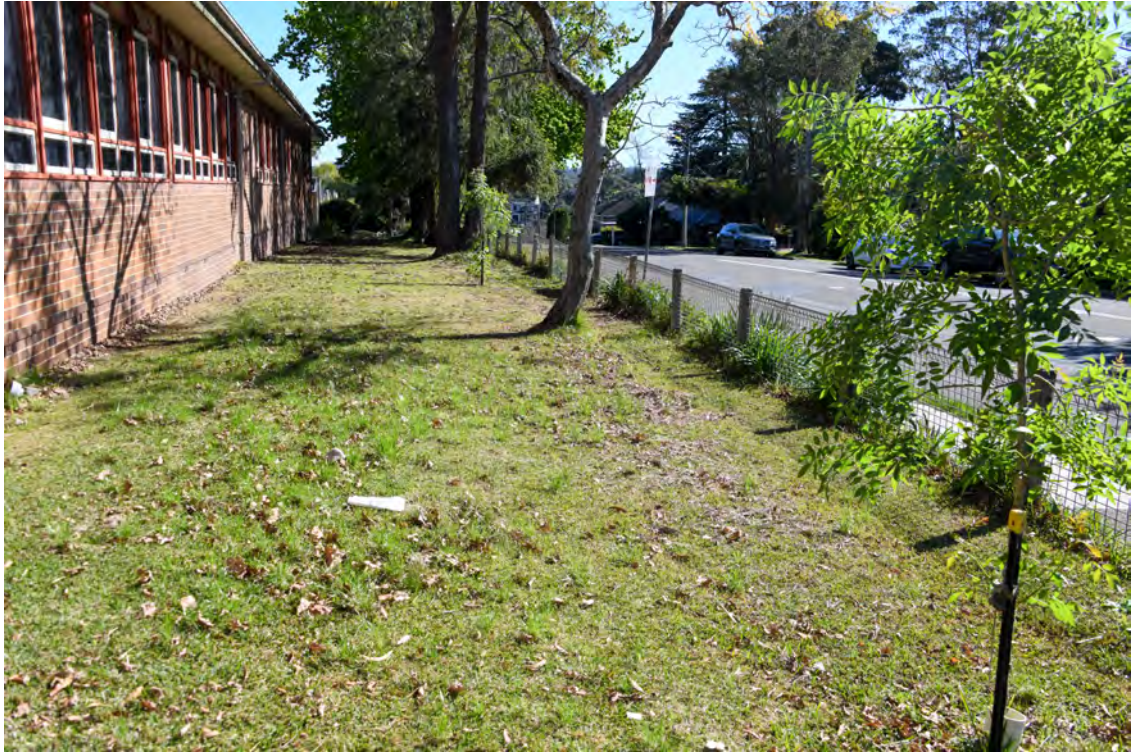
PRO\_1106.jpg

School boundaries. Eastern boundary fronting Ward Street. Area adjacent to Building G. Heading north.

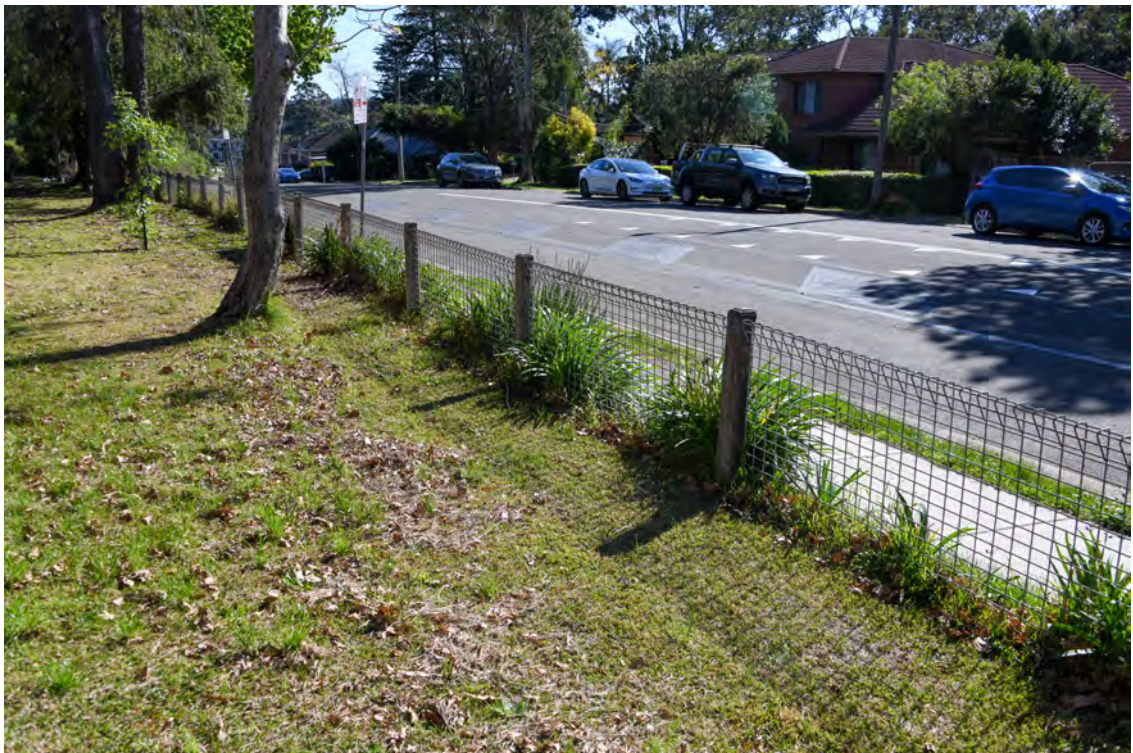
PRO\_1107.jpg

School boundaries. Eastern boundary fronting Ward Street. Area adjacent to Building G. Heading north.

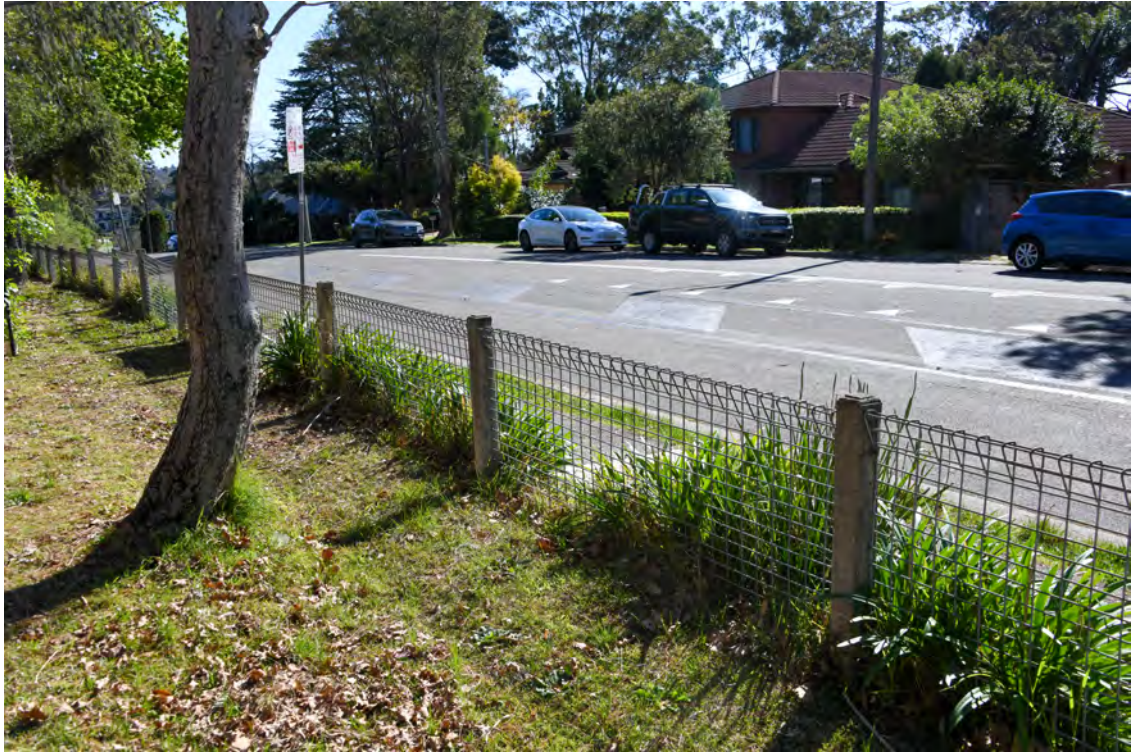
PRO\_1108.jpg

School boundaries. Eastern boundary fronting Ward Street. Area adjacent to Building G. Heading north.

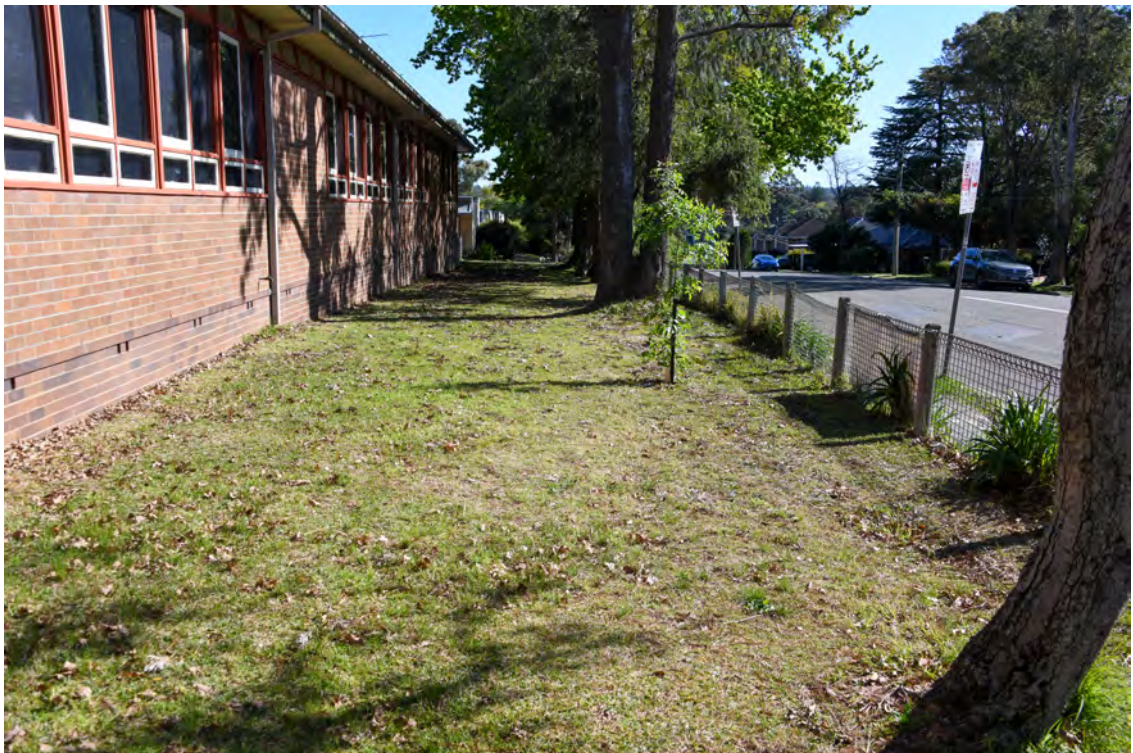
PRO\_1109.jpg

School boundaries. Eastern boundary fronting Ward Street. Area adjacent to Building G. Heading north.

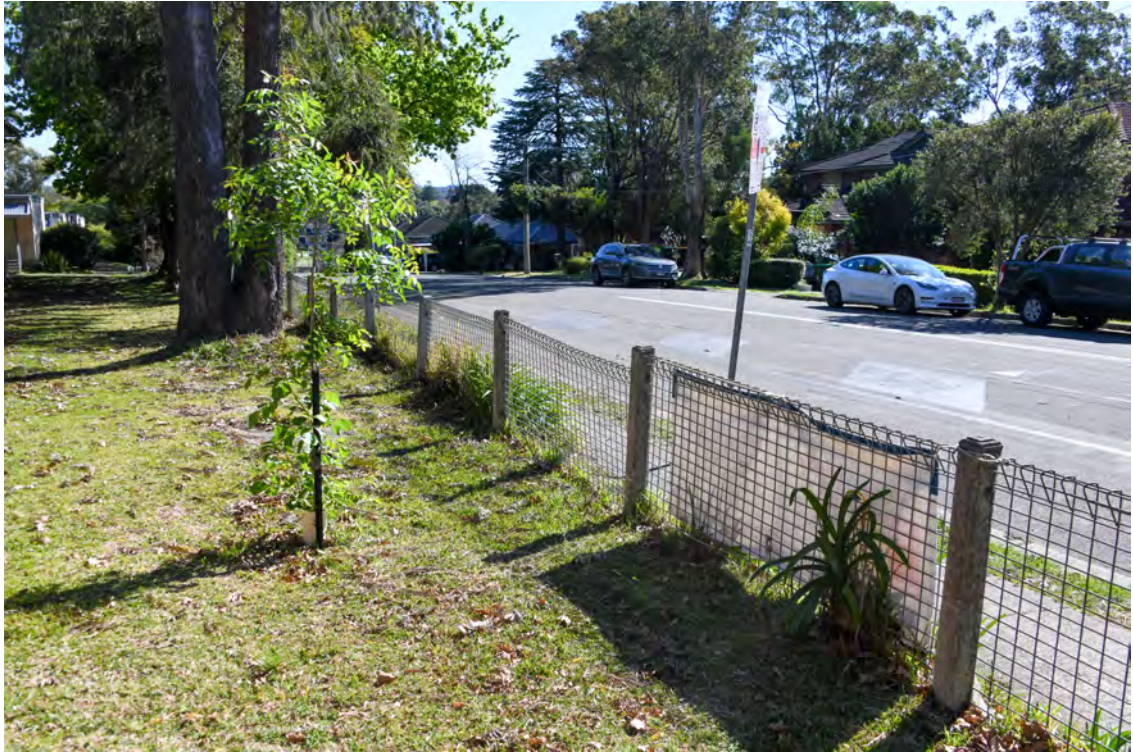
PRO\_1110.jpg

School boundaries. Eastern boundary fronting Ward Street. Area adjacent to Building G. Heading north.

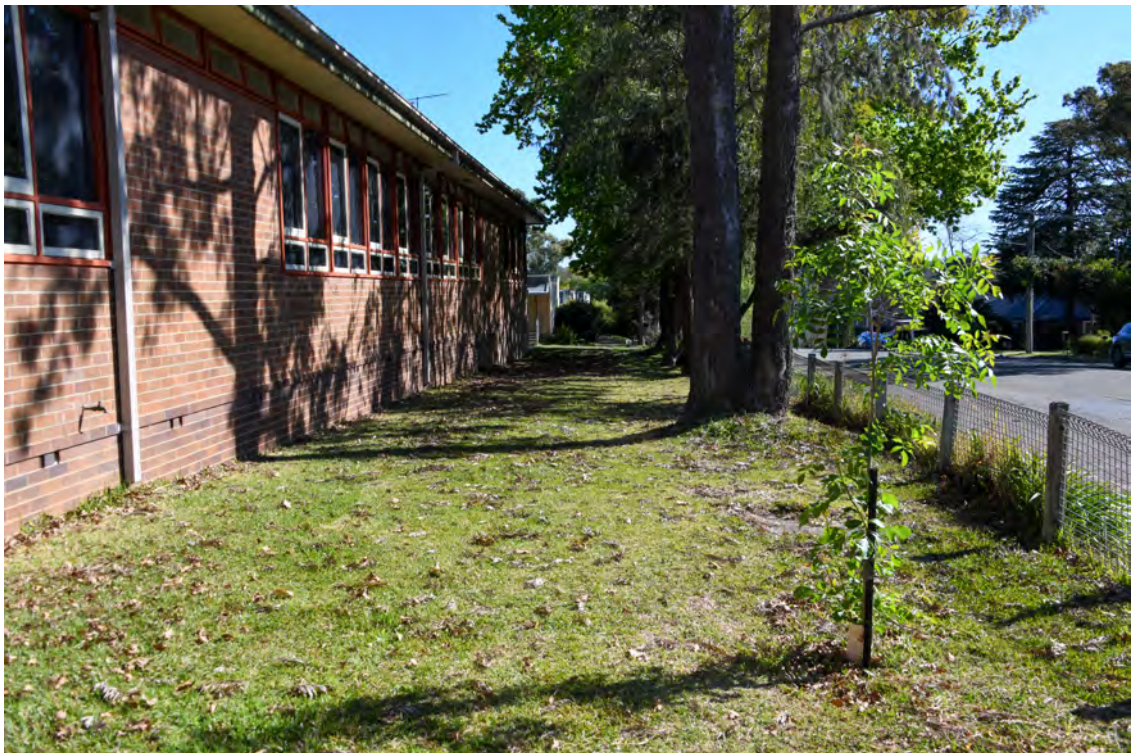
PRO\_1111.jpg

School boundaries. Eastern boundary fronting Ward Street. Area adjacent to Building G. Heading north.

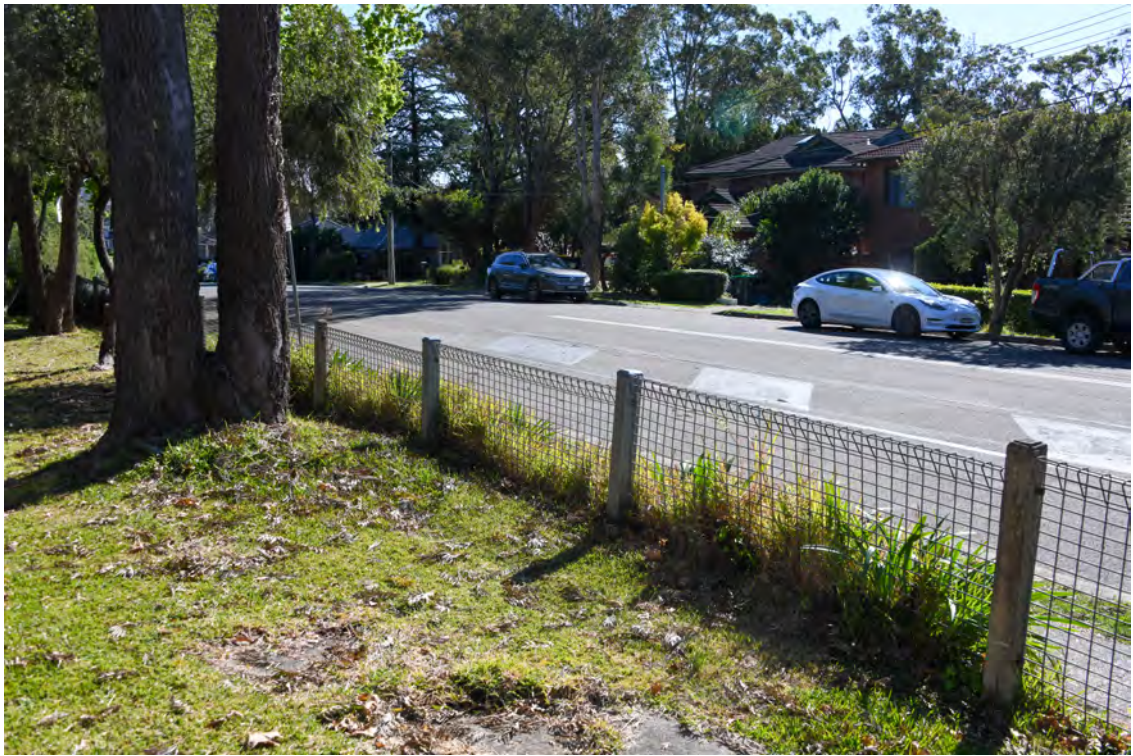
PRO\_1112.jpg

School boundaries. Eastern boundary fronting Ward Street. Area adjacent to Building G. Heading north.

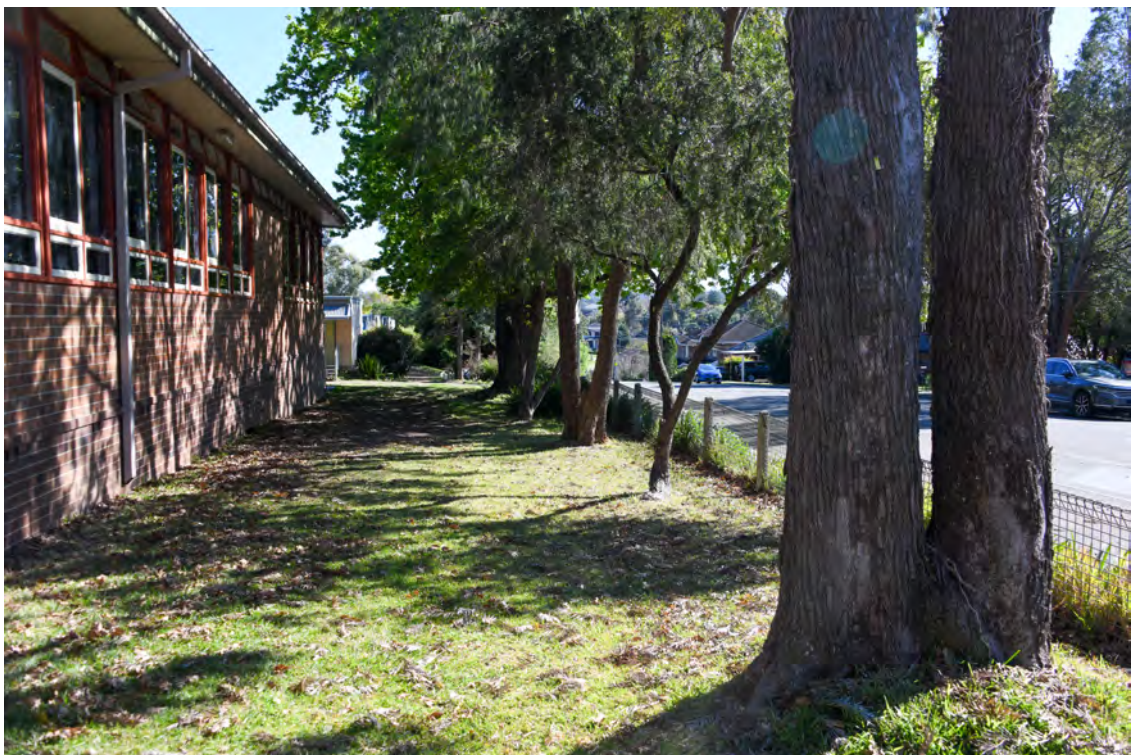
PRO\_1113.jpg

School boundaries. Eastern boundary fronting Ward Street. Area adjacent to Building G. Heading north.

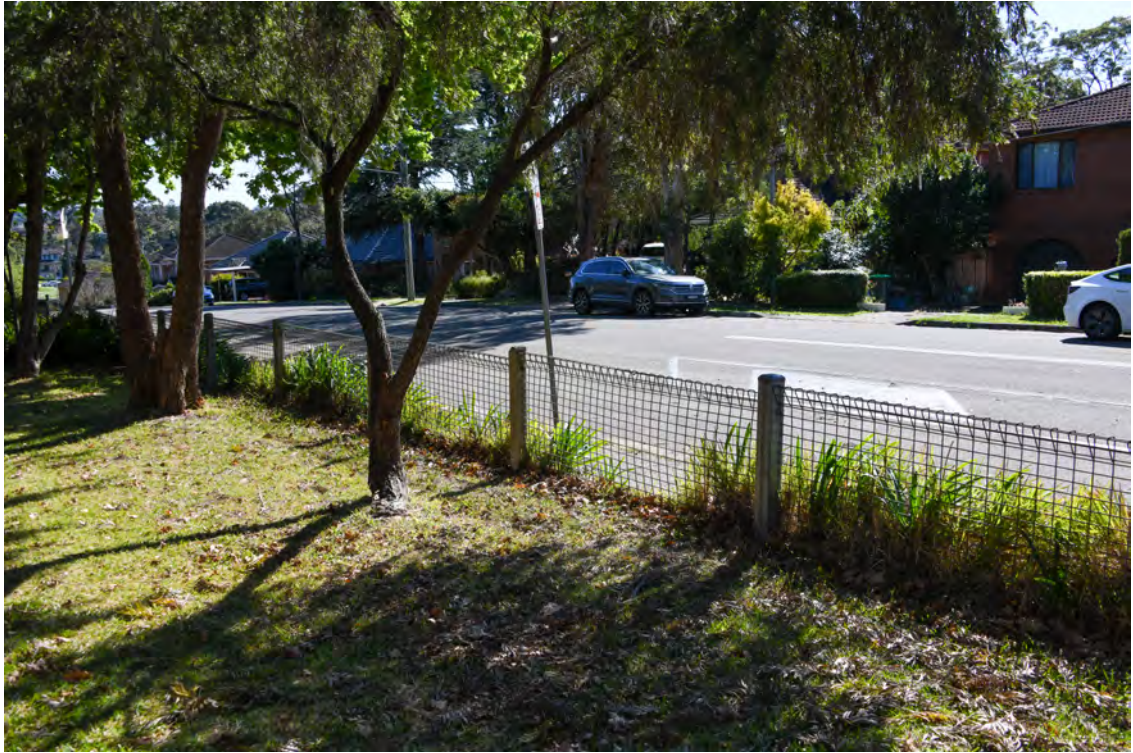
PRO\_1114.jpg

School boundaries. Eastern boundary fronting Ward Street. Area adjacent to Building G. Heading north.

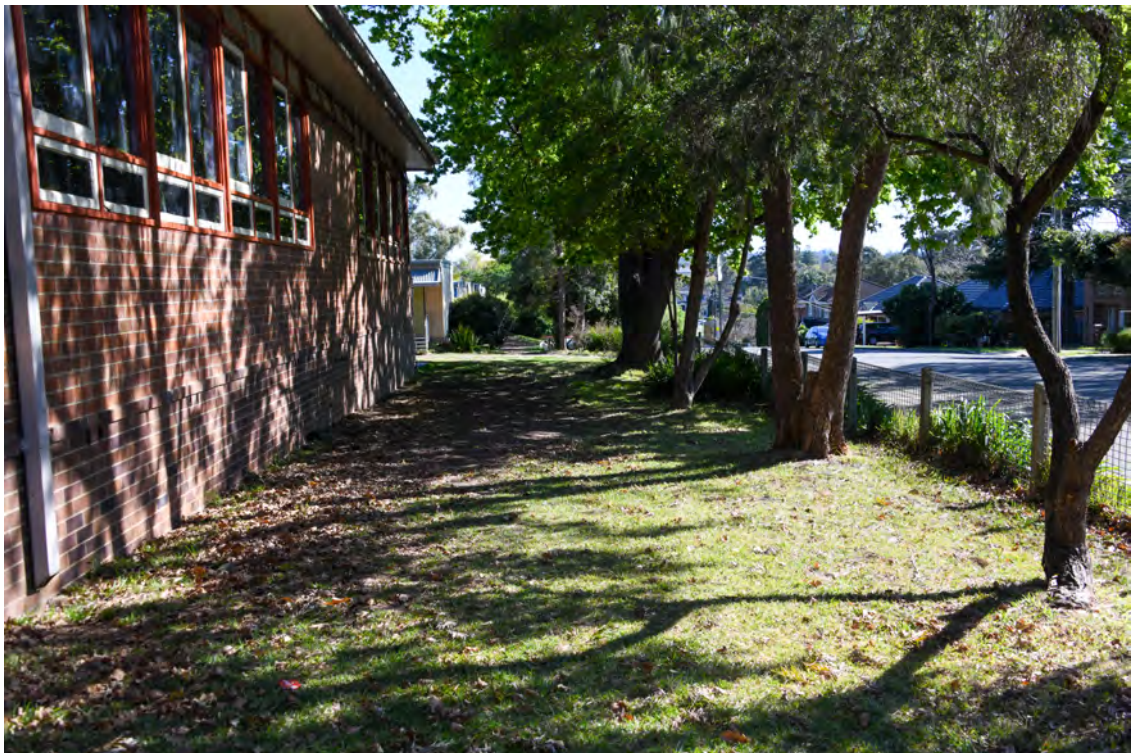
PRO\_1115.jpg

School boundaries. Eastern boundary fronting Ward Street. Area adjacent to Building G. Heading north.

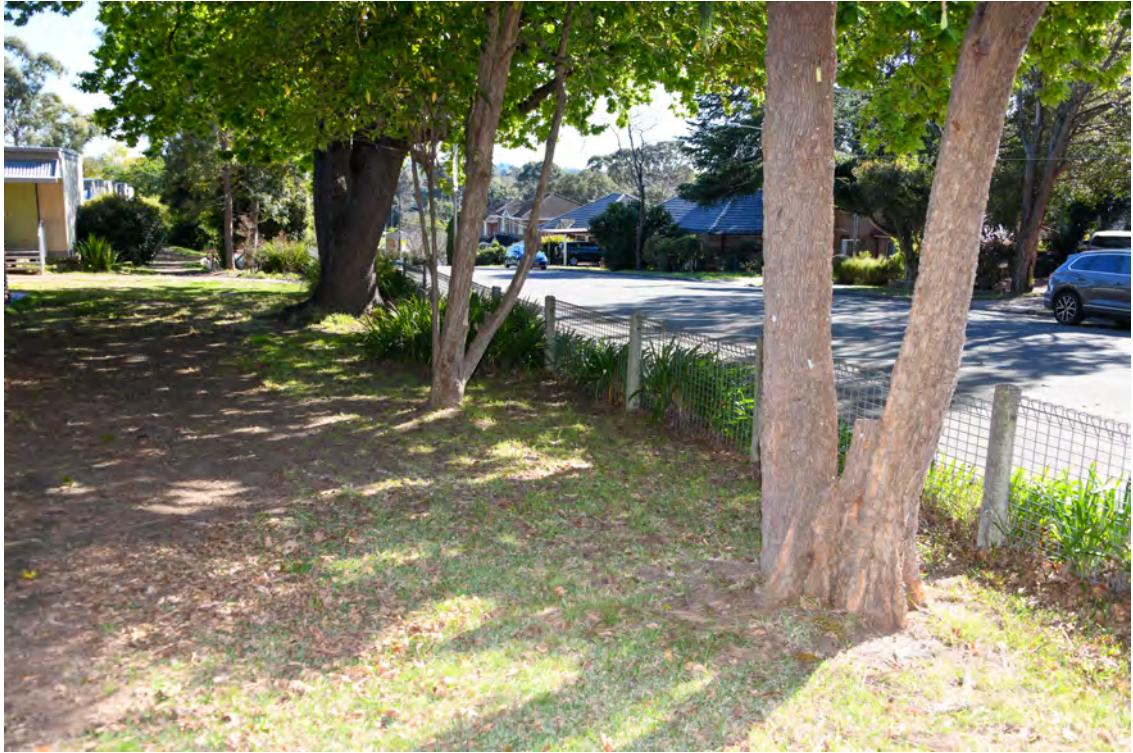
PRO\_1116.jpg

School boundaries. Eastern boundary fronting Ward Street. Area adjacent to Building G. Heading north.

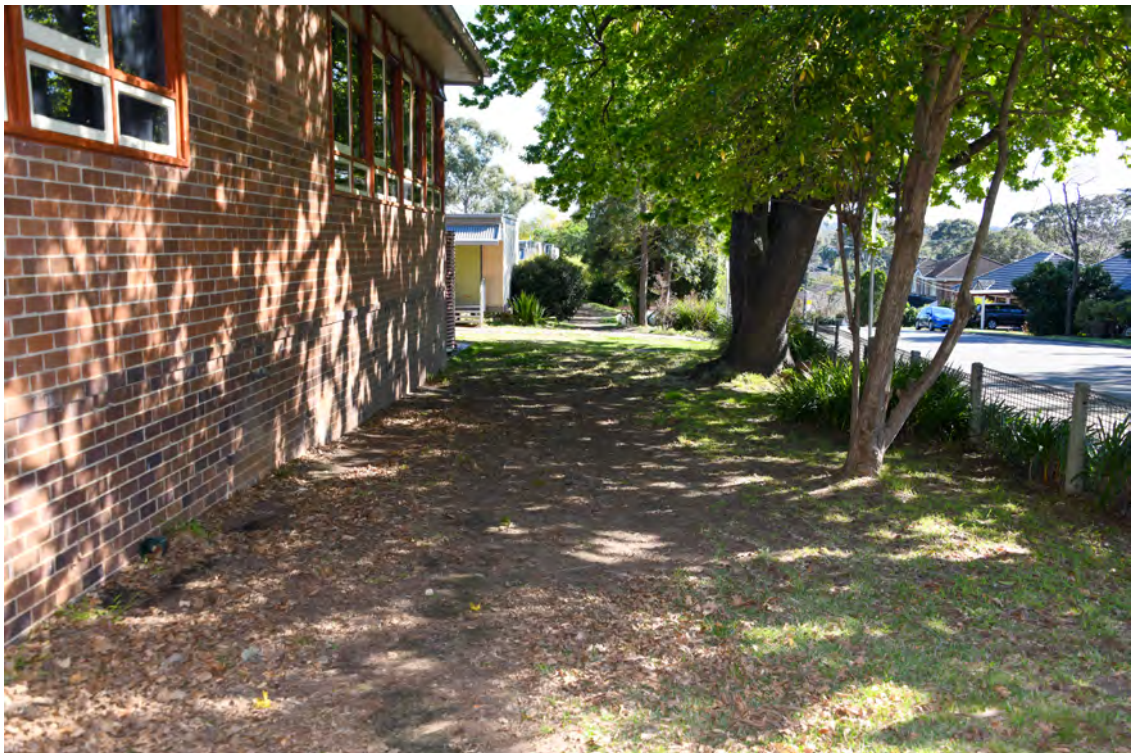
PRO\_1117.jpg

School boundaries. Eastern boundary fronting Ward Street. Area adjacent to Building G. Heading north.

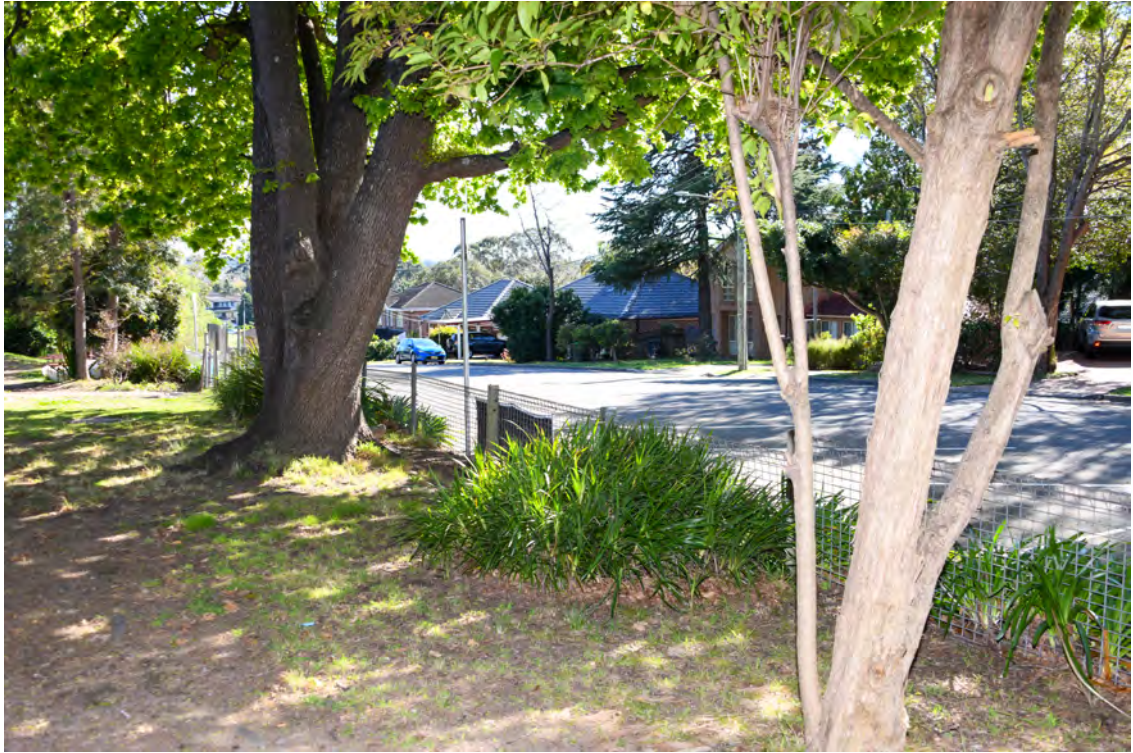
PRO\_1118.jpg

School boundaries. Eastern boundary fronting Ward Street. Area adjacent to Building G. Heading north.

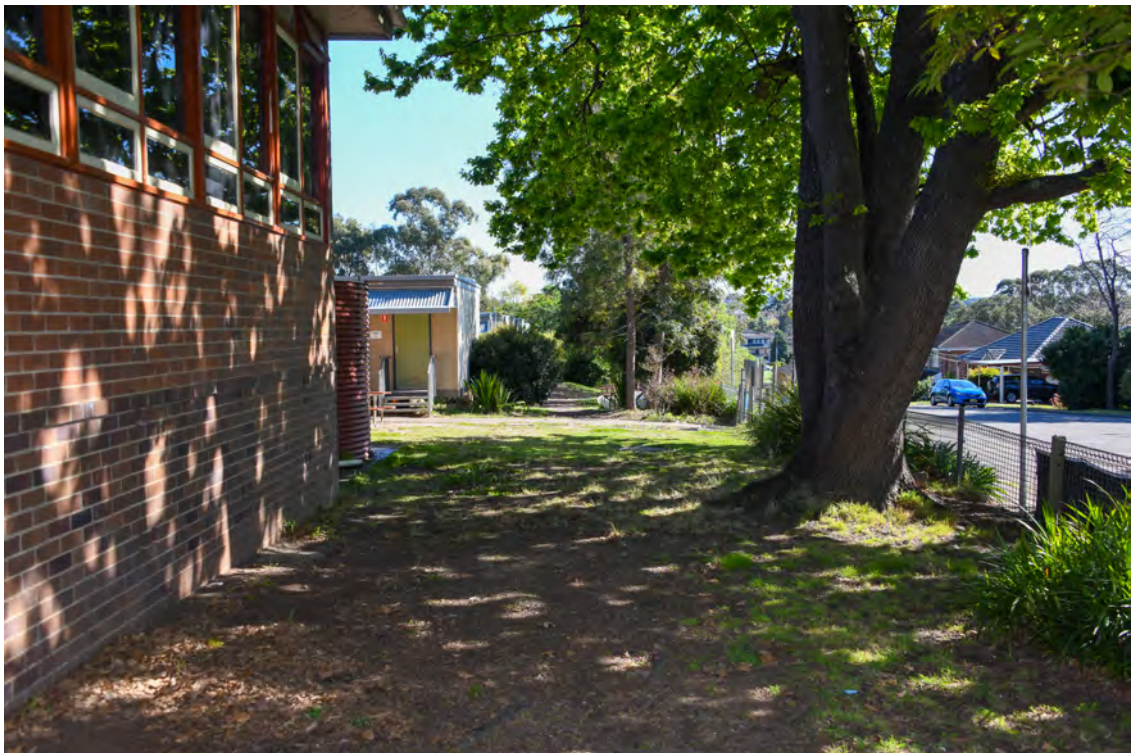
PRO\_1119.jpg

School boundaries. Eastern boundary fronting Ward Street. Area adjacent to Building G. Heading north.

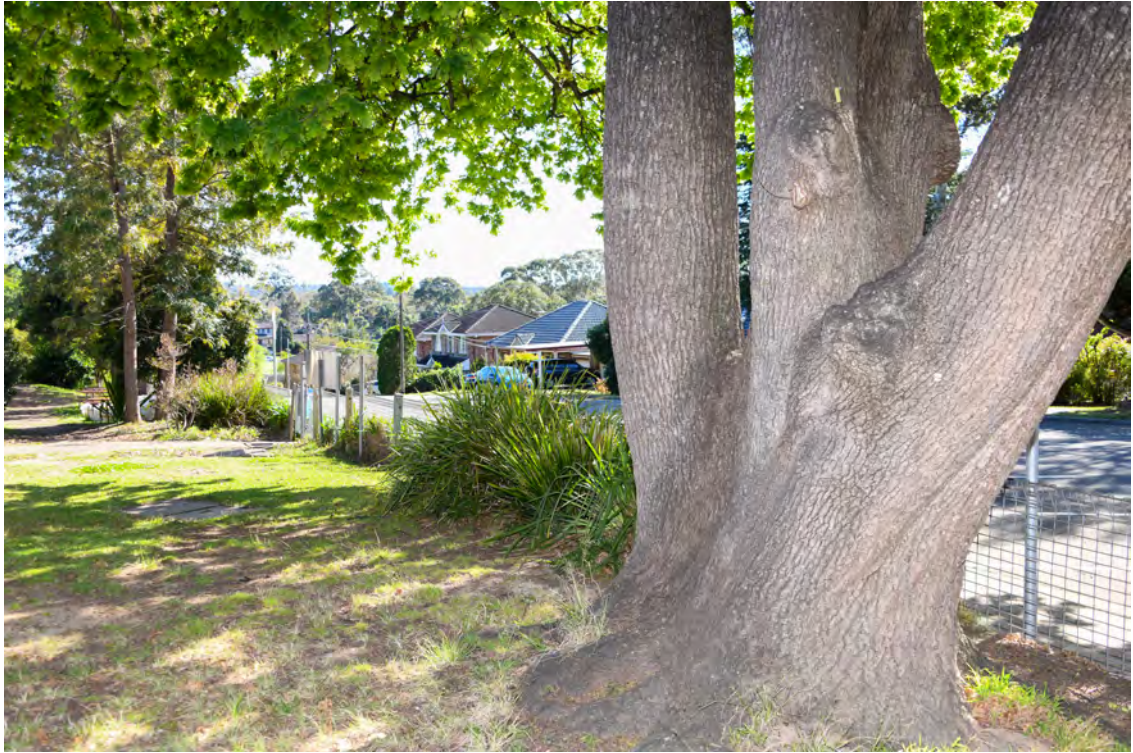
PRO\_1120.jpg

School boundaries. Eastern boundary fronting Ward Street. Area adjacent to Building G. Heading north.

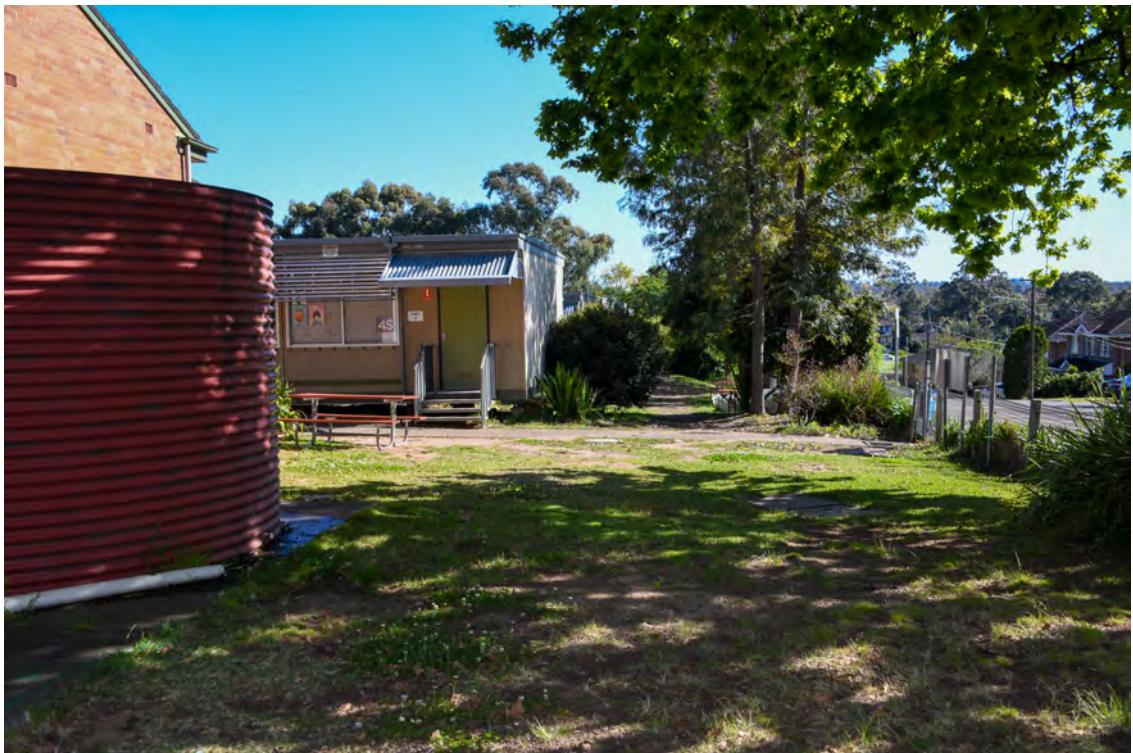
PRO\_1121.jpg

School boundaries. Eastern boundary fronting Ward Street. Area adjacent to Building F. Heading north.

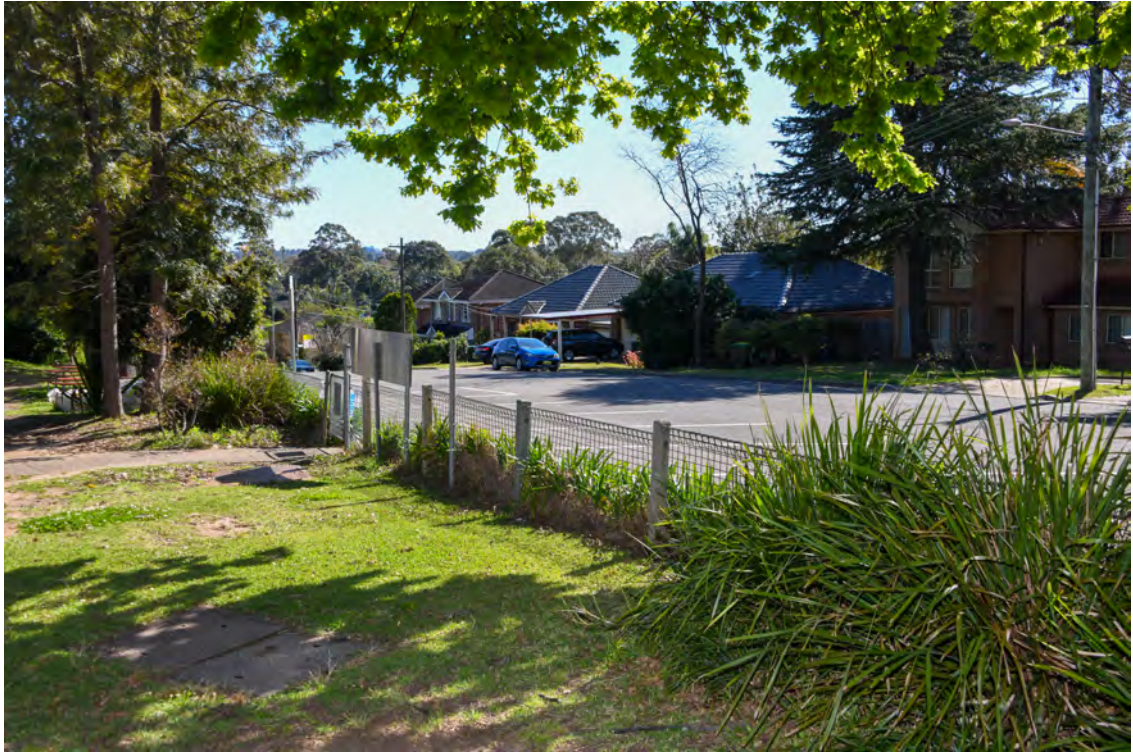
PRO\_1122.jpg

School boundaries. Eastern boundary fronting Ward Street. Area adjacent to Building F. Heading north.

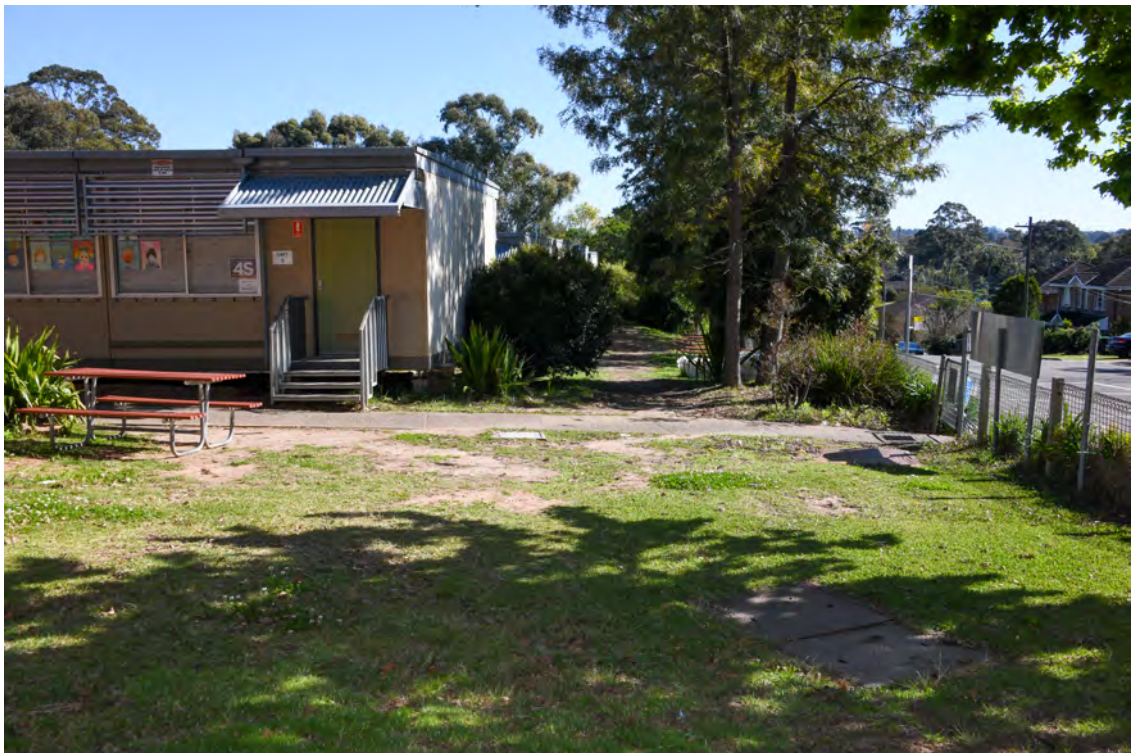
PRO\_1123.jpg

School boundaries. Eastern boundary fronting Ward Street. Area adjacent to Building F. Heading north.

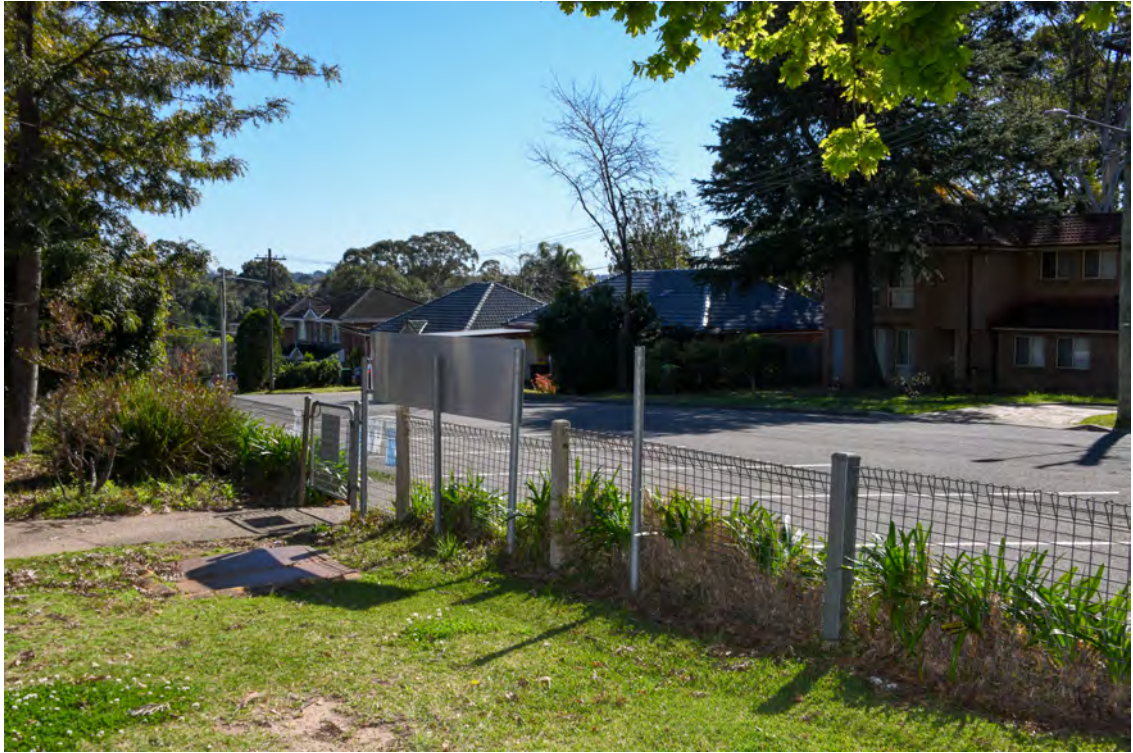
PRO\_1124.jpg

School boundaries. Eastern boundary fronting Ward Street. Area adjacent to Building F. Heading north.

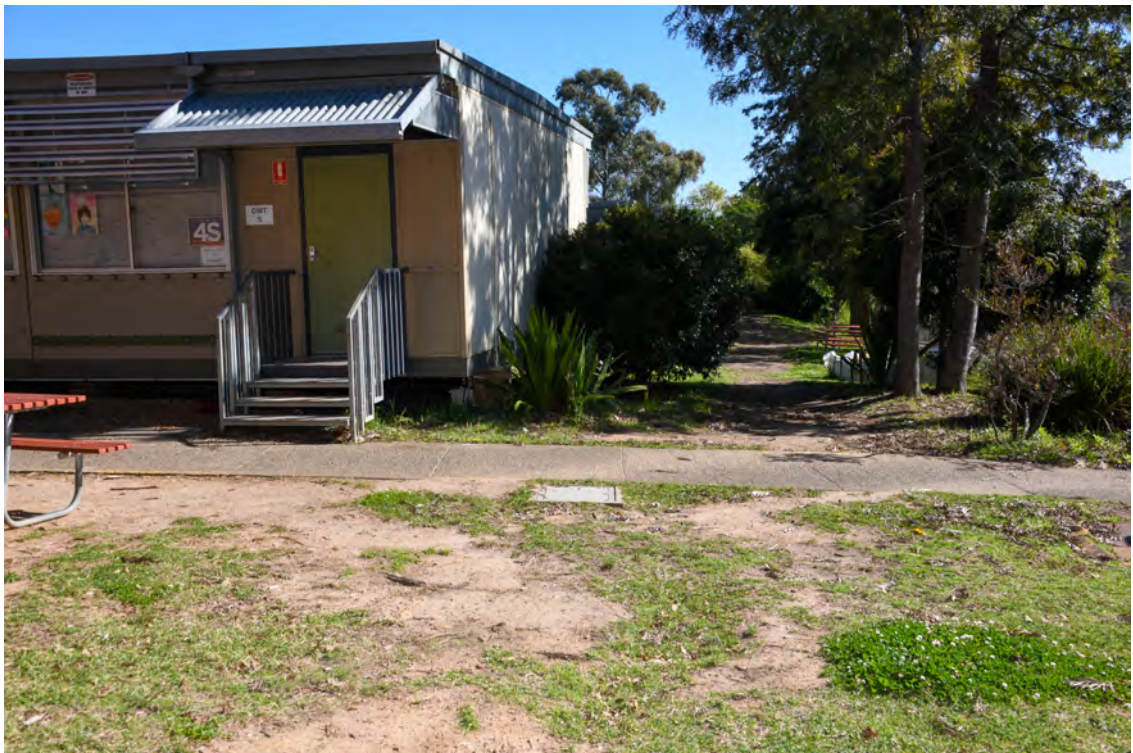
PRO\_1125.jpg

School boundaries. Eastern boundary fronting Ward Street. Area adjacent to Building F. Heading north.

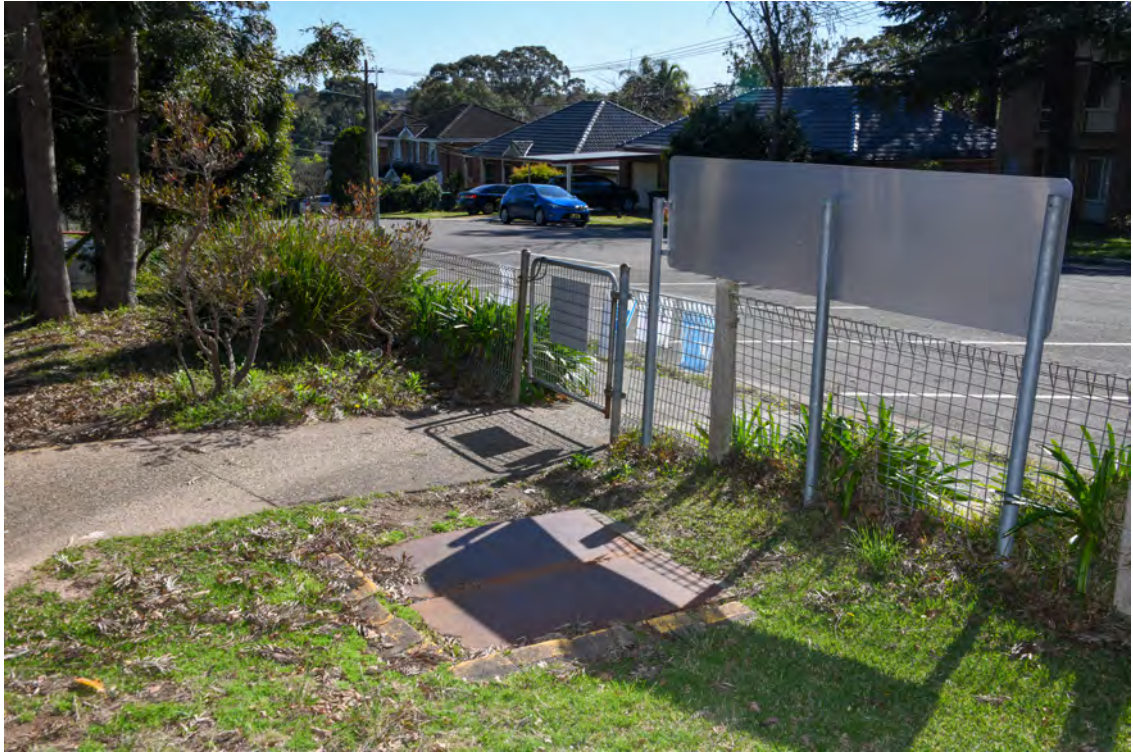
PRO\_1126.jpg

School boundaries. Eastern boundary fronting Ward Street. Area adjacent to the demountable buildings.

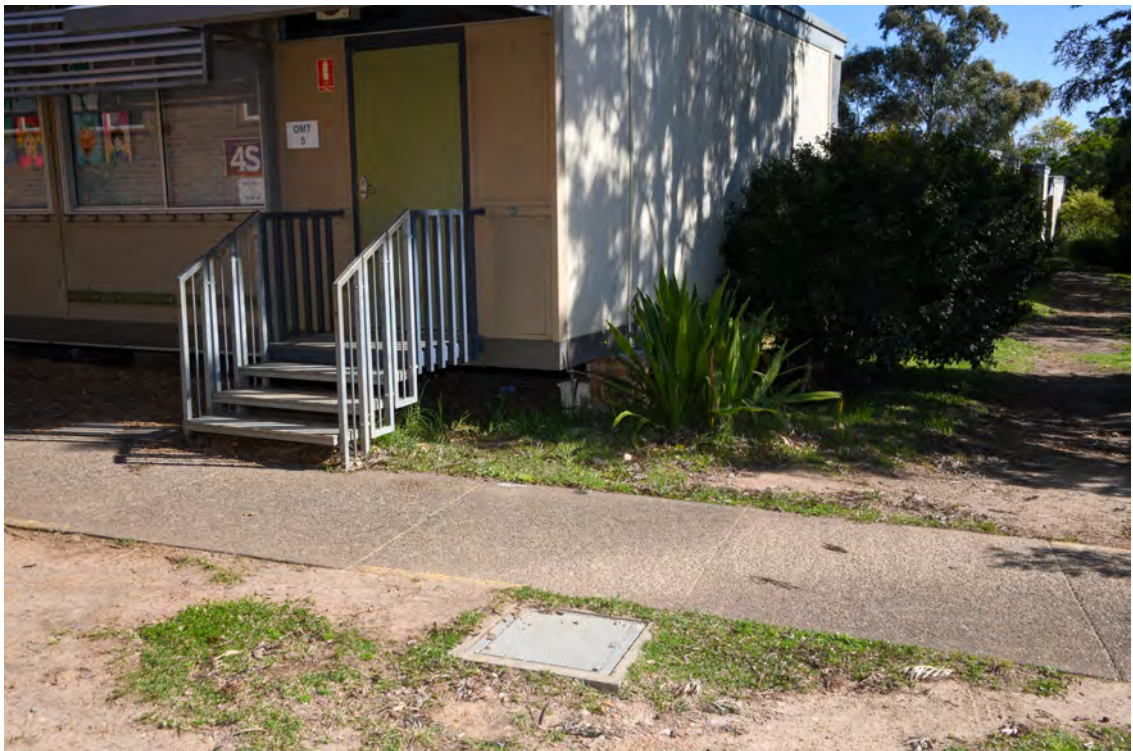
PRO\_1127.jpg

School boundaries. Eastern boundary fronting Ward Street. Heading north. Area adjacent to the demountable buildings.
