96-104 Carlingford Road, Epping NSW 2121

Epping West Public School

DILAPIDATION REPORT

7<sup>th</sup> September 2021

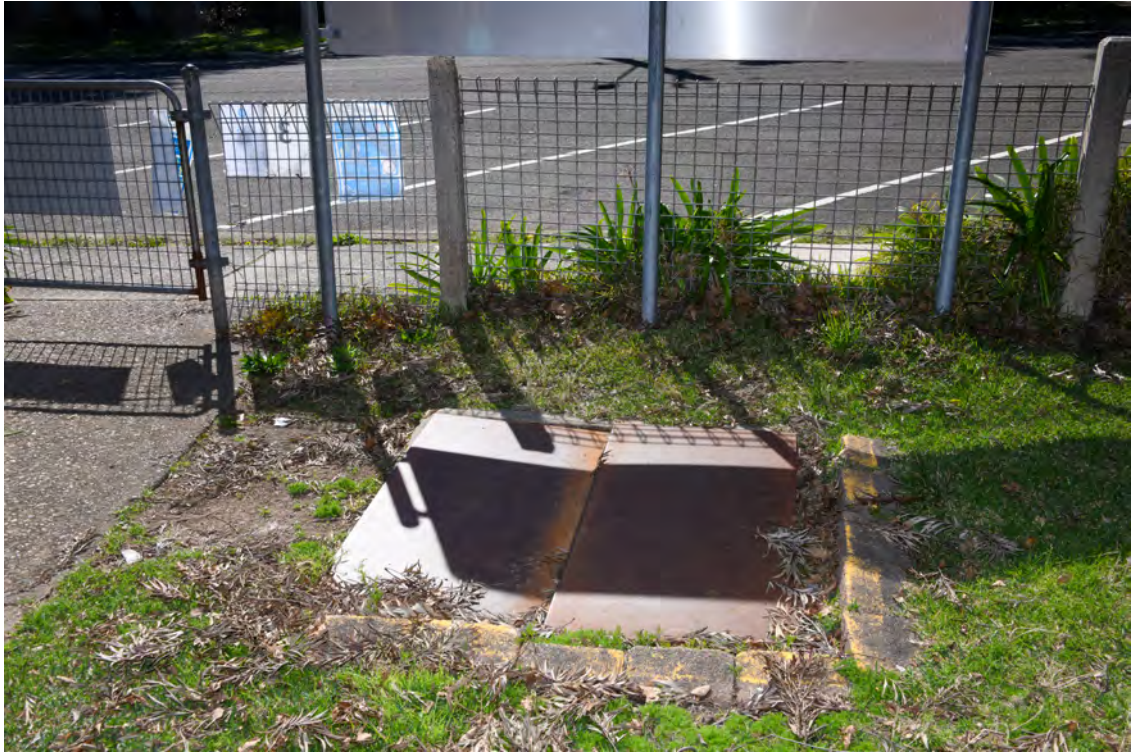
PRO\_1128.jpg

School boundaries. Eastern boundary fronting Ward Street. Heading north. Area adjacent to the demountable buildings.

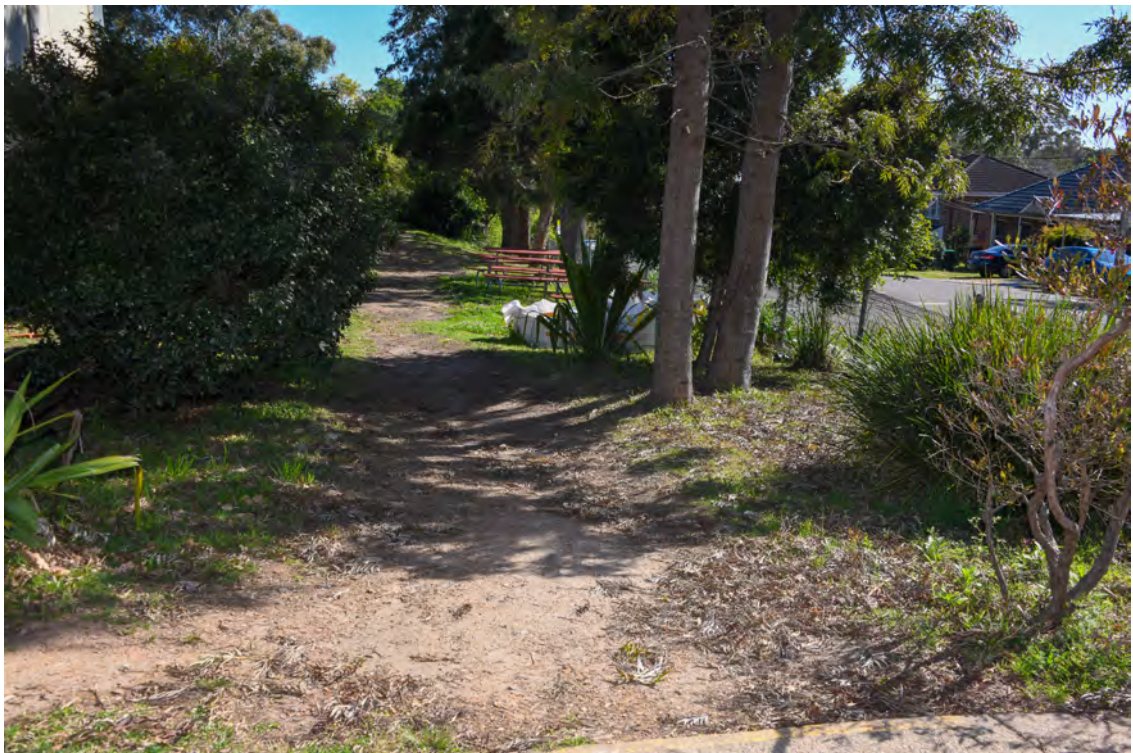
PRO\_1129.jpg

School boundaries. Eastern boundary fronting Ward Street. Heading north. Area adjacent to the demountable buildings.

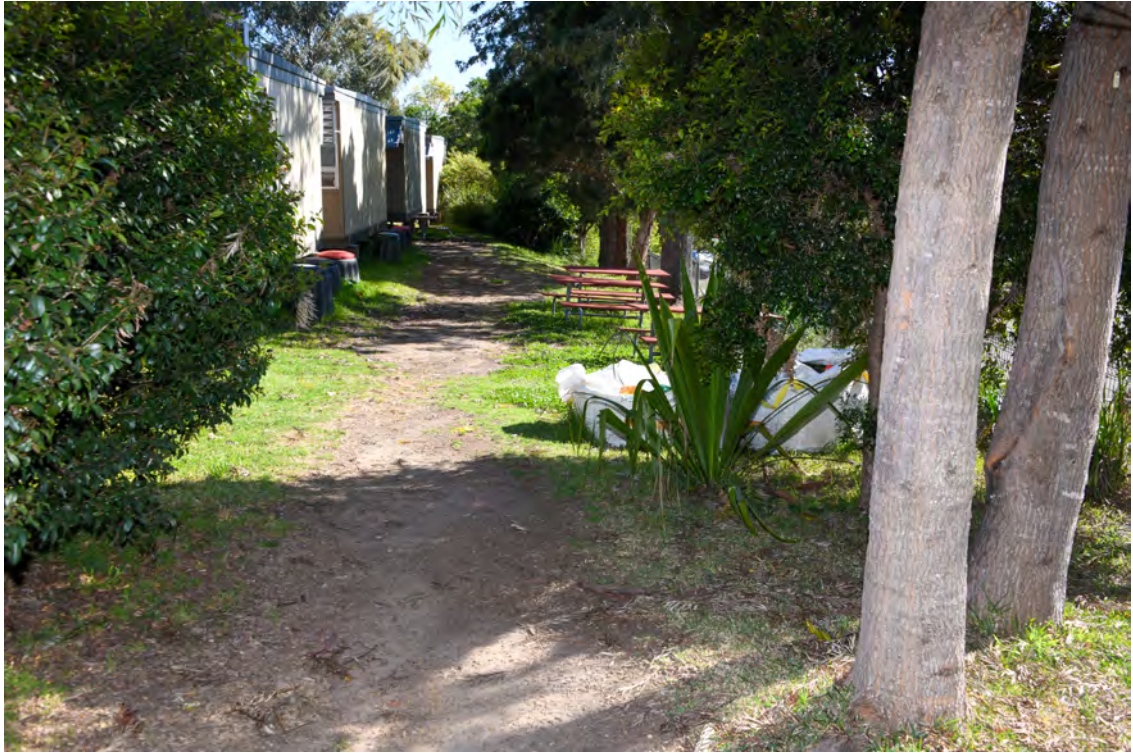
PRO\_1130.jpg

School boundaries. Eastern boundary fronting Ward Street. Heading north. Area adjacent to the demountable buildings.

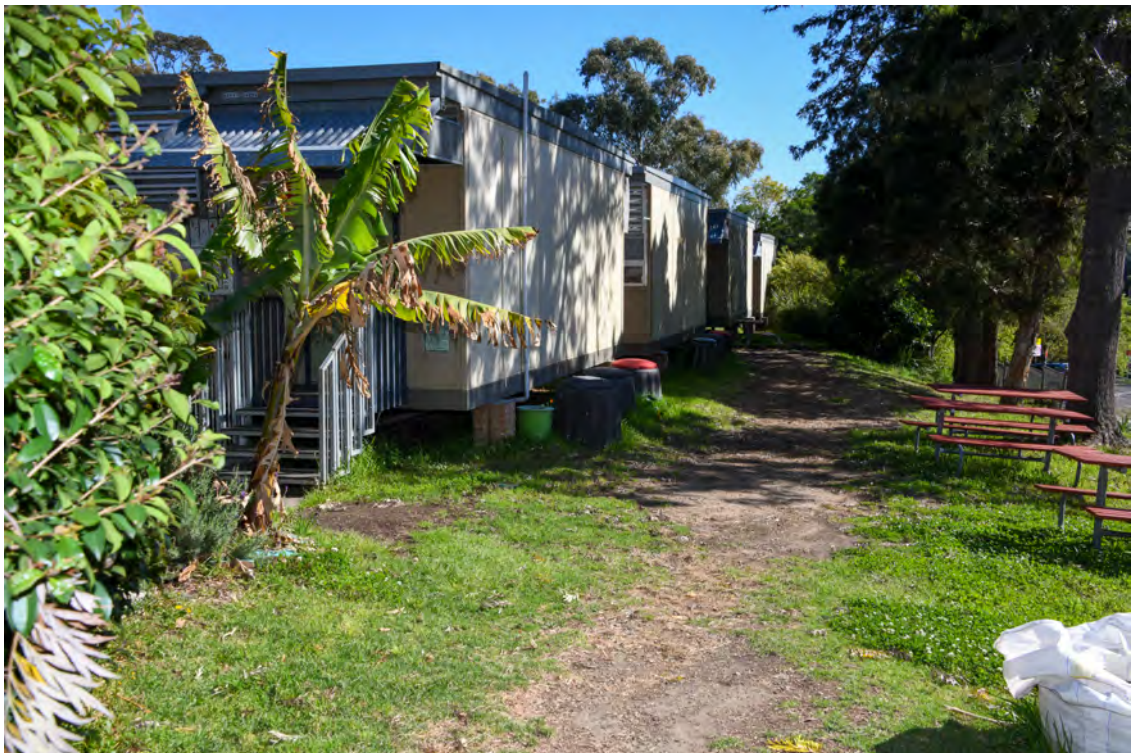
PRO\_1131.jpg

School boundaries. Eastern boundary fronting Ward Street. Heading north. Area adjacent to the demountable buildings.

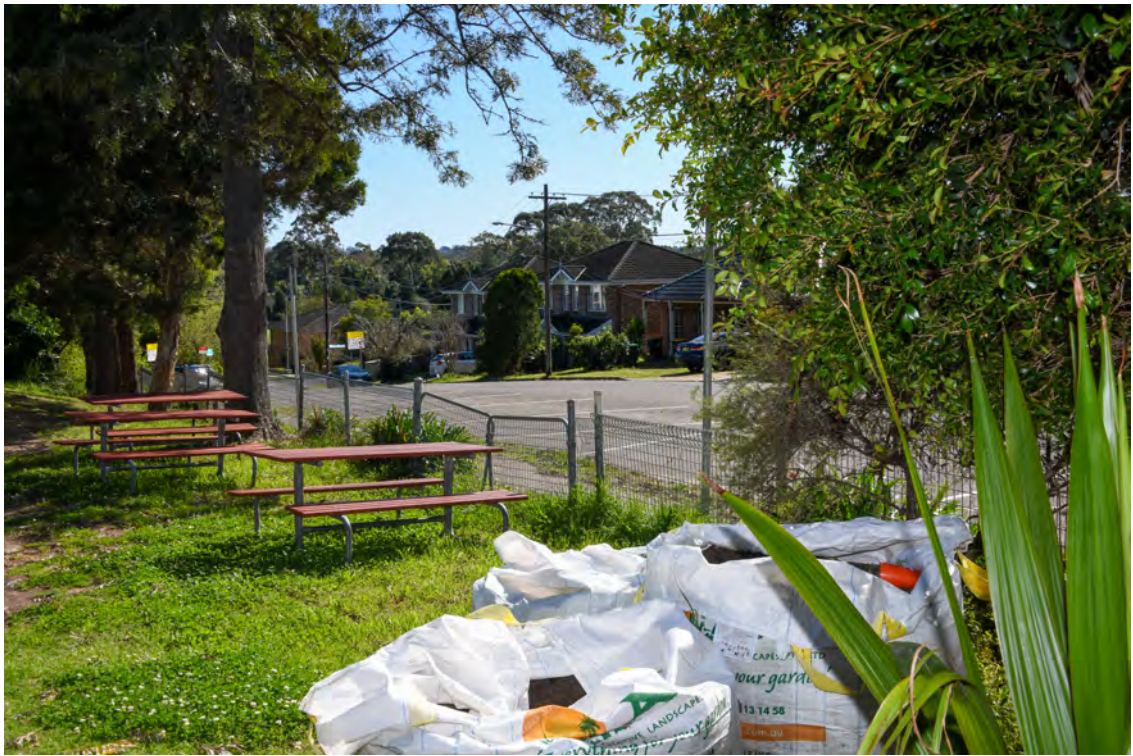
PRO\_1132.jpg

School boundaries. Eastern boundary fronting Ward Street. Heading north. Area adjacent to the demountable buildings.

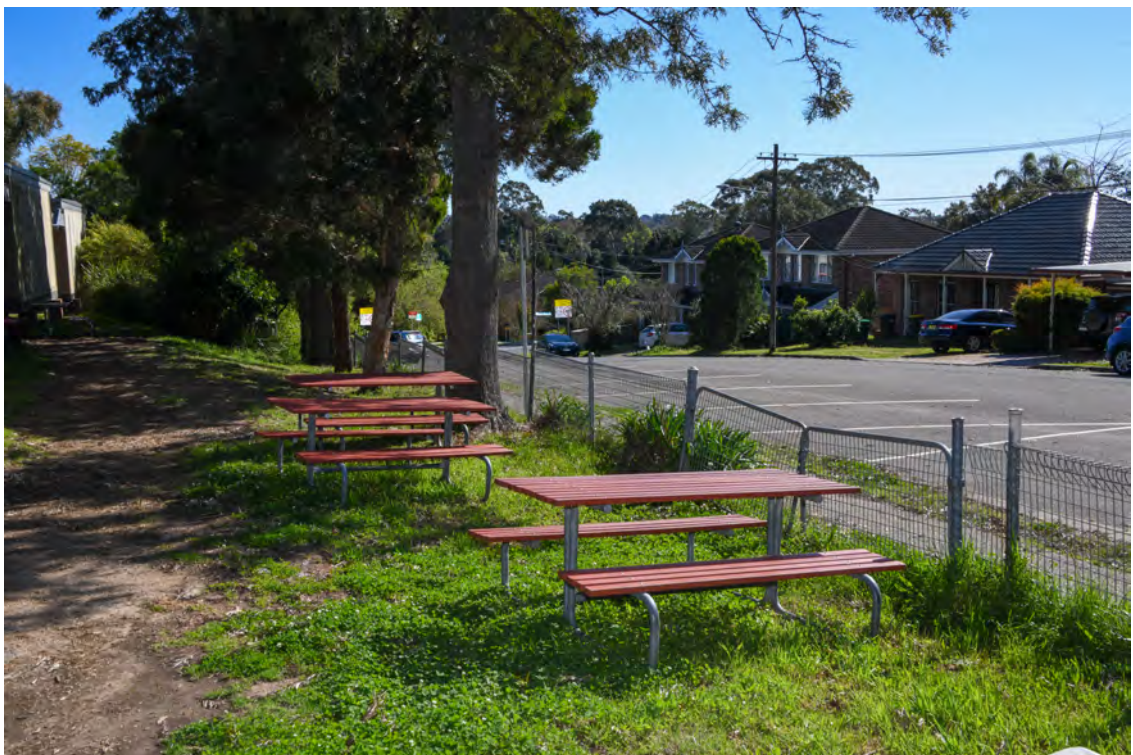
PRO\_1133.jpg

School boundaries. Eastern boundary fronting Ward Street. Heading north. Area adjacent to the demountable buildings.

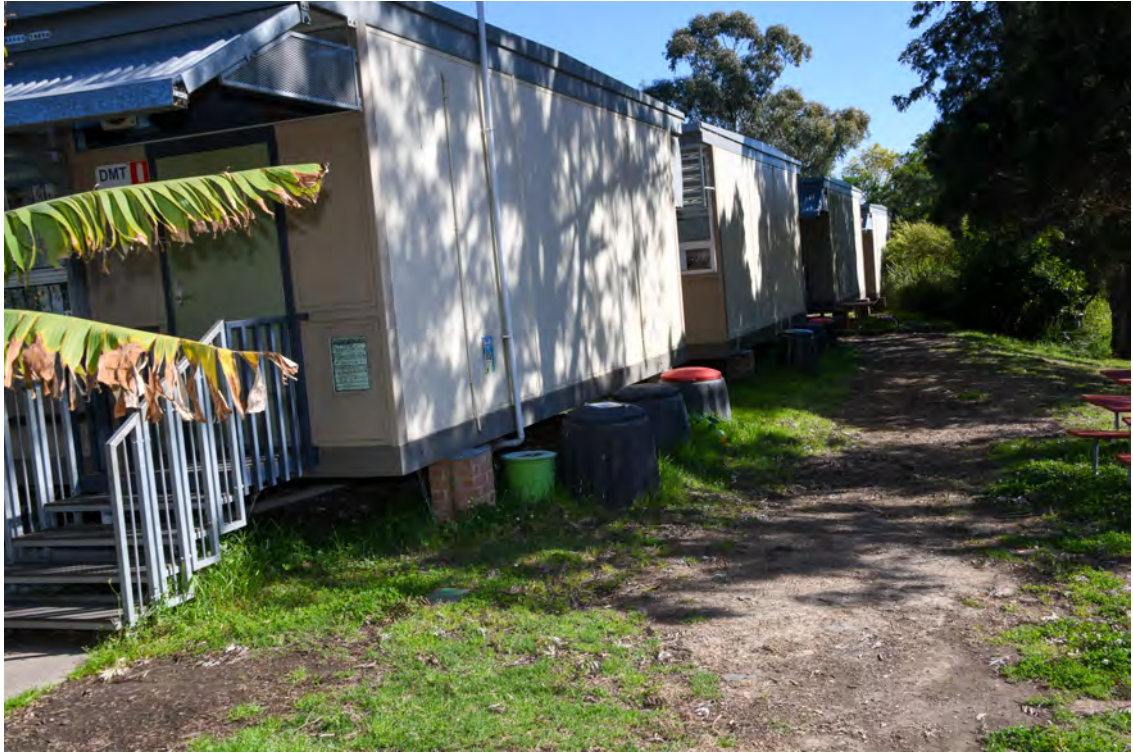
PRO\_1134.jpg

School boundaries. Eastern boundary fronting Ward Street. Heading north. Area adjacent to the demountable buildings.

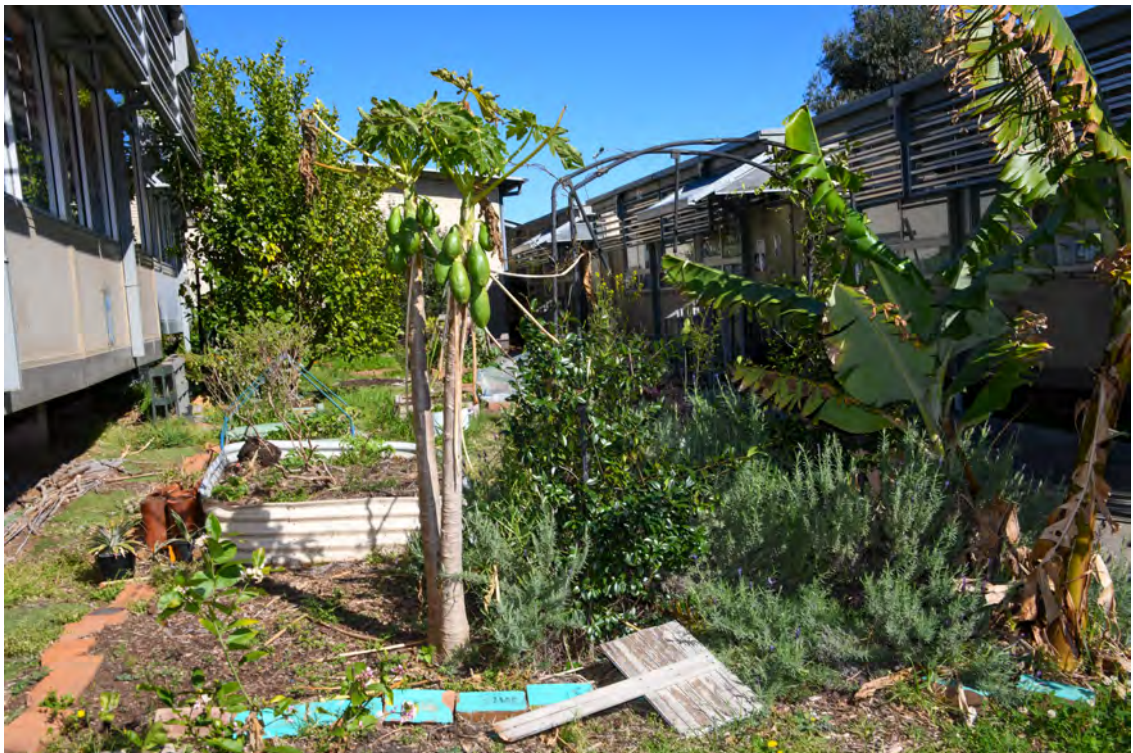
PRO\_1135.jpg

School boundaries. Eastern boundary fronting Ward Street. Heading north. Area adjacent to the demountable buildings.

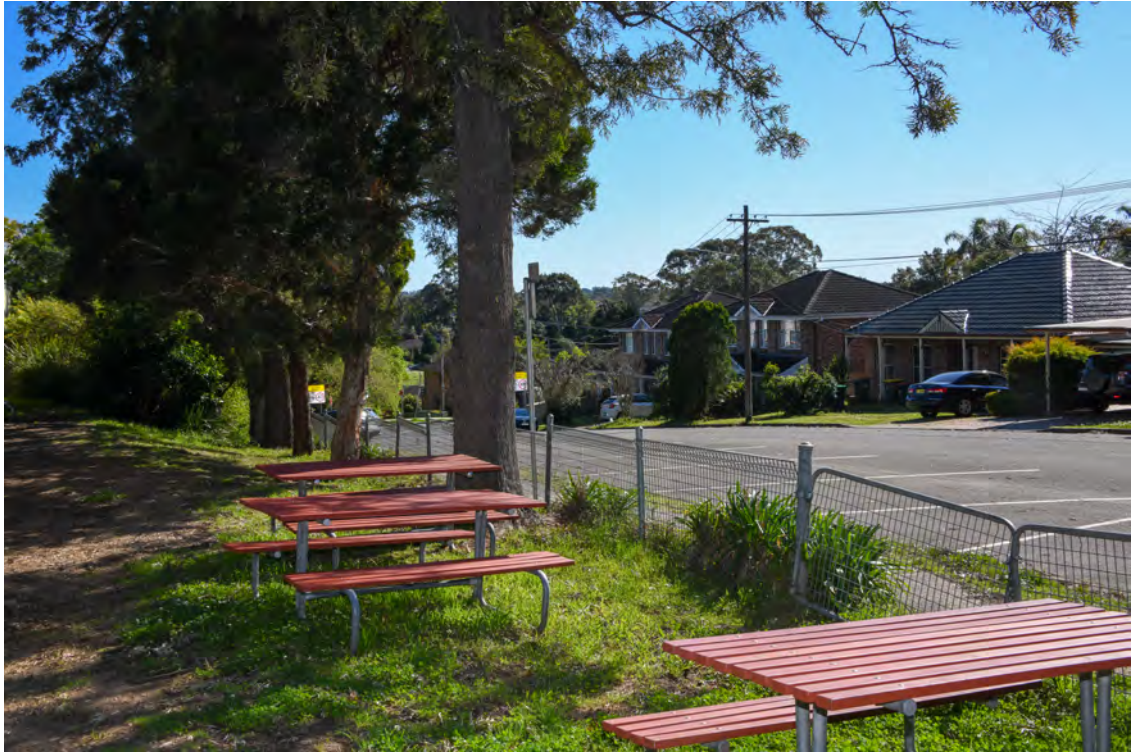
PRO\_1136.jpg

School boundaries. Eastern boundary fronting Ward Street. Heading north. Area adjacent to the demountable buildings.

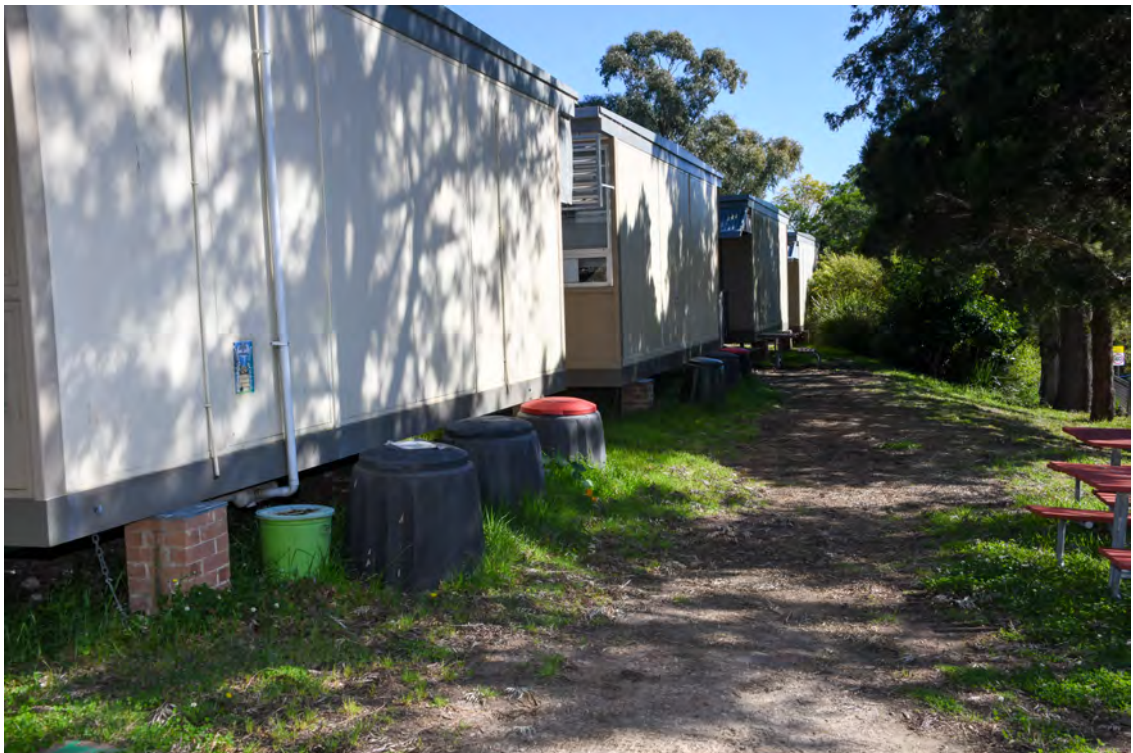
PRO\_1137.jpg

School boundaries. Eastern boundary fronting Ward Street. Heading north. Area adjacent to the demountable buildings.

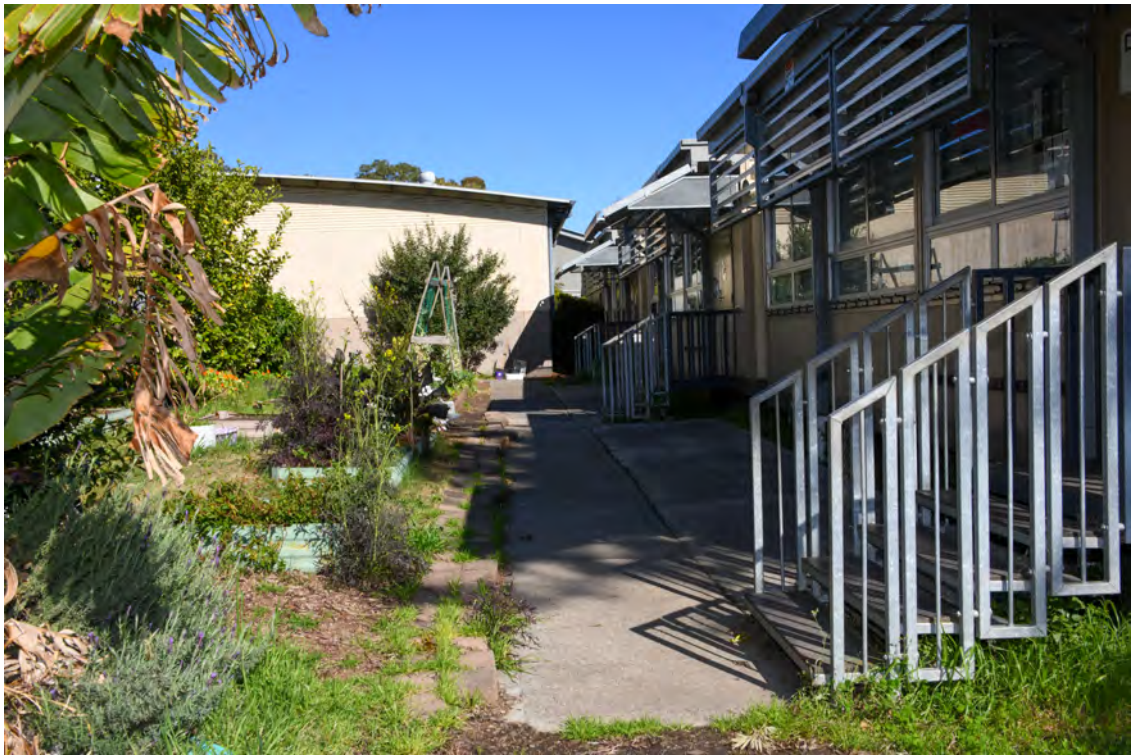
PRO\_1138.jpg

School boundaries. Eastern boundary fronting Ward Street. Heading north. Area adjacent to the demountable buildings.

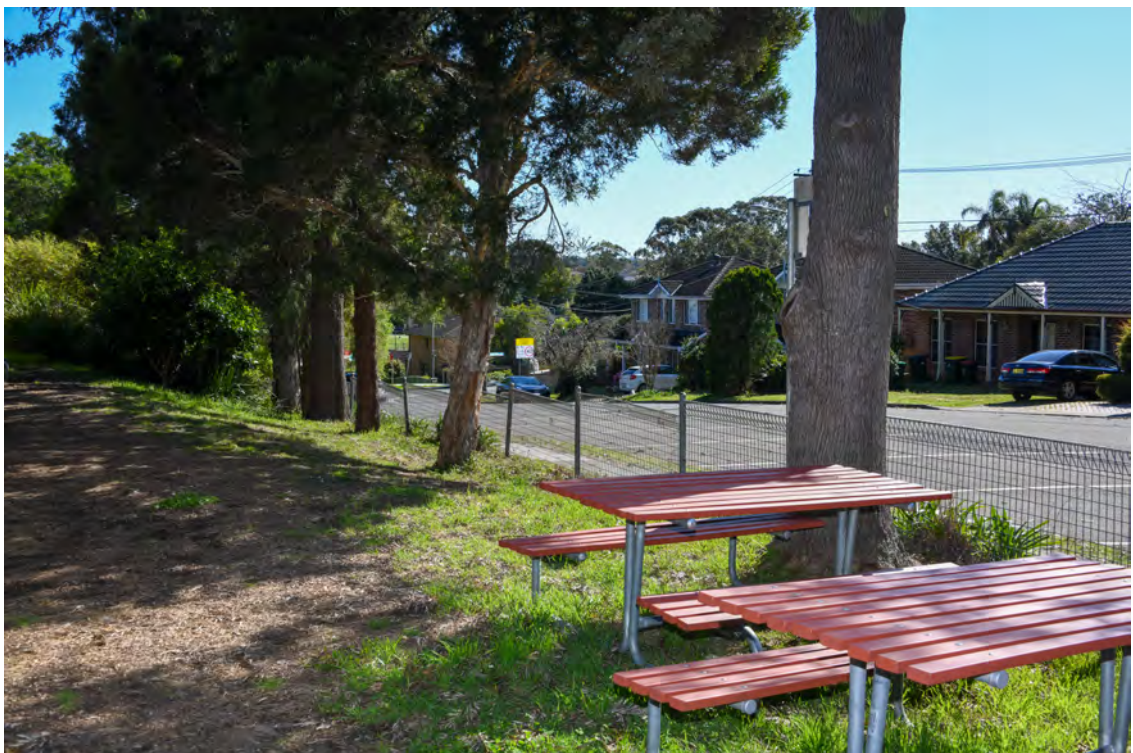
PRO\_1139.jpg

School boundaries. Eastern boundary fronting Ward Street. Heading north. Area adjacent to the demountable buildings.

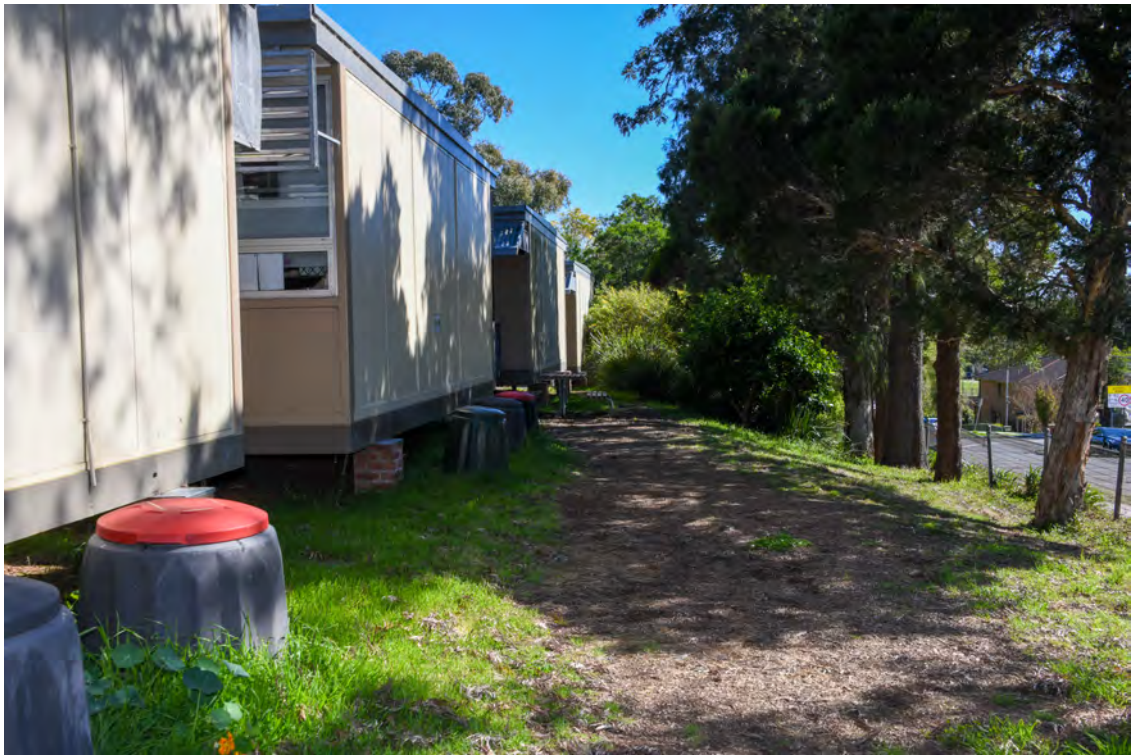
PRO\_1140.jpg

School boundaries. Eastern boundary fronting Ward Street. Heading north. Area adjacent to the demountable buildings.

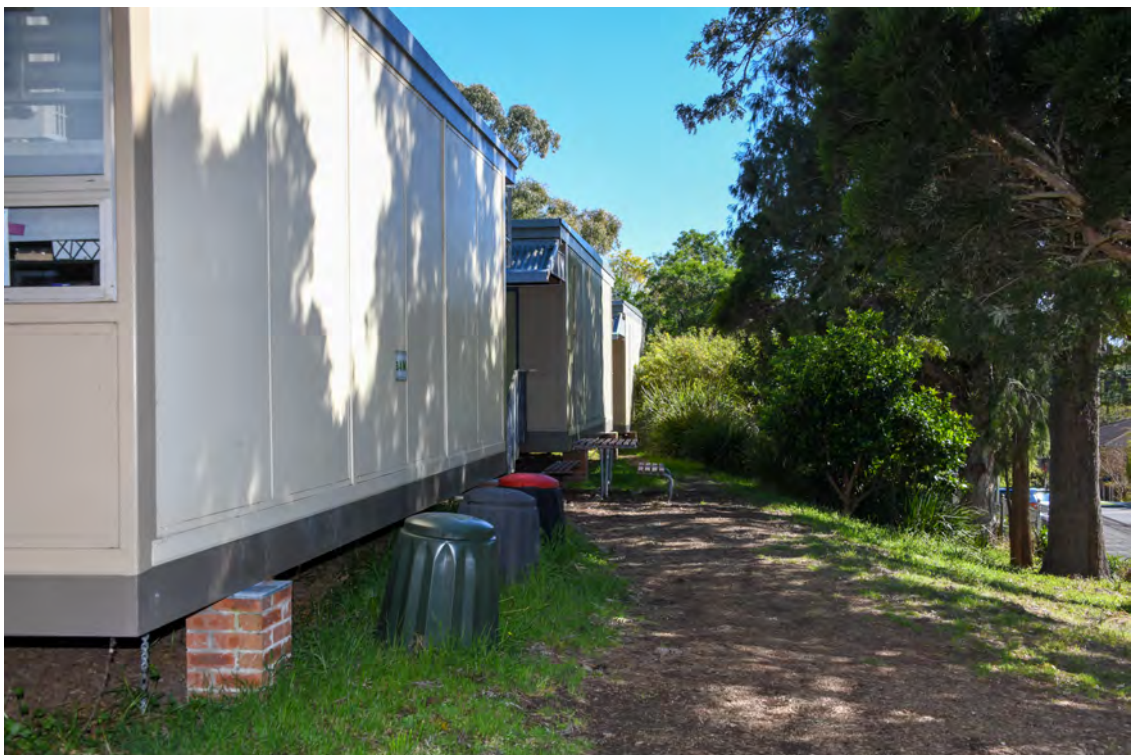
PRO\_1141.jpg

School boundaries. Eastern boundary fronting Ward Street. Heading north. Area adjacent to the demountable buildings.

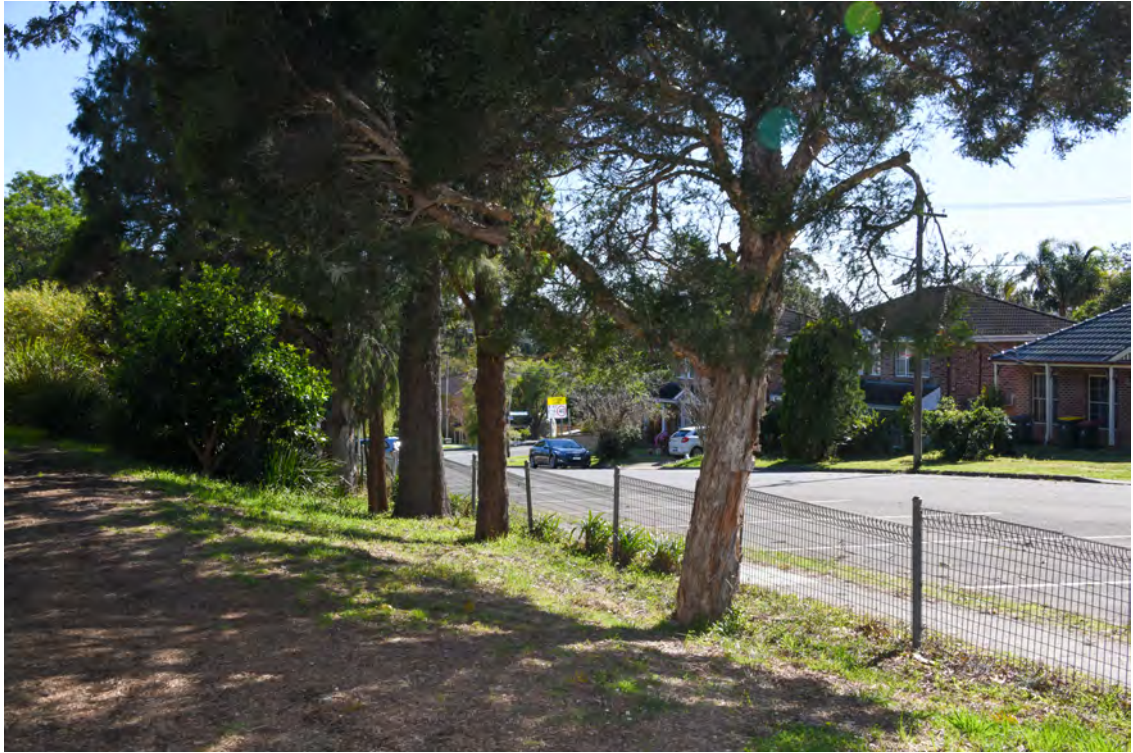
PRO\_1142.jpg

School boundaries. Eastern boundary fronting Ward Street. Heading north. Area adjacent to the demountable buildings.

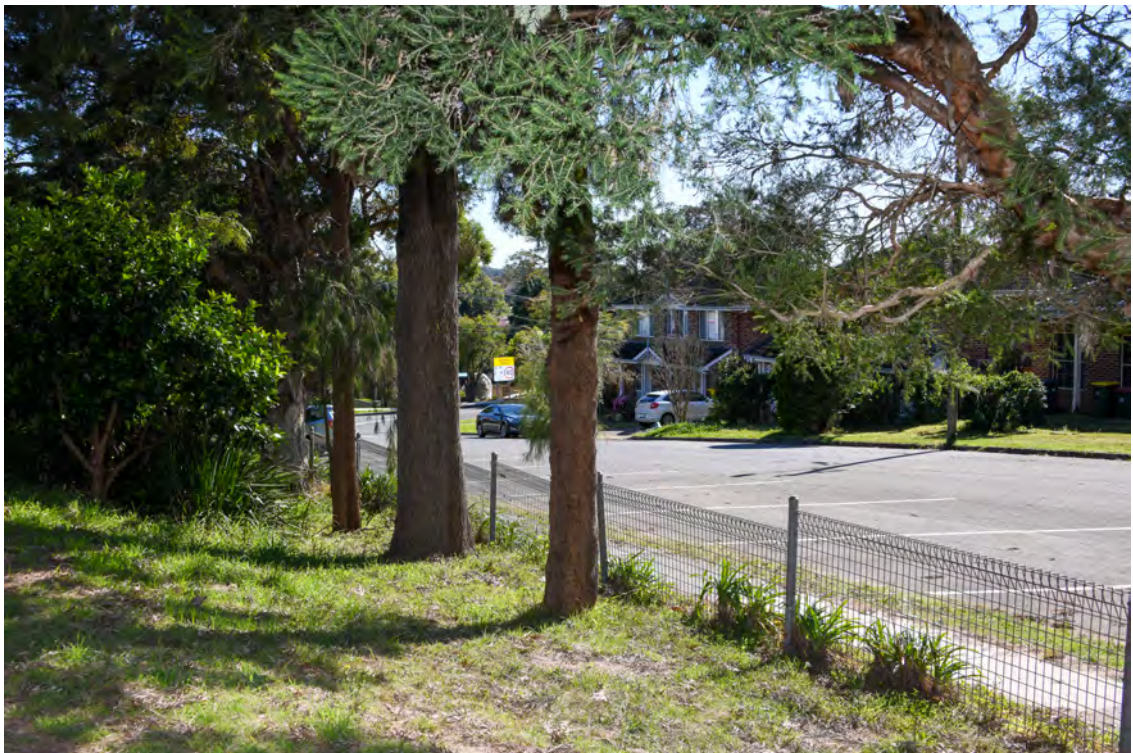
PRO\_1143.jpg

School boundaries. Eastern boundary fronting Ward Street. Heading north. Area adjacent to the demountable buildings.

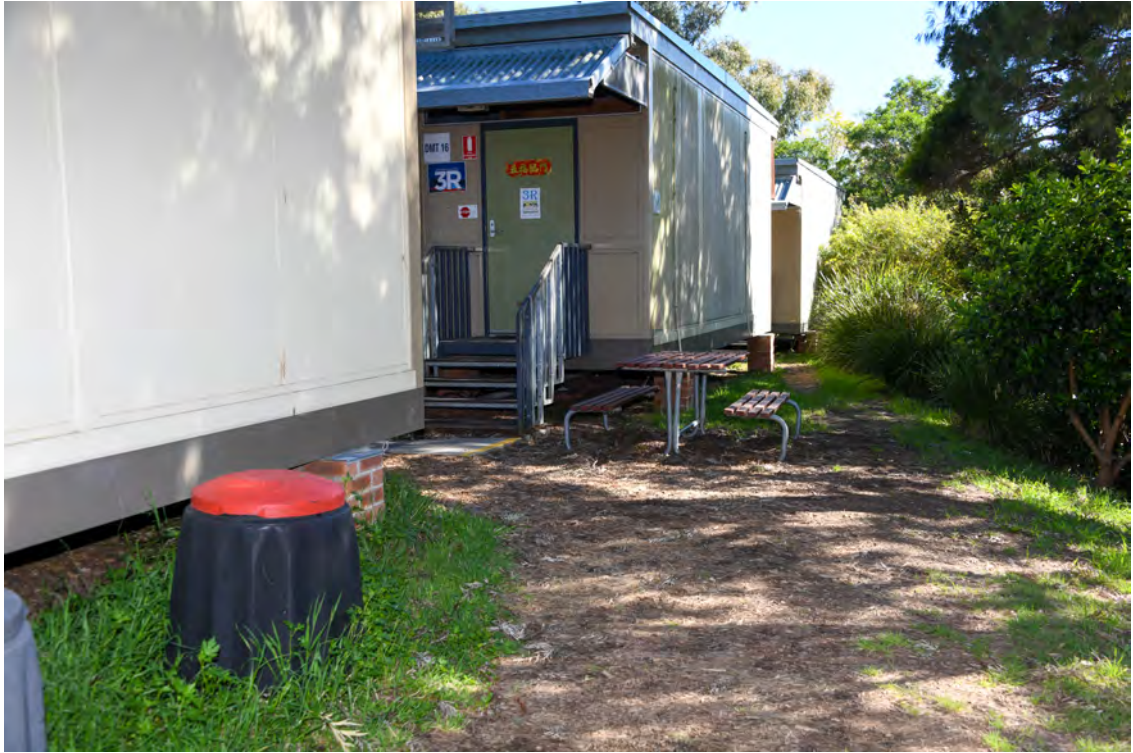
PRO\_1144.jpg

School boundaries. Eastern boundary fronting Ward Street. Heading north. Area adjacent to the demountable buildings.

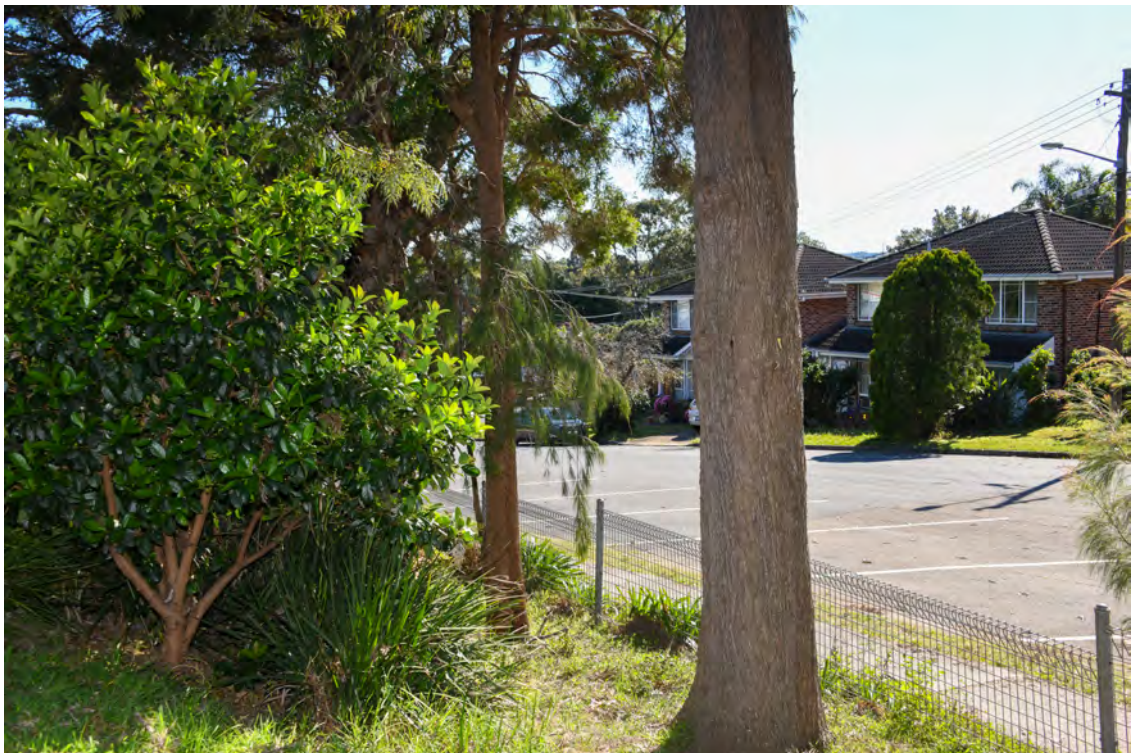
PRO\_1145.jpg

School boundaries. Eastern boundary fronting Ward Street. Heading north. Area adjacent to the demountable buildings.

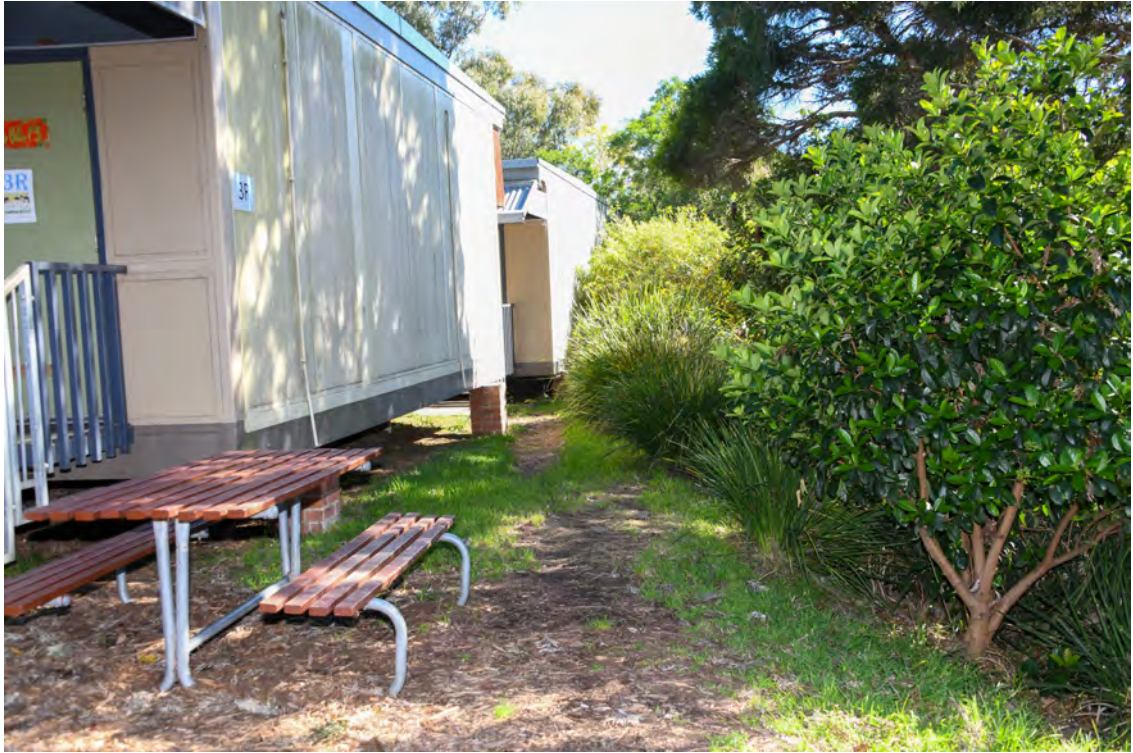
PRO\_1146.jpg

School boundaries. Eastern boundary fronting Ward Street. Heading north. Area adjacent to the demountable buildings.

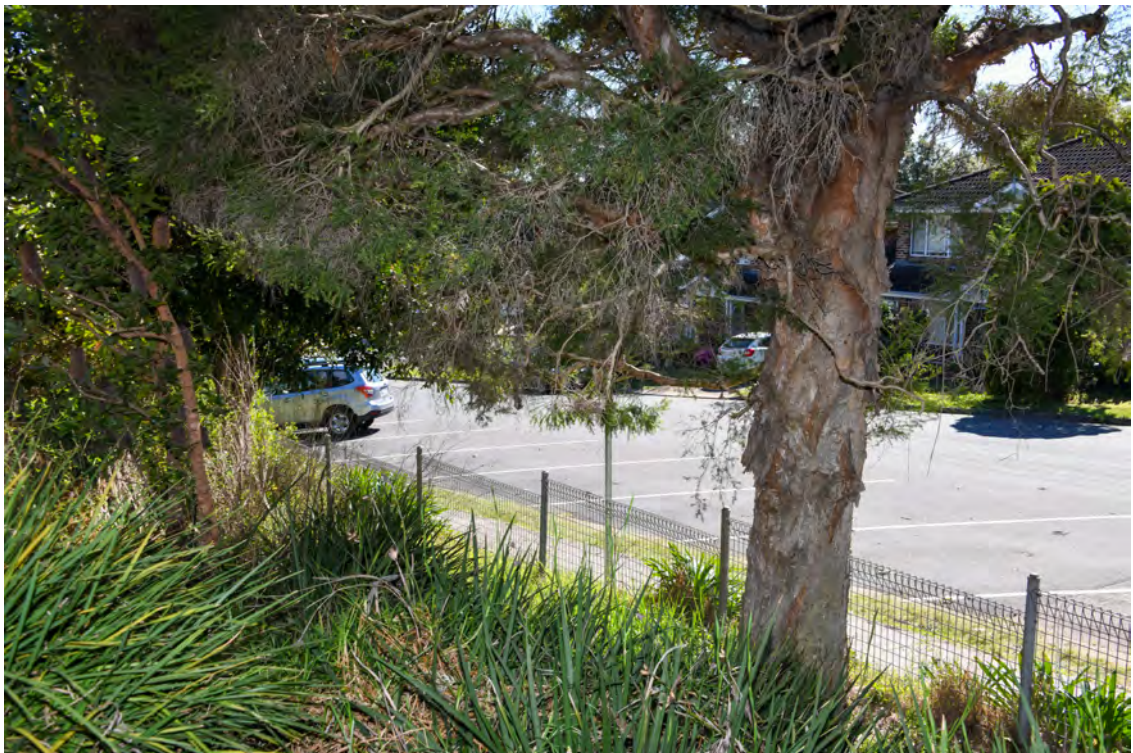
PRO\_1147.jpg

School boundaries. Eastern boundary fronting Ward Street. Heading north. Area adjacent to the demountable buildings.

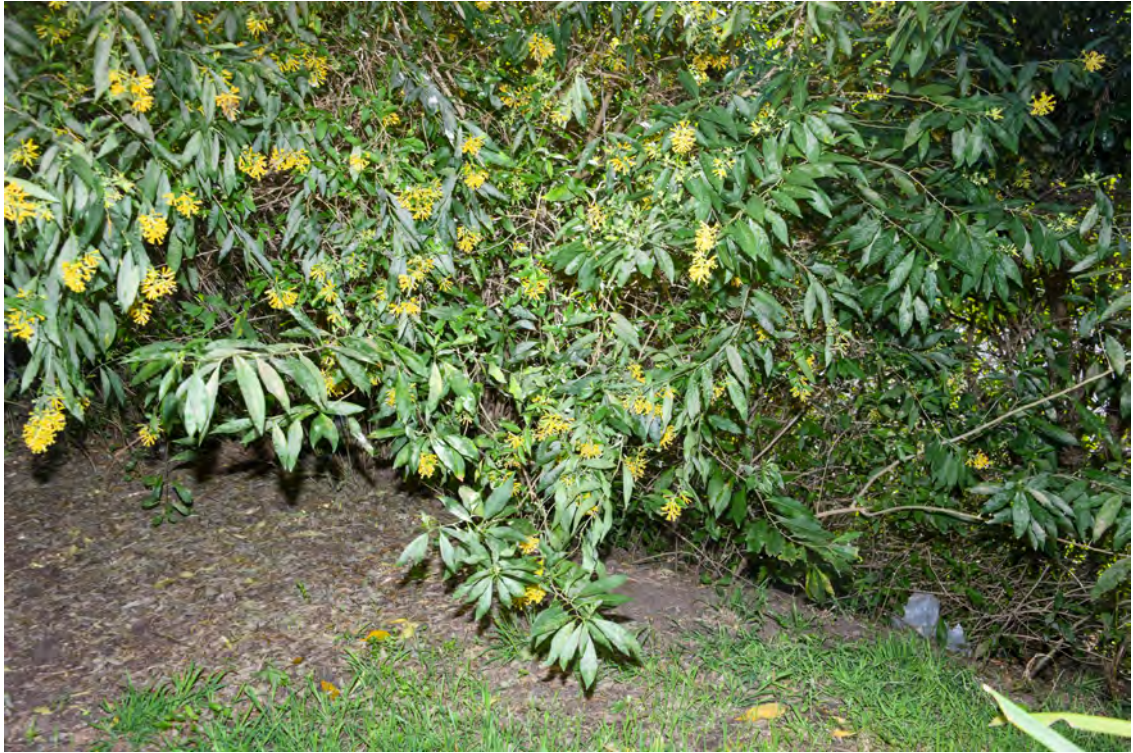
PRO\_1148.jpg

School boundaries. Eastern boundary fronting Ward Street. Heading north. Area adjacent to the demountable buildings.

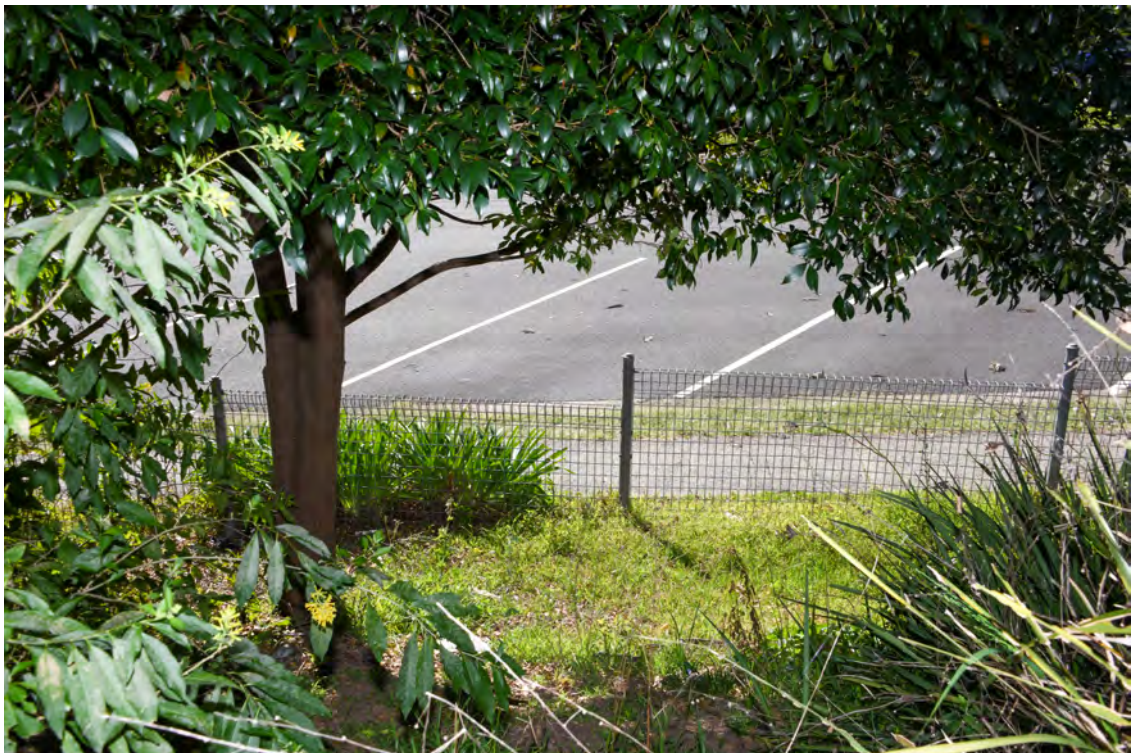
PRO\_1149.jpg

School boundaries. Eastern boundary fronting Ward Street. Heading north. Area adjacent to the demountable buildings.

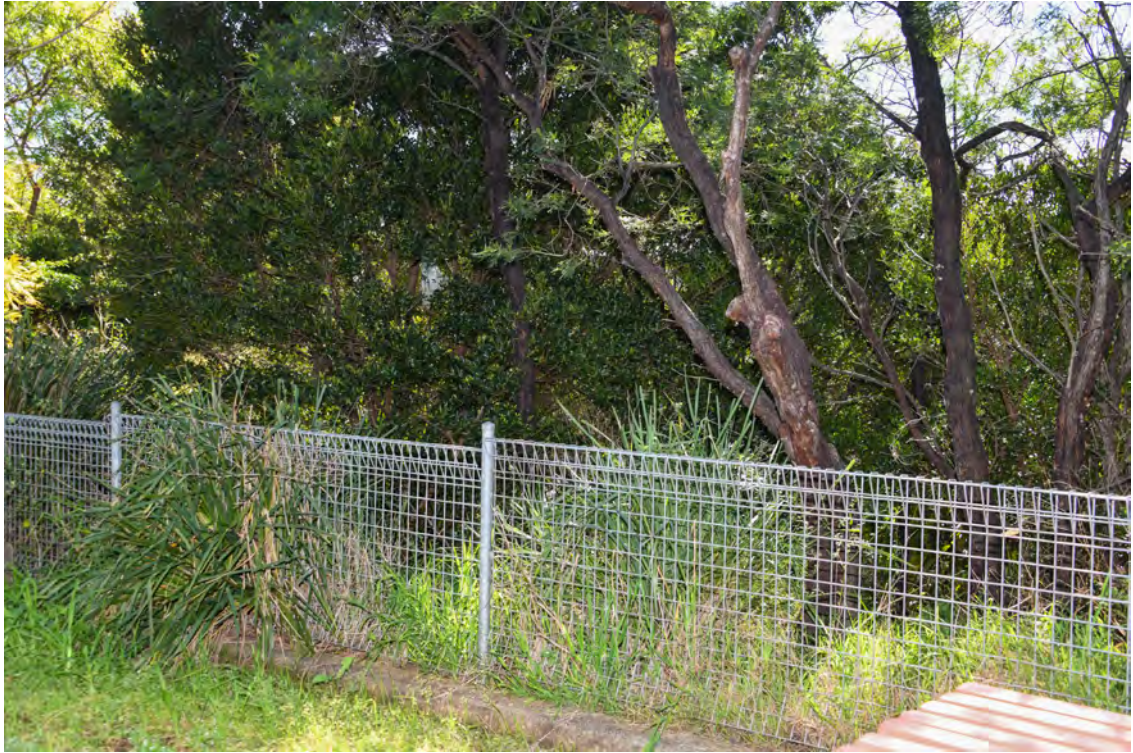
PRO\_1150.jpg

School boundaries. Eastern boundary fronting Ward Street. Heading north. Area adjacent to the demountable buildings.

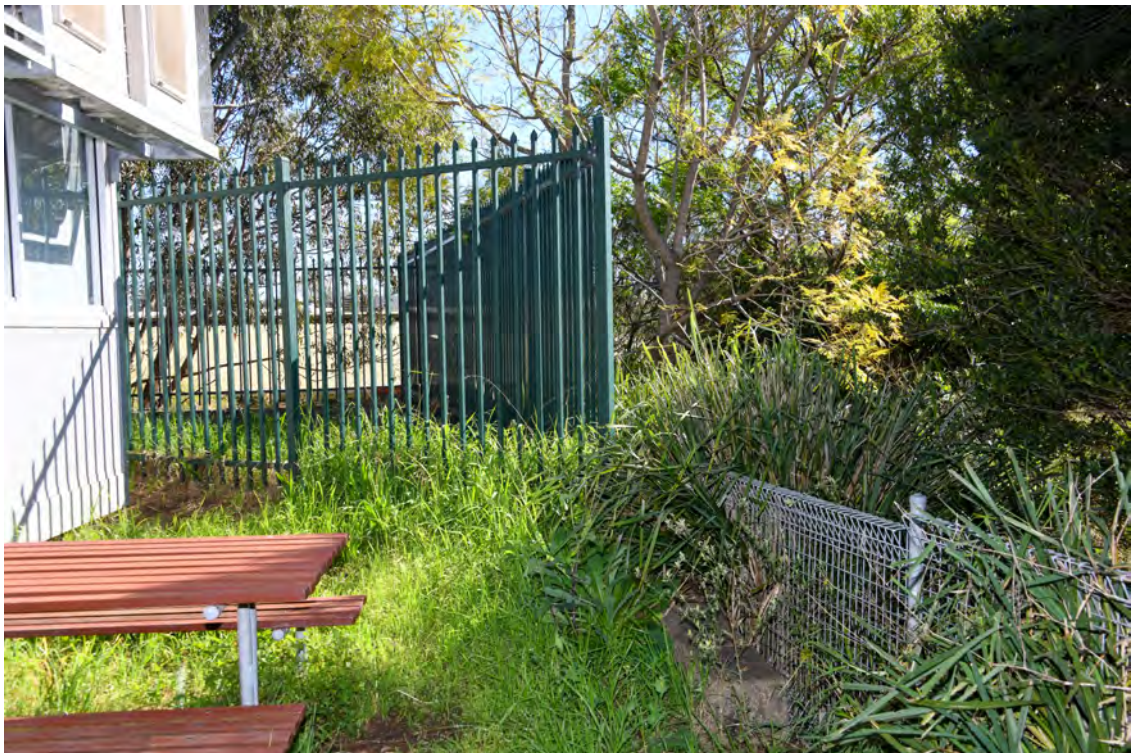
PRO\_1151.jpg

School boundaries. Eastern boundary fronting Ward Street. Heading north. Area adjacent to the demountable buildings.

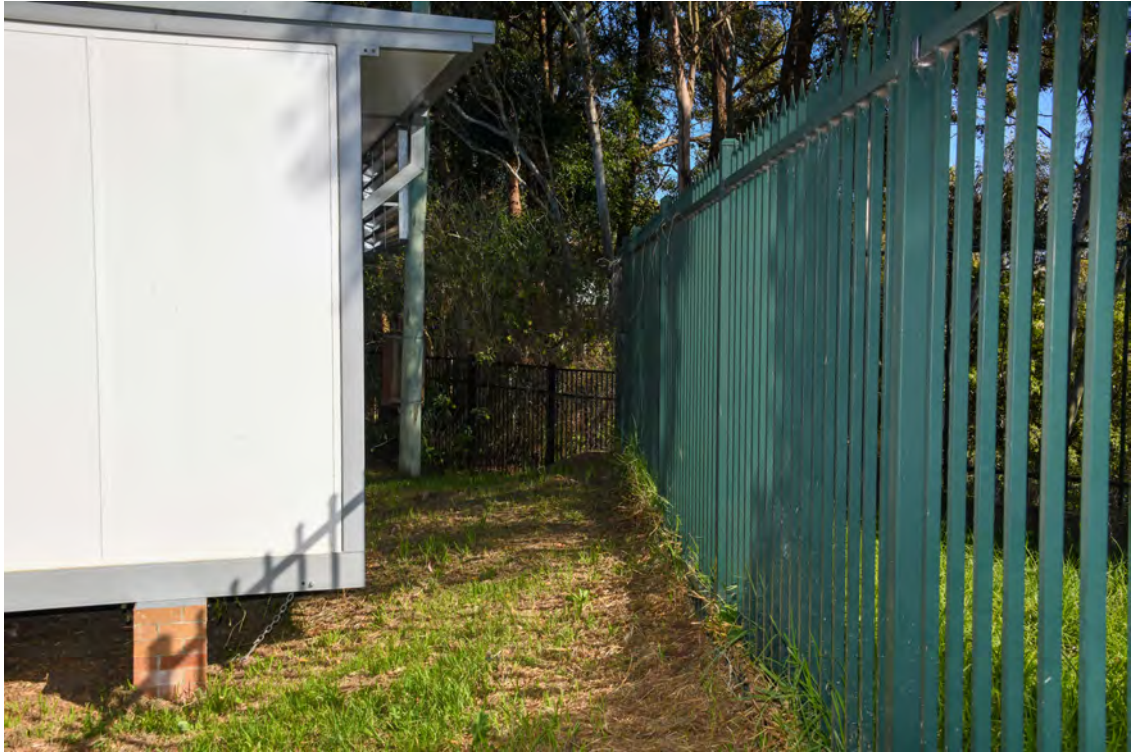
PRO\_1152.jpg

School boundaries. Eastern boundary fronting Ward Street. Heading north. Area adjacent to the demountable buildings.

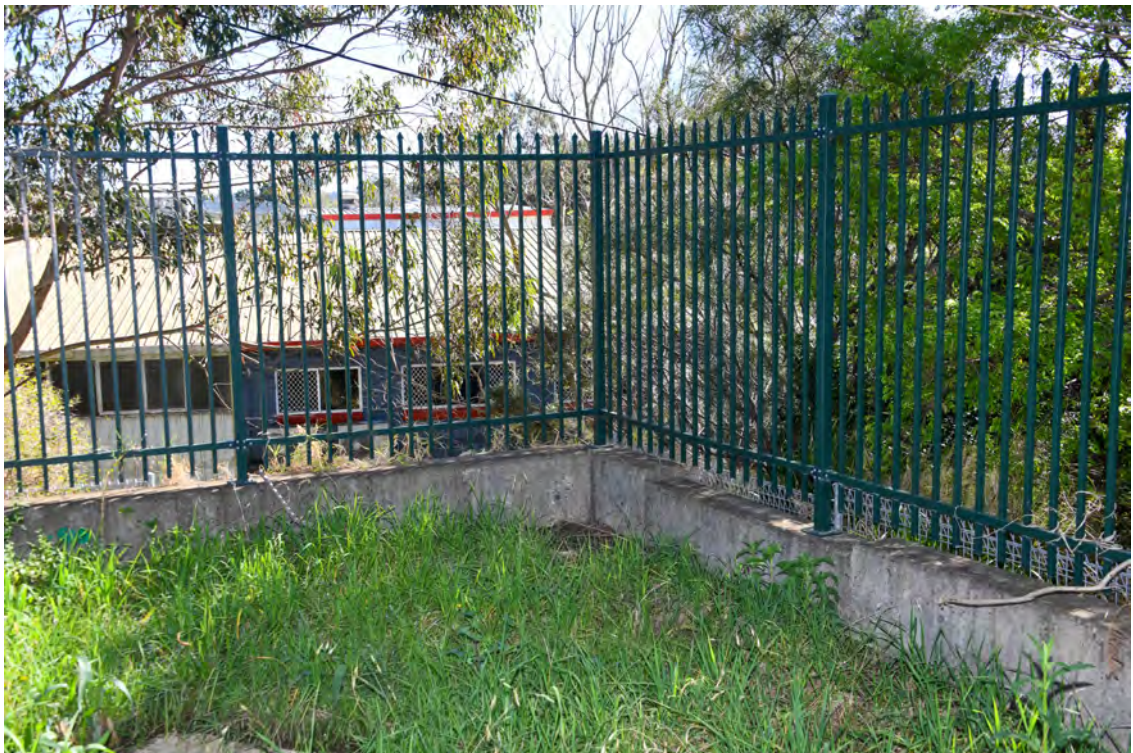
PRO\_1153.jpg

School boundaries. North-eastern corner of the school.
