96-104 Carlingford Road, Epping NSW 2121

Epping West Public School

DILAPIDATION REPORT

7<sup>th</sup> September 2021

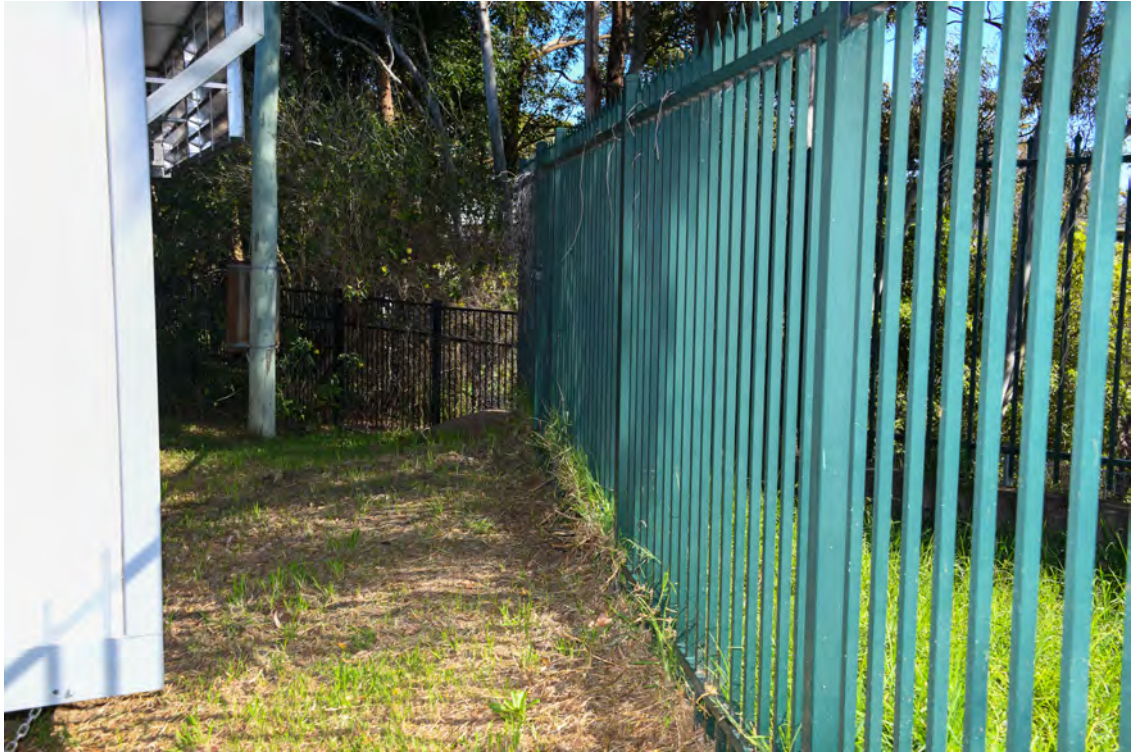
PRO\_1155.jpg

School boundaries. North-eastern corner of the school.

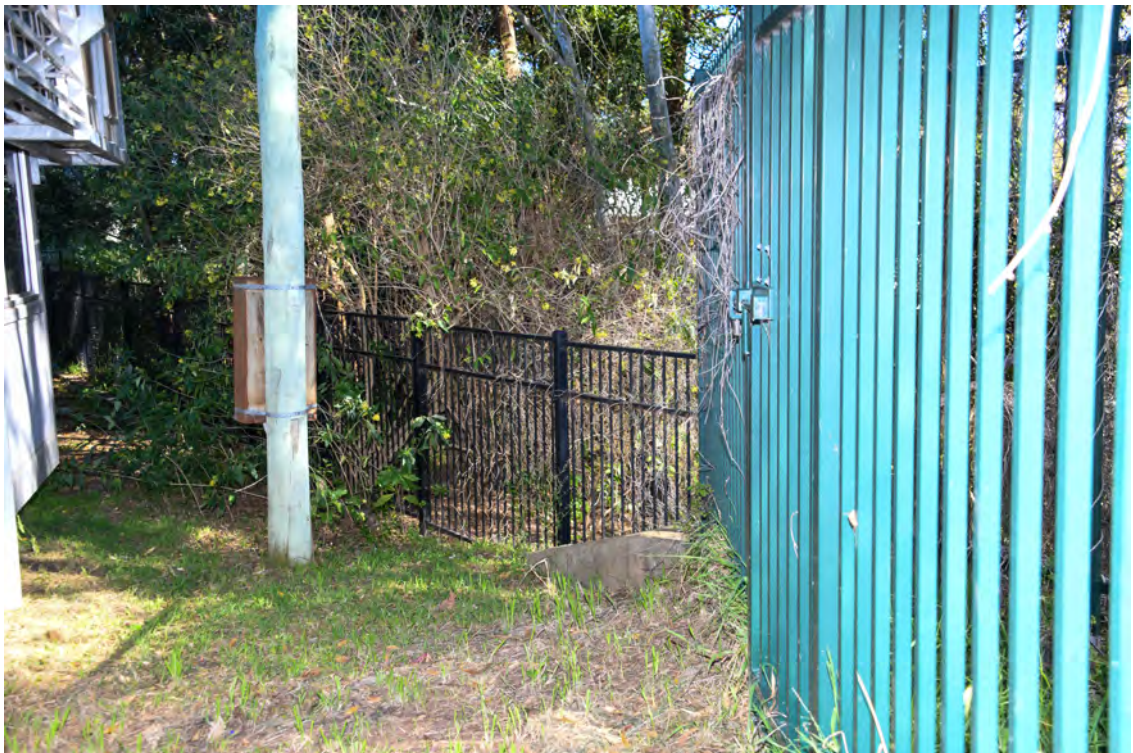
PRO\_1156.jpg

School boundaries. North-eastern corner of the school.

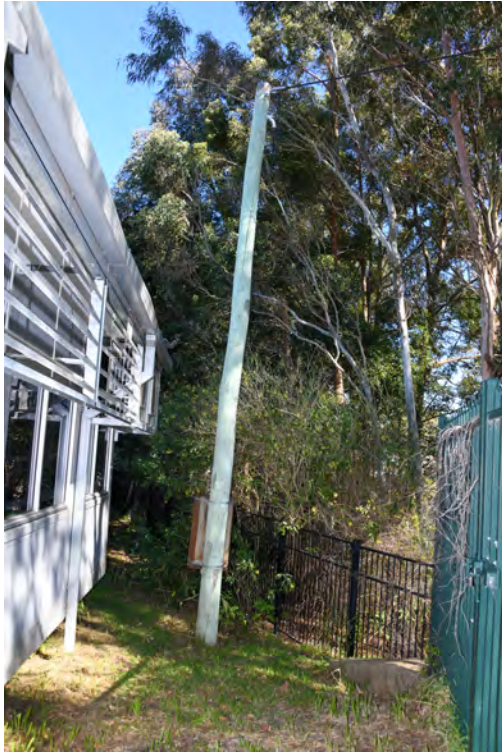
PRO\_1157.jpg

School boundaries. North-eastern corner of the school. Private power pole.

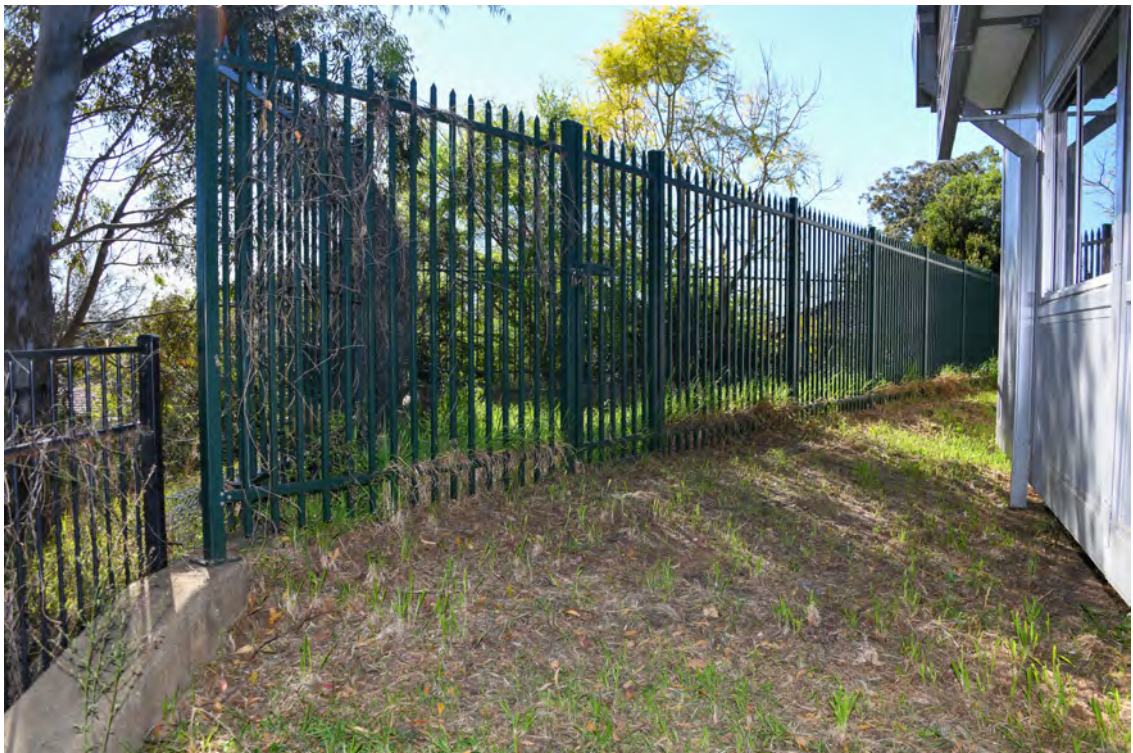
PRO\_1158.jpg

School boundaries. North-eastern corner of the school.

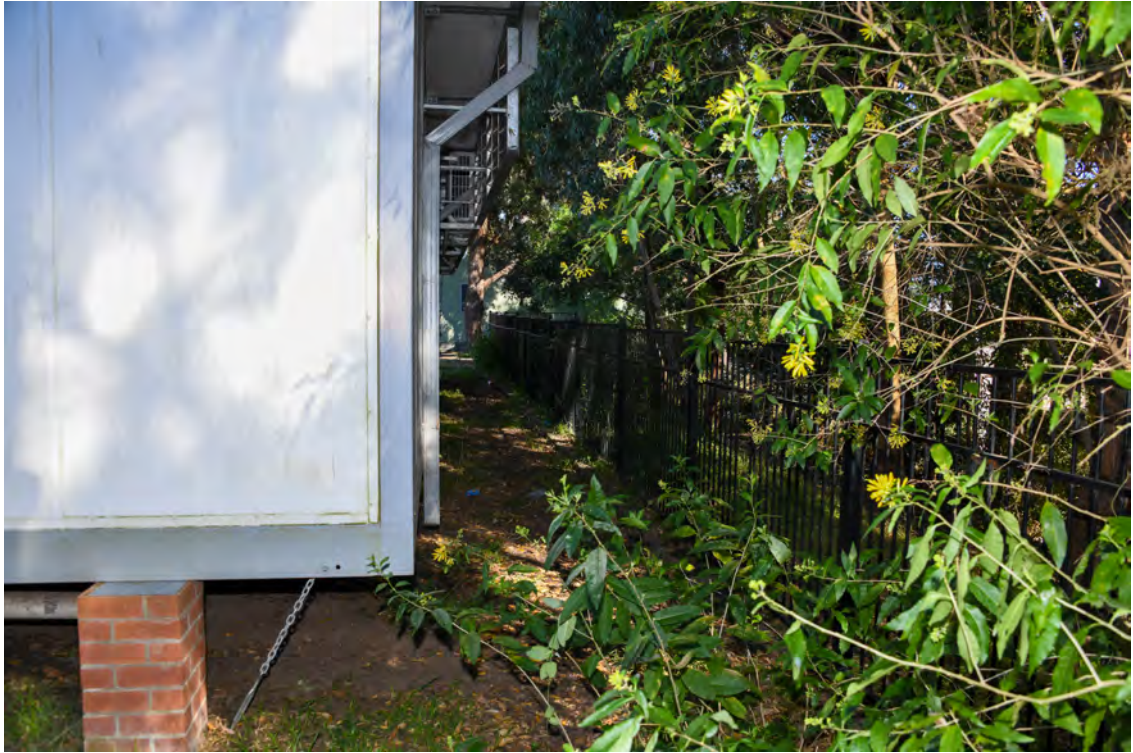
PRO\_1159.jpg

School boundaries. Northern boundary common with the YMCA. Heading west.

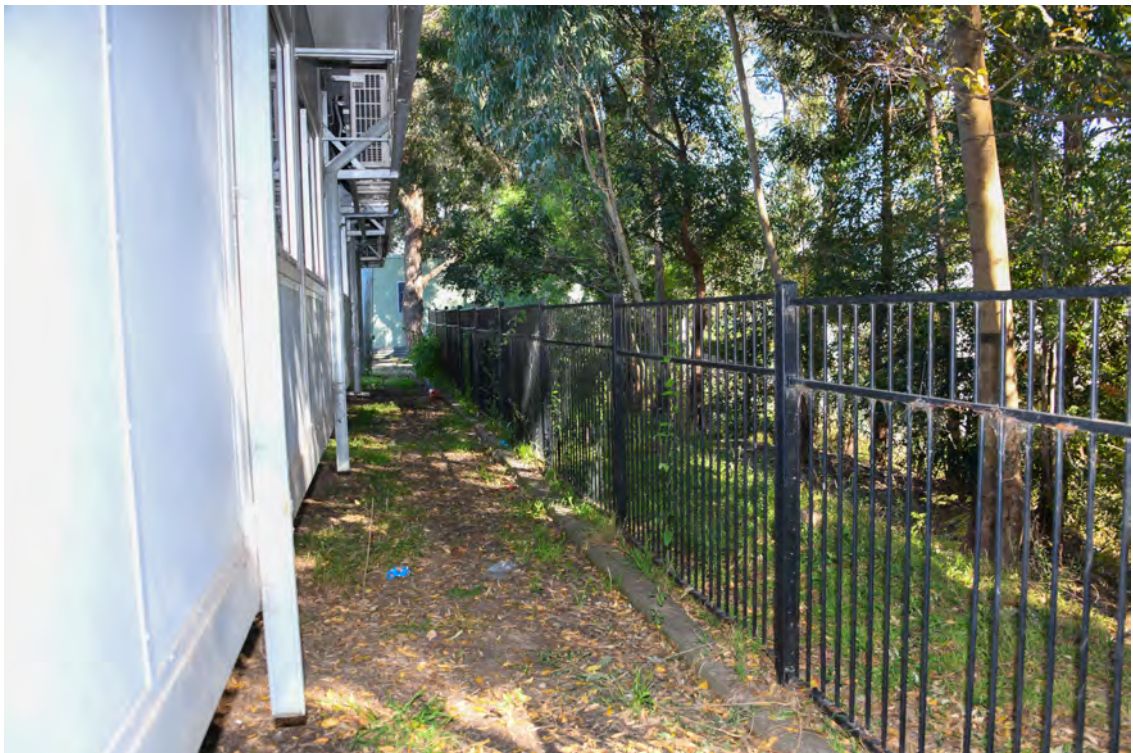
PRO\_1160.jpg

School boundaries. Northern boundary common with the YMCA. Heading west.

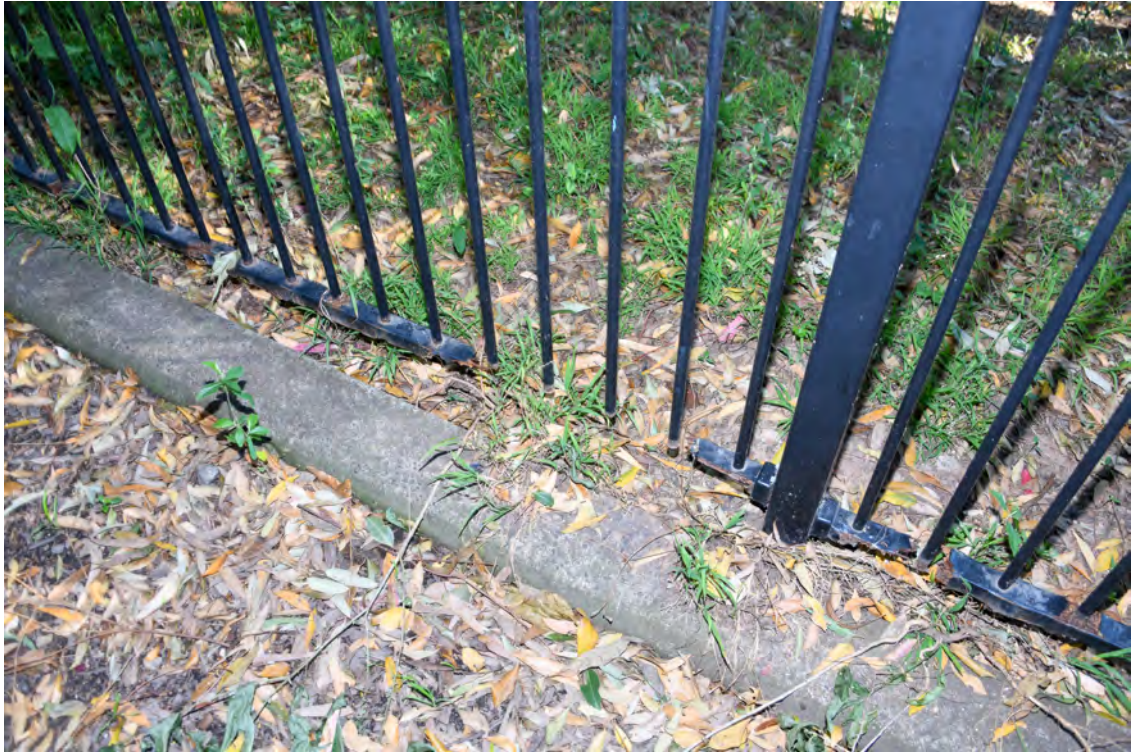
PRO\_1161.jpg

School boundaries. Northern boundary common with the YMCA. Heading west. Rusted and damaged boundary fence.

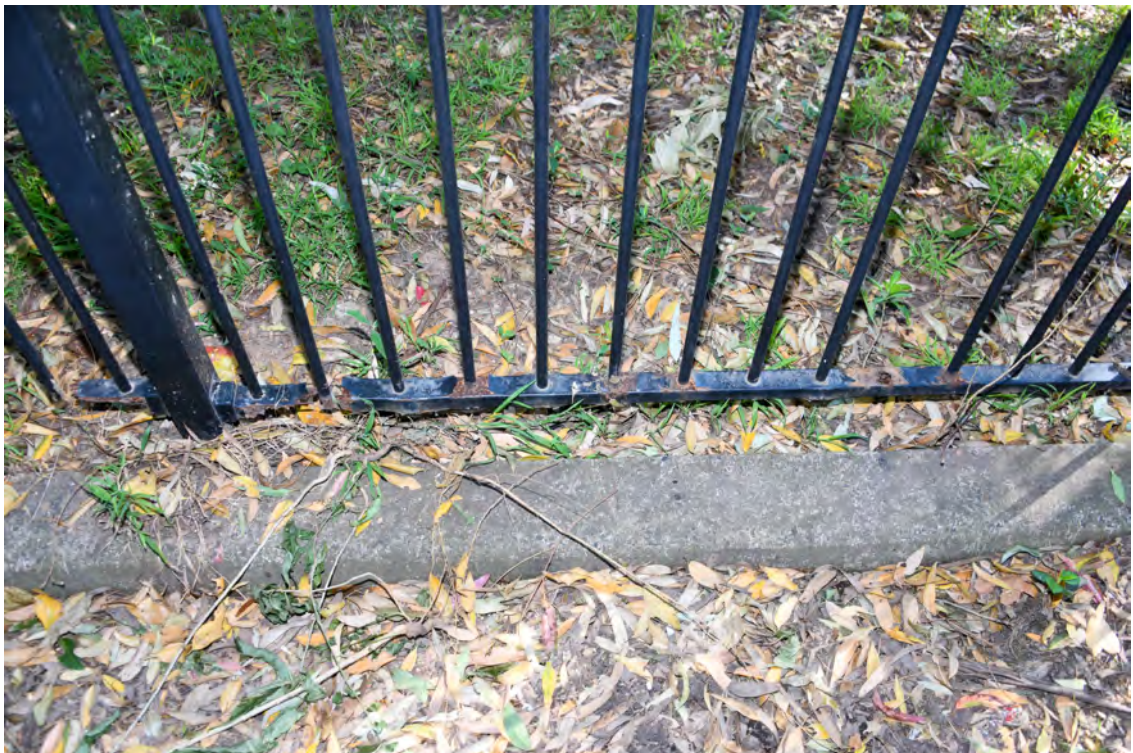
PRO\_1162.jpg

School boundaries. Northern boundary common with the YMCA. Heading west. Rusted and damaged boundary fence.

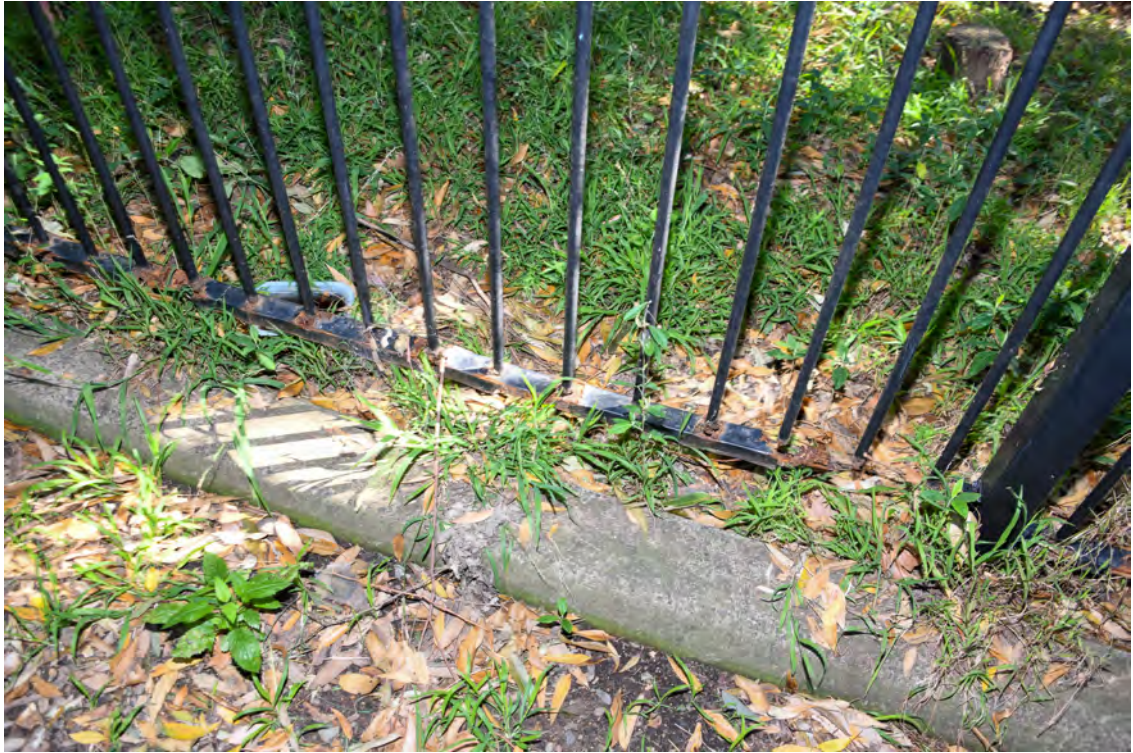
PRO\_1165.jpg

School boundaries. Northern boundary common with the YMCA. Heading west. Rusted and damaged boundary fence.

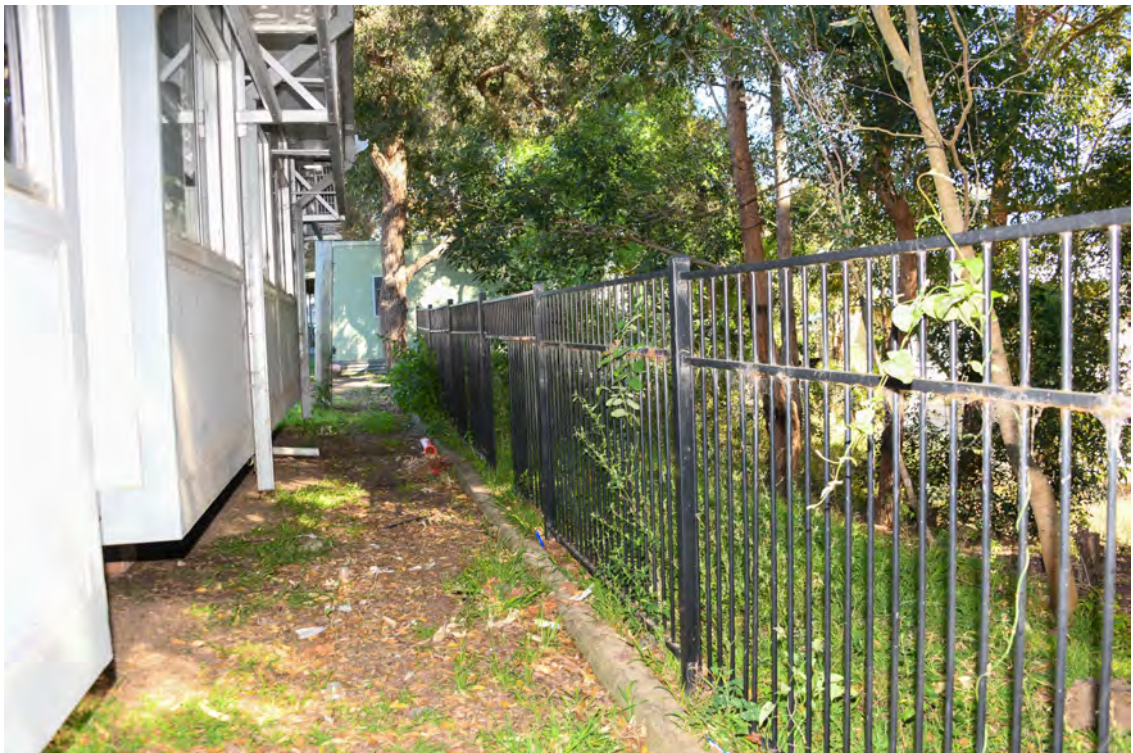
PRO\_1166.jpg

School boundaries. Northern boundary common with the YMCA. Heading west. Rusted and damaged boundary fence.

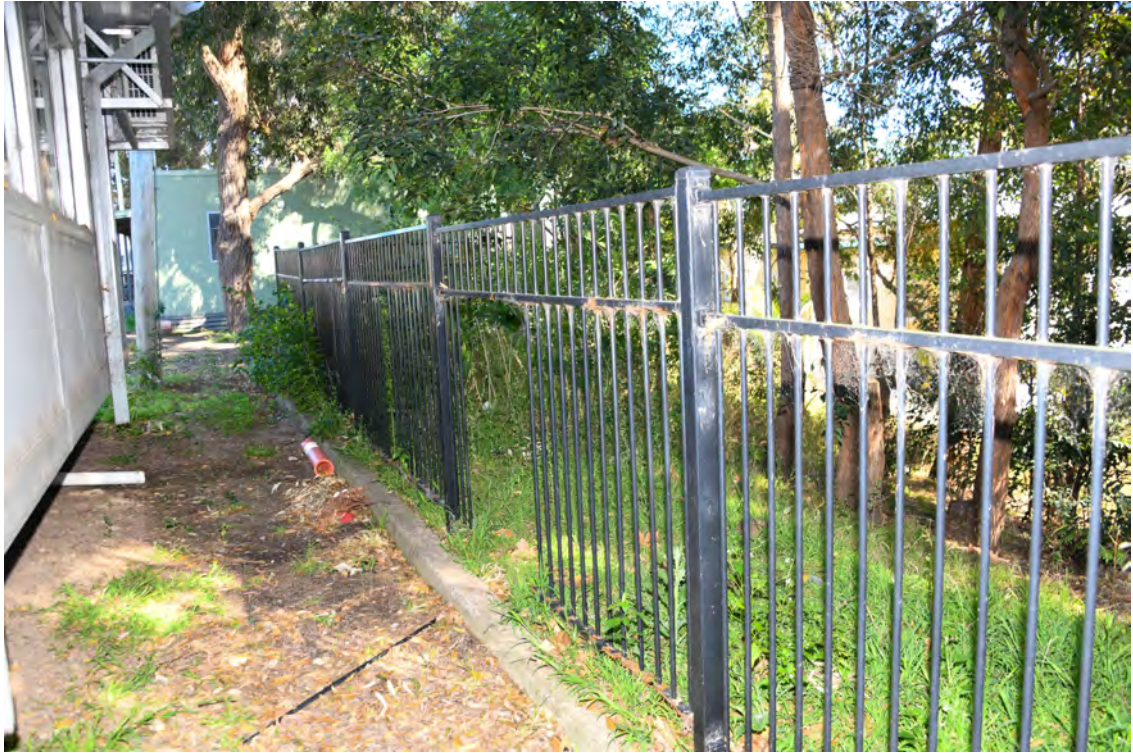
PRO\_1167.jpg

School boundaries. Northern boundary common with the YMCA. Heading west. Rusted and damaged boundary fence.

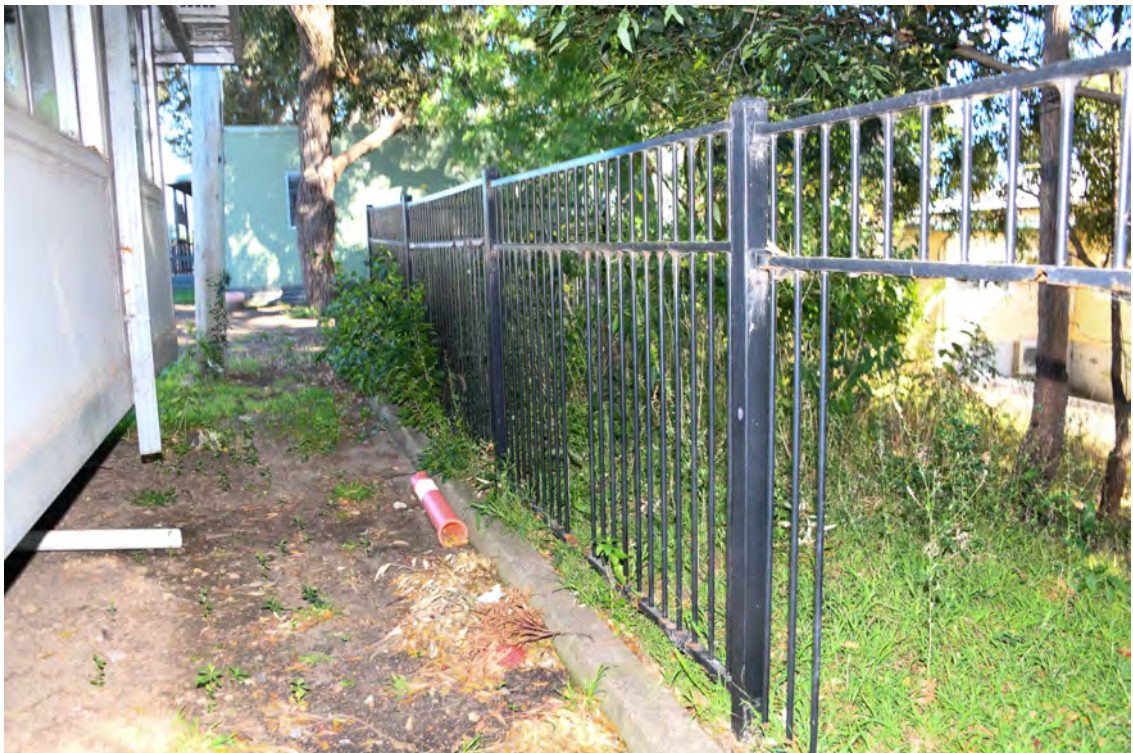
PRO\_1168.jpg

School boundaries. Northern boundary common with the YMCA. Heading west. Rusted and damaged boundary fence.

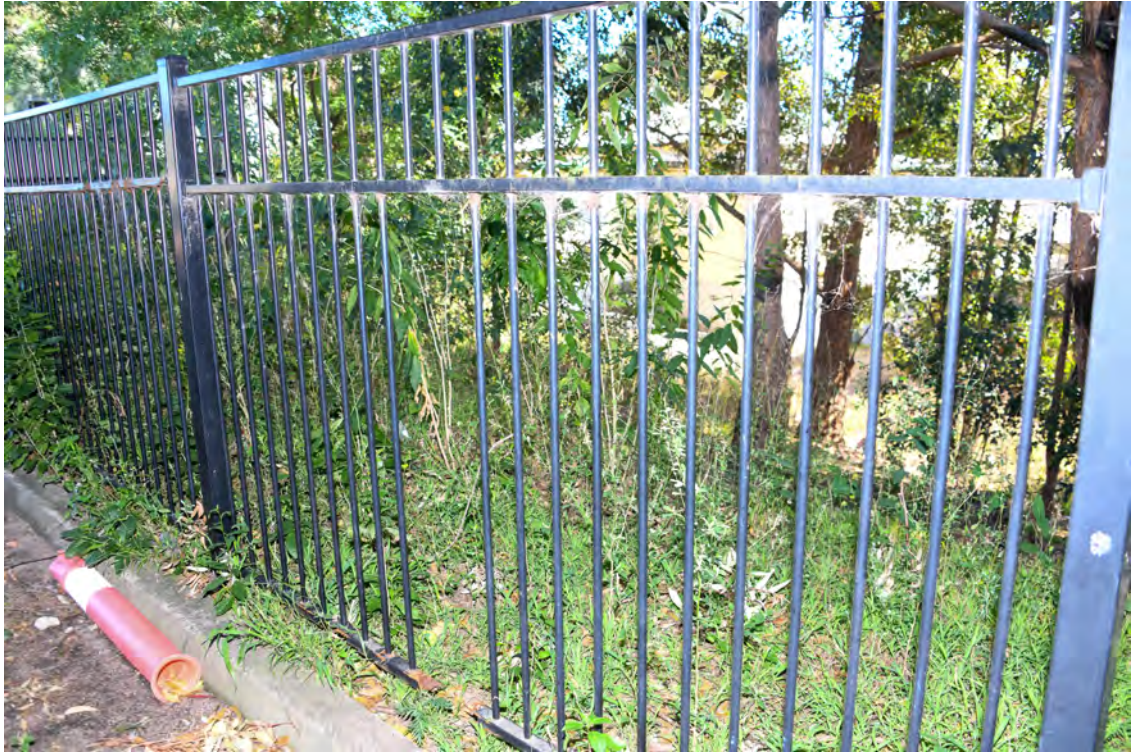
PRO\_1169.jpg

School boundaries. Northern boundary common with the YMCA. Heading west. Rusty and damaged boundary fence.

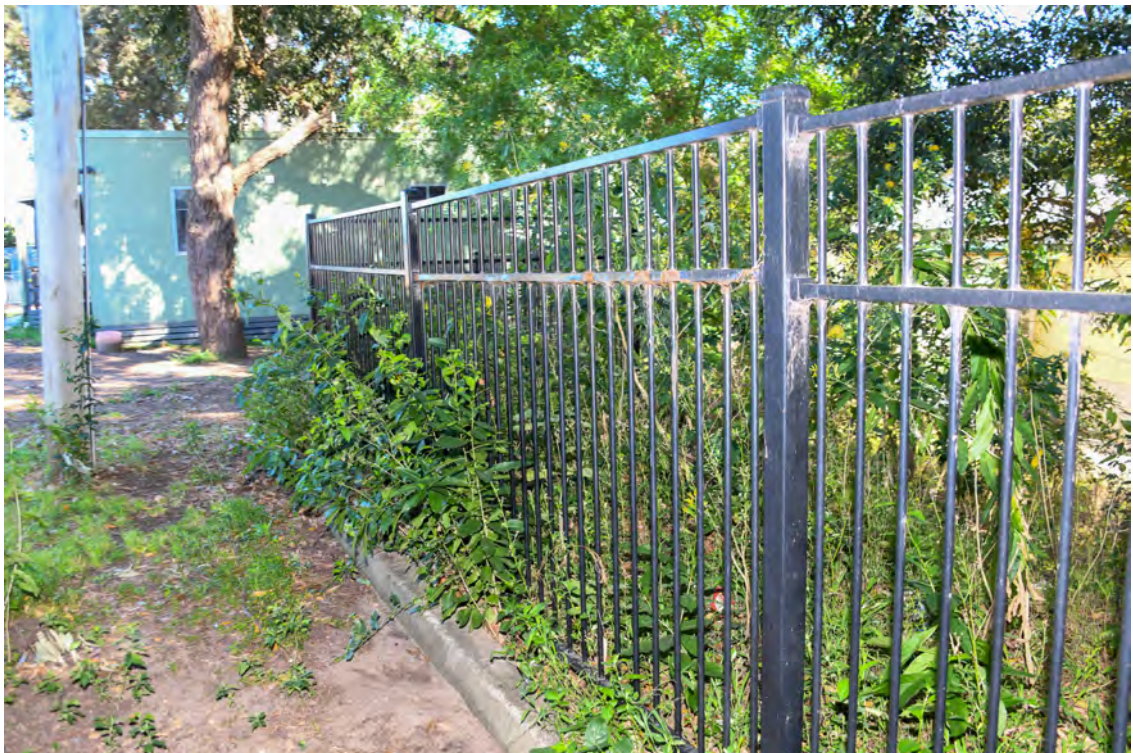
PRO\_1170.jpg

School boundaries. Northern boundary common with the YMCA. Heading west. Rusty and damaged boundary fence.

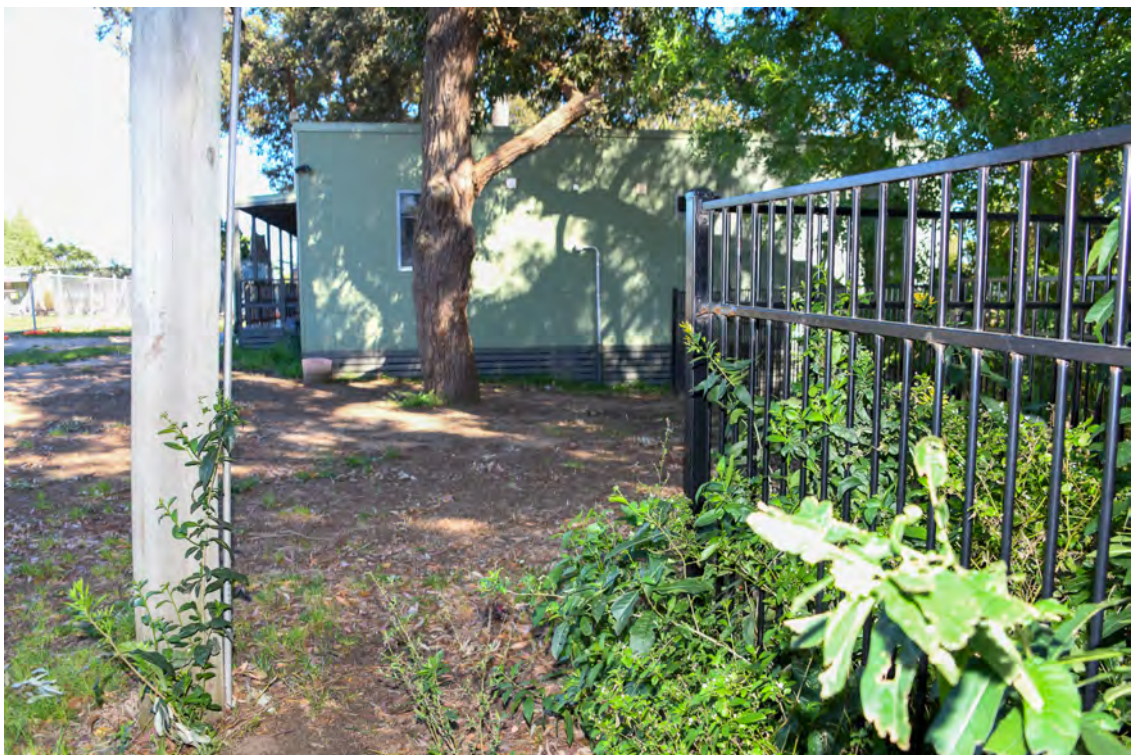
PRO\_1172.jpg

School boundaries. Northern boundary common with the YMCA. Heading west.

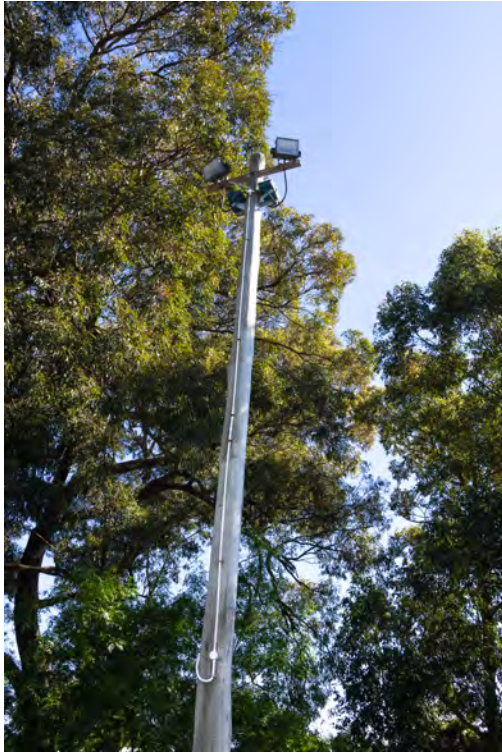
PRO\_1173.jpg

School boundaries. Northern boundary common with the YMCA. Heading west. Light pole.

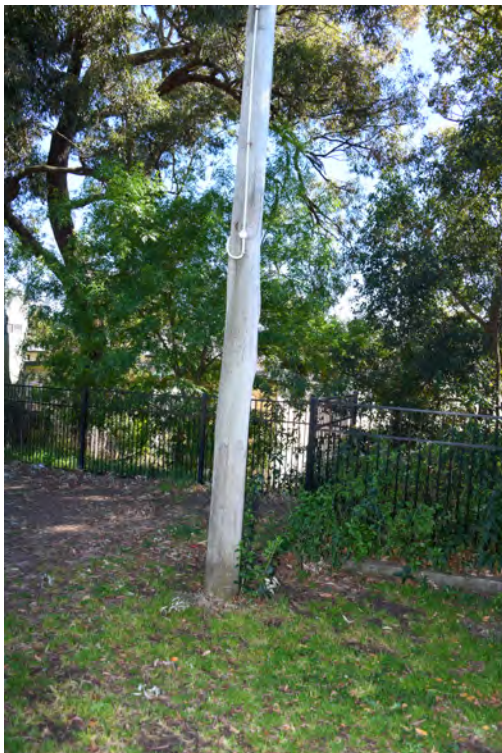
PRO\_1174.jpg

School boundaries. Northern boundary common with the YMCA. Heading west. Light pole.

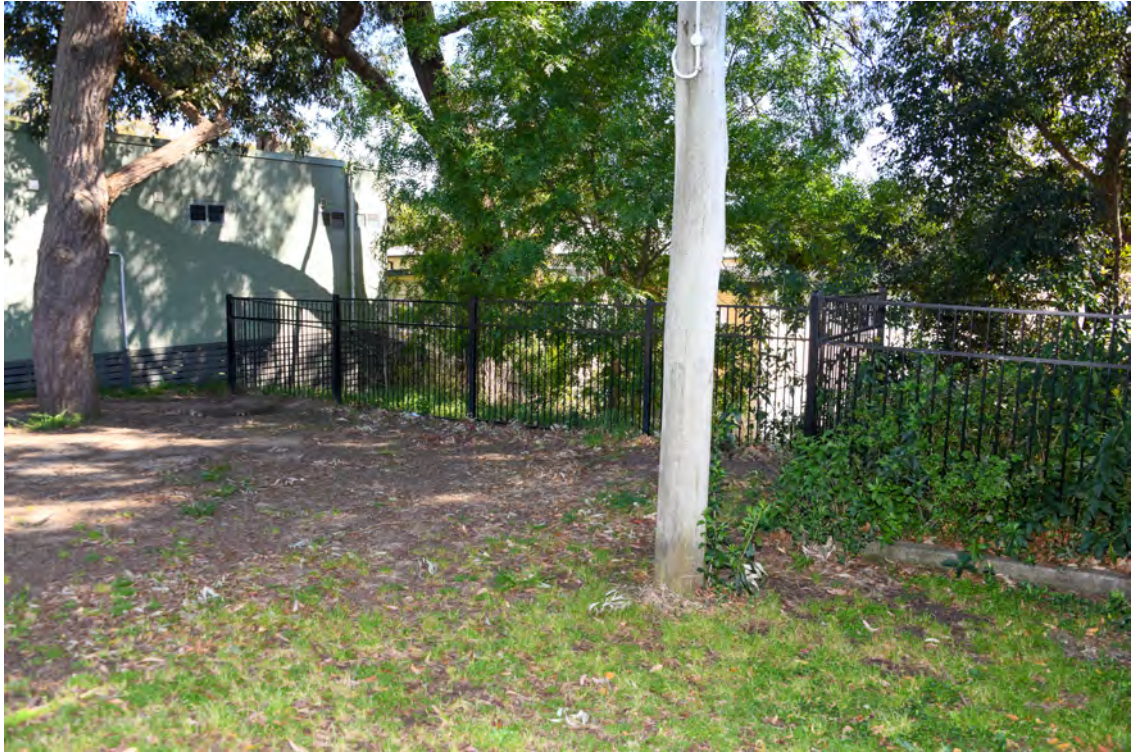
PRO\_1175.jpg

School boundaries. Northern boundary common with the YMCA. Heading west. Light pole.

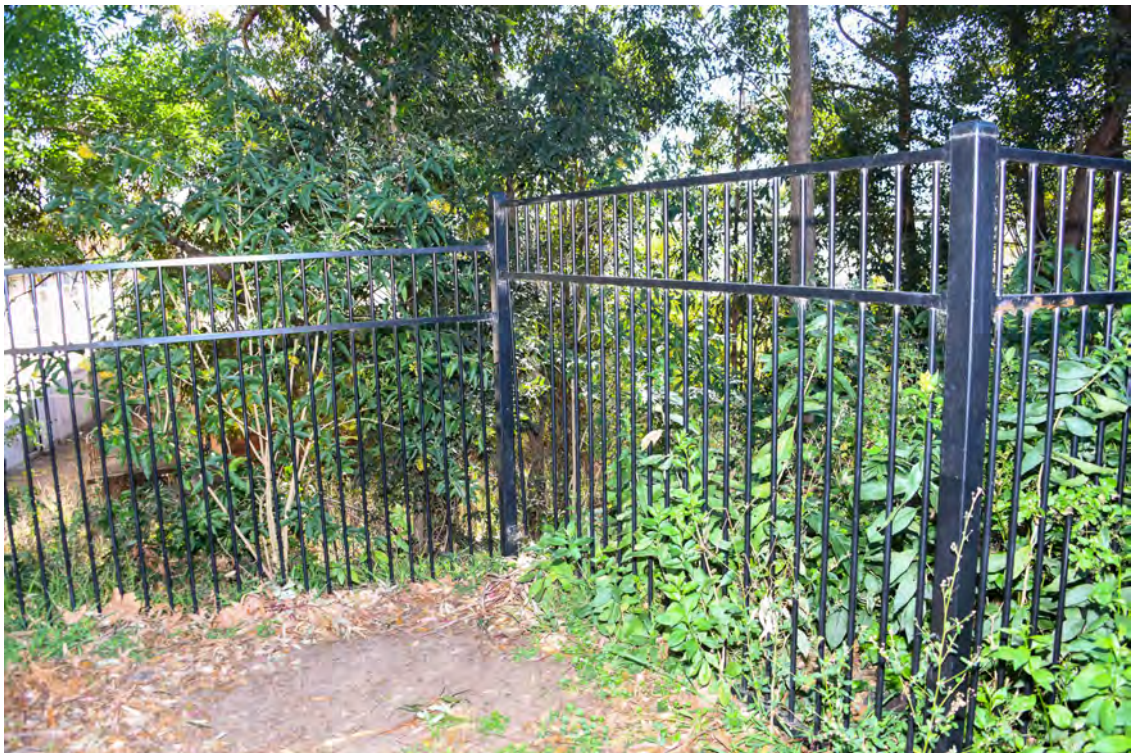
PRO\_1176.jpg

School boundaries. Northern boundary common with the YMCA. Heading west. Fencing.

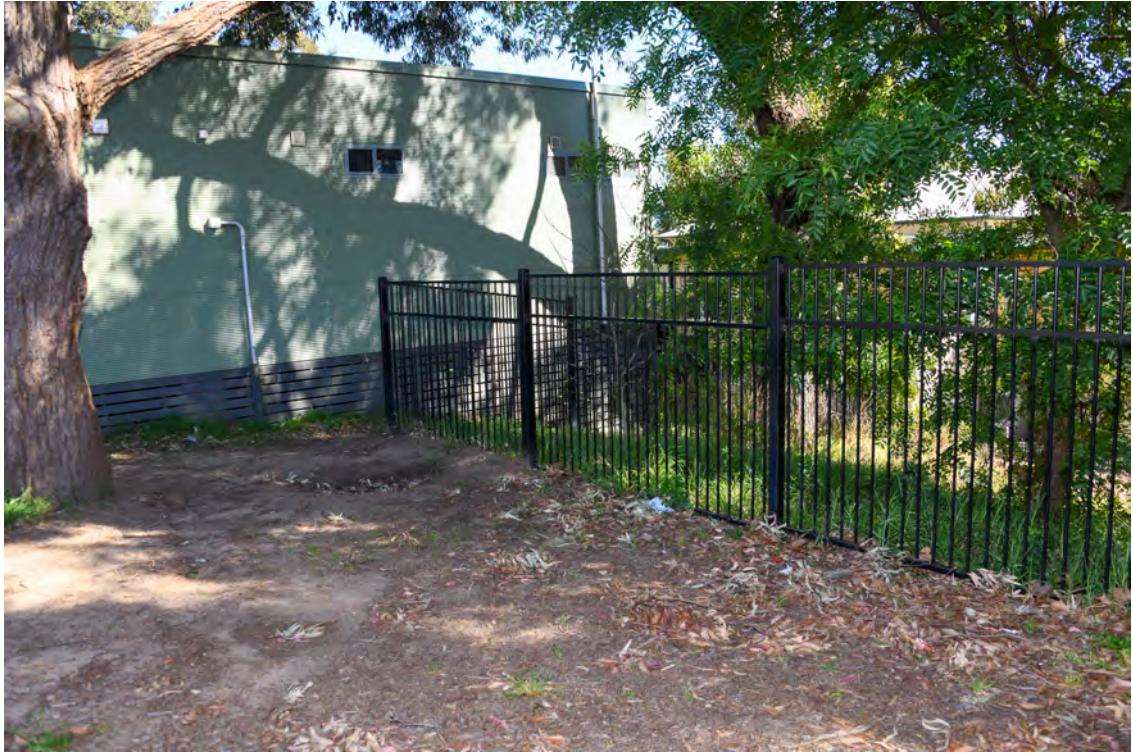
PRO\_1177.jpg

School boundaries. Northern boundary common with the YMCA. Heading west. Fencing.

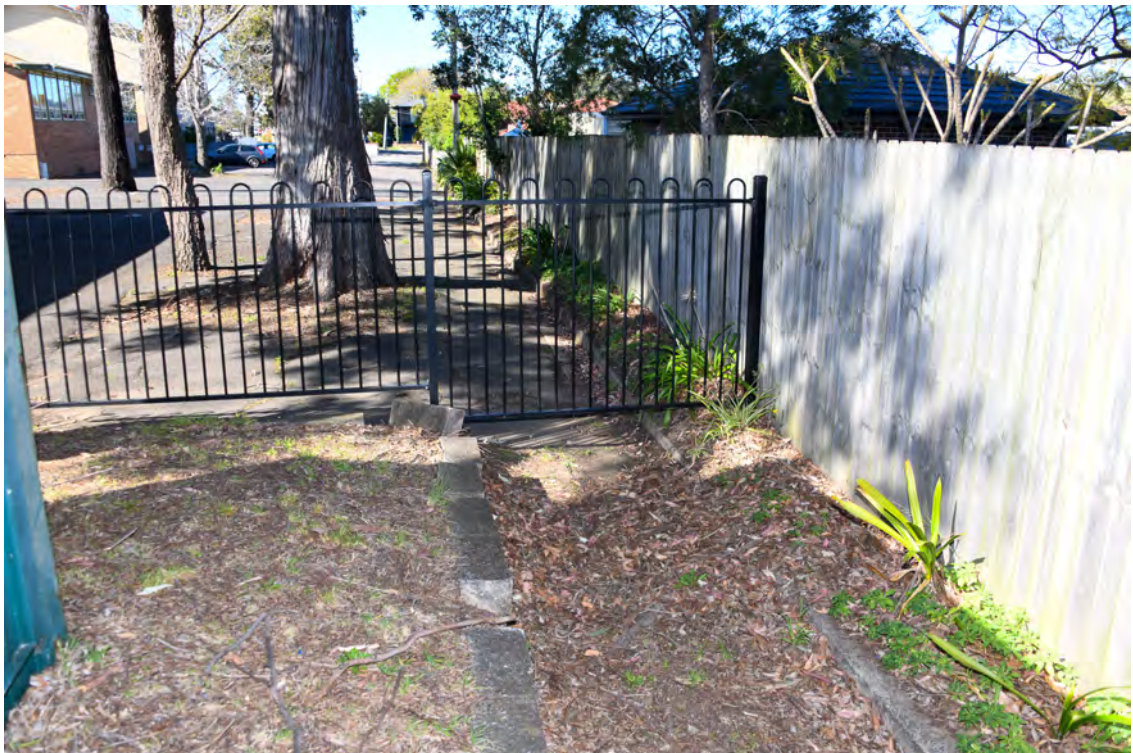
PRO\_1215.jpg

School boundaries. Western boundary. Heading south.

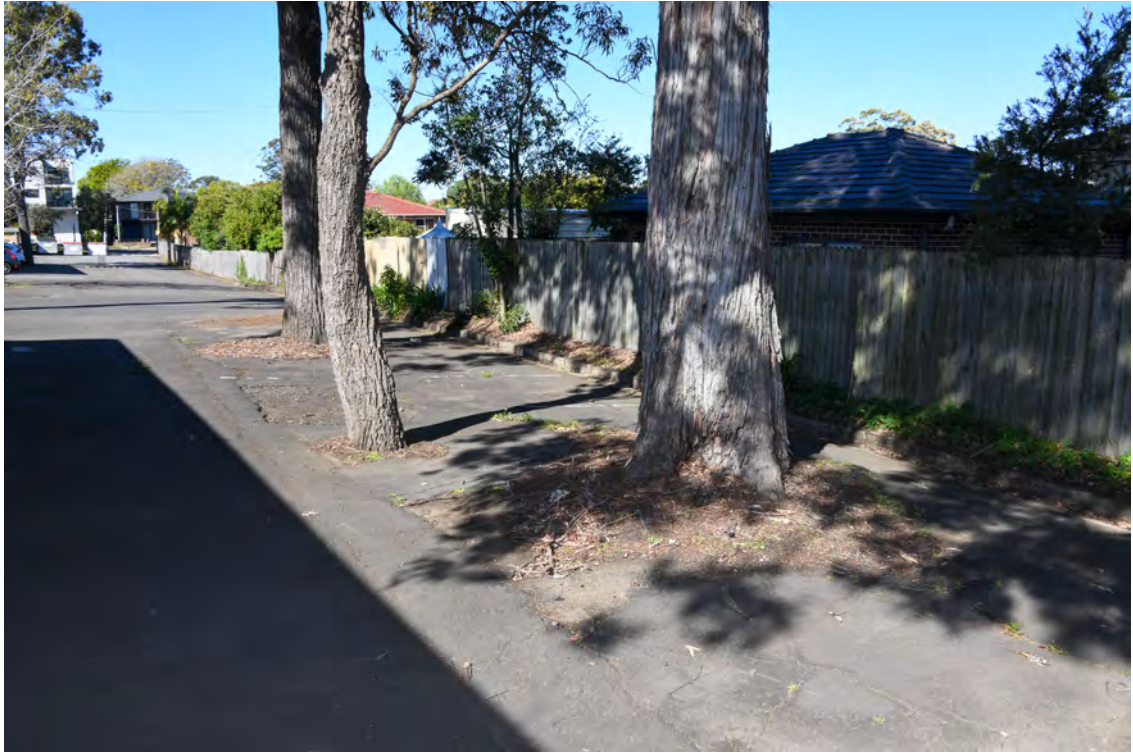
PRO\_1216.jpg

School boundaries. Western boundary. Heading south approaching Carlingford Road.

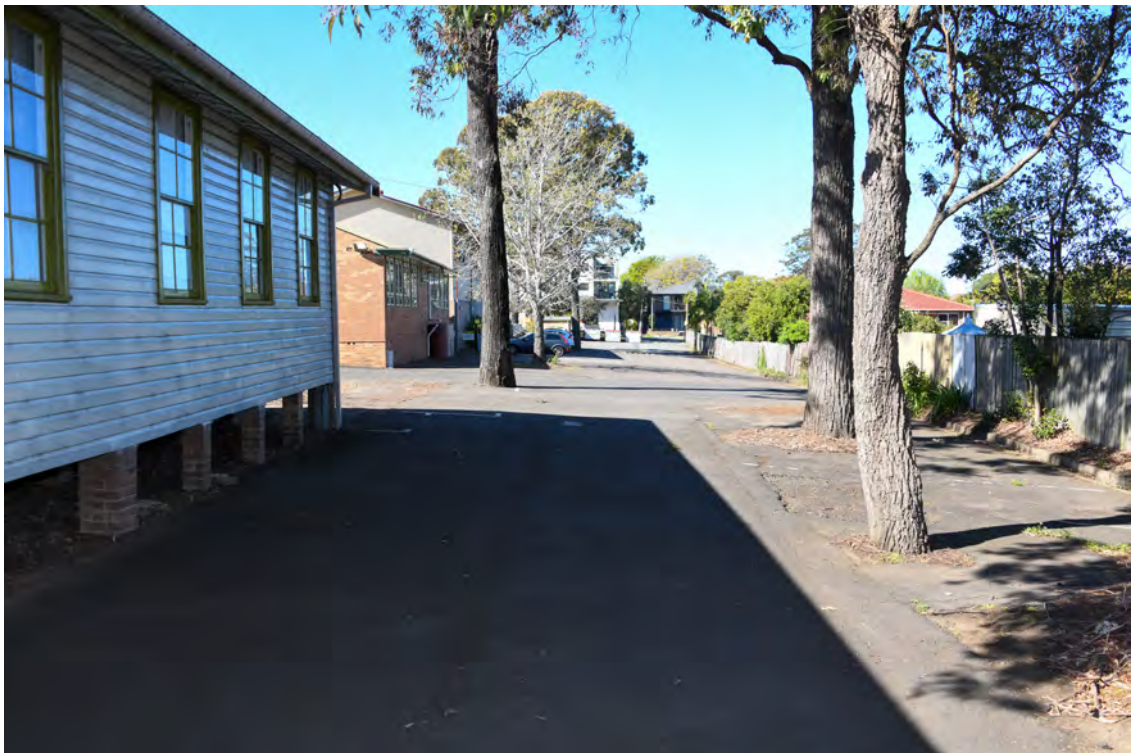
PRO\_1217.jpg

School boundaries. Western boundary. Heading south approaching Carlingford Road.

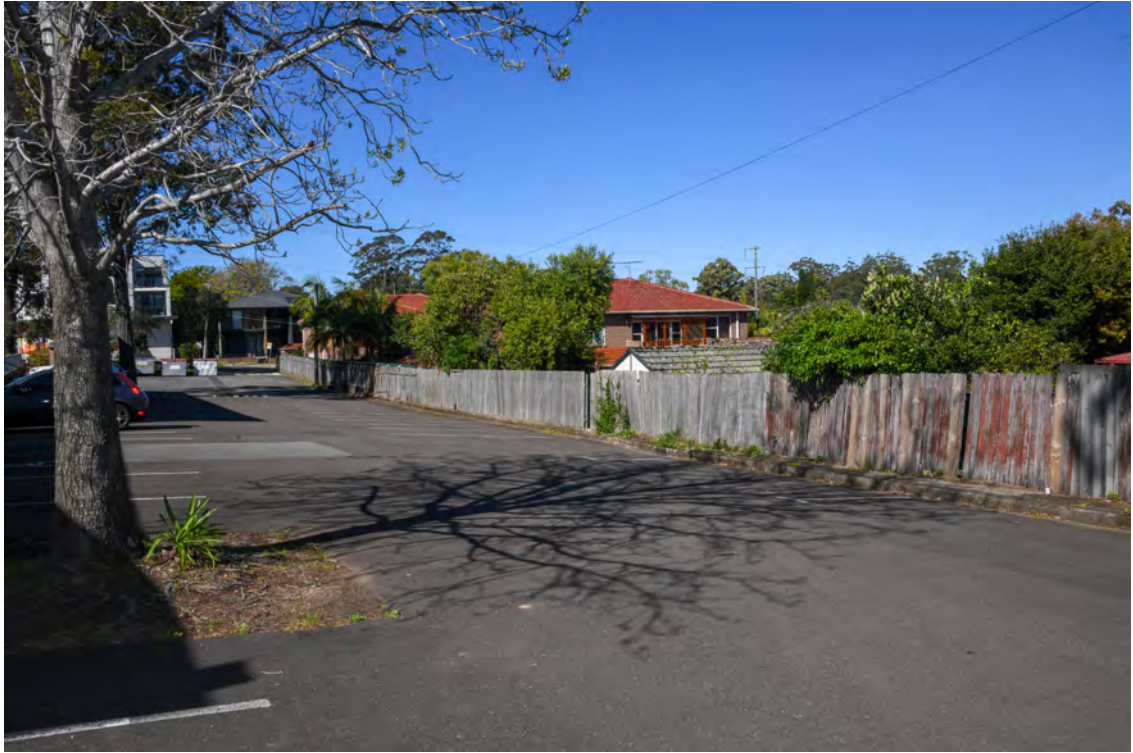
PRO\_1218.jpg

School boundaries. Western boundary. Heading south approaching Carlingford Road.

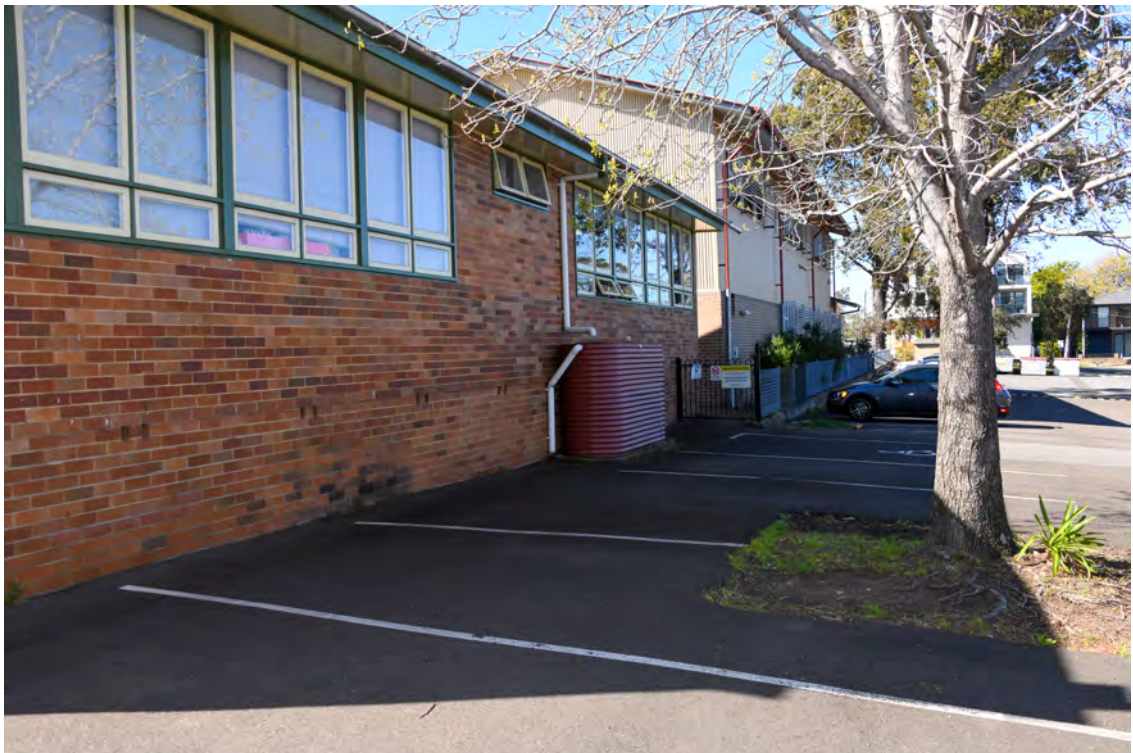
PRO\_1219.jpg

School boundaries. Western boundary. Heading south approaching Carlingford Road.

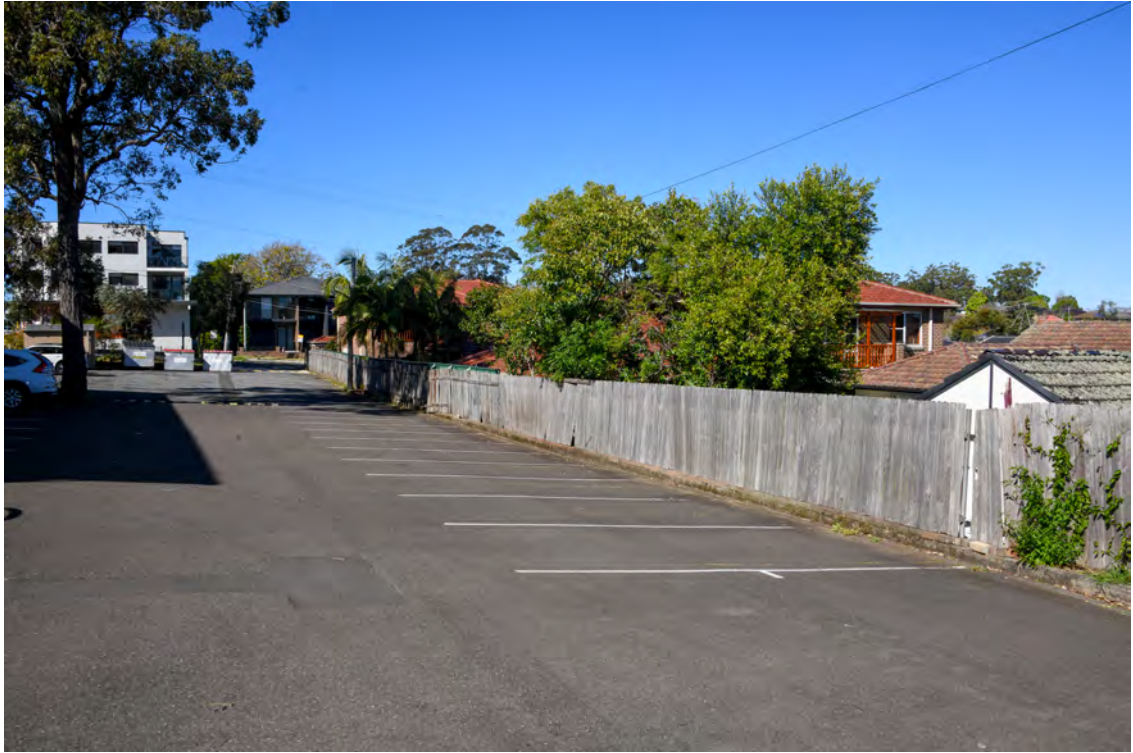
PRO\_1220.jpg

School boundaries. Western boundary. Heading south approaching Carlingford Road.

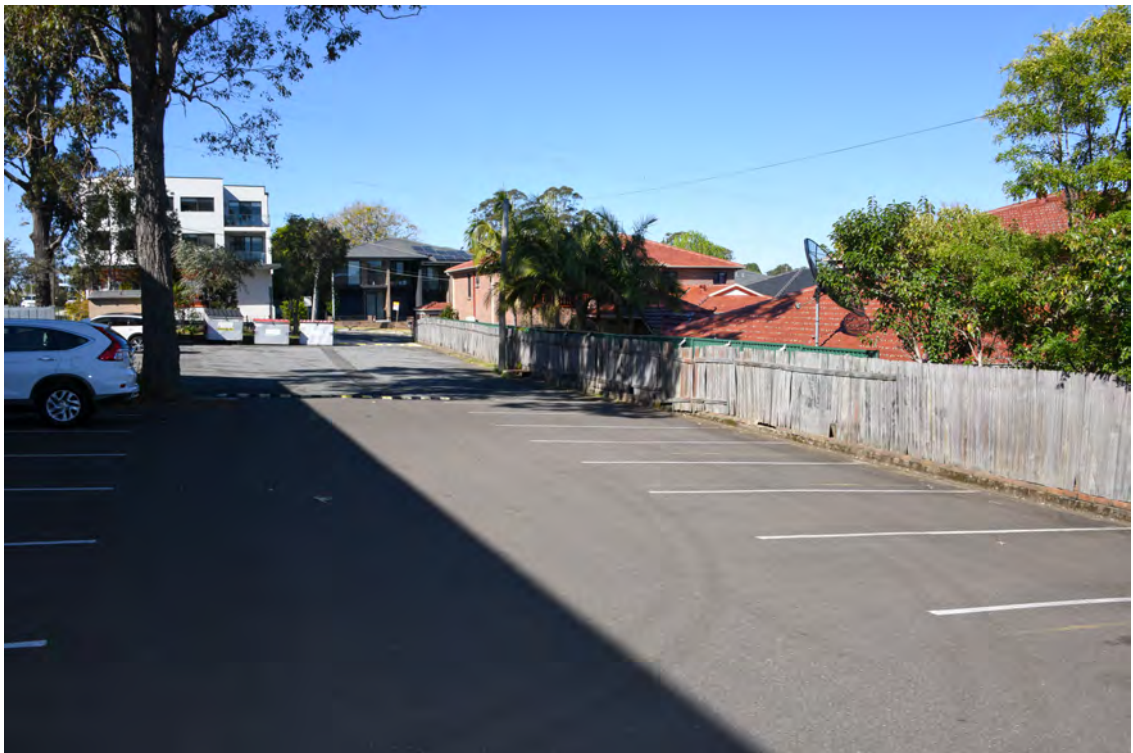
PRO\_1221.jpg

School boundaries. Western boundary. Heading south approaching Carlingford Road.

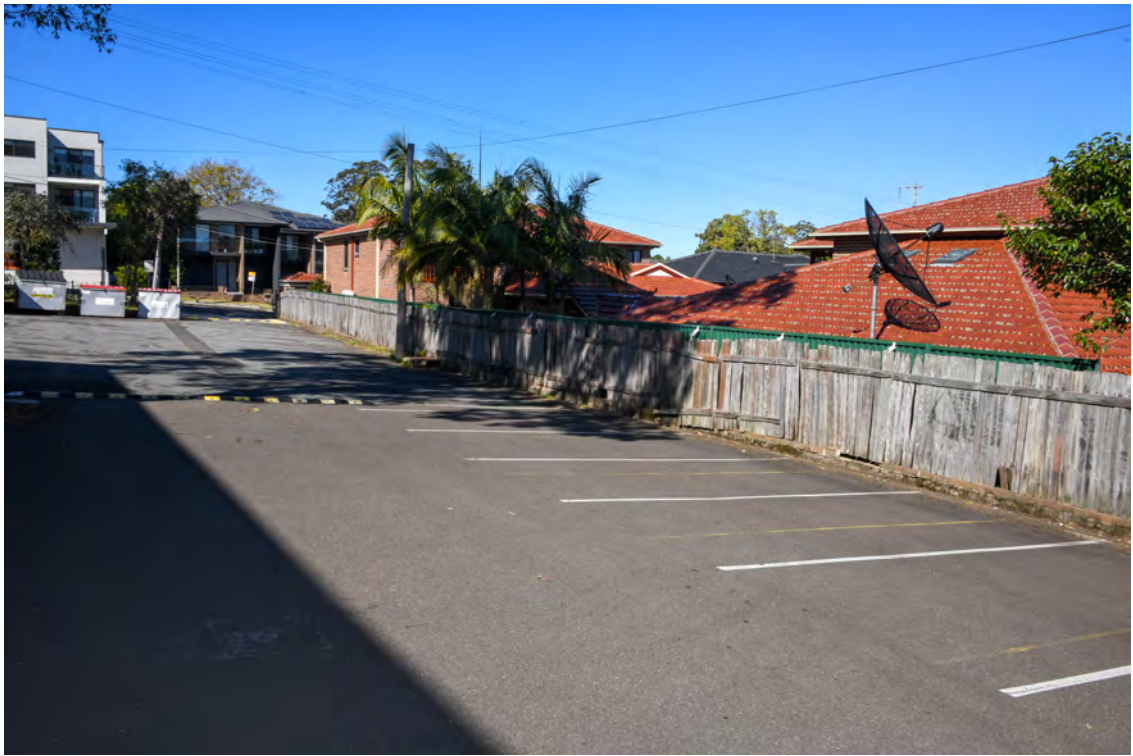
PRO\_1222.jpg

School boundaries. Western boundary. Heading south approaching Carlingford Road.
