96-104 Carlingford Road, Epping NSW 2121

Epping West Public School

DILAPIDATION REPORT

7<sup>th</sup> September 2021

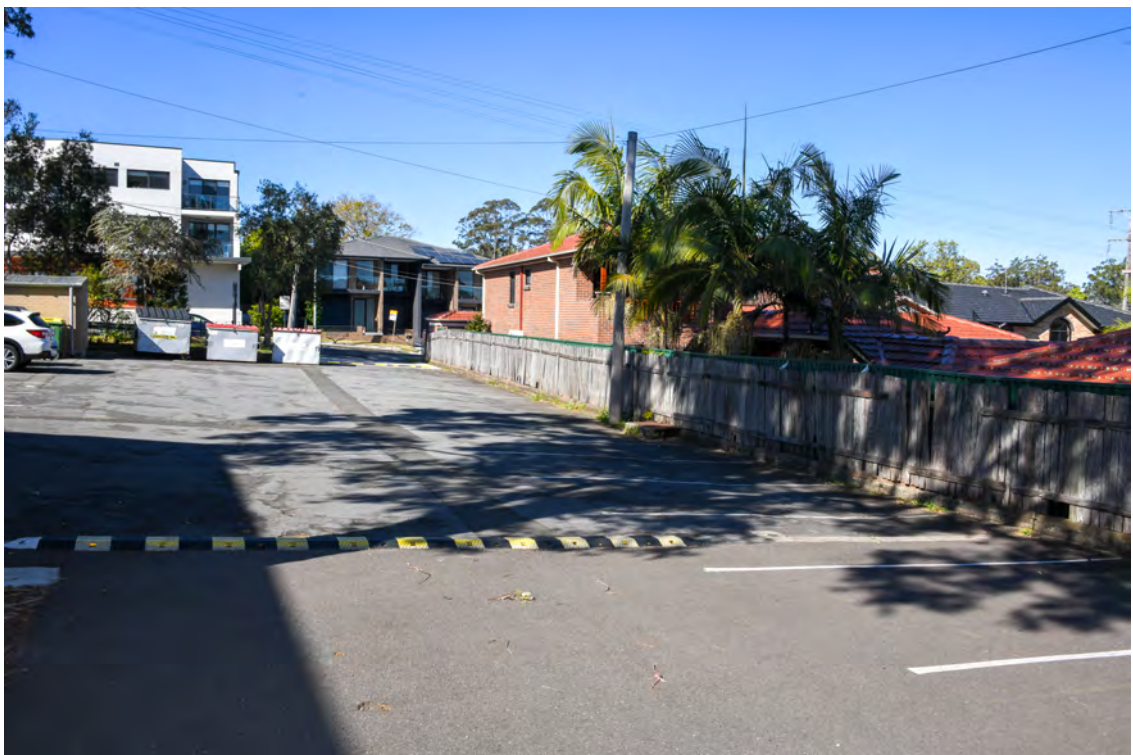
PRO\_1223.jpg

School boundaries. Western boundary. Heading south approaching Carlingford Road.

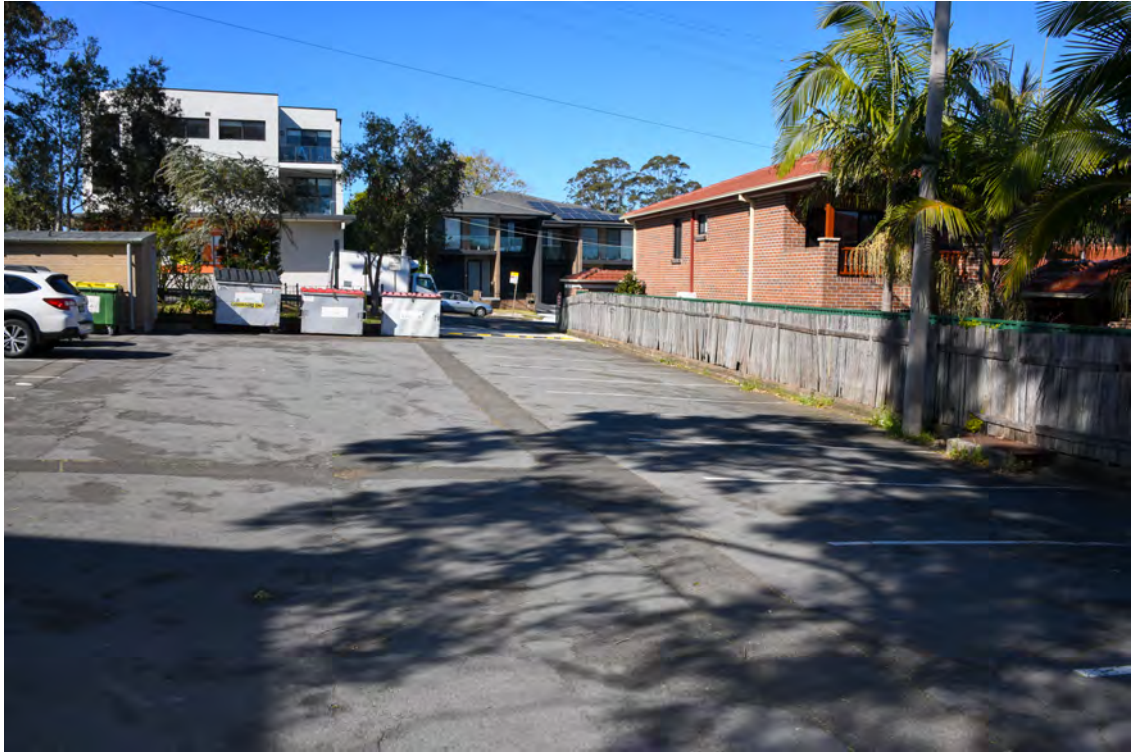
PRO\_1224.jpg

School boundaries. Western boundary. Heading south approaching Carlingford Road.

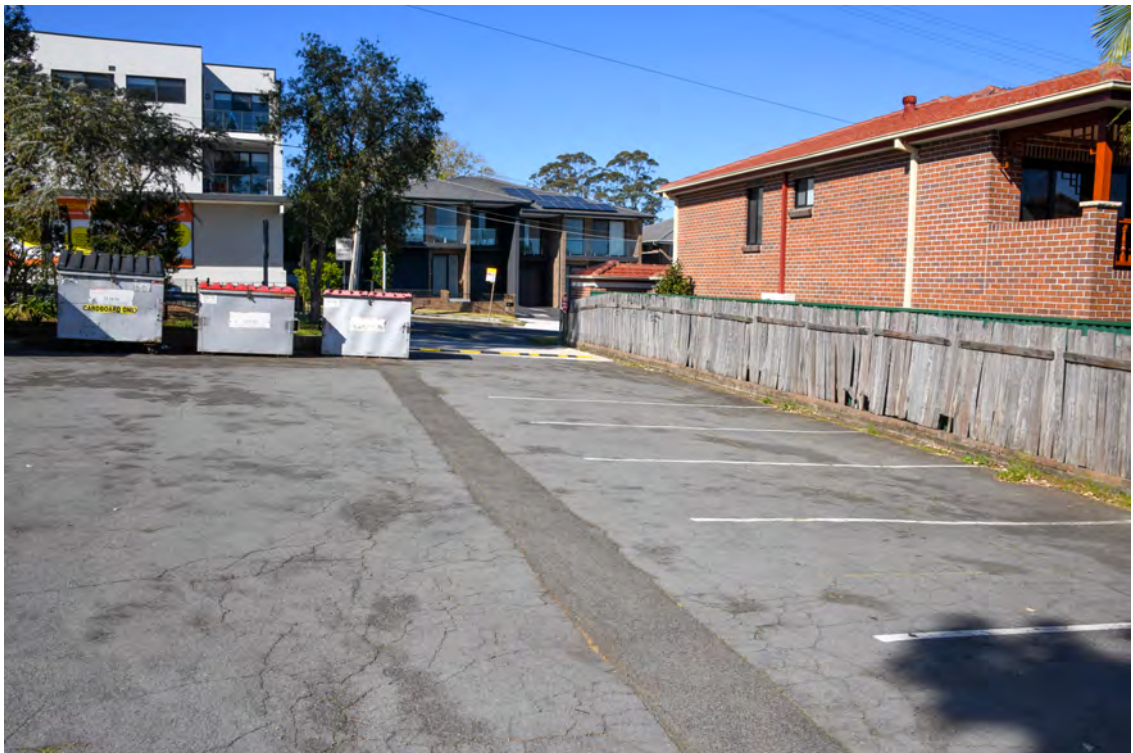
PRO\_1225.jpg

School boundaries. Western boundary. Heading south approaching Carlingford Road.

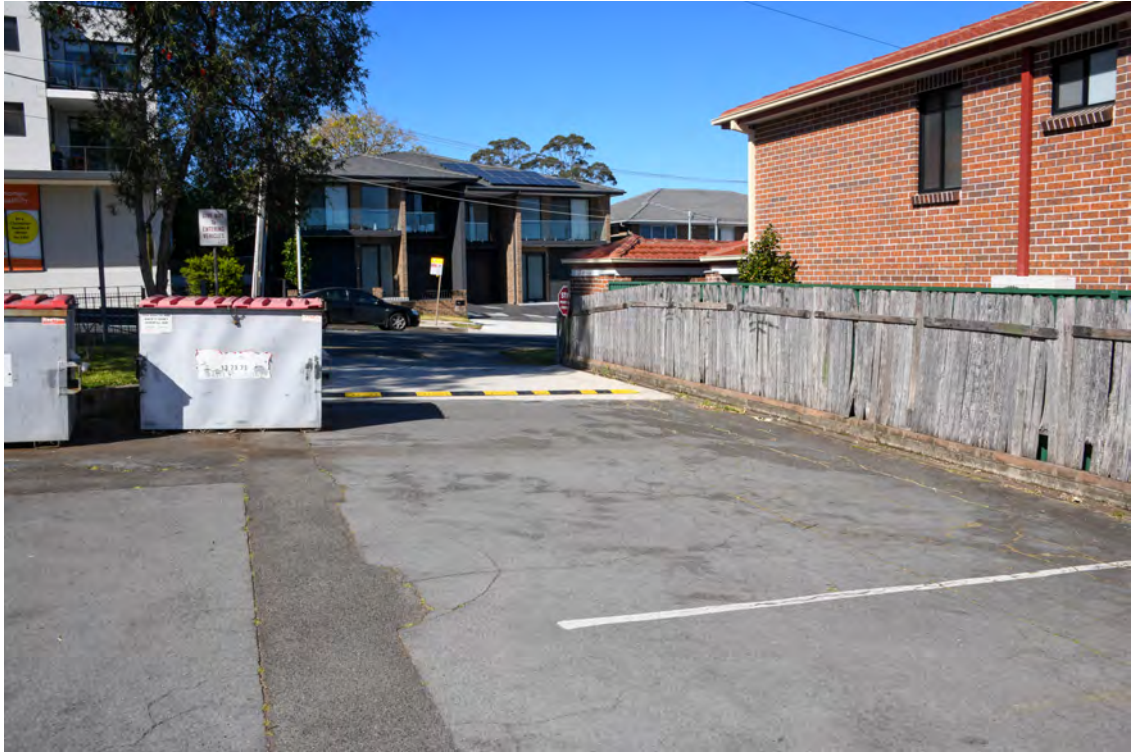
PRO\_1226.jpg

School boundaries. Western boundary. Heading south approaching Carlingford Road.

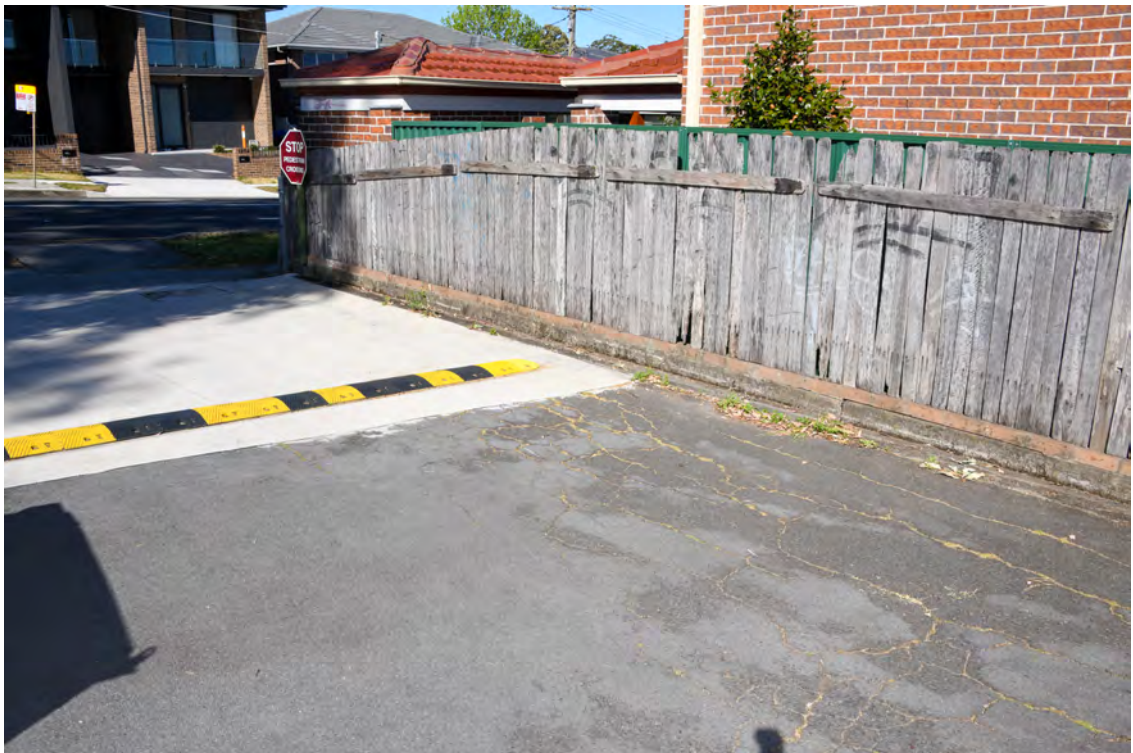
PRO\_1227.jpg

School boundaries. Western boundary. Heading south approaching Carlingford Road.

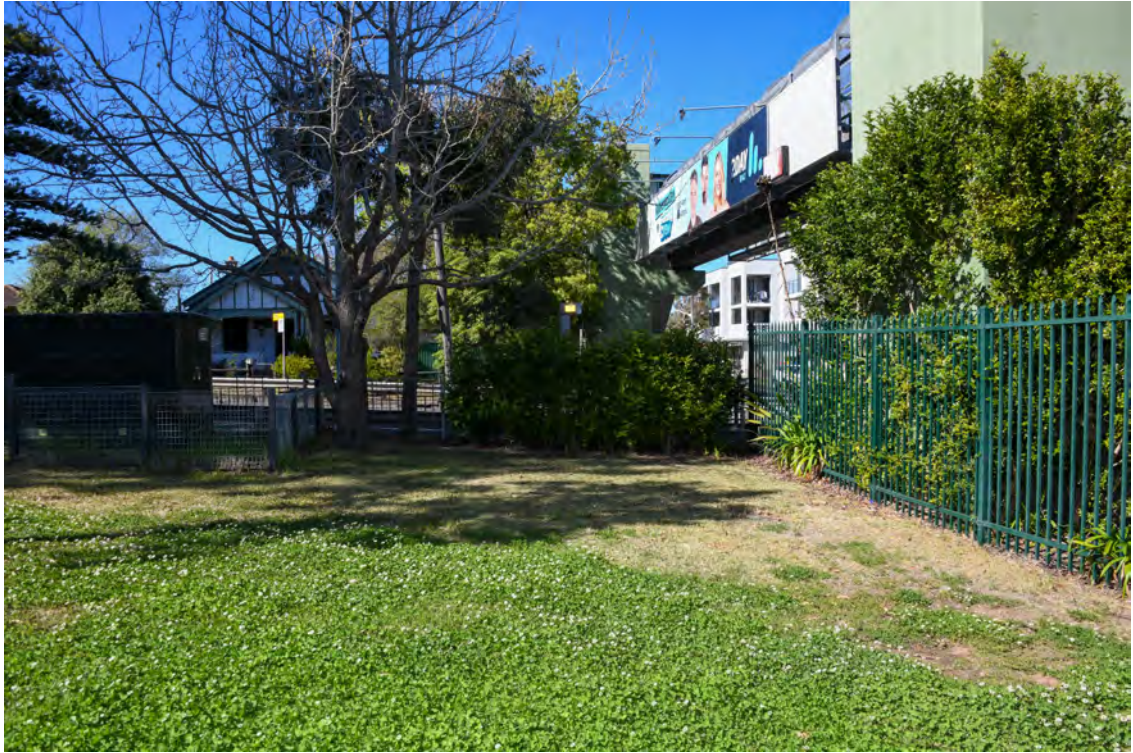
PRO\_1229.jpg

School boundaries. Southern boundary. Western end. Facing south towards Carlingford Road.

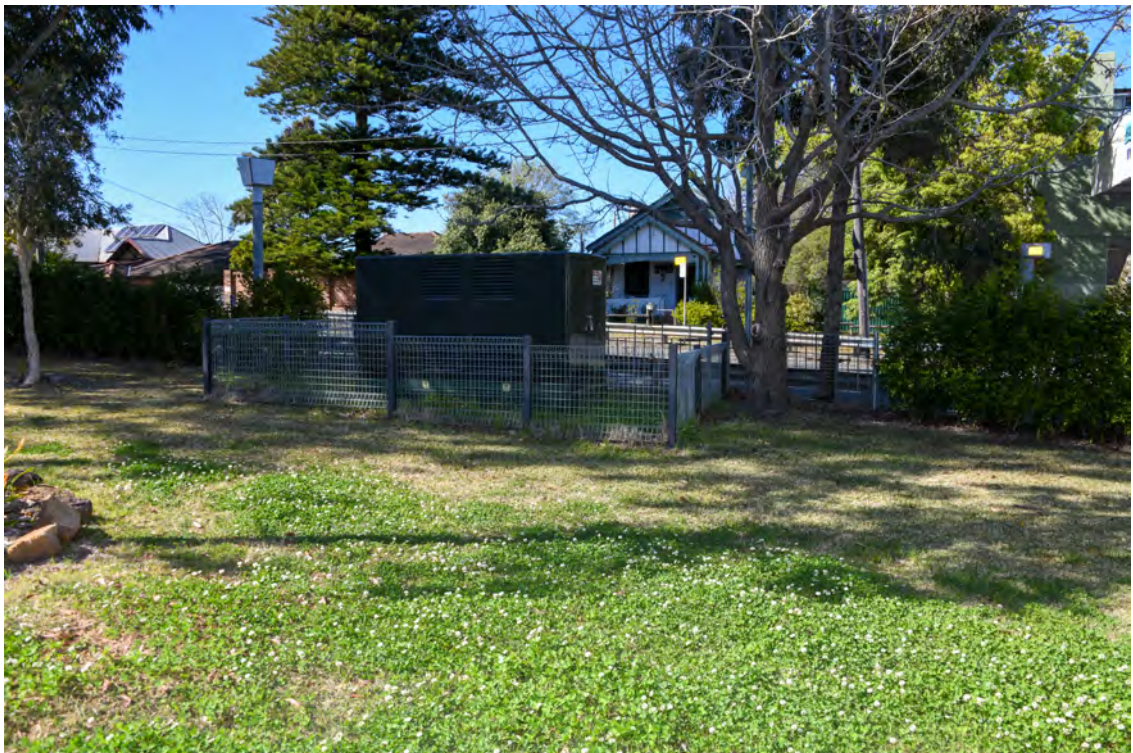
PRO\_1231.jpg

School boundaries. Southern boundary. Western end. Facing south towards Carlingford Road.

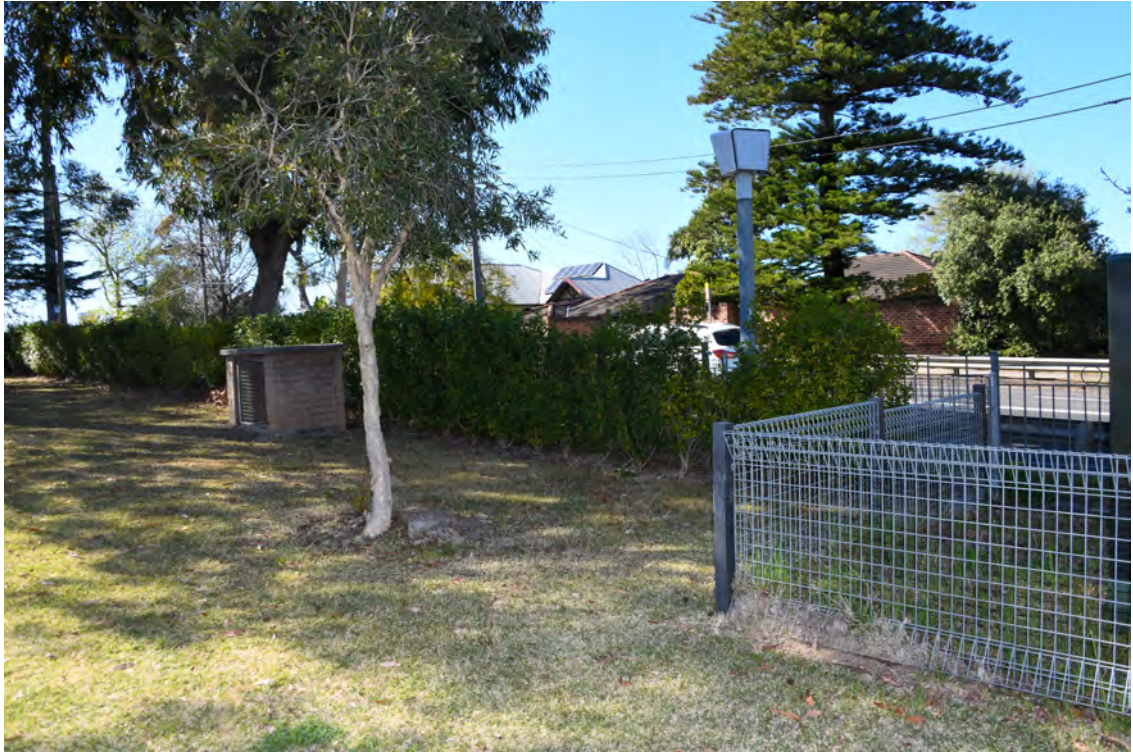
PRO\_1232.jpg

School boundaries. Southern boundary fronting Carlingford Road. Western end. Heading east.

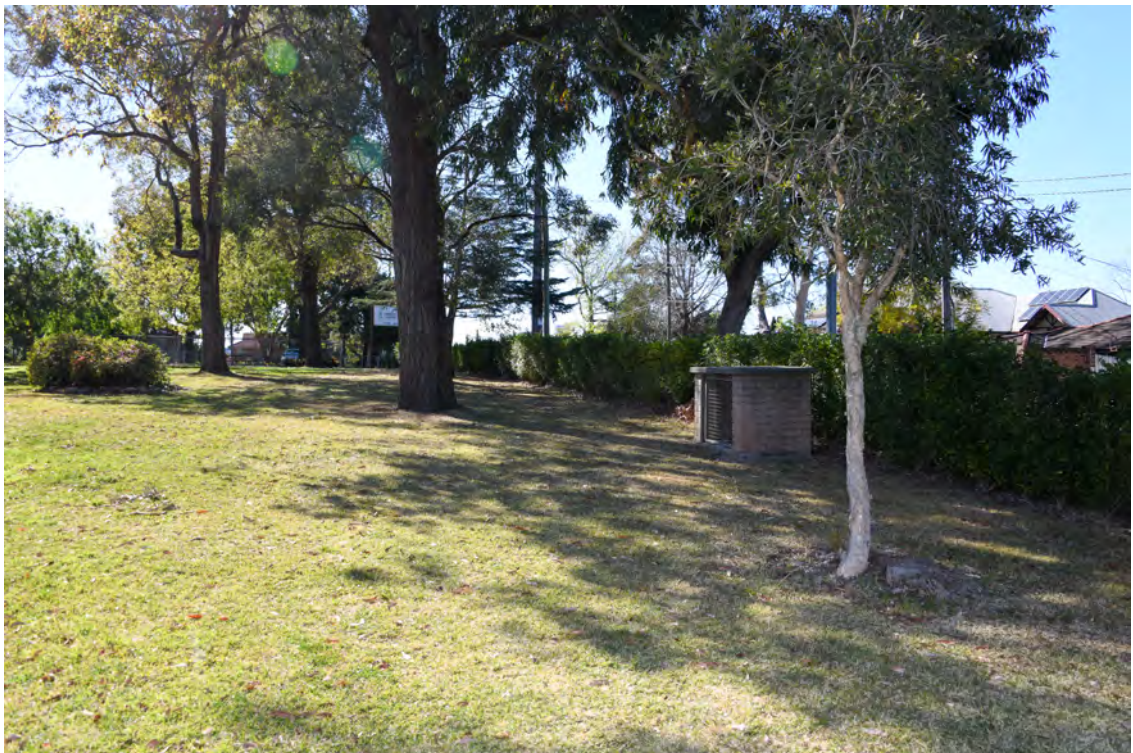
PRO\_1233.jpg

School boundaries. Southern boundary fronting Carlingford Road. Western end. Heading east.

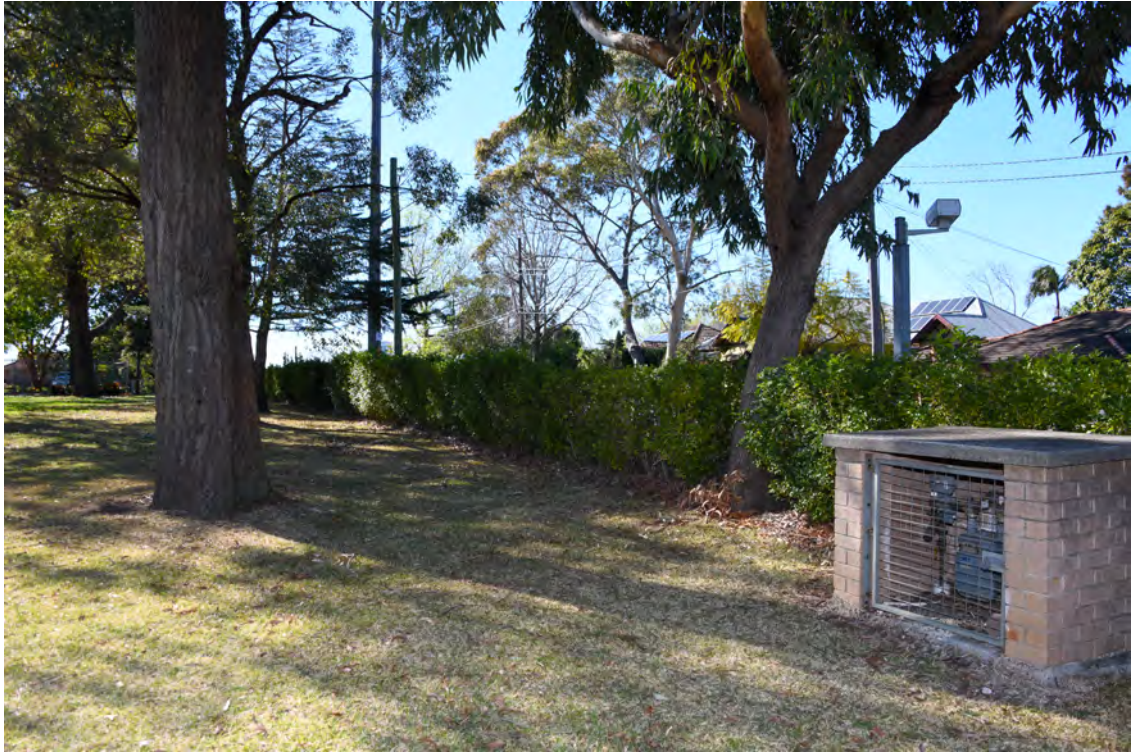
PRO\_1234.jpg

School boundaries. Southern boundary fronting Carlingford Road. Western end. Heading east.

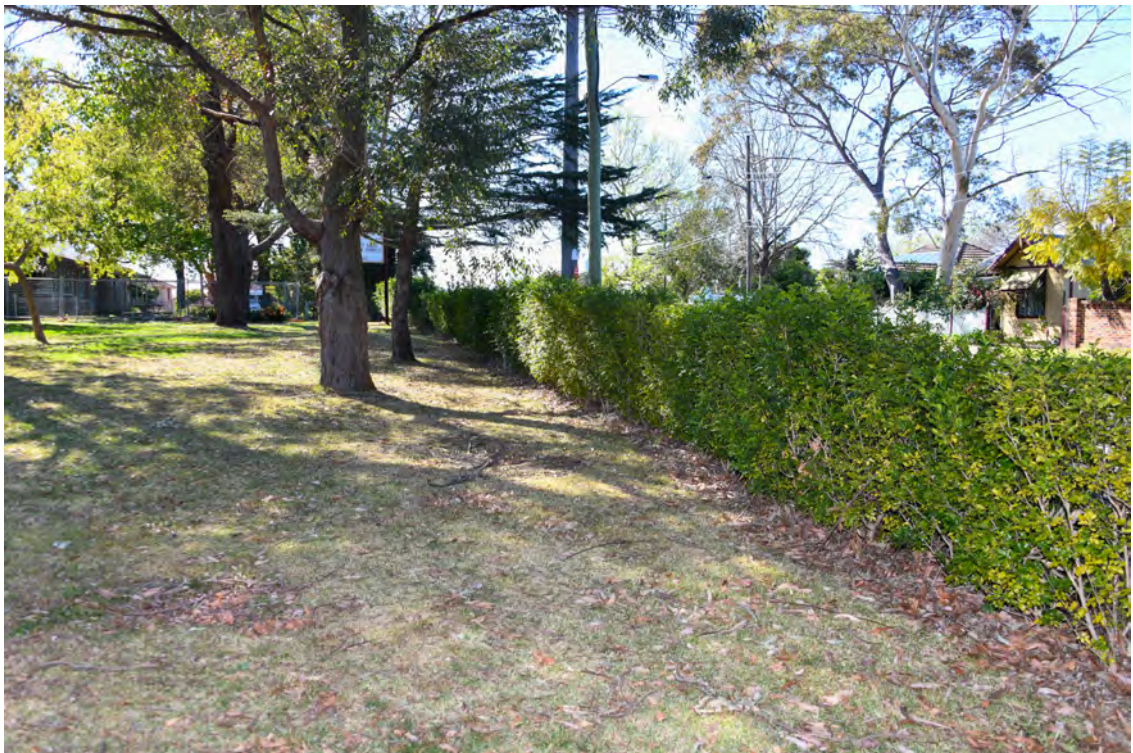
PRO\_1235.jpg

School boundaries. Southern boundary fronting Carlingford Road. Western end. Heading east.

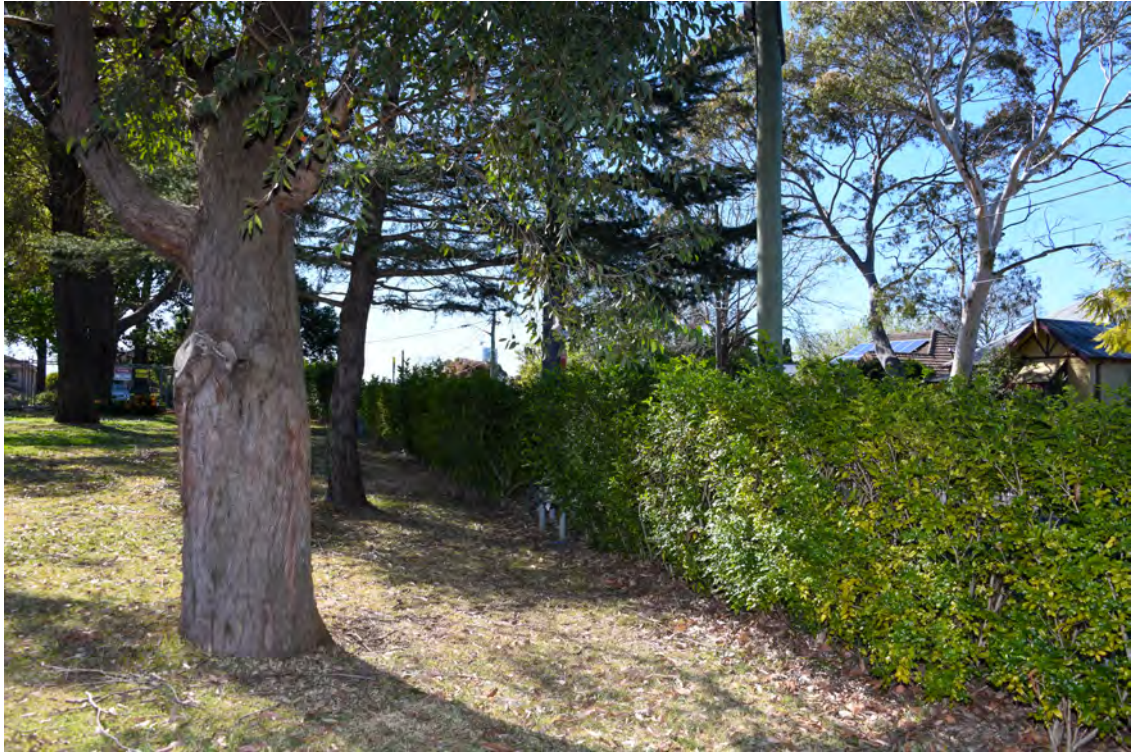
PRO\_1236.jpg

School boundaries. Southern boundary fronting Carlingford Road. Western end. Heading east.

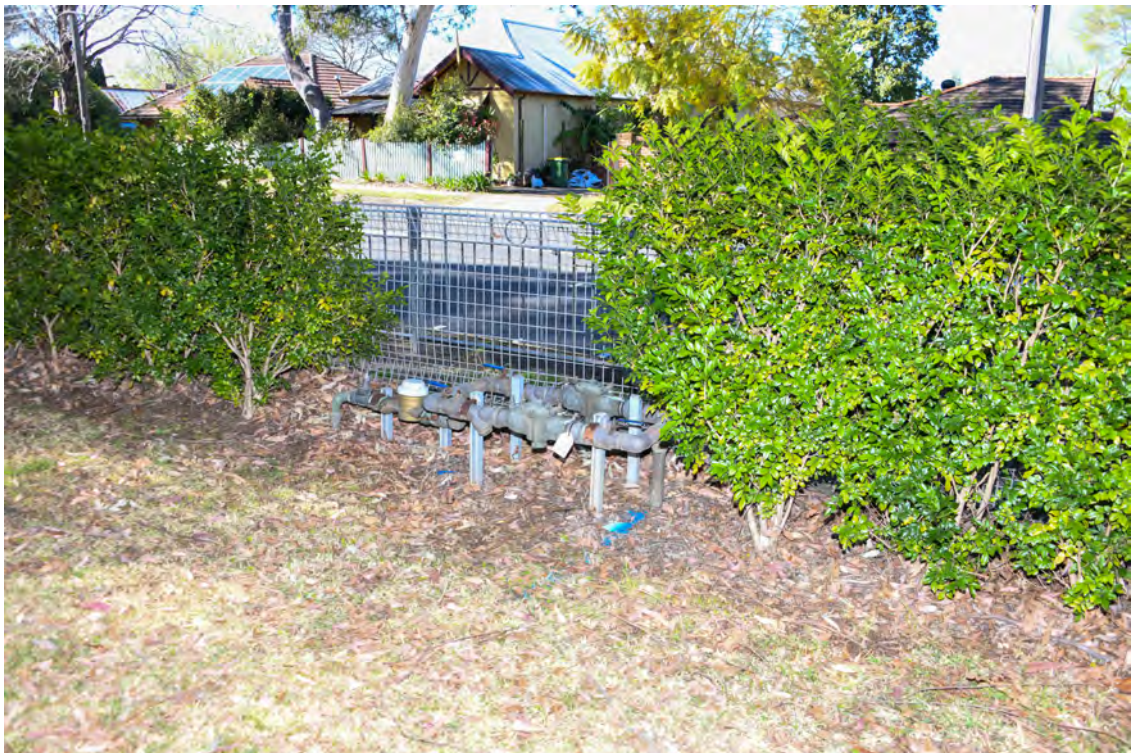
PRO\_1237.jpg

School boundaries. Southern boundary fronting Carlingford Road. Western end. Heading east.

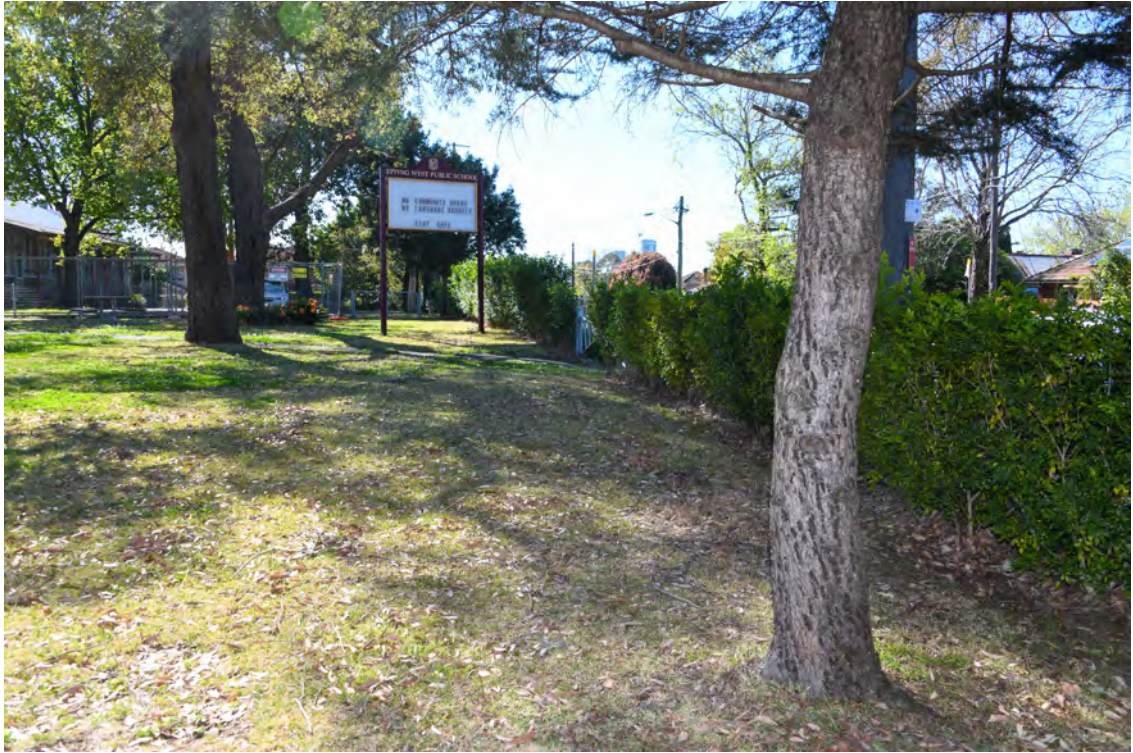
PRO\_1238.jpg

School boundaries. Southern boundary fronting Carlingford Road. Western end. Heading east.

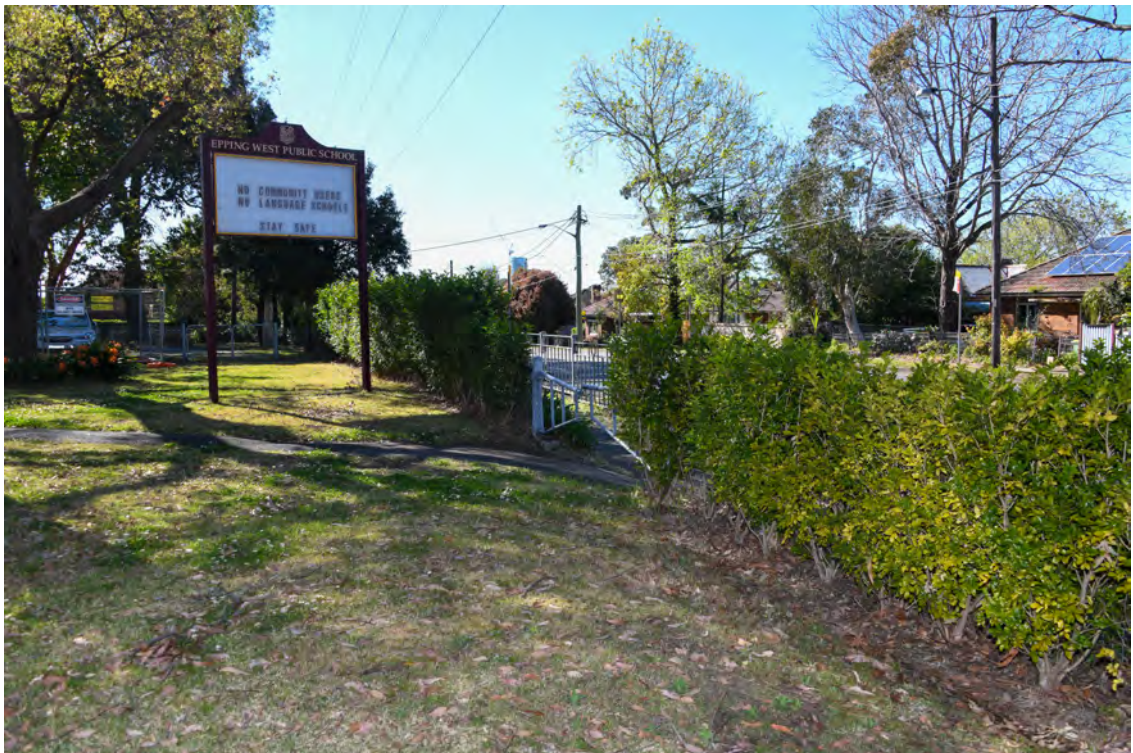
PRO\_1239.jpg

School boundaries. Southern boundary fronting Carlingford Road. Western end. Heading east.

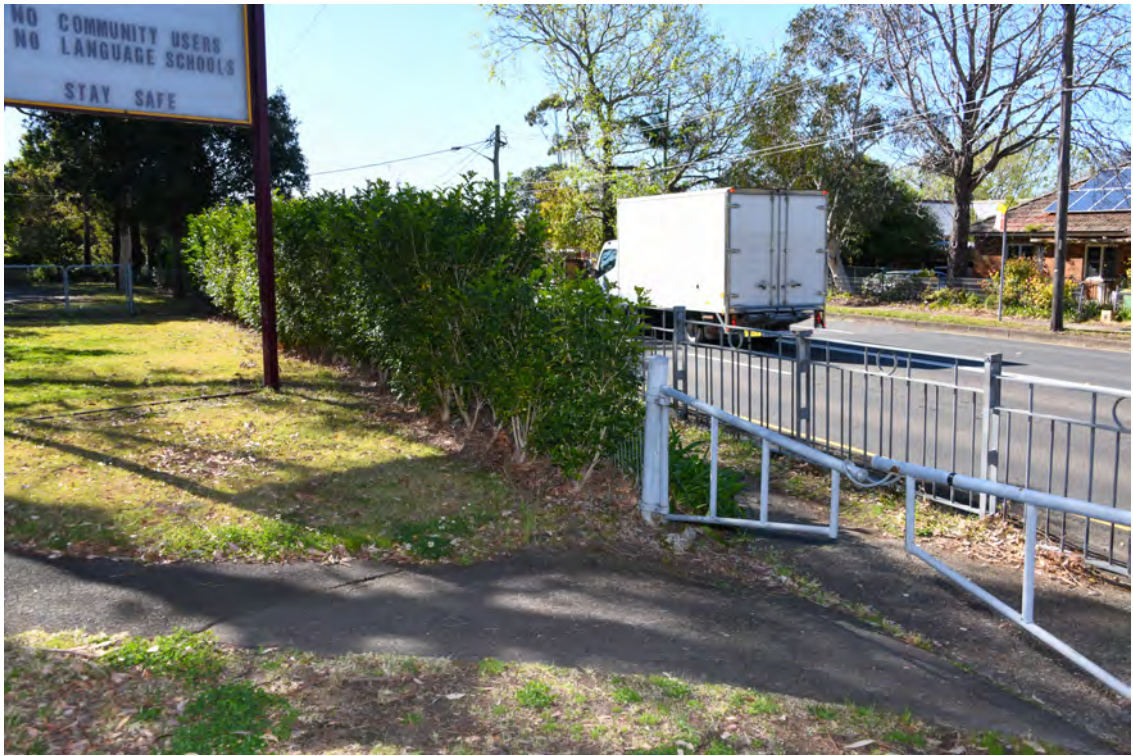
PRO\_1240.jpg

School boundaries. Southern boundary fronting Carlingford Road. Heading east.

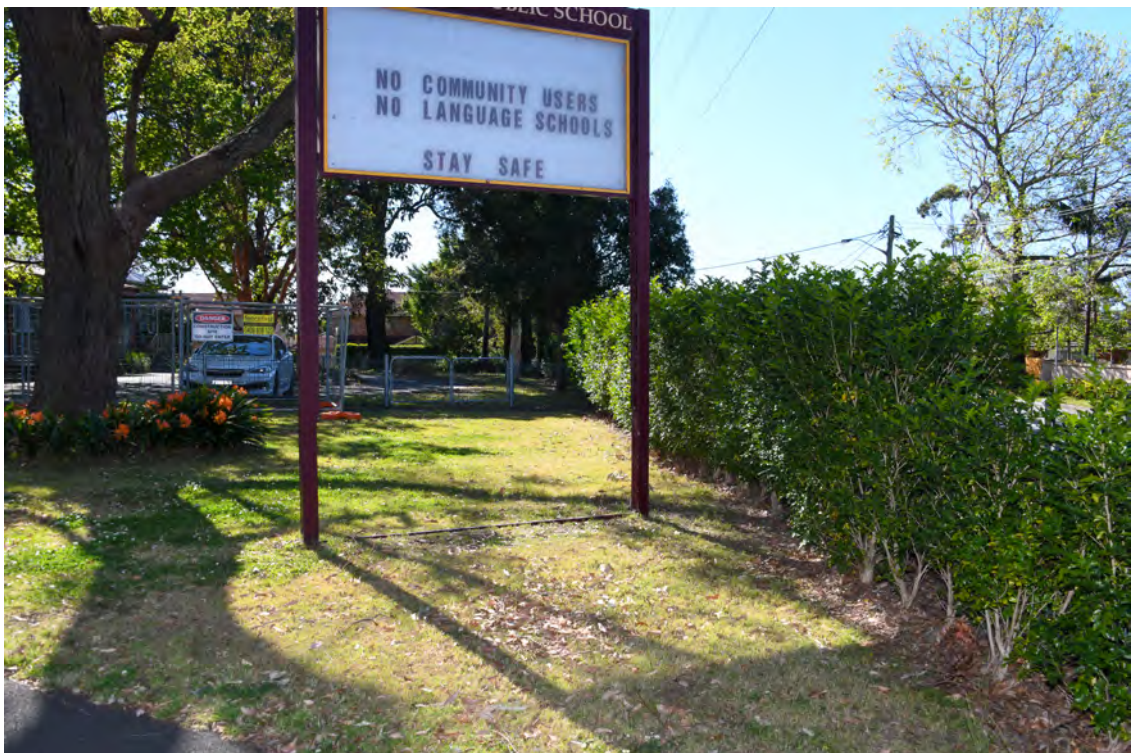
PRO\_1241.jpg

School boundaries. Southern boundary fronting Carlingford Road. Heading east.

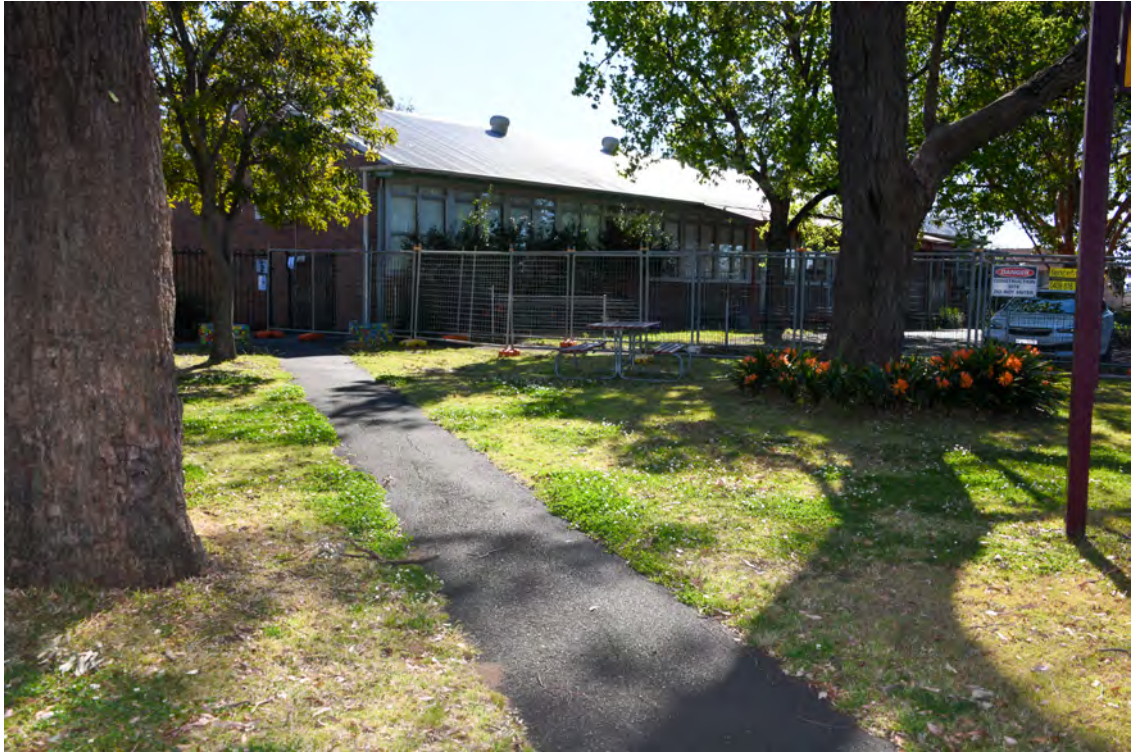
PRO\_1242.jpg

School boundaries. Southern boundary fronting Carlingford Road. Heading east.

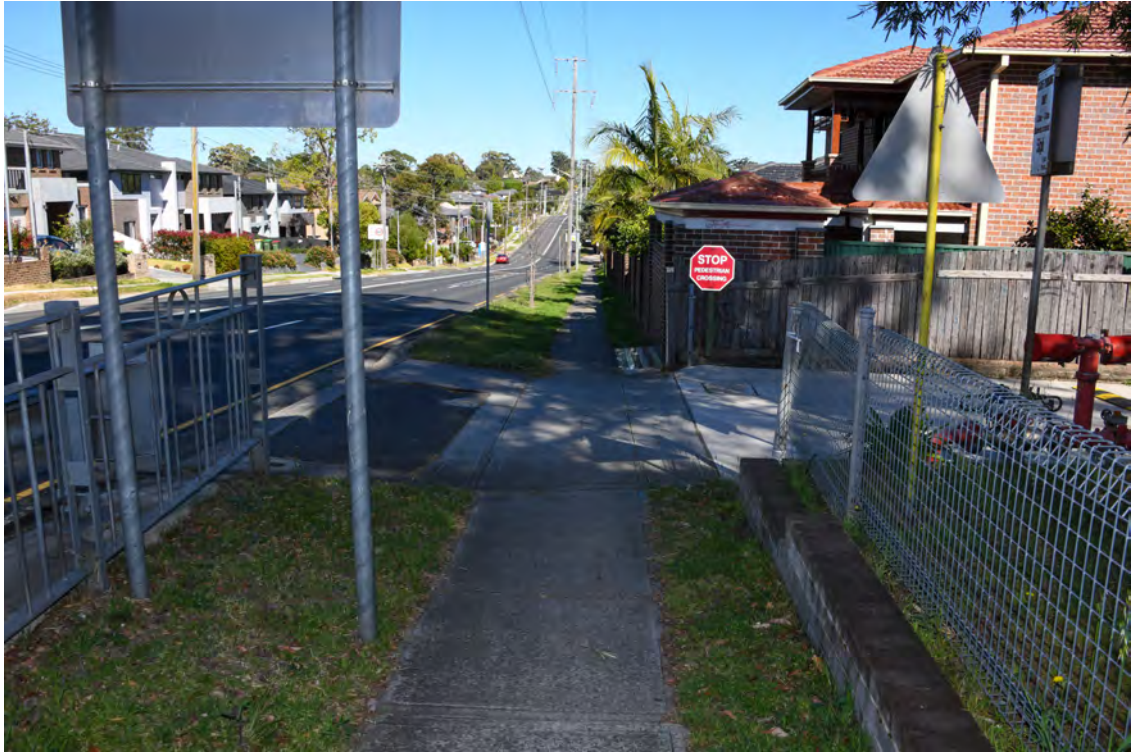
PRO\_1053.jpg

Carlingford Road. Intersection with the car park in the south-western corner of the school. Heading west.

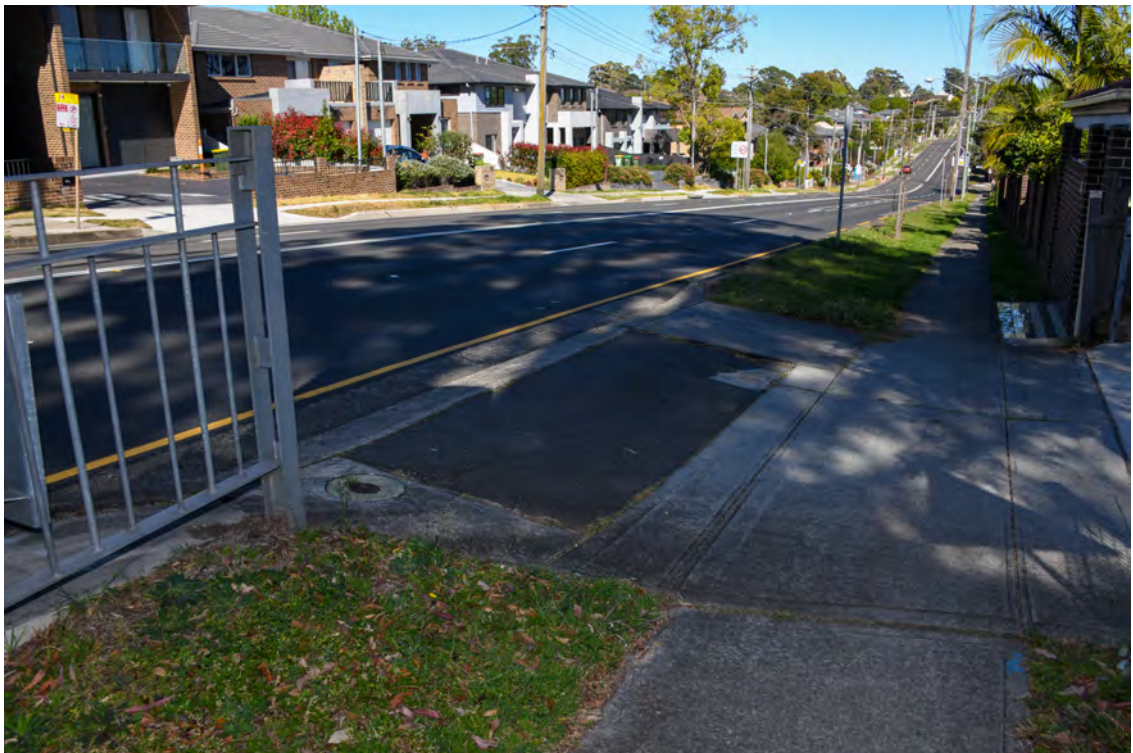
PRO\_1054.jpg

Carlingford Road. Intersection with the car park in the south-western corner of the school. Heading west.

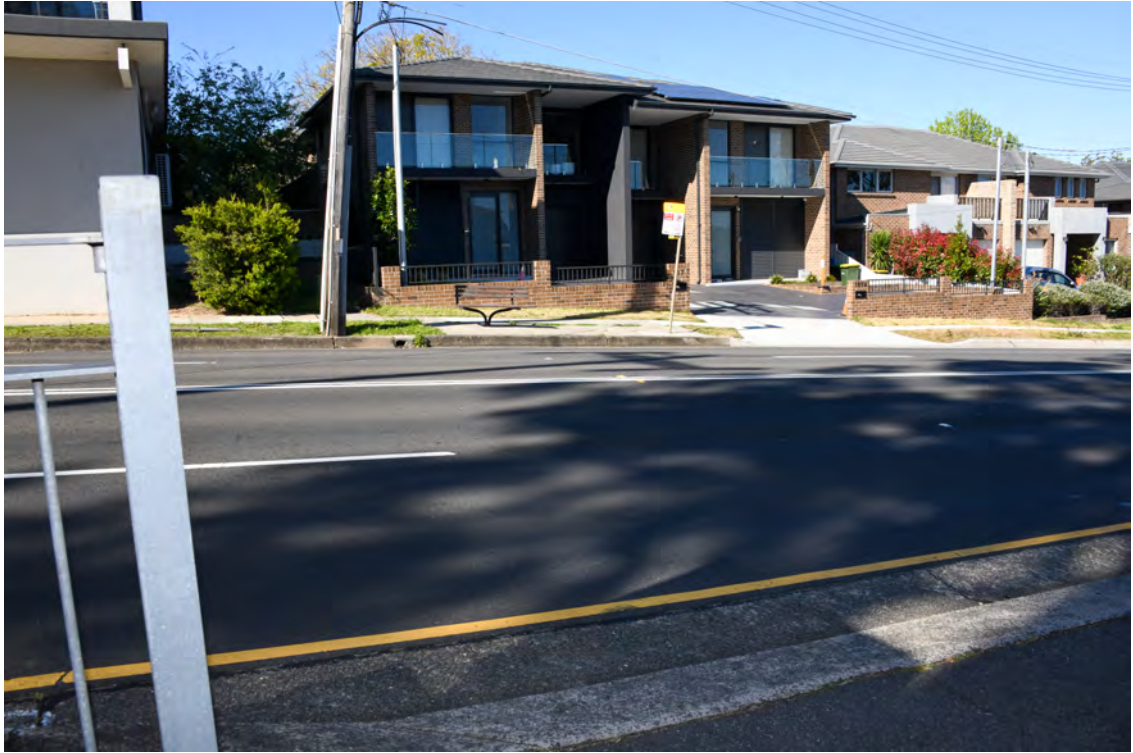
PRO\_1055.jpg

Carlingford Road. Intersection with the car park in the south-western corner of the school. Heading west.

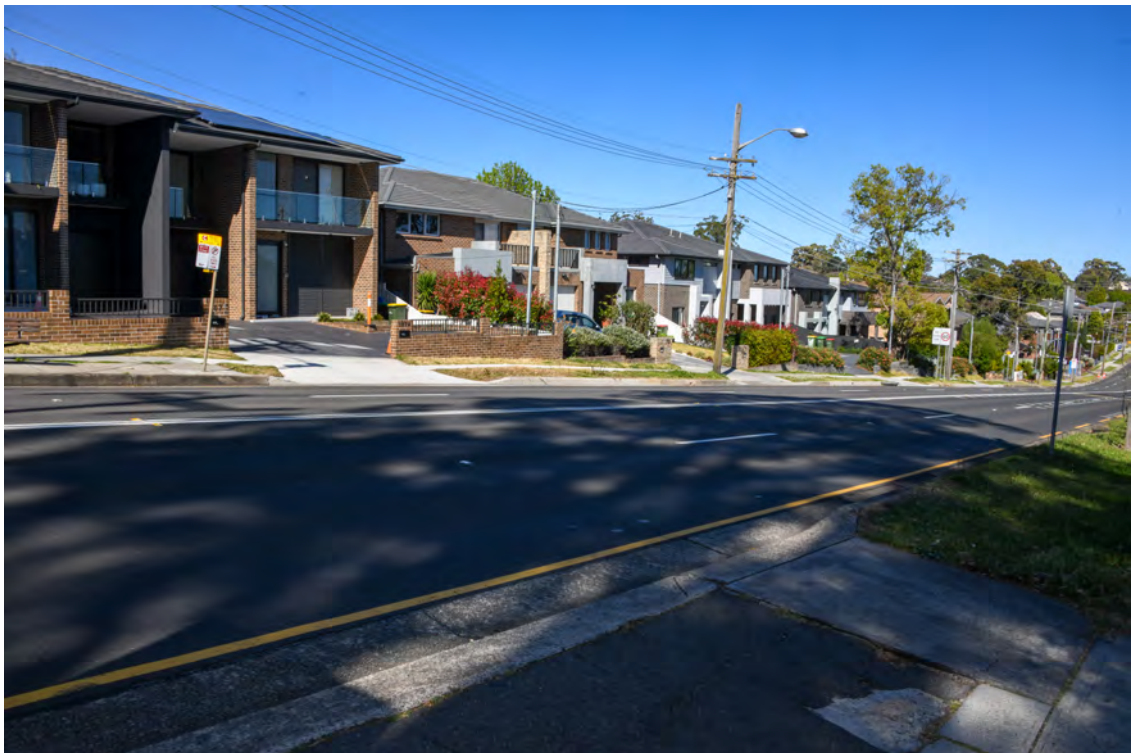
PRO\_1056.jpg

Carlingford Road. Intersection with the car park in the south-western corner of the school. Heading west.

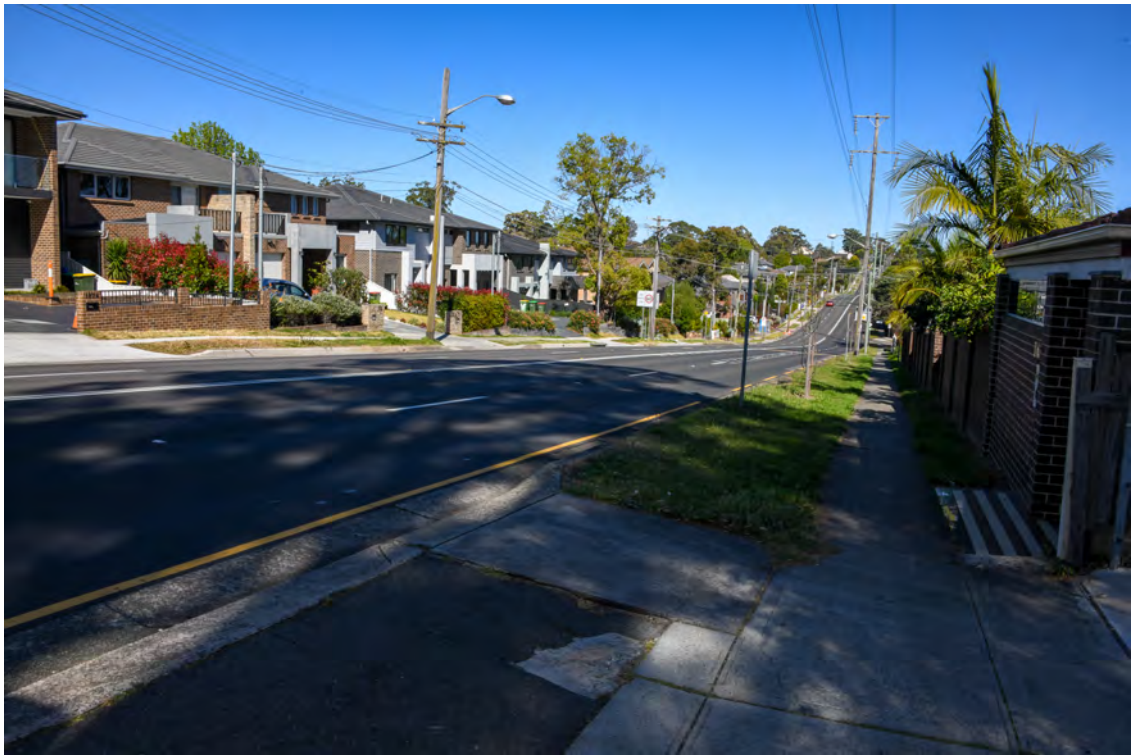
PRO\_1057.jpg

Carlingford Road. Intersection with the car park in the south-western corner of the school. Heading west.

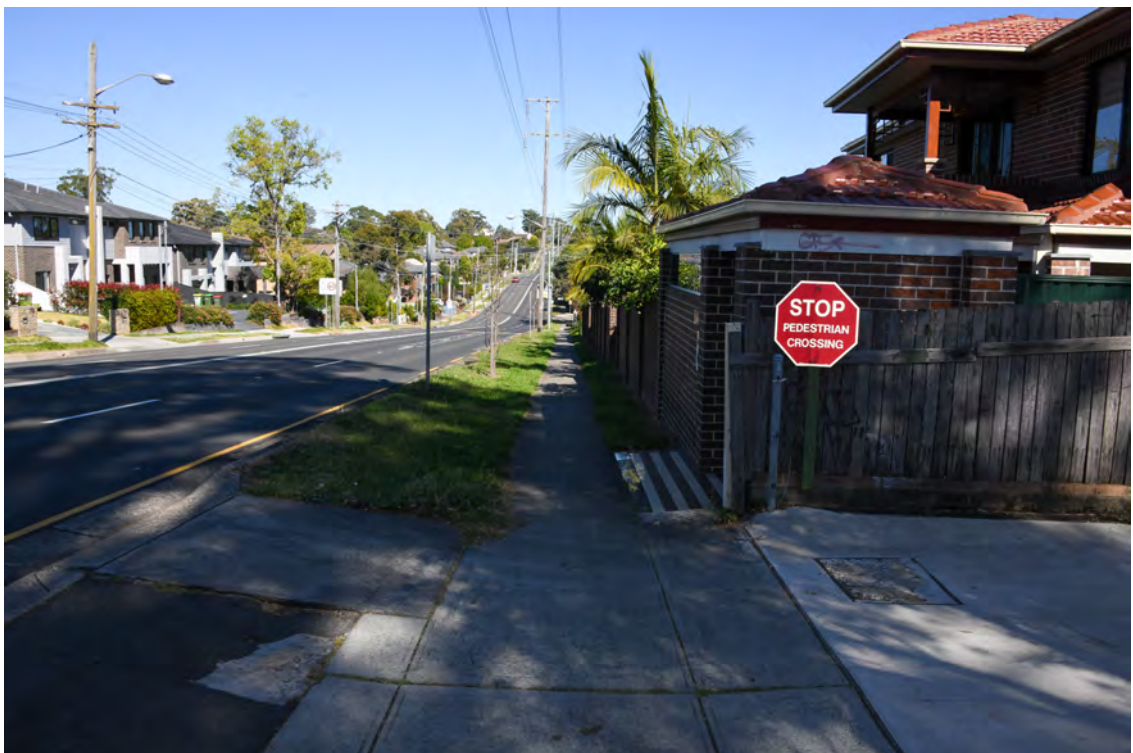
PRO\_1058.jpg

Carlingford Road. Intersection with the car park in the south-western corner of the school. Heading west.

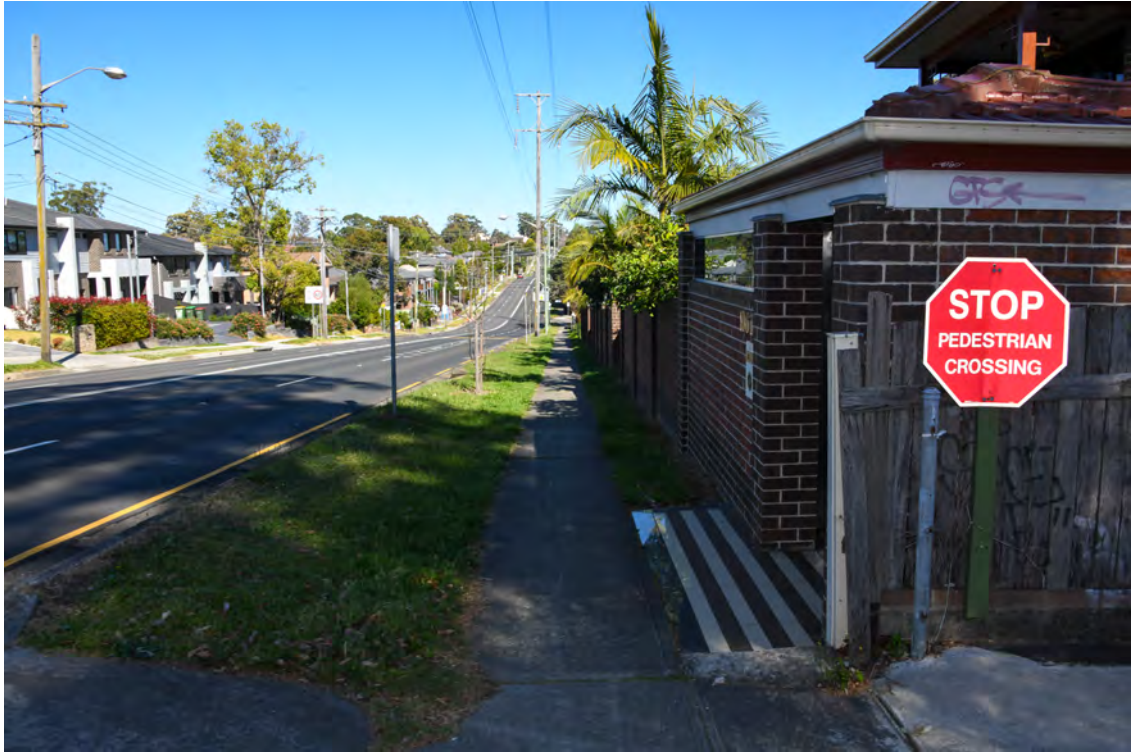
PRO\_1059.jpg

Carlingford Road. Intersection with the car park in the south-western corner of the school. Heading west.

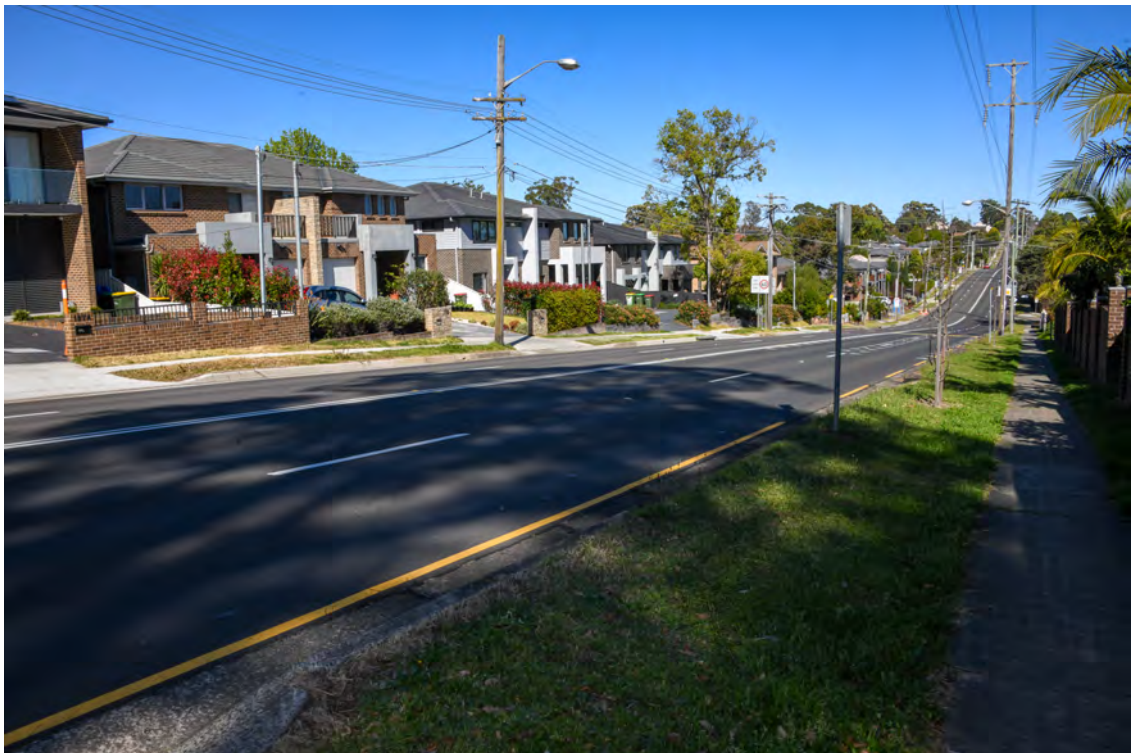
PRO\_1060.jpg

Carlingford Road. Intersection with the car park in the south-western corner of the school. Heading west.
