96-104 Carlingford Road, Epping NSW 2121

Epping West Public School

DILAPIDATION REPORT

7<sup>th</sup> September 2021

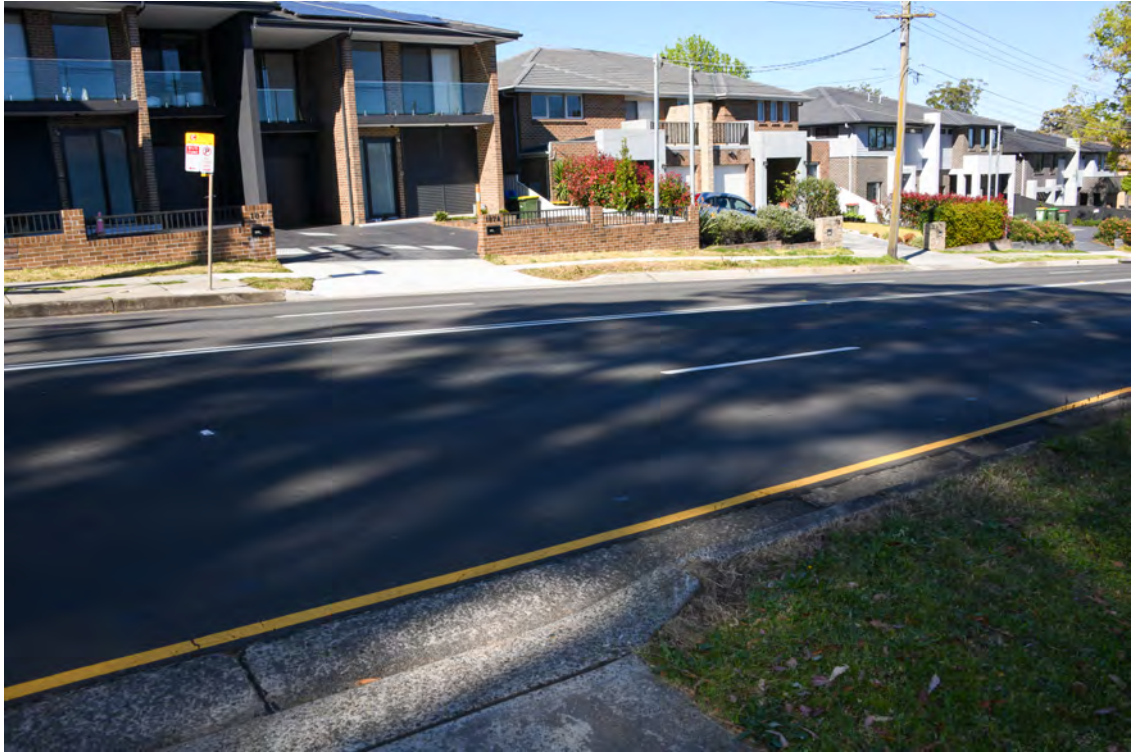
PRO\_1061.jpg

Carlingford Road. Intersection with the car park in the south-western corner of the school. Heading west.

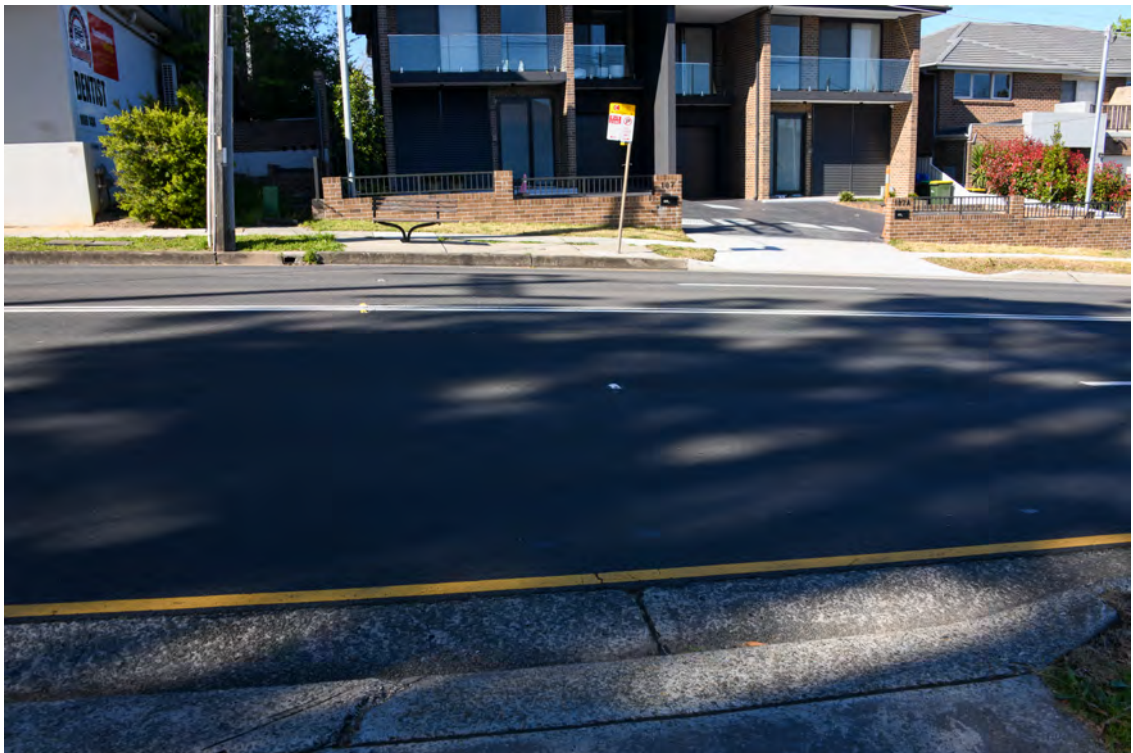
PRO\_1062.jpg

Carlingford Road. Intersection with the car park in the south-western corner of the school. Heading west.

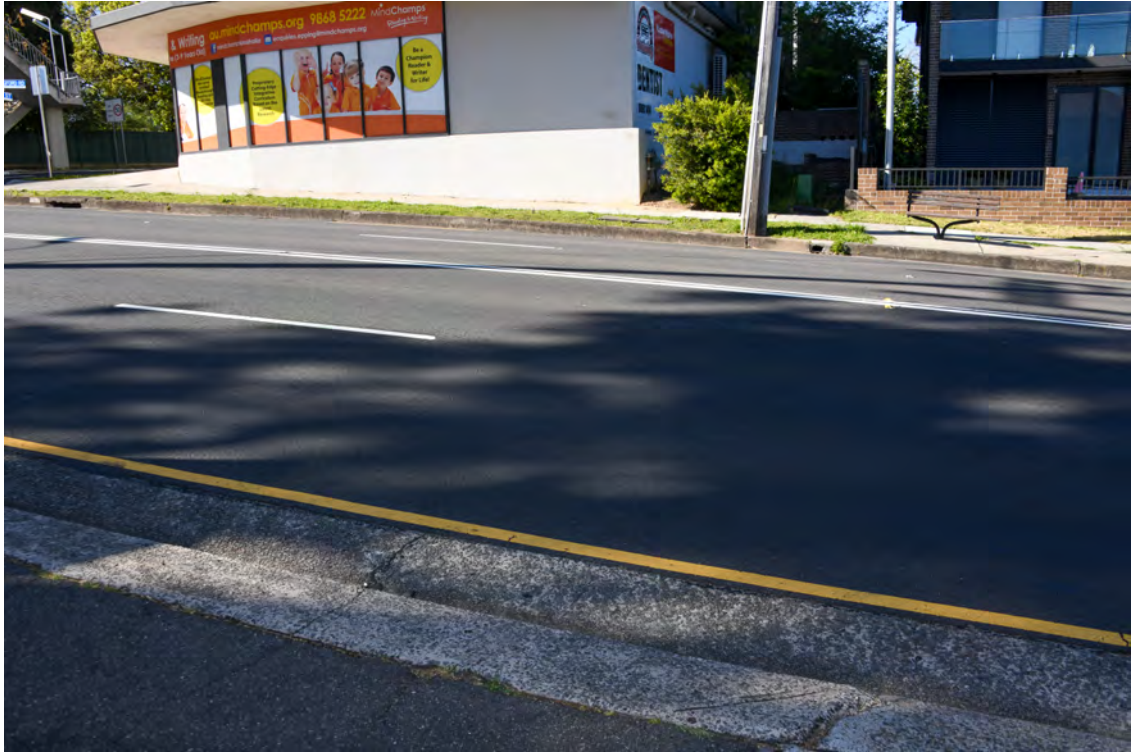
PRO\_1063.jpg

Carlingford Road. Intersection with the car park in the south-western corner of the school. Heading east.

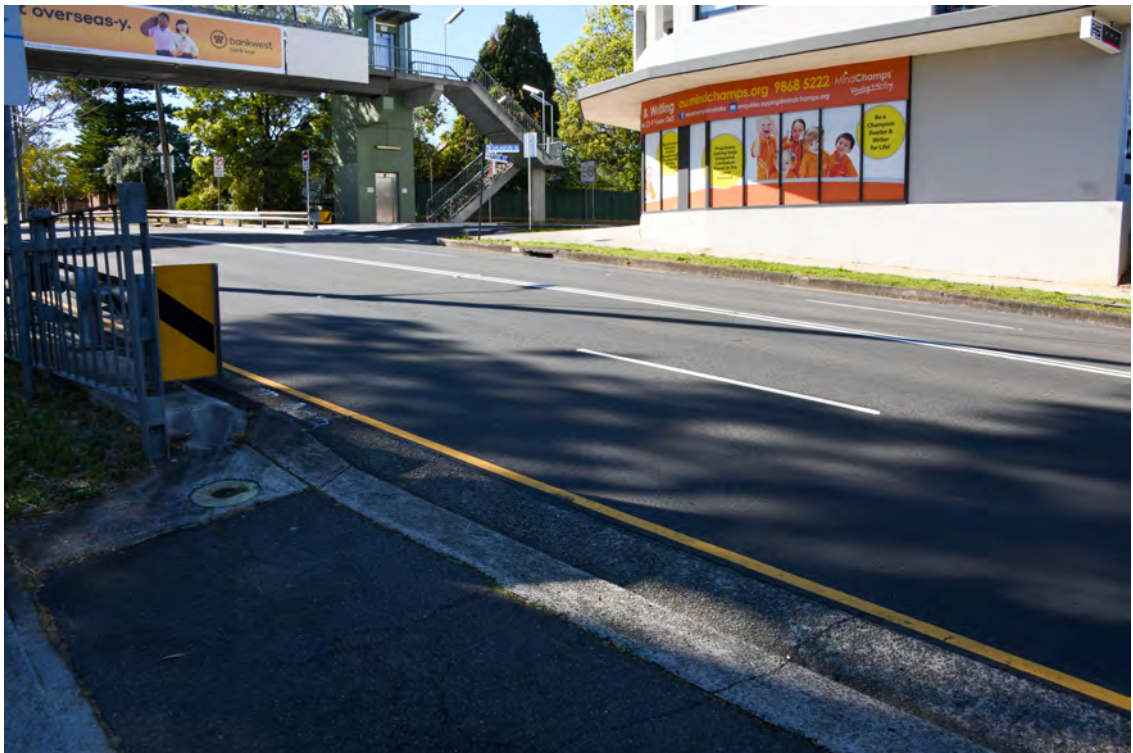
PRO\_1064.jpg

Carlingford Road. Intersection with the car park in the south-western corner of the school. Heading east.

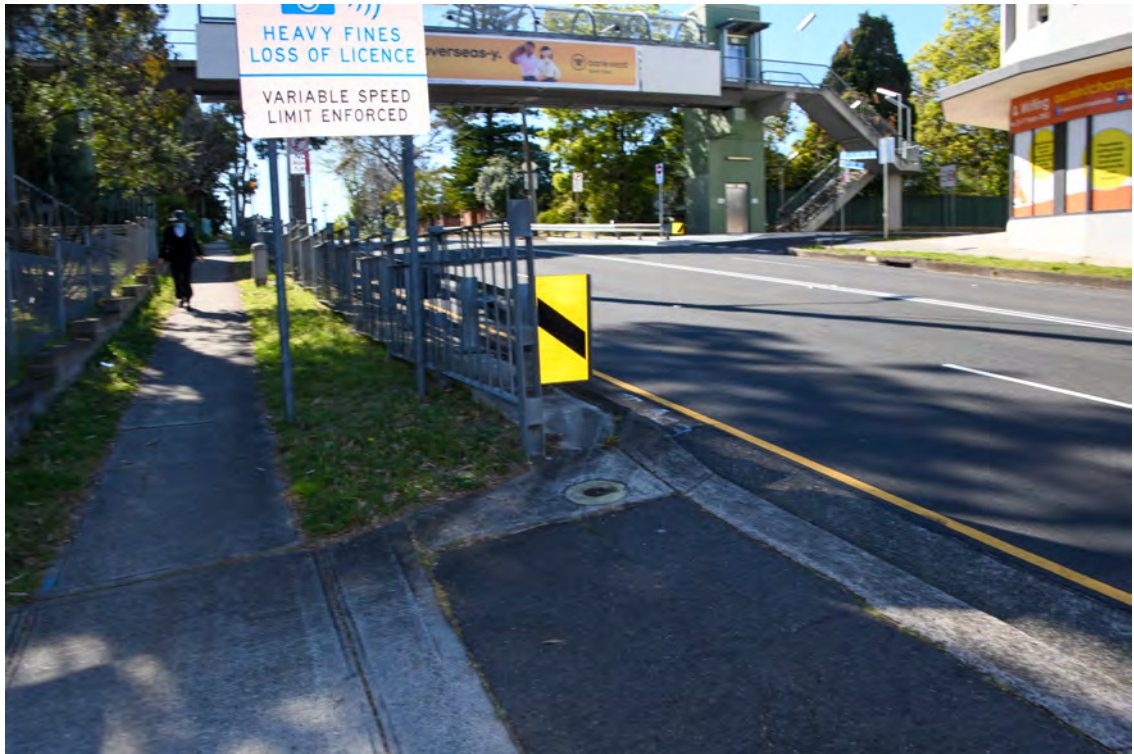
PRO\_1065.jpg

Carlingford Road. Intersection with the car park in the south-western corner of the school. Heading east.

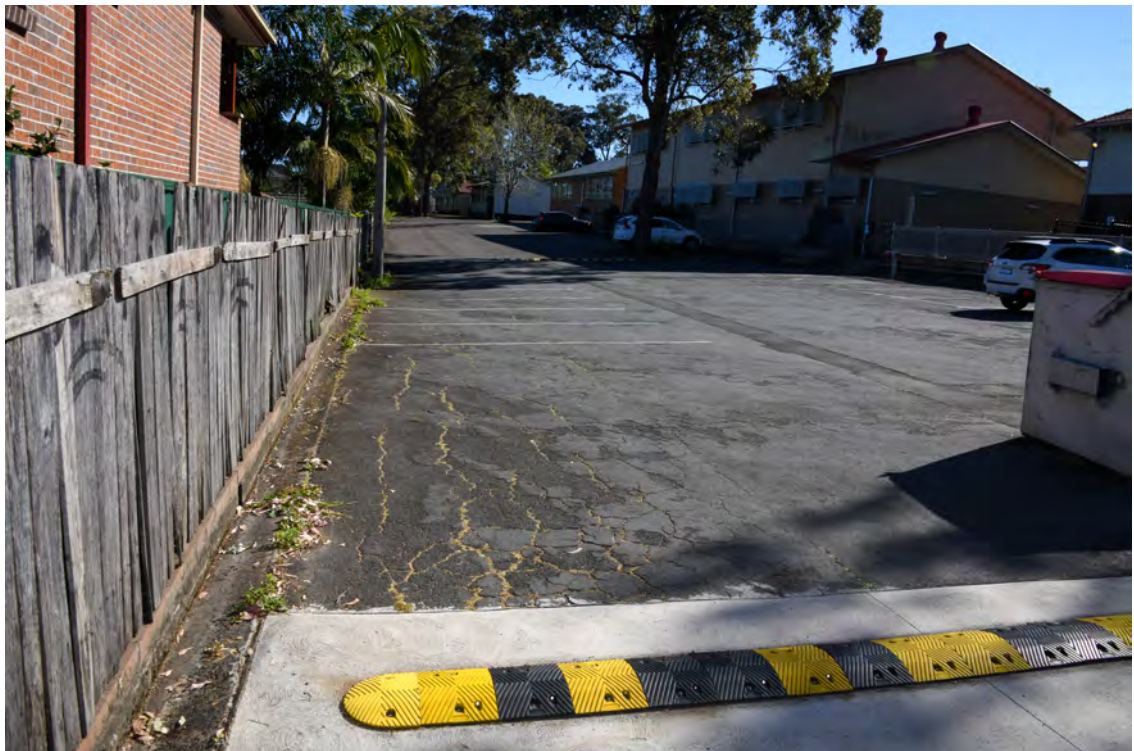
PRO\_1066.jpg

Carlingford Road. Intersection with the car park in the south-western corner of the school. Heading north.

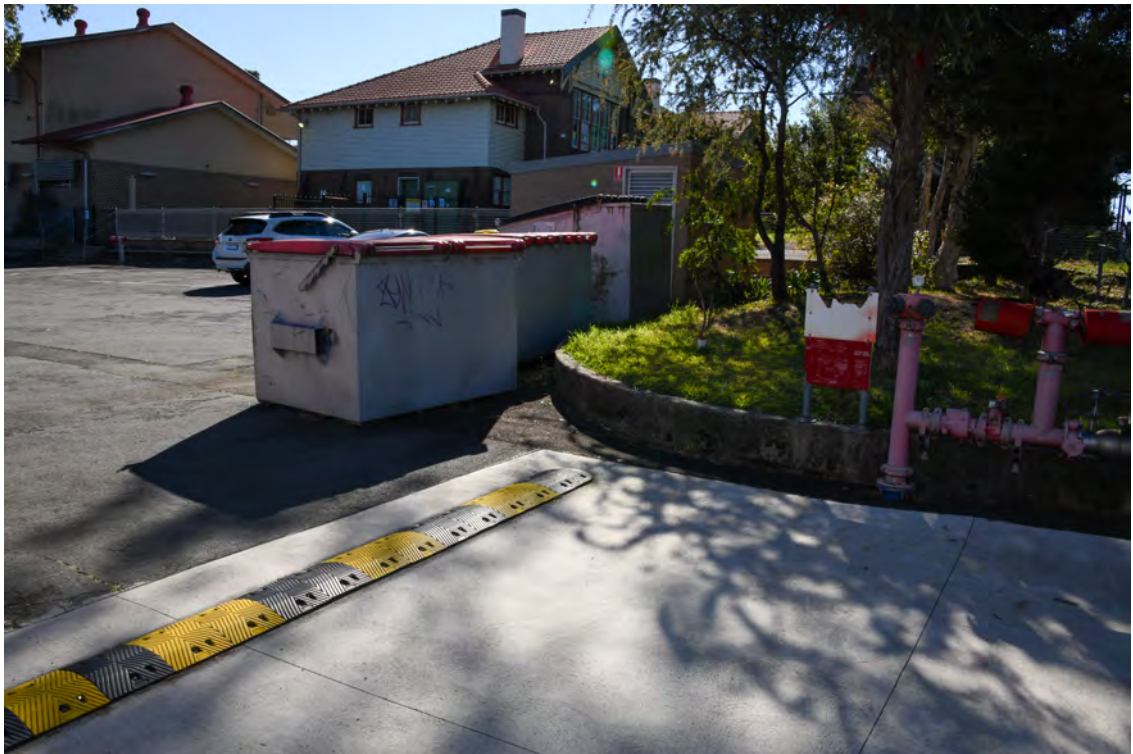
PRO\_1067.jpg

Carlingford Road. Intersection with the car park in the south-western corner of the school. Heading north.

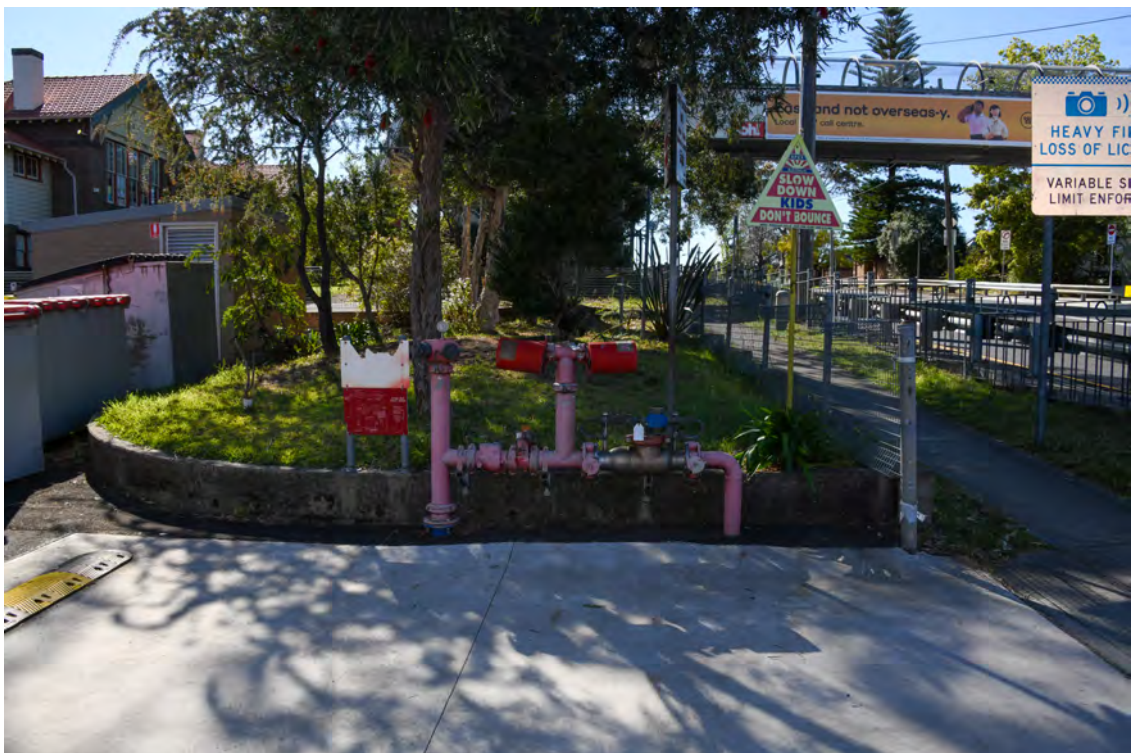
PRO\_1068.jpg

Carlingford Road. Intersection with the car park in the south-western corner of the school. Heading east.

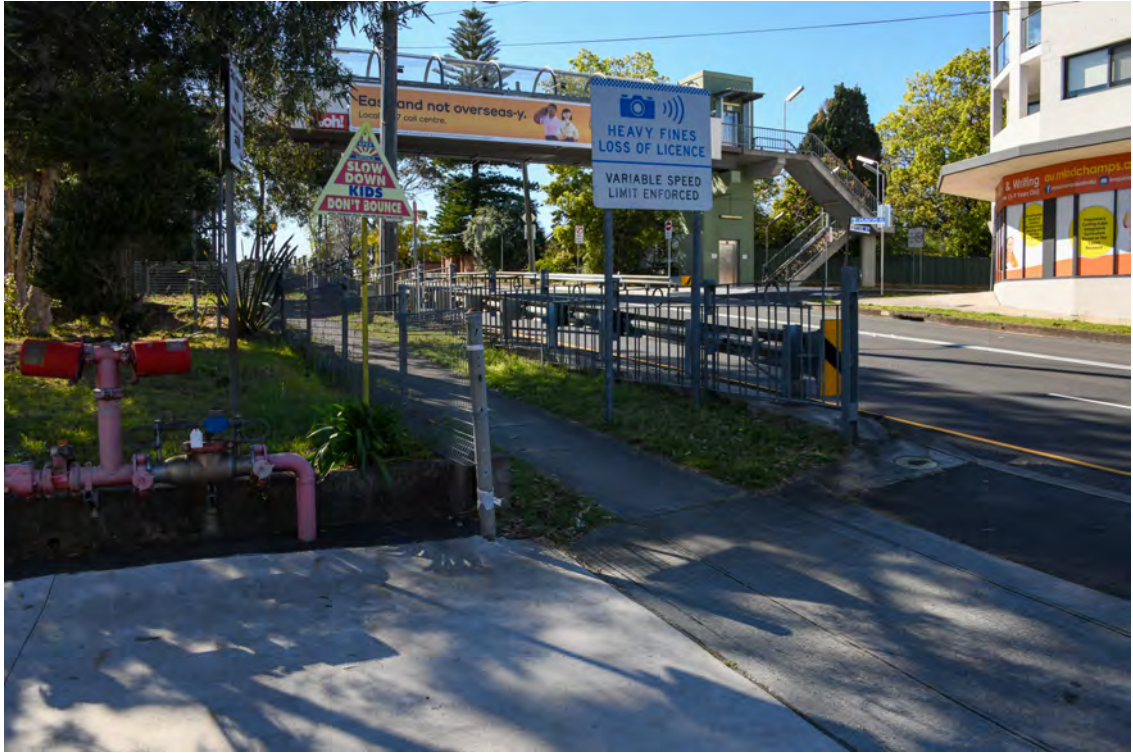
PRO\_1069.jpg

Carlingford Road. Intersection with the car park in the south-western corner of the school. Heading east.

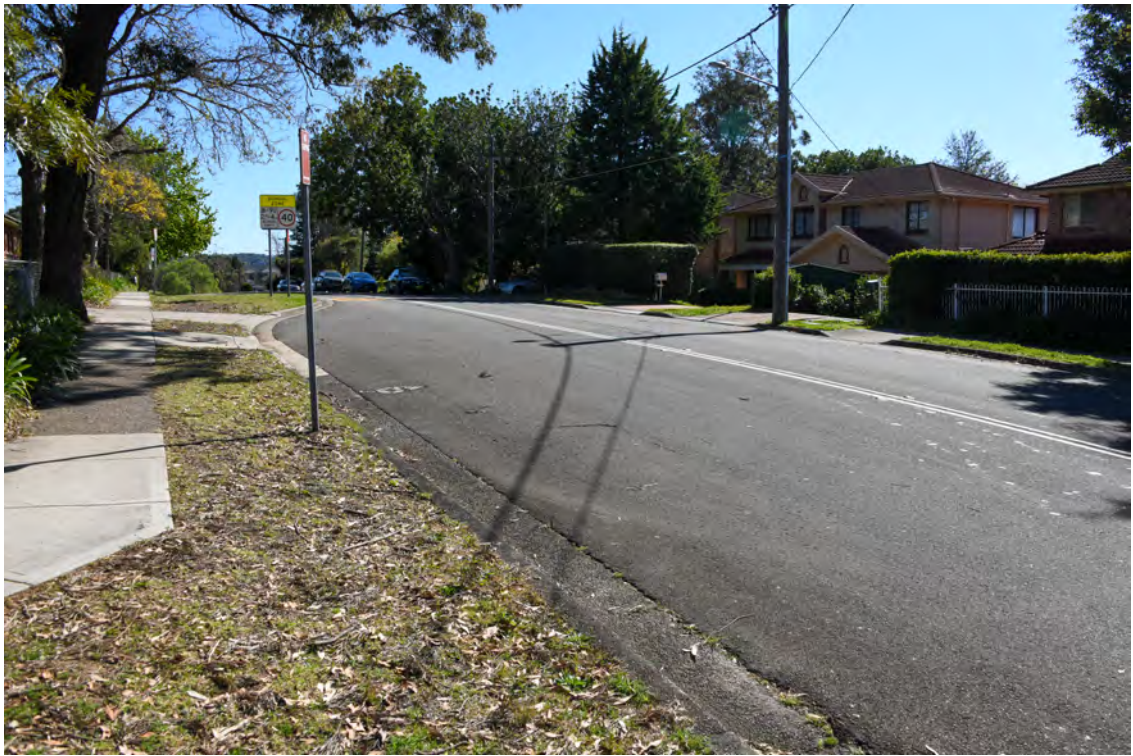
PRO\_1244.jpg

Ward Street. Area adjacent to the school. Western side of the street. Heading north.  
Area between the intersection with Carlingford Road and power pole no. EP73716.

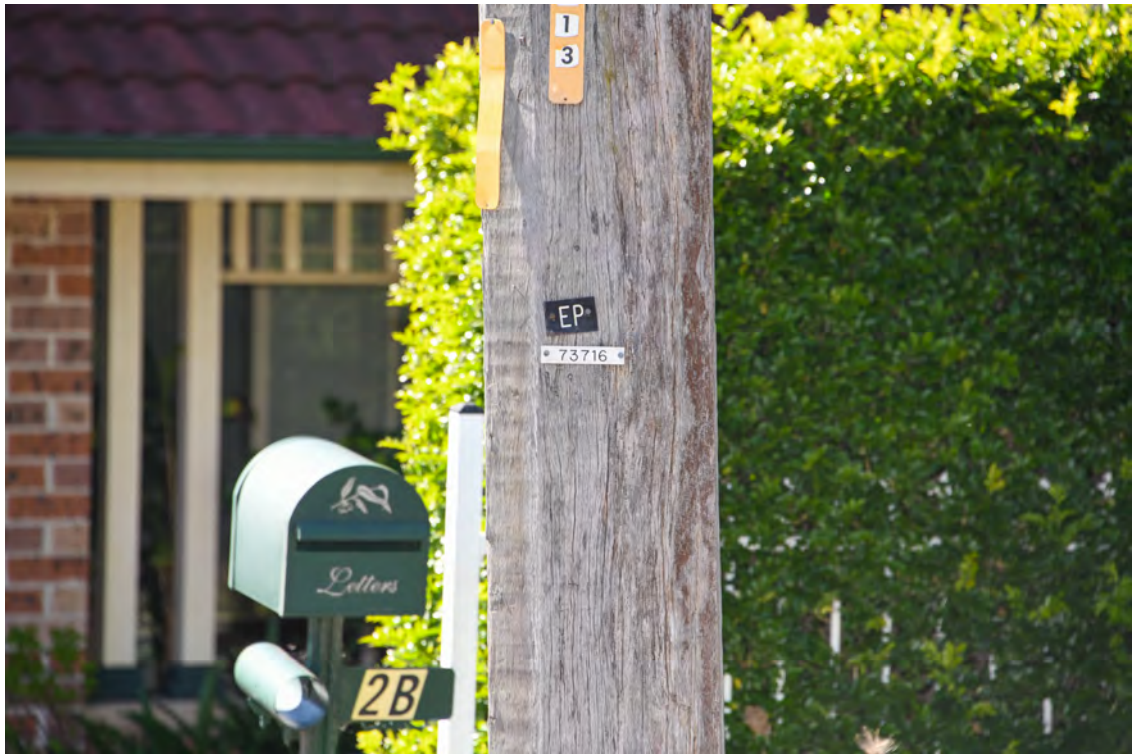
PRO\_1262.jpg

Ward Street. Area adjacent to the school. Western side of the street. Heading north.  
Area of power pole no. EP73716.

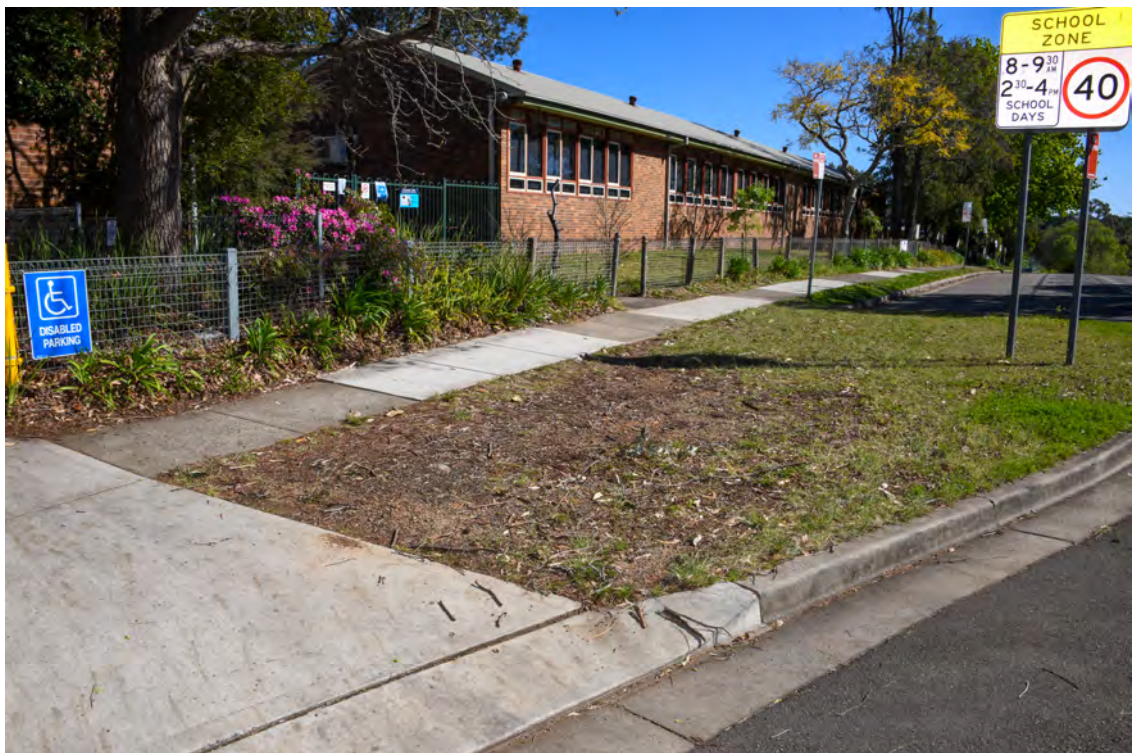
PRO\_1263.jpg

Ward Street. Area adjacent to the school. Western side of the street. Heading north.  
Area between power pole no. EP73716 & EP73715.

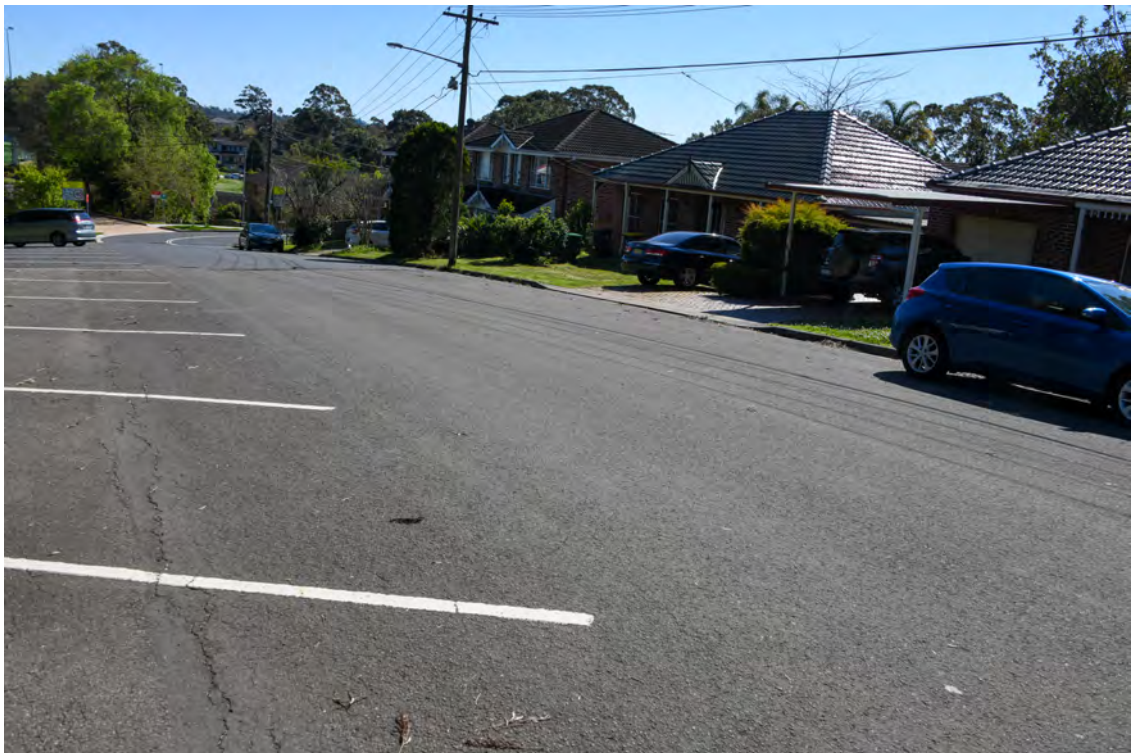
PRO\_1359.jpg

Ward Street. Area adjacent to the school. Western side of the street. Heading north.  
Area between power pole no. EP73713 & EP73712.

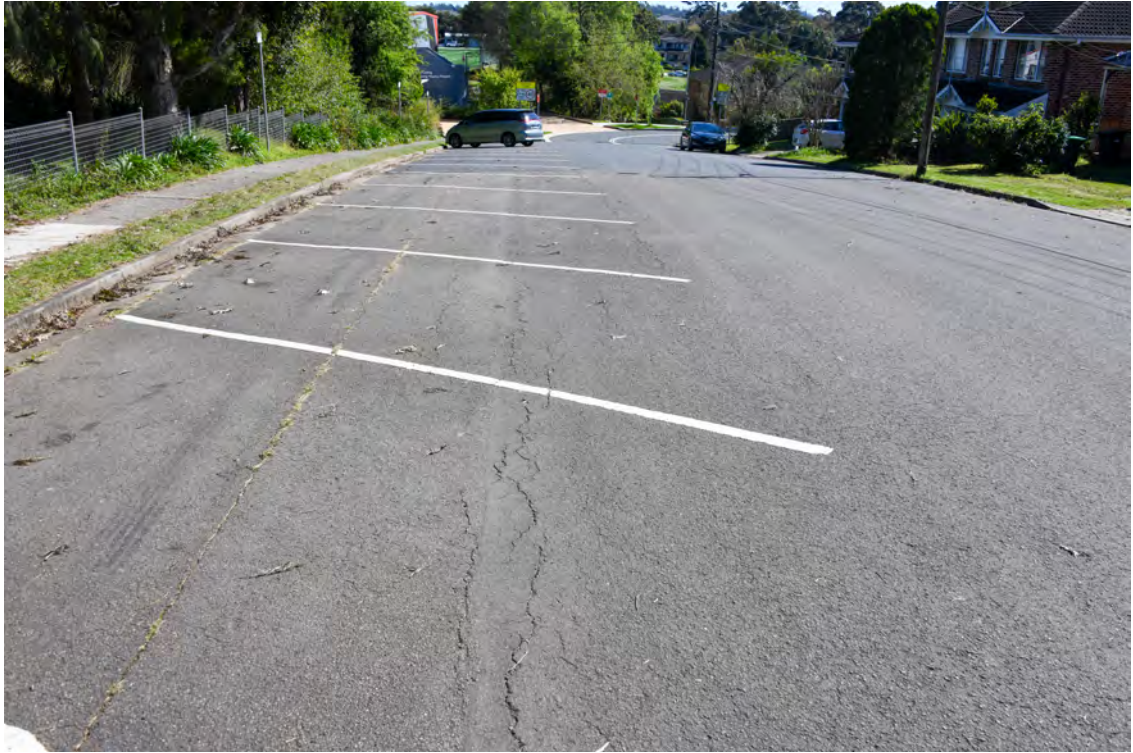
PRO\_1360.jpg

Ward Street. Area adjacent to the school. Western side of the street. Heading north.  
Area between power pole no. EP73713 & EP73712.

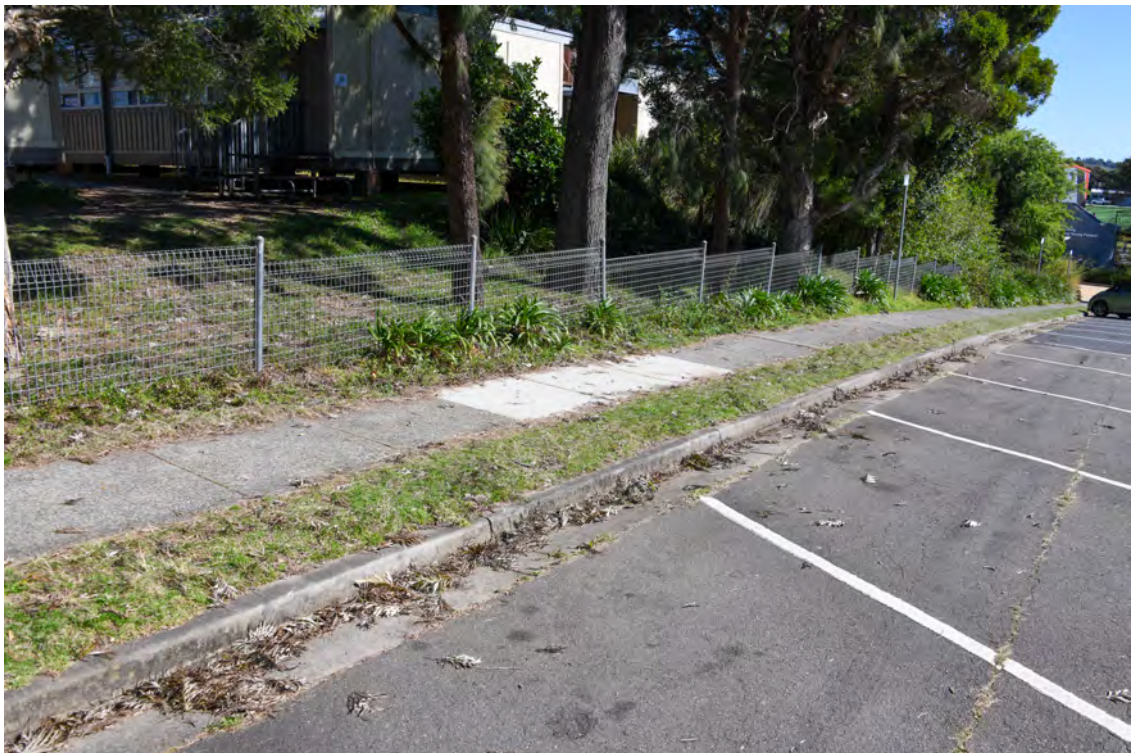
PRO\_1361.jpg

Ward Street. Area adjacent to the school. Western side of the street. Heading north.  
Area between power pole no. EP73713 & EP73712.

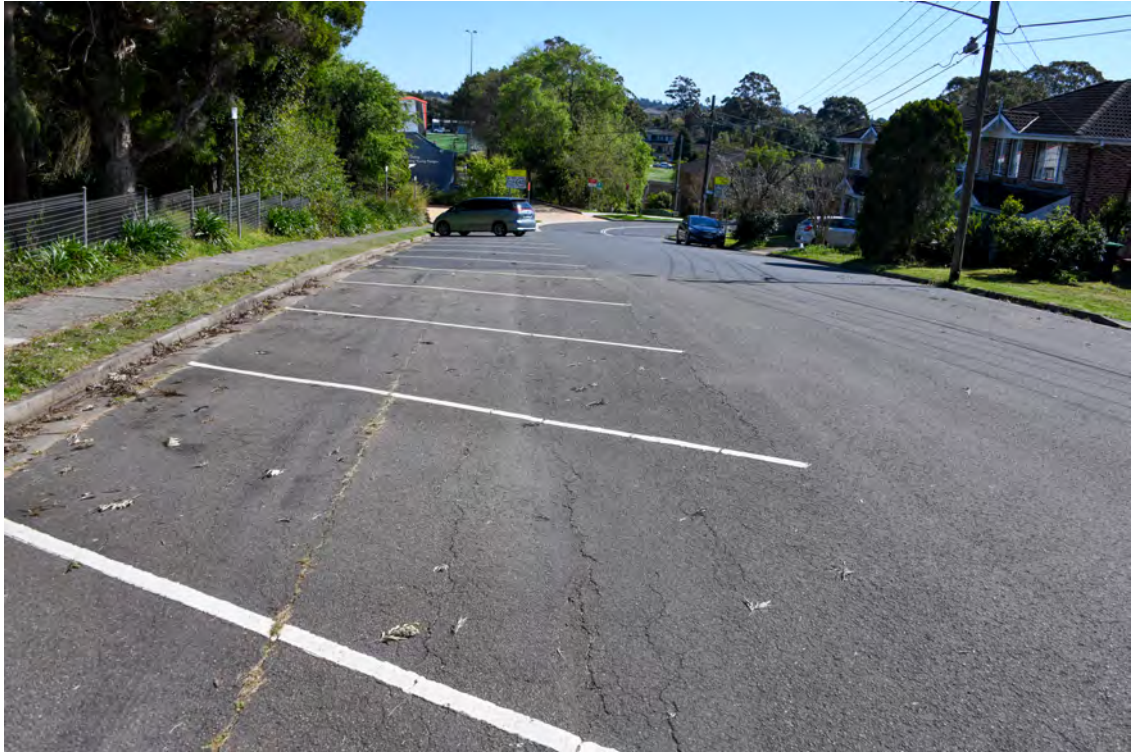
PRO\_1362.jpg

Ward Street. Area adjacent to the school. Western side of the street. Heading north.  
Area between power pole no. EP73713 & EP73712.

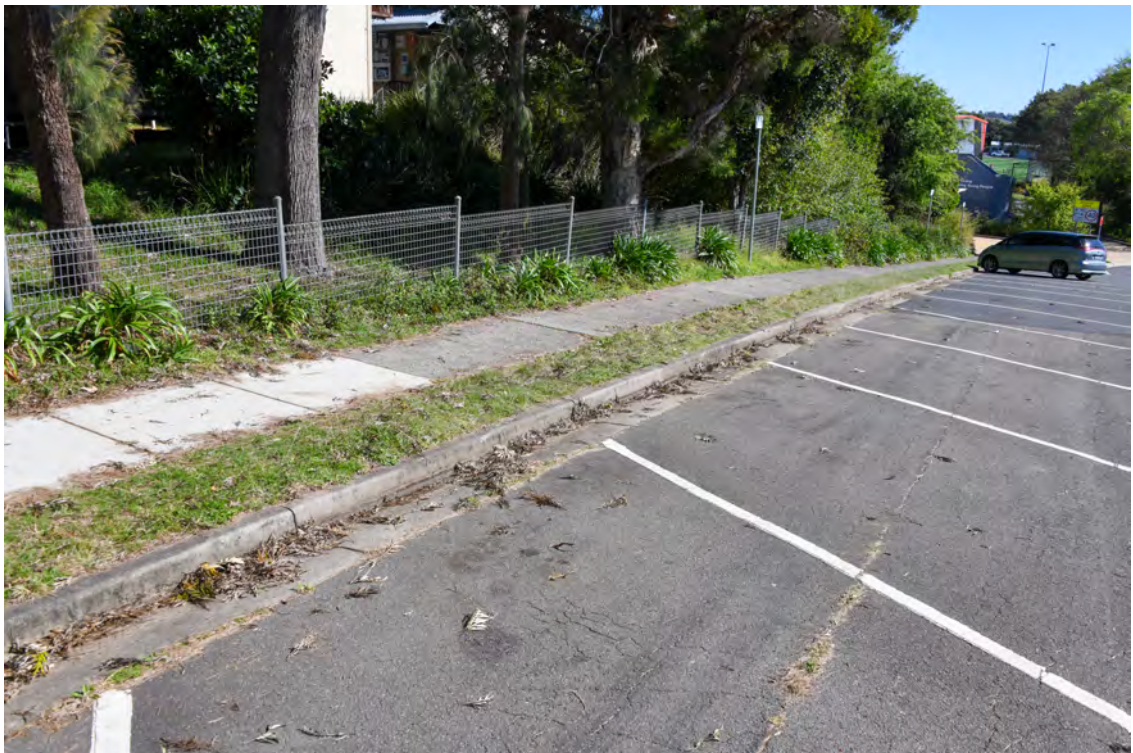
PRO\_1363.jpg

Ward Street. Area adjacent to the school. Western side of the street. Heading north.  
Area between power pole no. EP73713 & EP73712.

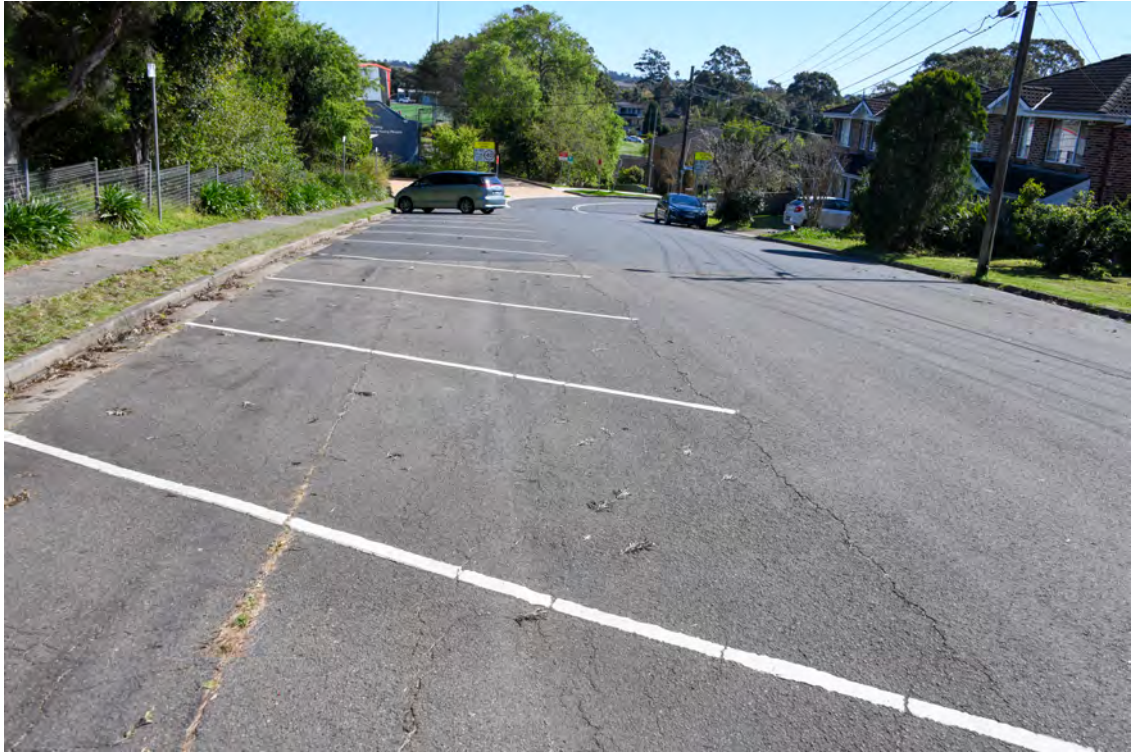
PRO\_1364.jpg

Ward Street. Area adjacent to the school. Western side of the street. Heading north.  
Area between power pole no. EP73713 & EP73712.

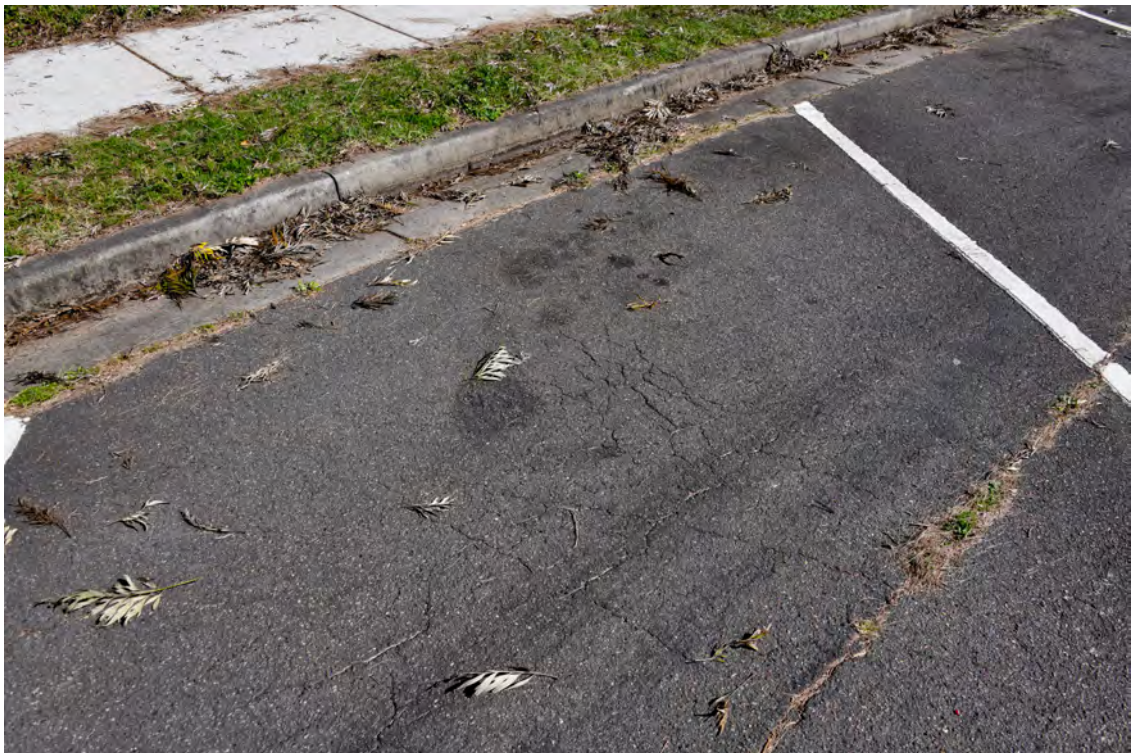
PRO\_1365.jpg

Ward Street. Area adjacent to the school. Western side of the street. Heading north.  
Area between power pole no. EP73713 & EP73712.

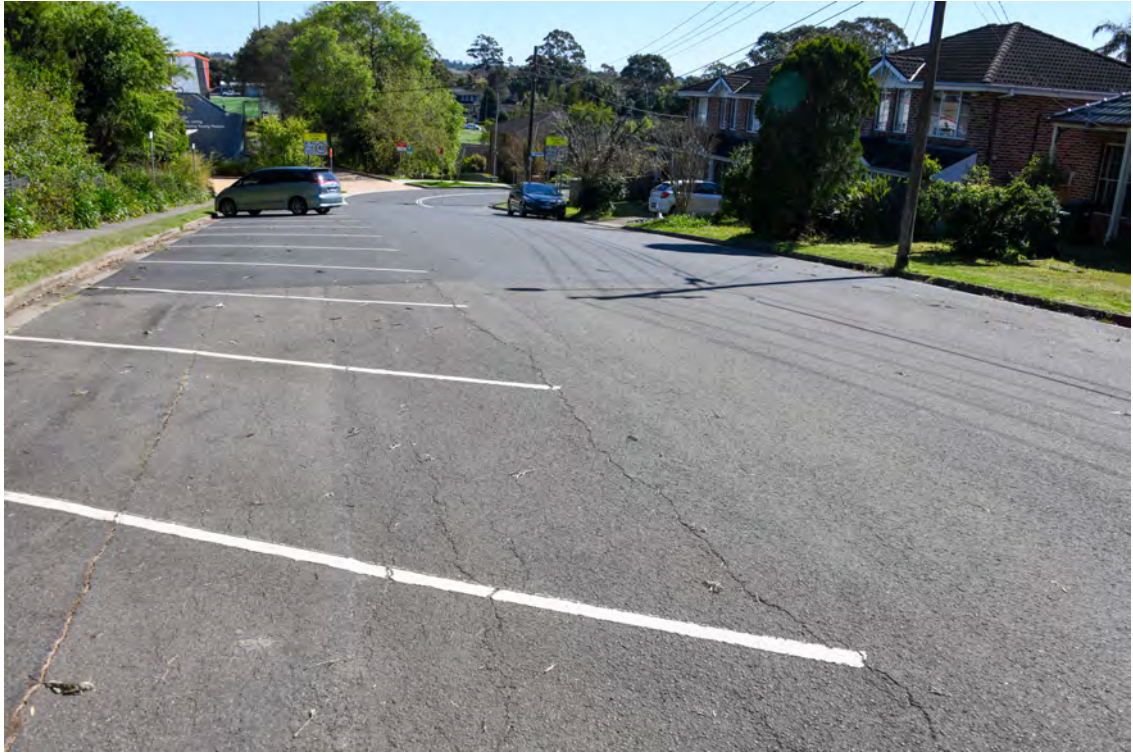
PRO\_1366.jpg

Ward Street. Area adjacent to the school. Western side of the street. Heading north.  
Area between power pole no. EP73713 & EP73712.

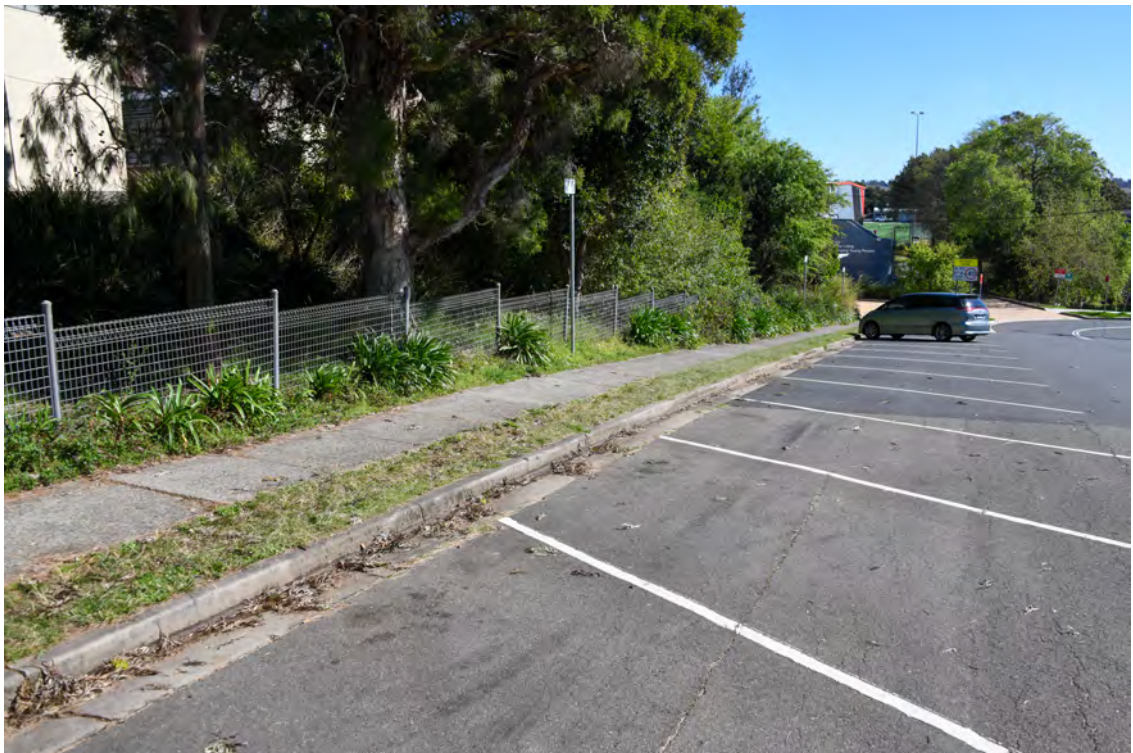
PRO\_1367.jpg

Ward Street. Area adjacent to the school. Western side of the street. Heading north.  
Area between power pole no. EP73713 & EP73712.

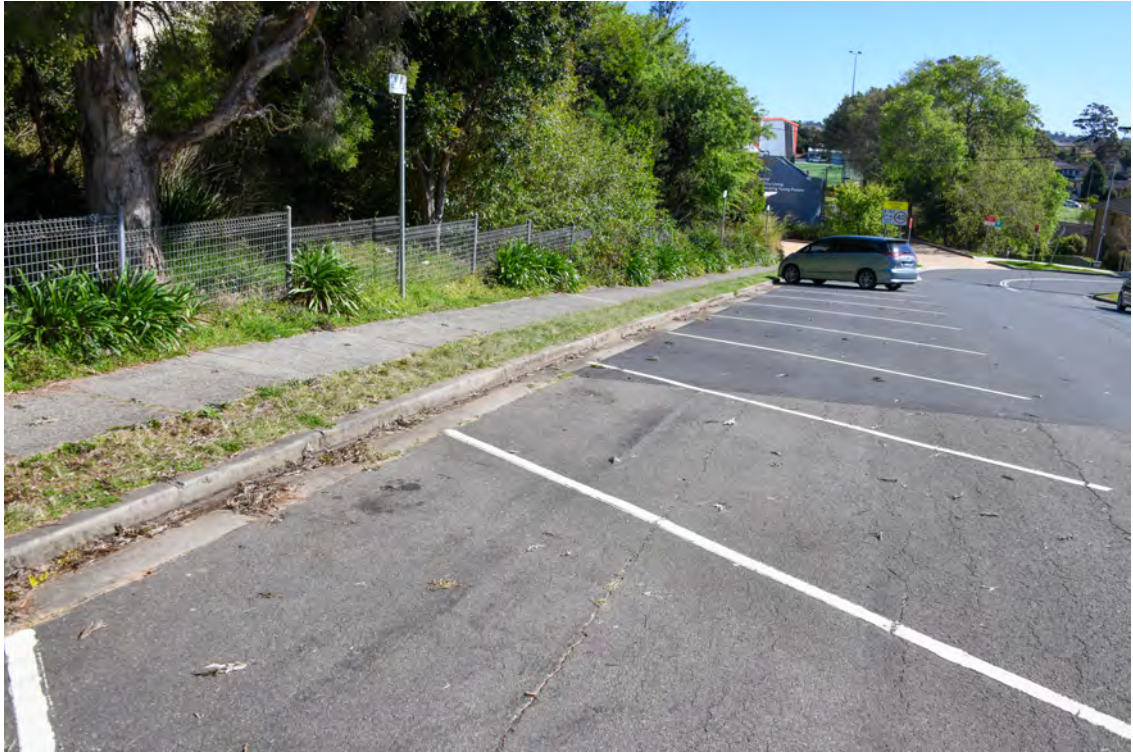
PRO\_1368.jpg

Ward Street. Area adjacent to the school. Western side of the street. Heading north.  
Area between power pole no. EP73713 & EP73712.

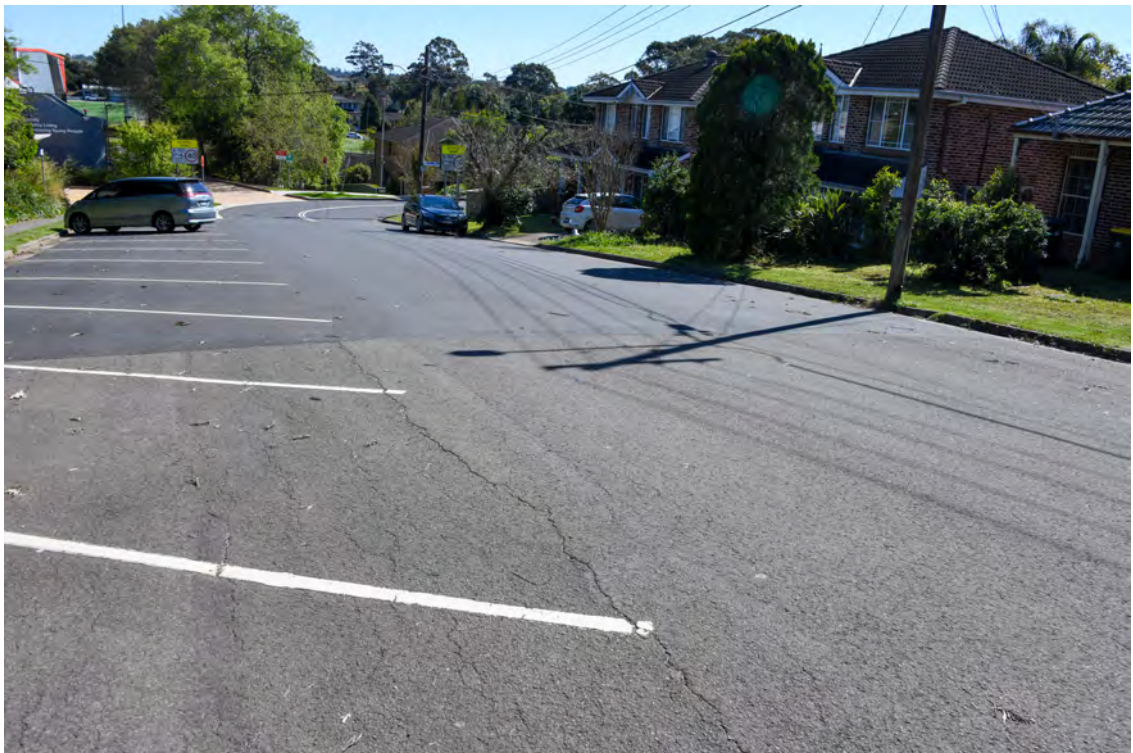
PRO\_1369.jpg

Ward Street. Area adjacent to the school. Western side of the street. Heading north.  
Area between power pole no. EP73713 & EP73712.

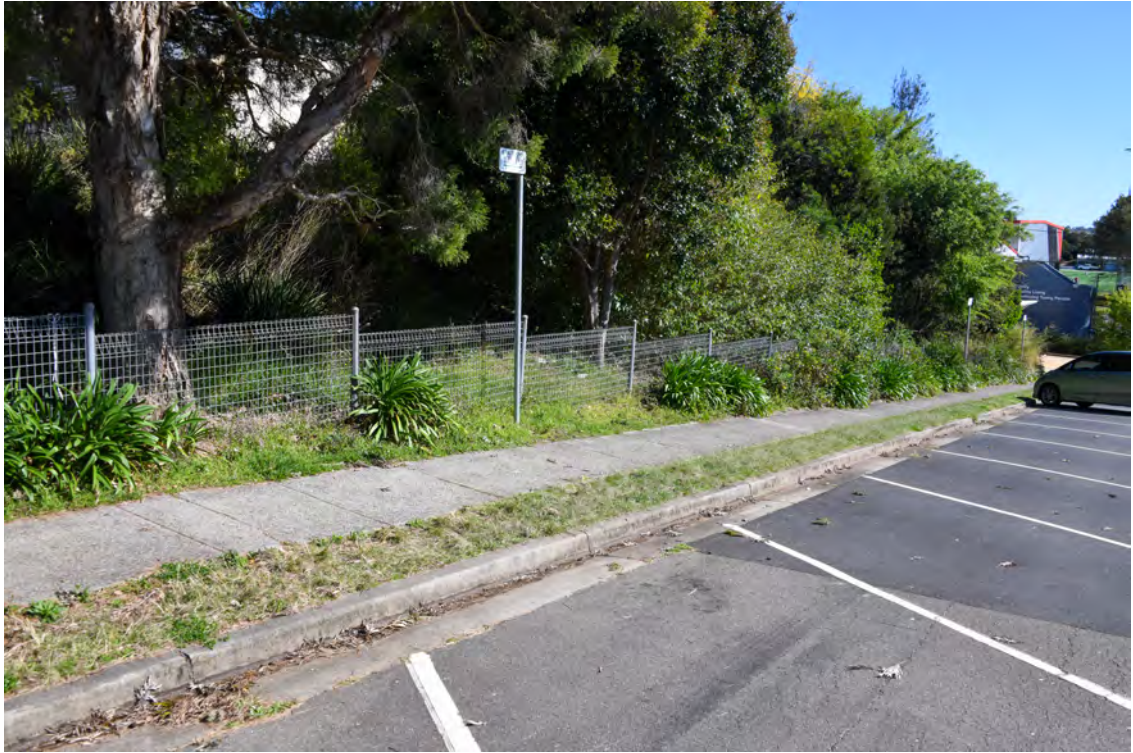
PRO\_1370.jpg

Ward Street. Area adjacent to the school. Western side of the street. Heading north.  
Area between power pole no. EP73713 & EP73712.

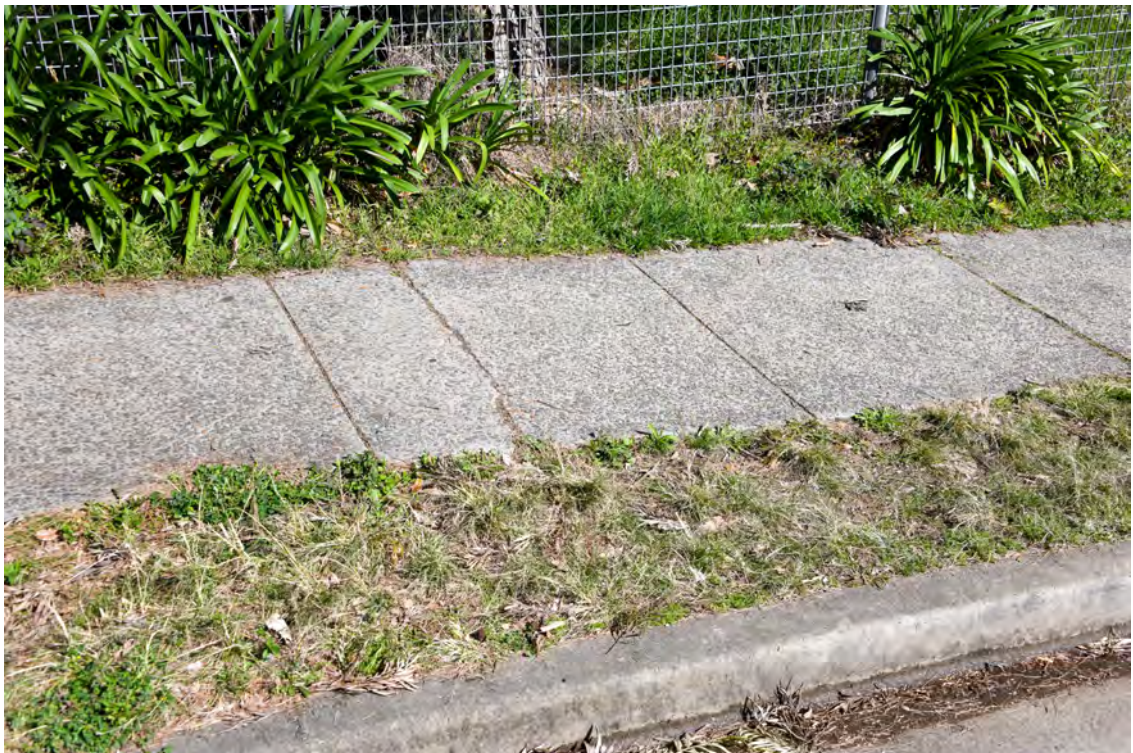
PRO\_1371.jpg

Ward Street. Area adjacent to the school. Western side of the street. Heading north.  
Area between power pole no. EP73713 & EP73712.

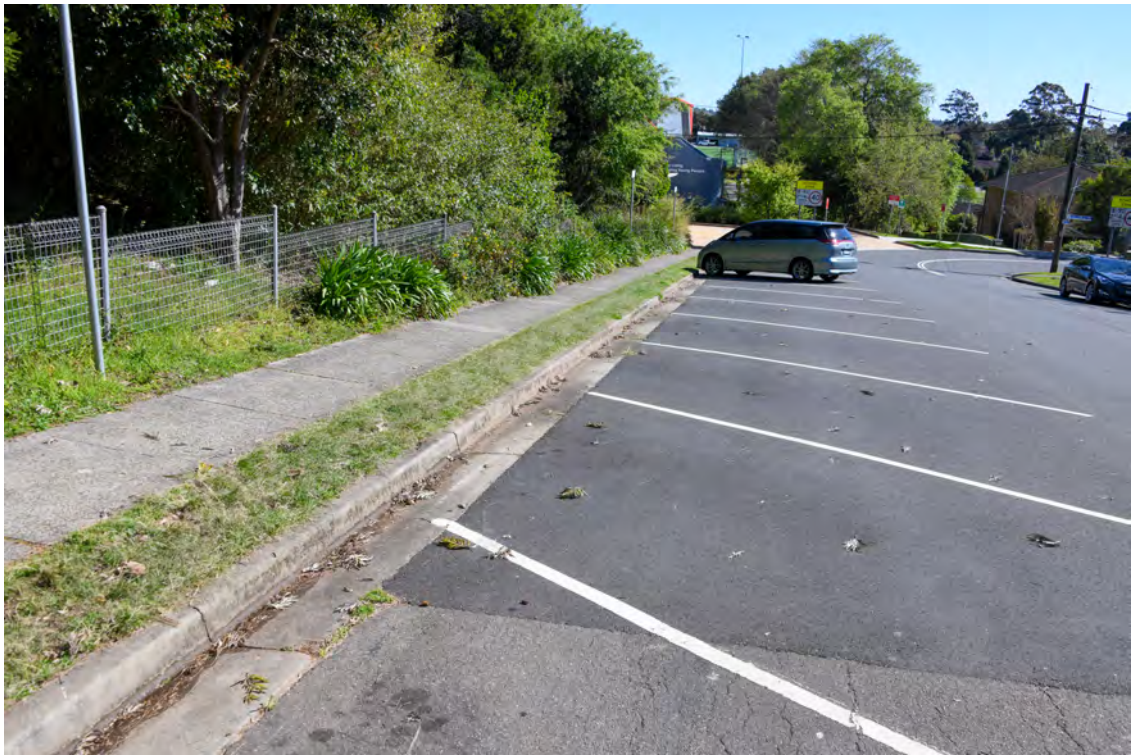
PRO\_1372.jpg

Ward Street. Area adjacent to the school. Western side of the street. Heading north.  
Area between power pole no. EP73713 & EP73712.
