96-104 Carlingford Road, Epping NSW 2121

Epping West Public School

DILAPIDATION REPORT

7<sup>th</sup> September 2021

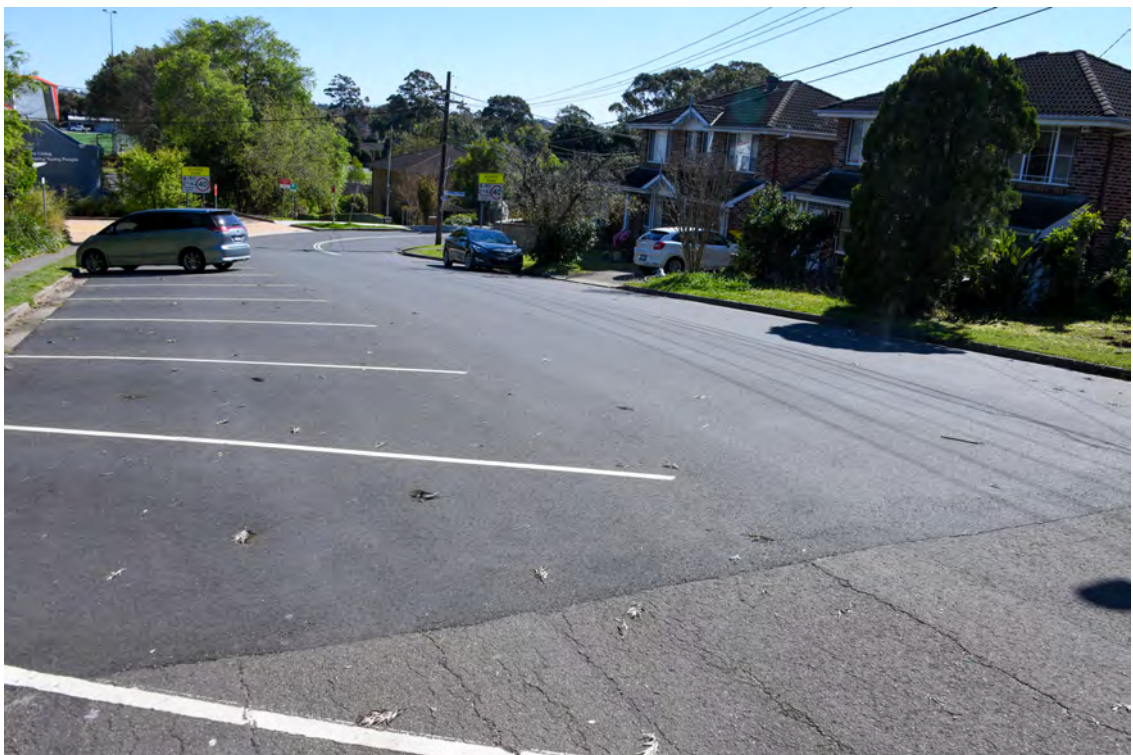
PRO\_1373.jpg

Ward Street. Area adjacent to the school. Western side of the street. Heading north.  
Area between power pole no. EP73713 & EP73712.

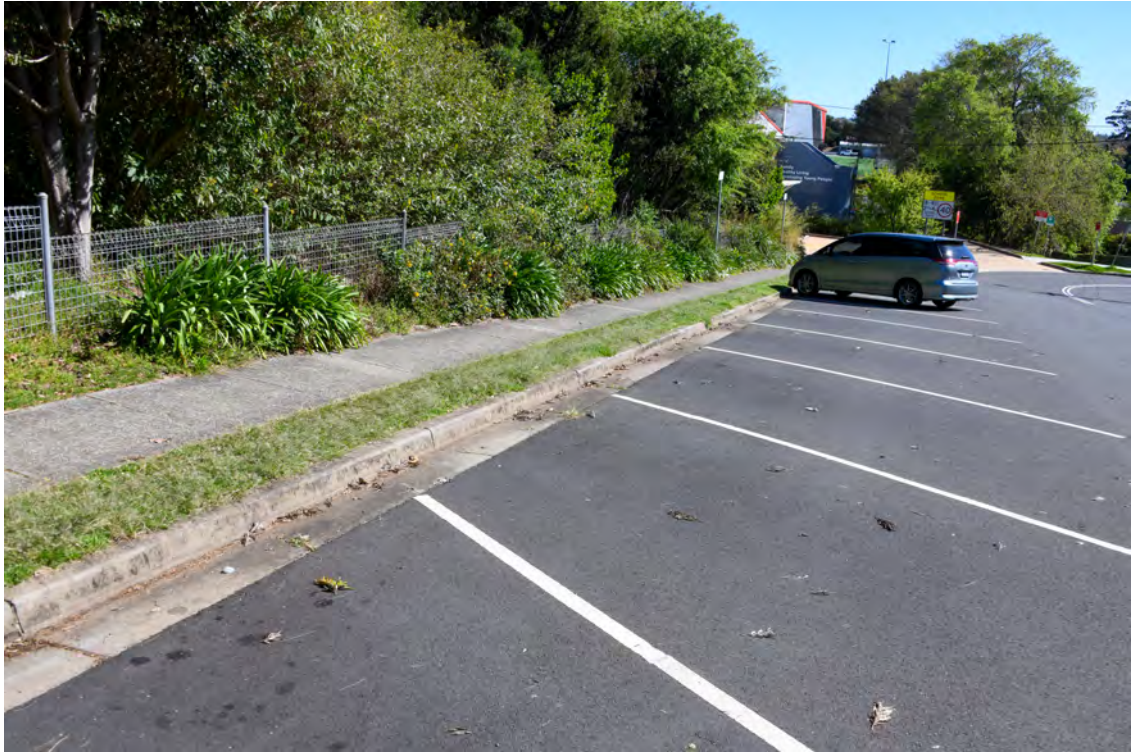
PRO\_1374.jpg

Ward Street. Area adjacent to the school. Western side of the street. Heading north.  
Area between power pole no. EP73713 & EP73712.

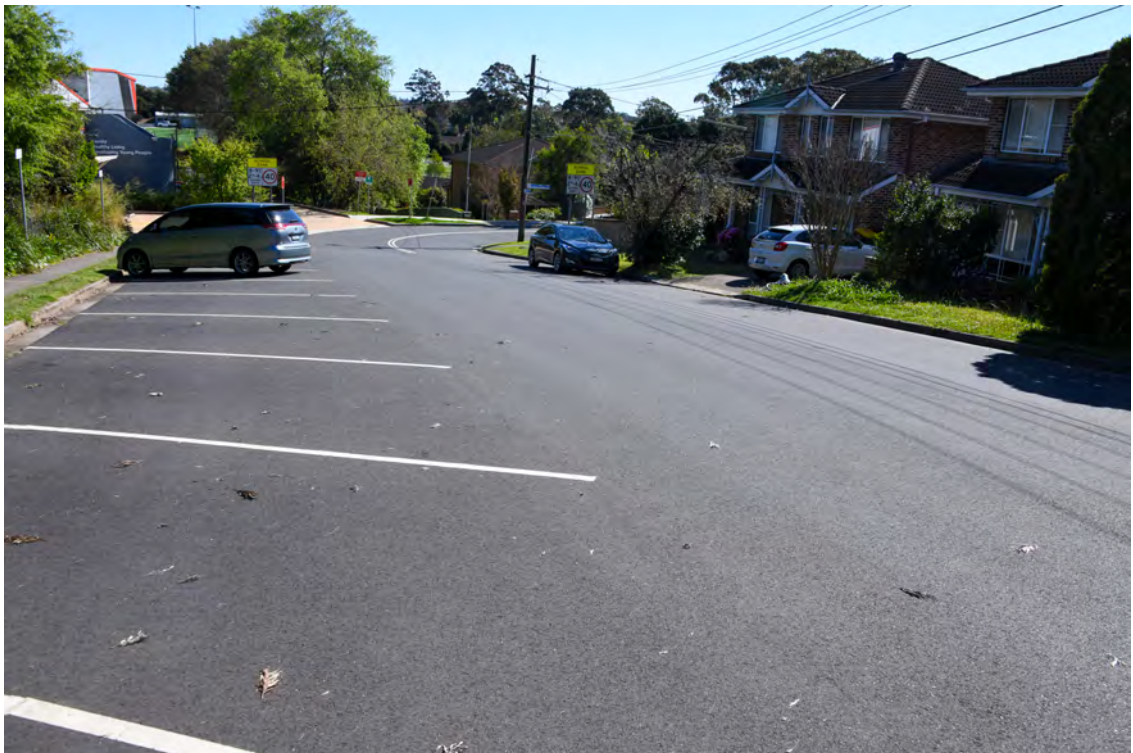
PRO\_1375.jpg

Ward Street. Area adjacent to the school. Western side of the street. Heading north.  
Area between power pole no. EP73713 & EP73712.

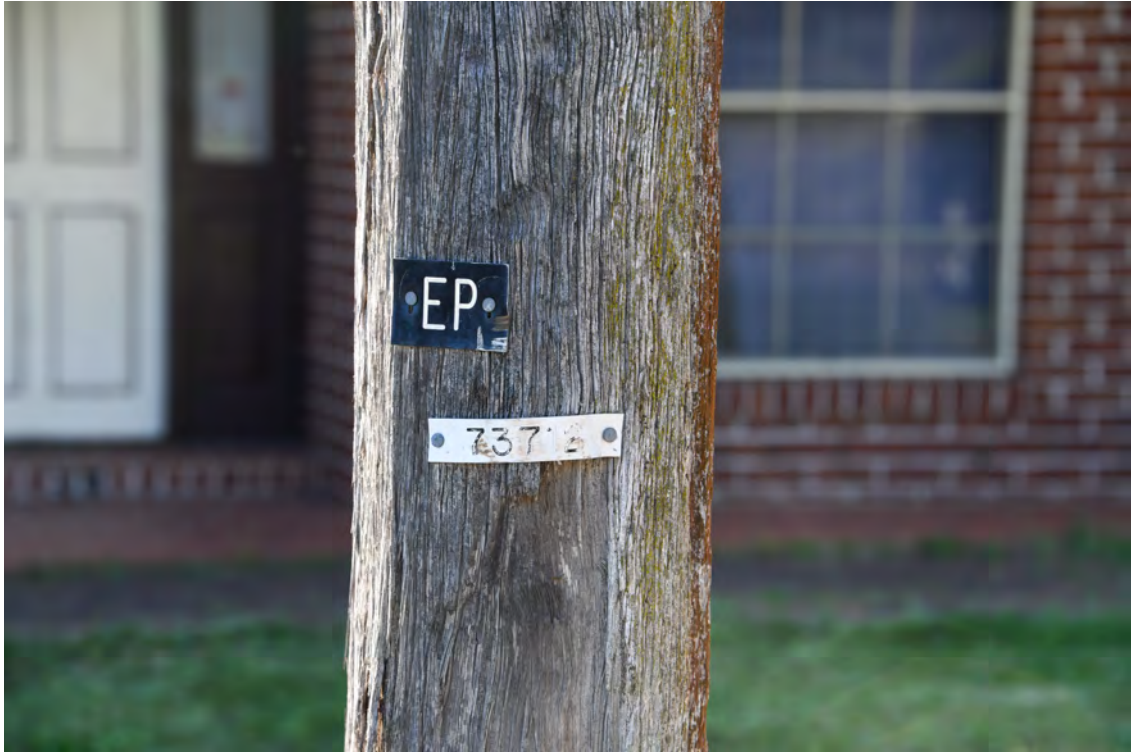
PRO\_1376.jpg

Ward Street. Area adjacent to the school. Western side of the street. Heading north.  
Power pole no. EP73712.

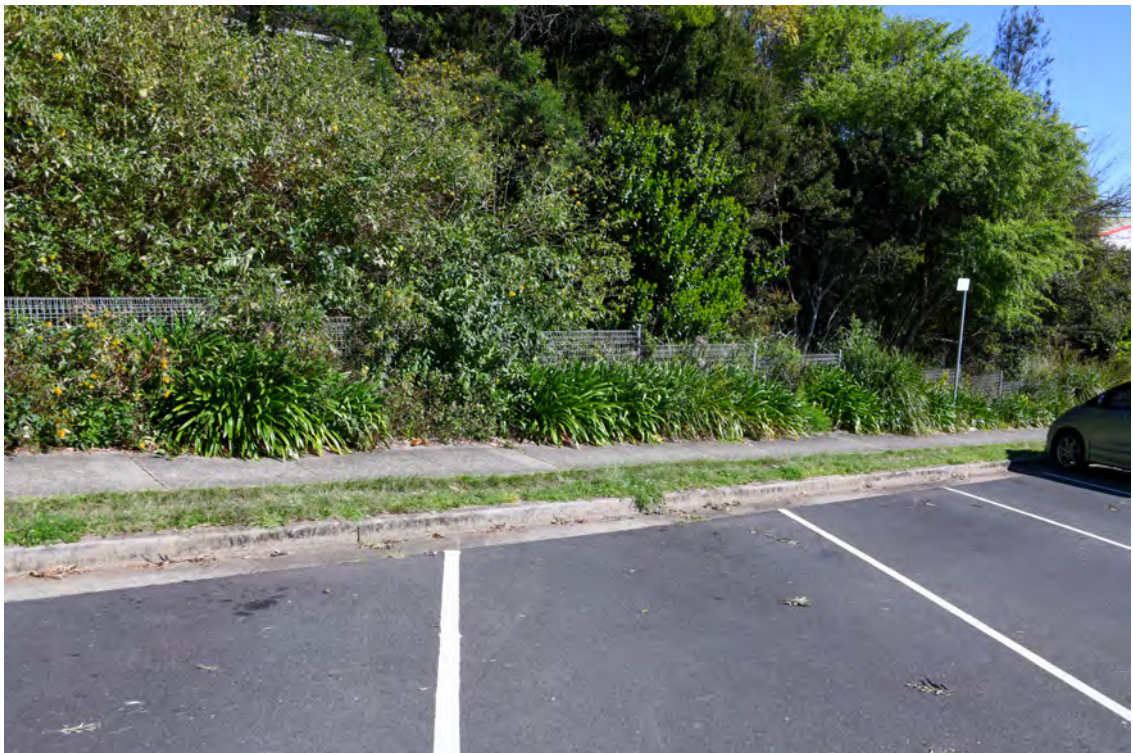
PRO\_1377.jpg

Ward Street. Area adjacent to the school. Western side of the street. Heading north.  
Area between power pole no. EP73712 & EP73711.

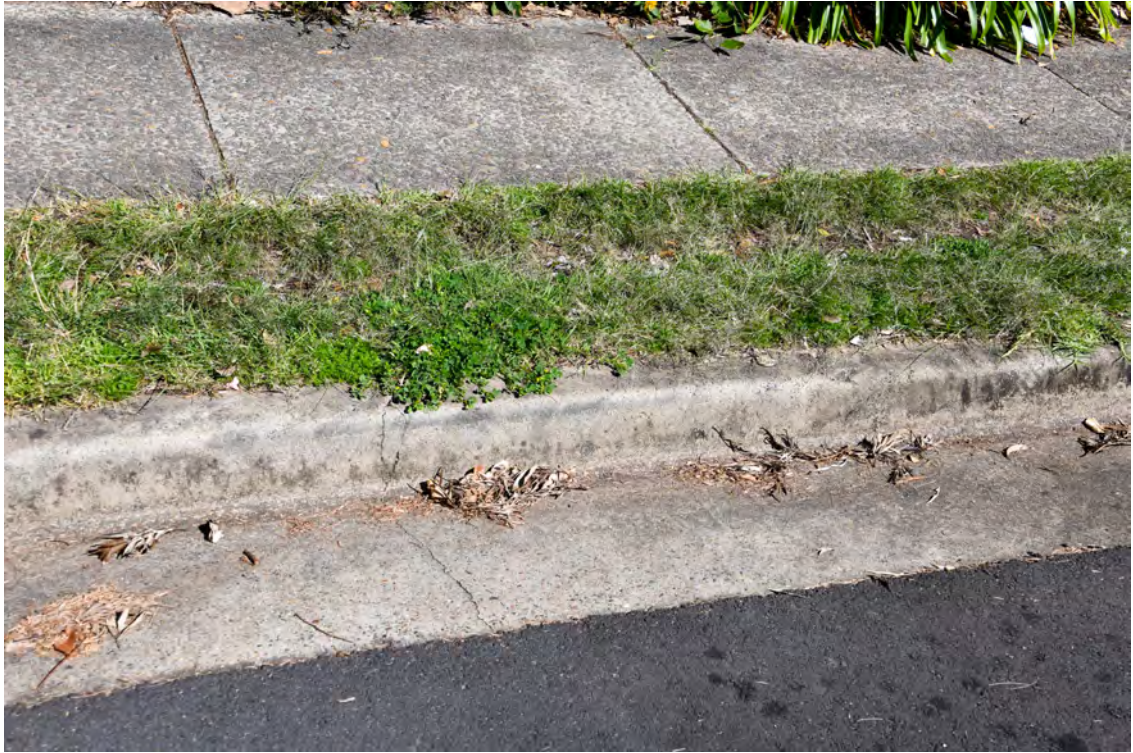
PRO\_1378.jpg

Ward Street. Area adjacent to the school. Western side of the street. Heading north.  
Area between power pole no. EP73712 & EP73711.

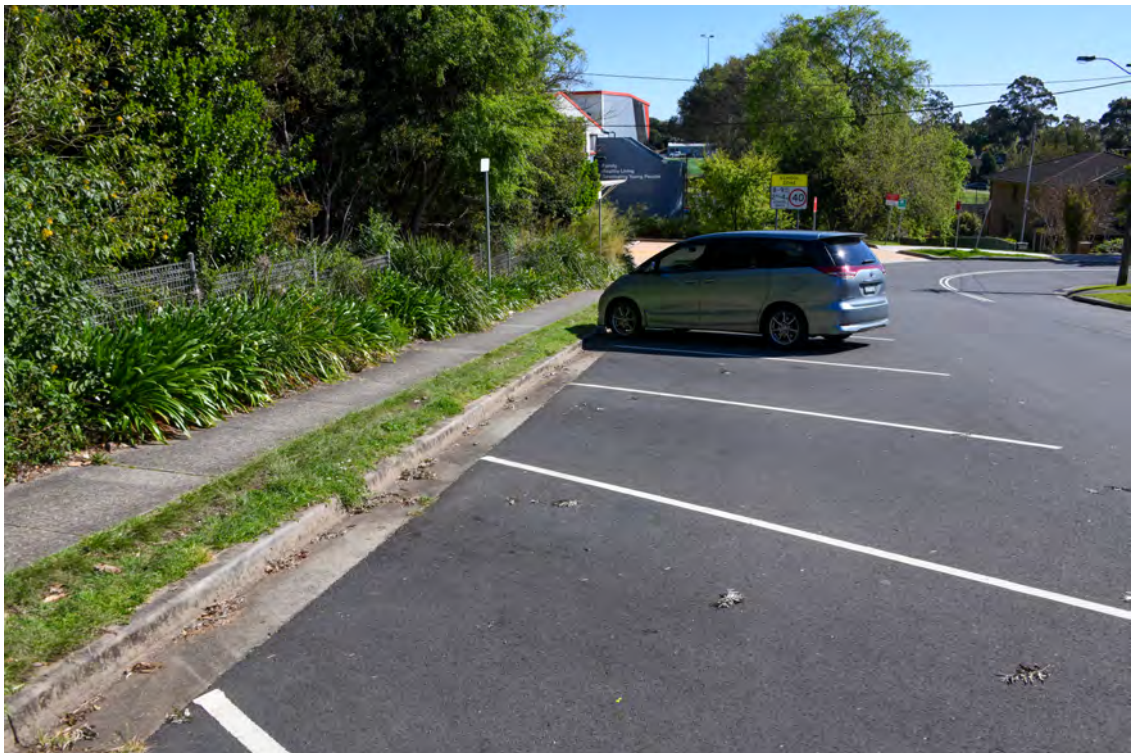
PRO\_1379.jpg

Ward Street. Area adjacent to the school. Western side of the street. Heading north.  
Area between power pole no. EP73712 & EP73711.

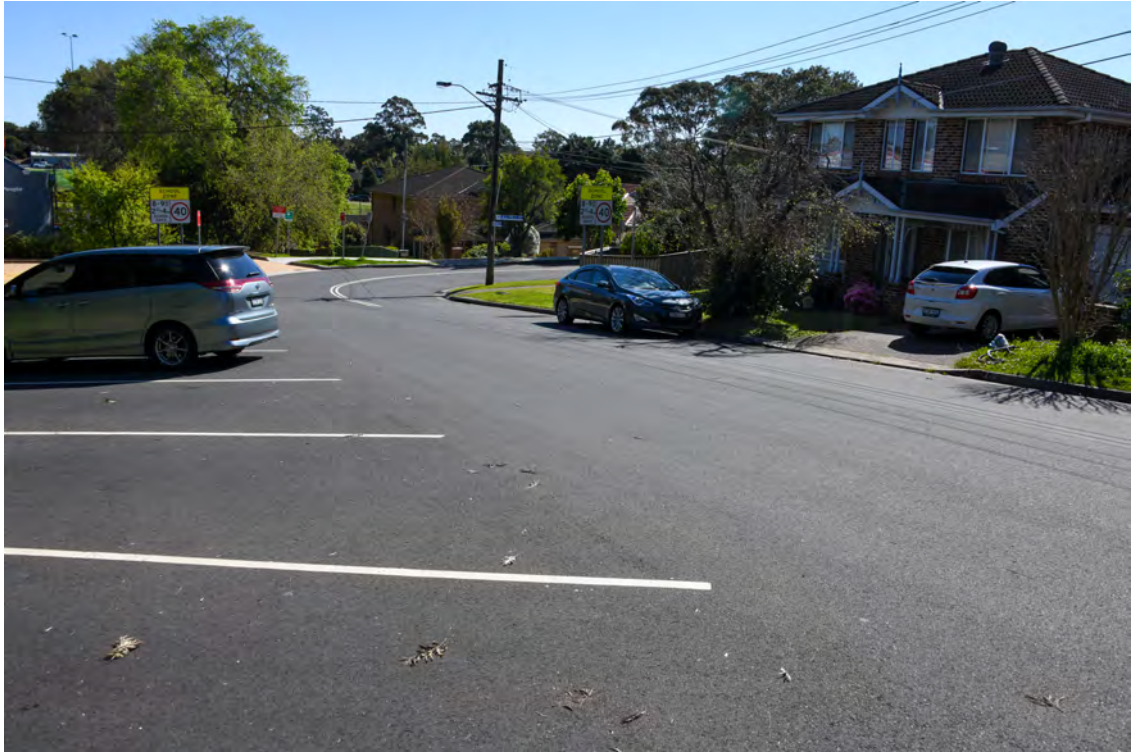
PRO\_1380.jpg

Ward Street. Area adjacent to the school. Western side of the street. Heading north.  
Area between power pole no. EP73712 & EP73711.

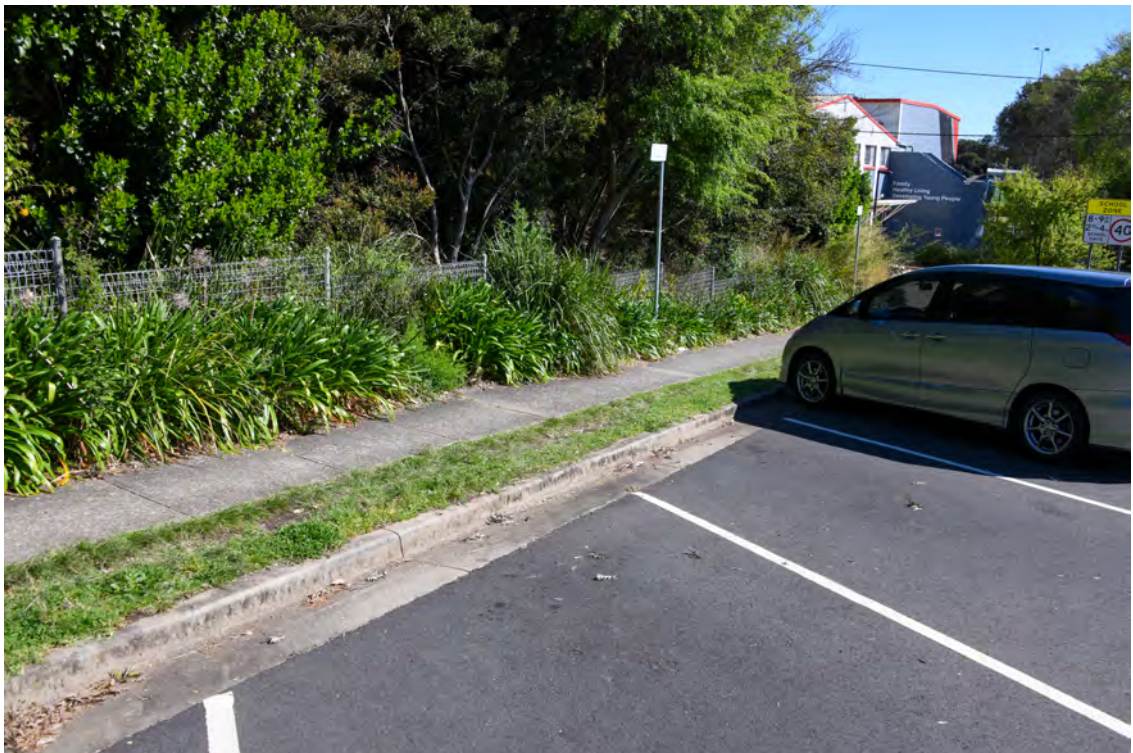
PRO\_1381.jpg

Ward Street. Area adjacent to the school. Western side of the street. Heading north.  
Area between power pole no. EP73712 & EP73711.

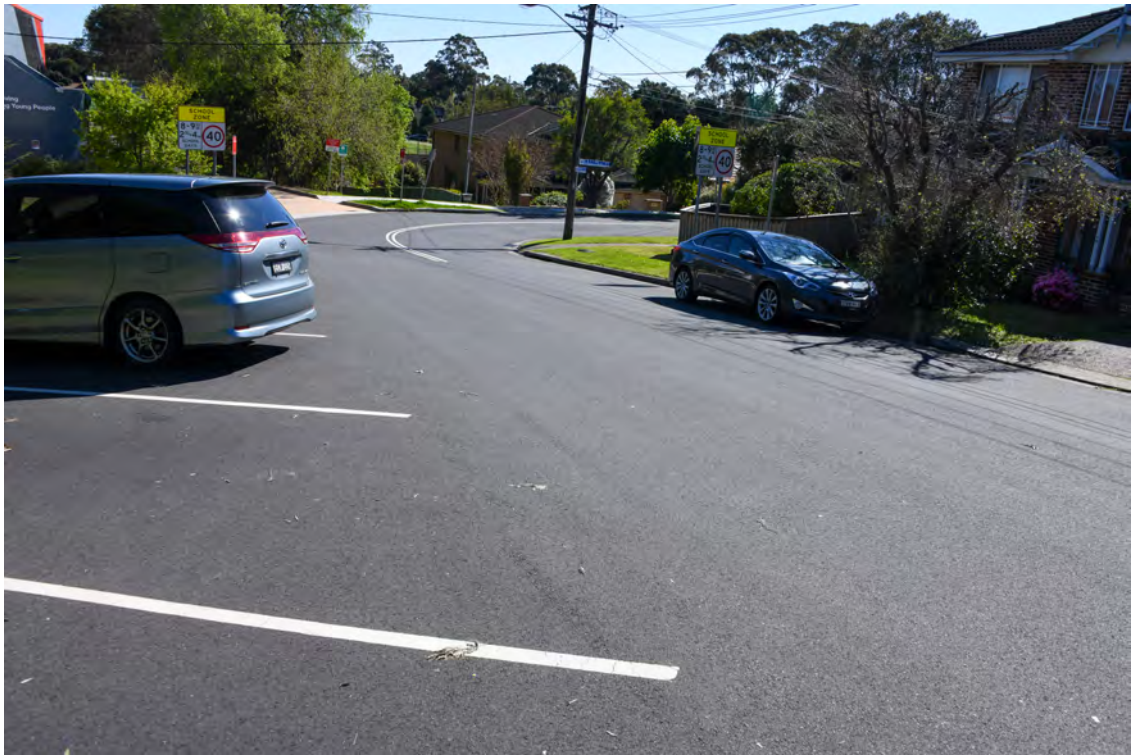
PRO\_1382.jpg

Ward Street. Area adjacent to the school. Western side of the street. Heading north.  
Area between power pole no. EP73712 & EP73711.

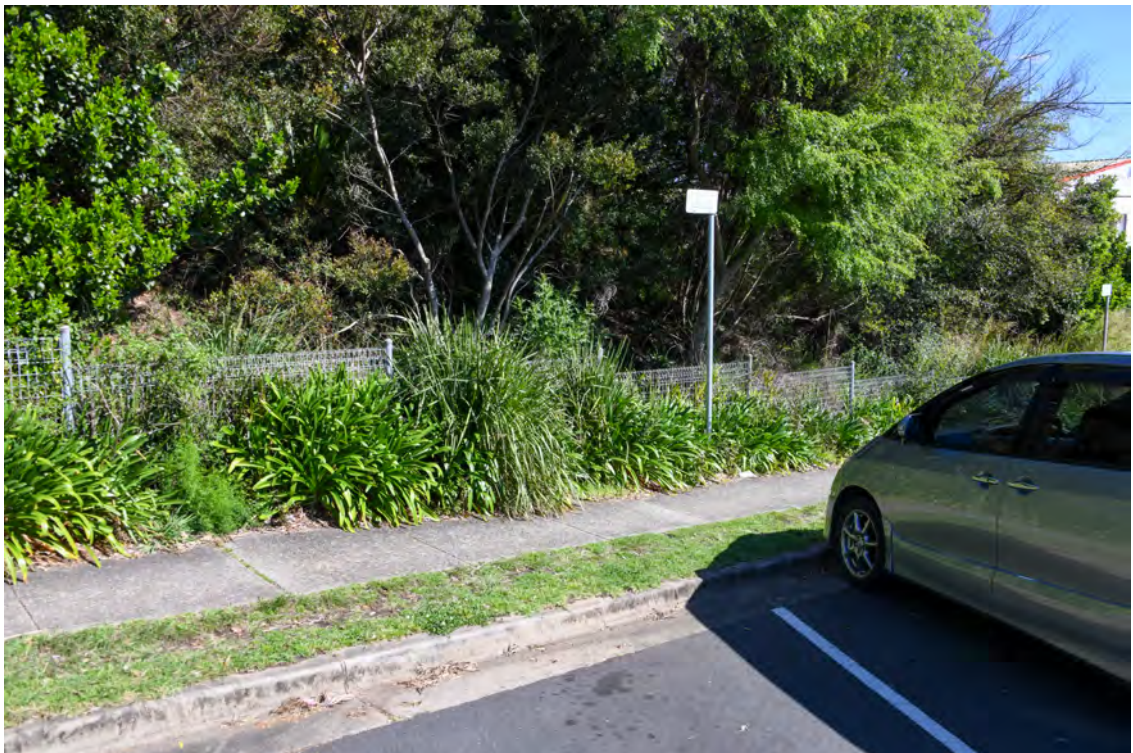
PRO\_1383.jpg

Ward Street. Area adjacent to the school. Western side of the street. Heading north.  
Area between power pole no. EP73712 & EP73711.

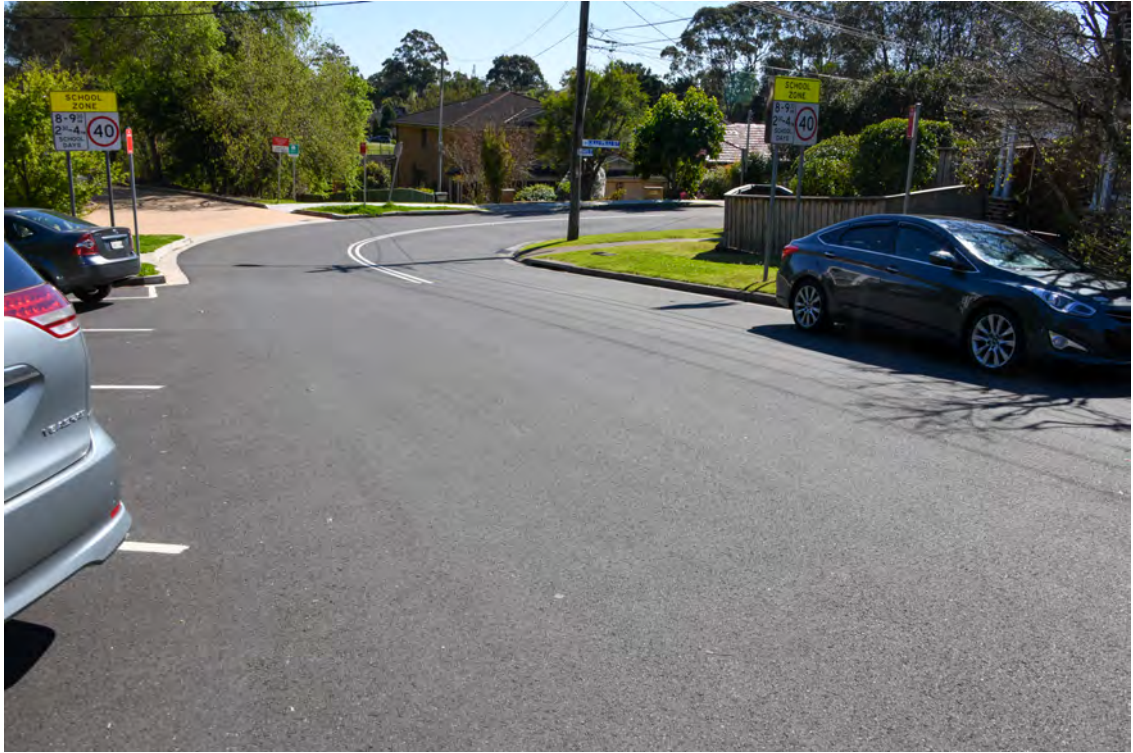
PRO\_1384.jpg

Ward Street. Area adjacent to the school. Western side of the street. Heading north.  
Area between power pole no. EP73712 & EP73711.

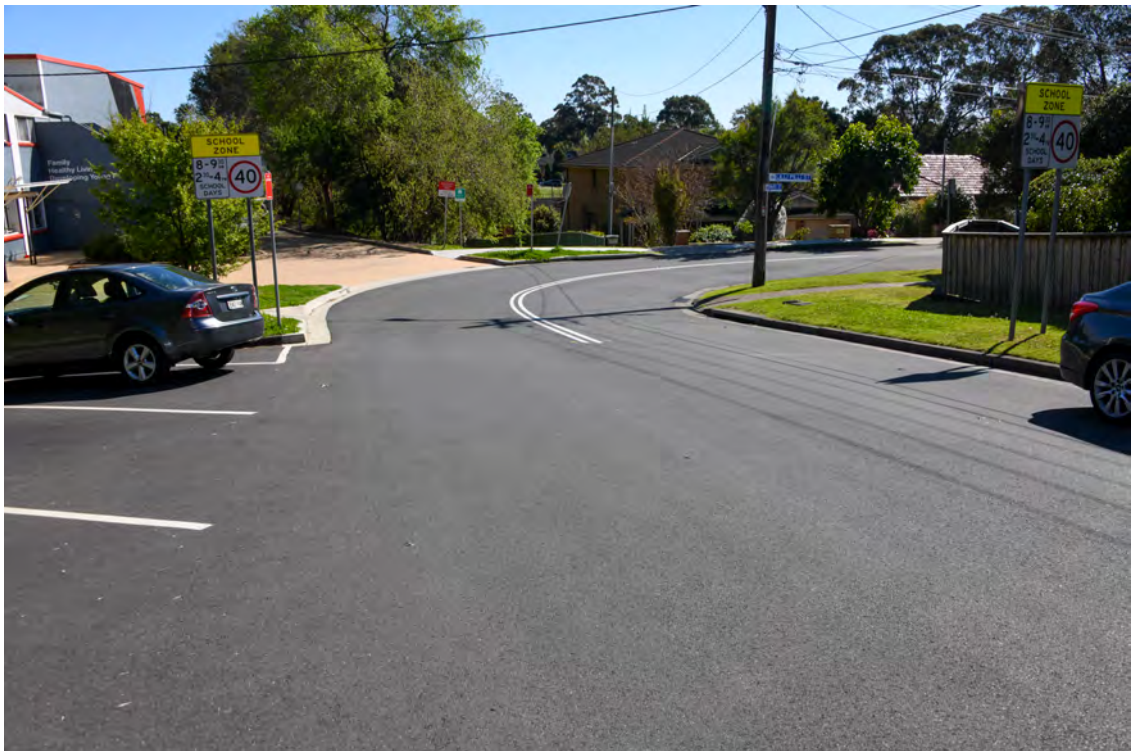
PRO\_1385.jpg

Ward Street. Area adjacent to the school. Western side of the street. Heading north.  
Area between power pole no. EP73712 & EP73711.

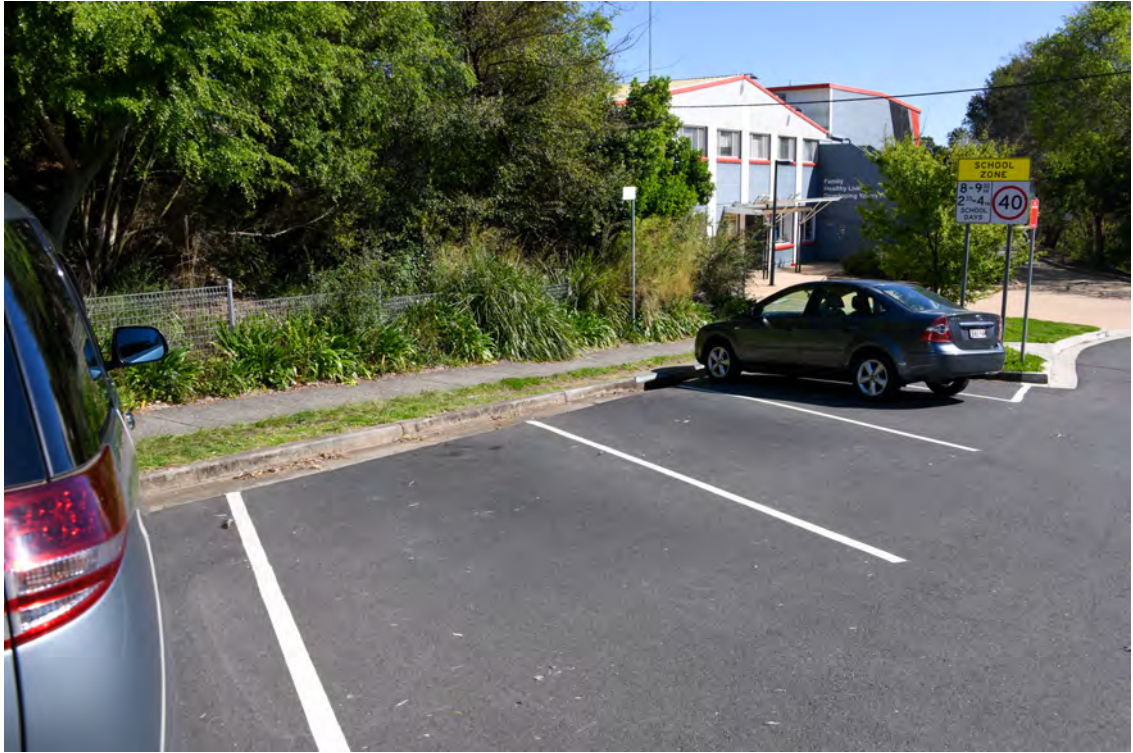
PRO\_1386.jpg

Ward Street. Area adjacent to the school. Western side of the street. Heading north.  
Area between power pole no. EP73712 & EP73711.

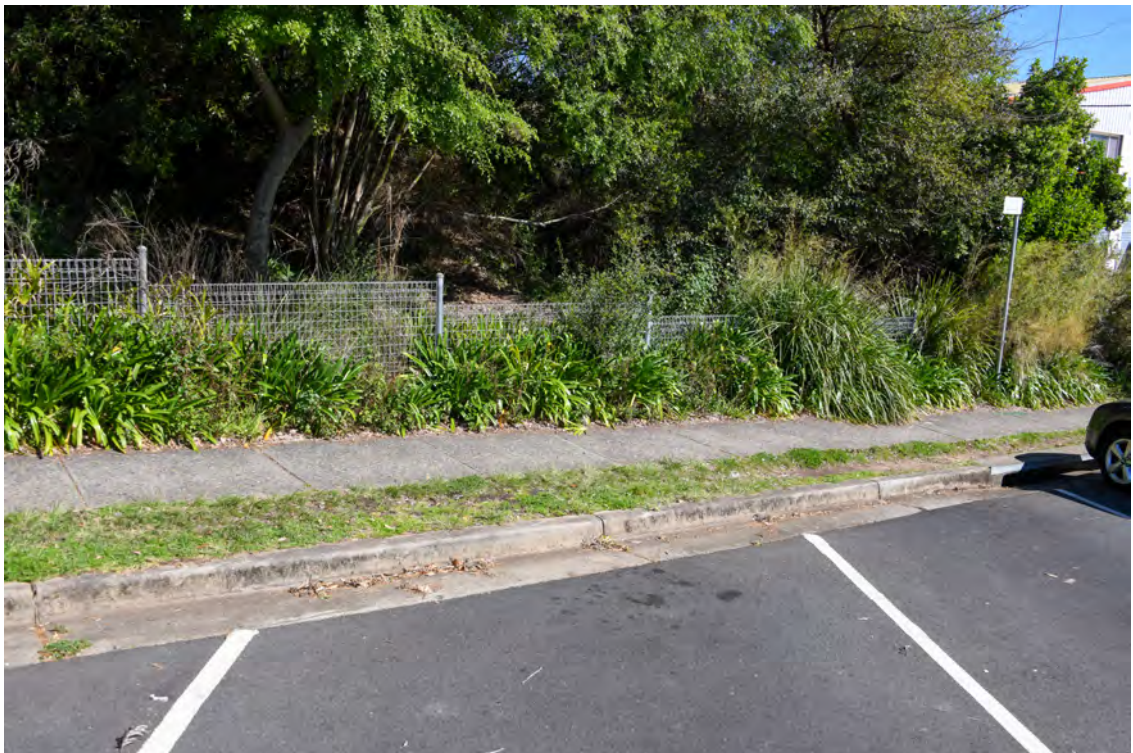
PRO\_1387.jpg

Ward Street. Area adjacent to the school. Western side of the street. Heading north.  
Area between power pole no. EP73712 & EP73711.

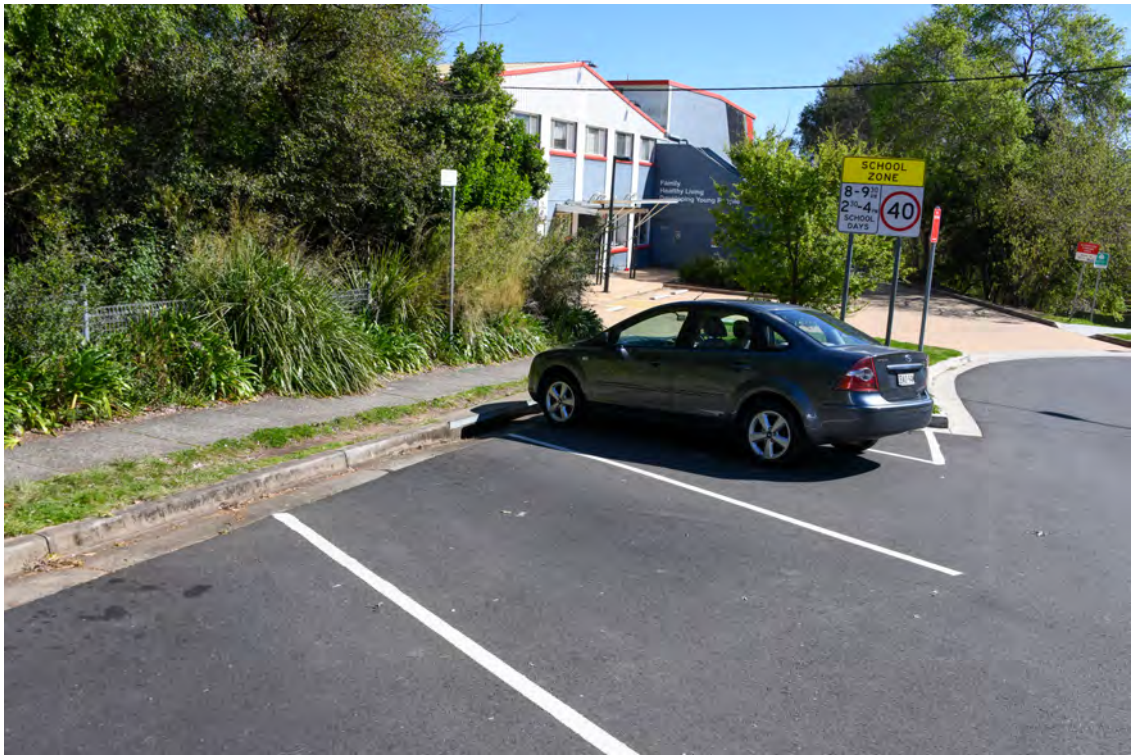
PRO\_1388.jpg

Ward Street. Area adjacent to the school. Western side of the street. Heading north.  
Area between power pole no. EP73712 & EP73711.

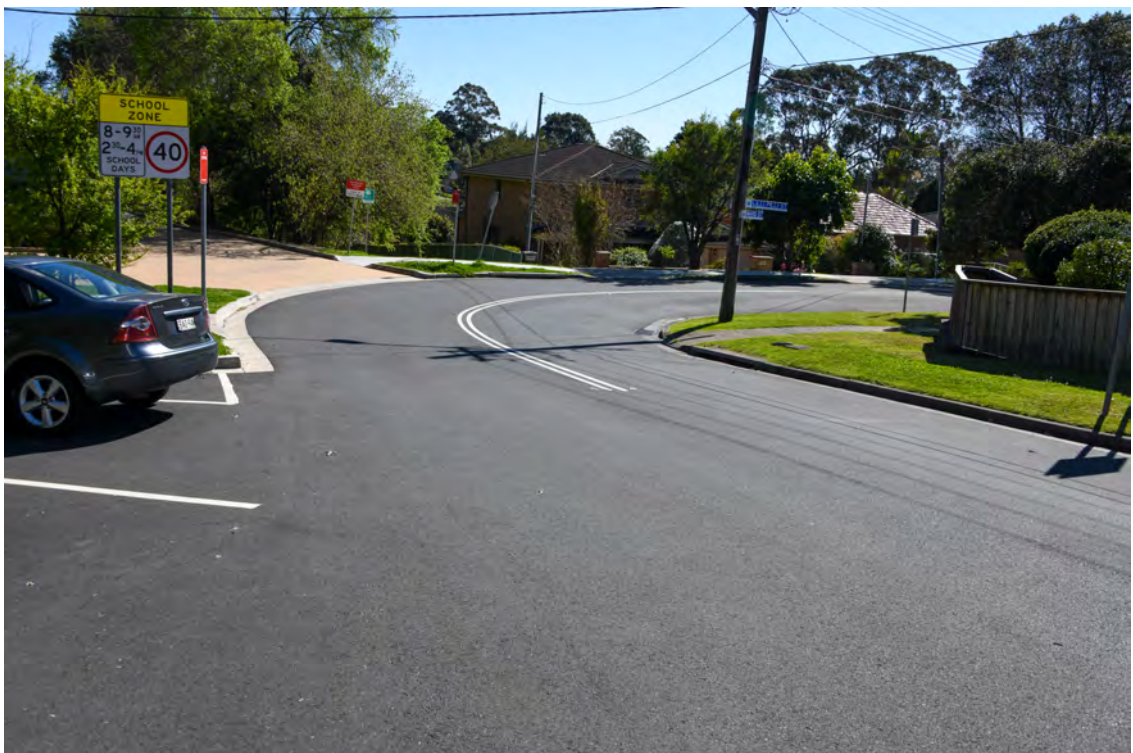
PRO\_1389.jpg

Ward Street. Area adjacent to the school. Western side of the street. Heading north.  
Area between power pole no. EP73712 & EP73711.

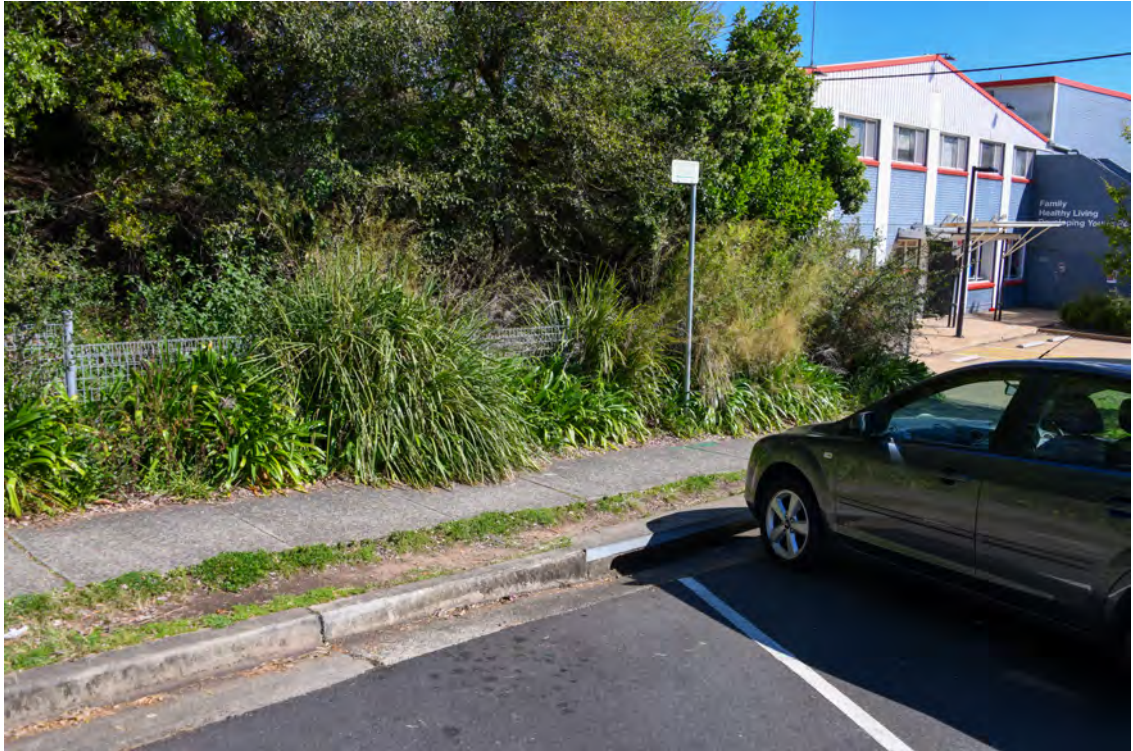
PRO\_1390.jpg

Ward Street. Area adjacent to the school. Western side of the street. Heading north.  
Area between power pole no. EP73712 & EP73711.

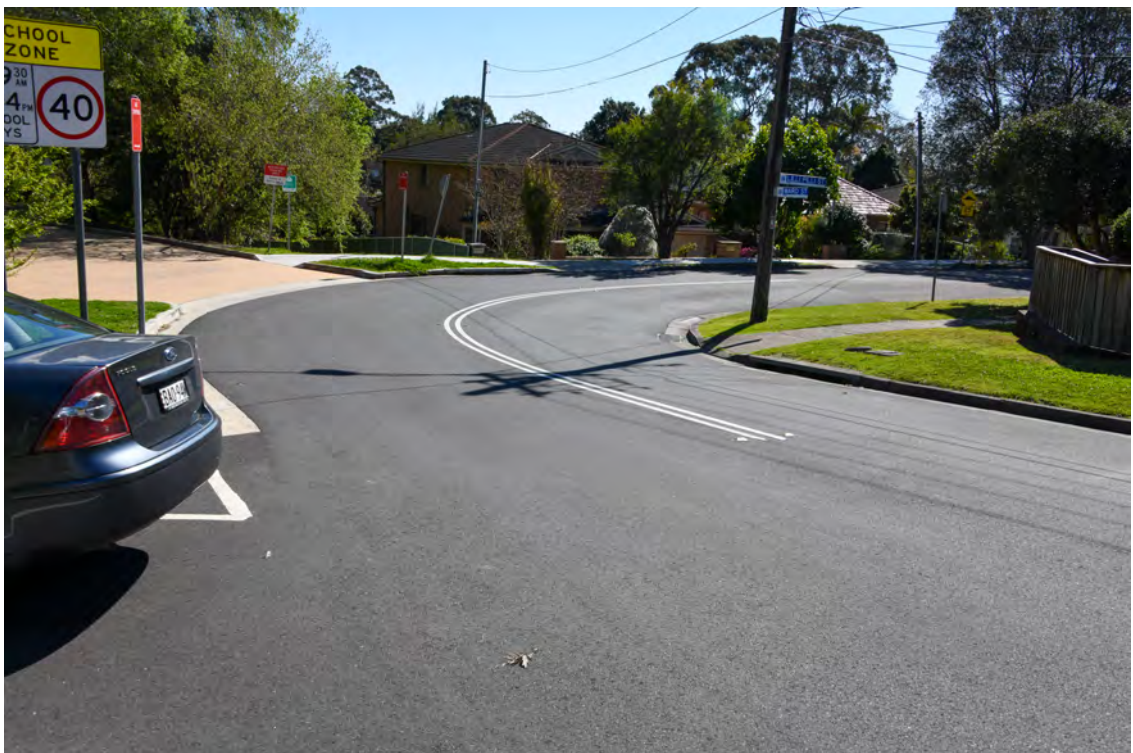
PRO\_1391.jpg

Ward Street. Area adjacent to the school. Western side of the street. Heading north.  
Area between power pole no. EP73712 & EP73711.

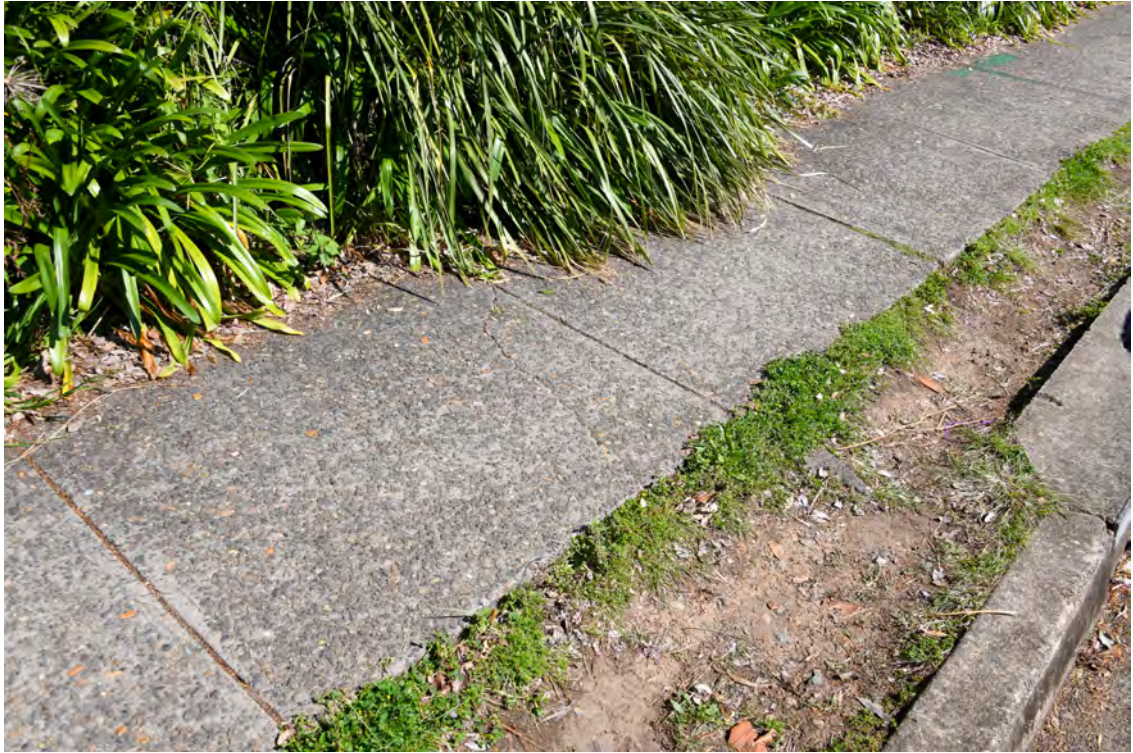
PRO\_1392.jpg

Ward Street. Area adjacent to the school. Western side of the street. Heading north.  
Area between power pole no. EP73712 & EP73711.

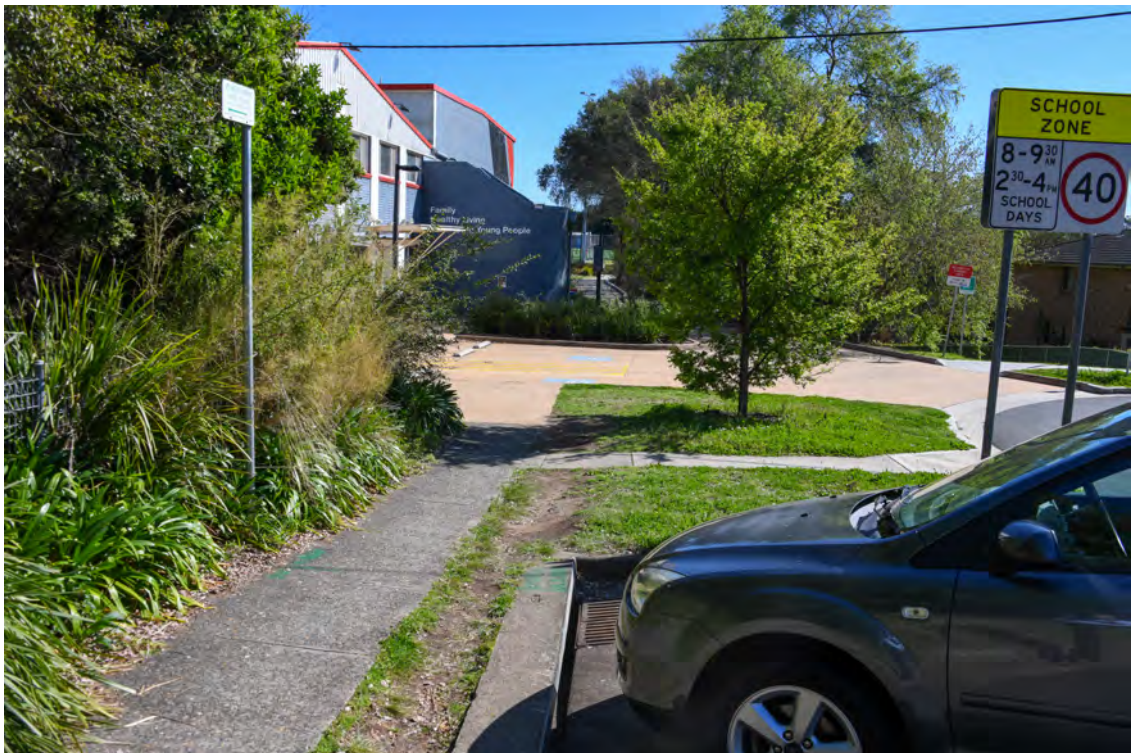
PRO\_1393.jpg

Ward Street. Area adjacent to the school. Western side of the street. Heading north.  
Area between power pole no. EP73712 & EP73711.

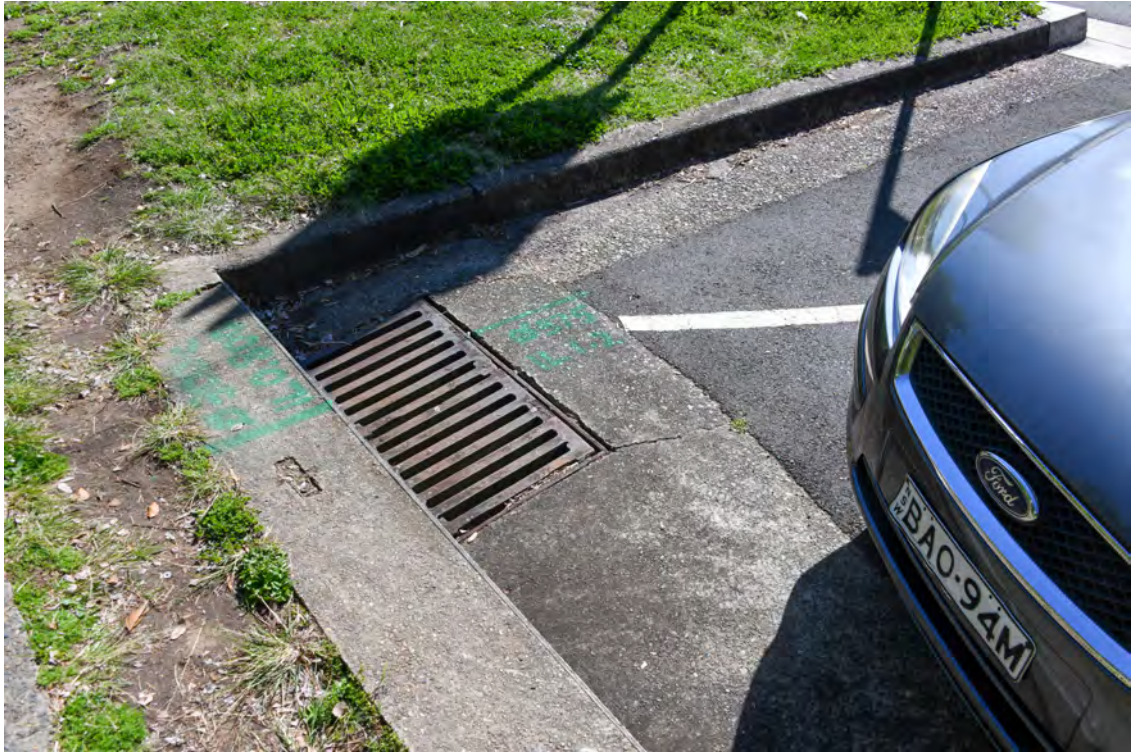
PRO\_1394.jpg

Ward Street. Area adjacent to the school. Western side of the street. Heading north.  
Area between power pole no. EP73712 & EP73711.

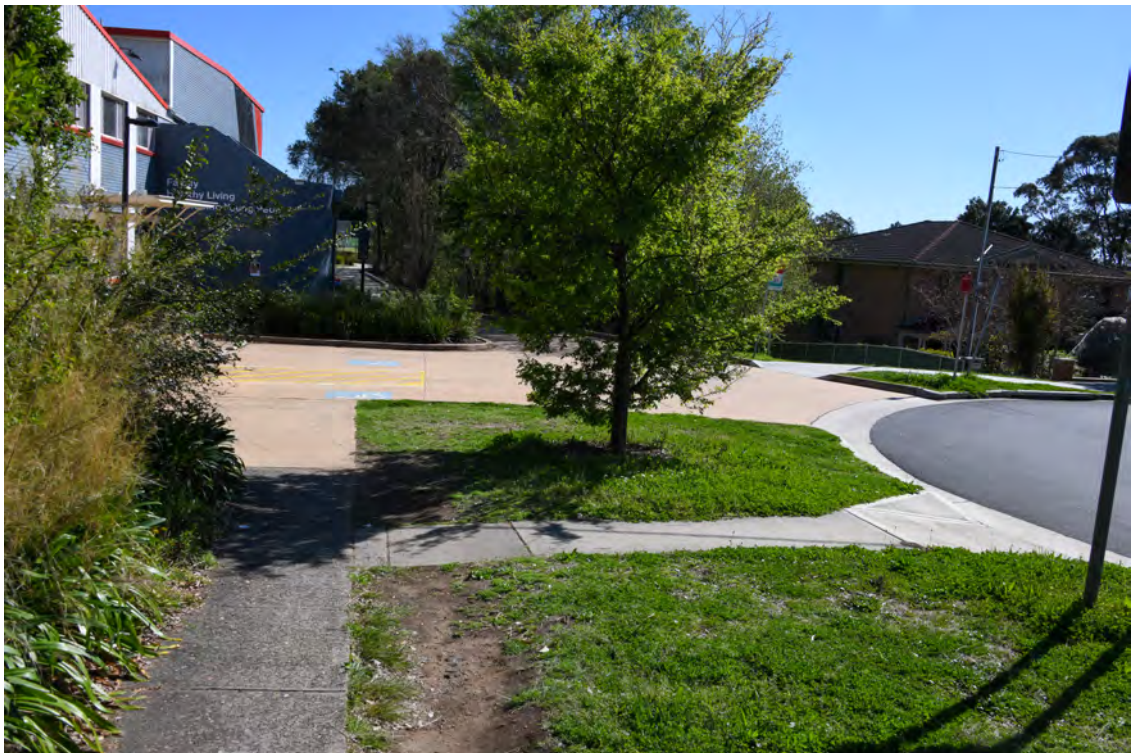
PRO\_1395.jpg

Ward Street. Area adjacent to the school. Western side of the street. Heading north.  
Area between power pole no. EP73712 & EP73711.

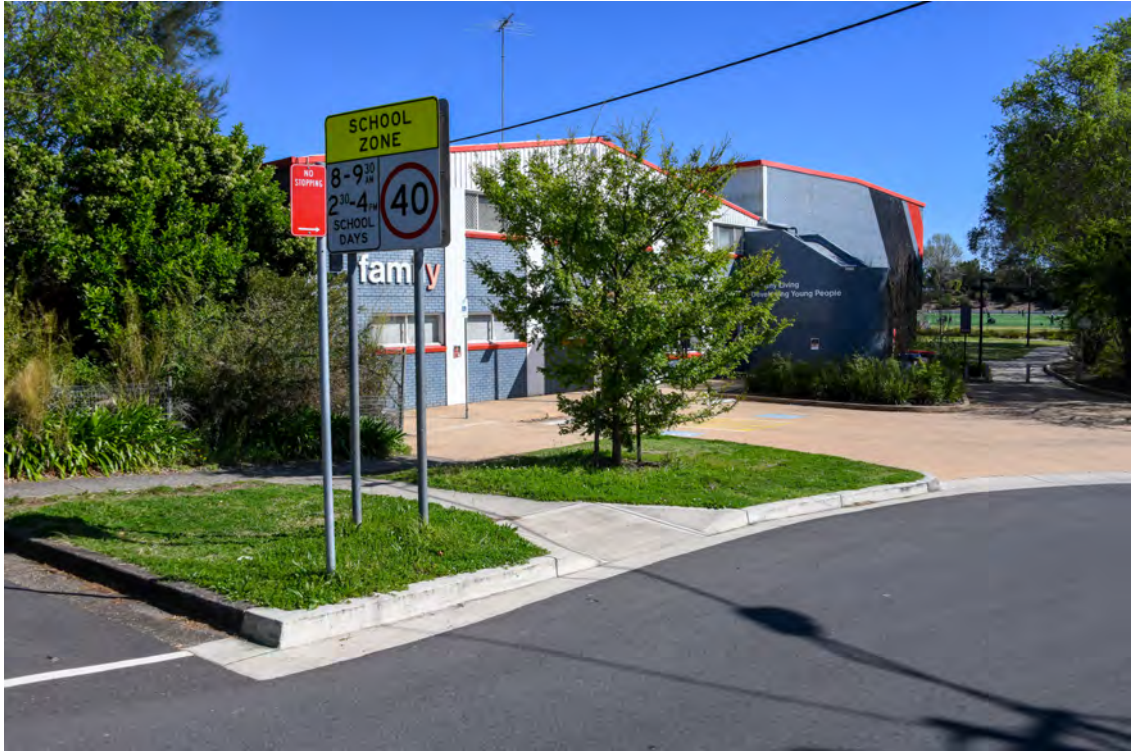
PRO\_1396.jpg

Ward Street. Area adjacent to the school. Western side of the street. Heading north. Area between power pole no. EP73712 & EP73711.

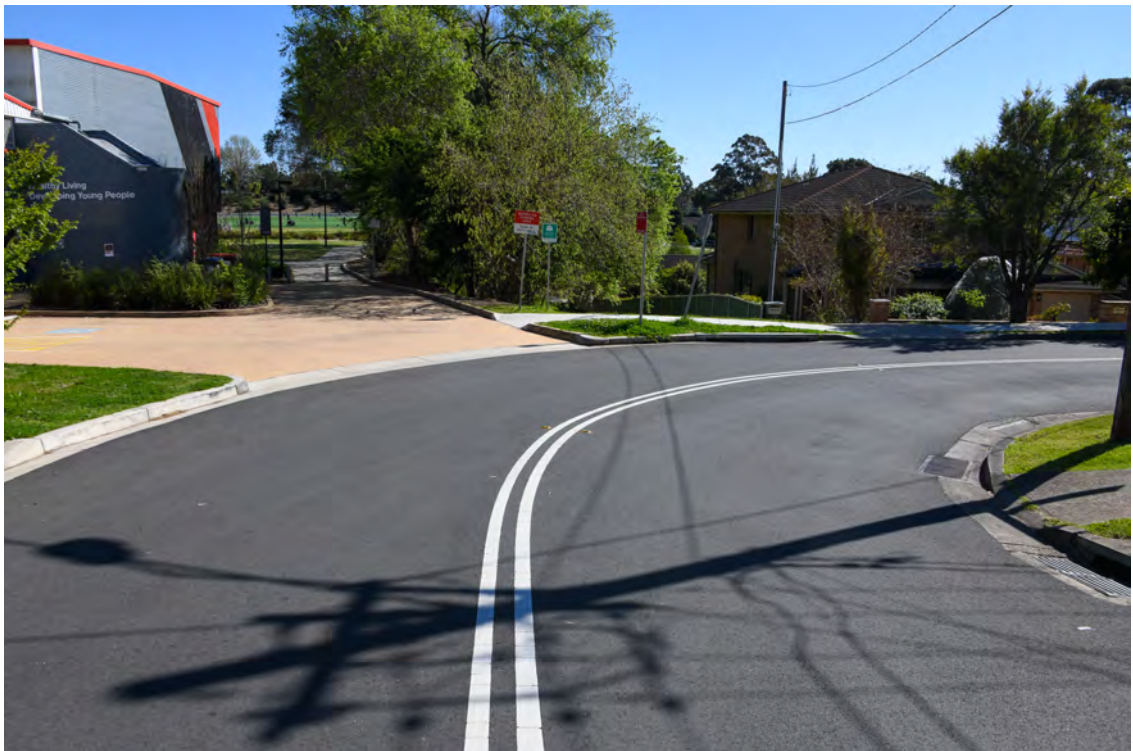
PRO\_1397.jpg

Ward Street. Intersection with Lilli Pilli Street. Area adjacent to the YMCA. Heading north. Area of power pole no. EP73711.

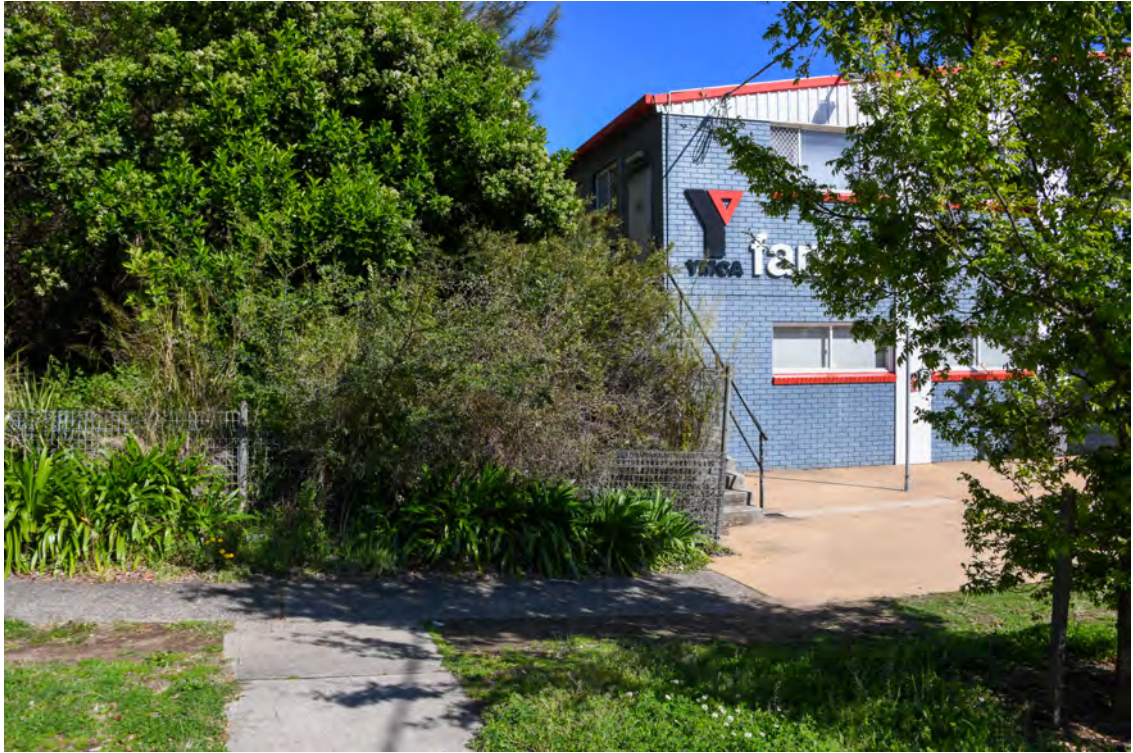
PRO\_1398.jpg

Ward Street. Intersection with Lilli Pilli Street. Area adjacent to the YMCA. Heading north. Area of power pole no. EP73711.
