96-104 Carlingford Road, Epping NSW 2121

Epping West Public School

DILAPIDATION REPORT

7<sup>th</sup> September 2021

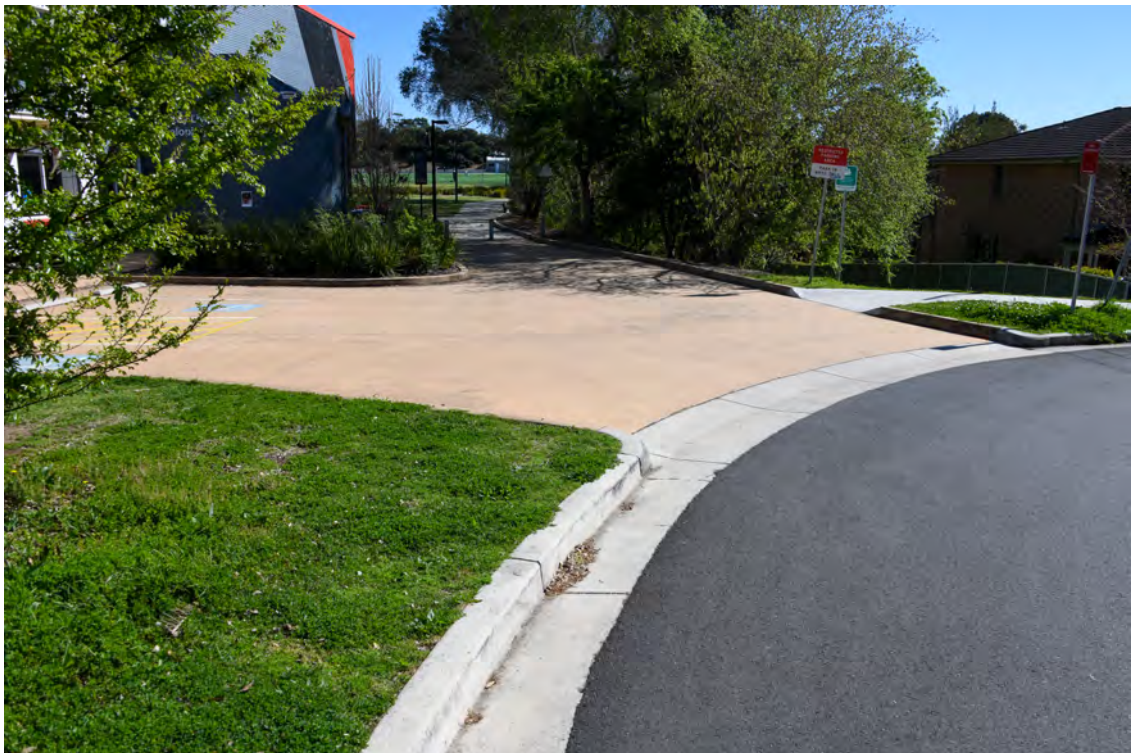
PRO\_1399.jpg

Ward Street. Intersection with Lilli Pilli Street. Area adjacent to the YMCA. Heading north. Area of power pole no. EP73711.

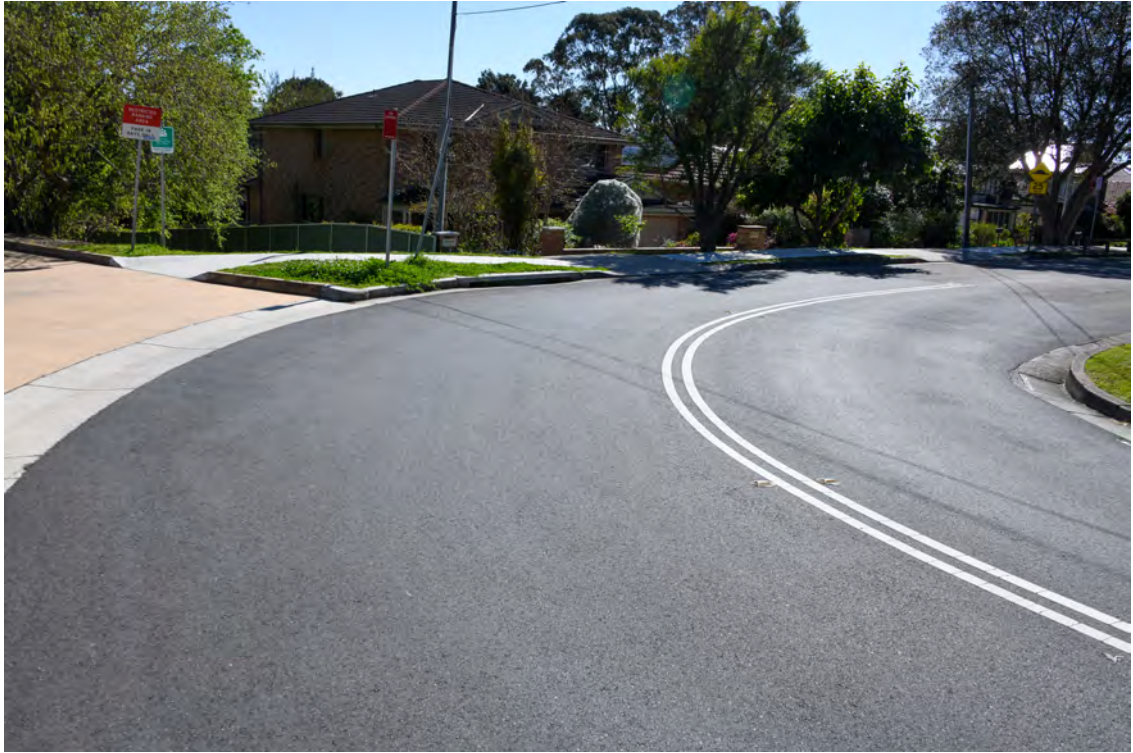
PRO\_1400.jpg

Ward Street. Intersection with Lilli Pilli Street. Area adjacent to the YMCA. Heading north. Area of power pole no. EP73711.

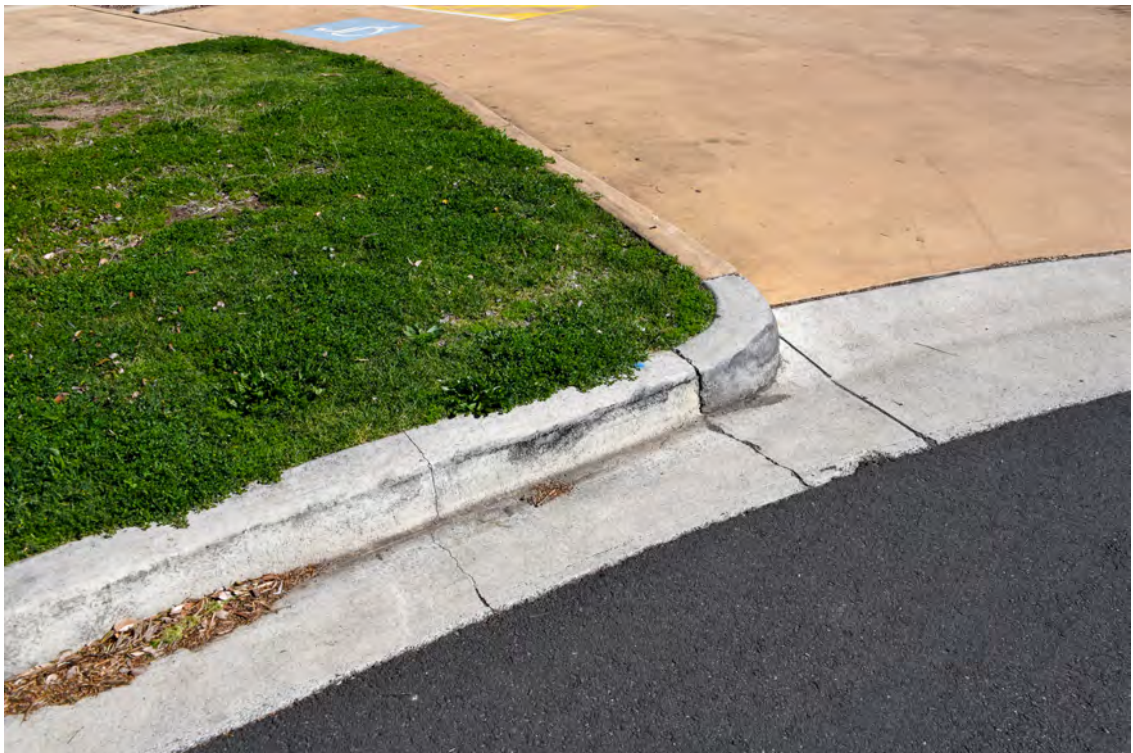
PRO\_1401.jpg

Ward Street. Intersection with Lilli Pilli Street. Area adjacent to the YMCA. Heading north. Area of power pole no. EP73711.

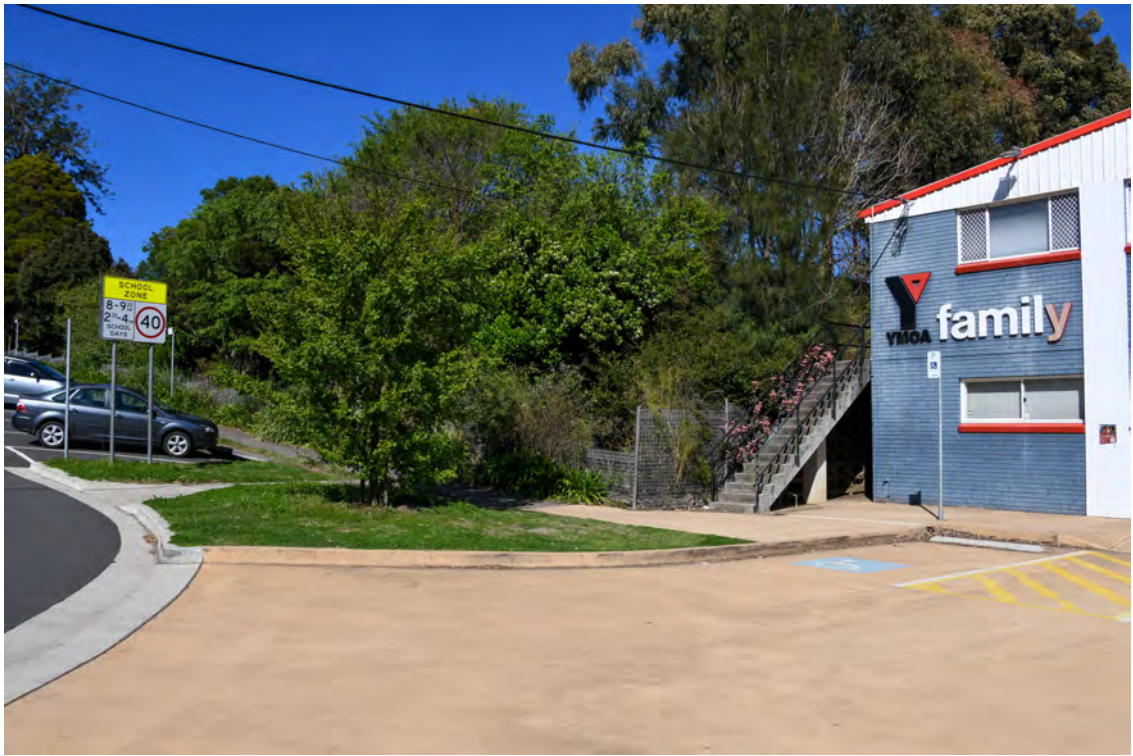
PRO\_1402.jpg

Ward Street. Intersection with Lilli Pilli Street. Area adjacent to the YMCA. Heading south. Area of power pole no. EP73711.

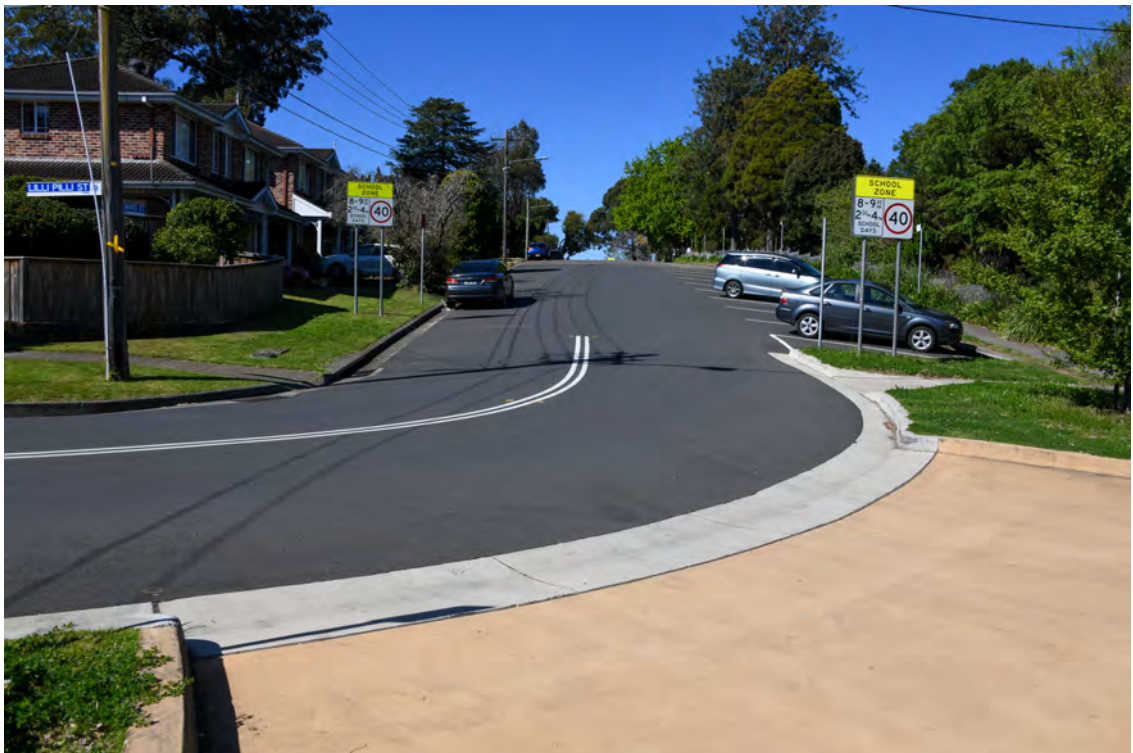
PRO\_1403.jpg

Ward Street. Intersection with Lilli Pilli Street. Area adjacent to the YMCA. Heading south. Area of power pole no. EP73711.

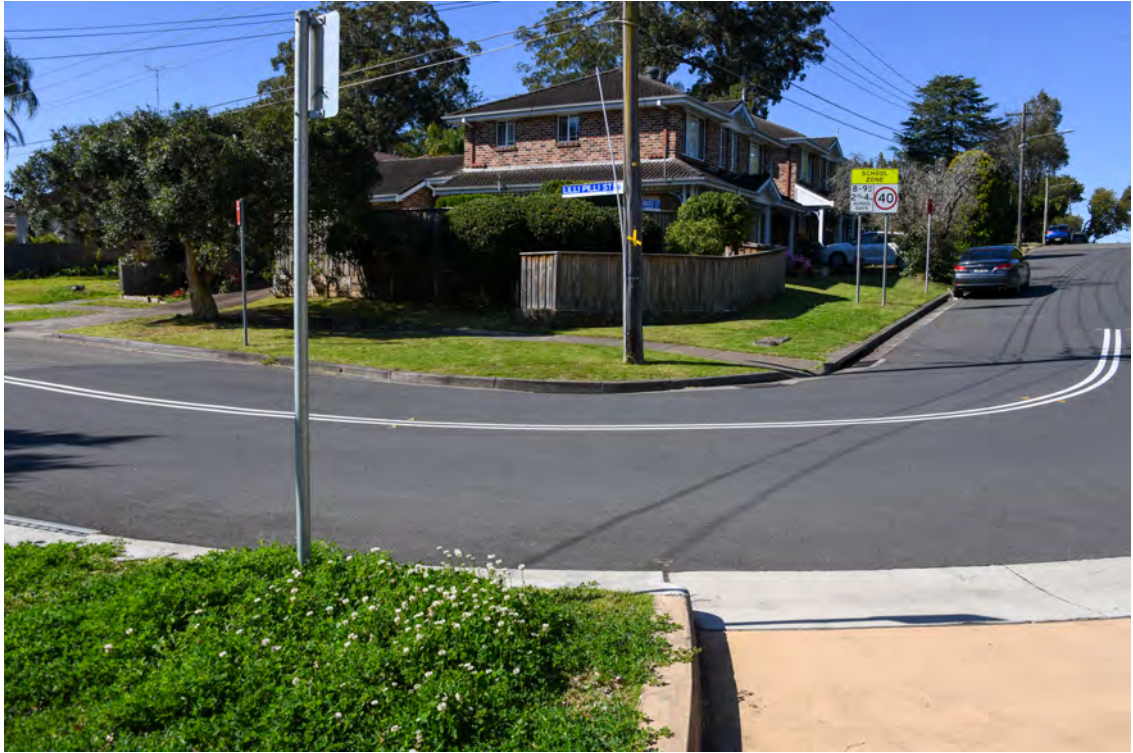
PRO\_1404.jpg

Ward Street. Intersection with Lilli Pilli Street. Area adjacent to the YMCA. Heading south. Area of power pole no. EP73711.

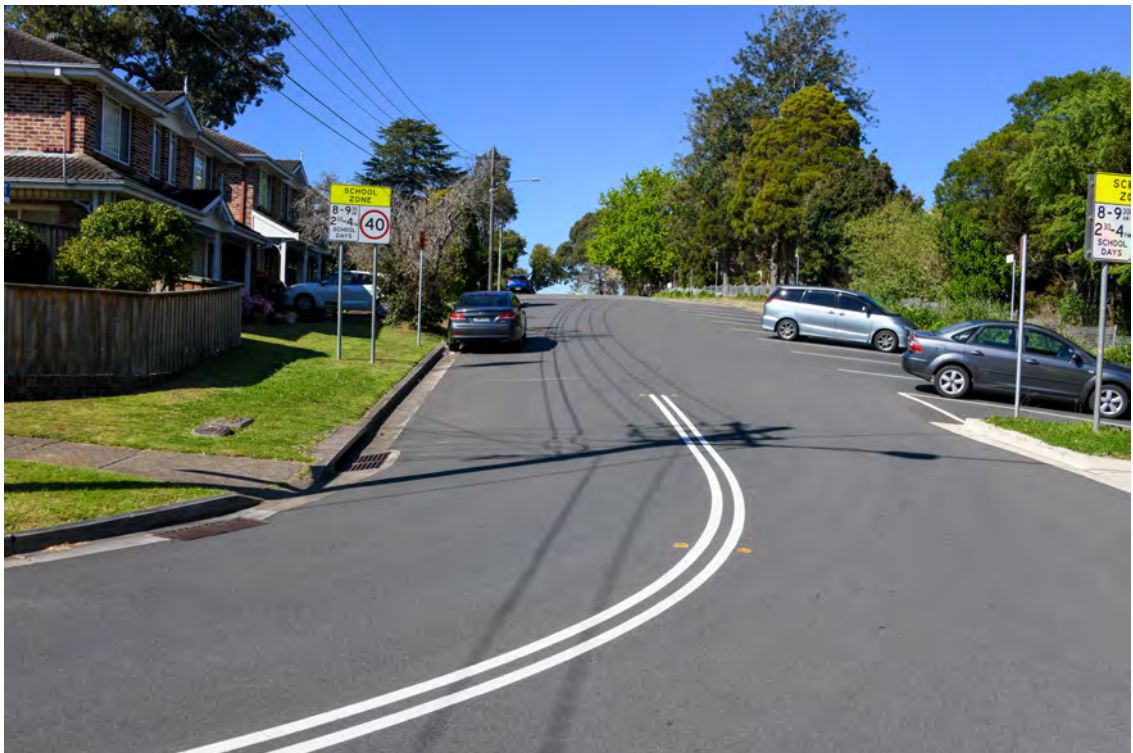
PRO\_1405.jpg

Ward Street. Eastern side of the street. Intersection with Lilli Pilli Street. Area adjacent to the YMCA. Heading south. Area of power pole no. EP73711.

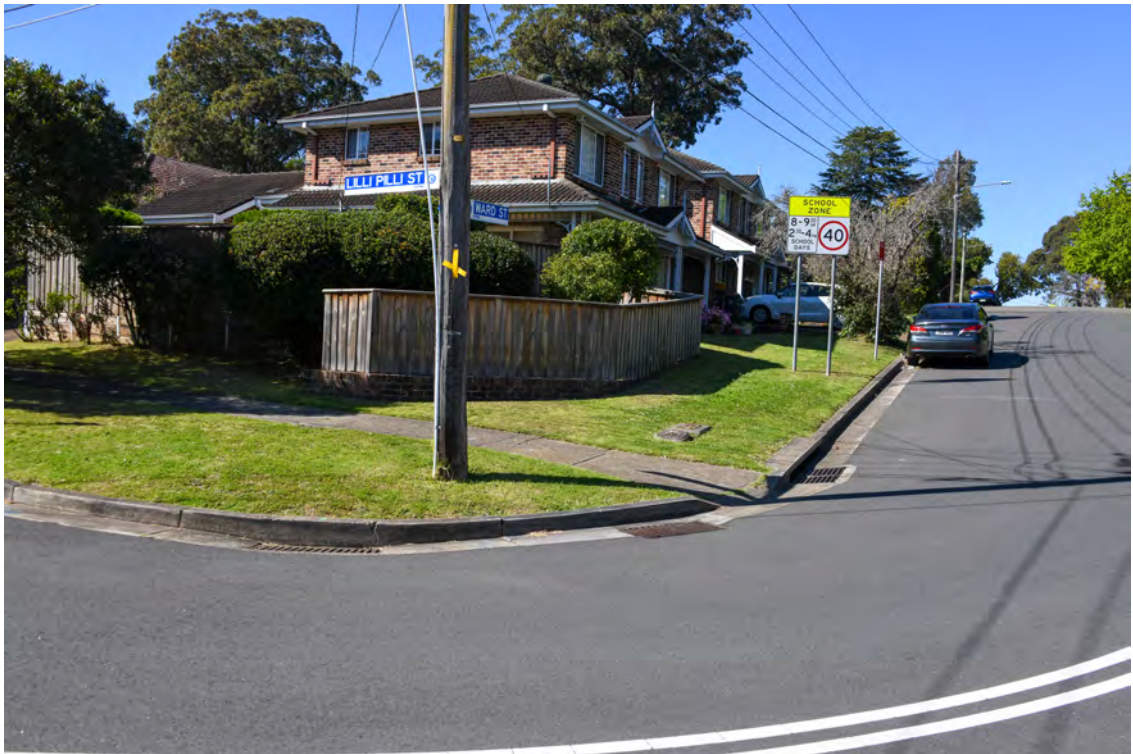
PRO\_1406.jpg

Ward Street. Eastern side of the street. Intersection with Lilli Pilli Street. Area adjacent to the YMCA. Heading south. Area of power pole no. EP73711.

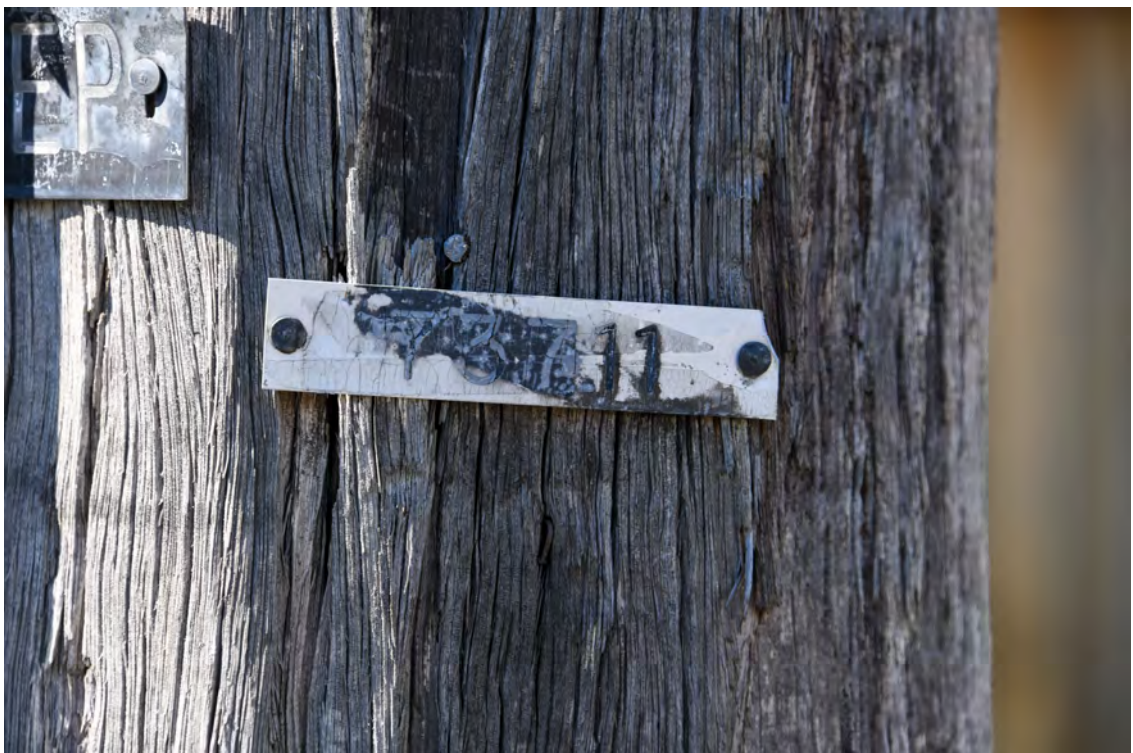
PRO\_1408.jpg

Ward Street. Eastern side of the street. Intersection with Lilli Pilli Street. Area adjacent to the YMCA. Heading south. Area of power pole no. EP73711.

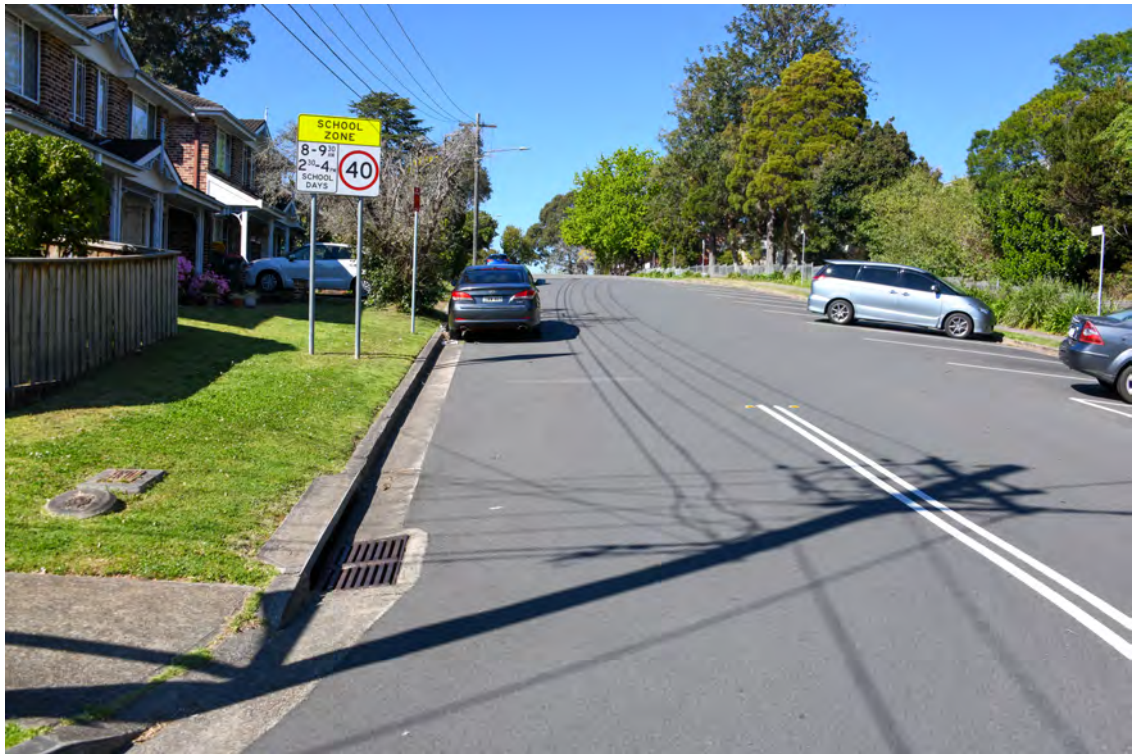
PRO\_1409.jpg

Ward Street. Eastern side of the street. Intersection with Lilli Pilli Street. Area adjacent to power pole no. EP73711. Heading south.

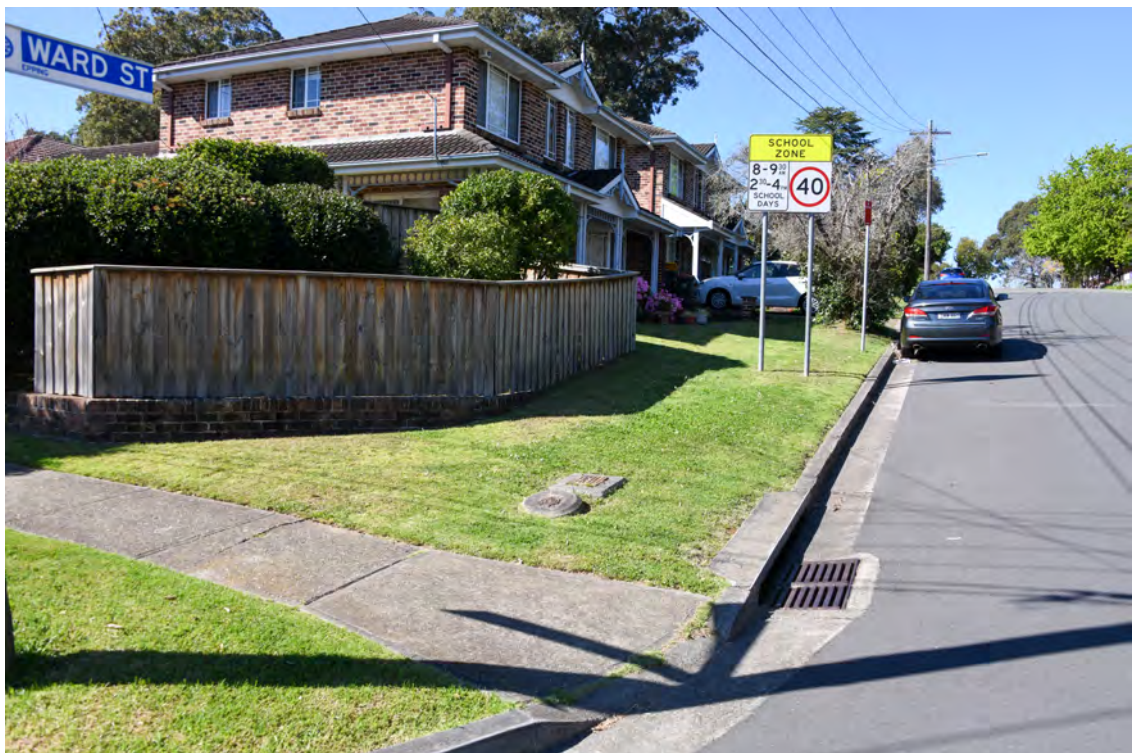
PRO\_1410.jpg

Ward Street. Eastern side of the street. Intersection with Lilli Pilli Street. Area adjacent to power pole no. EP73711. Heading south.

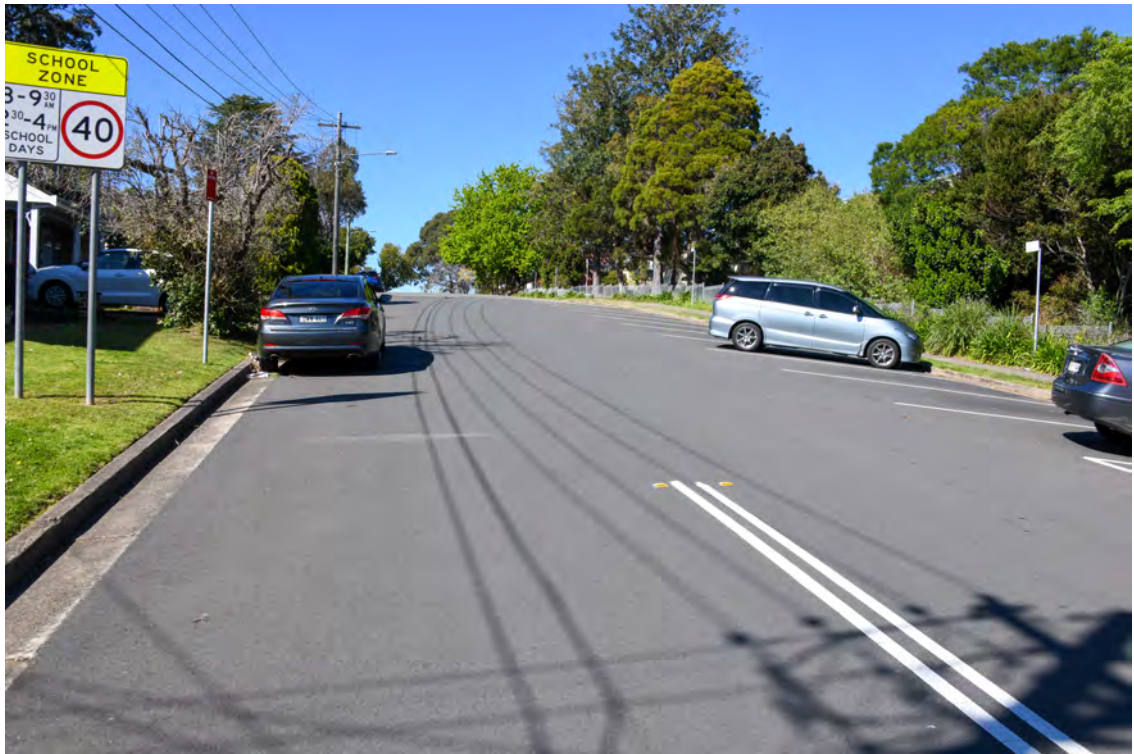
PRO\_1411.jpg

Ward Street. Eastern side of the street. Area between power pole no. EP73711 and EP73712. Heading south.

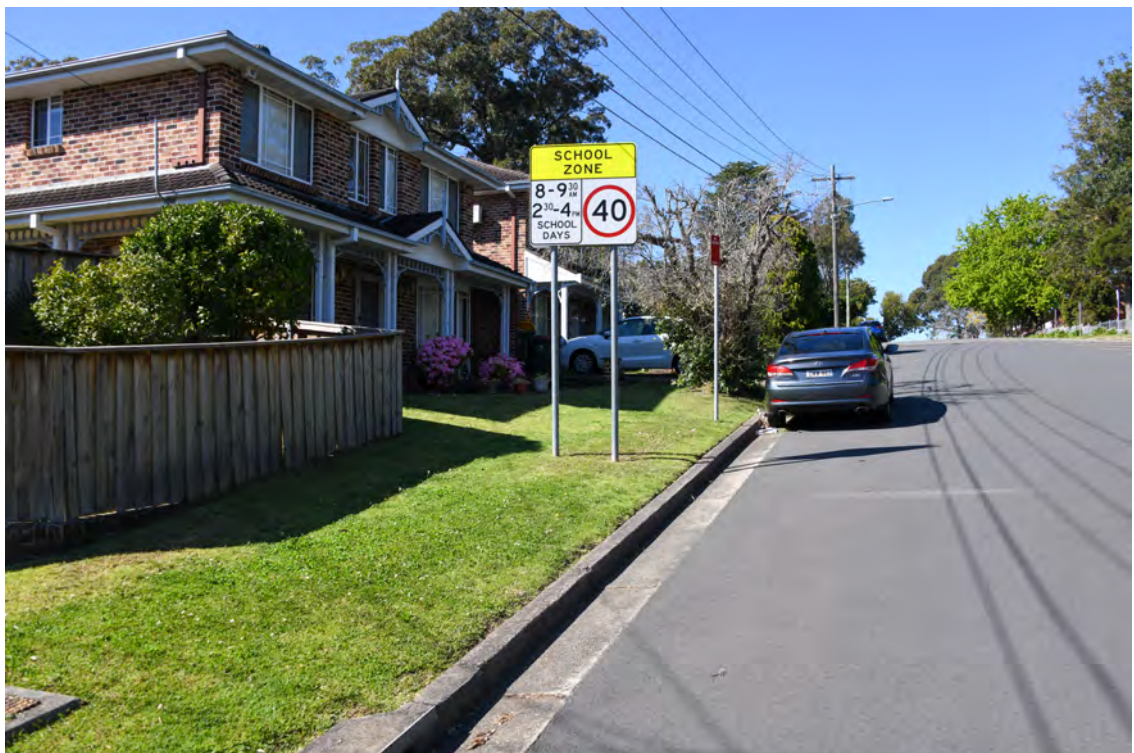
PRO\_1412.jpg

Ward Street. Eastern side of the street. Area between power pole no. EP73711 and EP73712. Heading south.

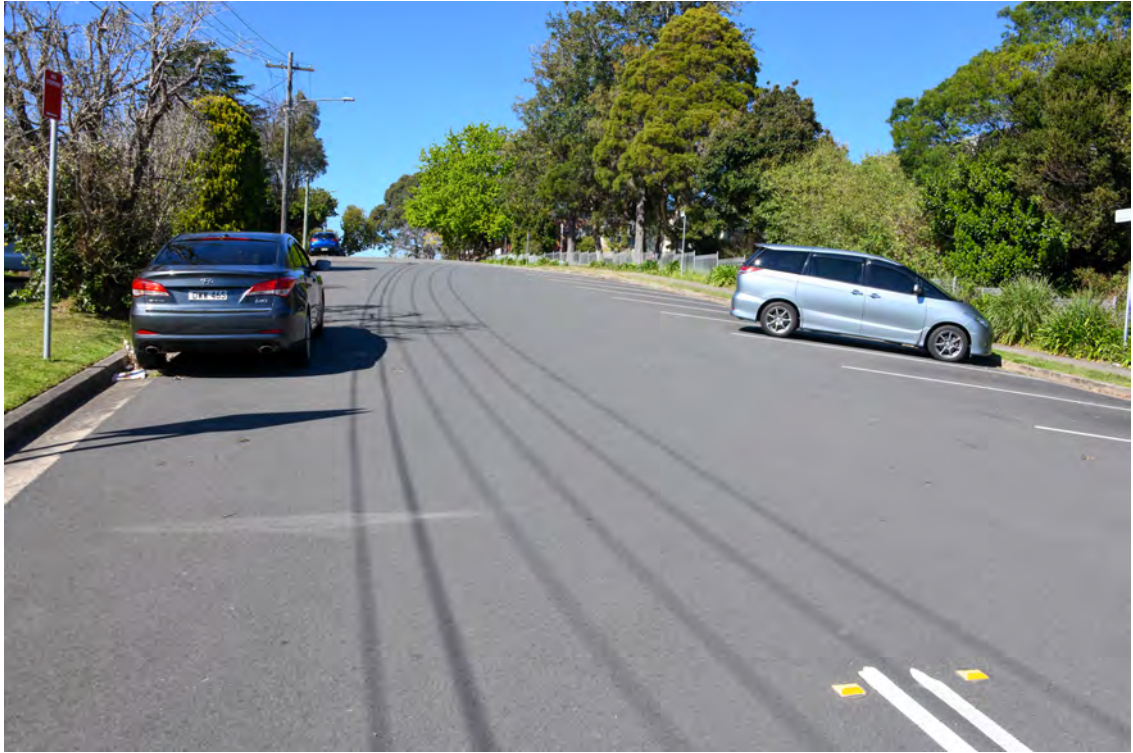
PRO\_1413.jpg

Ward Street. Eastern side of the street. Area between power pole no. EP73711 and EP73712. Heading south.

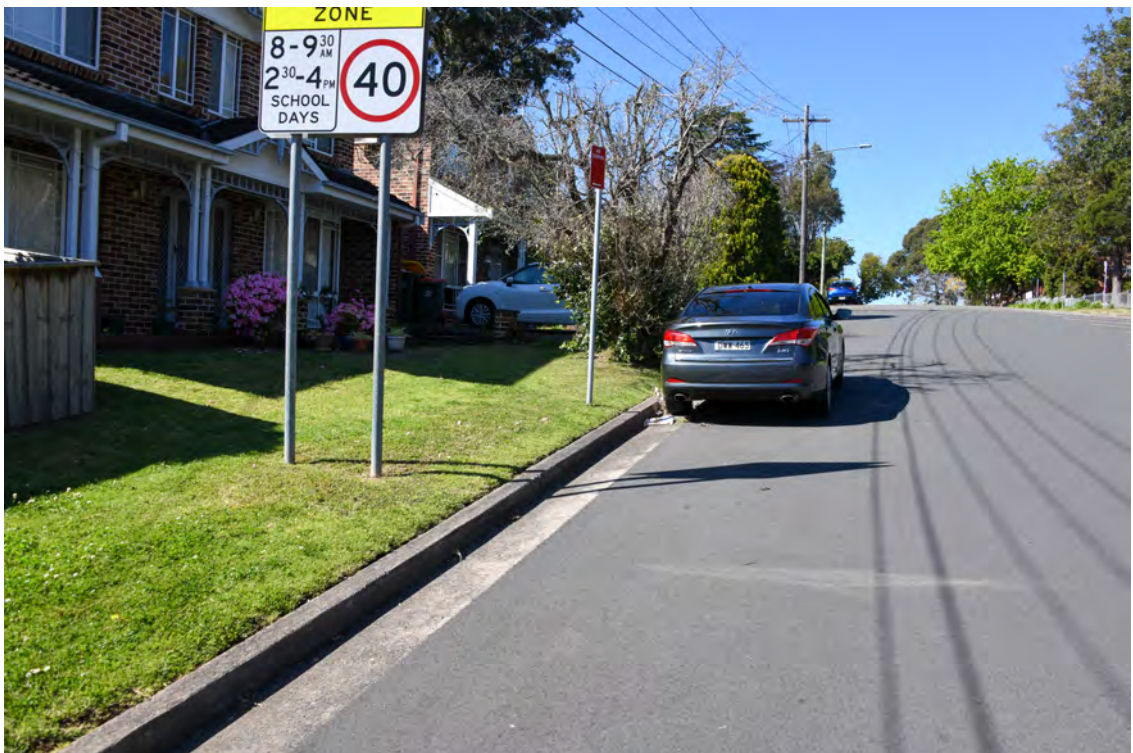
PRO\_1414.jpg

Ward Street. Eastern side of the street. Area between power pole no. EP73711 and EP73712. Heading south.

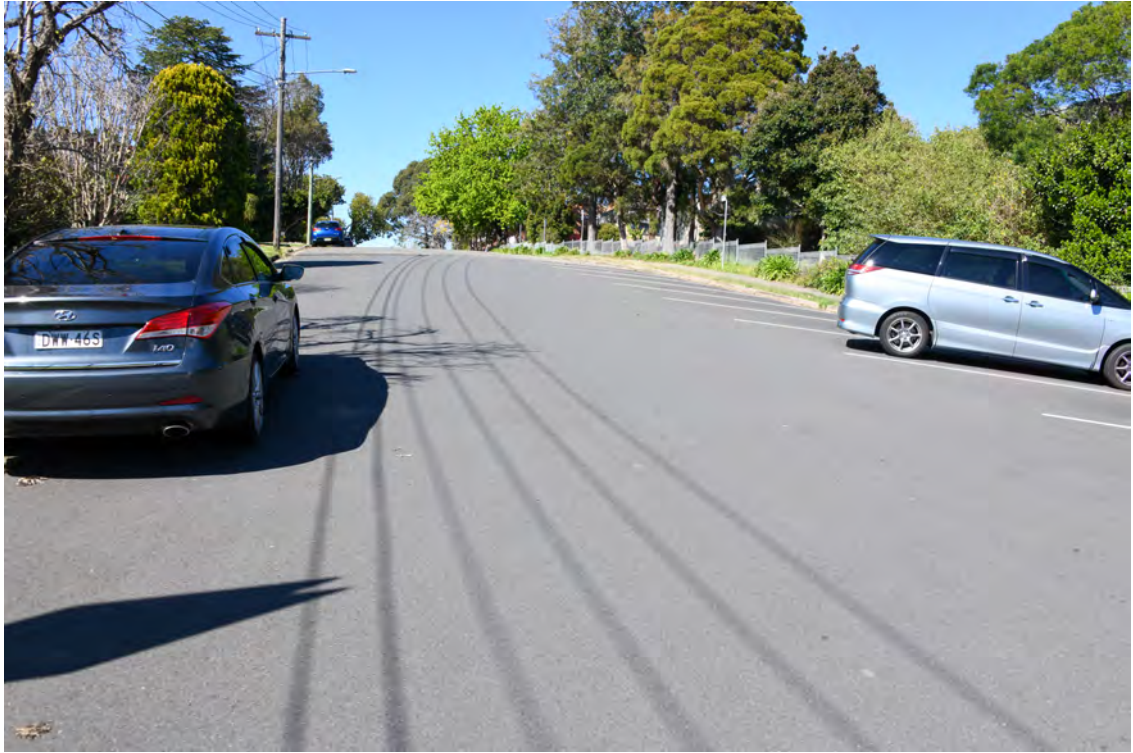
PRO\_1415.jpg

Ward Street. Eastern side of the street. Area between power pole no. EP73711 and EP73712. Heading south.

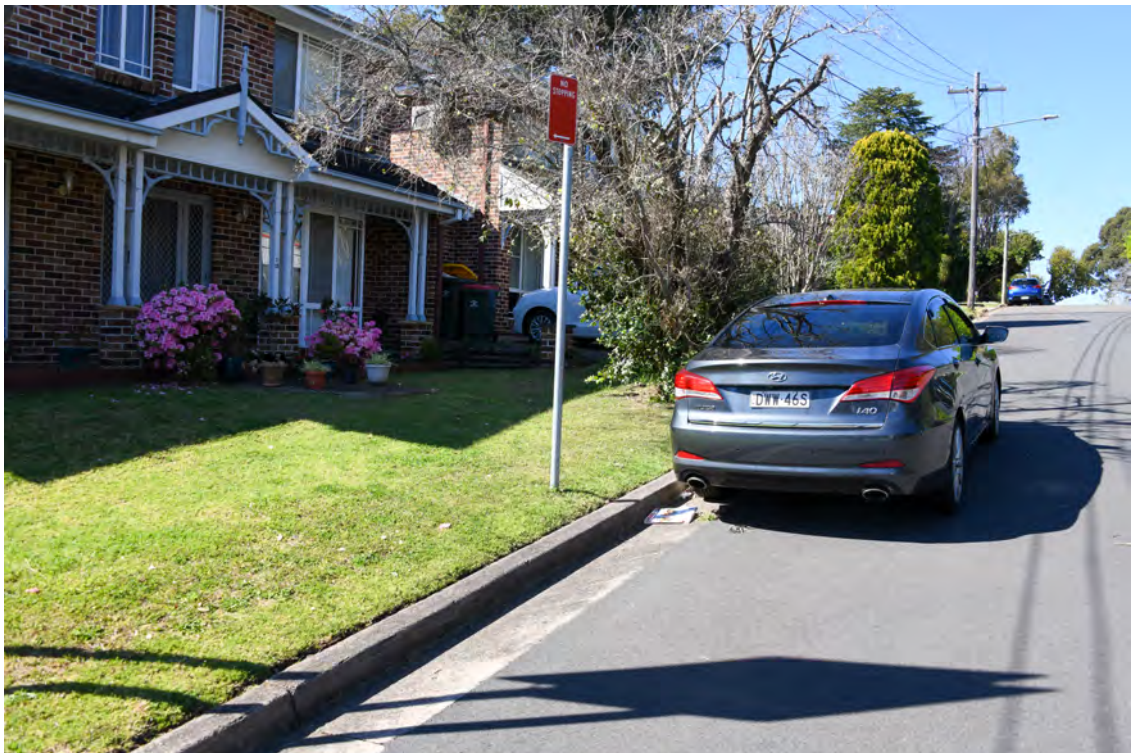
PRO\_1416.jpg

Ward Street. Eastern side of the street. Area between power pole no. EP73711 and EP73712. Heading south.

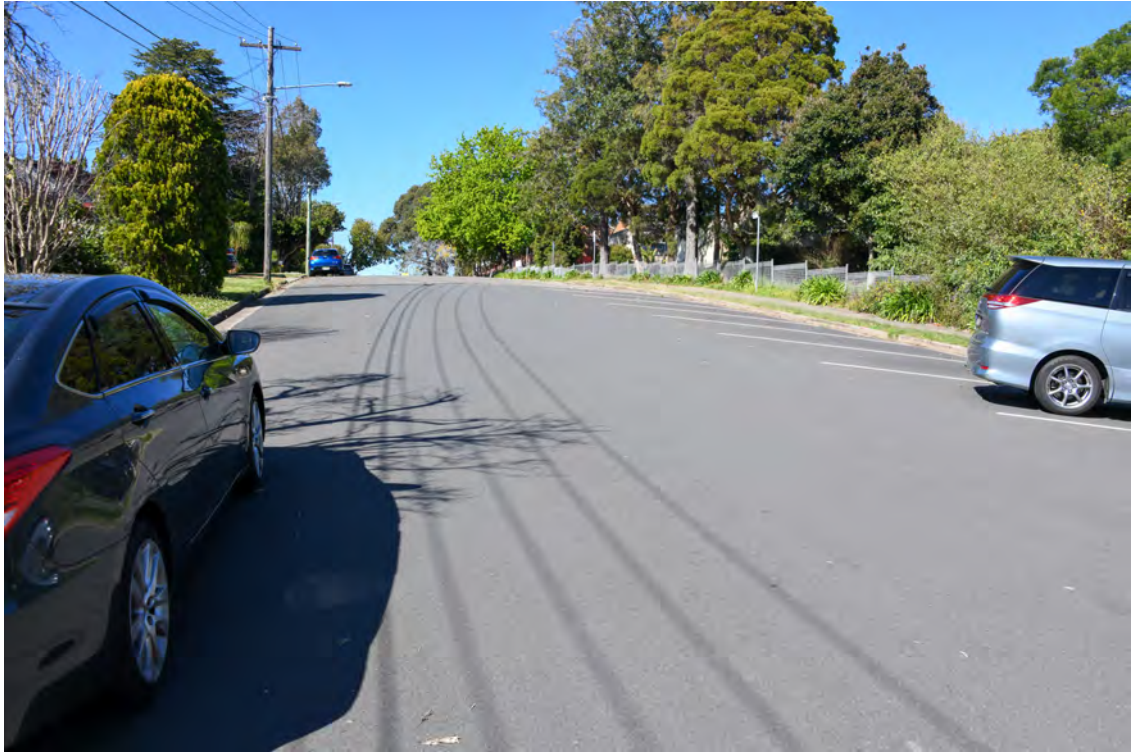
PRO\_1417.jpg

Ward Street. Eastern side of the street. Area between power pole no. EP73711 and EP73712. Heading south.

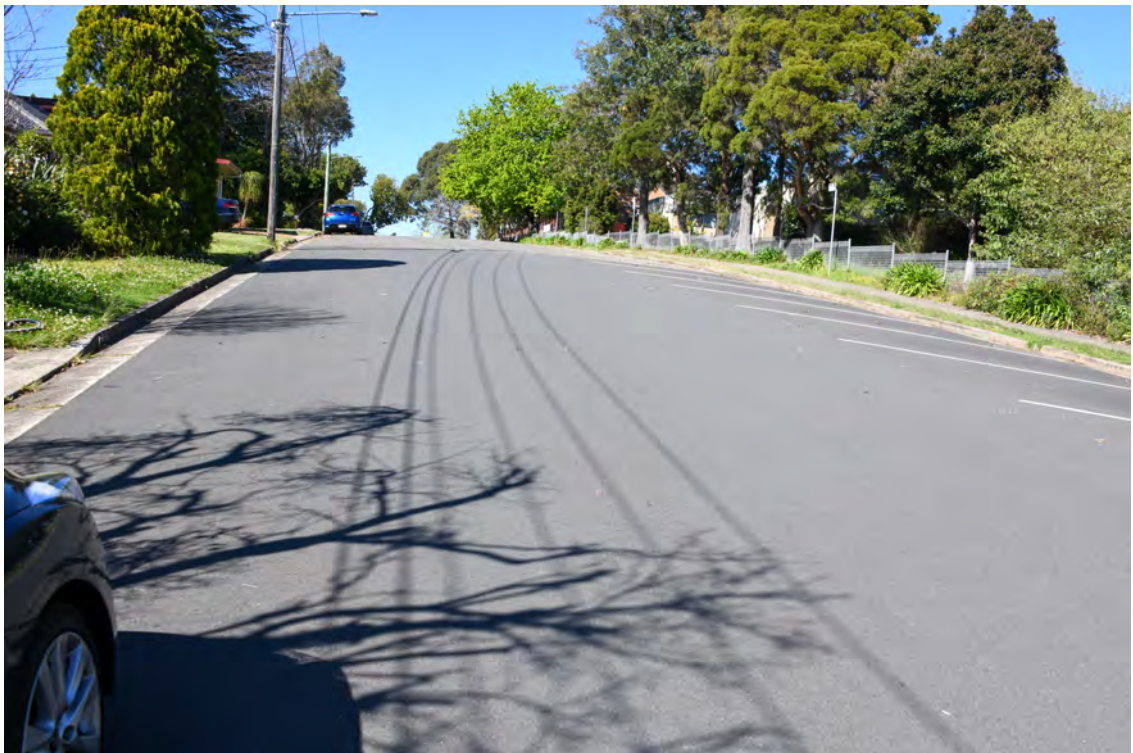
PRO\_1418.jpg

Ward Street. Eastern side of the street. Area between power pole no. EP73711 and EP73712. Heading south.

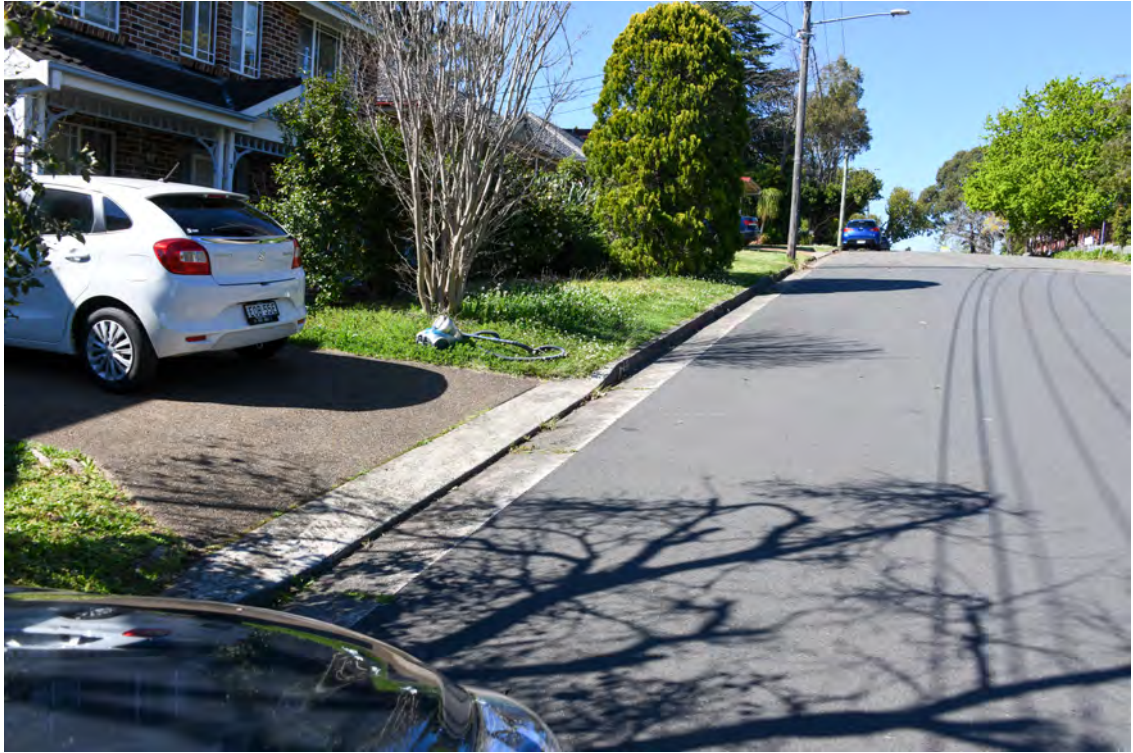
PRO\_1419.jpg

Ward Street. Eastern side of the street. Area between power pole no. EP73711 and EP73712. Heading south.

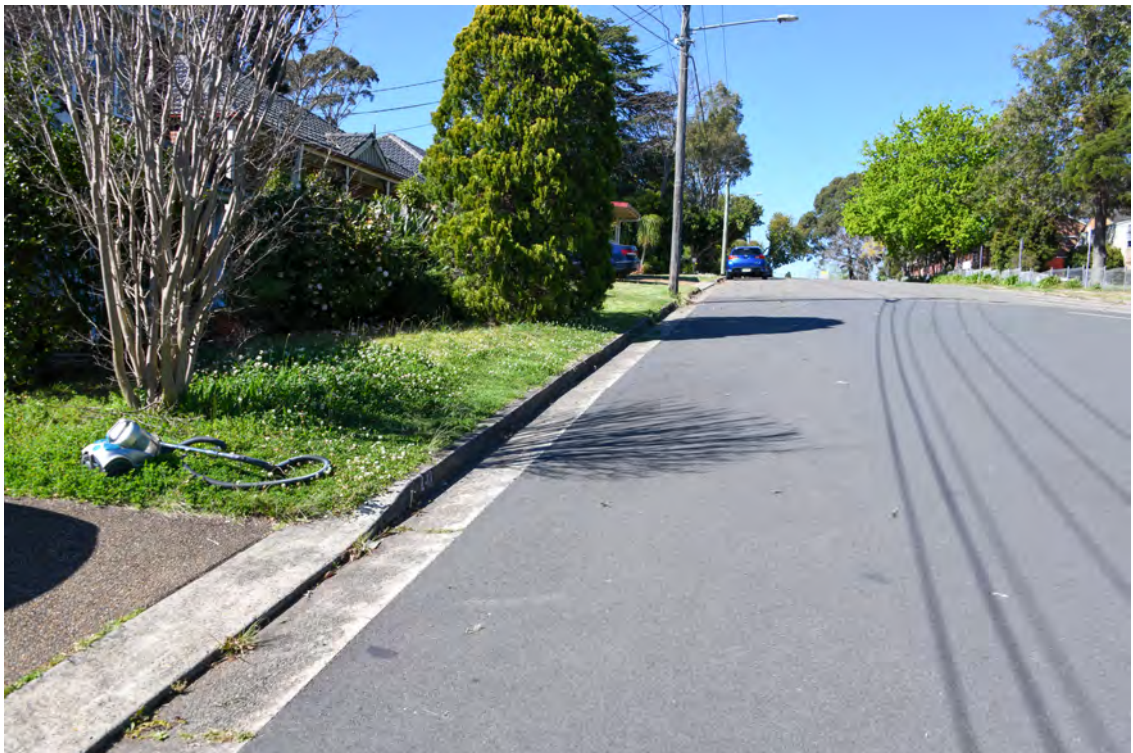
PRO\_1420.jpg

Ward Street. Eastern side of the street. Area between power pole no. EP73711 and EP73712. Heading south.

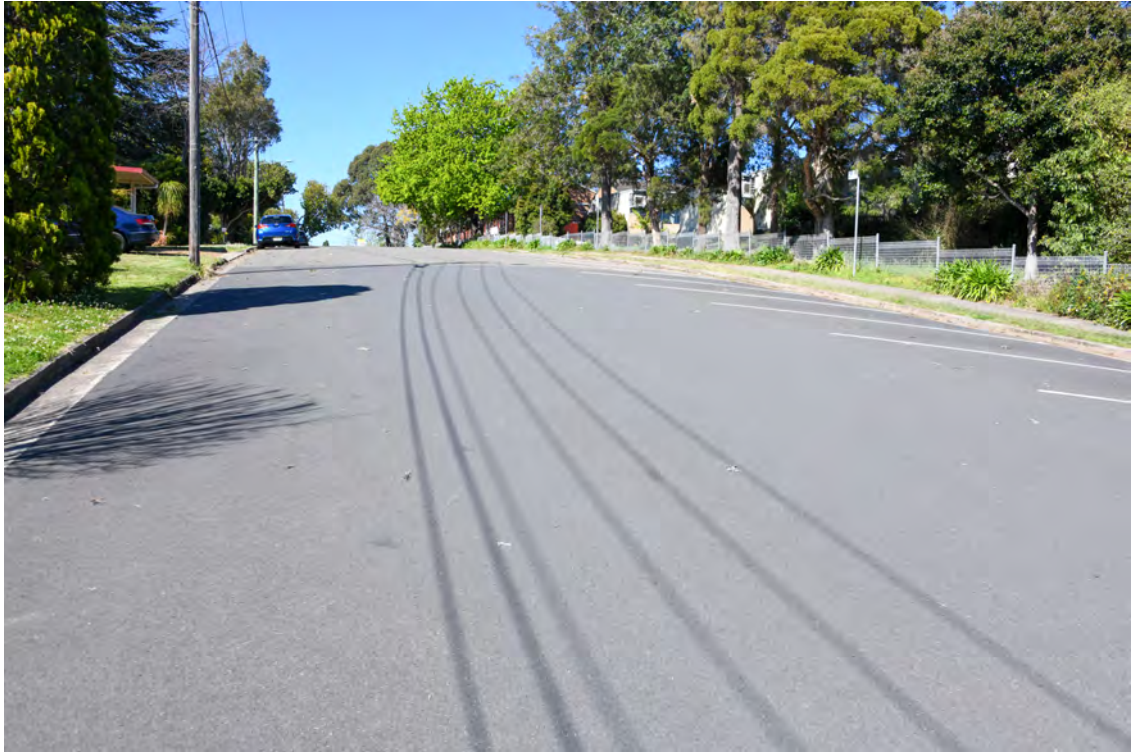
PRO\_1421.jpg

Ward Street. Eastern side of the street. Area between power pole no. EP73711 and EP73712. Heading south.

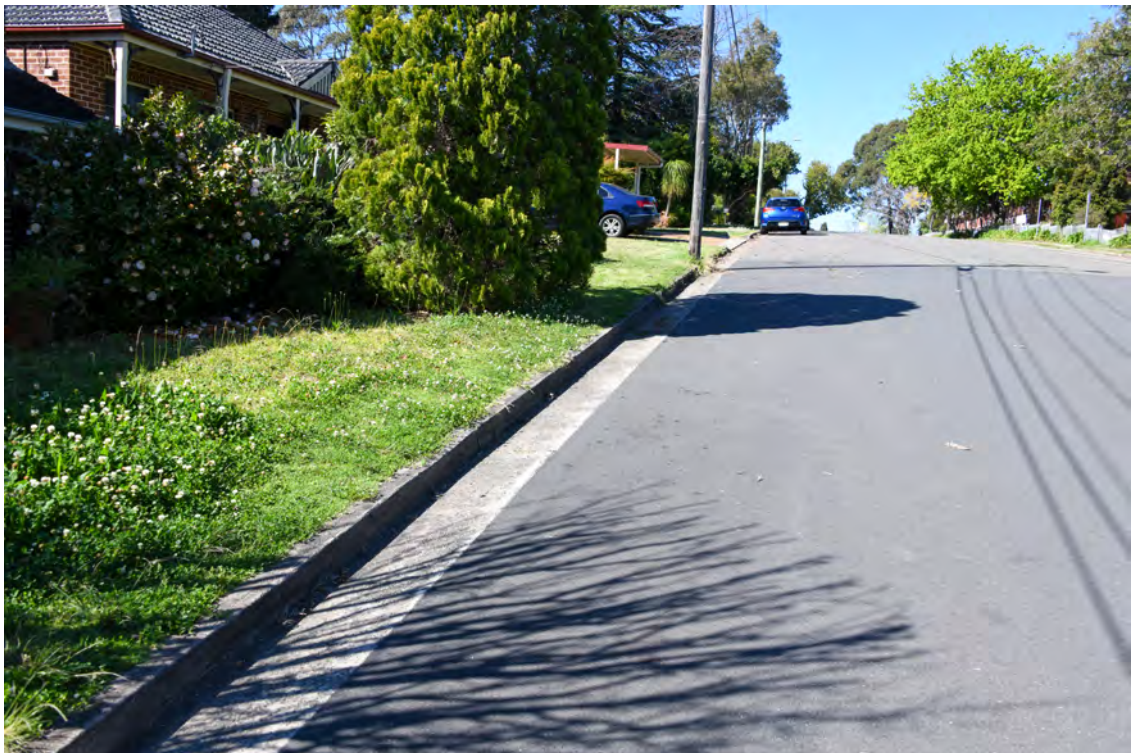
PRO\_1422.jpg

Ward Street. Eastern side of the street. Area between power pole no. EP73711 and EP73712. Heading south.

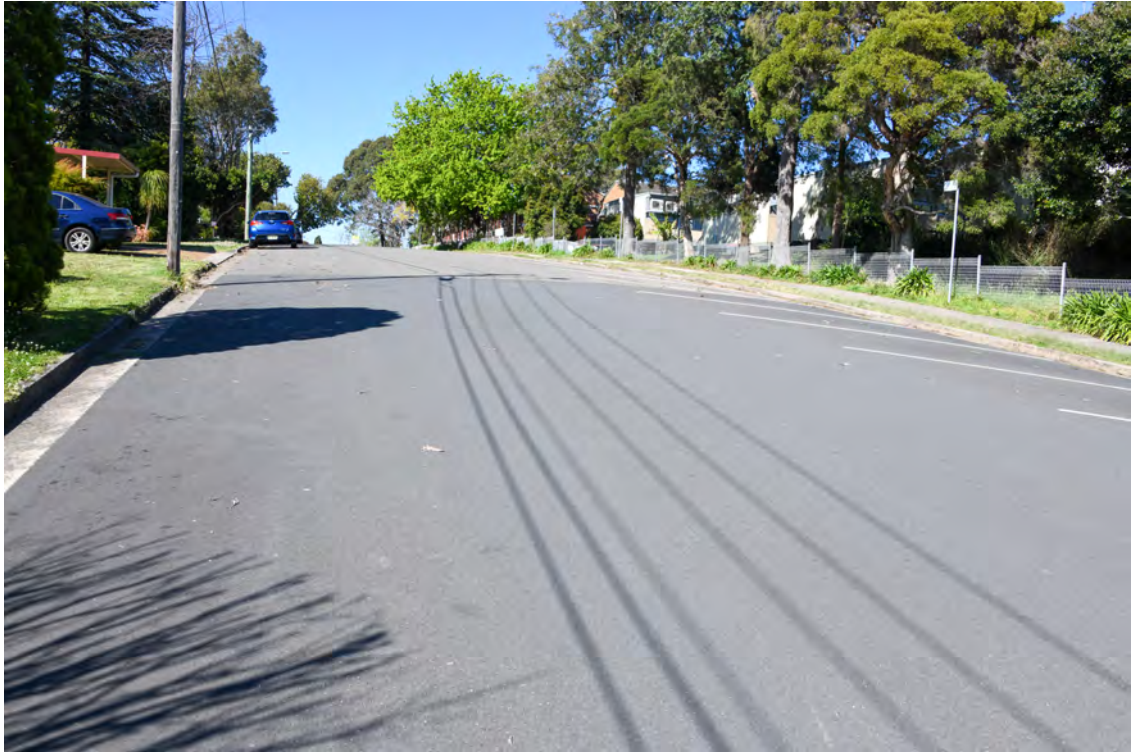
PRO\_1423.jpg

Ward Street. Eastern side of the street. Area between power pole no. EP73711 and EP73712. Heading south.

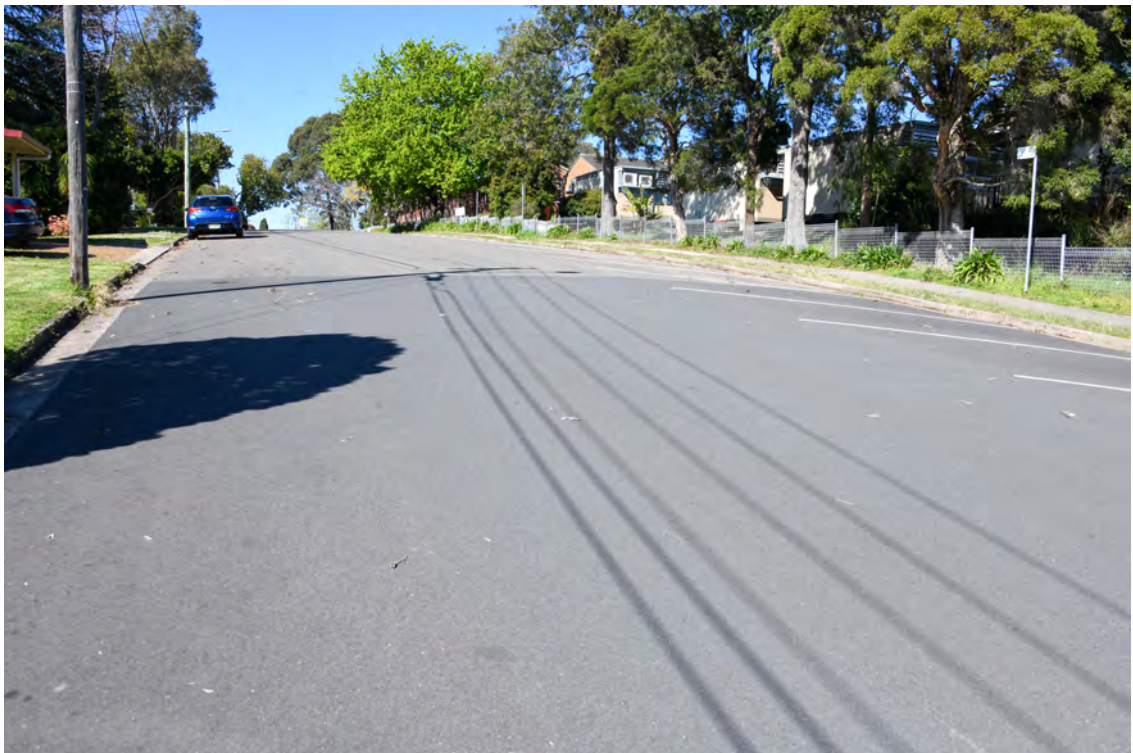
PRO\_1424.jpg

Ward Street. Eastern side of the street. Area between power pole no. EP73711 and EP73712. Heading south.

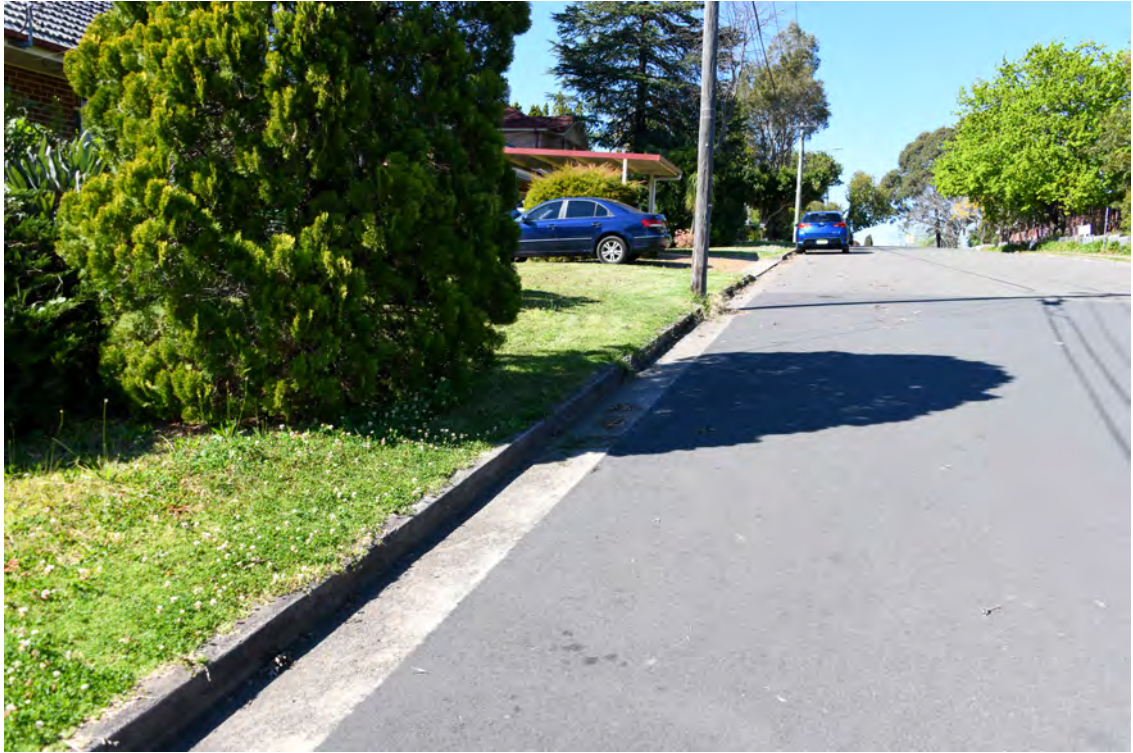
PRO\_1425.jpg

Ward Street. Eastern side of the street. Area between power pole no. EP73711 and EP73712. Heading south.
