96-104 Carlingford Road, Epping NSW 2121

Epping West Public School

DILAPIDATION REPORT

7<sup>th</sup> September 2021

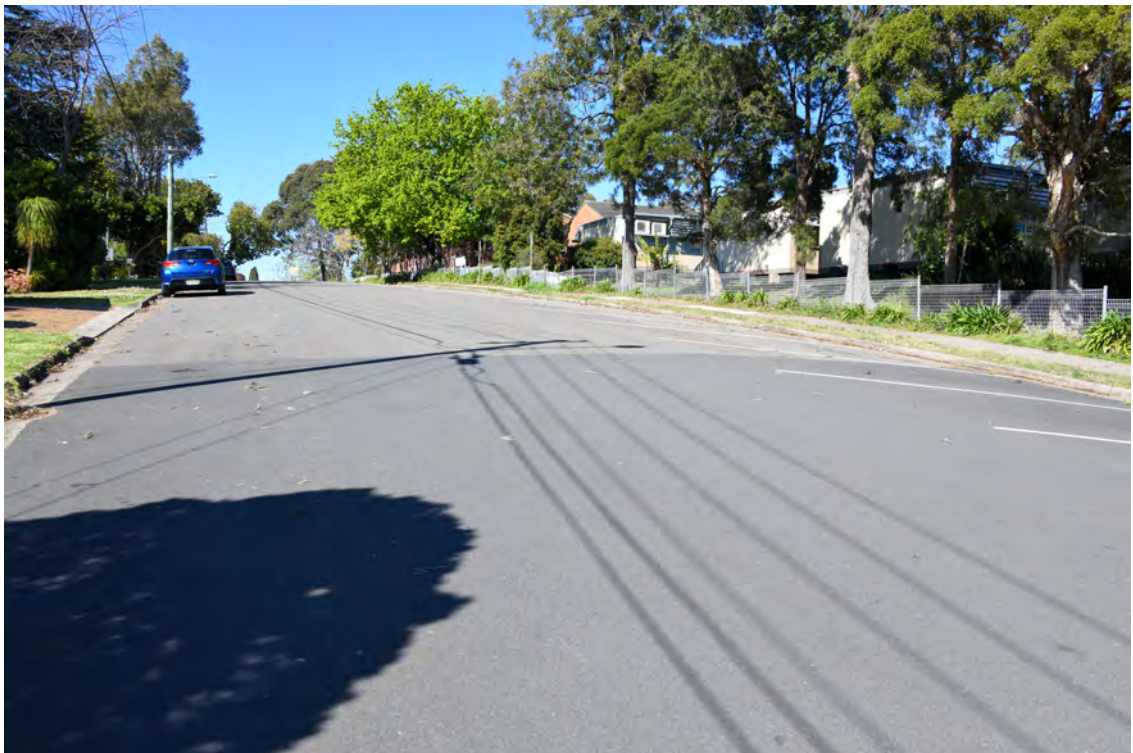
PRO\_1426.jpg

Ward Street. Eastern side of the street. Area between power pole no. EP73711 and EP73712. Heading south.

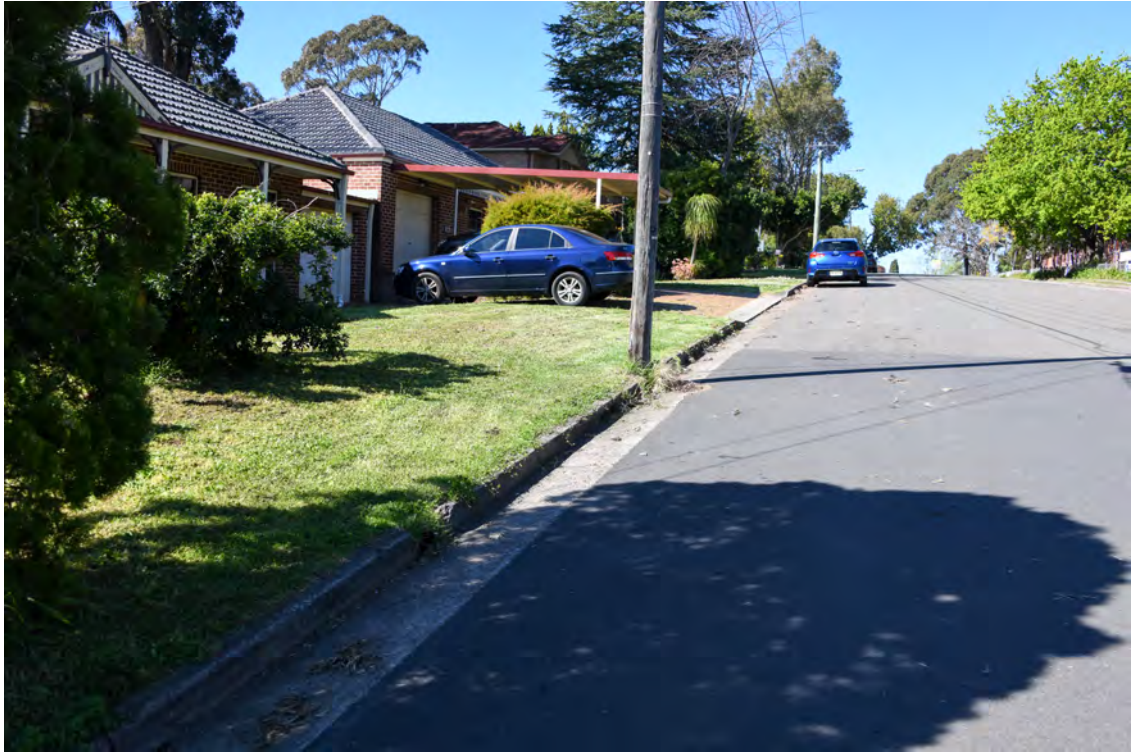
PRO\_1427.jpg

Ward Street. Eastern side of the street. Area between power pole no. EP73711 and EP73712. Heading south.

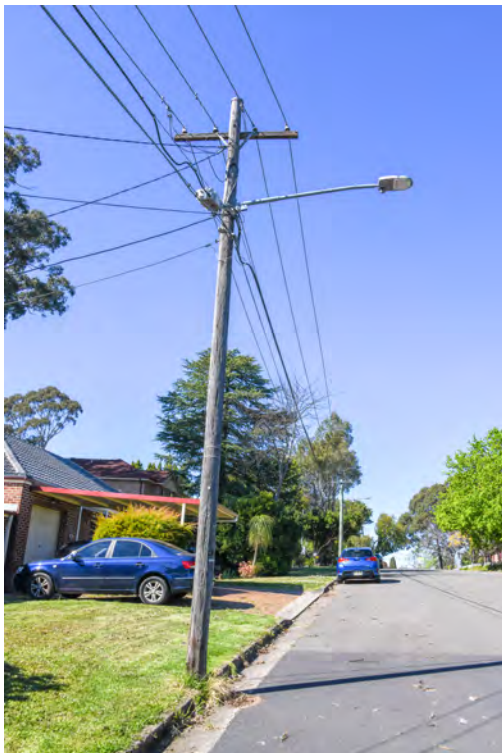
PRO\_1428.jpg

Ward Street. Eastern side of the street. Power pole no. EP73712. Heading south.

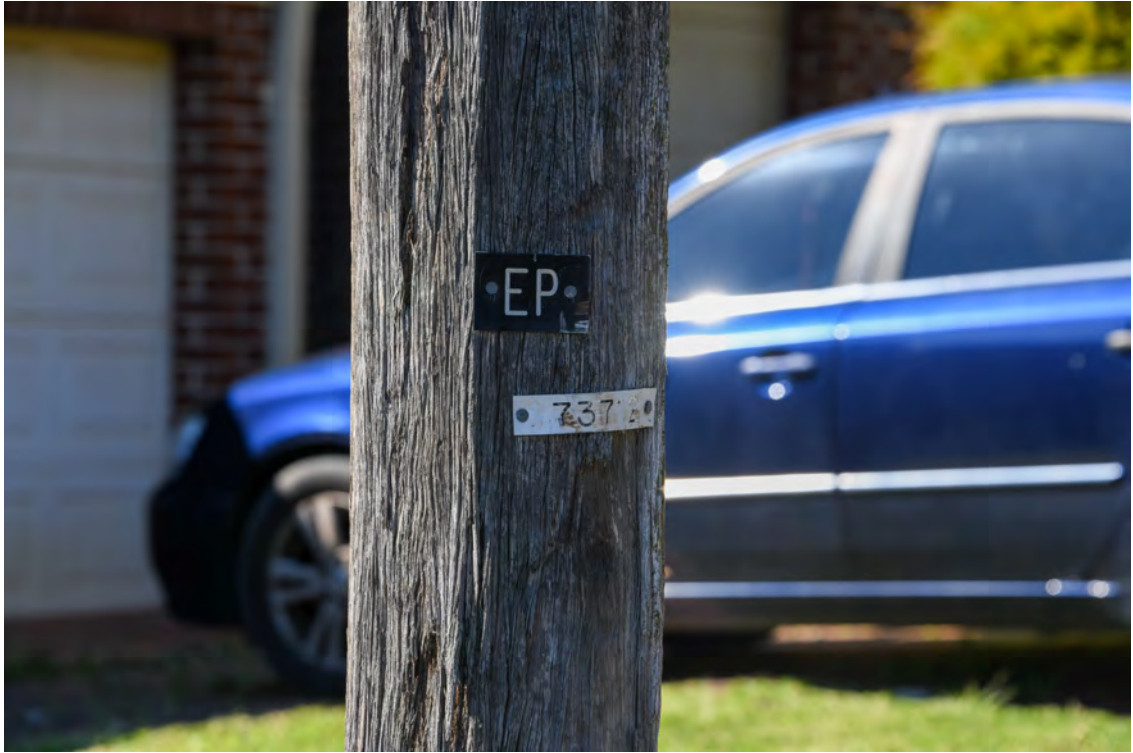
PRO\_1429.jpg

Ward Street. Eastern side of the street. Power pole no. EP73712. Heading south.

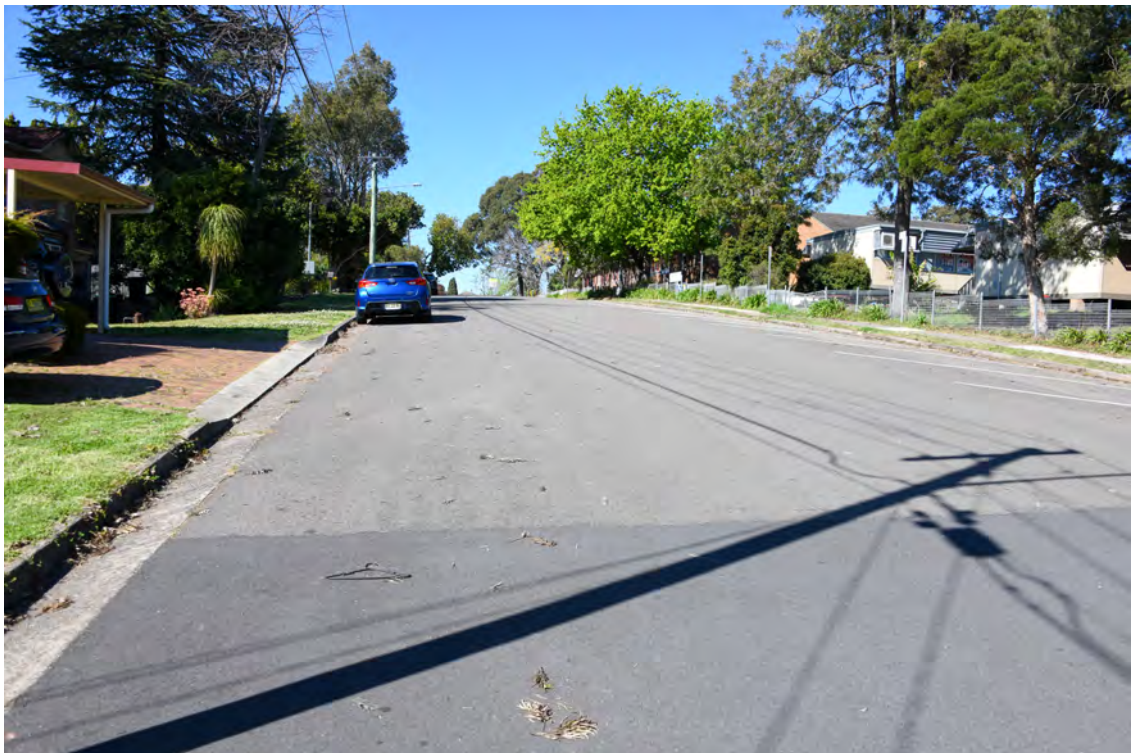
PRO\_1430.jpg

Ward Street. Eastern side of the street. Area between power pole no. EP73712 and EP73713. Heading south.

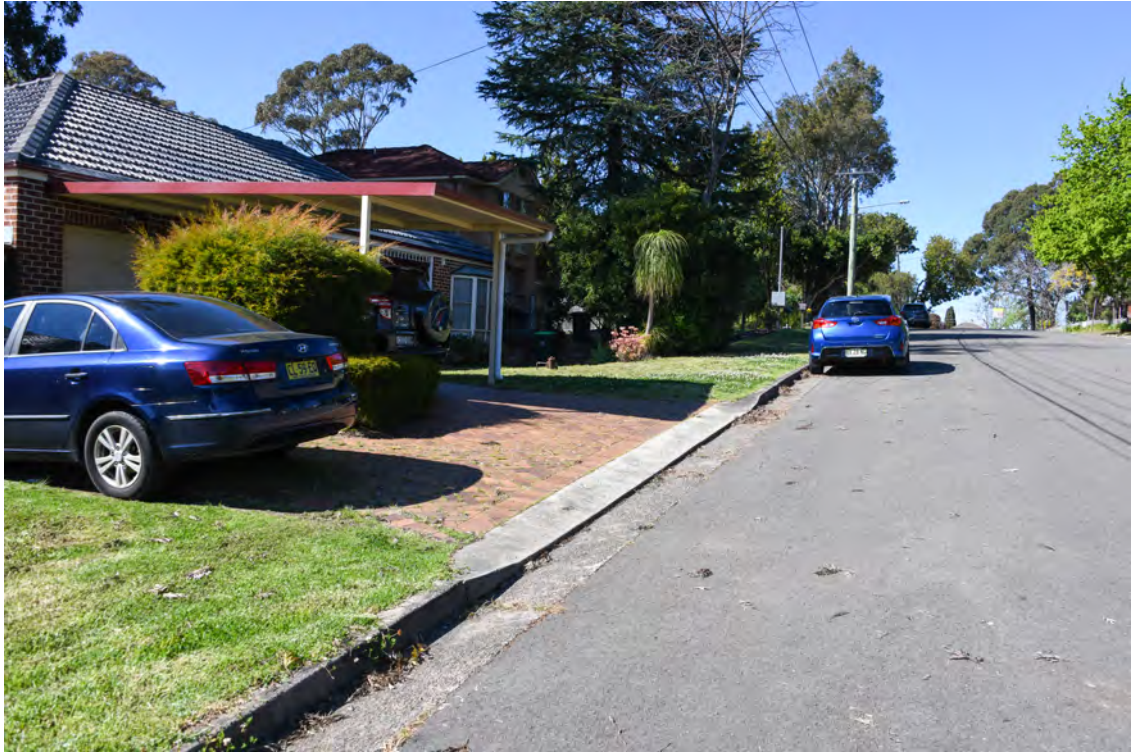
PRO\_1431.jpg

Ward Street. Eastern side of the street. Area between power pole no. EP73712 and EP73713. Heading south.

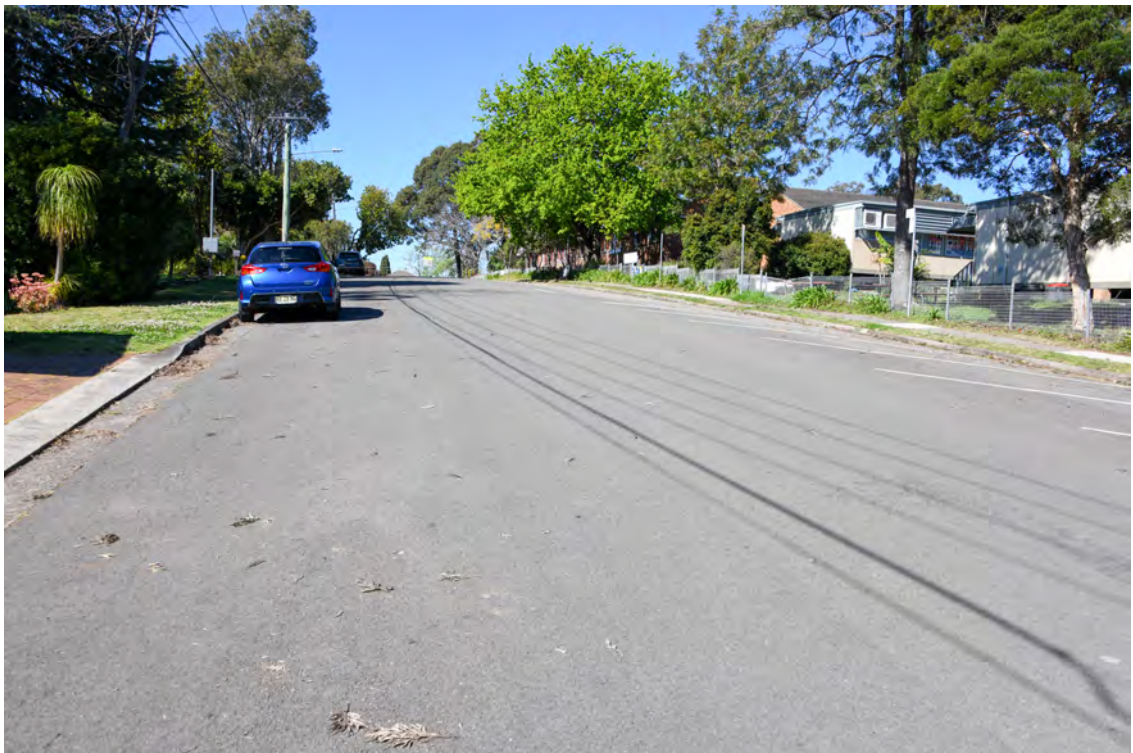
PRO\_1432.jpg

Ward Street. Eastern side of the street. Area between power pole no. EP73712 and EP73713. Heading south.

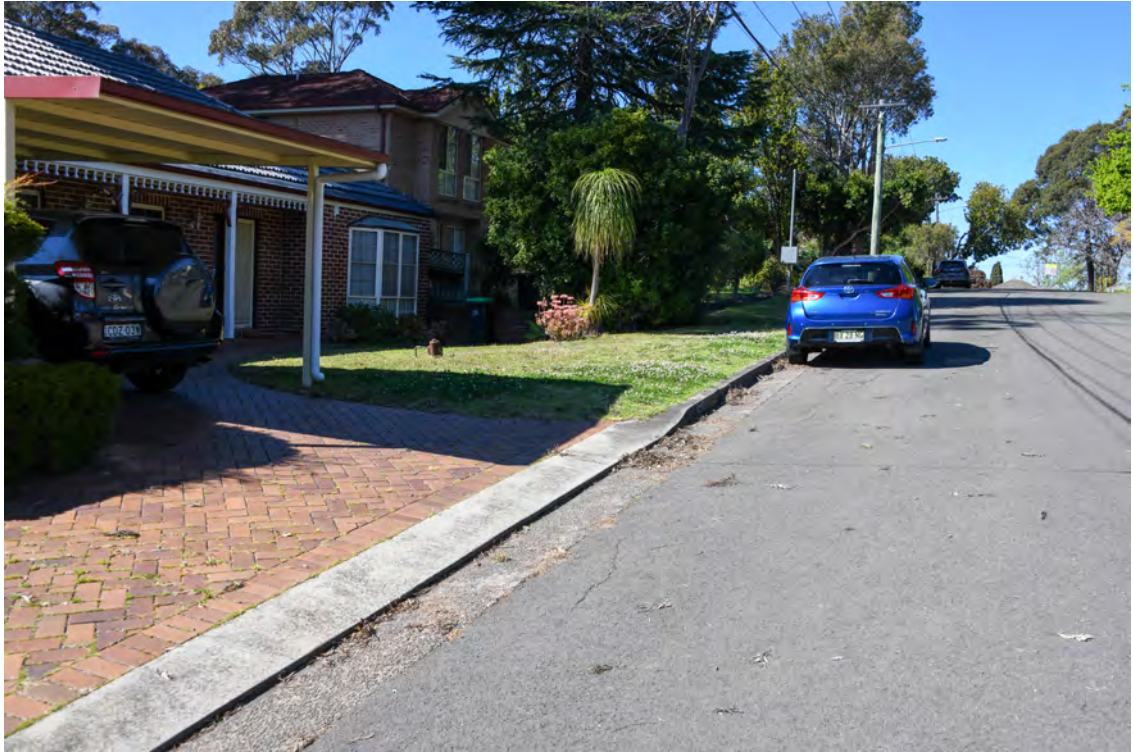
PRO\_1433.jpg

Ward Street. Eastern side of the street. Area between power pole no. EP73712 and EP73713. Heading south.

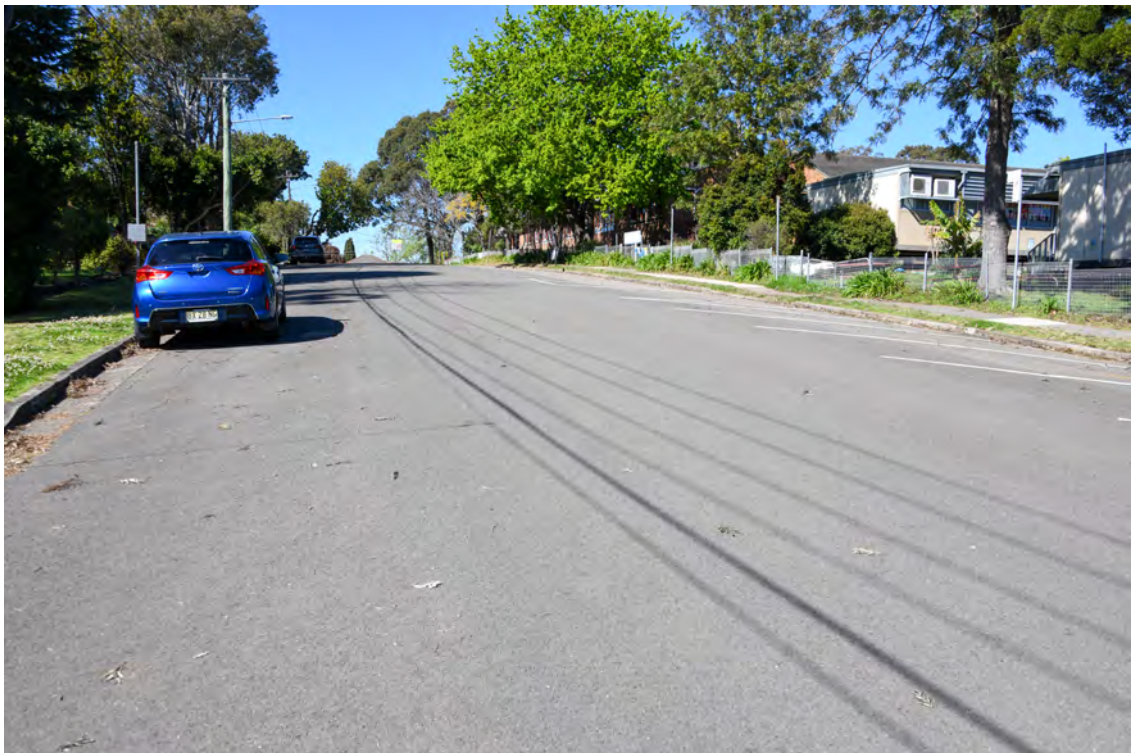
PRO\_1434.jpg

Ward Street. Eastern side of the street. Area between power pole no. EP73712 and EP73713. Heading south.

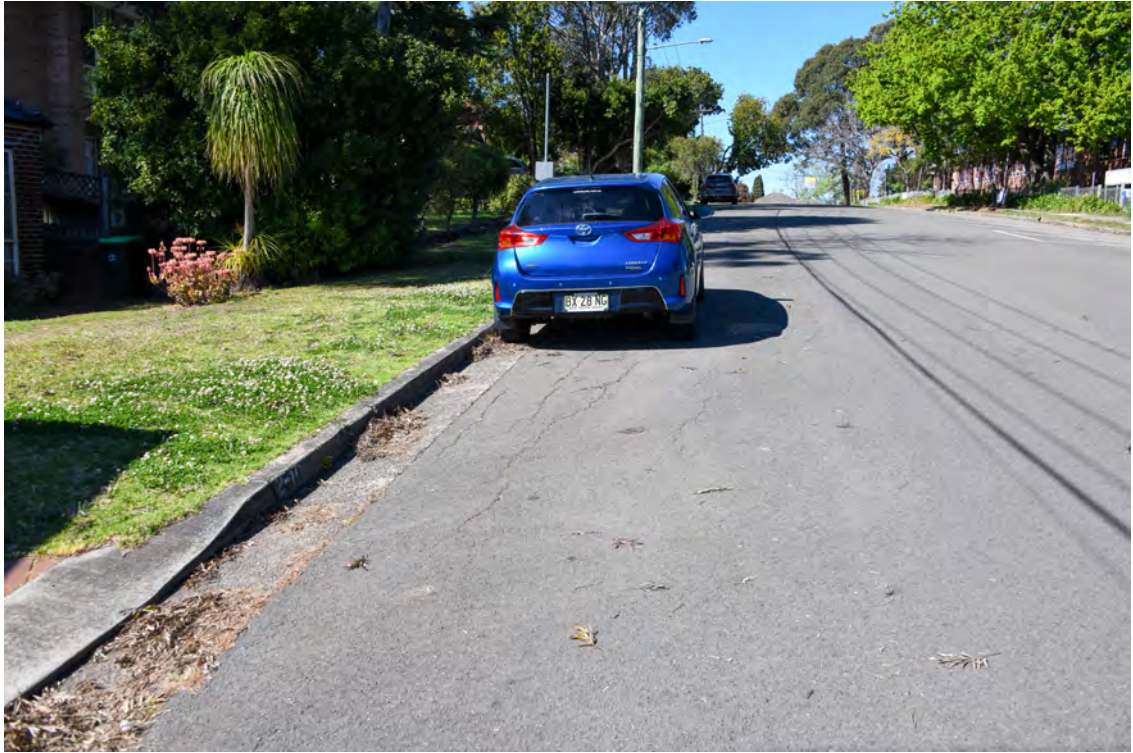
PRO\_1435.jpg

Ward Street. Eastern side of the street. Area between power pole no. EP73712 and EP73713. Heading south.

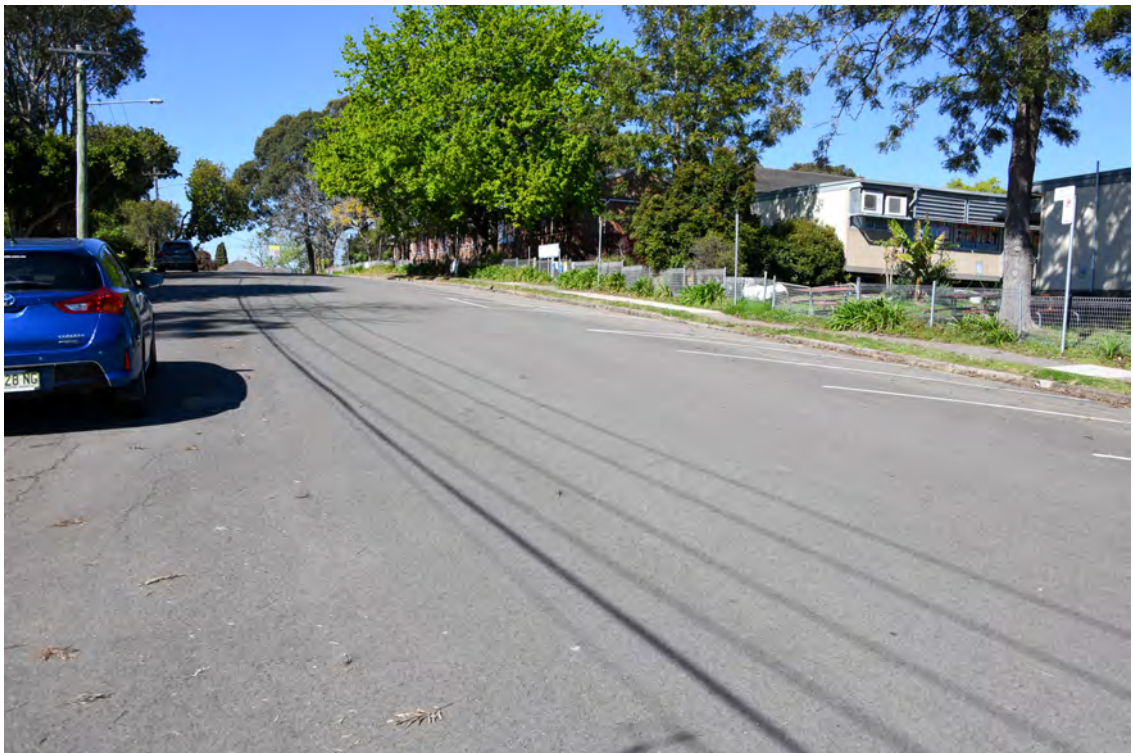
PRO\_1436.jpg

Ward Street. Eastern side of the street. Area between power pole no. EP73712 and EP73713. Heading south.

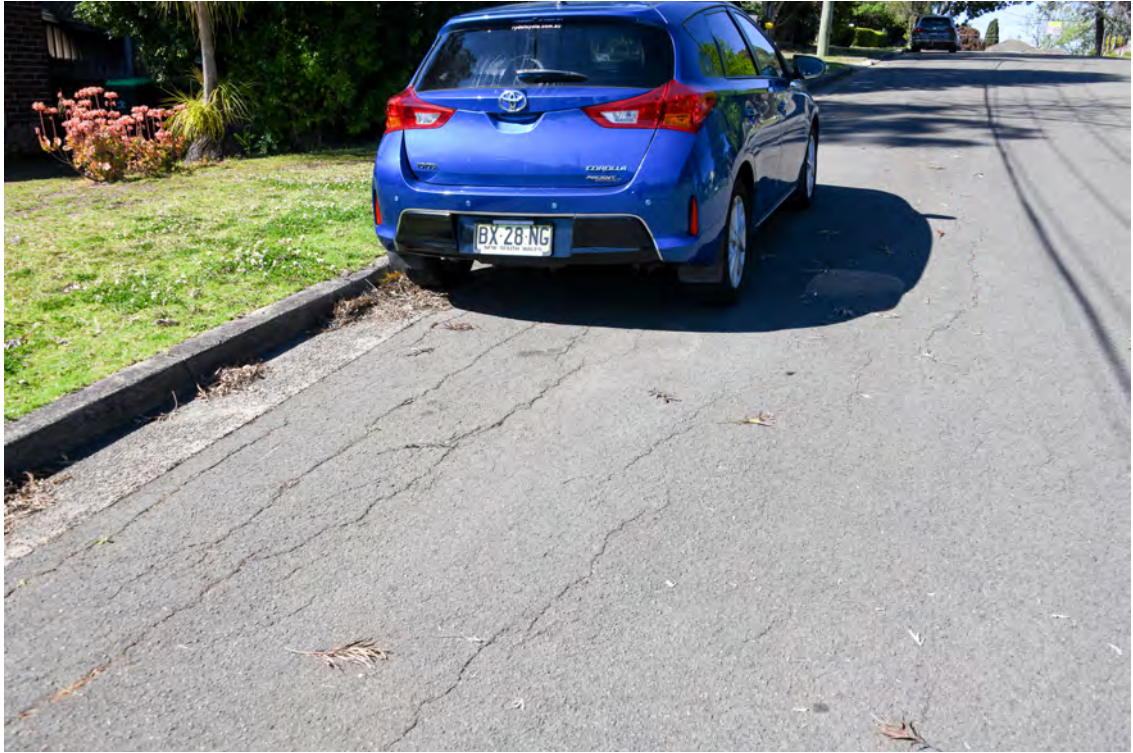
PRO\_1437.jpg

Ward Street. Eastern side of the street. Area between power pole no. EP73712 and EP73713. Heading south.

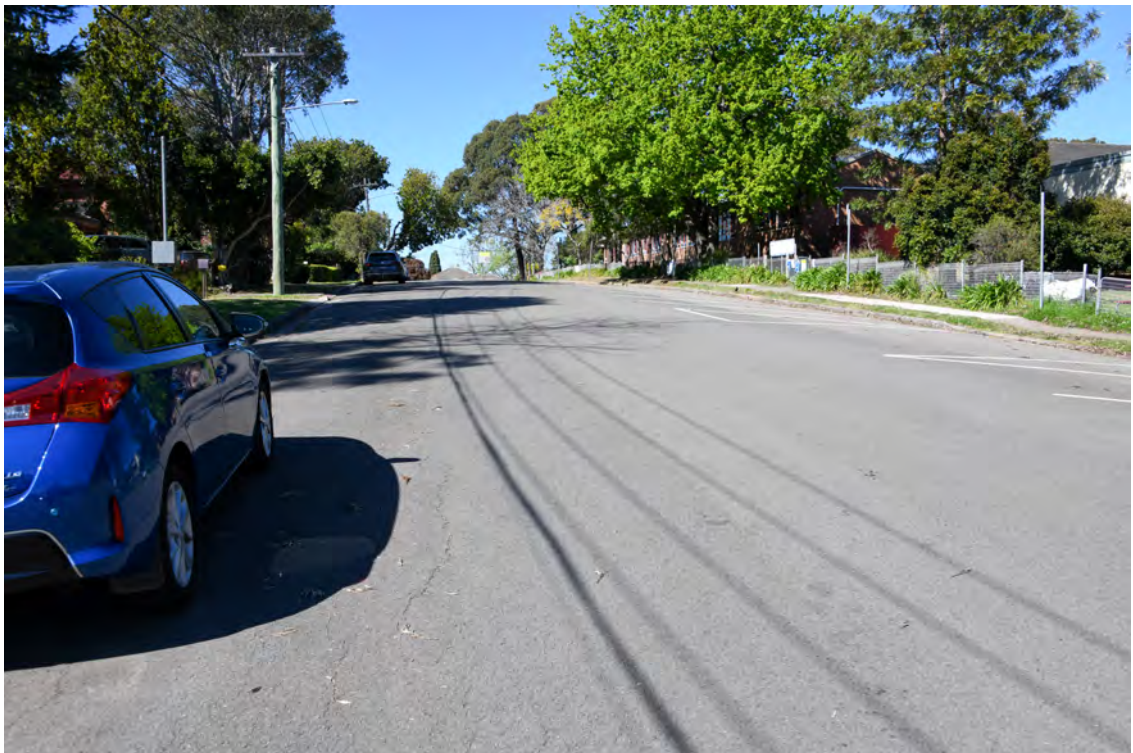
PRO\_1438.jpg

Ward Street. Eastern side of the street. Area between power pole no. EP73712 and EP73713. Heading south.

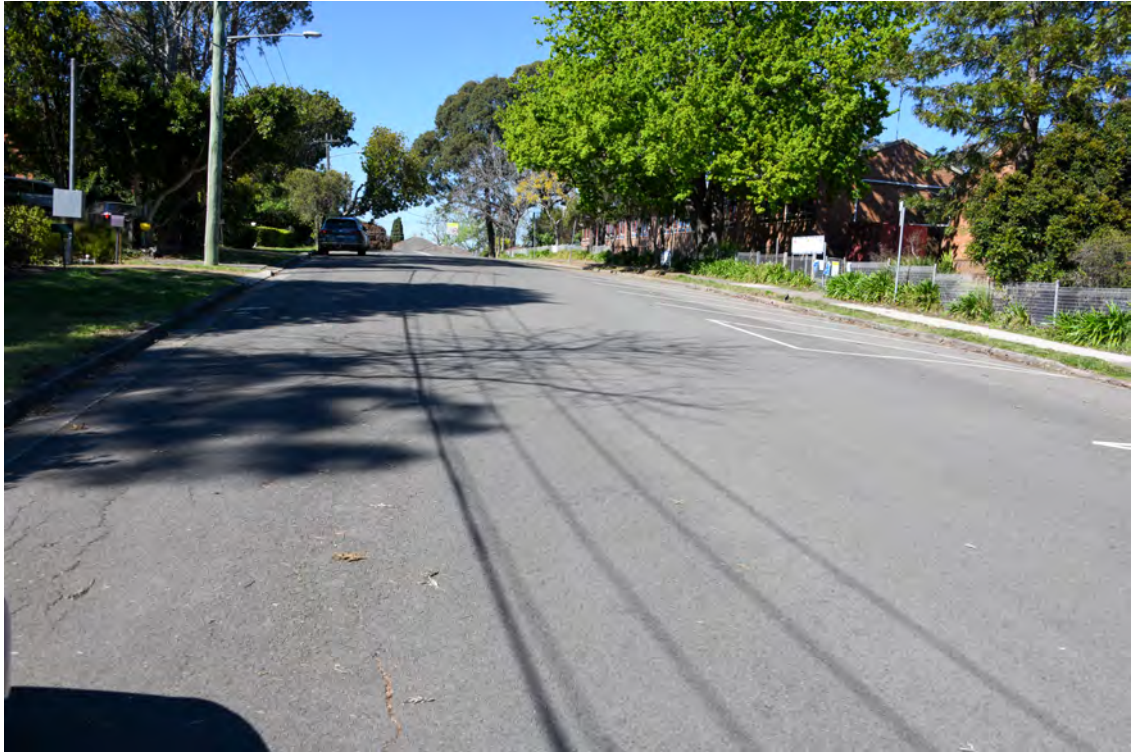
PRO\_1439.jpg

Ward Street. Eastern side of the street. Area between power pole no. EP73712 and EP73713. Heading south.

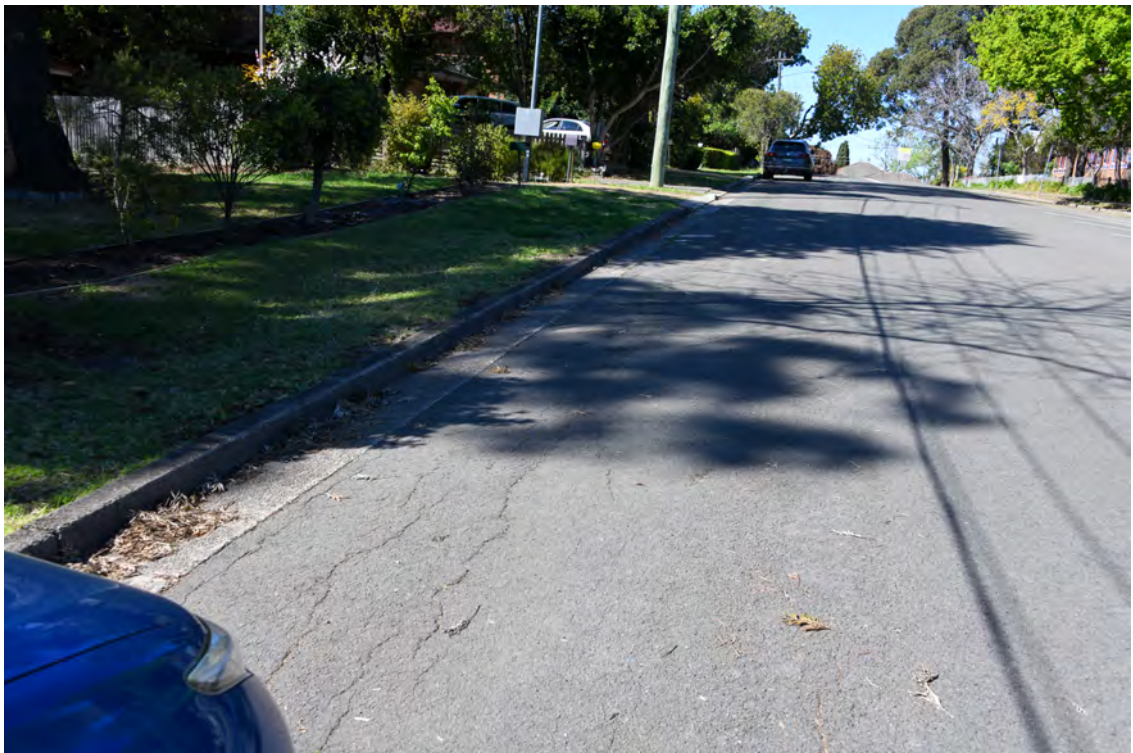
PRO\_1440.jpg

Ward Street. Eastern side of the street. Area between power pole no. EP73712 and EP73713. Heading south.

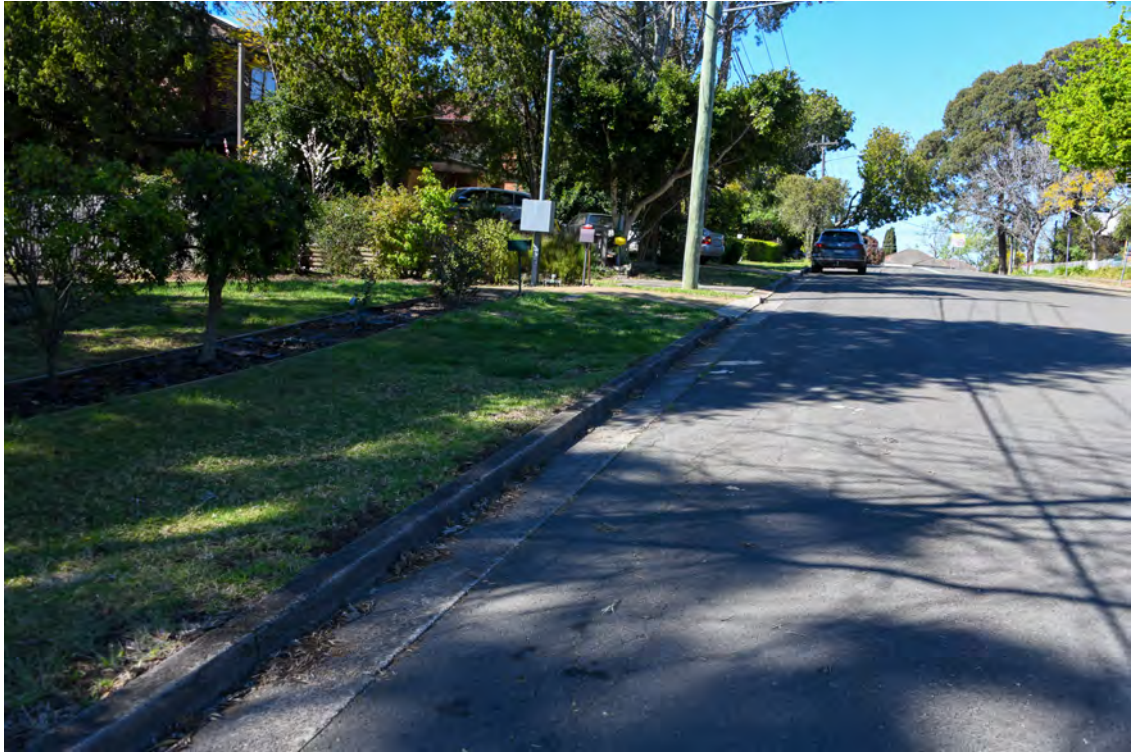
PRO\_1441.jpg

Ward Street. Eastern side of the street. Area between power pole no. EP73712 and EP73713. Heading south.

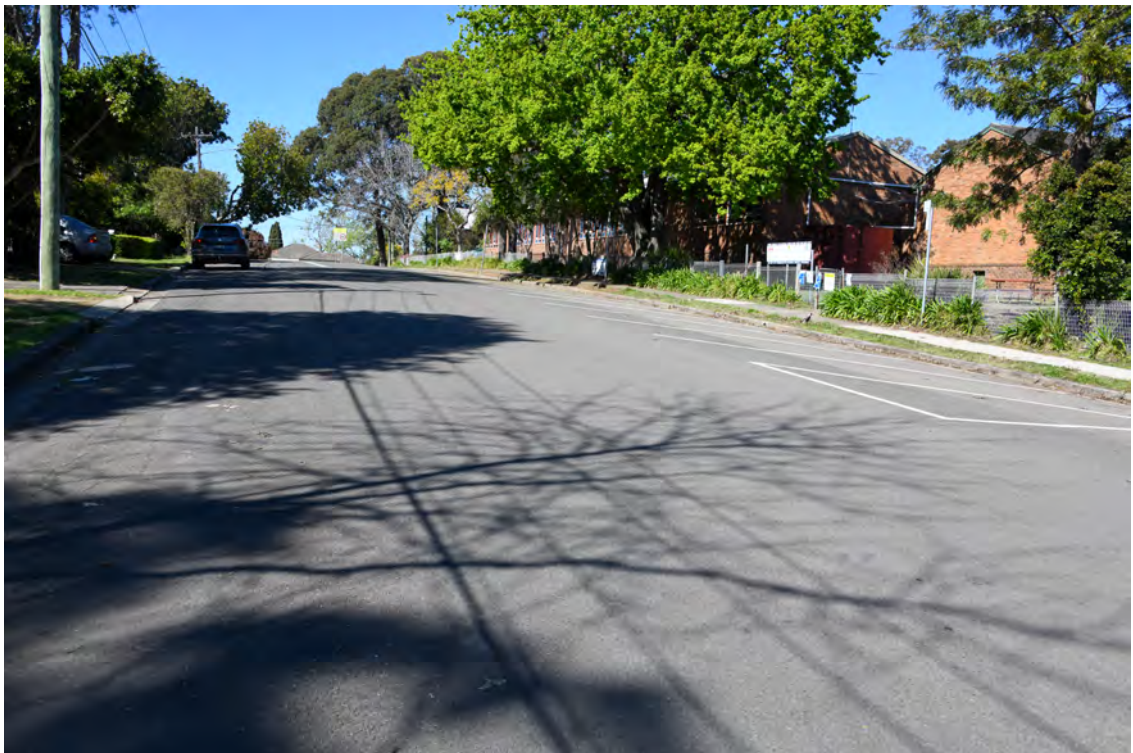
PRO\_1442.jpg

Ward Street. Eastern side of the street. Area between power pole no. EP73712 and EP73713. Heading south.

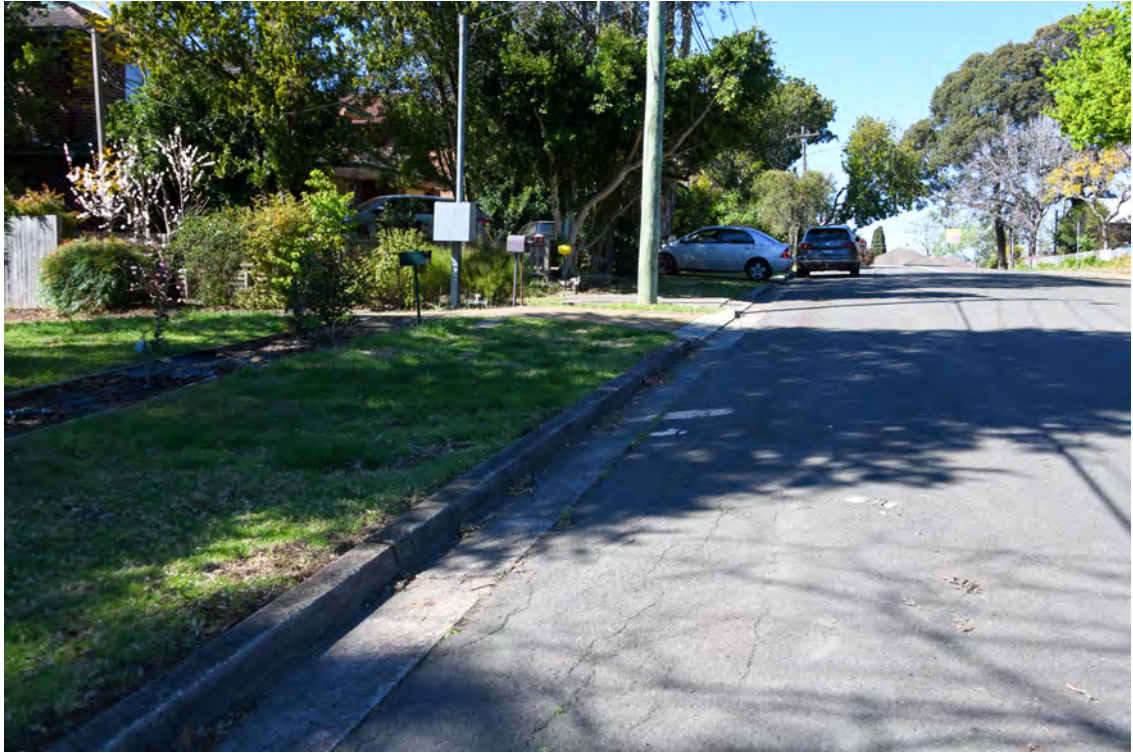
PRO\_1443.jpg

Ward Street. Eastern side of the street. Area between power pole no. EP73712 and EP73713. Heading south.

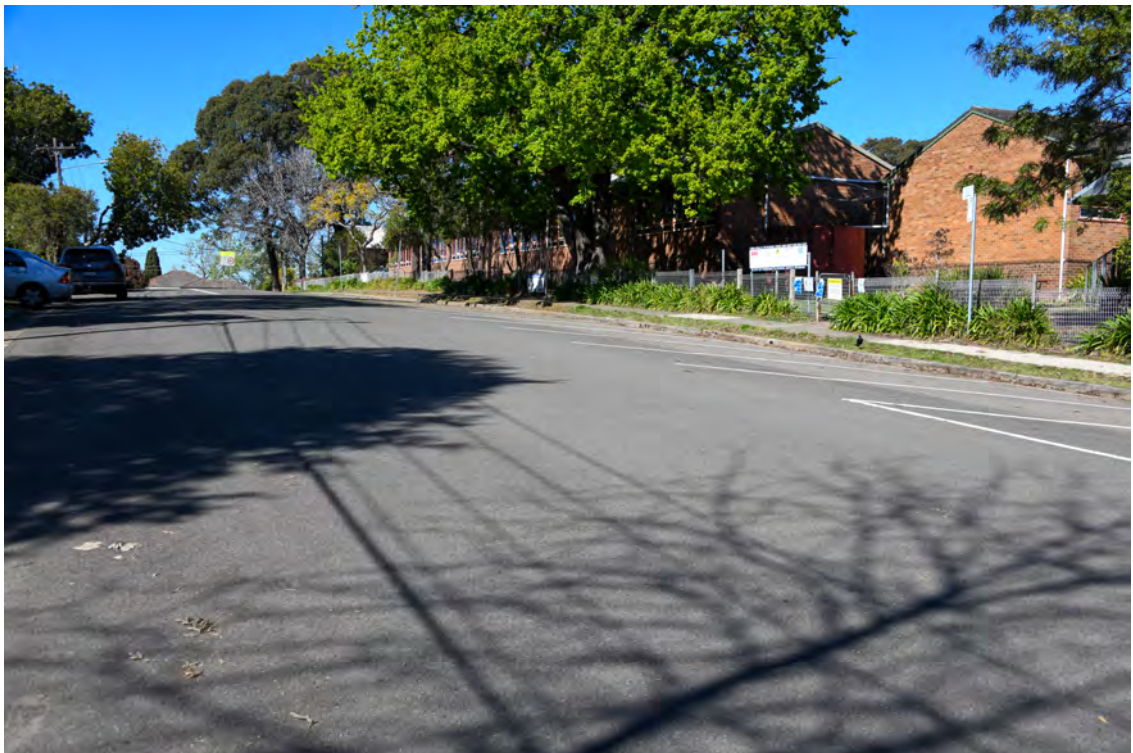
PRO\_1444.jpg

Ward Street. Eastern side of the street. Area between power pole no. EP73712 and EP73713. Heading south.

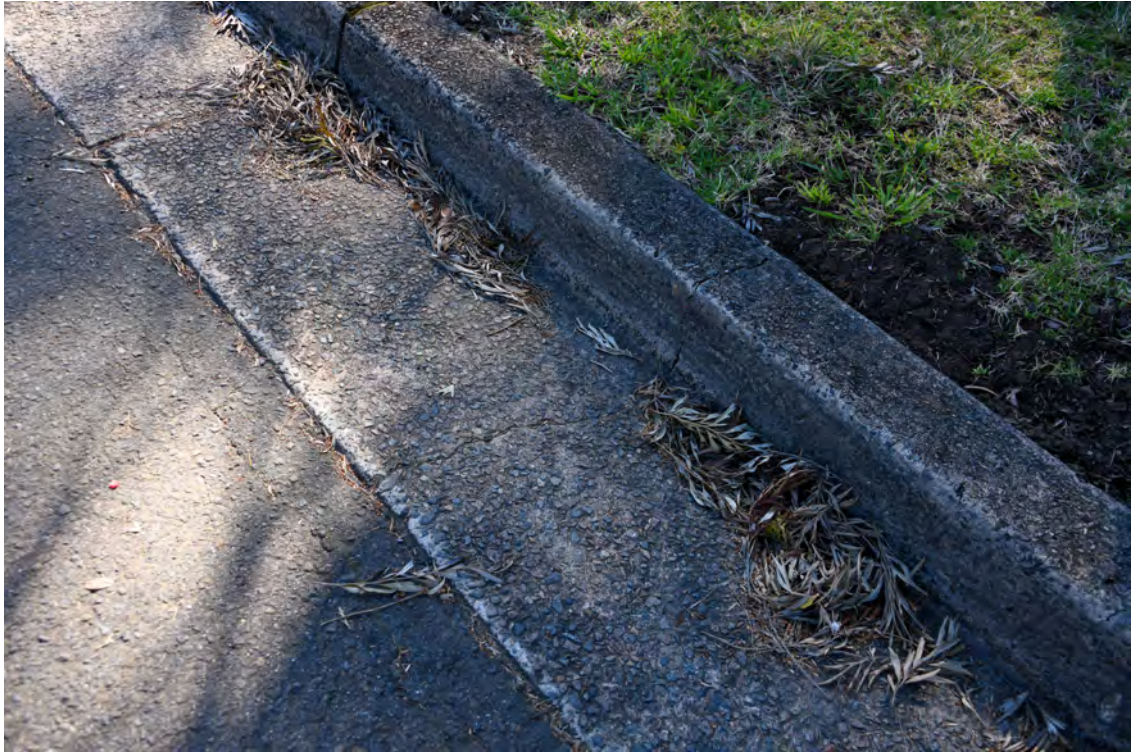
PRO\_1445.jpg

Ward Street. Eastern side of the street. Area between power pole no. EP73712 and EP73713. Heading south.

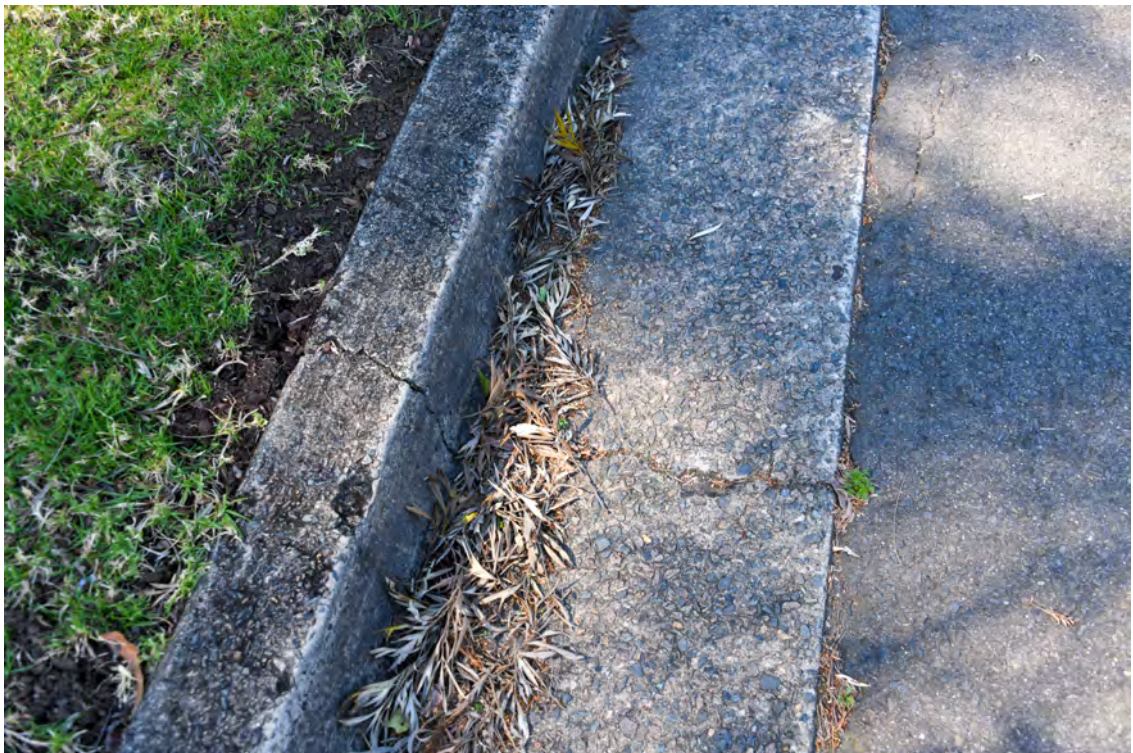
PRO\_1446.jpg

Ward Street. Eastern side of the street. Area between power pole no. EP73712 and EP73713. Heading south.

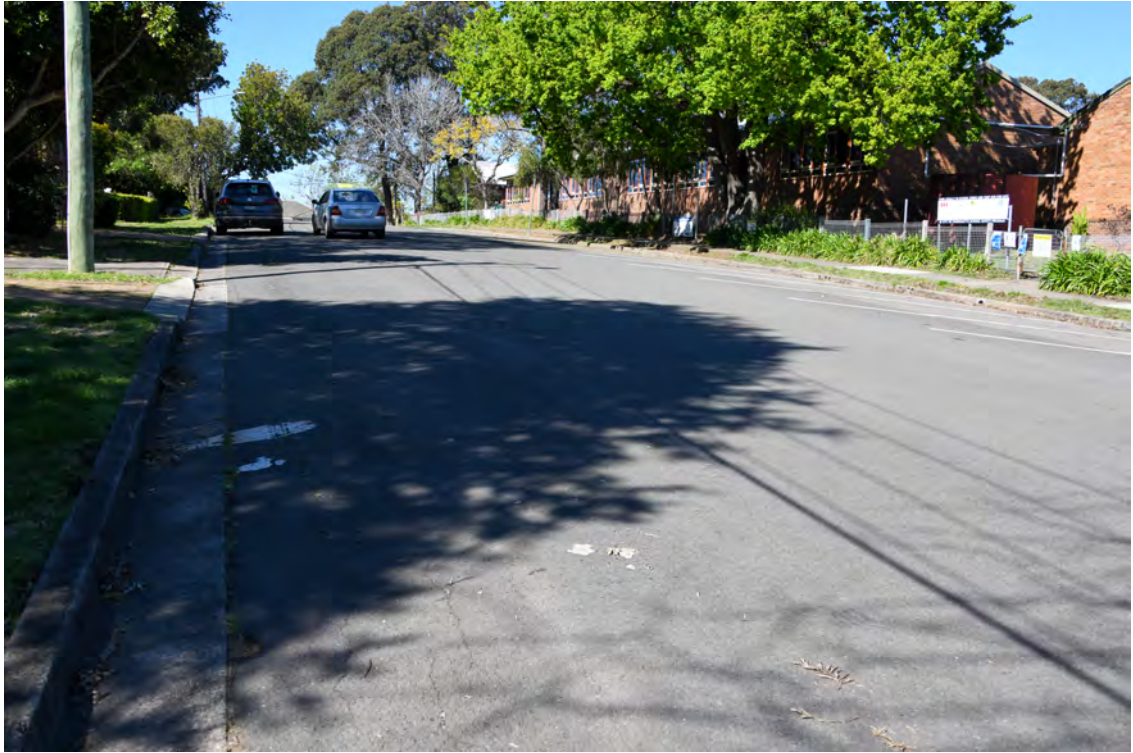
PRO\_1447.jpg

Ward Street. Eastern side of the street. Area between power pole no. EP73712 and EP73713. Heading south.

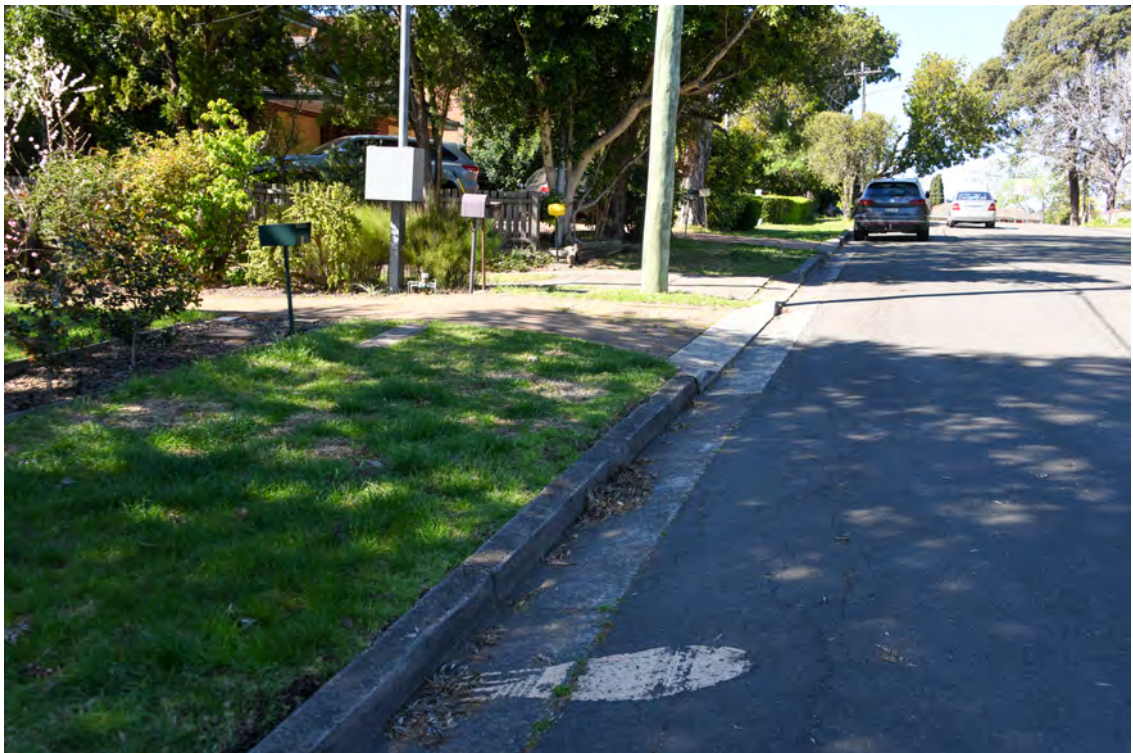
PRO\_1448.jpg

Ward Street. Eastern side of the street. Area between power pole no. EP73712 and EP73713. Heading south.

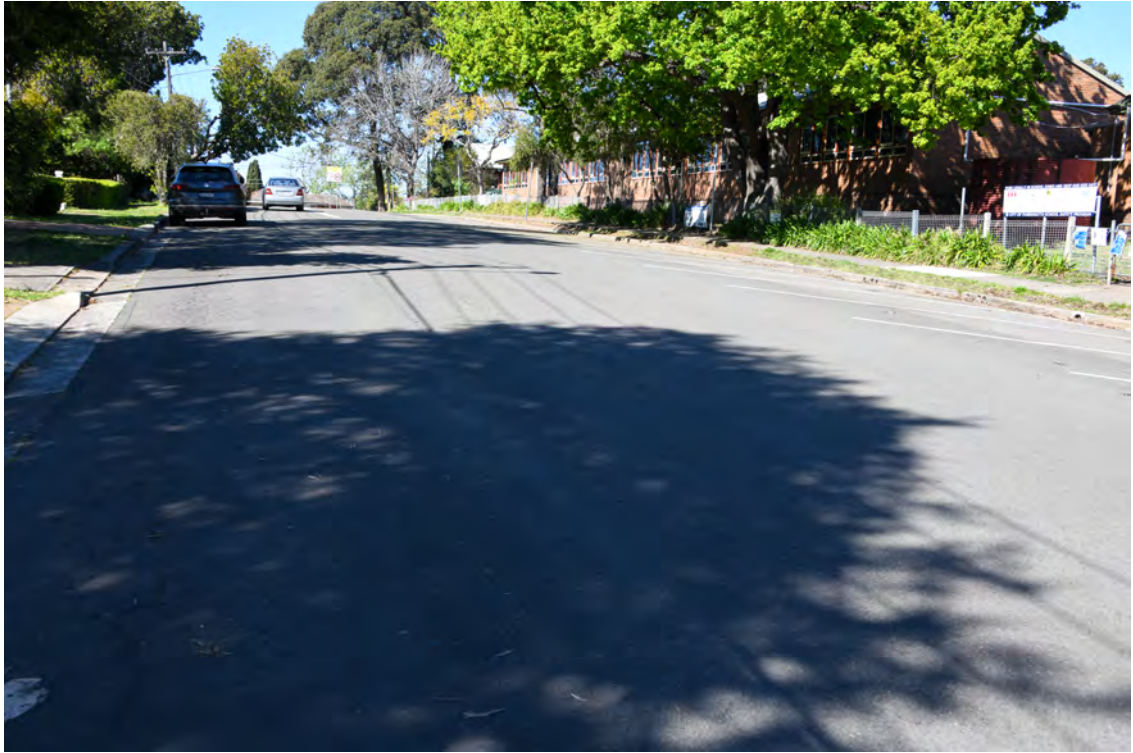
PRO\_1449.jpg

Ward Street. Eastern side of the street. Area between power pole no. EP73712 and EP73713. Heading south.

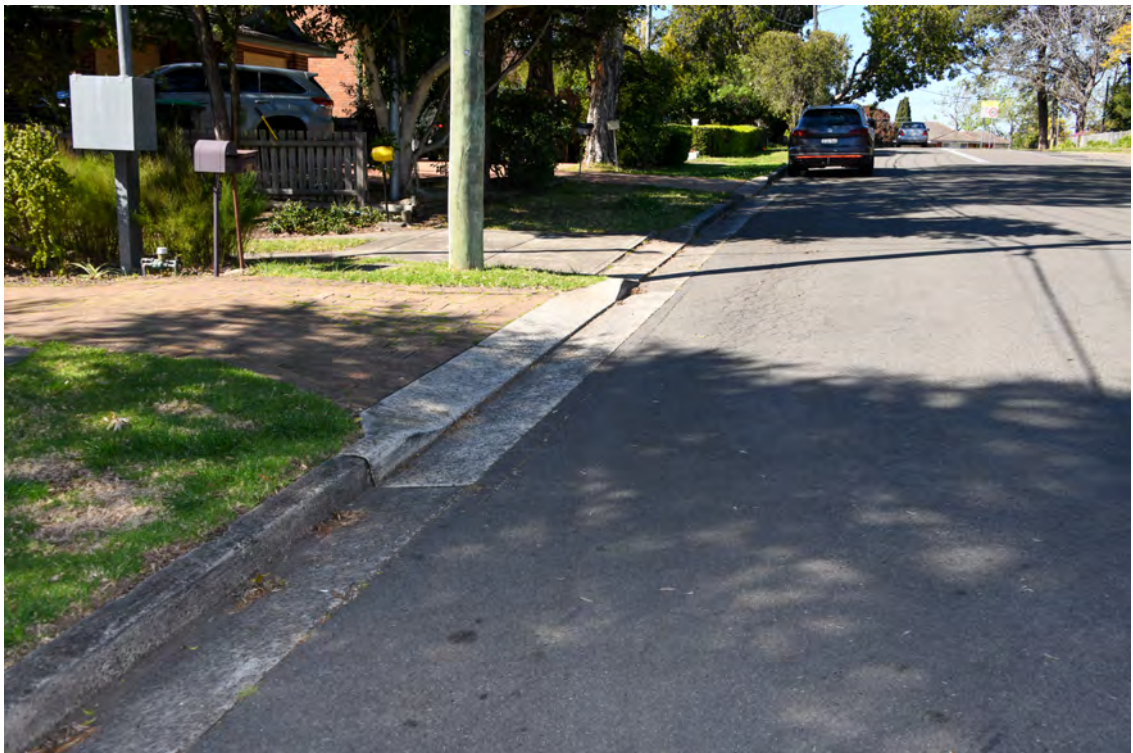
PRO\_1450.jpg

Ward Street. Eastern side of the street. Area between power pole no. EP73712 and EP73713. Heading south.

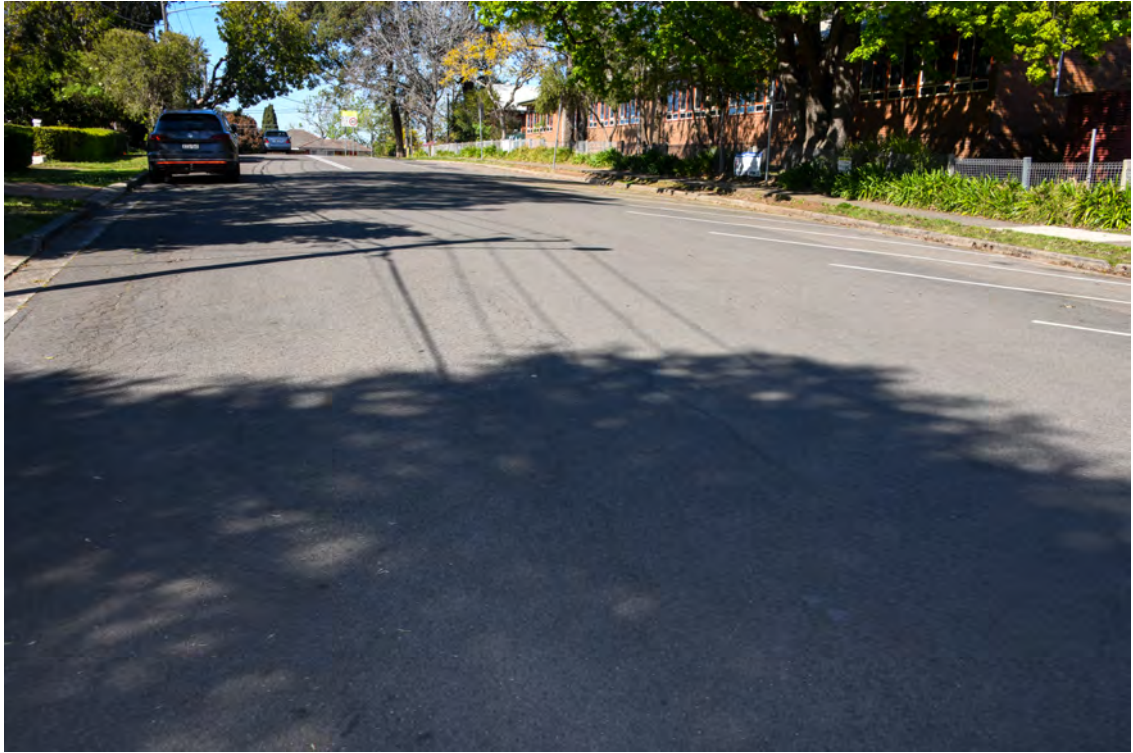
PRO\_1451.jpg

Ward Street. Eastern side of the street. Area between power pole no. EP73712 and EP73713. Heading south.
