96-104 Carlingford Road, Epping NSW 2121

Epping West Public School

DILAPIDATION REPORT

7<sup>th</sup> September 2021

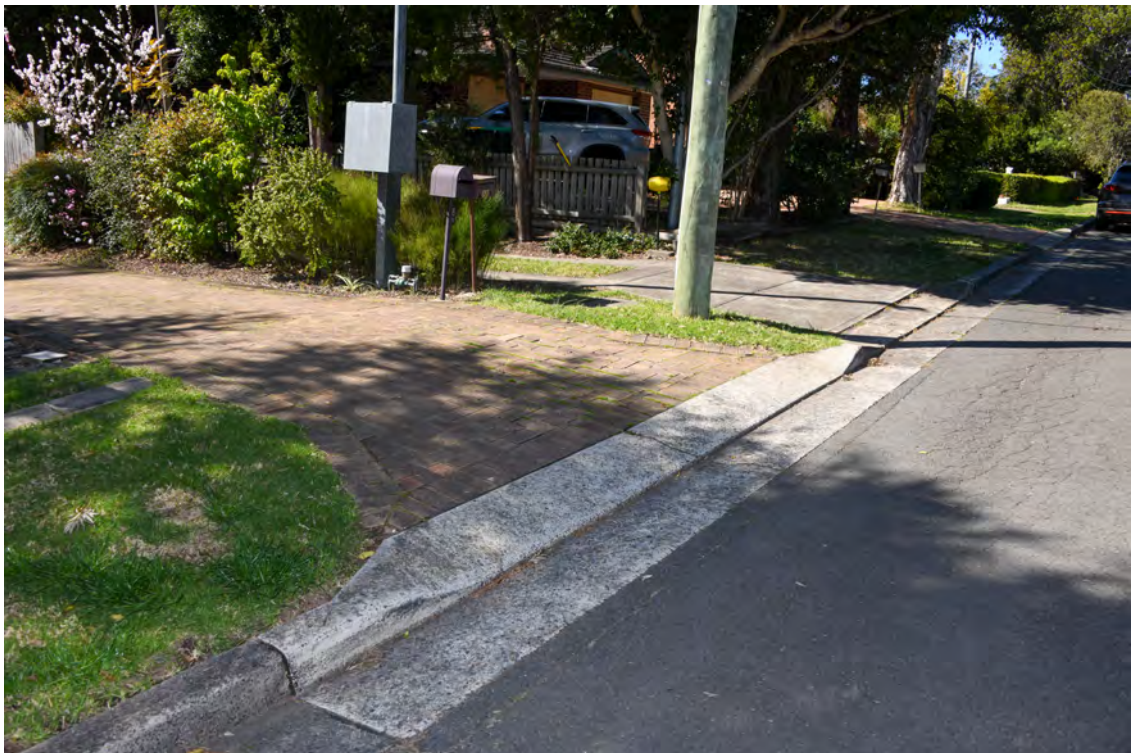
PRO\_1452.jpg

Ward Street. Eastern side of the street. Area between power pole no. EP73712 and EP73713. Heading south.

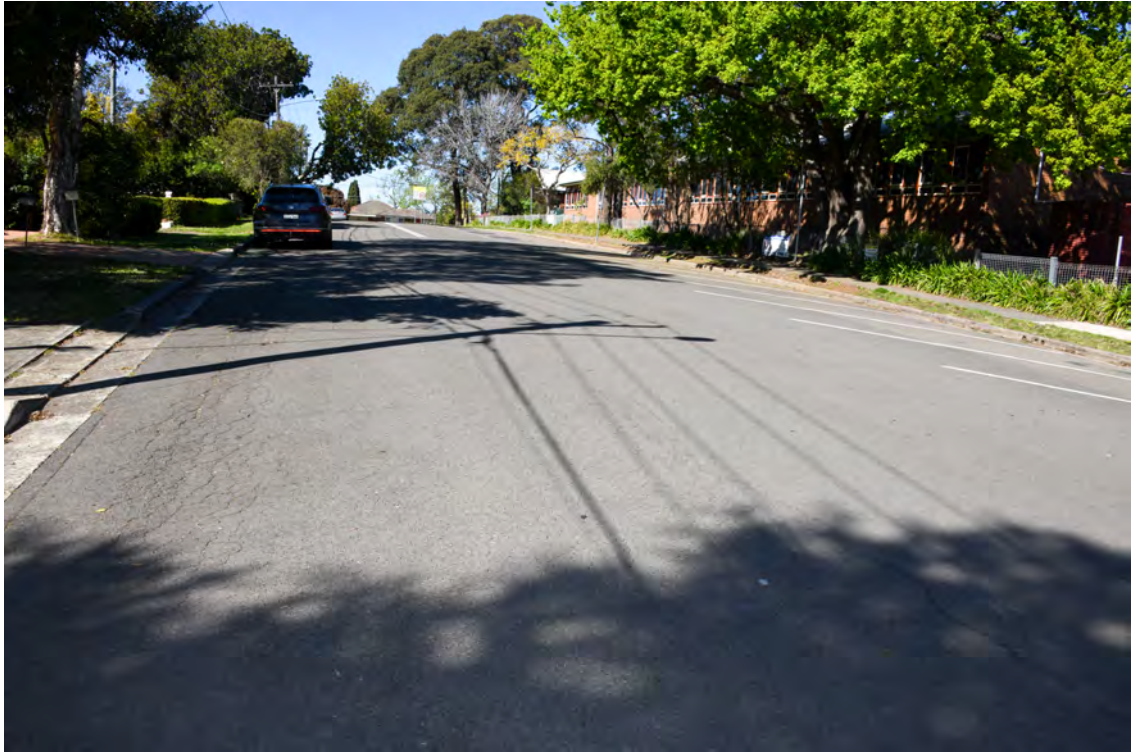
PRO\_1453.jpg

Ward Street. Eastern side of the street. Area between power pole no. EP73712 and EP73713. Heading south.

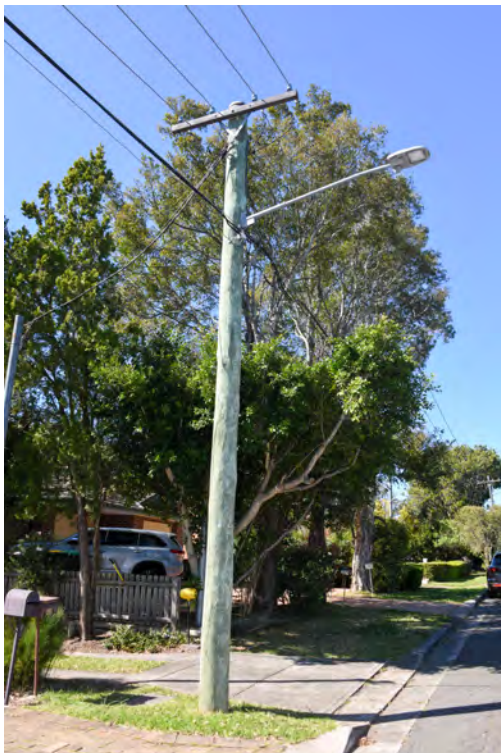
PRO\_1454.jpg

Ward Street. Eastern side of the street. Power pole no. EP73713.

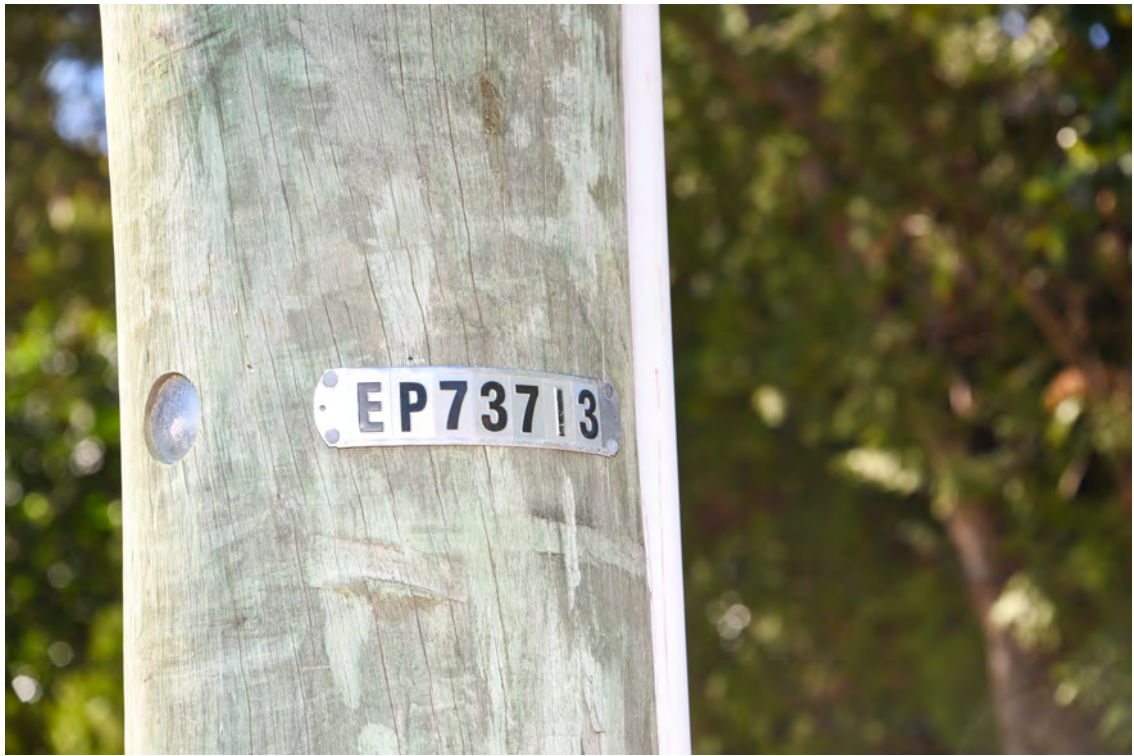
PRO\_1455.jpg

Ward Street. Eastern side of the street. Power pole no. EP73713.

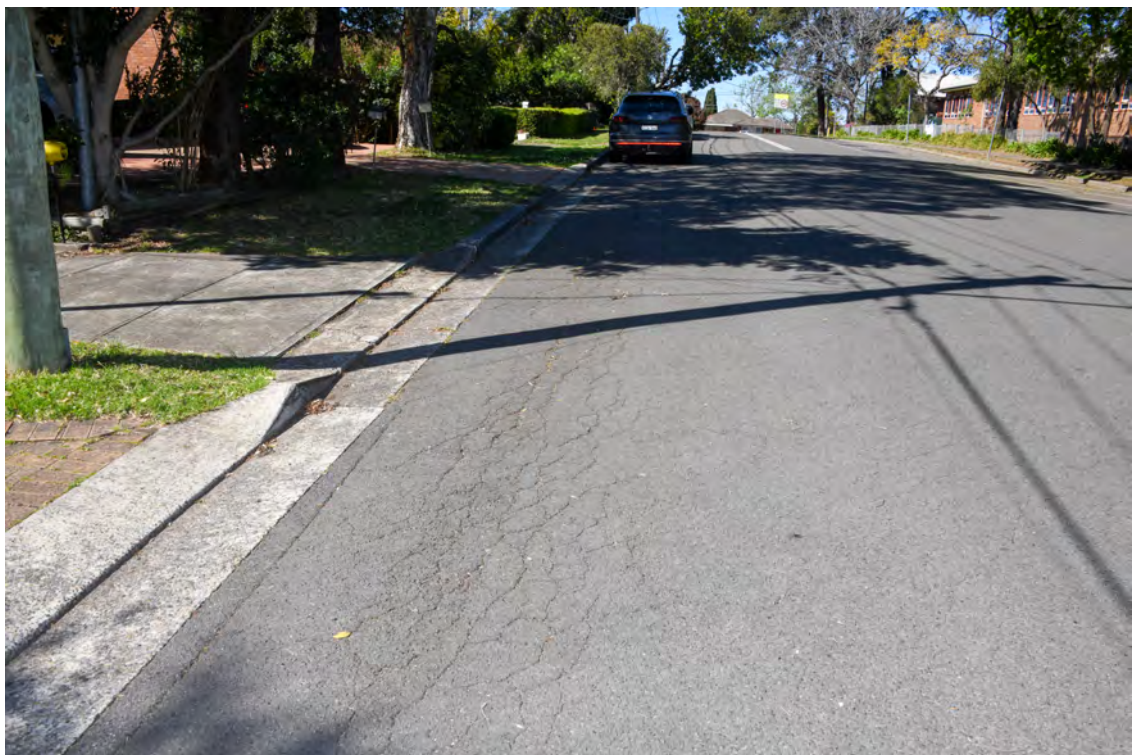
PRO\_1456.jpg

Ward Street. Eastern side of the street. Heading south. Area of power pole no. EP73713.

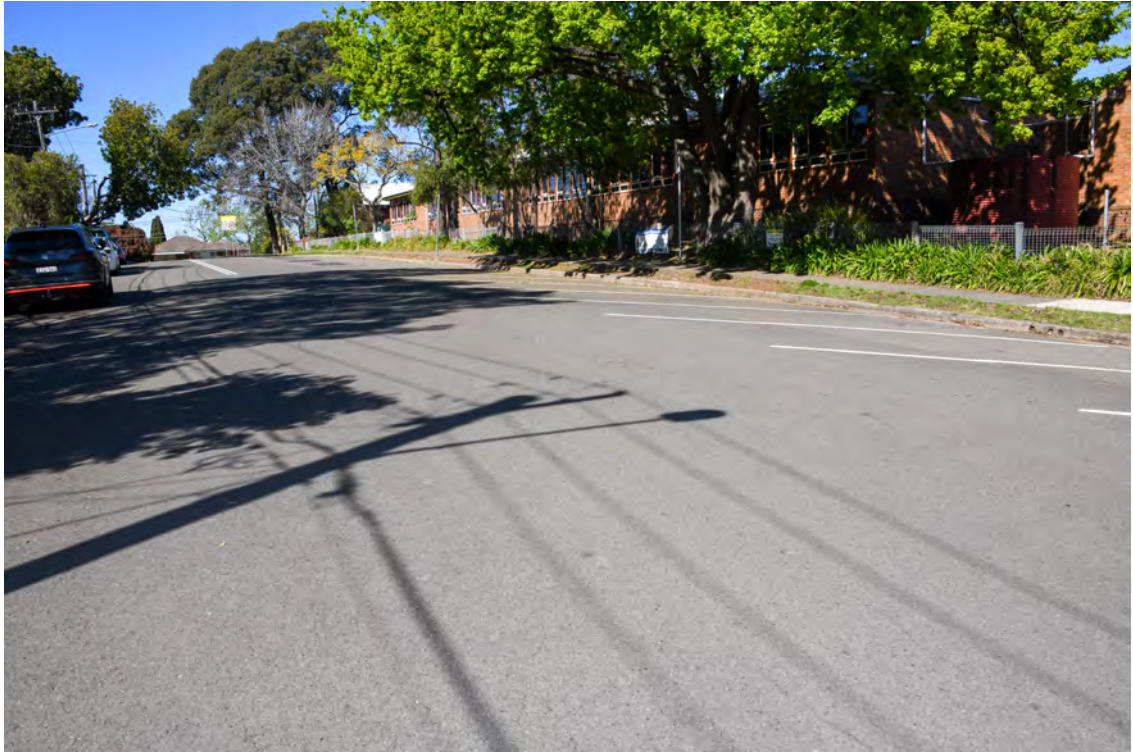
PRO\_1457.jpg

Ward Street. Eastern side of the street. Heading south. Area of power pole no. EP73713.

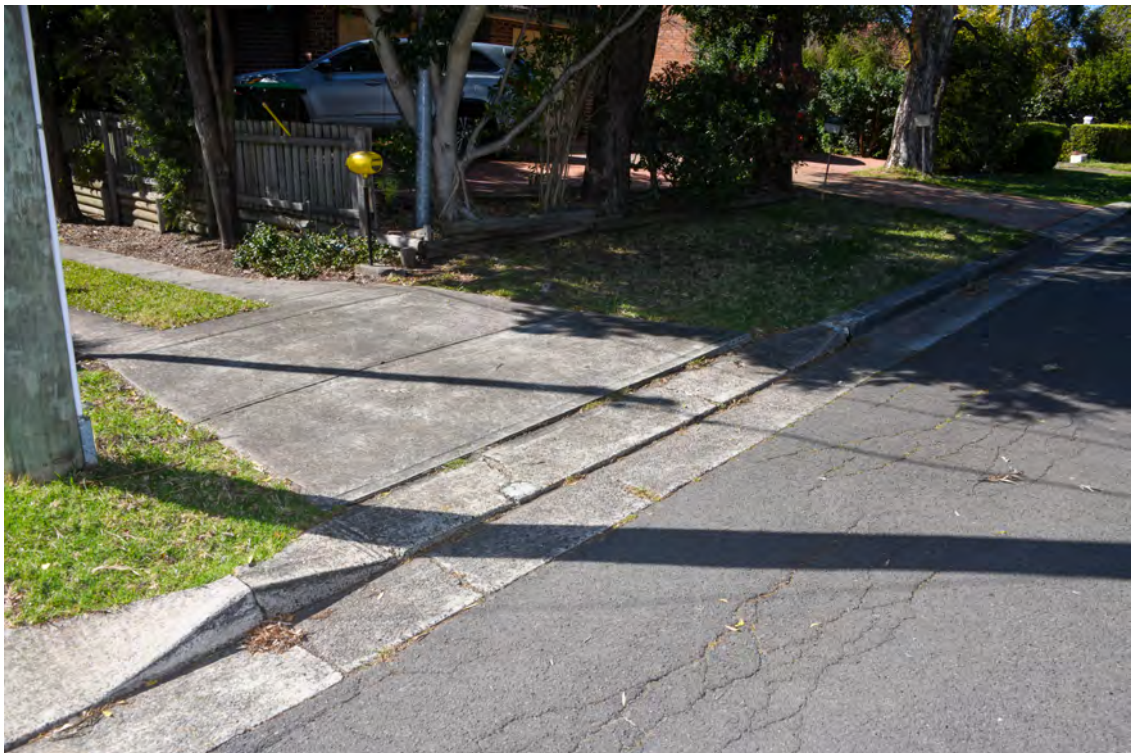
PRO\_1458.jpg

Ward Street. Eastern side of the street. Heading south. Area of power pole no. EP73713.

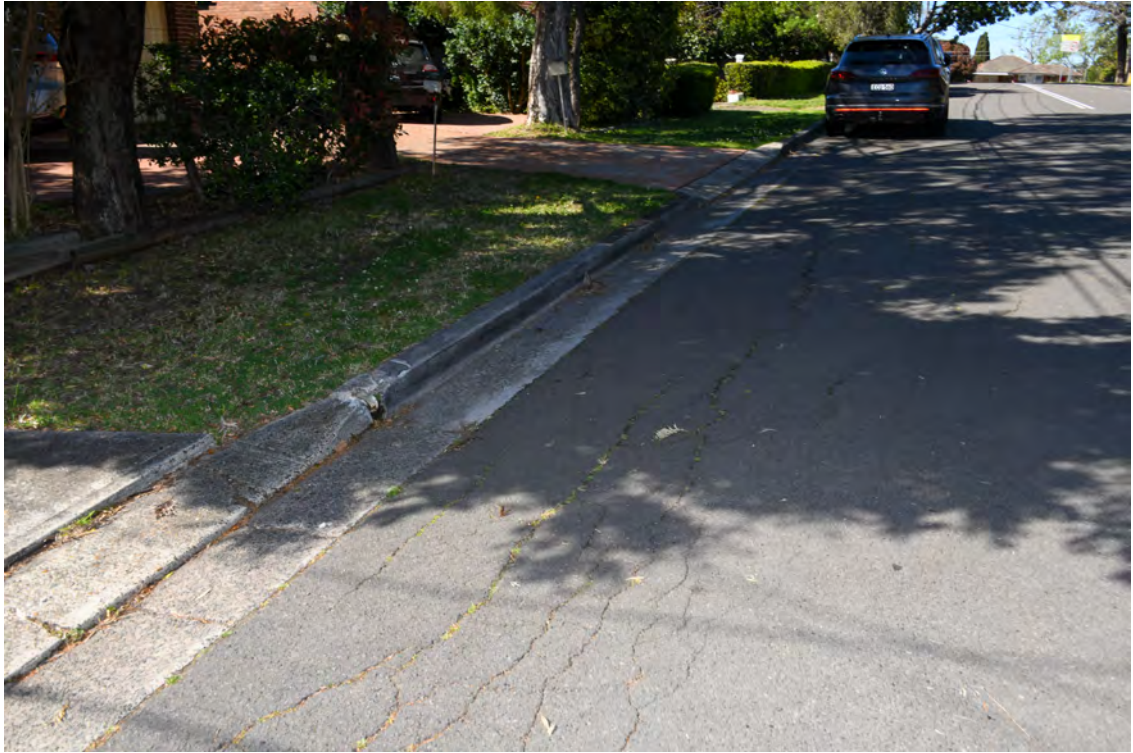
PRO\_1459.jpg

Ward Street. Eastern side of the street. Heading south. Area of power pole no. EP73713.

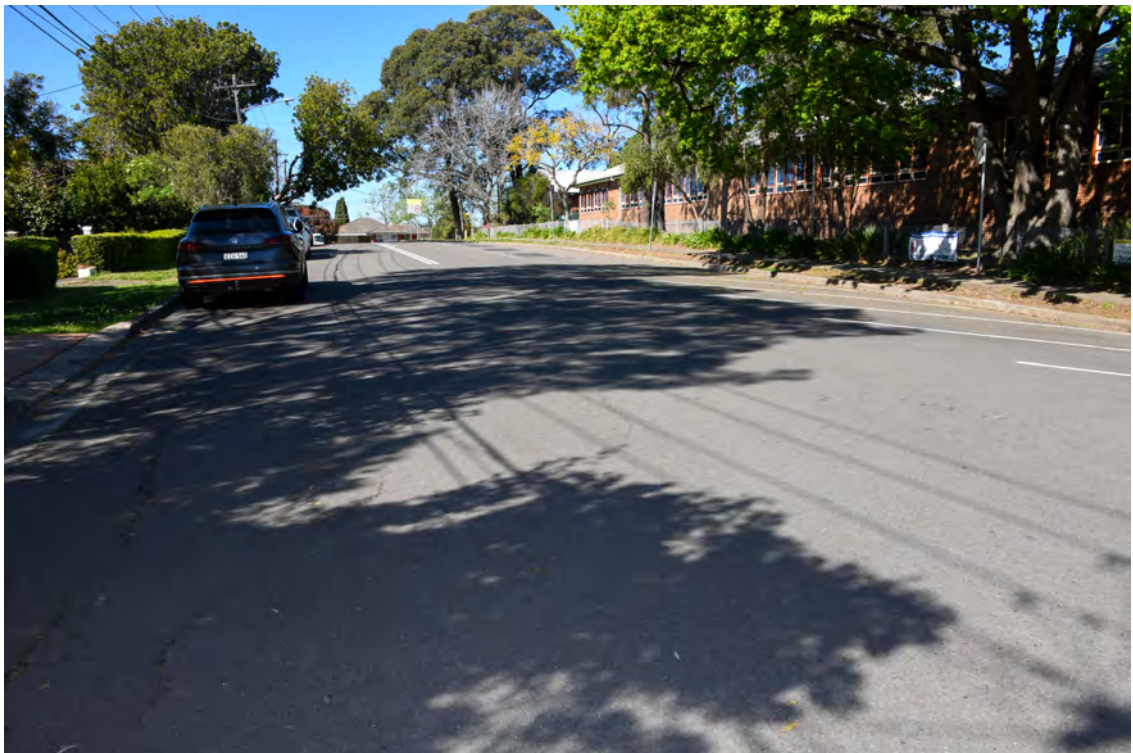
PRO\_1460.jpg

Ward Street. Eastern side of the street. Heading south. Area between power pole no. EP73713 and EP00051.

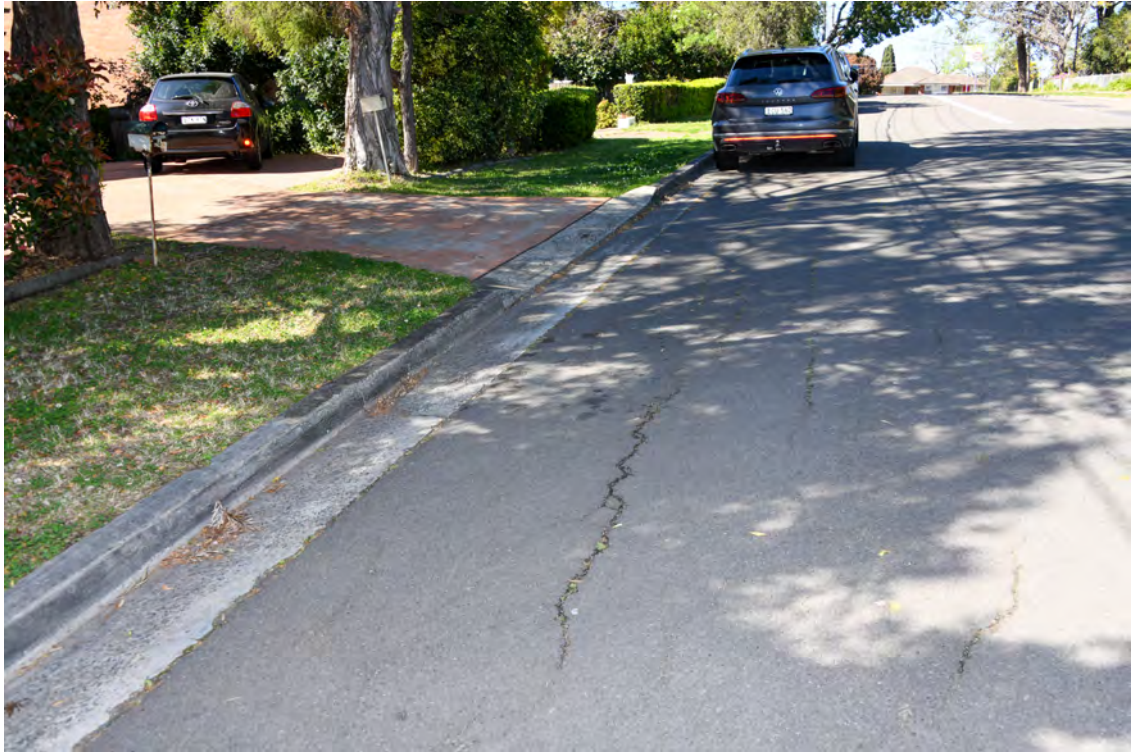
PRO\_1461.jpg

Ward Street. Eastern side of the street. Heading south. Area between power pole no. EP73713 and EP00051.

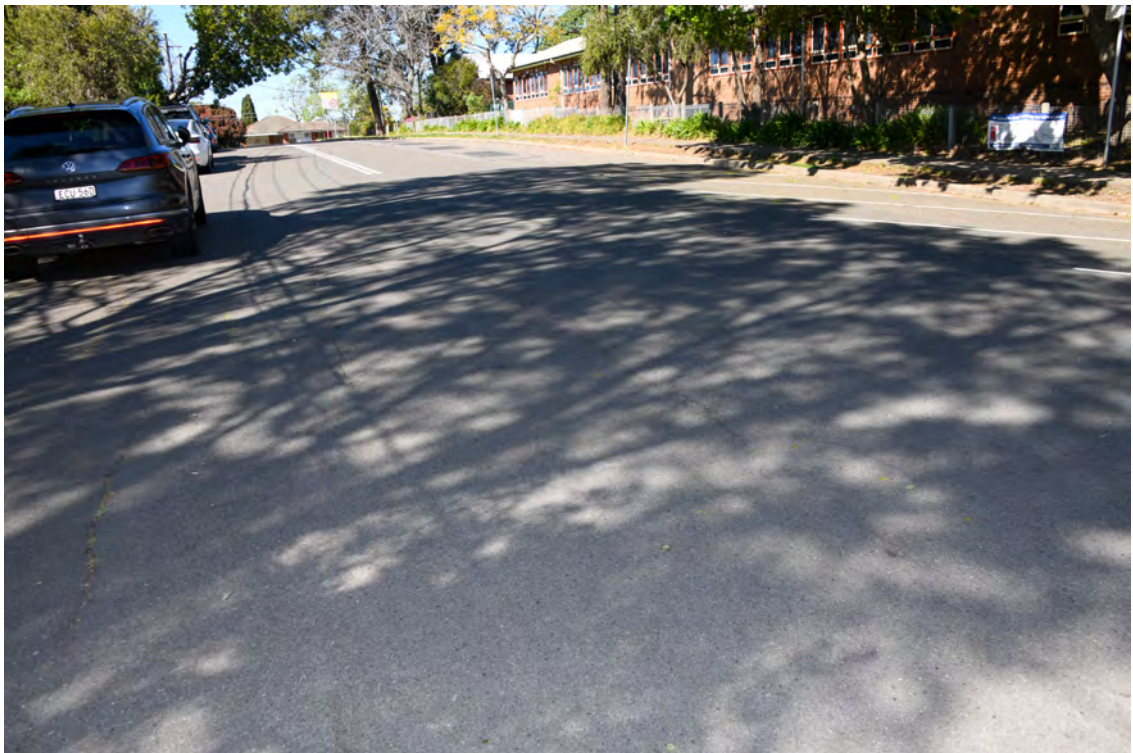
PRO\_1462.jpg

Ward Street. Eastern side of the street. Heading south. Area between power pole no. EP73713 and EP00051.

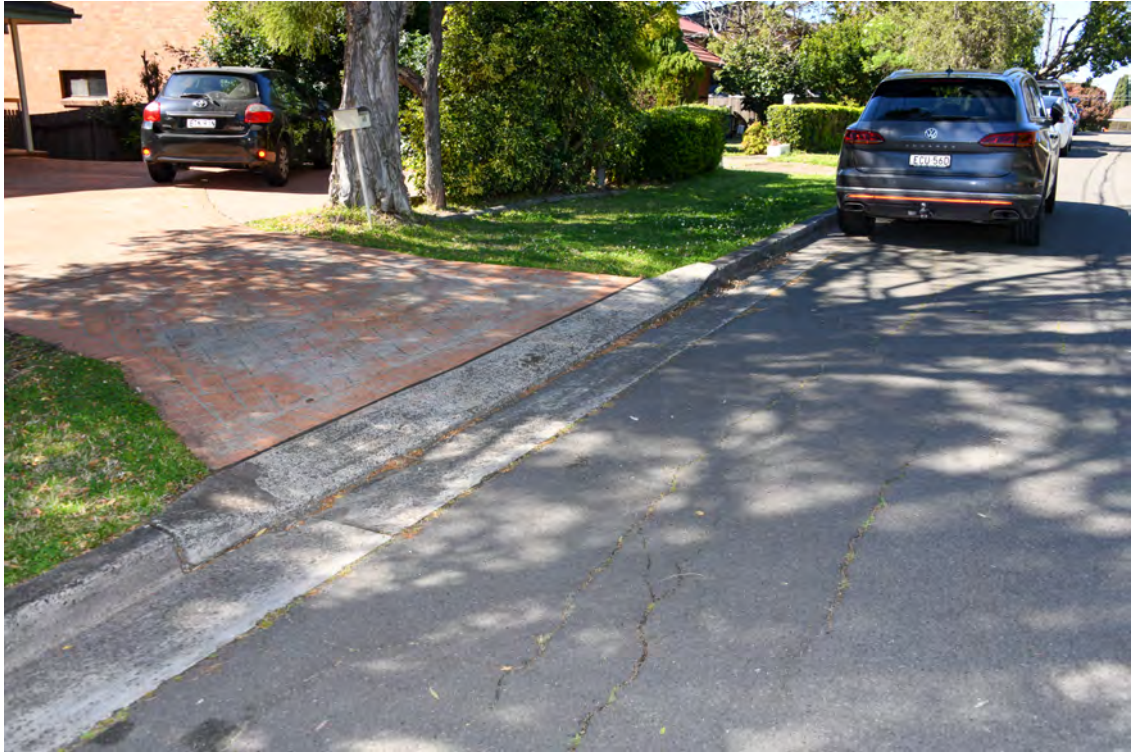
PRO\_1463.jpg

Ward Street. Eastern side of the street. Heading south. Area between power pole no. EP73713 and EP00051.

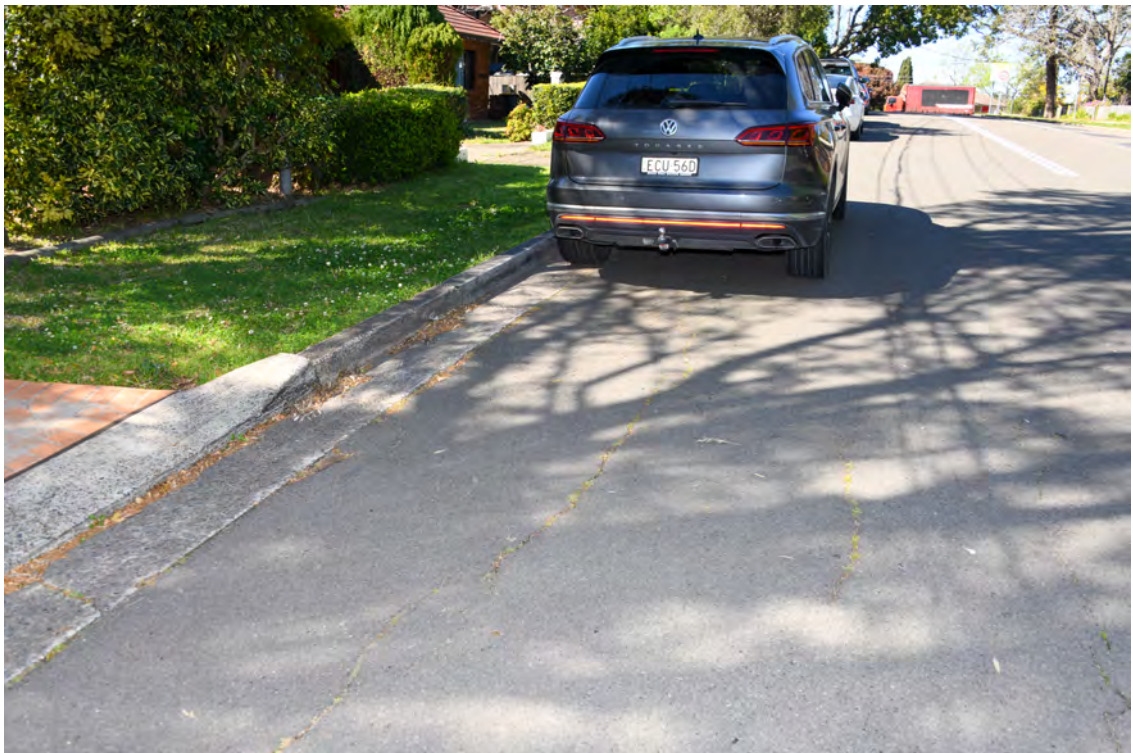
PRO\_1464.jpg

Ward Street. Eastern side of the street. Heading south. Area between power pole no. EP73713 and EP00051.

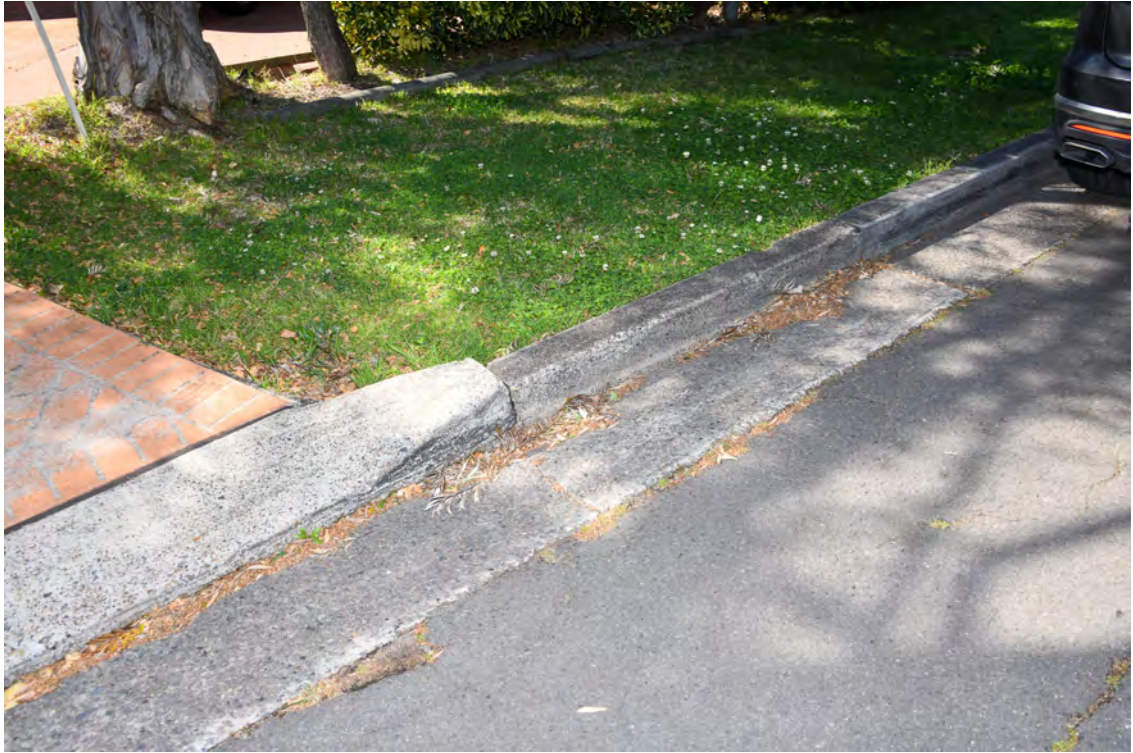
PRO\_1465.jpg

Ward Street. Eastern side of the street. Heading south. Area between power pole no. EP73713 and EP00051.

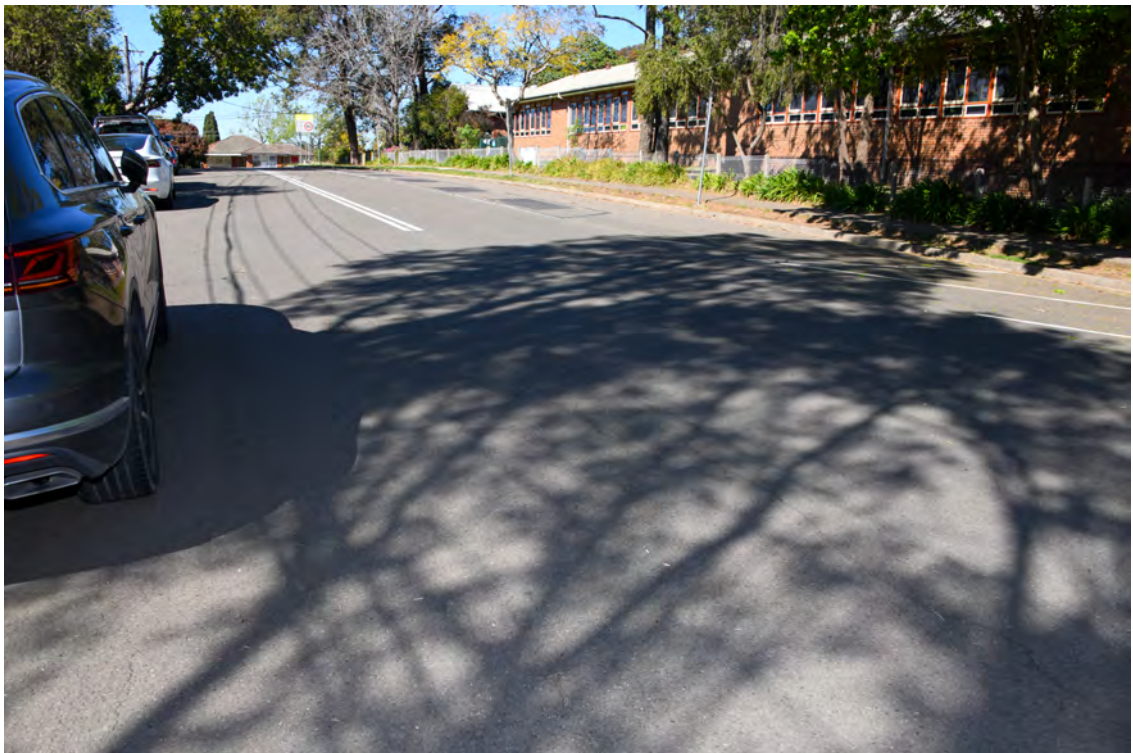
PRO\_1466.jpg

Ward Street. Eastern side of the street. Heading south. Area between power pole no. EP73713 and EP00051.

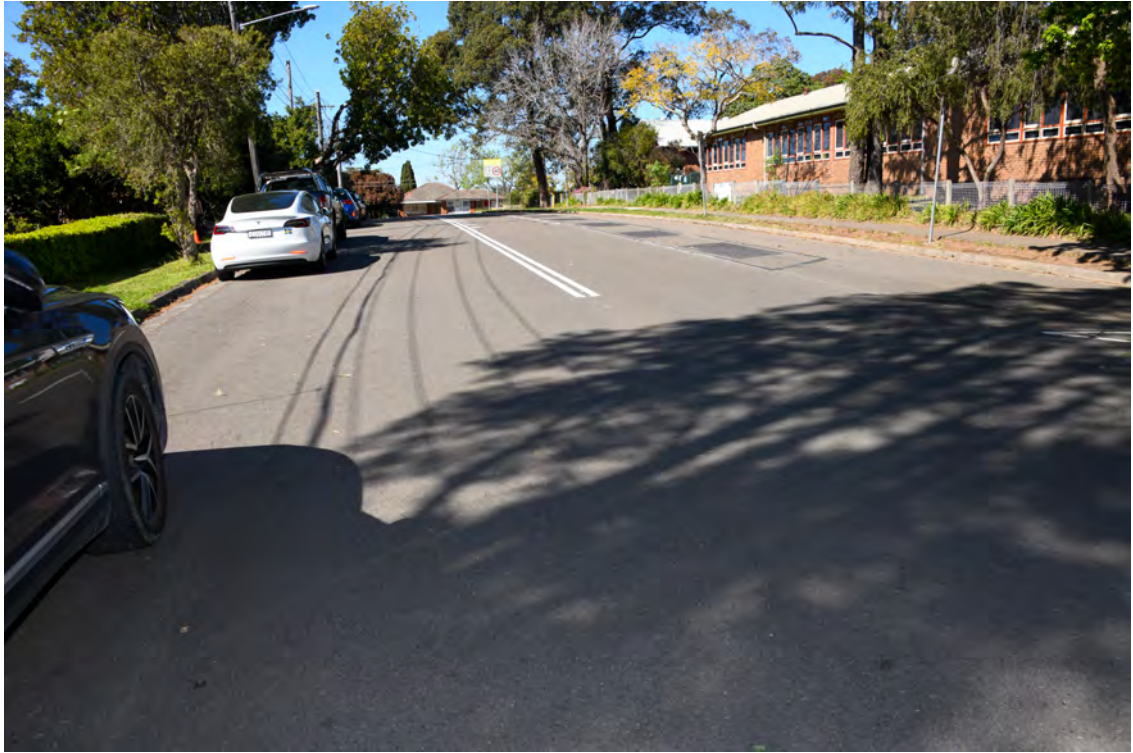
PRO\_1467.jpg

Ward Street. Eastern side of the street. Heading south. Area between power pole no. EP73713 and EP00051.

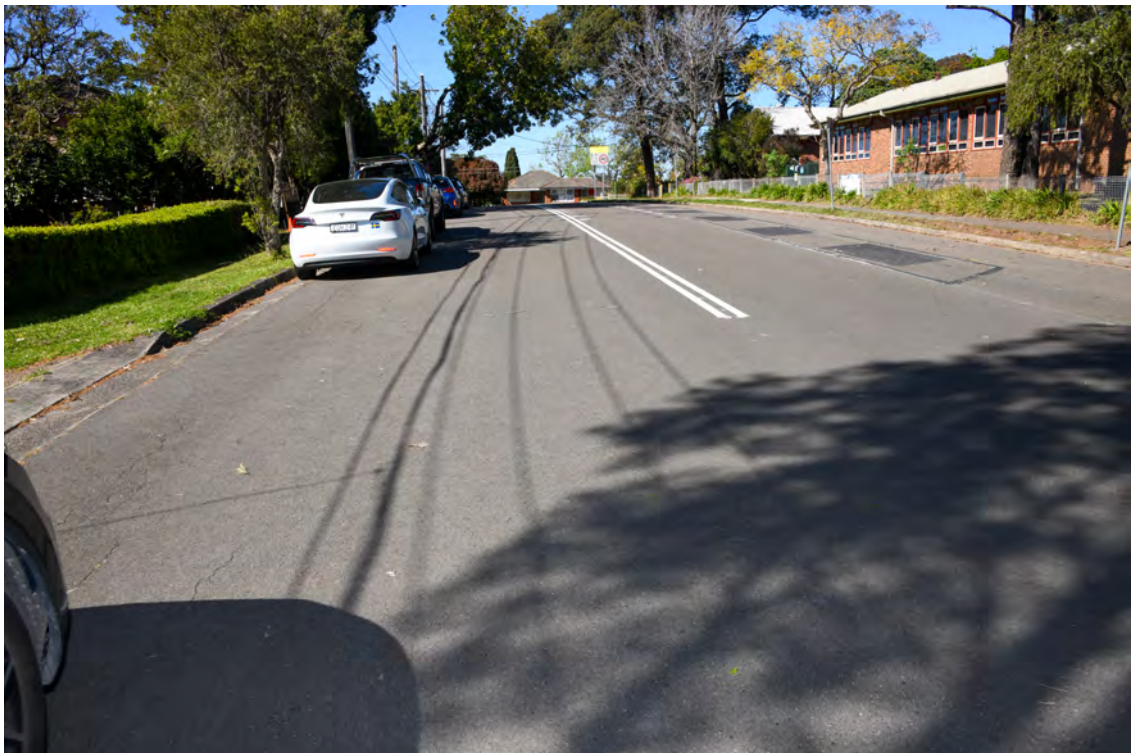
PRO\_1468.jpg

Ward Street. Eastern side of the street. Heading south. Area between power pole no. EP73713 and EP00051.

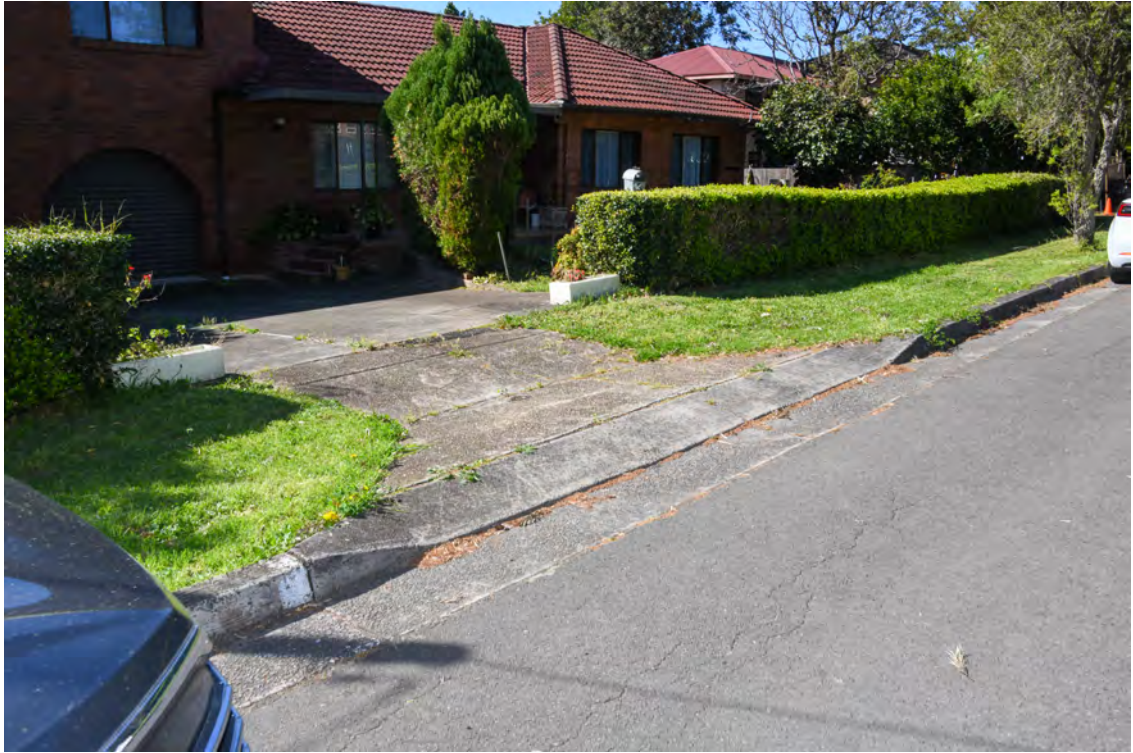
PRO\_1469.jpg

Ward Street. Eastern side of the street. Heading south. Area between power pole no. EP73713 and EP00051.

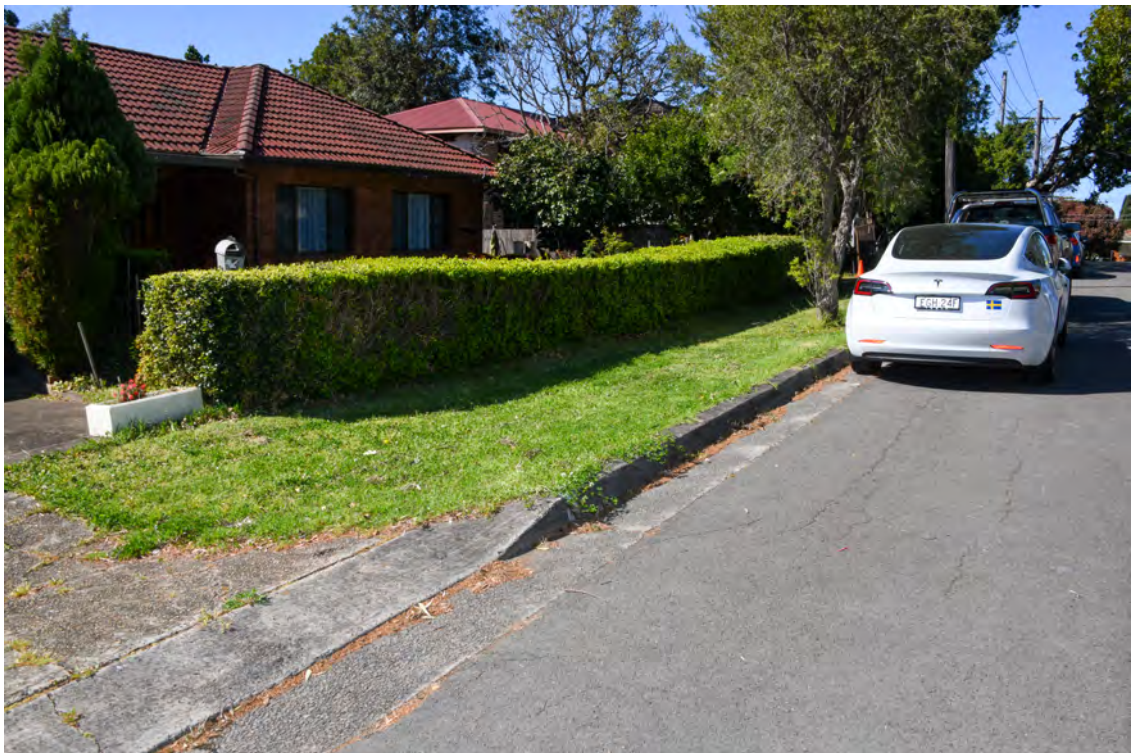
PRO\_1470.jpg

Ward Street. Eastern side of the street. Heading south. Area between power pole no. EP73713 and EP00051.

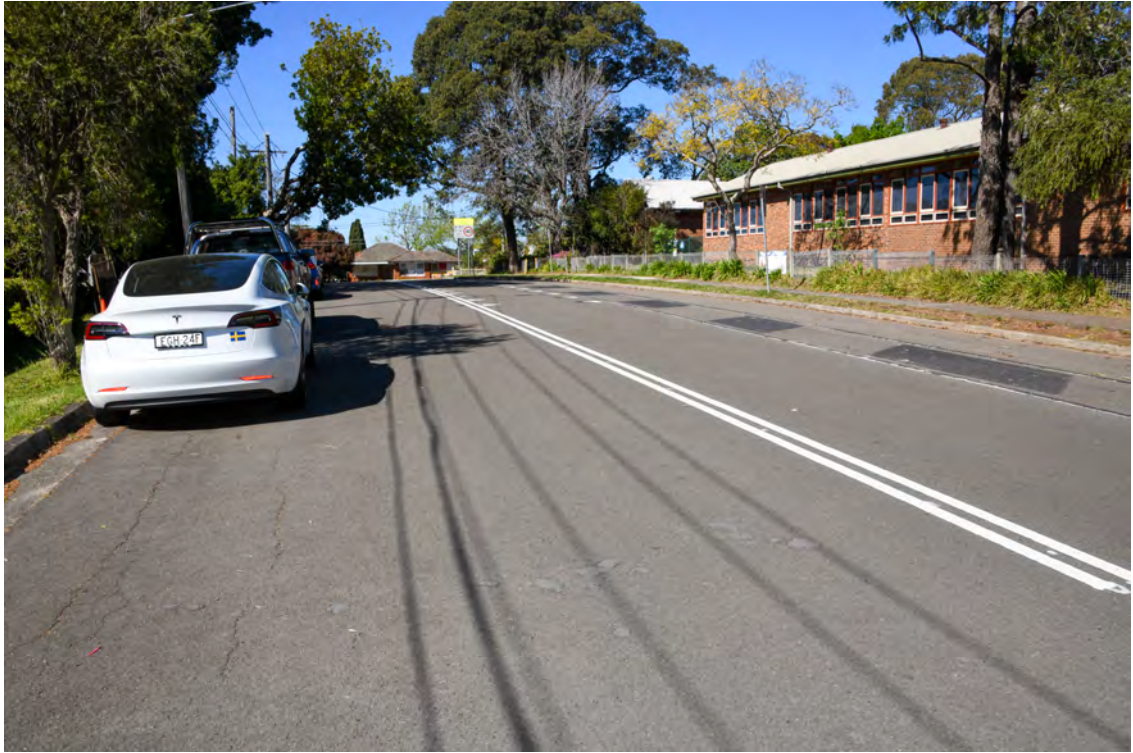
PRO\_1471.jpg

Ward Street. Eastern side of the street. Heading south. Area between power pole no. EP73713 and EP00051.

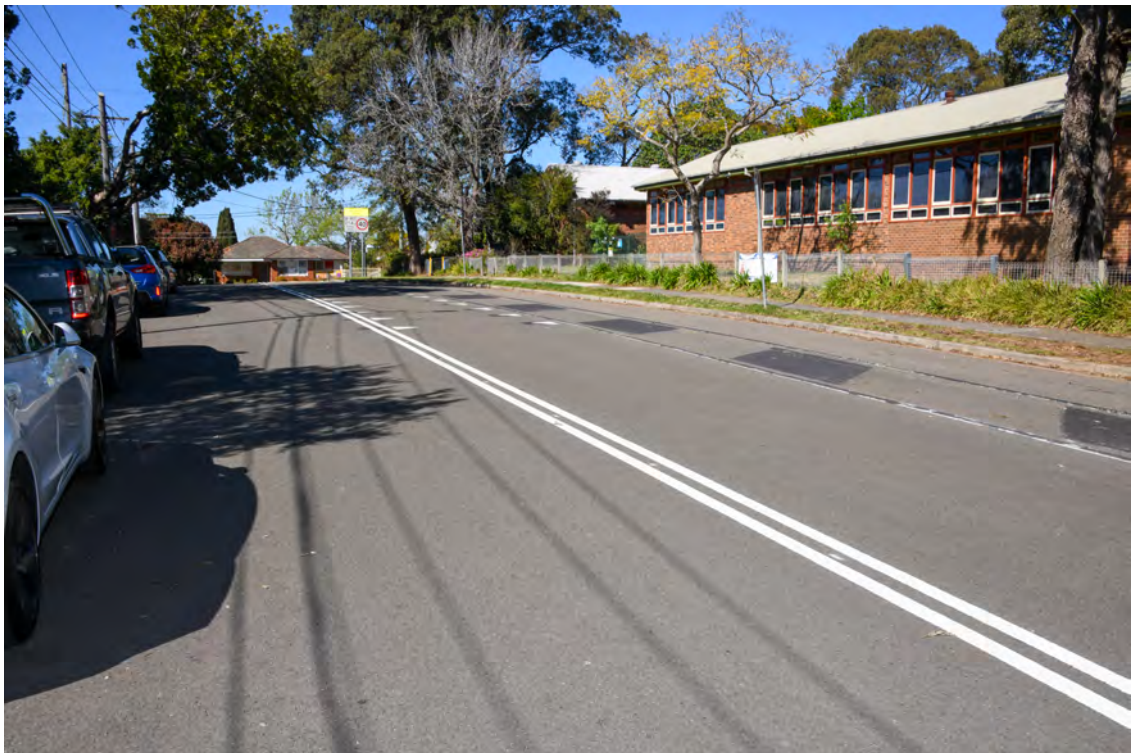
PRO\_1472.jpg

Ward Street. Eastern side of the street. Heading south. Area between power pole no. EP73713 and EP00051.

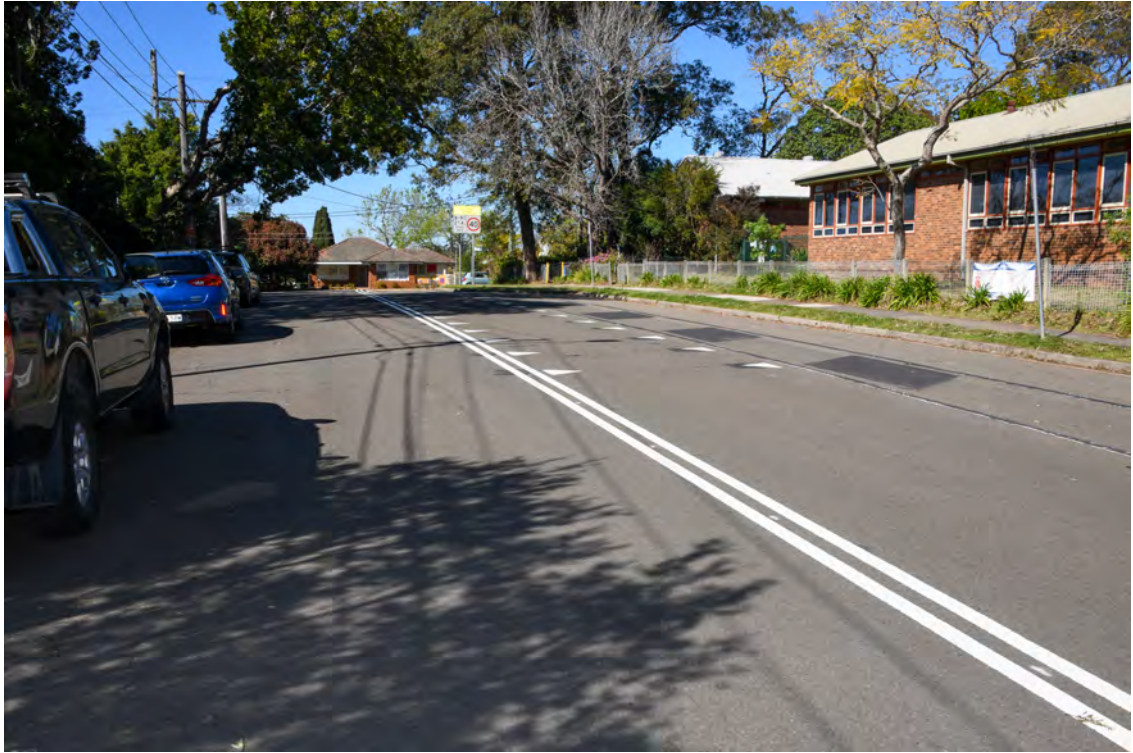
PRO\_1473.jpg

Ward Street. Eastern side of the street. Heading south. Area between power pole no. EP73713 and EP00051.

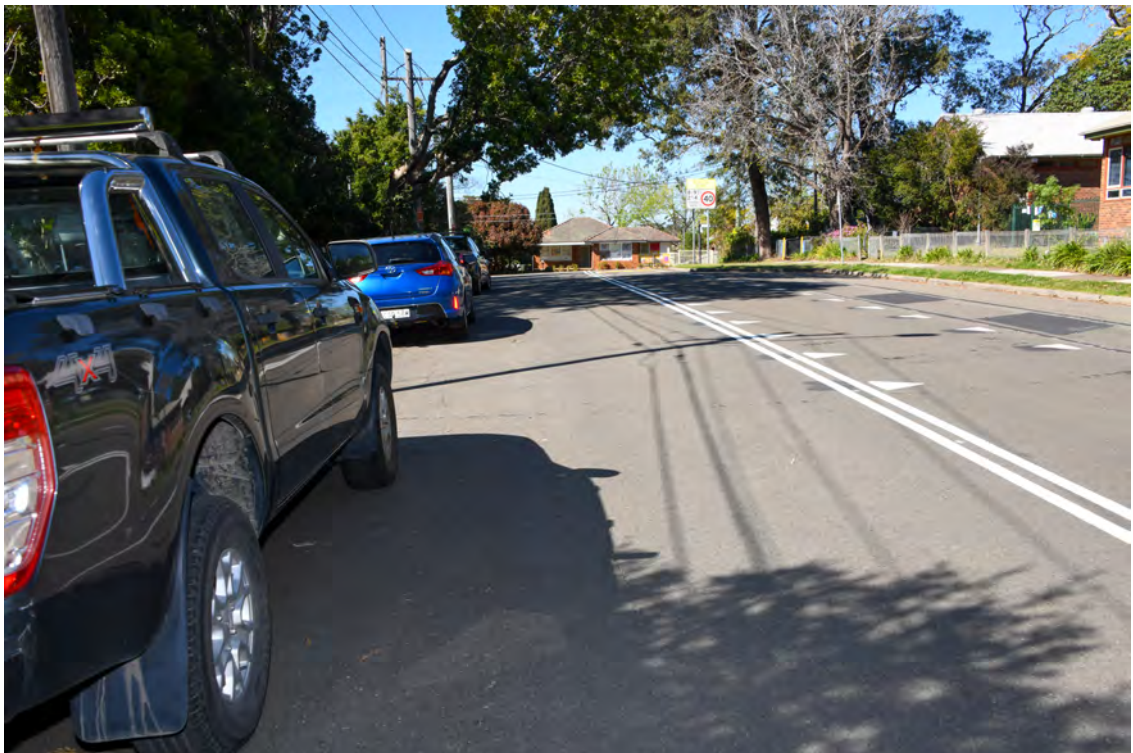
PRO\_1474.jpg

Ward Street. Eastern side of the street. Heading south. Area between power pole no. EP73713 and EP00051.

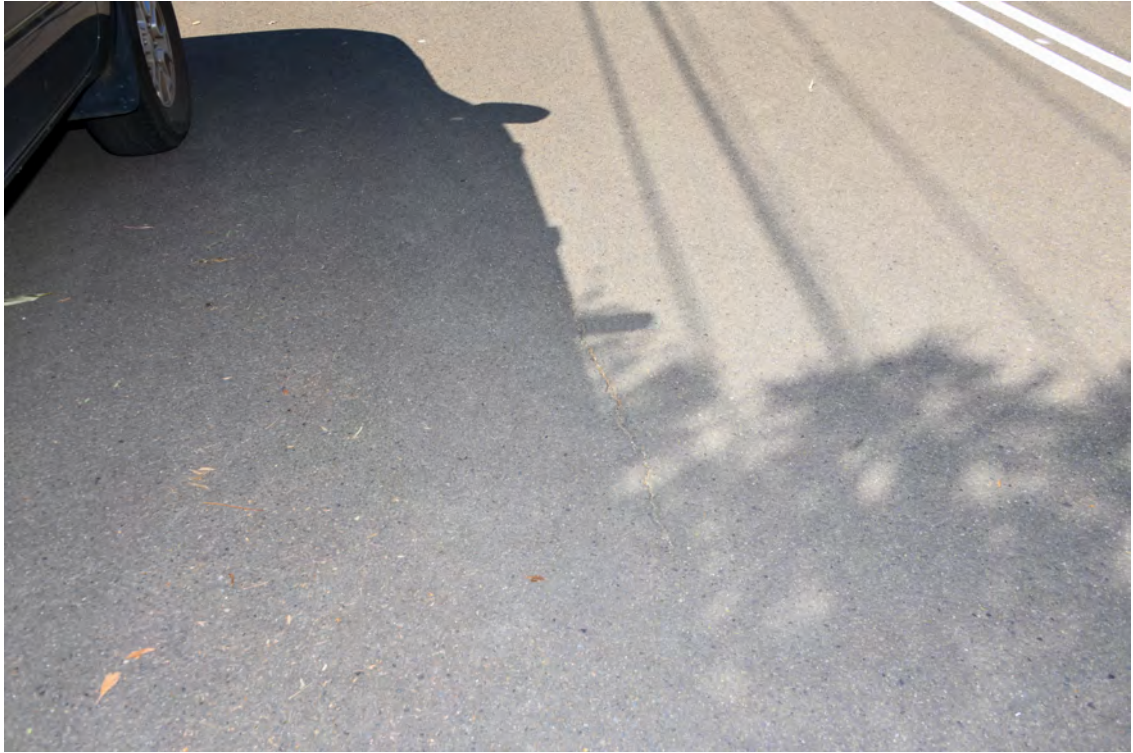
PRO\_1475.jpg

Ward Street. Eastern side of the street. Heading south. Area between power pole no. EP73713 and EP00051.

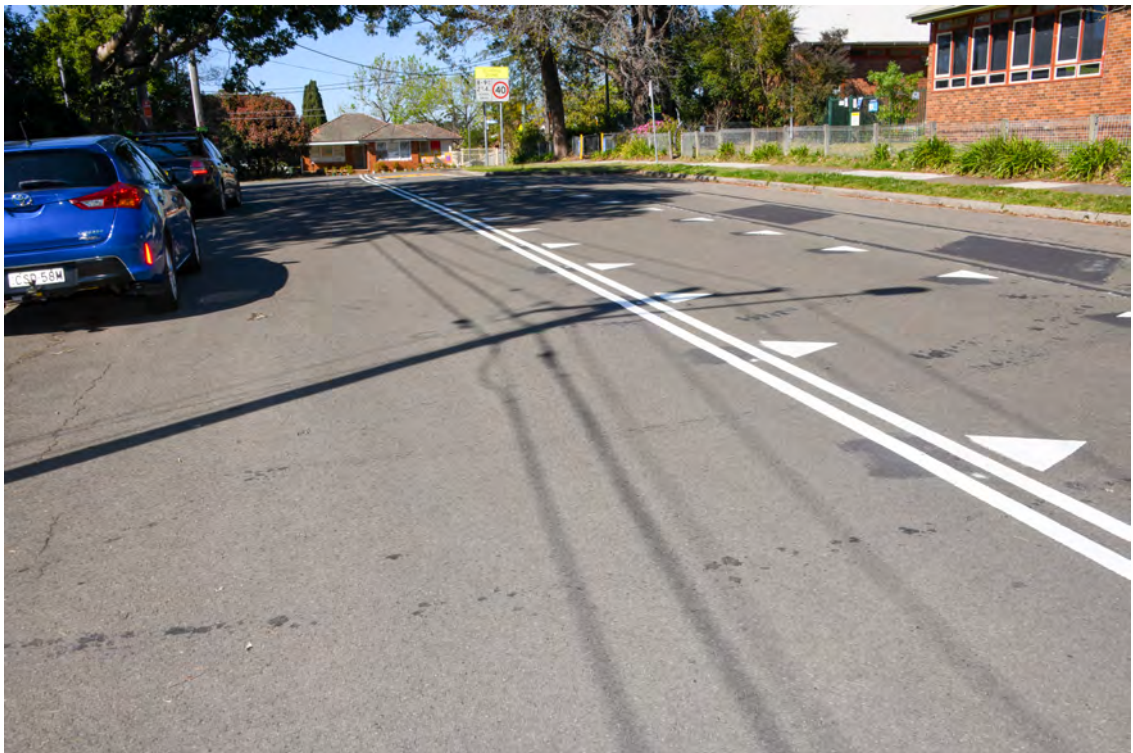
PRO\_1476.jpg

Ward Street. Eastern side of the street. Heading south. Area between power pole no. EP73713 and EP00051.

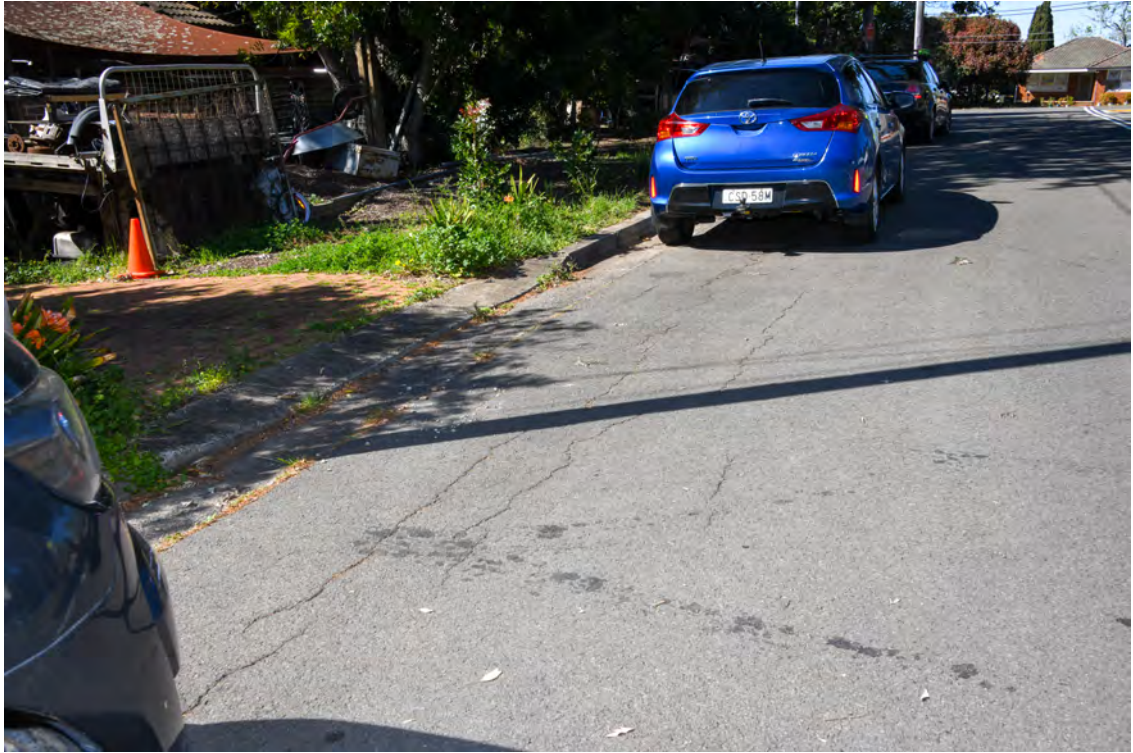
PRO\_1477.jpg

Ward Street. Eastern side of the street. Heading south. Area between power pole no. EP73713 and EP00051.
