96-104 Carlingford Road, Epping NSW 2121

Epping West Public School

DILAPIDATION REPORT

7<sup>th</sup> September 2021

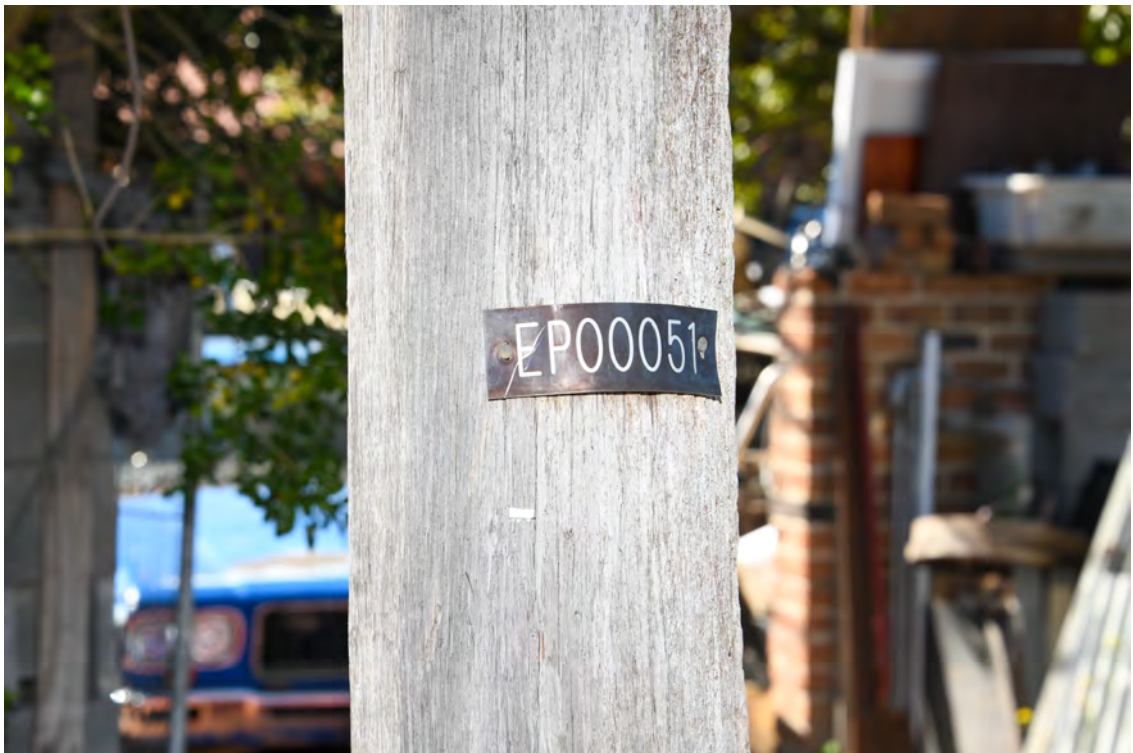
PRO\_1478.jpg

Ward Street. Eastern side of the street. Heading south. Power pole no. EP00051.

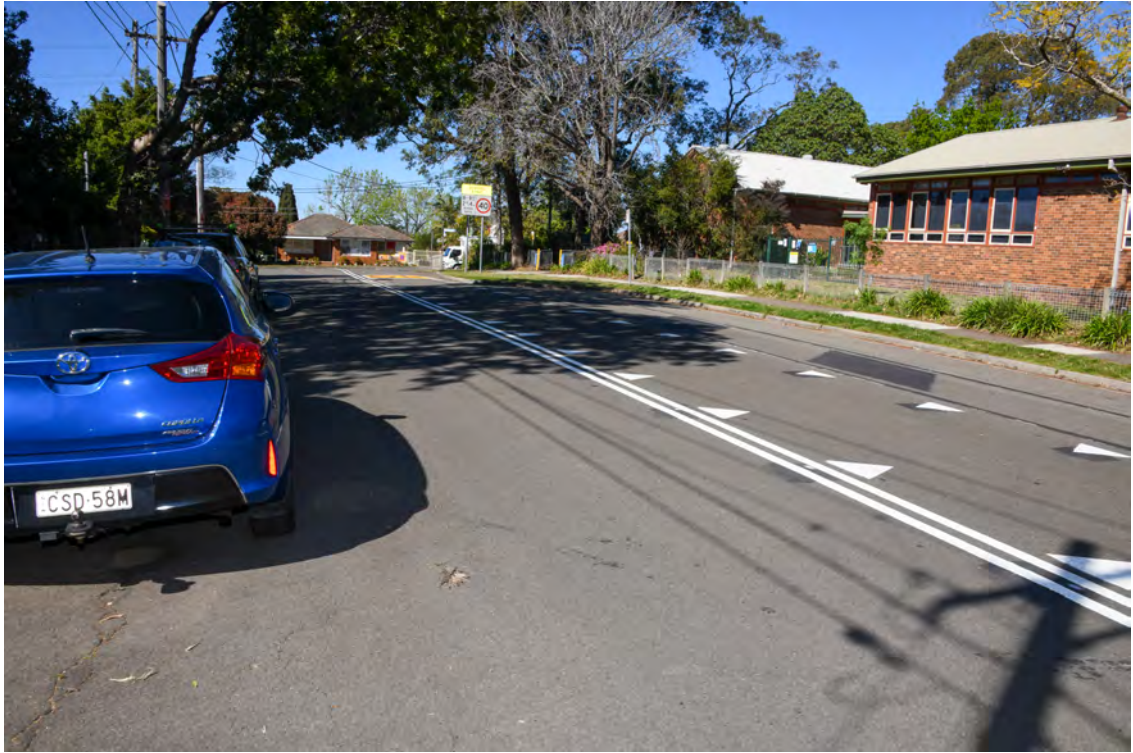
PRO\_1479.jpg

Ward Street. Eastern side of the street. Heading south. Area between power pole no. EP00051 and EP73715.

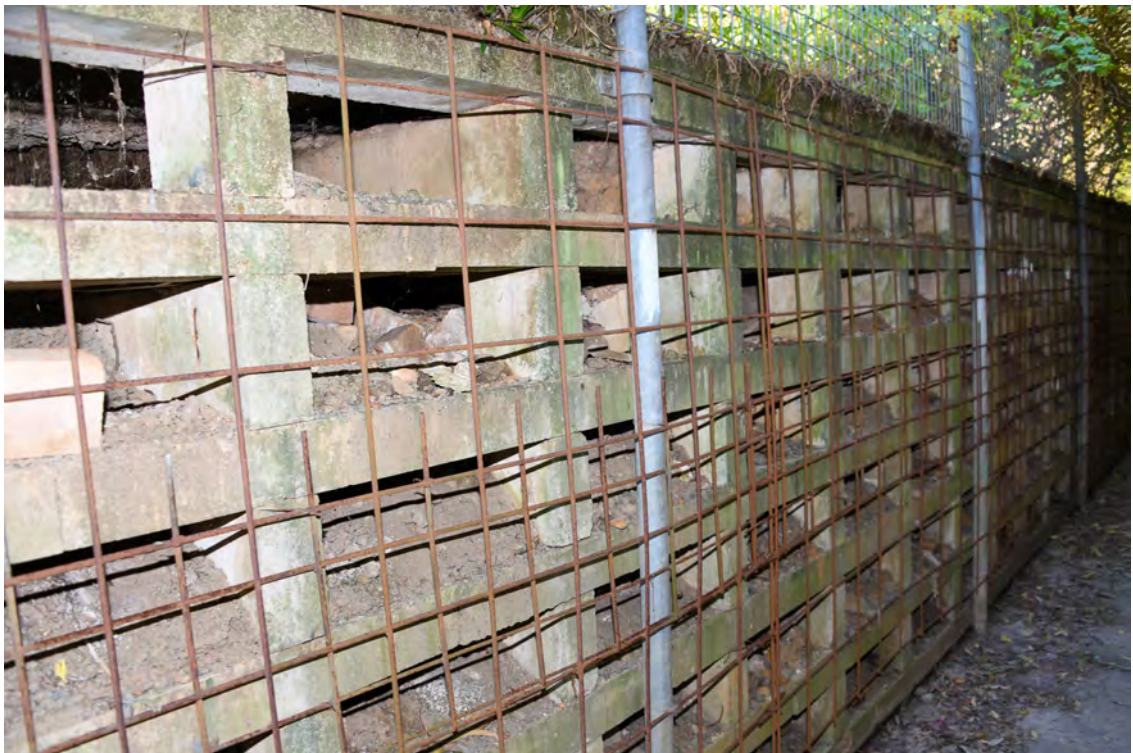
PRO\_1560.jpg

YMCA. Property to the north of Epping West Public School. Southern elevation. Heading west. Detail of the retaining wall along the boundary.

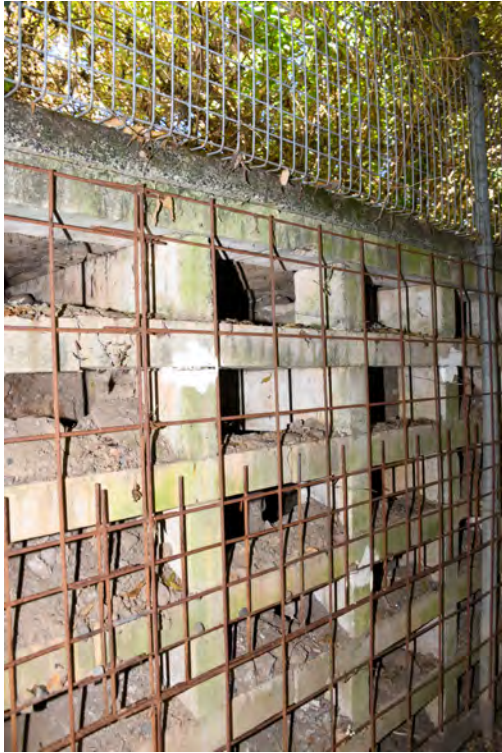
PRO\_1563.jpg

YMCA. Property to the north of Epping West Public School. Southern elevation. Heading west. Detail of the retaining wall along the boundary.

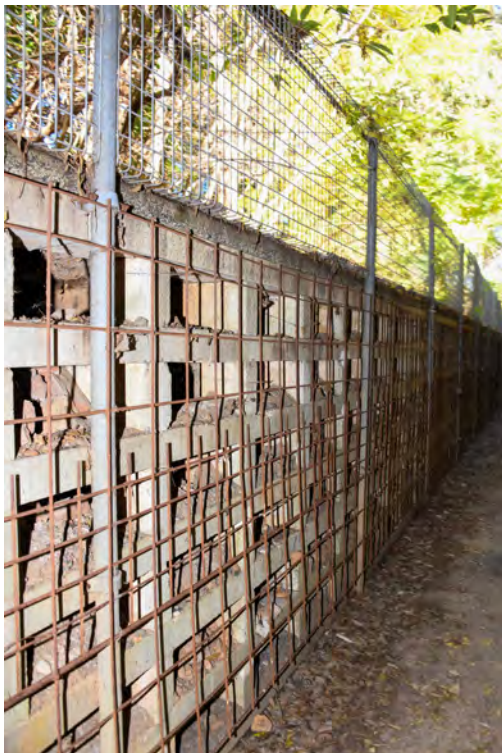
PRO\_1566.jpg

YMCA. Property to the north of Epping West Public School. Southern elevation. Heading west. Detail of the retaining wall along the boundary.

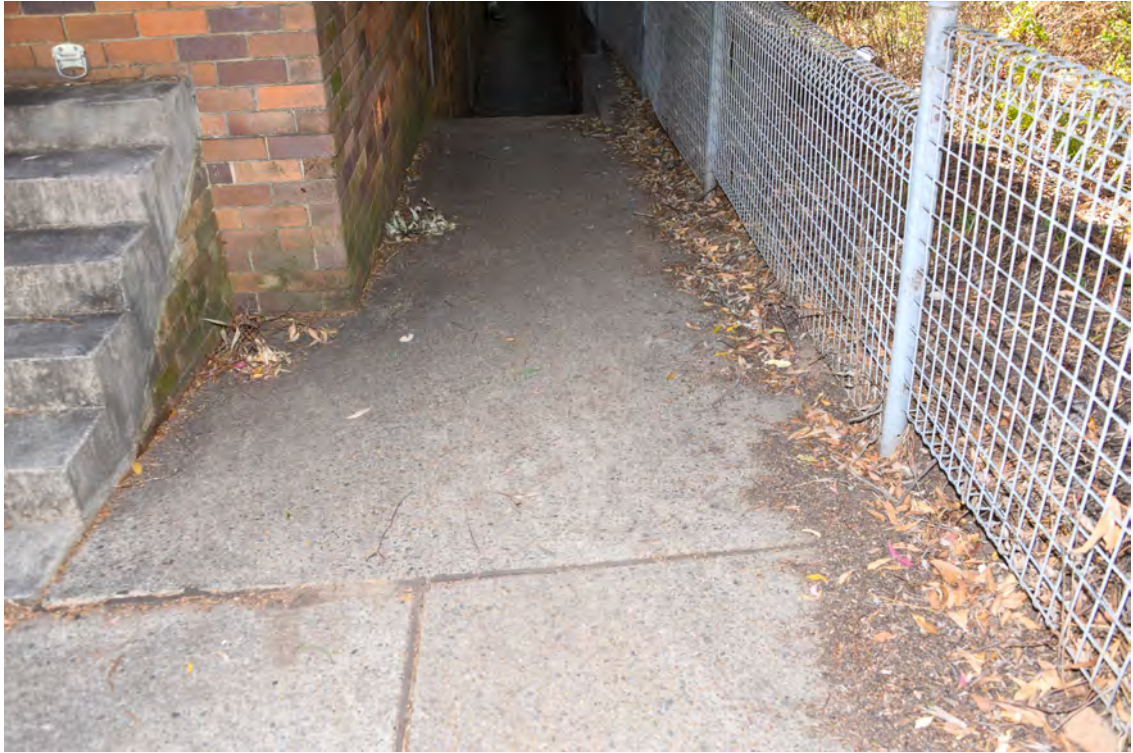
PRO\_1576.jpg

YMCA. Property to the north of Epping West Public School. Western elevation. Steps at the southern end.

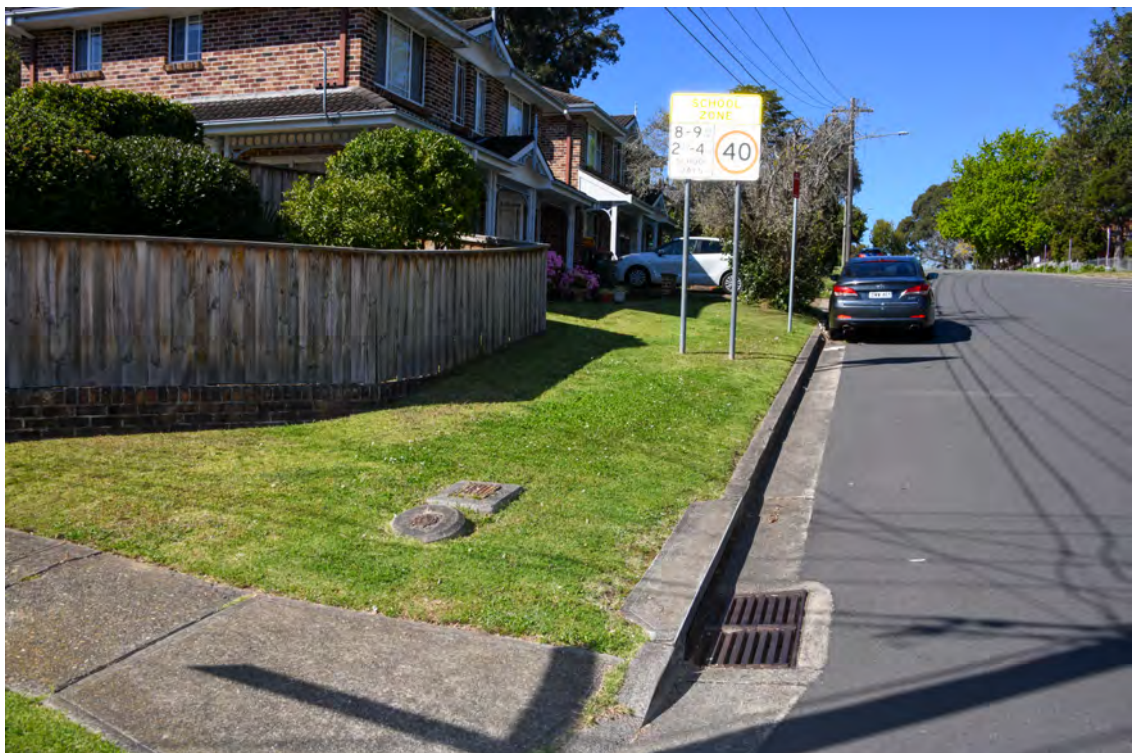
PRO\_1600.jpg

Ward Street. Street frontages of the residences on the eastern side of Ward Street opposite Epping West Public School. Heading south from the intersection with Lilli Pilli Street. Area adjacent to 12 Ward Street.

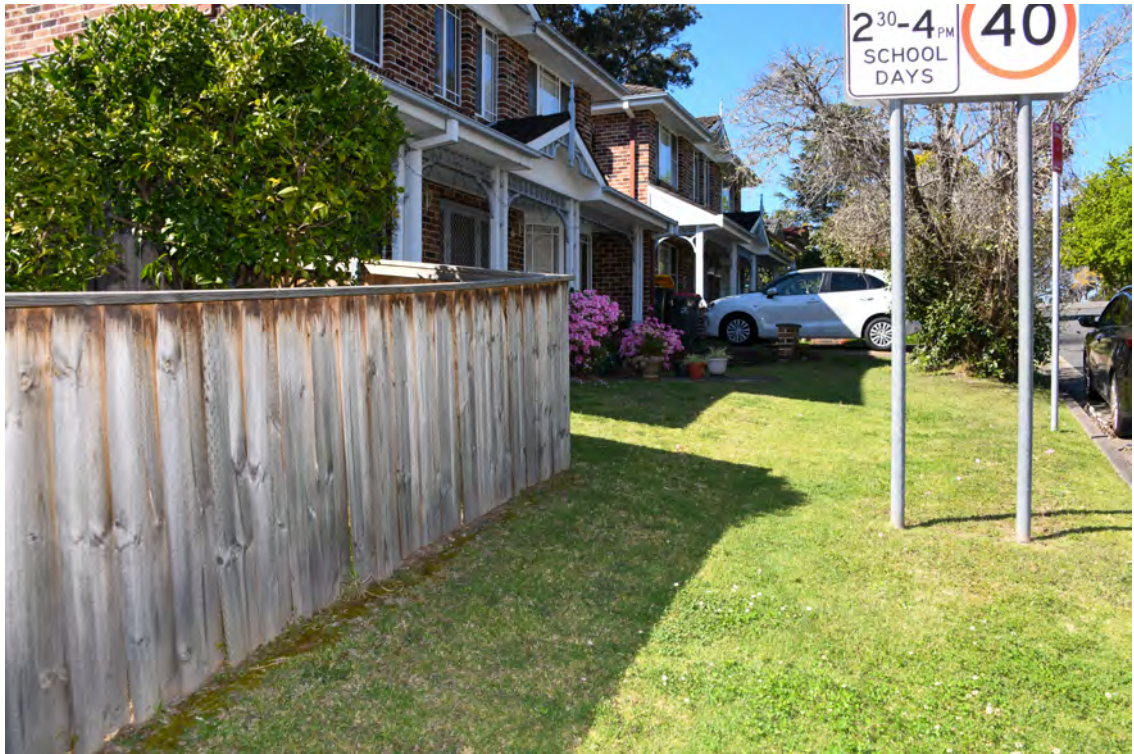
PRO\_1601.jpg

Ward Street. Street frontages of the residences on the eastern side of Ward Street opposite Epping West Public School. Heading south. Area adjacent to 12 Ward Street.

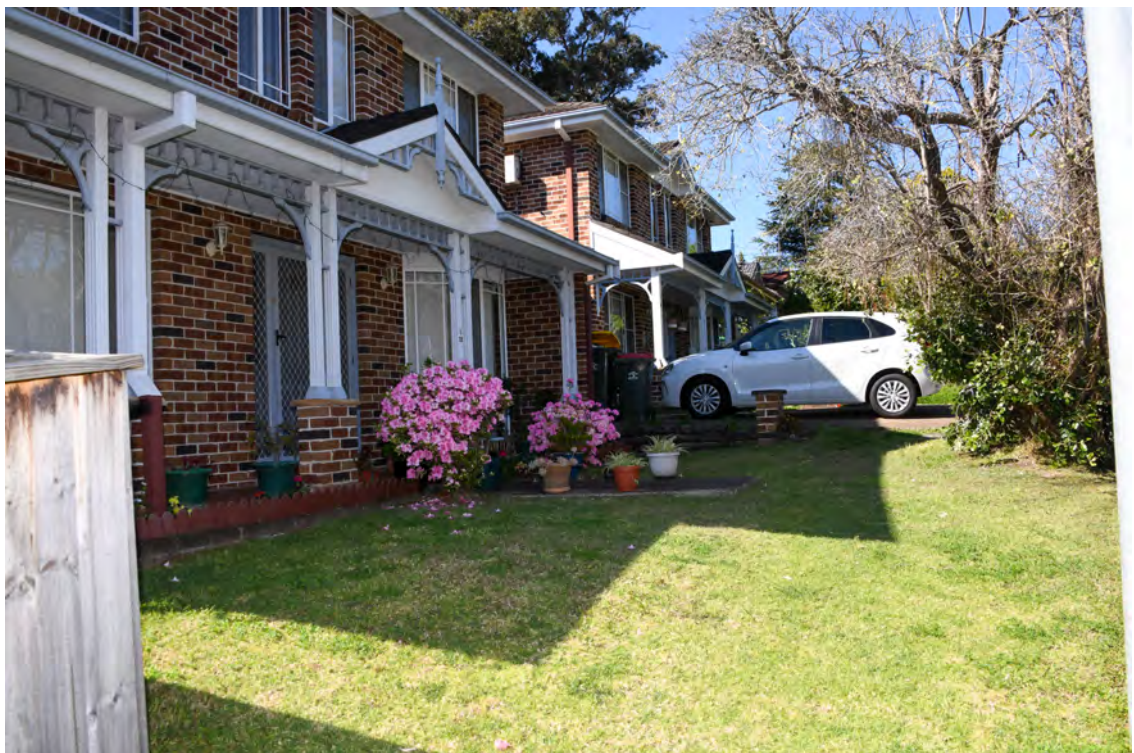
PRO\_1602.jpg

Ward Street. Street frontages of the residences on the eastern side of Ward Street opposite Epping West Public School. Heading south. Area adjacent to 12 Ward Street.

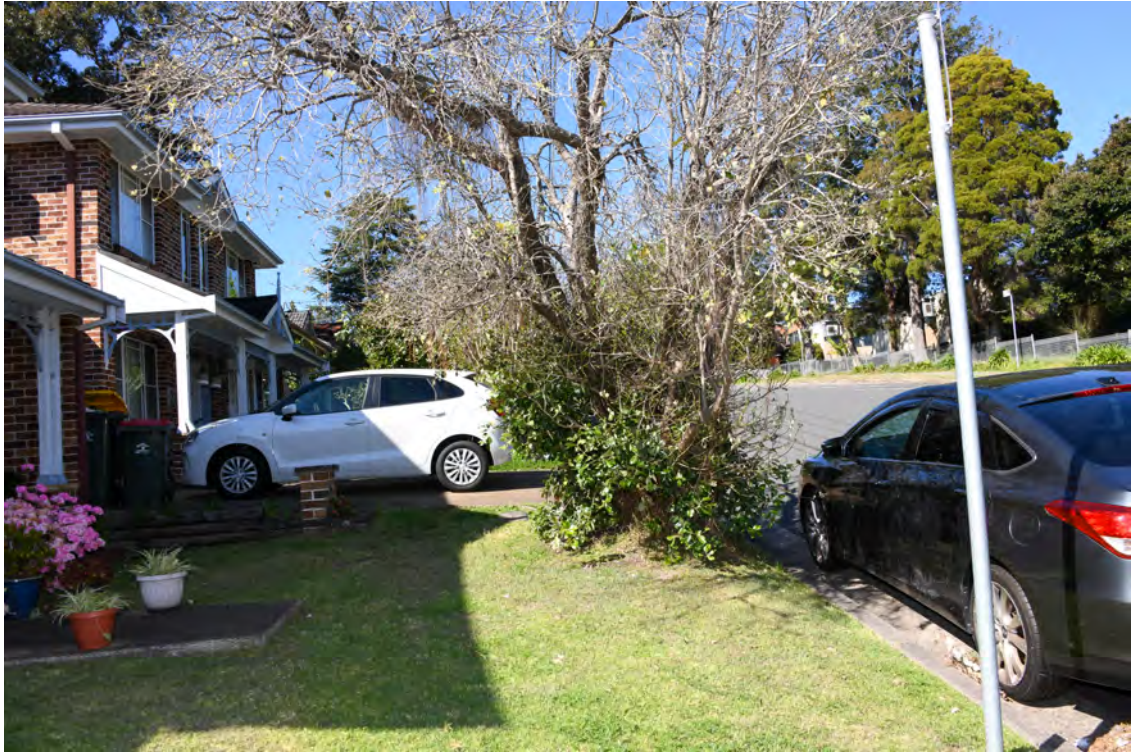
PRO\_1603.jpg

Ward Street. Street frontages of the residences on the eastern side of Ward Street opposite Epping West Public School. Heading south. Area adjacent to 12 Ward Street.

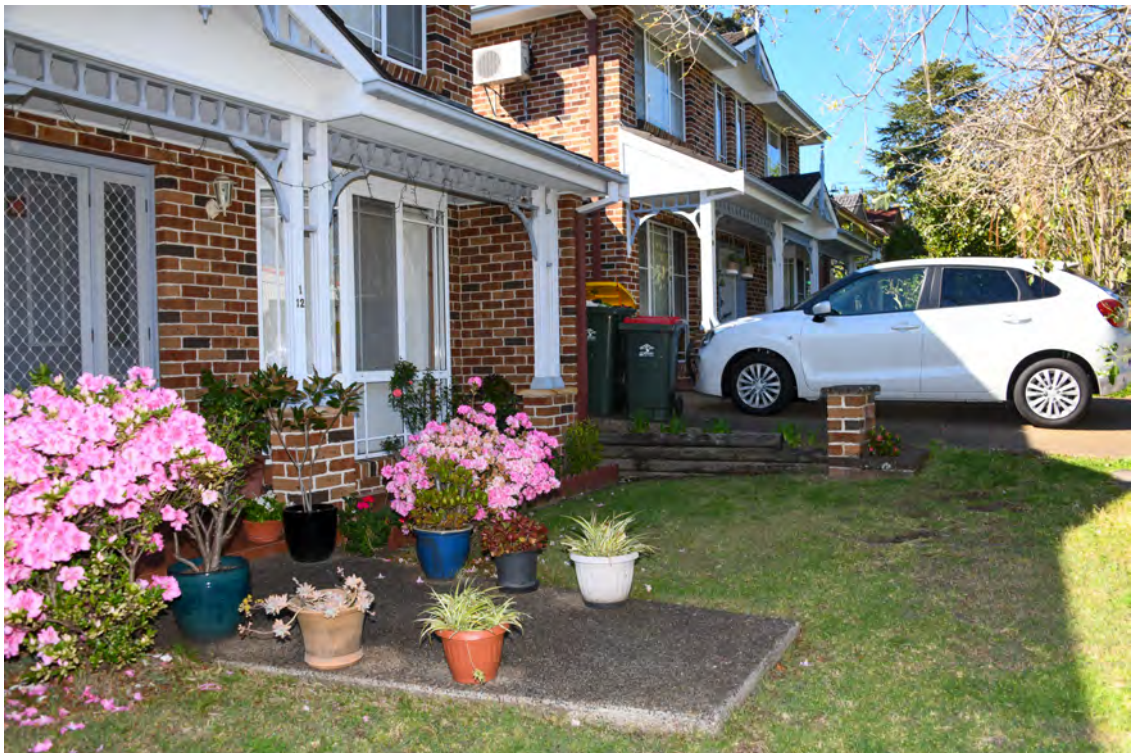
PRO\_1604.jpg

Ward Street. Street frontages of the residences on the eastern side of Ward Street opposite Epping West Public School. Heading south. Area adjacent to 12 Ward Street.

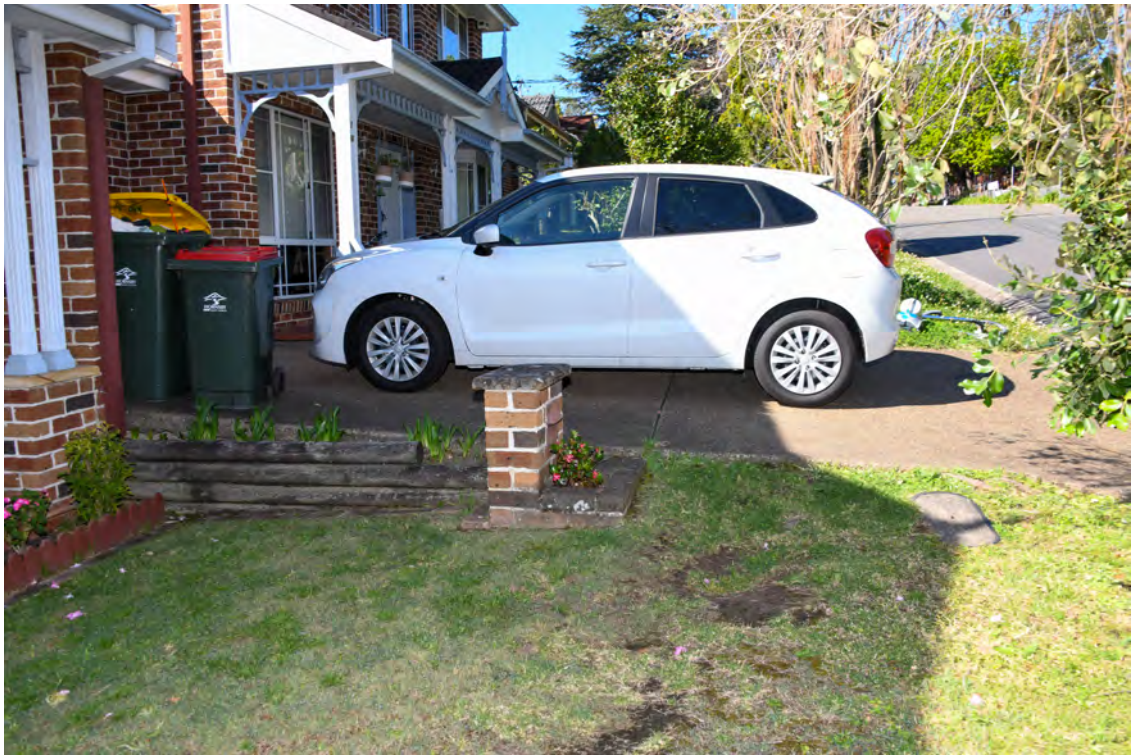
PRO\_1605.jpg

Ward Street. Street frontages of the residences on the eastern side of Ward Street opposite Epping West Public School. Heading south. Area adjacent to 12 Ward Street.

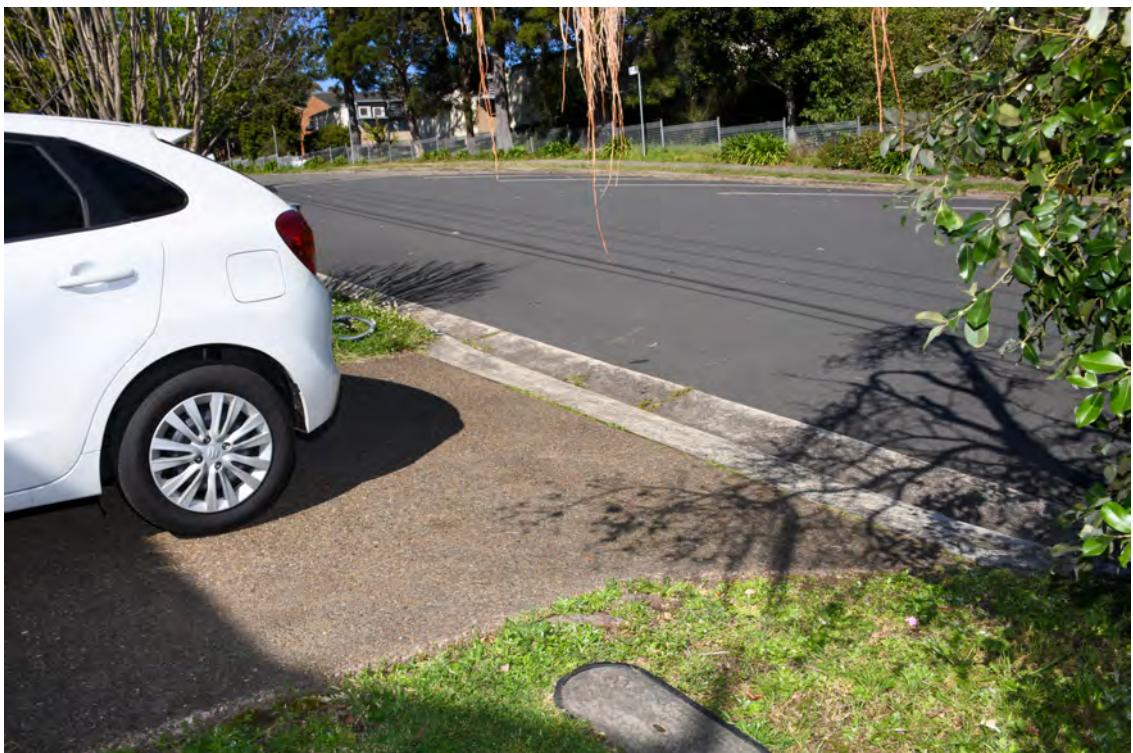
PRO\_1606.jpg

Ward Street. Street frontages of the residences on the eastern side of Ward Street opposite Epping West Public School. Heading south. Area adjacent to 12 Ward Street.

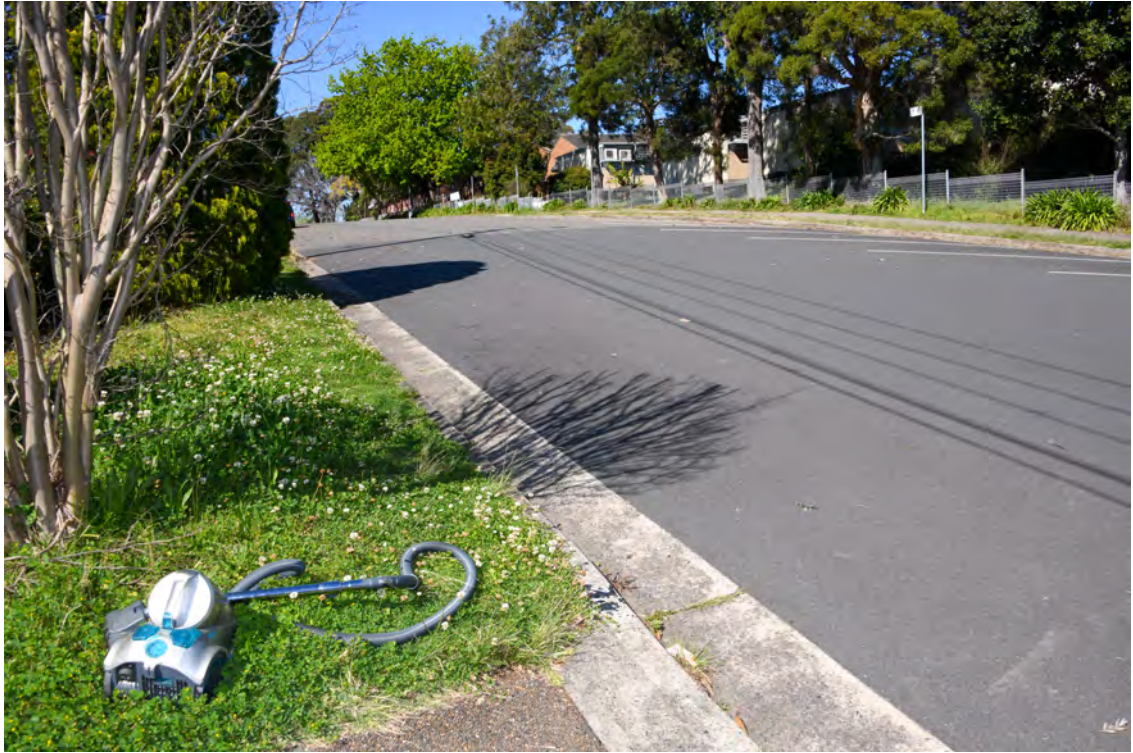
PRO\_1607.jpg

Ward Street. Street frontages of the residences on the eastern side of Ward Street opposite Epping West Public School. Heading south. Area adjacent to 12 Ward Street.

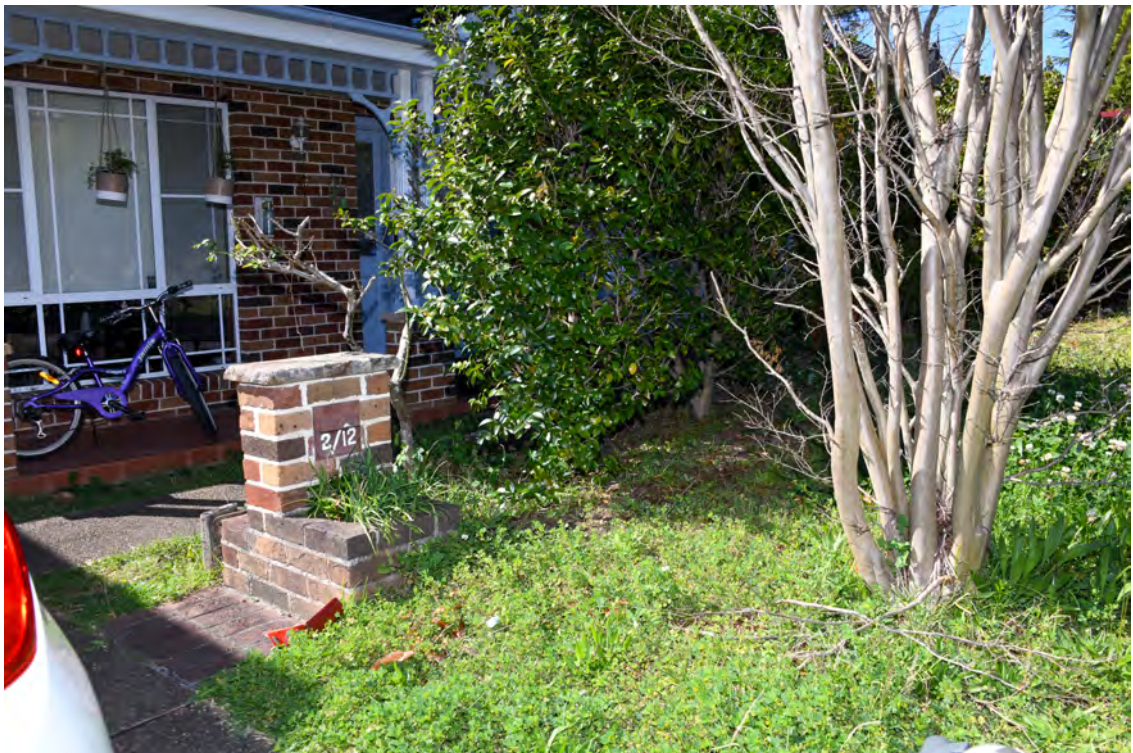
PRO\_1608.jpg

Ward Street. Street frontages of the residences on the eastern side of Ward Street opposite Epping West Public School. Heading south. Area adjacent to 12 Ward Street.

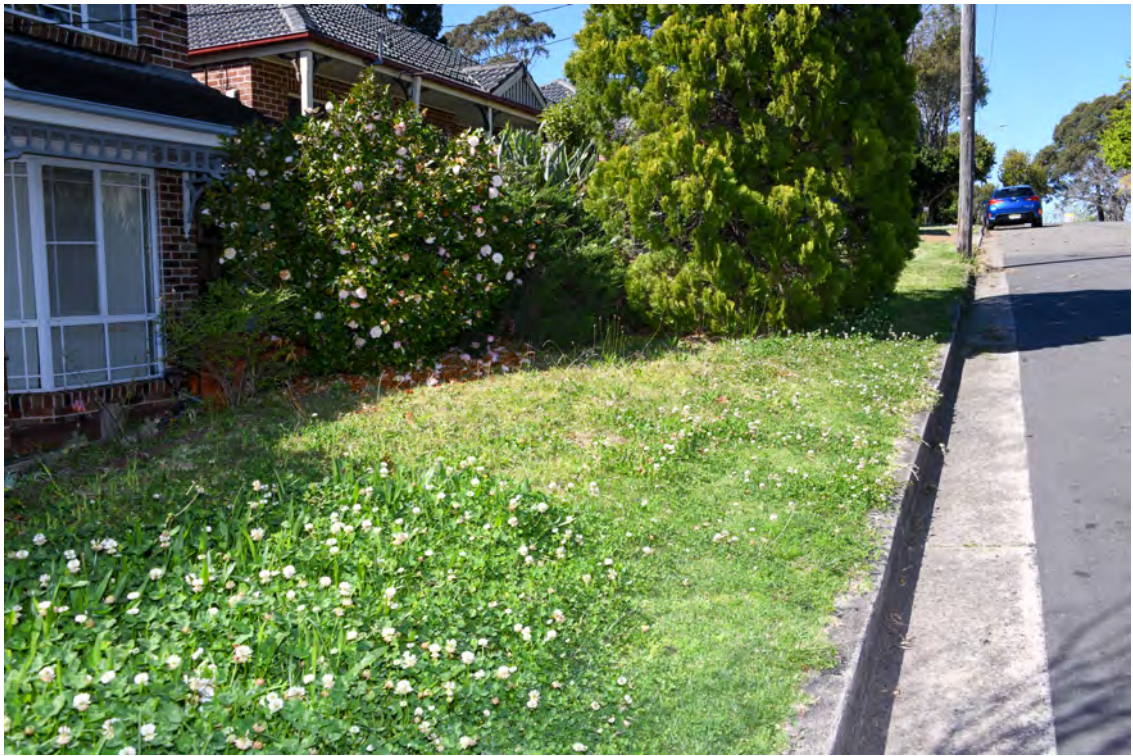
PRO\_1609.jpg

Ward Street. Street frontages of the residences on the eastern side of Ward Street opposite Epping West Public School. Heading south. Area adjacent to 12 Ward Street.

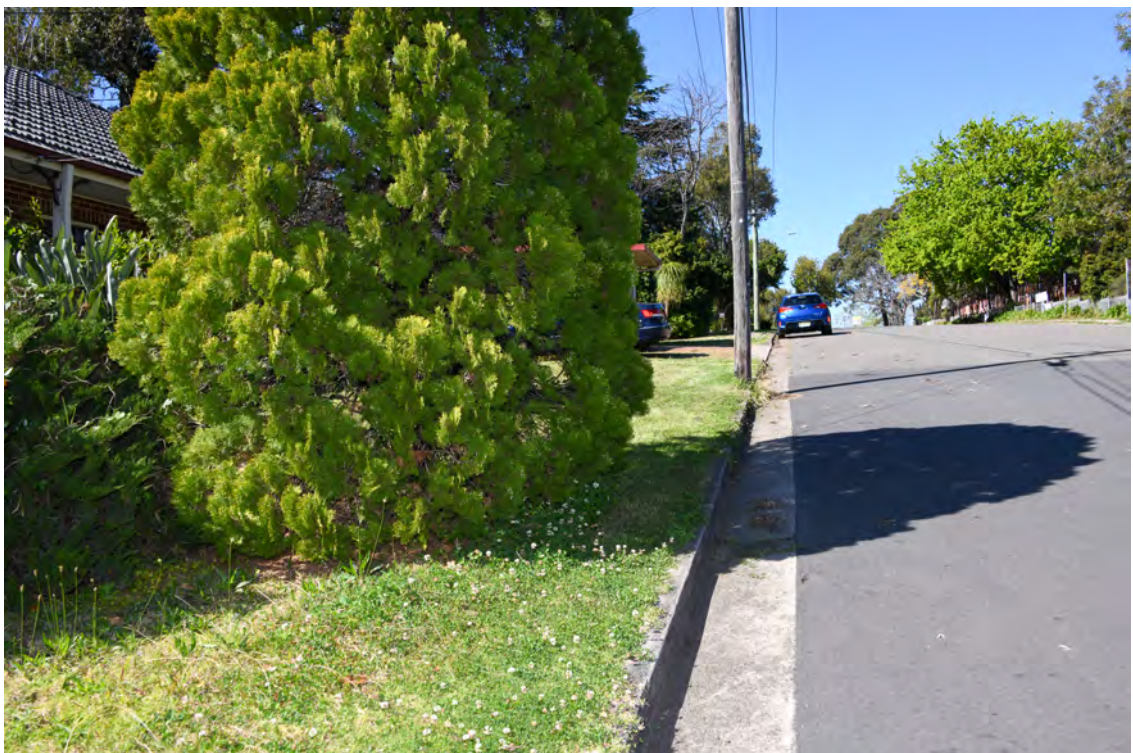
PRO\_1610.jpg

Ward Street. Street frontages of the residences on the eastern side of Ward Street opposite Epping West Public School. Heading south. Area adjacent to 12 Ward Street.

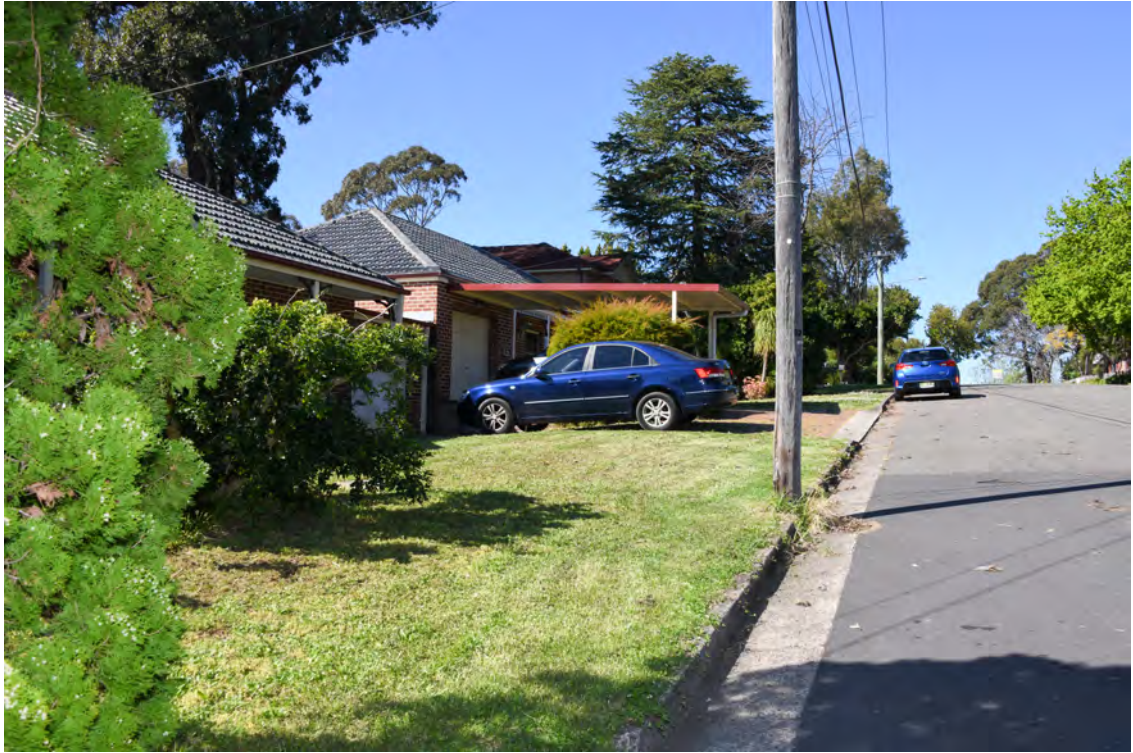
PRO\_1611.jpg

Ward Street. Street frontages of the residences on the eastern side of Ward Street opposite Epping West Public School. Heading south. Area adjacent to 12 Ward Street.

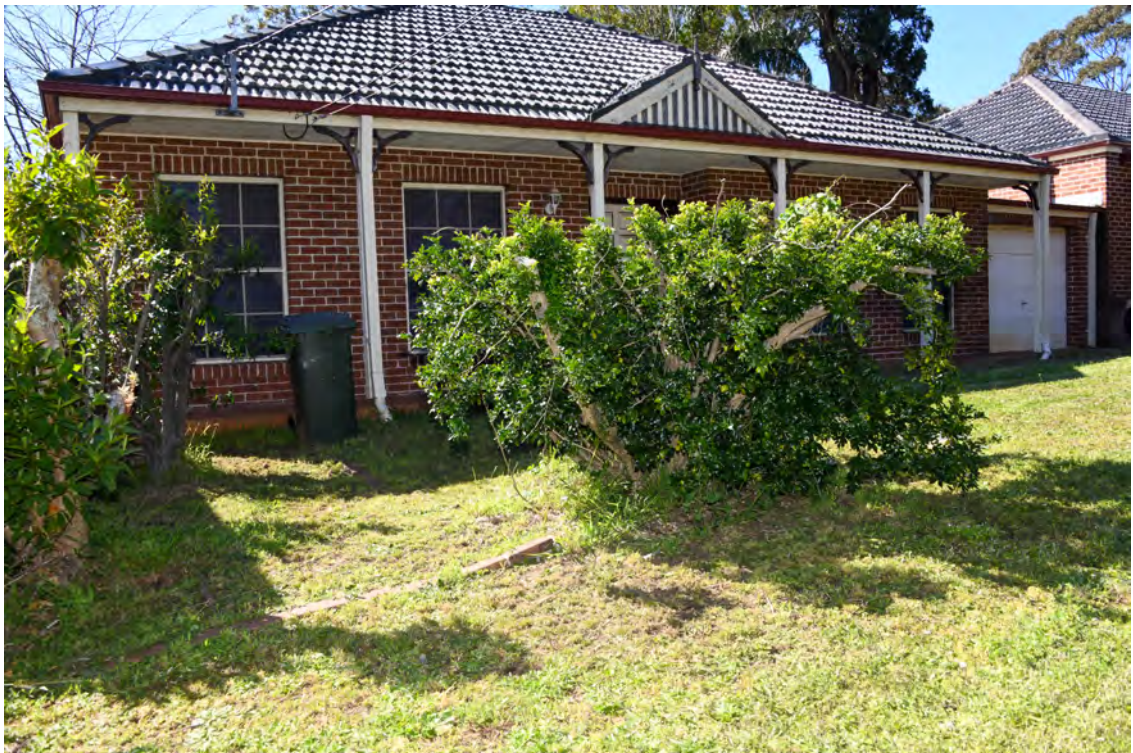
PRO\_1612.jpg

Ward Street. Street frontages of the residences on the eastern side of Ward Street opposite Epping West Public School. Heading south. Area adjacent to 10 Ward Street.

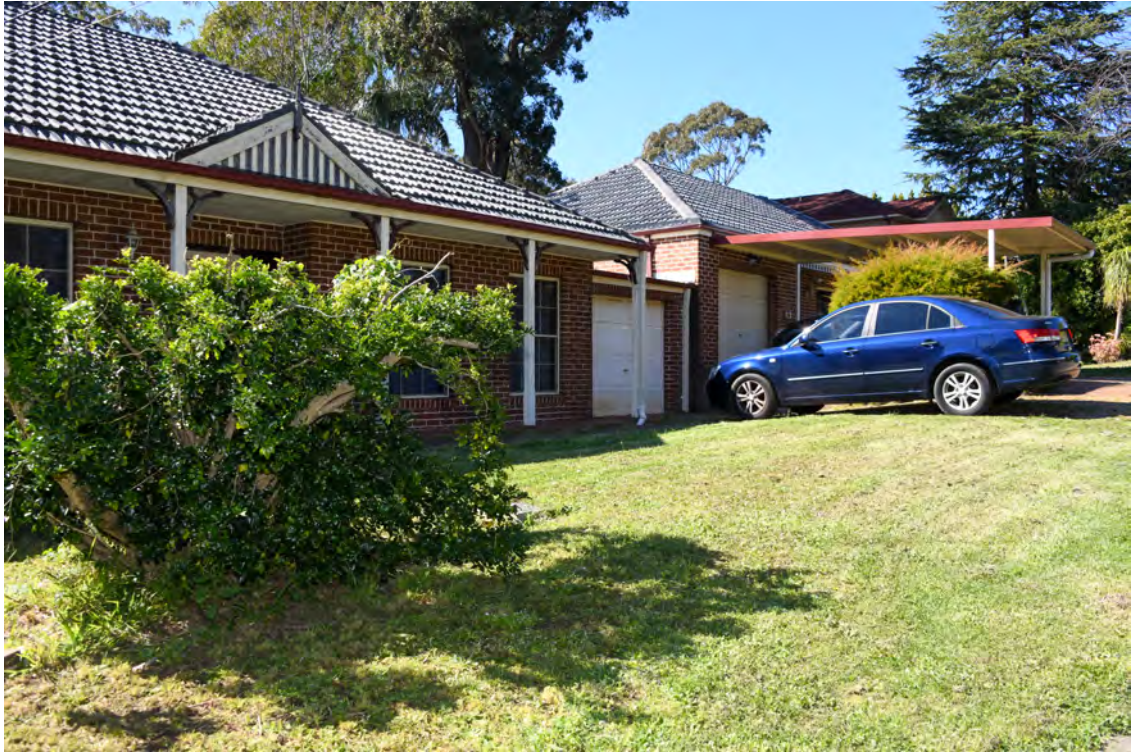
PRO\_1613.jpg

Ward Street. Street frontages of the residences on the eastern side of Ward Street opposite Epping West Public School. Heading south. Area adjacent to 10 Ward Street.

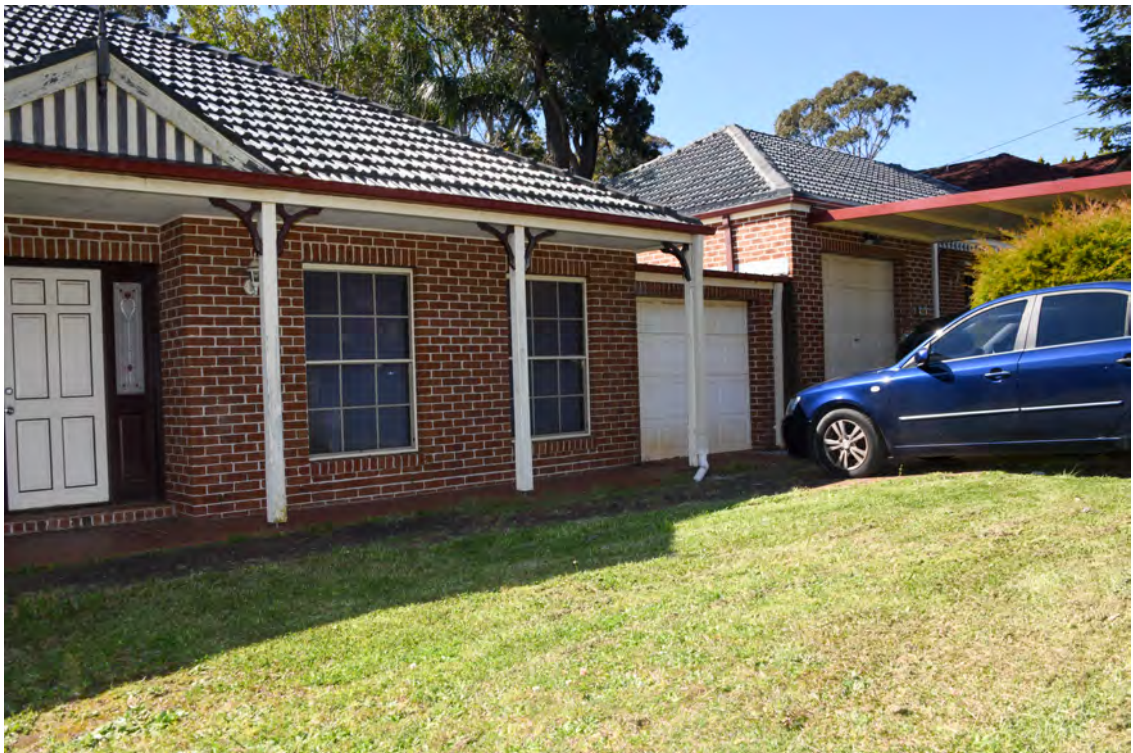
PRO\_1614.jpg

Ward Street. Street frontages of the residences on the eastern side of Ward Street opposite Epping West Public School. Heading south. Area adjacent to 10 Ward Street.

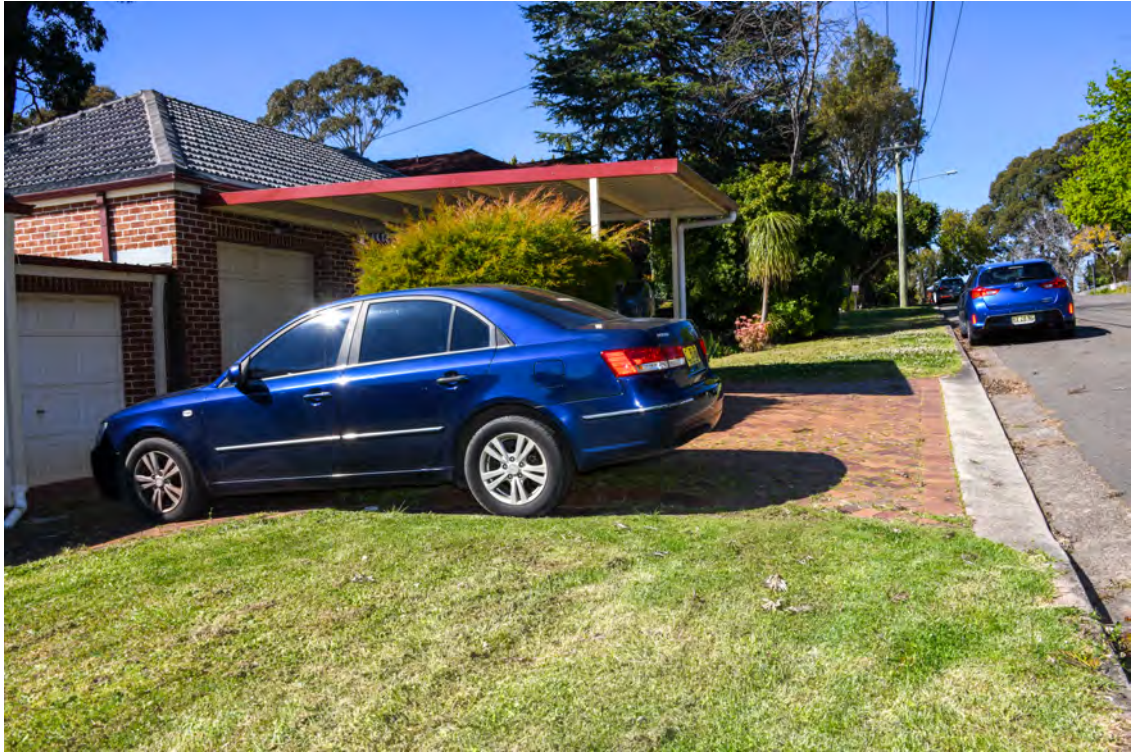
PRO\_1615.jpg

Ward Street. Street frontages of the residences on the eastern side of Ward Street opposite Epping West Public School. Heading south. Area adjacent to 10 Ward Street.

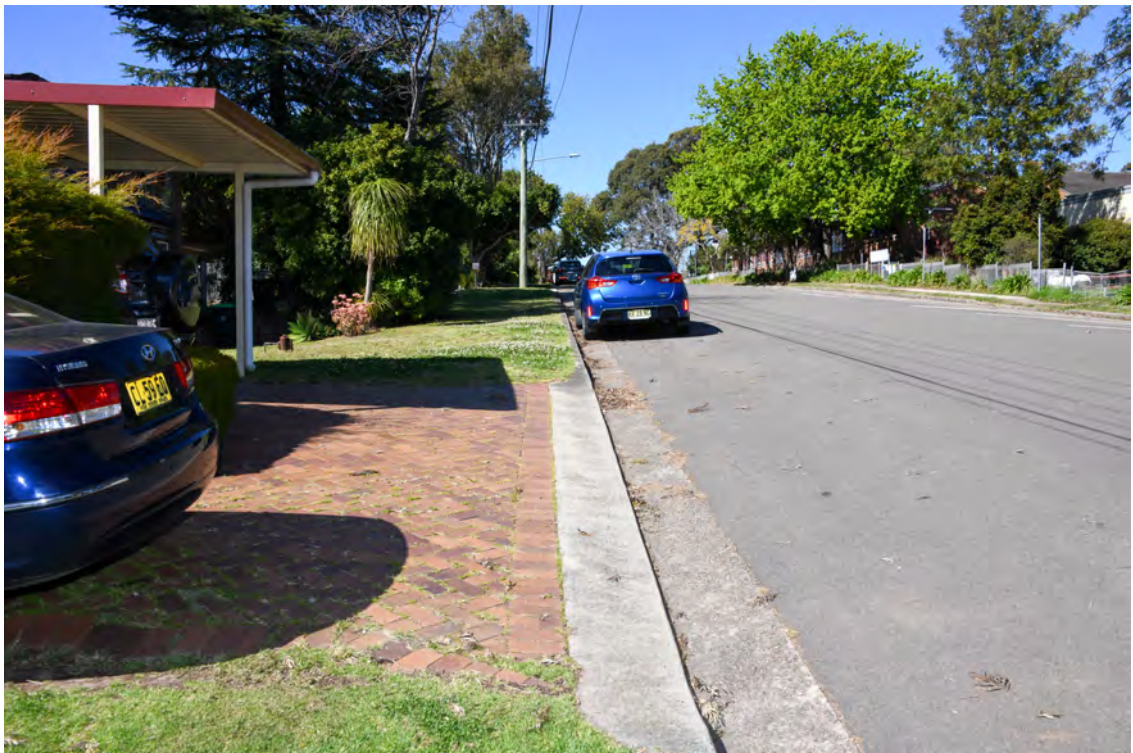
PRO\_1616.jpg

Ward Street. Street frontages of the residences on the eastern side of Ward Street opposite Epping West Public School. Heading south. Area adjacent to 10 Ward Street.

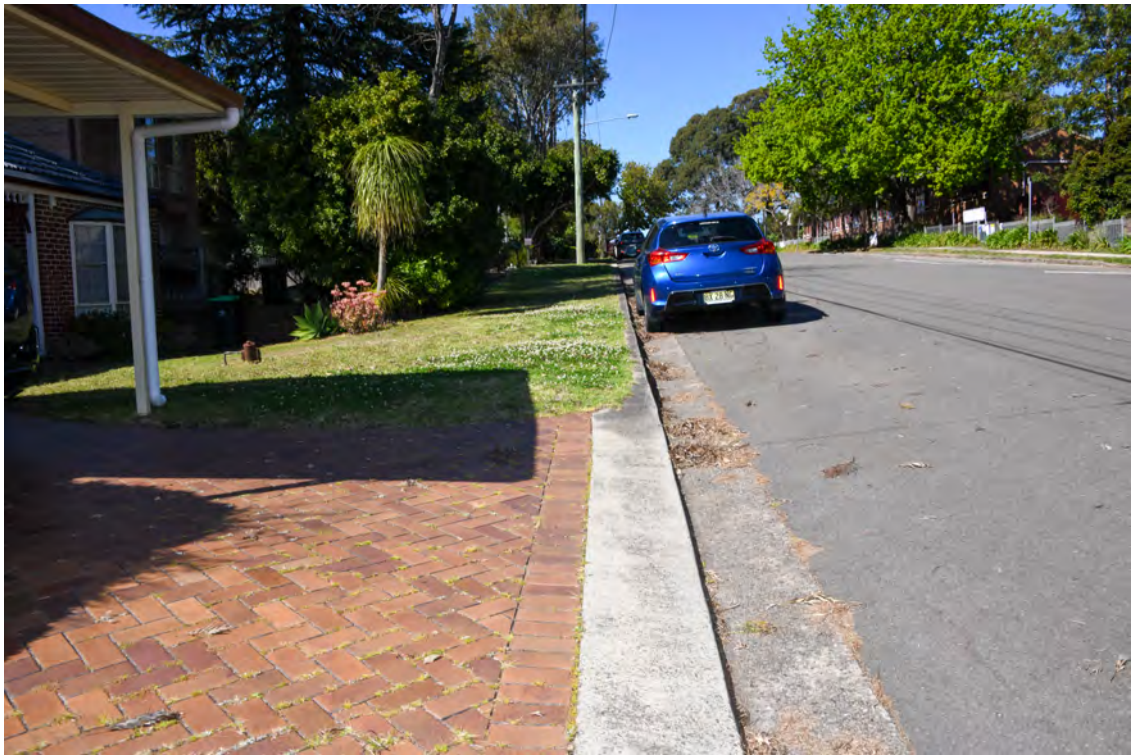
PRO\_1617.jpg

Ward Street. Street frontages of the residences on the eastern side of Ward Street opposite Epping West Public School. Heading south. Area adjacent to 8 Ward Street.

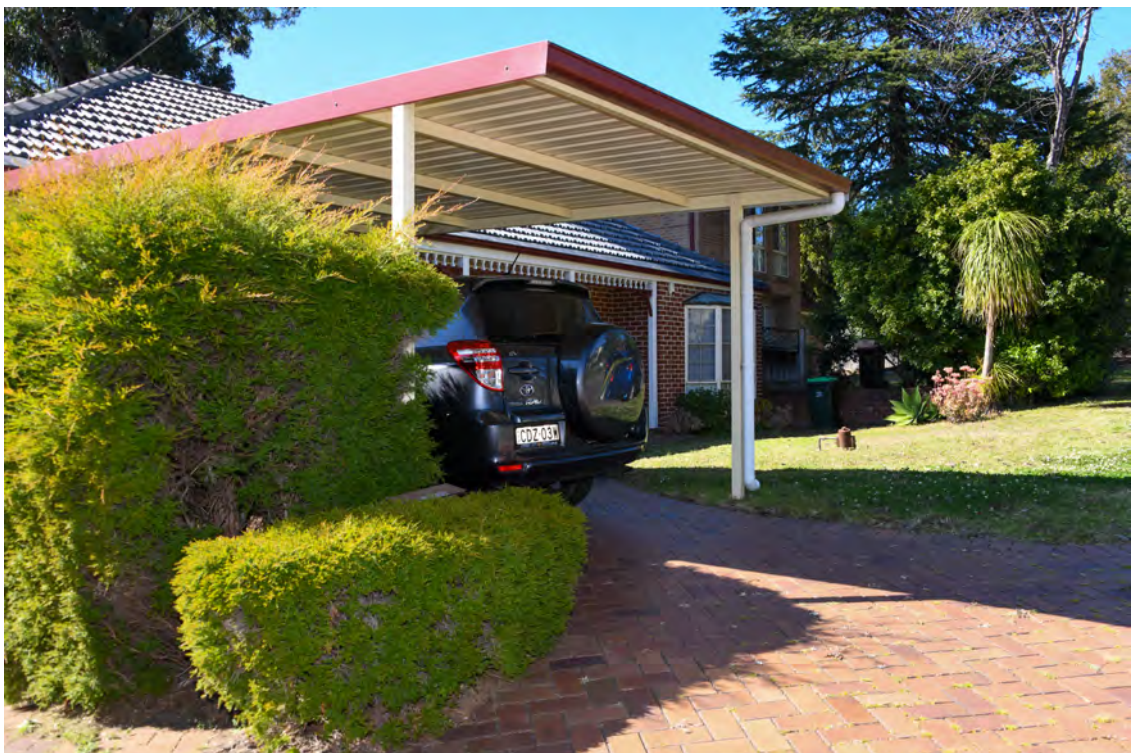
PRO\_1618.jpg

Ward Street. Street frontages of the residences on the eastern side of Ward Street opposite Epping West Public School. Heading south. Area adjacent to 8 Ward Street.

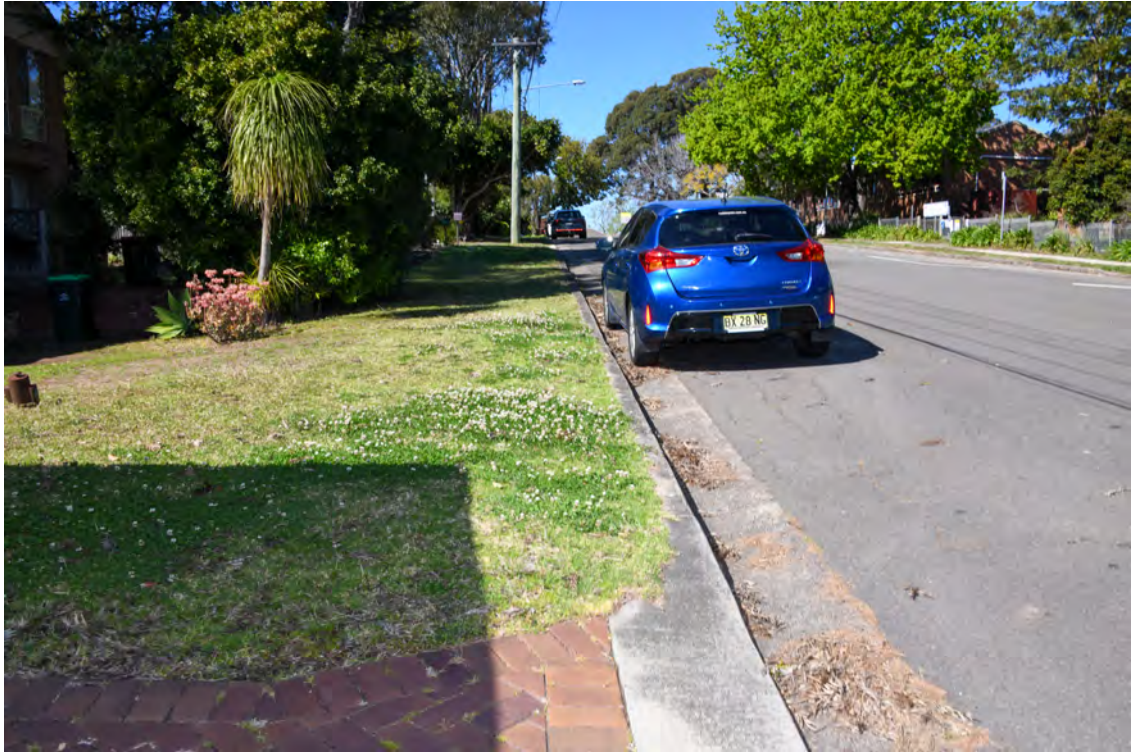
PRO\_1619.jpg

Ward Street. Street frontages of the residences on the eastern side of Ward Street opposite Epping West Public School. Heading south. Area adjacent to 8 Ward Street.
