96-104 Carlingford Road, Epping NSW 2121

Epping West Public School

DILAPIDATION REPORT

7<sup>th</sup> September 2021

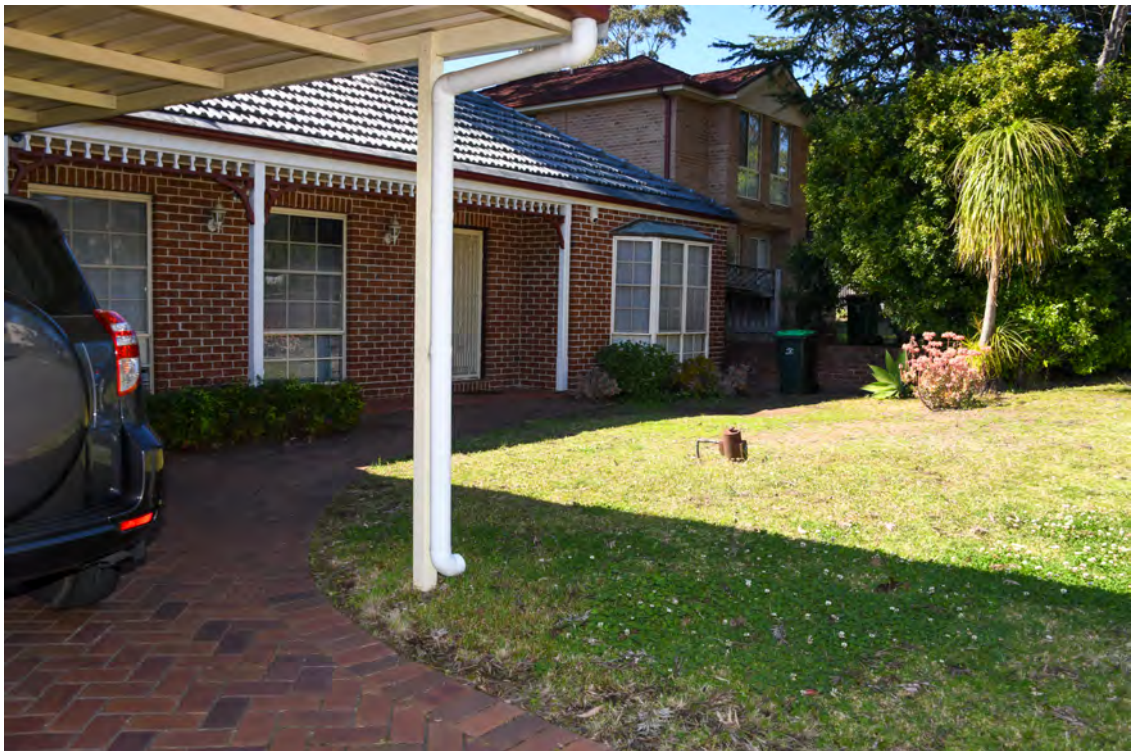
PRO\_1620.jpg

Ward Street. Street frontages of the residences on the eastern side of Ward Street opposite Epping West Public School. Heading south. Area adjacent to 8 Ward Street.

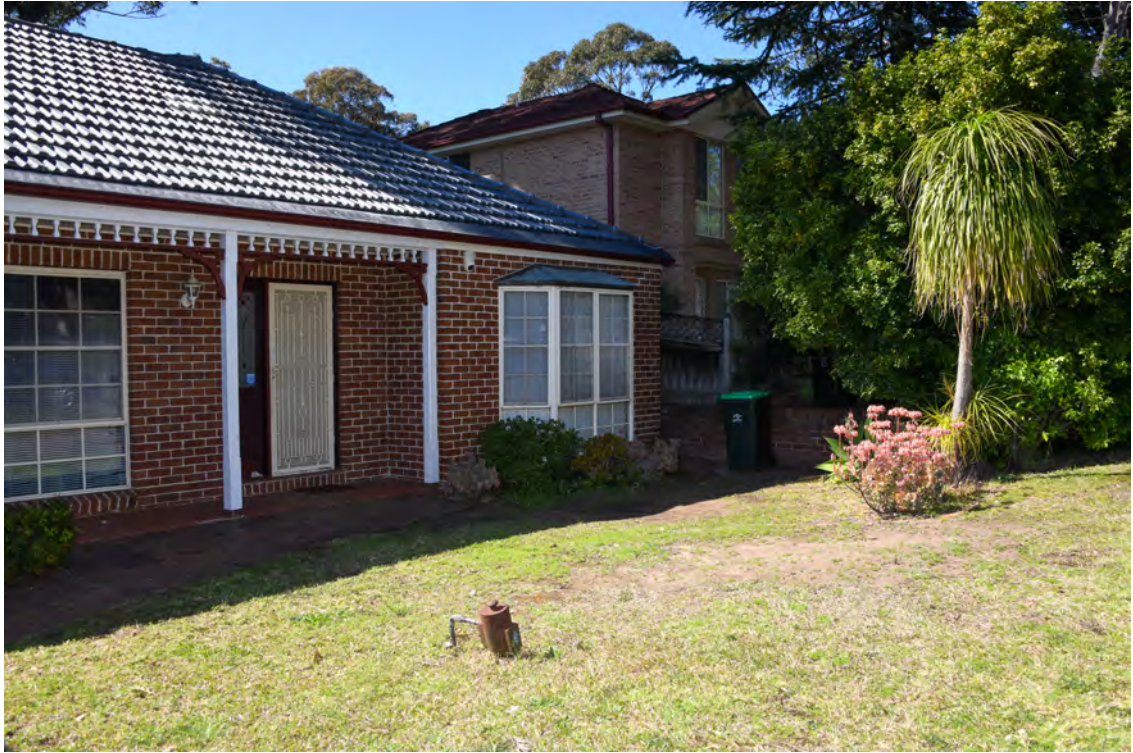
PRO\_1621.jpg

Ward Street. Street frontages of the residences on the eastern side of Ward Street opposite Epping West Public School. Heading south. Area adjacent to 8 Ward Street.

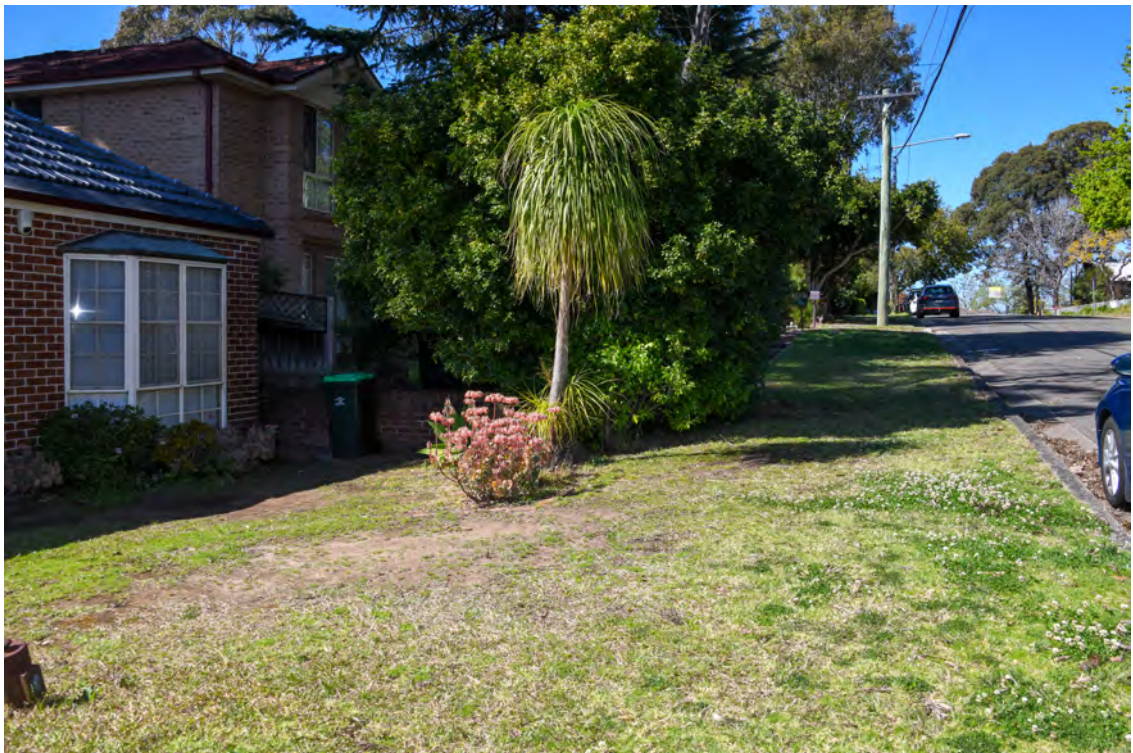
PRO\_1622.jpg

Ward Street. Street frontages of the residences on the eastern side of Ward Street opposite Epping West Public School. Heading south. Area adjacent to 8 Ward Street.

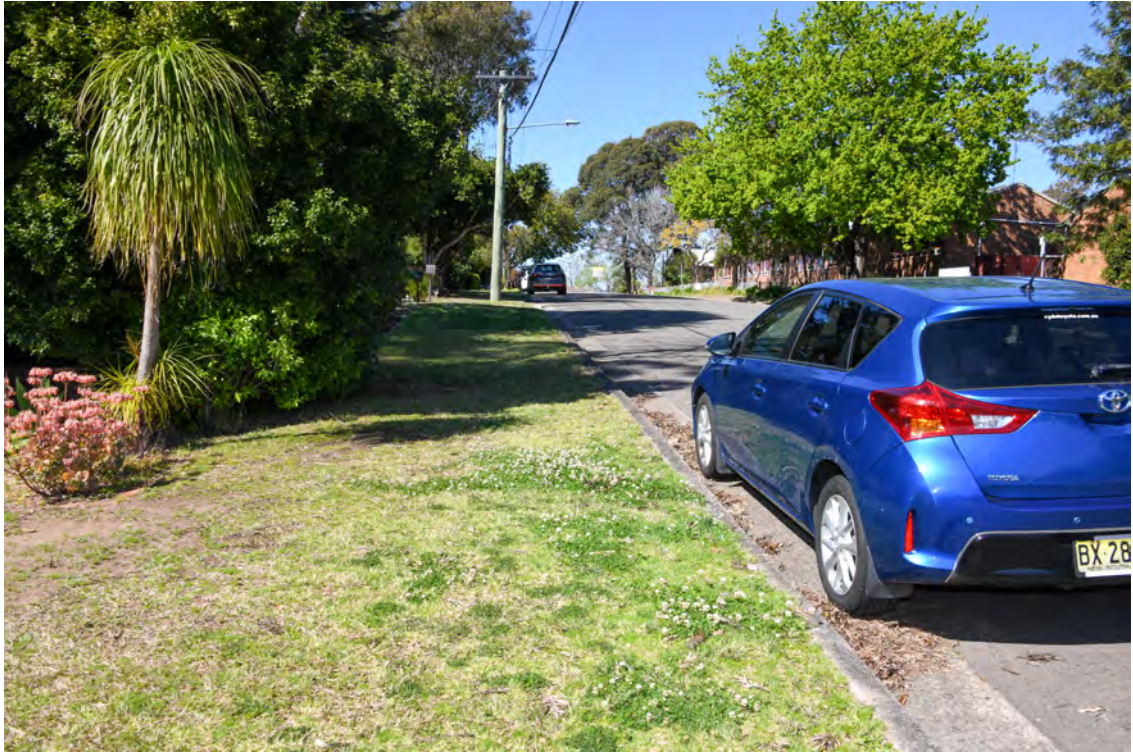
PRO\_1623.jpg

Ward Street. Street frontages of the residences on the eastern side of Ward Street opposite Epping West Public School. Heading south. Area adjacent to 8 Ward Street.

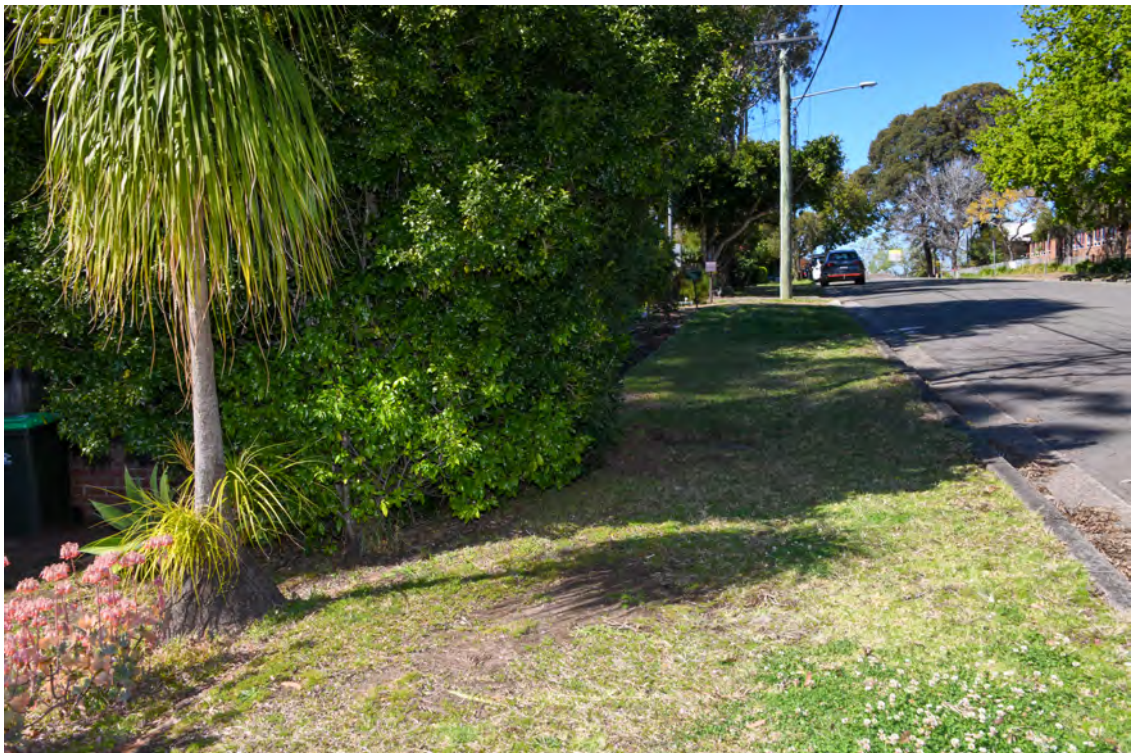
PRO\_1624.jpg

Ward Street. Street frontages of the residences on the eastern side of Ward Street opposite Epping West Public School. Heading south. Area adjacent to 8 Ward Street.

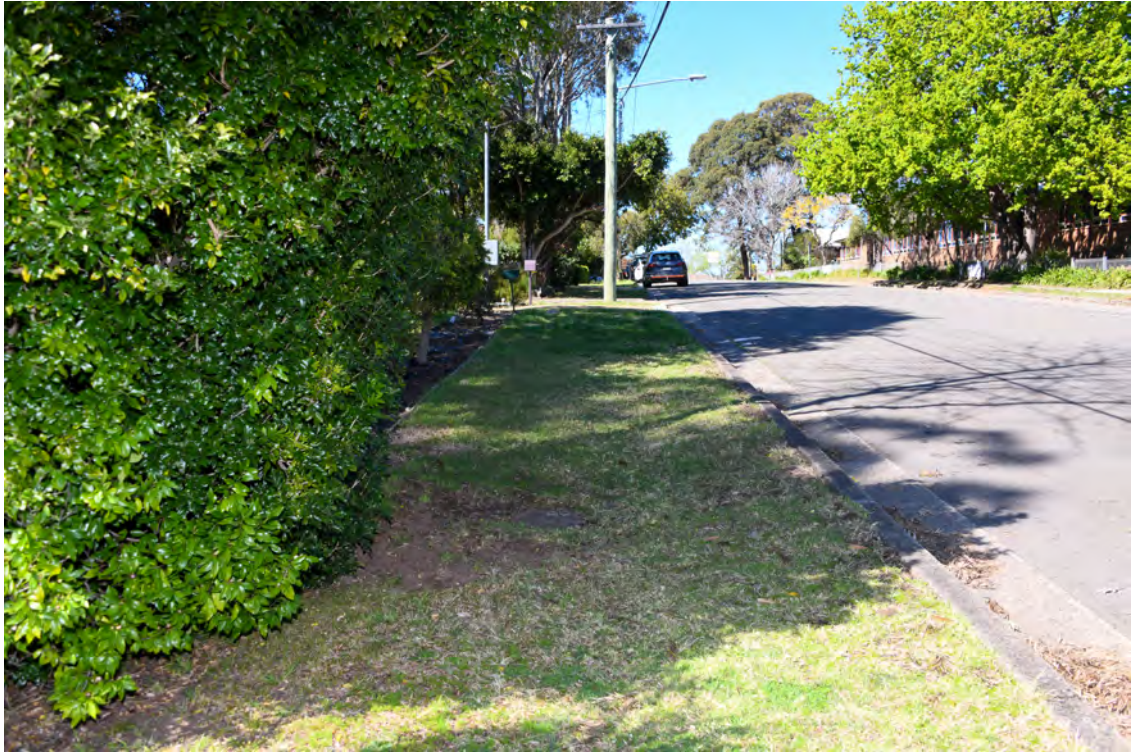
PRO\_1625.jpg

Ward Street. Street frontages of the residences on the eastern side of Ward Street opposite Epping West Public School. Heading south. Area adjacent to 8 Ward Street.

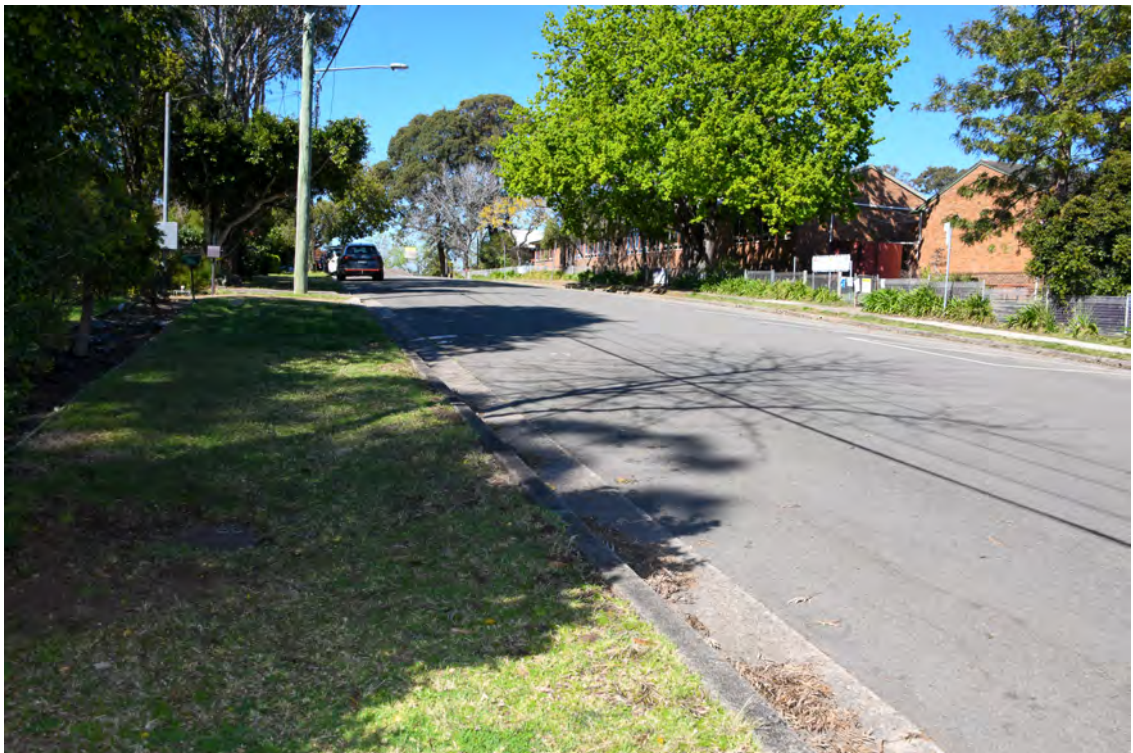
PRO\_1626.jpg

Ward Street. Street frontages of the residences on the eastern side of Ward Street opposite Epping West Public School. Heading south. Area adjacent to 8 Ward Street.

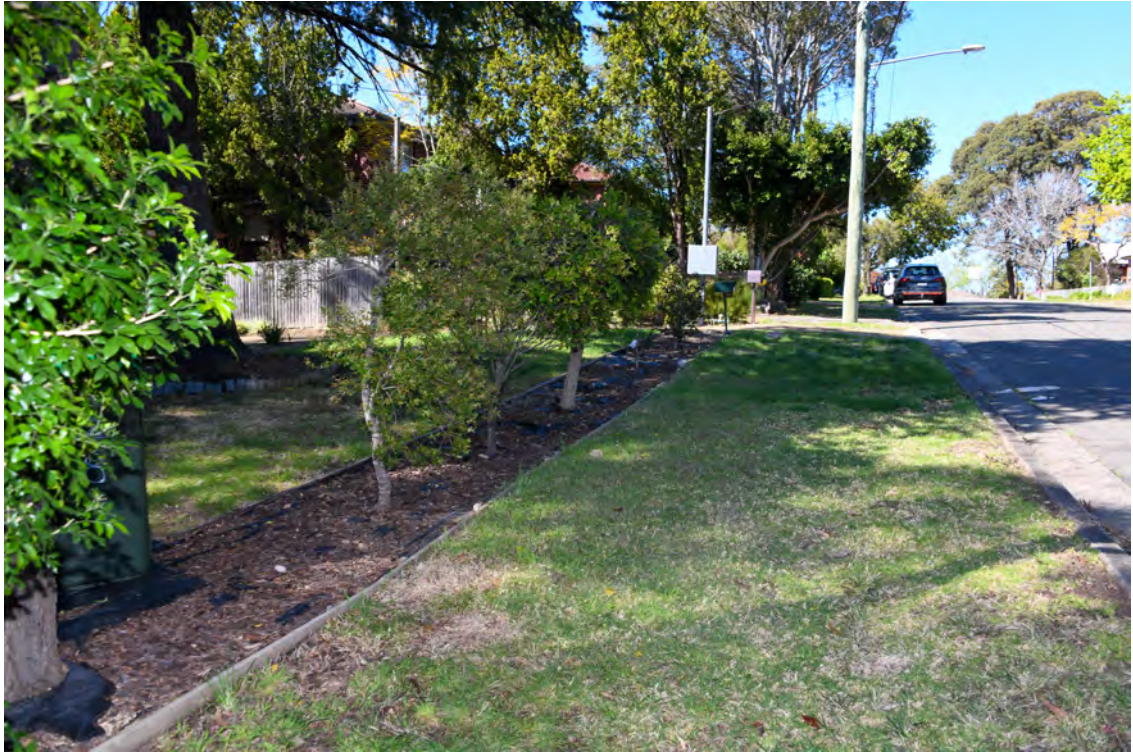
PRO\_1627.jpg

Ward Street. Street frontages of the residences on the eastern side of Ward Street opposite Epping West Public School. Heading south. Area adjacent to 8 Ward Street.

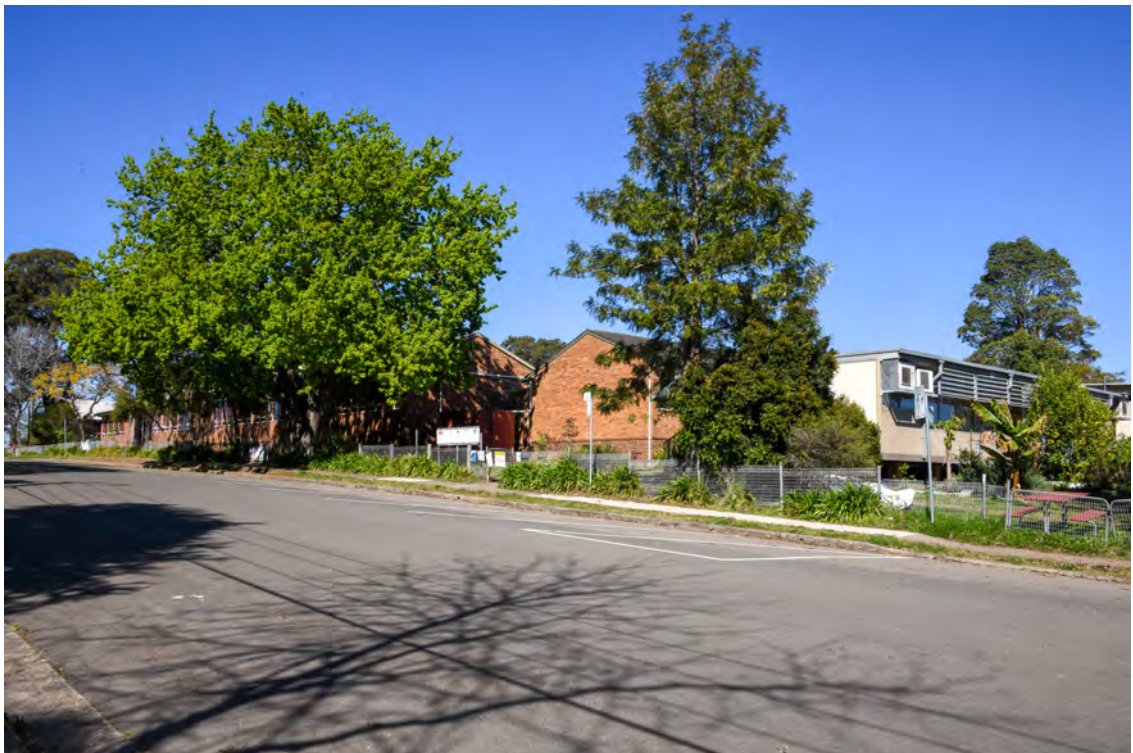
PRO\_1628.jpg

Ward Street. Street frontages of the residences on the eastern side of Ward Street opposite Epping West Public School. Heading south. Area adjacent to 8 Ward Street.

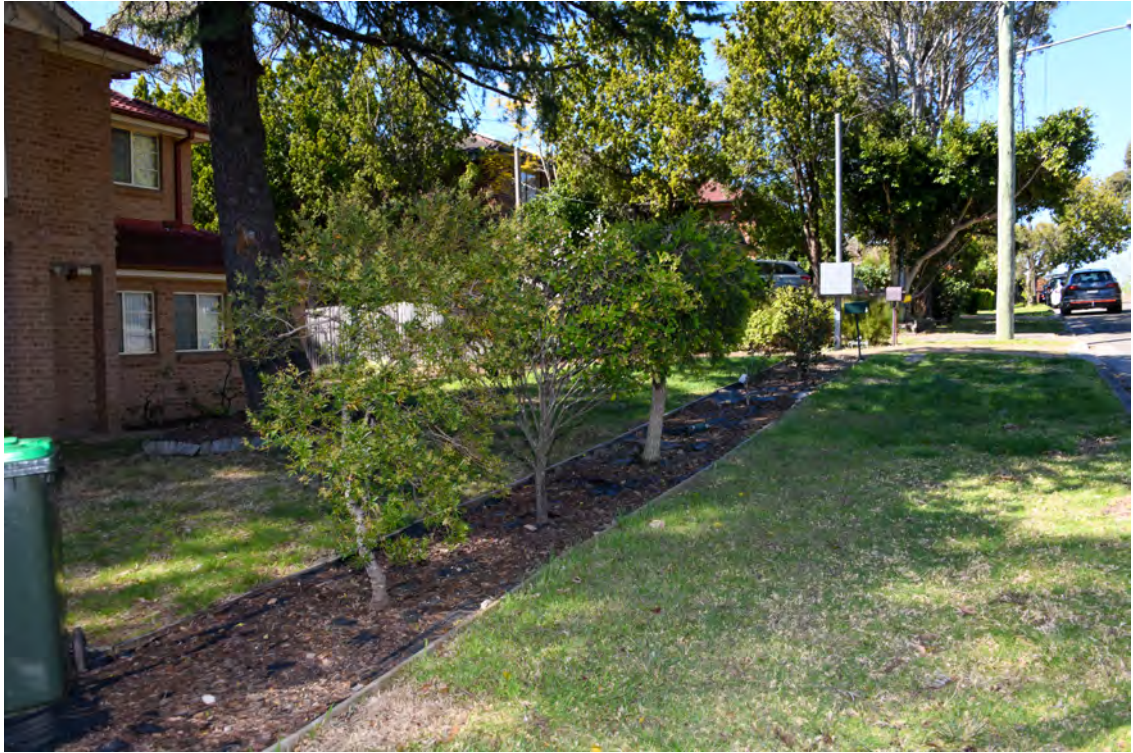
PRO\_1629.jpg

Ward Street. Street frontages of the residences on the eastern side of Ward Street opposite Epping West Public School. Heading south. Area adjacent to 8 Ward Street.

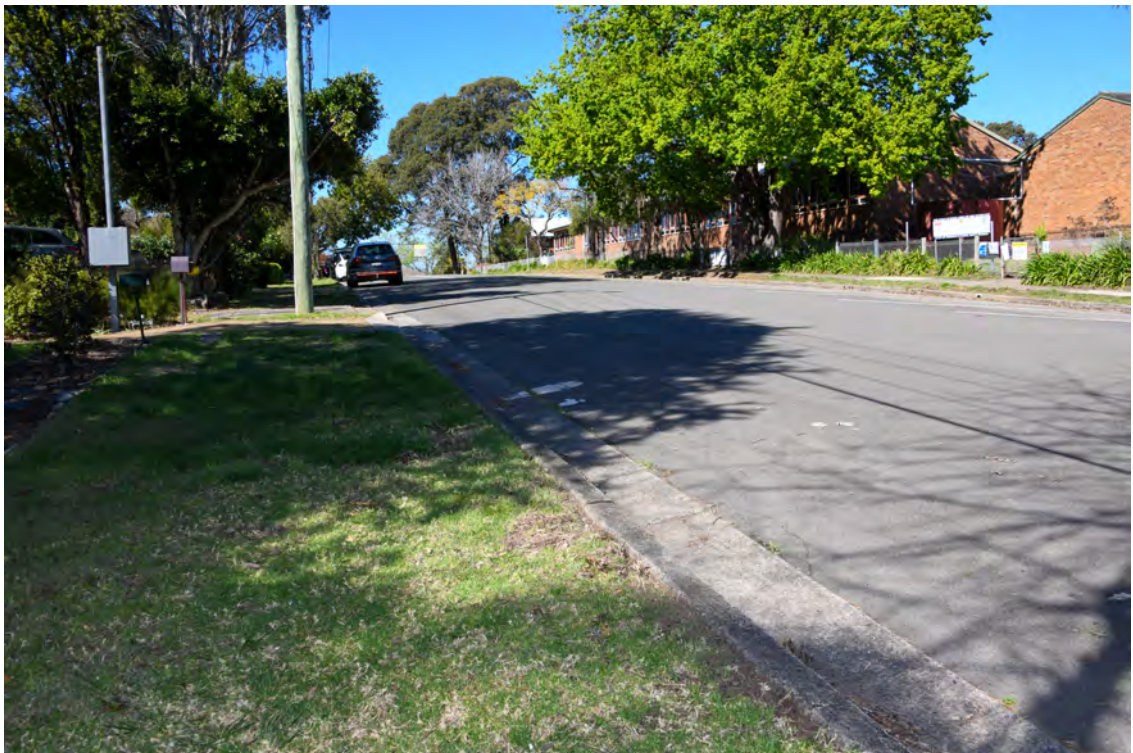
PRO\_1630.jpg

Ward Street. Street frontages of the residences on the eastern side of Ward Street opposite Epping West Public School. Heading south. Area adjacent to 8 Ward Street.

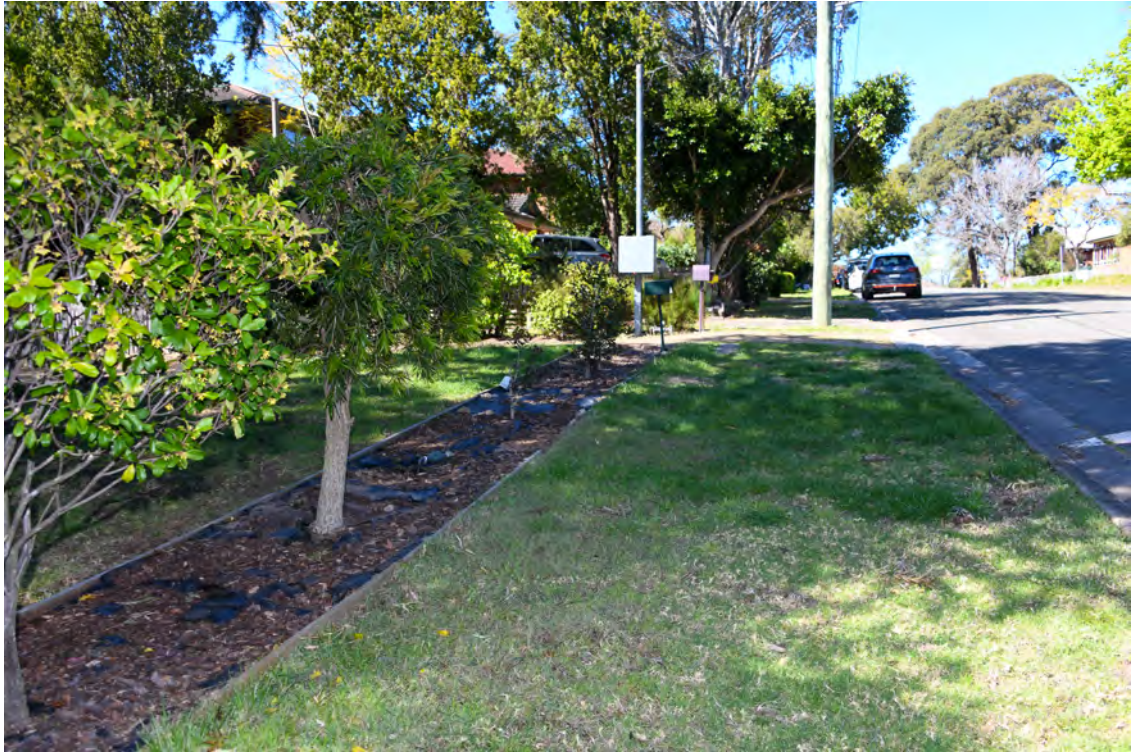
PRO\_1631.jpg

Ward Street. Street frontages of the residences on the eastern side of Ward Street opposite Epping West Public School. Heading south. Area adjacent to 8 Ward Street.

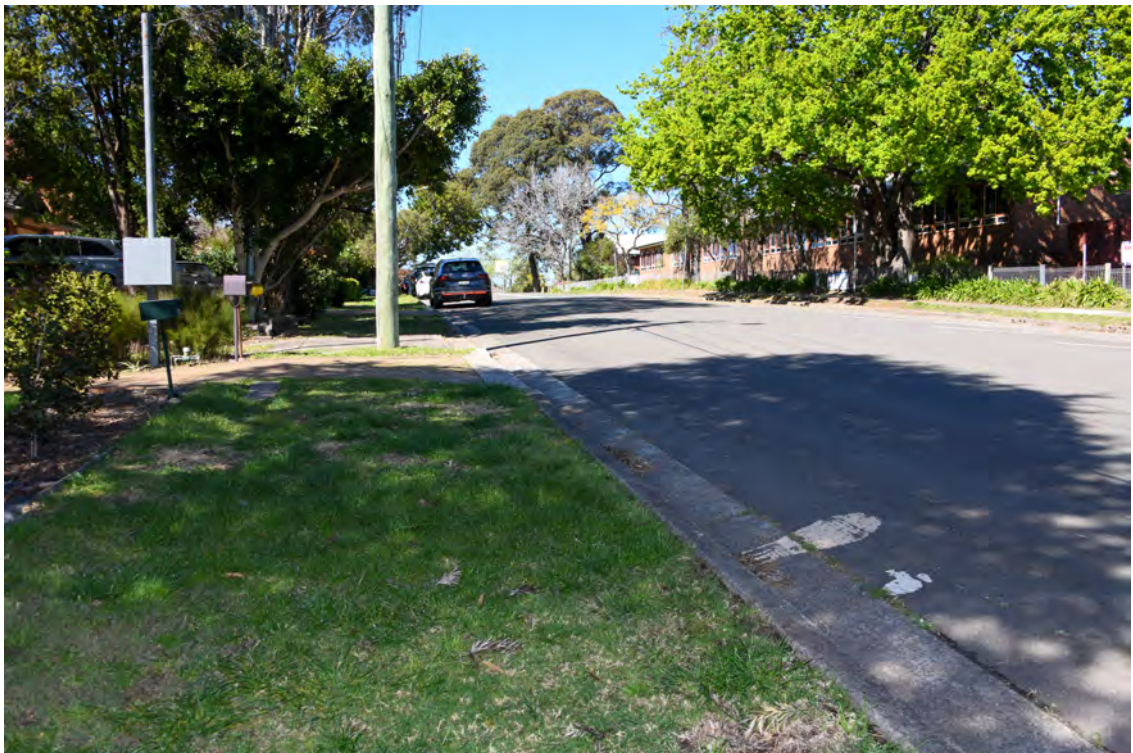
PRO\_1632.jpg

Ward Street. Street frontages of the residences on the eastern side of Ward Street opposite Epping West Public School. Heading south. Area adjacent to 8 Ward Street.

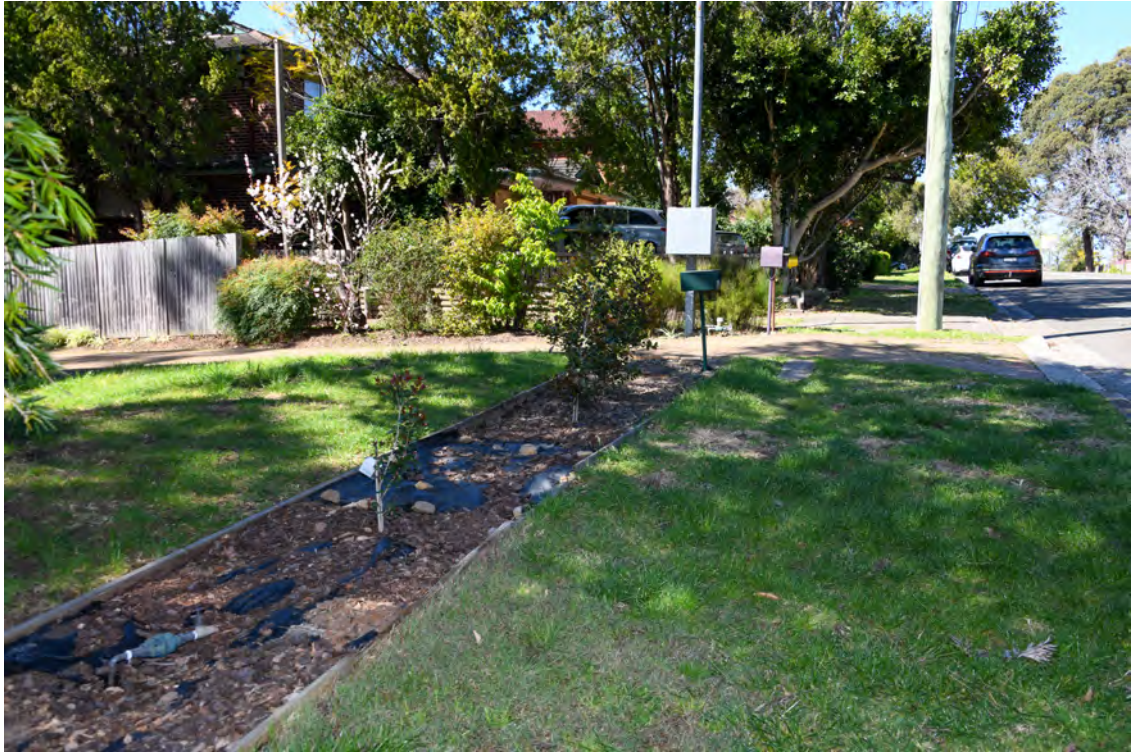
PRO\_1633.jpg

Ward Street. Street frontages of the residences on the eastern side of Ward Street opposite Epping West Public School. Heading south. Area adjacent to 8 Ward Street.

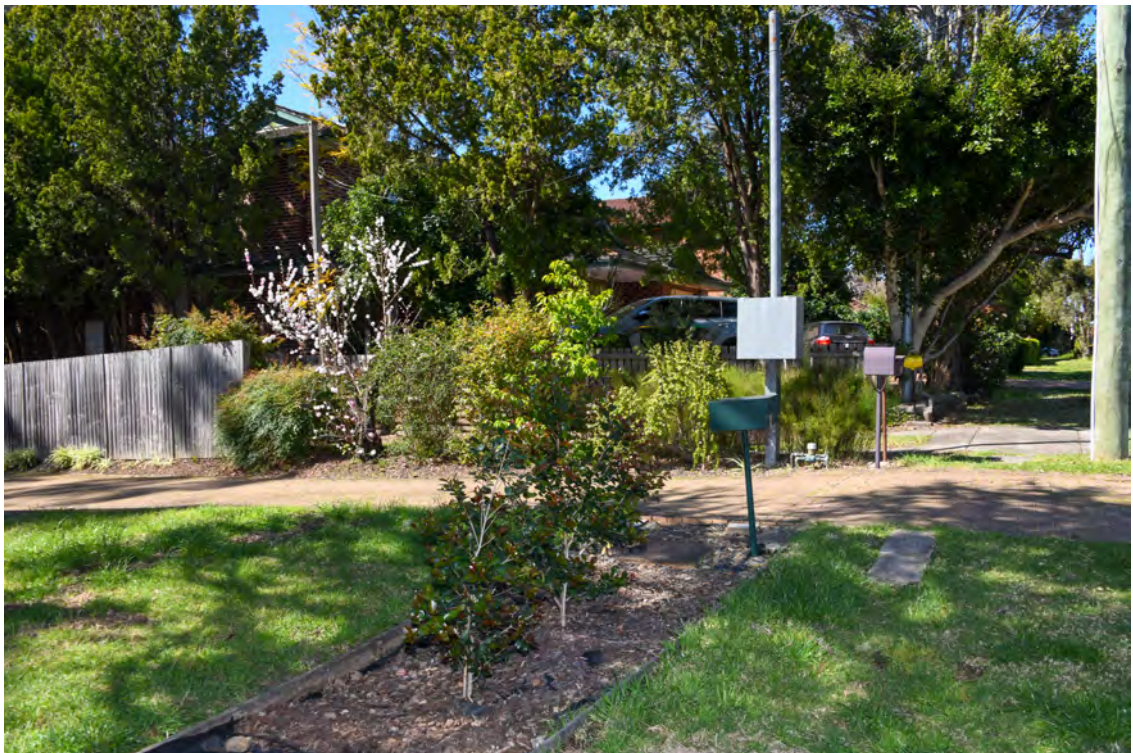
PRO\_1634.jpg

Ward Street. Street frontages of the residences on the eastern side of Ward Street opposite Epping West Public School. Heading south. Area adjacent to 8 Ward Street.

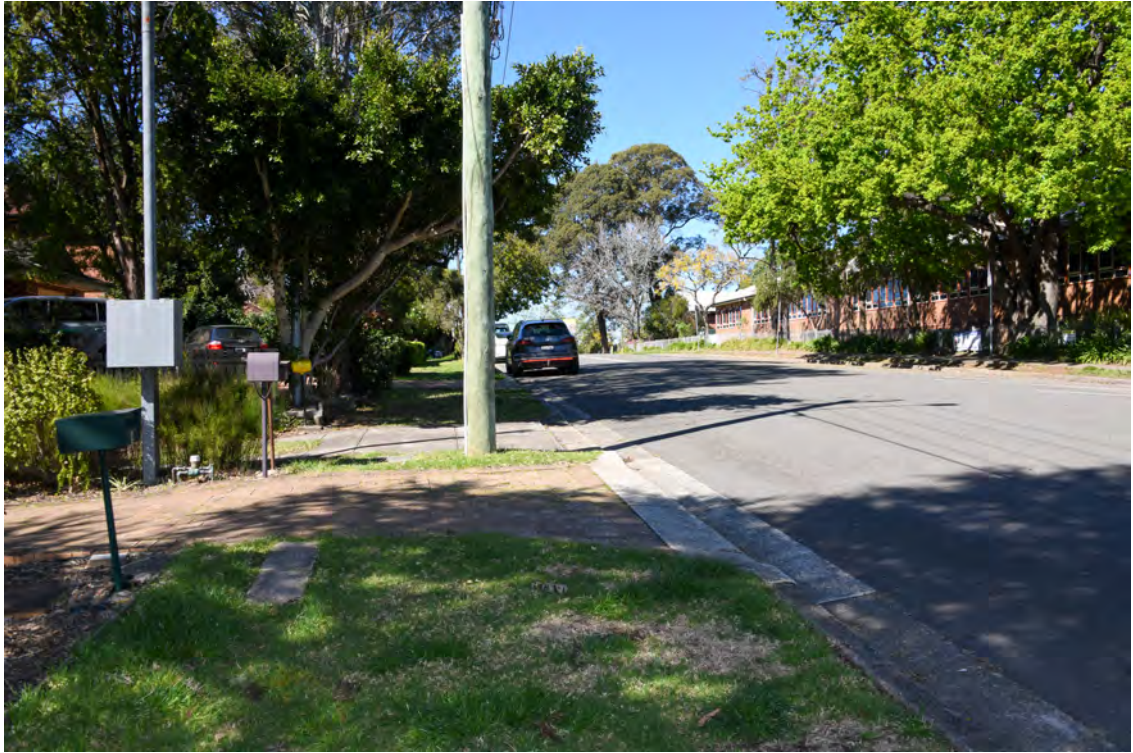
PRO\_1635.jpg

Ward Street. Street frontages of the residences on the eastern side of Ward Street opposite Epping West Public School. Heading south. Area adjacent to 8 Ward Street.

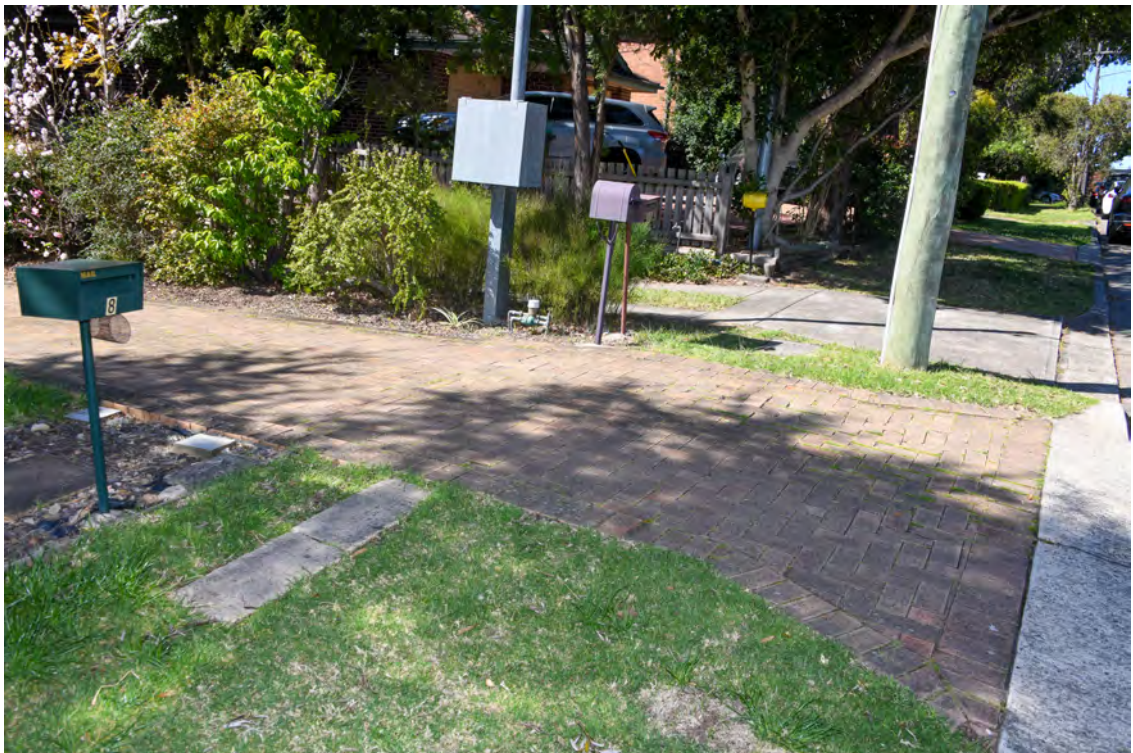
PRO\_1636.jpg

Ward Street. Street frontages of the residences on the eastern side of Ward Street opposite Epping West Public School. Heading south. Area adjacent to 8 Ward Street.

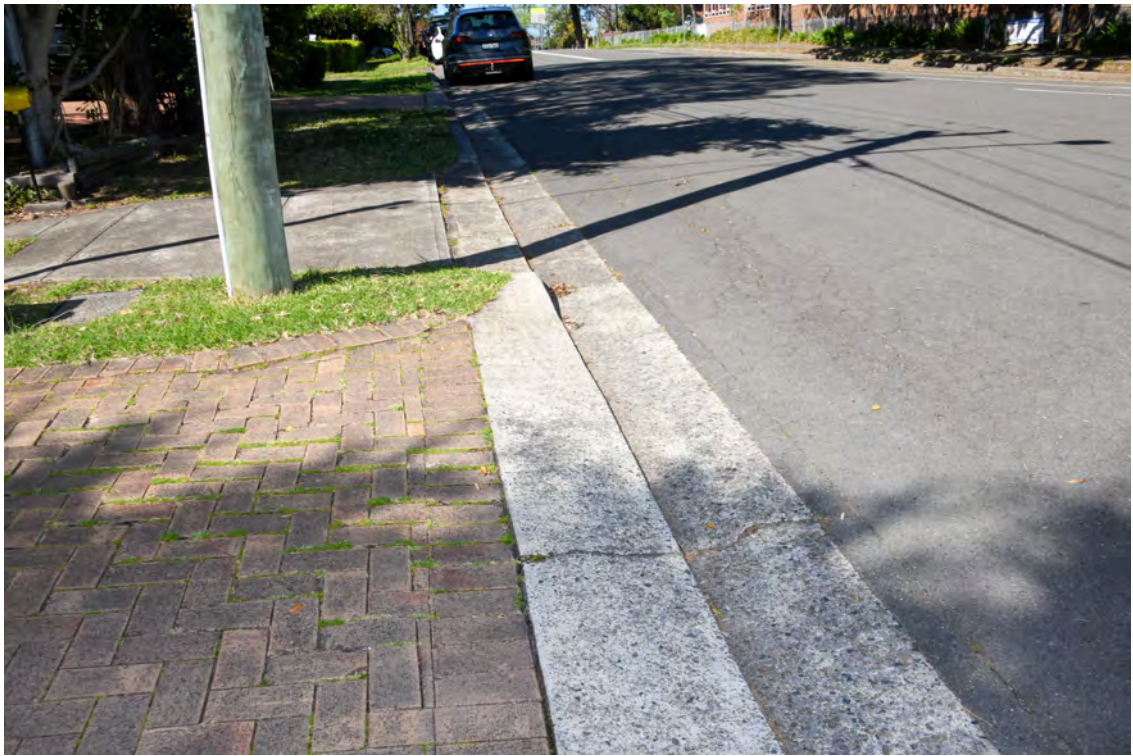
PRO\_1637.jpg

Ward Street. Street frontages of the residences on the eastern side of Ward Street opposite Epping West Public School. Heading south. Area adjacent to 8 Ward Street.

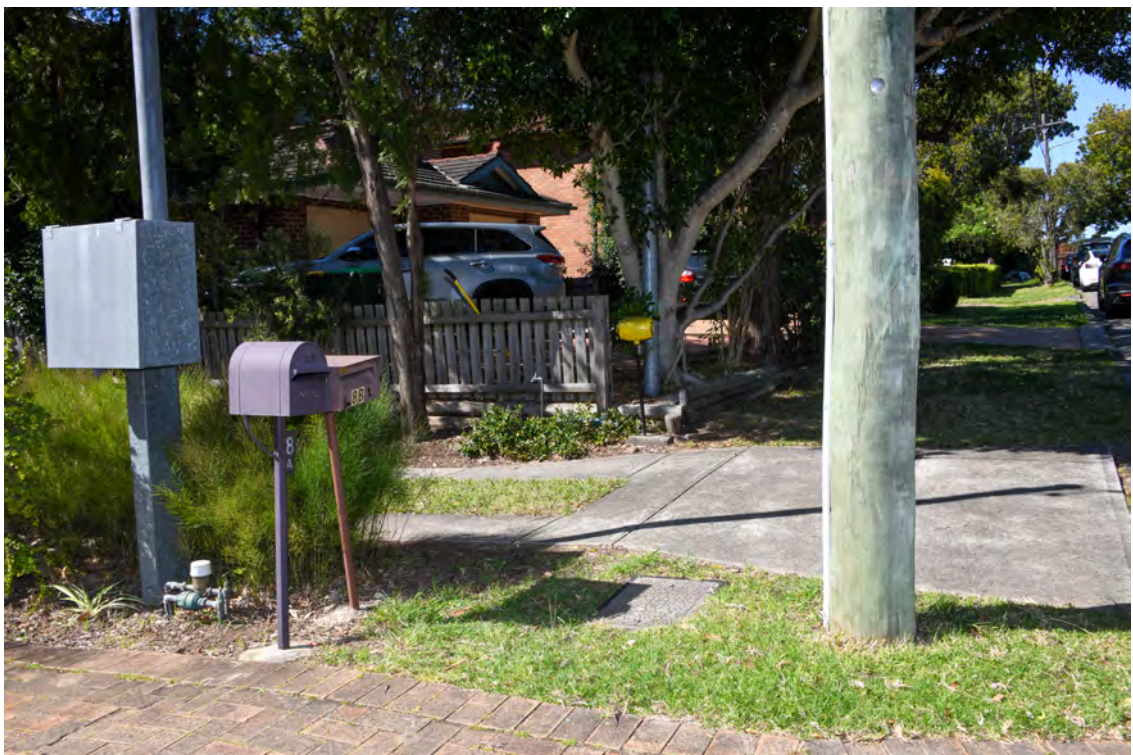
PRO\_1638.jpg

Ward Street. Street frontages of the residences on the eastern side of Ward Street opposite Epping West Public School. Heading south. Area adjacent to 8 Ward Street.

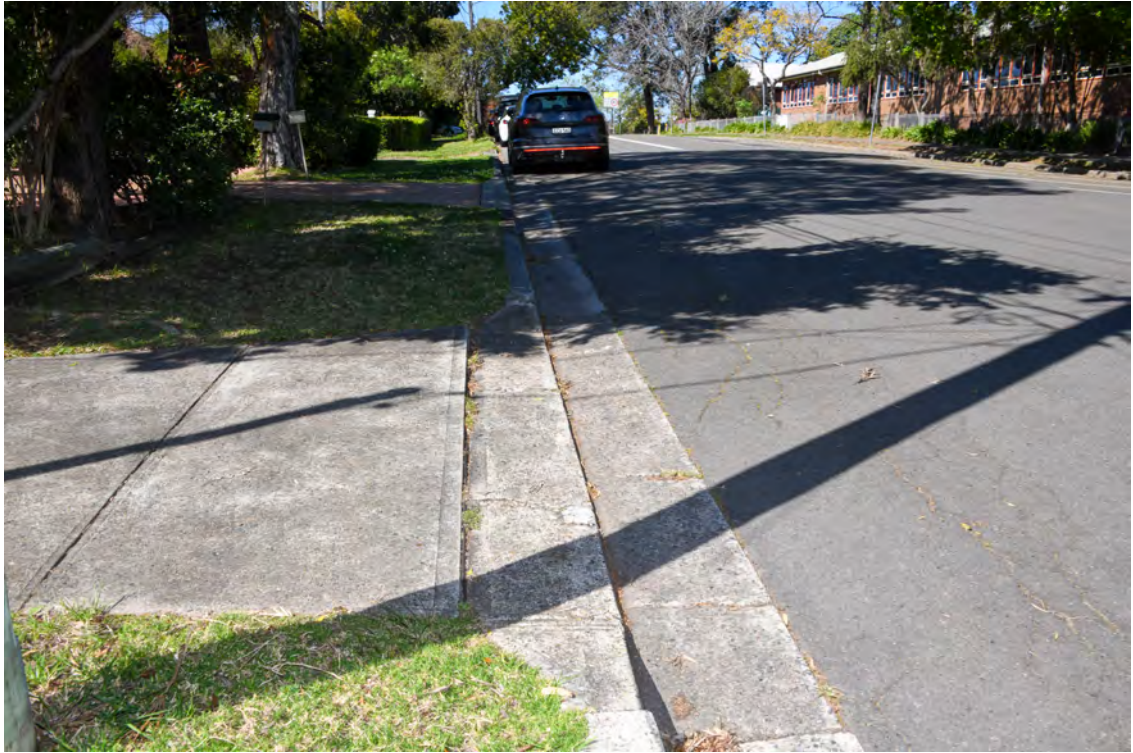
PRO\_1639.jpg

Ward Street. Street frontages of the residences on the eastern side of Ward Street opposite Epping West Public School. Heading south. Area adjacent to 8 Ward Street.

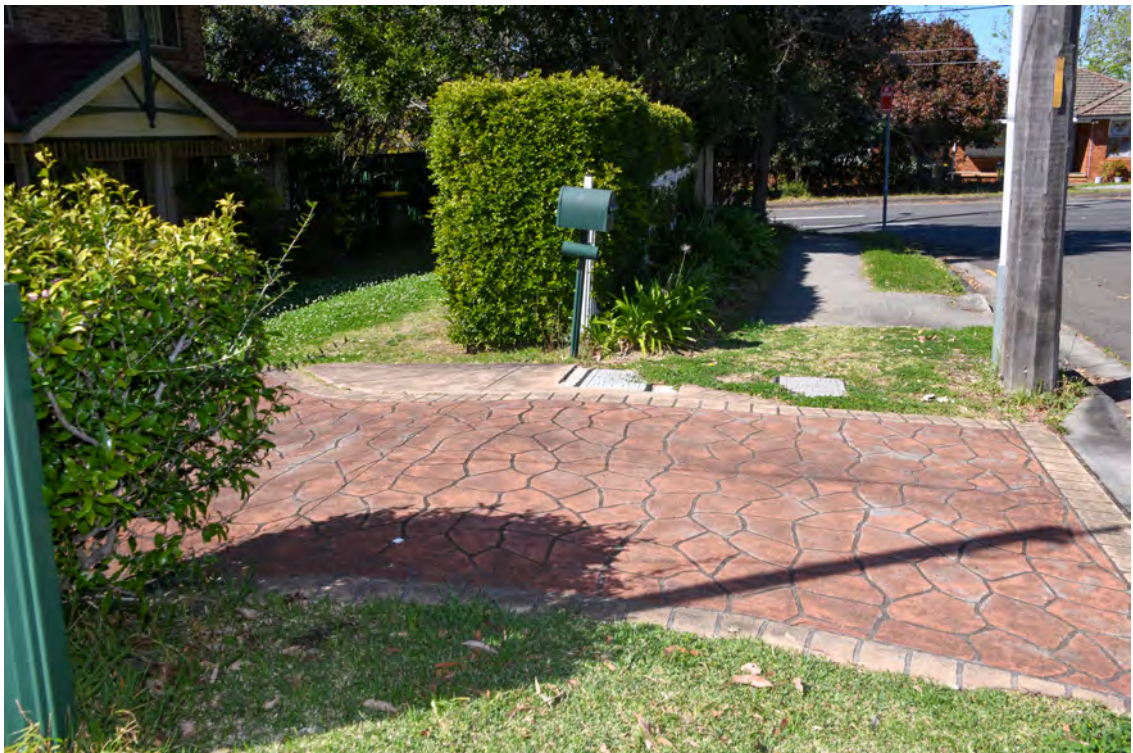
PRO\_1680.jpg

Ward Street. Street frontages of the residences on the eastern side of Ward Street opposite Epping West Public School. Heading south. Area adjacent to 2B Ward Street.

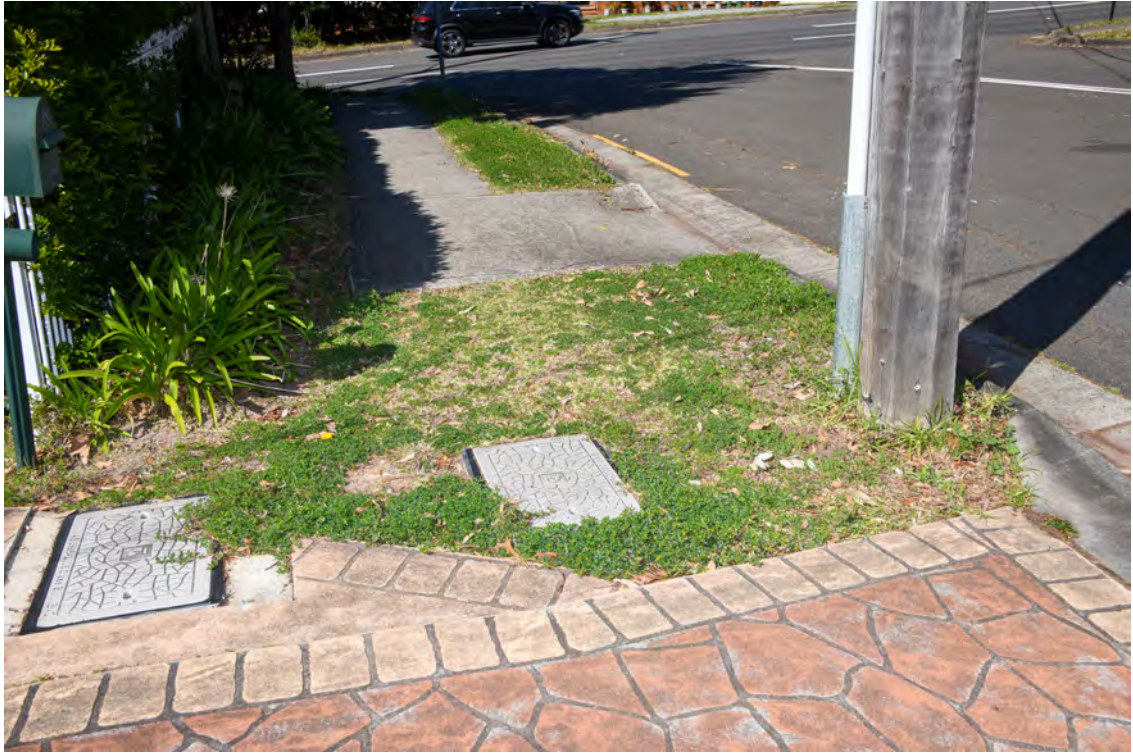
PRO\_1681.jpg

Ward Street. Street frontages of the residences on the eastern side of Ward Street opposite Epping West Public School. Heading south. Area adjacent to 2B Ward Street.

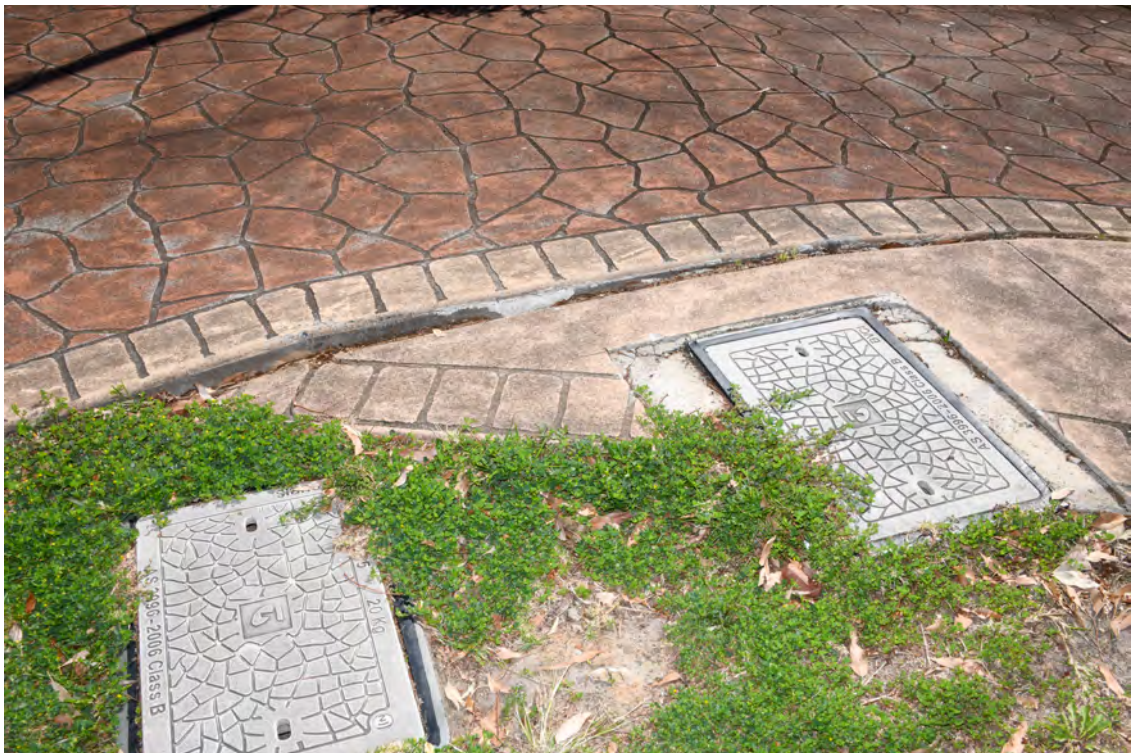
PRO\_1682.jpg

Ward Street. Street frontages of the residences on the eastern side of Ward Street opposite Epping West Public School. Heading south. Area adjacent to 2B Ward Street.

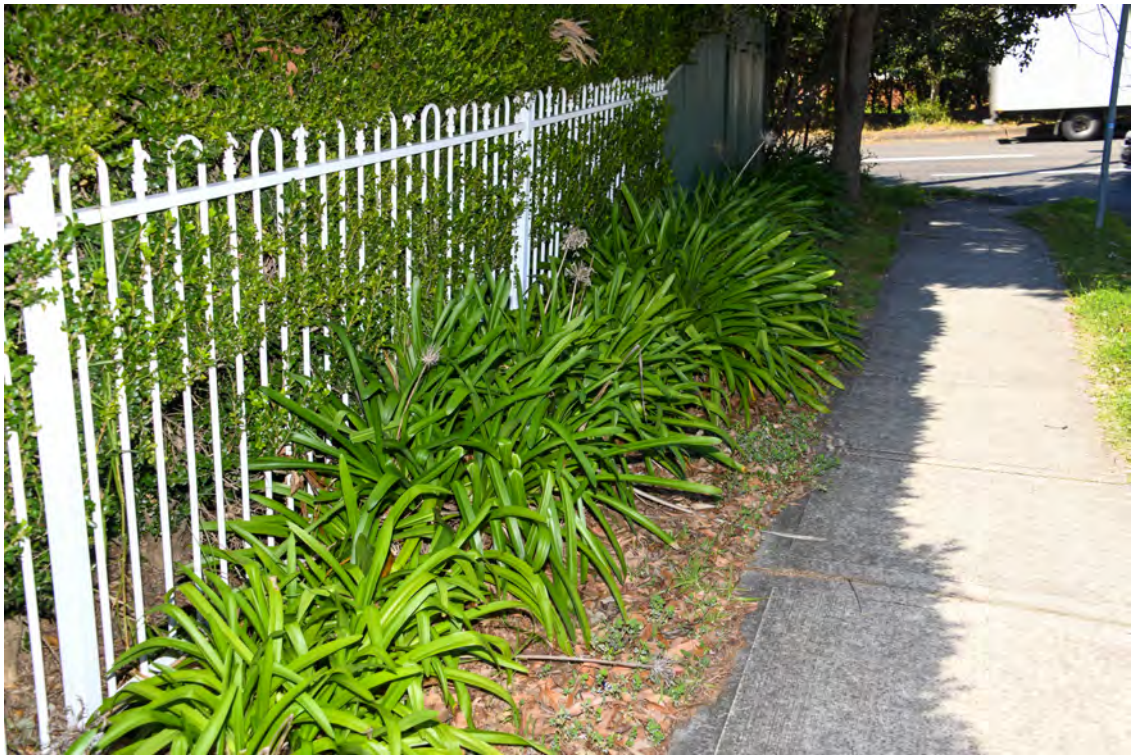
PRO\_1683.jpg

Ward Street. Street frontages of the residences on the eastern side of Ward Street opposite Epping West Public School. Heading south. Area adjacent to 2B Ward Street.

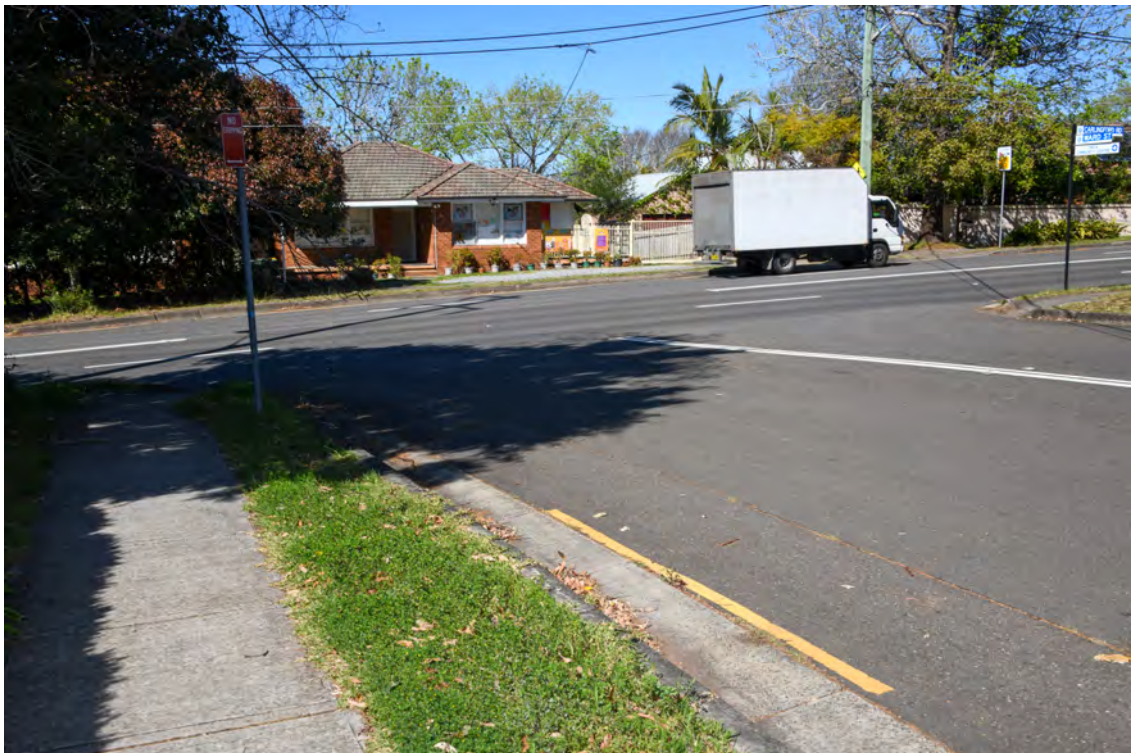
PRO\_1684.jpg

Ward Street. Street frontages of the residences on the eastern side of Ward Street opposite Epping West Public School. Heading south. Area adjacent to 2B Ward Street.
