96-104 Carlingford Road, Epping NSW 2121

Epping West Public School

DILAPIDATION REPORT

7<sup>th</sup> September 2021

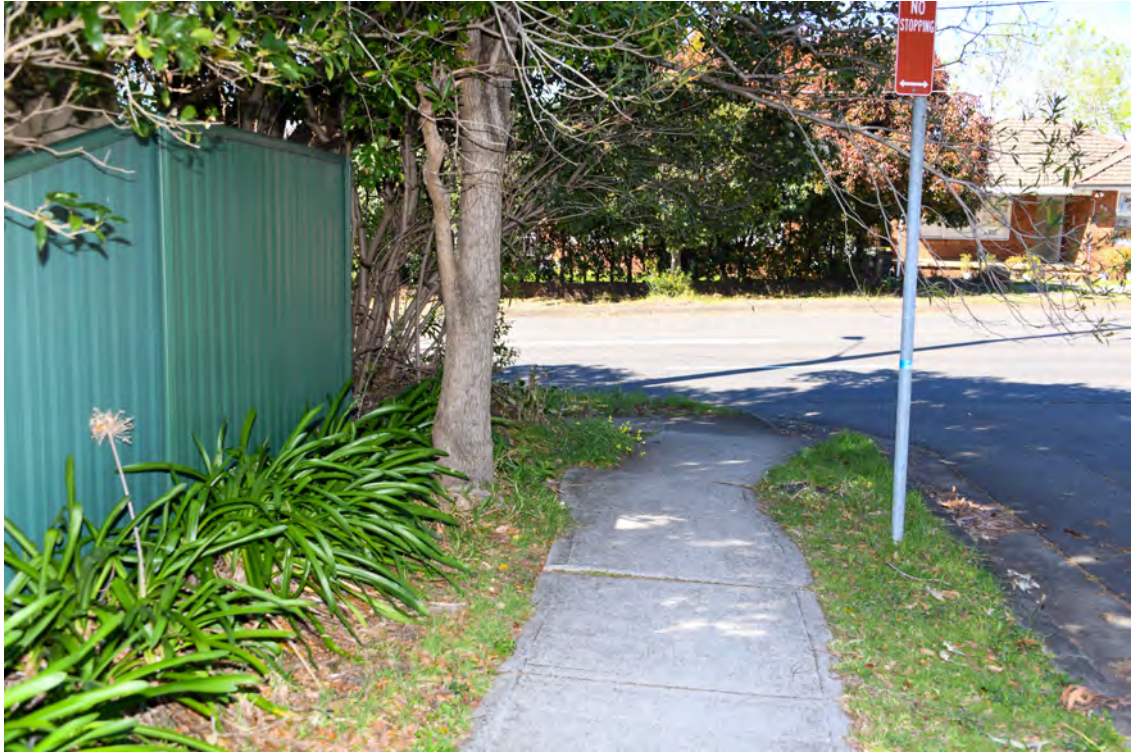
PRO\_1685.jpg

Ward Street. Street frontages of the residences on the eastern side of Ward Street opposite Epping West Public School. Heading south. Area adjacent to 2B Ward Street.

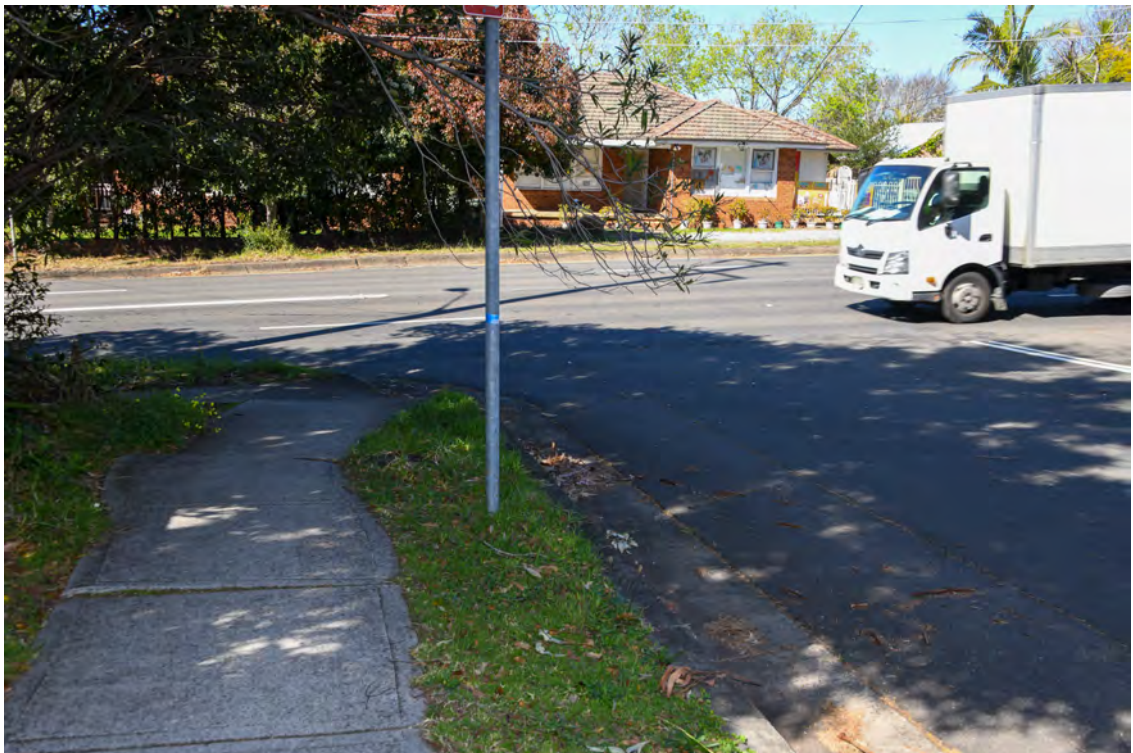
PRO\_1686.jpg

Ward Street. Street frontages of the residences on the eastern side of Ward Street opposite Epping West Public School. Heading south. Area adjacent to 2B Ward Street.

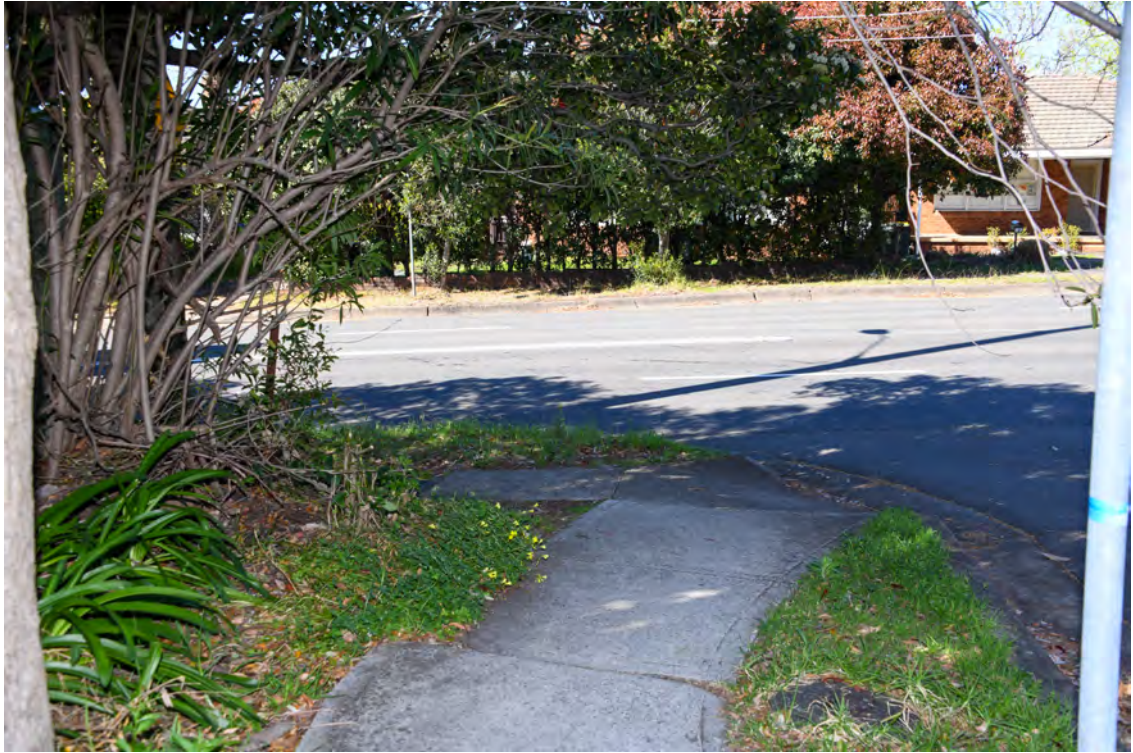
PRO\_1687.jpg

Ward Street. Street frontages of the residences on the eastern side of Ward Street opposite Epping West Public School. Heading south. Area adjacent to 2B Ward Street.

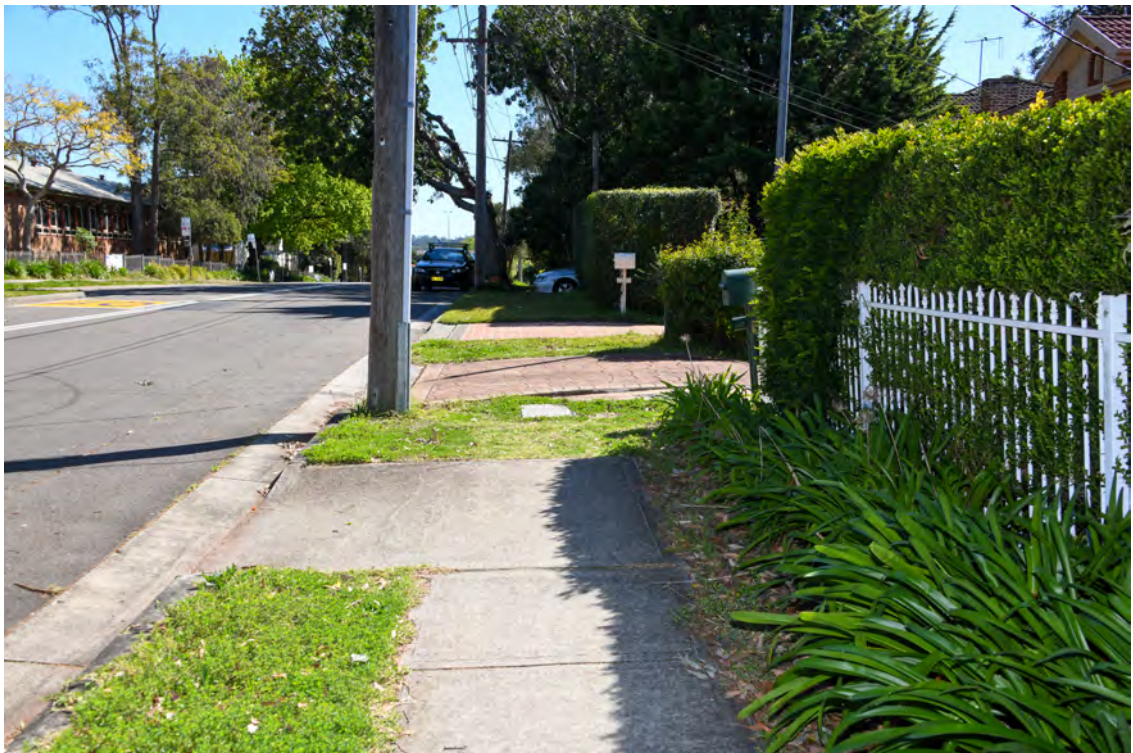
PRO\_1688.jpg

Ward Street. Street frontages of the residences on the eastern side of Ward Street opposite Epping West Public School. Heading north. Area adjacent to 2A Ward Street.

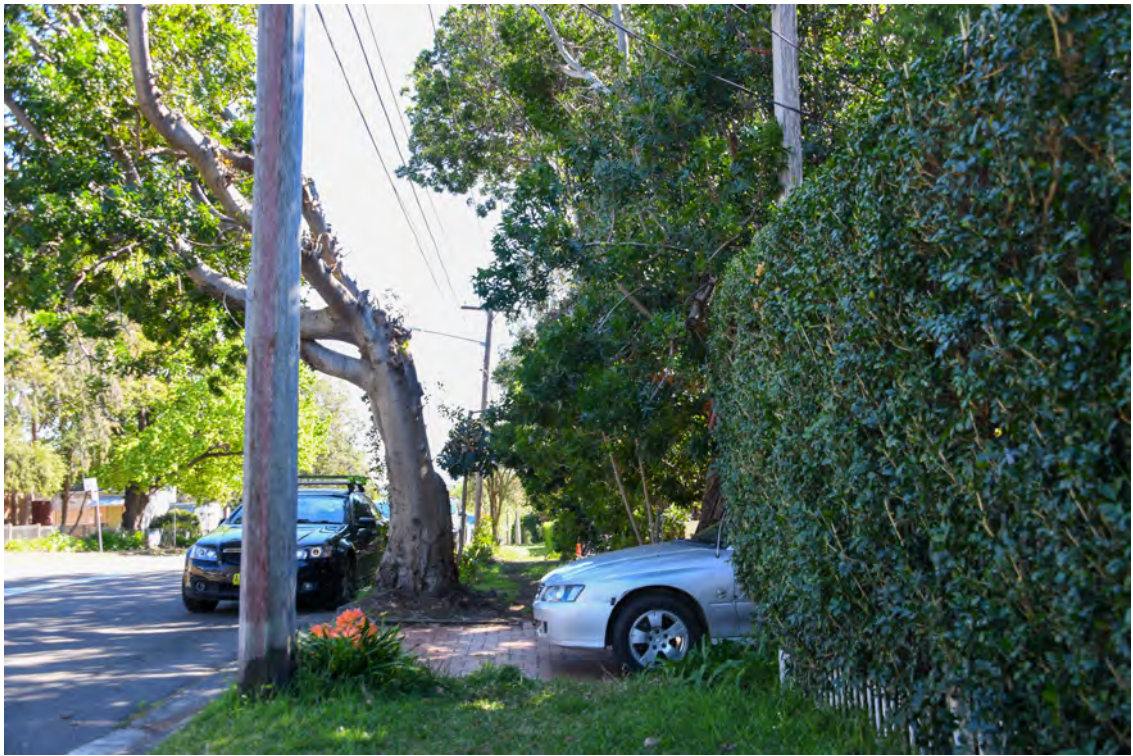
PRO\_1689.jpg

Ward Street. Street frontages of the residences on the eastern side of Ward Street opposite Epping West Public School. Heading north. Area adjacent to 2A Ward Street.

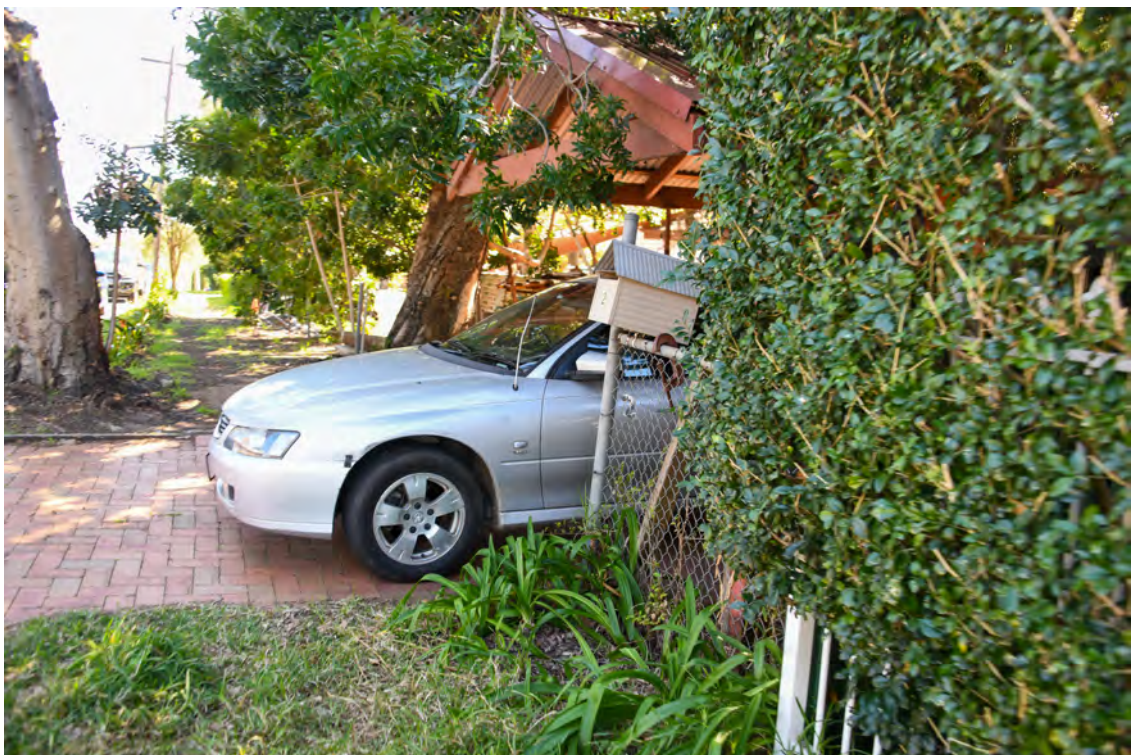
PRO\_1690.jpg

Ward Street. Street frontages of the residences on the eastern side of Ward Street opposite Epping West Public School. Heading north. Area adjacent to 2 Ward Street.

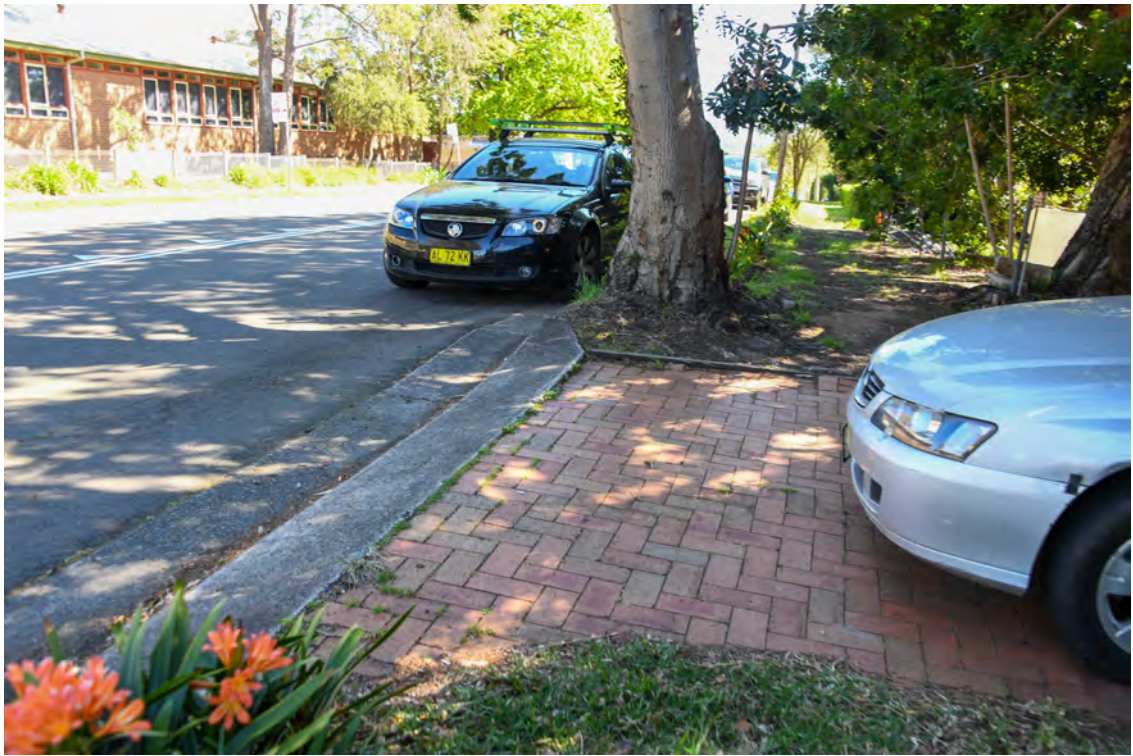
PRO\_1691.jpg

Ward Street. Street frontages of the residences on the eastern side of Ward Street opposite Epping West Public School. Heading north. Area adjacent to 2 Ward Street.

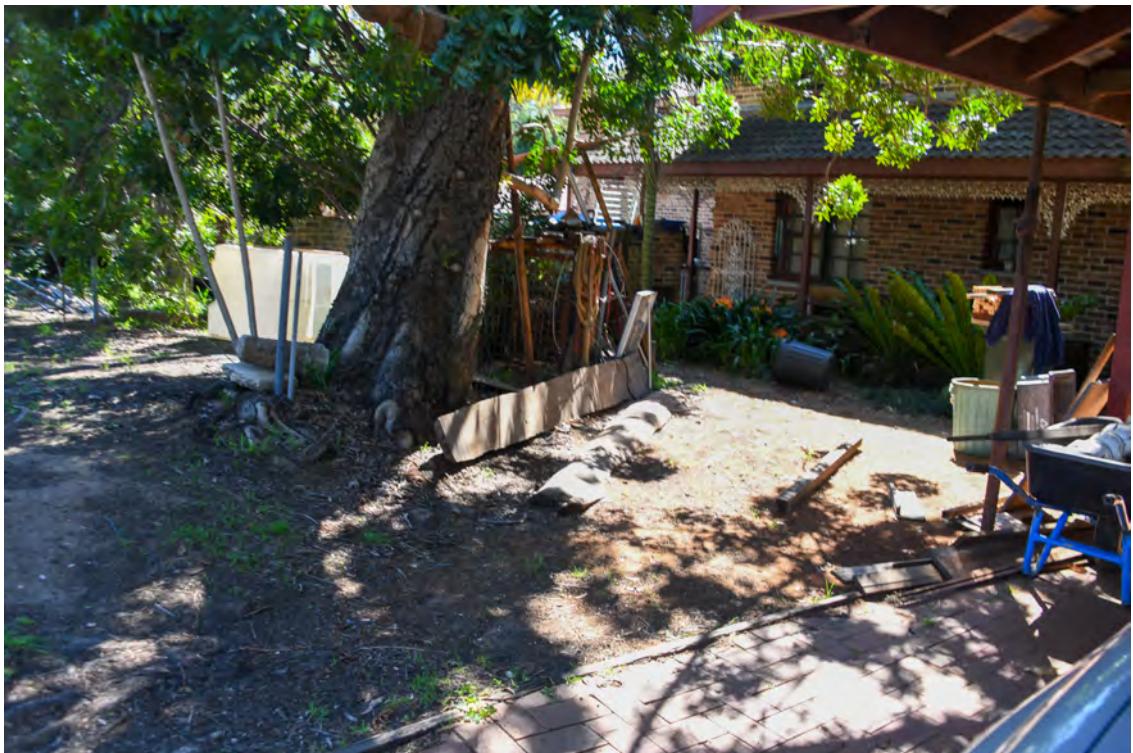
PRO\_1692.jpg

Ward Street. Street frontages of the residences on the eastern side of Ward Street opposite Epping West Public School. Heading north. Area adjacent to 2 Ward Street.

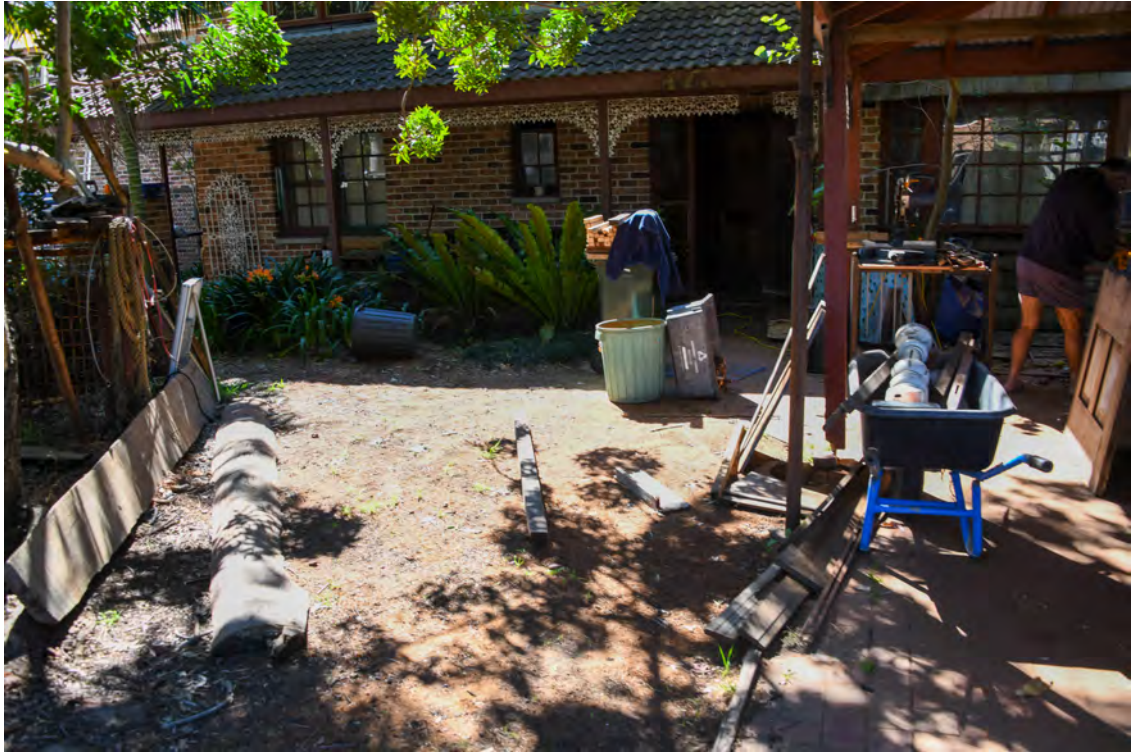
PRO\_1693.jpg

Ward Street. Street frontages of the residences on the eastern side of Ward Street opposite Epping West Public School. Heading north. Area adjacent to 2 Ward Street.

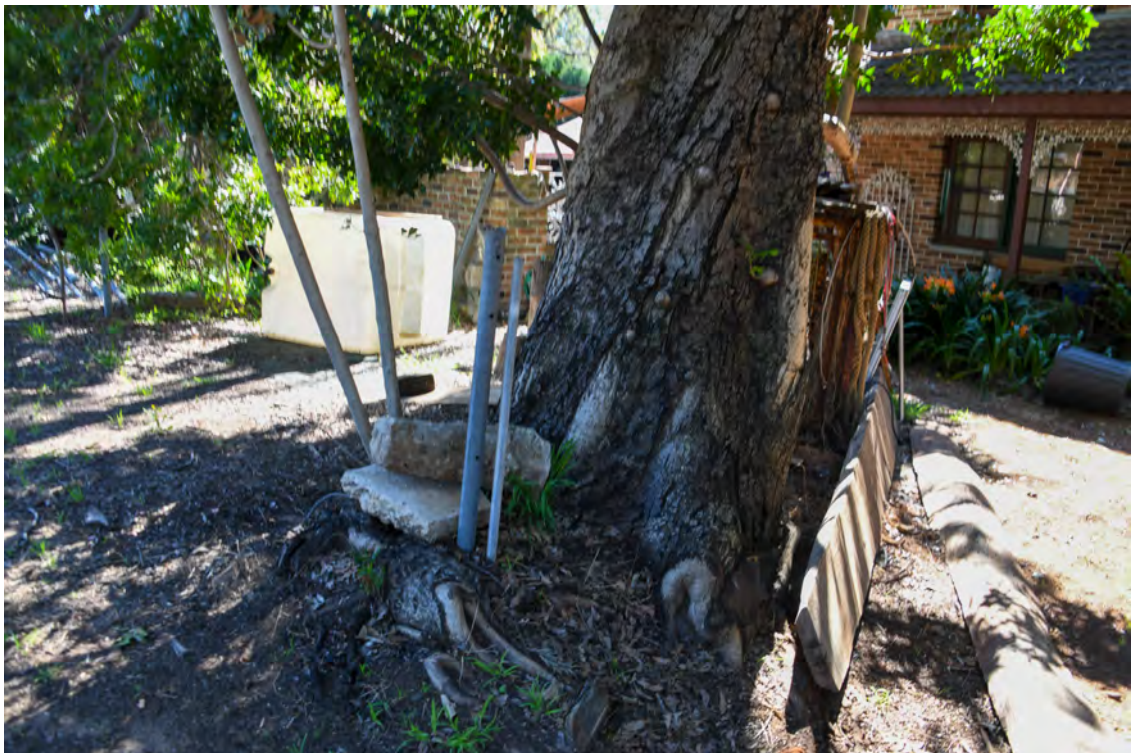
PRO\_1694.jpg

Ward Street. Street frontages of the residences on the eastern side of Ward Street opposite Epping West Public School. Heading north. Area adjacent to 2 Ward Street.

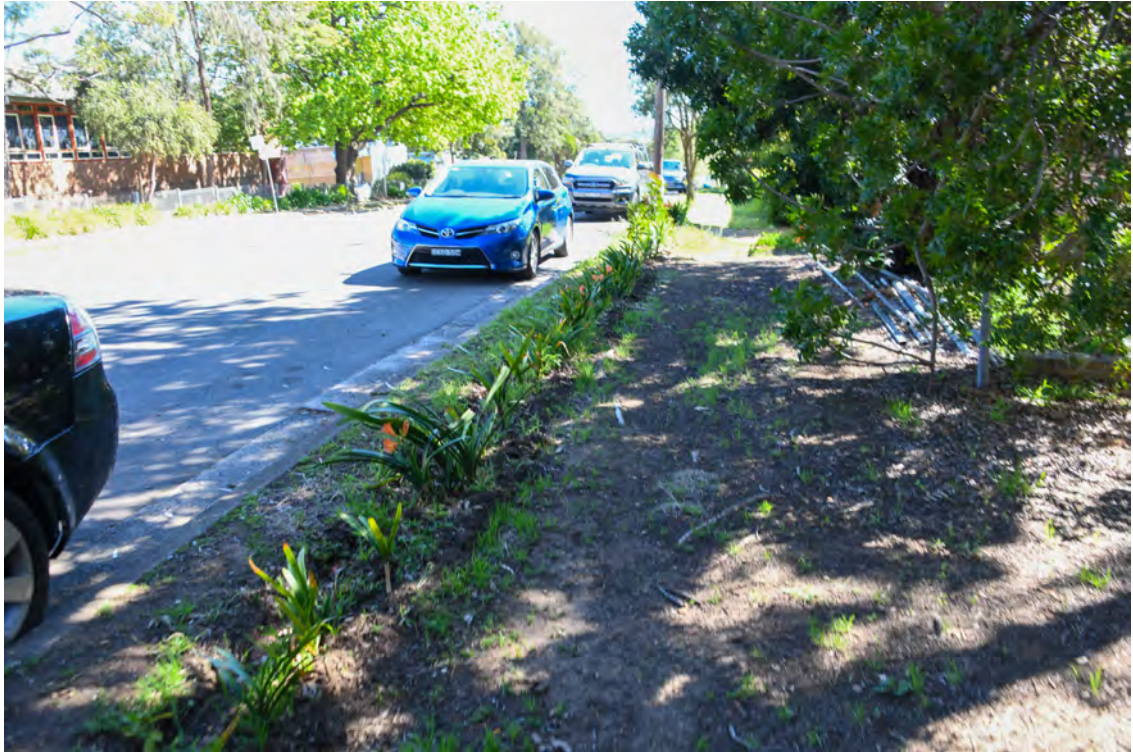
PRO\_1695.jpg

Ward Street. Street frontages of the residences on the eastern side of Ward Street opposite Epping West Public School. Heading north. Area adjacent to 2 Ward Street.

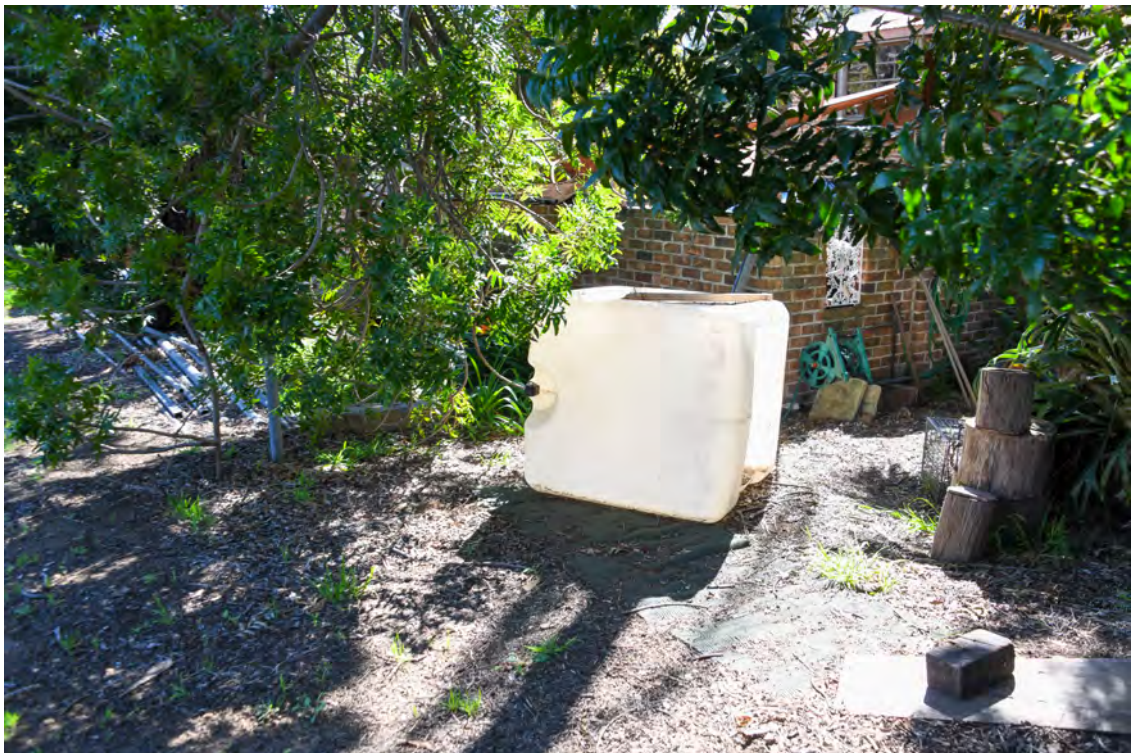
PRO\_1696.jpg

Ward Street. Street frontages of the residences on the eastern side of Ward Street opposite Epping West Public School. Heading north. Area adjacent to 2 Ward Street.

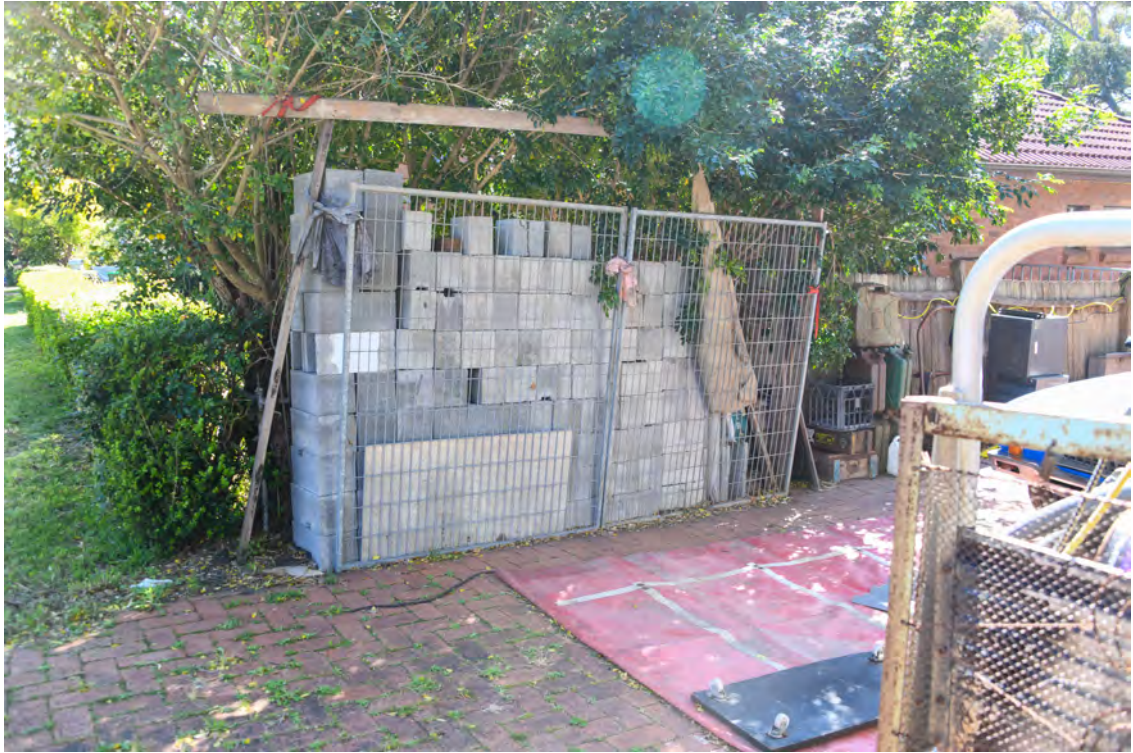
PRO\_1697.jpg

Ward Street. Street frontages of the residences on the eastern side of Ward Street opposite Epping West Public School. Heading north. Area adjacent to 2 Ward Street.
