JBS&G Hazardous Material Assessment Report

Pells Sullivan Meynink
Hazardous Building Materials Survey

Chatswood High School
24 Centennial Avenue, Chatswood, NSW

Pells Sullivan Meynink
Hazardous Building Materials Survey
Chatswood High School
24 Centennial Avenue, Chatswood, NSW
15 March 2019
55579/120,669 (Rev 0)
JBS&G

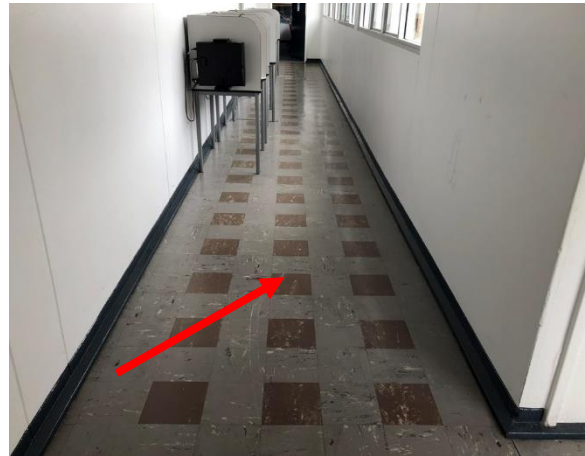
Photo 1: Building A, asbestos containing grey vinyl floor tiles to Room R1001

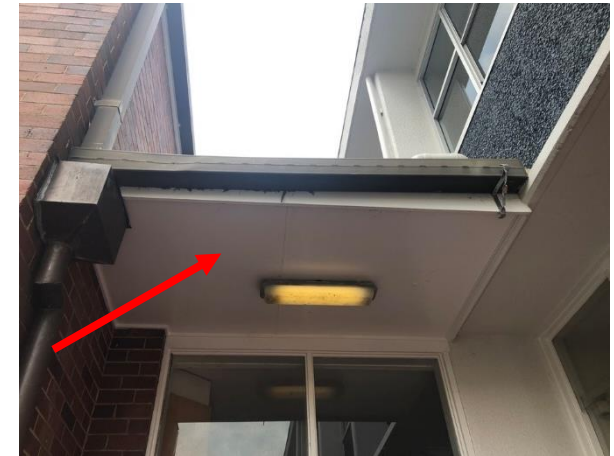
Photo 2: Building A, asbestos containing brown vinyl floor tiles to Room R1010

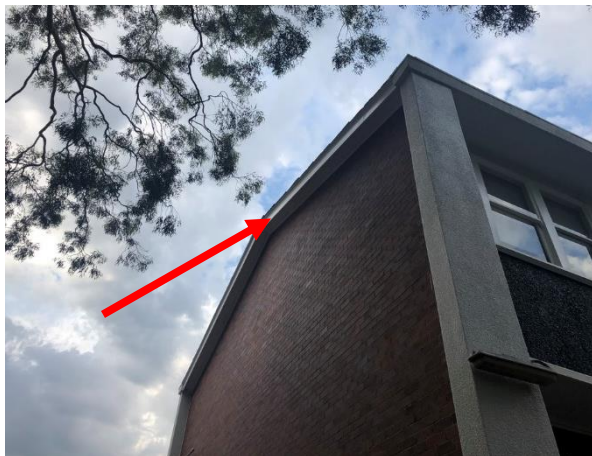
Photo 3: Building A, asbestos containing fibre cement sheeting to east and west entry soffits (R011 & R017)

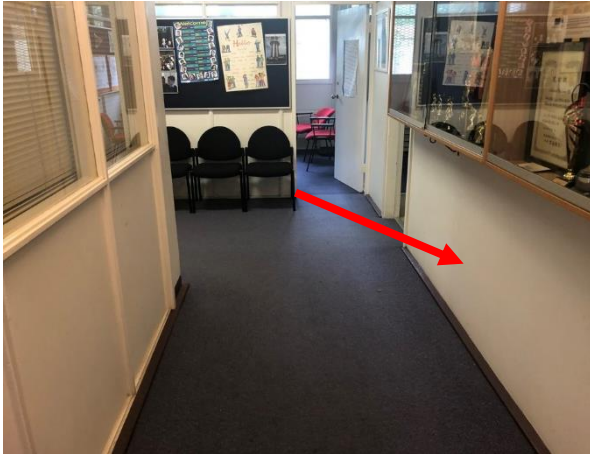
Photo 7: Building A, lead based cream paint to ground floor walls

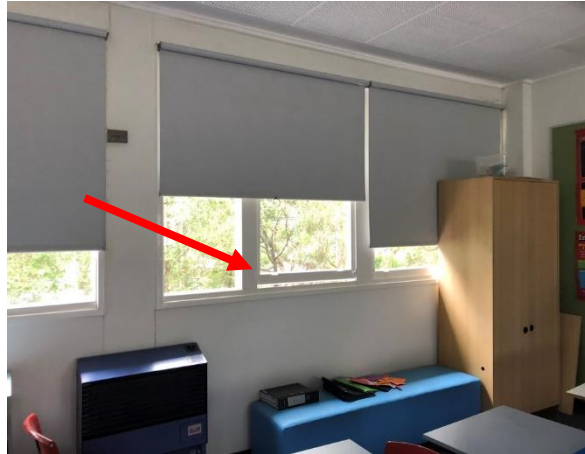
Photo 8: Building A, lead based white paint to Room R1001 windows

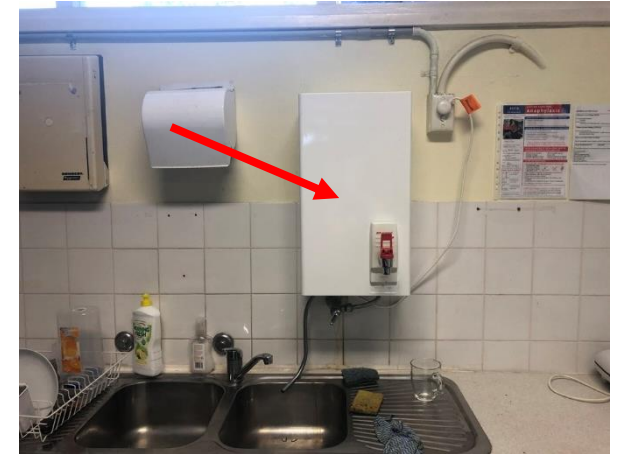
Photo 9: Building A, suspected SMF insulation core to instant hot water system in Room R0014

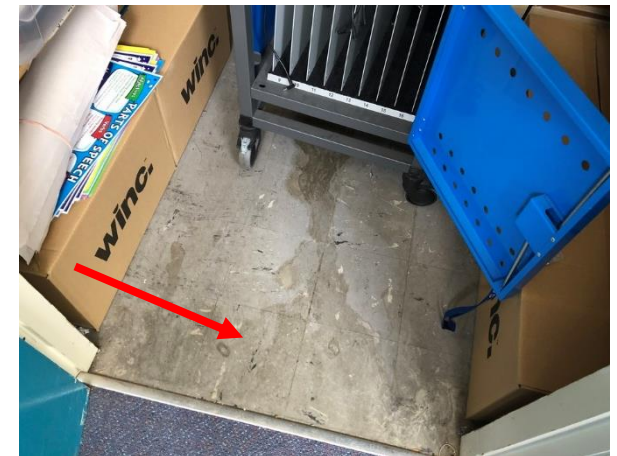
Photo 12: Building B, asbestos containing grey vinyl floor tiles to Room R1004

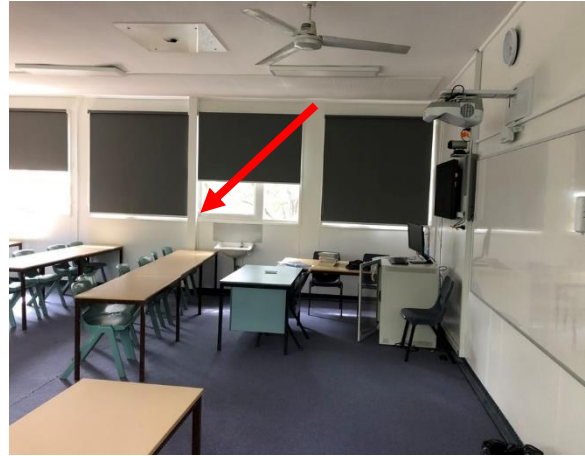
Photo 14: Building B, lead based cream paint to first floor internal windows

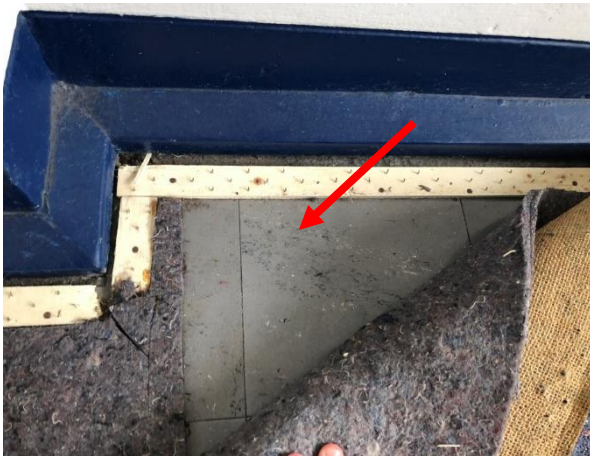
Photo 16: Building C, asbestos containing grey vinyl floor tiles to Room R1008

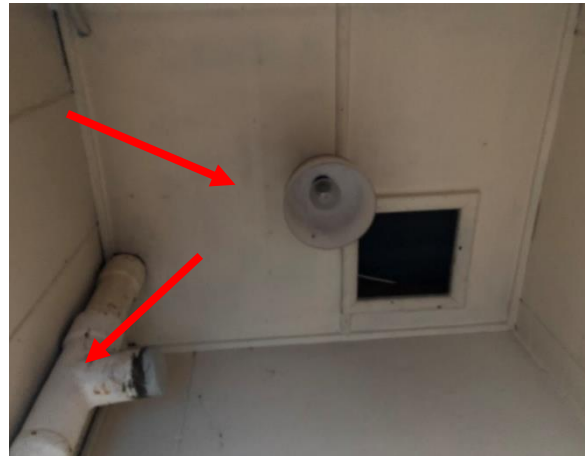
Photo 17: Building C, asbestos containing fibre cement sheeting to the ceiling and asbestos containing fibre cement flue pipe in Room R0017

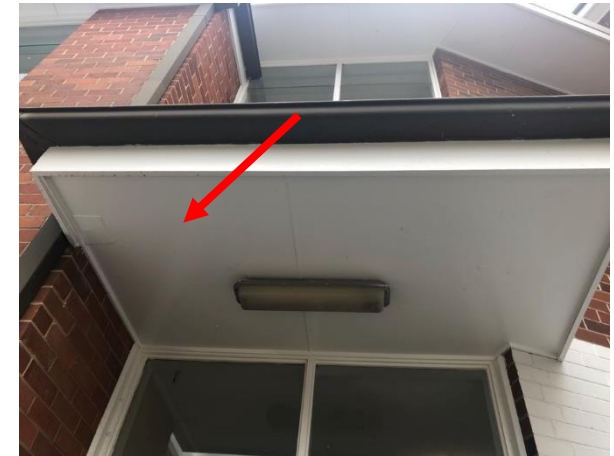
Photo 18: Building C, asbestos containing fibre cement sheeting to east and west entry soffits (R0013 & R0016)

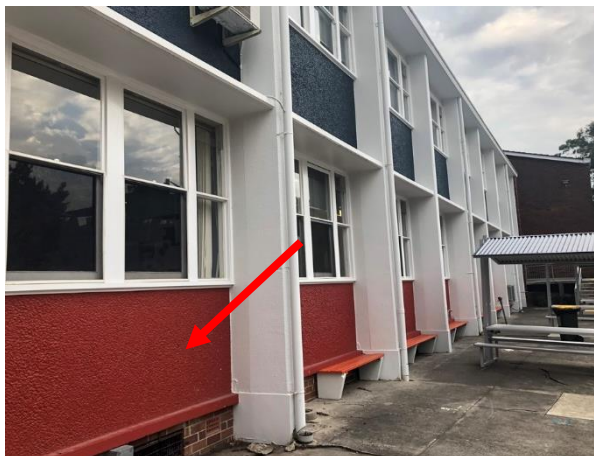
Photo 19: Building C, lead based orange/red paint to external walls

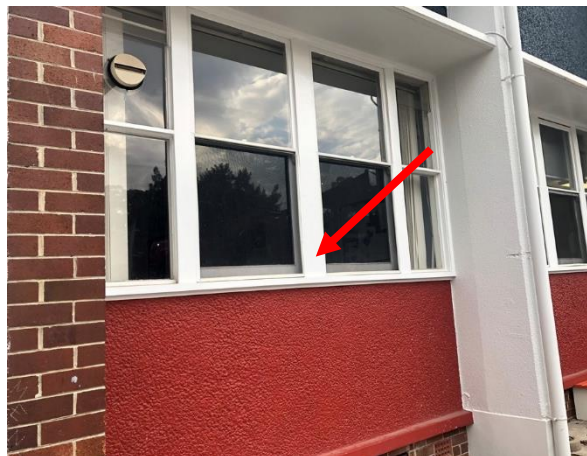
Photo 20: Building C, lead based white paint to external windows

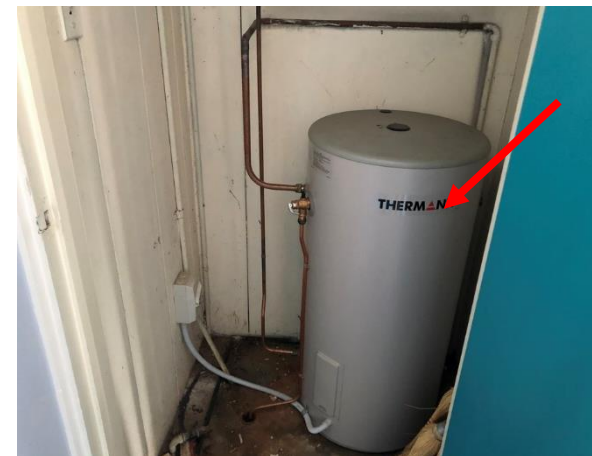
Photo 21: Building C, suspected SMF insulation core to hot water system in Room R0017

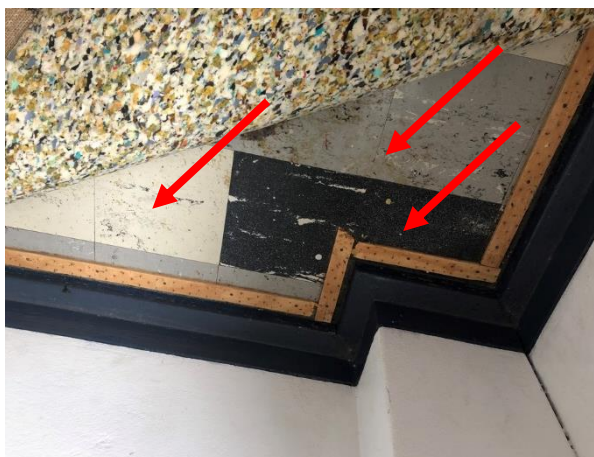
Photo 22: Building D, asbestos containing grey, black and cream vinyl floor tiles to Room R1001

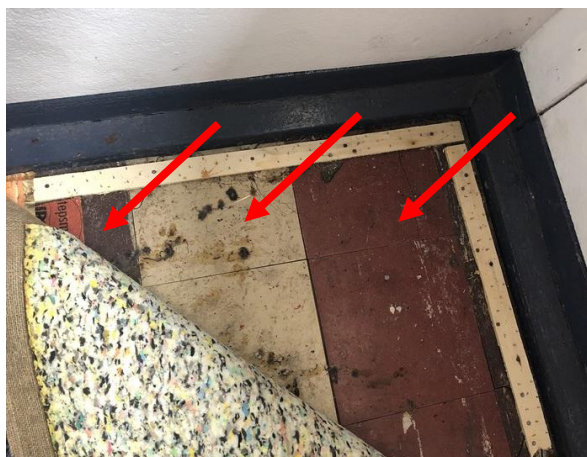
Photo 23: Building D, asbestos containing red, beige and brown vinyl floor tiles to Room R1002

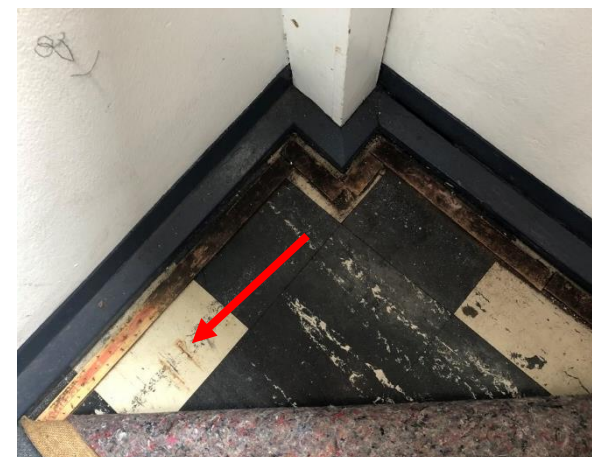
Photo 24: Building D, asbestos containing white vinyl floor tiles to Room R1010

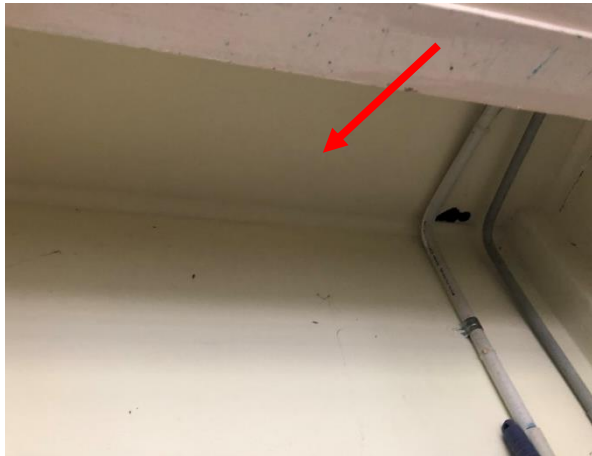
Photo 25: Building D, asbestos containing fibre cement sheeting to ceiling of Room R1012

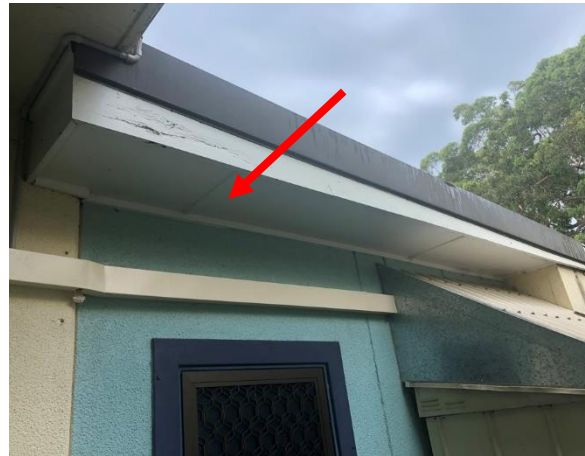
Photo 26: Building D, asbestos containing fibre cement sheeting to the external eaves of Room R0026

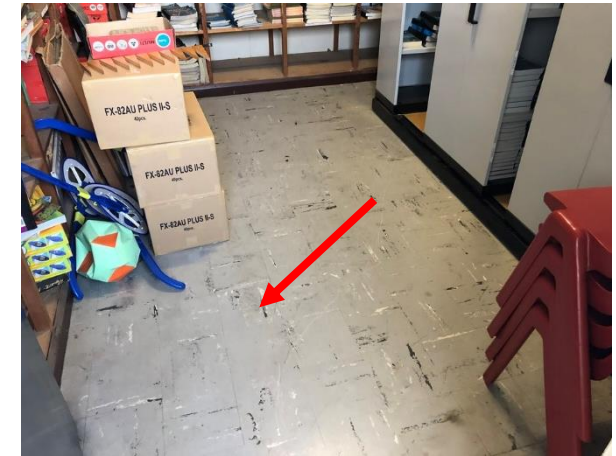
Photo 27: Building E, asbestos containing grey vinyl floor tiles to Room R1004

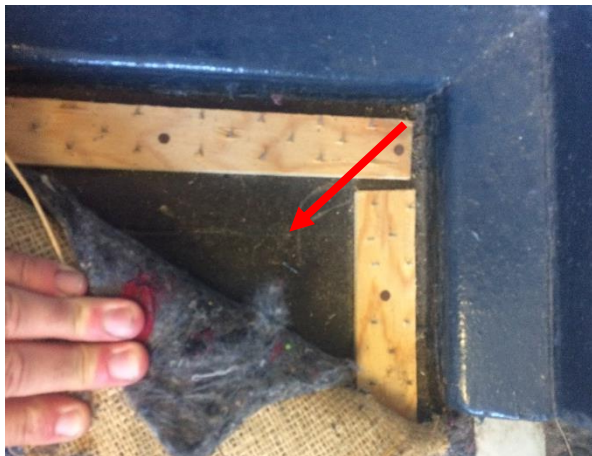
Photo 28: Building E, asbestos containing black vinyl floor tiles to Room R0007

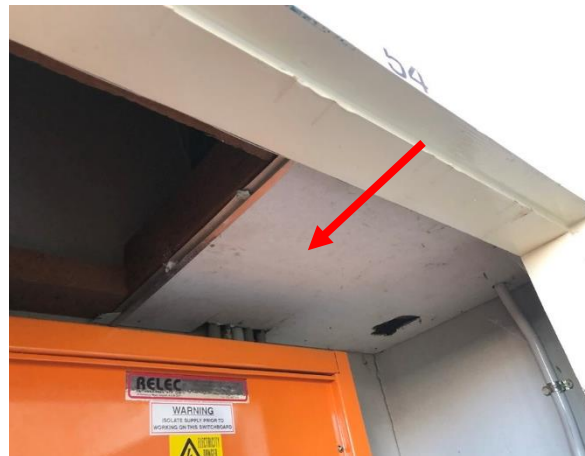
Photo 29: Building E, asbestos containing fibre cement sheeting to ceiling of Room R0009

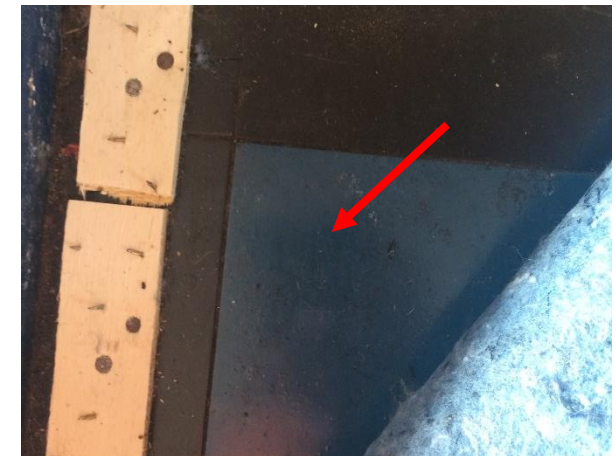
Photo 30: Building E, asbestos containing blue vinyl floor tiles to Room R1001

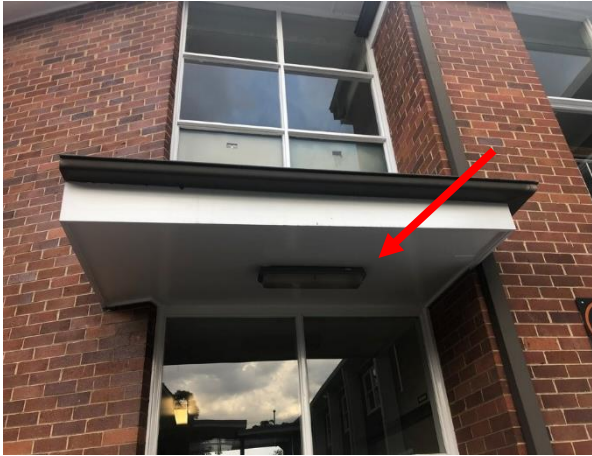
Photo 31: Building E, asbestos containing fibre cement sheeting to east and west entry soffits (R0014, R0020 & R0021)

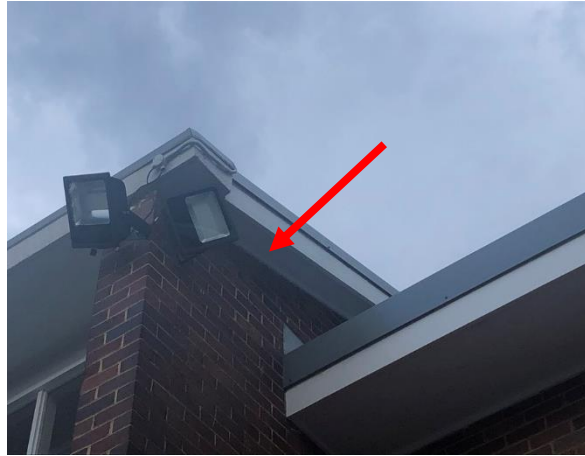
Photo 32: Building E, suspected asbestos containing fibre cement sheeting to eaves

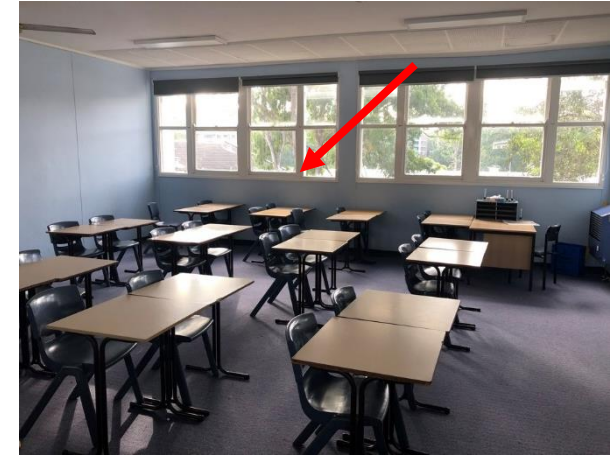
Photo 33: Building E, lead based white paint to Room R1007 windows

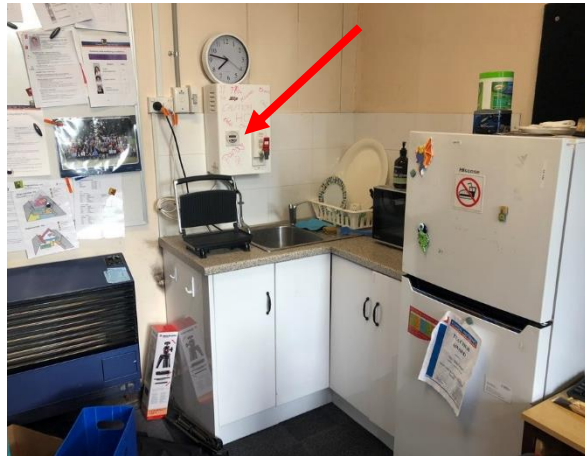
Photo 35: Building E, suspected SMF internal insulation core to instant hot water system in Room R0010

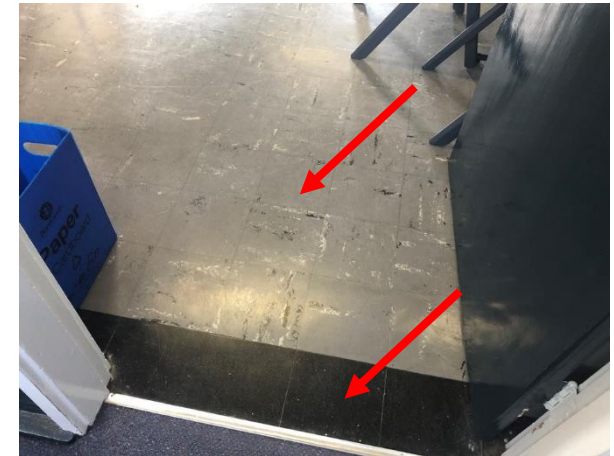
Photo 36: Building F, asbestos containing grey and black vinyl floor tiles to Room R1019

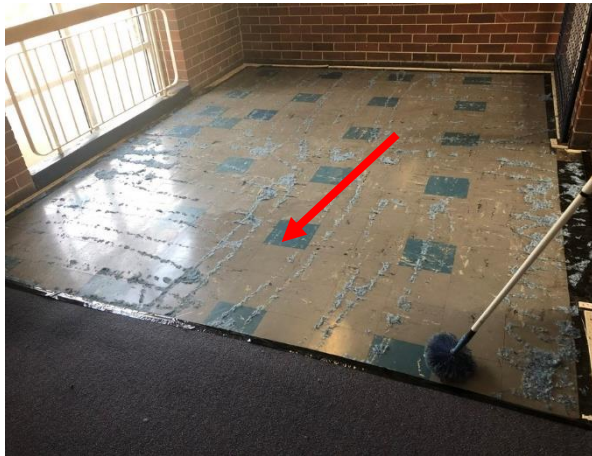
Photo 37: Building F, asbestos containing light blue vinyl floor tiles to Room R1012

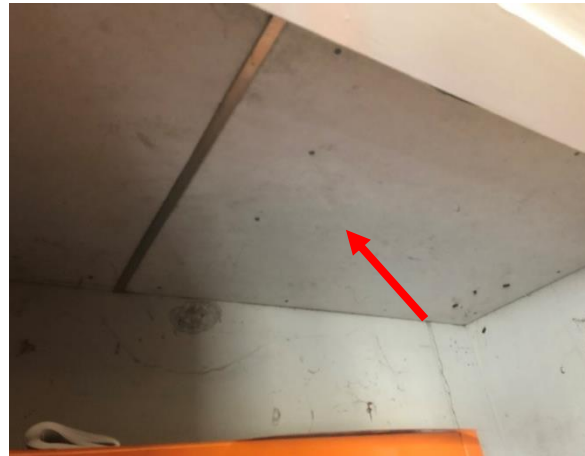
Photo 38: Building C, asbestos containing fibre cement sheeting to ceiling of Room R1004

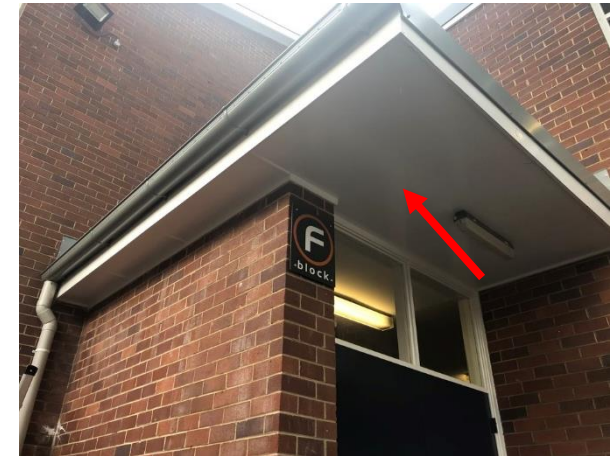
Photo 39: Building F, asbestos containing fibre cement sheeting to east and west entry soffits (R0017 & R0018)

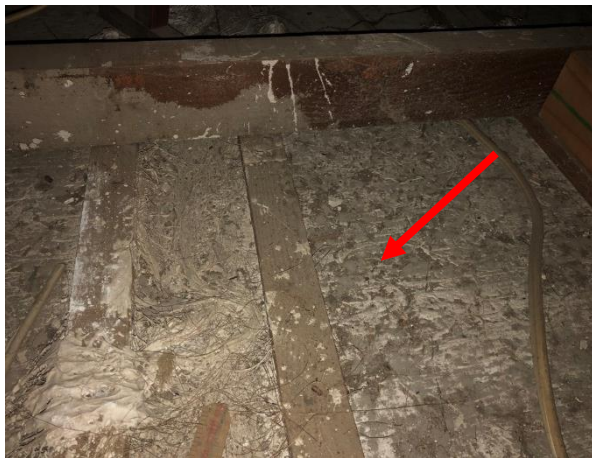
Photo 40: Building F, lead containing accumulated dust within roof void

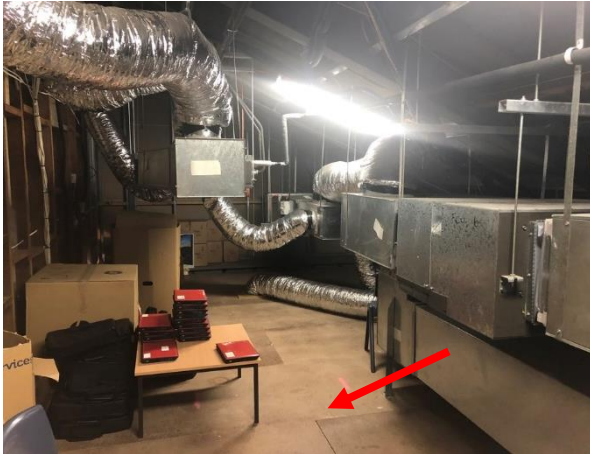
Photo 43: Building H, lead containing accumulated dust to the floor of Room M2008

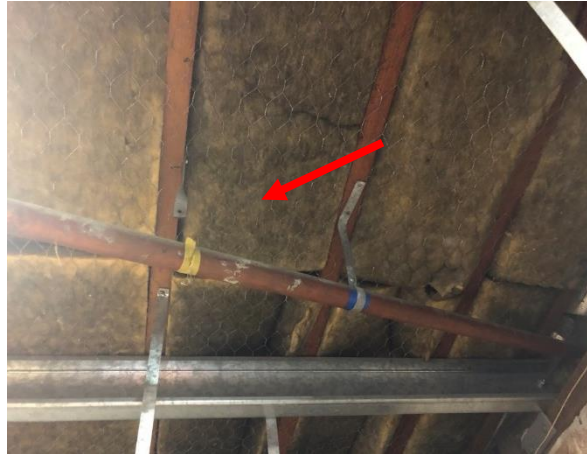
Photo 44: Building H, suspected SMF insulation to roof sarking

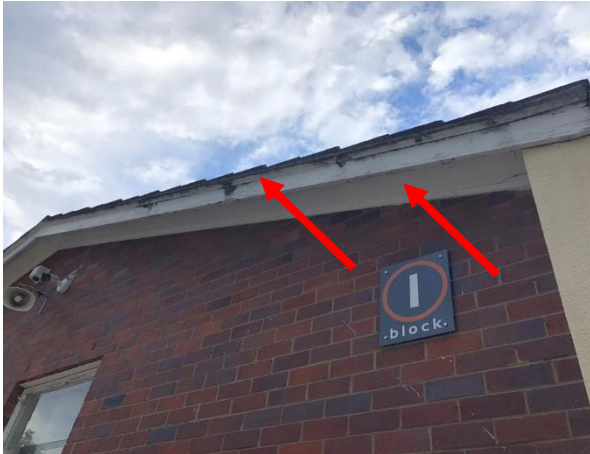
Photo 49: Building I, asbestos containing fibre cement sheeting to eaves and verge linings

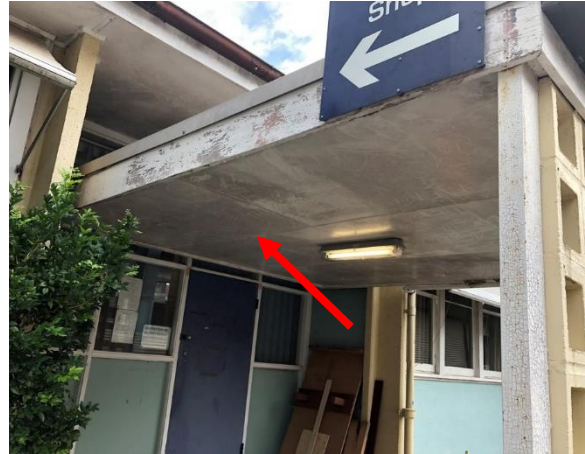
Photo 50: Building I, asbestos containing fibre cement sheeting to external soffit lining (R0017)

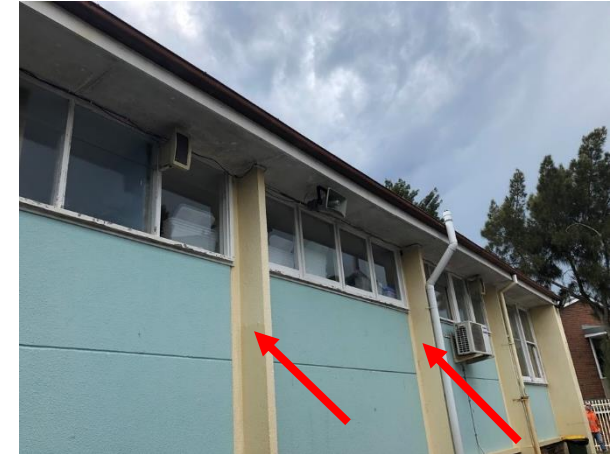
Photo 51: Building I, lead based cream paint to external walls

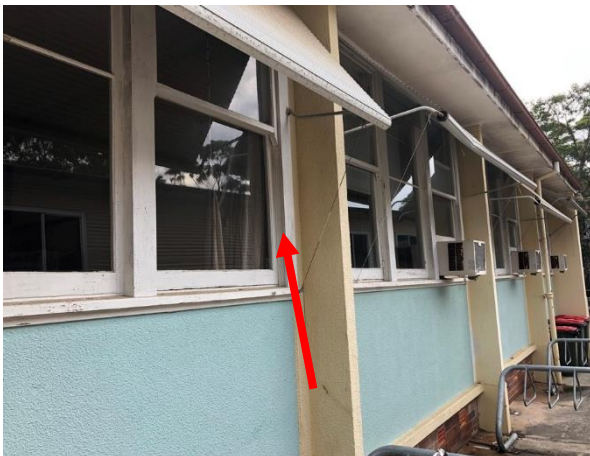
Photo 52: Building I, lead based white paint to external windows

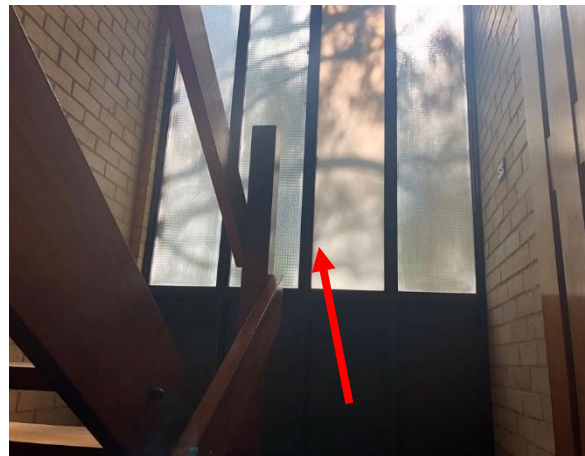
Photo 53: Building J, asbestos containing putty to aluminium framed windows

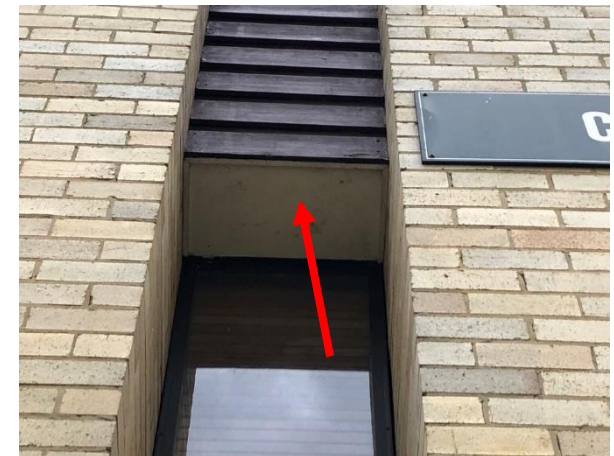
Photo 54: Building J, suspected asbestos containing fibre cement sheeting to eaves above windows

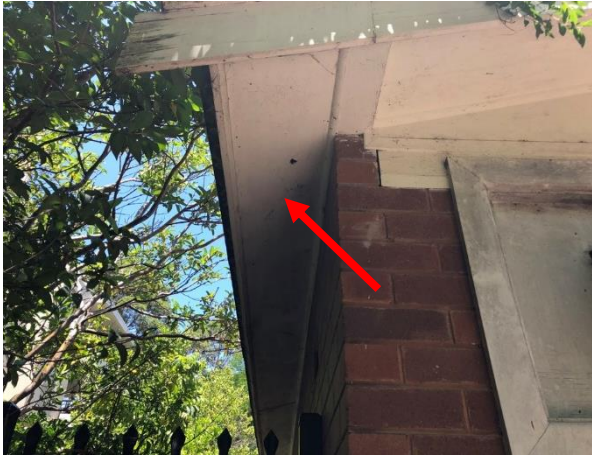
Photo 55: Building AA, asbestos containing fibre cement sheeting to eaves

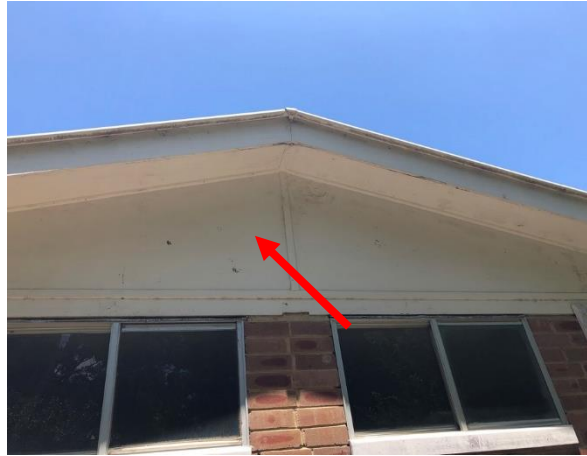
Photo 56: Building AA, asbestos containing fibre cement sheeting to gable panels

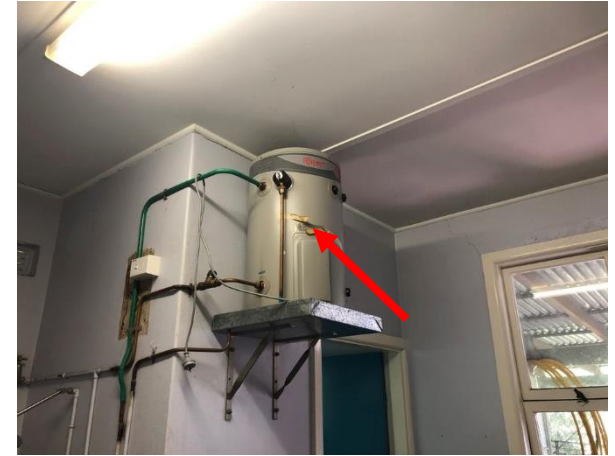
Photo 57: Building AA, suspected SMF insulation core to hot water system in Room R0007

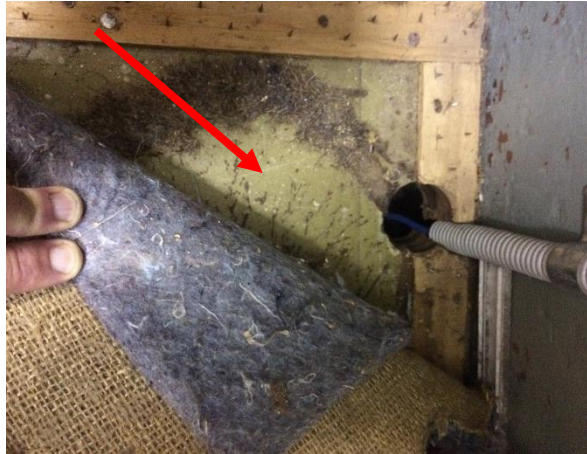
Photo 2: Building A, asbestos containing beige vinyl floor tiles to Room R0010

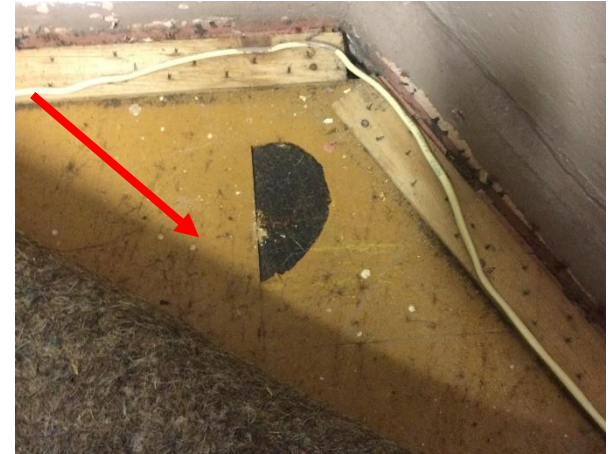
Photo 3: Building A, asbestos containing mustard vinyl floor tiles to Room R0031

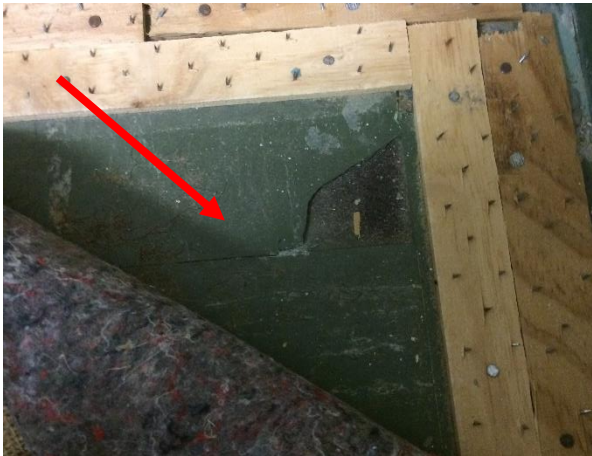
Photo 4: Building A, asbestos containing green vinyl floor tiles to Room R1003

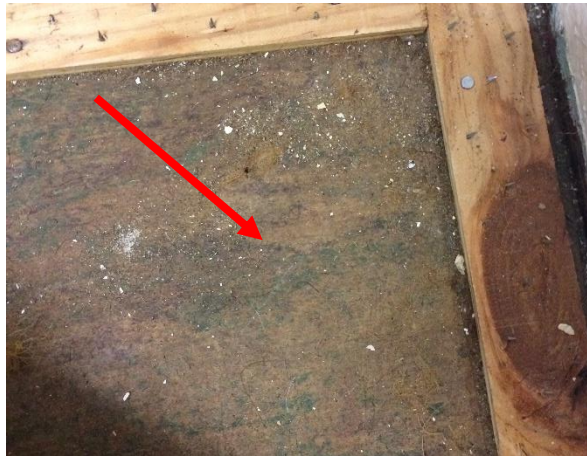
Photo 5: Building A, asbestos containing brown vinyl floor tiles to Room R1007

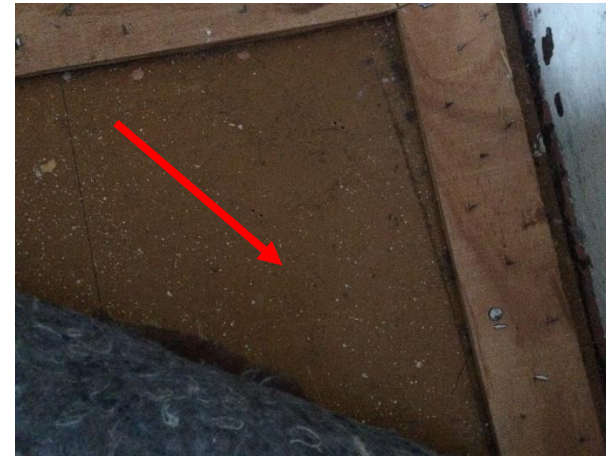
Photo 6: Building A, asbestos containing orange vinyl floor tiles to Room R1012

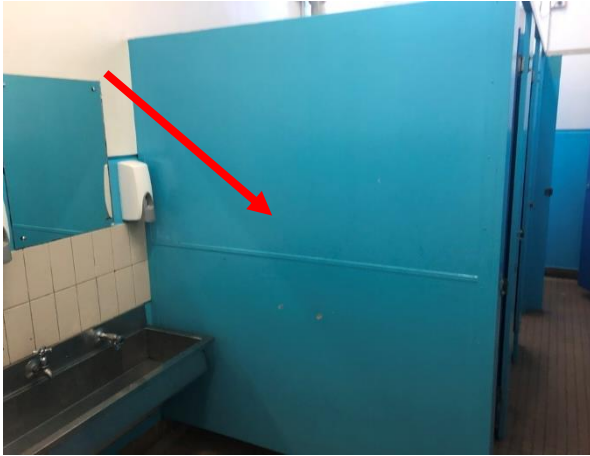
Photo 7: Building A, asbestos containing fibre cement cubicle partitions to Room R0023

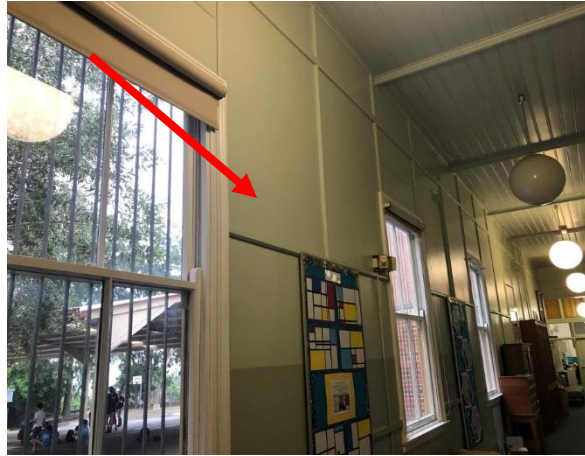
Photo 8: Building A, asbestos containing fibre cement sheeting to western wall of Room R0031

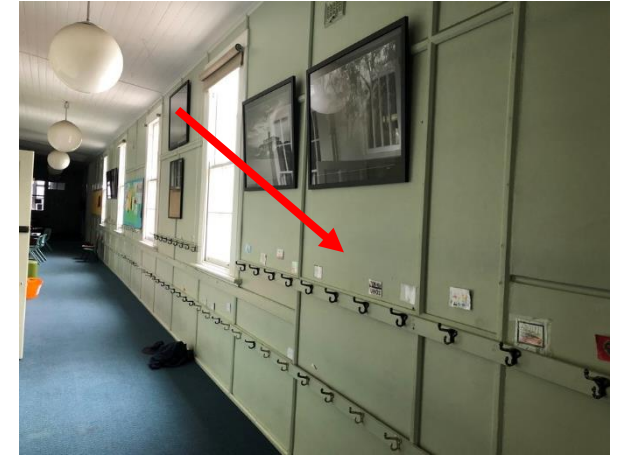
Photo 9: Building A, asbestos containing fibre cement sheeting to western wall of Room R1018

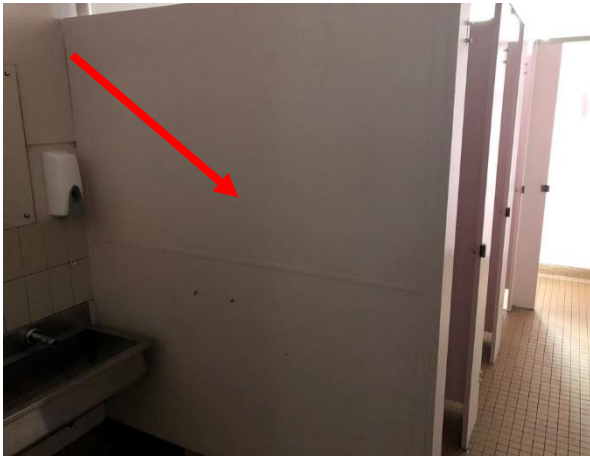
Photo 10: Building A, asbestos containing fibre cement cubicle partitions to Room R1005

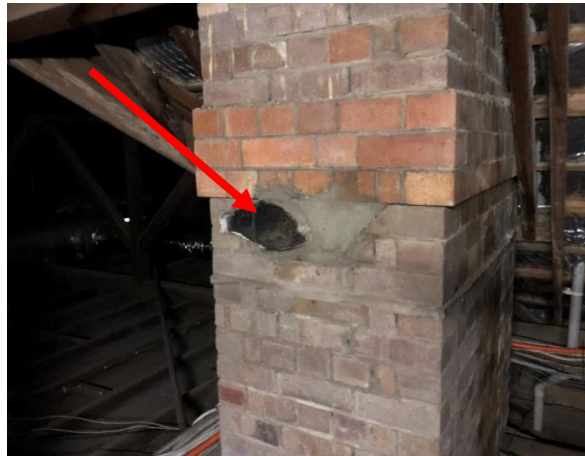
Photo 11: Building A, asbestos containing fibre cement chimney flue pipe in roof void

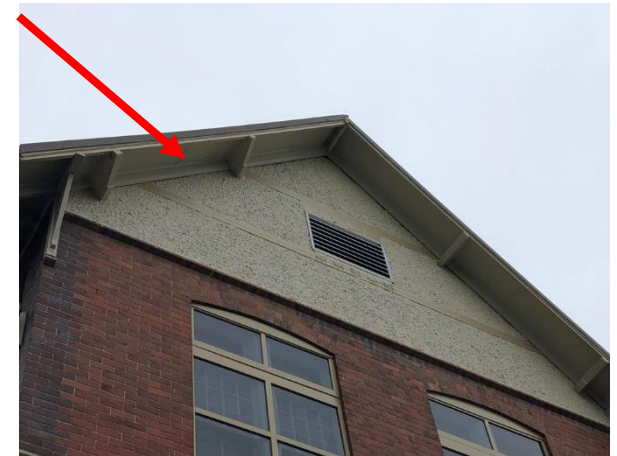
Photo 12: Building A, suspected asbestos containing fibre cement eaves

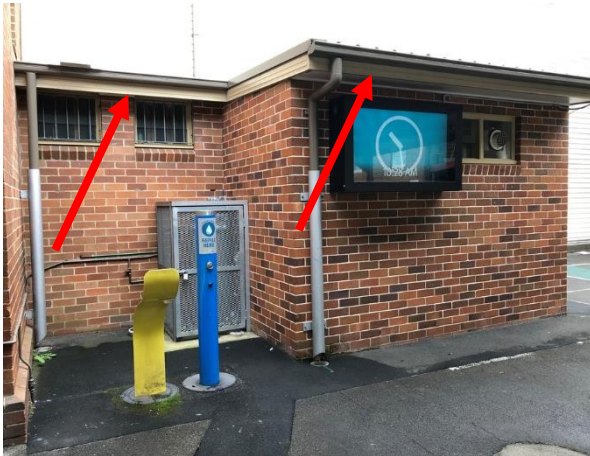
Photo 13: Building A, asbestos containing fibre cement eaves to R0022 and R0044

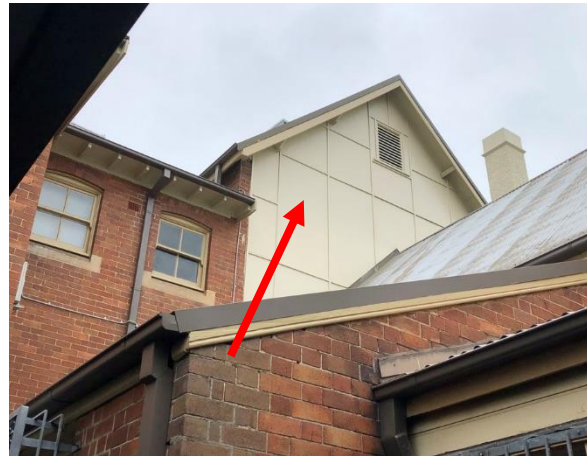
Photo 14: Building A, asbestos containing fibre cement sheeting to south gable

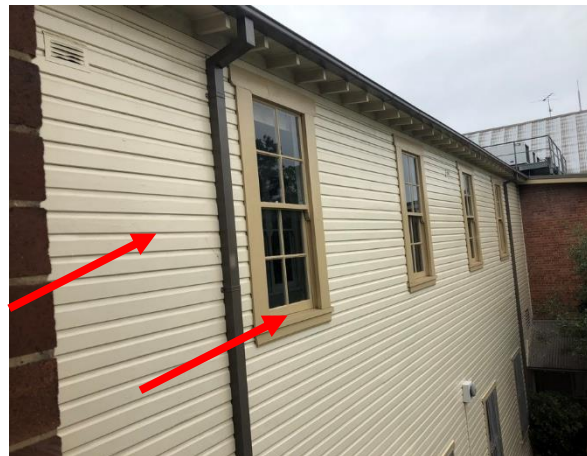
Photo 17: Building A, lead based cream paint to timber cladding and lead based tan paint to windows

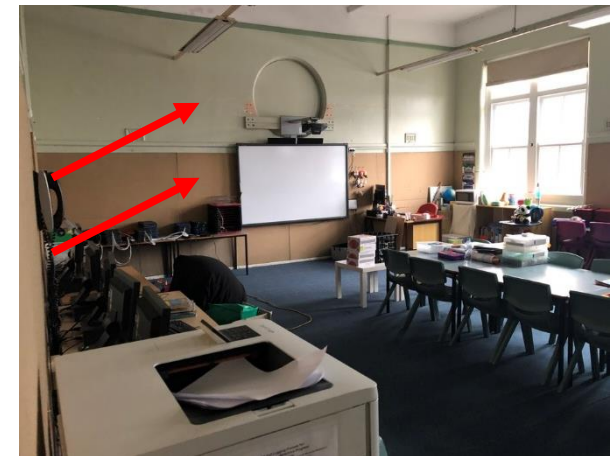
Photo 18: Building A, lead based green/orange paint to walls of Room R1012

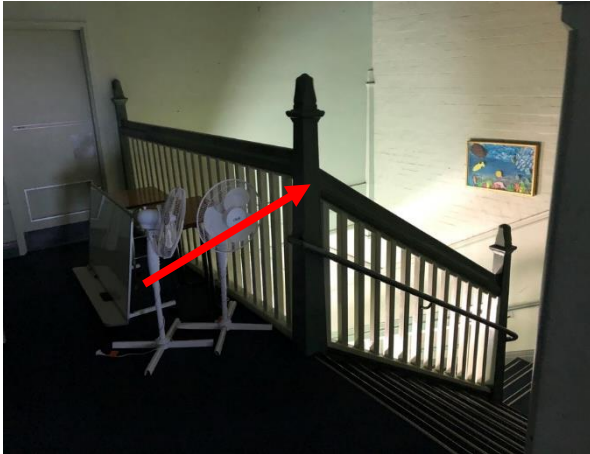
Photo 19: Building A, lead based green paint to stair handrail in Room R1020

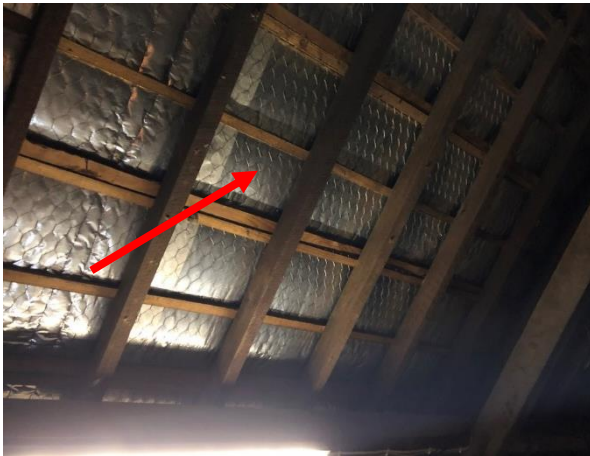
Photo 22: Building A, suspected SMF insulation to roof sarking

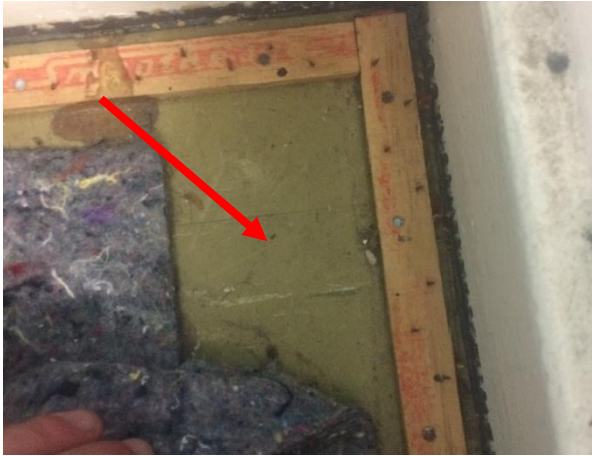
Photo 25: Building B, asbestos containing olive vinyl floor tiles to Room R1007

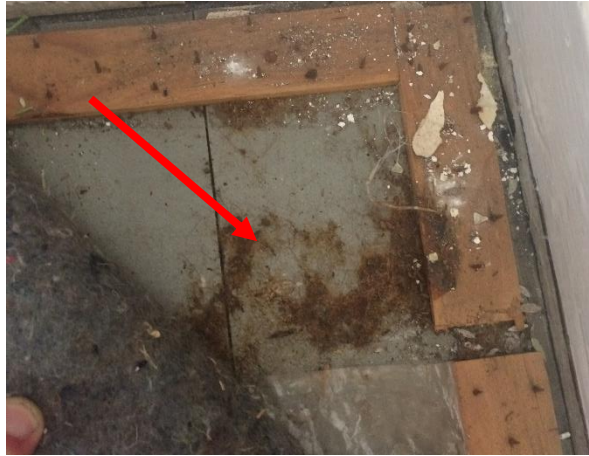
Photo 26: Building B, asbestos containing grey vinyl floor tiles to Room R1015

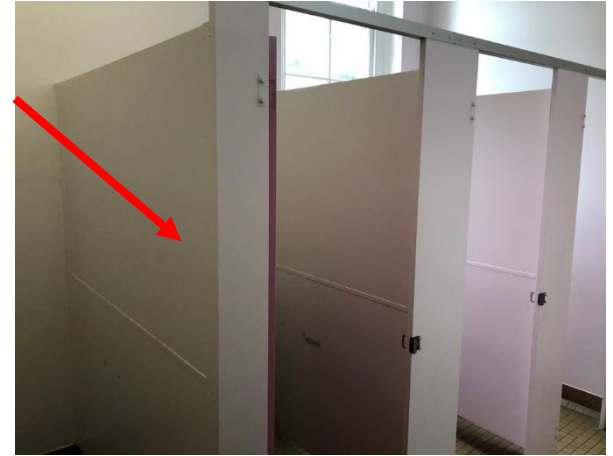
Photo 27: Building B, asbestos containing fibre cement cubicle partitions to Room R0004

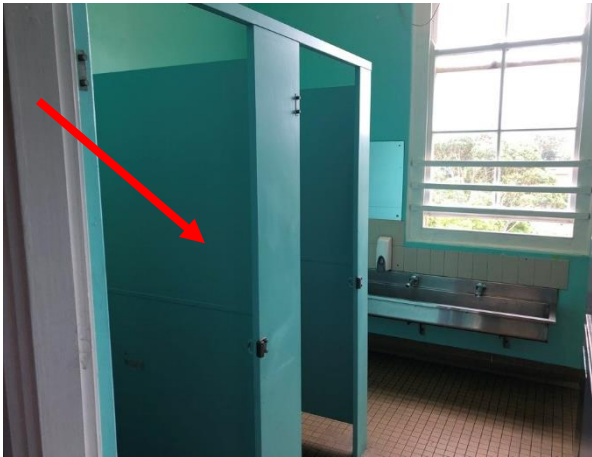
Photo 28: Building B, asbestos containing fibre cement cubicle partitions to Room R1003

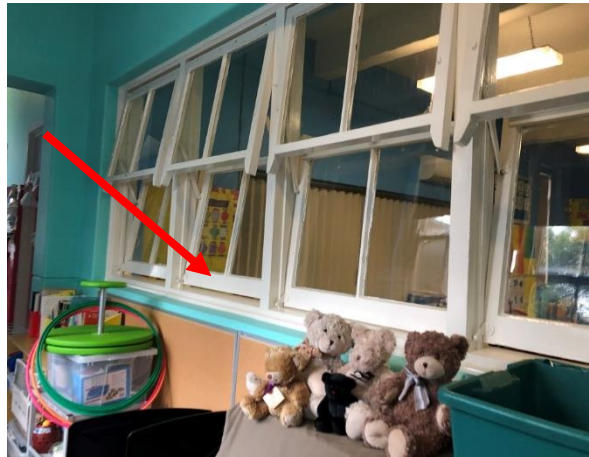
Photo 29: Building B, lead based white paint to windows in Room R0008

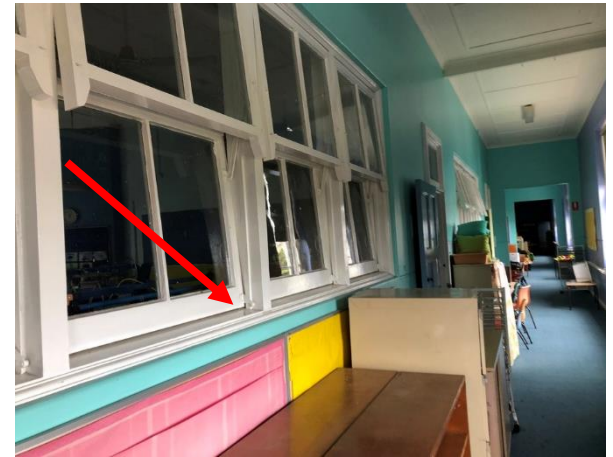
Photo 30: Building B, lead based white paint to windows in Room R1005

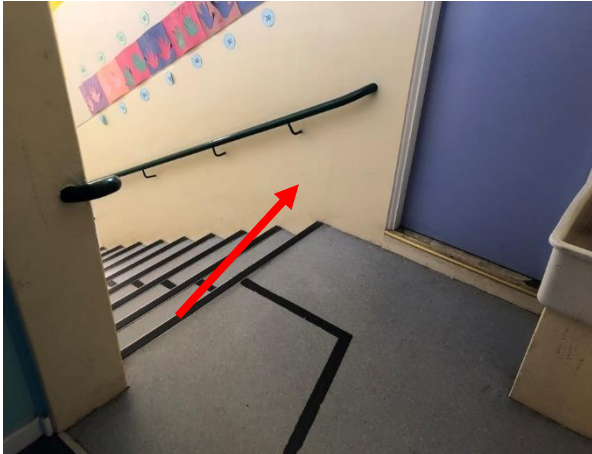
Photo 31: Building B, lead based beige paint to walls of Room R1017

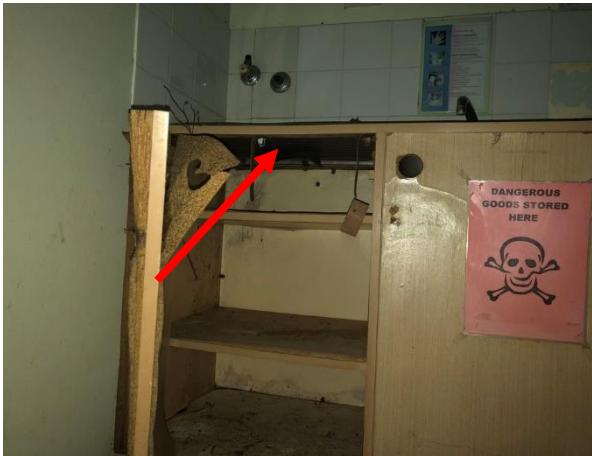
Photo 34: Building C, asbestos containing bituminous pad under sink in Room R0004

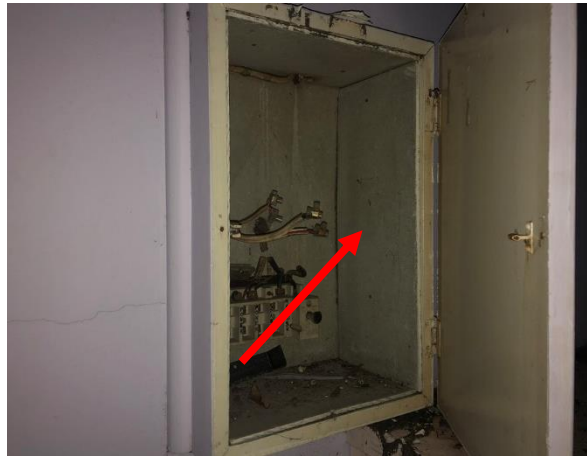
Photo 35: Building C, asbestos containing fibre cement sheeting to electrical panel in Room R0011

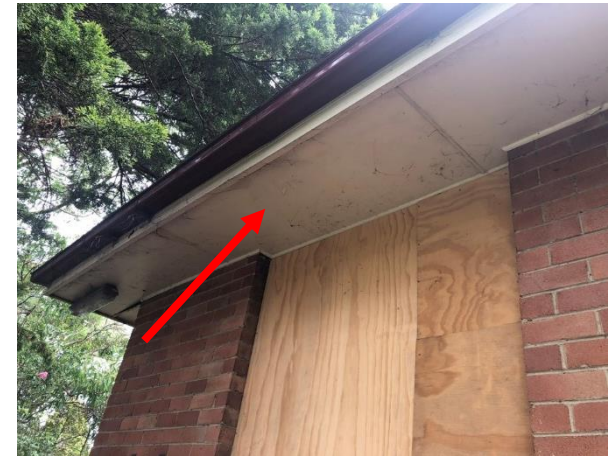
Photo 36: Building C, asbestos containing fibre cement eaves

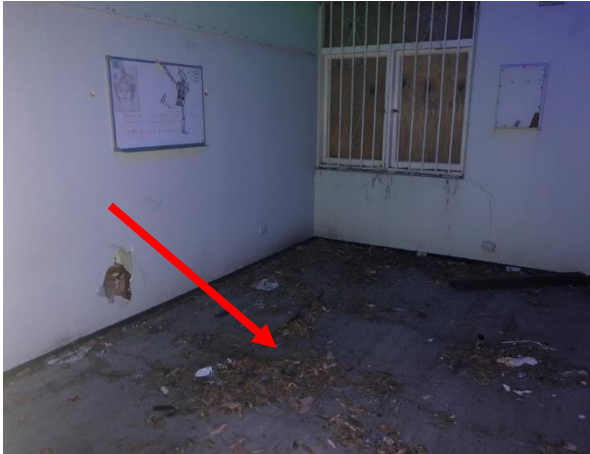
Photo 37: Building C, lead containing dust to Room R0015

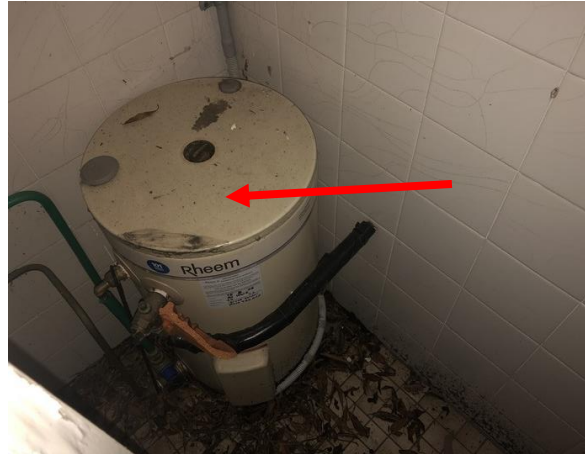
Photo 38: Building C, suspected SMF insulation core to hot water system in Room R0010

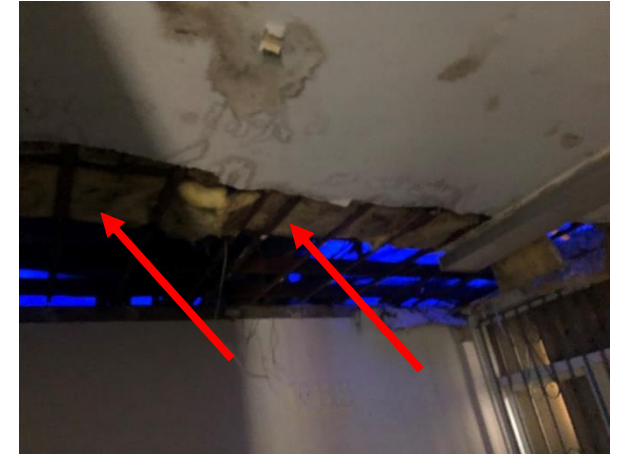
Photo 39: Building C, suspected SMF insulation throughout roof void

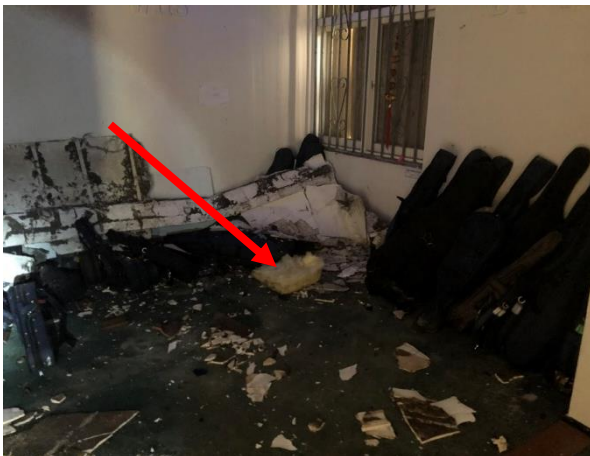
Photo 40: Building C, suspected SMF insulation debris throughout internal areas

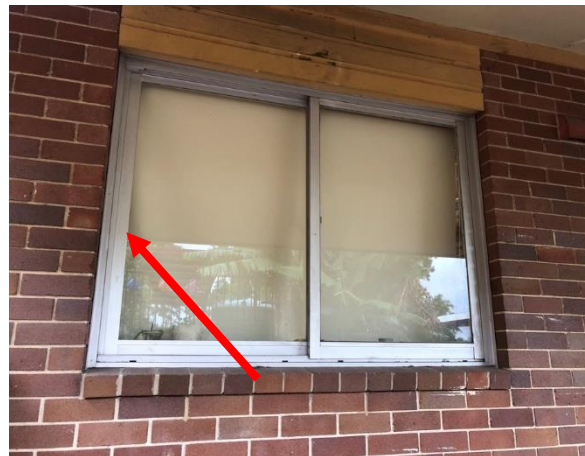
Photo 41: Building H, assumed asbestos containing putty to aluminium windows

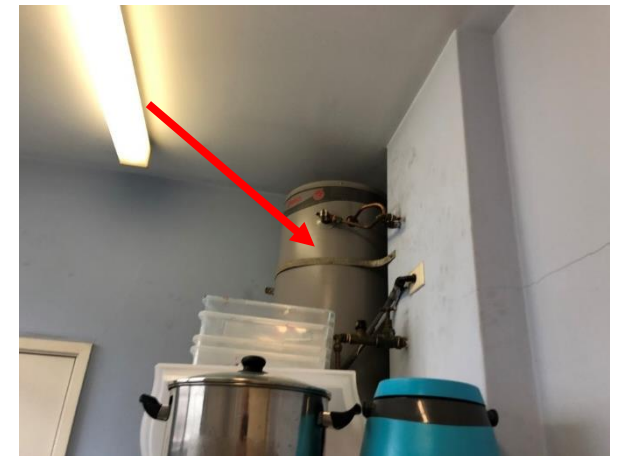
Photo 42: Building H, suspected SMF insulation core to hot water system in Room R0016
