# Arboricultural Impact Assessment

Revision 4

Western Sydney University, Milperra Campus  
NSW, 2214  
2/-/DP129184 + 1/-/DP101147  
Job No. 2400116  
19/03/2026

**Temporal Tree Management Pty Ltd.**

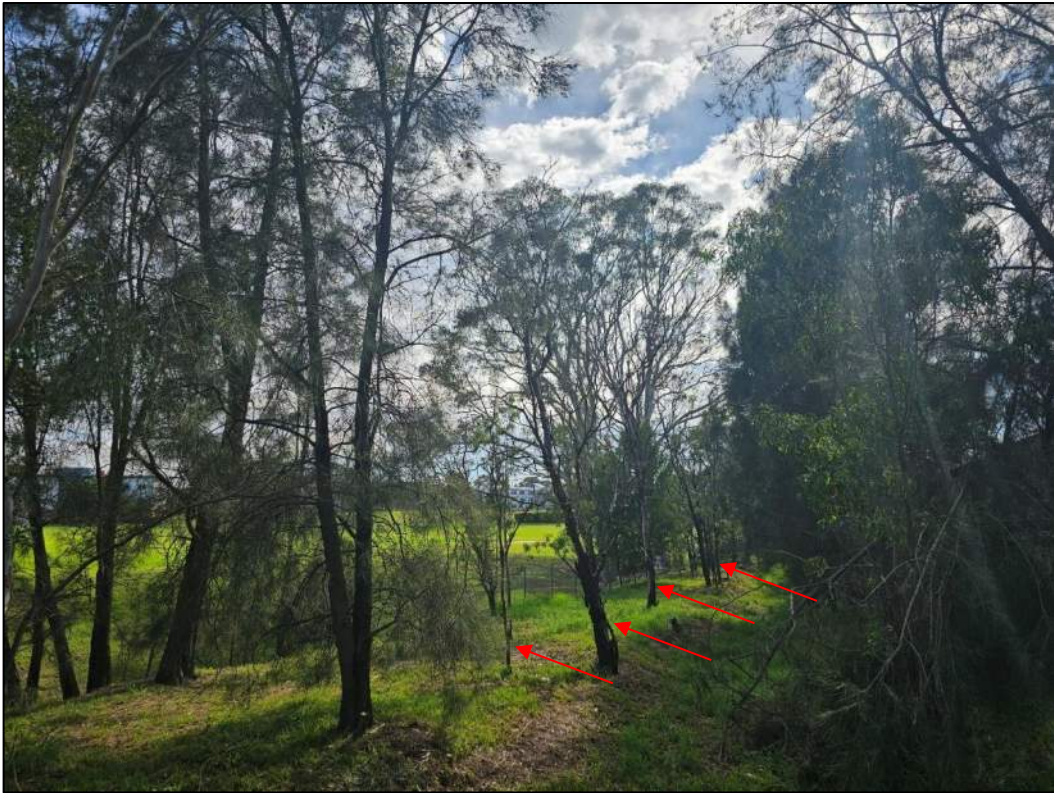
**Figure 3 Small and dead trees within the assessment area.**

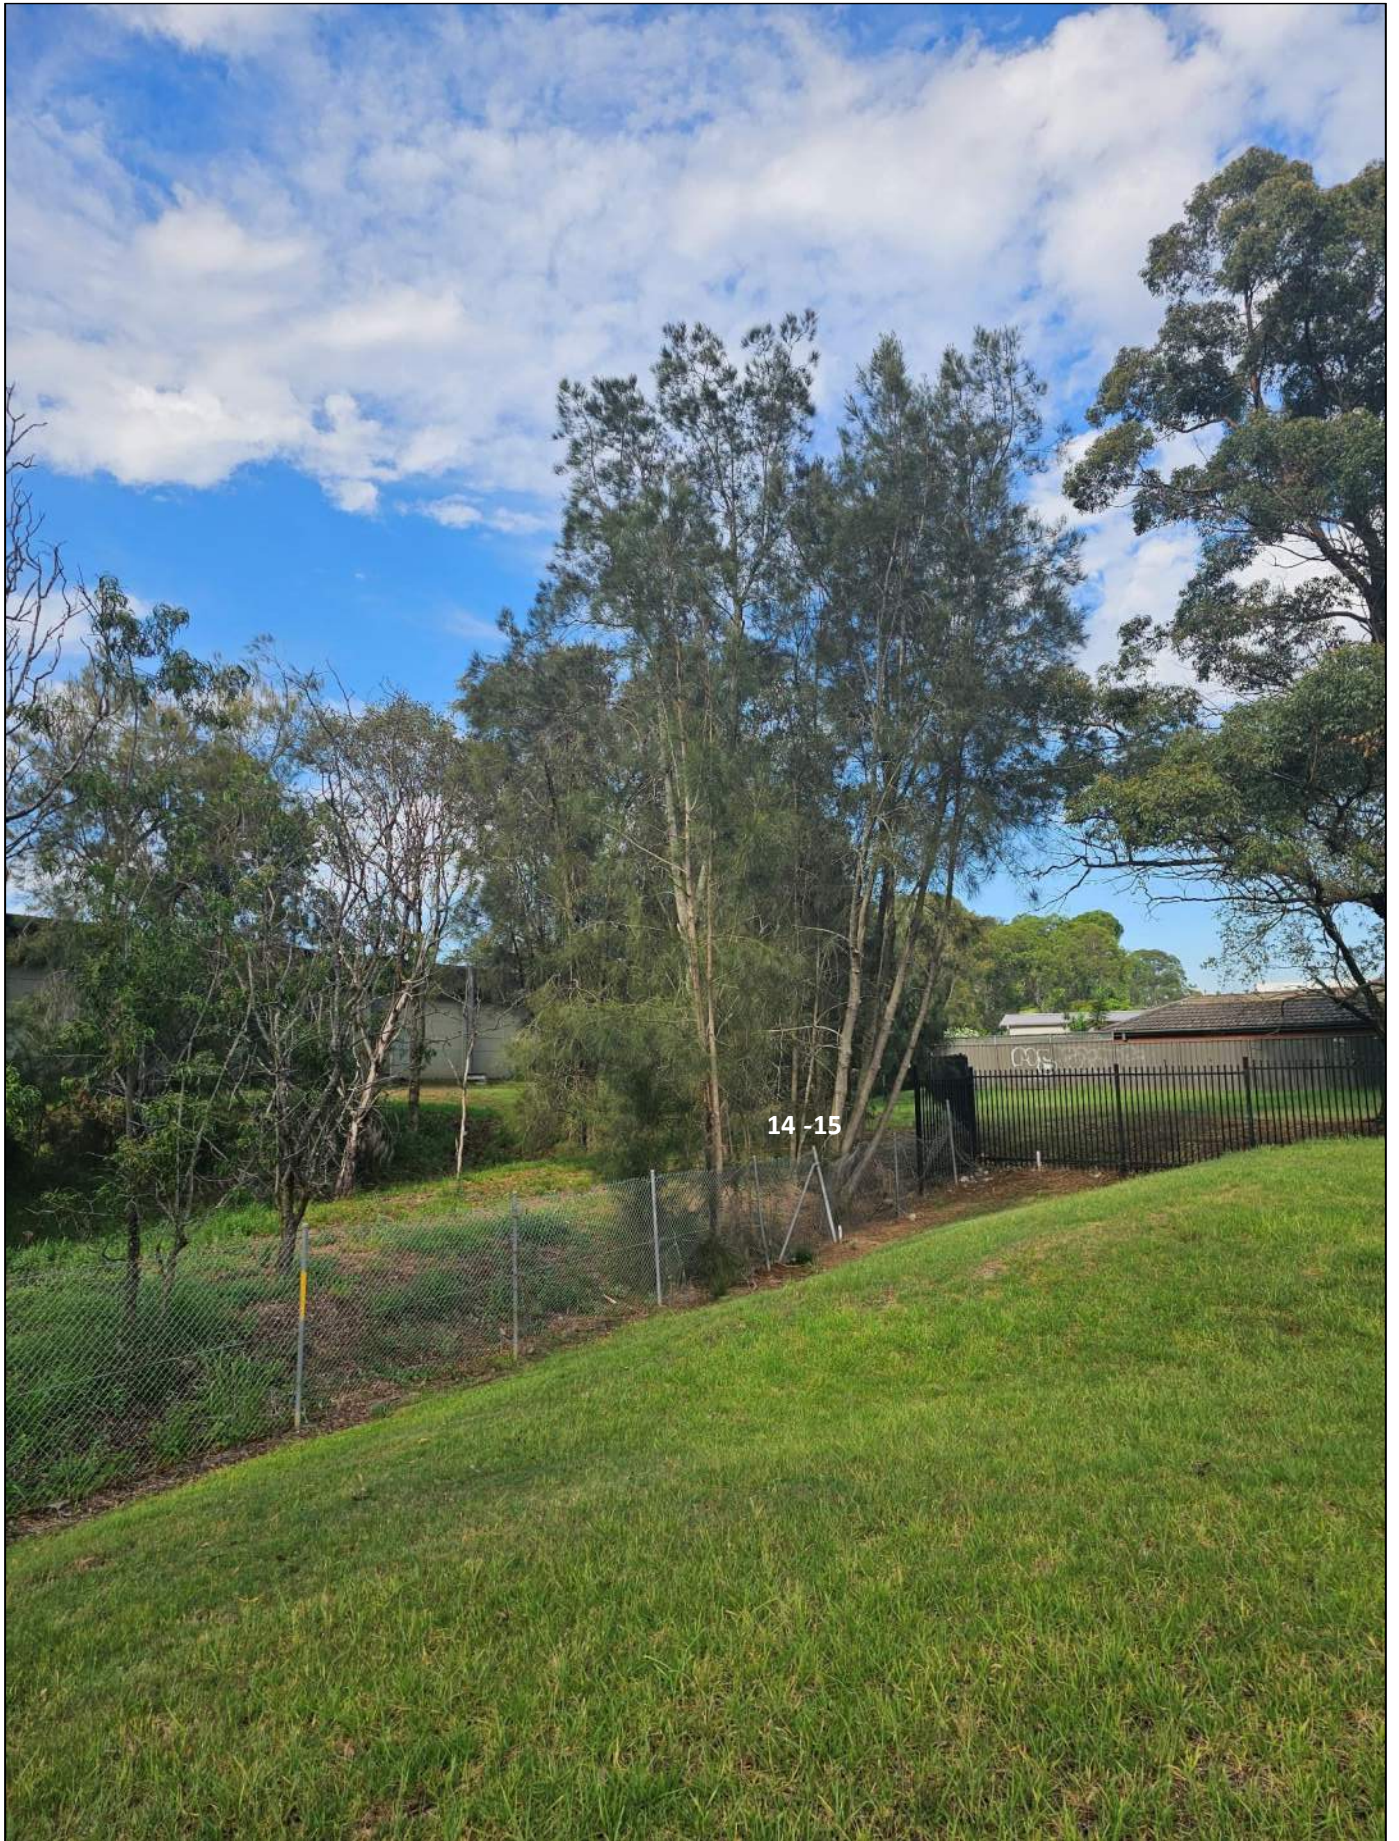
**Figure 5 Tree 14 -15 *Casuarina glauca***

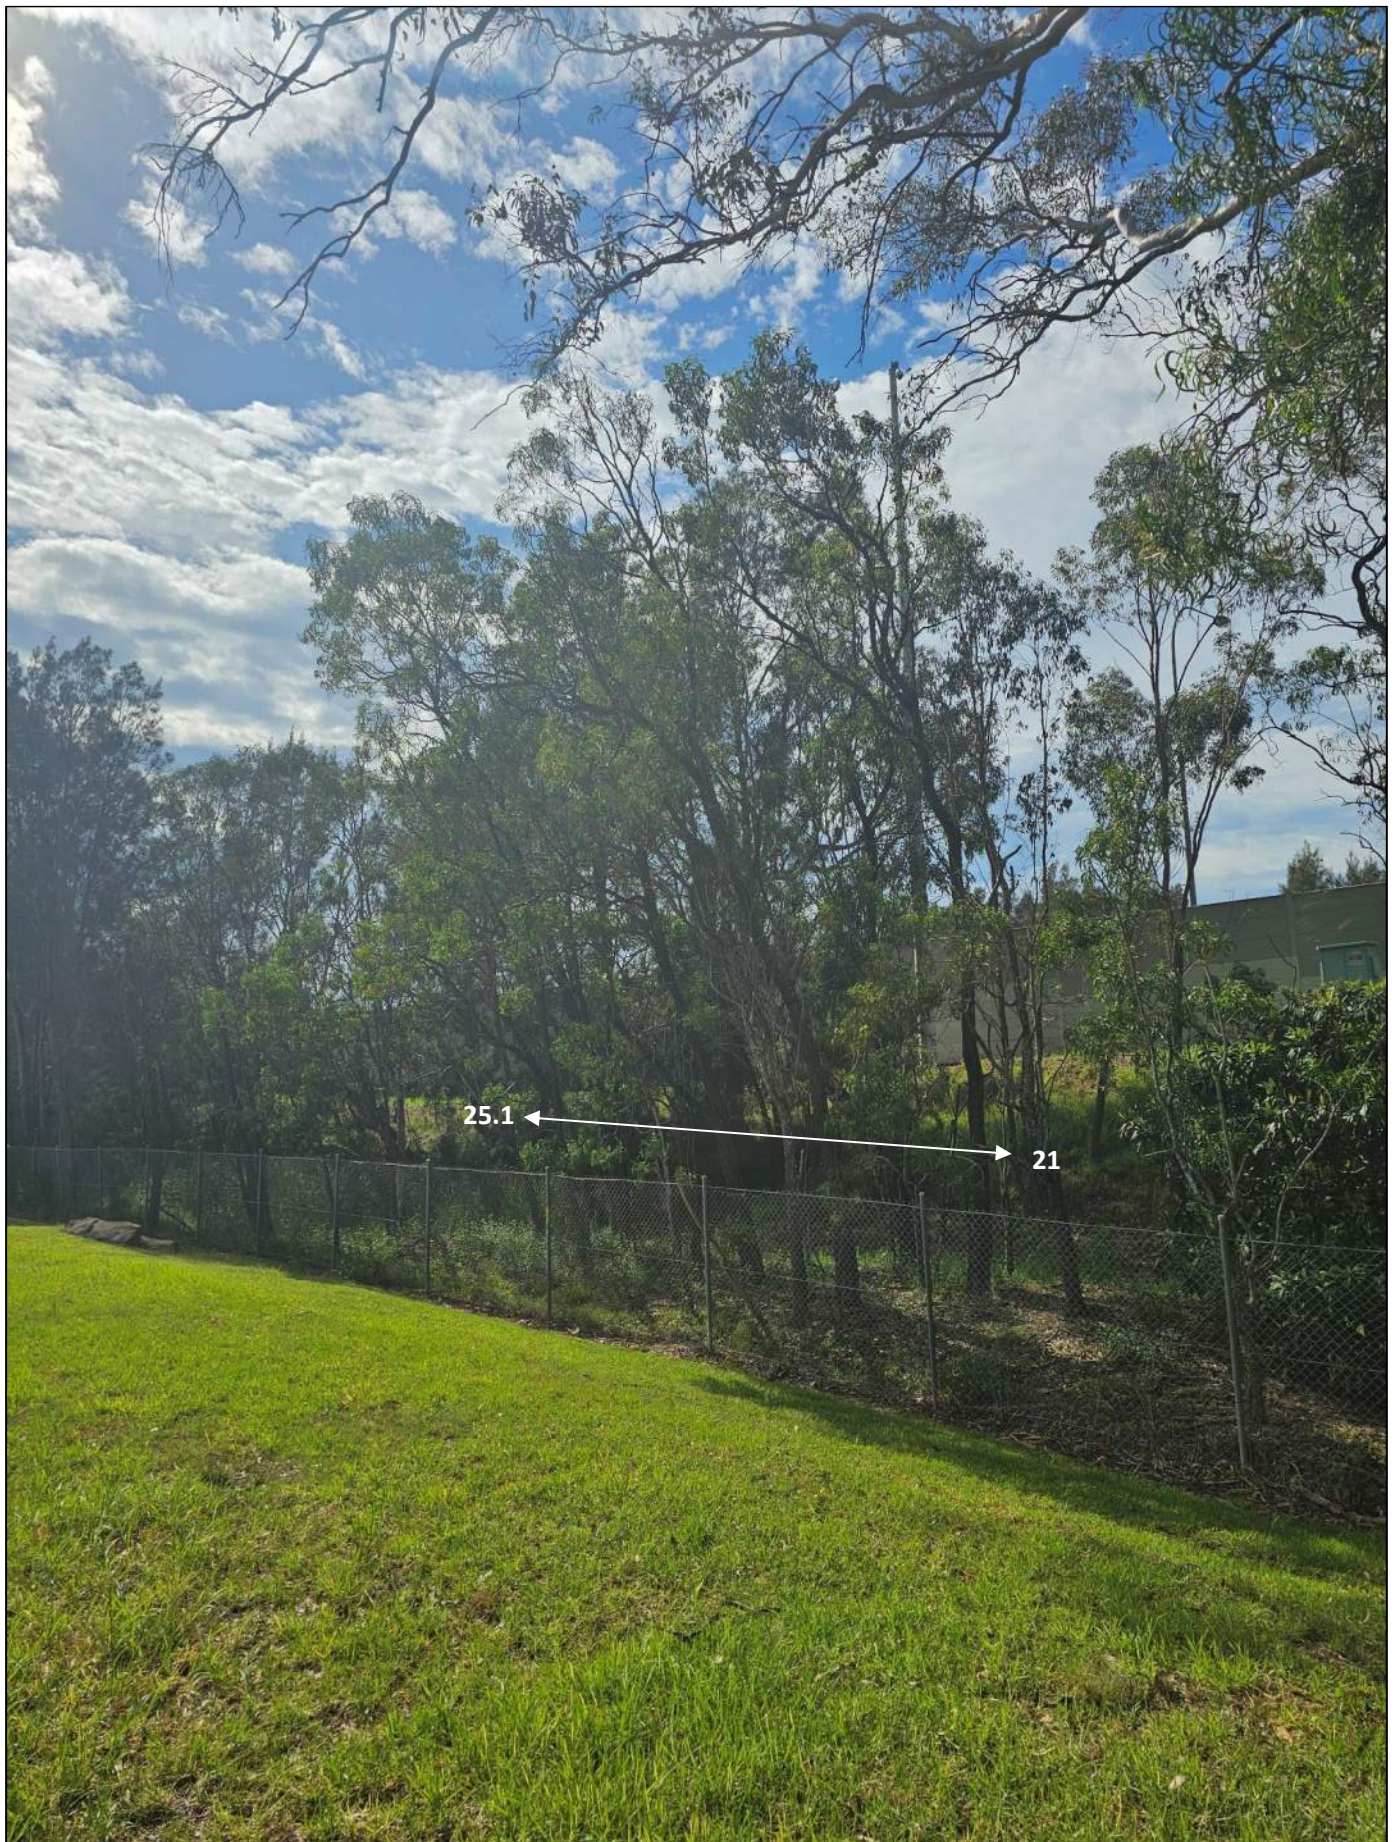
**Figure 7 21 – 25.1 *Acacia implexa***

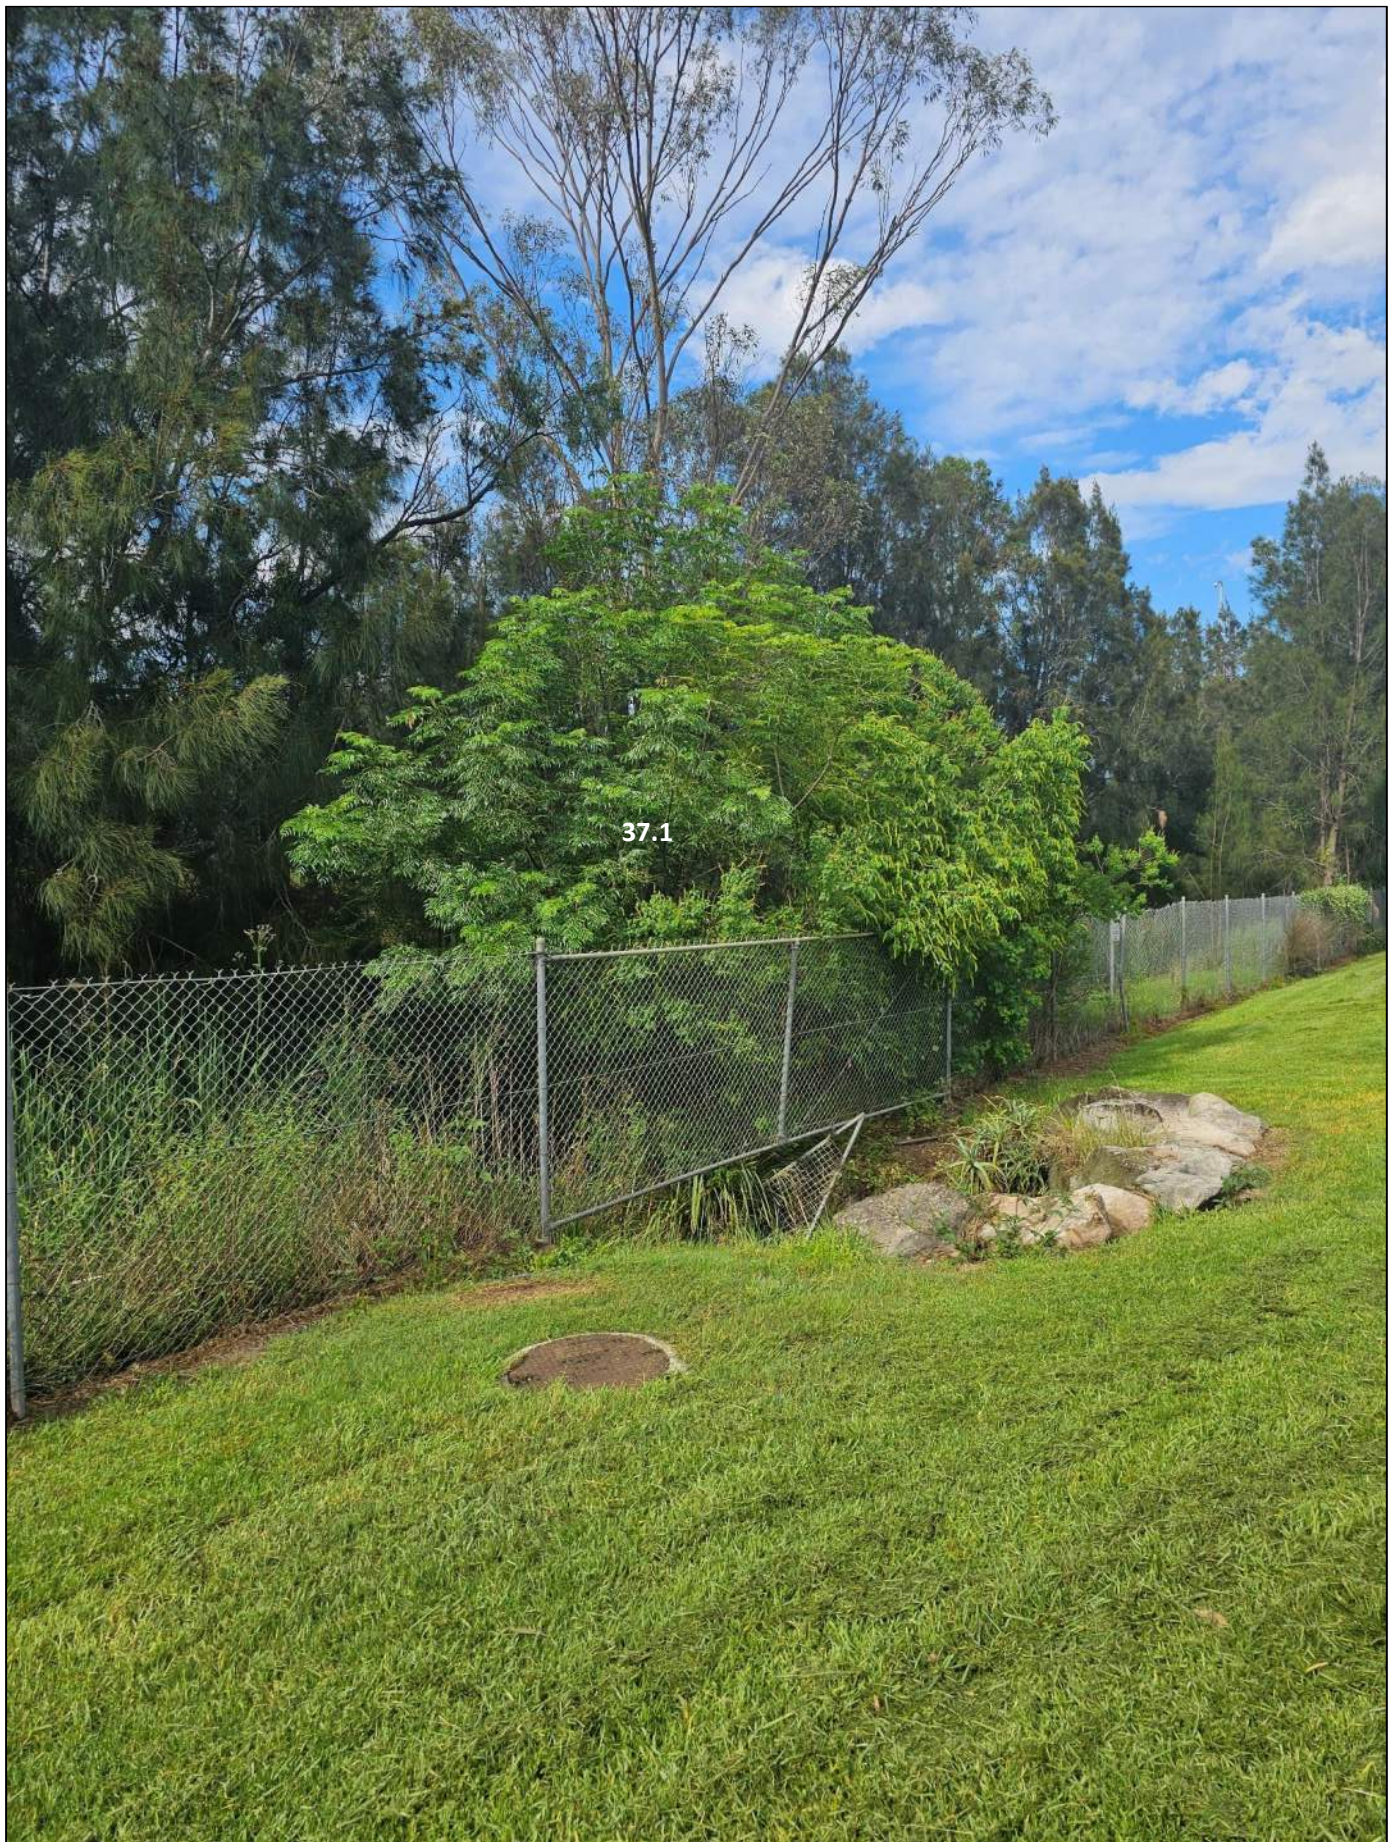
**Figure 9 Tree 37.1 *Melia azederach***

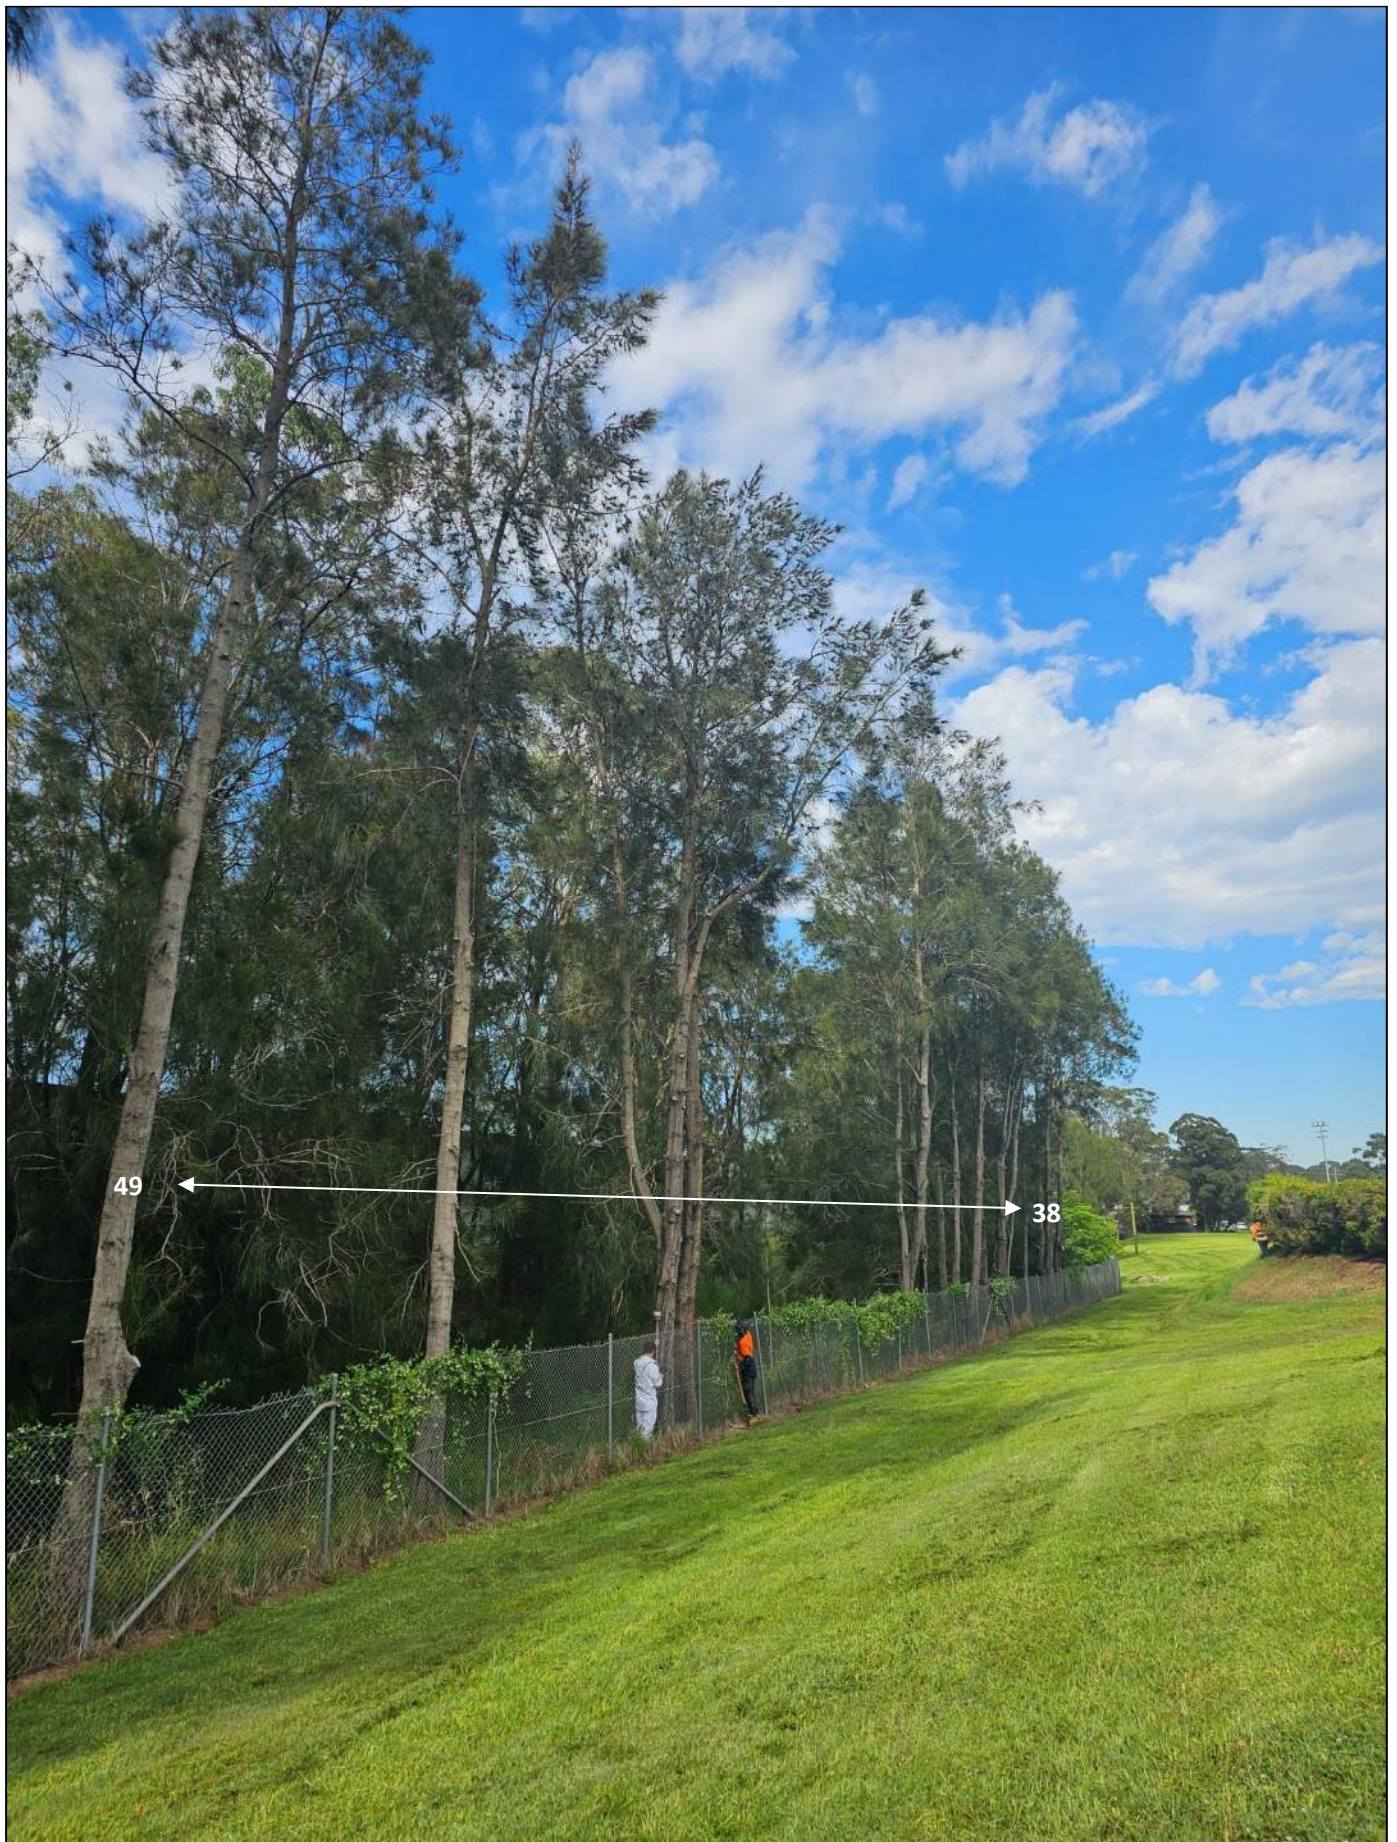
**Figure 10 Trees 38-49 *Casuarina glauca***

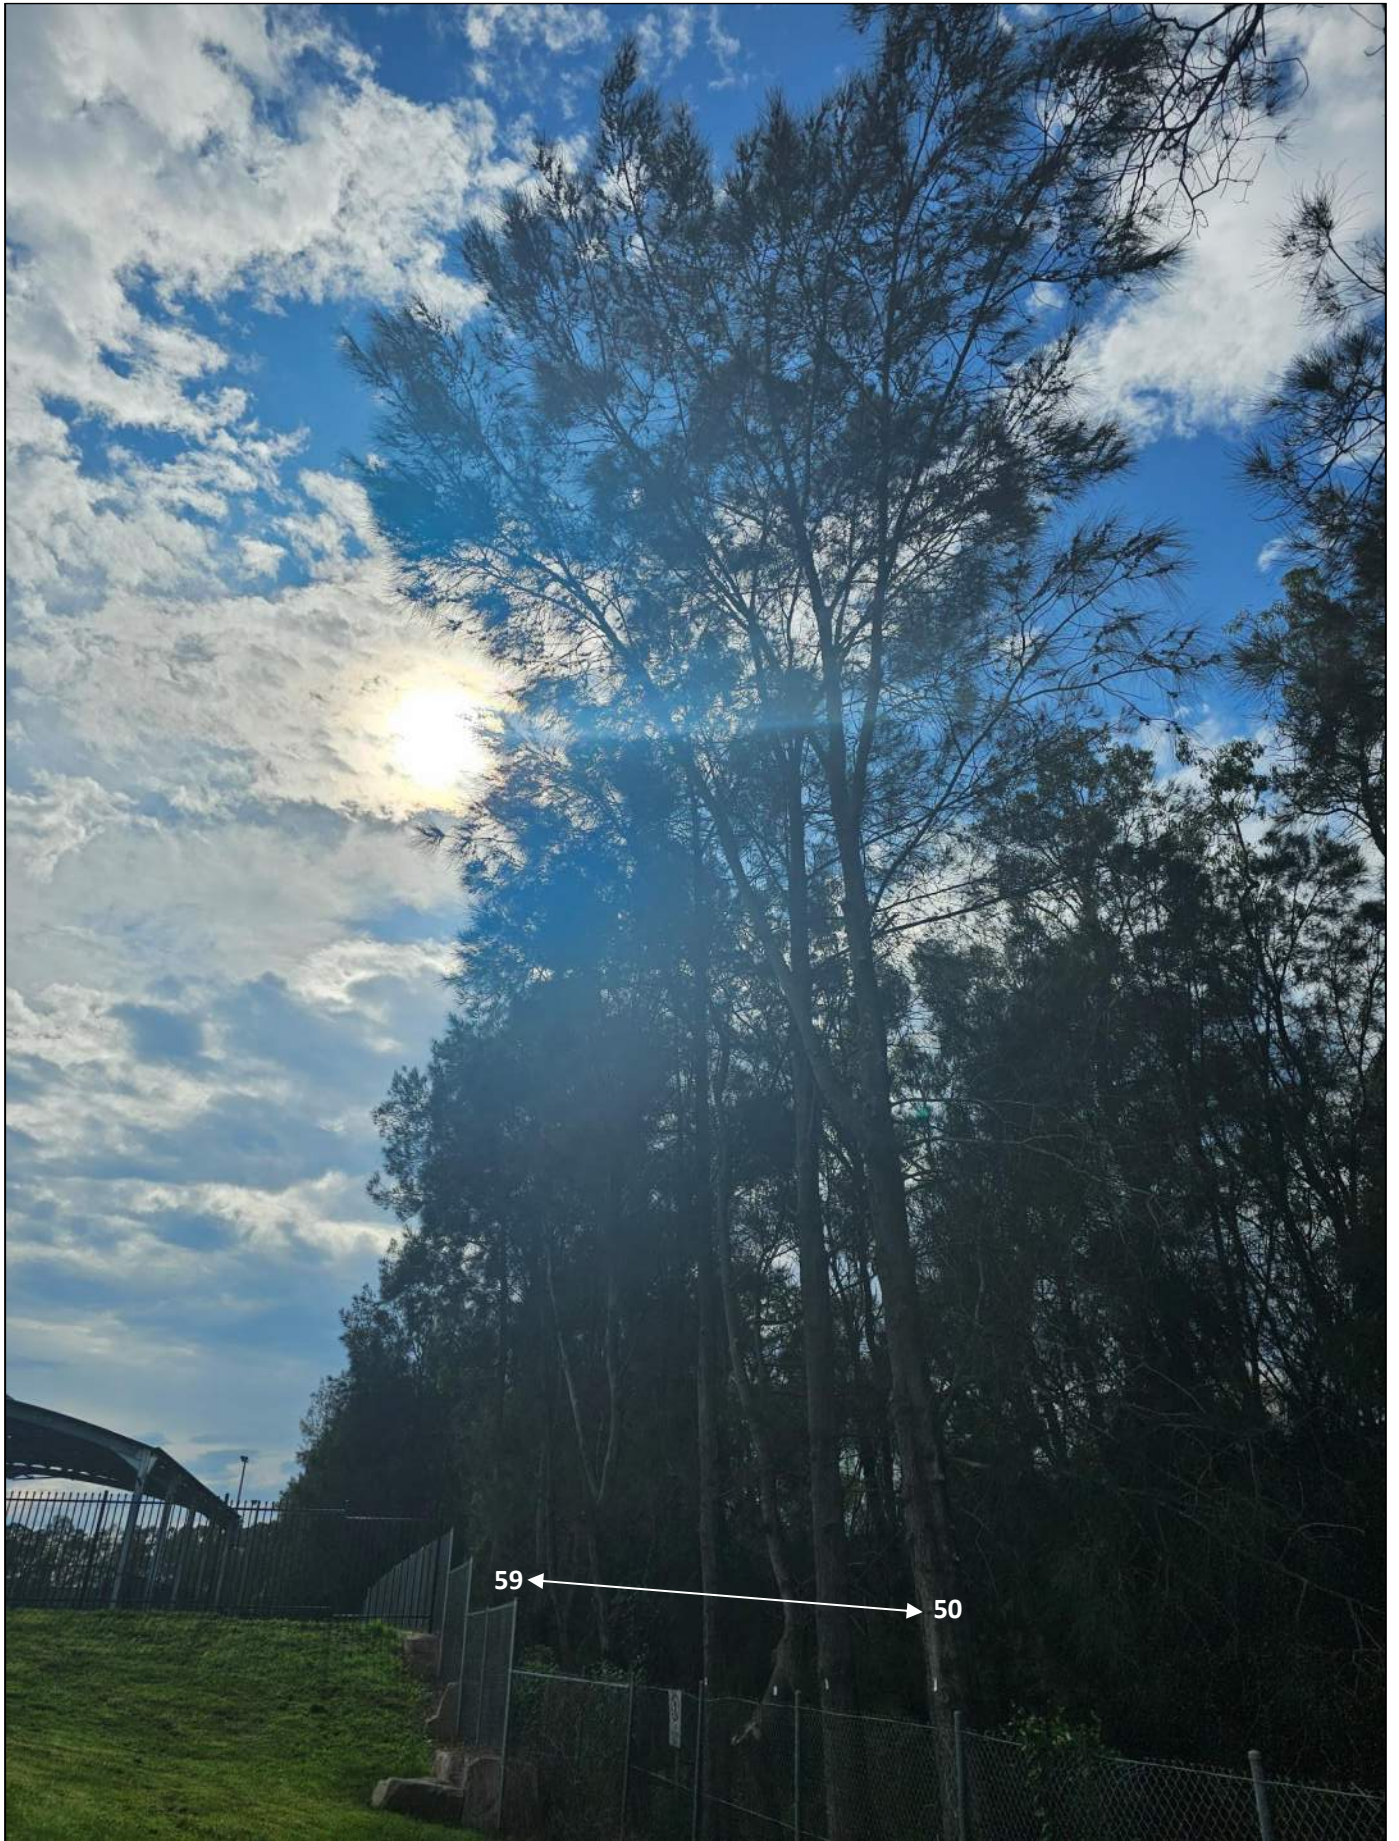
**Figure 11 Trees 50-59 *Casuarina glauca***

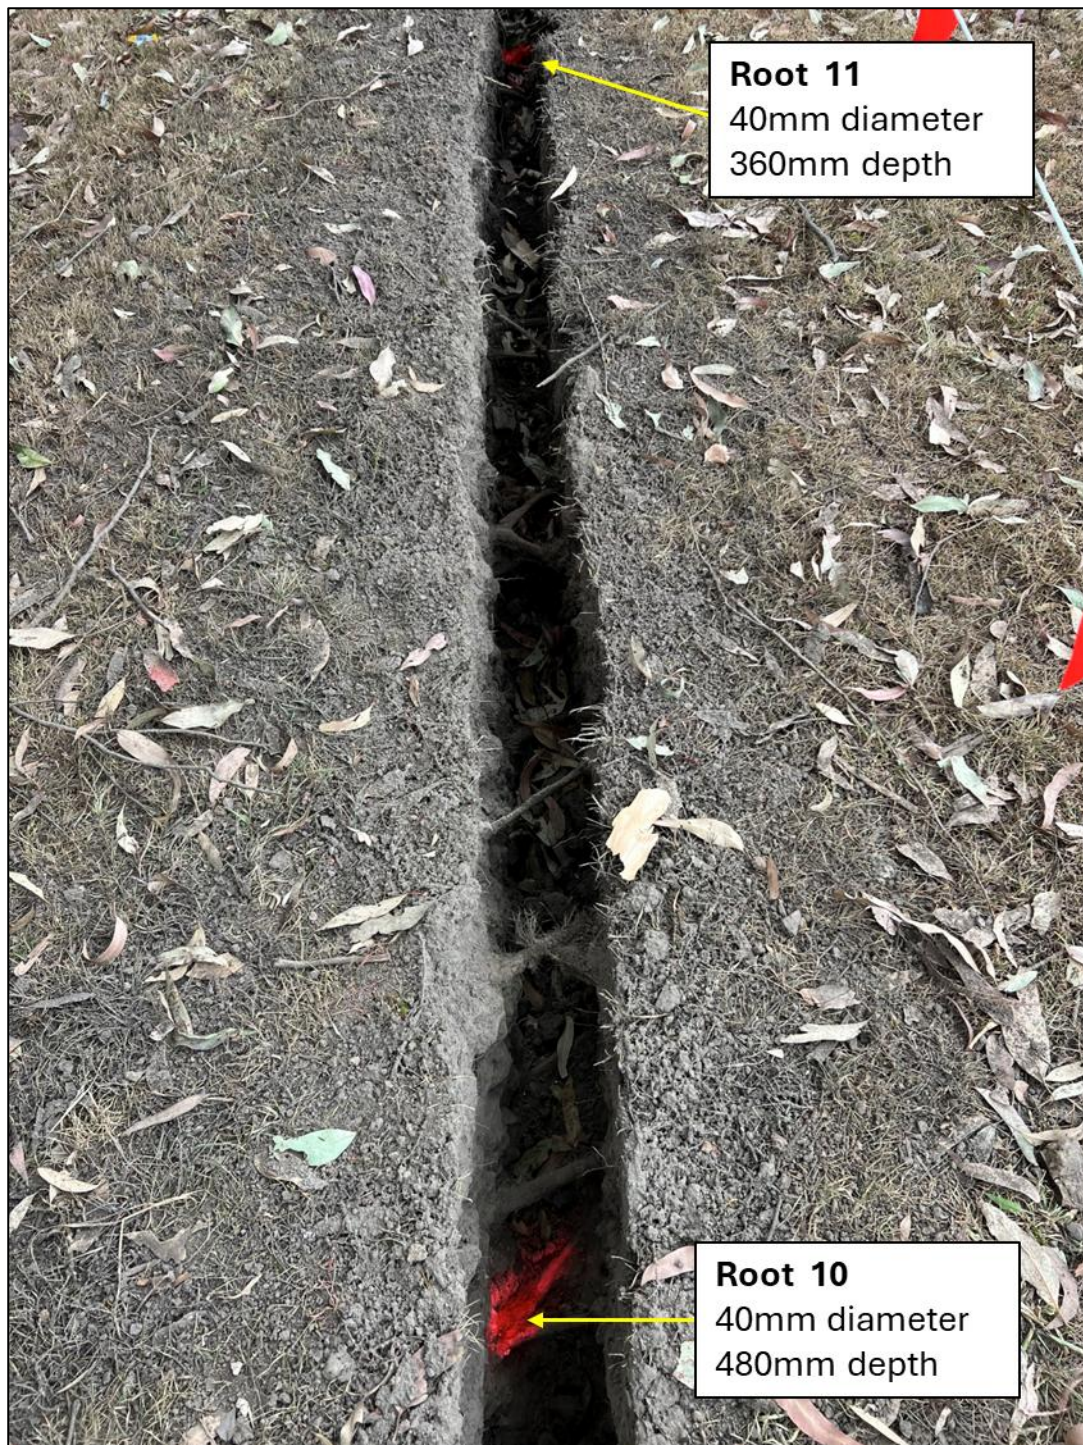
Figure 11. Eastern edge of Survey Trench 2.

Figure 12. Eastern portion of Survey Trench 2.

Figure 13. Central portion of Survey Trench 2.

Figure 14. Central portion of Survey Trench 2.

Figure 15. Western portion of Survey Trench 2.

Figure 16. Western edge of Survey Trench 2.

- **Survey Trench 2** – The proposed stormwater line within the eastern boundary is suitable for installation within the proposed location without amendment. Due to their smaller size (max. diameter of 55mm), eleven major roots with diameters of less than 60mm and forty-nine minor roots growing from Trees 43, 44, 46, 48 and 50 are suitable for pruning to facilitate the installation of this stormwater line (Table 2) (Figure 11-Figure 16).

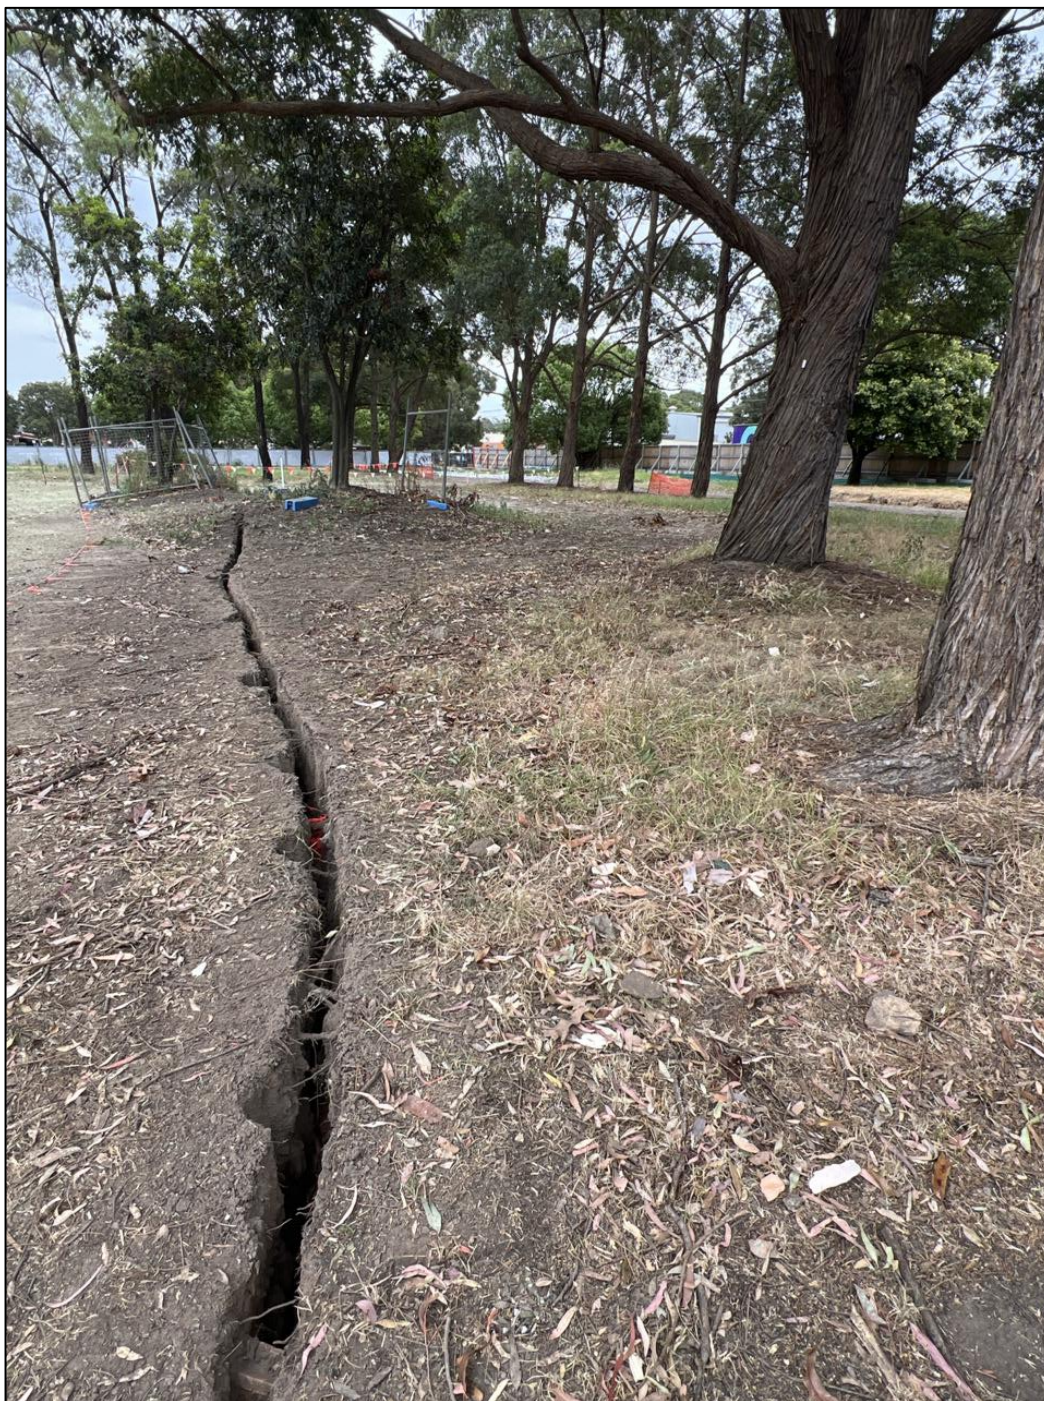
Figure 17. Survey Trench 3 with three Major roots encountered. Image taken from eastern edge of trench.

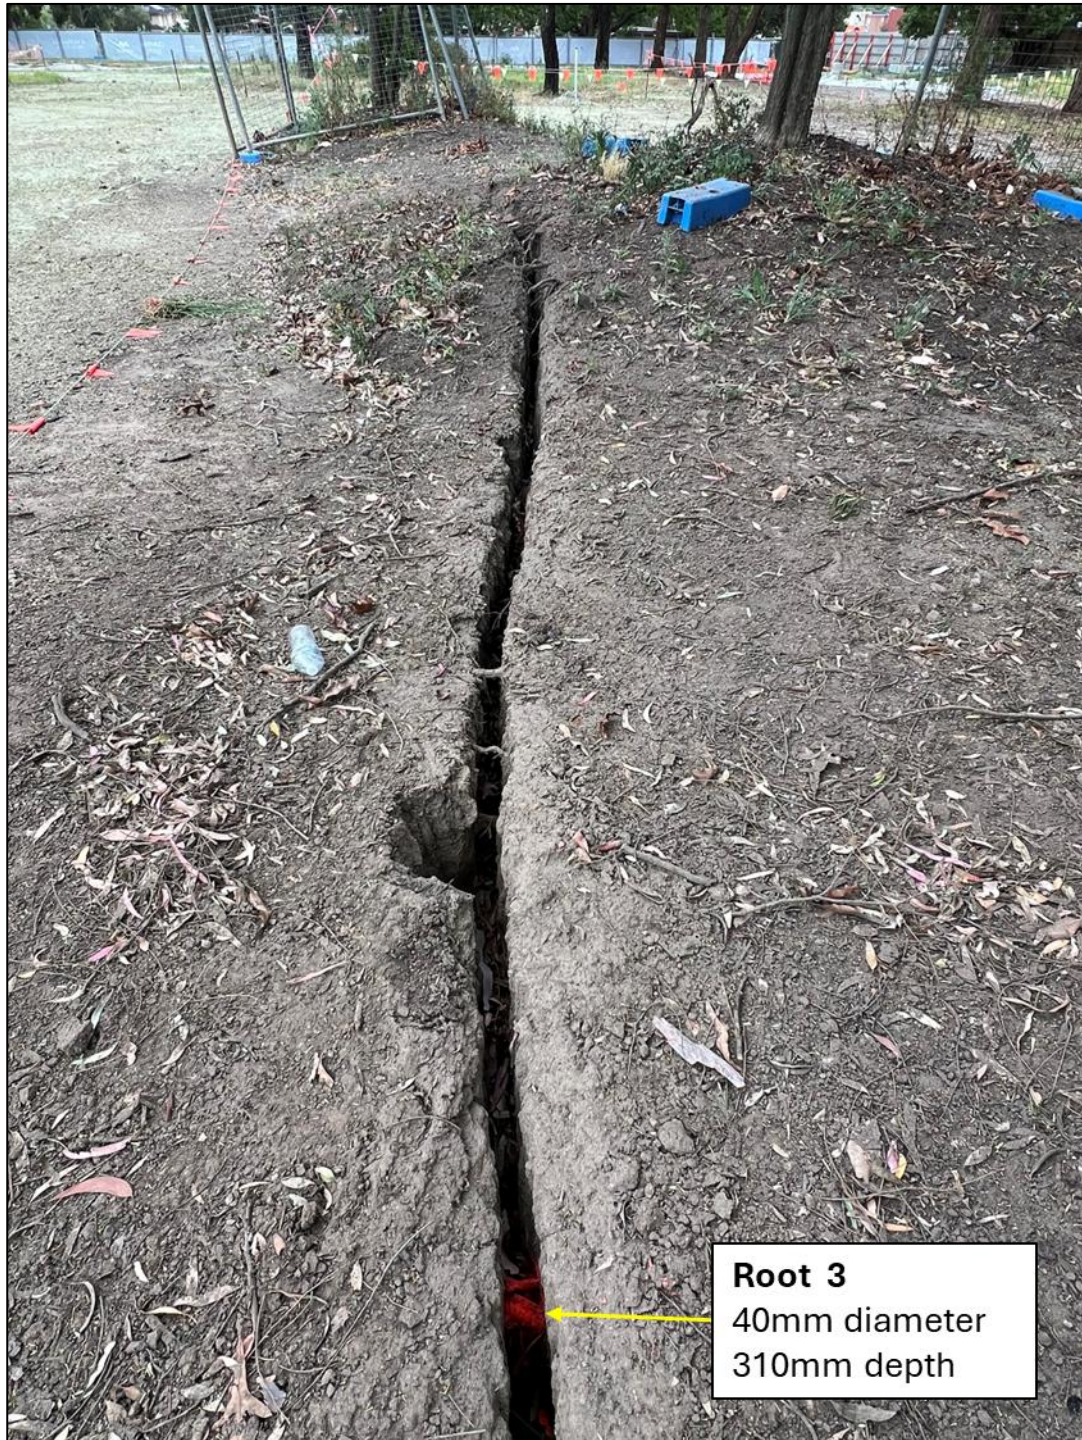
Figure 21. Western edge of Survey Trench 3.

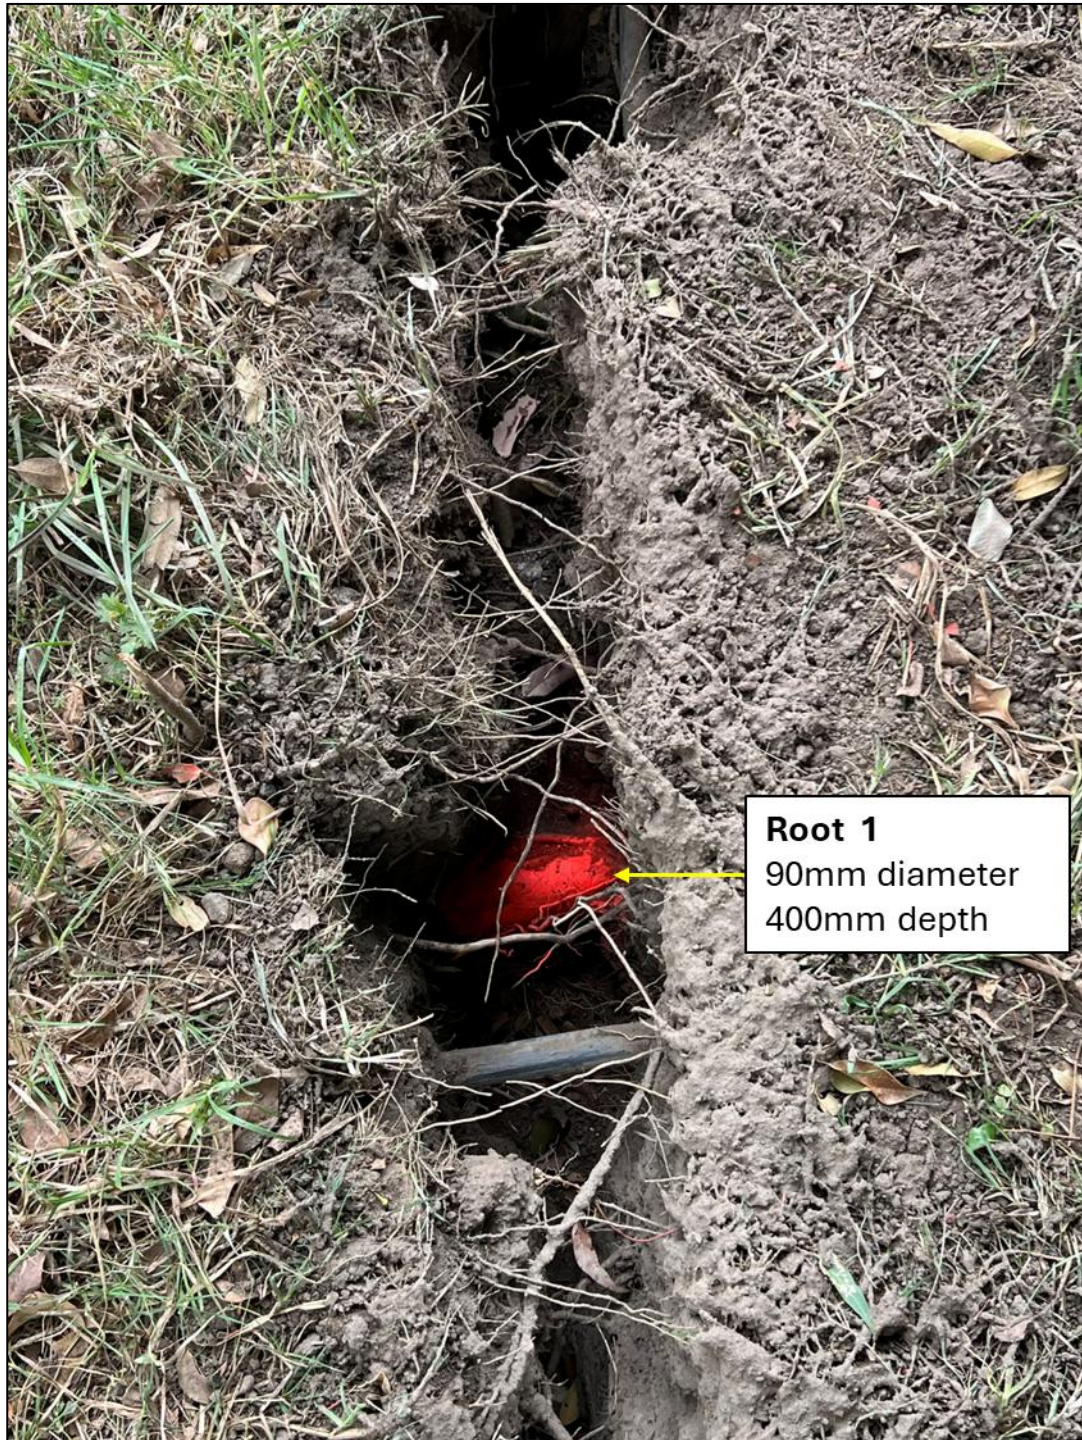
Figure 24. Root 1 in Survey Trench 5.

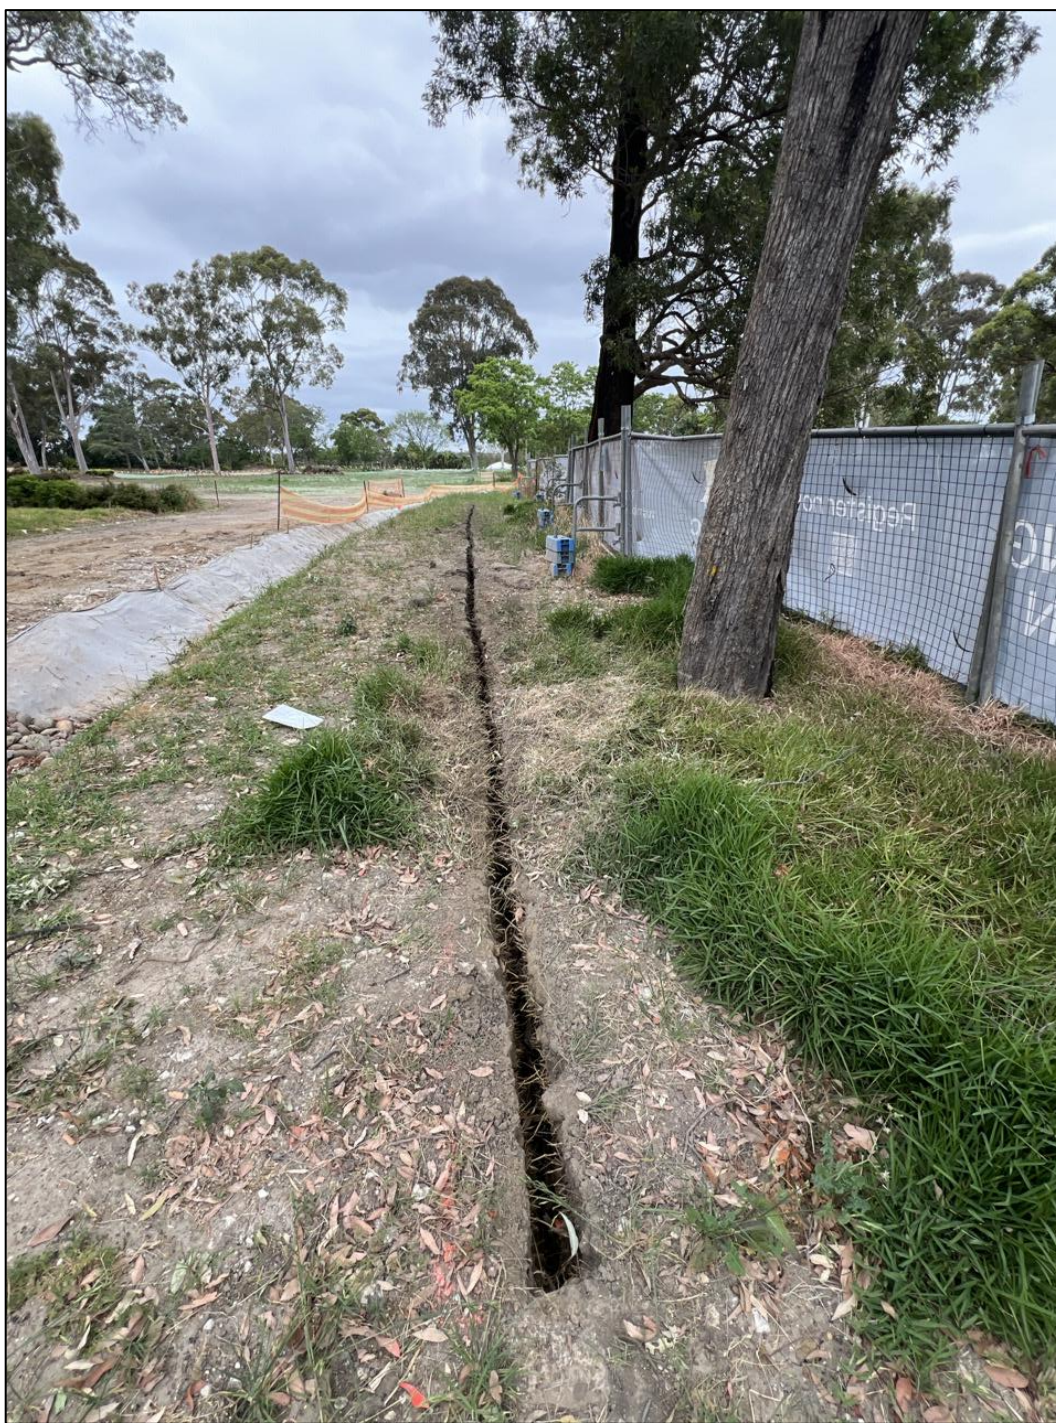
Trench excavated to a depth of 600 mm along nearest edge of proposed footpath that is within the NRZs of Trees 209-211. No major roots encountered. Heavily compacted clay soils within trench likely to have underpinned restricted root growth from trees. Proposed pathway can be installed in proposed location on eastern side of trees. Fourteen minor roots that were encountered are suitable for pruning if required.

Figure 30. Trench 7 with no major or minor roots encountered. Image taken from northern edge of trench.
