# Arboricultural Impact Assessment

Revision 4

Western Sydney University, Milperra Campus  
NSW, 2214  
2/-/DP129184 + 1/-/DP101147  
Job No. 2400116  
19/03/2026

**Temporal Tree Management Pty Ltd.**

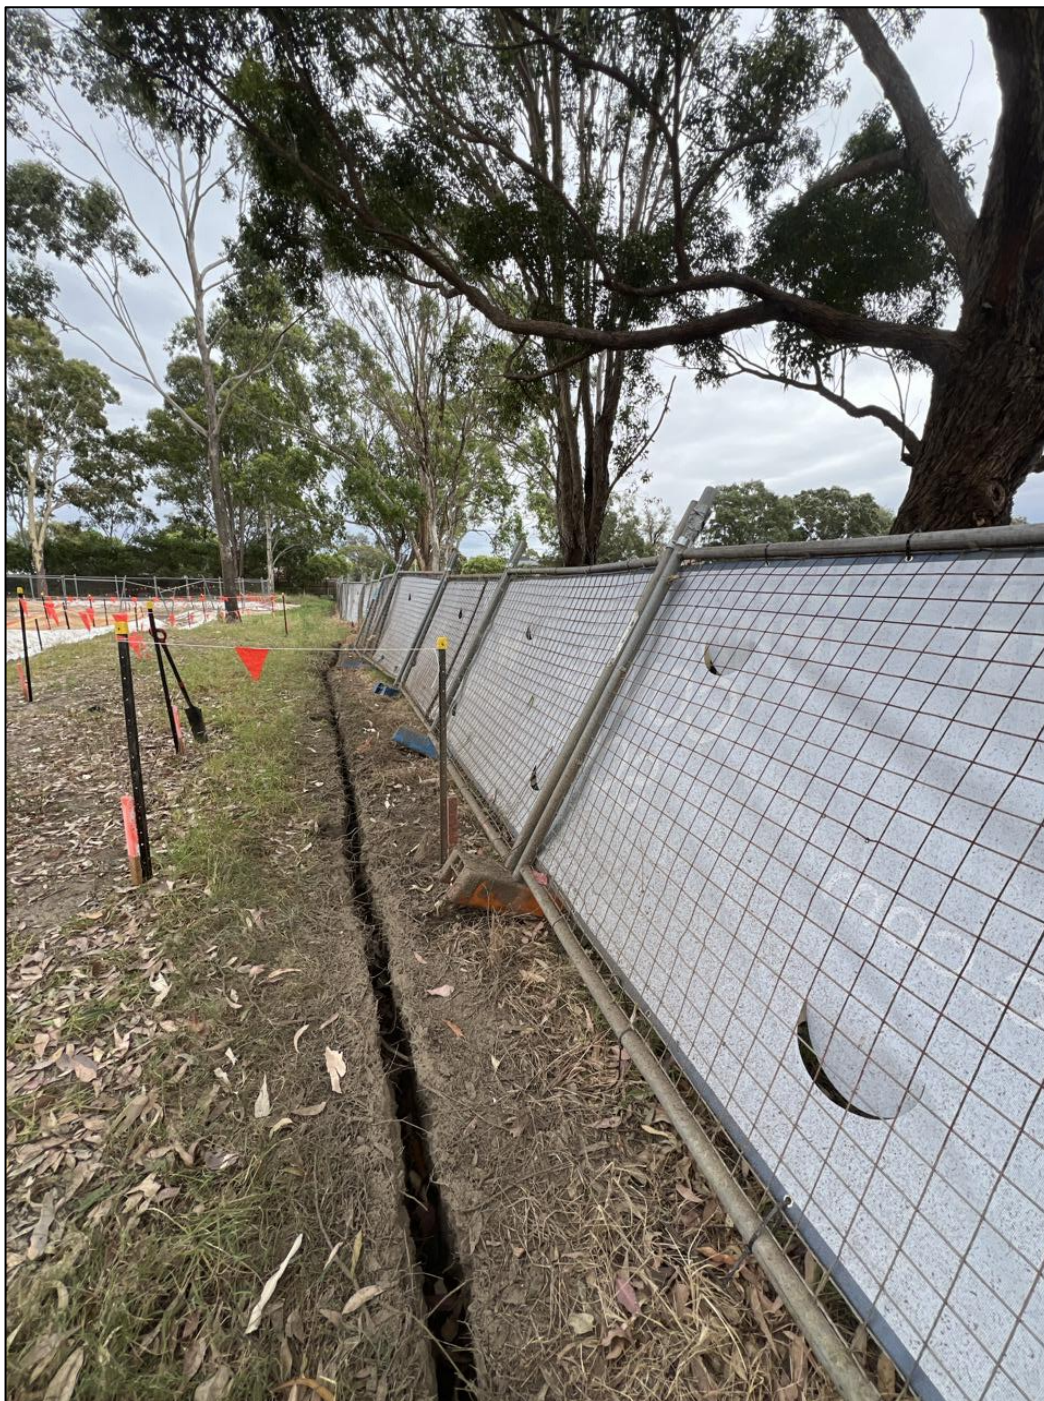
Trench excavated to a depth of 600 mm along nearest edge of proposed footpath that is within the NRZs of Trees 237 and 238. No major roots encountered. Heavily compacted clay soils within trench likely to have underpinned restricted root growth from tree. Proposed pathway can be installed in proposed location on southern side of tree. Four minor roots that were encountered are suitable for pruning if required.

Figure 34. Trench 9 with no major roots encountered. Image taken from eastern edge of trench.

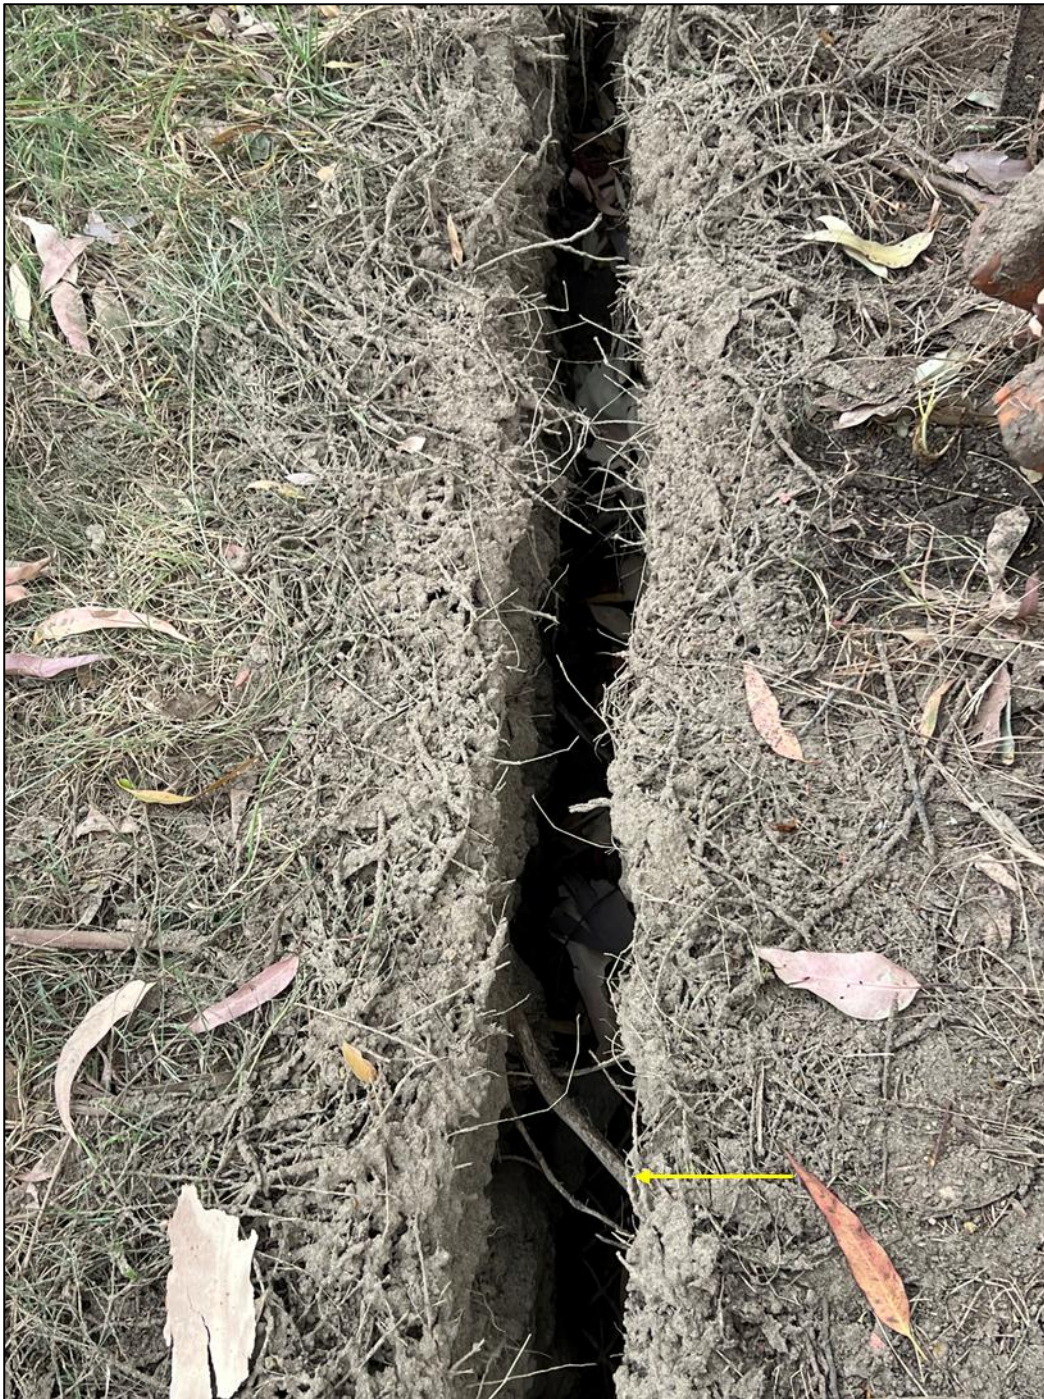
Figure 35. No major roots encountered in Survey Trench 9. Four minor roots encountered.

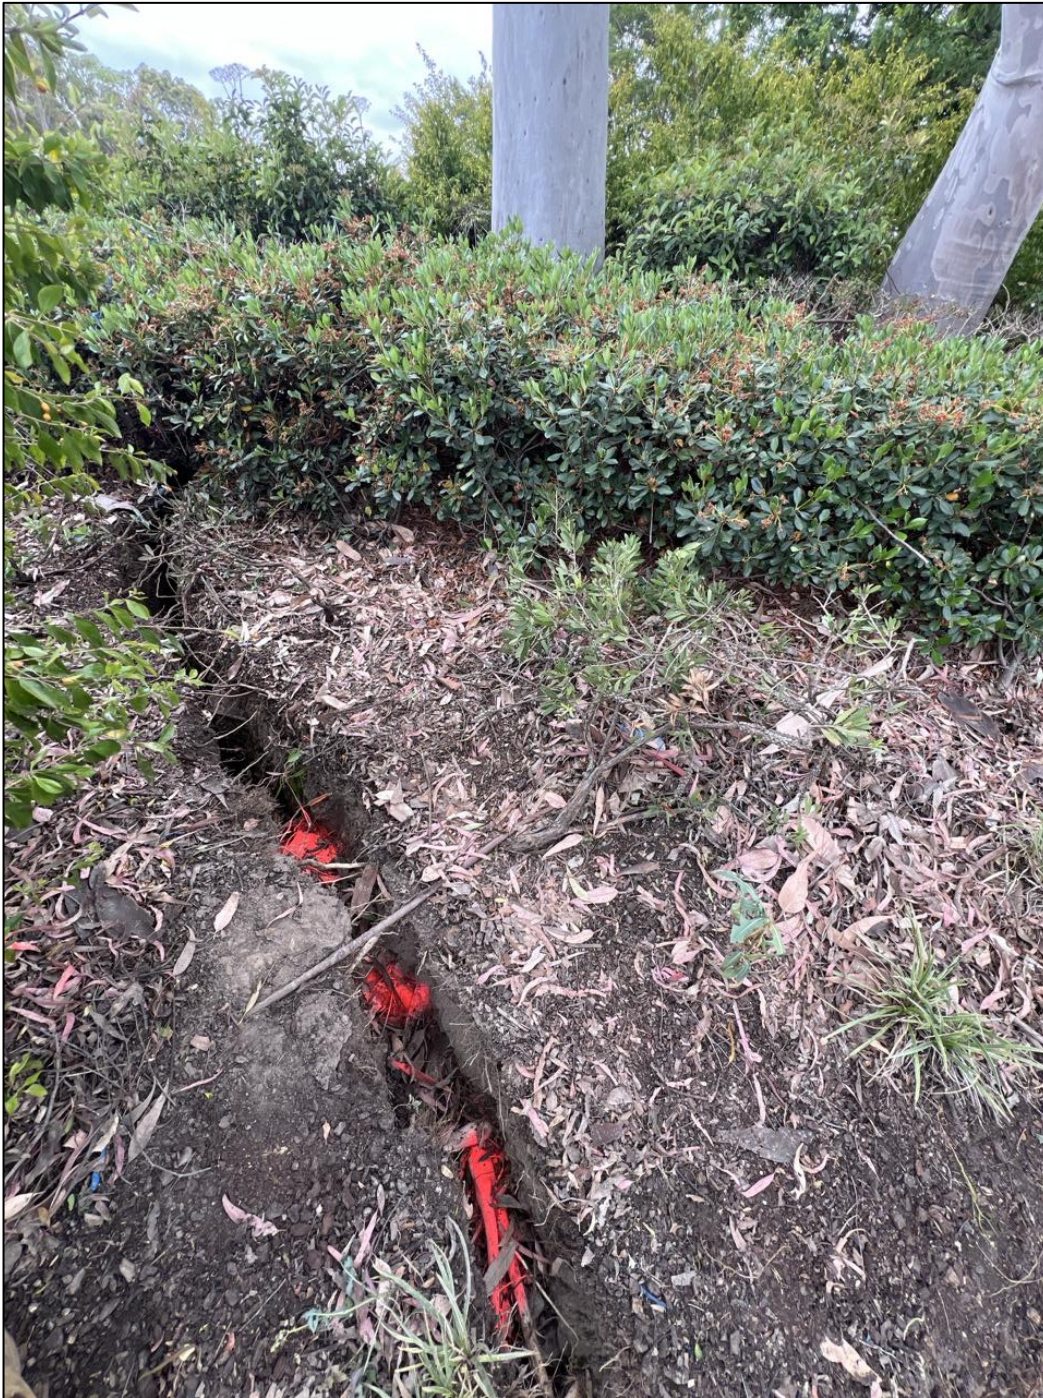
Trench excavated to a depth of 500mm along portion of proposed pathway that is within the NRZs of Trees 317-318. Only three major roots observed. All three major roots are within 1.4 metres of the southern edge of the proposed pathway and are at depths of greater than or equal to 250 mm. The three encountered major roots are growing from Tree 317. Roots 2 and 3 (diameters 75mm and 150mm) are larger roots. These two roots must be retained to ensure Tree 317 remains viable. Root 1 is a smaller major root (diameter 45mm). This root is suitable for pruning if required.

Figure 50. Trench 13 with three major roots encountered. Image taken from south-eastern edge of trench.

- **Survey Trench 13** – The proposed footpath within the central park on the northern side of Trees 317 and 318 is suitable for construction in the proposed location. Three major roots were encountered within the southern portion of this trench. A maximum excavation depth of 250 mm must not be exceeded for the portion of this pathway on the southern side of Tree 317 (Figure 50). Eleven minor roots observed within this trench are suitable for pruning to facilitate the proposed excavation.

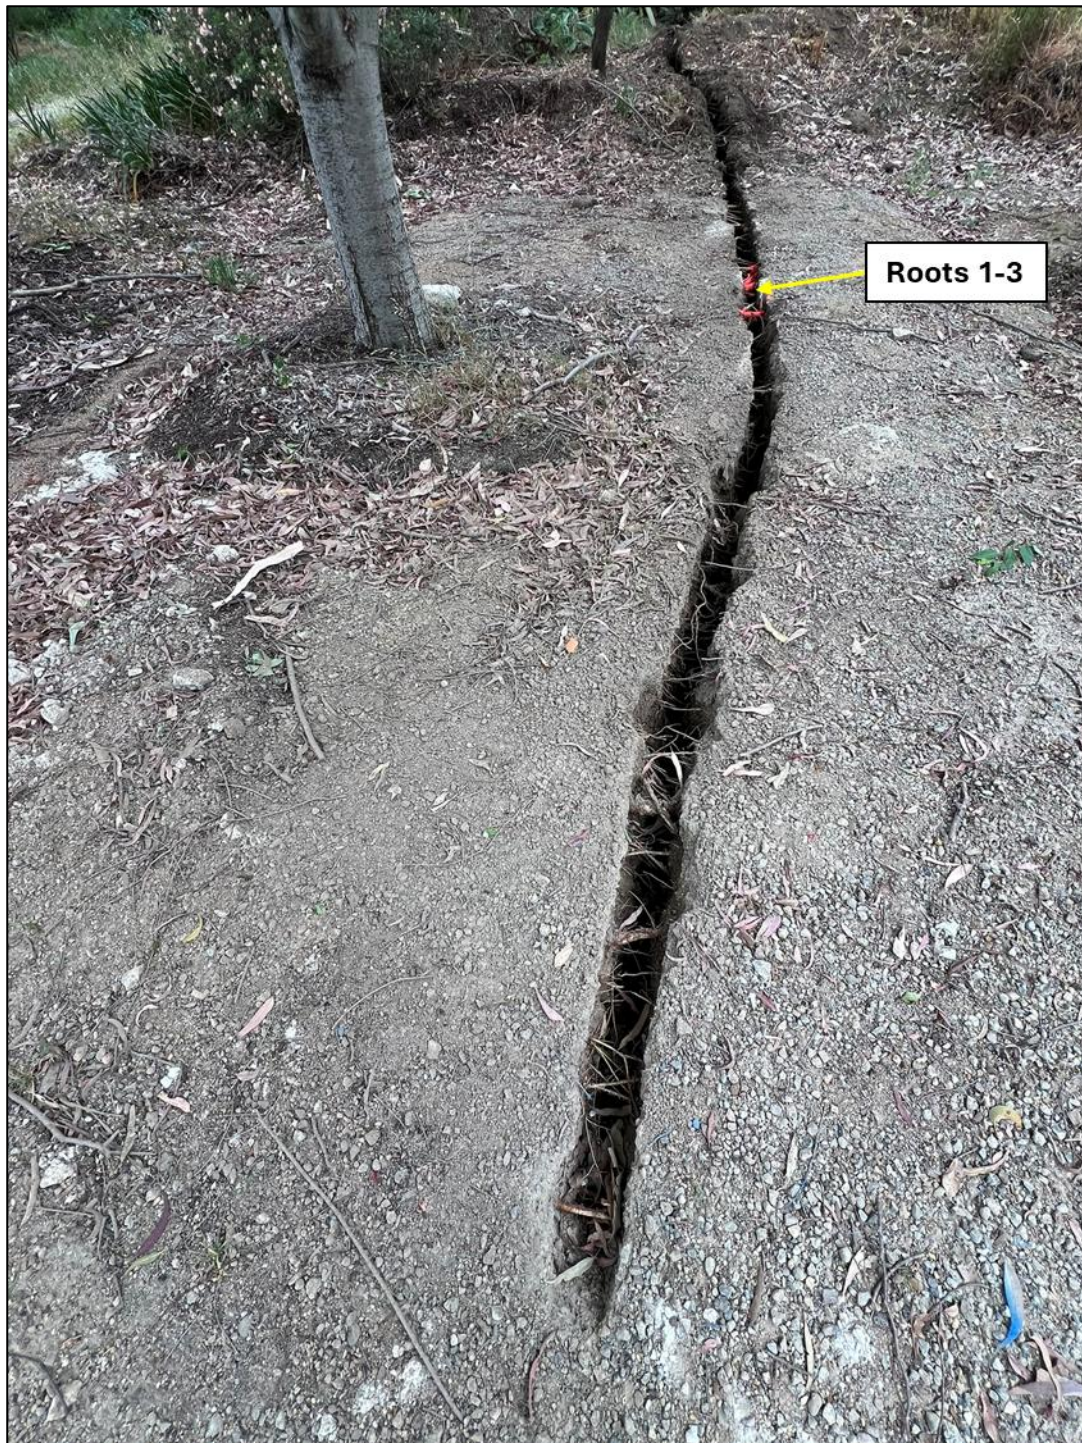
Trench excavated to a depth of 500mm along portion of proposed pathway that is within the NRZs of Trees 340, 341, 343 and 344. Only three major roots observed. All three major roots are growing from Tree 341. All three are smaller major root (diameters of 40mm and 50mm). These three roots are suitable for pruning to facilitate the proposed pathway due to their smaller size and the good health observed for Tree 341.

| Root | Distance from Western edge of trench (m) | Diameter of root (mm) | Depth of root [mm] | Comments |
|---|---|---|---|---|
| 1 | 4.3 | 40 | 60 | Smaller major root crossing trench laterally. Originates from Tree 351. Root is suitable for pruning if required to due to smaller size and good health observed for Tree 341. |
| 2 | 4.9 | 50 | 60 | Smaller major root crossing trench laterally. Originates from Tree 351. Root is suitable for pruning if required to due to smaller size and good health observed for Tree 341. |

Figure 55. Roots 1-3 in western portion of Survey Trench 14 adjacent to Tree 341.

Trees 340, 341, 343 and 344 is supported within the proposed location without amendment. Due to their smaller size (max. diameter of 50mm), three major roots growing from Tree 341 and twenty-four minor roots growing are suitable for pruning to facilitate construction of this proposed footpath (Table 10) (Figure 55).

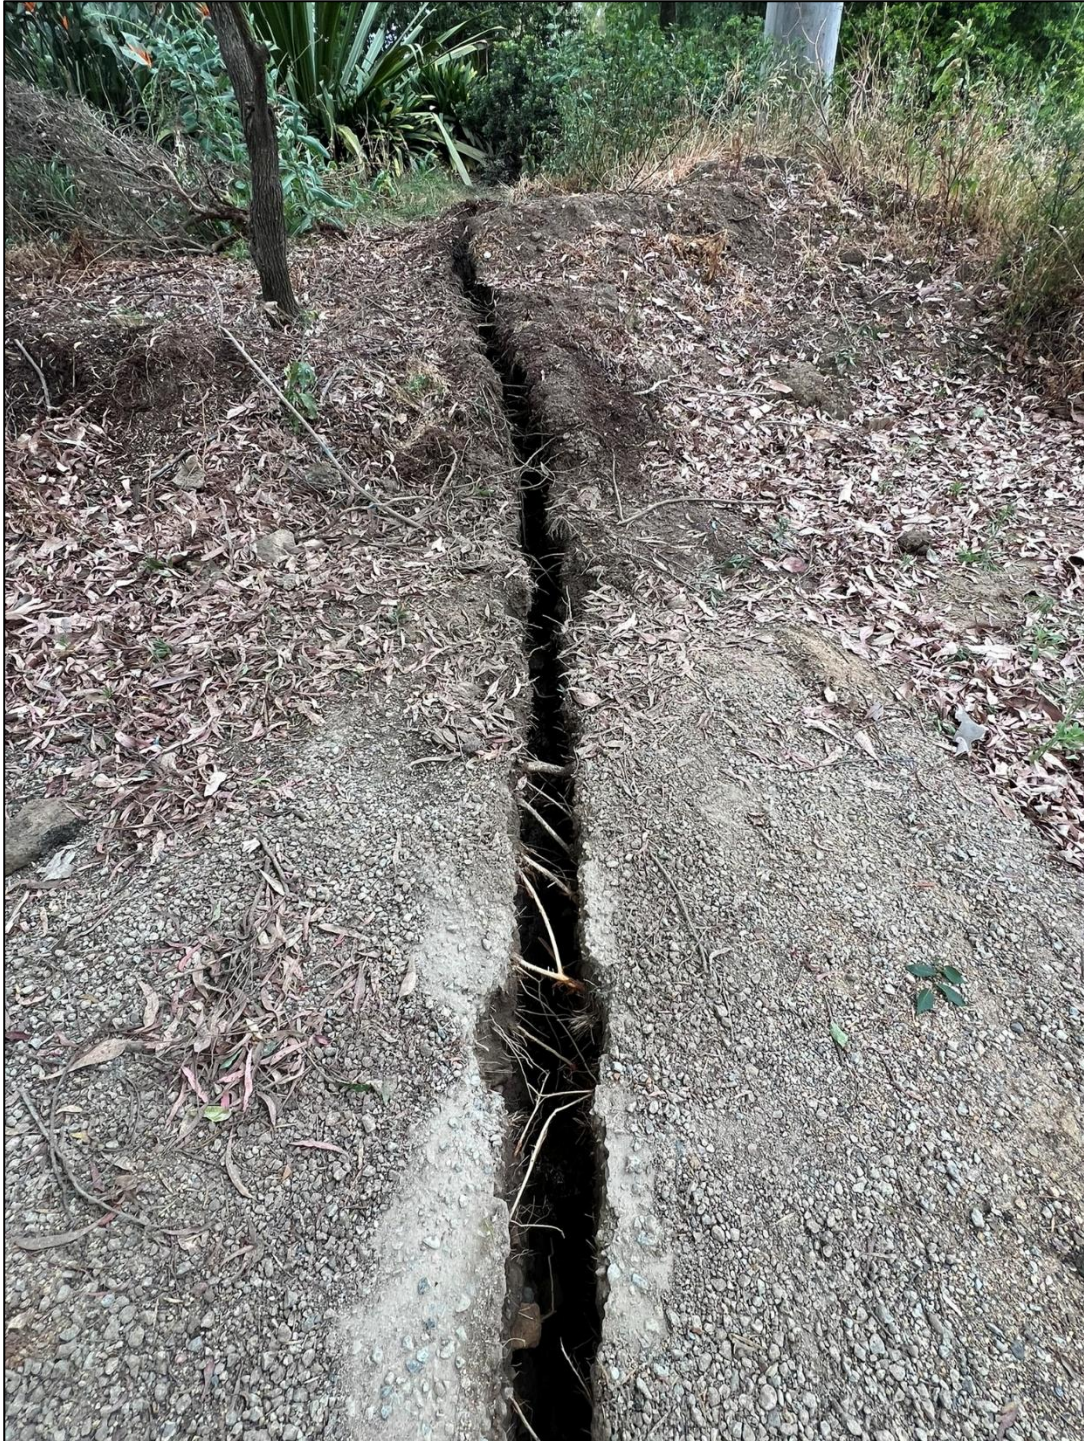
Figure 57. No major roots encountered within the central portion of Trench 14.

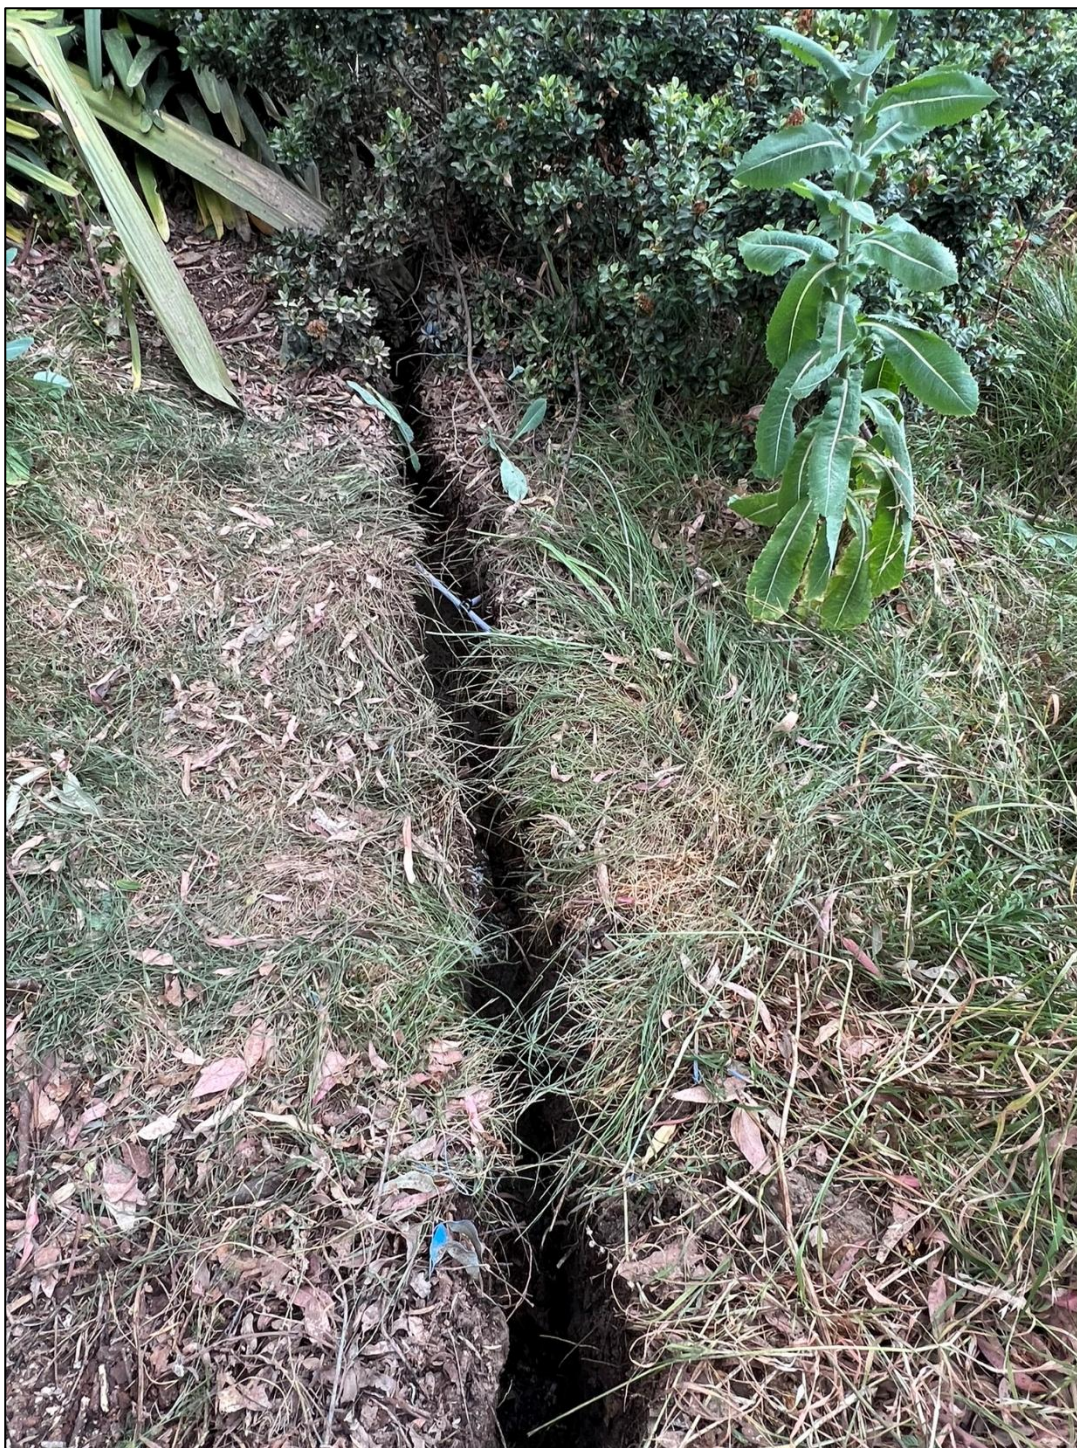
Figure 58. No major roots encountered within the central portion of Trench 14.

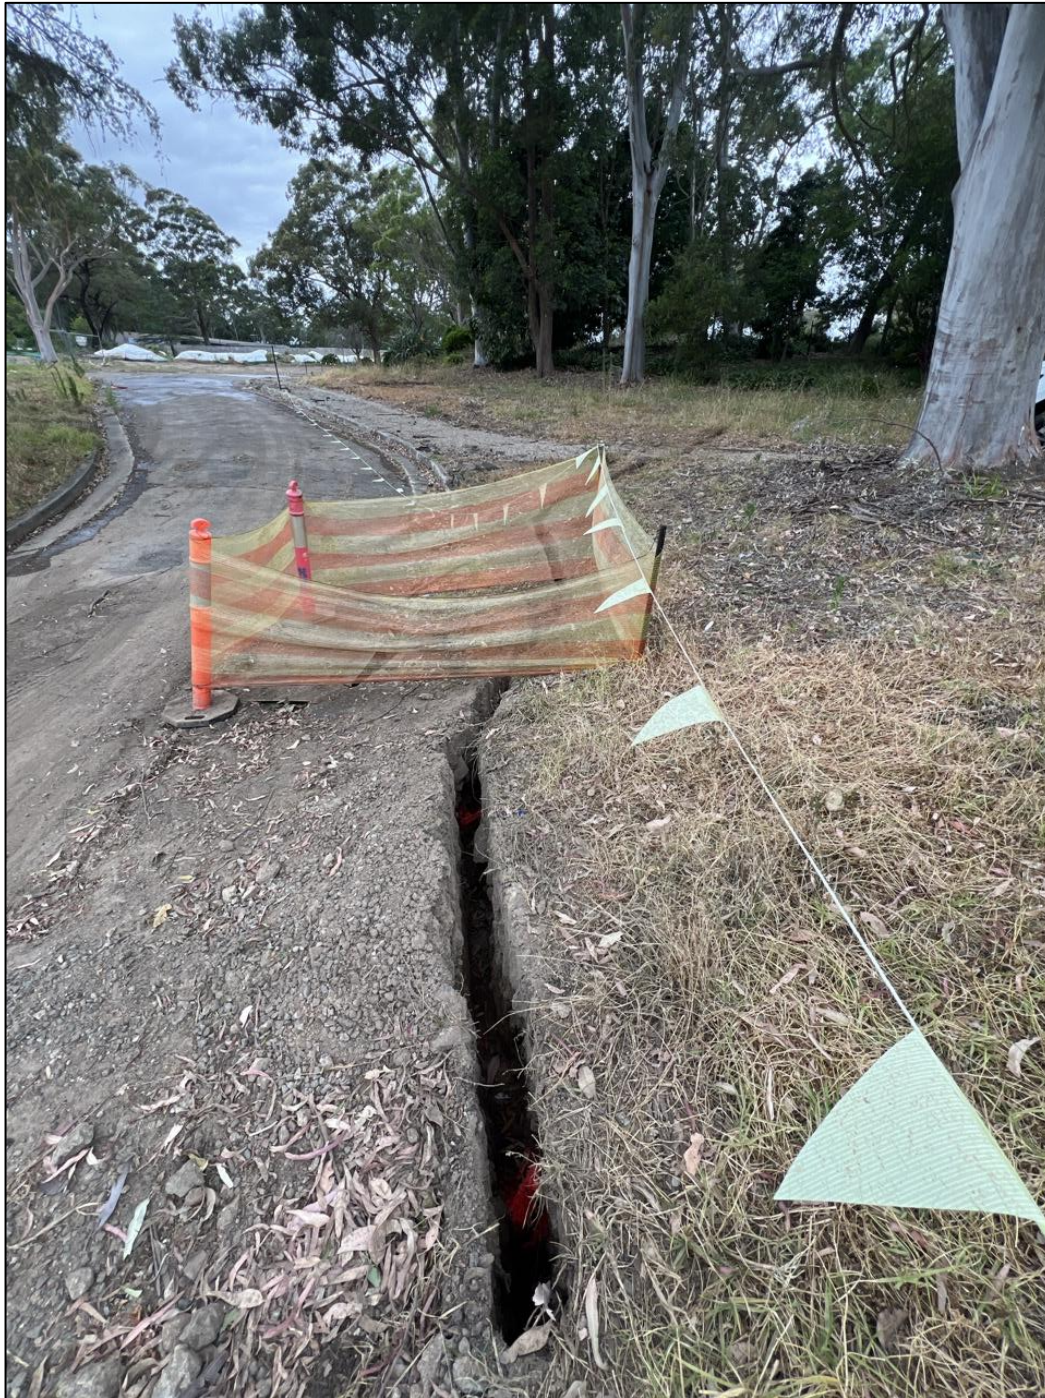
| Distance from Western edge of trench (m) | Diameter of root (mm) | Depth of root [mm] | Comments |
|---|---|---|---|
| 6.9 | 40 | 450 | Smaller major root crossing trench laterally. Originates from Tree 353. Root is growing below the required depth of excavation. |

Figure 59. Trench 15 with three major roots encountered. Image taken from western edge of trench.

- **Survey Trench 15** – The footpath within the central park on the northern side of Tree 353 is supported within the proposed location without amendment. Three major roots growing from Tree 353 were observed at greater than 450 mm depth and will remain below the required depth of excavation (Table 11) (Figure 60 and Figure 61).

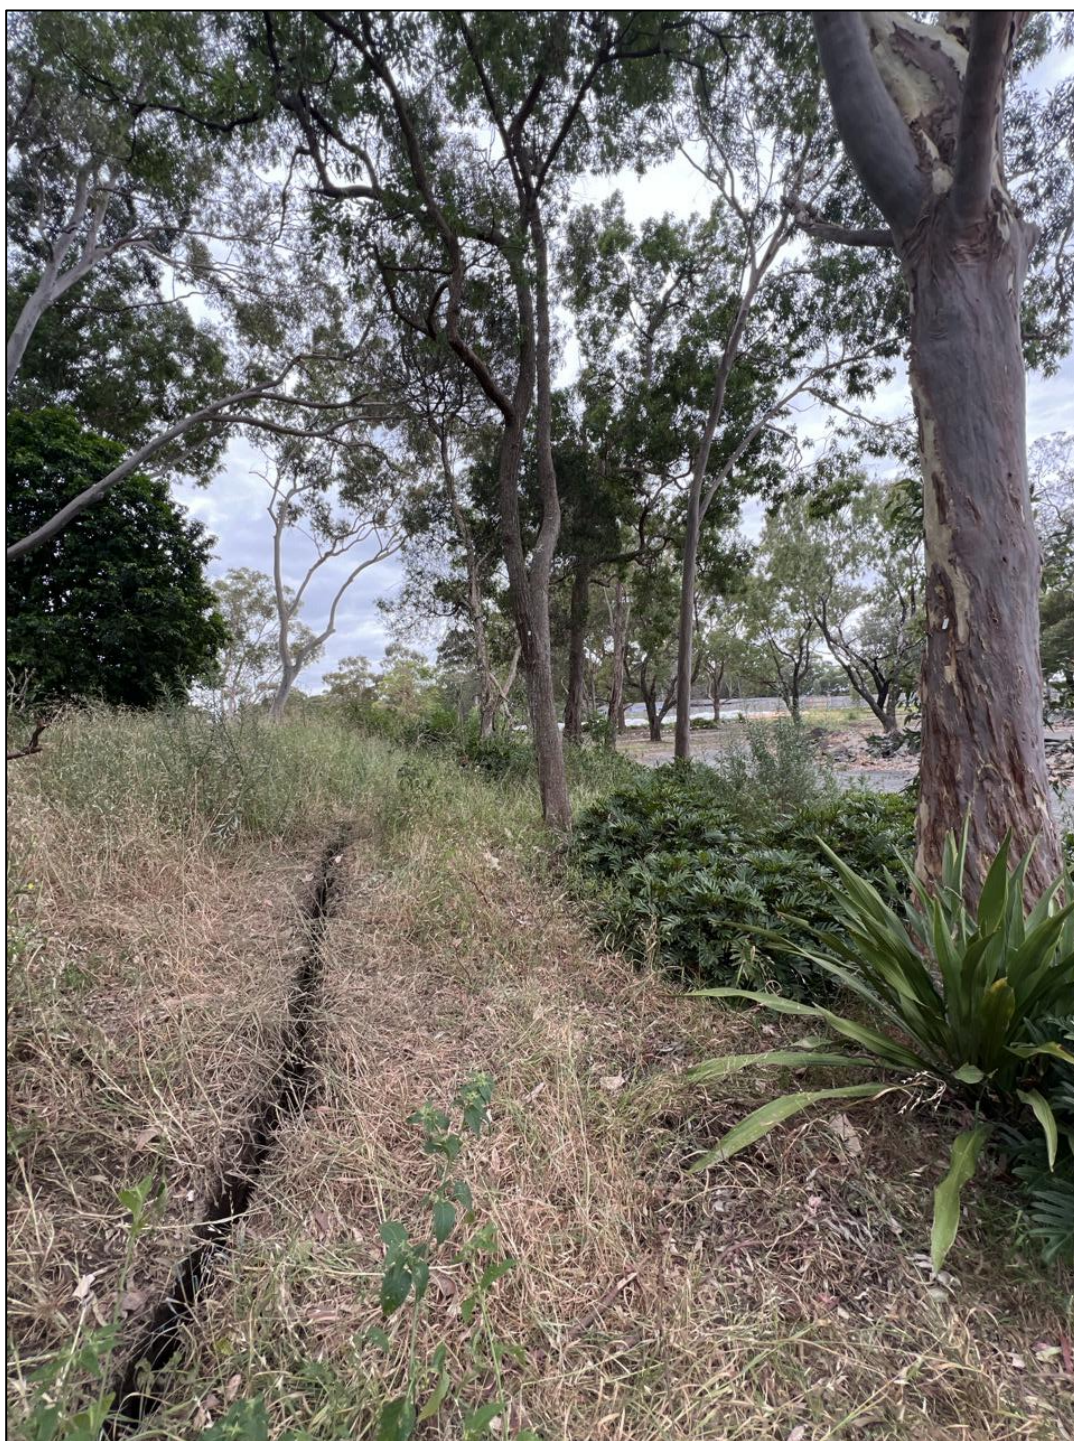
Trench excavated to a depth of 500 mm along nearest edge of proposed retaining wall that is within the NRZs of Trees 371 and 373. No major encountered. Heavily compacted clay soils encountered within trench likely to have underpinned restricted root growth from tree. Proposed retaining wall and services can be installed on western side of tree. Thirteen minor roots were encountered, which are suitable for pruning to facilitate works.

Figure 62. Trench 16 with no major or minor roots encountered. Image taken from southern edge of trench.

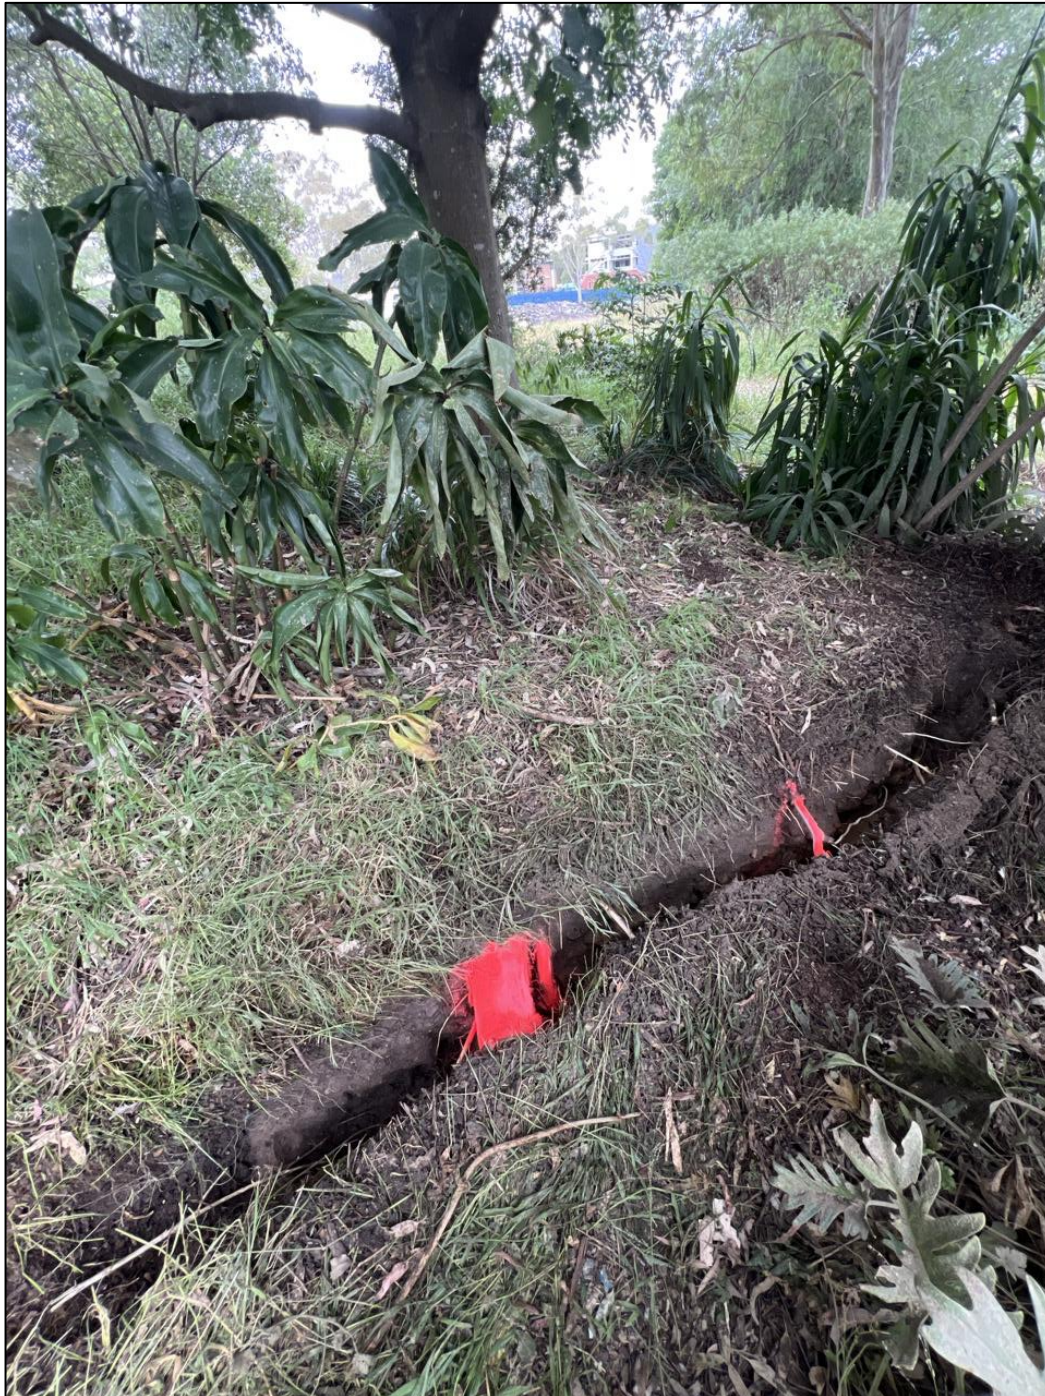
| Root | Distance from Western edge of trench (m) | Diameter of root (mm) | Depth of root [mm] | Comments |
|---|---|---|---|---|
| 3 | 1.9 | 40 | 50 | Major root crossing trench laterally. From Tree 354. Smaller diameter of root and Good health of Tree 354 renders root suitable for pruning. |

Figure 63. Trench 17 with three major roots encountered.

- **Survey Trench 17** – The design of the proposed footpath on the western side Tree 354 within the central park will require amendment. Three major roots were encountered in Survey Trench 17 (Table 12) (Figure 63-Figure 65). Severing Root 1 within Survey Trench 354 will compromise the viability of Tree 17. It is recommended that the pathway is moved in the western direction so that it is entirely outside the NRZ of this tree.

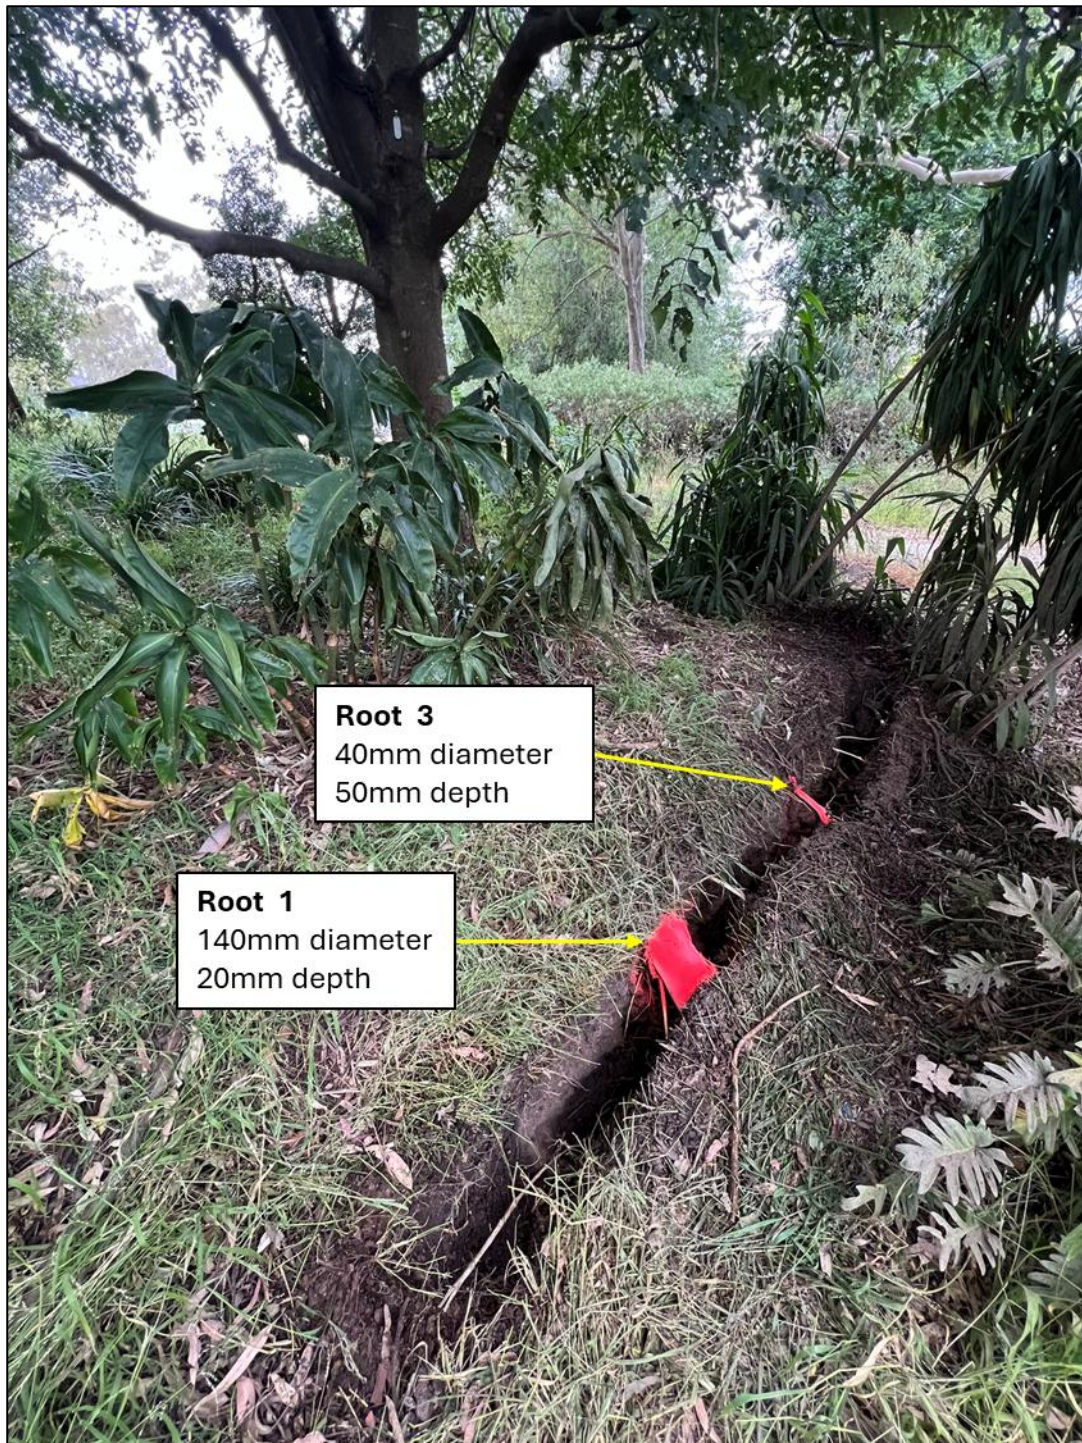
Figure 64. Roots 1-3 in central portion of Survey Trench 17.

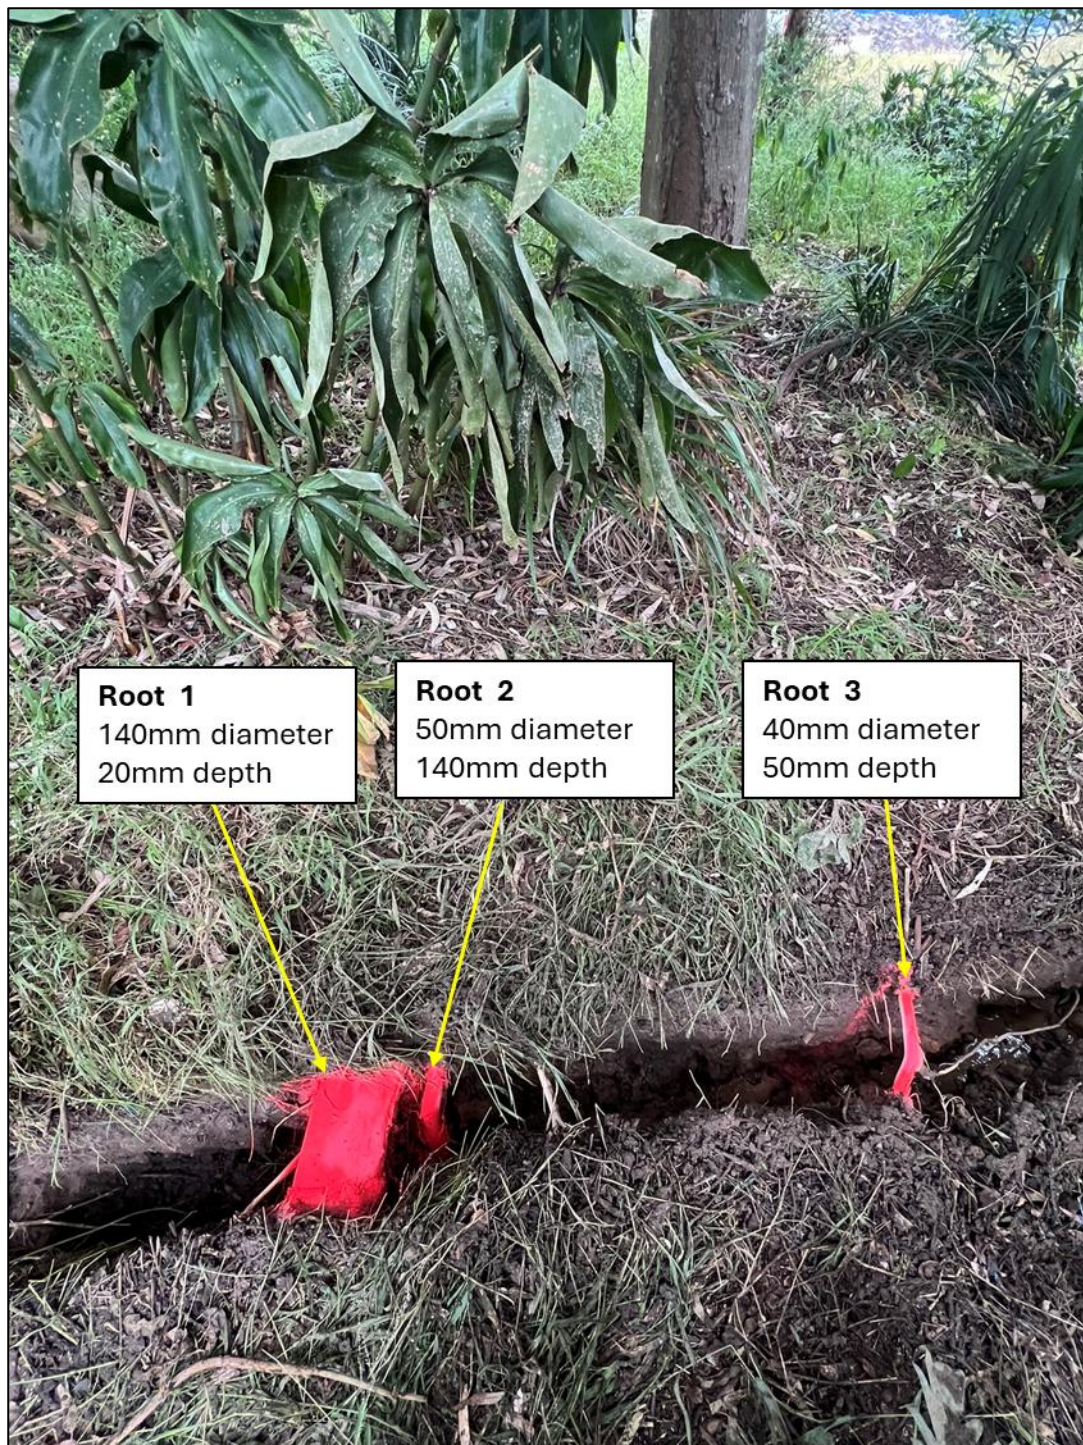
Figure 65. Roots 1-3 in central portion of Survey Trench 17.

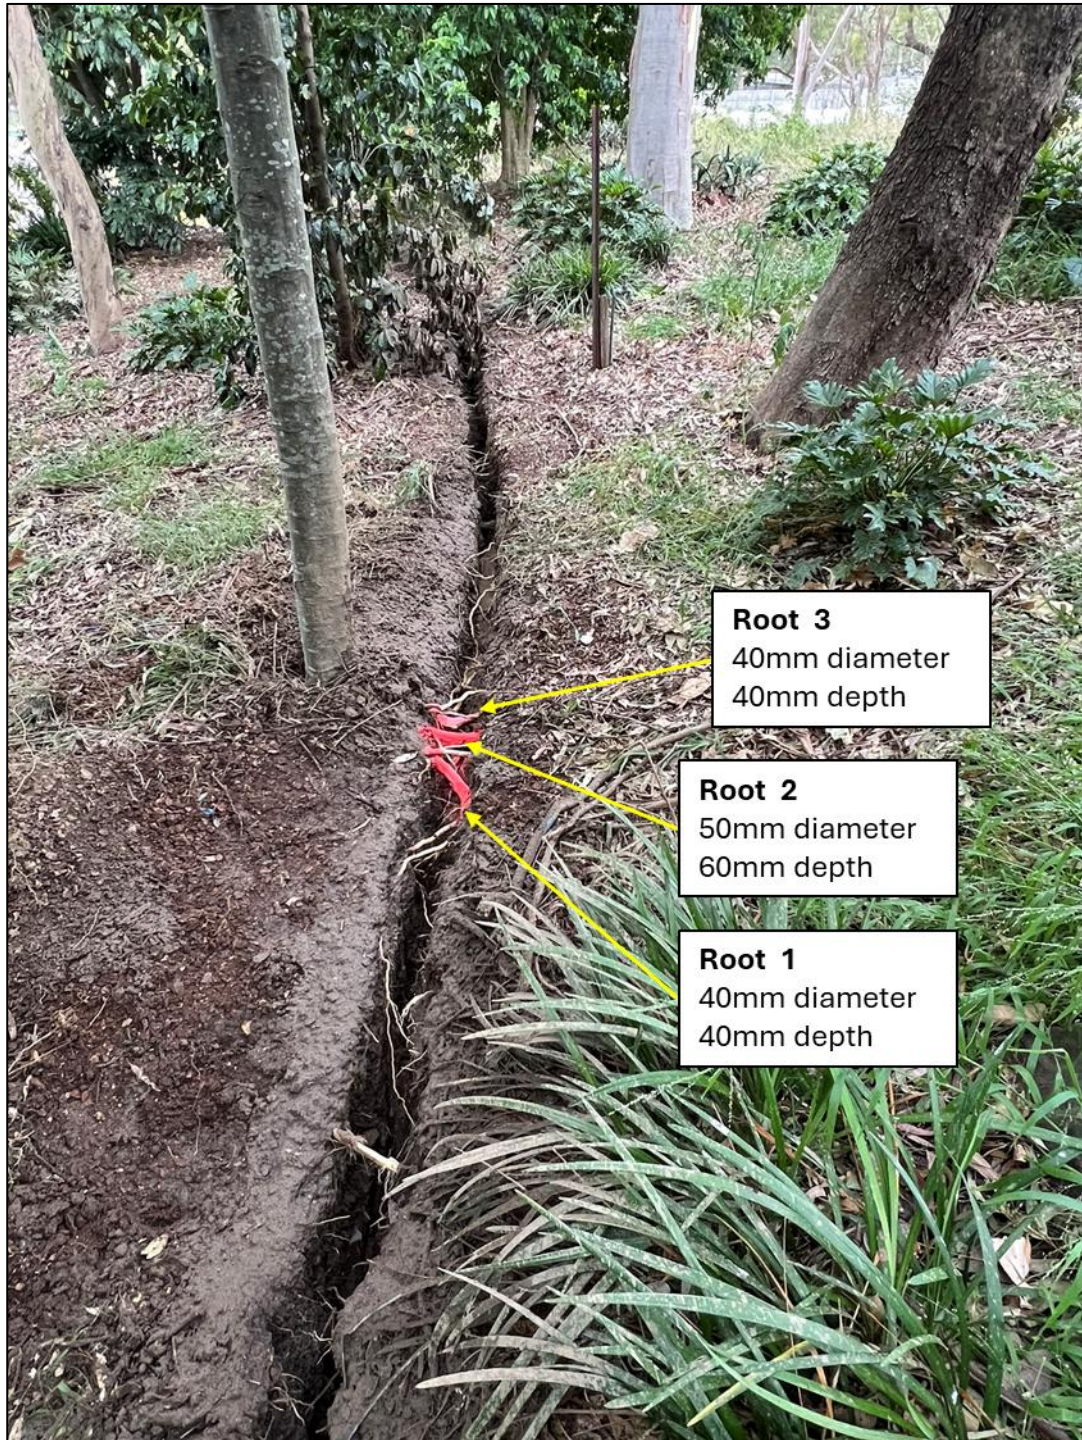
Figure 67. Roots 1-3 in southern portion of Survey Trench 18.

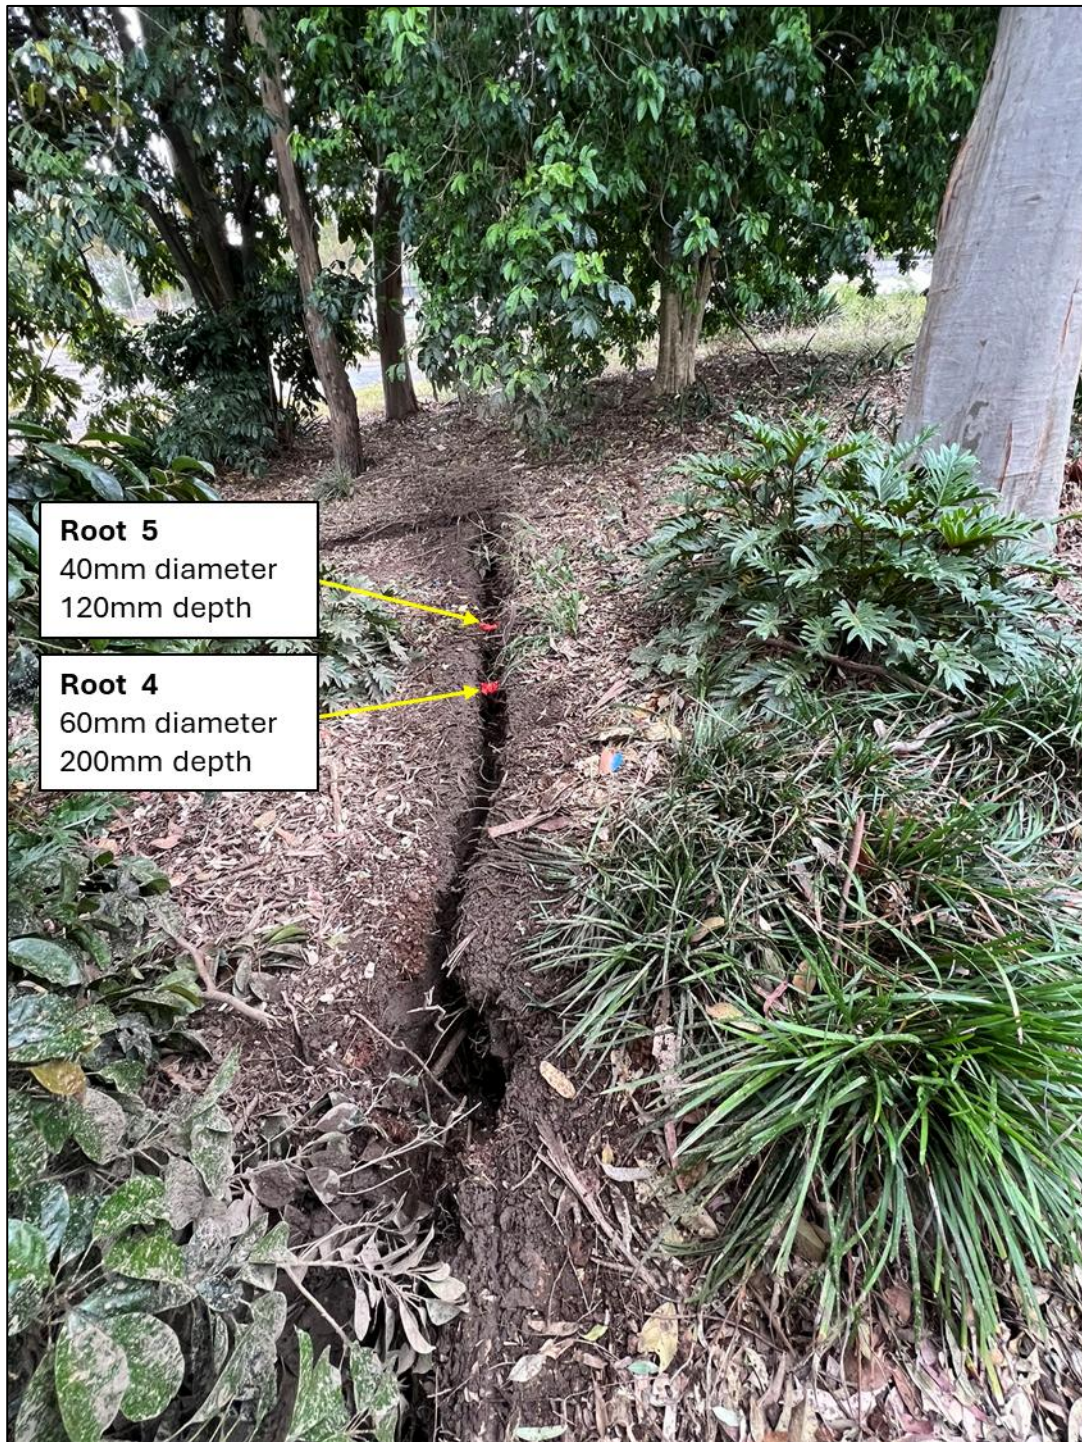
Figure 68. Roots 4 and 5 in southern portion of Survey Trench 18.

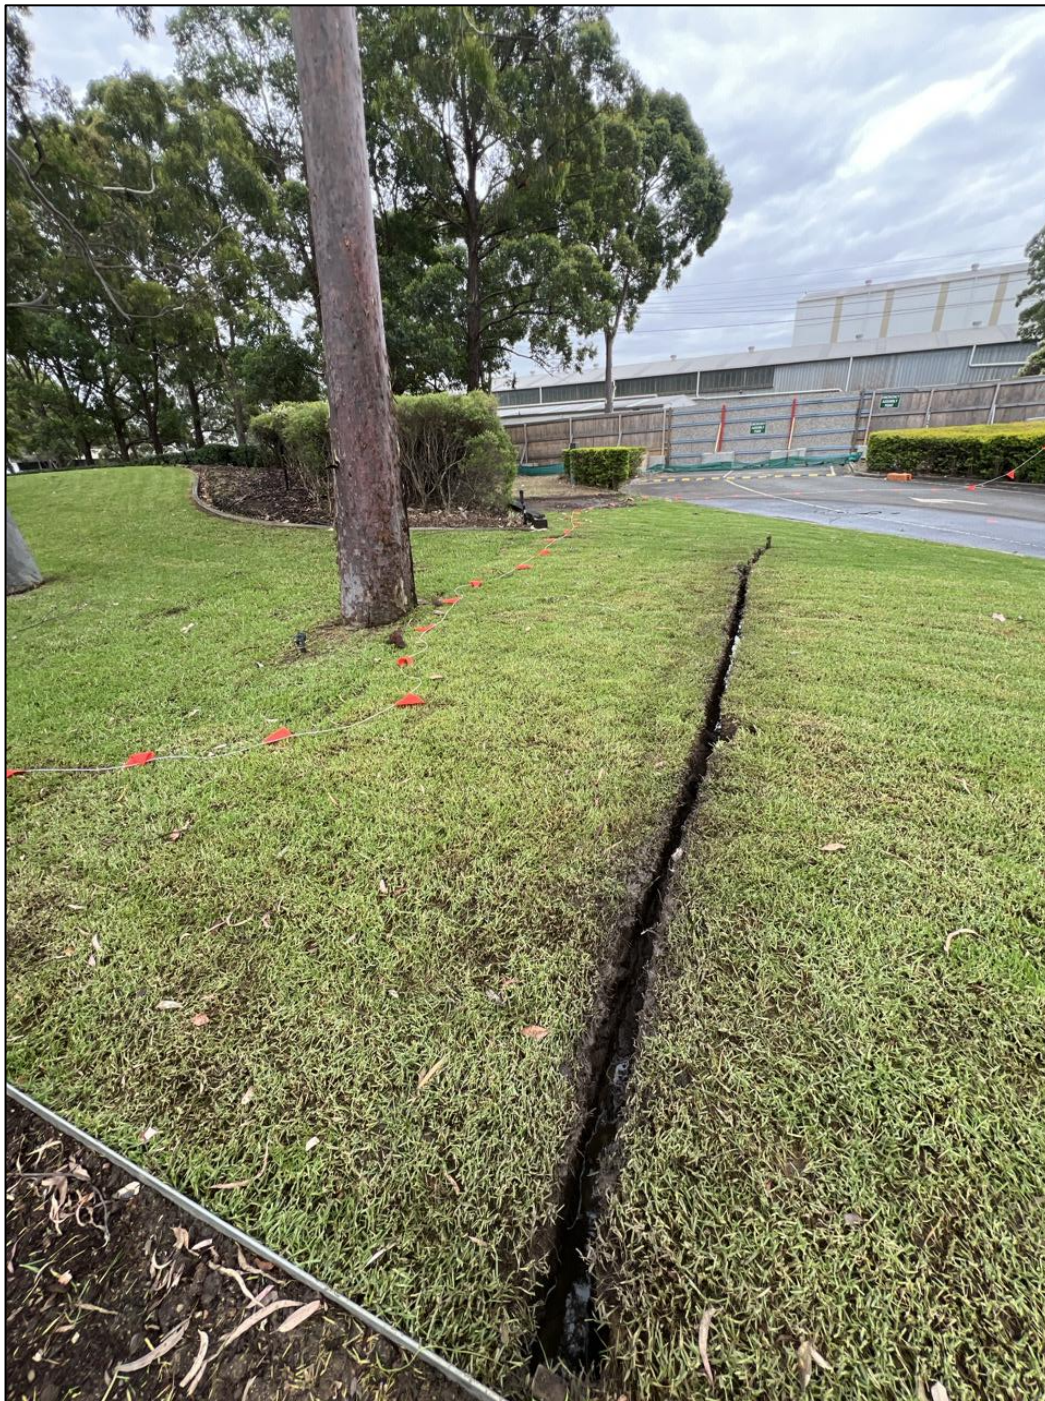
Trench excavated to a depth of 500 mm along nearest edge of proposed footpath that is within the NRZ of Tree 122. No major or minor roots were encountered. Construction of proposed footpath suitable in proposed location.

Figure 71. Trench 20 with no major or minor roots encountered. Image taken from southern edge of trench.
