# Arboricultural Impact Assessment

Revision 4

Western Sydney University, Milperra Campus  
NSW, 2214  
2/-/DP129184 + 1/-/DP101147  
Job No. 2400116  
19/03/2026

**Temporal Tree Management Pty Ltd.**

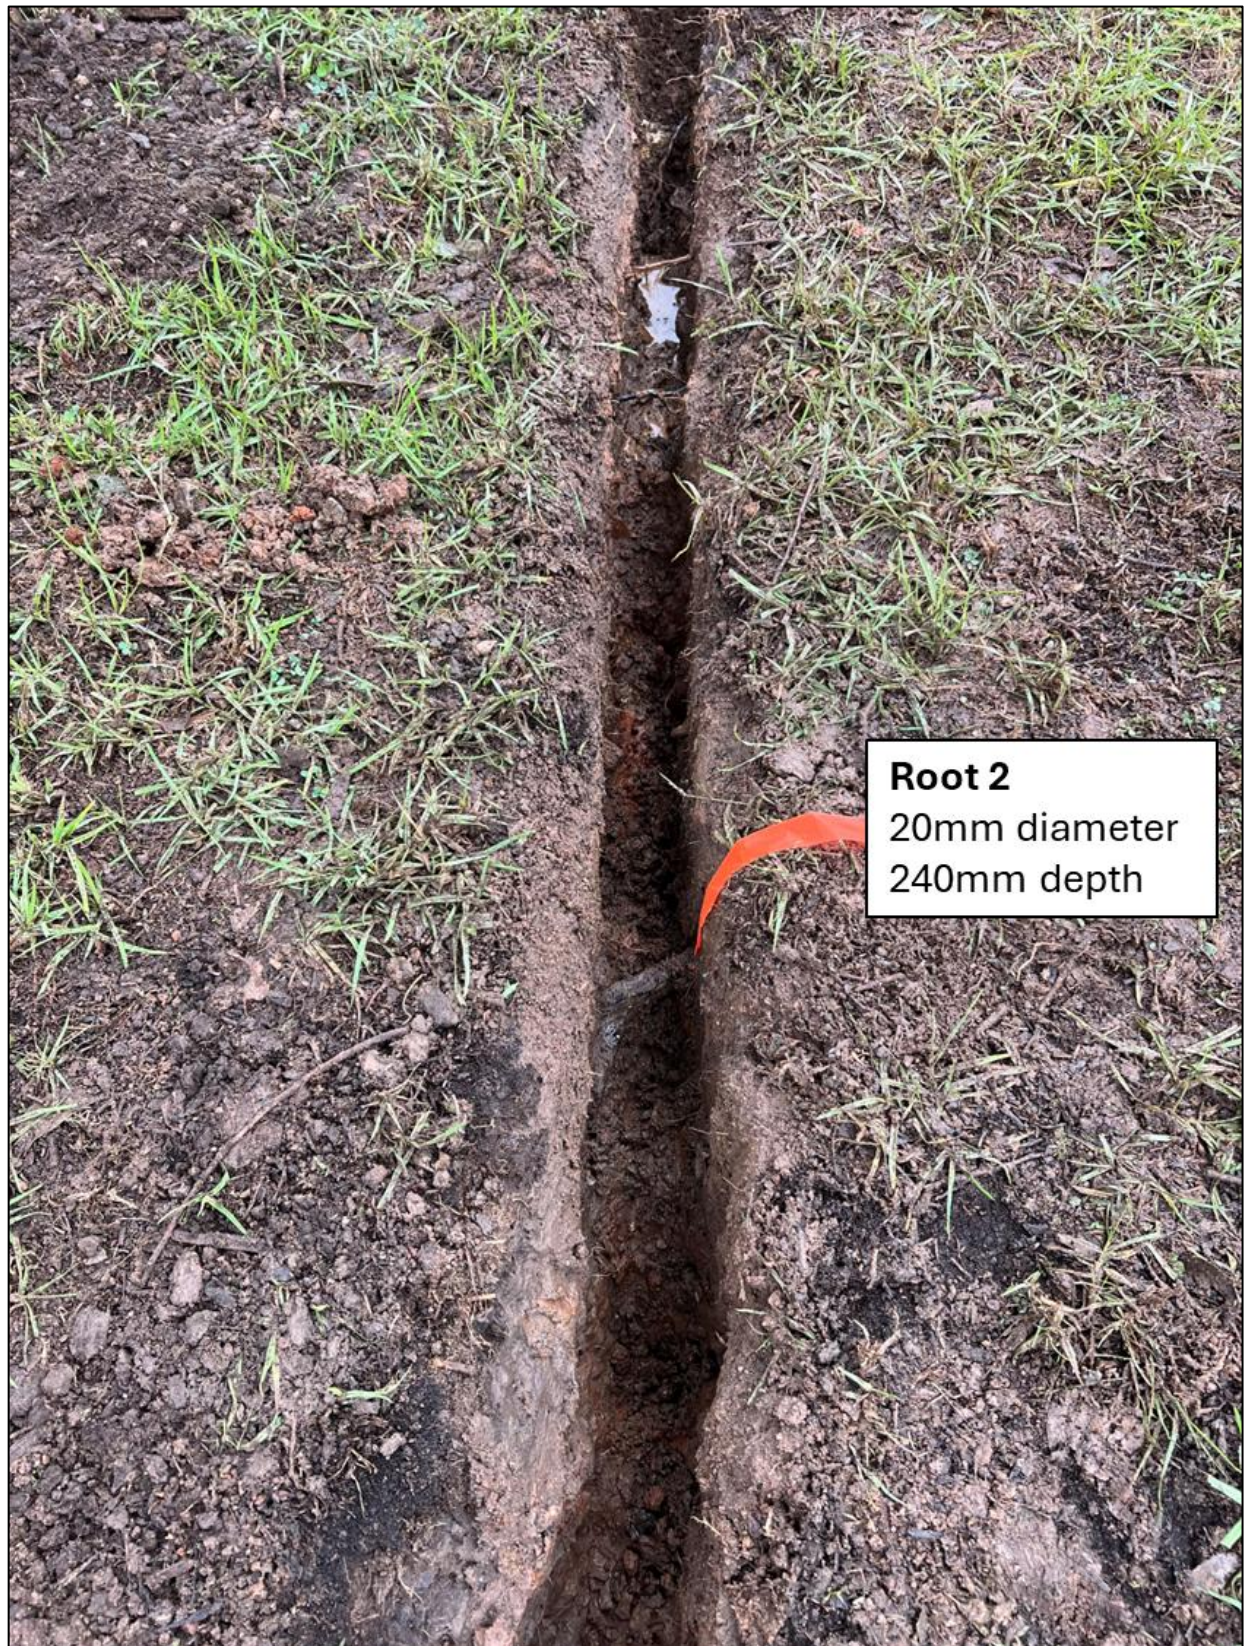
Figure 13. Position of Roots 9-15 within the northern portion and northern edge of Survey Trench 1.
