# Georgiou Group Dilapidation Report, Windsor Bridge Replacement Project, Windsor NSW

S-03139.DilapidationReport.001

**Pre-Dilapidation Photos Taken:** 20<sup>th</sup> June 2018

**Post-Dilapidation Photos Taken:** 8<sup>th</sup> July 2021

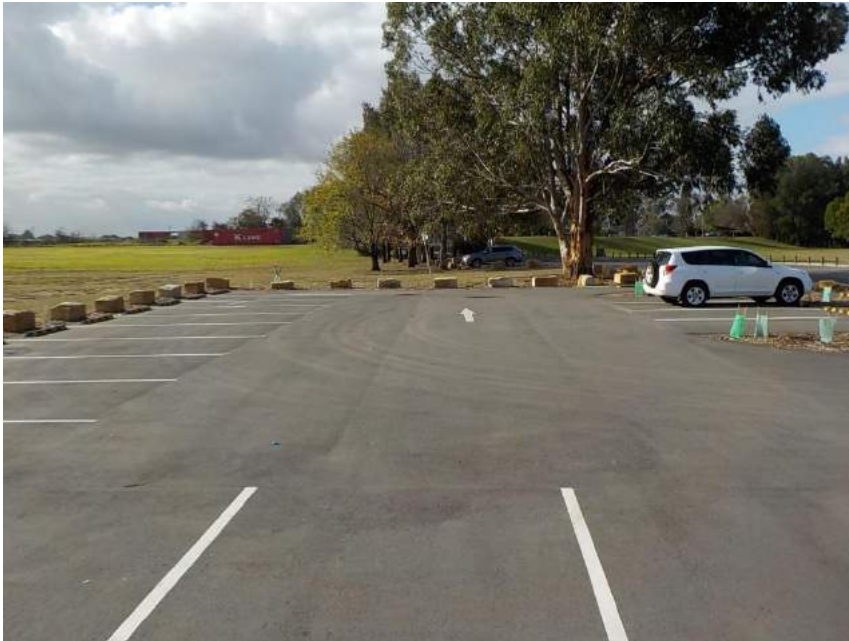
**2018:** General condition of far end of carpark.

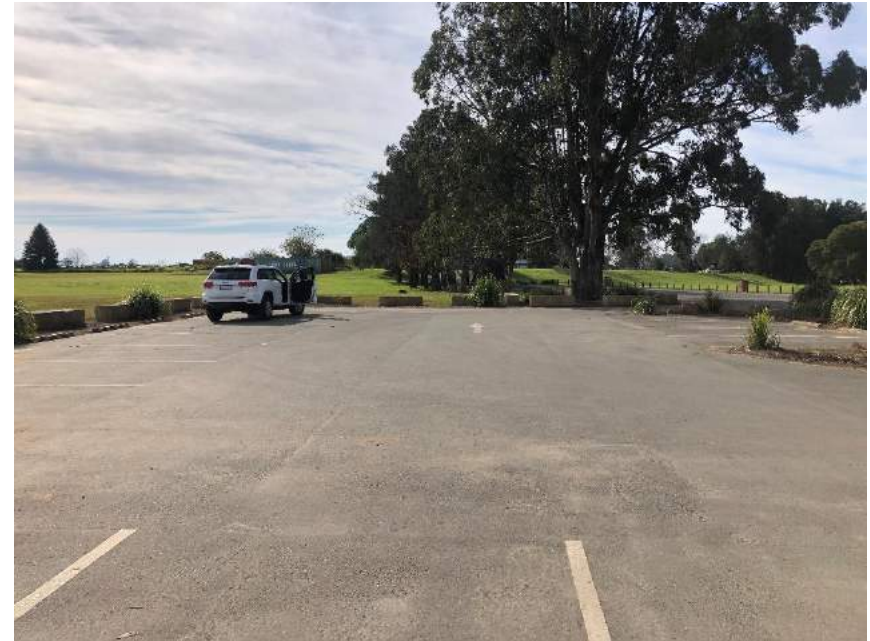
**2021:** General condition of far end of carpark unchanged since previous survey.

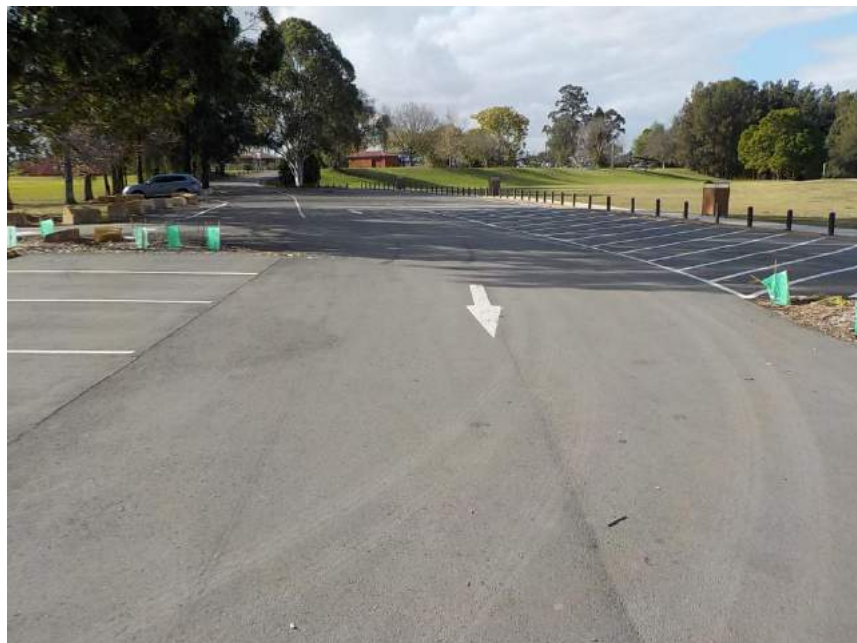
**2018:** General condition of far end of carpark – joints and cracking noticeable.

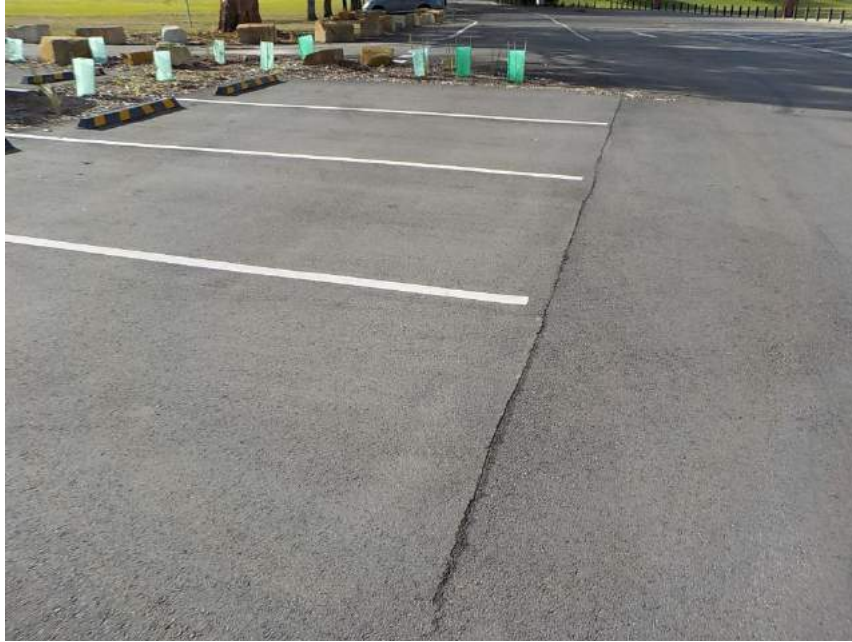
**2018:** Close up of joint/cracking in asphalt.

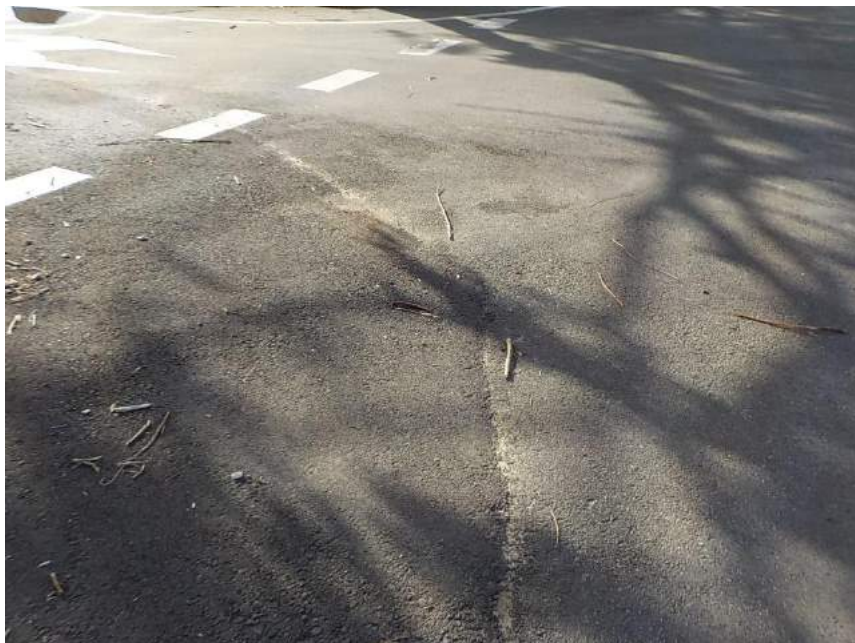
**2018:** Close up of joint/cracking in asphalt.

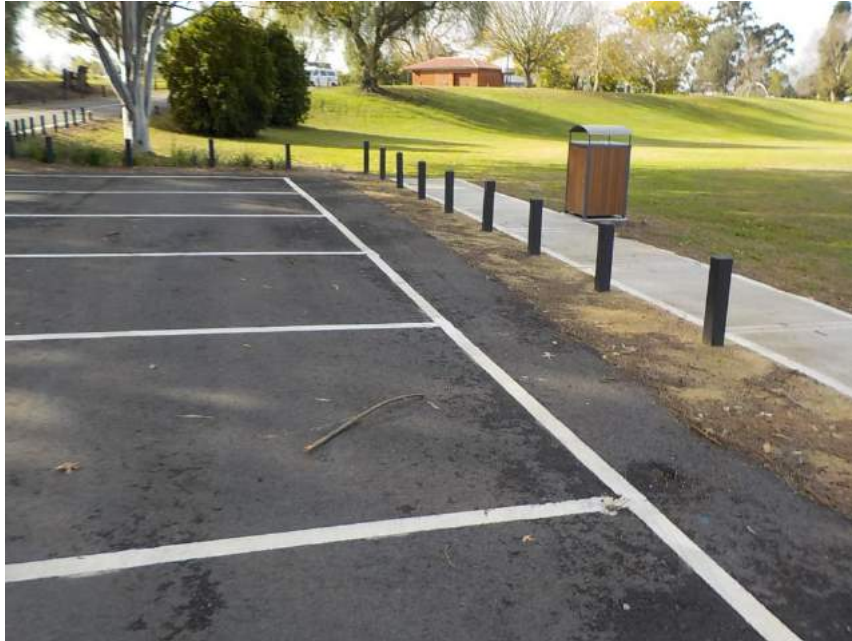
**2018:** General condition of asphalt.

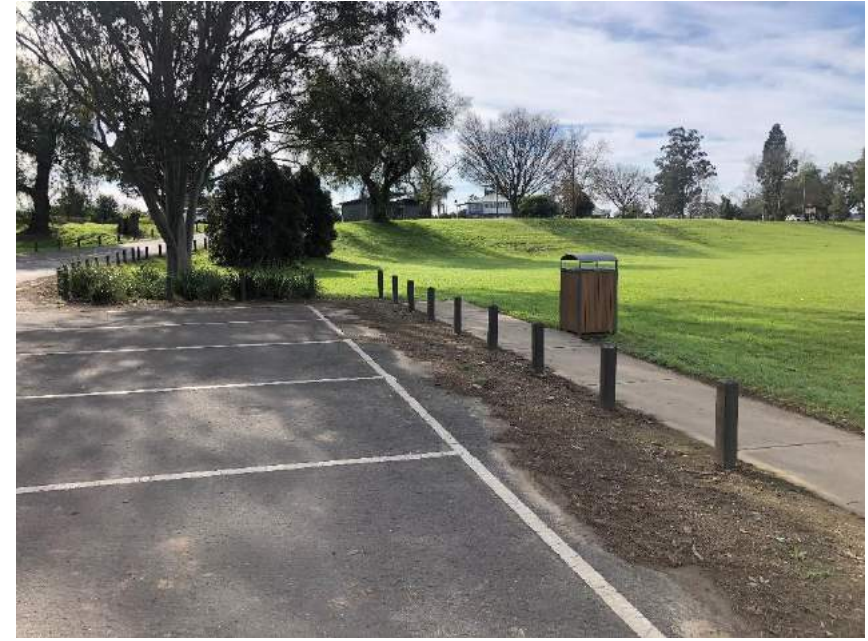
**2021:** General condition of asphalt – little to no change observed compared to pre-construction survey conditions.

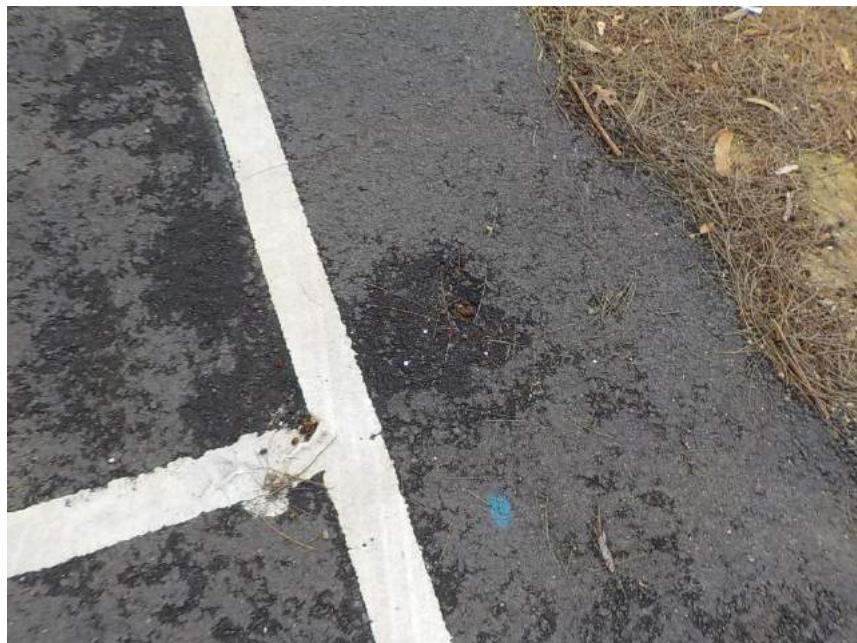
**2018:** Ravelling/potholes evident throughout carpark surface.

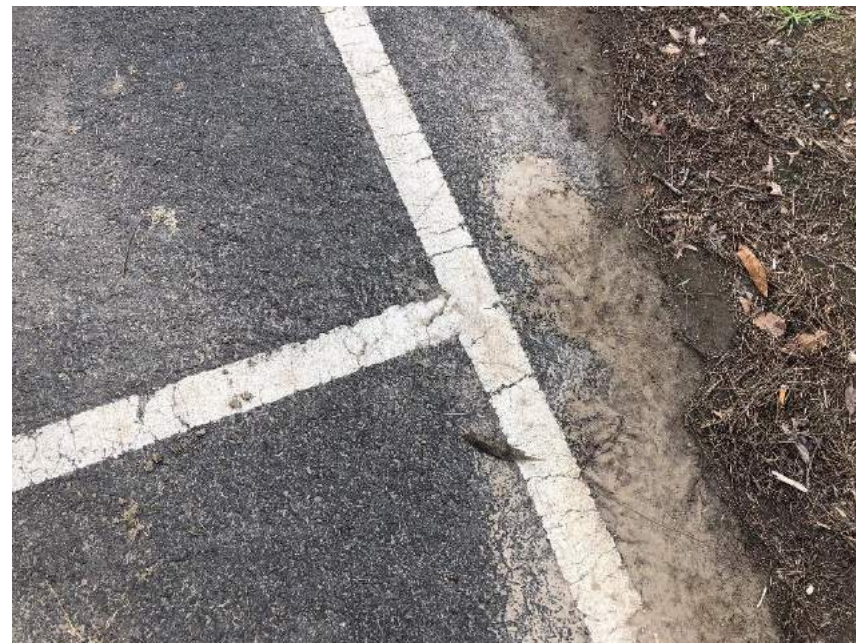
**2021:** Ravelling/potholes evident throughout carpark surface – consistent with pre-construction survey, no change observed.

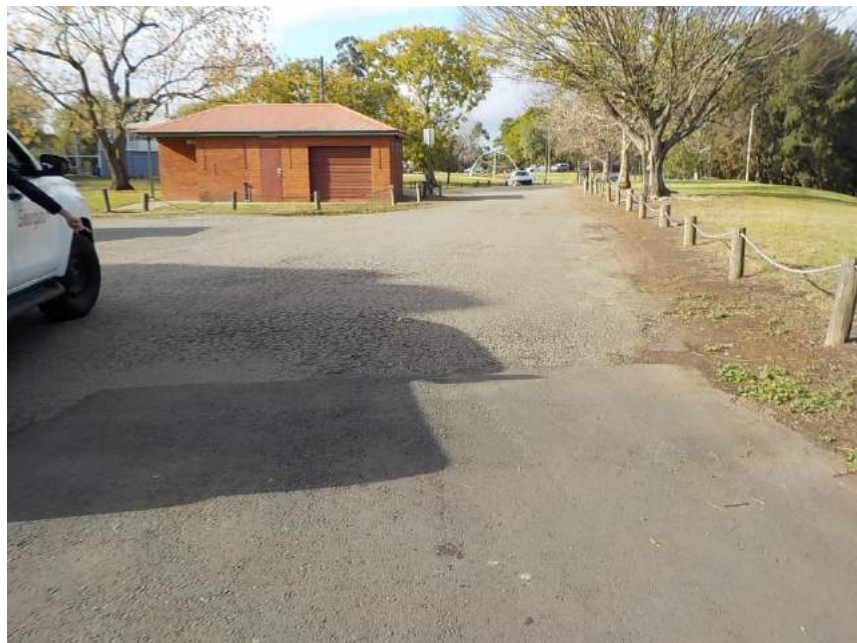
**2018:** Ravelling and gashes on asphalt surface – wire rope not tensioned.

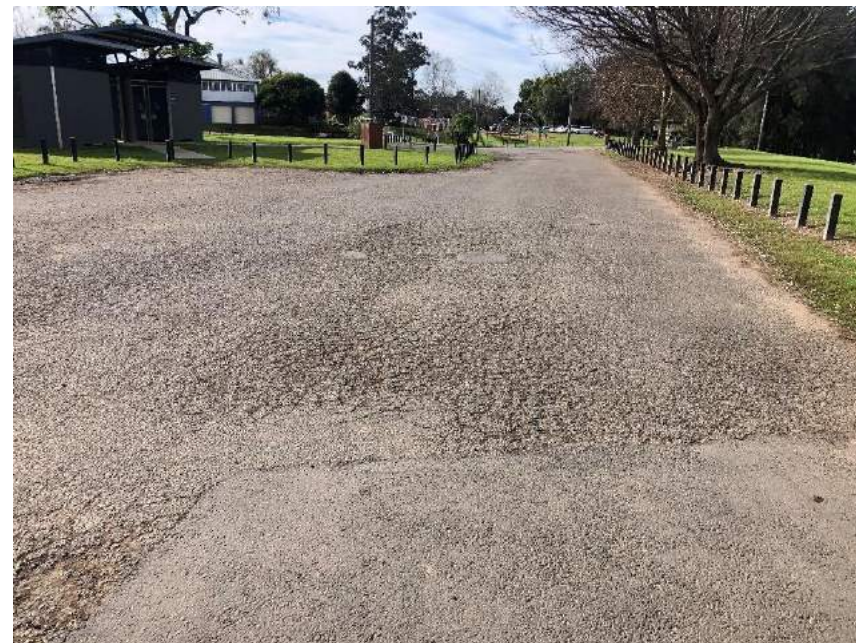
**2021:** Ravelling and gashes on asphalt surface. Upgrades including replacement of barricade/fencing and new amenities building.

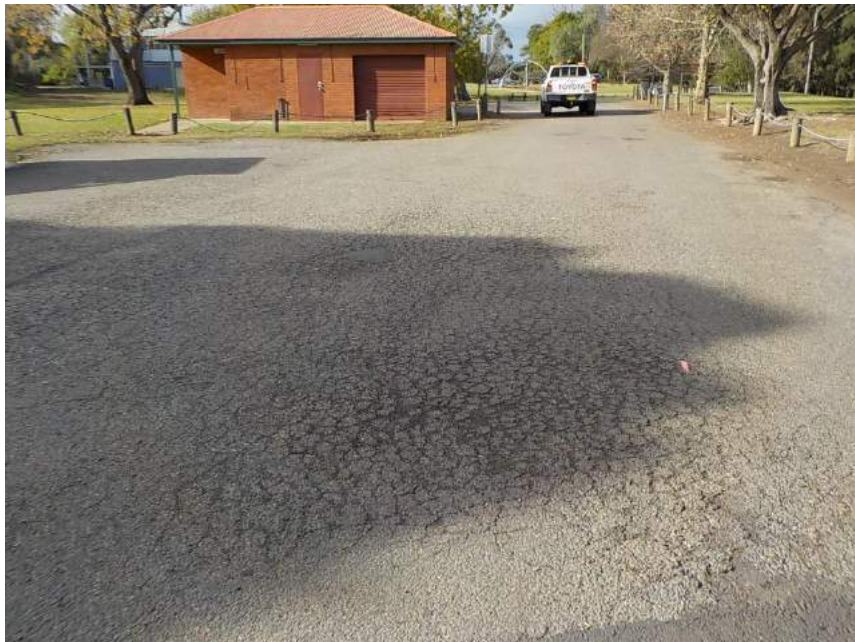
**2018:** Evidence of severe ravelling and crocodile cracking on asphalt surface.

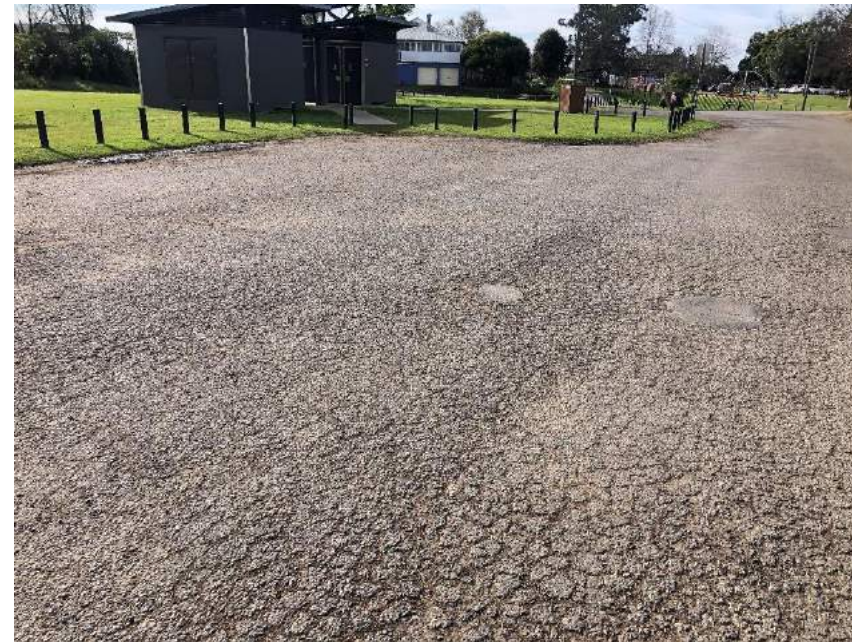
**2021:** Evidence of severe ravelling and crocodile cracking on asphalt surface consistent with previous observations, marginal change due to high traffic area and not associated with construction activities.

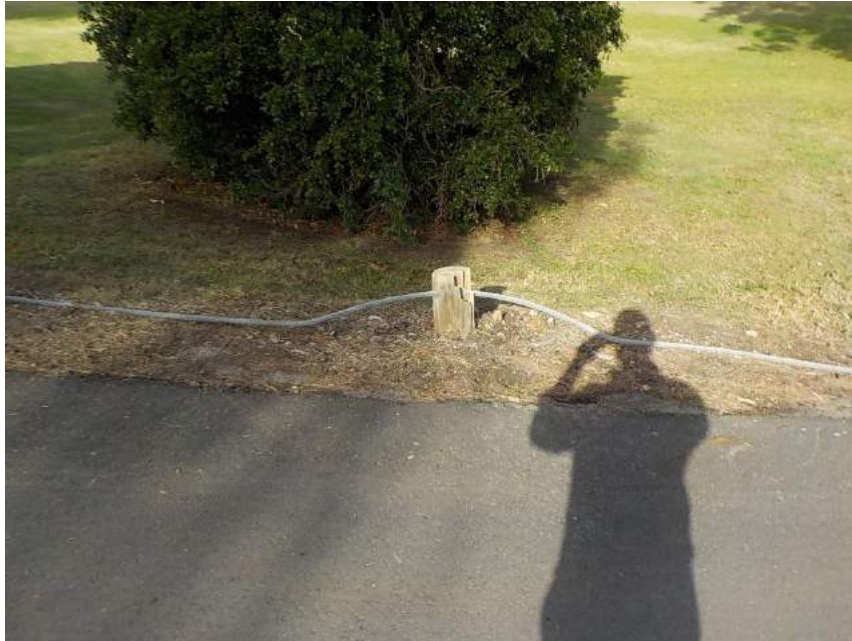
**2018:** Wire rope not tensioned – damaged posts.

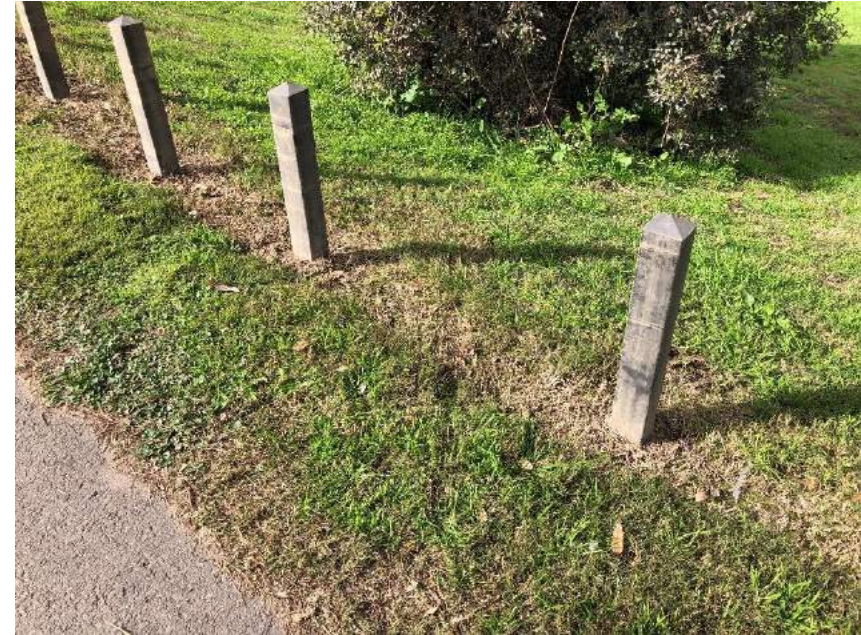
**2021:** Replacement of posts and wire barricade.

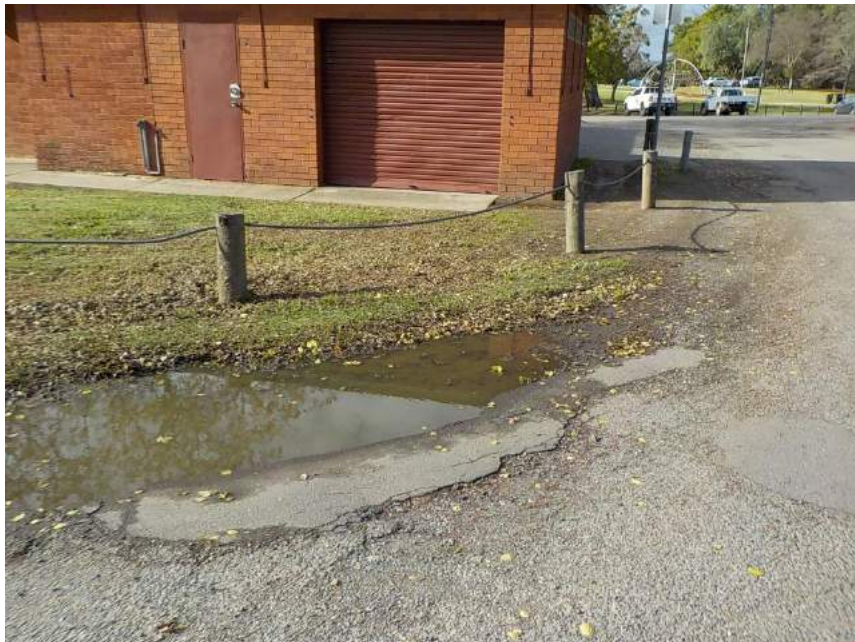
**2018:** Severe ravelling and crocodile cracking on asphalt surface – water pooling.

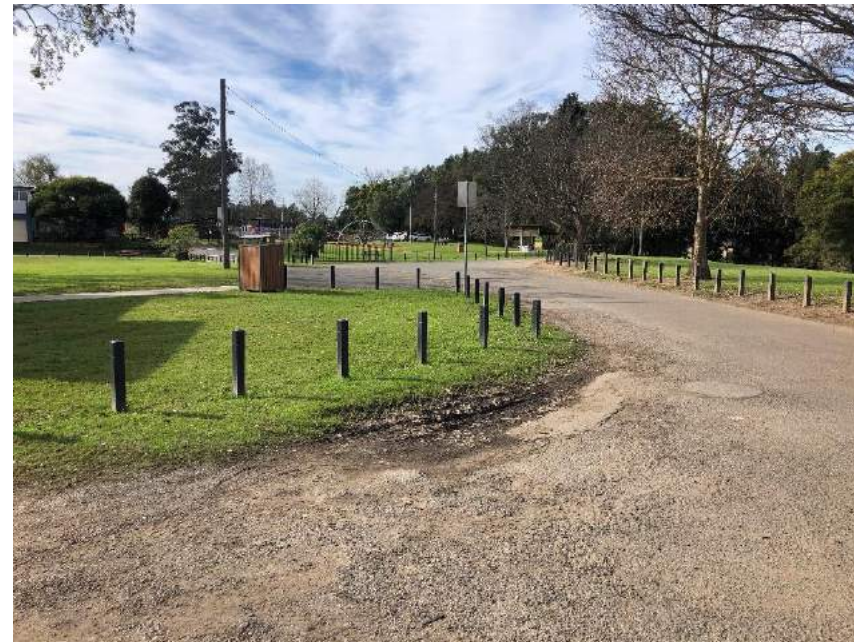
**2021:** Replacement of fencing, no observed changes to asphalt surfacing – consistent with pre-construction survey conditions, removal of amenities building.

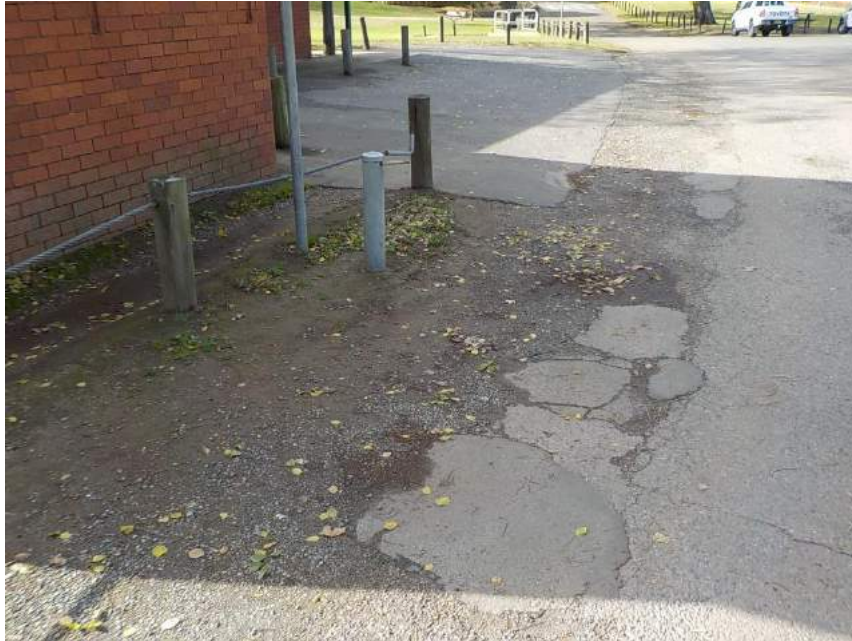
**2018:** Severe damage to asphalt.

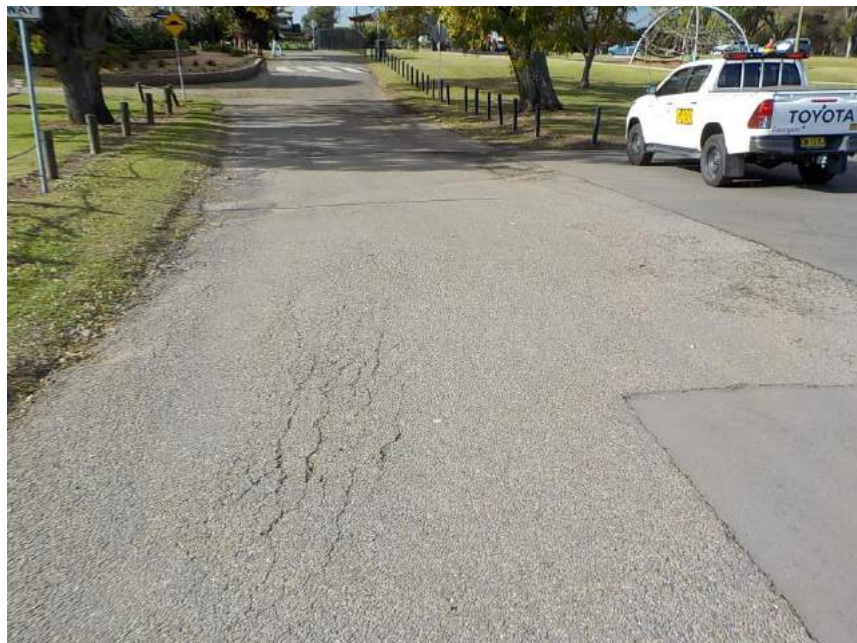
**2018:** Cracking present throughout carpark.

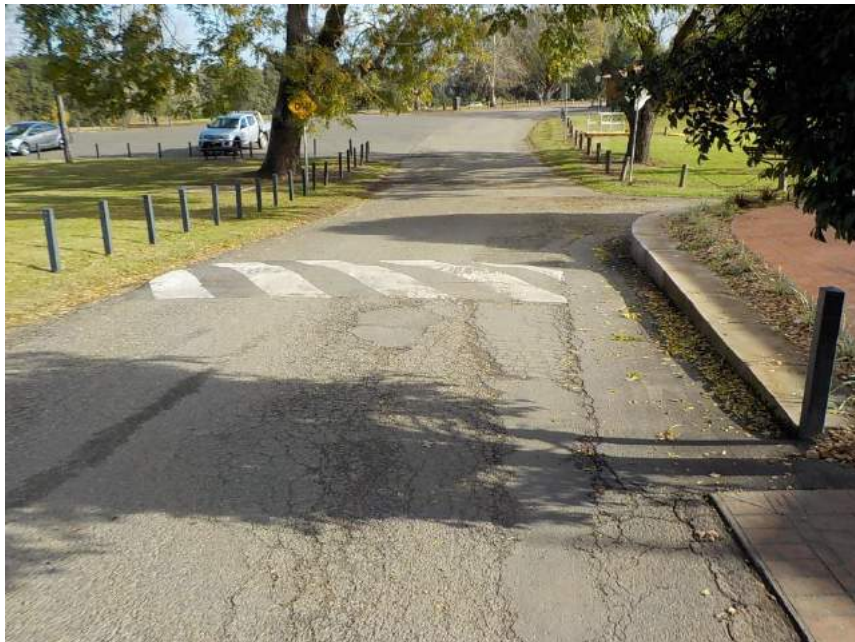
**2018:** Severe damage to asphalt (facing west, toward the end of the carpark).

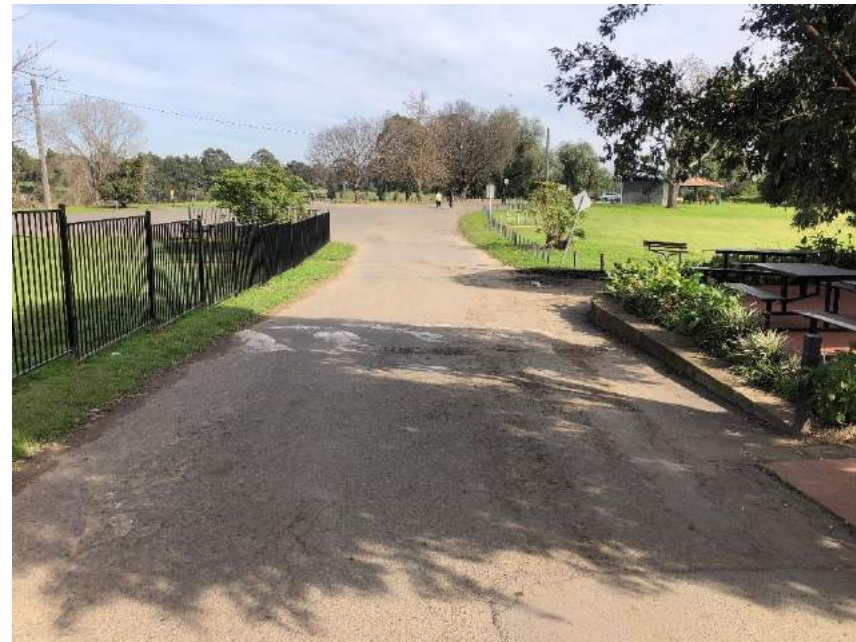
**2021:** Severe damage to asphalt (facing west, toward the end of the carpark) with little to no change compared to pre-construction conditions, fence installation surrounding playground.

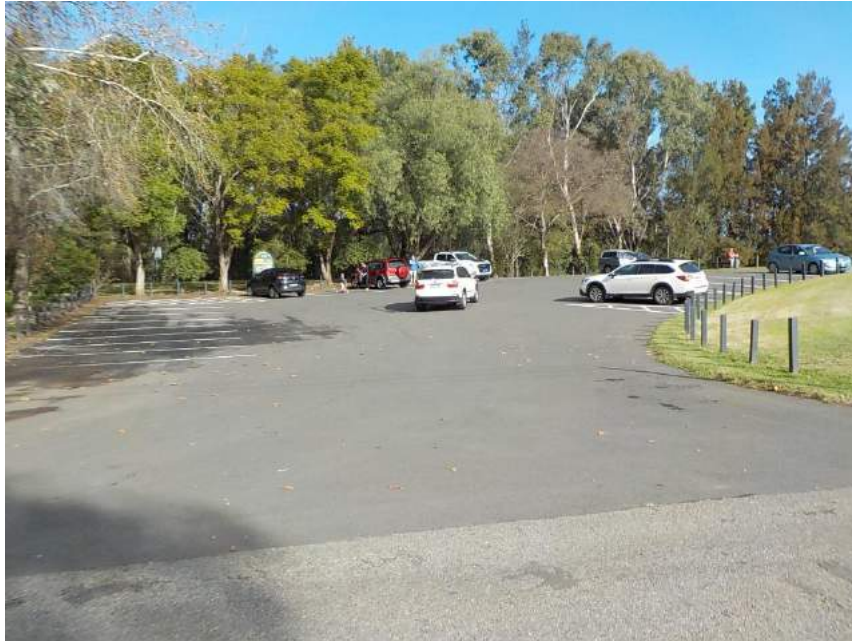
**2018:** General view of carpark toward entrance of Macquarie Park (facing south).

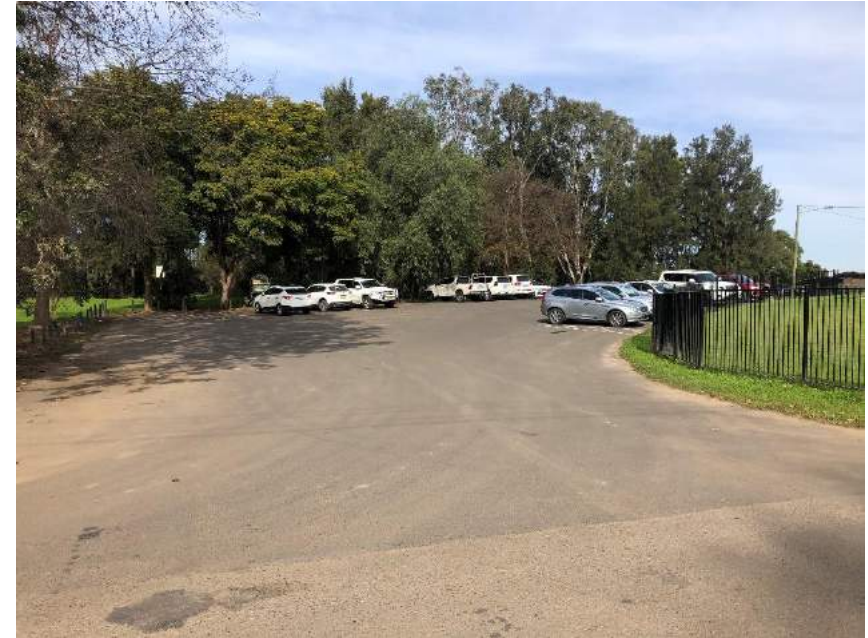
**2021:** General view of carpark toward entrance of Macquarie Park (facing south) – little to no change observed compared to pre-construction survey conditions with the exception of fence installation to the right of carpark entry.

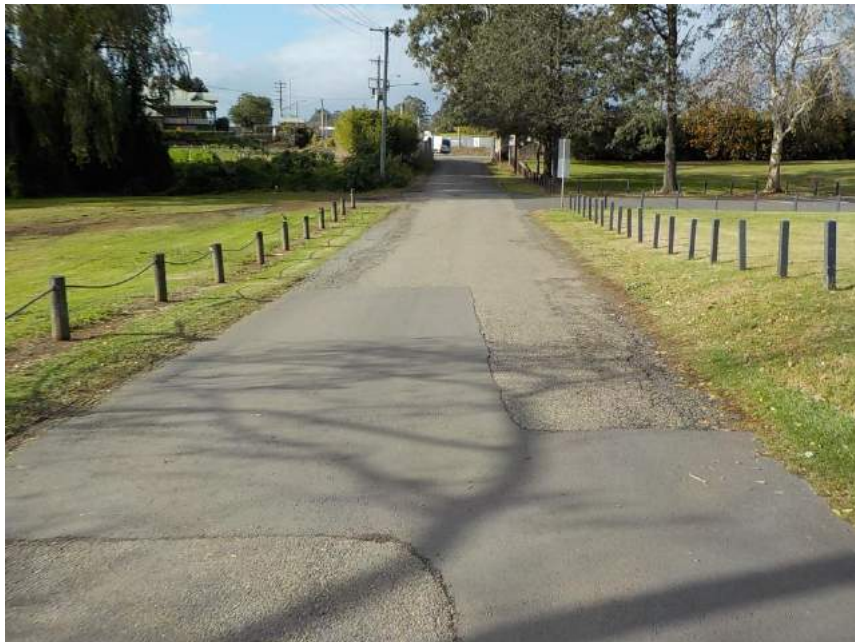
**2018:** Condition of repaired pavement (facing east toward the front gate).

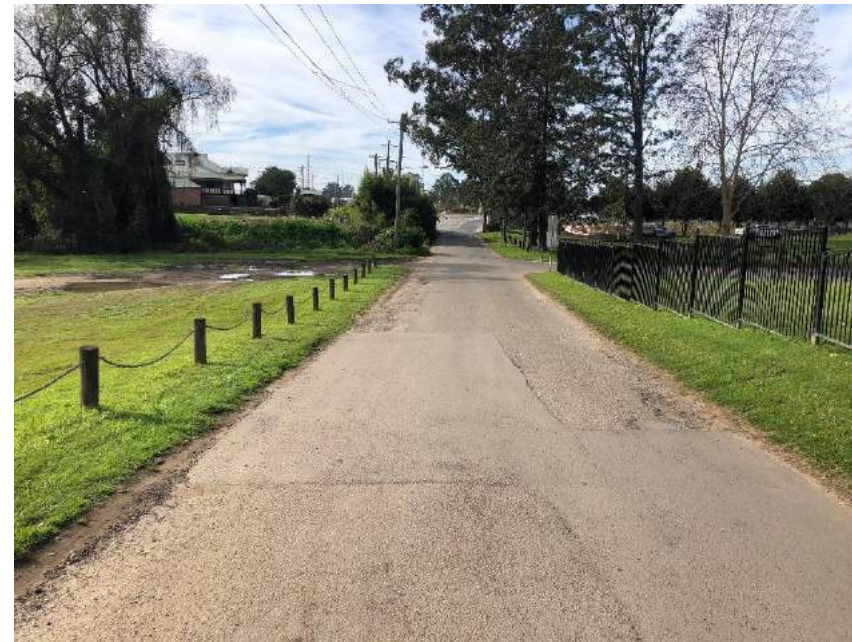
**2021:** Condition of repaired pavement (facing east toward the front gate) – little to no change observed compared to pre-construction survey conditions, installation of fencing to the north of the road.

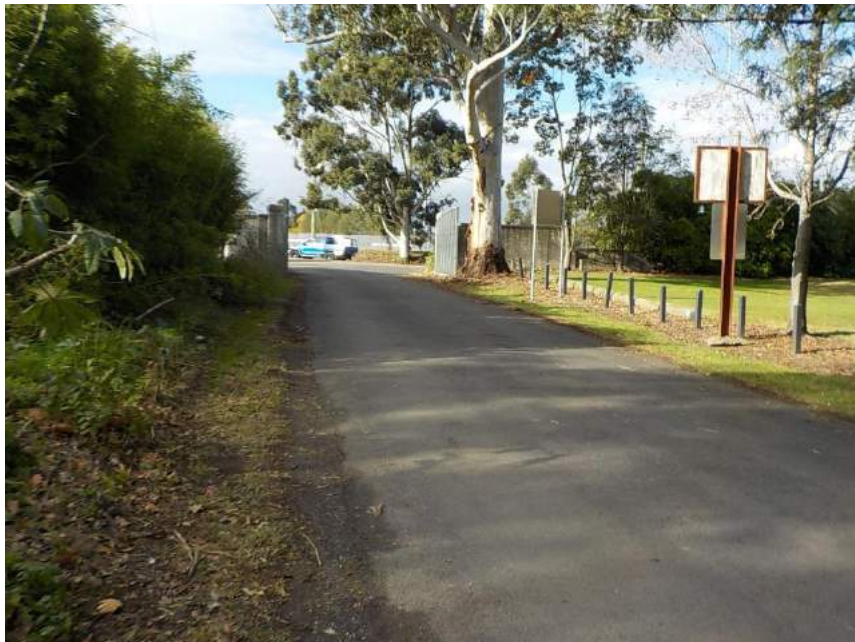
**2018:** Front entrance of Macquarie Park - ravelling along edge of pavement and cracking throughout carpark.

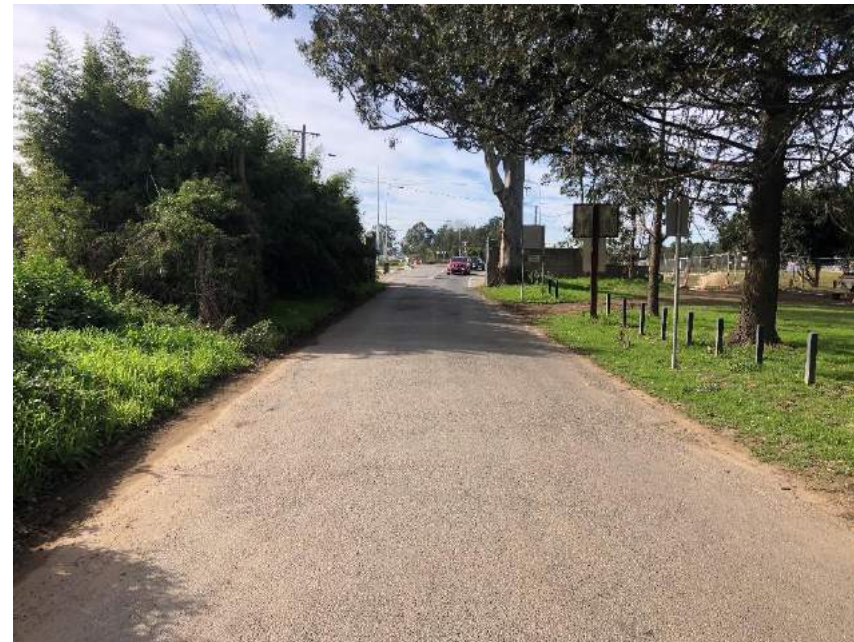
**2021:** Front entrance of Macquarie Park - ravelling along edge of pavement and cracking throughout carpark – little to no change observed compared to pre-construction survey conditions.

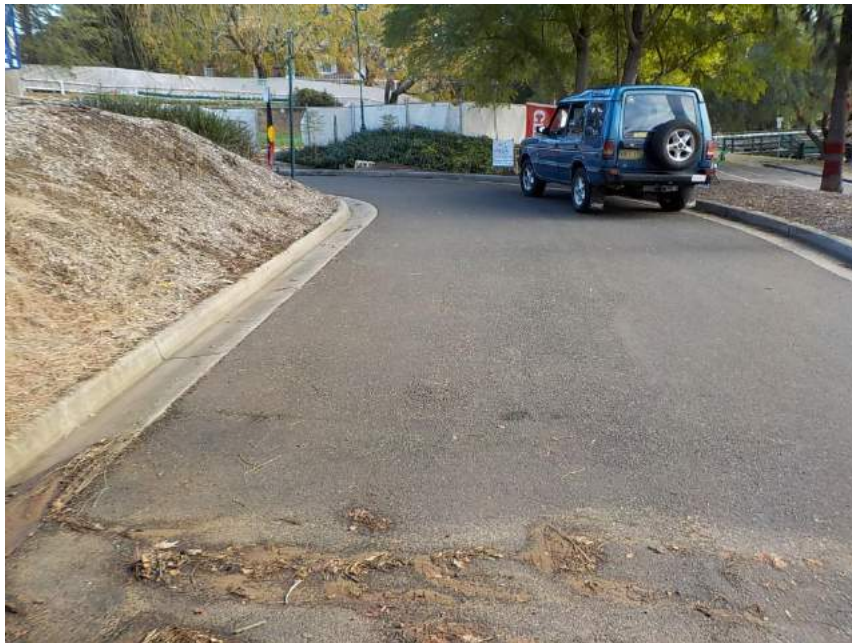
**2018:** Condition carpark front entrance via Old Bridge St.

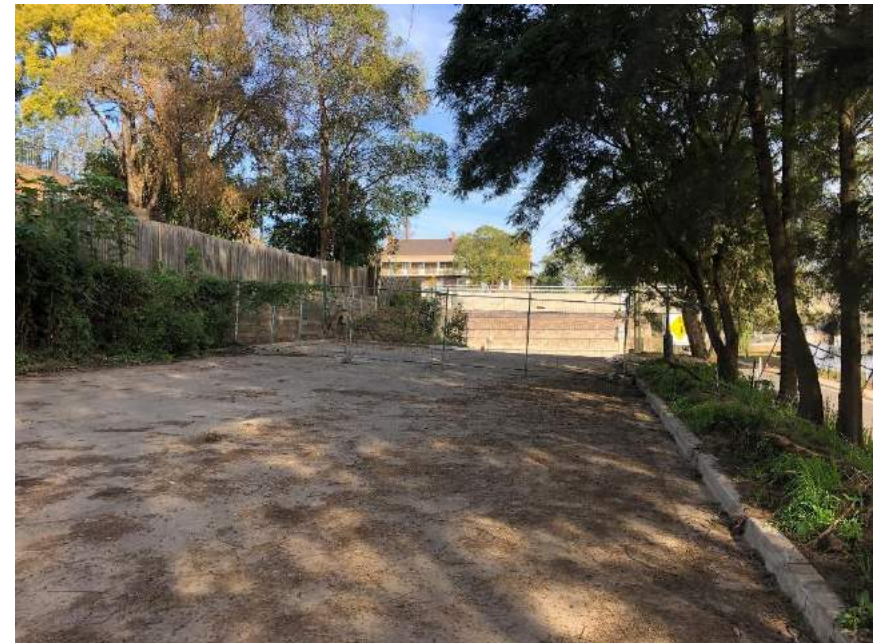
**2021:** Condition carpark front entrance via Old Bridge St – little to no change to asphalt and kerb compared to pre-construction survey conditions. Several portions of temporary fencing remain in place.

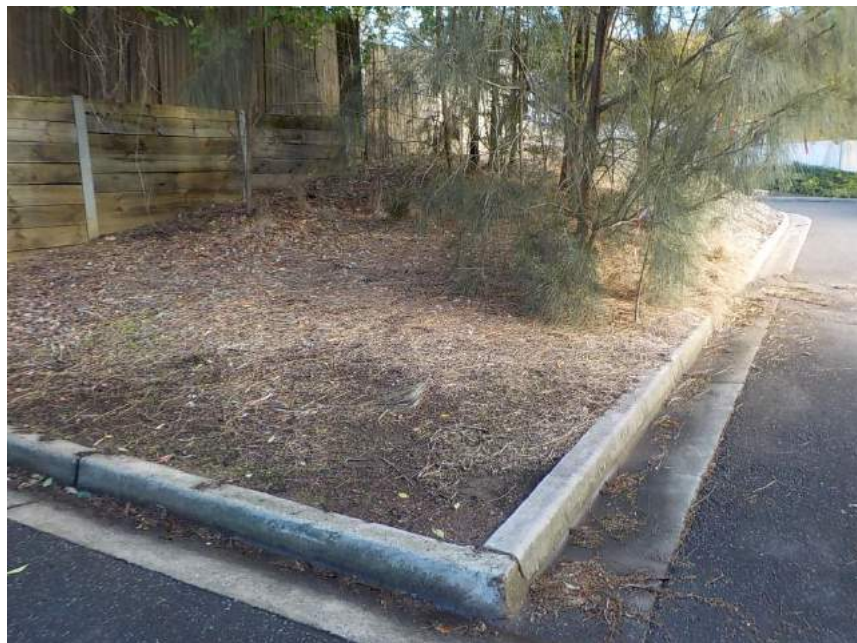
**2018:** Carpark front entrance – general condition of gutter and existing log retaining wall.

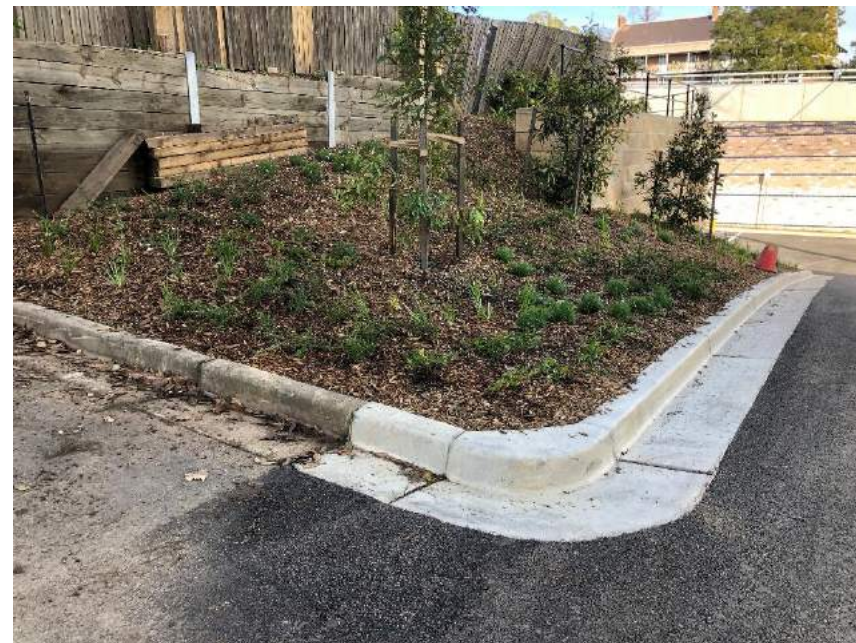
**2021:** Carpark front entrance – upgrades to gutter, new landscaping and log retaining wall remains in place.

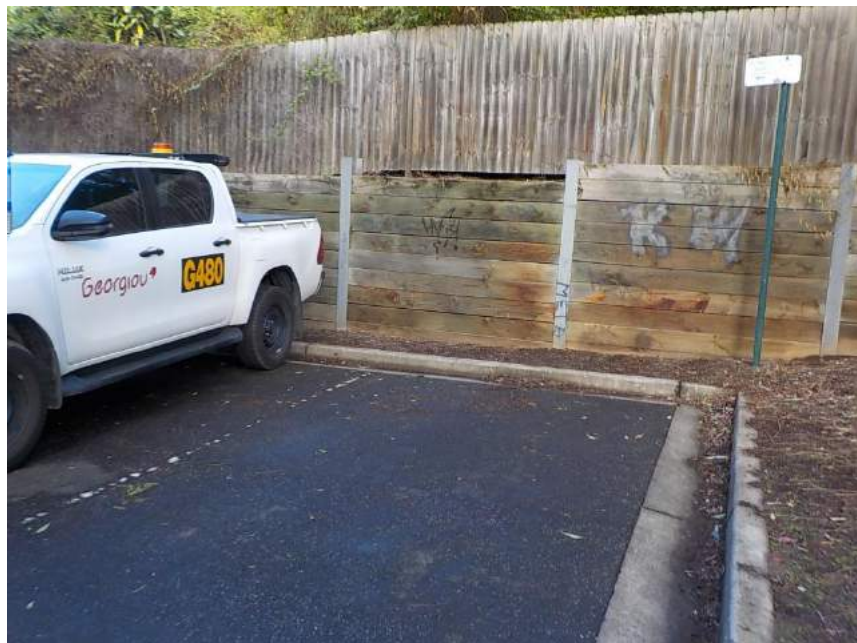
**2018:** First parking spot of carpark – retaining wall weathered and graffiti present. Line marking heavily worn.

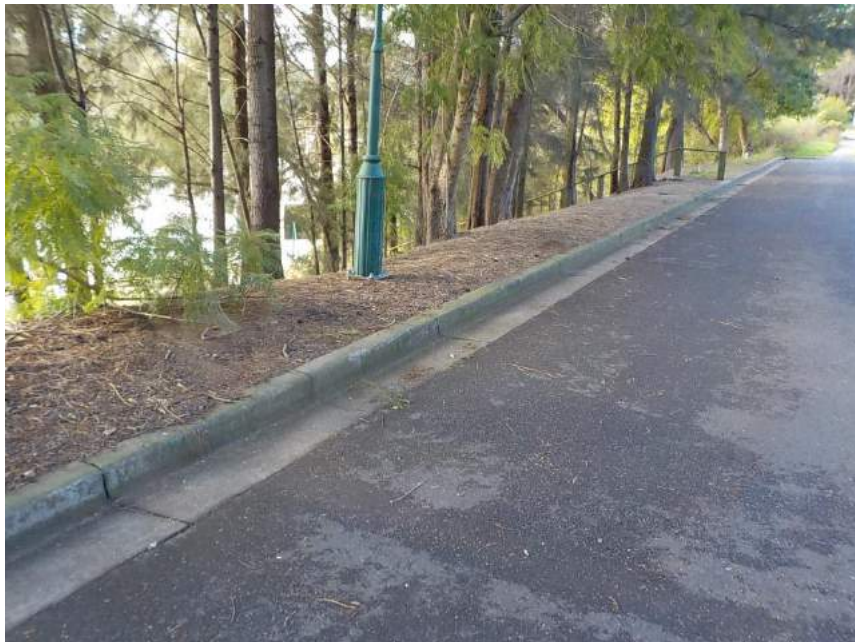
**2018:** General condition of carpark and kerb and gutter.

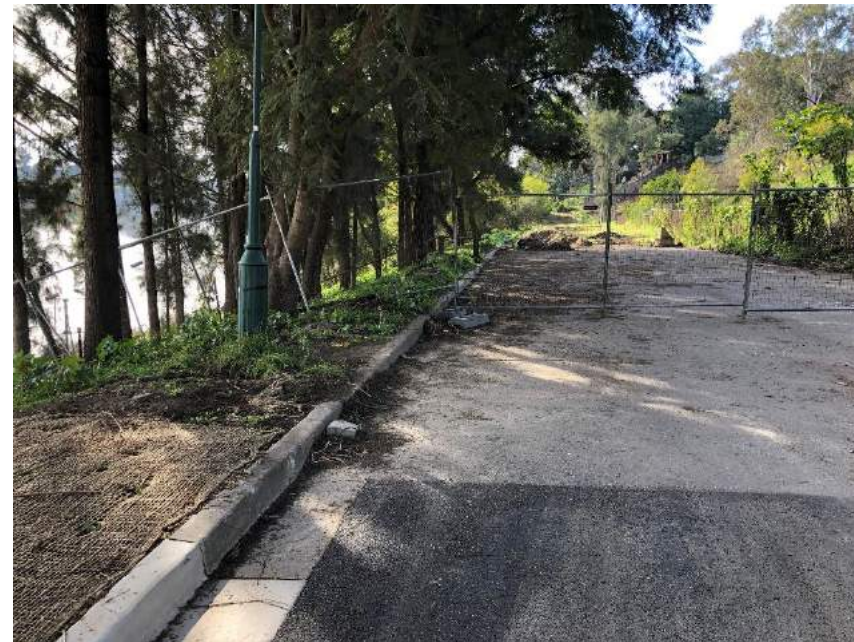
**2021:** General condition of carpark and kerb and gutter, portions of asphalt resurfacing and temporary fencing remain in place.

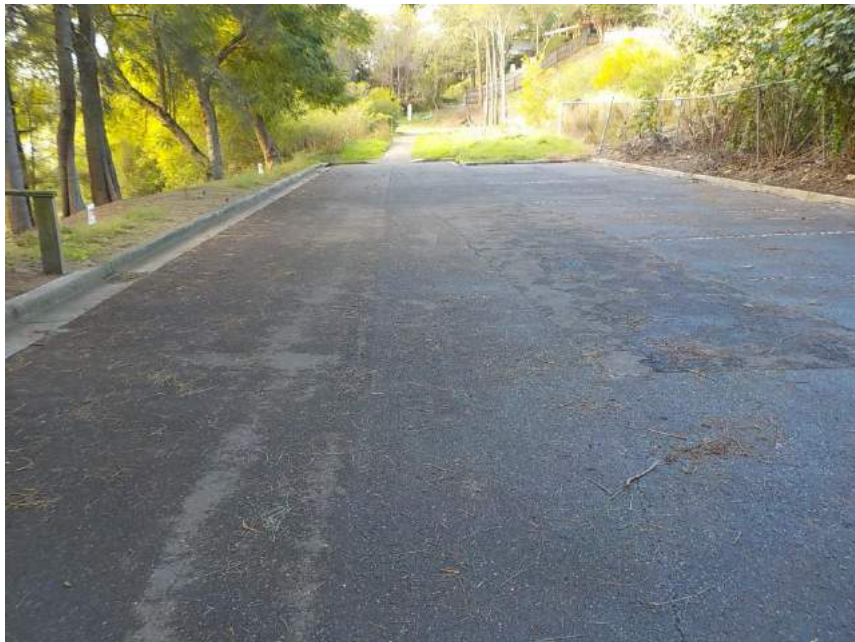
**2018:** General condition of carpark – notable damage and repair work on asphalt surface.

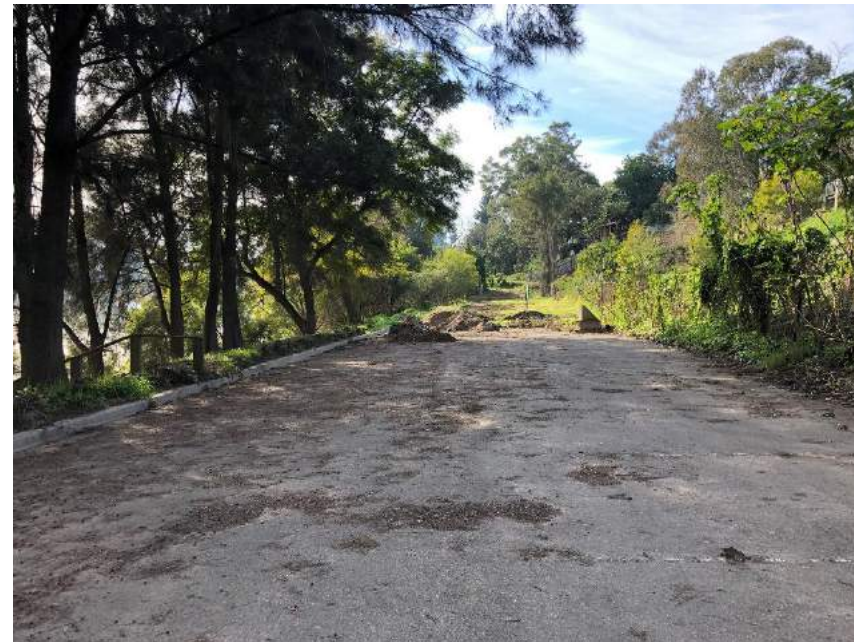
**2021:** General condition of carpark – little to no change observed compared to pre-construction survey conditions surface. Increased sediment located across carpark surface associated with recent flooding event and not construction related.

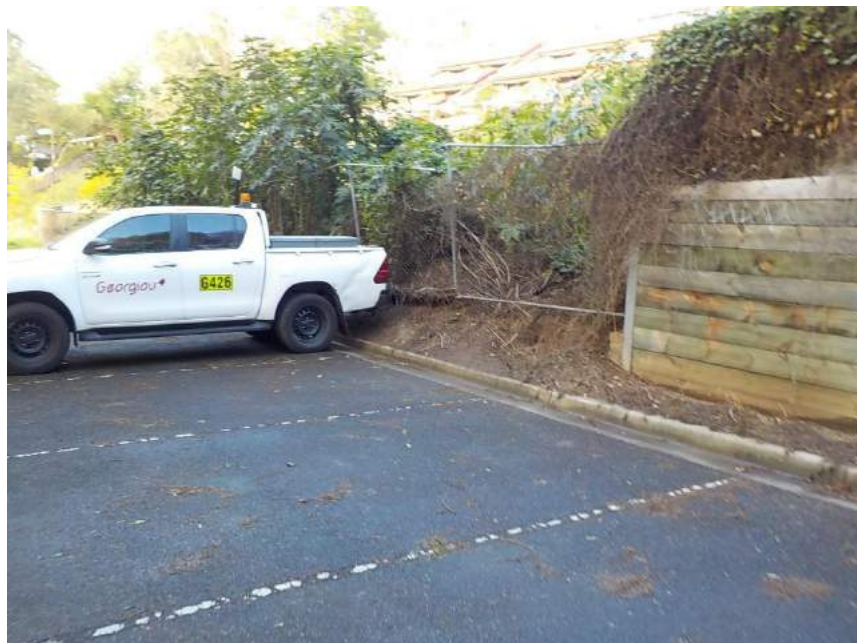
**2018:** Line marking worn out – retaining wall and fence damaged – cracking and pieces missing from kerb.

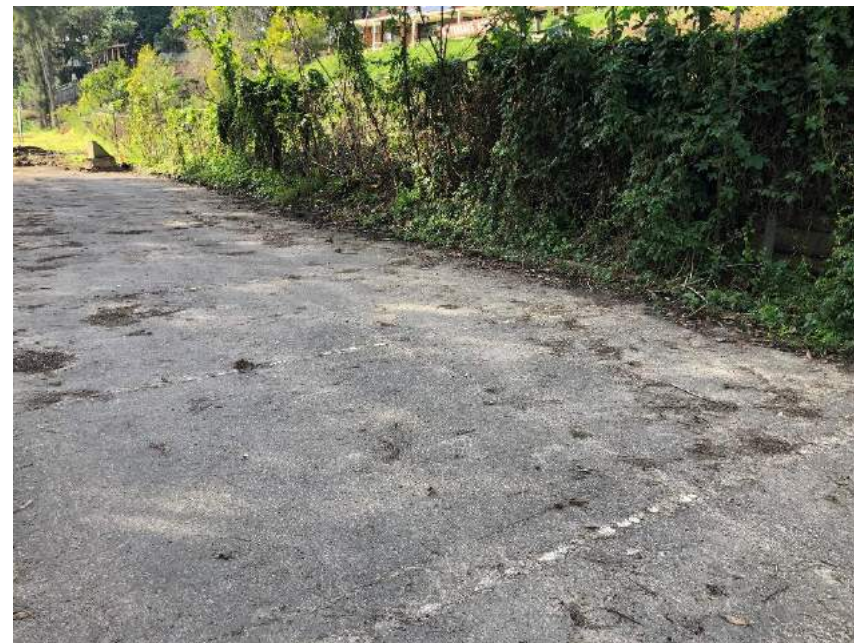
**2021:** Line marking worn out consistent with pre-construction condition – vegetation along retaining wall and fence overgrown.

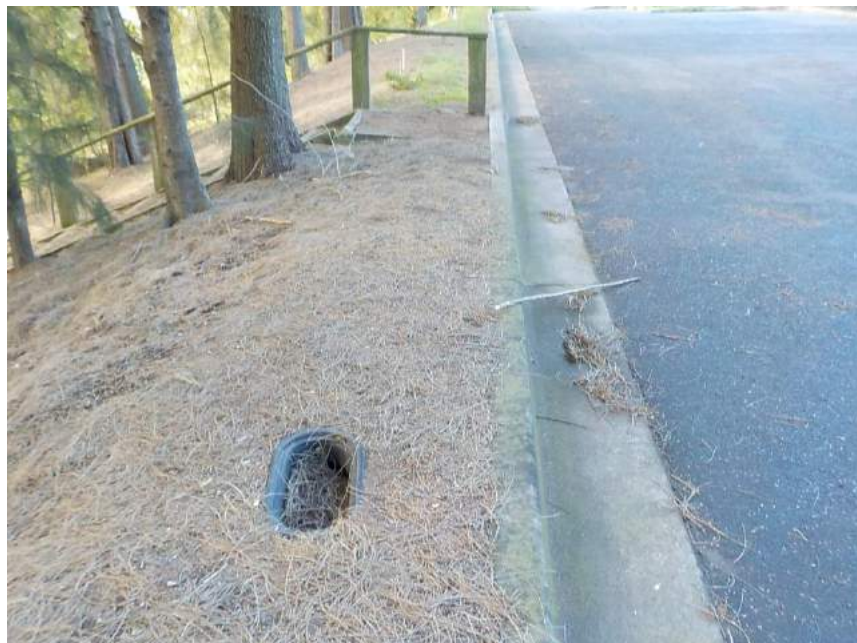
**2018:** Condition of kerb gutter – missing pit lid.

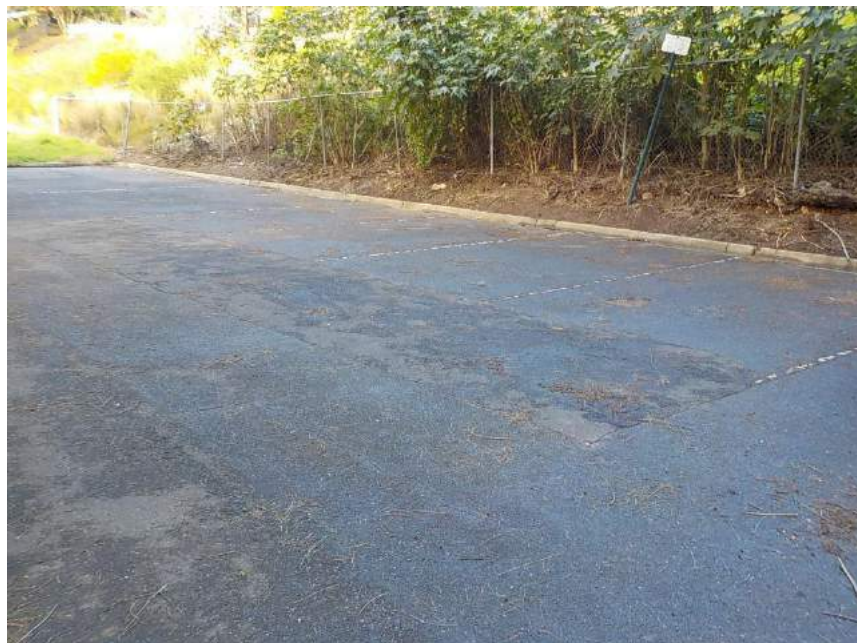
**2018:** Damage to asphalt surface with repaired patches present.
