# Georgiou Group Dilapidation Report, Windsor Bridge Replacement Project, Windsor NSW

S-03139.DilapidationReport.001

**Pre-Dilapidation Photos Taken:** 20<sup>th</sup> June 2018

**Post-Dilapidation Photos Taken:** 8<sup>th</sup> July 2021

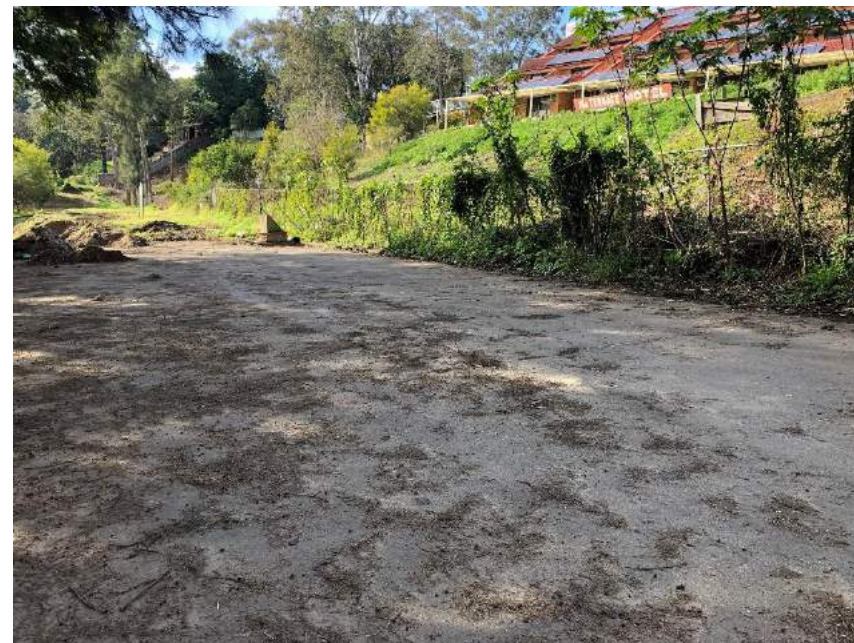
**2021:** Damage to asphalt surface consistent with pre-construction survey conditions, increased surface covering with sand and leaf materials from recent flooding event.

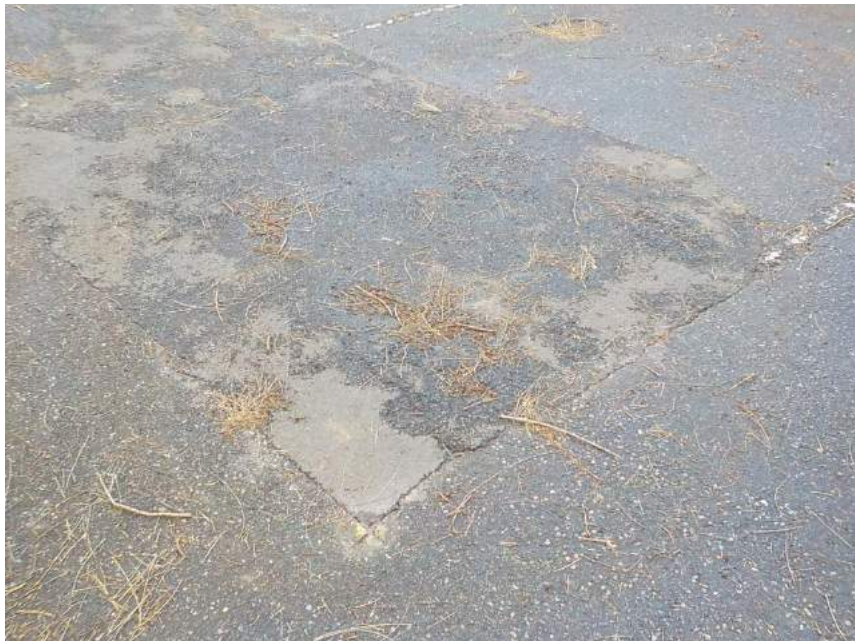
**2018:** Cracking and repair work to asphalt surface.

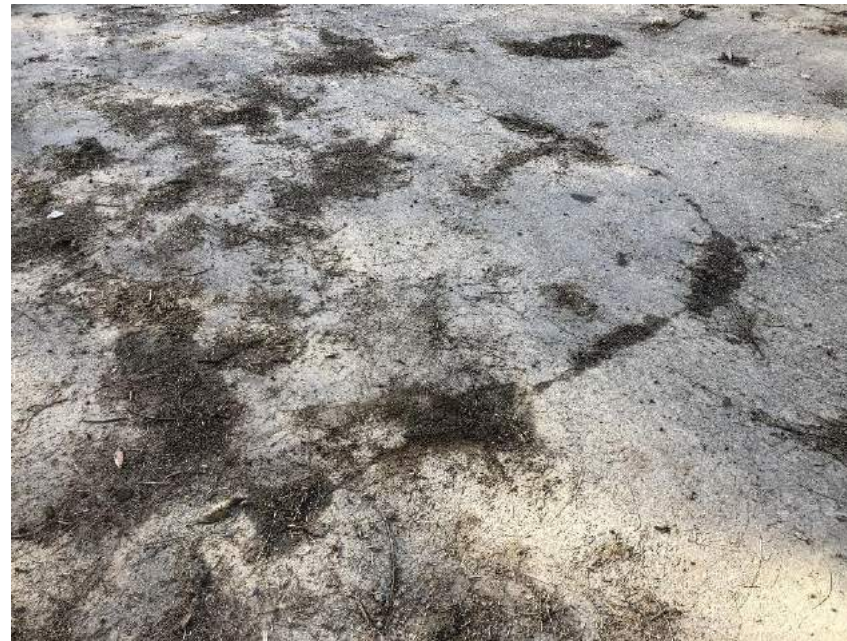
**2021:** Cracking and repair work to asphalt surface – little to no change observed compared to pre-construction survey conditions.

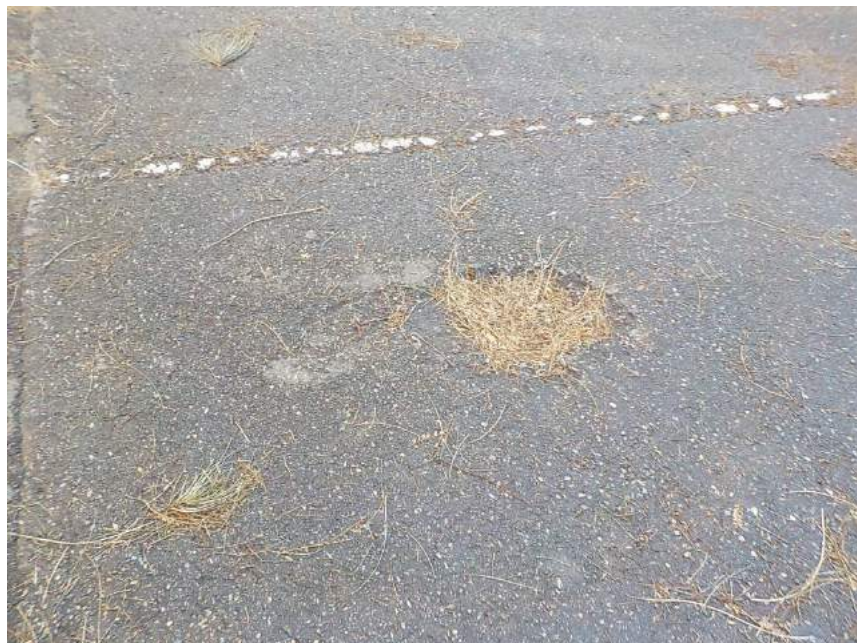
**2018:** Pothole in asphalt surface.

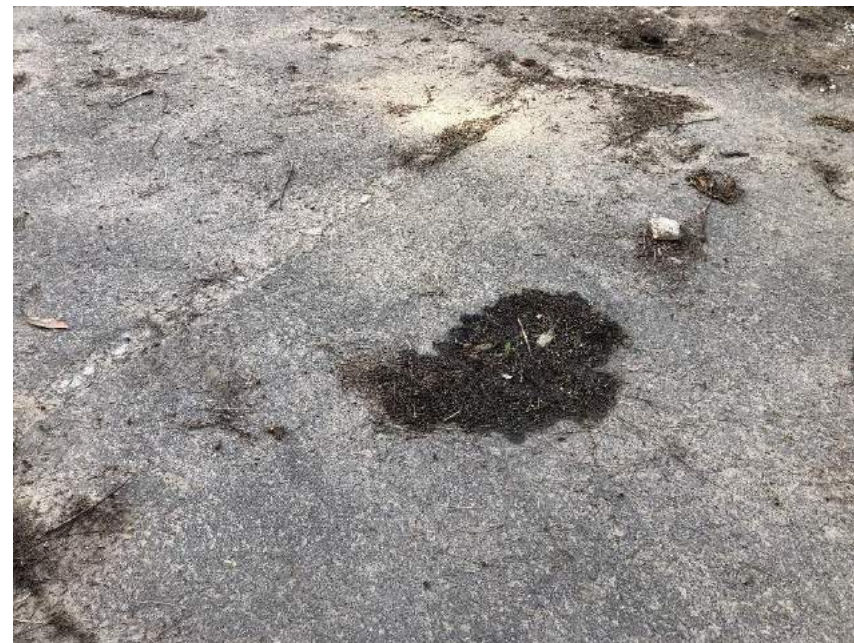
**2021:** Pothole in asphalt surface – little to no change observed compared to pre-construction survey conditions.

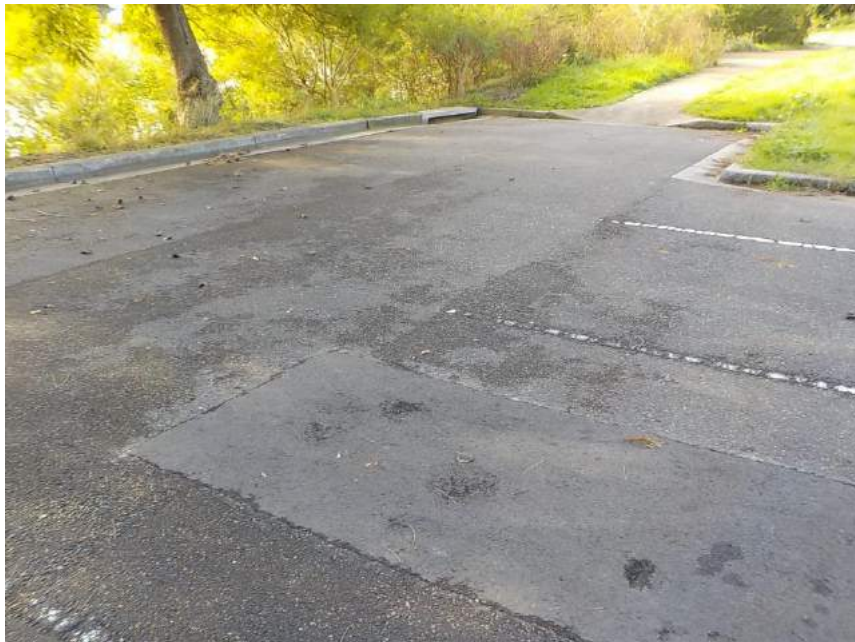
**2018:** Cracking and repair work to asphalt surface - line marking worn.

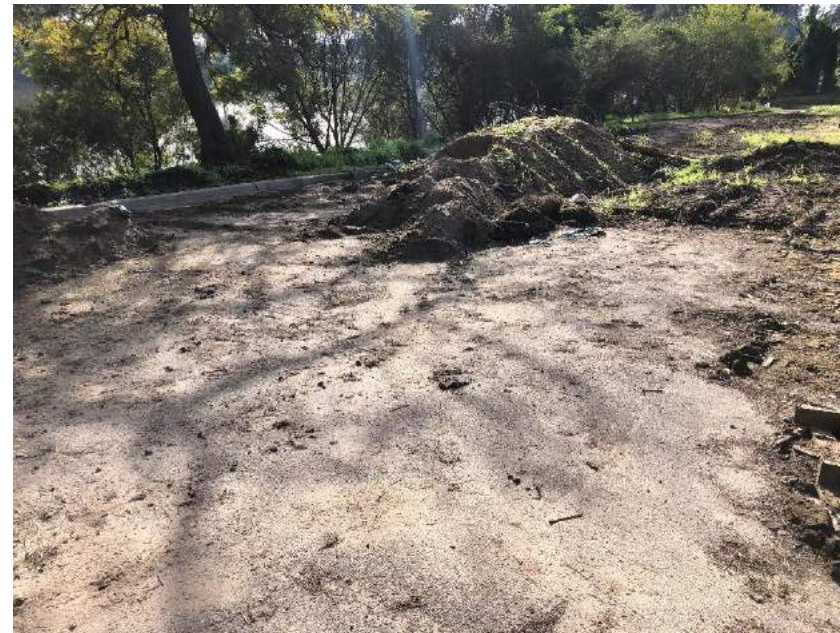
**2021:** Cracking and repair work to asphalt surface, line marking worn – little to no change observed compared to pre-construction survey conditions. Small stockpiles of sand materials located towards the rear of the carpark and not associated with project.

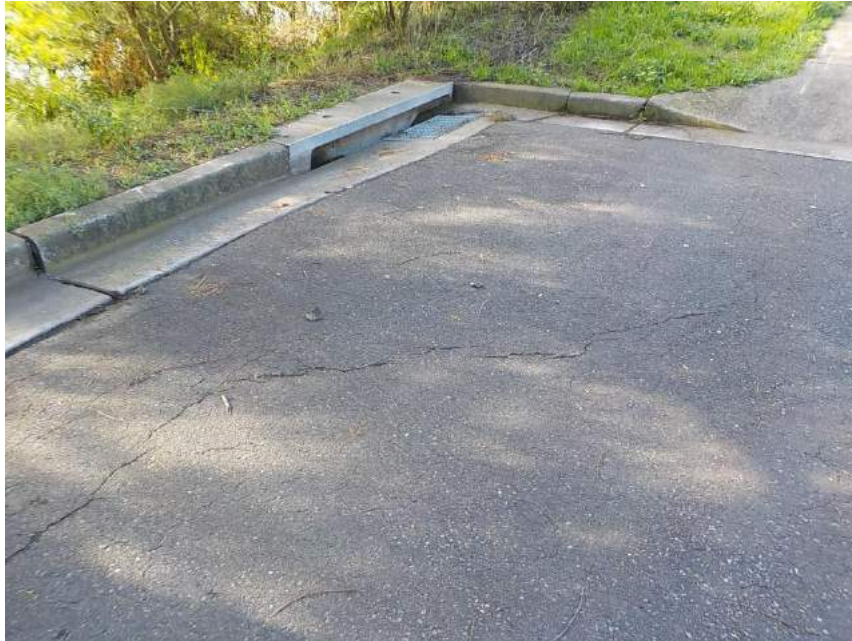
**2018:** Cracking on asphalt surface, kerb, and gutter.

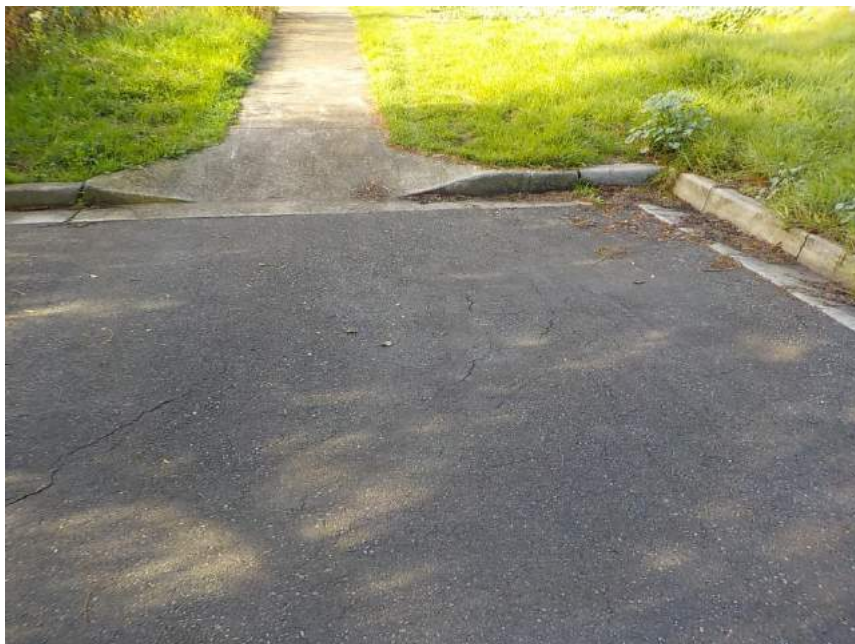
**2018:** Cracking on asphalt surface, kerb and gutter.

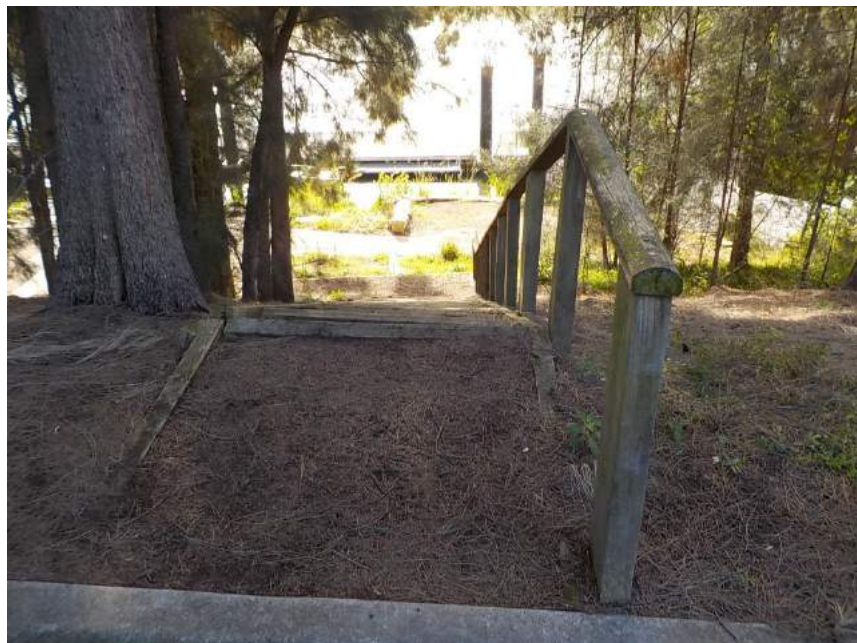
**2018:** Condition of staircase leading from carpark to the wharf – weathered steps and handrail.

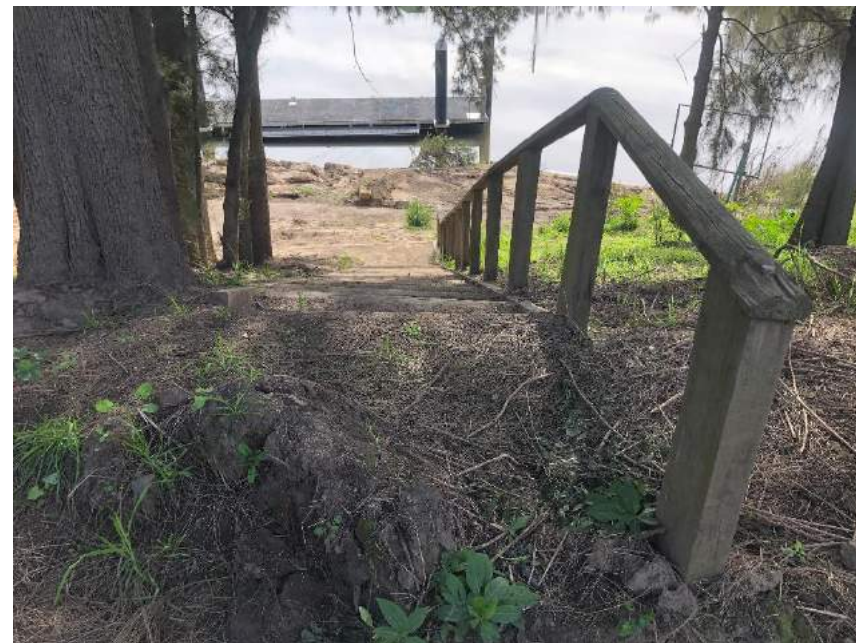
**2021:** Condition of staircase leading from carpark to the wharf – weathered steps and handrail – little to no change observed compared to pre-construction survey conditions.

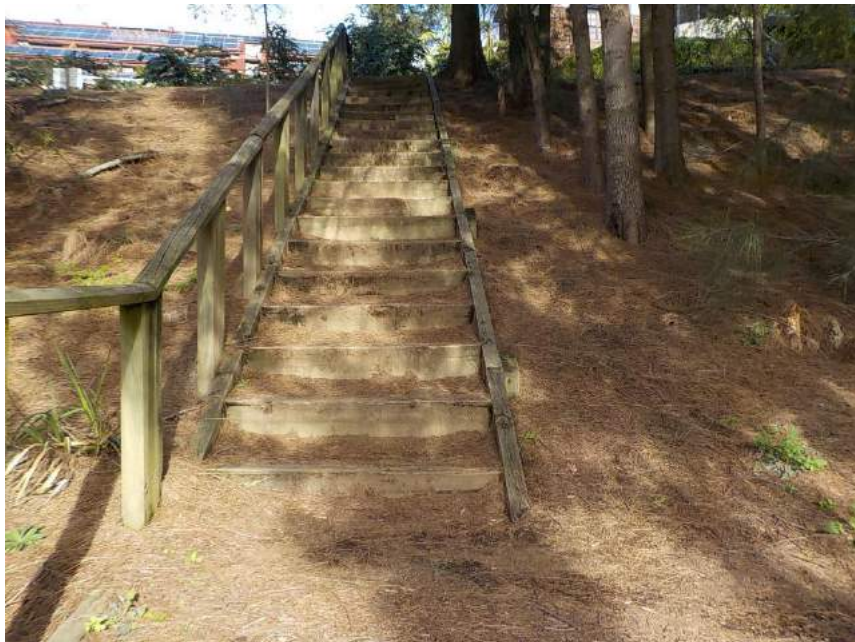
**2018:** Condition of staircase leading from wharf to the carpark – weathered steps and handrail.

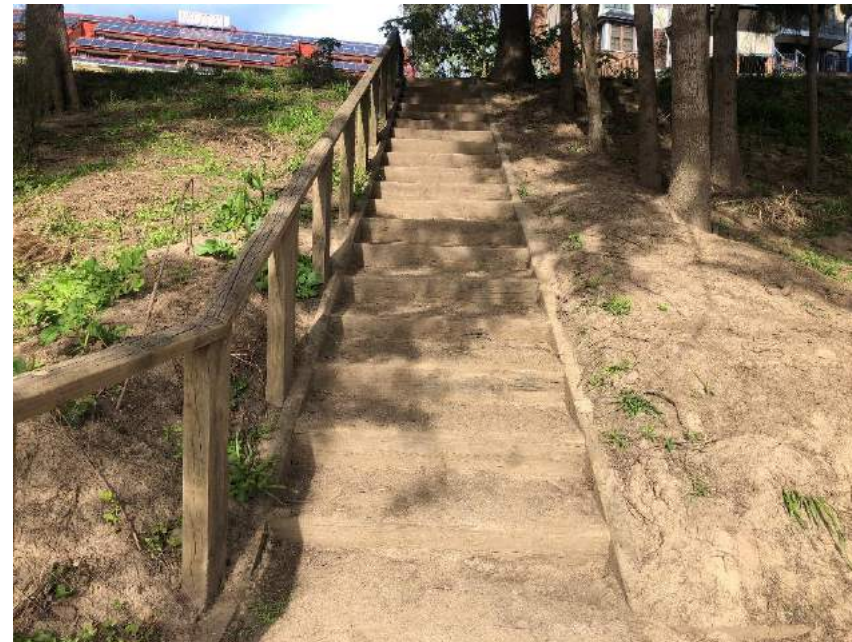
**2021:** Condition of staircase leading from wharf to the carpark – weathered steps and handrail – little to no change observed compared to pre-construction survey conditions.

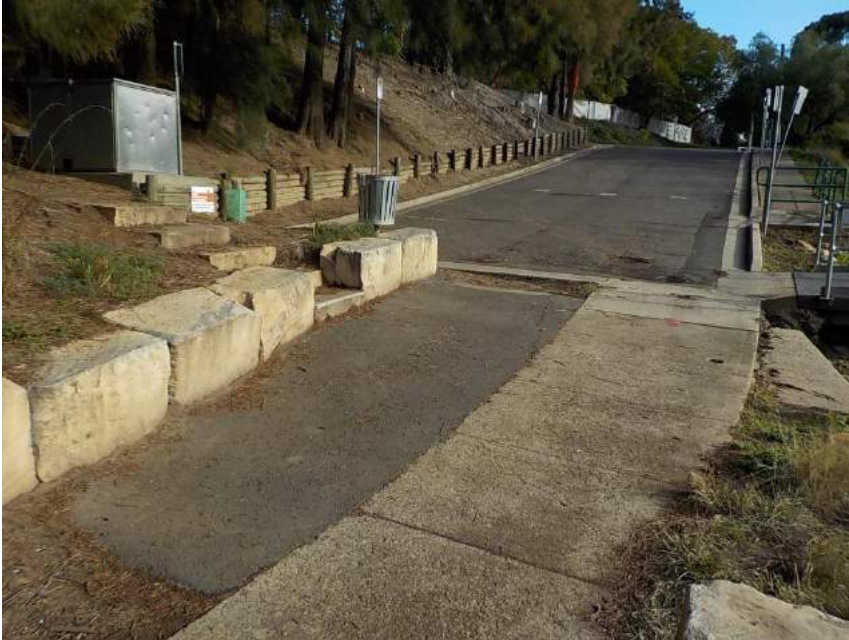
**2018:** General view from bottom of staircase/wharf facing the existing bridge.

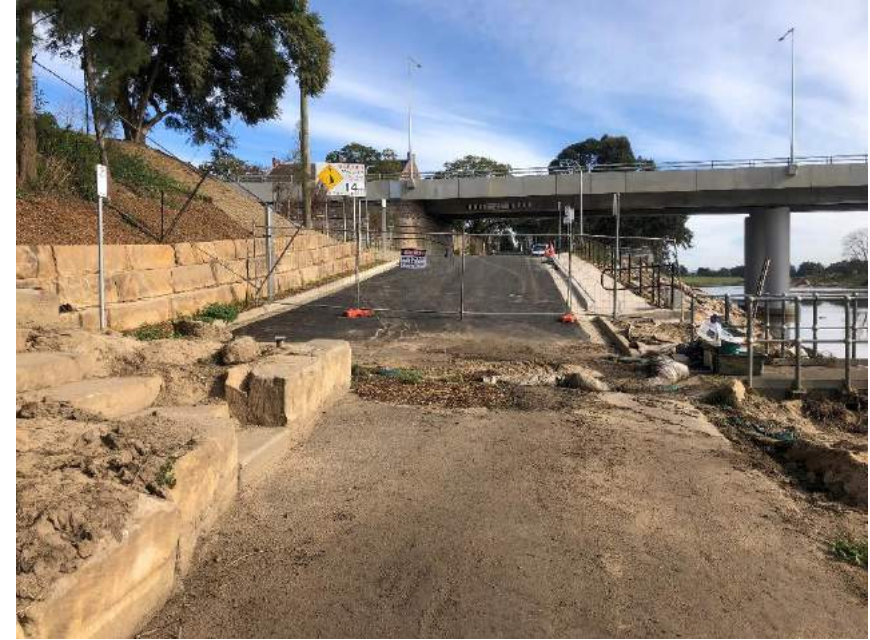
**2021:** View from bottom of staircase/wharf facing the newly constructed bridge and surrounding relandscaped area. Upgrades to asphalt surfacing, sandstone retaining walls and barricades.

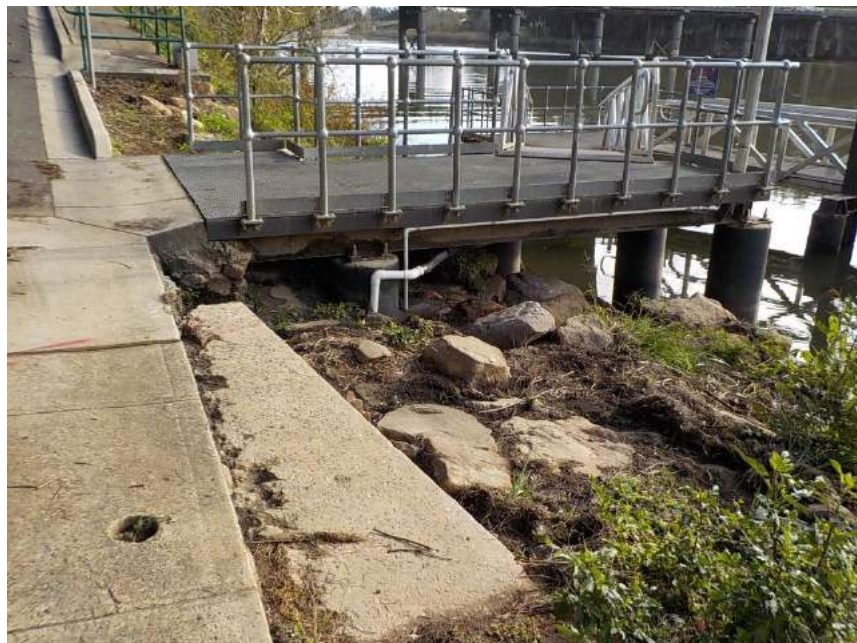
**2018:** General condition of jetty.

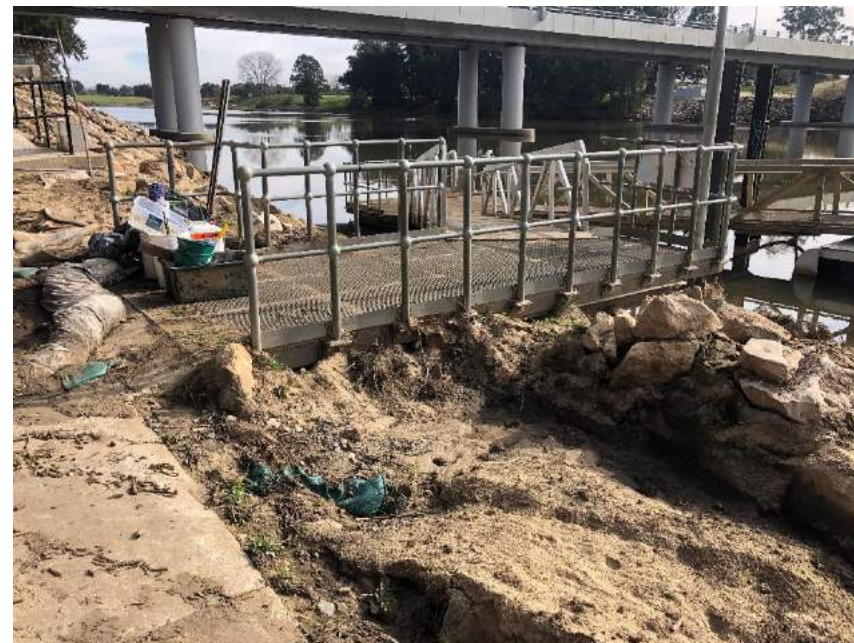
**2021:** General condition of jetty consistent with pre-construction survey conditions, additional sand materials stockpiled surrounding jetty associated with recent flooding.

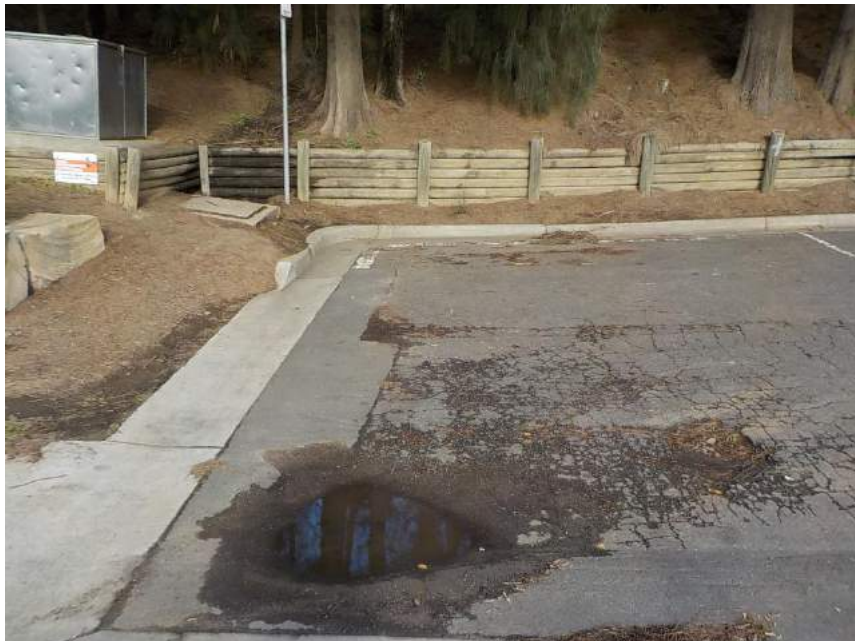
**2018:** Pavement from jetty entrance – heavily damaged asphalt surface – severe cracking and potholing – pooling on surface – damaged log retaining wall – cracking on gutter and pram ramp.

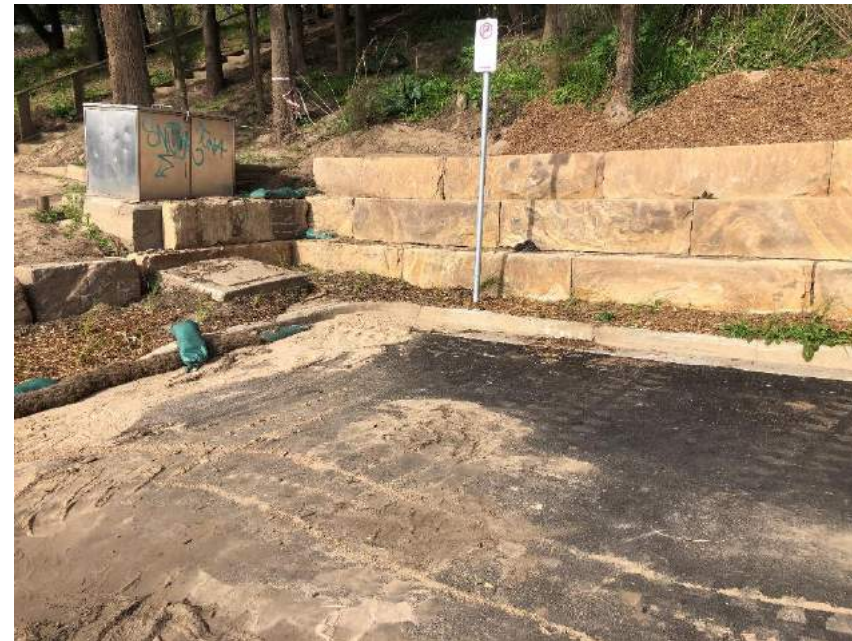
**2021:** Pavement from jetty entrance – newly installed asphalt surface and sandstone retaining wall.

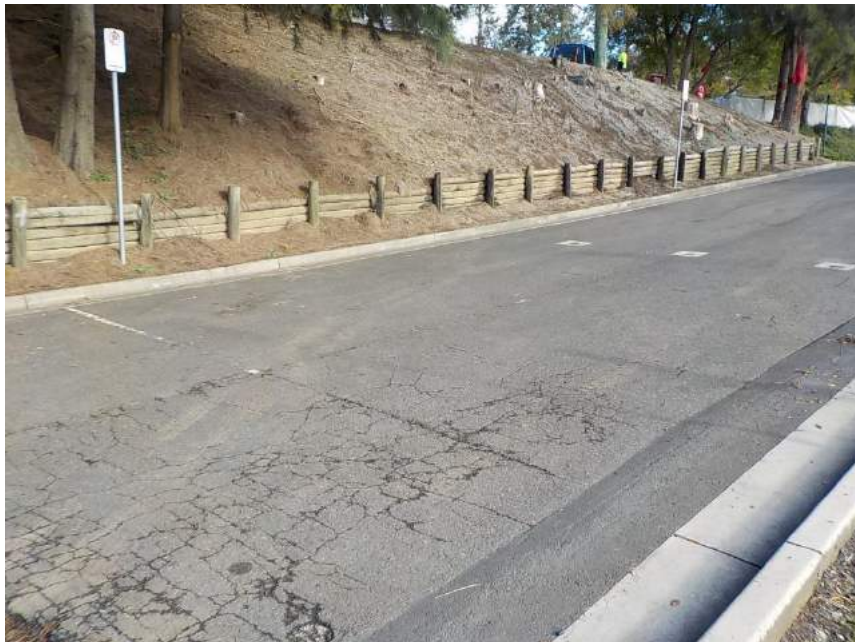
**2018:** Pavement from jetty entrance – heavily damaged asphalt surface – severe cracking and potholing – damaged log retaining wall with one section blown out and material coming through.

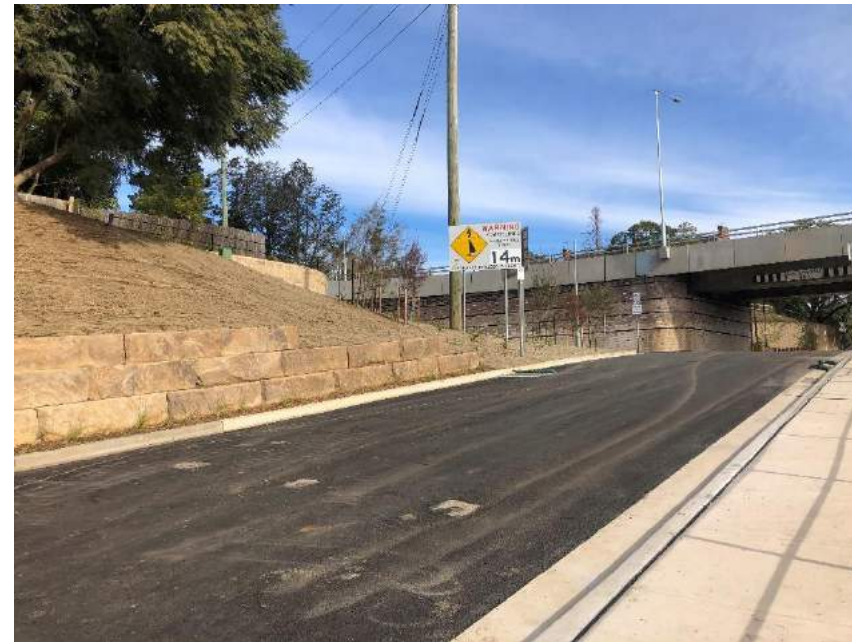
**2021:** Pavement from jetty entrance – newly installed asphalt surface and sandstone retaining wall.

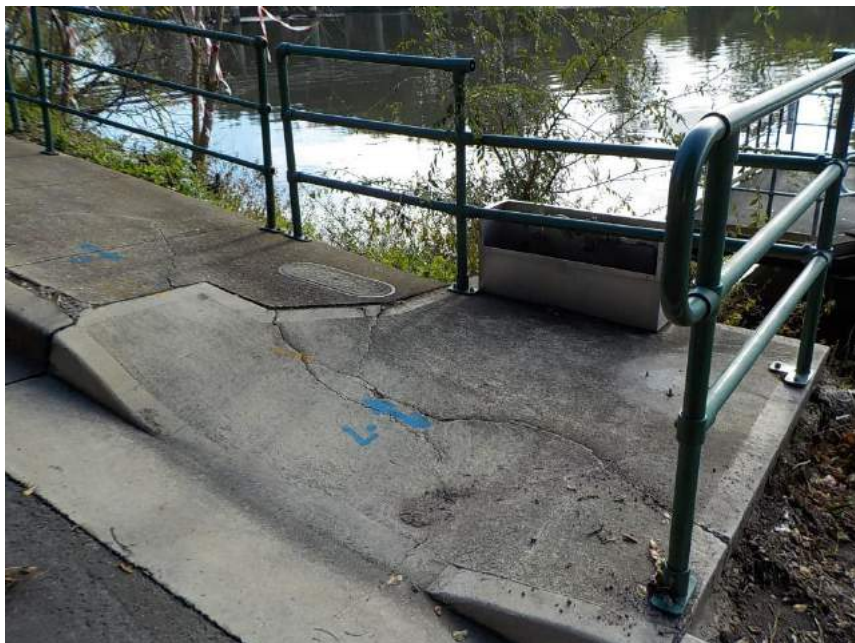
**2018:** Severe cracking on footpath entrance – section of top rail missing from handrail.

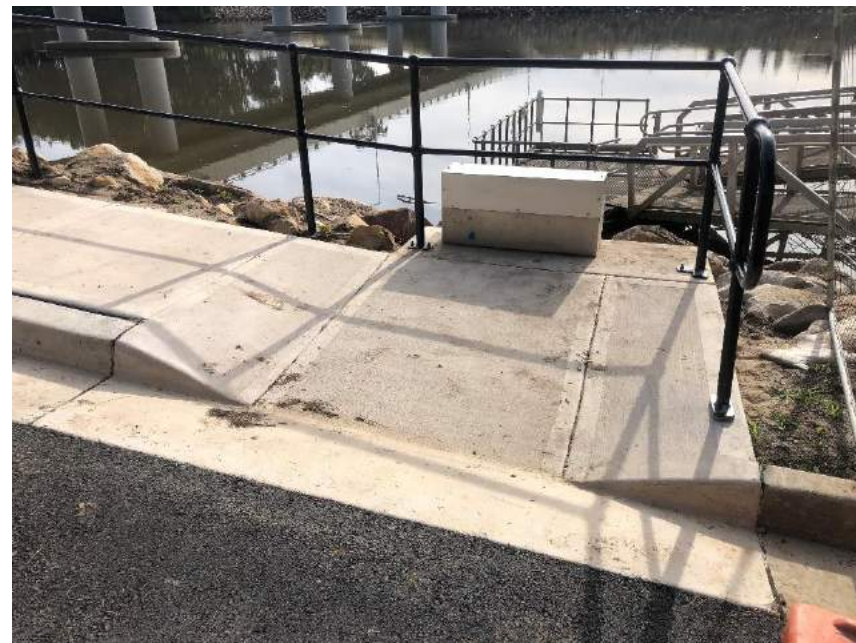
**2021:** Newly installed concrete across footpath entrance and repaired handrail.

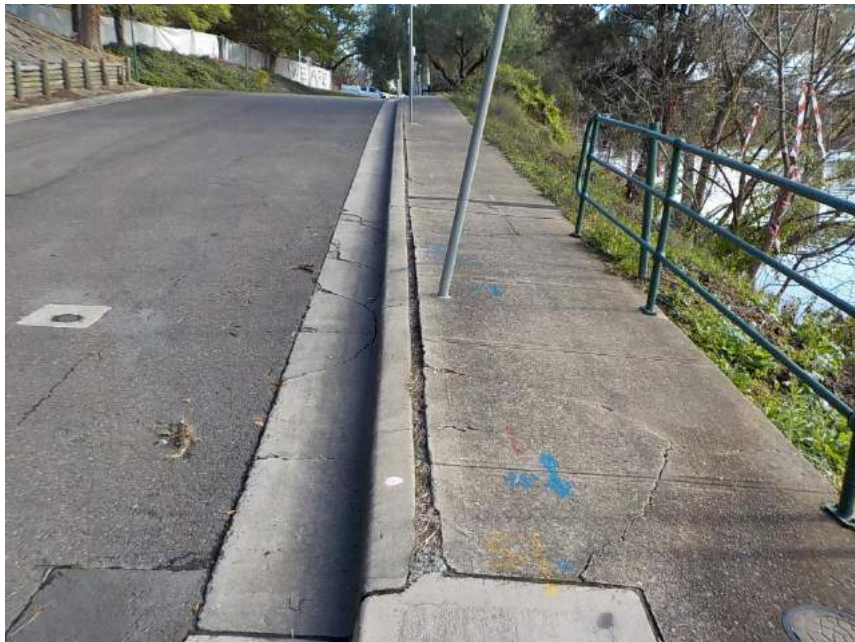
**2018:** Severe cracking on footpath – noticeable heaving in footpath – signpost on an angle – separation between kerb and footpath – cracking on kerb, gutter and asphalt surface.

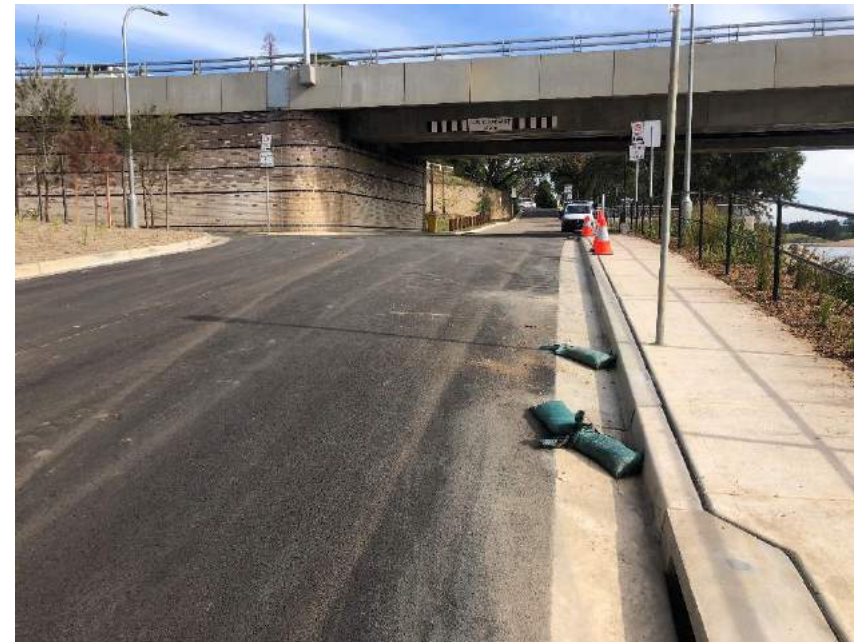
**2021:** Re-concreting along footpath, newly installed handrail, signage, and asphalt road surfacing. Facing towards new bridge. Several silt stocks and cones remain.

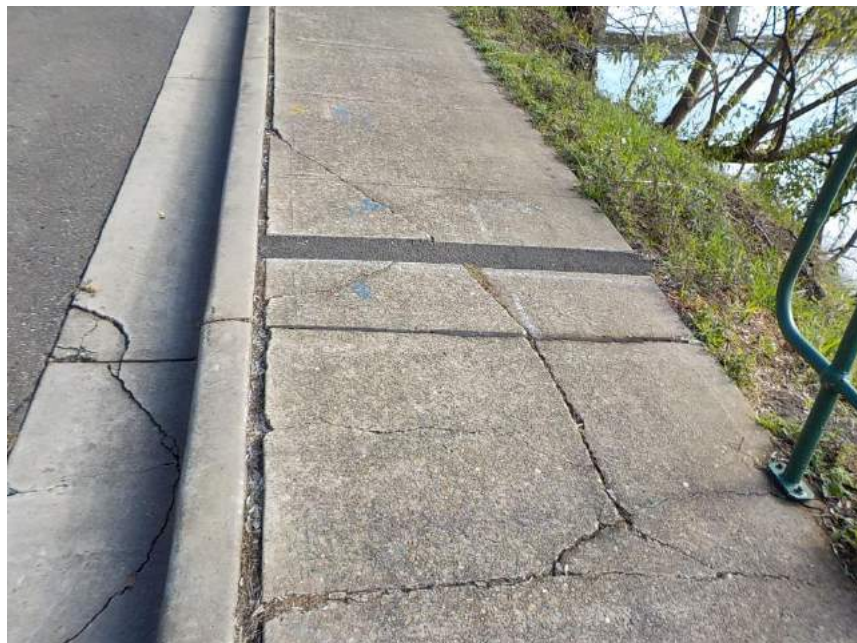
**2018:** Severe cracking on footpath – noticeable heaving in footpath – separation between kerb and footpath – cracking on kerb, gutter and asphalt surface – cold mix repair work on footpath.

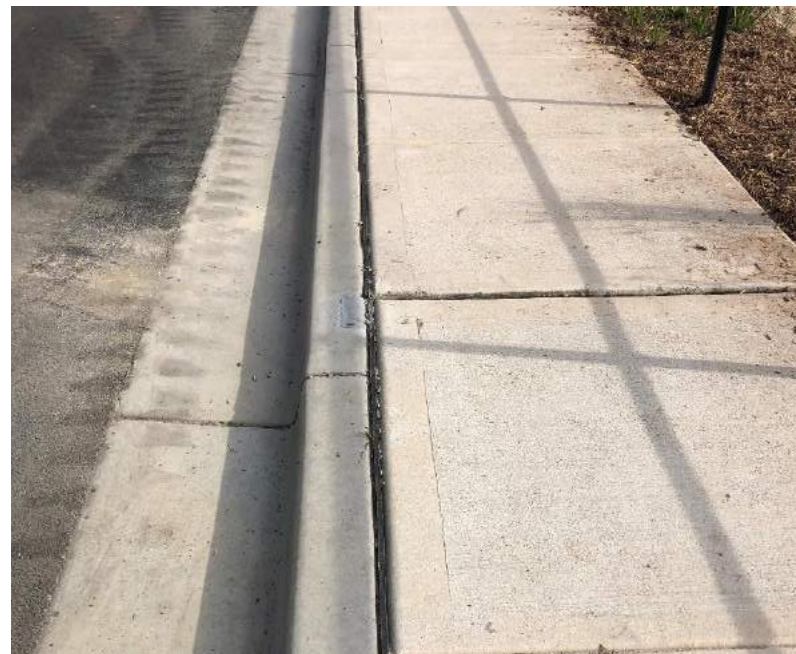
**2021:** New concrete of footpath and gutter.

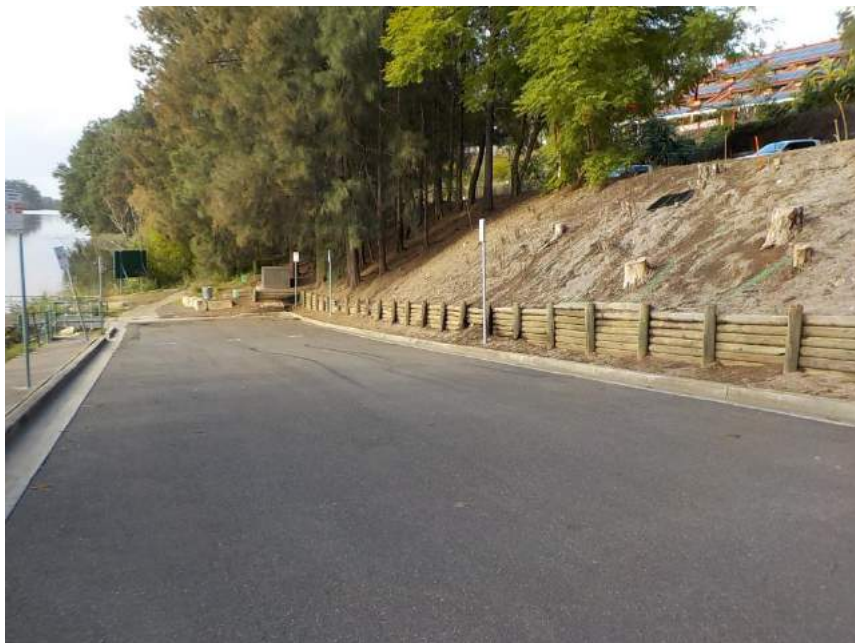
**2018:** General view facing staircase/jetty.

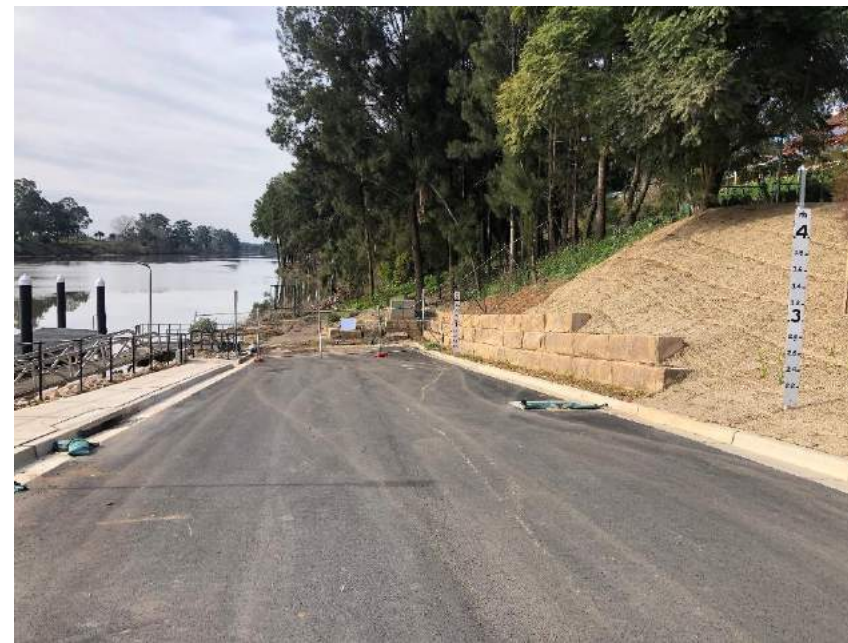
**2021:** General view facing staircase/jetty – roadway resurfacing, newly installed footpaths, retaining wall and landscaping.

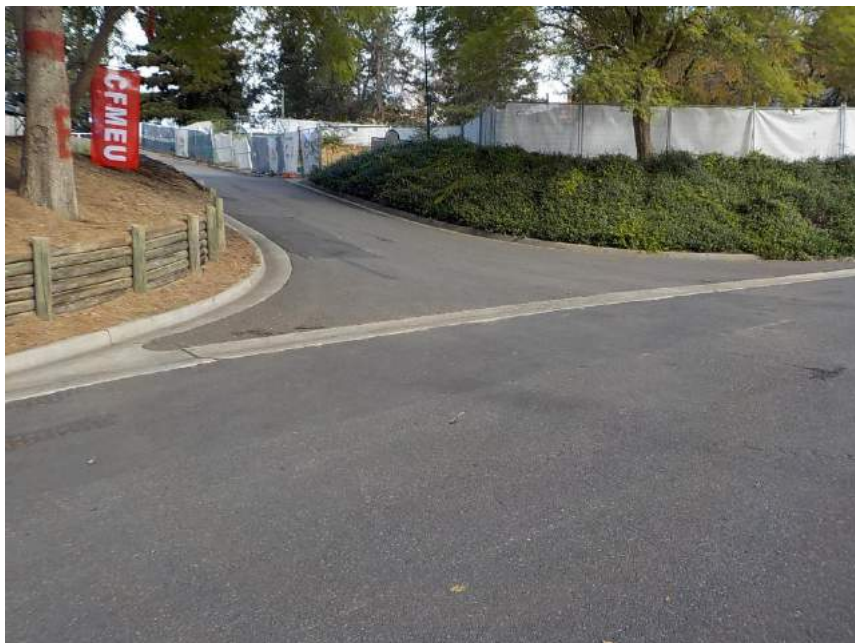
**2018:** Intersection with Old Bridge St.

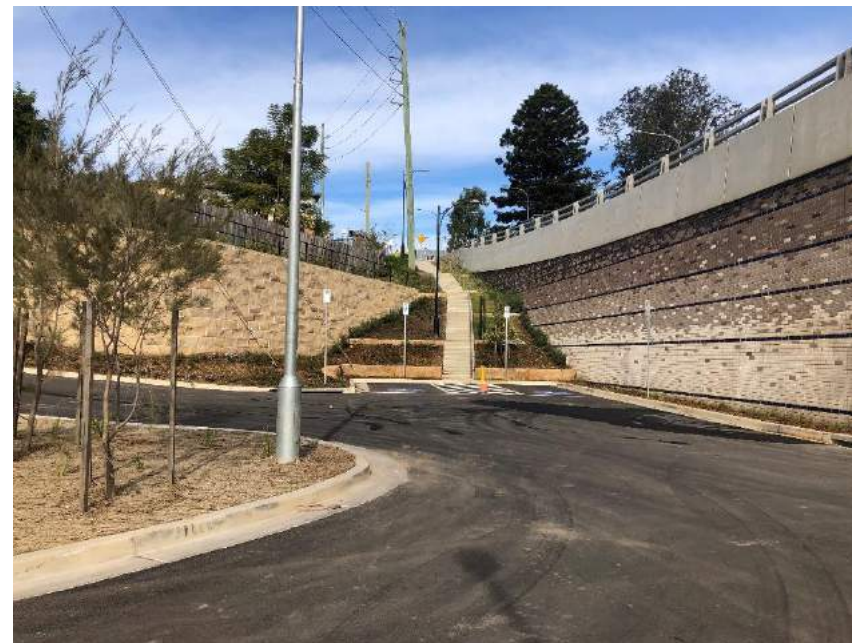
**2021:** Significant changes to structure and landscaping with new bridge infrastructure, asphalt upgrades and installation of staircase to access Bridge Road.

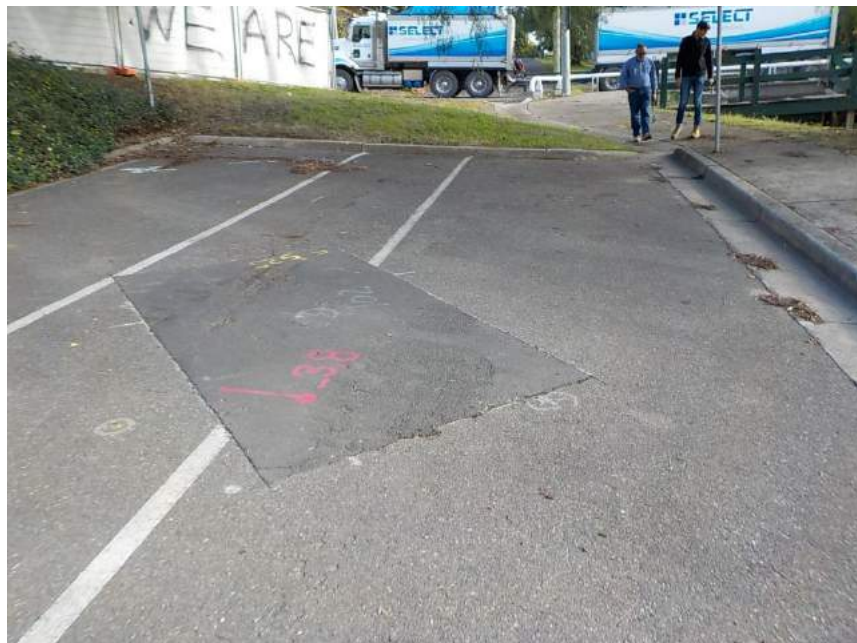
**2018:** End of pavement facing existing bridge – cracking on asphalt surface – repair work present.

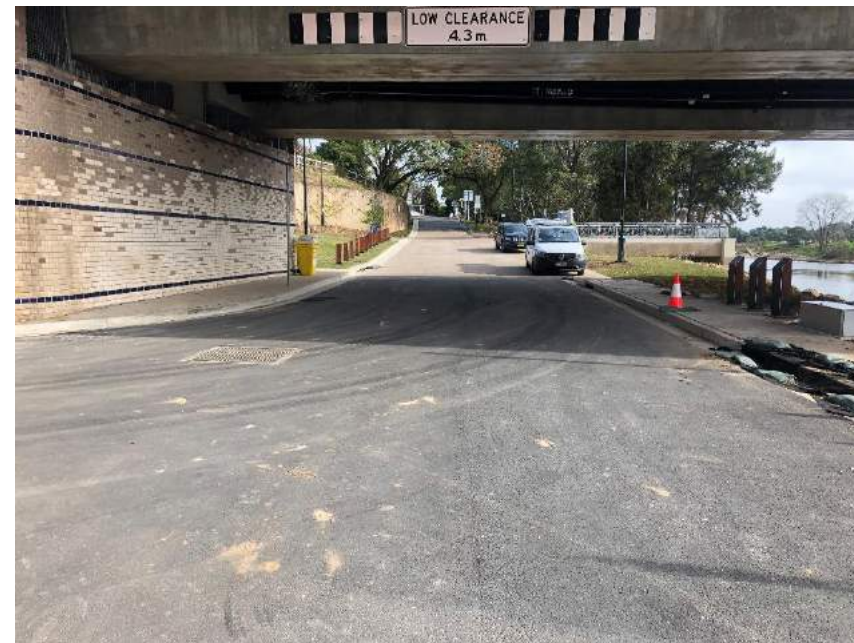
**2021:** Pavement of underpass connecting to Terrace Street beneath the new bridge.

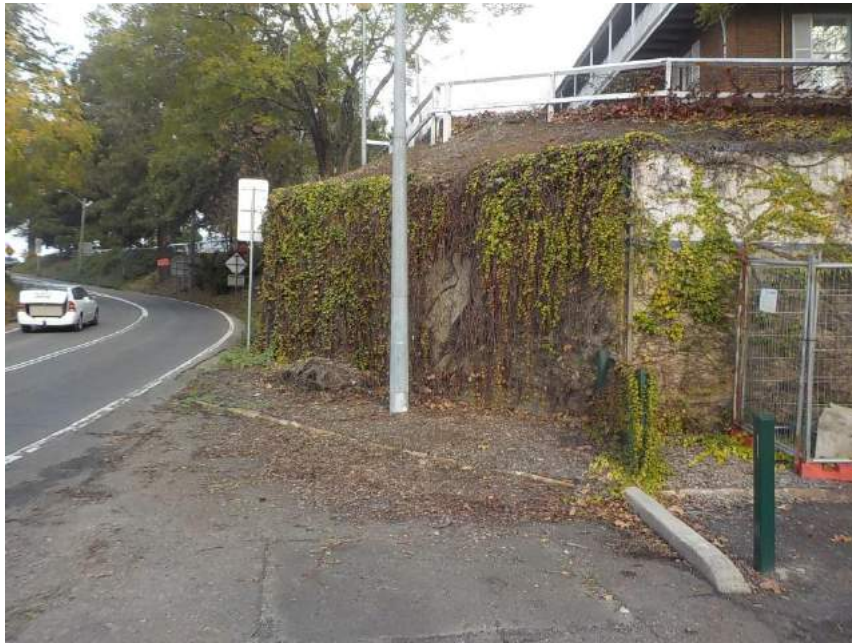
**2018:** General condition of retaining wall (Thompson Square located above wall) – cracking and patch repairs on asphalt surface.

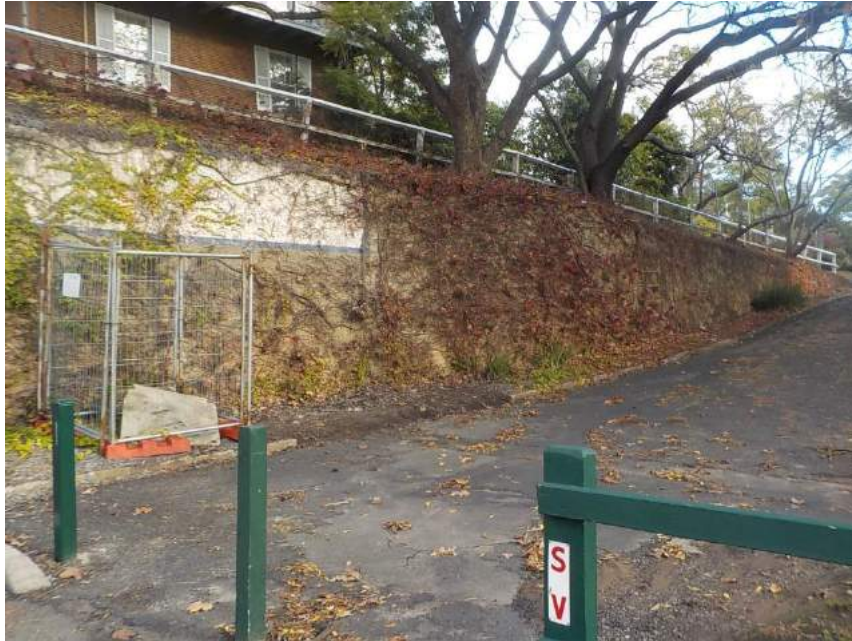
**2018:** General condition of retaining wall (Thompson Square located above wall) – cracking and patch repairs on asphalt surface – pit lid removed (temporary fence surrounding).

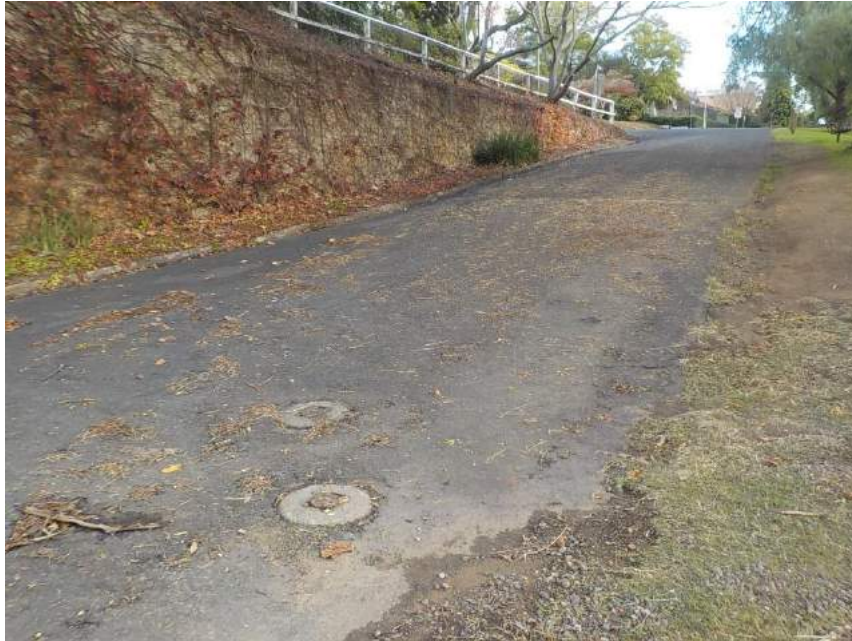
**2018:** Cracking and patch repairs on asphalt surface.

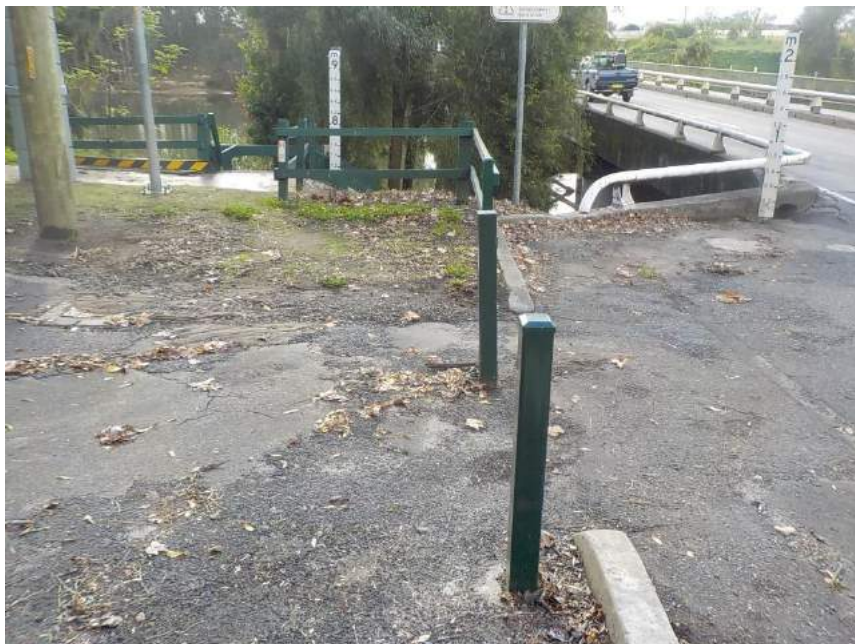
**2018:** Cracking and patch repairs on asphalt surface – general condition of existing timber handrail and posts.

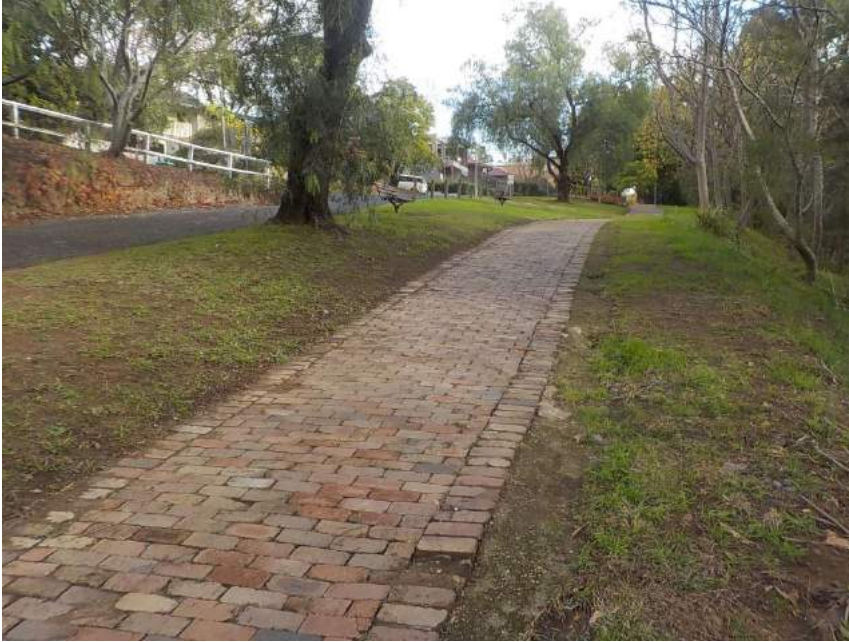
**2018:** General condition of existing footpath – bricks/stones missing from footpath  
-scouring on edges of footpath – damage to vegetation.

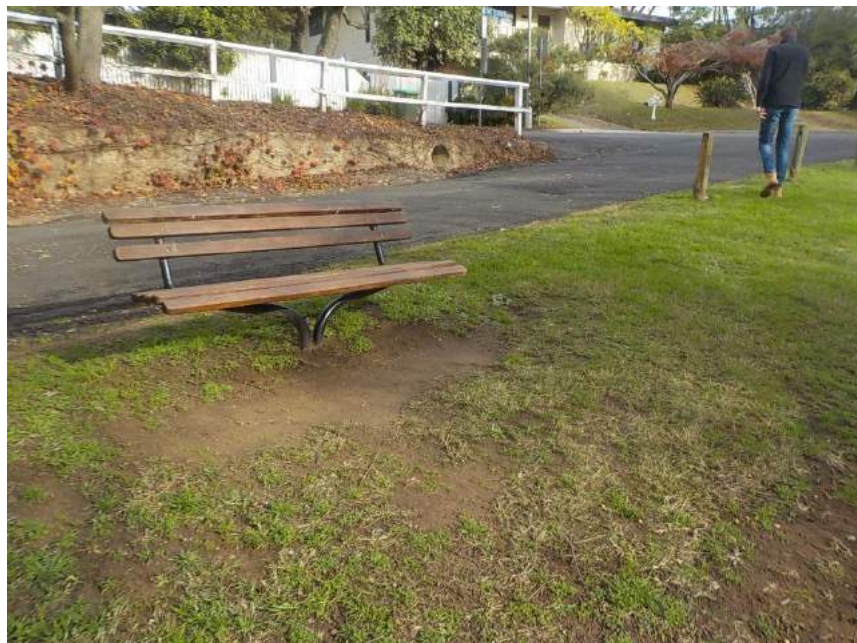
**2018:** General condition of existing furniture – damage to vegetation.

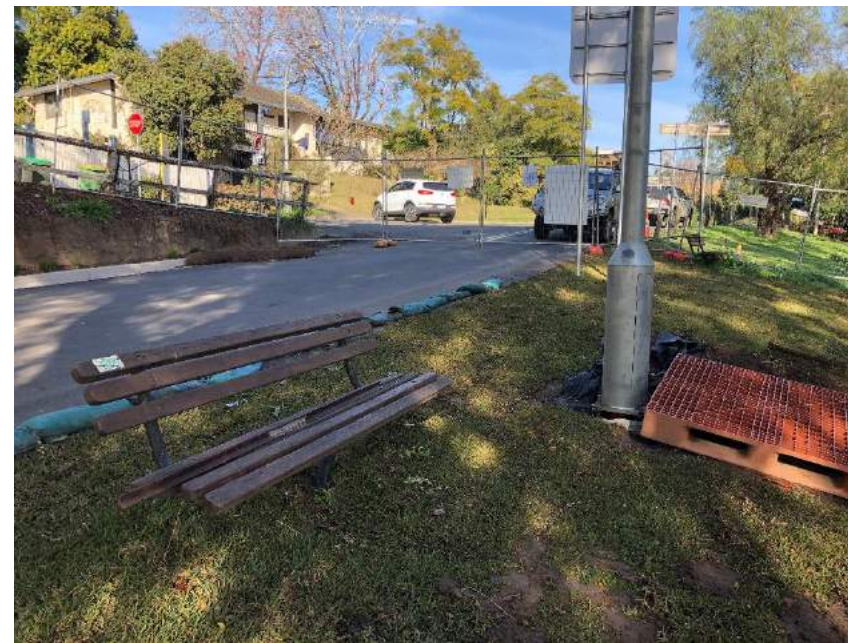
**2021:** General condition of existing furniture, damage to vegetation – little to no change observed compared to pre-construction survey conditions, sections of temporary fencing remain in place.
