# Georgiou Group Dilapidation Report, Windsor Bridge Replacement Project, Windsor NSW

S-03139.DilapidationReport.001

**Pre-Dilapidation Photos Taken:** 20<sup>th</sup> June 2018

**Post-Dilapidation Photos Taken:** 8<sup>th</sup> July 2021

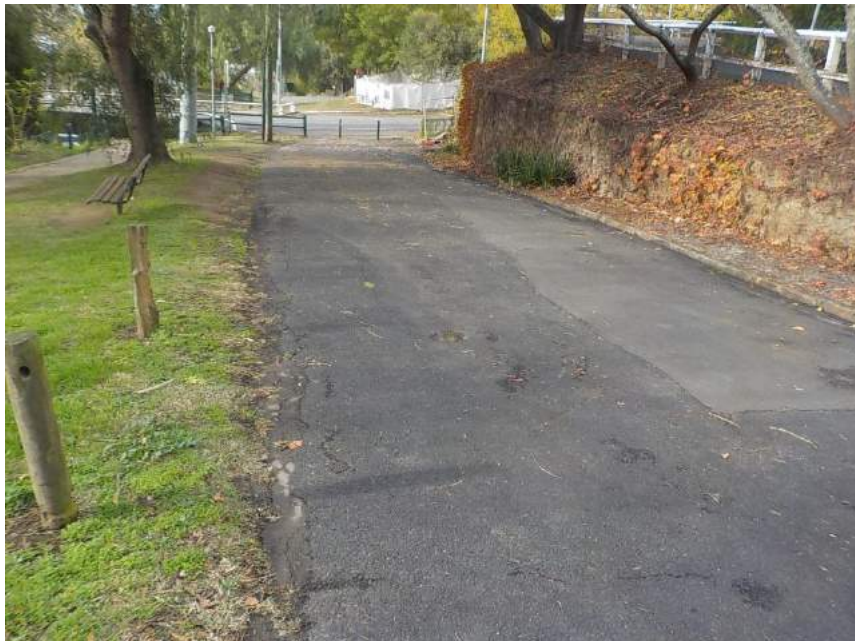
**2018:** General view from merge point between Terrace St and Thompson Square  
– cracking, potholing and patch repairs present on asphalt surface.

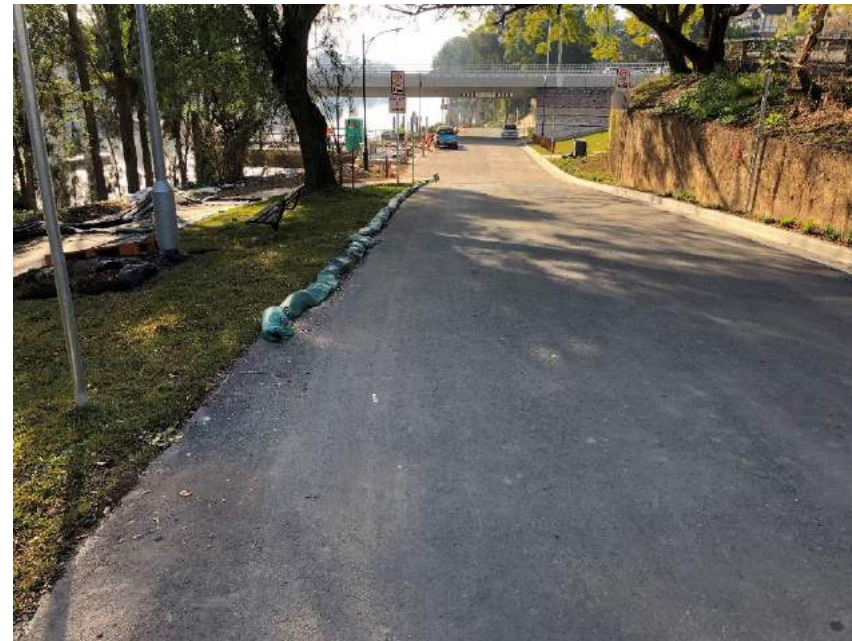
**2021:** General view from merge point between Terrace St and Thompson Square  
– newly lain asphalt surface and upgrades to gutter.

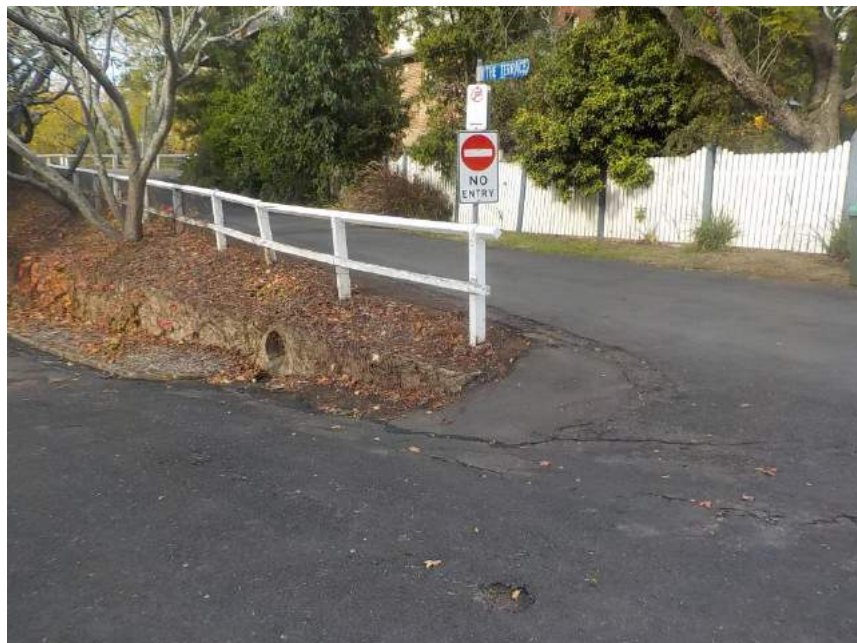
**2018:** General view from merge point between Terrace St and Thompson Square – cracking, potholing and patch repairs present on asphalt surface.

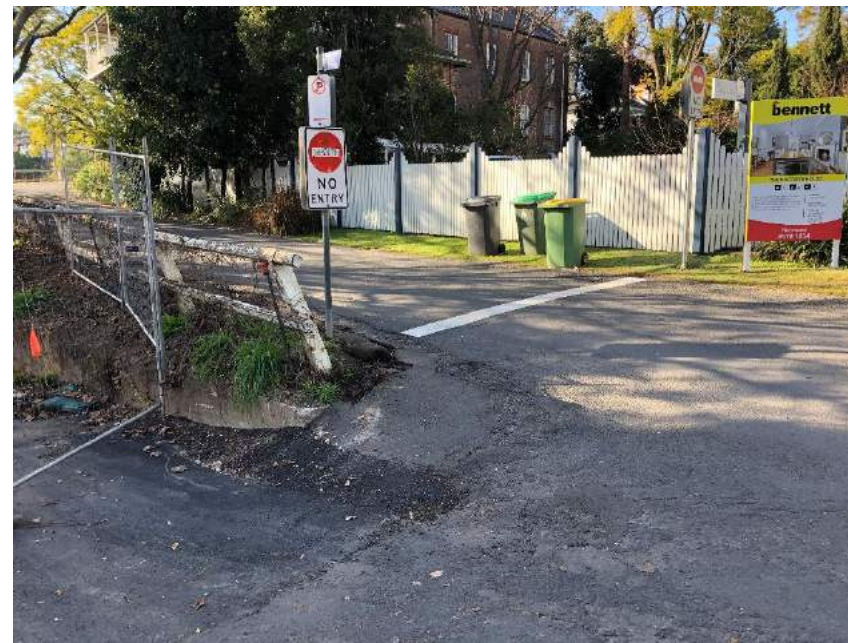
**2021:** General view from merge point between Terrace St and Thompson Square – cracking, potholing and patch repairs present on asphalt surface – little to no change observed compared to pre-construction survey conditions, visible joint with new asphalt surfacing.

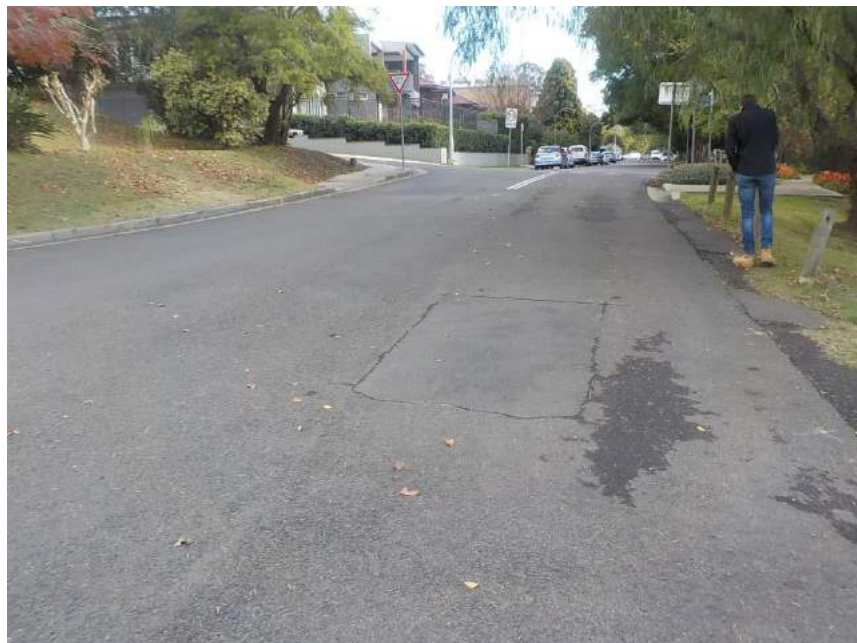
**2018:** General view of Terrace St facing the Baker St intersection - condition of asphalt.

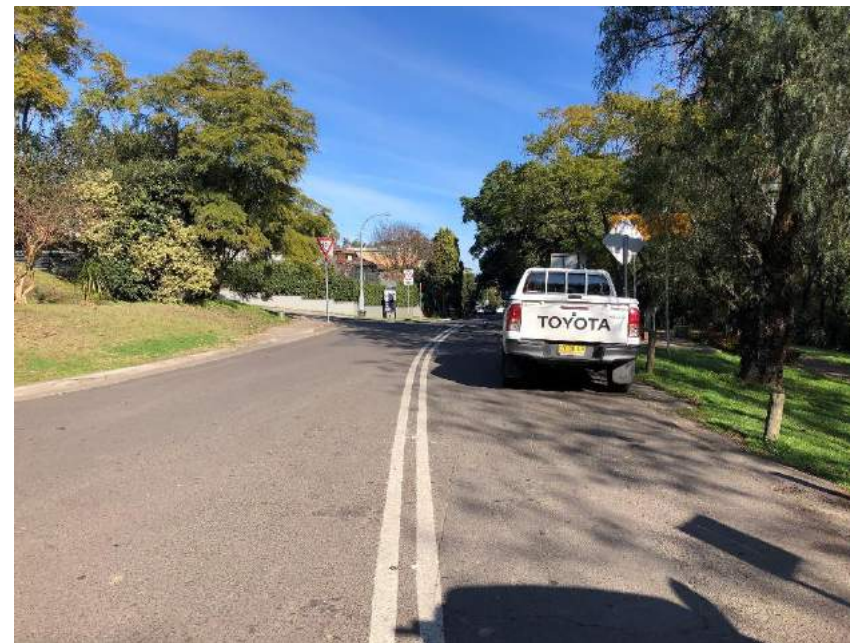
**2021:** General view of Terrace St facing the Baker St intersection - condition of asphalt consistent with previous pre-construction survey, new line markings.

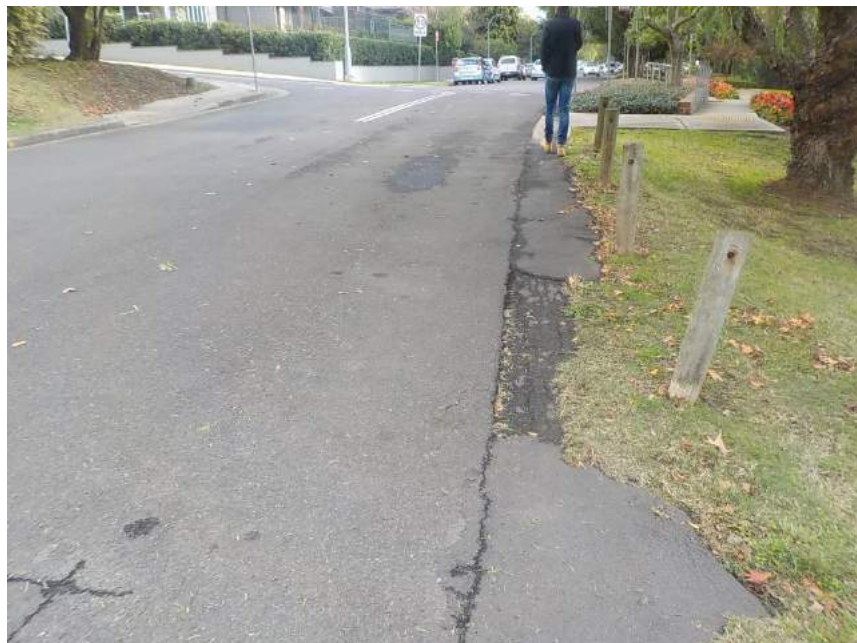
**2018:** General condition of asphalt surface and furniture.

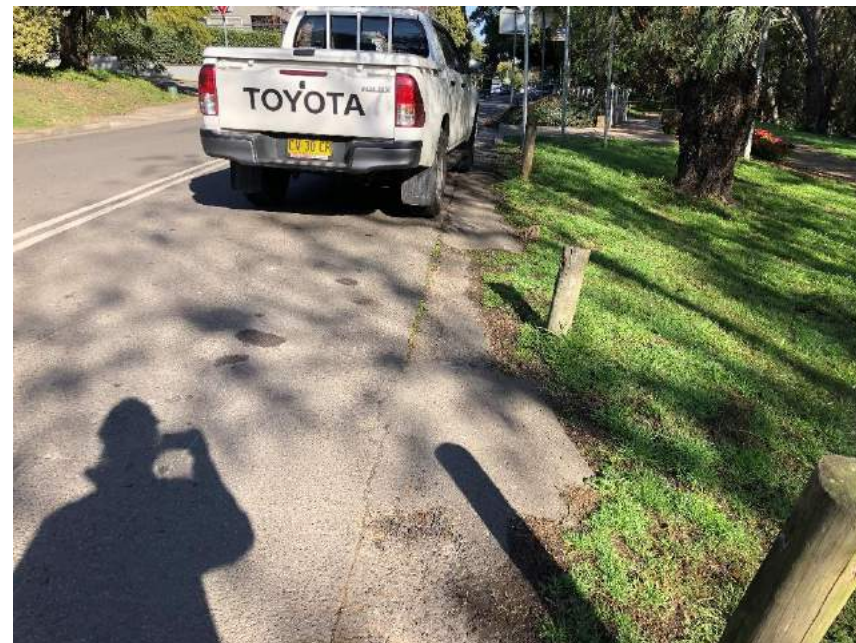
**2021:** General condition of asphalt surface and furniture – little to no change observed compared to pre-construction survey conditions.

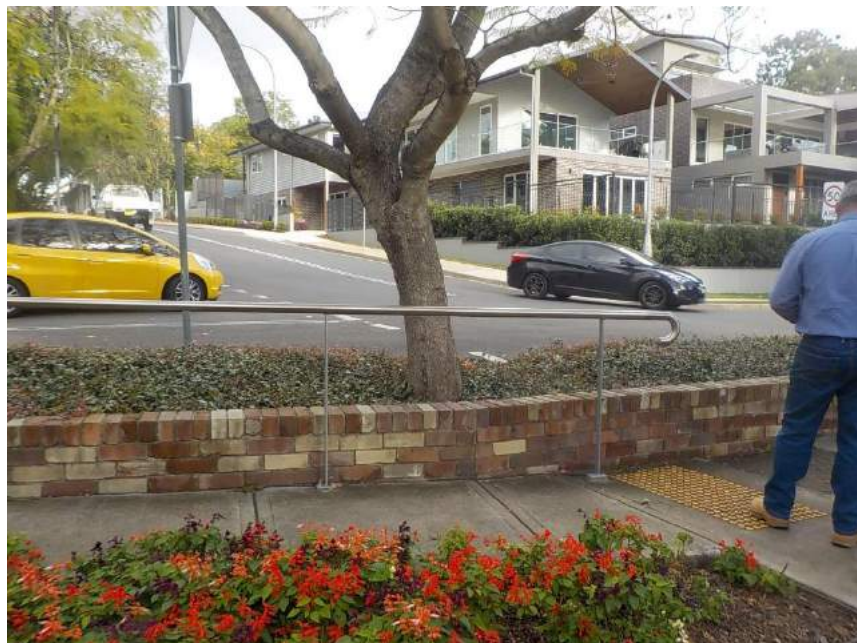
**2018:** General view of Terrace St footpath facing the Baker St intersection - condition of footpath and landscaping.

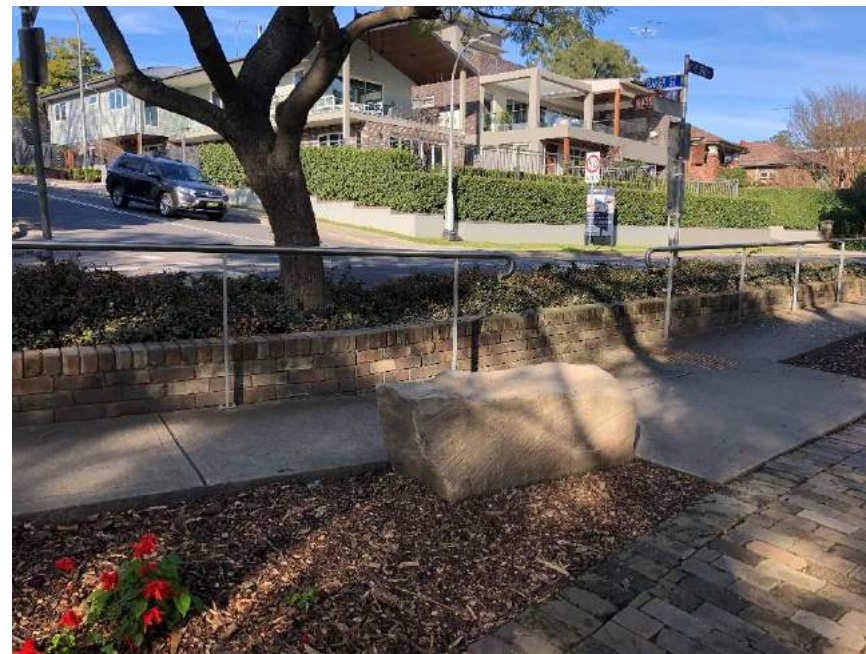
**2021:** General view of Terrace St footpath facing the Baker St intersection - condition of footpath, retaining wall and landscaping remain largely unchanged compared to pre-construction survey conditions, addition of sandstone block in garden bed.

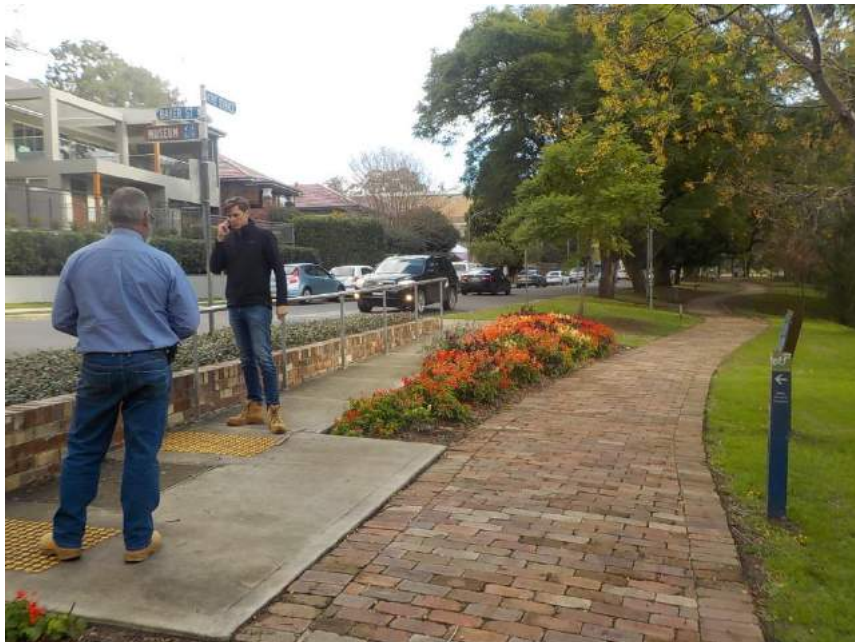
**2018:** General view of Terrace St footpath facing the Baker St intersection - condition of footpath and landscaping.

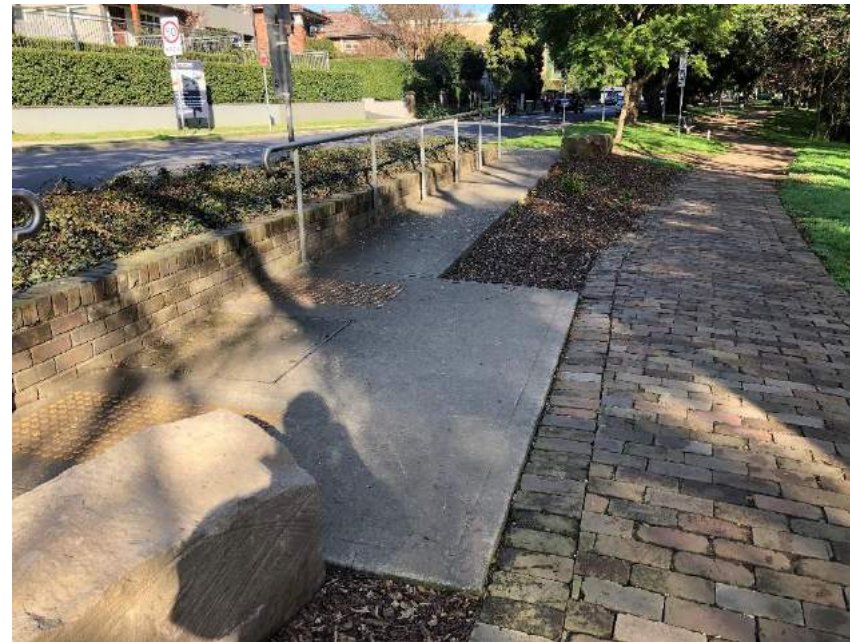
**2021:** General view of Terrace St footpath facing the Baker St intersection - condition of footpath and landscaping remain largely unchanged compared to pre-construction survey.

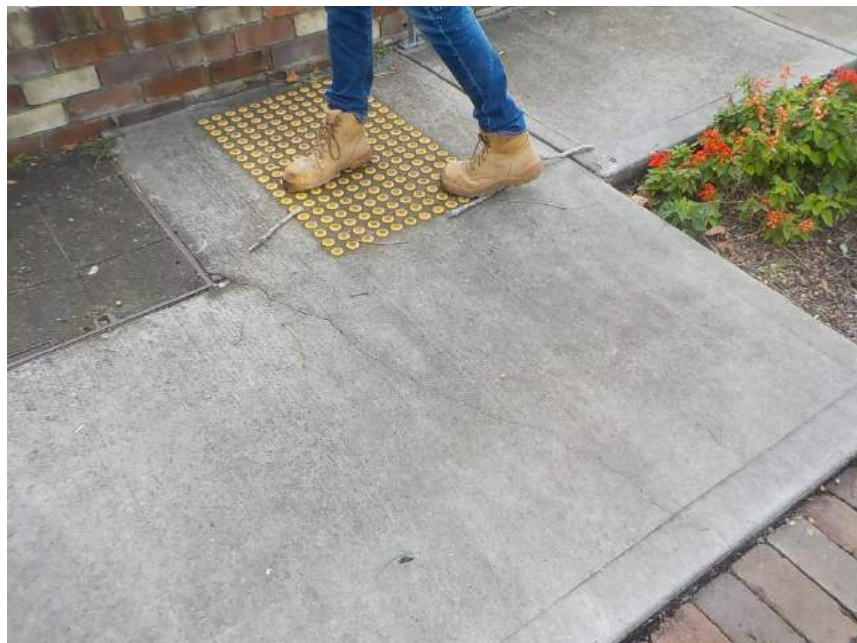
**2018:** Cracking on footpath.

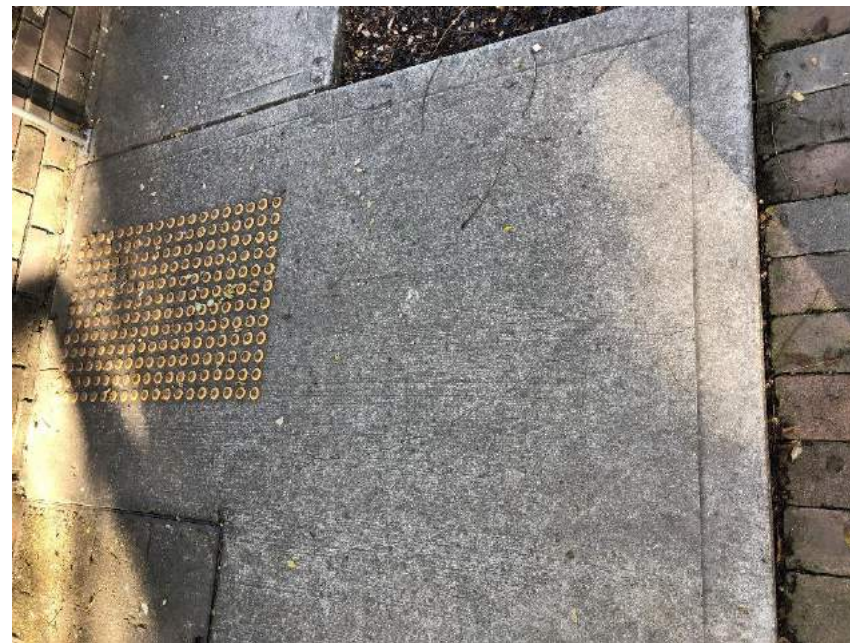
**2021:** Cracking on footpath – little to no change observed compared to pre-construction survey conditions.

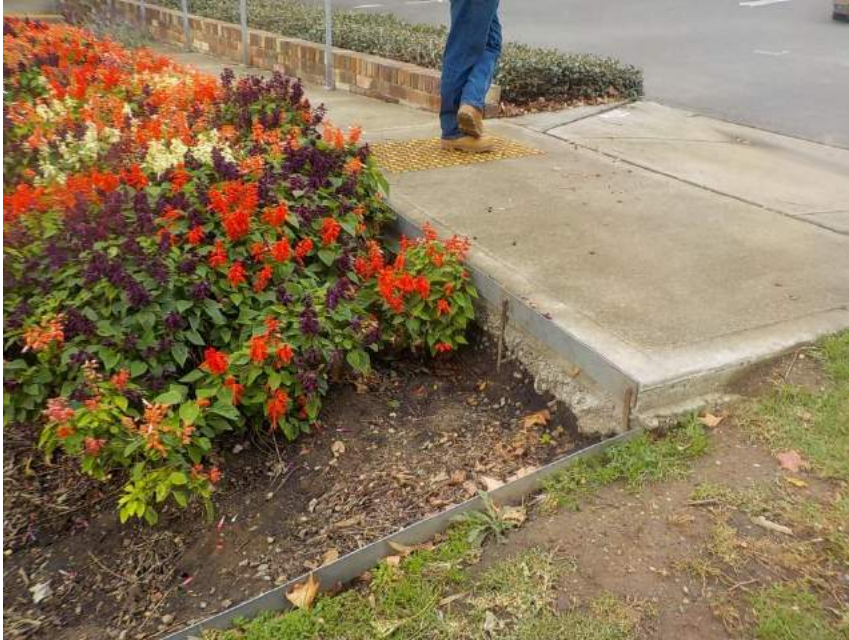
**2018:** Footpath not backfilled, exposing steel and blinding surface.

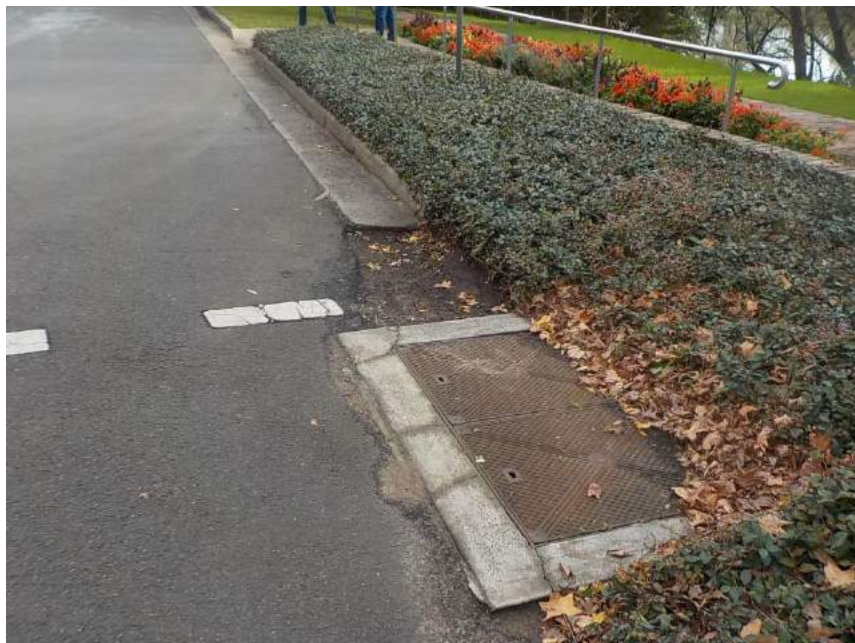
**2018:** Terrace St and Baker St Intersection - condition of asphalt surface – cracking on concrete surrounding utilities box

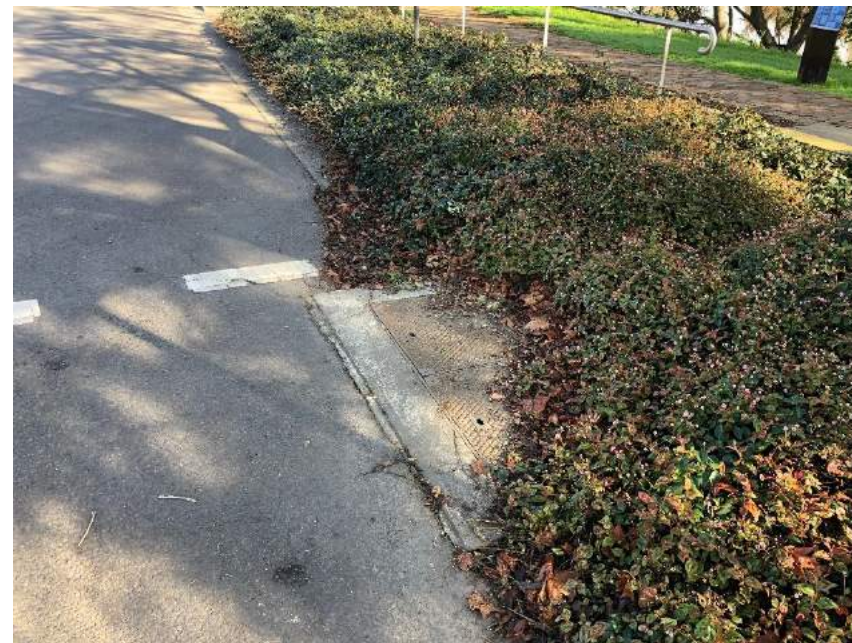
**2021:** Terrace St and Baker St Intersection - condition of asphalt surface – cracking on concrete surrounding utilities box – little to no change observed compared to pre-construction survey conditions.

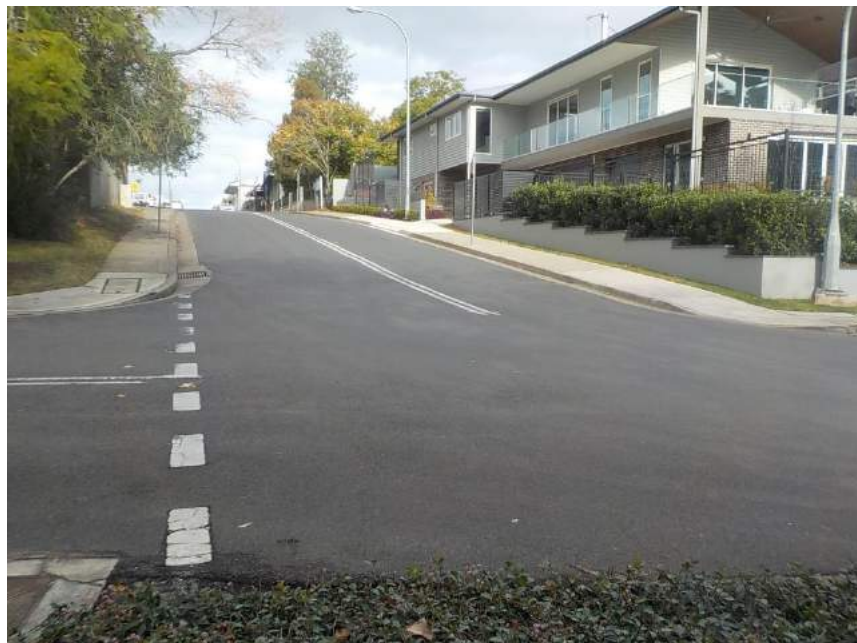
**2018:** General view of Terrace St and Baker St intersection.

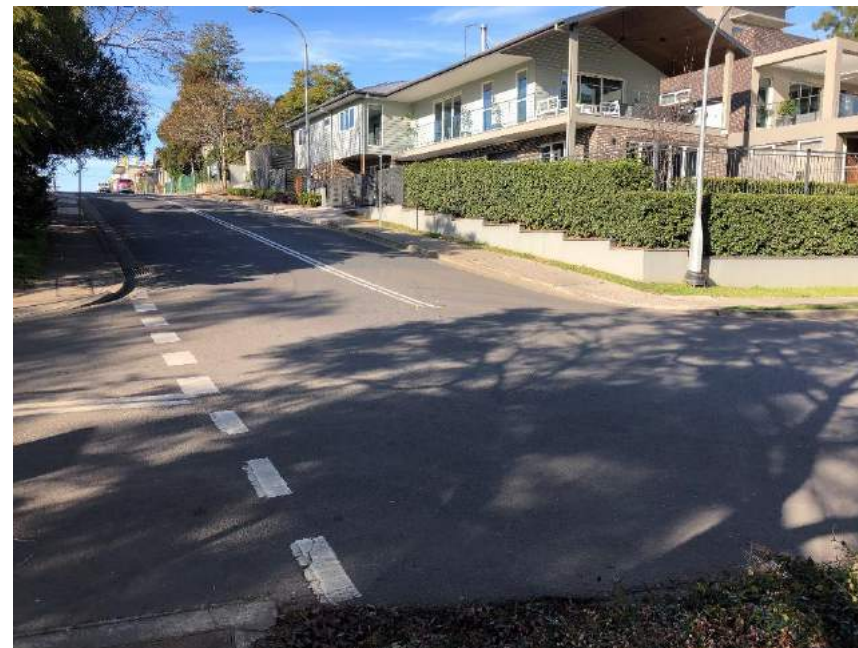
**2021:** General view of Terrace St and Baker St intersection – little to no change observed compared to pre-construction survey conditions.

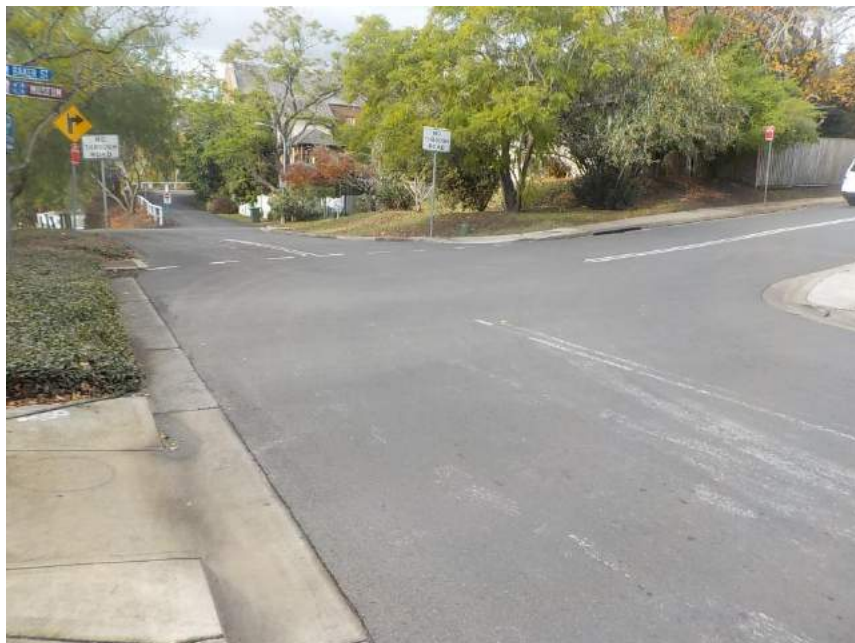
**2018:** General view of Terrace St and Baker St intersection.

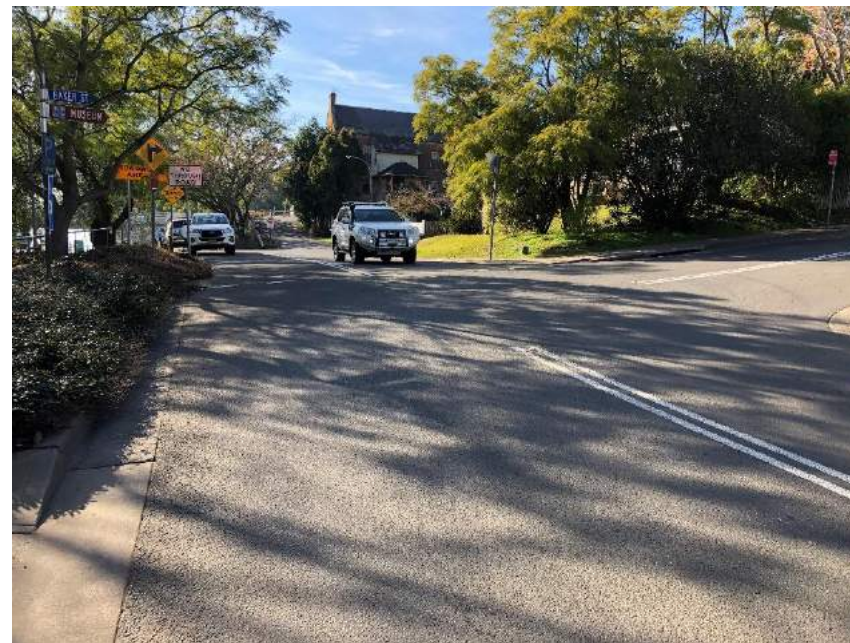
**2021:** General view of Terrace St and Baker St intersection – little to no change observed compared to pre-construction survey conditions.

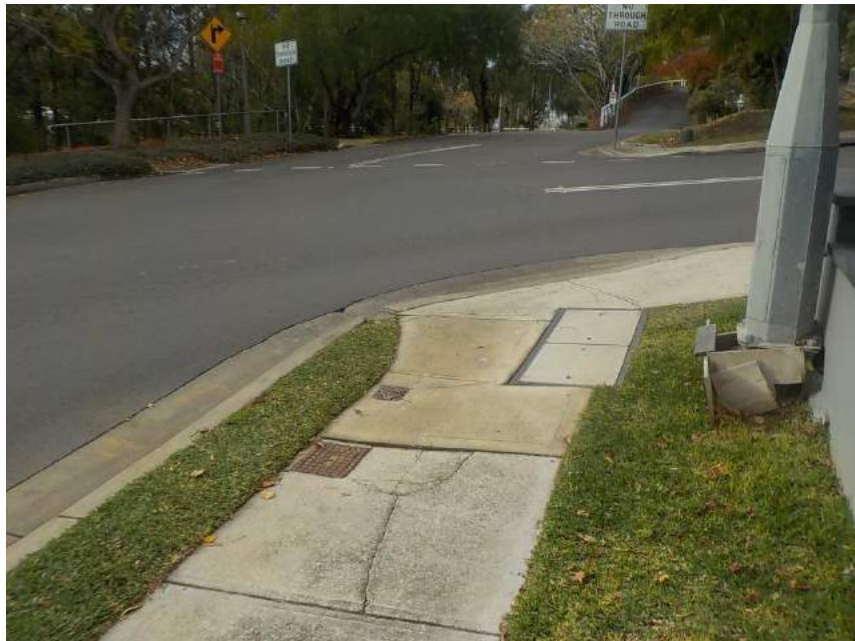
**2018:** Corner of Terrace St and Baker St – severe cracking in footpath – formwork around streetlight.

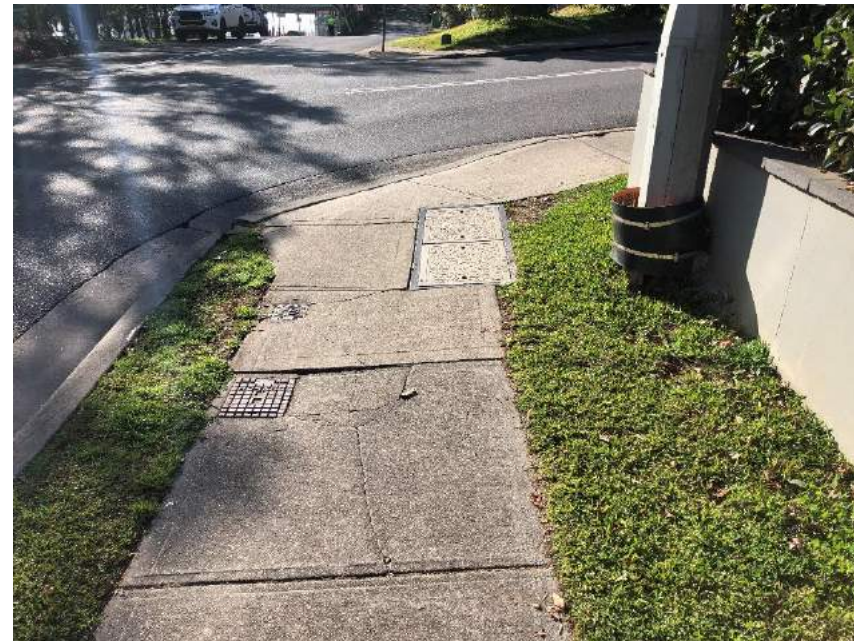
**2021:** Corner of Terrace St and Baker St – severe cracking in footpath consistent with pre-construction survey conditions – installation of improved formwork around streetlight.

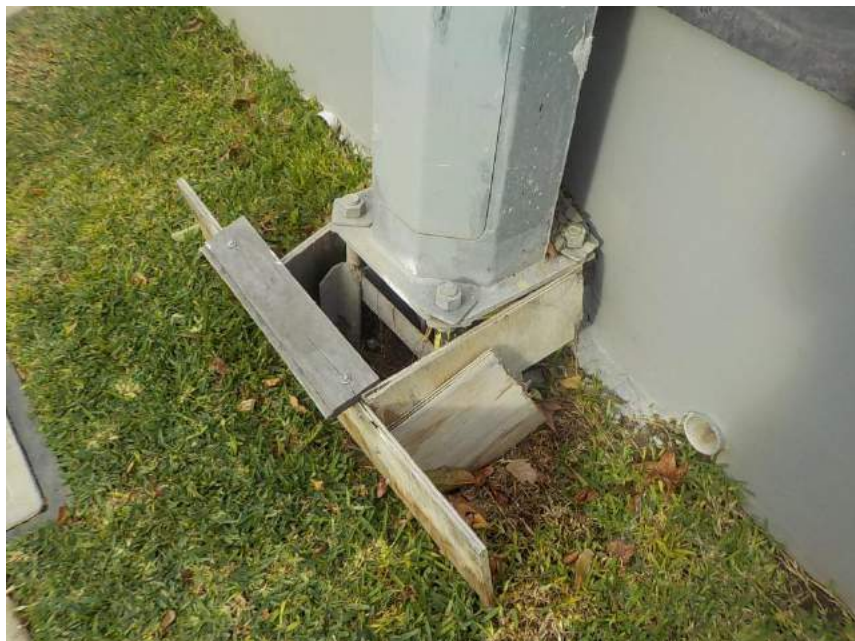
**2018:** Corner of Terrace St and Baker St – formwork around streetlight.

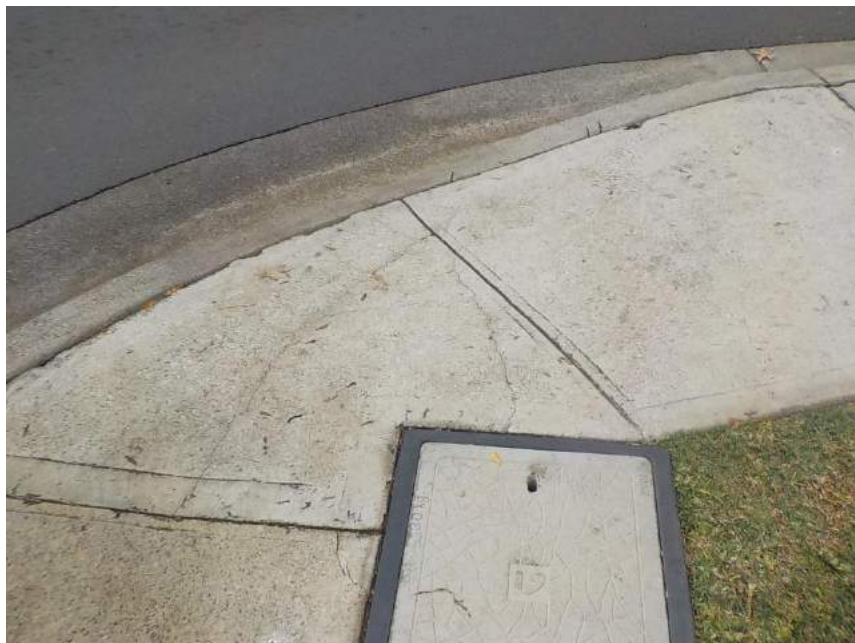
**2018:** Corner of Terrace St and Baker St – noticeable cracking in footpath.

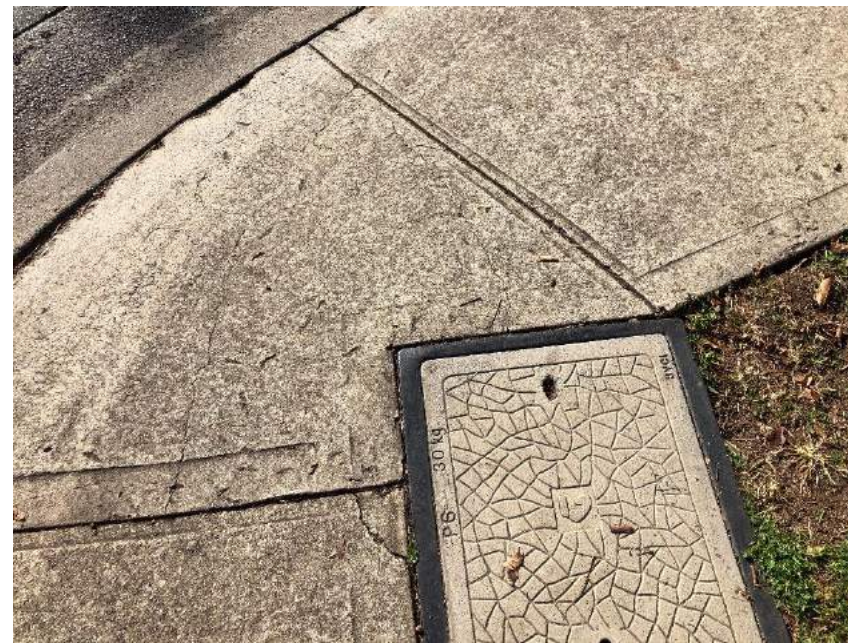
**2021:** Corner of Terrace St and Baker St – noticeable cracking in footpath – little to no change observed compared to pre-construction survey conditions.

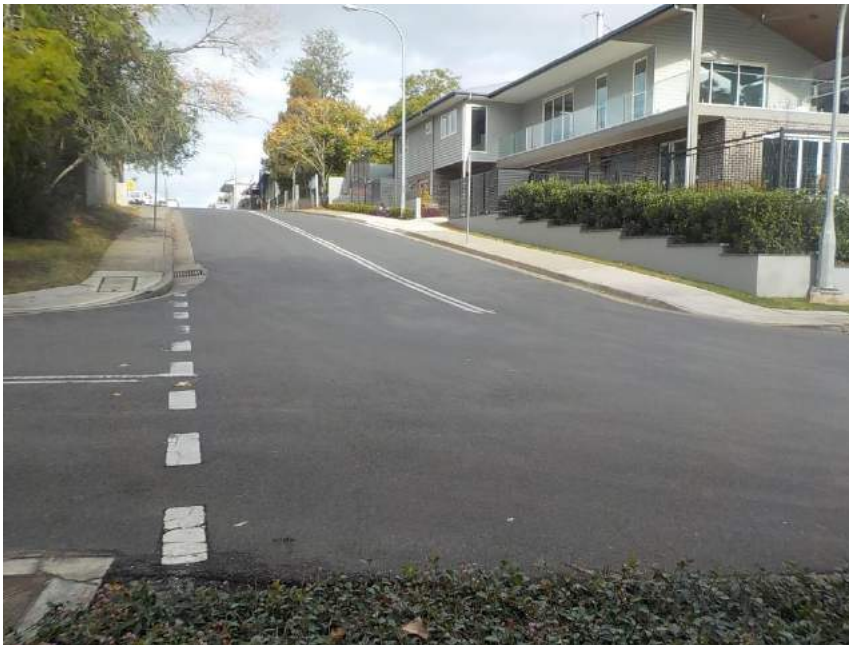
**2018:** General view of Terrace St and Baker St intersection.

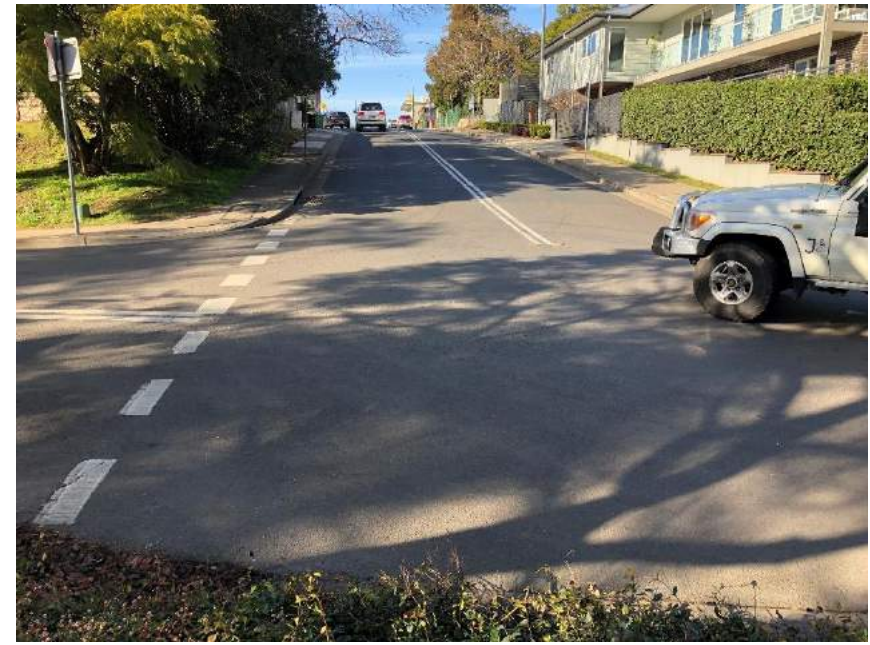
**2021:** General view of Terrace St and Baker St intersection – little to no change observed compared to pre-construction survey conditions.

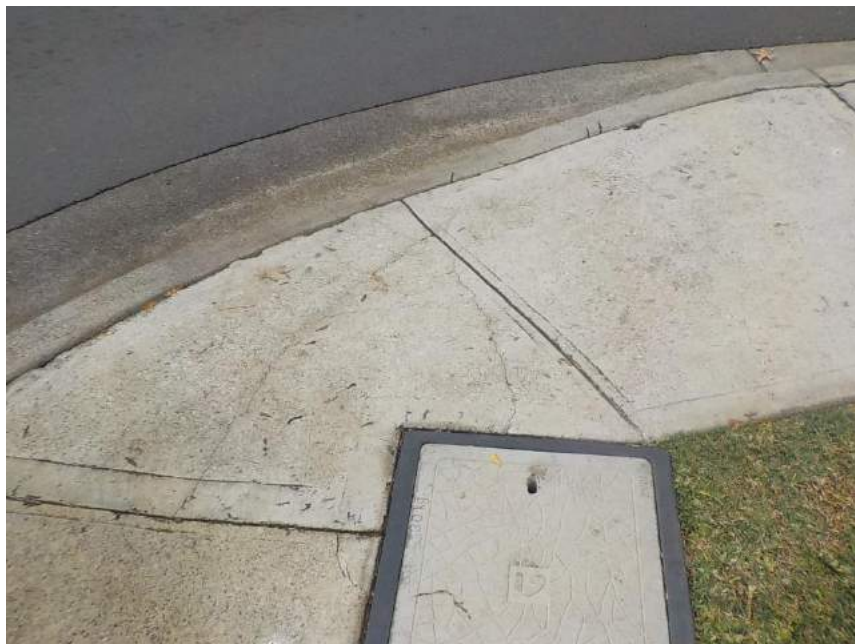
**2018:** Corner of Terrace St and Baker St – noticeable cracking in footpath.

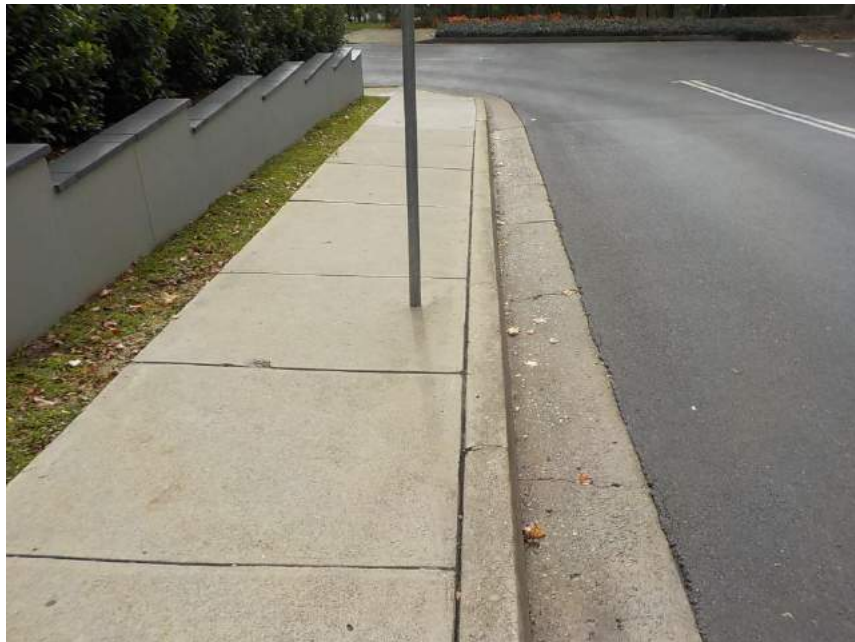
**2018:** Baker St facing Terrace St Intersection – general condition of footpath and kerb – cracking in kerb and gutter.

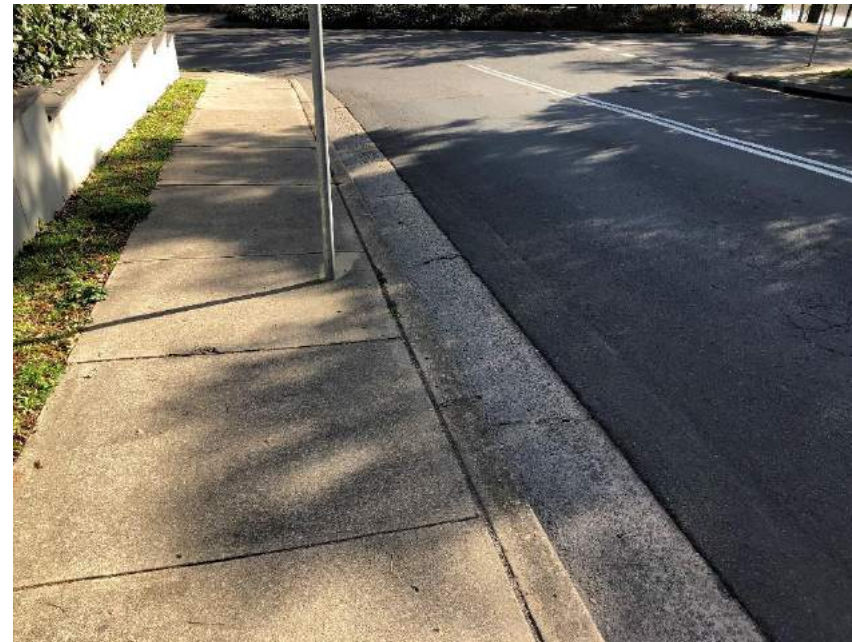
**2021:** Baker St facing Terrace St Intersection – general condition of footpath and kerb – cracking in kerb and gutter – little to no change observed compared to pre-construction survey conditions.

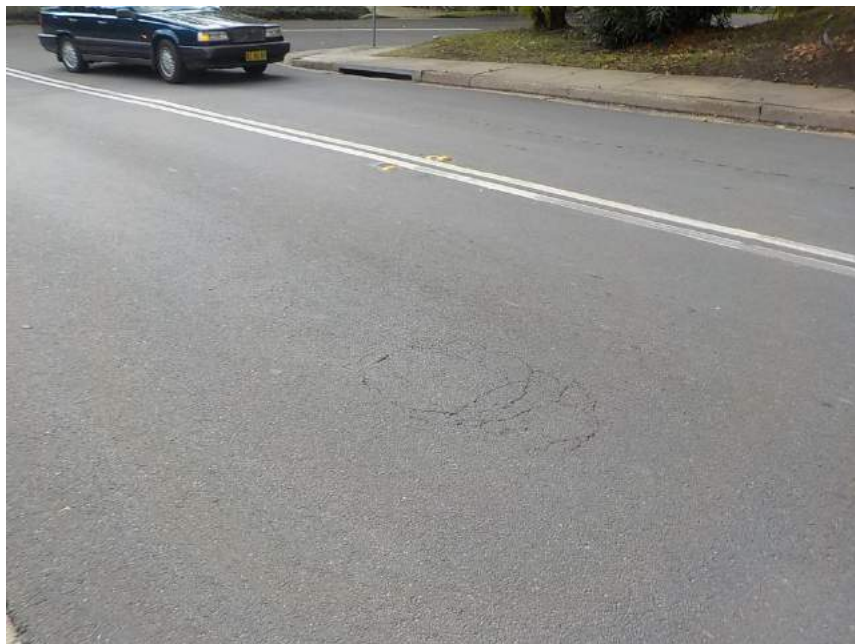
**2018:** General condition of pavement – crocodile cracking and rutting in asphalt surface.

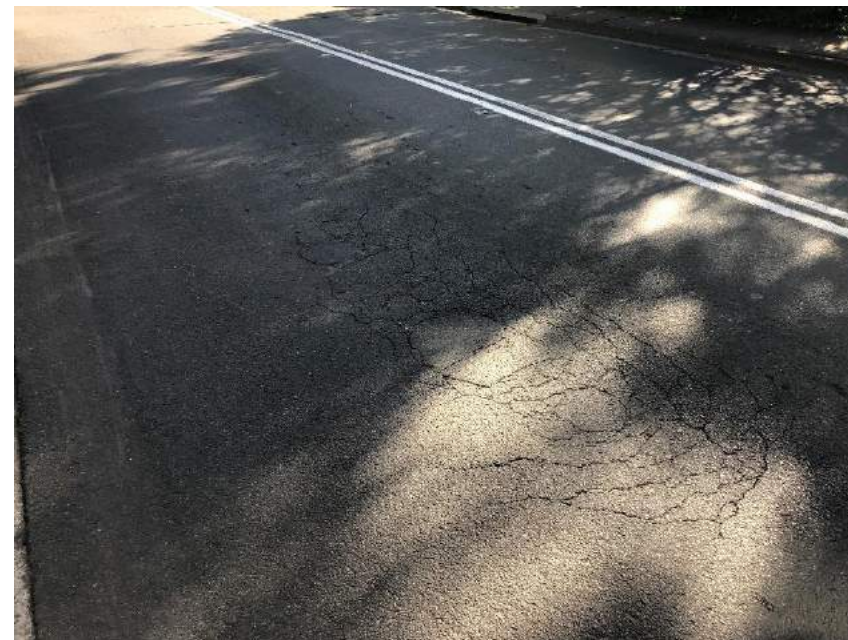
**2021:** General condition of pavement – crocodile cracking and slight enlargement of rutting in asphalt surface with marginal changes due to high traffic areas and not associated with construction.

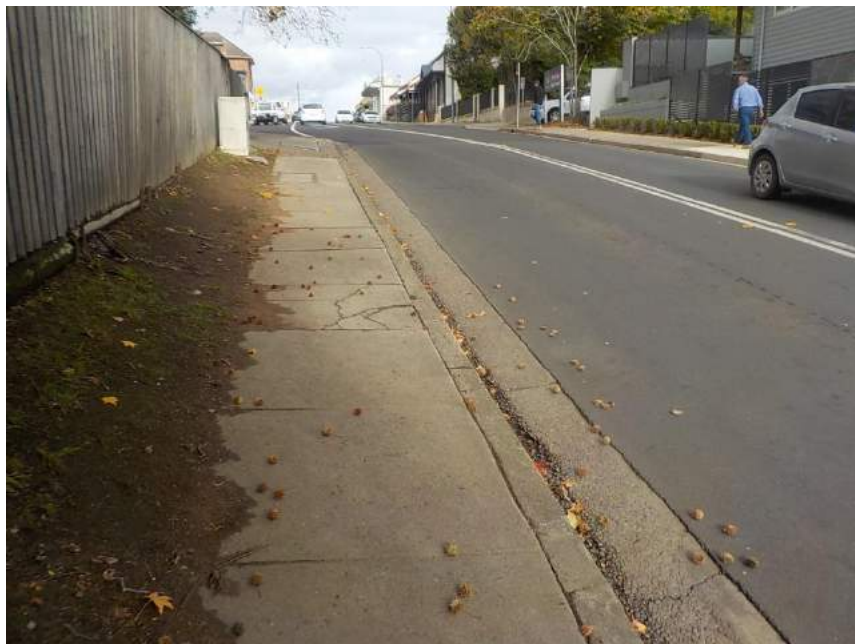
**2018:** Cracking in footpath and kerb – rutting in asphalt surface.

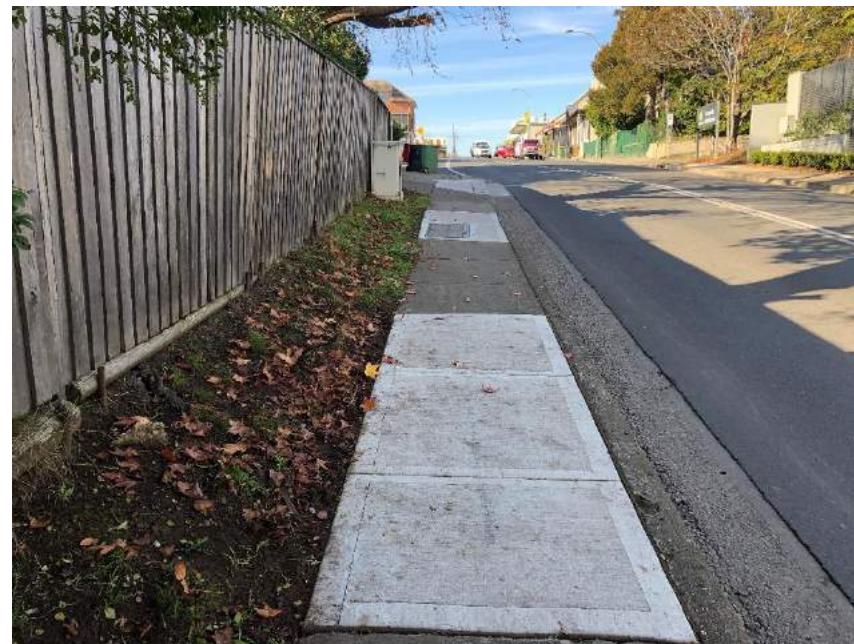
**2021:** Replacement of cracked footpath sections, asphalt and gutter remain in a condition consistent with previous observations.

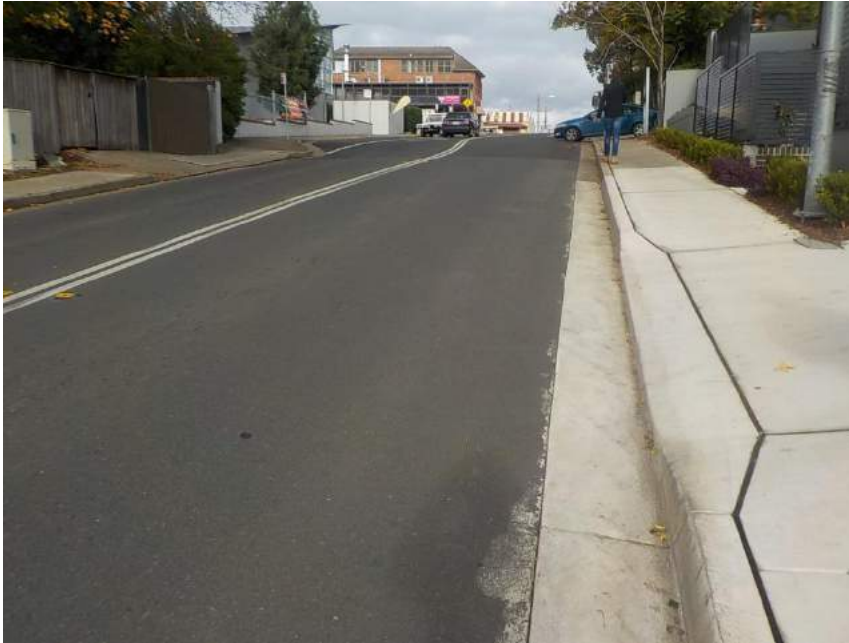
**2018:** General view of pavement and footpath – cracking in gutter.

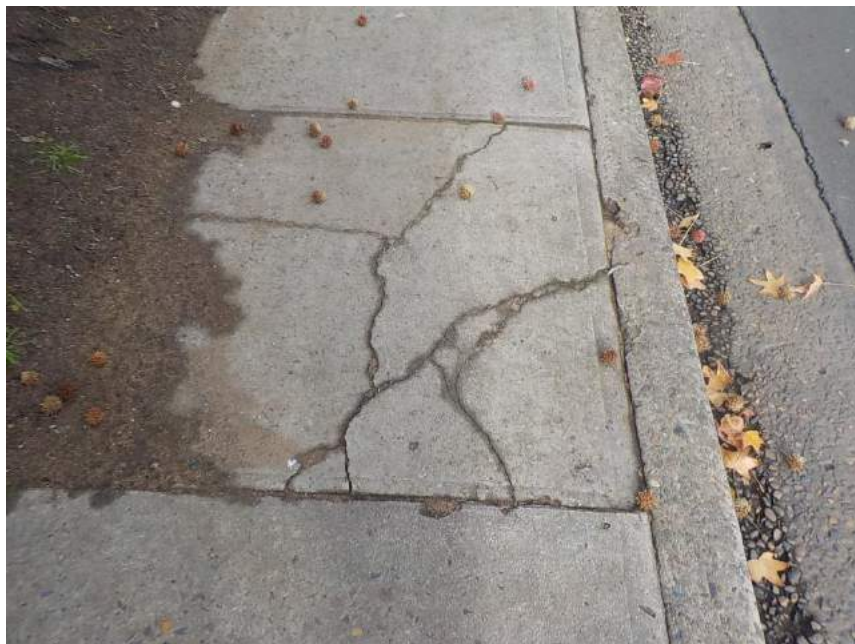
**2018:** Severe cracking in footpath.

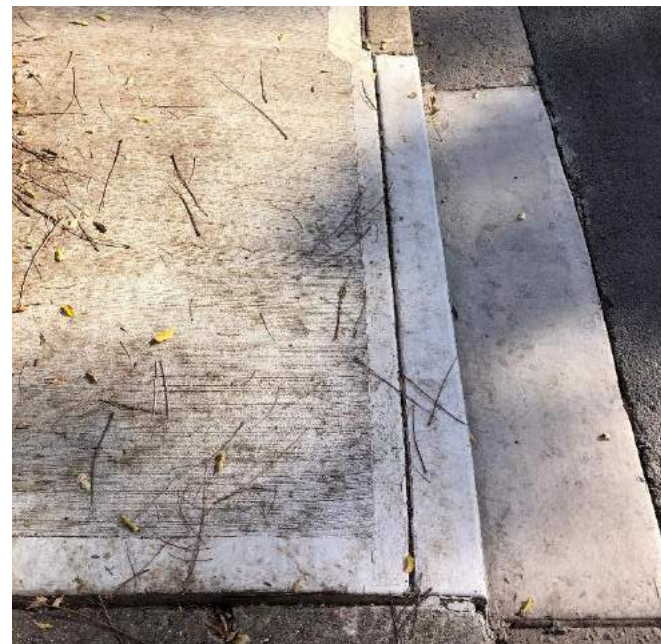
**2021:** Segment of pavement and gutter replaced.

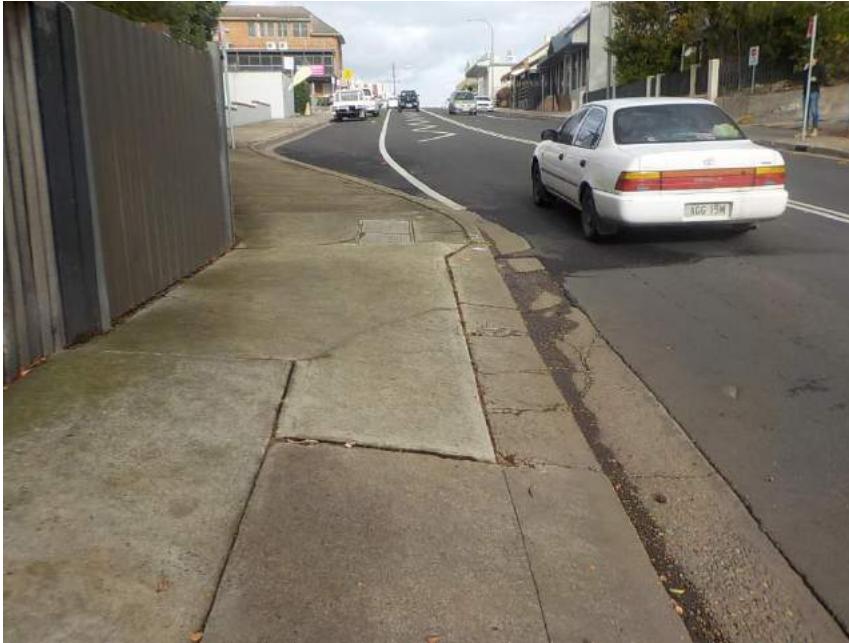
**2018:** cracking in footpath, ramp, kerb and gutter.

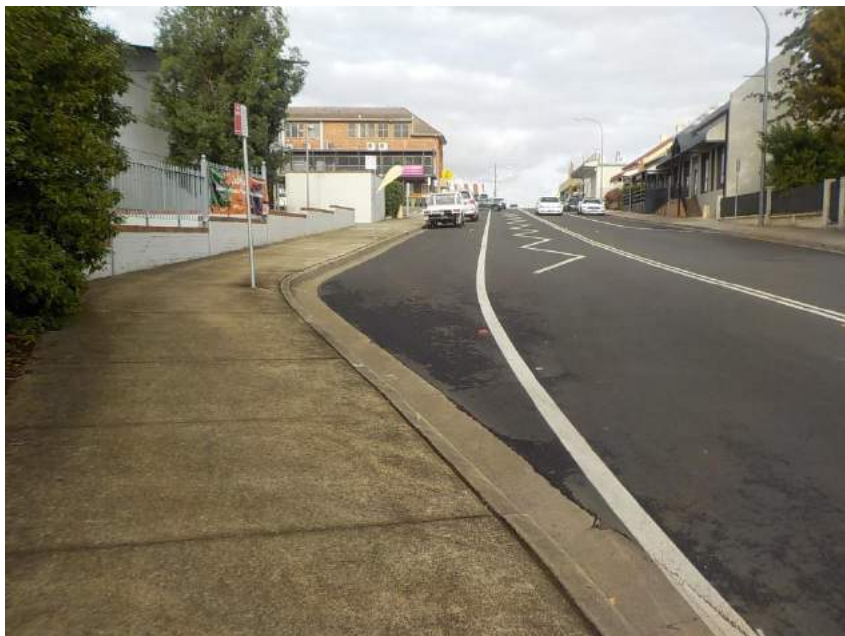
**2018:** General condition of pavement and footpath.
