# Georgiou Group Dilapidation Report, Windsor Bridge Replacement Project, Windsor NSW

S-03139.DilapidationReport.001

**Pre-Dilapidation Photos Taken:** 20<sup>th</sup> June 2018

**Post-Dilapidation Photos Taken:** 8<sup>th</sup> July 2021

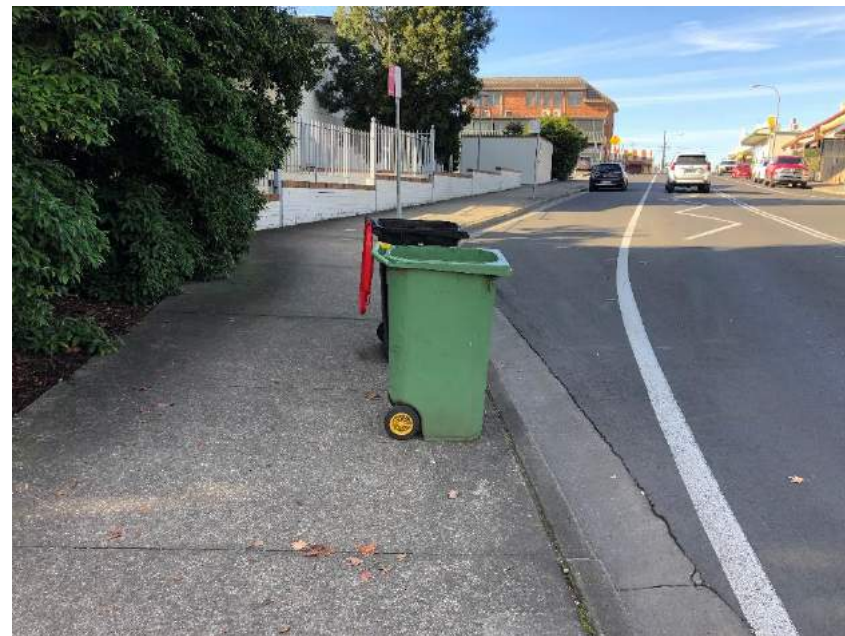
**2021:** General condition of pavement and footpath – little to no change observed compared to pre-construction survey conditions.

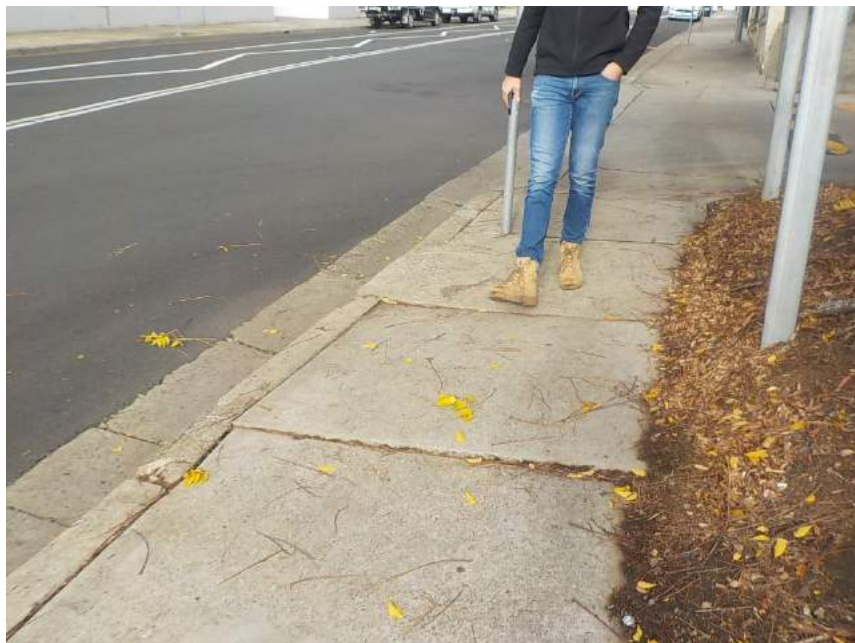
**2018:** Heaving in footpath – cracking in kerb and gutter – cracking in asphalt surface

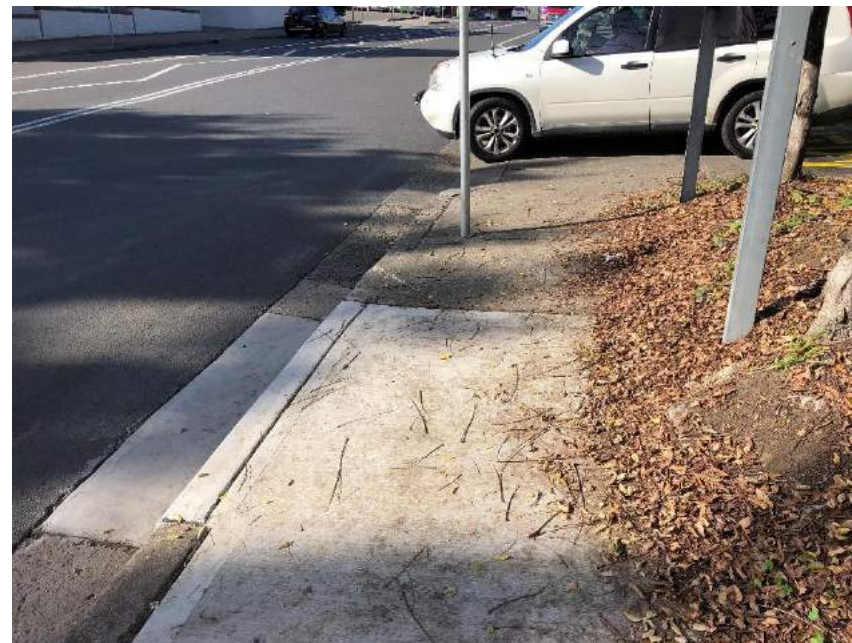
**2021:** Replaced concrete of footpath and cutter, condition of asphalt remains consistent with pre-construction survey.

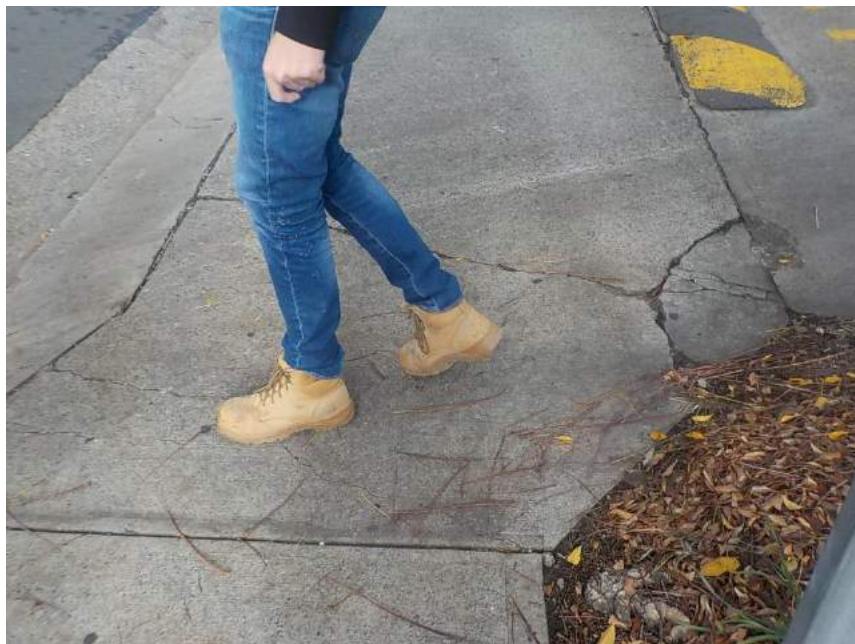
**2018:** Severe cracking on footpath/driveway.

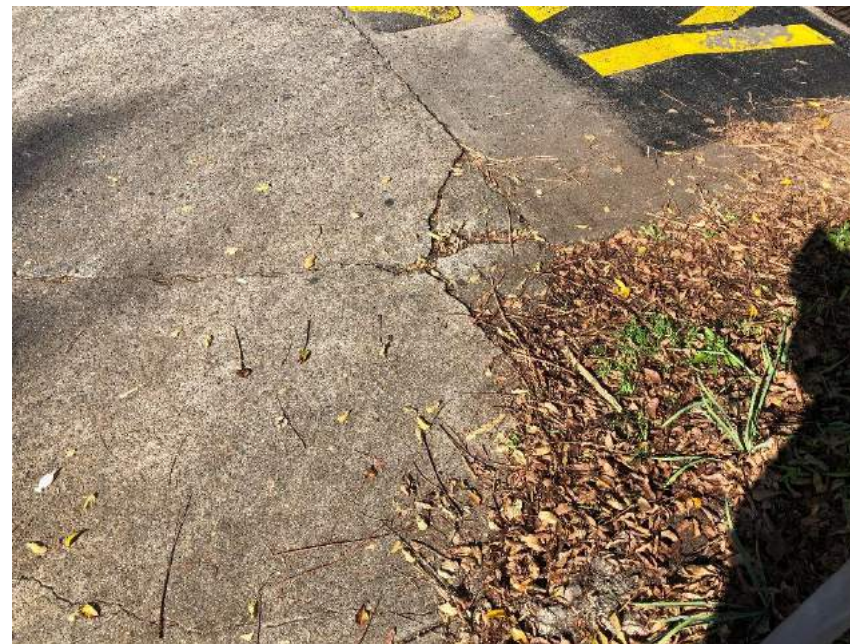
**2021:** Severe cracking on footpath/driveway – little to no change observed compared to pre-construction survey conditions.

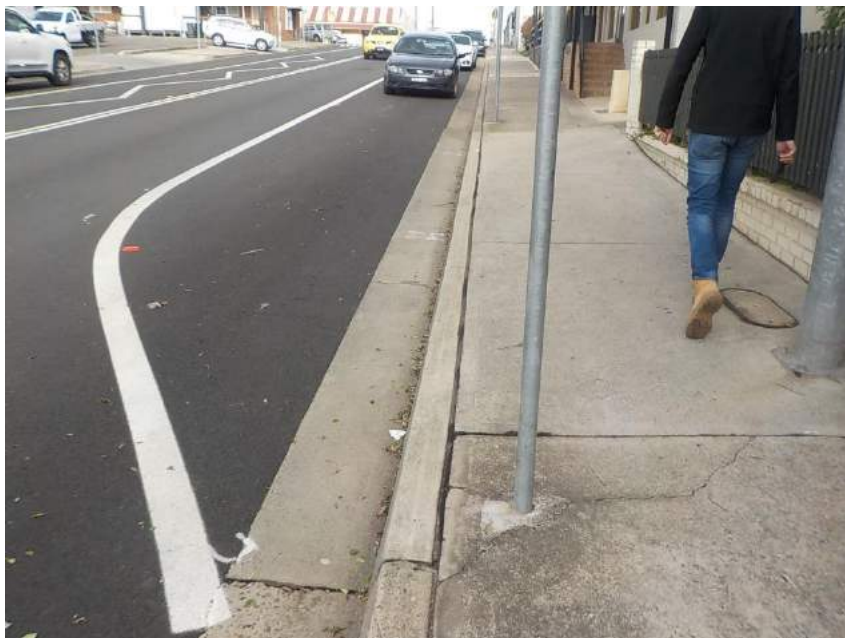
**2018:** General view of footpath and pavement – noticeable cracking in footpath at post footing.

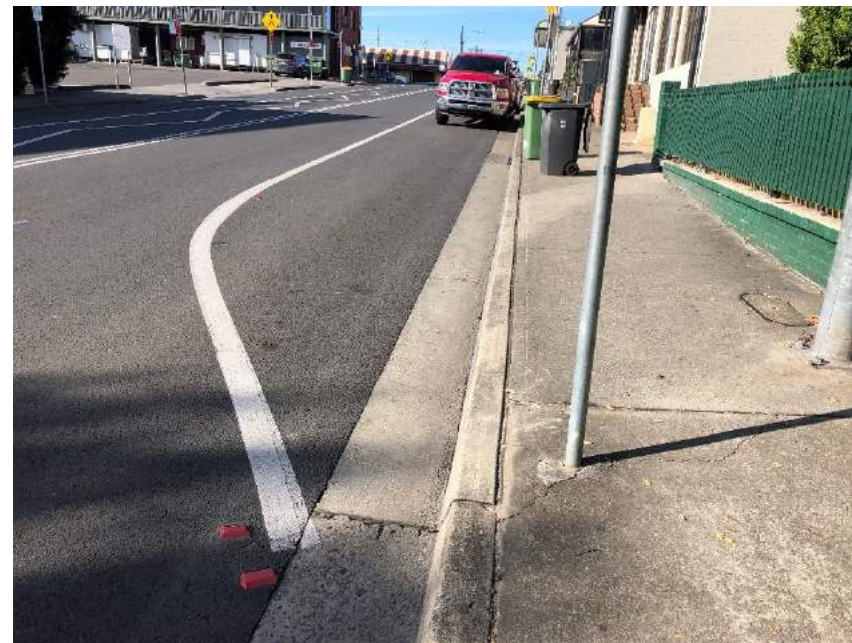
**2021:** General view of footpath and pavement – noticeable cracking in footpath at post footing consistent with pre-construction survey condition.

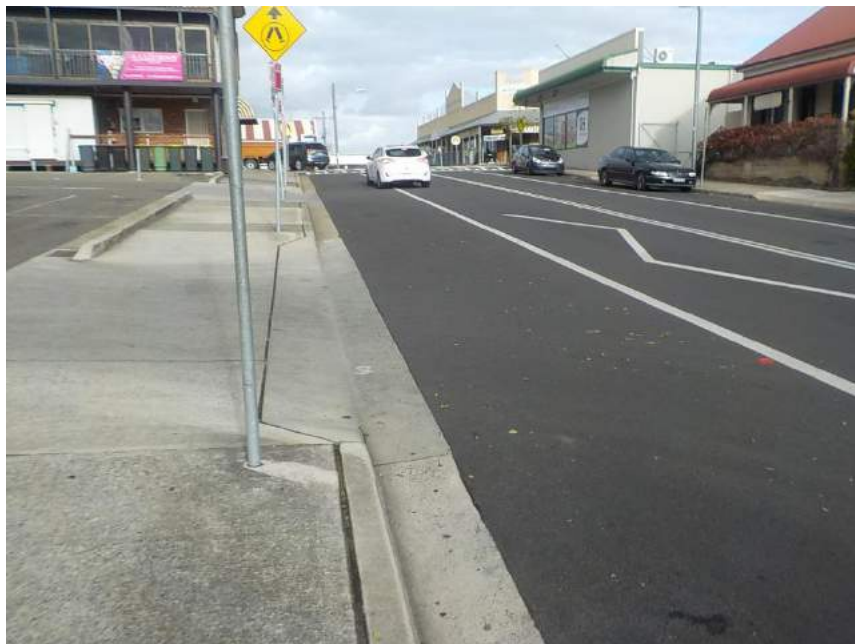
**2018:** Severe cracking on footpath/driveway.

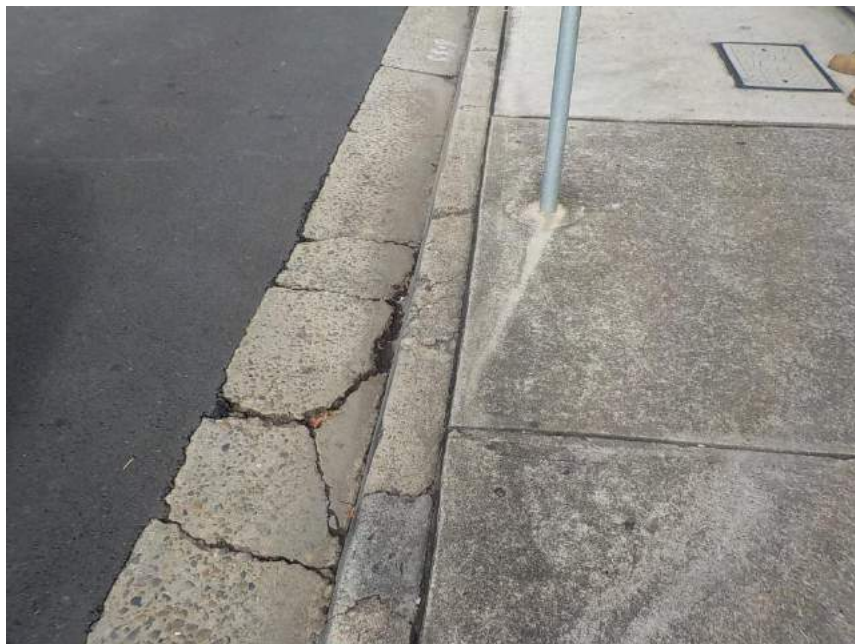
**2018:** Cracking in kerb and gutter.

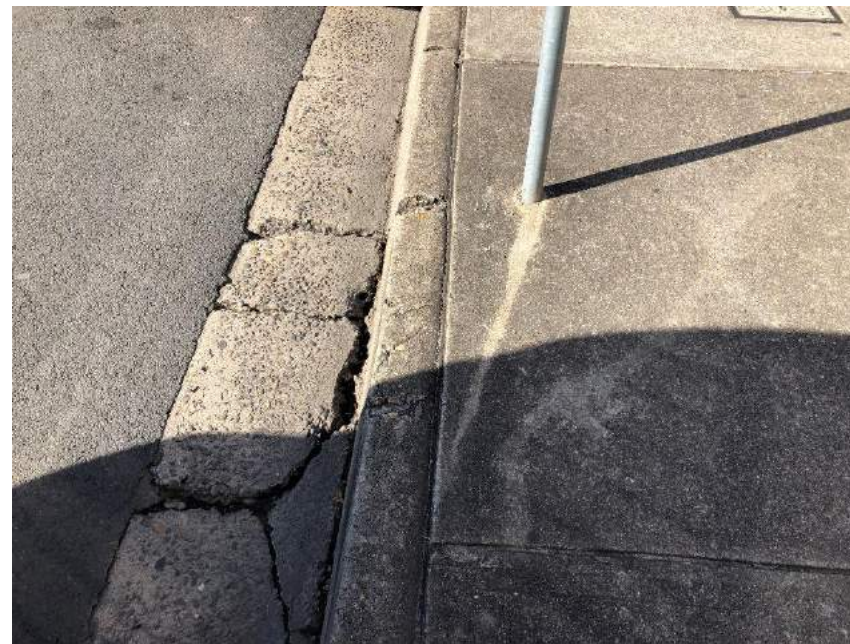
**2021:** Cracking in kerb and gutter – little to no change observed compared to pre-construction survey conditions.

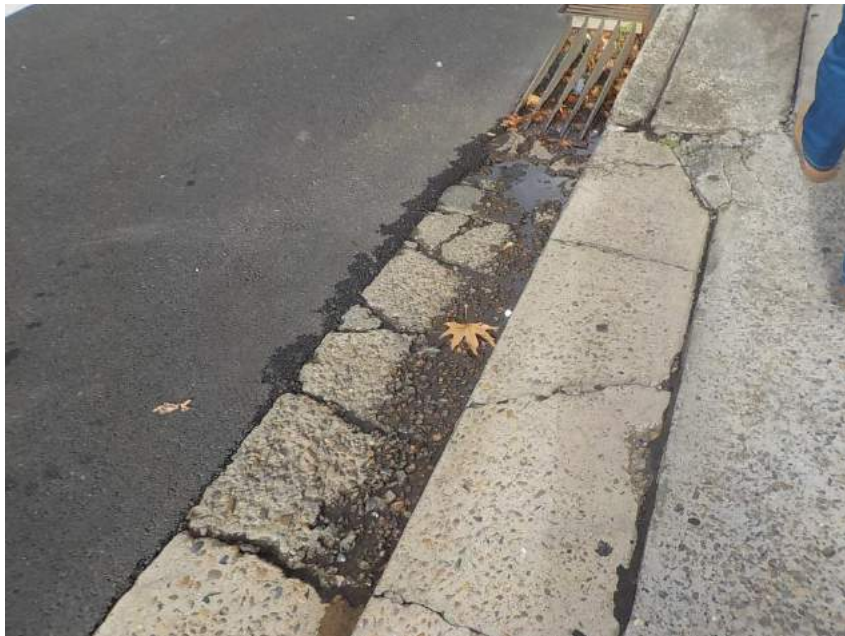
**2018:** Severe cracking in gutter, driveway ramp and footpath.

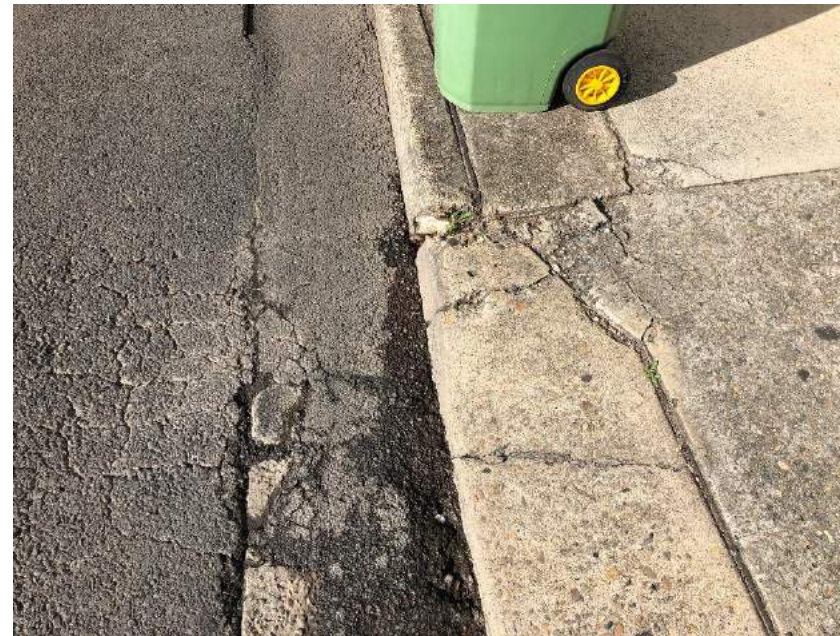
**2021:** Severe cracking in gutter, driveway ramp and footpath – little to no change observed compared to pre-construction survey conditions, minor cracking of asphalt surface consistent with high traffic use of the area and not associated with project, removal of drainage grate and instatement of asphalt.

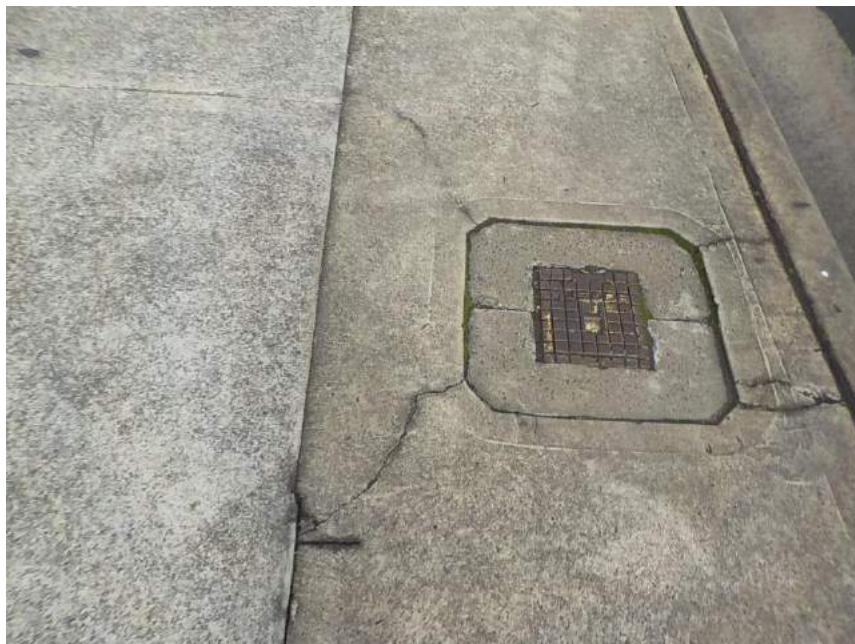
**2018:** Shear cracking around pit lid.

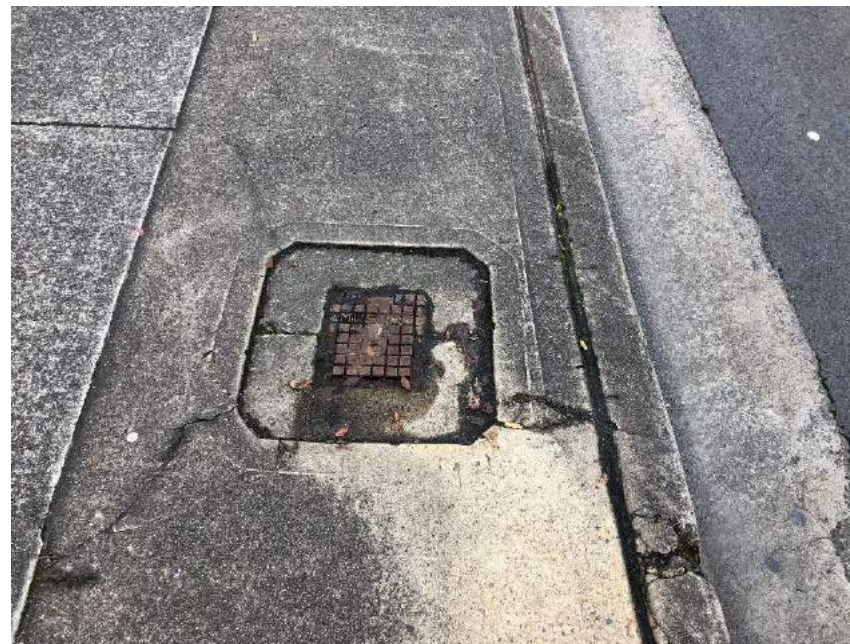
**2021:** Shear cracking around pit lid – little to no change observed compared to pre-construction survey conditions.

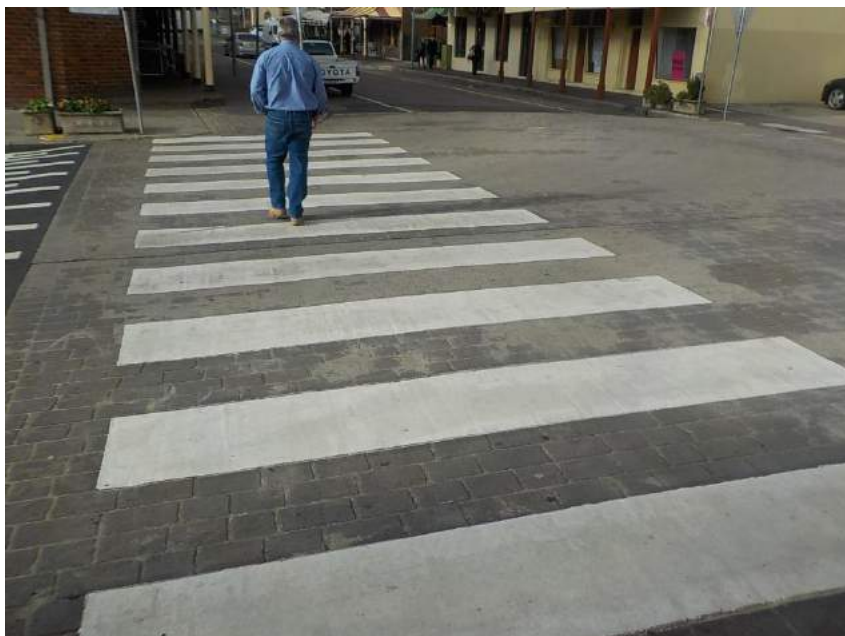
**2018:** General condition of road crossing – severe fading and wearing of surface.

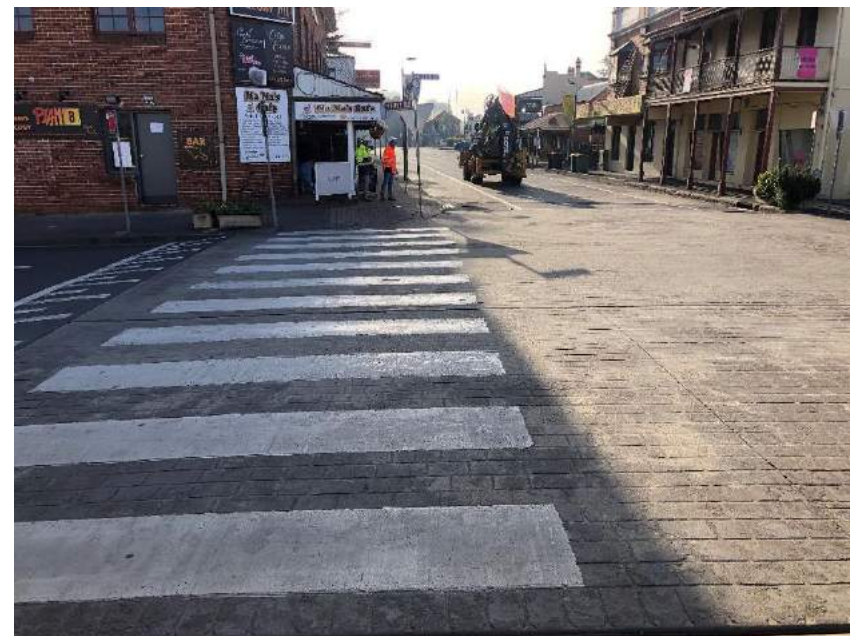
**2021:** General condition of road crossing – severe fading and wearing of surface – little to no change observed compared to pre-construction survey conditions.

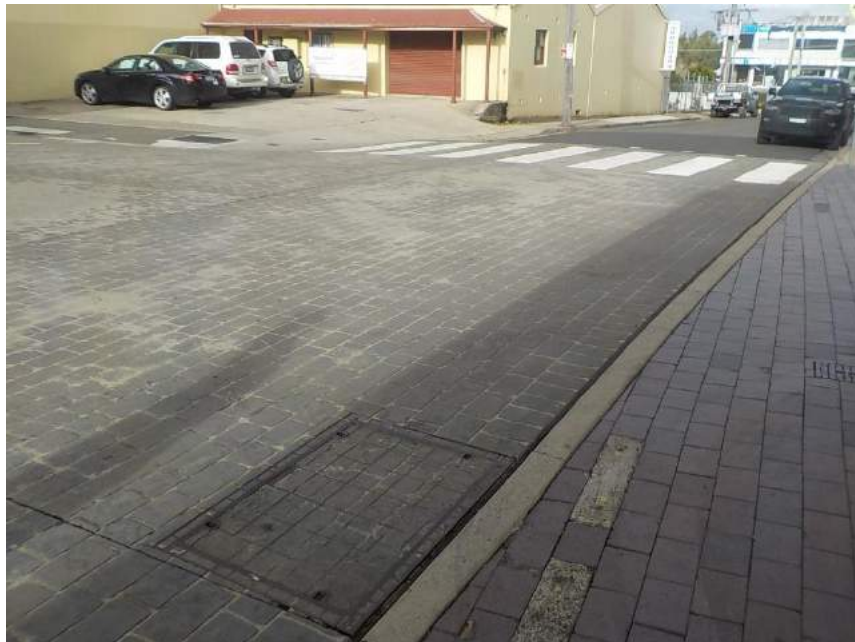
**2018:** General condition of road crossing – severe wearing of surface.

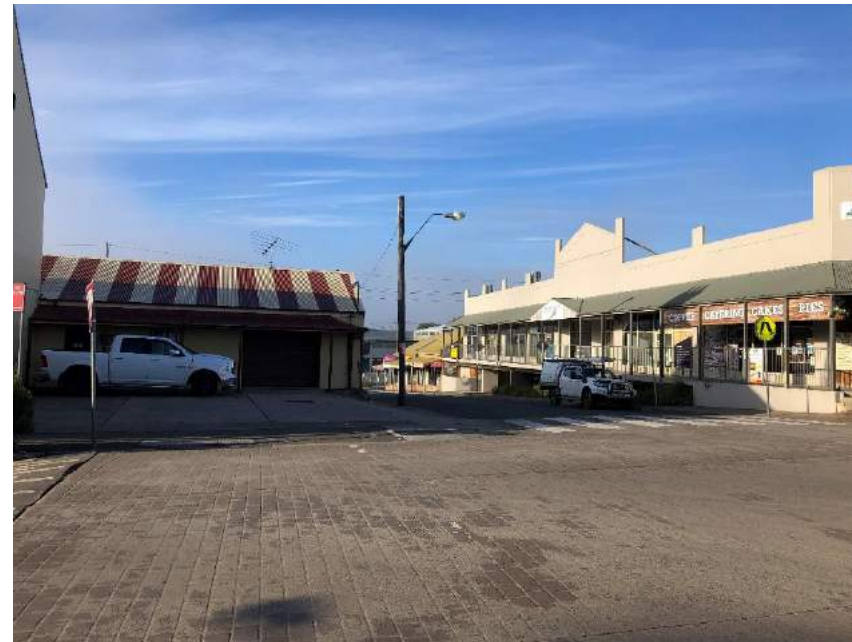
**2021:** General condition of road crossing – severe wearing of surface – little to no change observed compared to pre-construction survey conditions and minor change due to high traffic use of the area and not associated with construction.

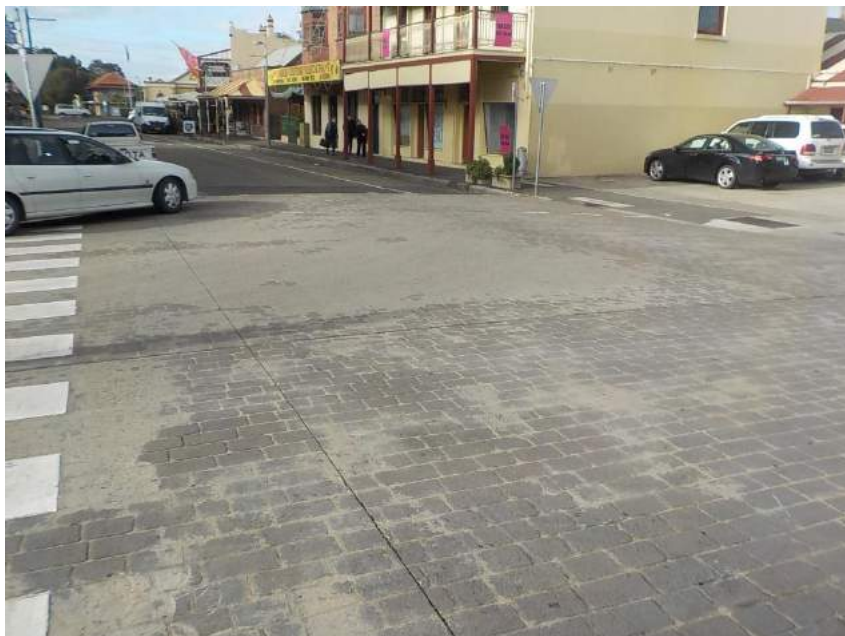
**2018:** General condition of road crossing – severe wearing of surface.

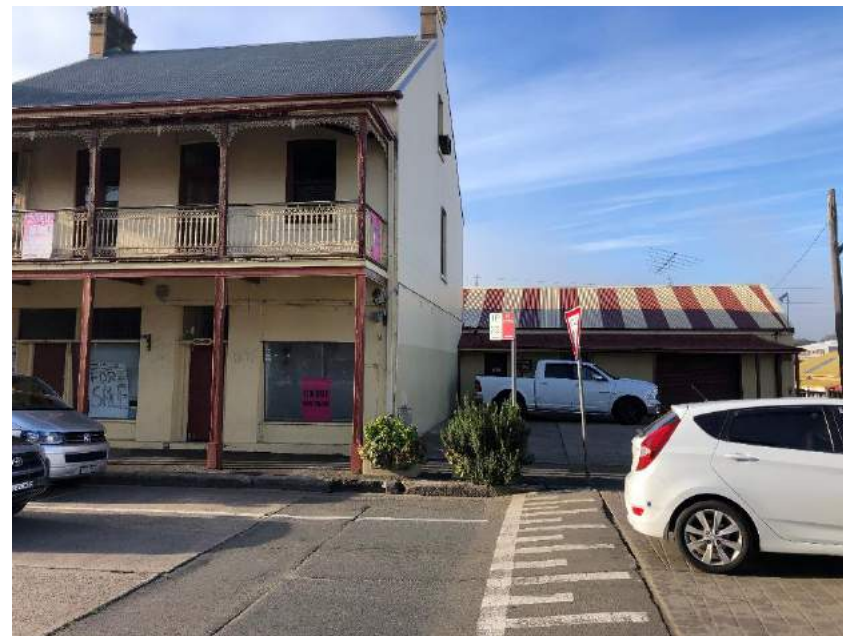
**2021:** General condition of road crossing – little to no change observed compared to pre-construction survey conditions.

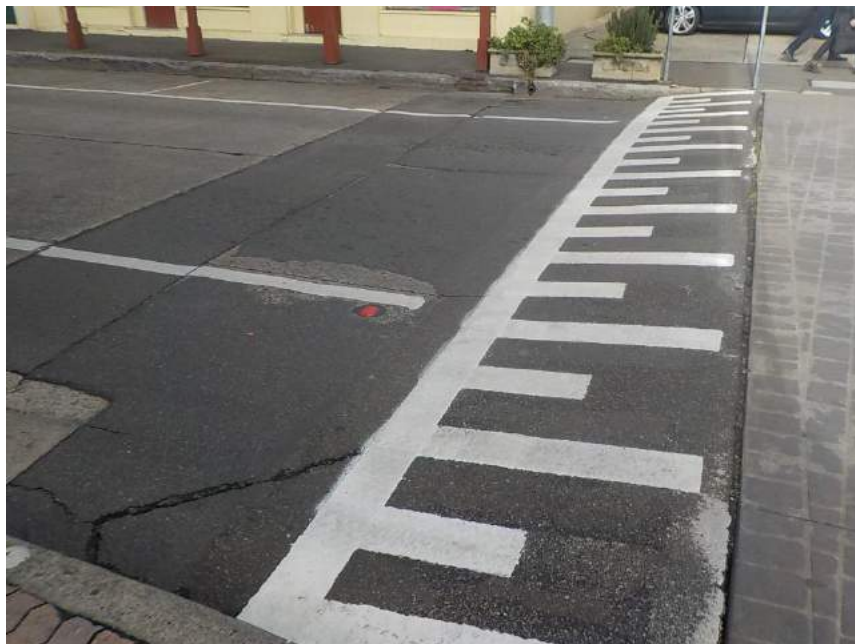
**2018:** General condition of road crossing – severe wearing and cracking of surface.

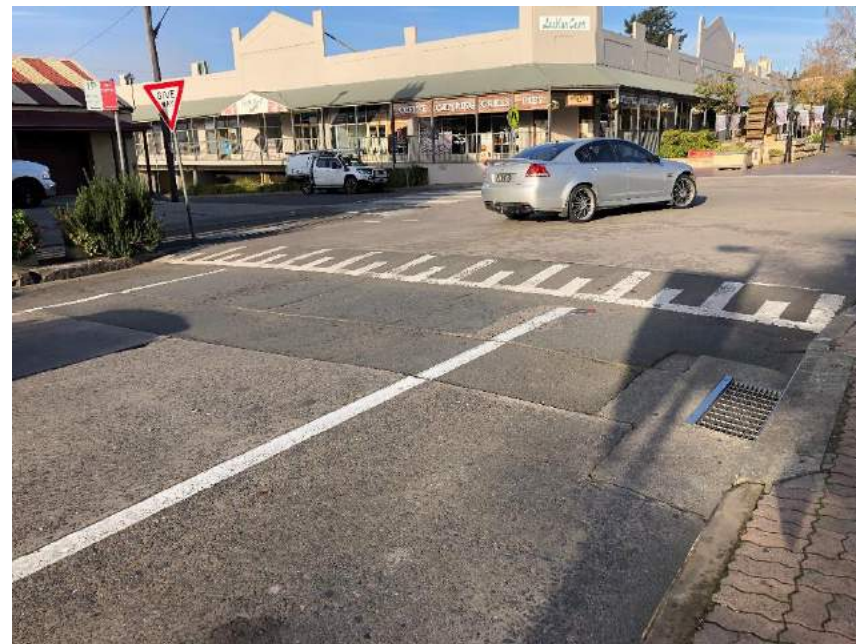
**2021:** General condition of road crossing – severe wearing and cracking of surface – little to no change observed compared to pre-construction survey conditions.

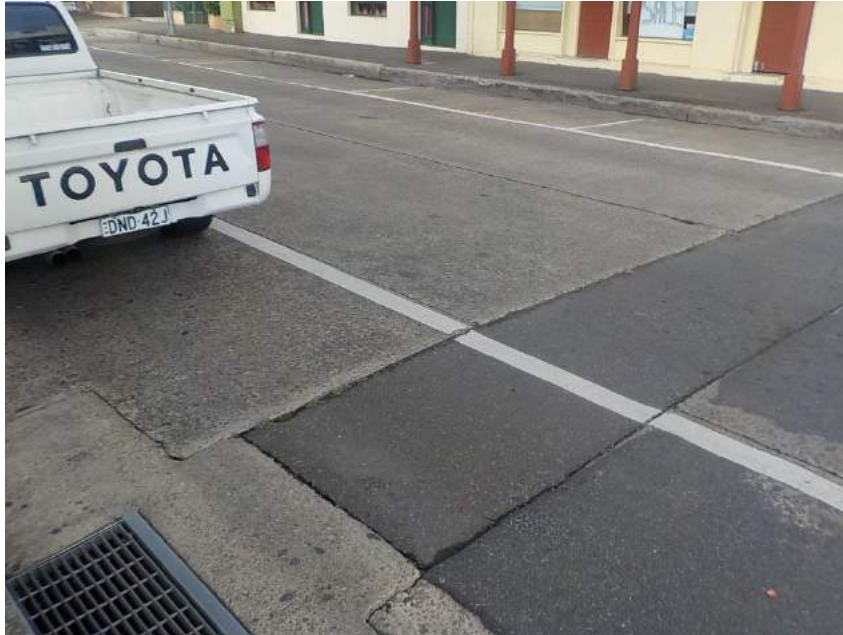
**2018:** General condition of pavement.

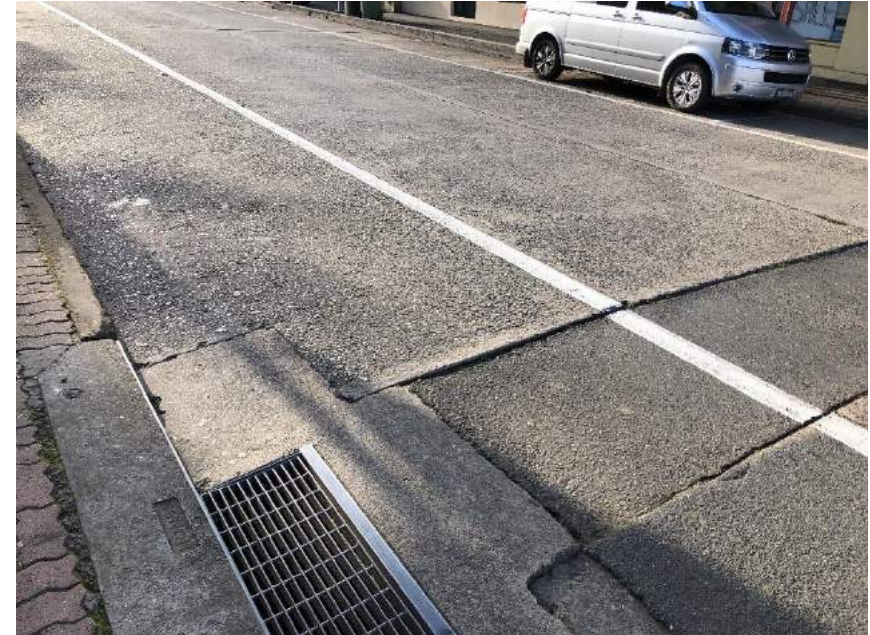
**2021:** General condition of pavement – little to no change observed compared to pre-construction survey conditions.

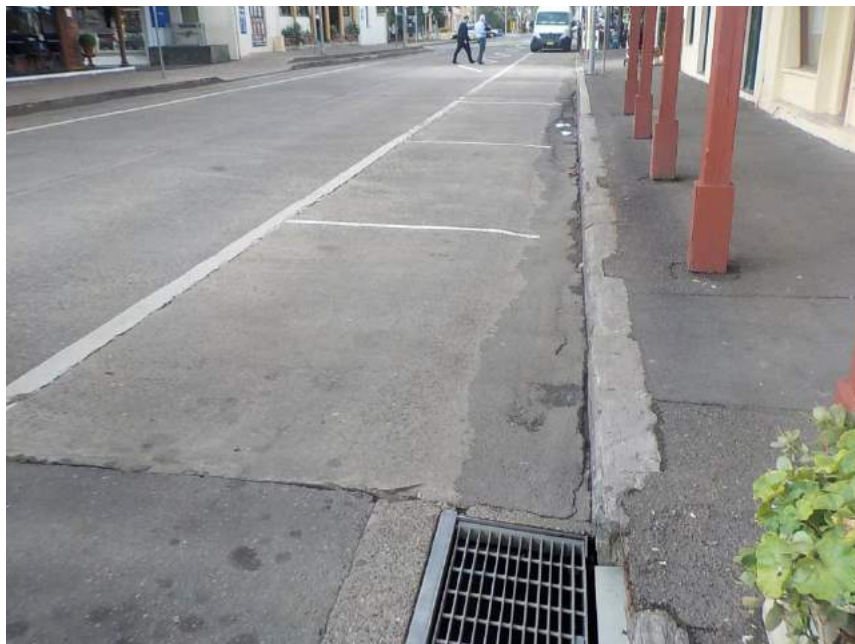
**2018:** General condition of pavement, sandstone kerb and footpath.

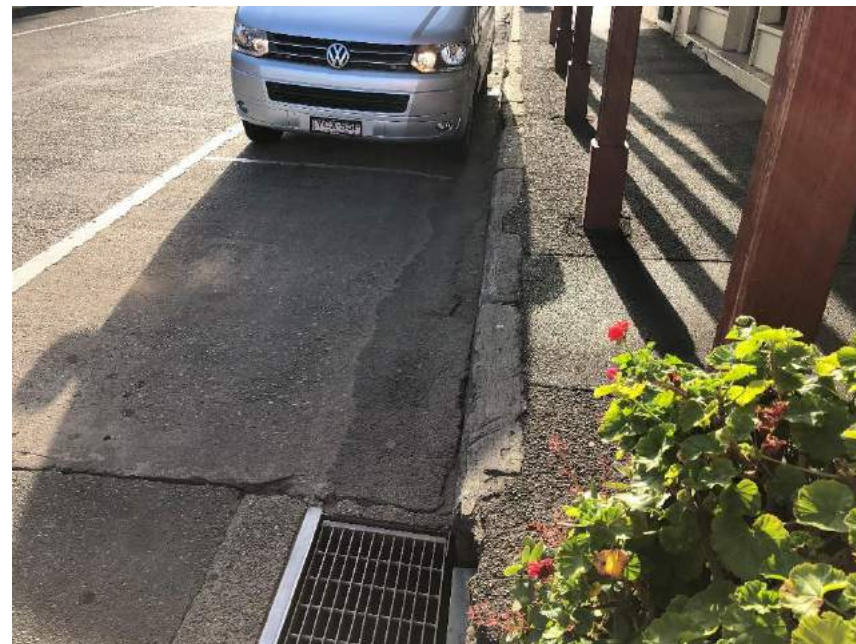
**2021:** General condition of pavement, sandstone kerb and footpath – little to no change observed compared to pre-construction survey conditions.

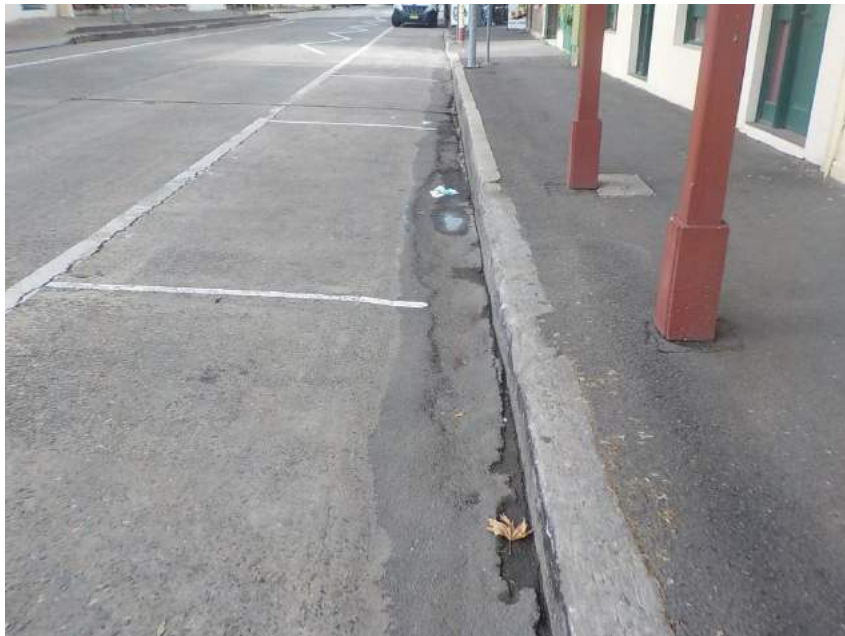
**2018:** General condition of pavement, sandstone kerb and footpath – ravelling and rutting of asphalt surface and gutter.

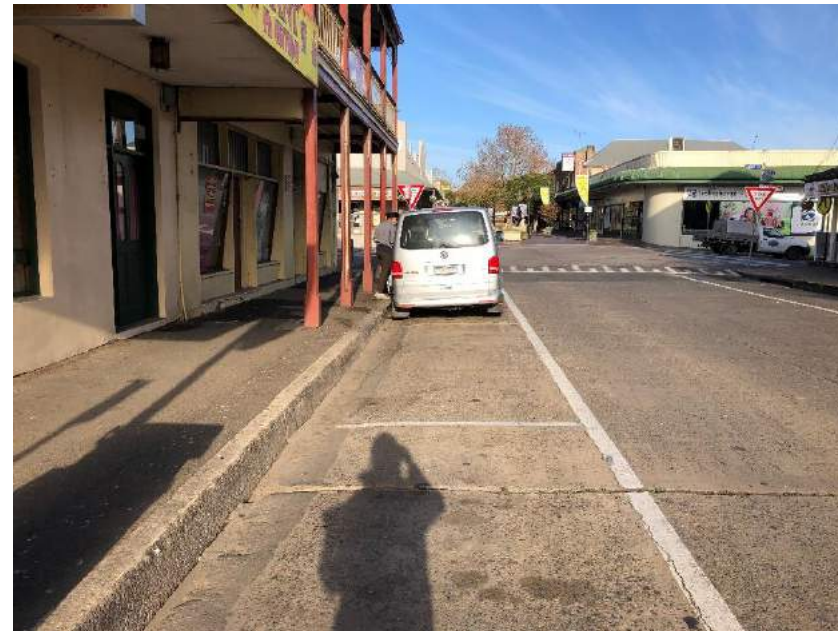
**2021:** General condition of pavement, sandstone kerb and footpath – little to no change observed compared to pre-construction survey conditions.

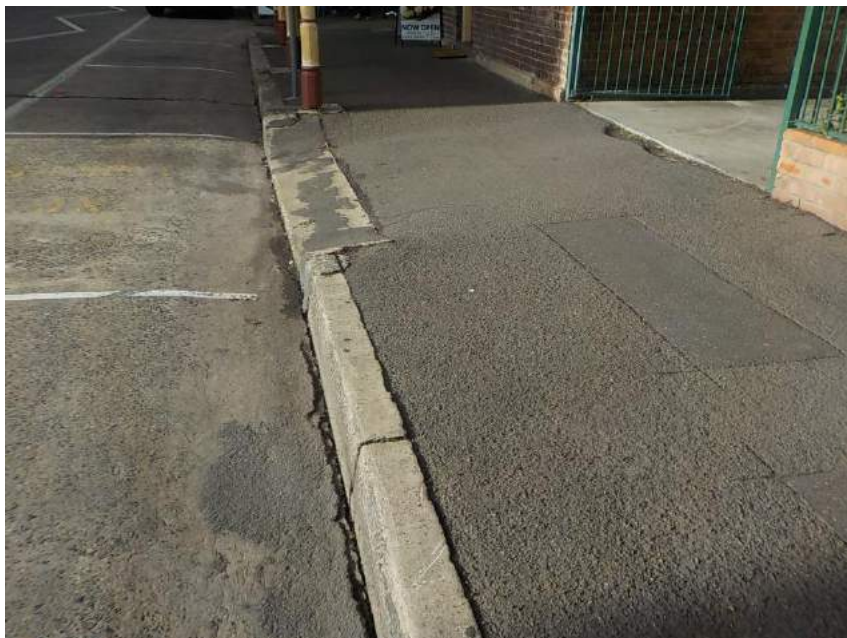
**2018:** General condition of pavement, sandstone kerb and footpath – ravelling and rutting of asphalt surface and gutter.

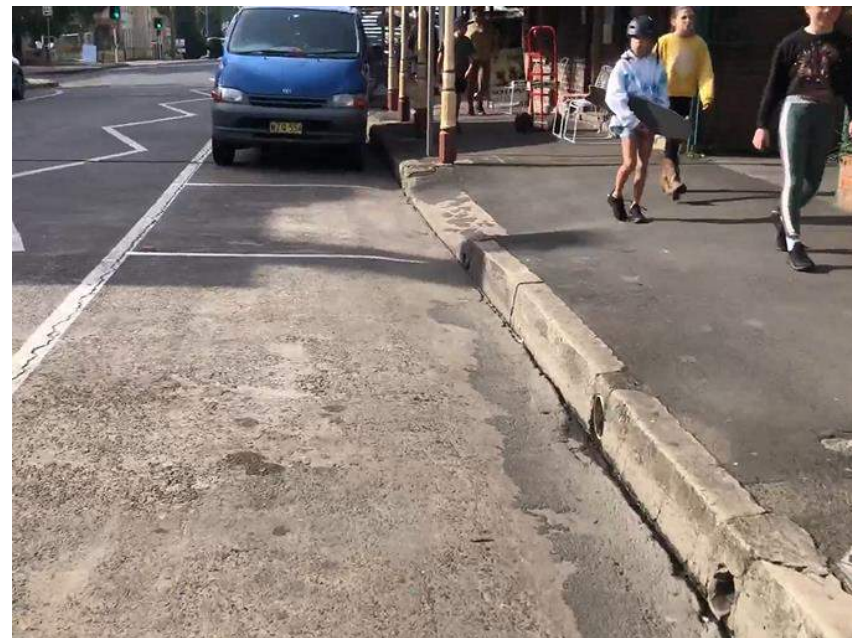
**2021:** General condition of pavement, sandstone kerb and footpath – little to no change observed compared to pre-construction survey conditions.

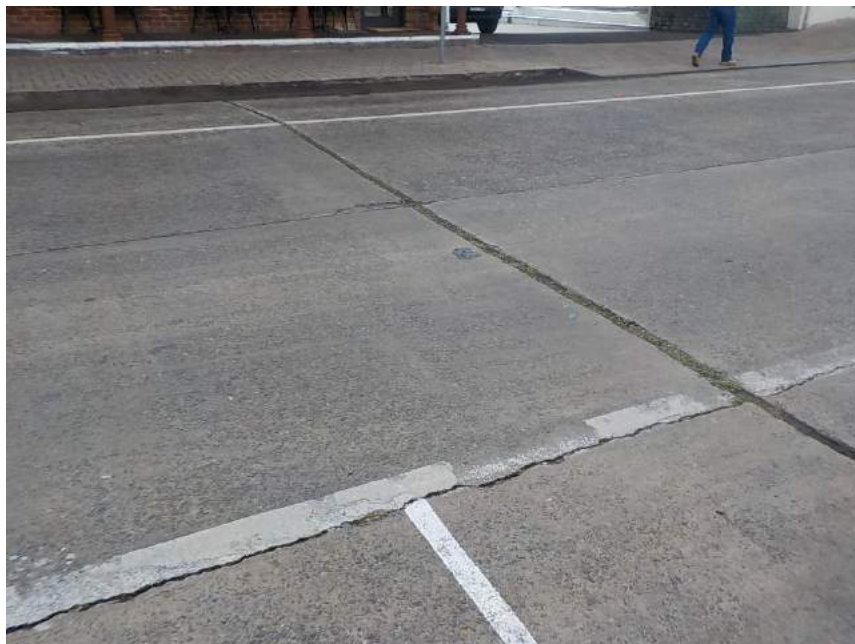
**2018:** General condition of pavement.

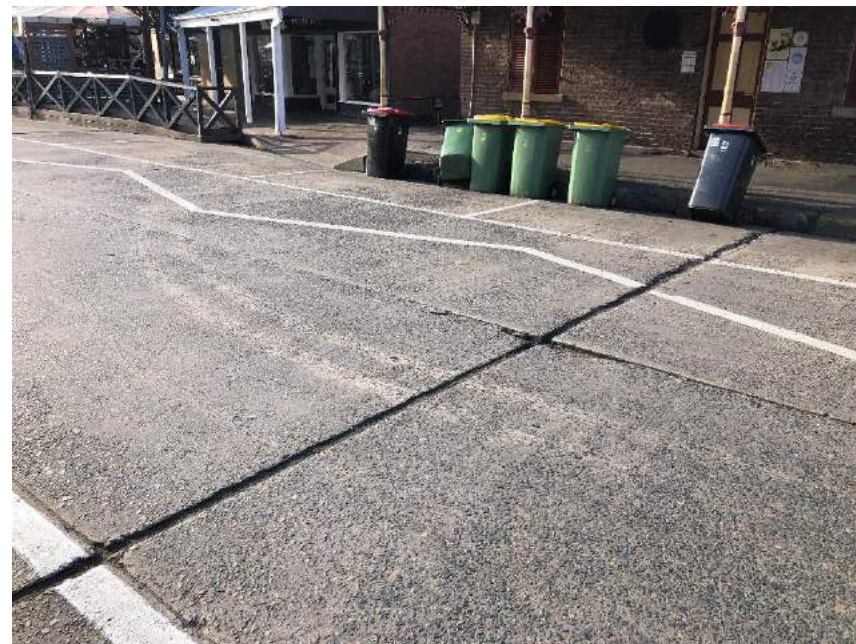
**2021:** General condition of pavement – little to no change observed compared to pre-construction survey conditions.

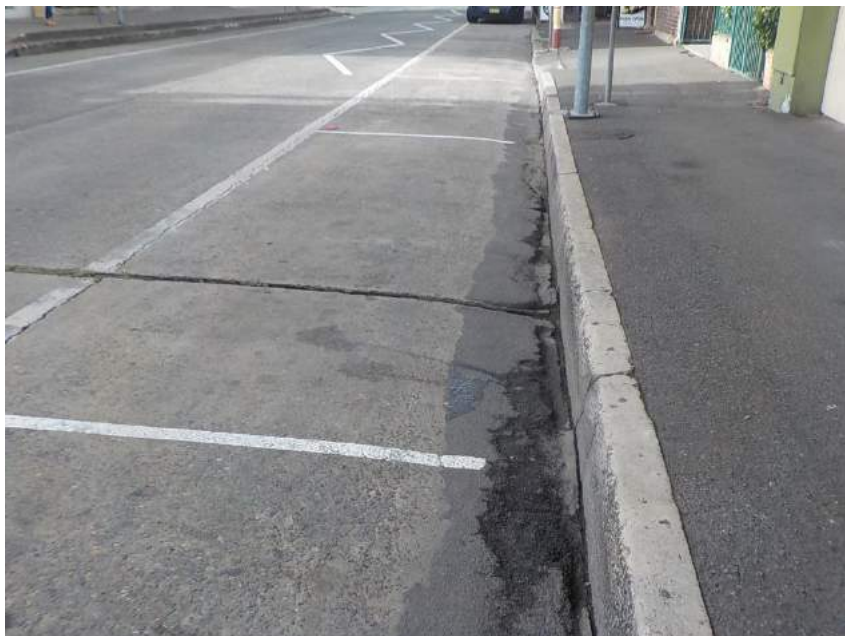
**2018:** General condition of pavement, sandstone kerb and footpath.

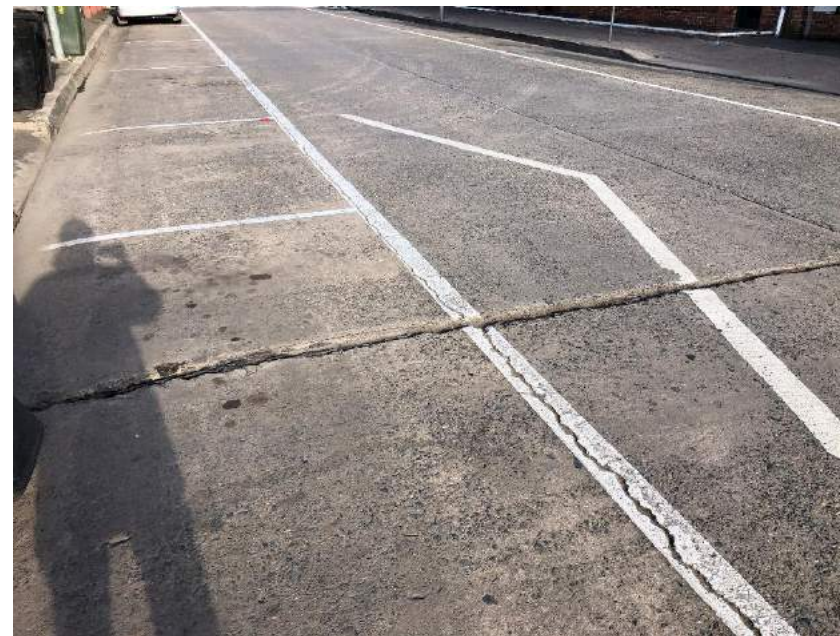
**2021:** General condition of pavement, sandstone kerb and footpath – little to no change observed compared to pre-construction survey conditions.

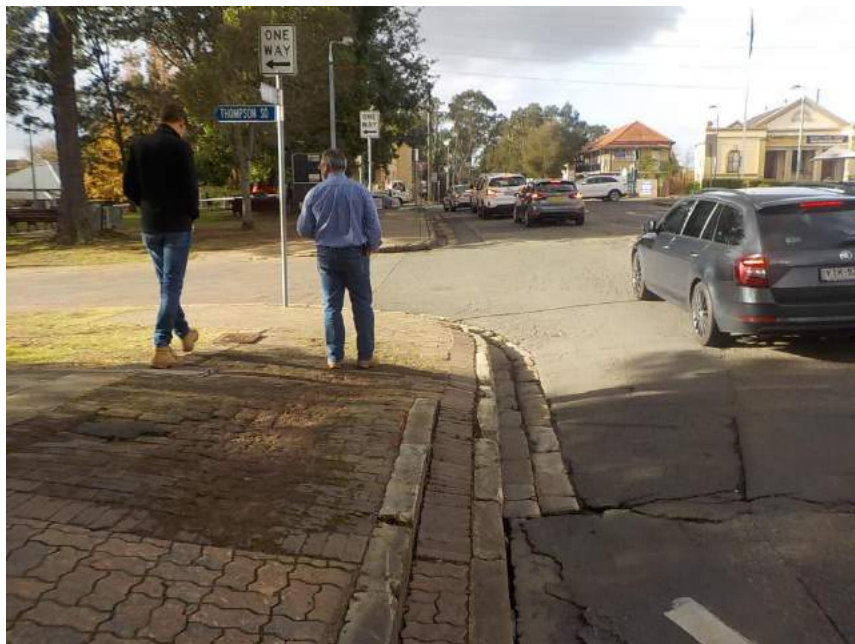
**2018:** Severe wearing to footpath – extensive cracking and heaving on asphalt surface.

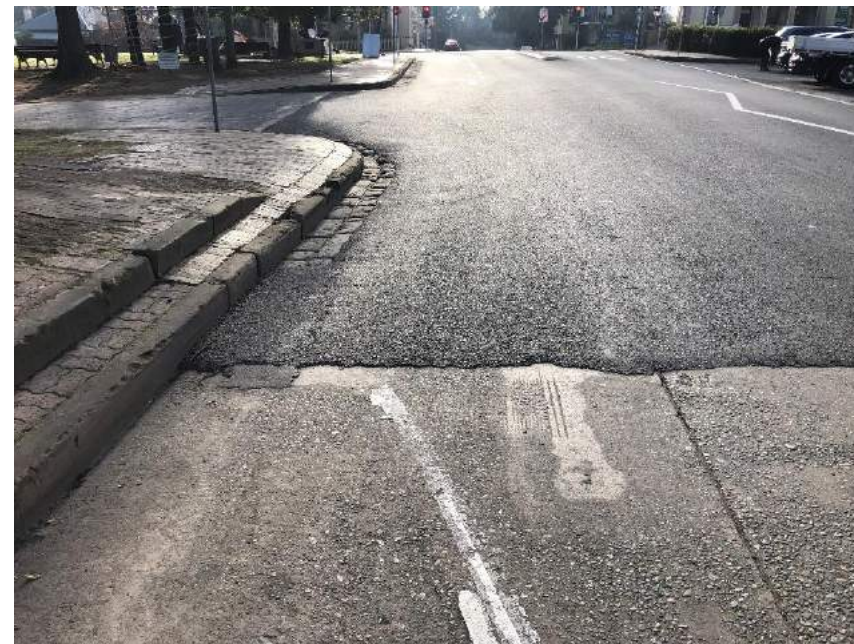
**2021:** Wearing to footpath consistent with pre-construction survey conditions, meeting point for newly installed asphalt and original roadway surfacing.

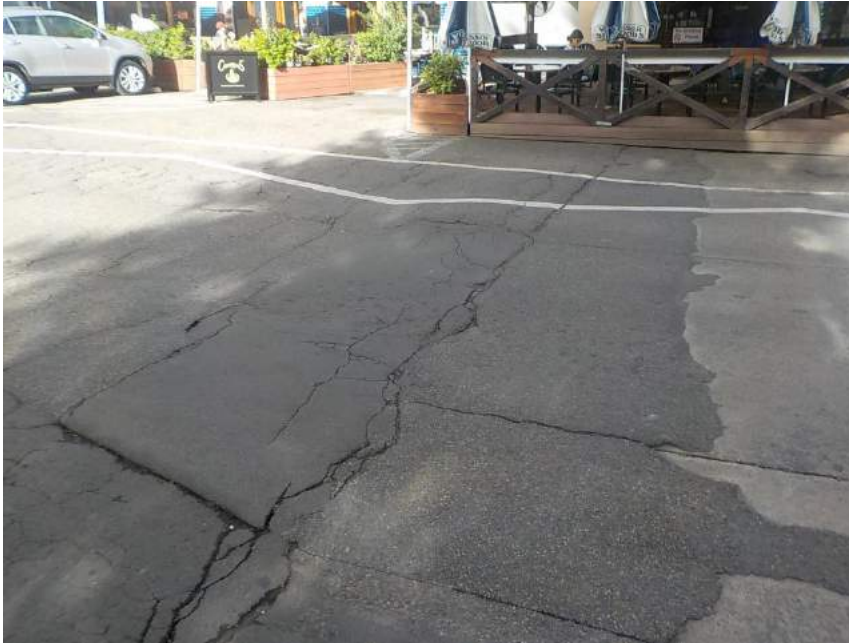
**2018:** Severe cracking and heaving on asphalt surface.

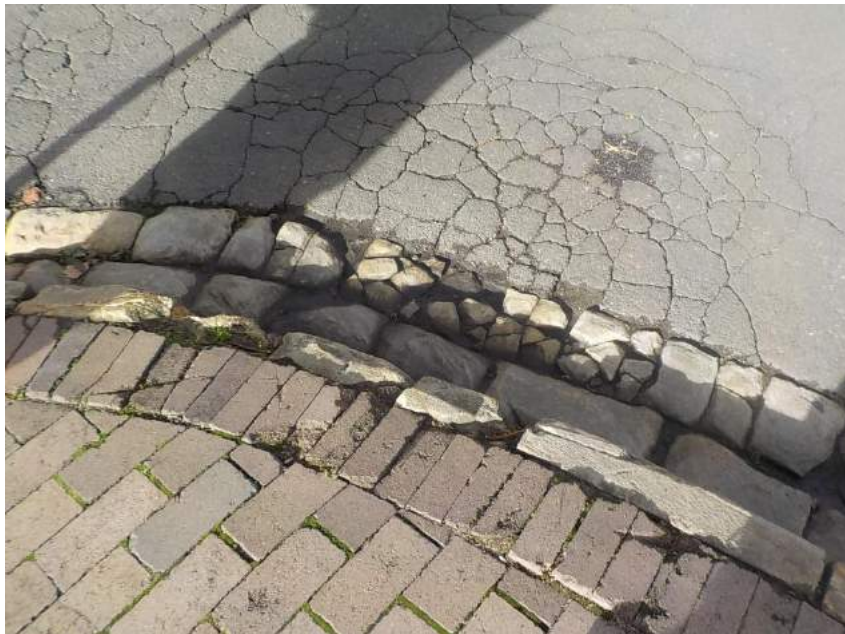
**2018:** General condition of sandstone kerb and gutter – crocodile cracking on asphalt surface.

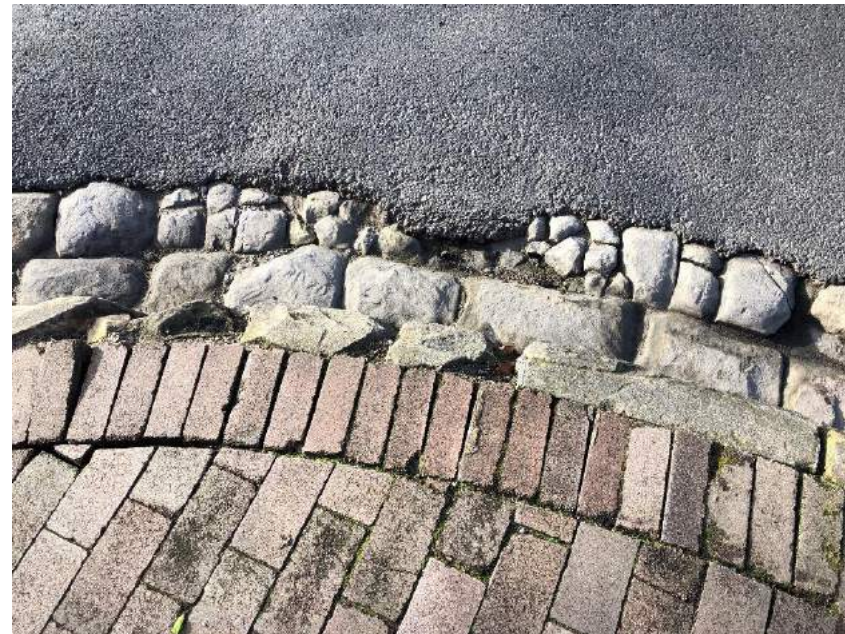
**2021:** General condition of sandstone kerb and gutter consistent with pre-construction survey condition – replacement of asphalt surface.

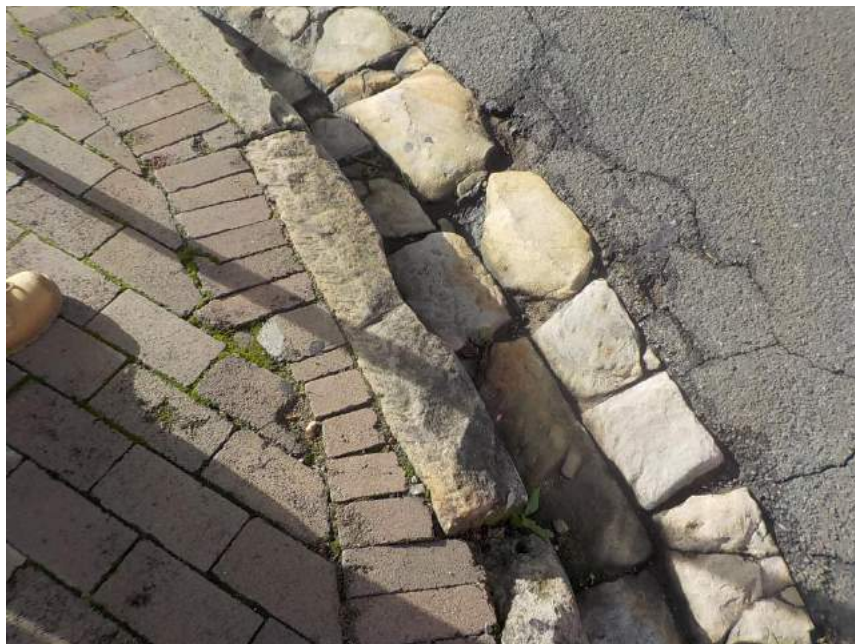
**2018:** General condition of sandstone kerb and gutter – cracking on asphalt surface.
