# Georgiou Group Dilapidation Report, Windsor Bridge Replacement Project, Windsor NSW

S-03139.DilapidationReport.001

**Pre-Dilapidation Photos Taken:** 20<sup>th</sup> June 2018

**Post-Dilapidation Photos Taken:** 8<sup>th</sup> July 2021

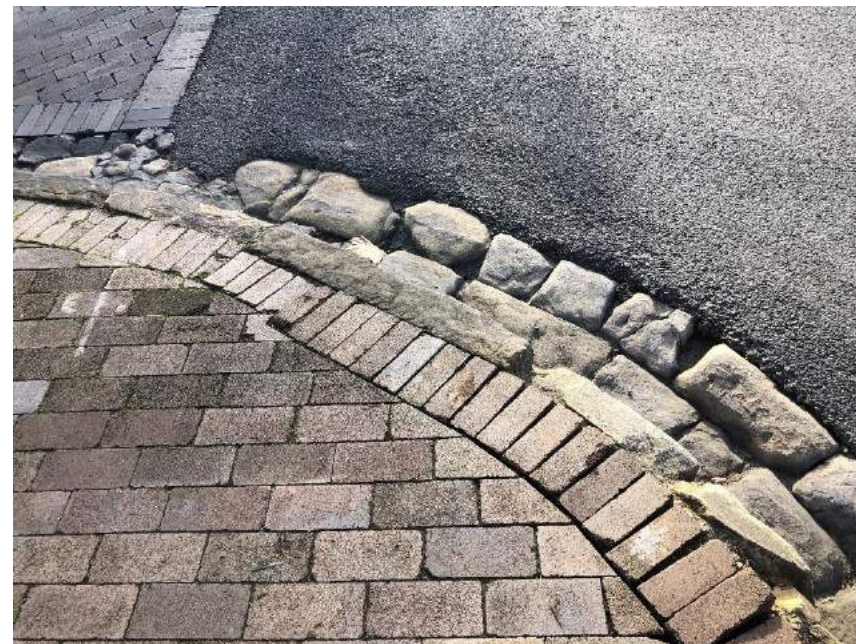
**2021:** General condition of sandstone kerb and gutter consistent with pre-construction survey conditions – replacement of surrounding asphalt surface.

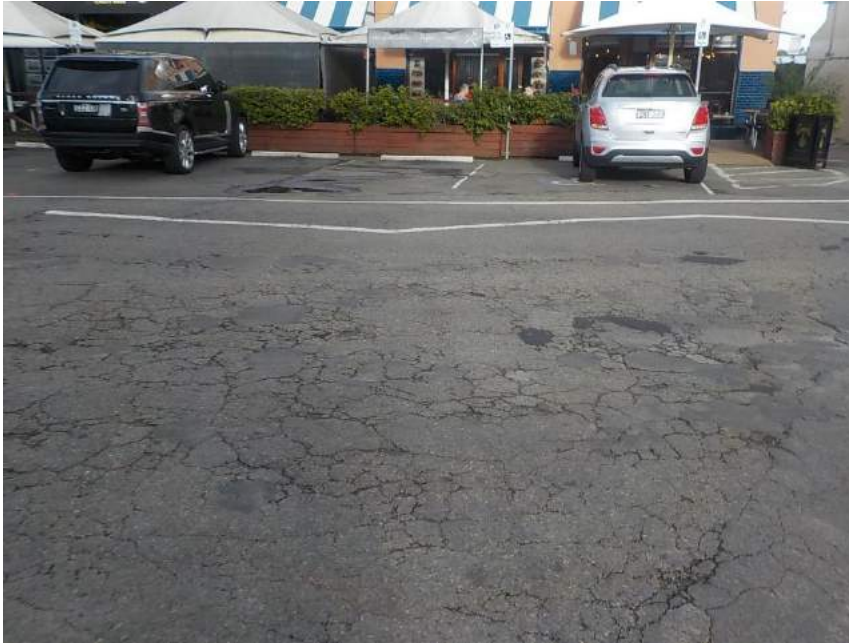
**2018:** Severe crocodile cracking and ravelling on asphalt surface.

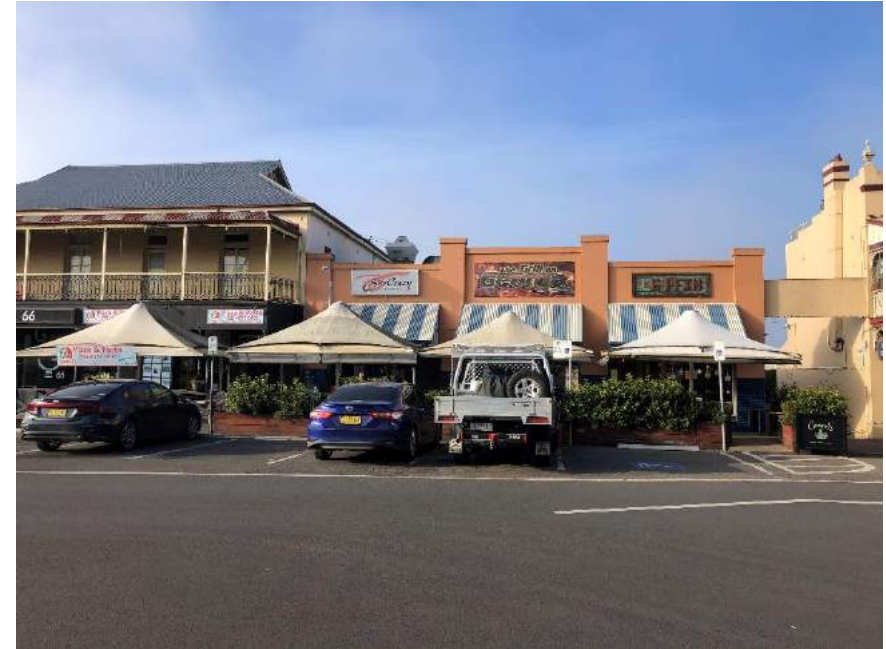
**2021:** Replacement of roadway asphalt surface.

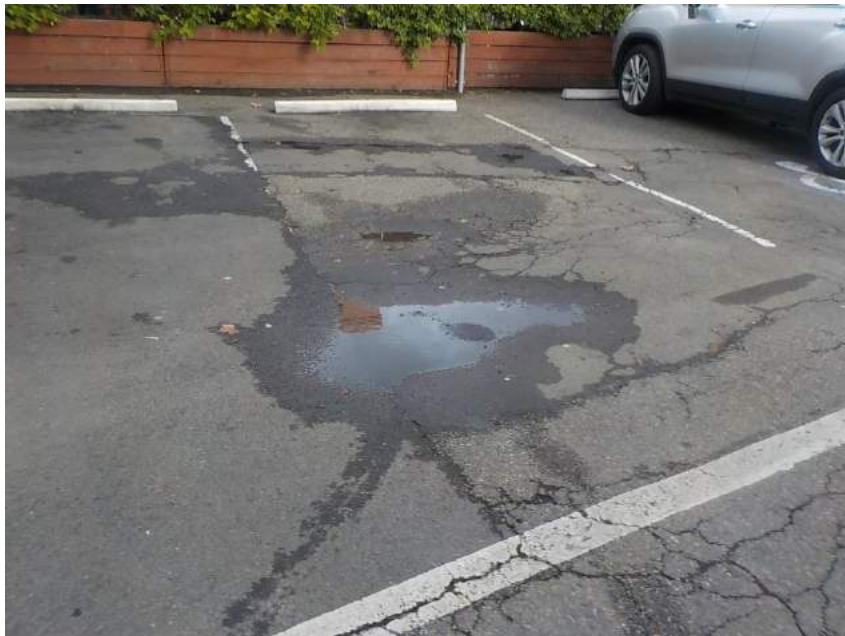
**2018:** Severe crocodile cracking and ravelling on asphalt surface – pooling.

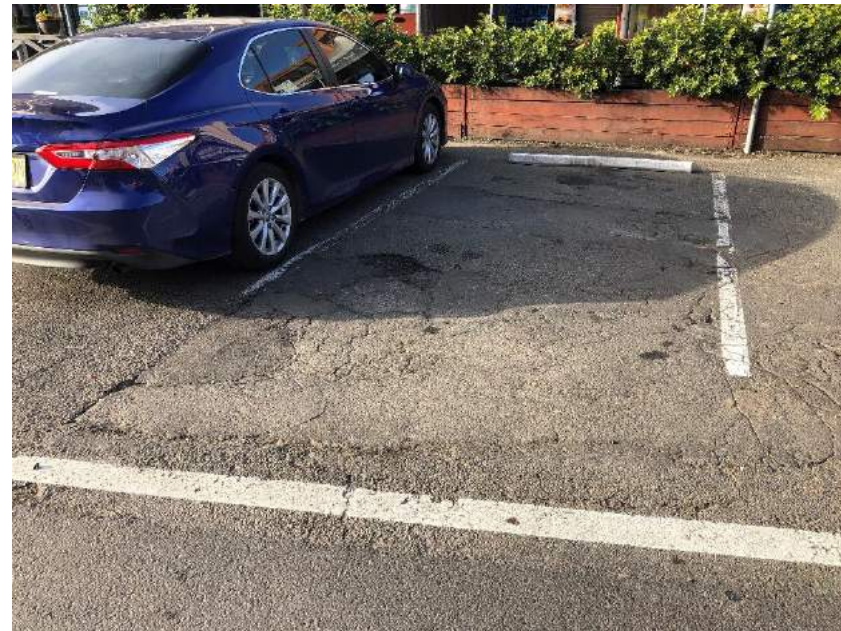
**2021:** Severe crocodile cracking and ravelling on asphalt surface little to no change observed compared to pre-construction survey conditions with areas of asphalt filling across previous pooling areas.

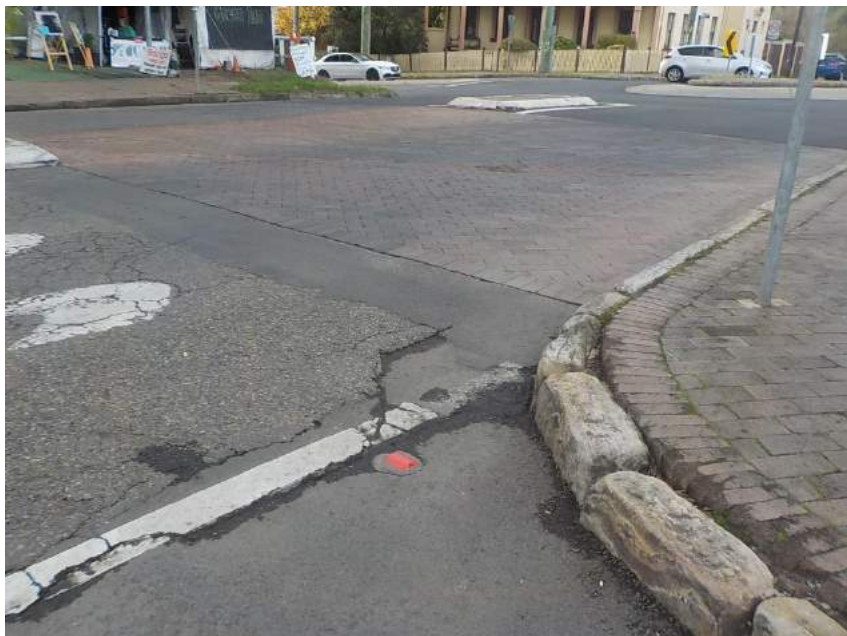
**2018:** General condition of pavement and sandstone kerb.

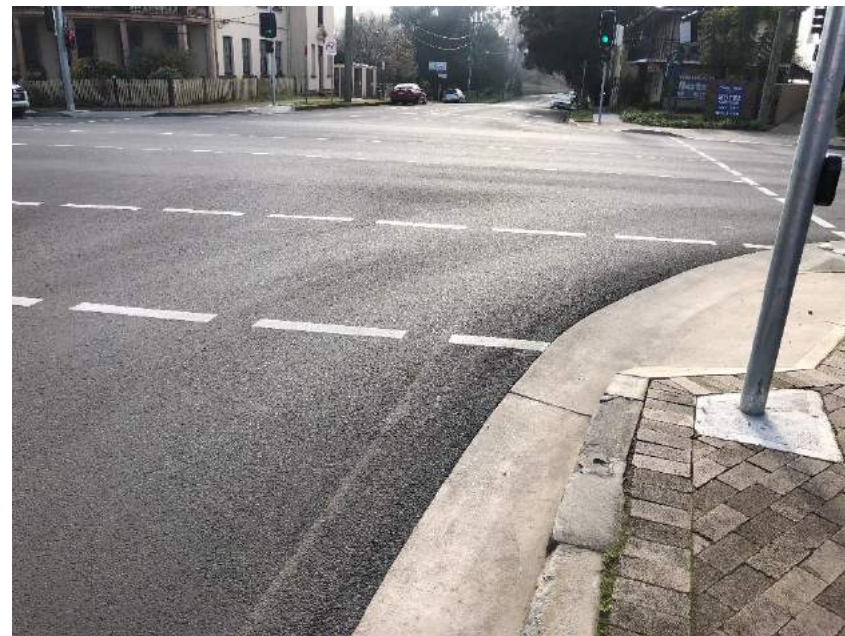
**2021:** Improved general condition of pavement and sandstone kerb – upgrades to asphalt, gutter and intersection.

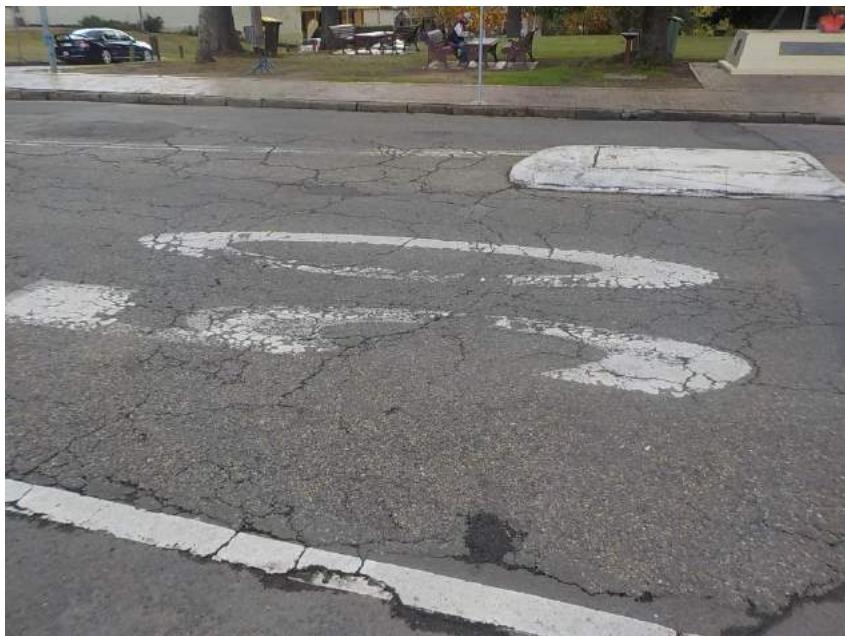
**2018:** General condition of pavement – cracking in Median Island.

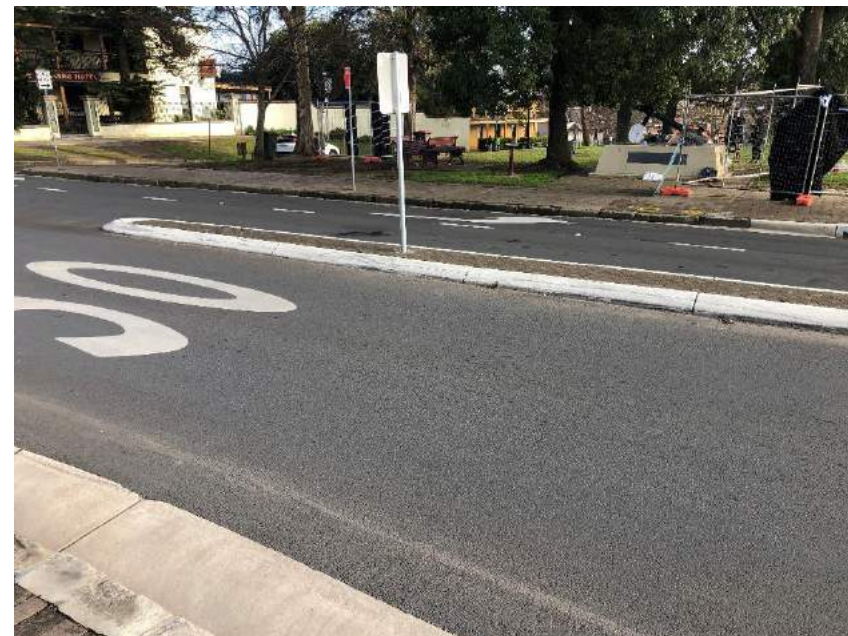
**2021:** General condition of pavement – replacement of asphalt and median island.

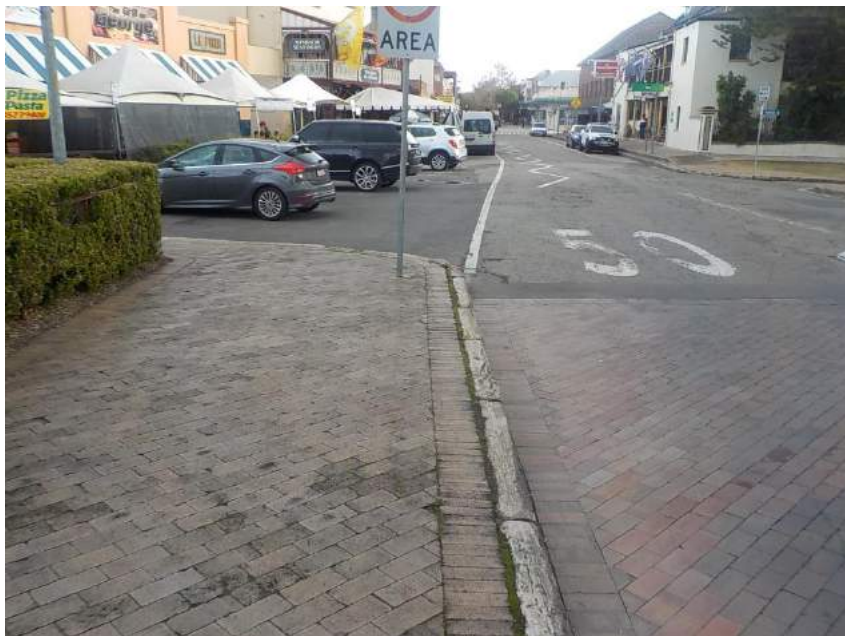
**2018:** General view of George St from the roundabout intersection with Bridge St.

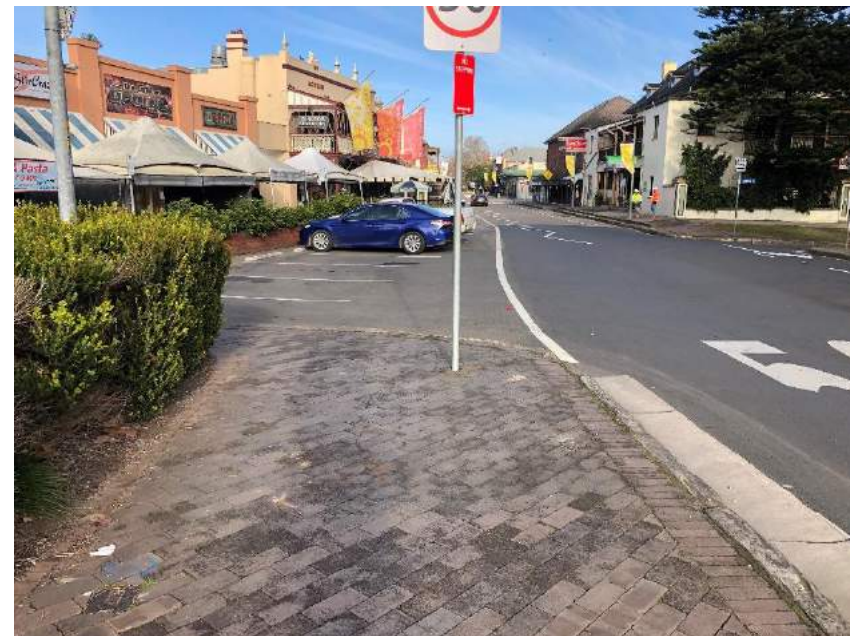
**2021:** General view of George St from the traffic light intersection with Bridge St – little to no change observed to footpath and carpark area compared to pre-construction survey conditions, replacement of asphalt and kerb.

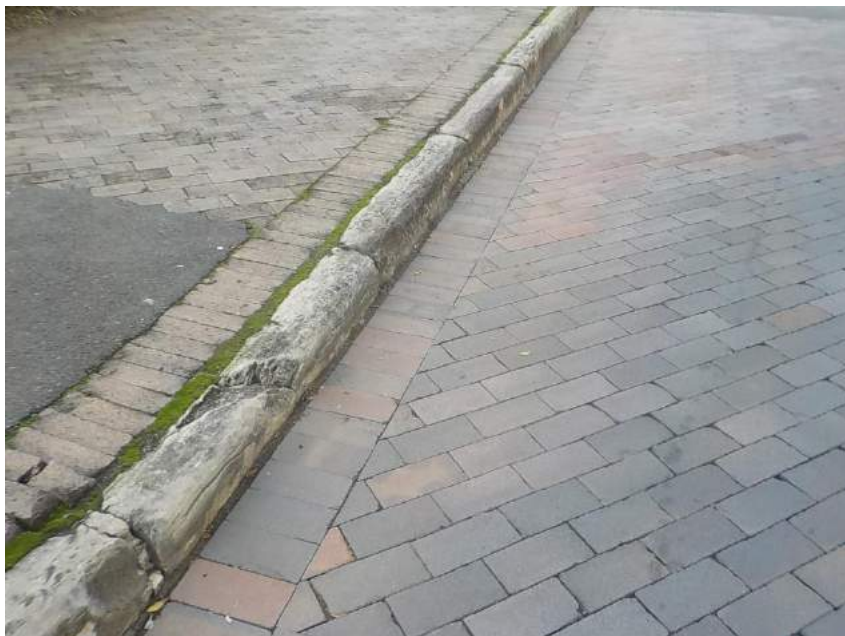
**2018:** General condition of footpath, kerb and pavement.

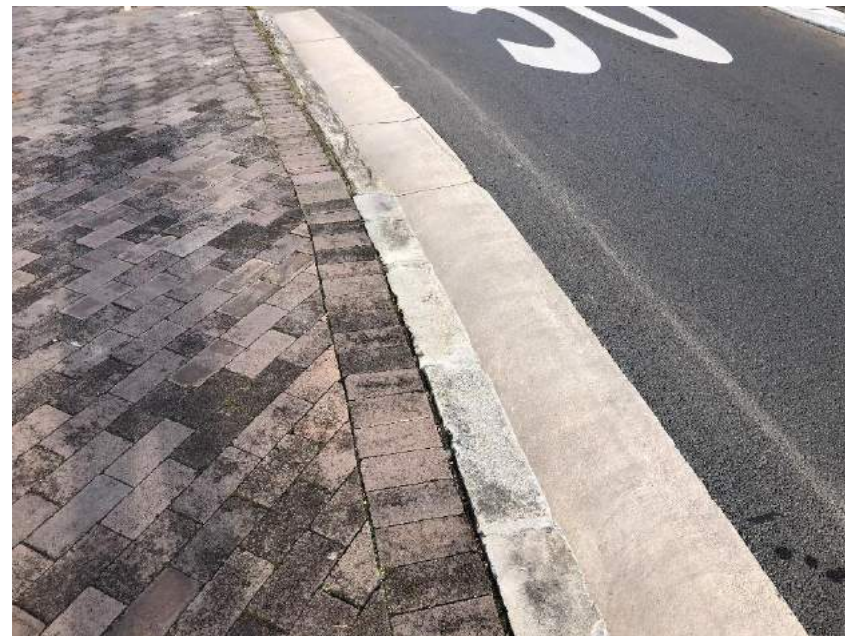
**2021:** General condition of footpath, kerb and pavement – replacement of paver roadway and gutter.

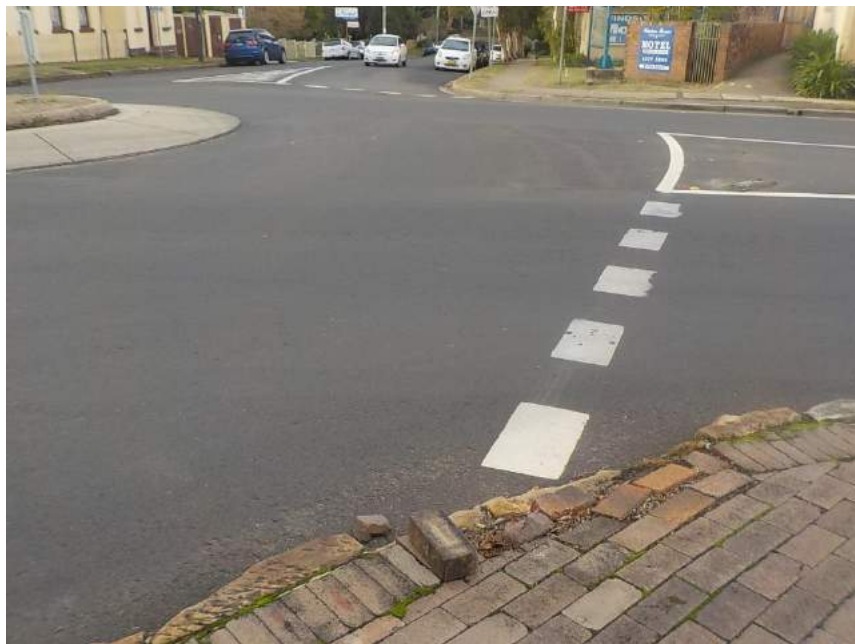
**2018:** General view of roundabout intersection on corner of George St and Bridge St – damage to kerb.

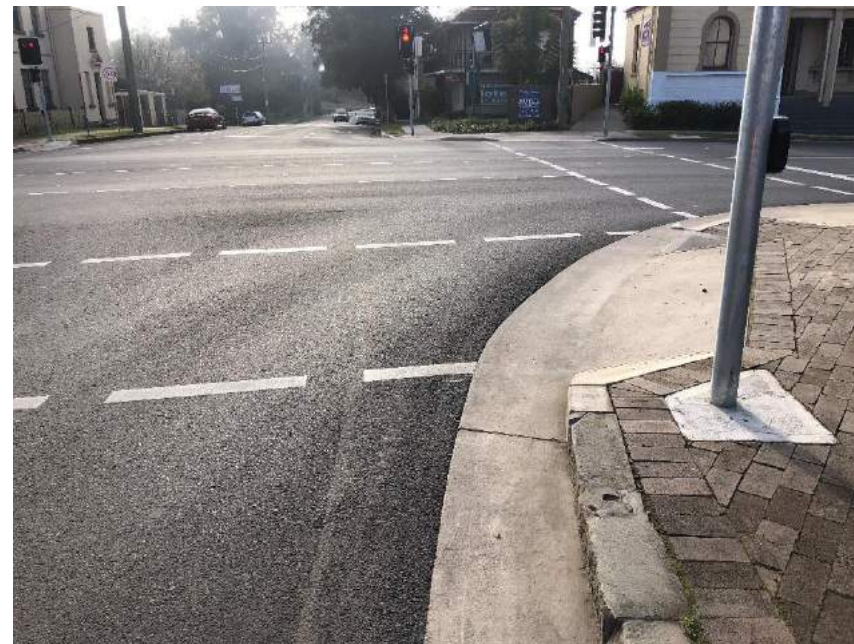
**2021:** General view of intersection on corner of George St and Bridge St – replacement of kerb, gutters and asphalt.

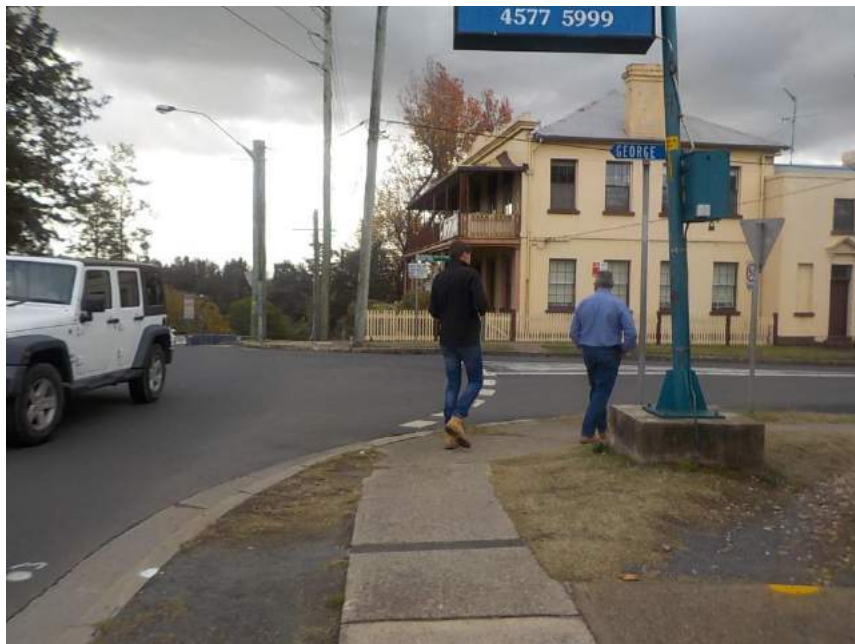
**2018:** General view of roundabout intersection on corner of George St and Bridge St, at Windsor Hotel sign.

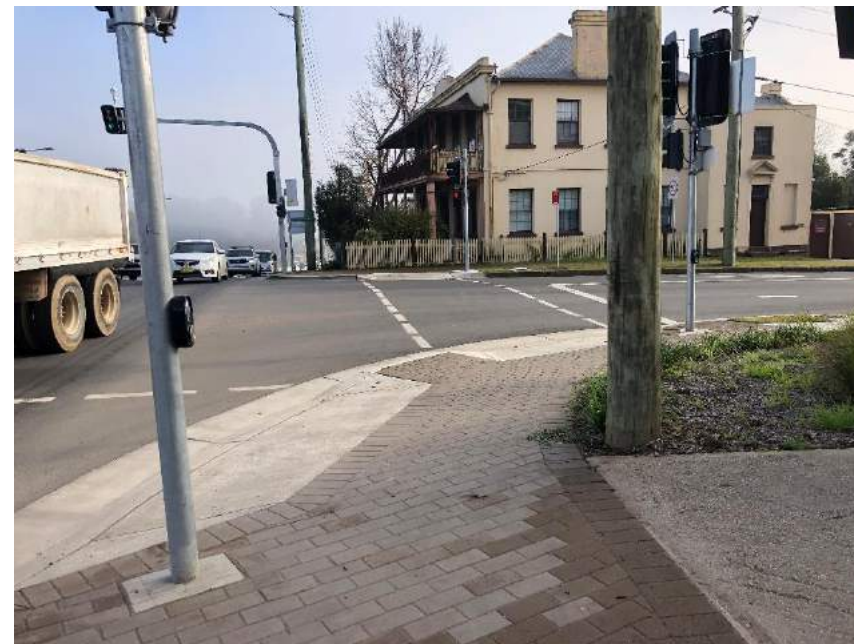
**2021:** General view of intersection on corner of George St and Bridge St, at Windsor Hotel. Evident upgrades to pedestrian walkway, roadway and traffic flow.

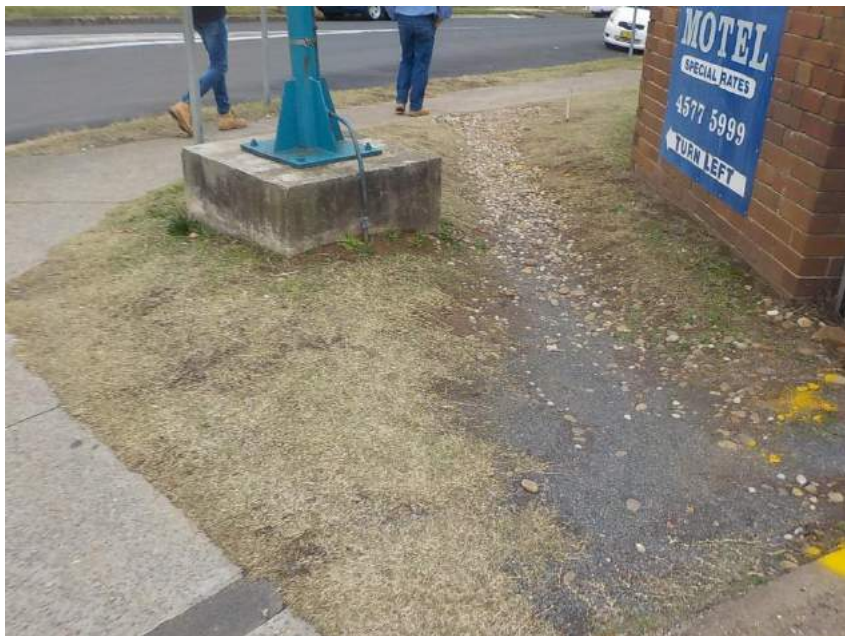
**2018:** General condition of footpath and landscaping – rutting present.

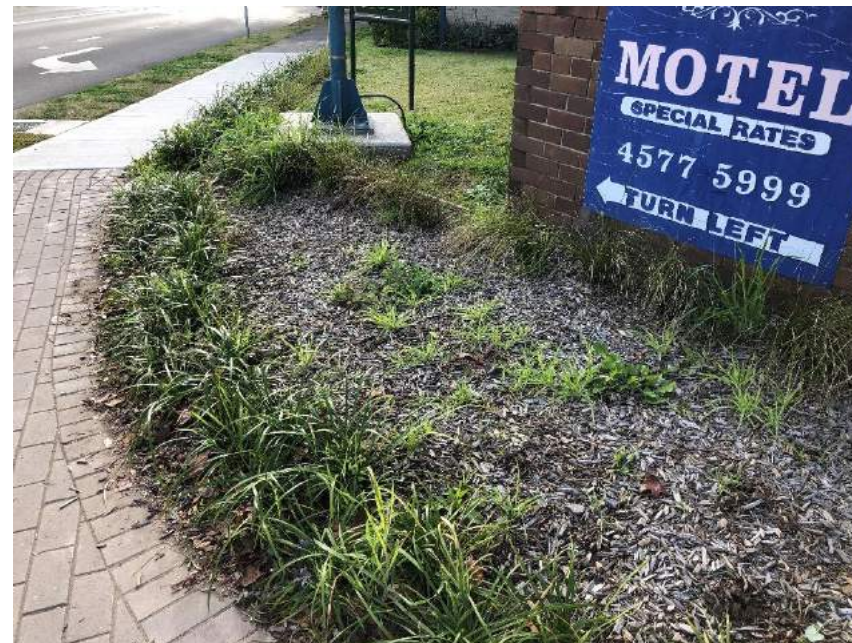
**2021:** General condition of footpath and landscaping – installation of new footpath and garden area.

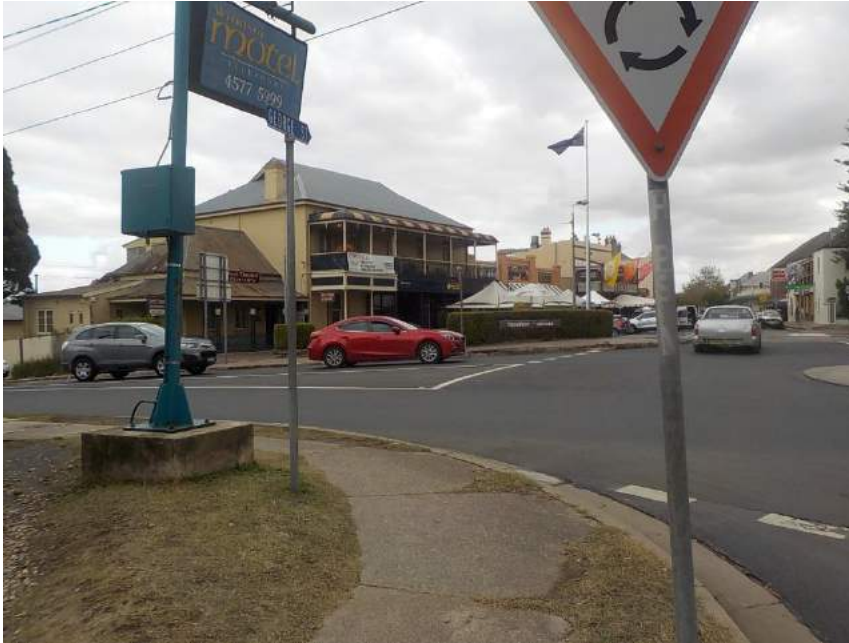
**2018:** General view of roundabout intersection on corner of George St and Bridge St – cracking in footpath.

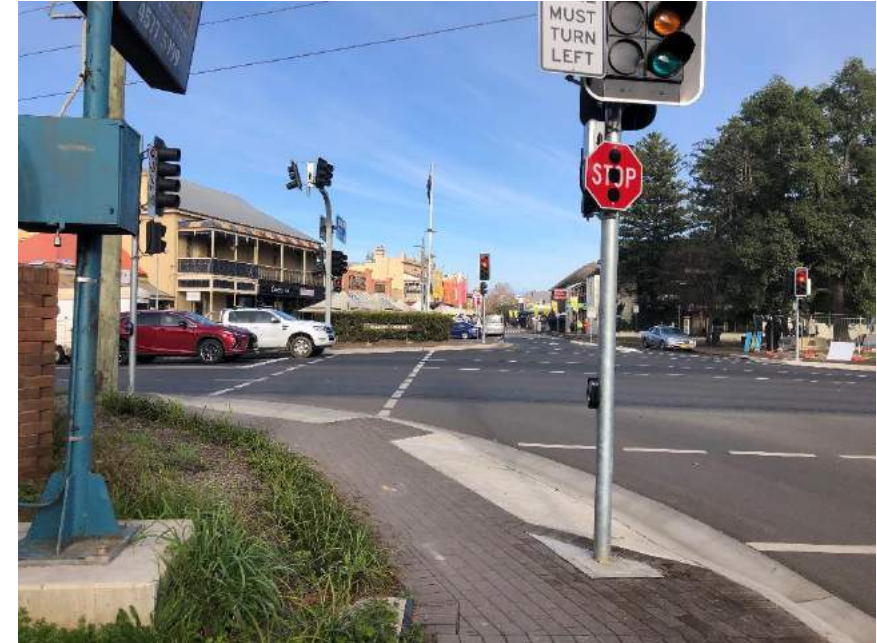
**2021:** General view of intersection on corner of George St and Bridge St – installation of new landscaping, asphalt, traffic lights and footpath.

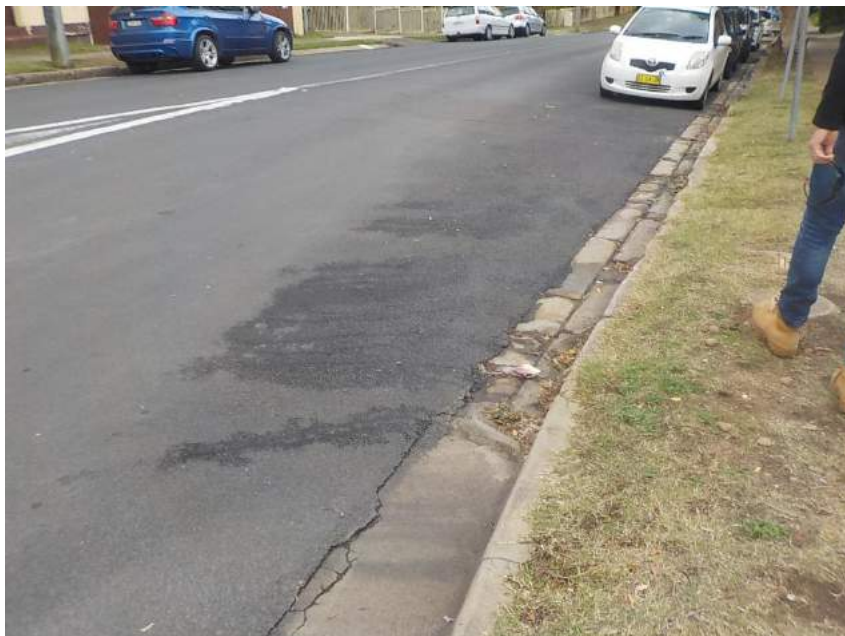
**2018:** General view of George St pavement and kerb.

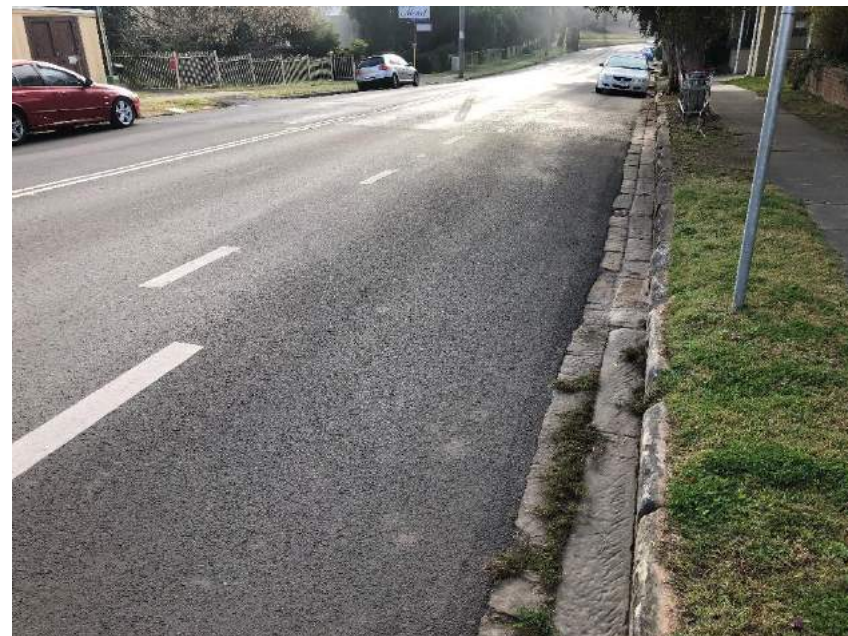
**2021:** General view of George St pavement and kerb – little to no change observed compared to pre-construction survey conditions.

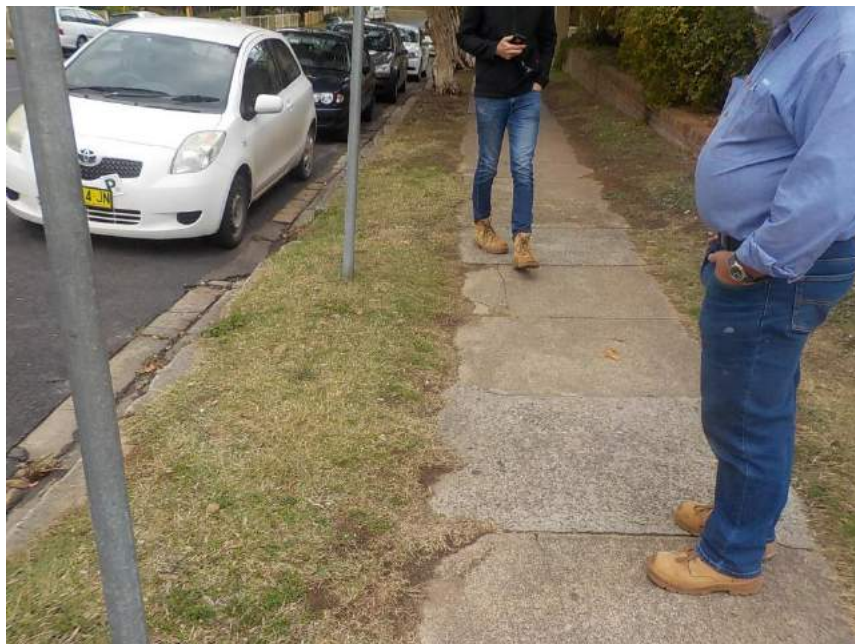
**2018:** General view of footpath.

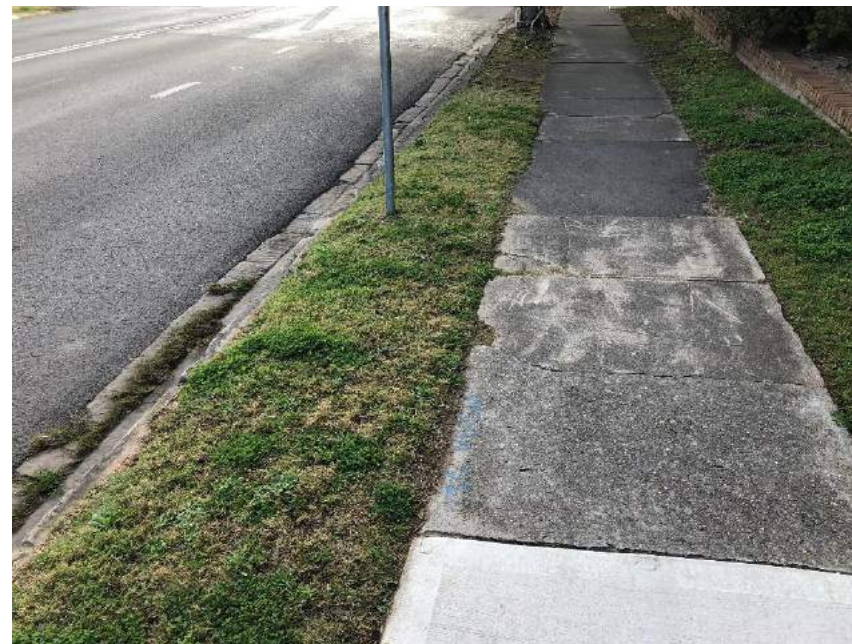
**2021:** General view of footpath – replacement of several previously damaged footpath sections.

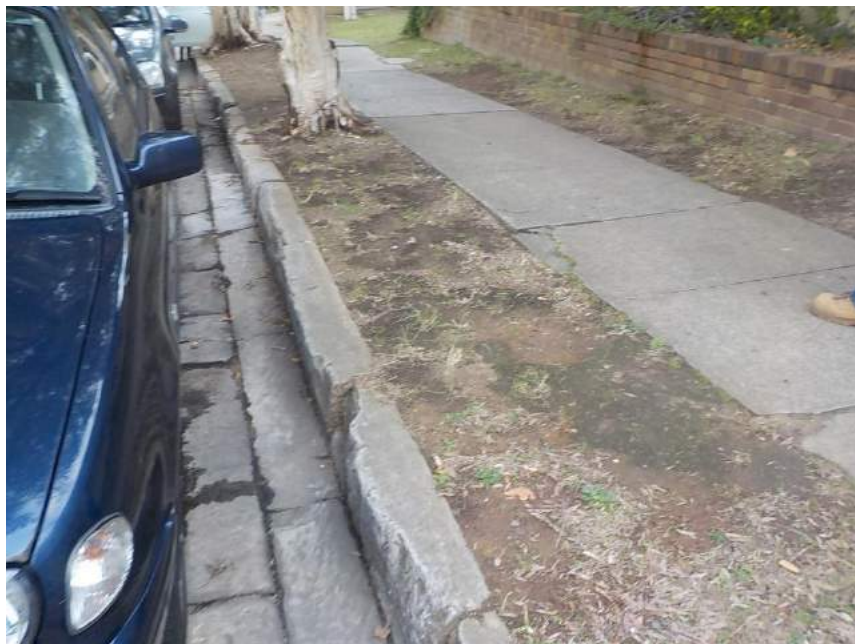
**2018:** General view of footpath, kerb and gutter leading to Windsor Motel.

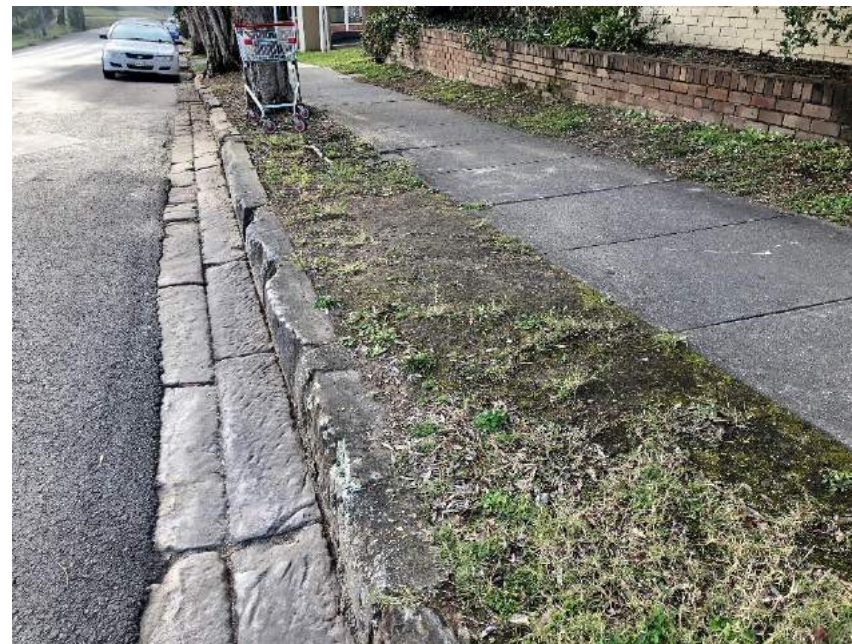
**2021:** General view of footpath, kerb and gutter leading to Windsor Motel – little to no change observed compared to pre-construction survey conditions.

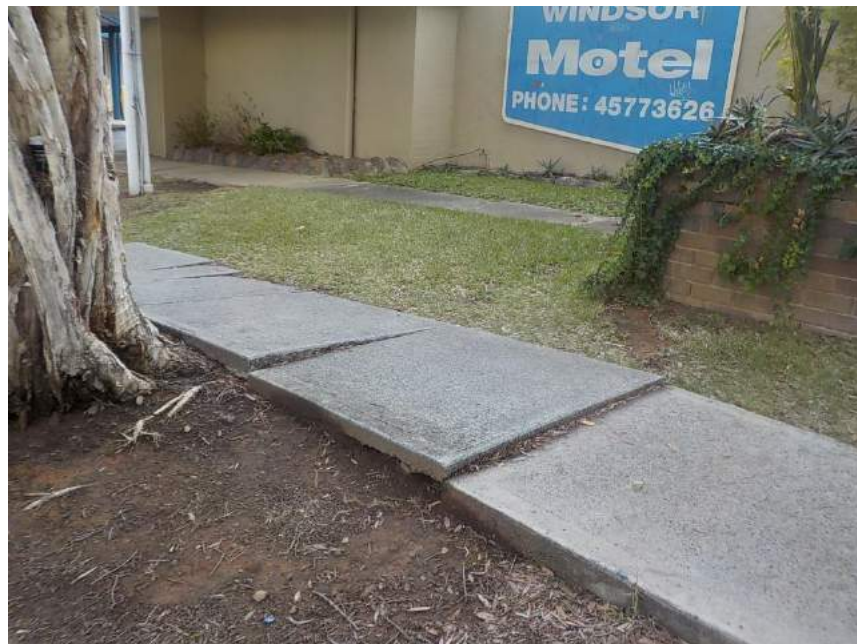
**2018:** Severe heaving of footpath in front of Windsor Motel.

**2021:** Replacement of heaving footpath in front of Windsor Motel.

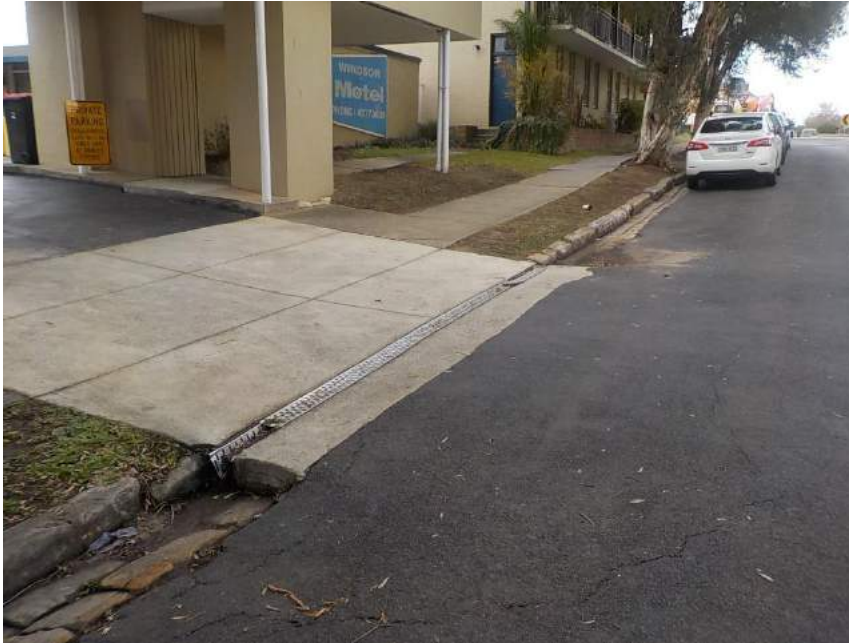
**2018:** General condition of Windsor Motel driveway.

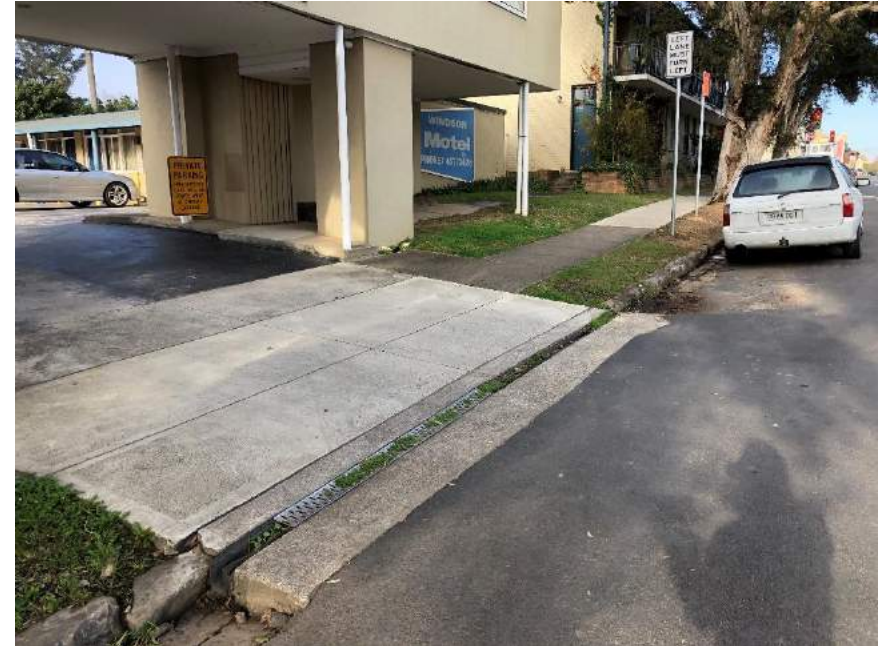
**2021:** General condition of Windsor Motel driveway – replaced concrete sections of driveway.

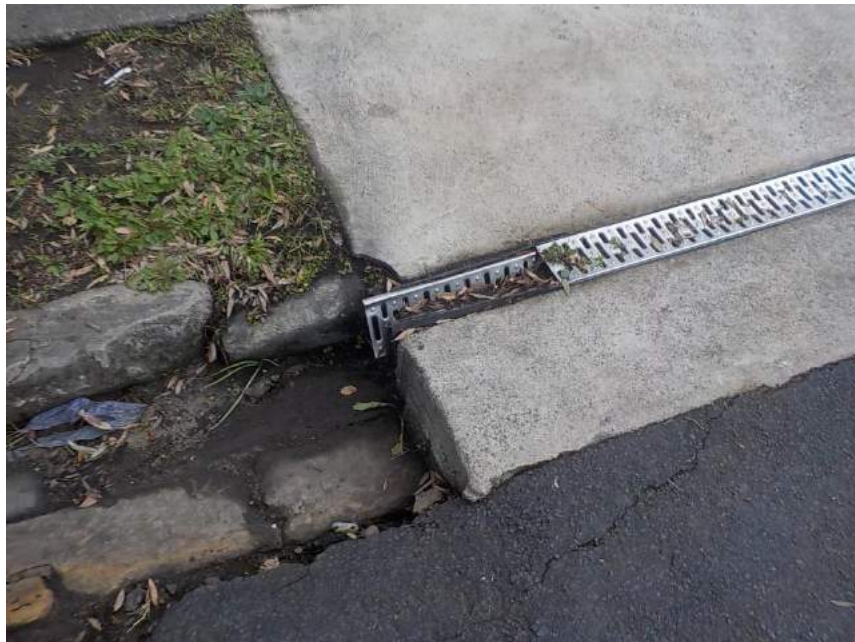
**2018:** General condition of Windsor Motel driveway – cracking on asphalt surface.

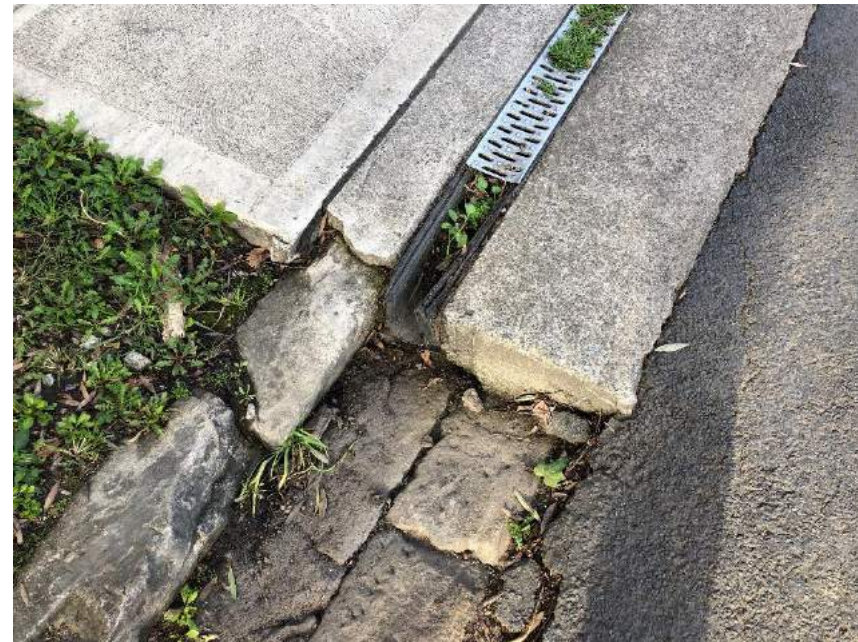
**2021:** General condition of Windsor Motel driveway – cracking on asphalt surface consistent with pre-construction survey conditions, upgrades to driveway surfacing.

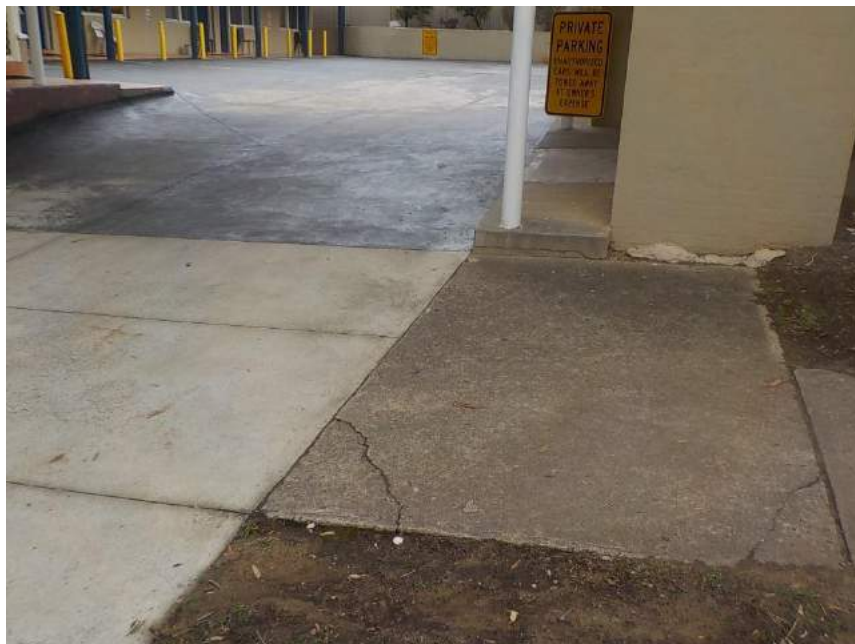
**2018:** Cracking in footpath at Windsor Motel.

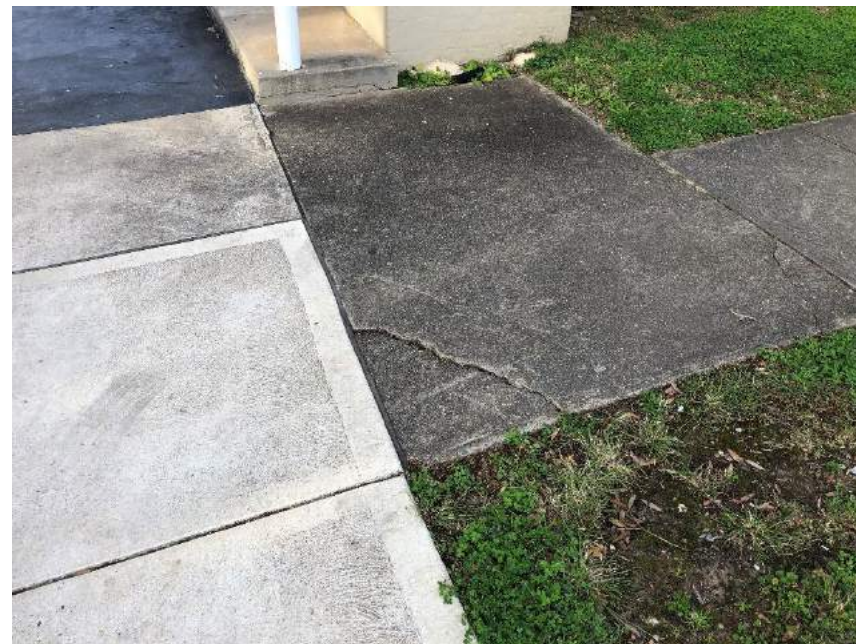
**2021:** Cracking in footpath at Windsor Motel – little to no change observed to footpath compared to pre-construction survey conditions, replacement of motel cement driveway.

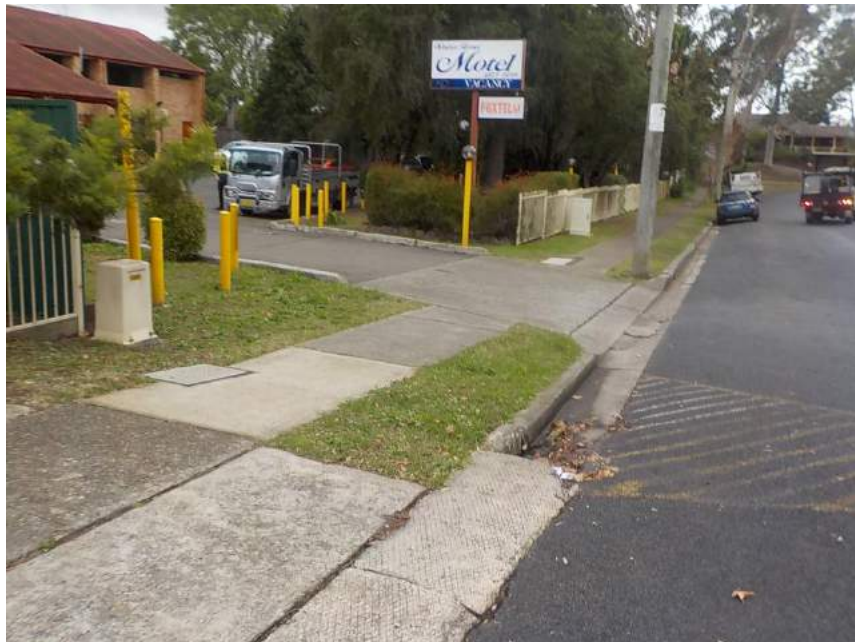
**2018:** General condition of footpath opposite Windsor Motel driveway.

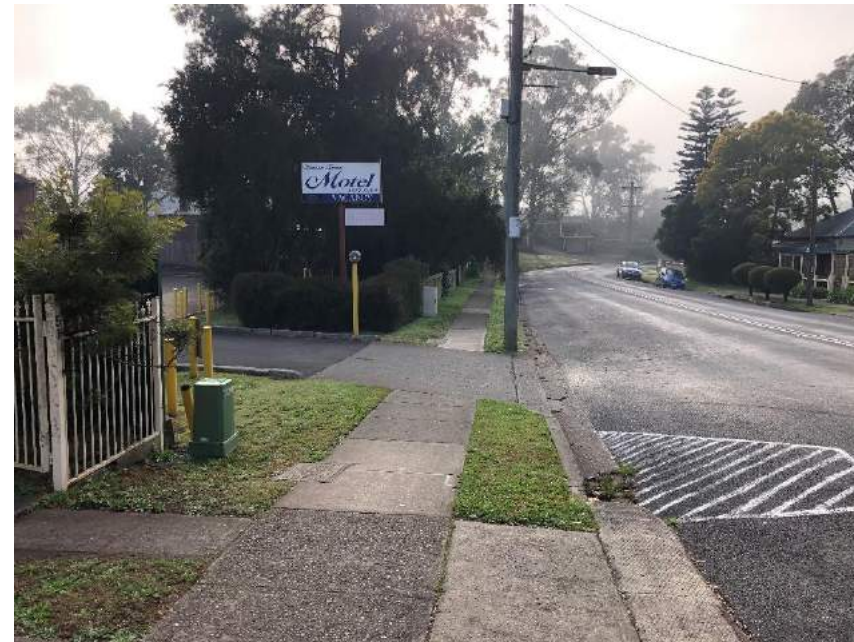
**2021:** General condition of footpath opposite Windsor Motel driveway – little to no change observed compared to pre-construction survey conditions, remarking of lined area on asphalt.

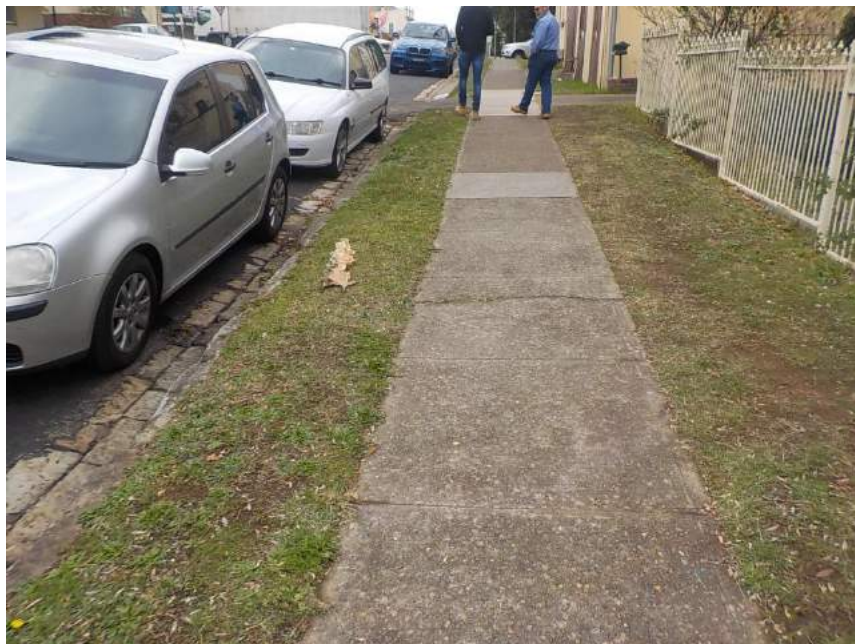
**2018:** General condition of footpath heading back up to roundabout.

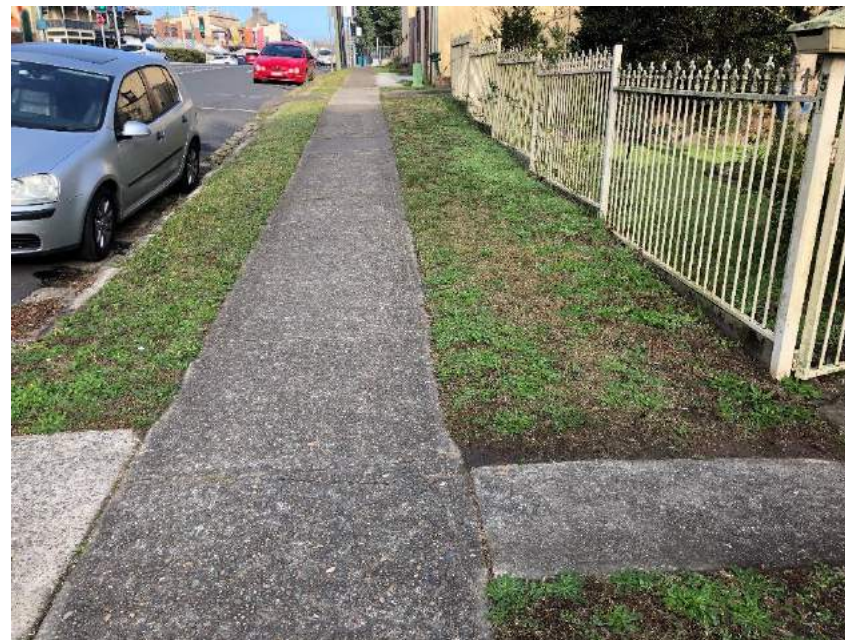
**2021:** General condition of footpath heading back up to intersection – little to no change observed compared to pre-construction survey conditions.

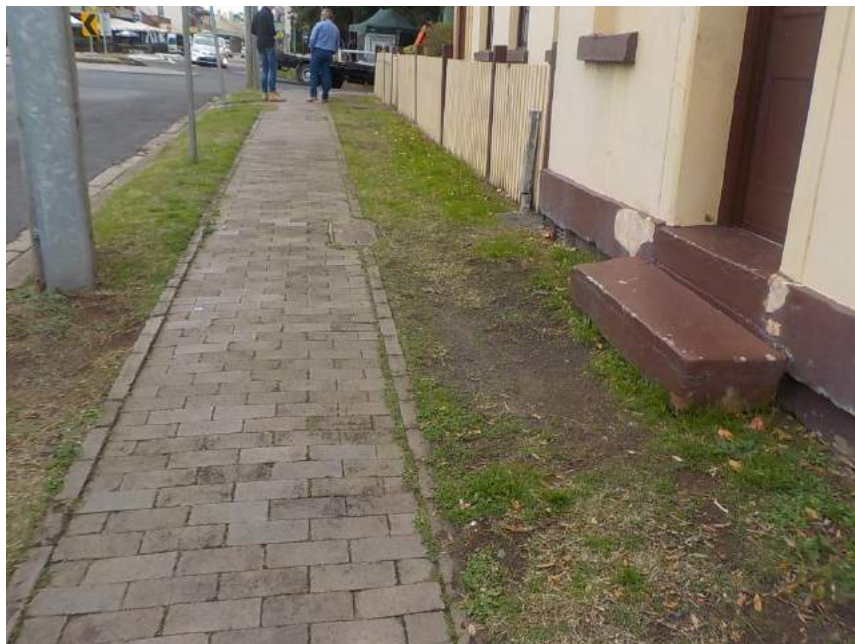
**2018:** Cracking and paint peeling on existing structure – wearing of landscape.

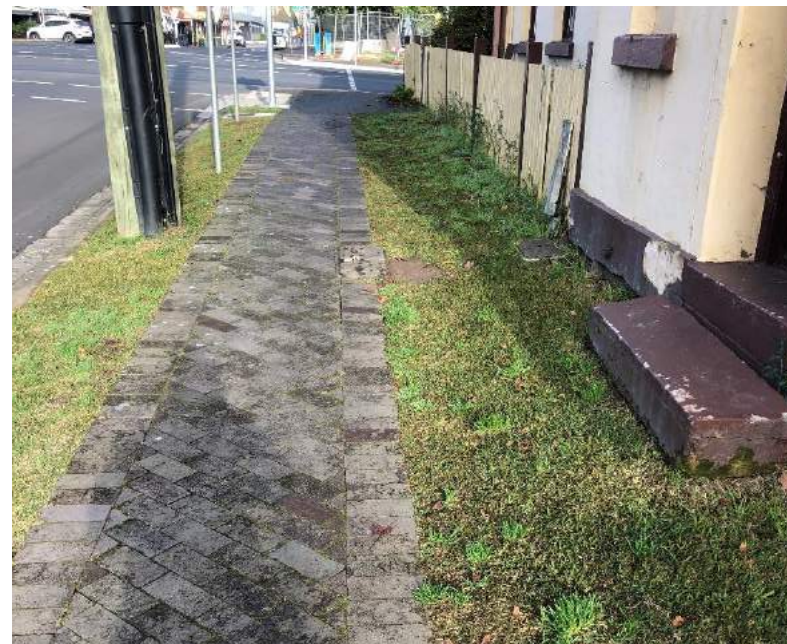
**2021:** Cracking and paint peeling on existing structure with little to no changed observed compared to pre-construction survey conditions – replacement of pavers along footpath.
