# Georgiou Group Dilapidation Report, Windsor Bridge Replacement Project, Windsor NSW

S-03139.DilapidationReport.001

**Pre-Dilapidation Photos Taken:** 20<sup>th</sup> June 2018

**Post-Dilapidation Photos Taken:** 8<sup>th</sup> July 2021

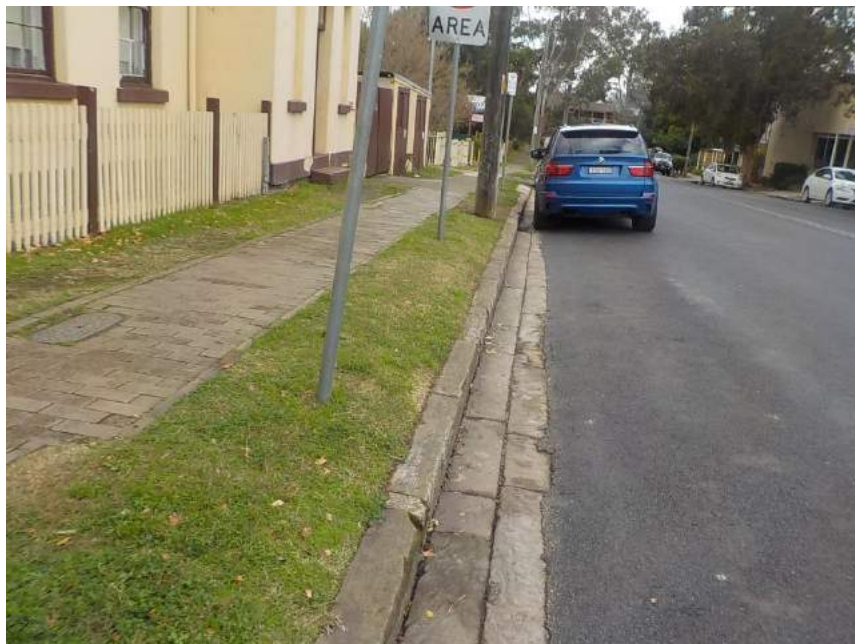
**2018:** General condition of footpath, kerb, gutter and pavement.

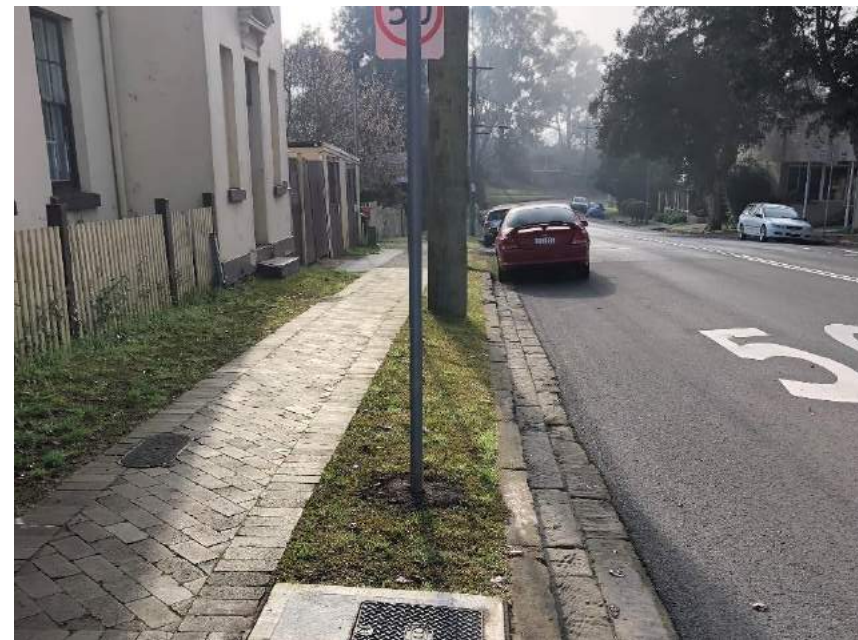
**2021:** General condition of footpath, kerb, gutter and pavement – replacement of footpath pavers and asphalt, little to no change to gutter and surrounding structures compared to pre-construction survey.

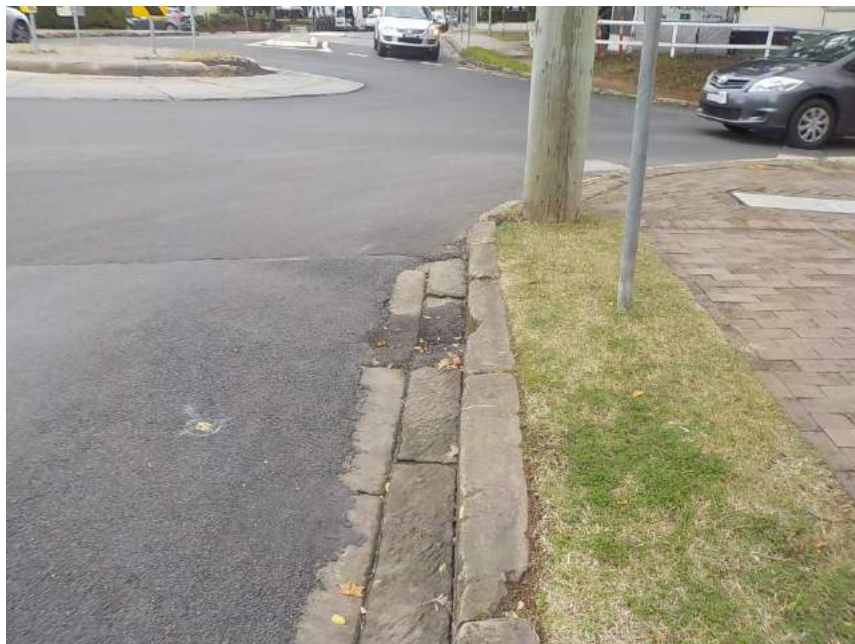
**2018:** General condition of footpath, kerb, gutter and pavement.

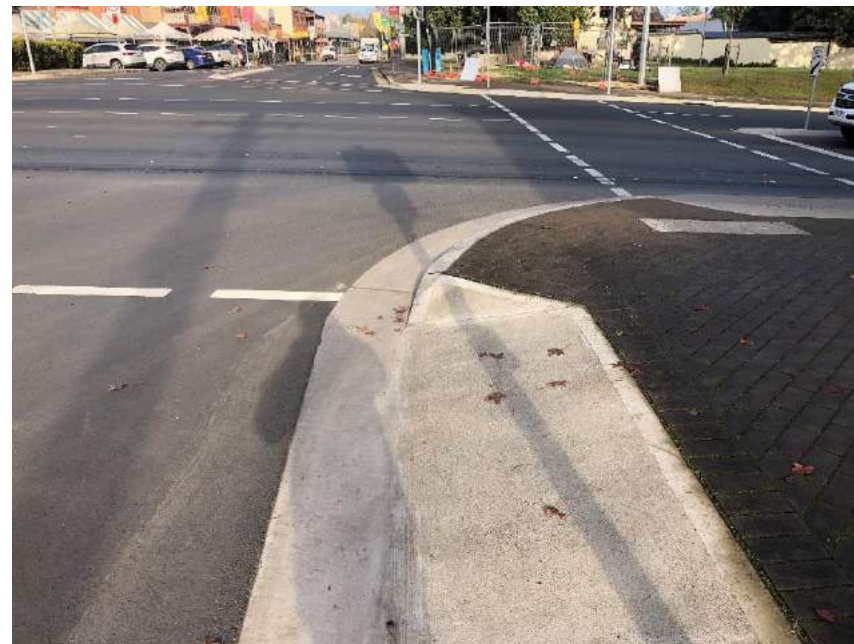
**2021:** General condition of footpath, kerb, gutter and pavement – reworking of intersection and footpath structure.

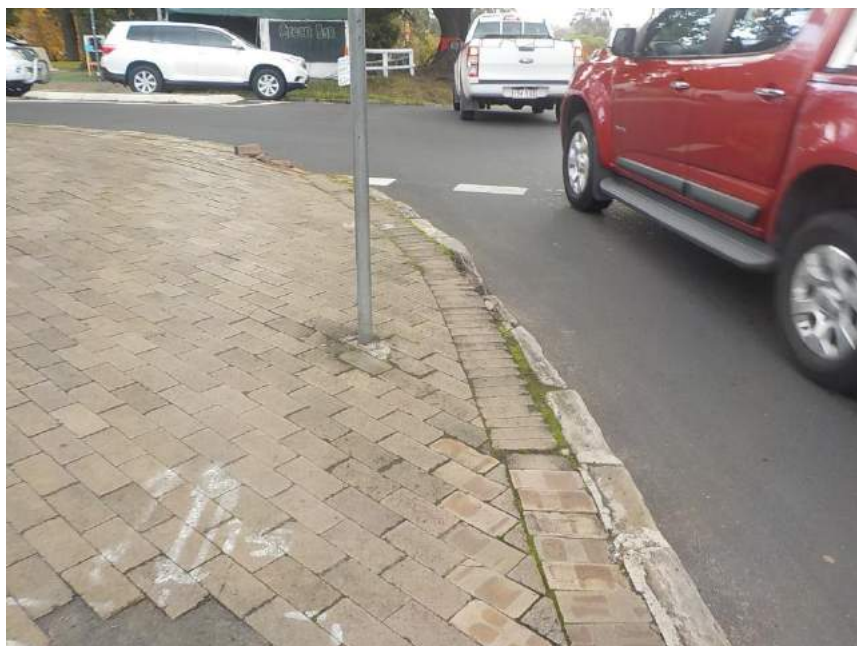
**2018:** General condition of footpath, kerb, gutter and pavement – at George St/Bridge roundabout facing the existing bridge

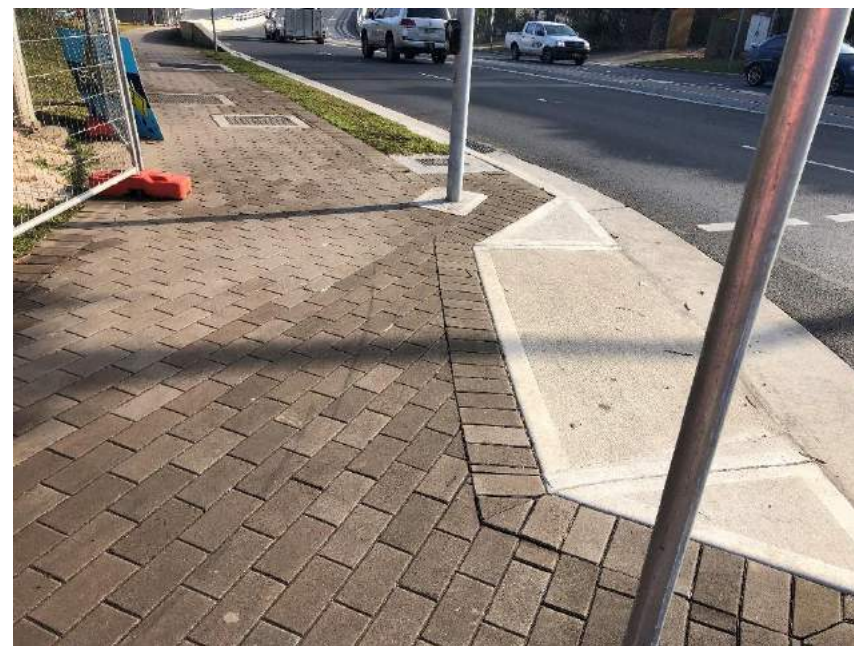
**2021:** General improved condition of footpath, kerb, gutter and pavement at George St/Bridge intersection facing the new bridge – upgrades to footpath, gutter kerb and asphalt.

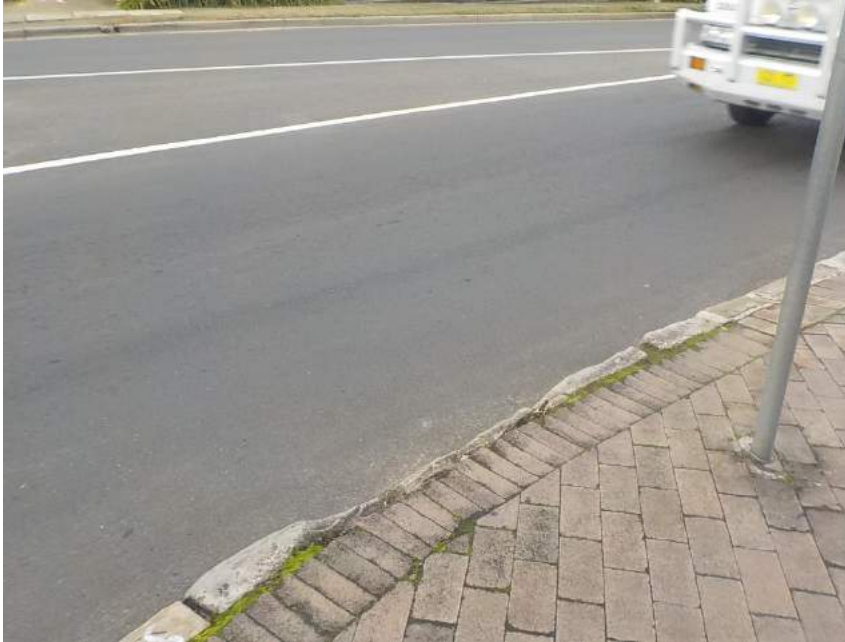
**2018:** Kerb damaged – rutting on asphalt surface.

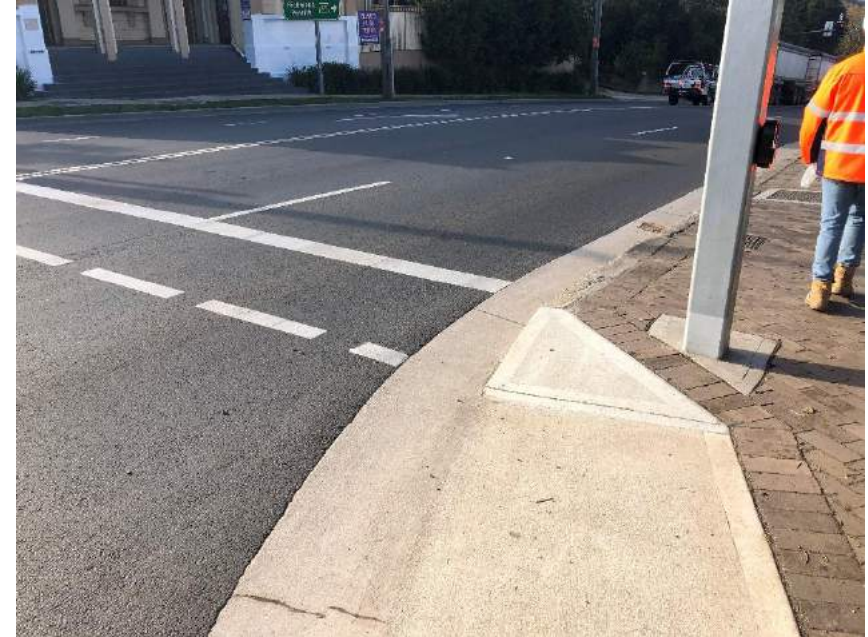
**2021:** Replacement of kerb, asphalt and gutter with traffic light crossing installation.

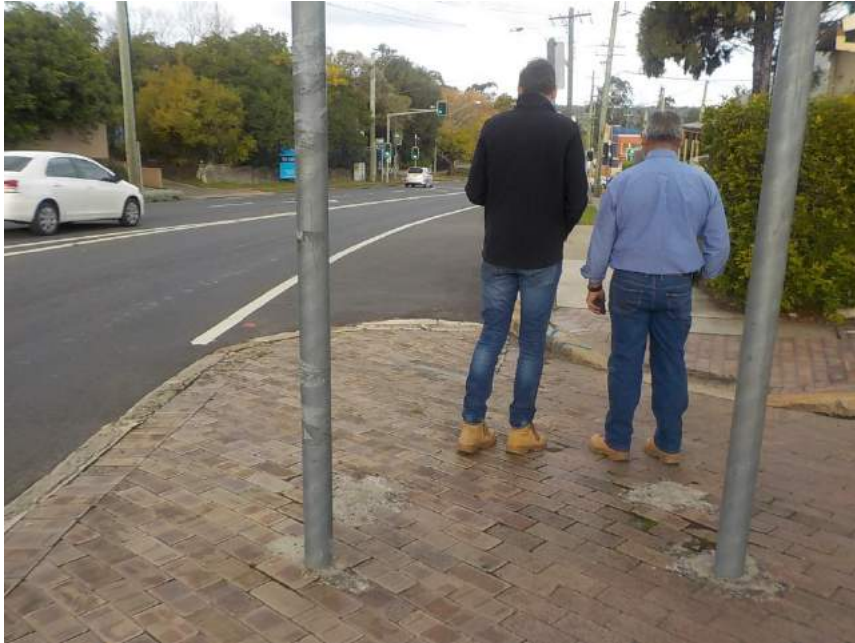
**2018:** General condition of footpath.

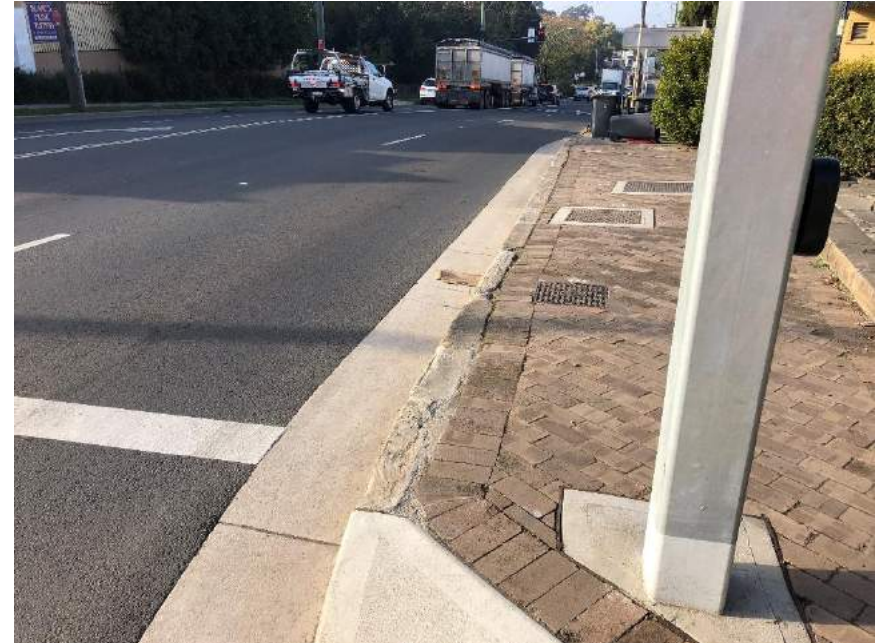
**2021:** Replacement of footpath structure through installation of traffic light intersection.

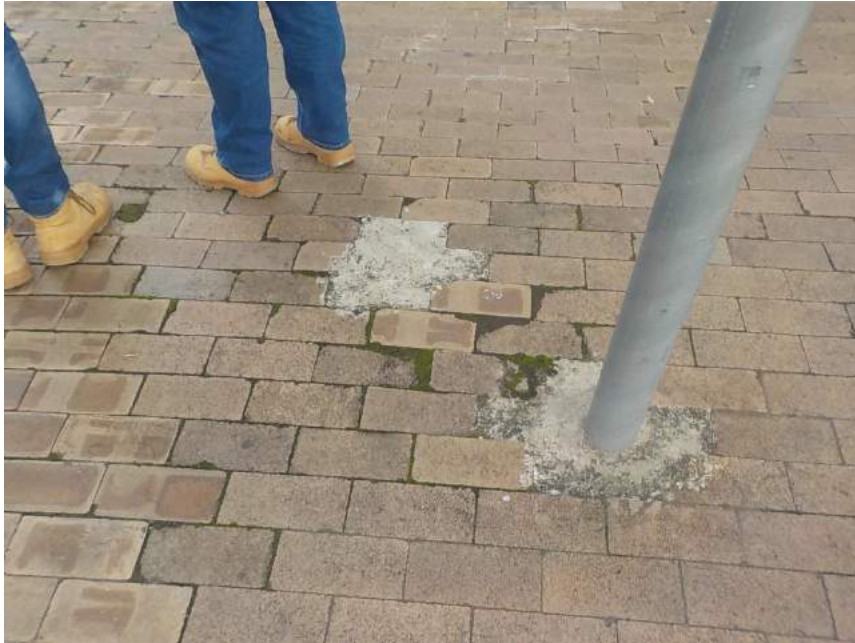
**2018:** Concrete on surface of footpath.

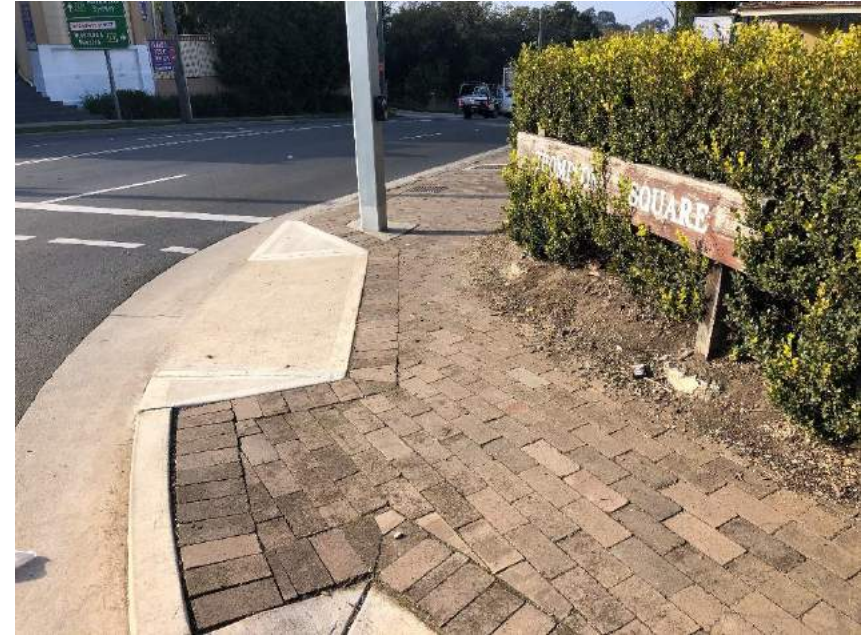
**2021:** Removal of posts and replacement of damaged footpath materials, reworking of footpath and intersection structure.

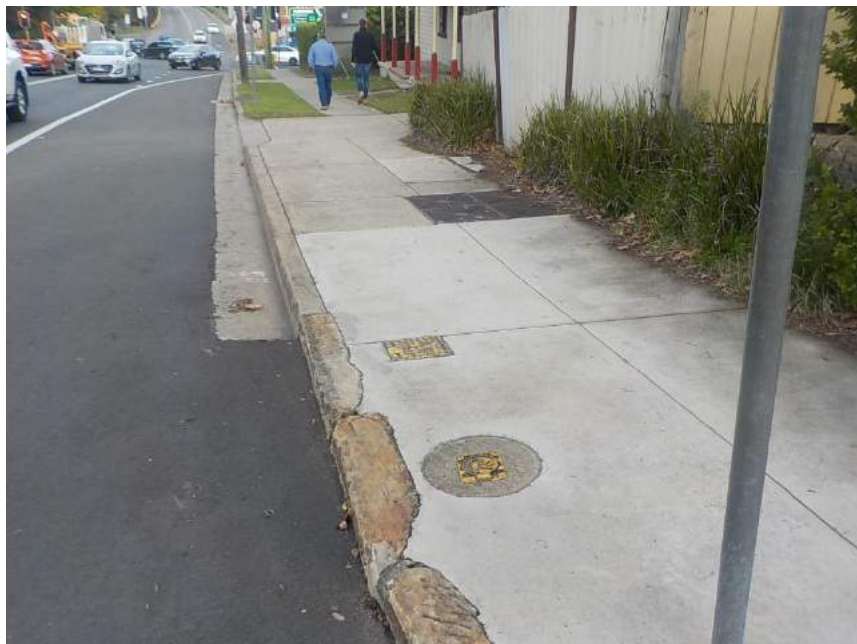
**2018:** General condition of footpath heading towards Macquarie St.

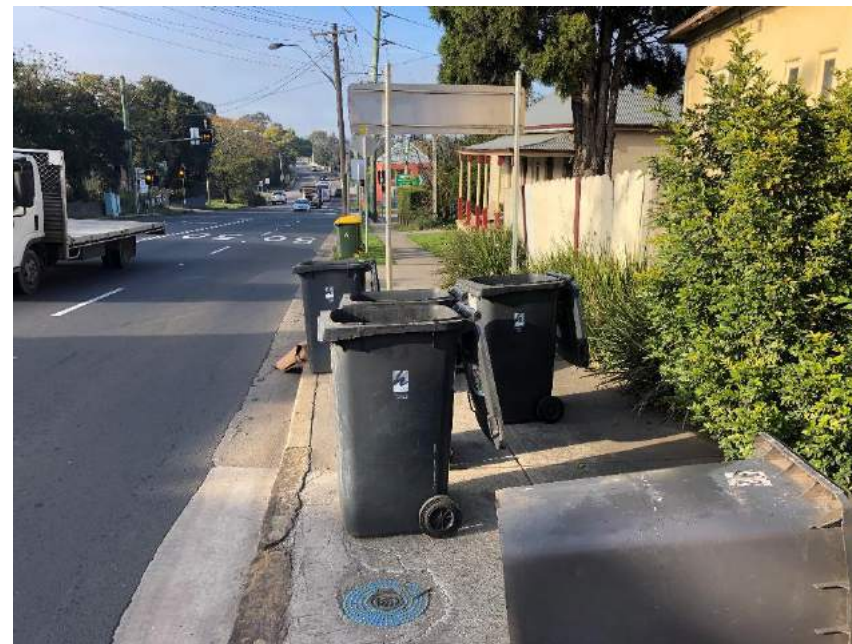
**2021:** General condition of footpath heading towards Macquarie St – little to no change observed compared to pre-construction survey conditions. Replaced asphalt and road sandstone gutter.

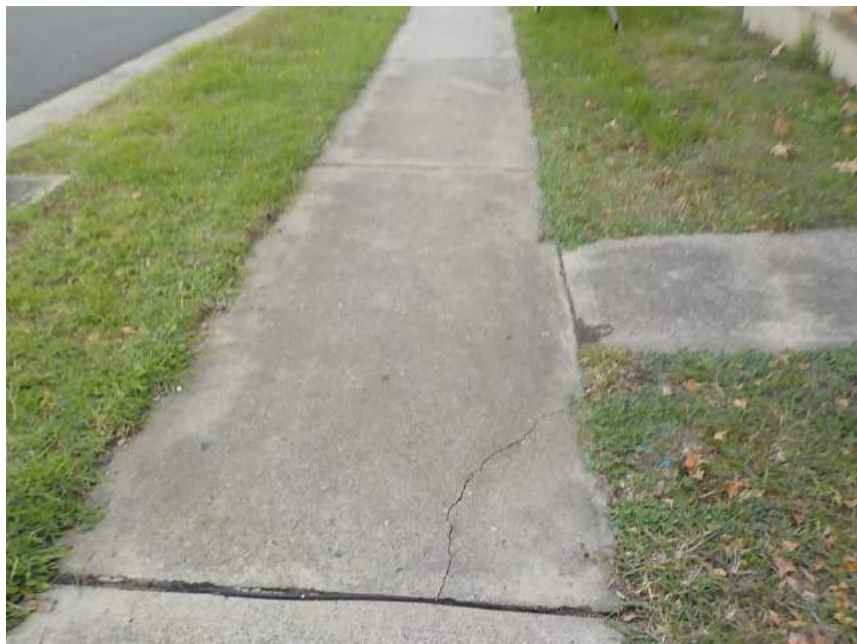
**2018:** Cracking in footpath.

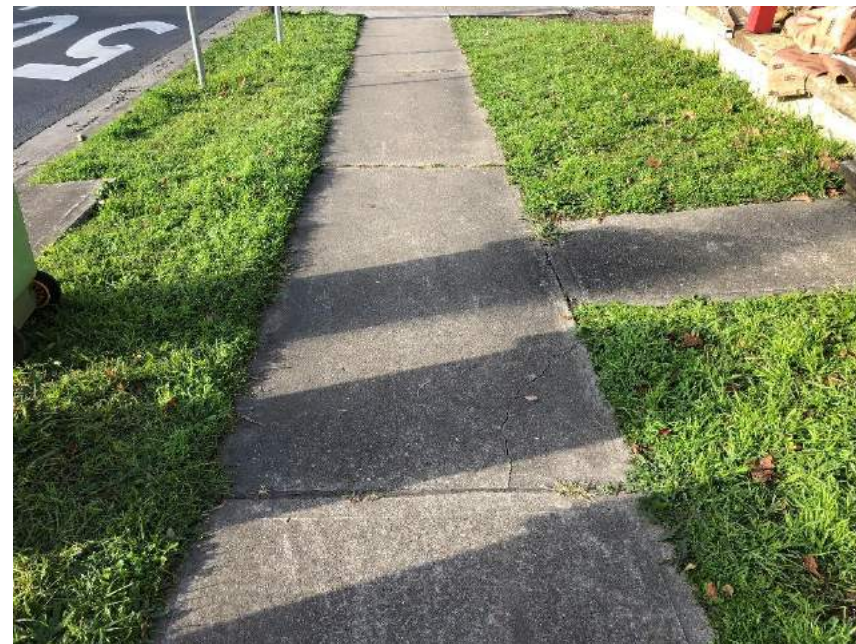
**2021:** Cracking in footpath – little to no change observed compared to pre-construction survey conditions.

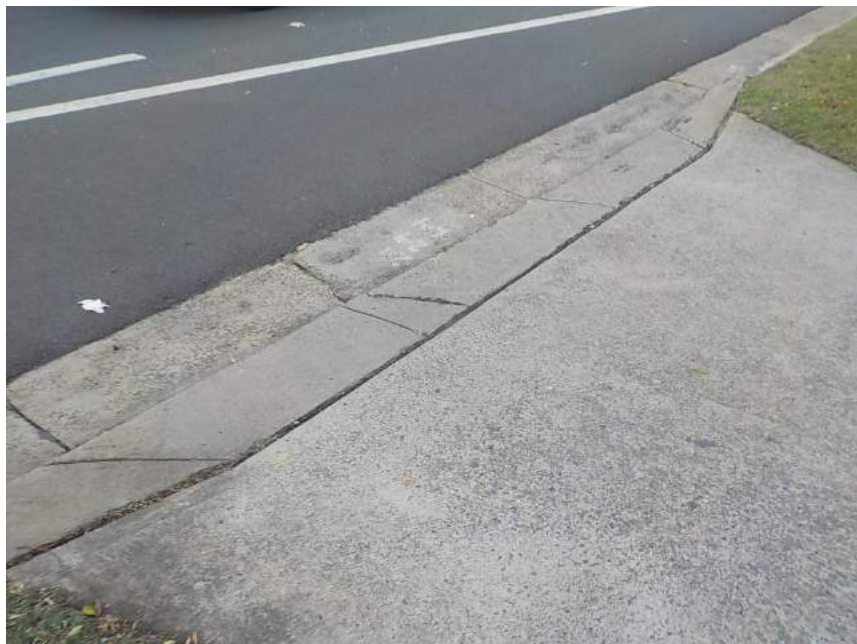
**2018:** Cracking on driveway ramp and gutter.

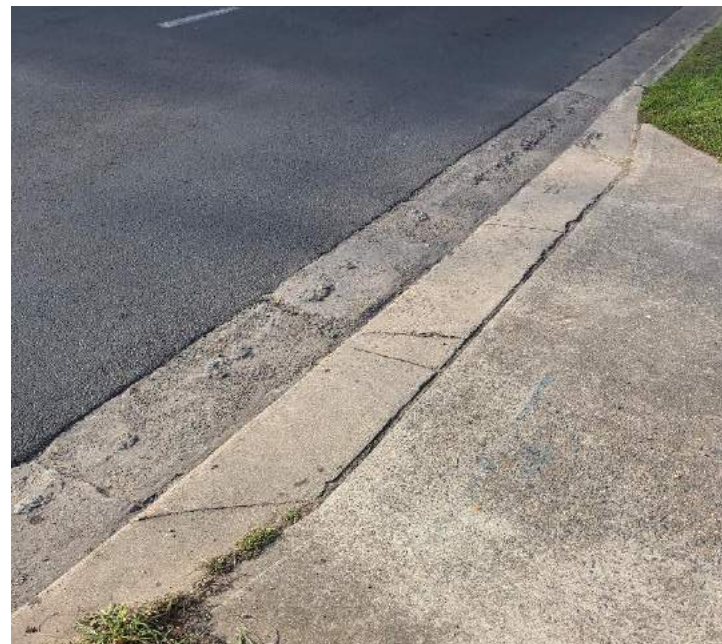
**2021:** Cracking on driveway ramp and gutter – little to no change observed compared to pre-construction survey conditions.

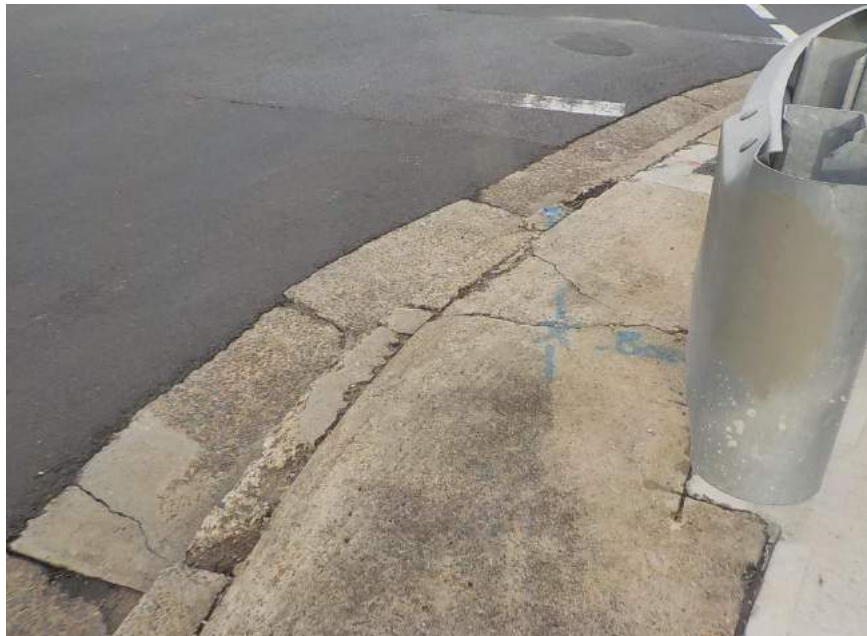
**2018:** Severe cracking on footpath, kerb and gutter – cracking and patchwork repair on asphalt surface.

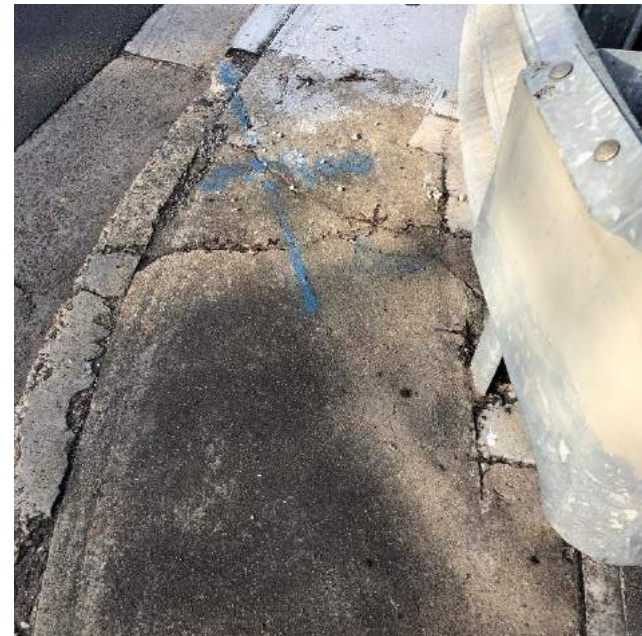
**2021:** Severe cracking on footpath, kerb and gutter – cracking and patchwork repair on asphalt surface – little to no change observed compared to pre-construction survey conditions.

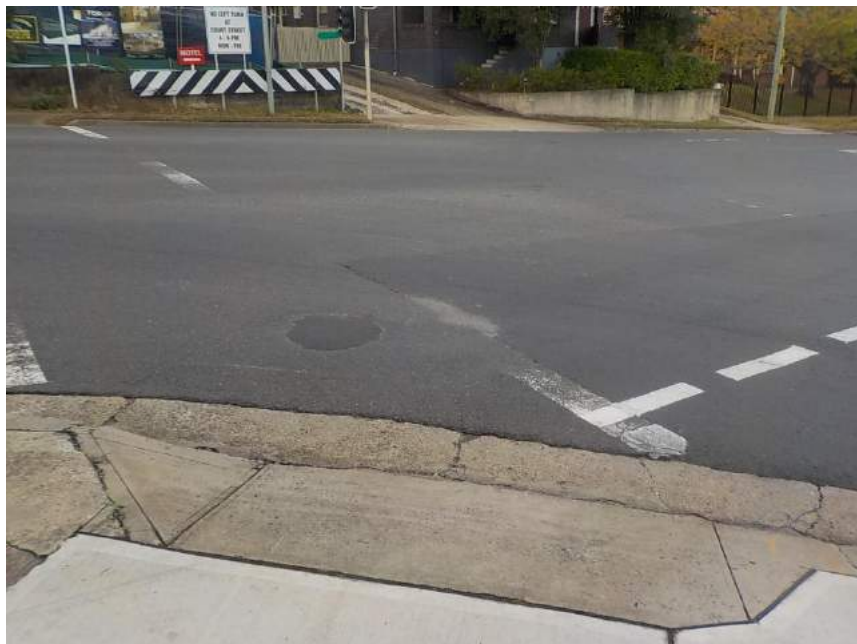
**2018:** General condition of asphalt surface at Bridge St and Macquarie St Intersection - severe cracking on kerb and gutter.

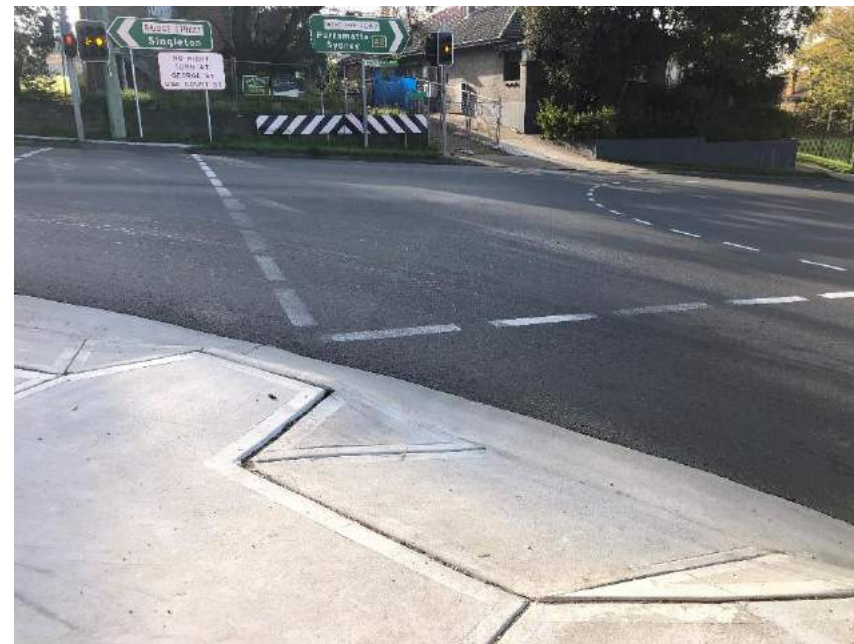
**2021:** Improved general condition of asphalt surface at Bridge St and Macquarie St Intersection – replacement of asphalt, kerb and footpath.

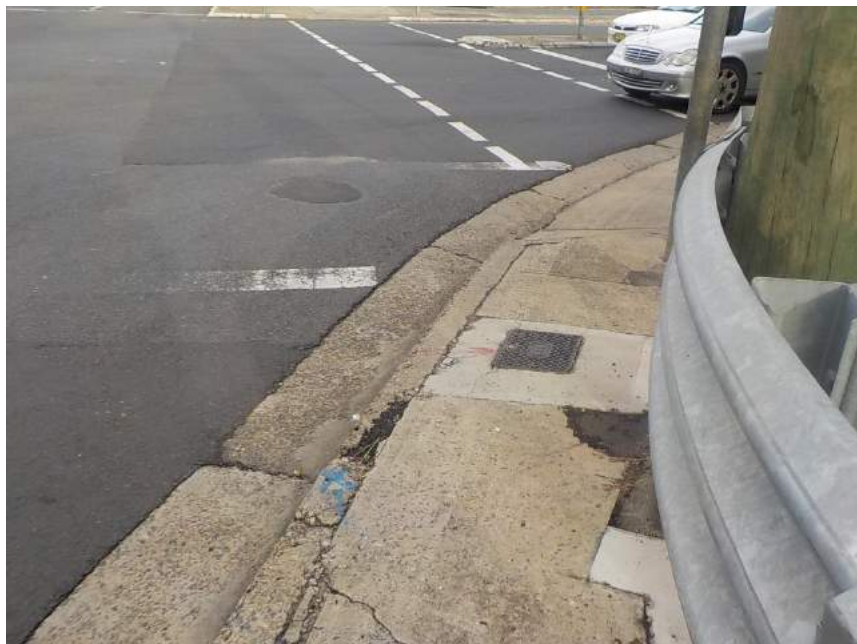
**2018:** Severe cracking on footpath, kerb and gutter – cracking and patchwork repair on asphalt surface.

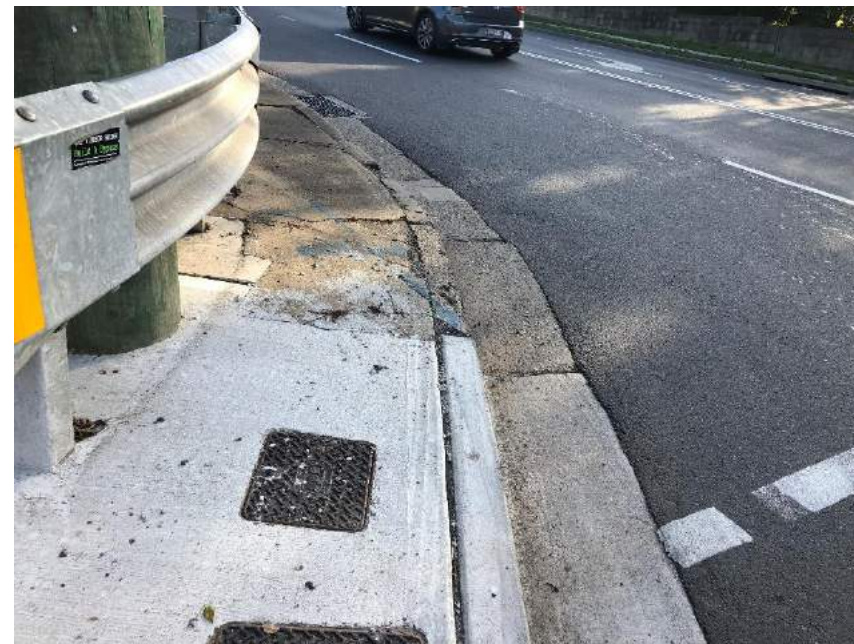
**2021:** Cracking remains in portions of the kerb and gutter consistent with pre-construction survey condition, areas of new concrete surrounding utility points, and replaced asphalt road surfacing.

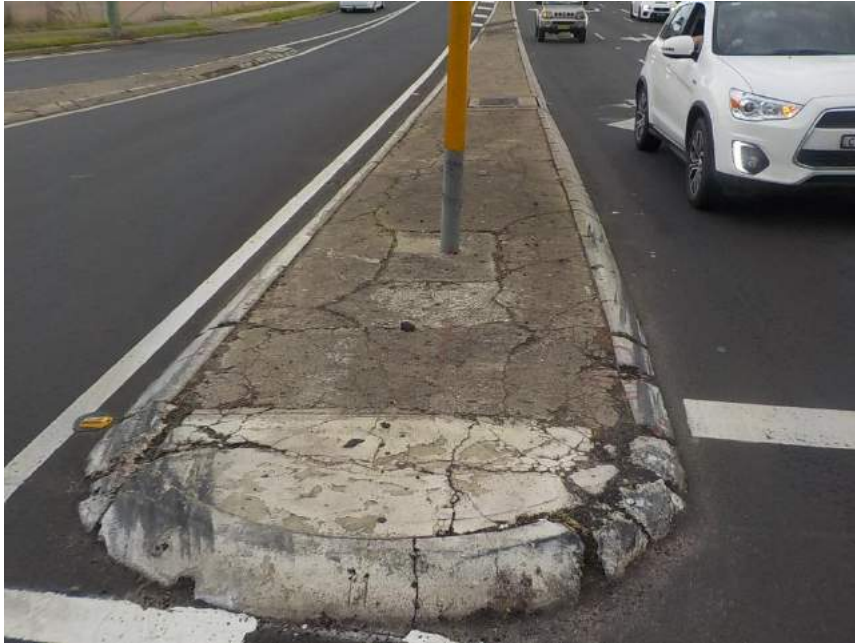
**2018:** Severe damage to Macquarie Street Median Island.

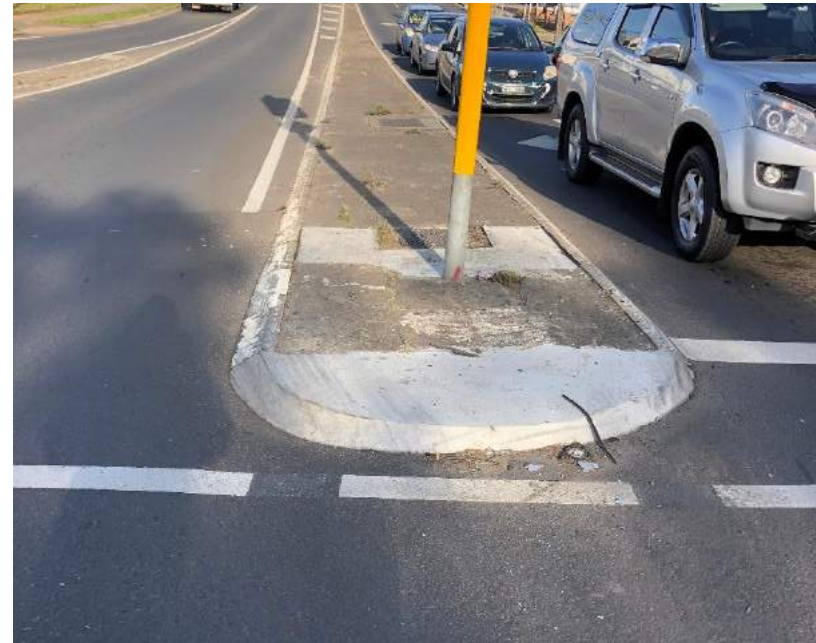
**2021:** Replacement of median island end and patch repair of cracked areas.

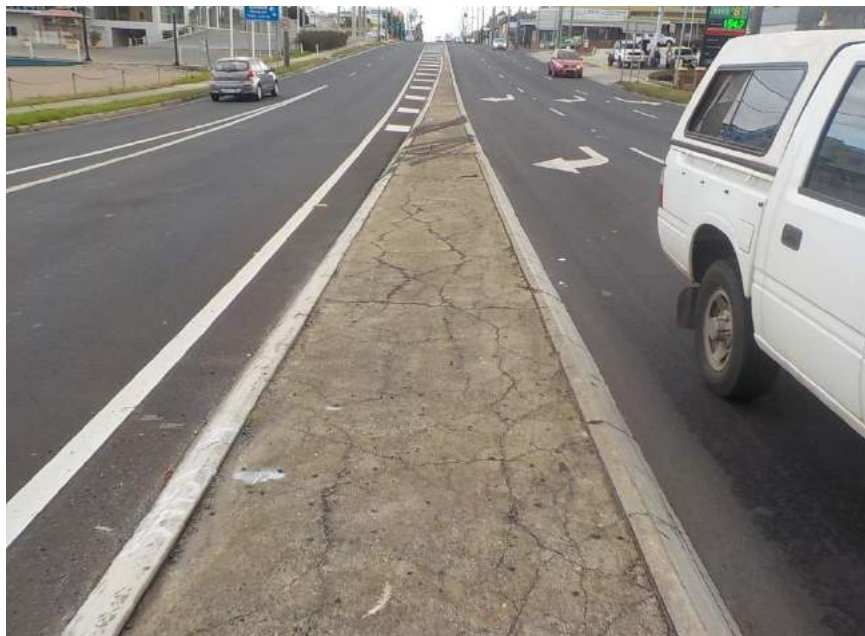
**2018:** Severe damage to Macquarie Street Median Island.

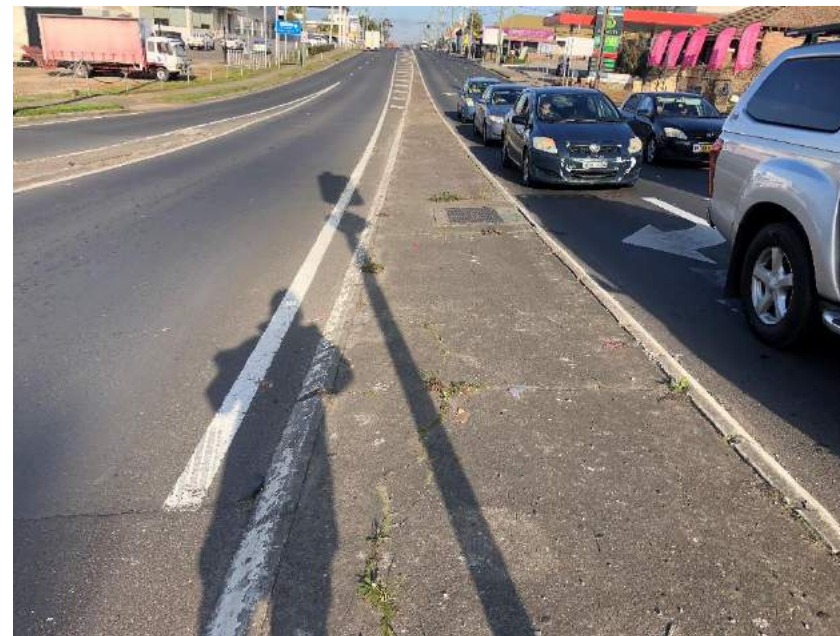
**2021:** Severe damage to Macquarie Street Median Island – little to no change observed compared to pre-construction survey conditions.

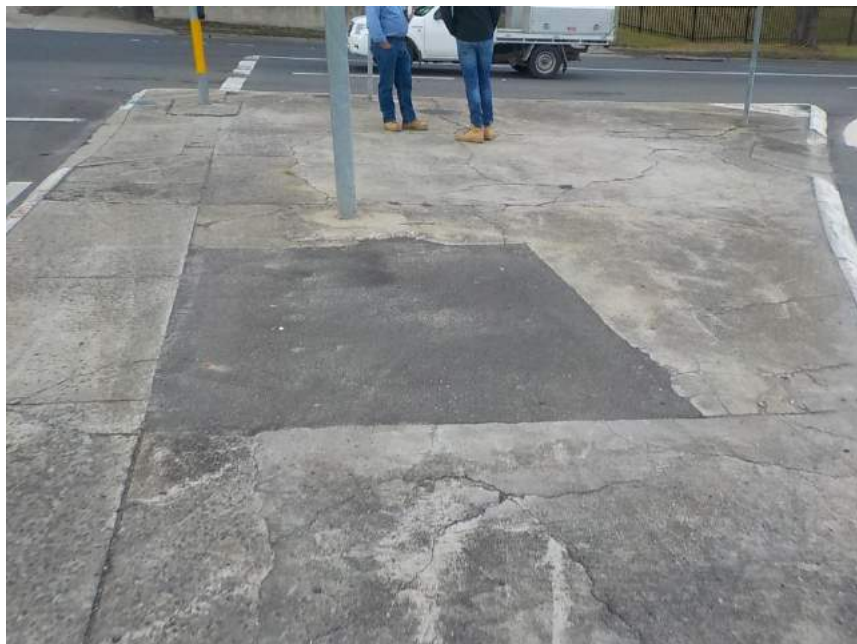
**2018:** Extensive cracking and repair work Macquarie Street Median Island.

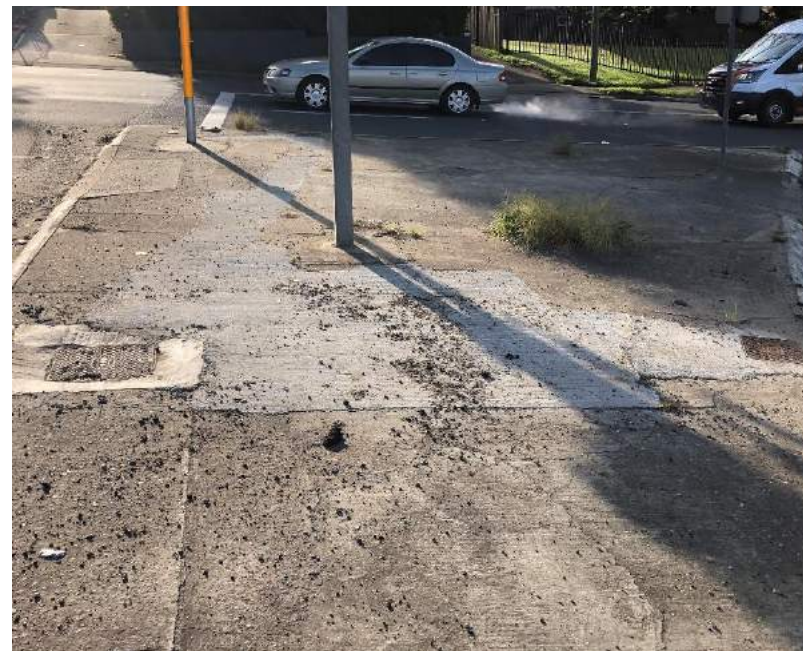
**2021:** Extensive cracking and patchworked repair work on Macquarie Street Median Island – marginal changes due to high traffic area and not associated with construction activities.

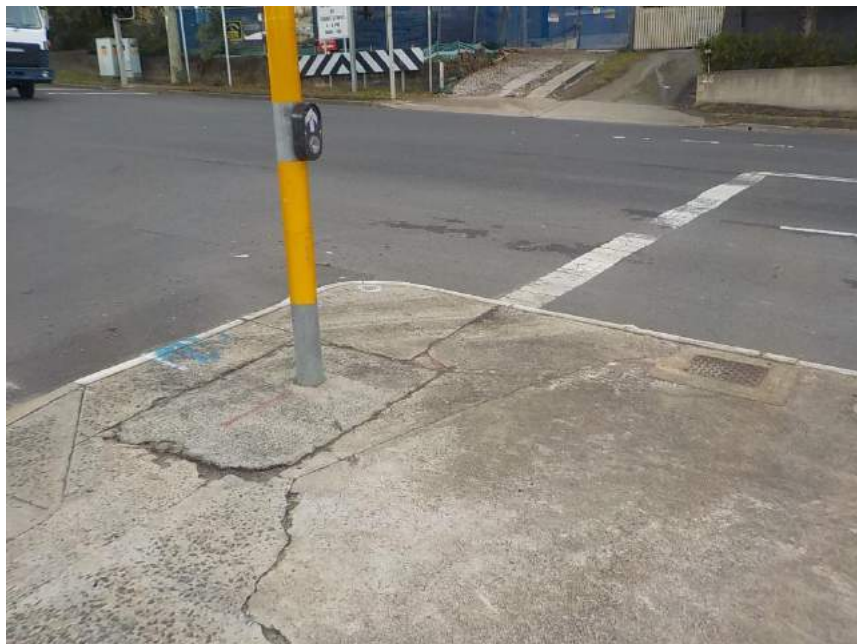
**2018:** Extensive cracking on Macquarie Street Median Island.

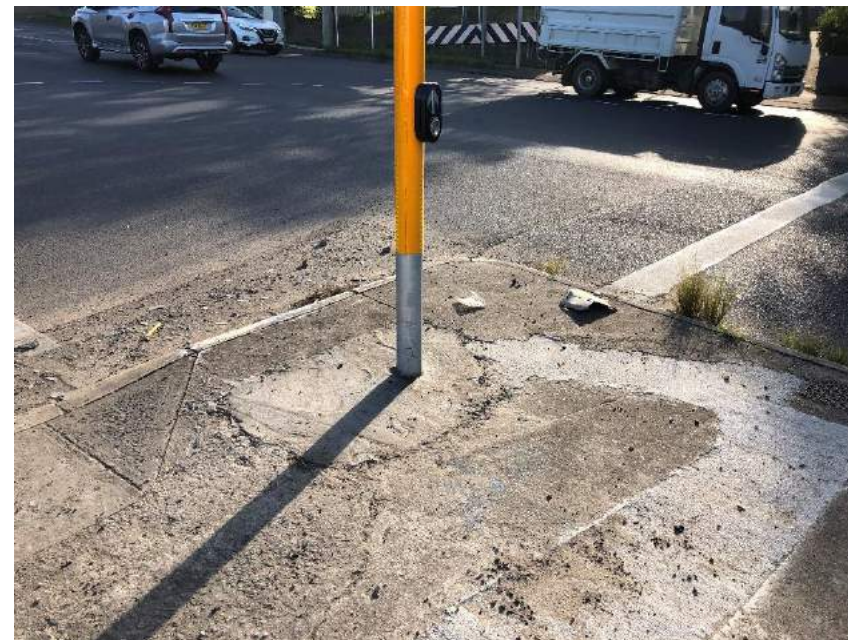
**2021:** Extensive cracking on Macquarie Street Median Island consistent with condition of pre-construction survey, concrete repair across portions of cracked surfacing

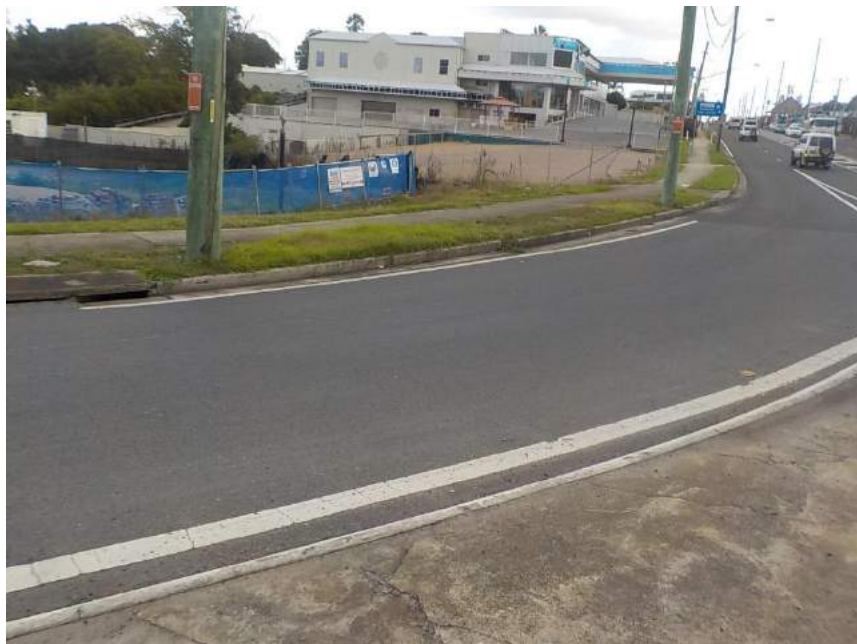
**2018:** General condition of Macquarie St Turning Lane.

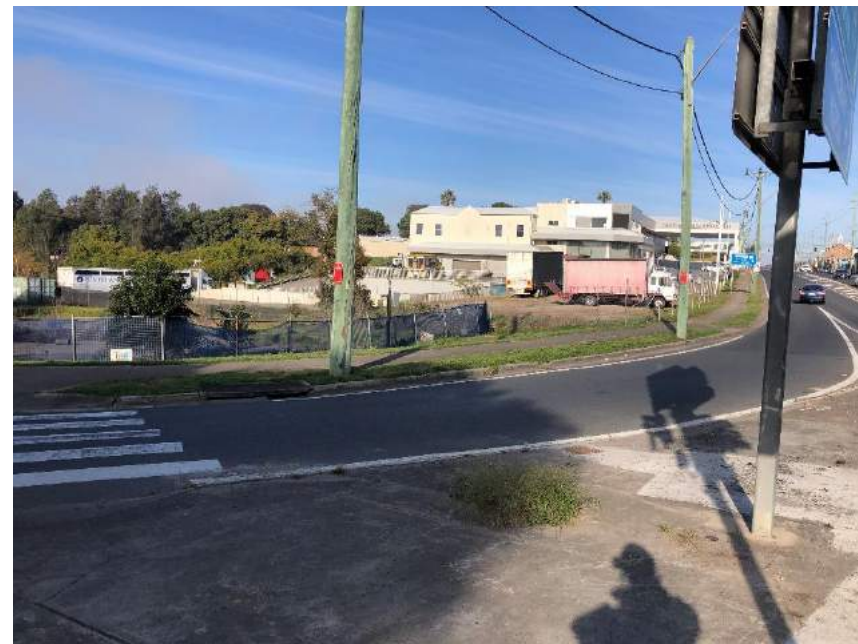
**2021:** General condition of Macquarie St Turning lane – little to no change observed compared to pre-construction survey conditions.

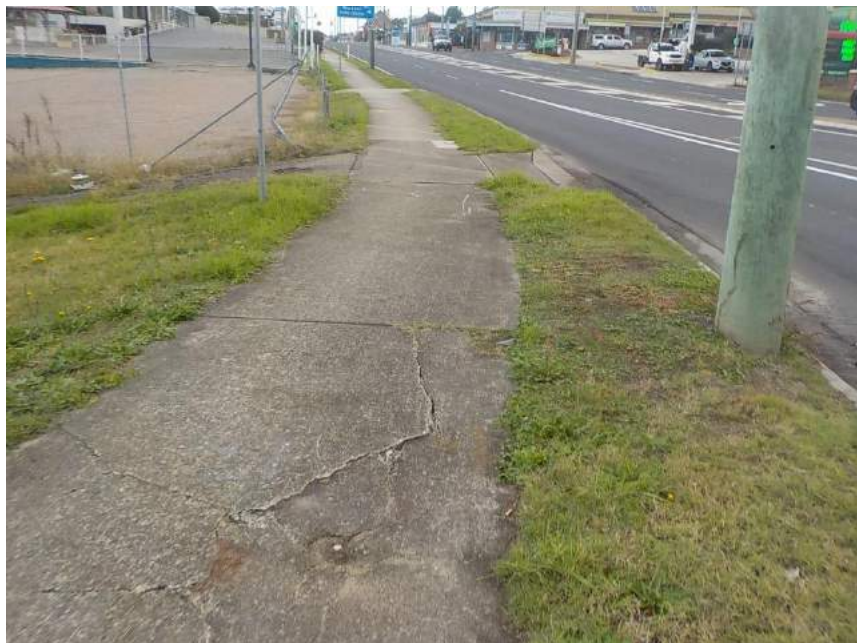
**2018:** Cracking and heaving on footpath at Macquarie St corner.

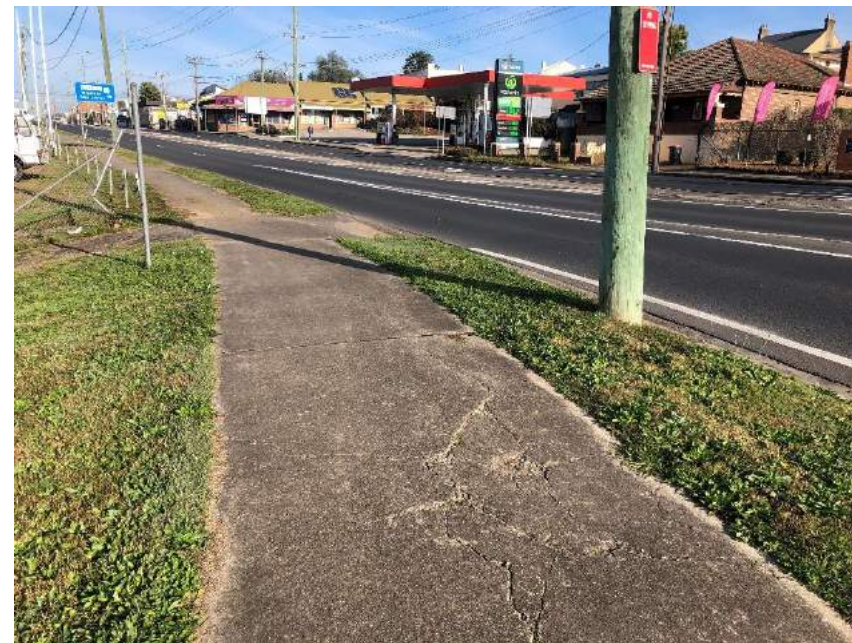
**2021:** Cracking and heaving on footpath at Macquarie St corner – little to no change observed compared to pre-construction survey conditions.

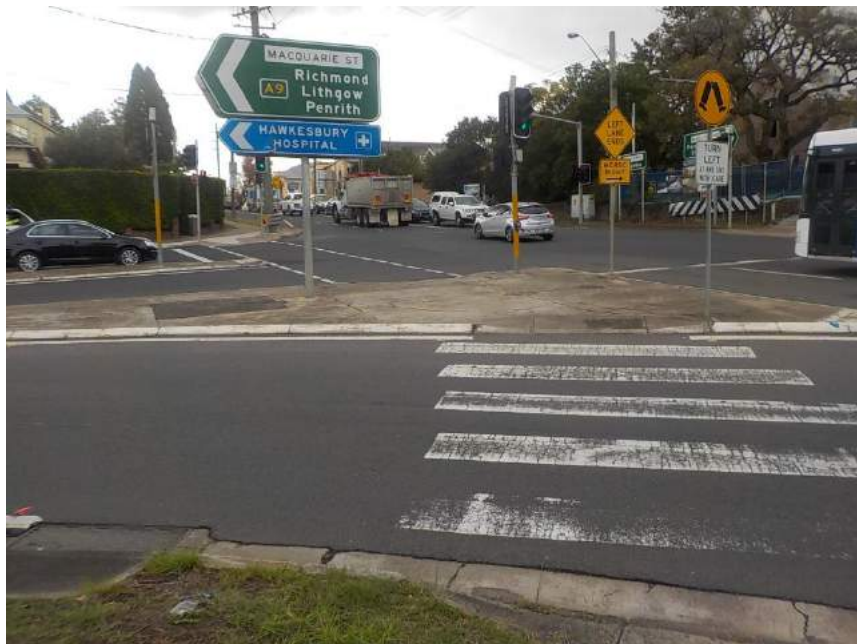
**2018:** General condition of Macquarie St and Bridge St intersection - wearing of pedestrian crossing – damage to Hawkesbury Hospital sign face.

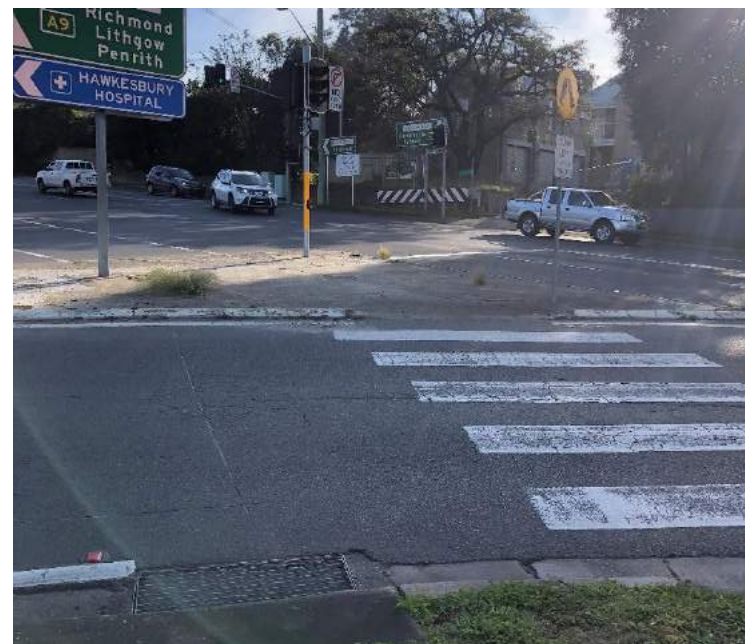
**2021:** General condition of Macquarie St and Bridge St intersection - wearing of pedestrian crossing – little to no change observed compared to pre-construction survey conditions. Replacement of Hawkesbury Hospital sign.

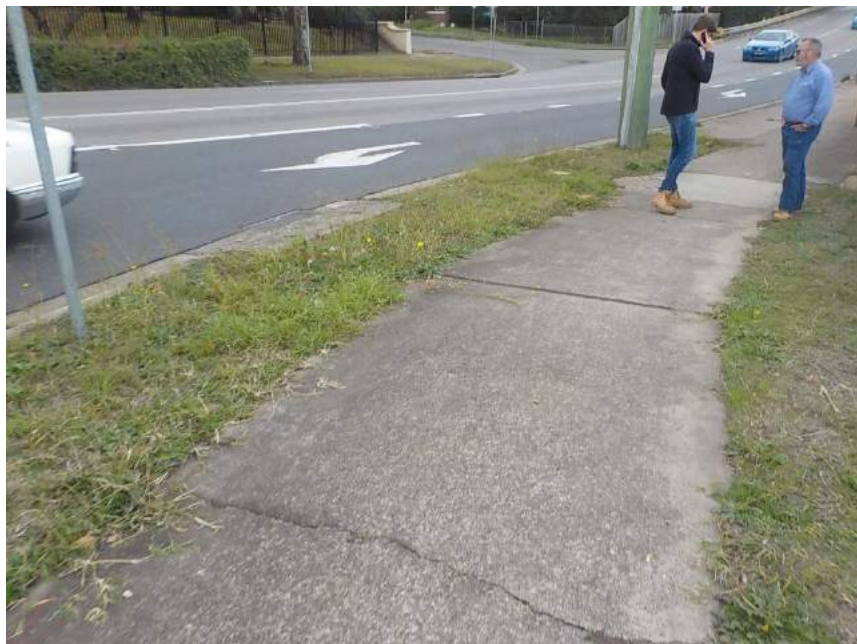
**2018:** Cracking on footpath leading to limit of works/Court St.

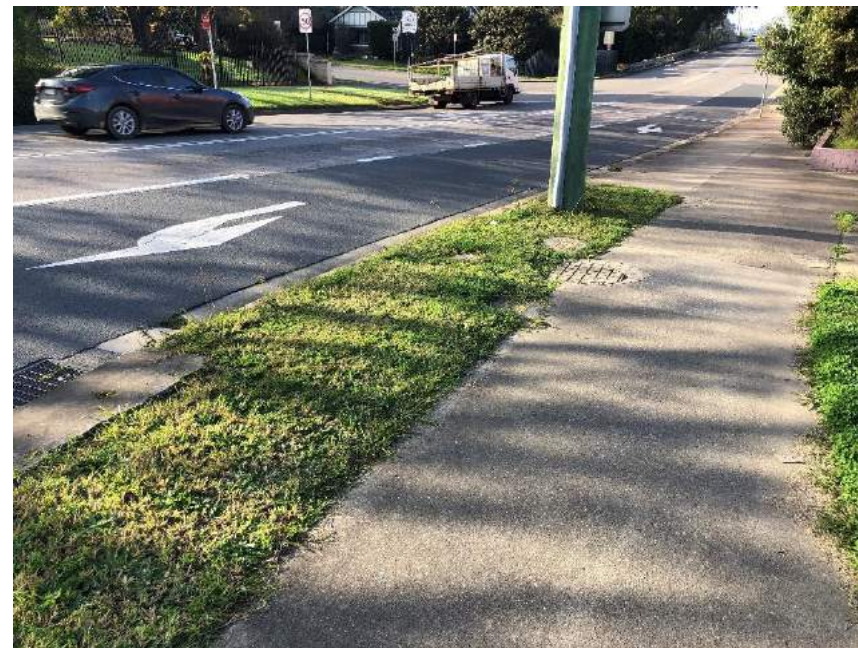
**2021:** Footpath leading to Court St – little to no change observed compared to pre-construction survey conditions.
