# Georgiou Group Dilapidation Report, Windsor Bridge Replacement Project, Windsor NSW

S-03139.DilapidationReport.001

**Pre-Dilapidation Photos Taken:** 20<sup>th</sup> June 2018

**Post-Dilapidation Photos Taken:** 8<sup>th</sup> July 2021

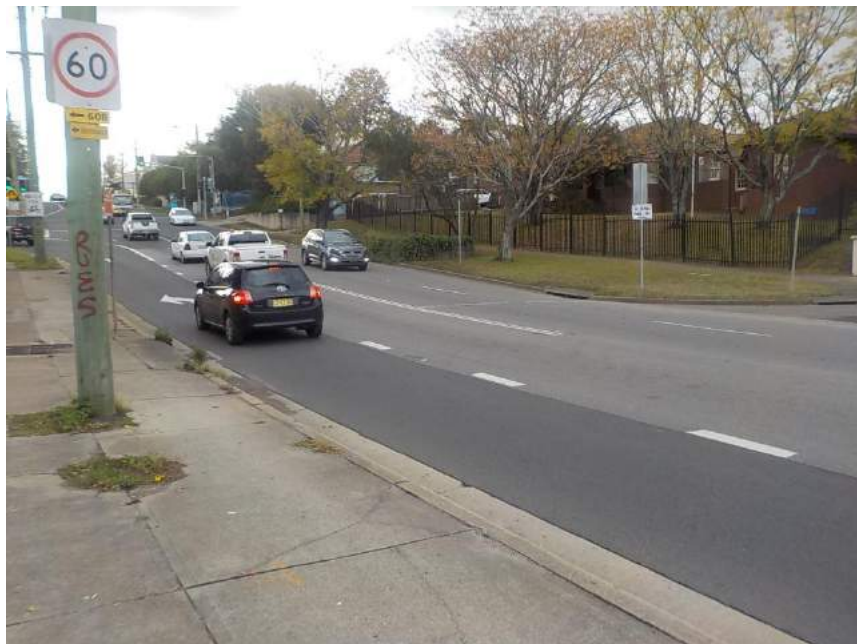
**2018:** General condition of pavement and footpath at Bridge St and Court St intersection – Graffiti on electrical post.

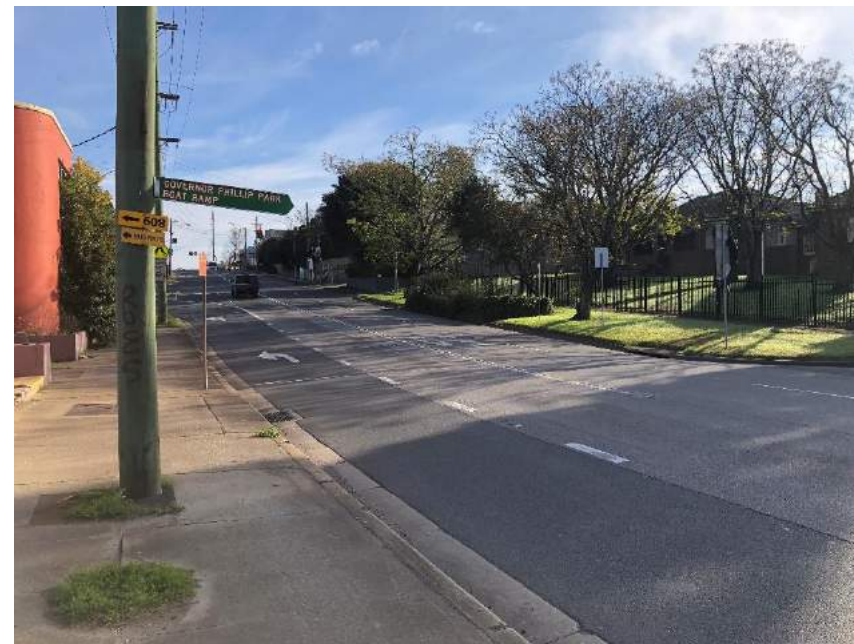
**2021:** General condition of pavement and footpath at Bridge St and Court St intersection – Graffiti on electrical post – little to no change observed compared to pre-construction survey conditions.

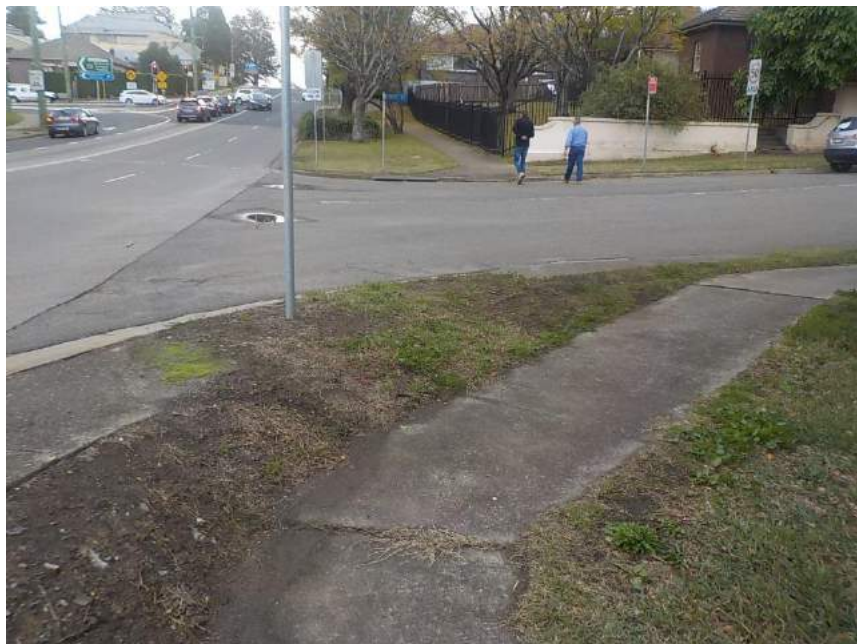
**2018:** General condition of pavement and footpath at corner of Bridge St and Court St.

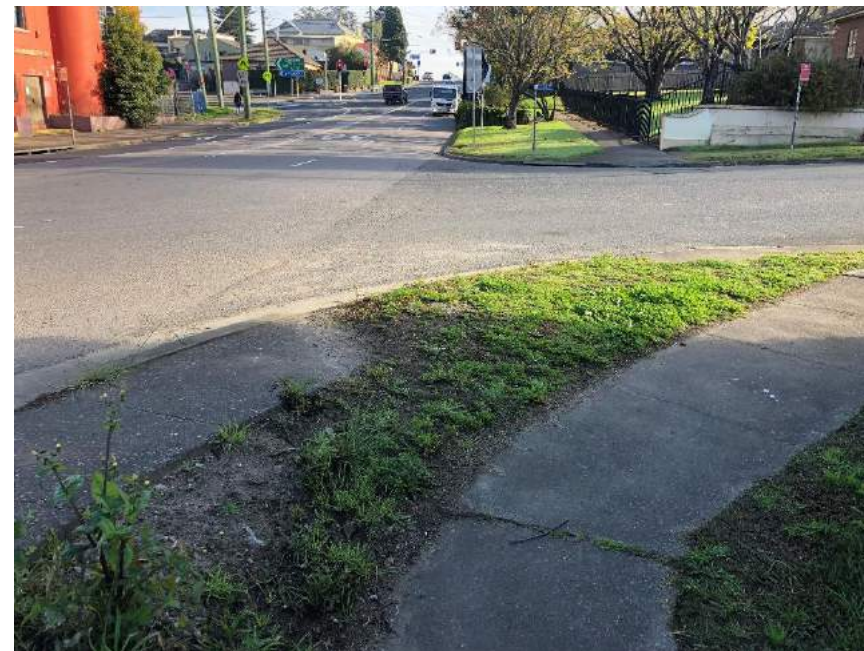
**2021:** General condition of pavement and footpath at corner of Bridge St and Court St – little to no change observed compared to pre-construction survey conditions.

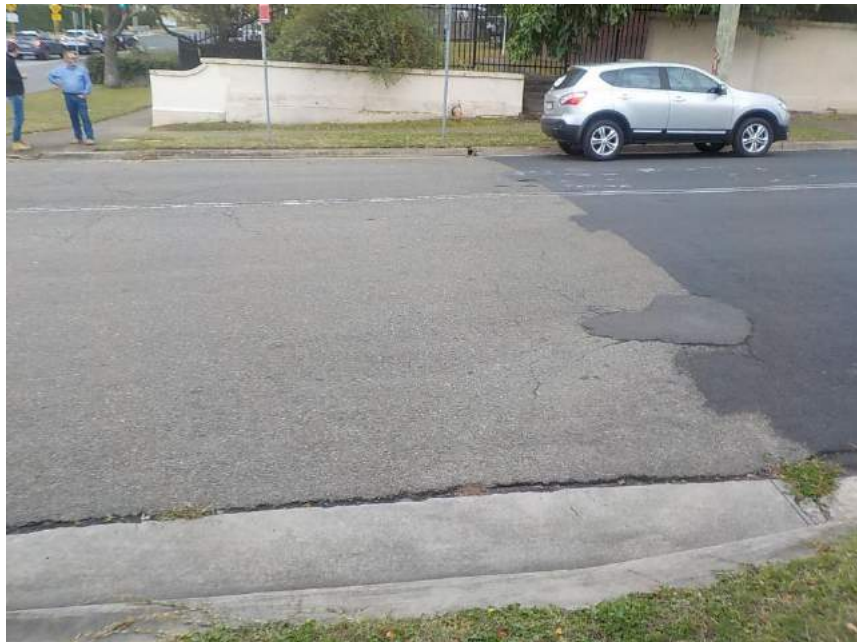
**2018:** Condition of pavement at old and new asphalt surface transition at on Court St – patch repair work – cracking.

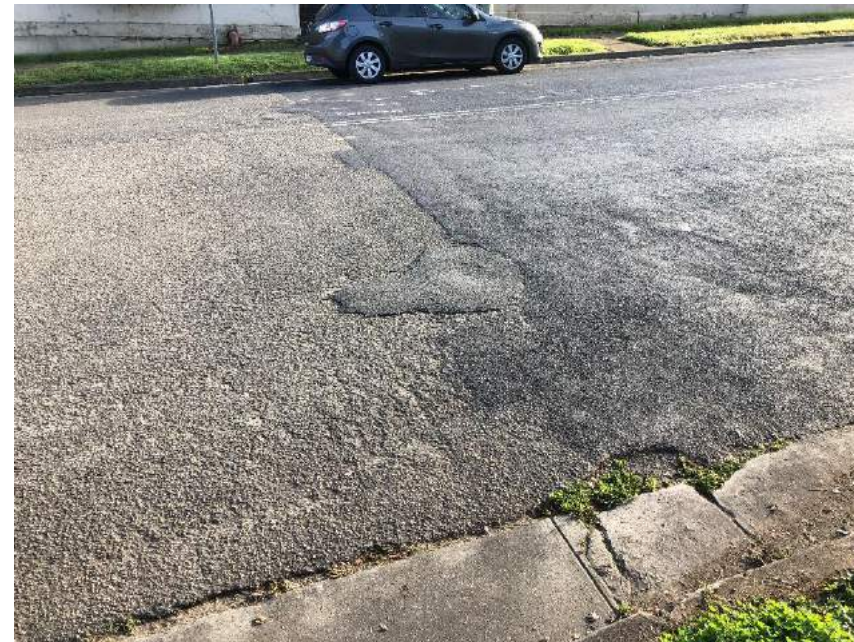
**2021:** Condition of pavement at old and new asphalt surface transition at on Court St including patch repair work and cracking – little to no change observed compared to pre-construction survey conditions.

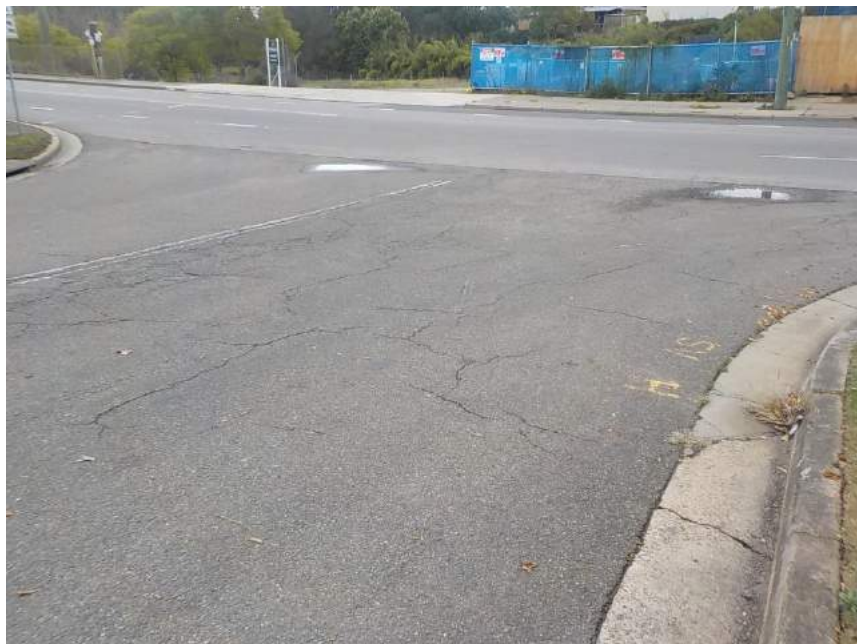
**2018:** General condition of pavement surface at corner of Bridge St and Court St.

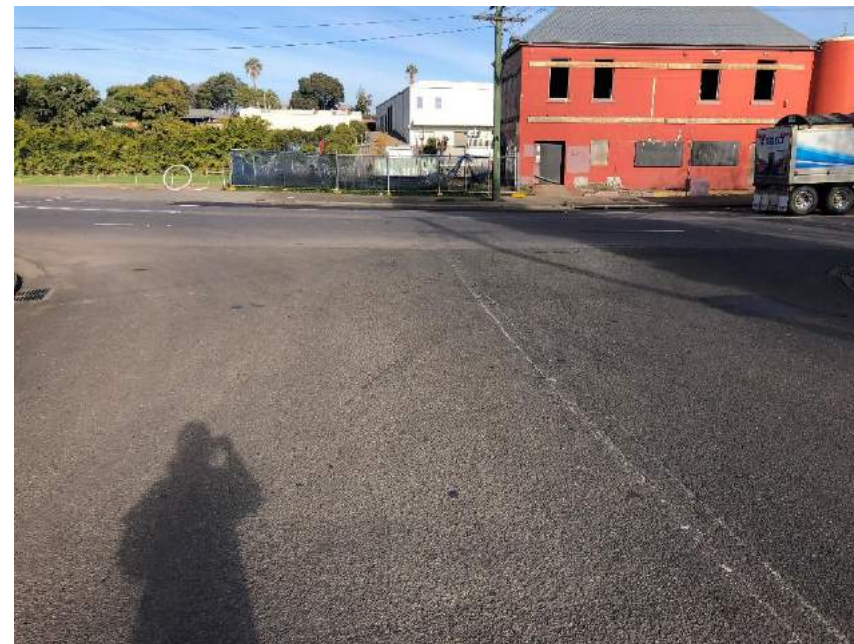
**2021:** General condition of pavement surface at corner of Bridge St and Court St – little to no change observed compared to pre-construction survey conditions.

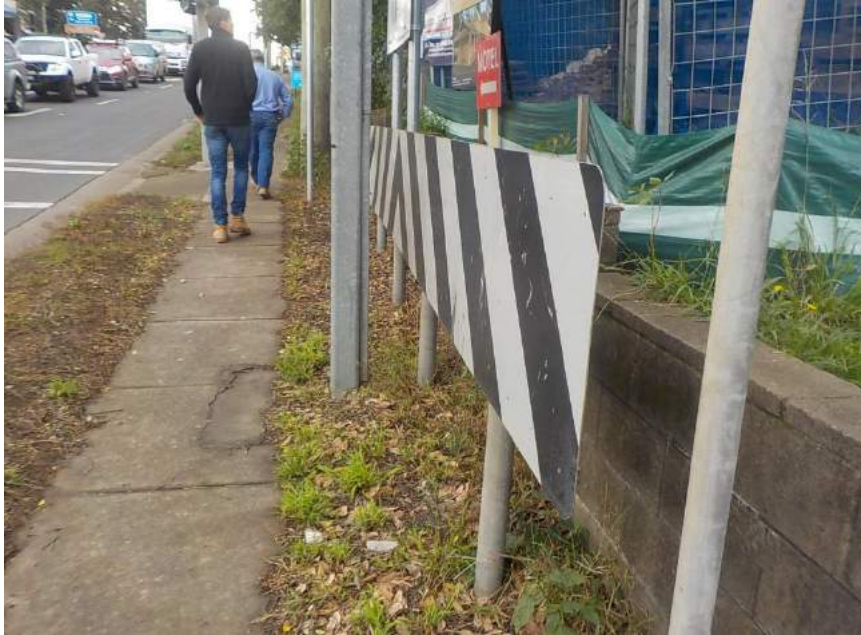
**2018:** General condition of footpath and signage adjacent the Bridge St/Macquarie St intersection.

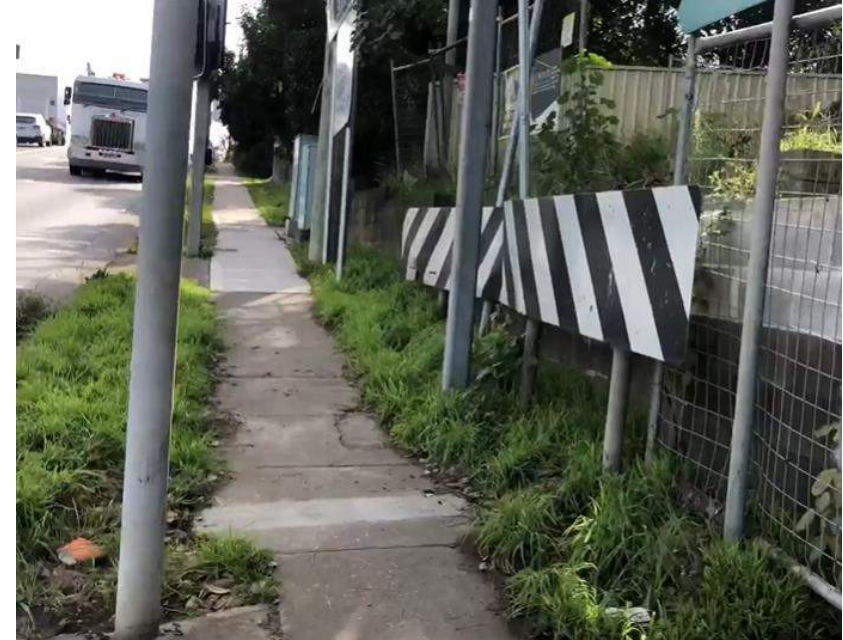
**2021:** General condition of footpath and signage adjacent the Bridge St/Macquarie St intersection – little to no change observed compared to pre-construction survey conditions, with portions of reinstated footpath surfacing.

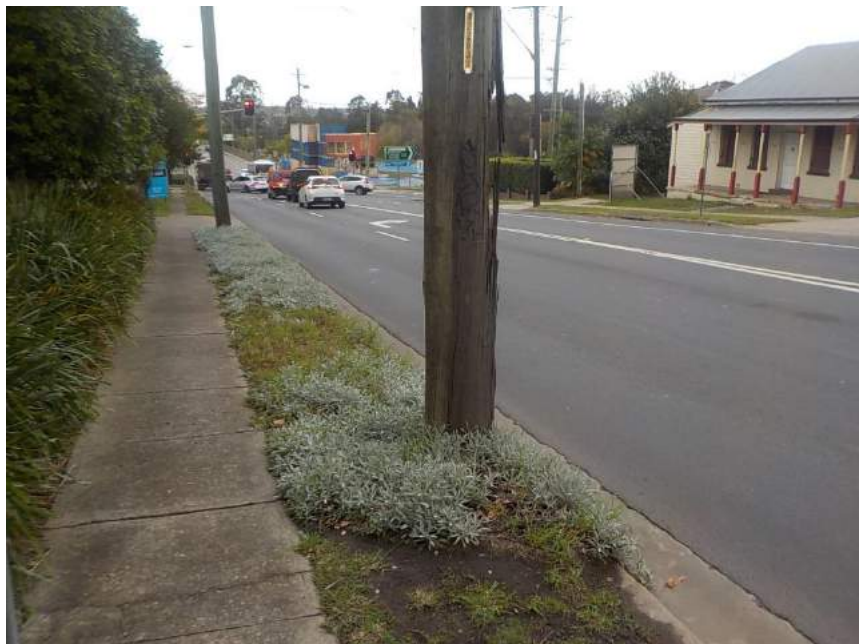
**2018:** General condition of pavement and footpath at Bridge St facing Macquarie St.

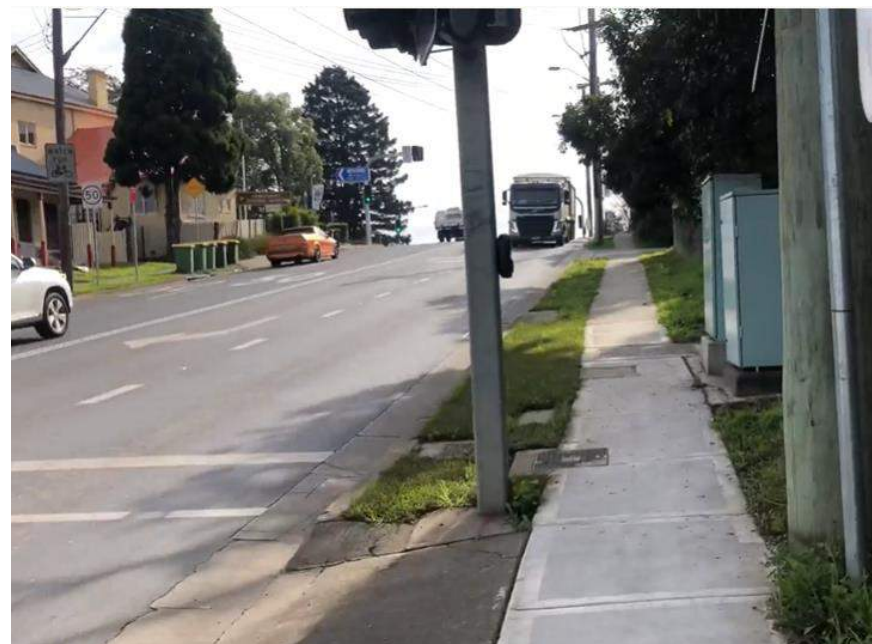
**2021:** General condition of pavement and footpath at Bridge St facing George St – reinstatement of footpath with new concrete surfacing.

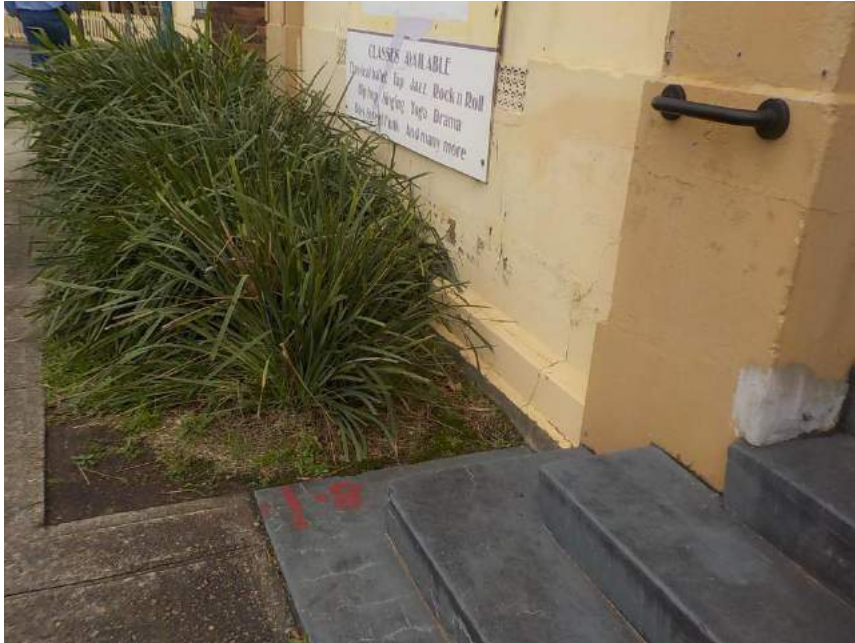
**2018:** Damage to stairs and existing structure – wearing, cracking and paint chipping.

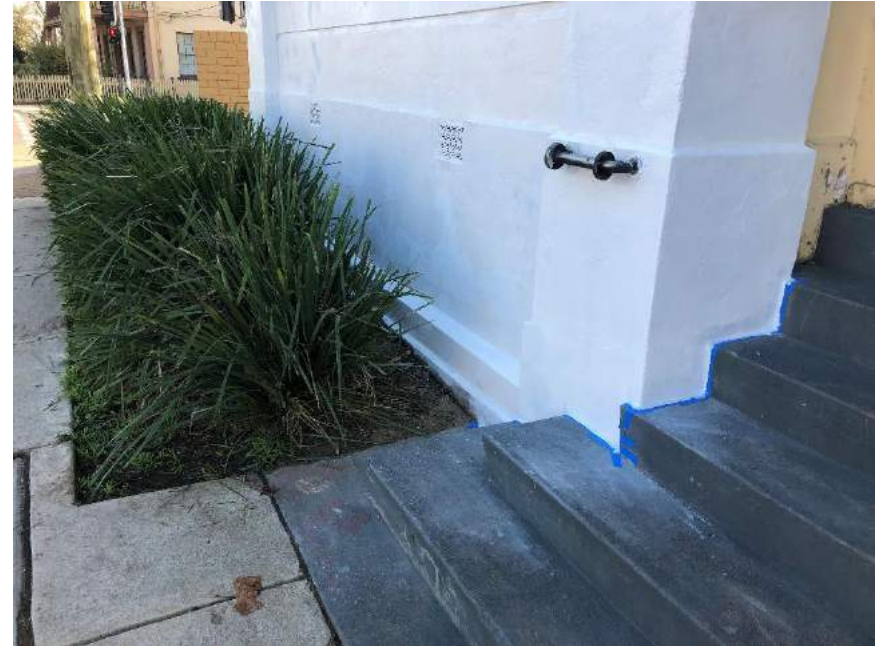
**2021:** Repainting of existing stairs and walls, with other structural changes to wall shape.

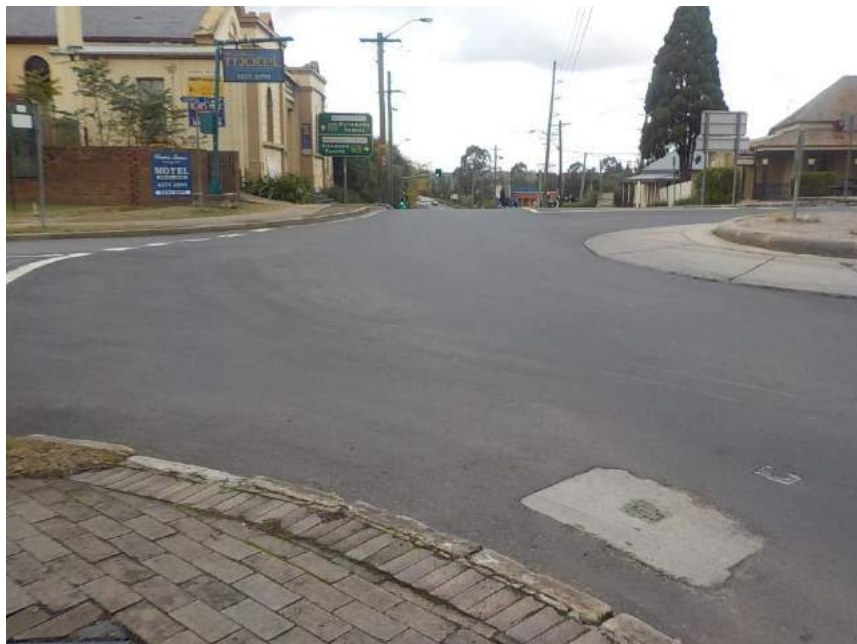
**2018:** General condition of pavement at Bridge St and George St roundabout.

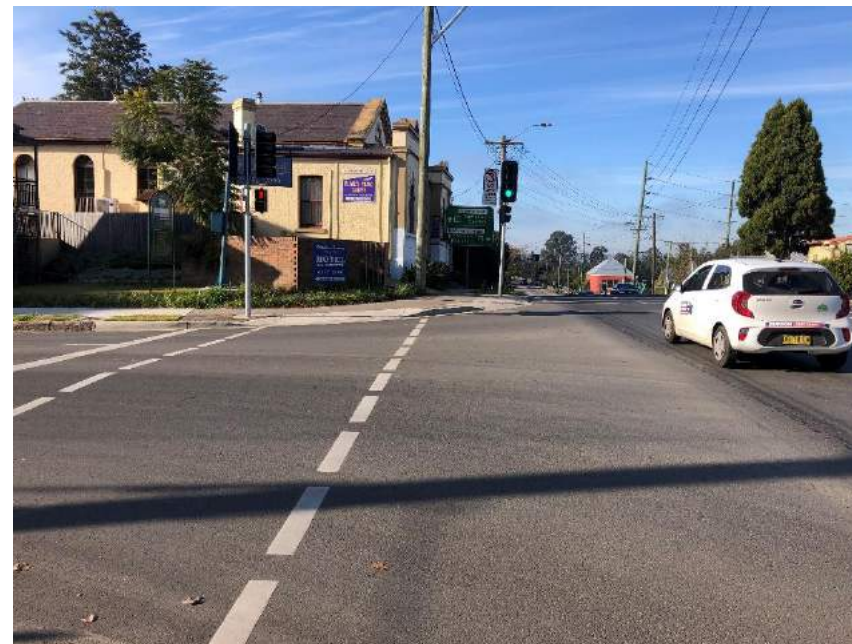
**2021:** General condition of pavement at Bridge St and George St intersection – removal of roundabout and installation of traffic lights including new asphalt and kerbs.

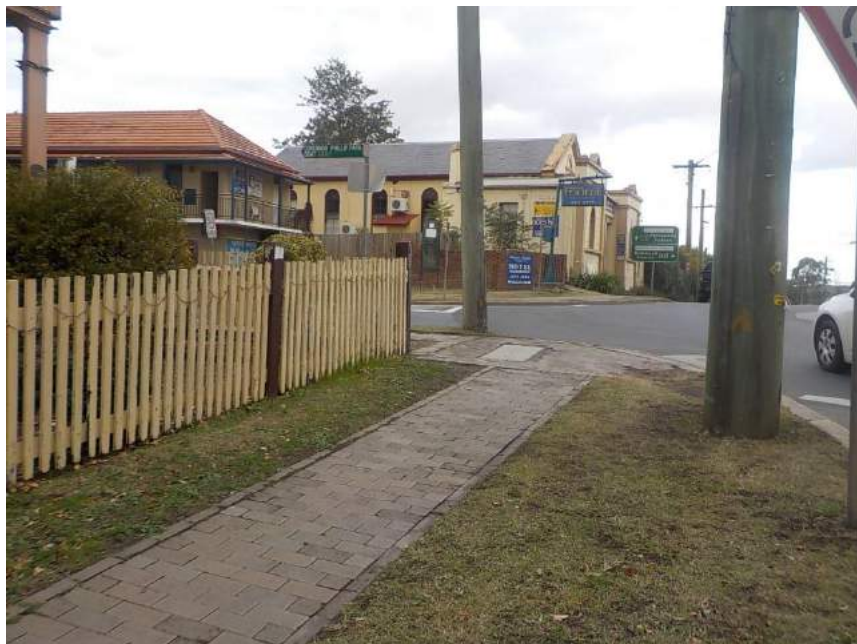
**2018:** General condition of footpath at Bridge St and George St roundabout/

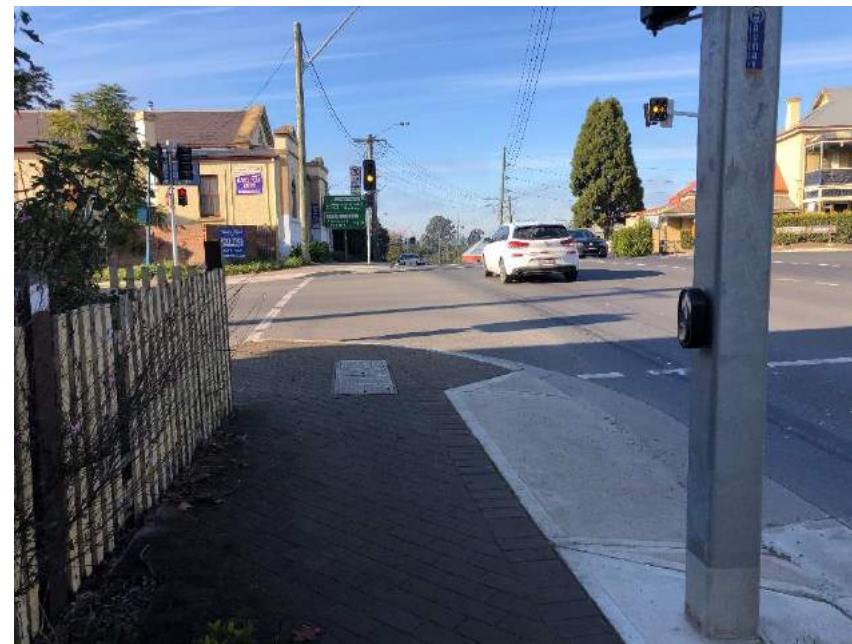
**2021:** General condition of footpath at Bridge St and George St intersection – installation of traffic lights, new asphalt and footpaths.

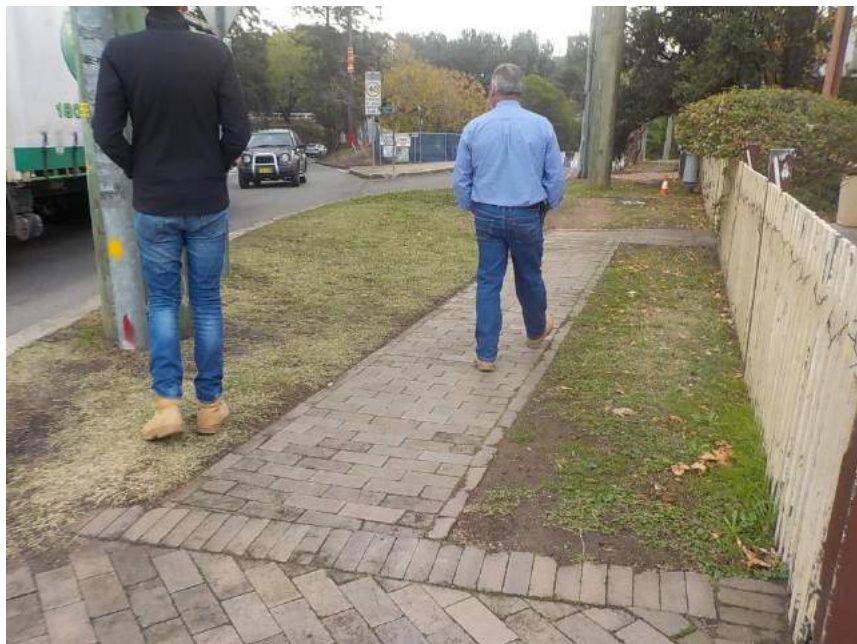
**2018:** General condition of footpath at Bridge St and George St roundabout towards Old Bridge St.

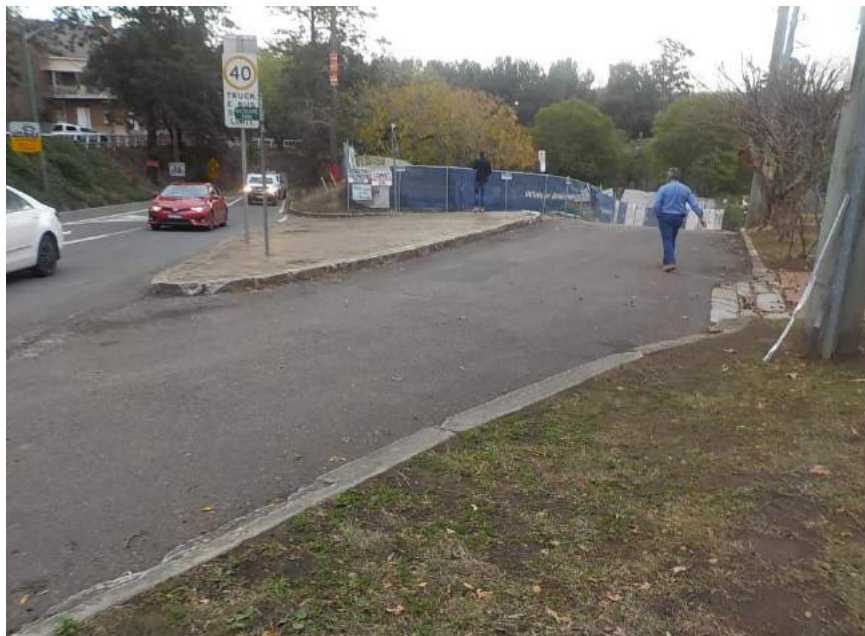
**2018:** General condition of pavement on Old Bridge St.

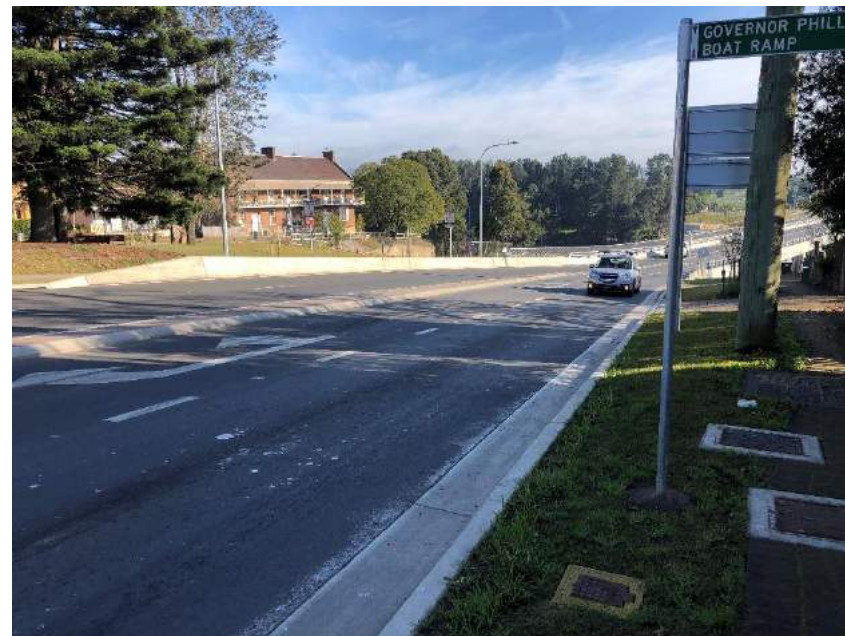
**2021:** Improved general condition of pavement towards the newly installed bridge – removal of Old Bridge St, significant structural reworking of roadway leading to bridge.

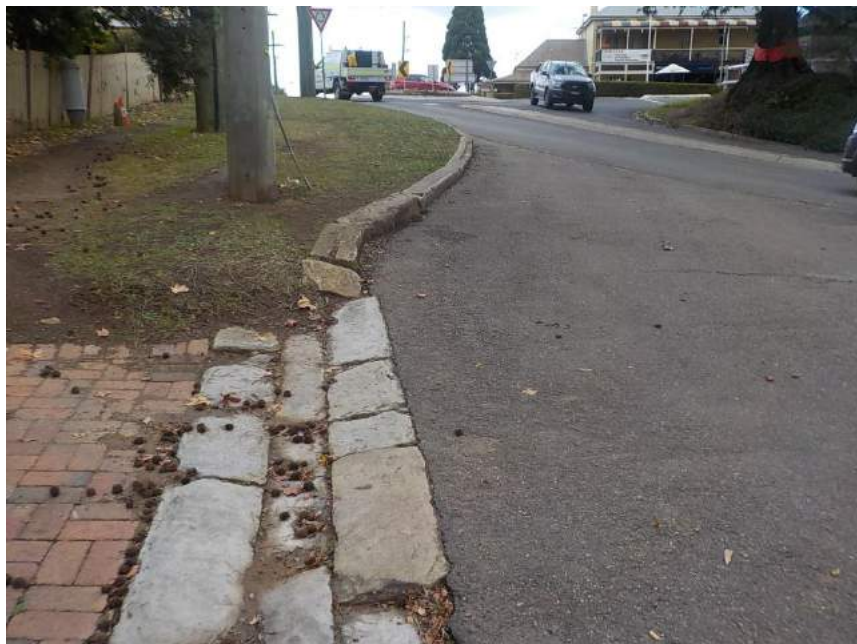
**2018:** General condition of pavement on Old Bridge St facing the roundabout – cracks on pavement and driveway ramp.

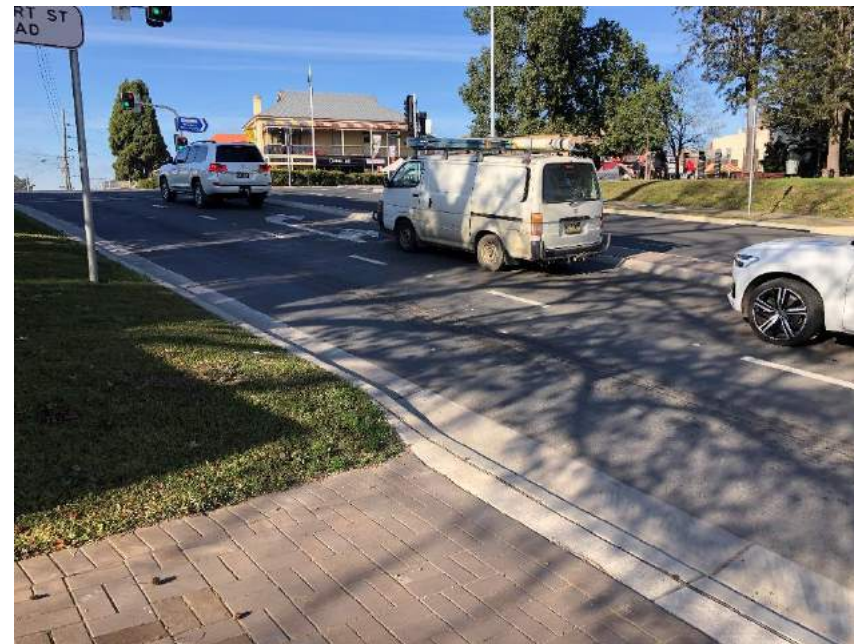
**2021:** General condition of pavement on Bridge St facing the George St intersection – new asphalt, grass and replaced gutter and paving of driveway.

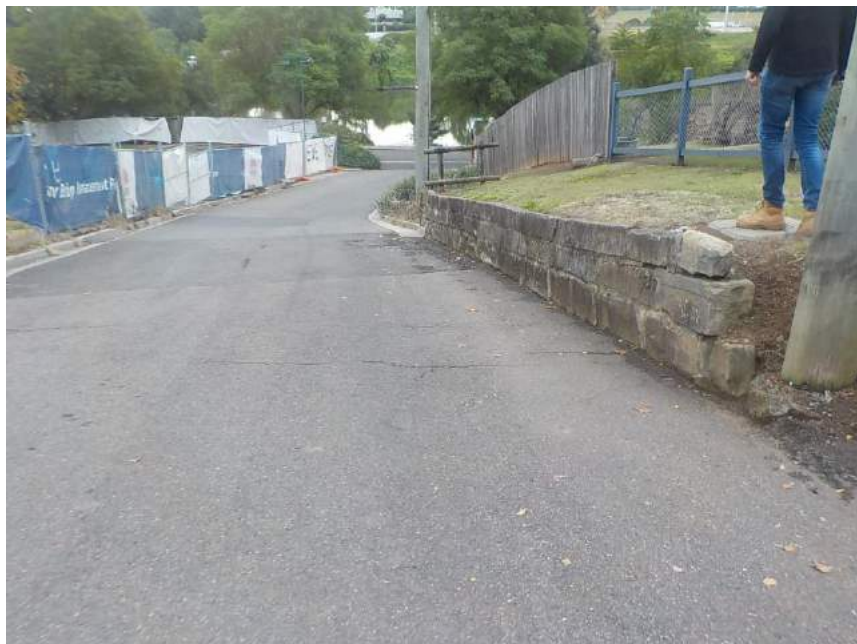
**2018:** General condition of pavement and retaining wall on Old Bridge St.

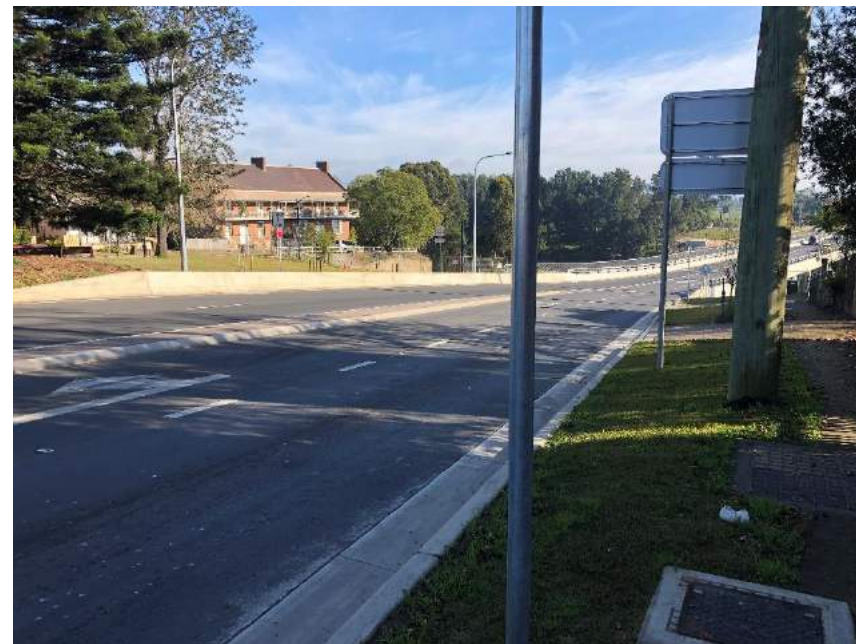
**2021:** General condition of pavement of Bridge St – removal of retaining wall, reworking of road structure and flow, new asphalt, kerbs and gutters.

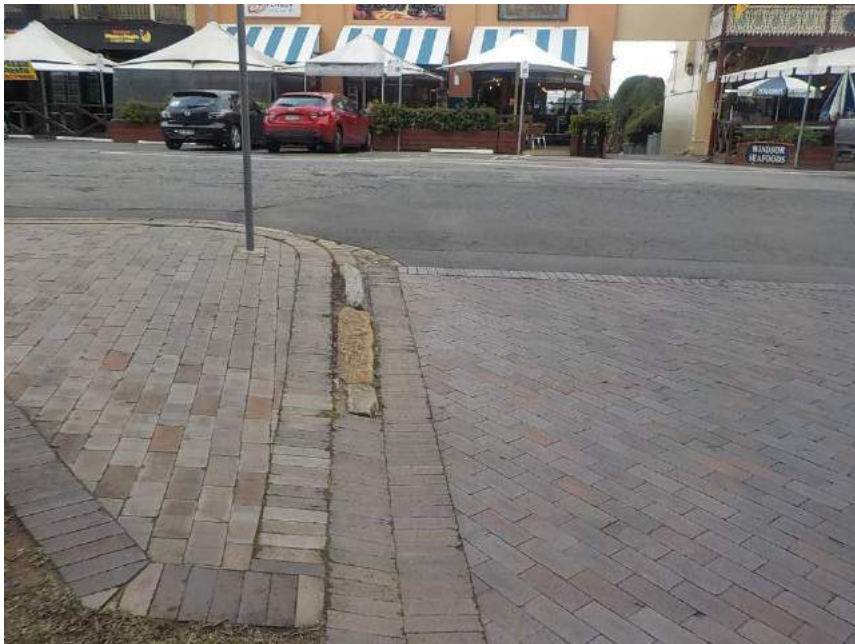
**2018:** General condition of pavement, footpath and kerb at George St and Thompson Square intersection.

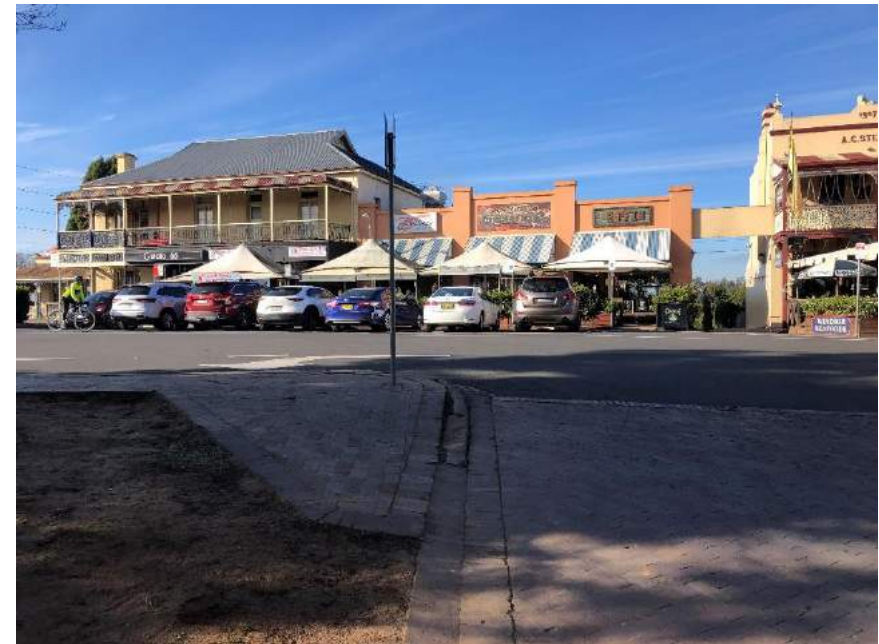
**2021:** General condition of pavement, footpath and kerb at George St and Thompson Square intersection – little to no change observed compared to pre-construction survey conditions.

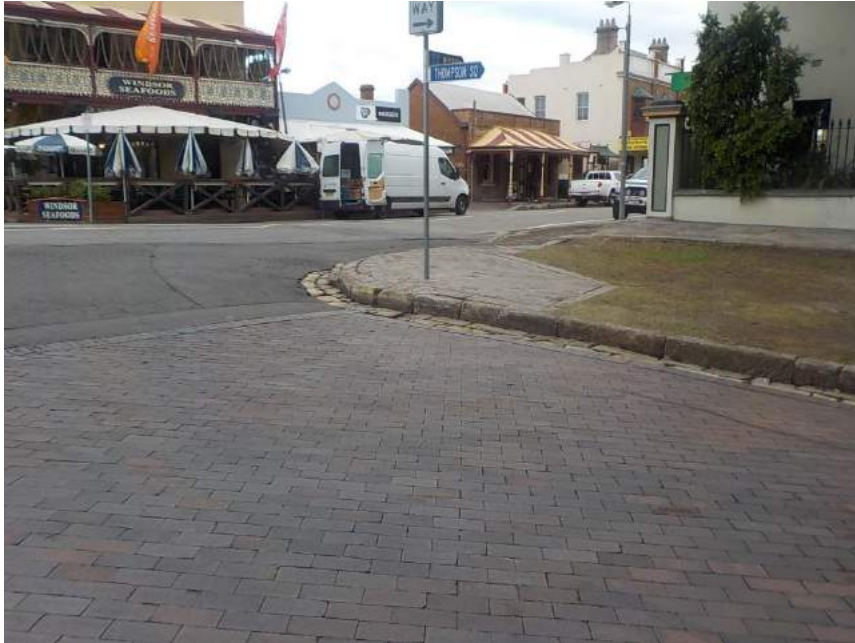
**2018:** General condition of pavement, footpath and kerb at George St and Thompson Square intersection.

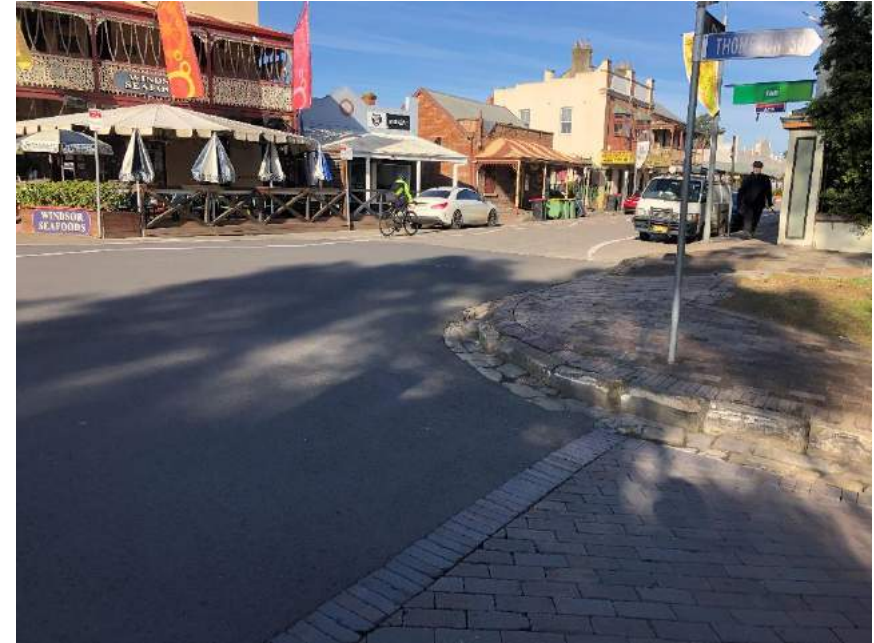
**2021:** General condition of pavement, footpath and kerb at George St and Thompson Square intersection – new asphalt evident along George St.

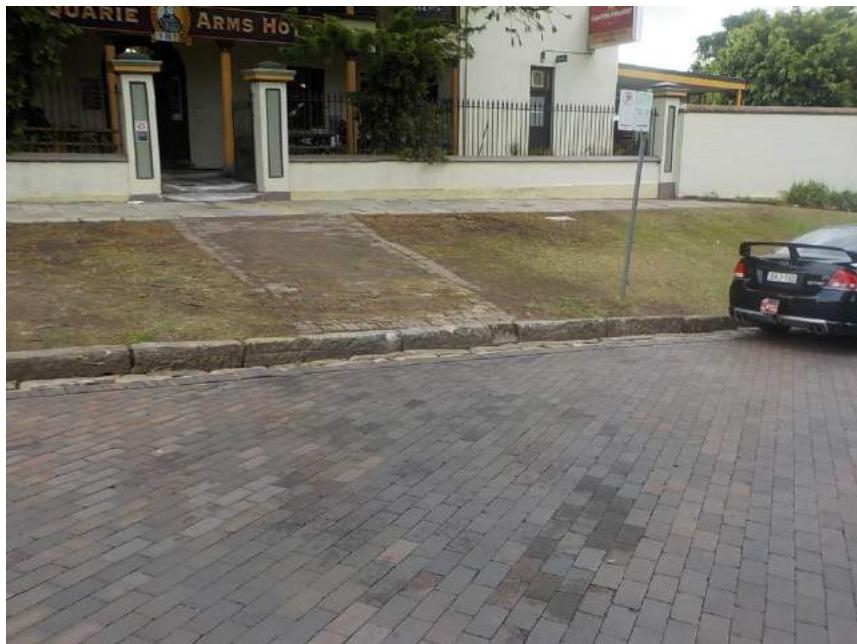
**2018:** General condition of pavement, footpath and kerb in front of the Arms Hotel.

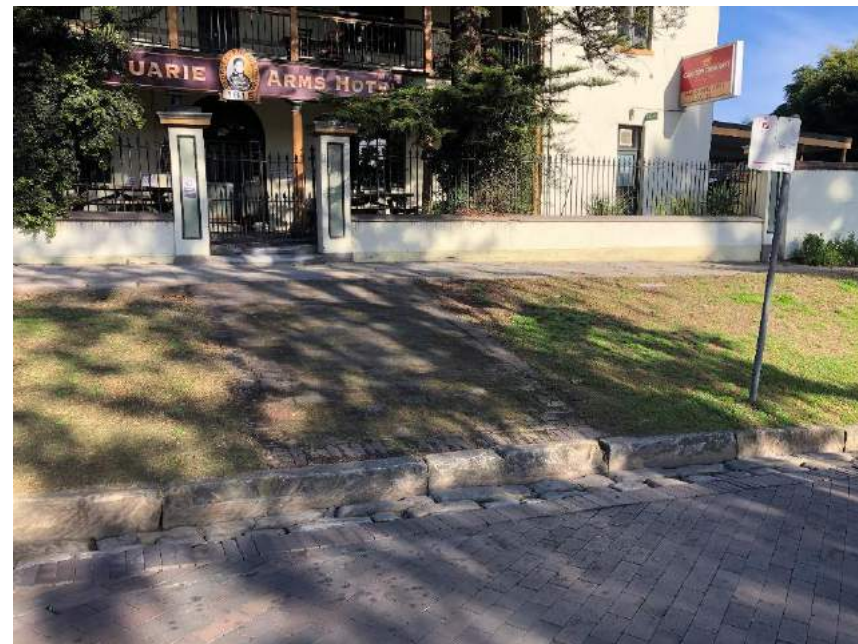
**2021:** General condition of pavement, footpath and kerb in front of the Arms Hotel – little to no change observed compared to pre-construction survey conditions.

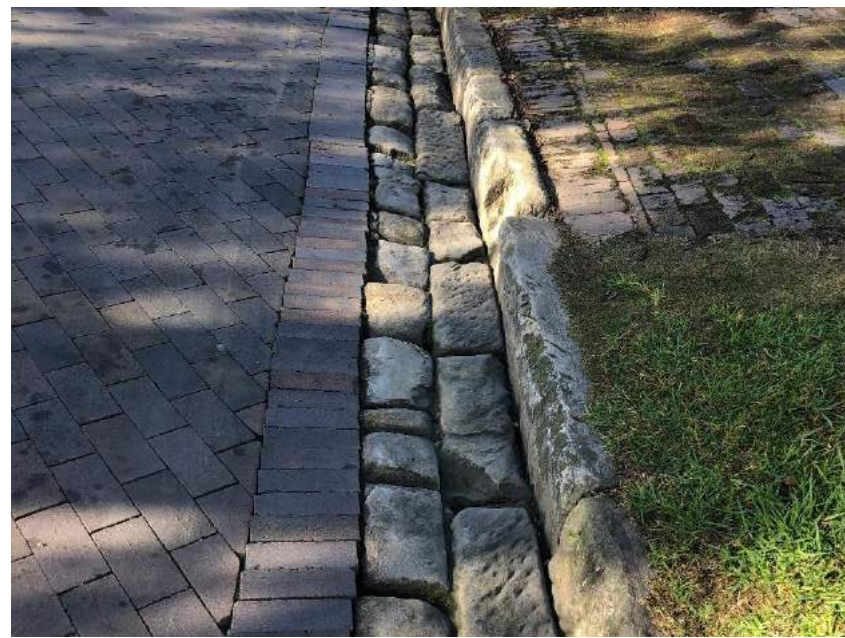
**2021:** General condition of kerb – little to no change observed compared to pre-construction survey conditions.

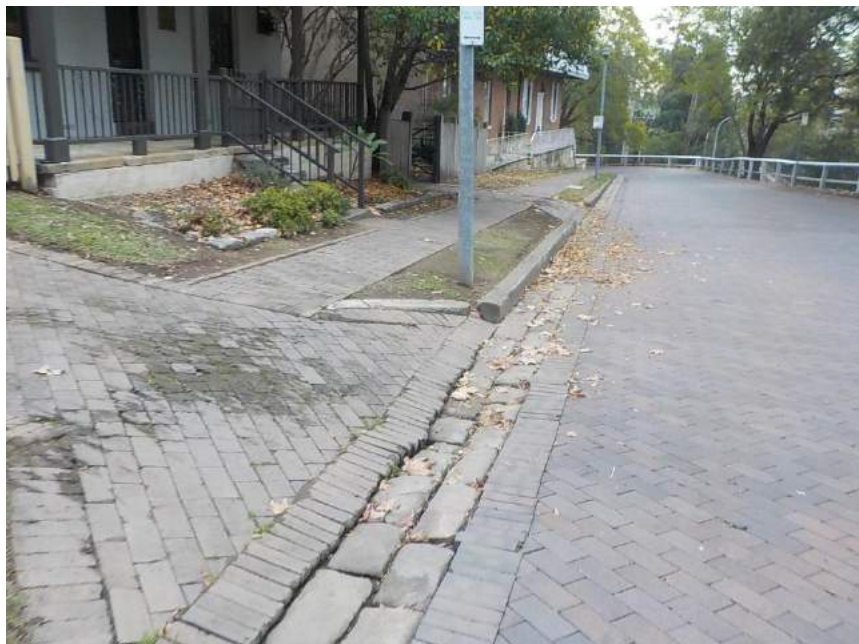
**2018:** General condition of pavement, footpath and kerb.

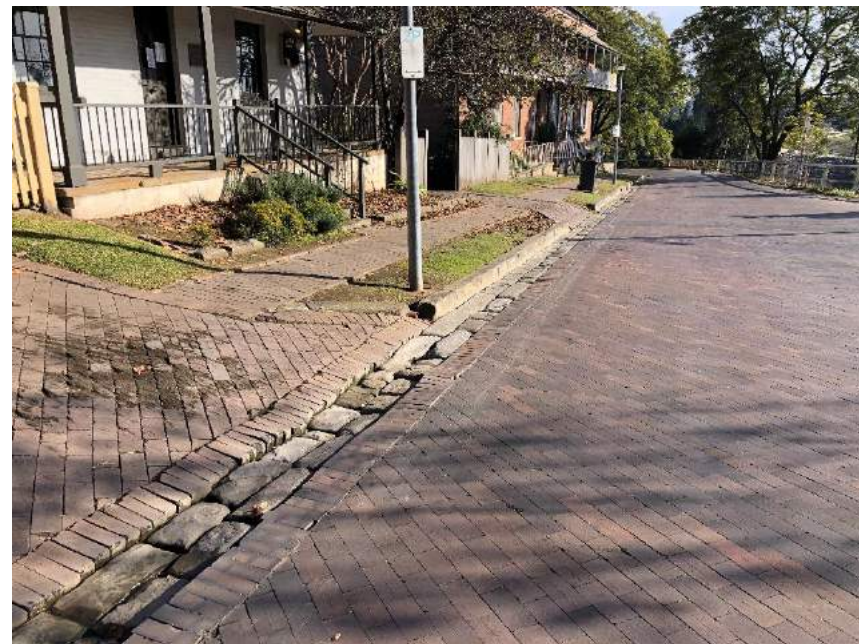
**2021:** General condition of pavement, footpath and kerb – little to no change observed compared to pre-construction survey conditions.

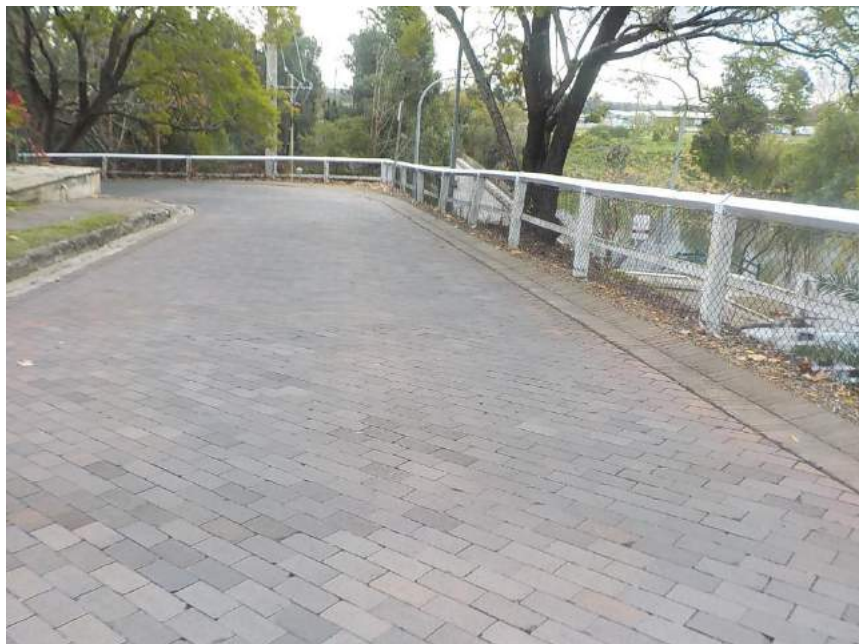
**2018:** General condition of pavement and kerb – existing fence weathered.

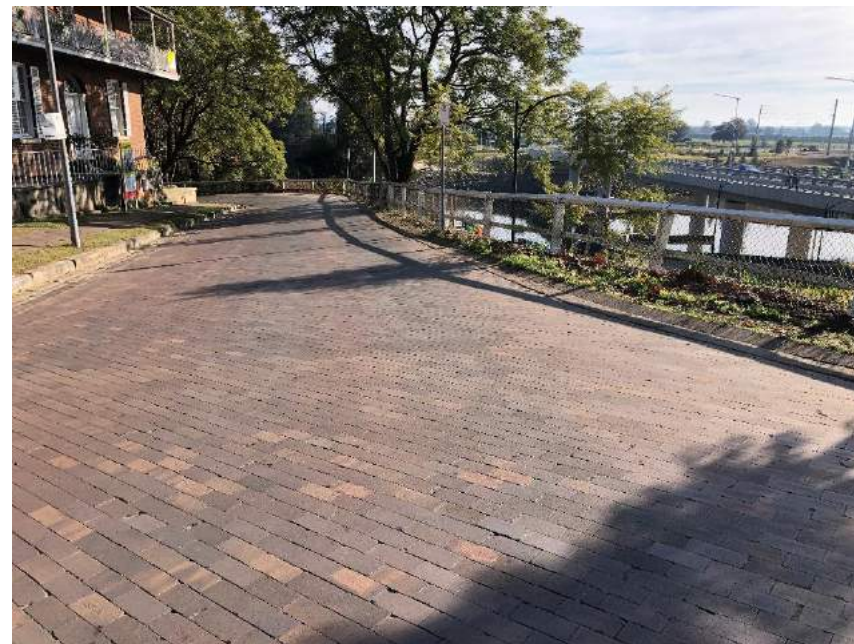
**2021:** General condition of pavement and kerb – existing fence weathered – little to no change observed compared to pre-construction survey conditions.

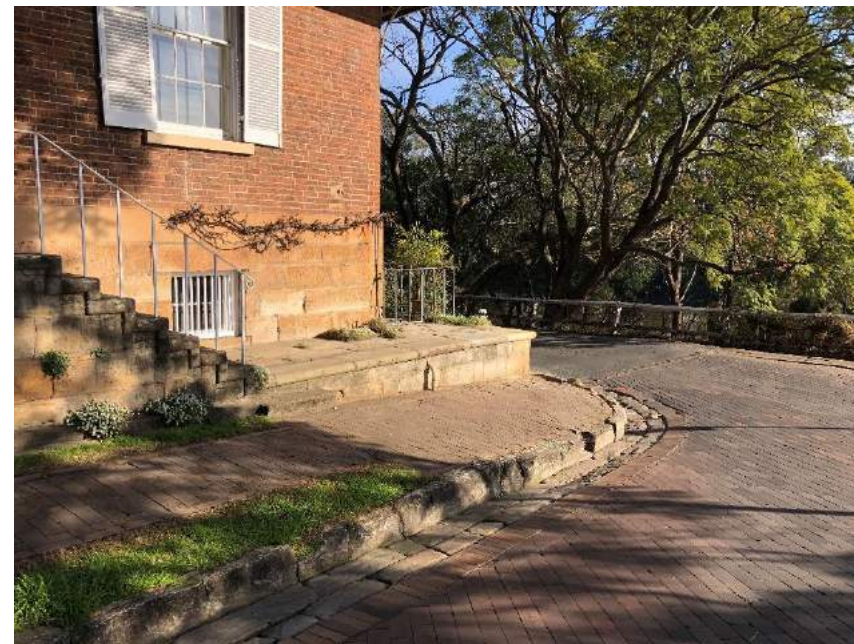
**2021:** General condition of pavement, footpath and existing structure – Thompson Square merging with Terrace St – little to no change observed compared to pre-construction survey conditions.

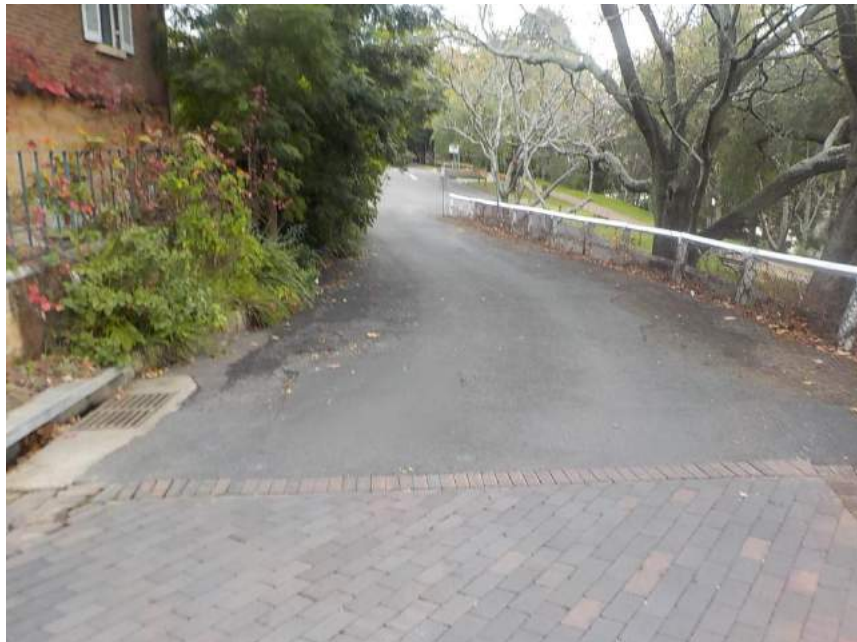
**2018:** Thompson Square merging with Terrace St – cracking on asphalt surface and edges peeling away.

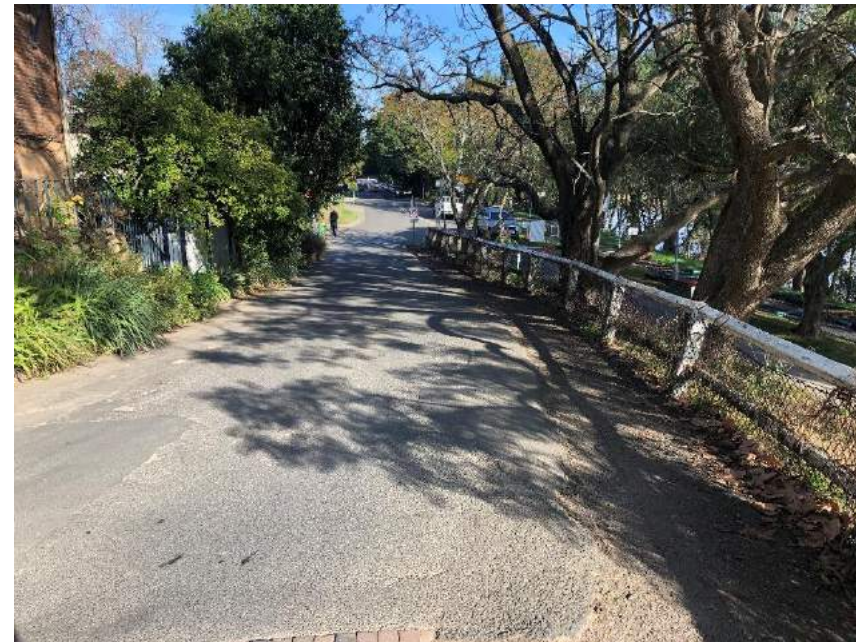
**2021:** Thompson Square merging with Terrace St – cracking on asphalt surface and edges peeling away – little to no change observed compared to pre-construction survey conditions.
