# Georgiou Group Dilapidation Report, Windsor Bridge Replacement Project, Windsor NSW

S-03139.DilapidationReport.001

**Pre-Dilapidation Photos Taken:** 20<sup>th</sup> June 2018

**Post-Dilapidation Photos Taken:** 8<sup>th</sup> July 2021

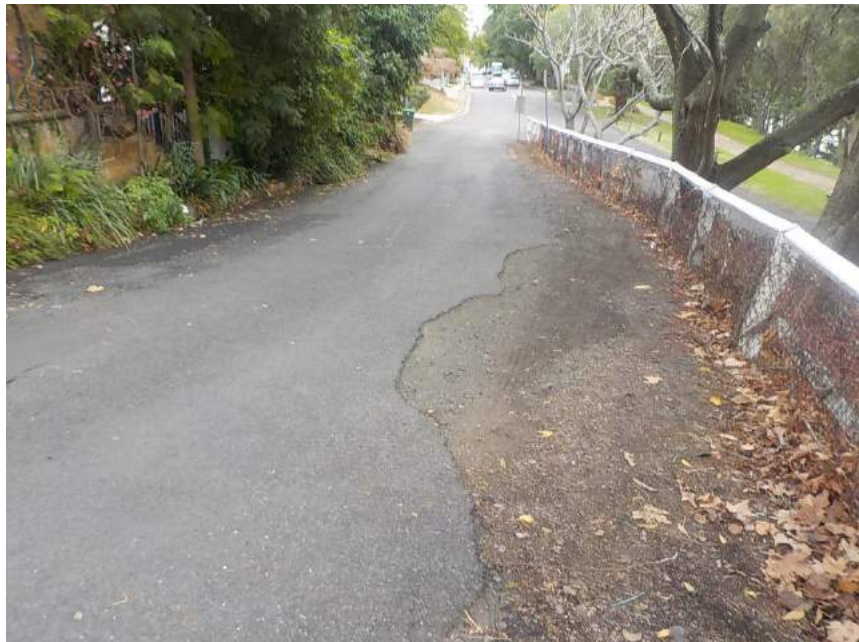
**2018:** Asphalt surface severely damaged – fence leaning towards the edge of the drop.

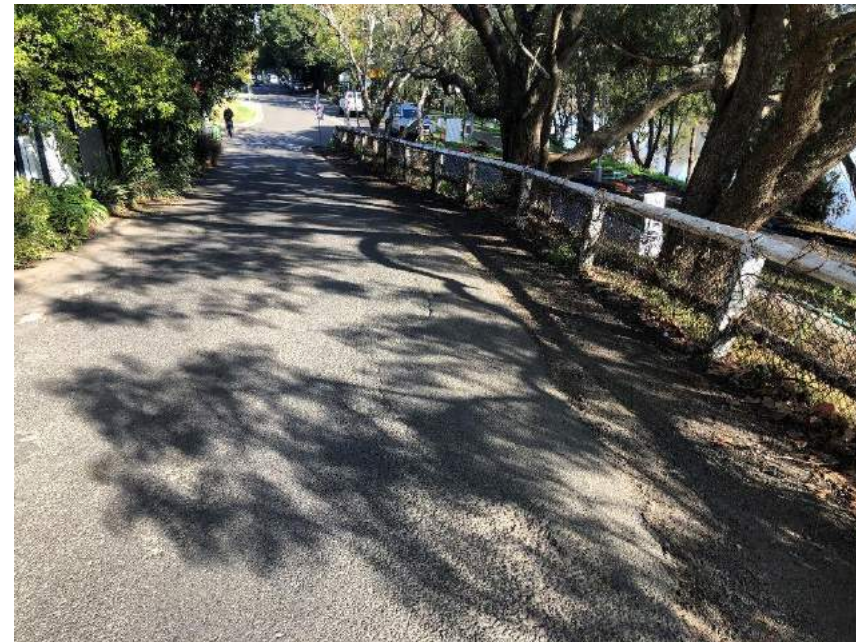
**2021:** Asphalt surface severely damaged, additional asphalt areas added to edge – fence leaning towards the edge of the drop – marginal changes due to high traffic area and not associated with construction.

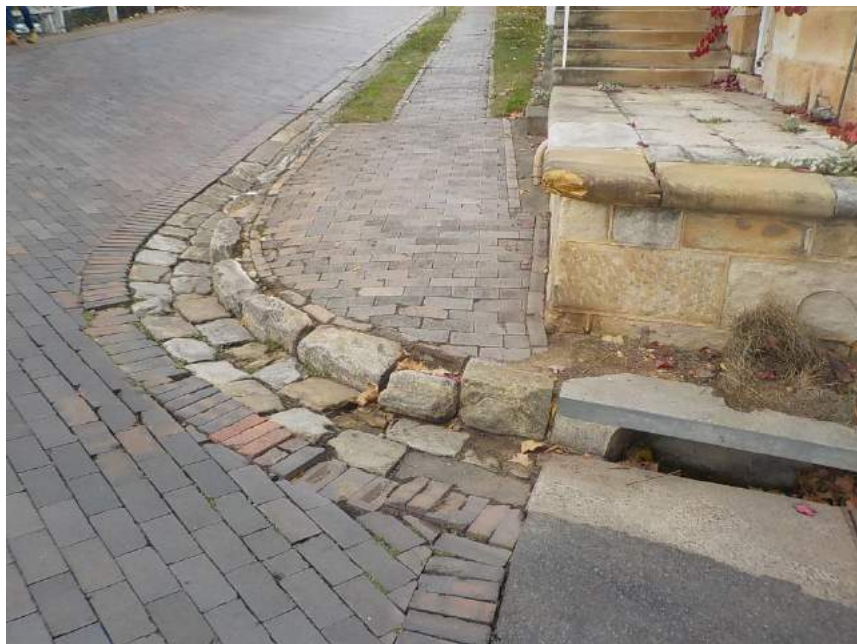
**2018:** General condition of pavement, footpath and existing structure – Thompson Square merging with Terrace St.

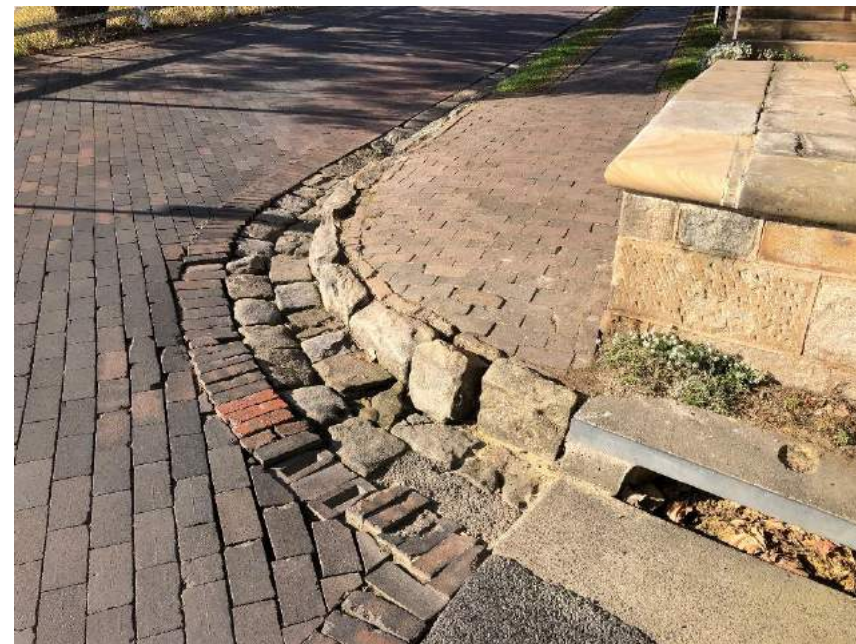
**2021:** General condition of pavement, footpath and existing structure – Thompson Square merging with Terrace St – little to no change observed compared to pre-construction survey conditions, with edge chipped sandstone replaced.

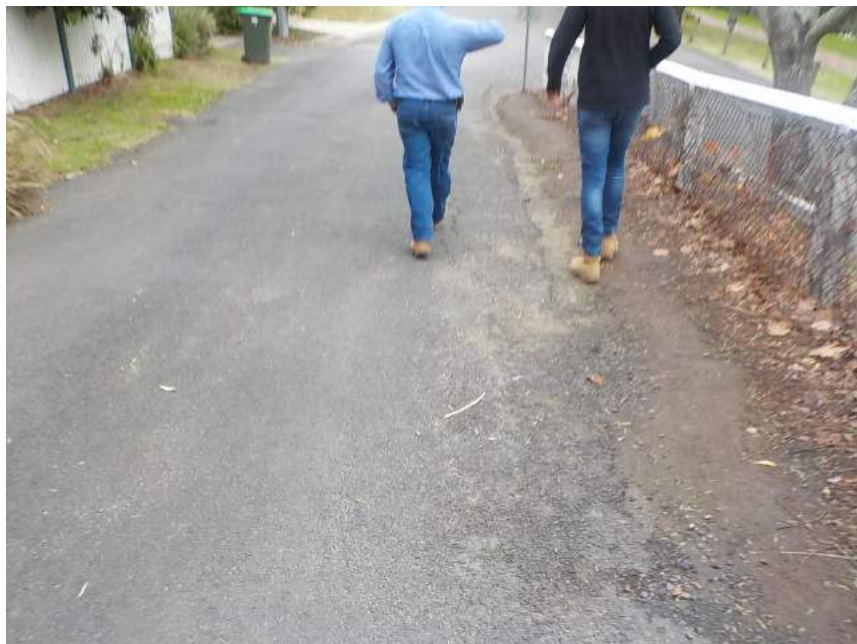
**2018:** General condition of pavement.

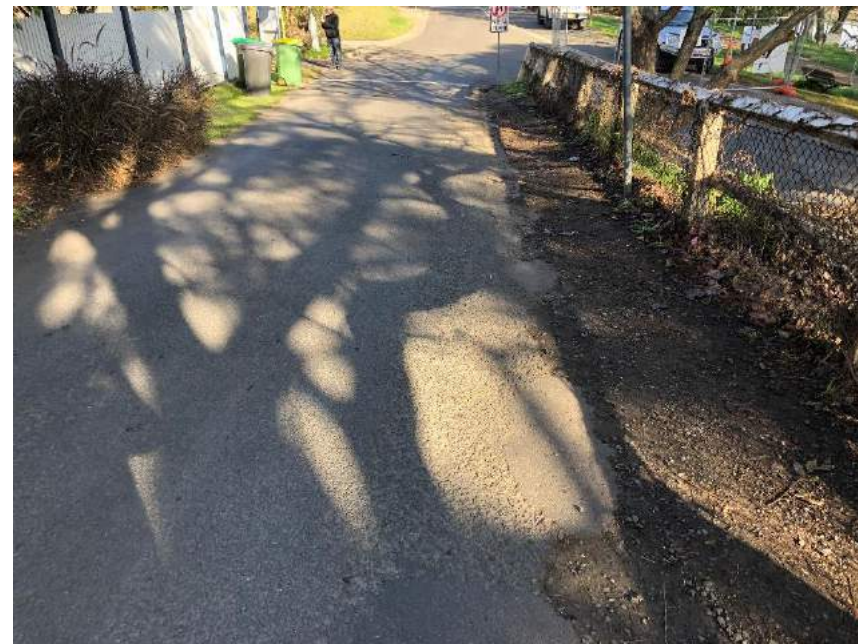
**2021:** General condition of pavement – little to no change observed compared to pre-construction survey conditions, portions of patch repair along road edge.

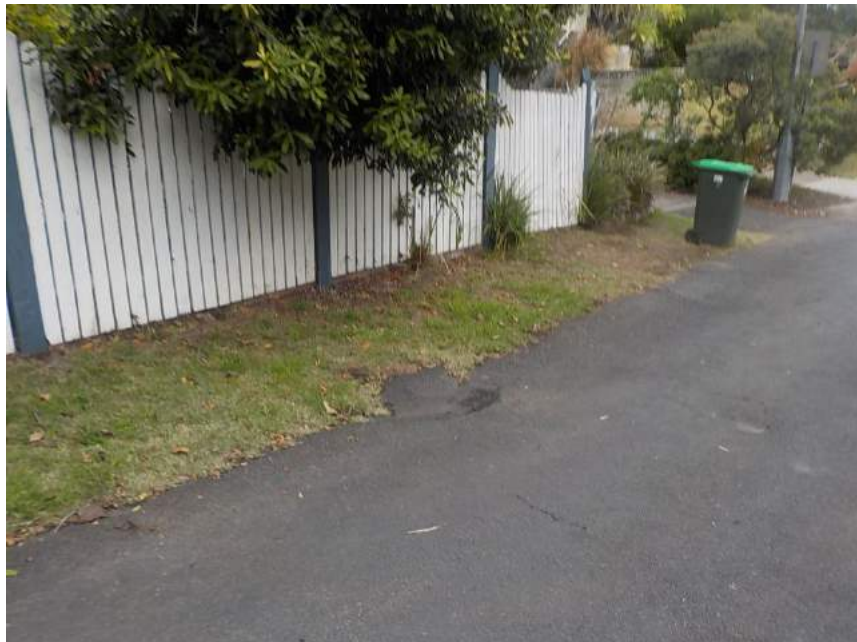
**2018:** Cracking, rutting and potholing present in asphalt surface.

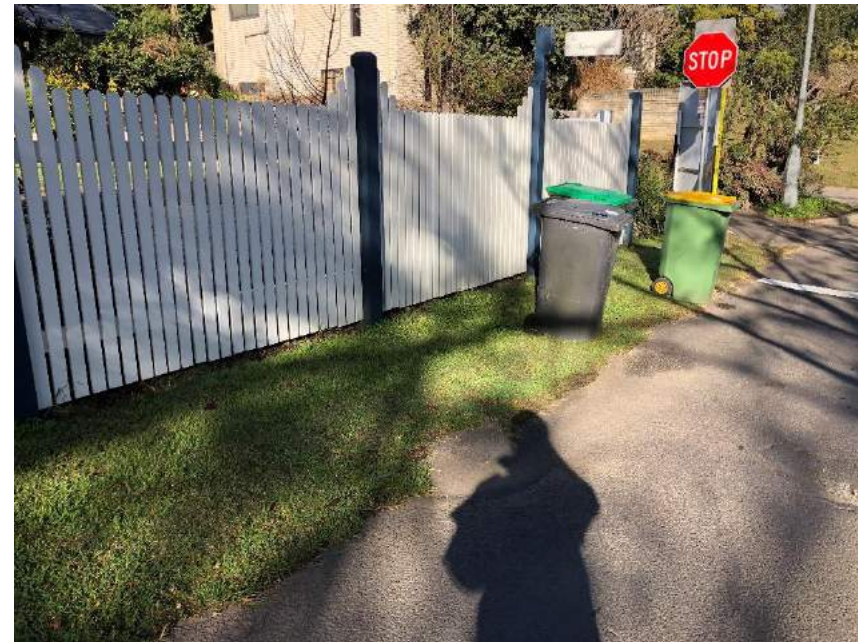
**2021:** Cracking, rutting and potholing present in asphalt surface – little to minor change associated with high traffic use of the area and not associated with project activities.

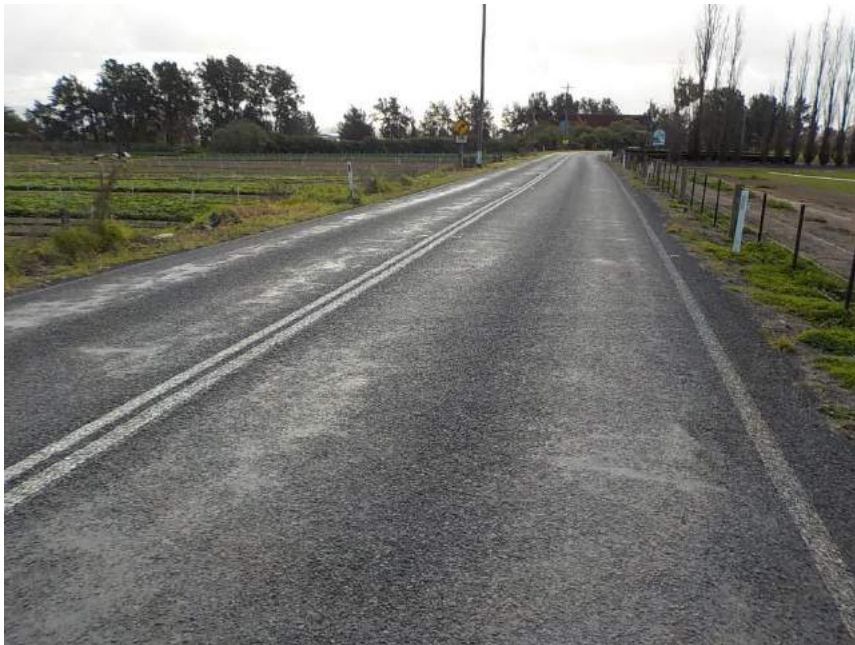
**2018:** General condition of asphalt surface – facing away from Wilberforce Rd.

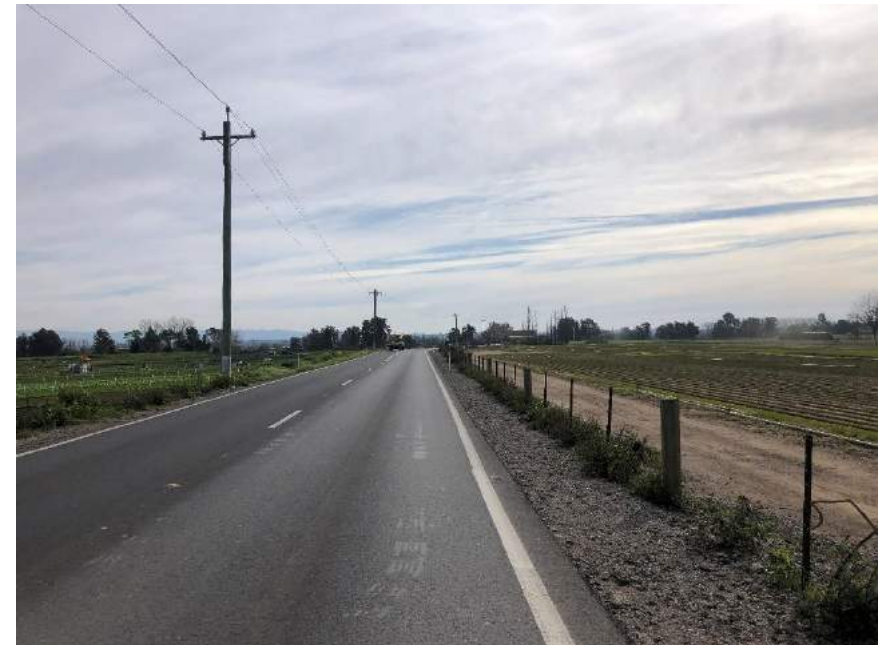
**2021:** General condition of asphalt surface – facing away from Wilberforce Rd – replaced asphalt along roadway, with little to no change observed changes to surrounding structures compared to pre-construction survey conditions.

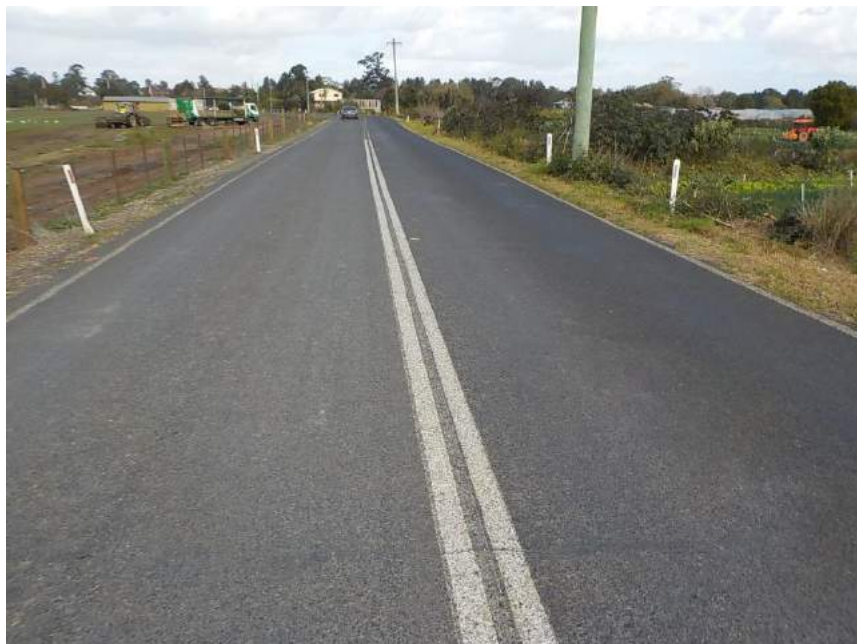
**2018:** Cracking on asphalt surface – facing Wilberforce Rd.

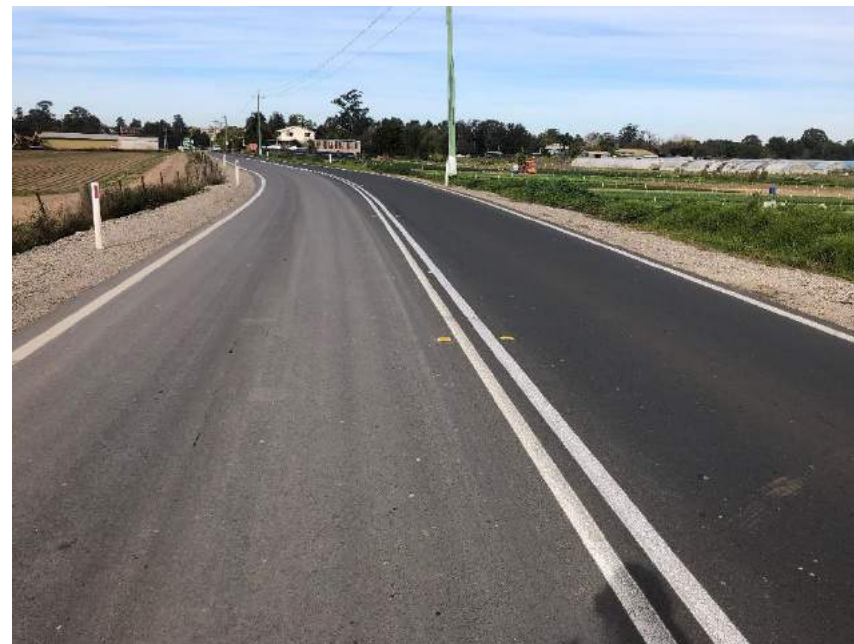
**2021:** Improved surface condition including replaced asphalt extending along Freemans Reach Rd.

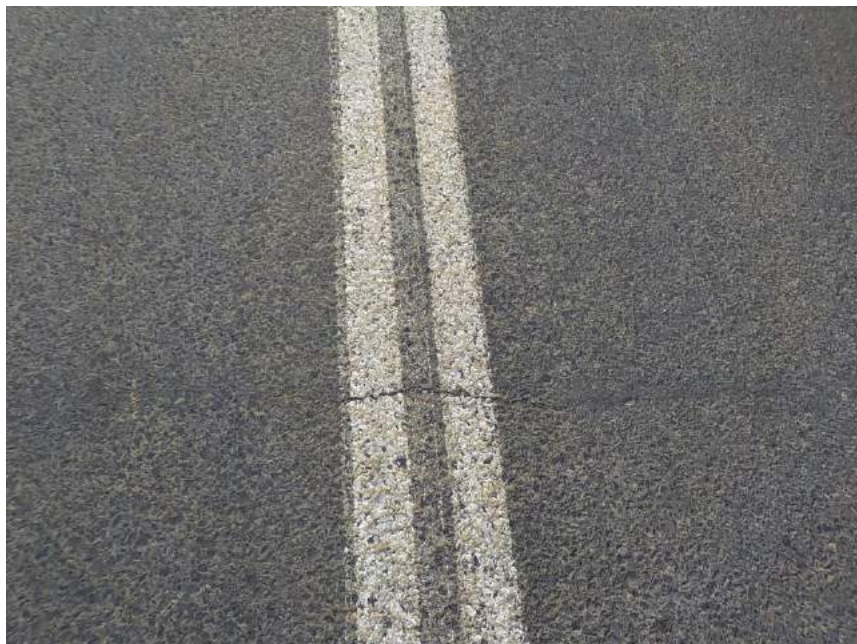
**2018:** Cracking on asphalt surface.

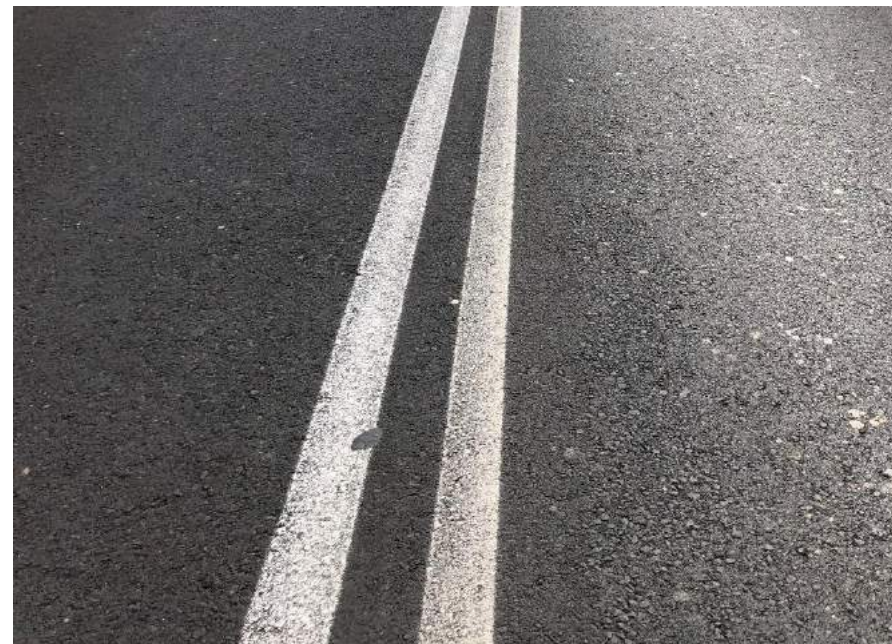
**2021:** No cracking of asphalt visible along the length of the road, new asphalt and line markings observed.

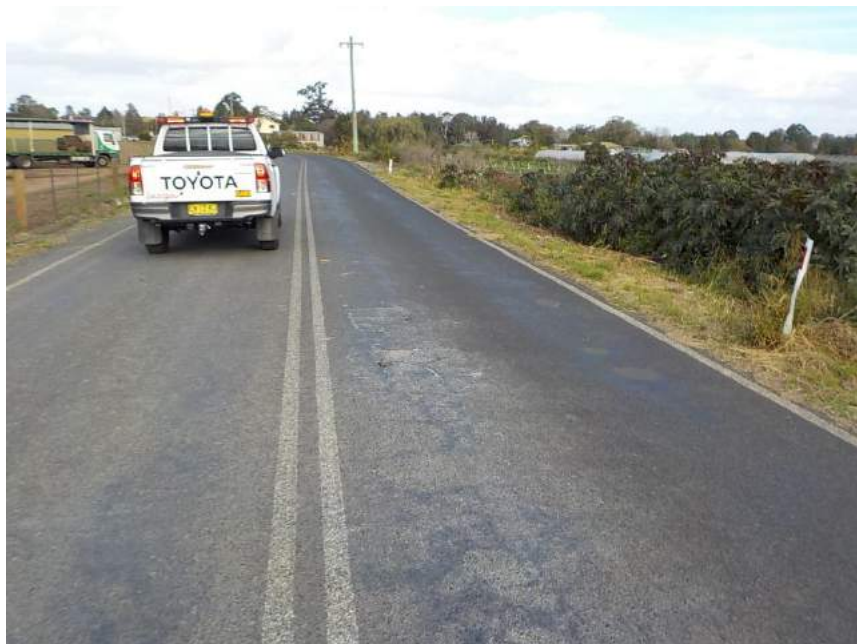
**2018:** Crocodile cracking on asphalt surface – line marking worn.

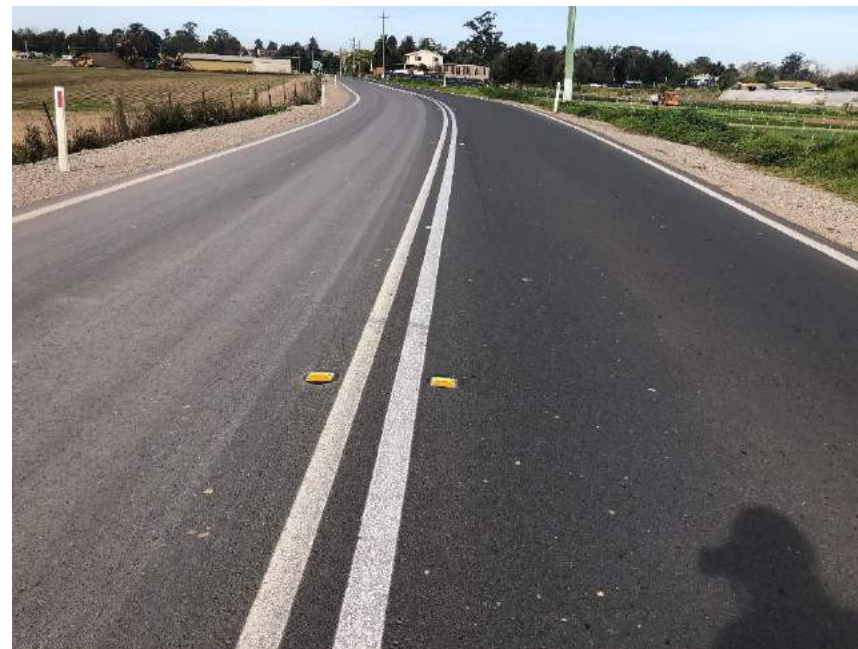
**2021:** Replacement of asphalt along Freemans Reach Rd, new line markings and light reflectors.

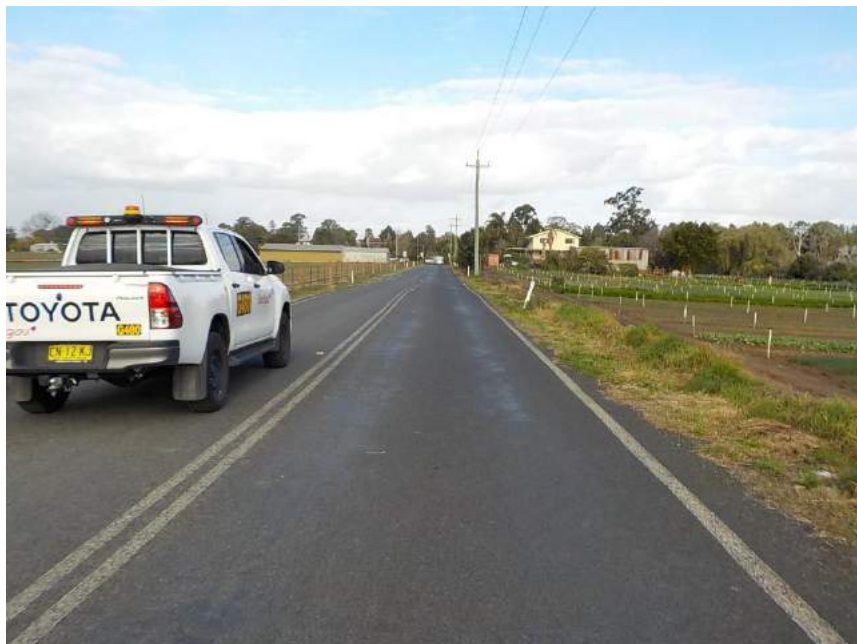
**2018:** General condition of pavement and shoulder.

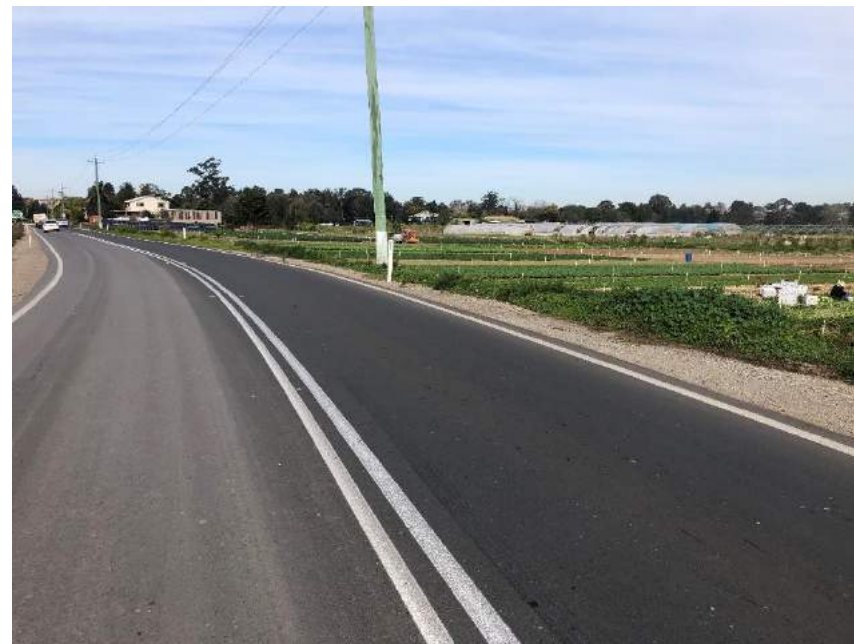
**2021:** General condition of pavement and shoulder – replaced asphalt, new line markings and gravel along roadway edge.

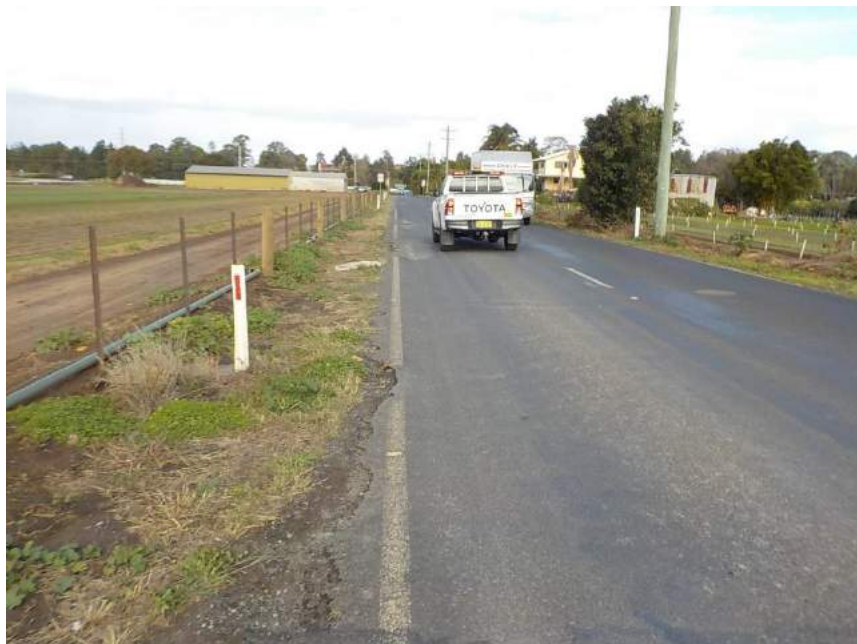
**2018:** General condition of pavement and shoulder -

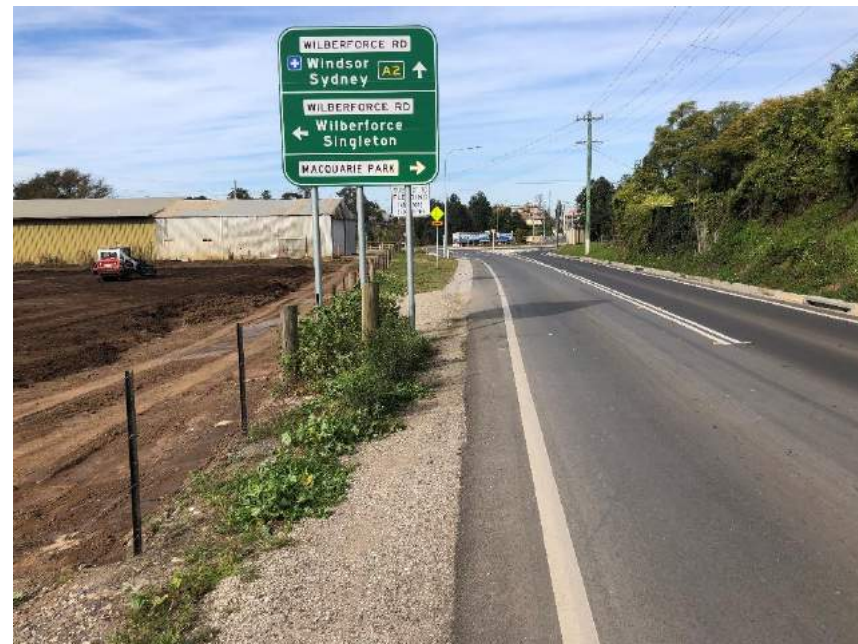
**2021:** Improved condition of pavement and shoulder – new asphalt, line markings, gravel road edge, new signage and gutter.

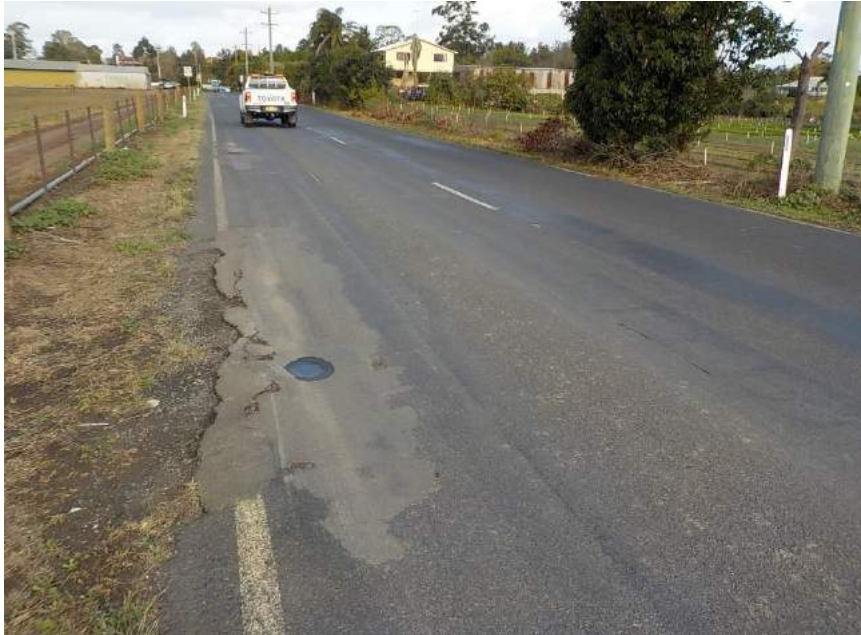
**2018:** General condition of pavement and shoulder.

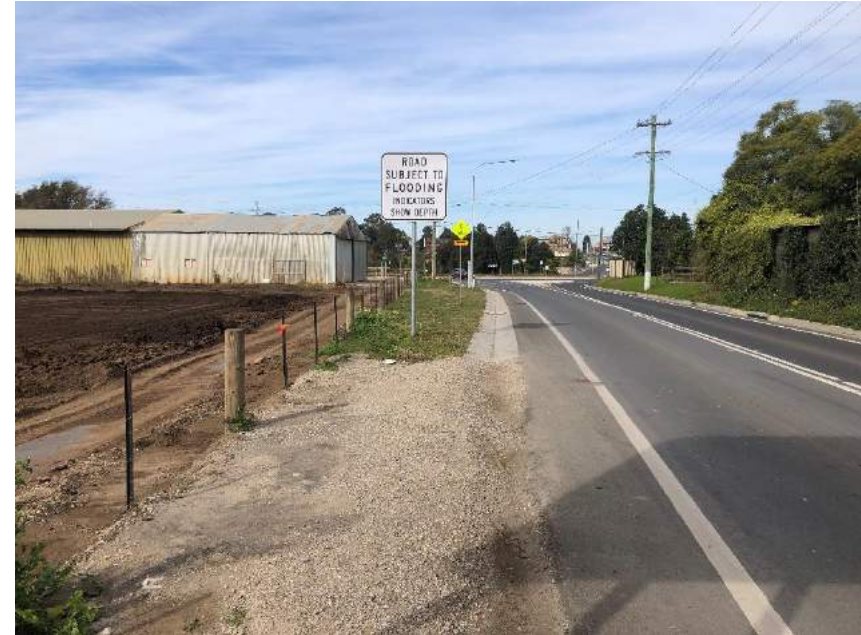
**2021:** General condition of pavement and shoulder – replaced asphalt, signage and installation of road gutters.

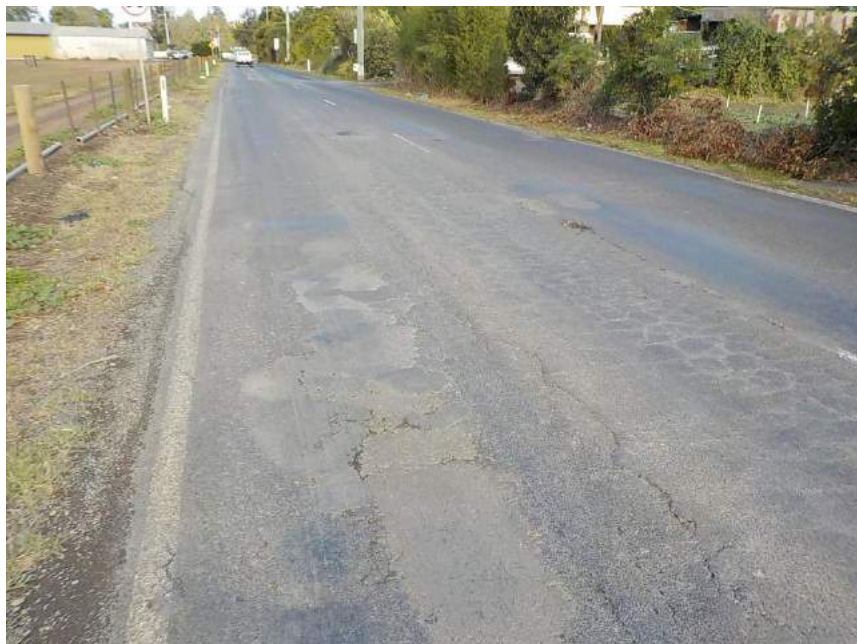
**2018:** Crocodile cracking and rutting on asphalt surface.

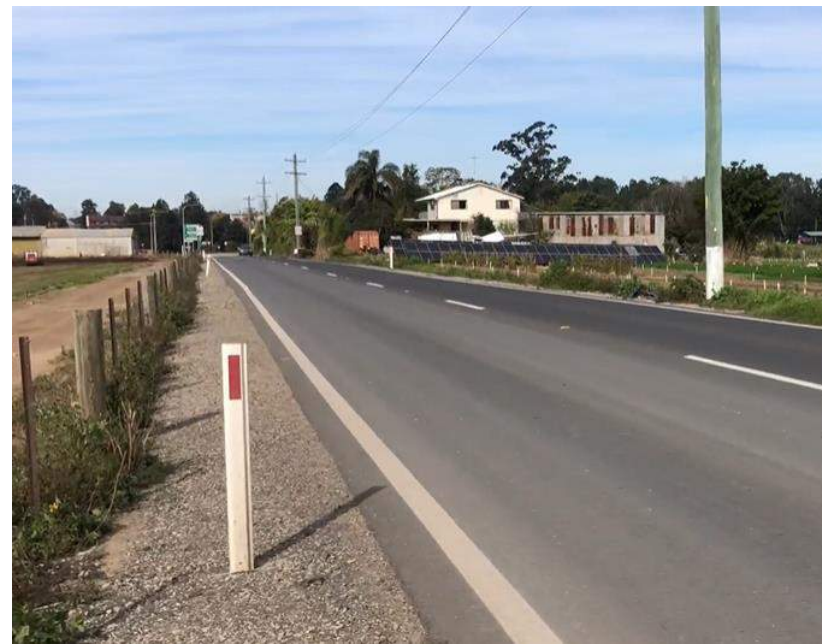
**2021:** New asphalt, line markings and shoulder posts extending along road towards roundabout.

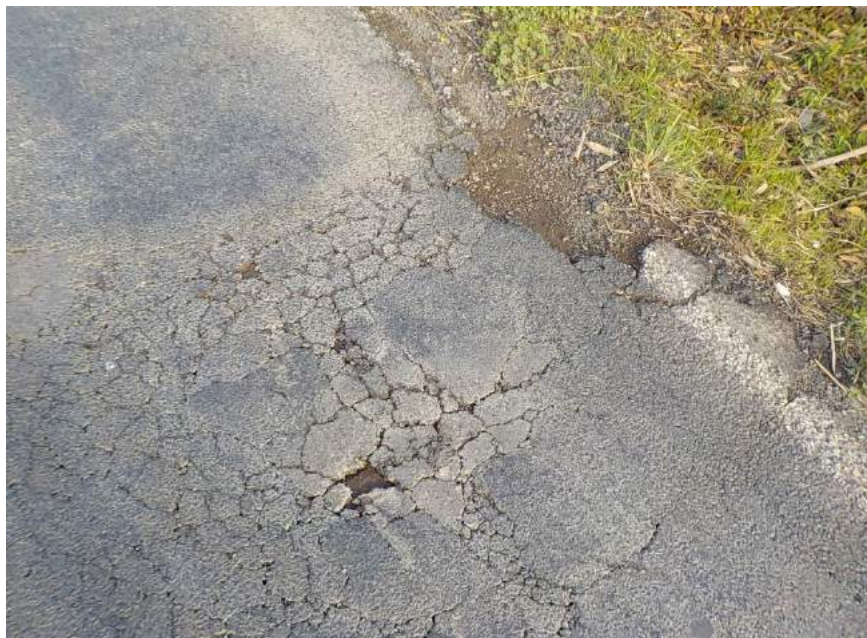
**2018:** Asphalt surface heavily damaged.

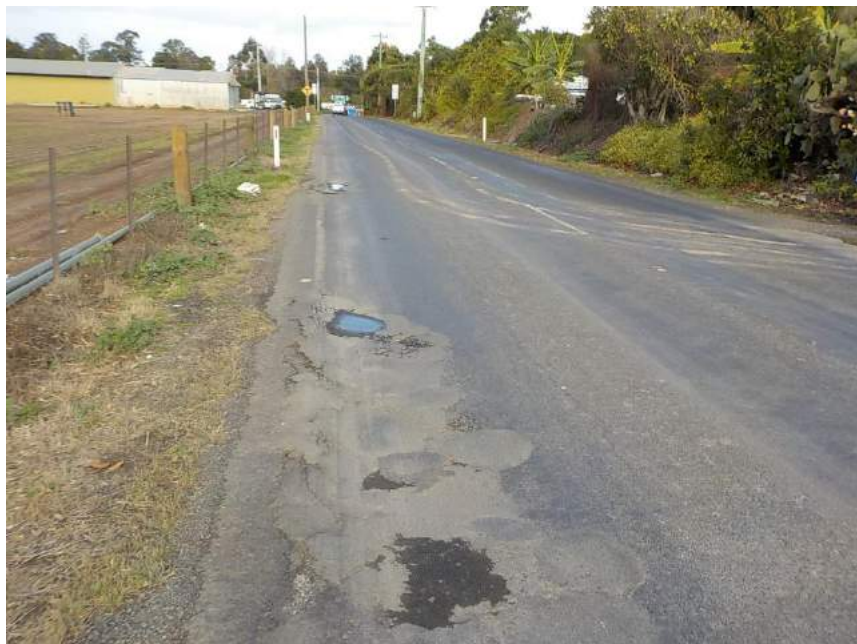
**2018:** General condition of asphalt surface.

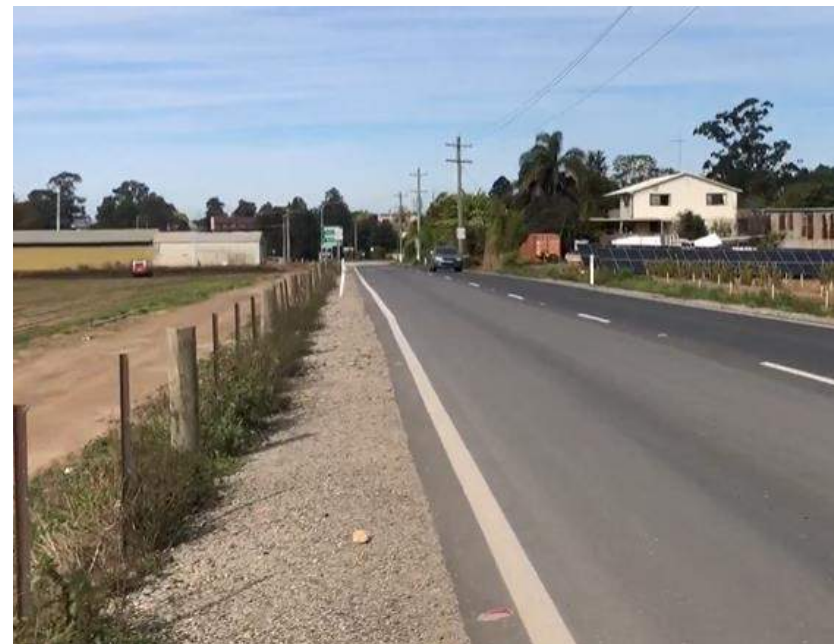
**2021:** General condition of pavement and shoulder – replaced asphalt road surfacing, gravel road edge and gutter on western road edge.

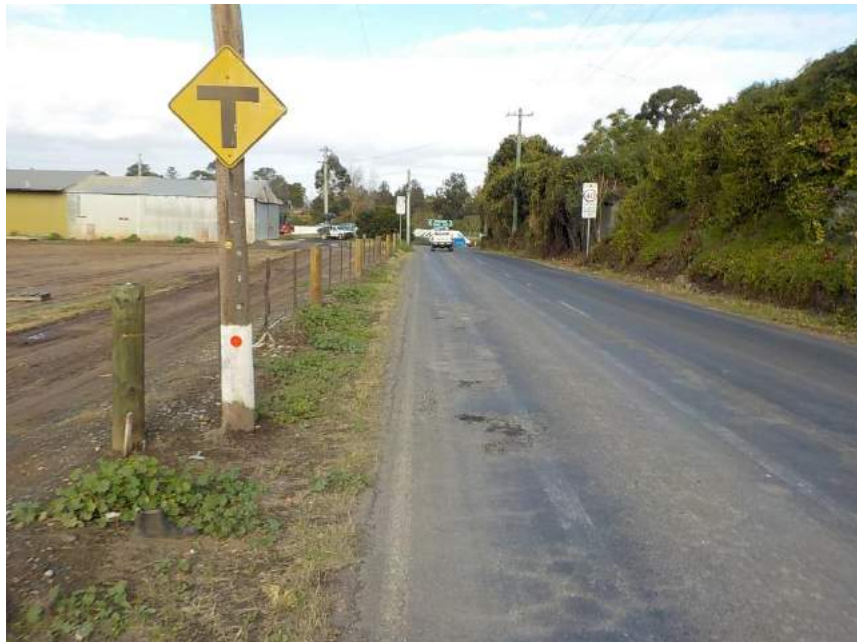
**2018:** General condition of pavement, shoulder and fence.

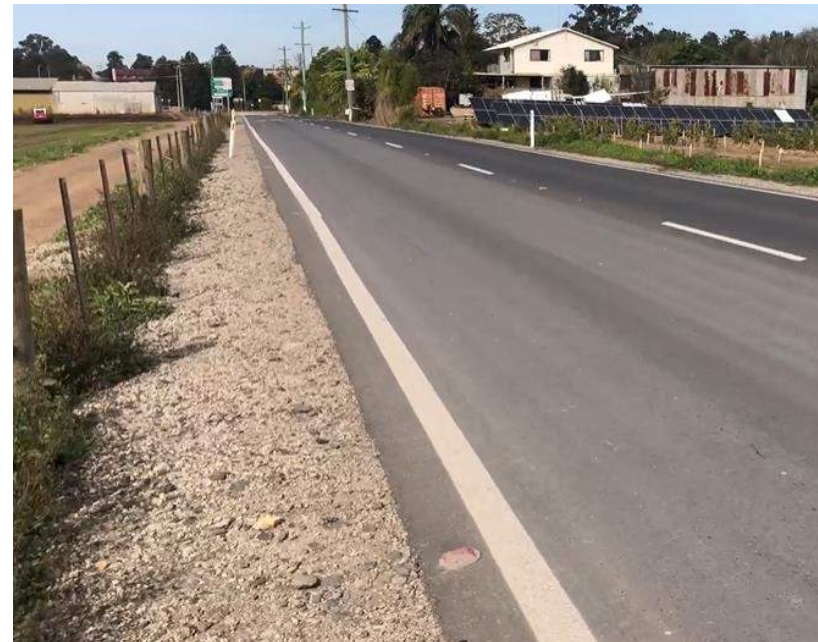
**2021:** General condition of pavement and shoulder improved since pre-construction survey with new asphalt surfacing. Condition of adjacent fence remains consistent with pre-construction survey.

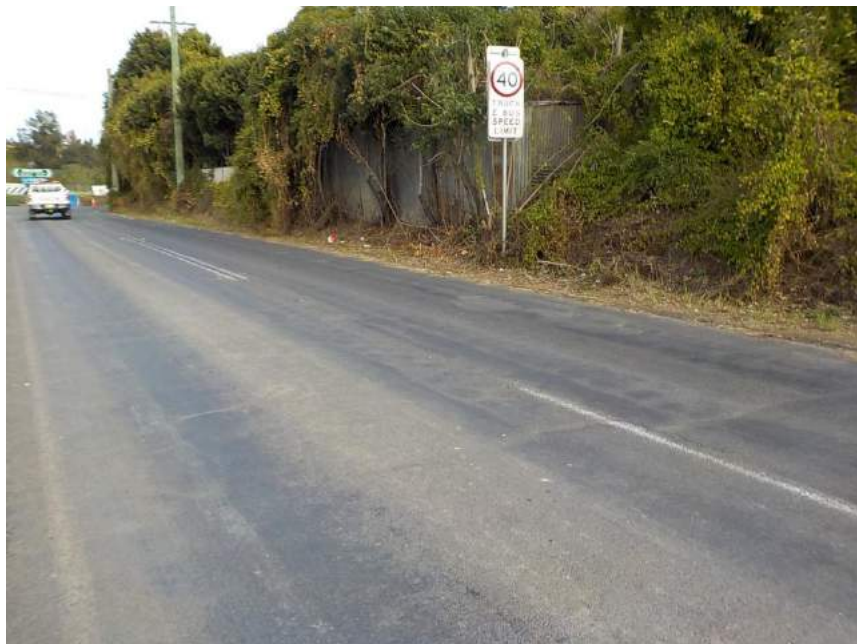
**2018:** General condition of pavement, shoulder and fence – cracking on surface and line marking weathered.

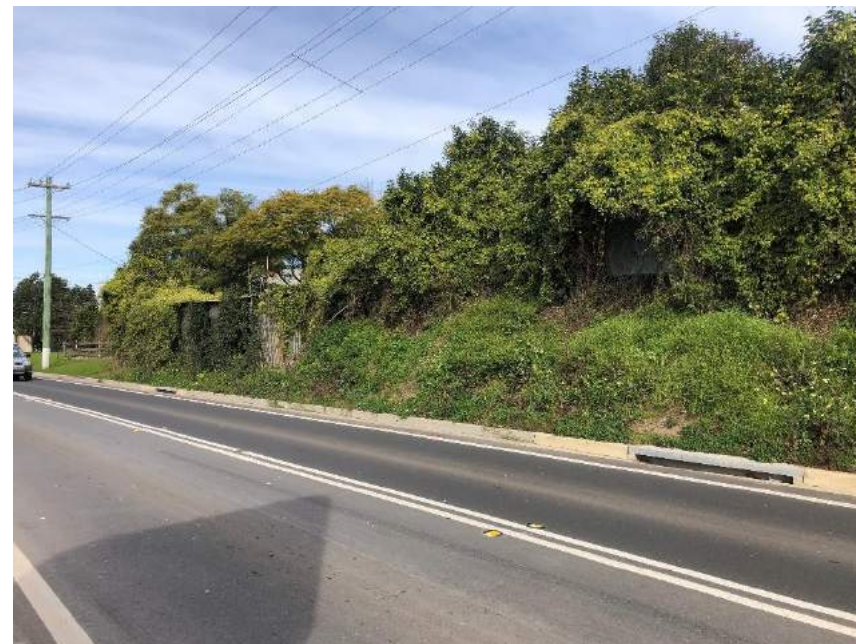
**2021:** General improved condition of pavement, shoulder and fence – installation of new asphalt, gutter and stormwater drains

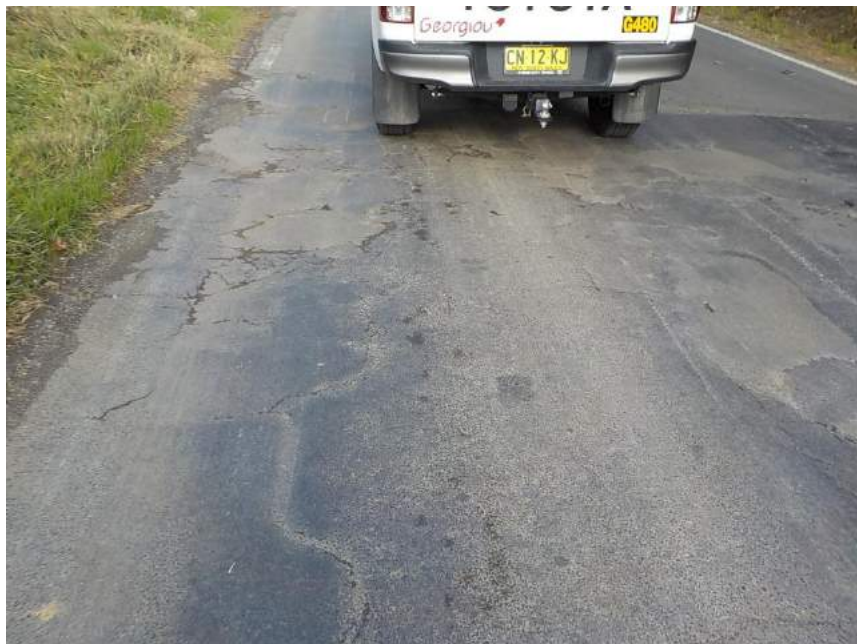
**2018:** General condition of pavement and shoulder.

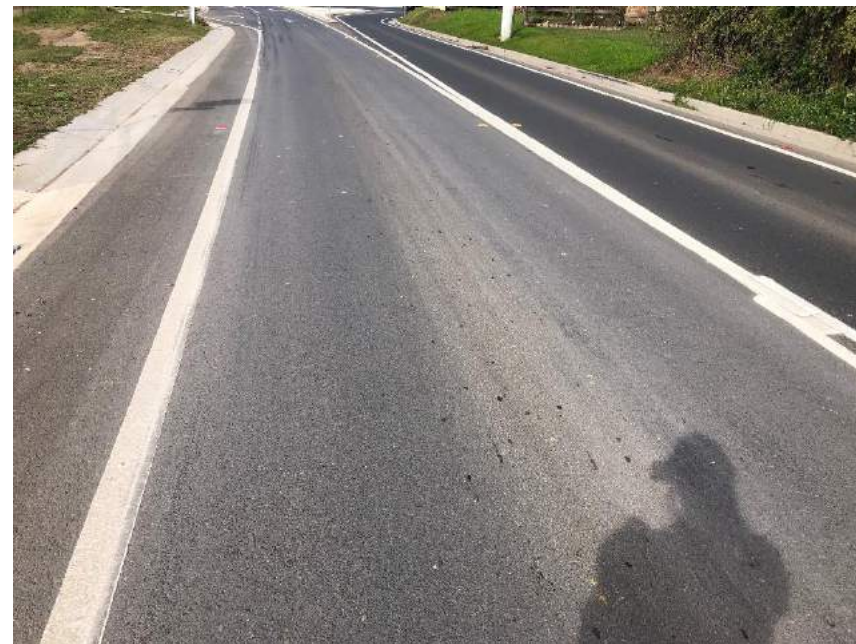
**2021:** General improved condition of pavement and shoulder – newly installed asphalt, gutter and drainage channels on road edge.

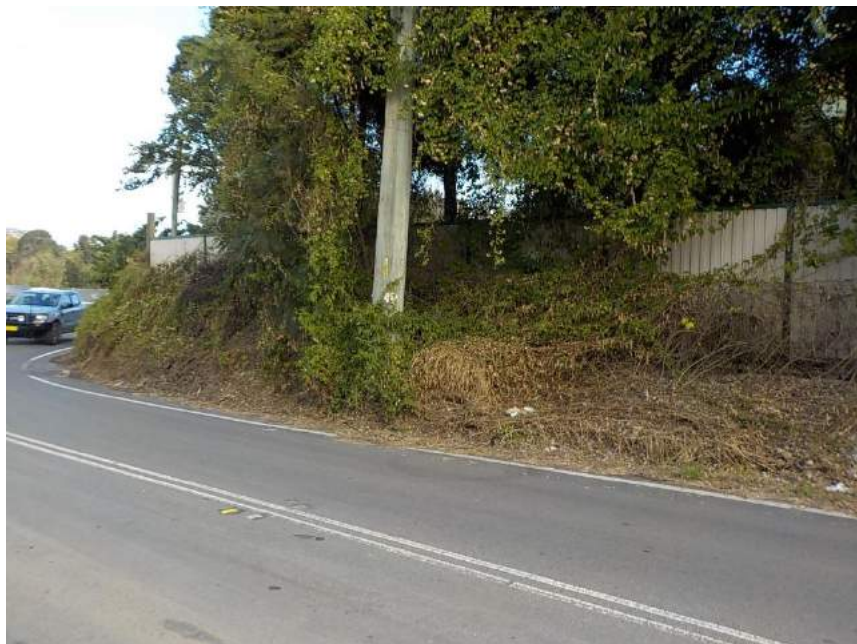
**2018:** General condition of pavement and fence at Freemans Reach Rd and Wilberforce Rd intersection.

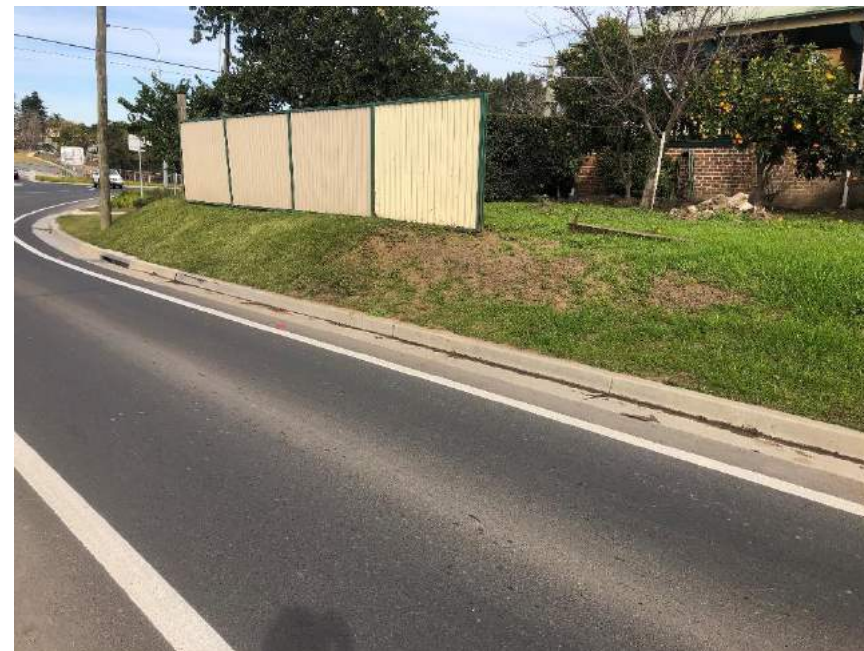
**2021:** General condition of pavement and fence at Freemans Reach Rd and Wilberforce Rd roundabout – removal of overgrown vegetation, new gutters and road kerb.

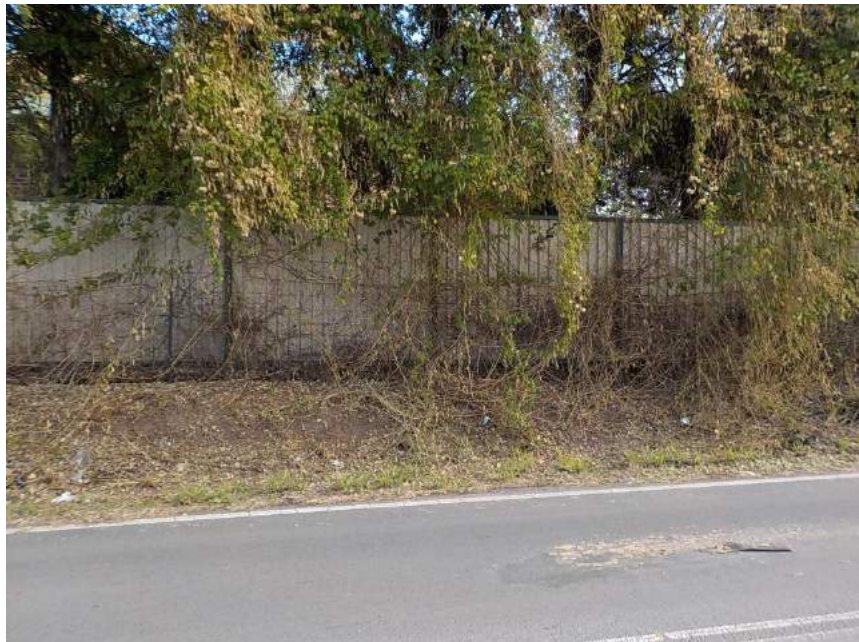
**2018:** General condition of pavement and fence at Freemans Reach Rd and Wilberforce Rd intersection – potholing present on asphalt surface.

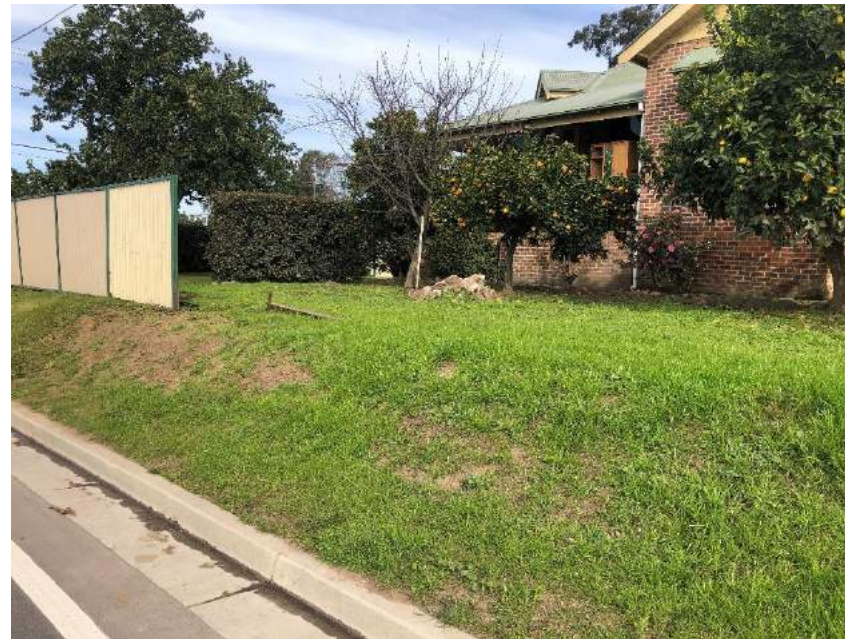
**2021:** General condition of gutter and fence at Freemans Reach Rd and Wilberforce Rd roundabout intersection – removal of fence panels and overgrown vegetation.

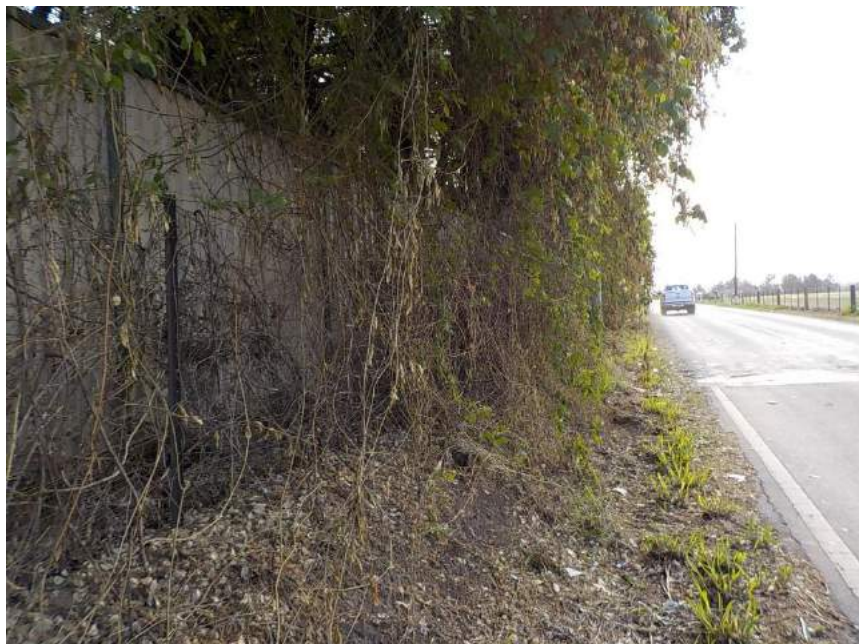
**2018:** General condition of fence at Freemans Reach Rd and Wilberforce Rd intersection.

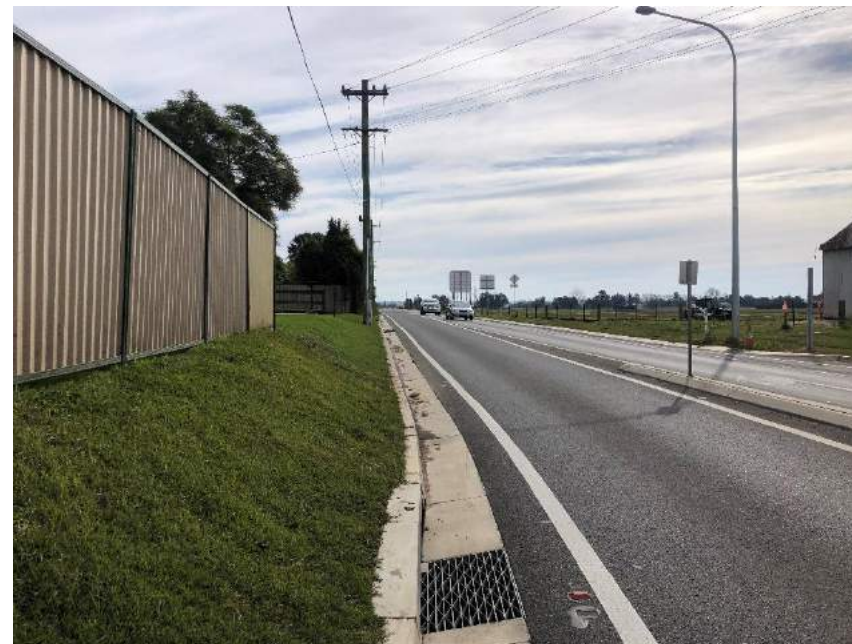
**2021:** General condition of fence at Freemans Reach Rd and Wilberforce Rd roundabout intersection – removal of overgrown vegetation, installation of new asphalt surfacing, gutter and stormwater drains.
