School Infrastructure NSW
Hazardous Building Materials Survey

Fort Street Public School
Observatory Hill, Upper Fort Street,
Millers Point, NSW

8 August 2019

56262/123,436 (Rev 1)

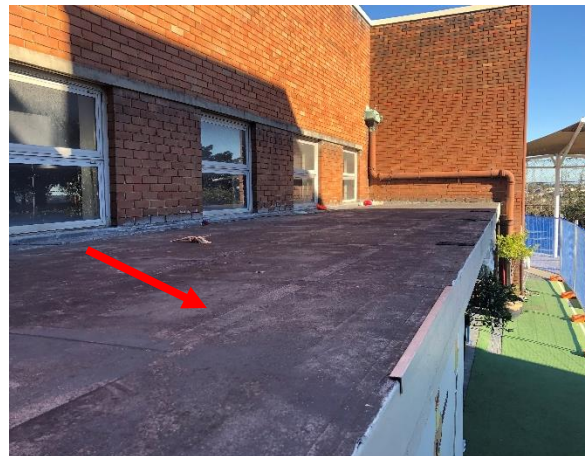
Photo 5: Building A, asbestos containing bituminous membrane to the external concrete roof of Rooms R0027 and R0028

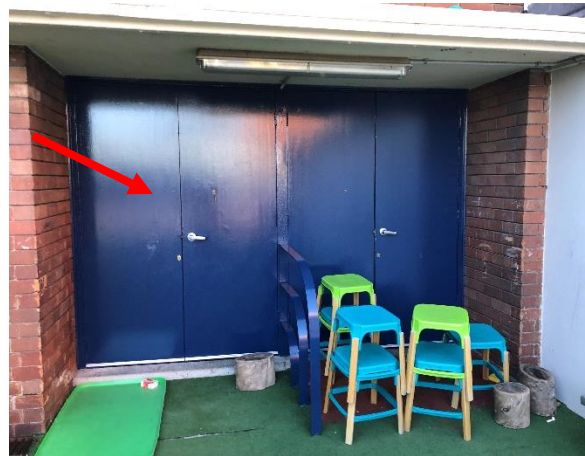
Photo 8: Building A, lead based blue paint to the internal and external faces of all external timber doors

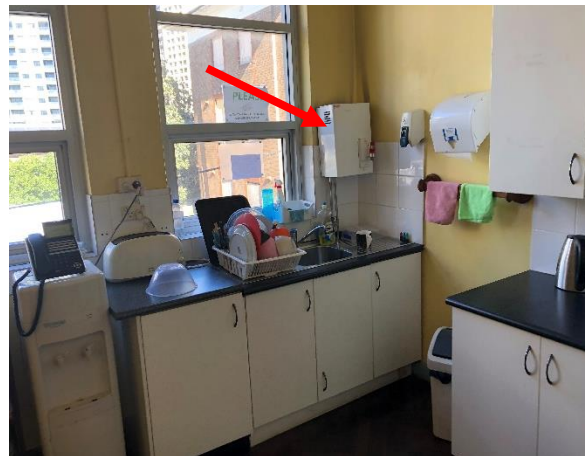
Photo 11: Building A, assumed SMF insulation core to instant hot water system in Room R1005

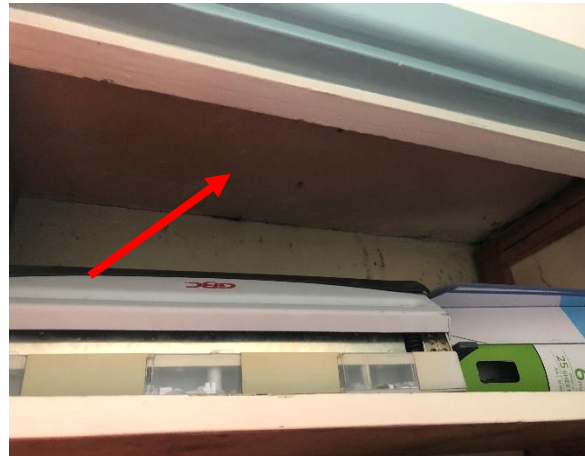
Photo 14: Building B (EEC), asbestos containing fibre cement sheeting to ceiling of the cupboard within Room R0006

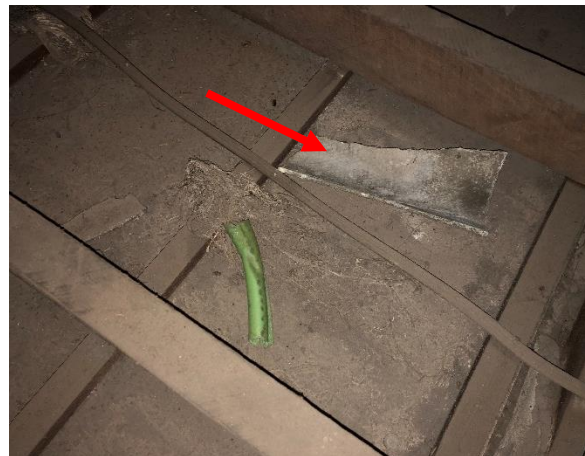
Photo 17: Building B (EEC), asbestos containing corrugated fibre cement debris within the eastern roof void

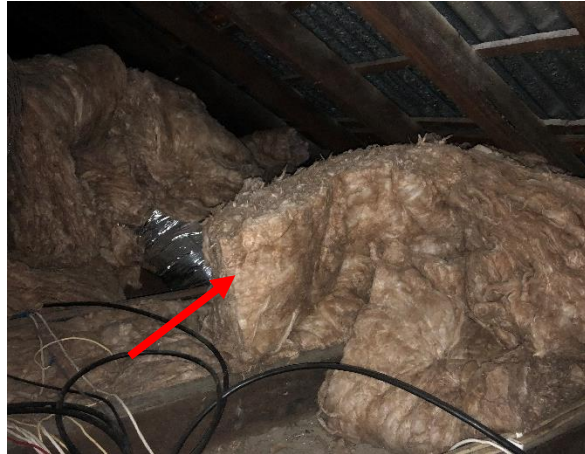
Photo 38: Cottage, assumed SMF insulation batts throughout the roof void

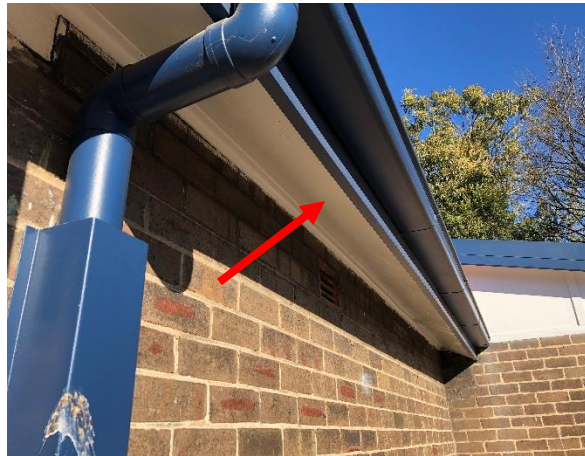
Photo 41: Garage, asbestos containing fibre cement sheeting to the eaves of the northern portion

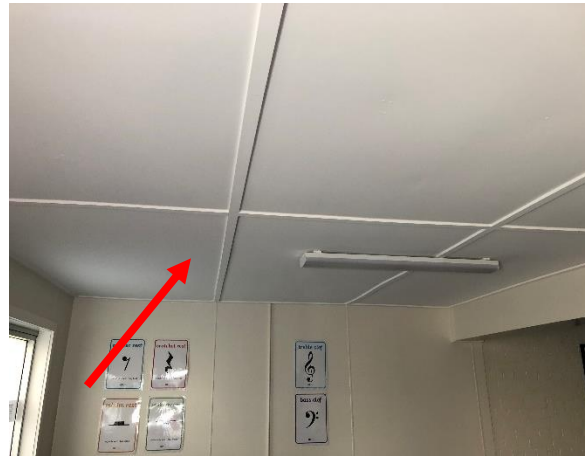
Photo 44: Garage, asbestos containing fibre cement sheeting to the ceiling of the southern portion

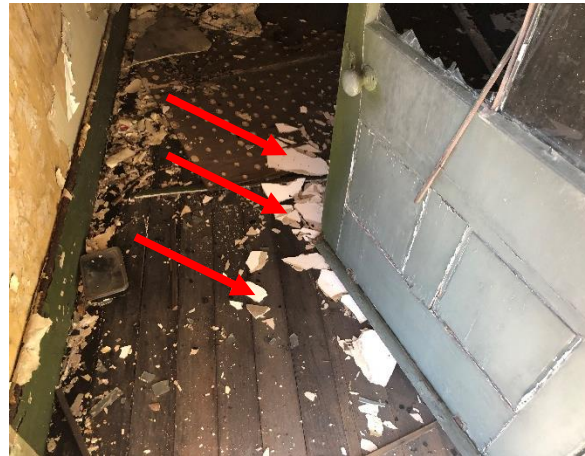
Photo 56: MET Building, assumed asbestos containing fibre cement debris to the ground surface on the first and second floors

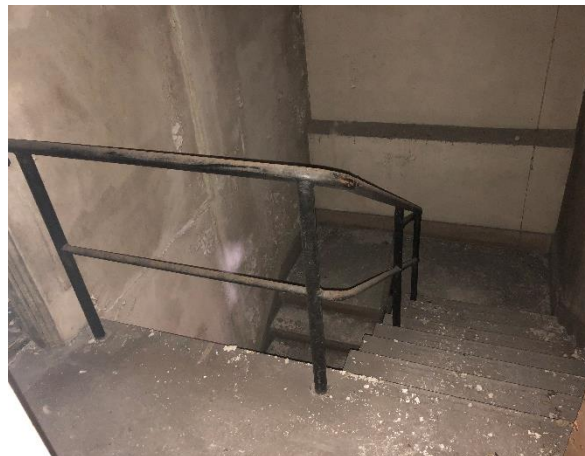
Photo 59: MET Building, lead containing dust to the northern stair landing on the first floor
