Asbestos & Synthetic Mineral Fibre Survey & Register Gosford Hospital, Holden Street, Gosford

22 June 2005

Central Coast Health Service

HLA-Envirosciences Pty Limited

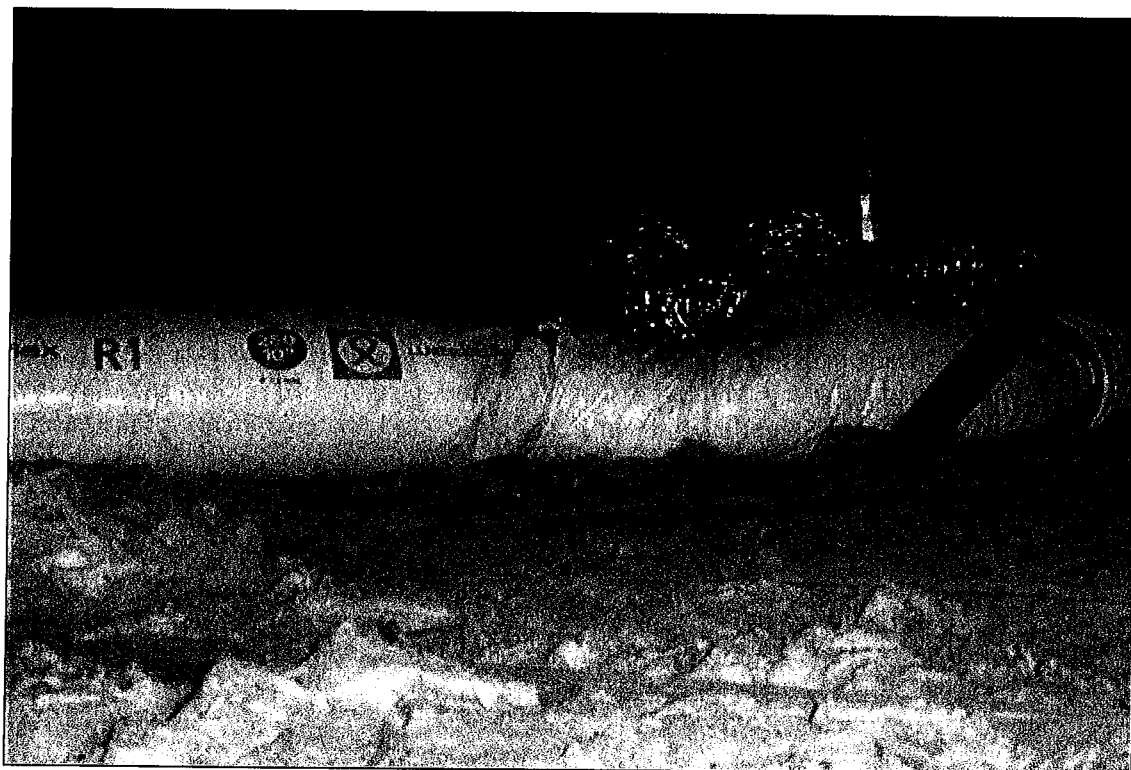
Photograph No. 14: SMF in Plastic Insulation to Flexible A/C Ducts

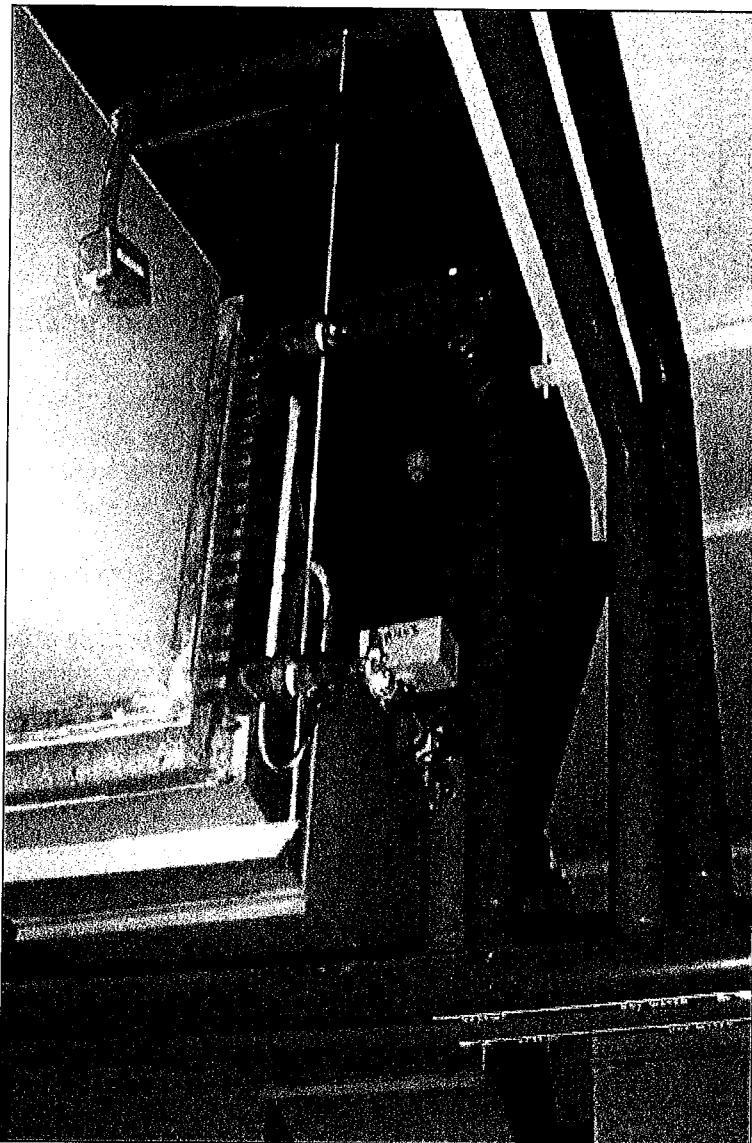
Photograph No. 23: SMF In Metal Insulation to Hot Water Flow and Return Pipes

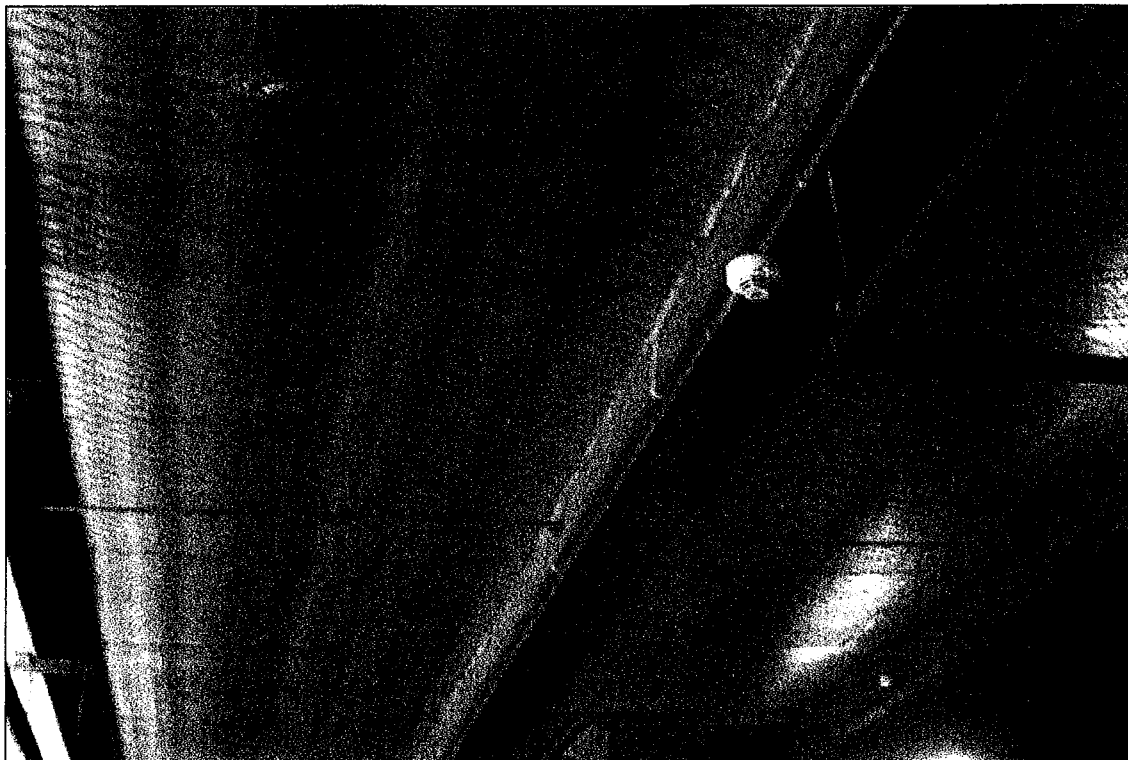
Photograph No. 39: SMF on Foil/Wire Insulation to Lift Motor Room Roof

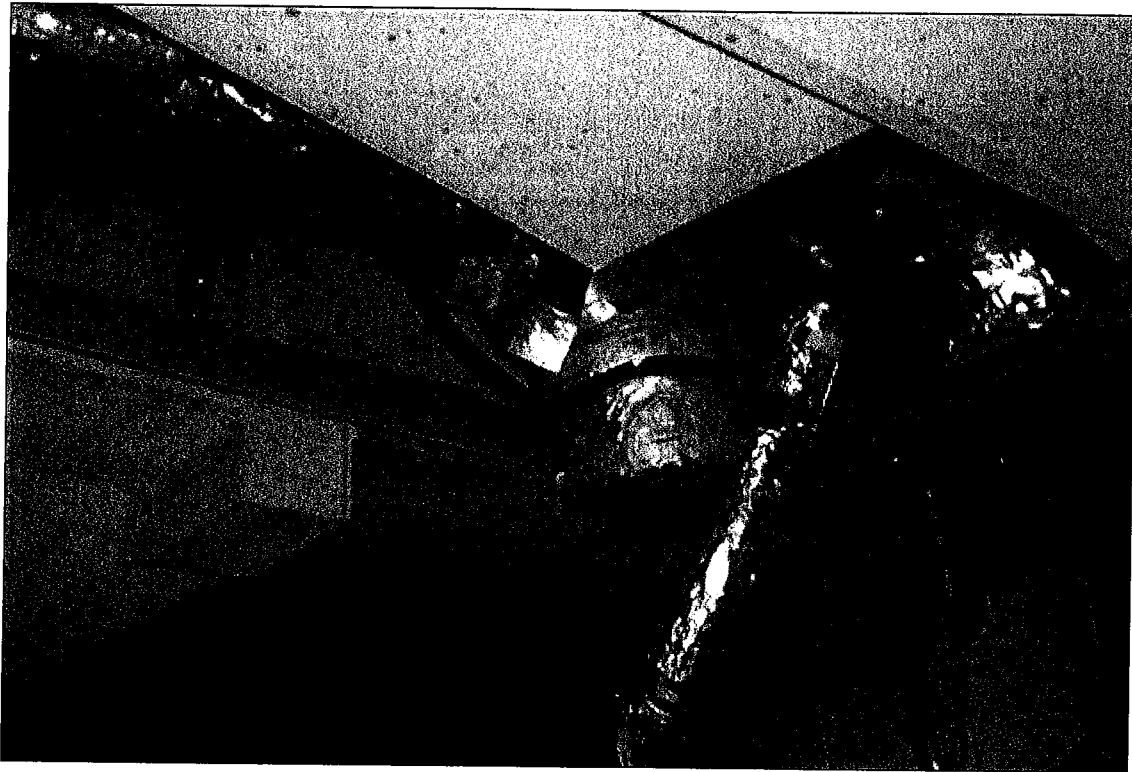
Photograph No. 52: Old Hot Water Steam Pipes in Tunnel Ceiling Space Insulated with SMF in Foil

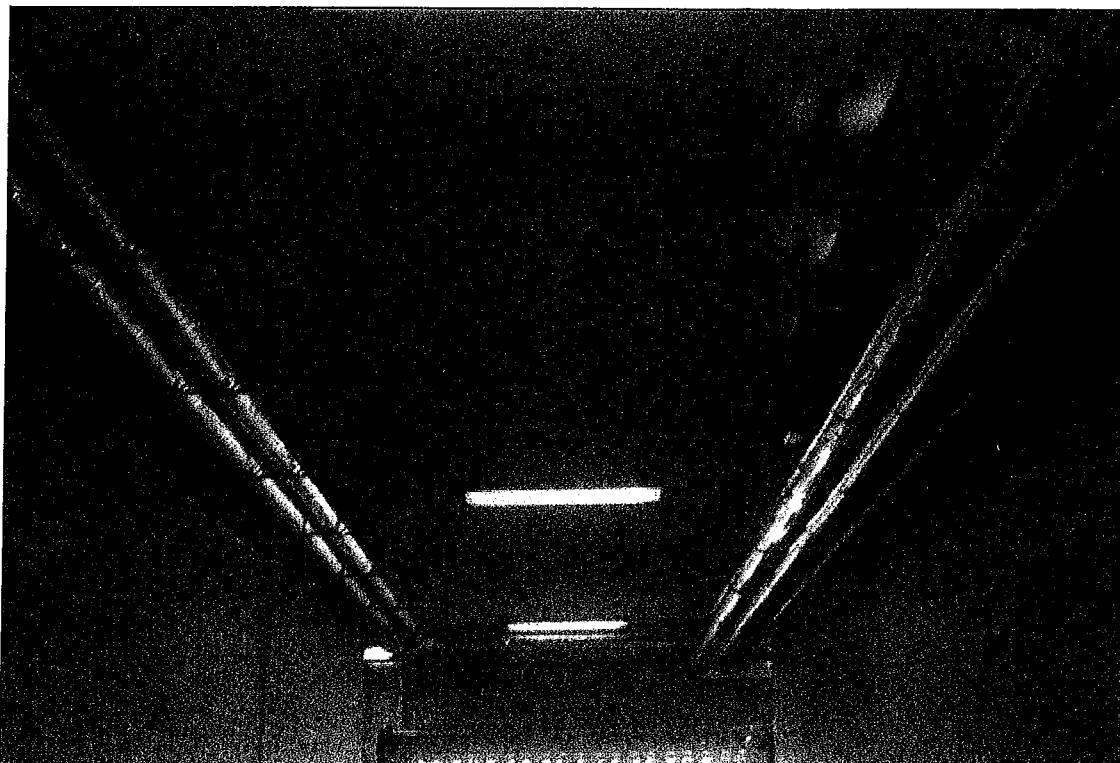
Photograph No. 56: Corridors - Hot Water Pipes Insulated with SMF in Foil

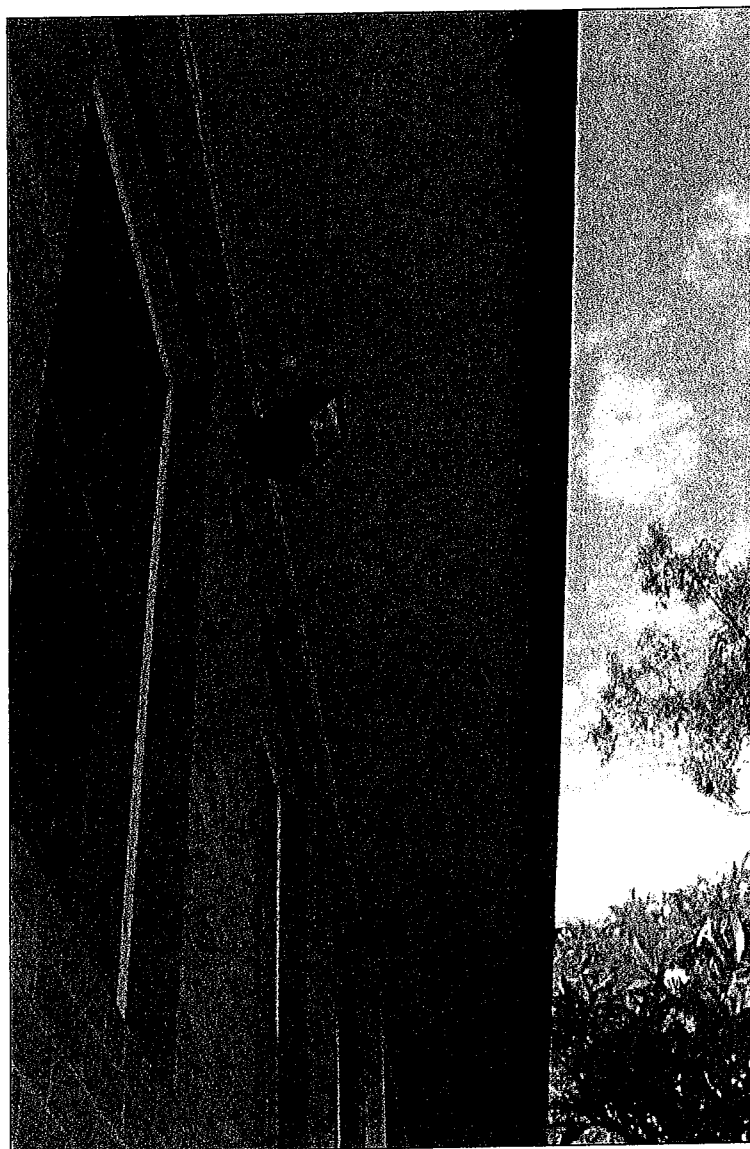
Photograph No. 62: Suspected Asbestos Cement Eave Lining to Building

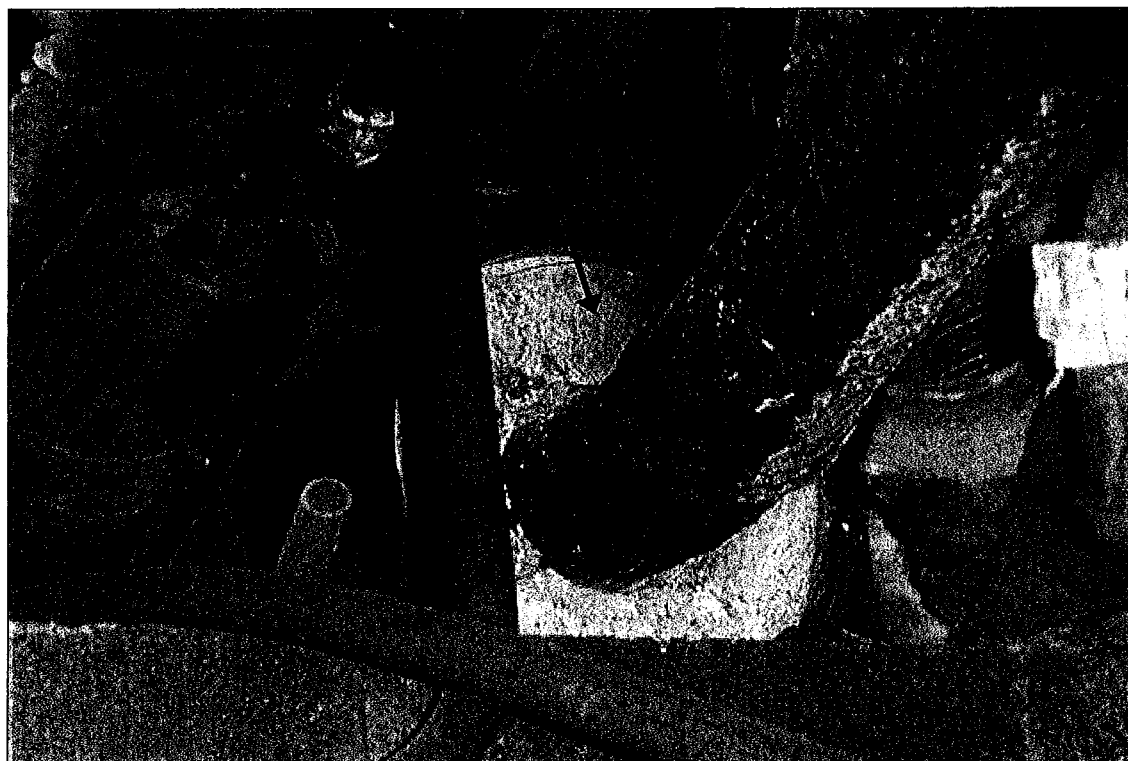
Photograph No. 76: Old Asbestos Insulated Pipe in Plant Room 8

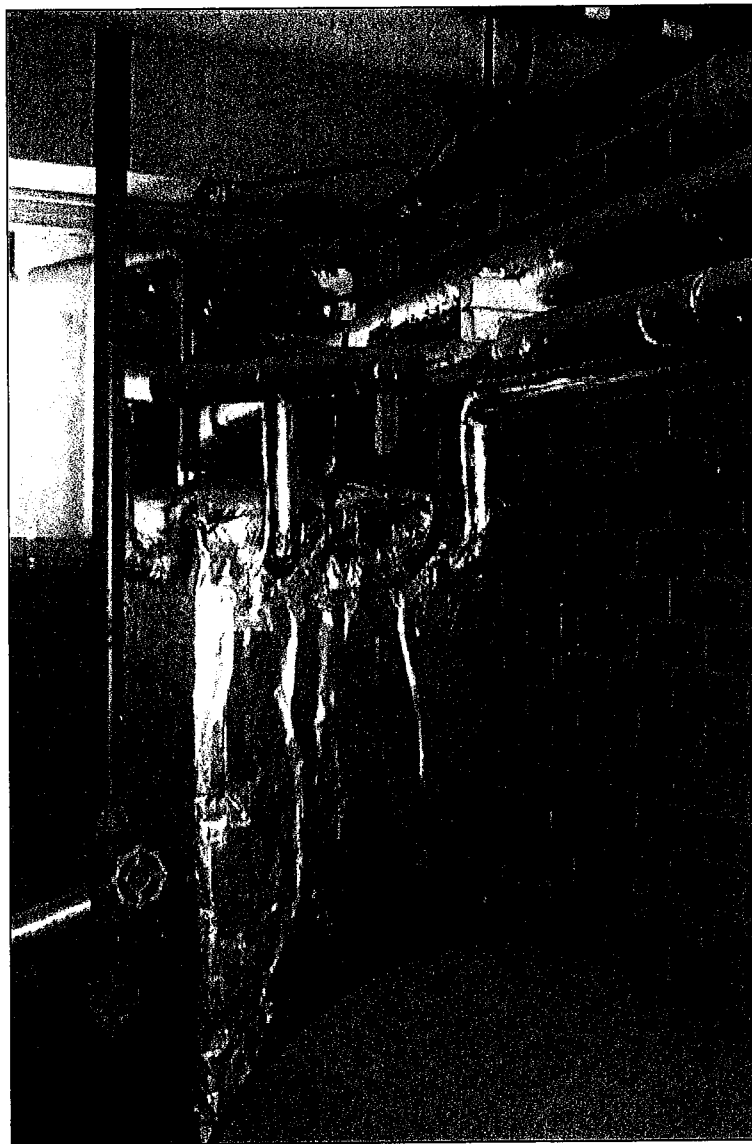
Photograph No. 81: SMF / Foil Insulation to Calorifier - Plant Room 7

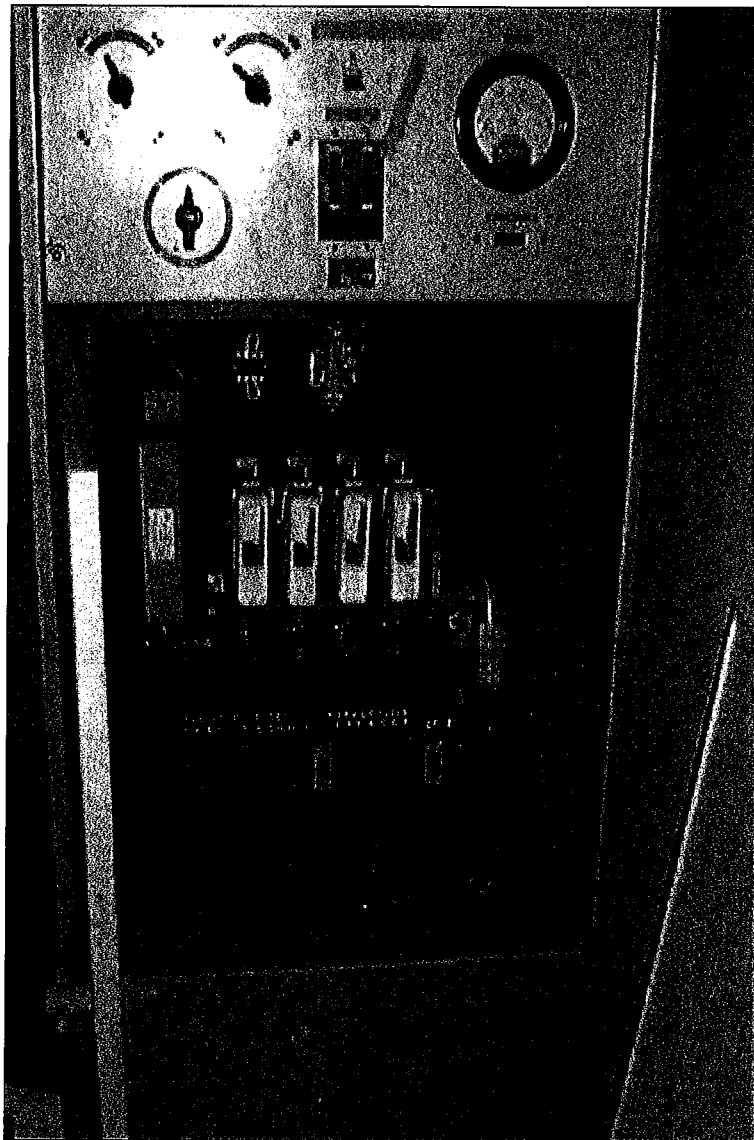
Photograph No. 83: Suspected Zelnite Board to Old Switchboard in Basement Below Children's Ward

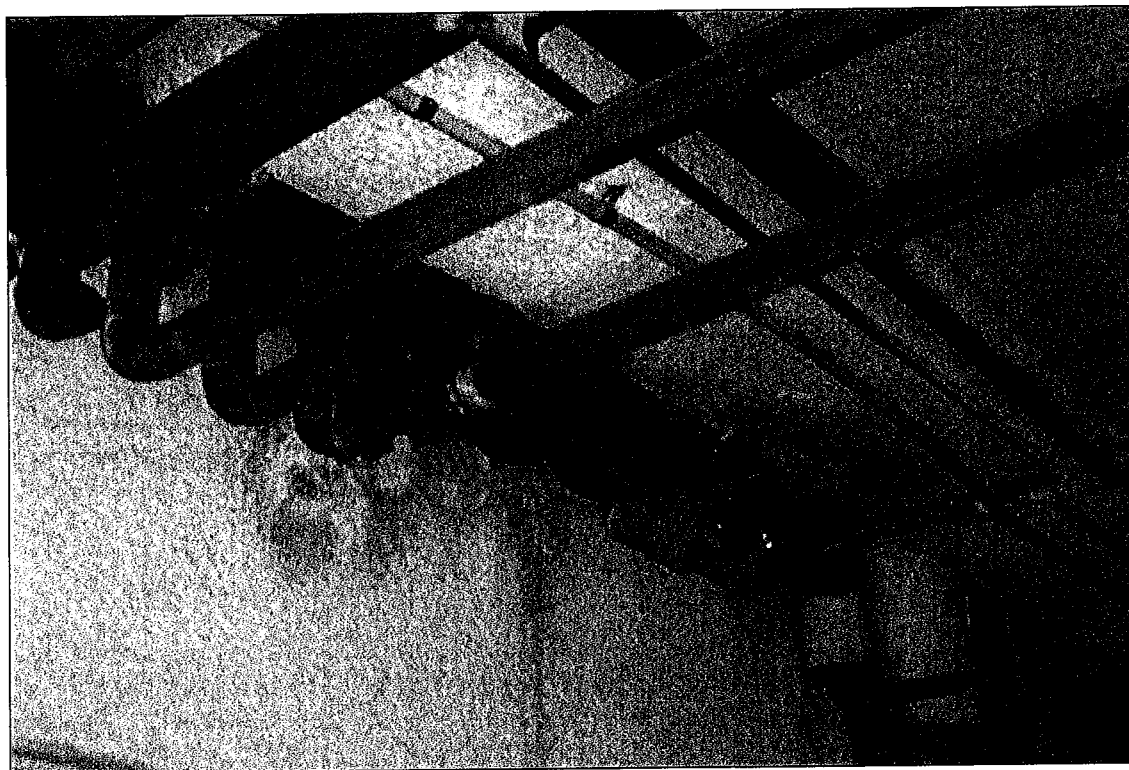
Photograph No. 88: SMF Insulated Pipe in Riser - Plant Room 6

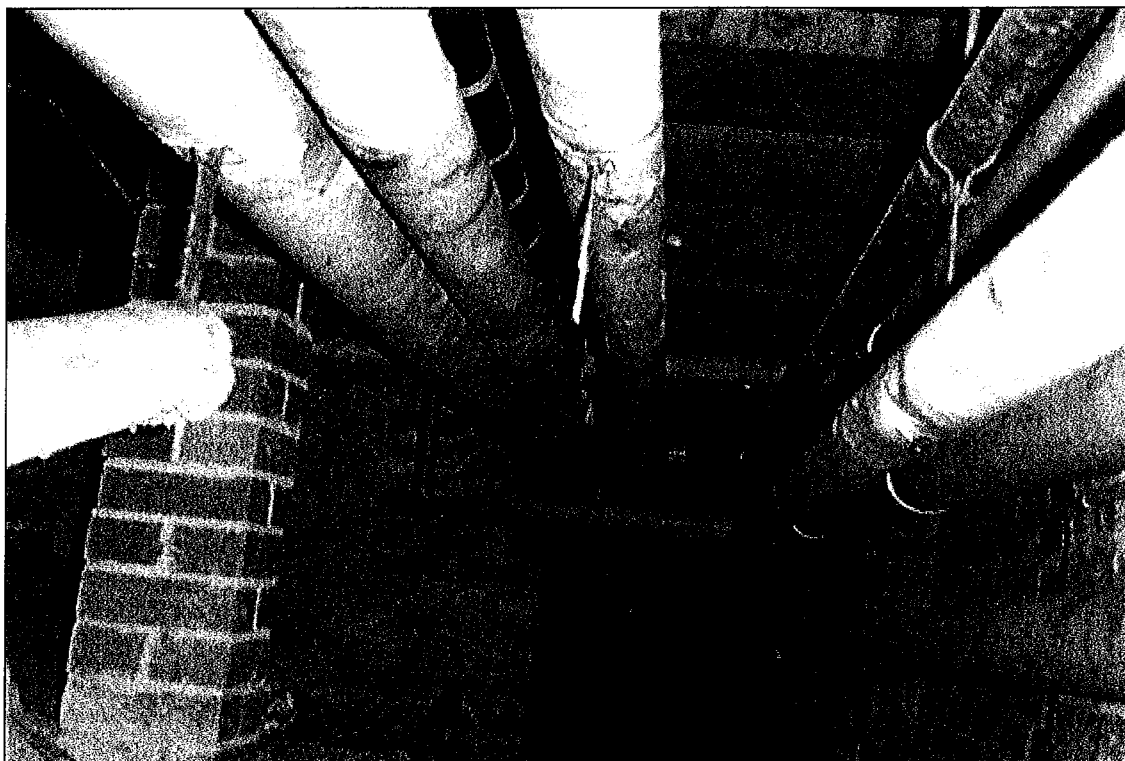
Photograph No. 113: SMF Insulated Pipes in Sub-Floor Area

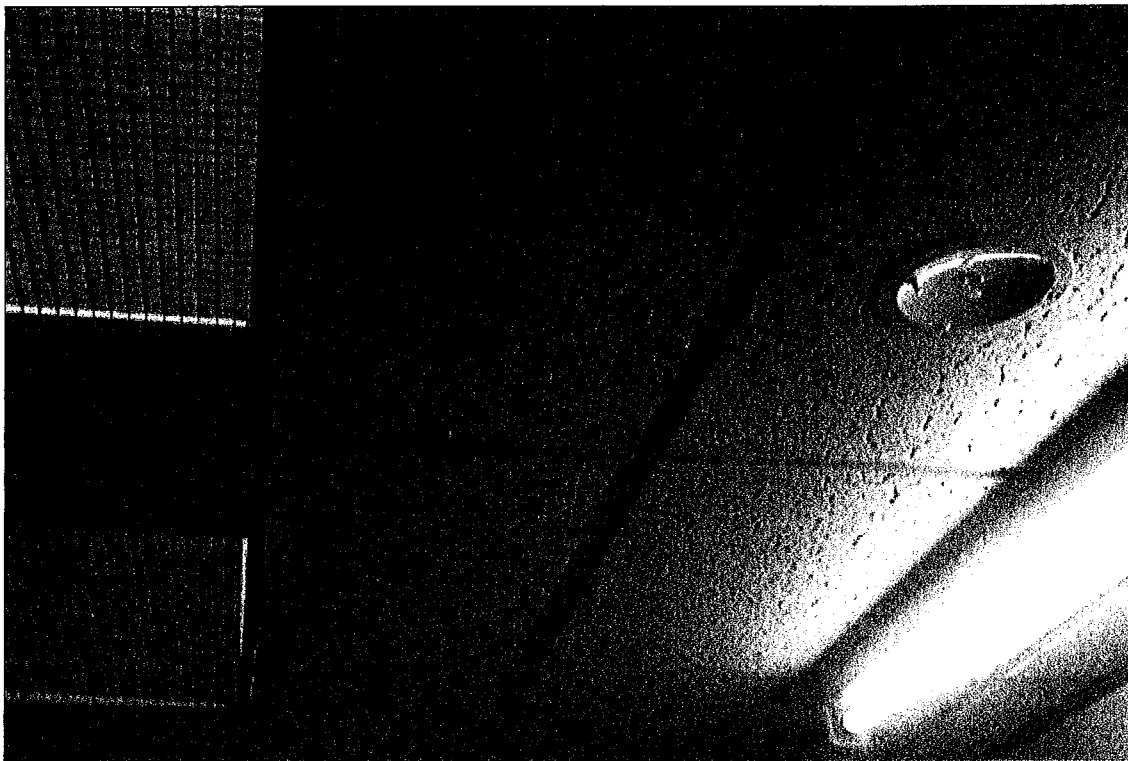
Photograph No. 118: Organic and Synthetic Mineral Fibre Tiles to Office Ceilings - Level 3

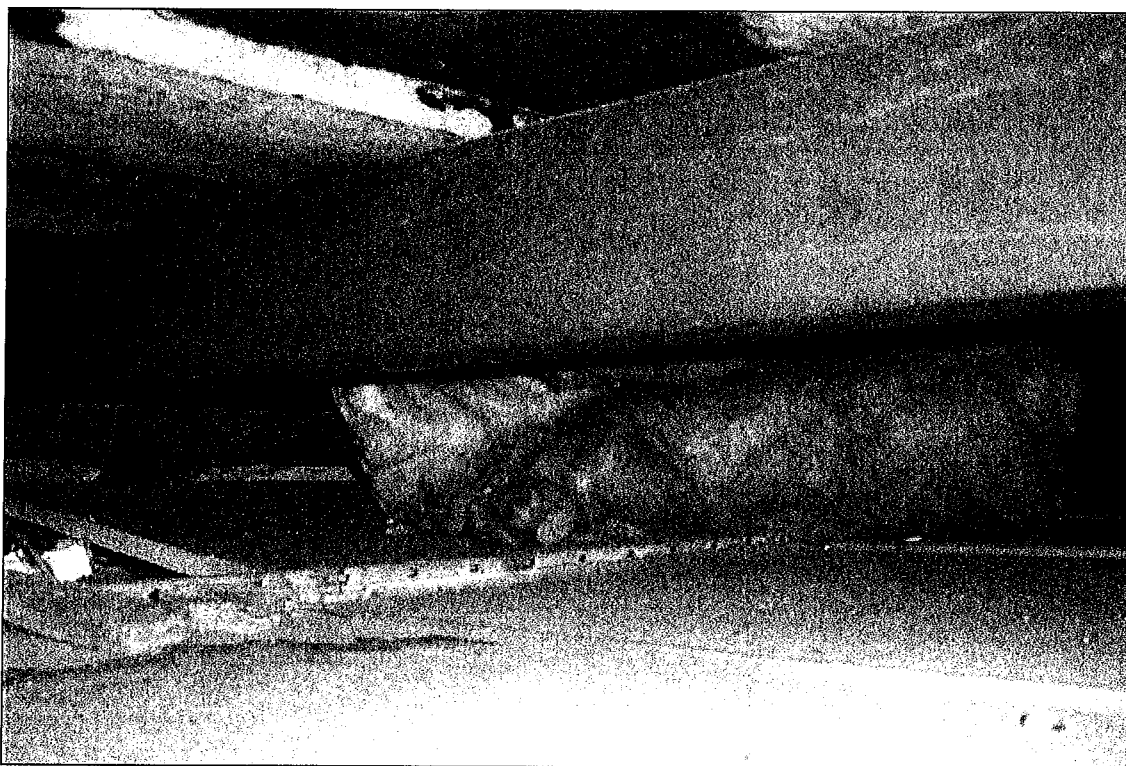
Photograph No. 123: SMF Batts in Ceiling Space
