**1-15 AND 2-12 CONFERTA AVENUE,
ROUSE HILL NSW 2155
TALLAWONG STATION PRECINCT SOUTH
PRE-DILAPIDATION REPORT**

**DEICORP PROJECTS
(TALLAWONG STATION) PTY LTD**

Job No. 191294.0
24/03/2020

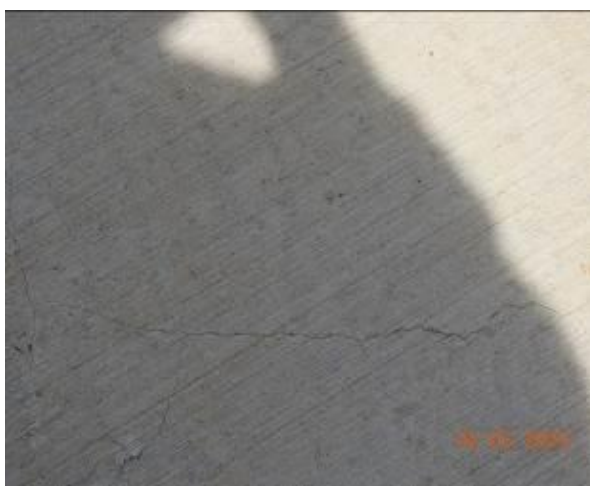
Figure 3 – Crack propagation through footpath pavement

At the same time the kerb, gutter and footpath which accompany the road way were also inspected. At the time of this inspection they were found to be in a good condition. There was evidence of material loss, cracking through the kerb, gutter and footpath, as well as cases of patchwork through the kerb and gutter.

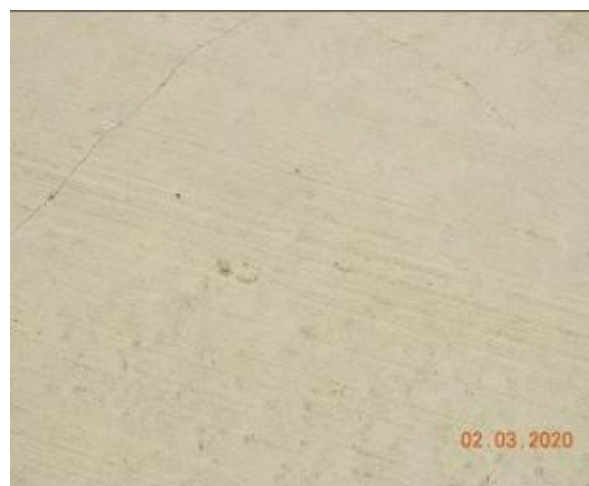
Figure 4 – Crack propagation through footpath pavement

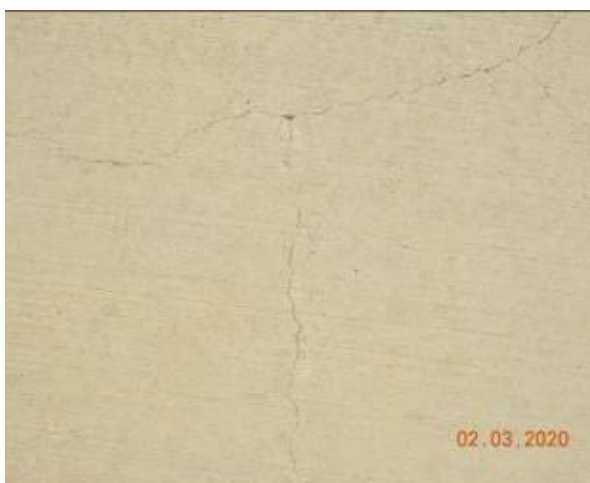
Figure 5 – Crack propagation through footpath pavement

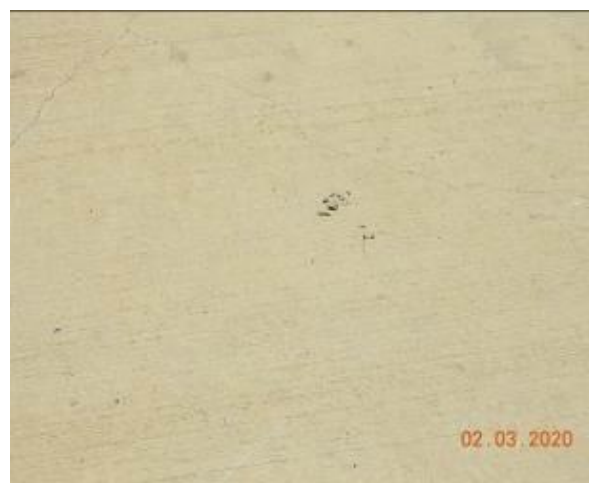
Figure 6 – Crack propagation through footpath pavement

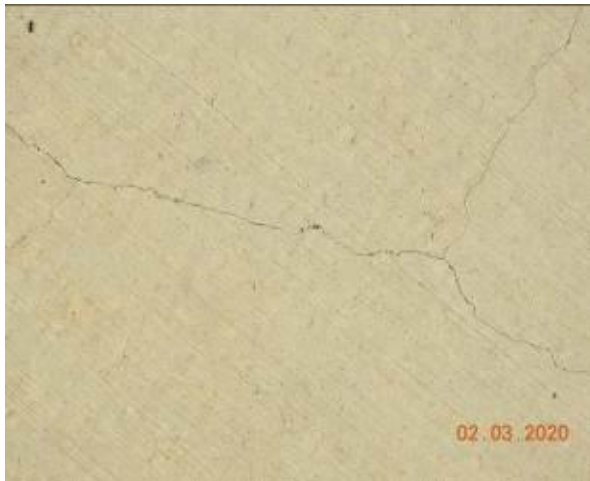
Figure 7 – Crack propagation through footpath pavement

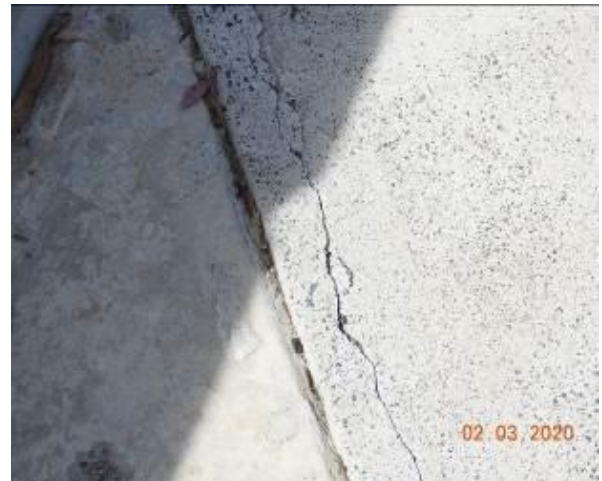
Figure 8 – Crack propagation and loss of material through footpath pavement

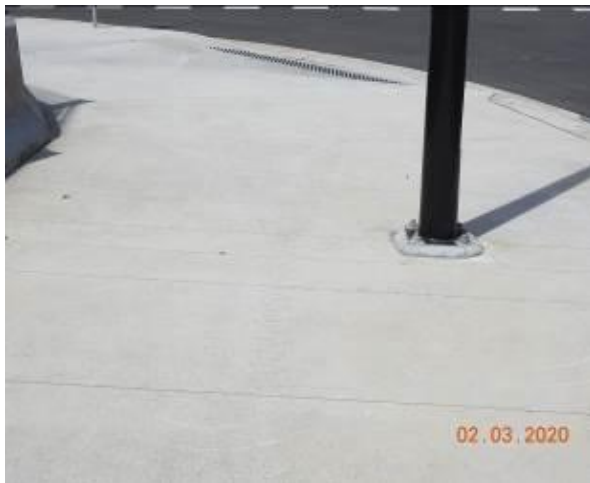
Figure 9 – General Condition of footpath pavement

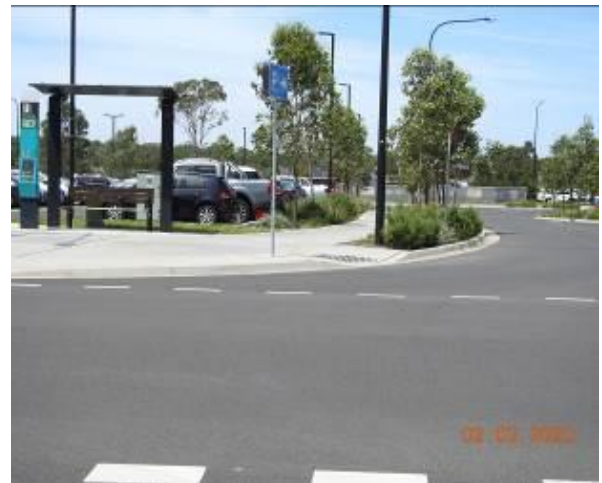
Figure 10 – General Condition of footpath pavement

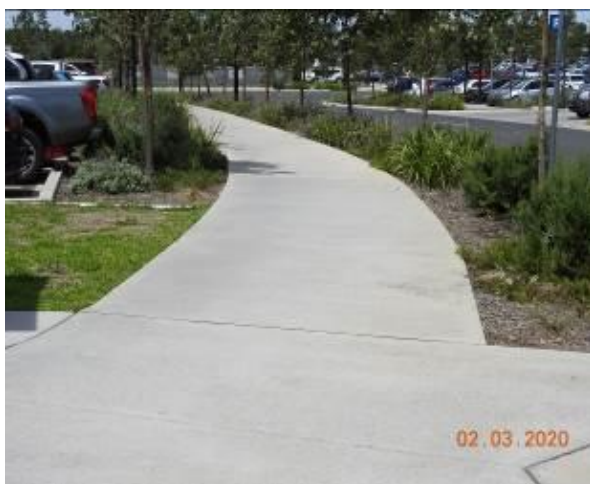
Figure 11 – General Condition of footpath pavement

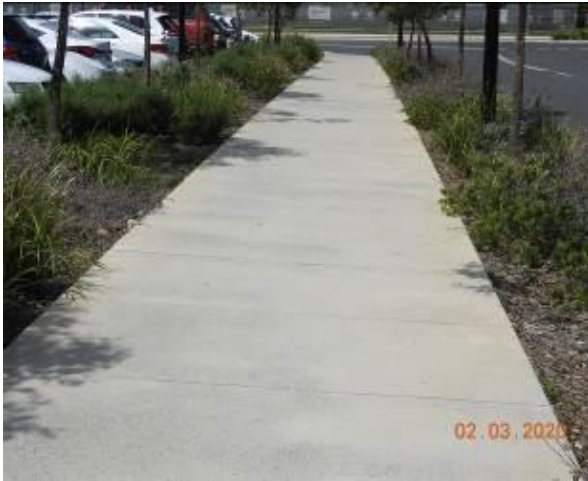
Figure 13 – General Condition of footpath pavement

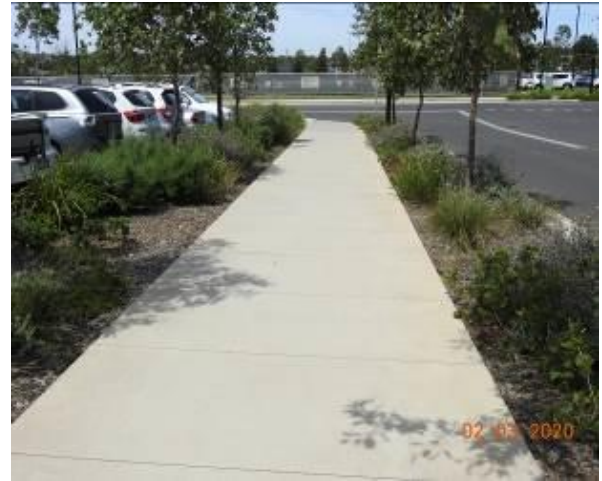
Figure 14 – General Condition of footpath pavement

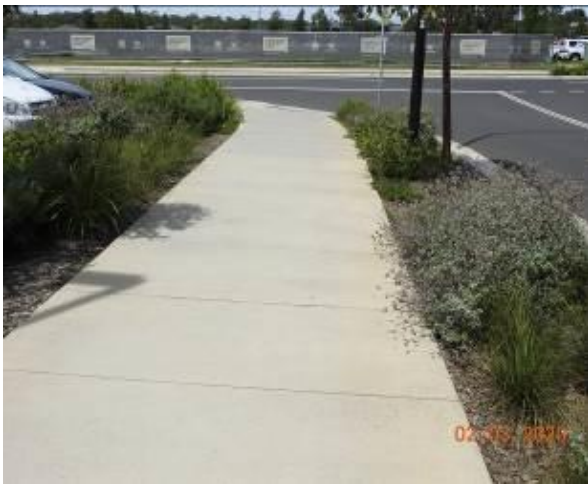
Figure 15 – General Condition of footpath pavement

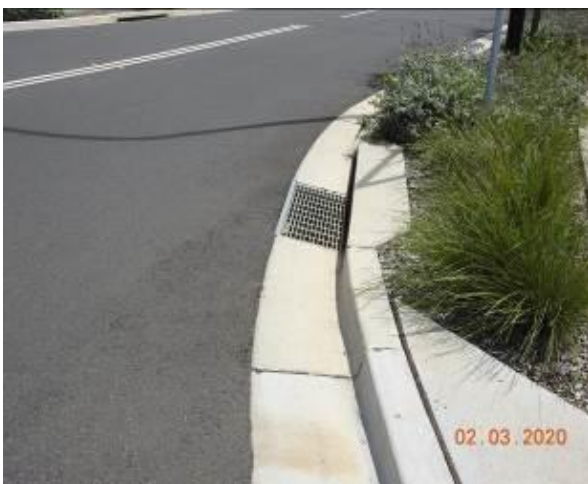
Figure 17 – General Condition of kerb and gutter

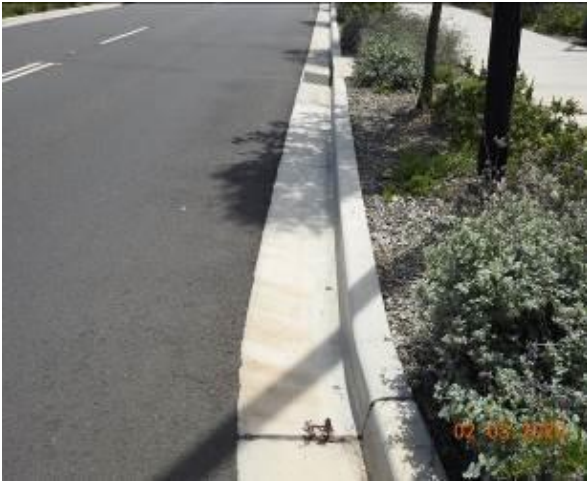
Figure 19 – General Condition of kerb and gutter

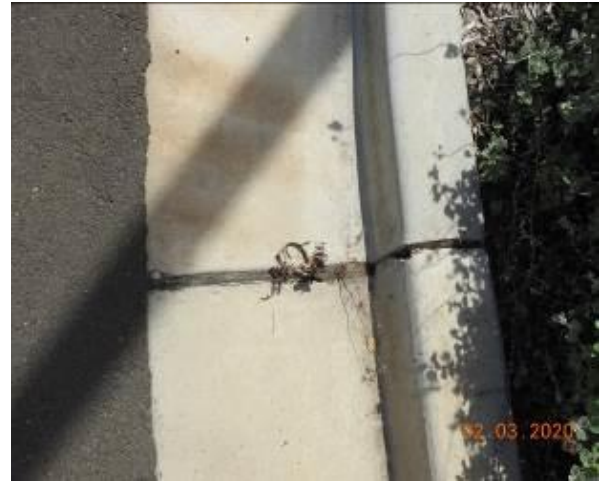
Figure 20 – Loss of material through kerb and gutter

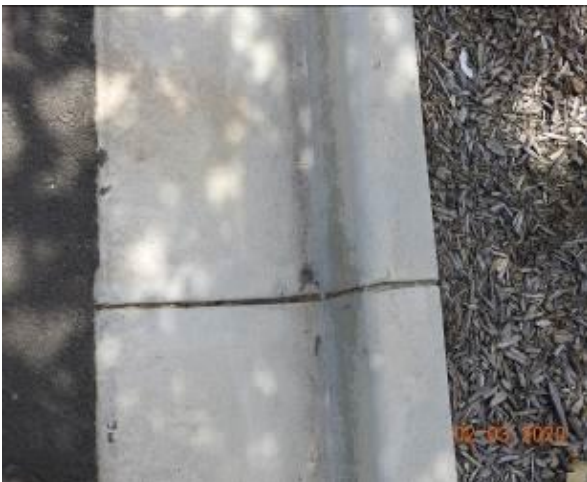
Figure 21 – Crack propagation through kerb and gutter

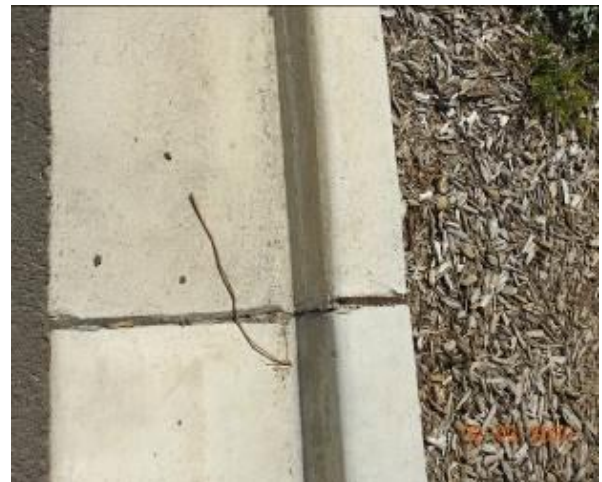
Figure 22 – Crack propagation through kerb and gutter

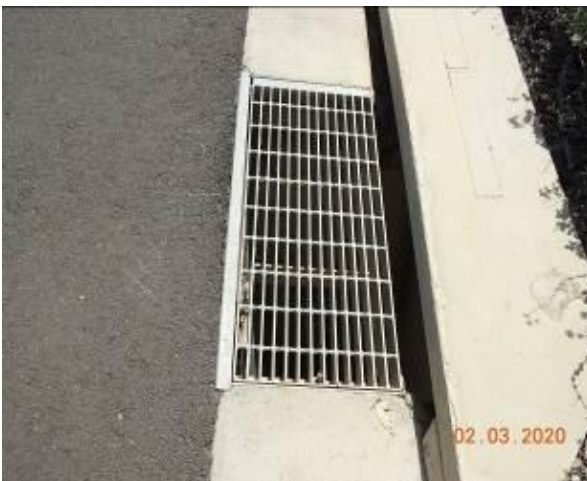
Figure 23 – General Condition of stormwater inlet pit

The condition of the lamp posts, plantation, stormwater inlet pits and street signs was also inspected and were determined to be in a reasonable condition.

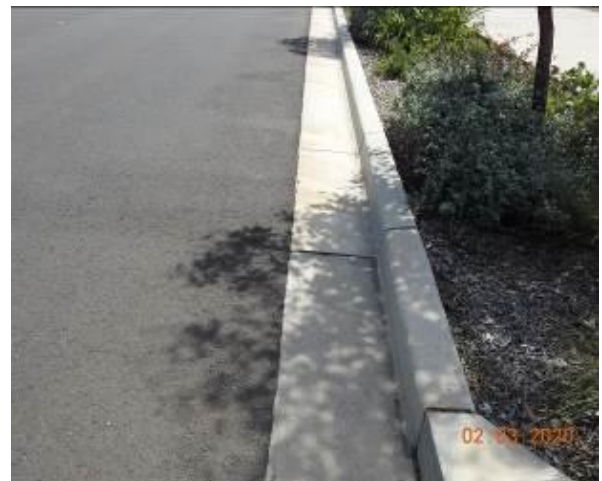
Figure 24 – General Condition of kerb and gutter

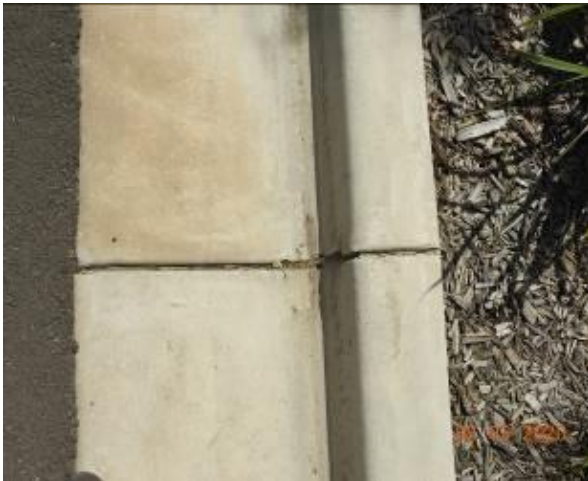
Figure 27 – Crack propagation through kerb and gutter

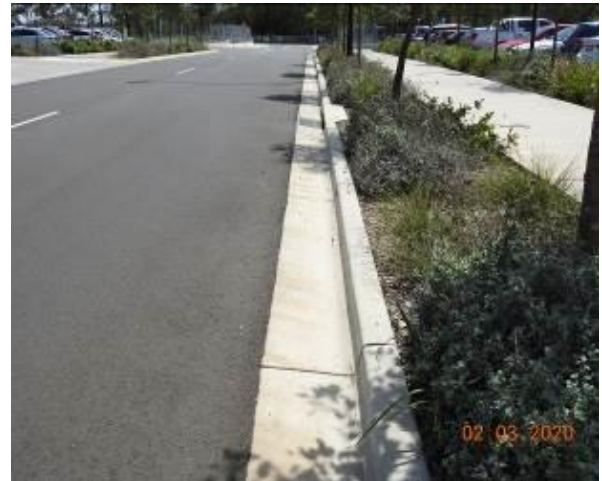
Figure 28 – General Condition of kerb and gutter

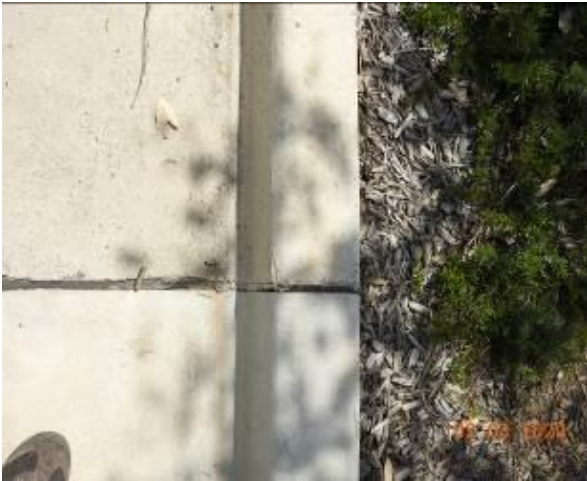
Figure 31 – Crack propagation through kerb and gutter

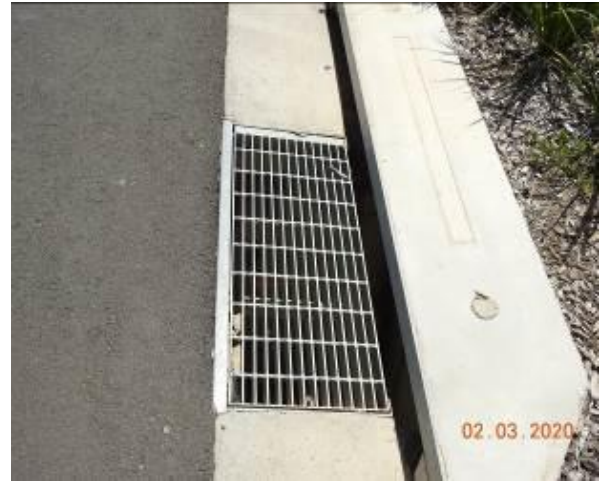
Figure 32 – General Condition of stormwater inlet pit

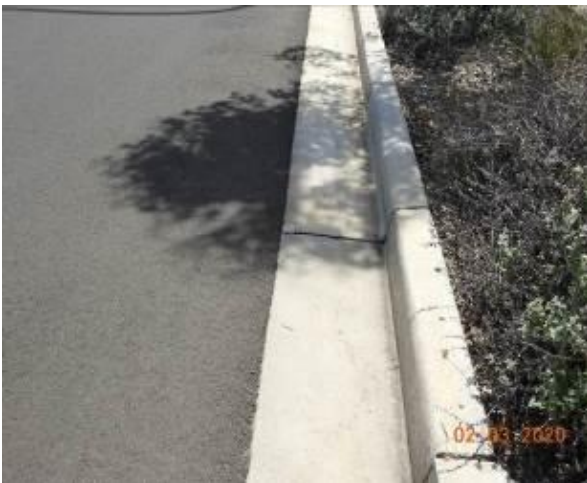
Figure 33 – General Condition of kerb and gutter

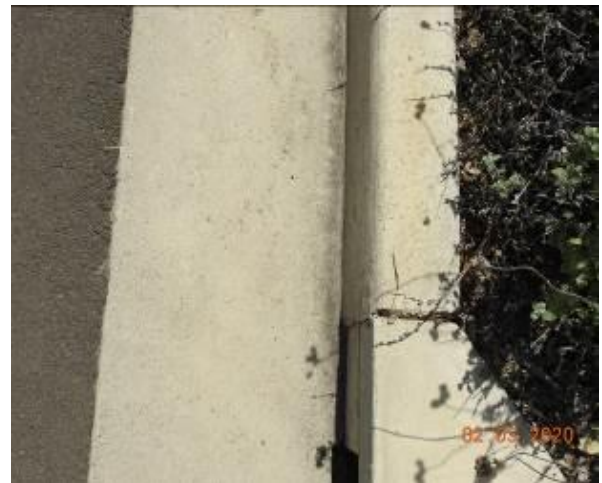
Figure 34 – Crack propagation through kerb and gutter

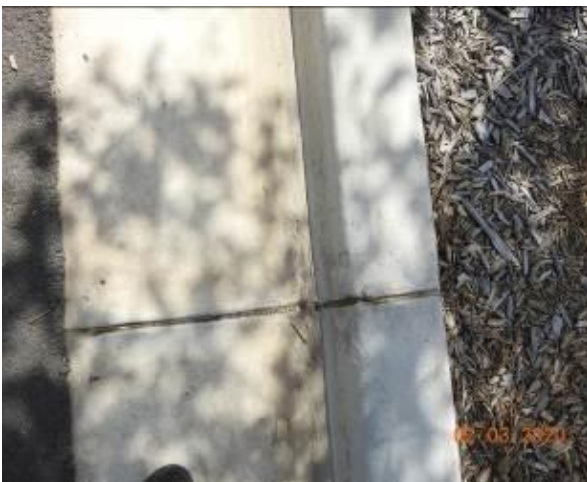
Figure 35 – Crack propagation through kerb and gutter

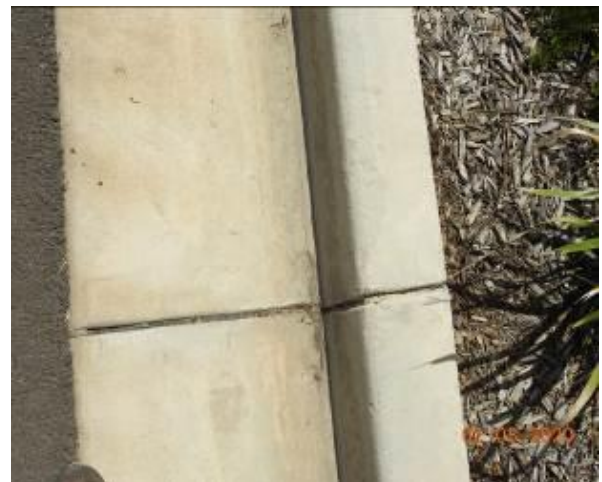
Figure 36 – Crack propagation through kerb and gutter

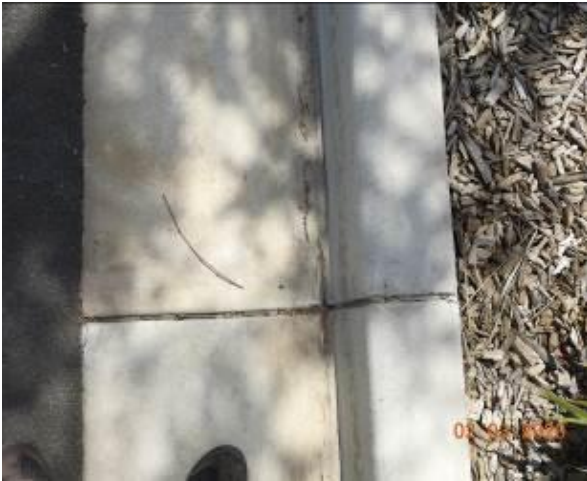
Figure 37 – Crack propagation through kerb and gutter

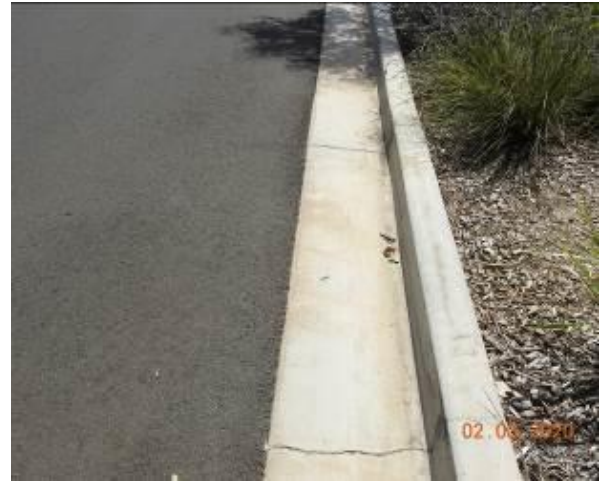
Figure 38 – General Condition of kerb and gutter

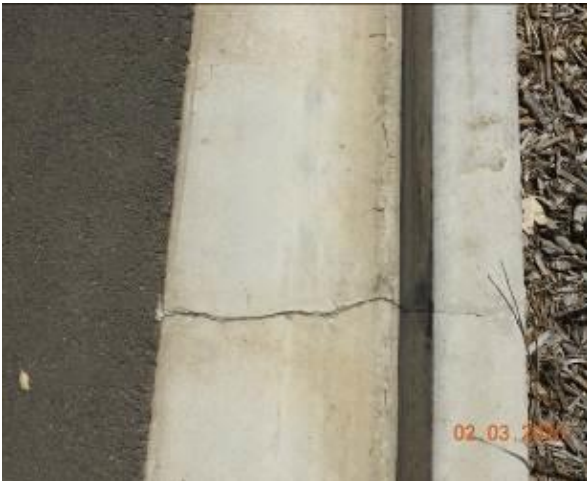
Figure 39 – Crack propagation through kerb and gutter

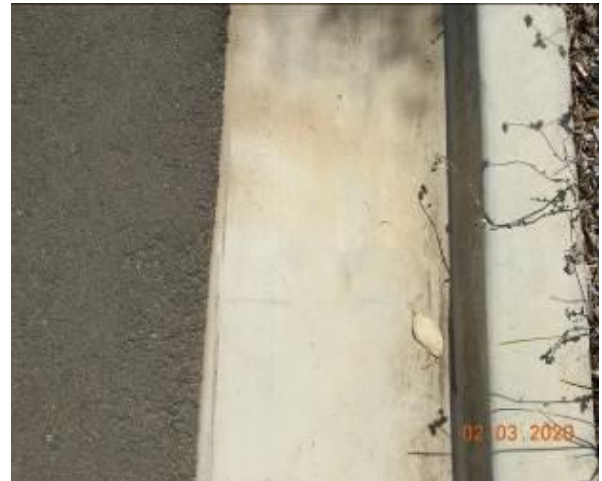
Figure 40 – Crack propagation through kerb and gutter

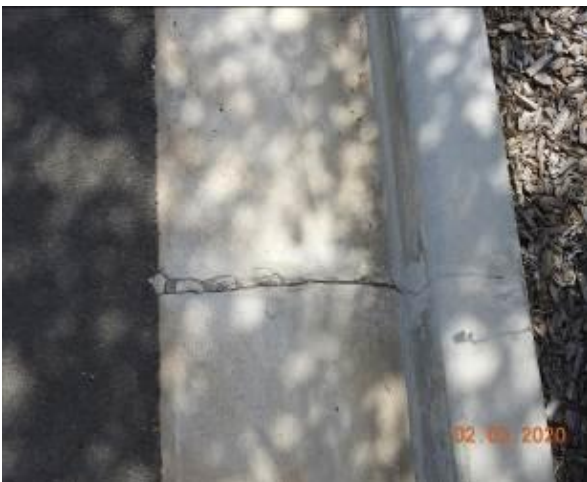
Figure 41 – Crack propagation and loss of material through kerb and gutter

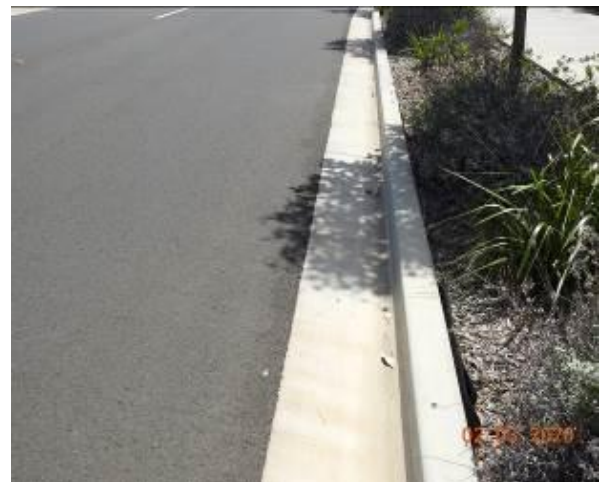
Figure 42 – General Condition of kerb and gutter

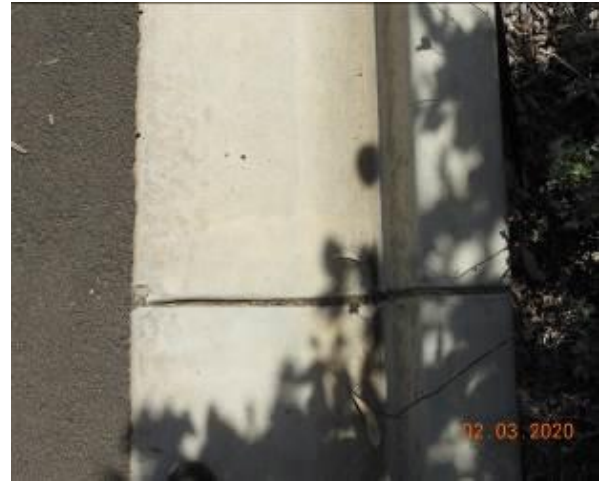
Figure 44 – Crack propagation and loss of material through kerb and gutter

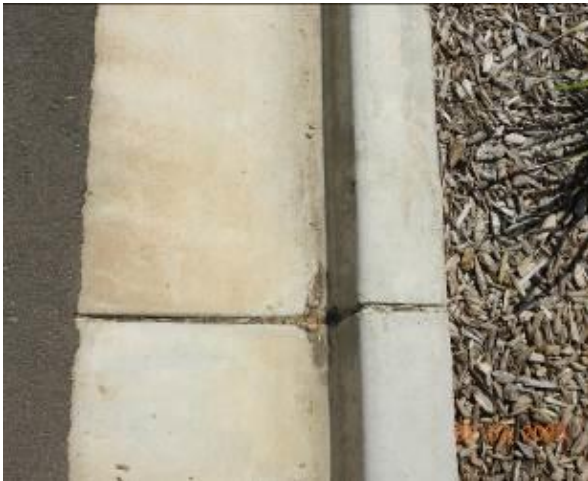
Figure 45 – Crack propagation through kerb

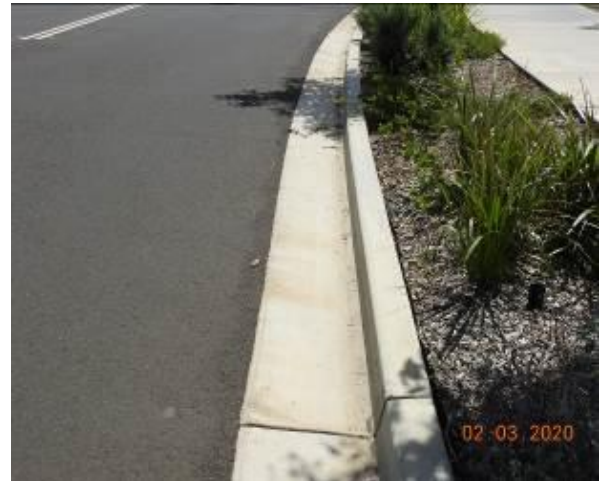
Figure 46 – General Condition of kerb and gutter

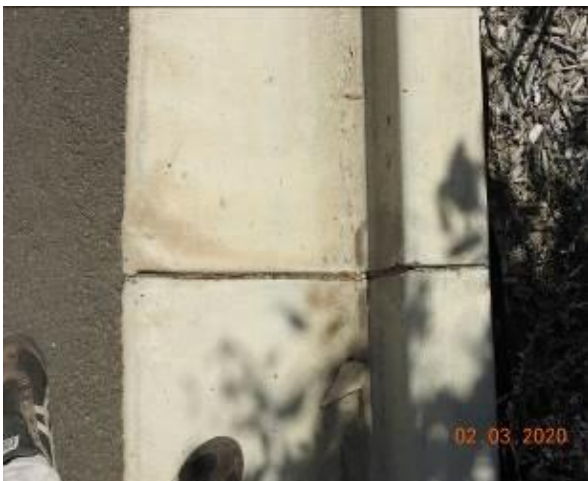
Figure 47 – Crack propagation through kerb

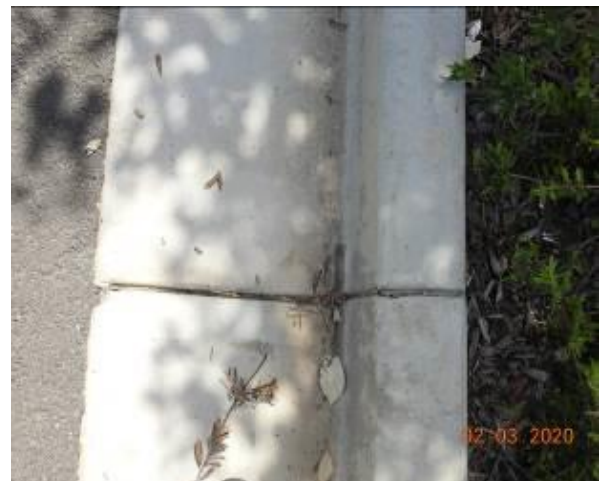
Figure 48 – Crack propagation through kerb and gutter

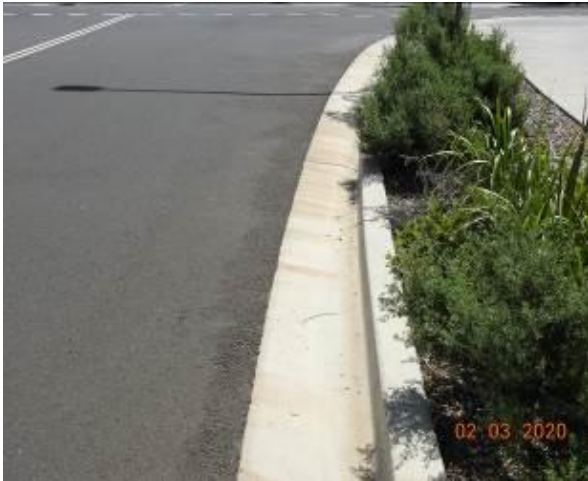
Figure 49 – General Condition of kerb and gutter

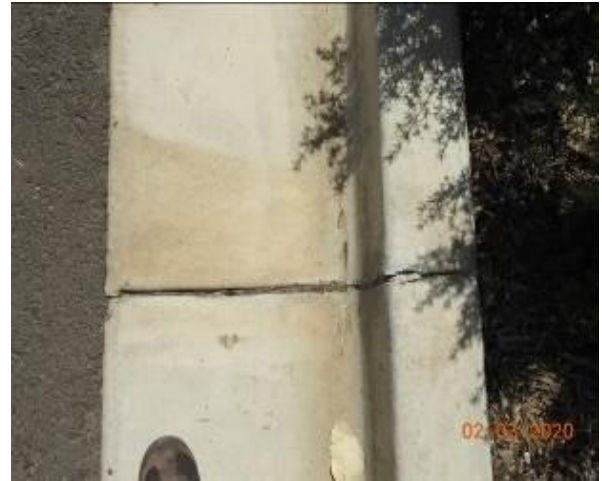
Figure 50 – Crack propagation through kerb and gutter

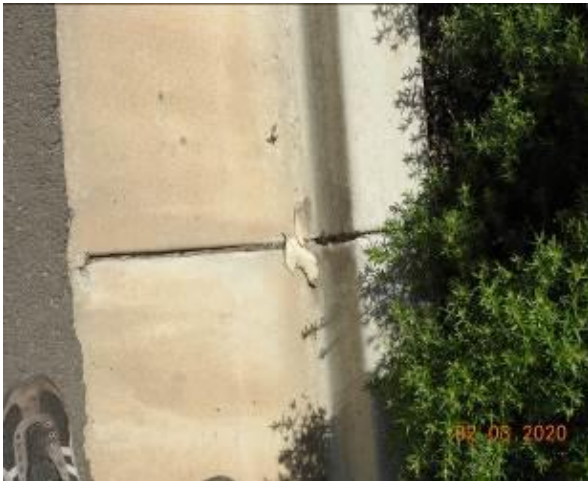
Figure 51 – Crack propagation through kerb and gutter

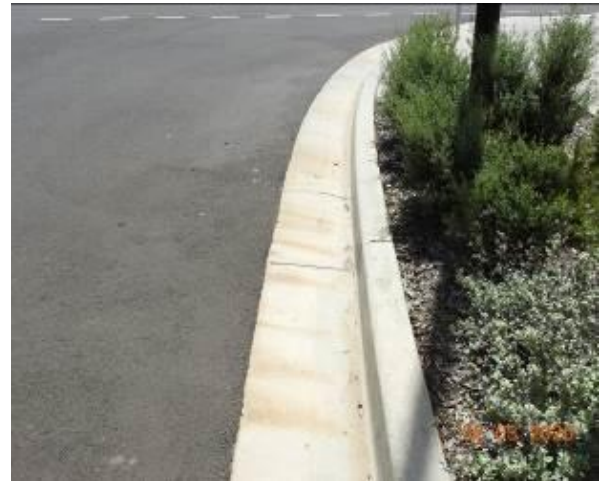
Figure 52 – General Condition of kerb and gutter

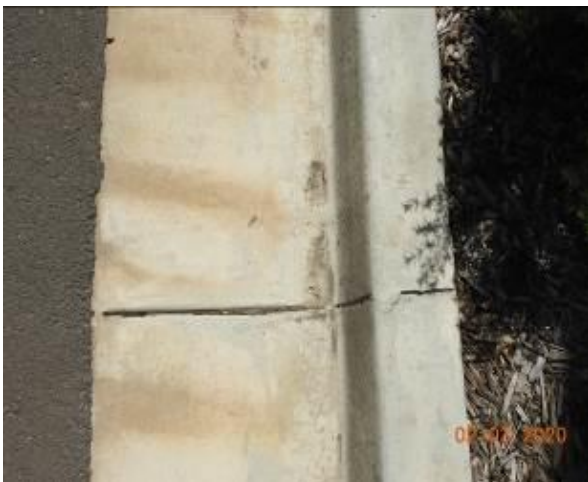
Figure 53 – Crack propagation through kerb and gutter

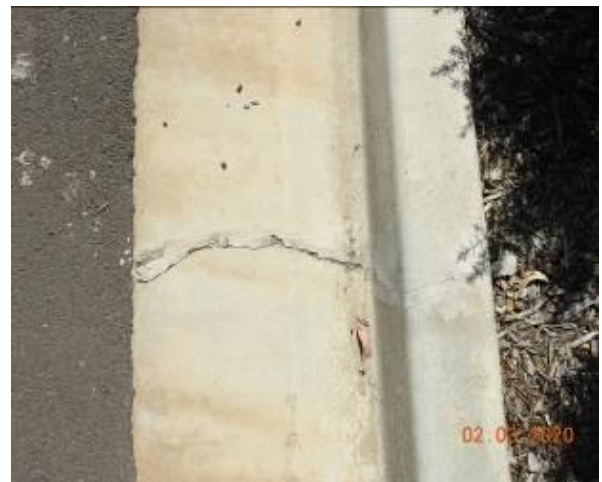
Figure 54 – Crack propagation and evidence of patchwork through kerb and gutter

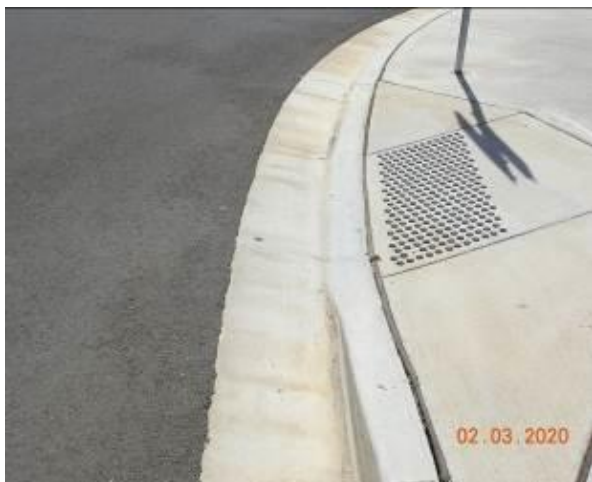
Figure 55 – Crack propagation through kerb and gutter

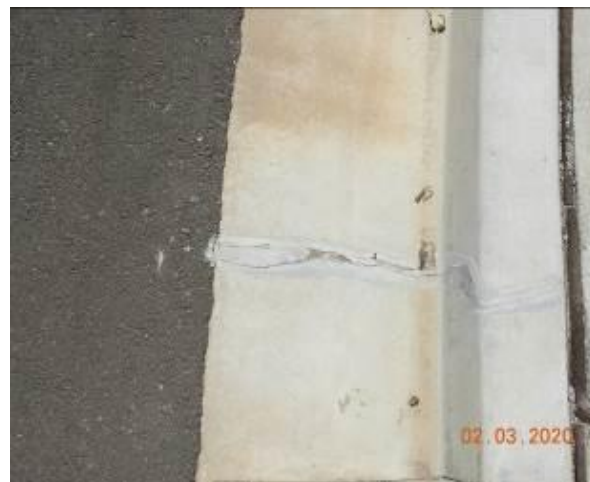
Figure 56 – Crack propagation and evidence of patchwork through kerb and gutter

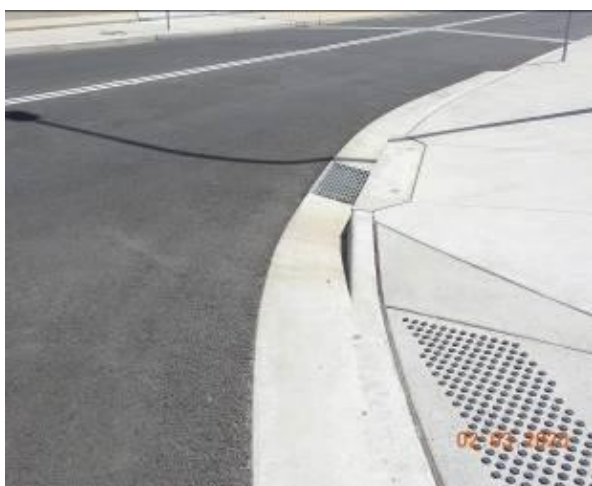
Figure 57 – General Condition of layback and gutter

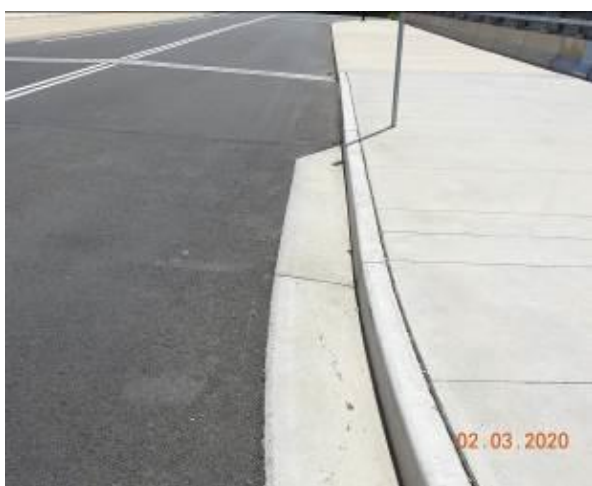
Figure 59 – General Condition of kerb and gutter

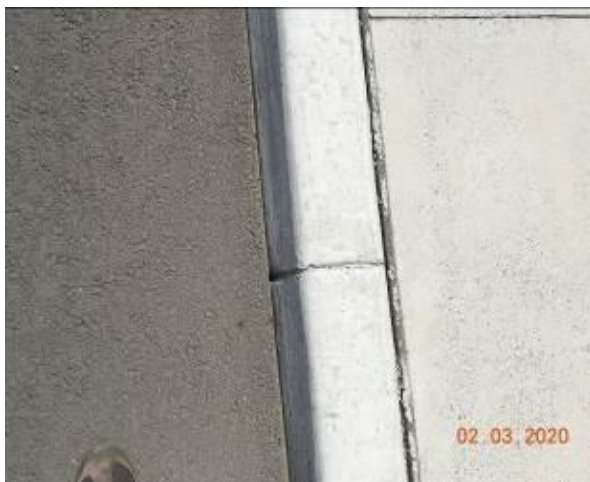
Figure 61 – Crack propagation through kerb

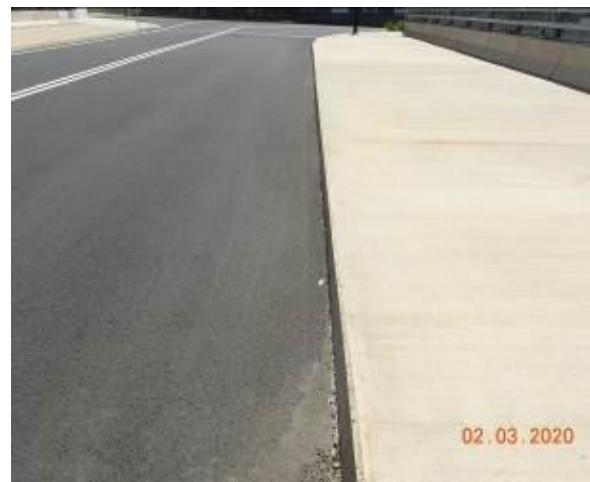
Figure 62 – General Condition of kerb

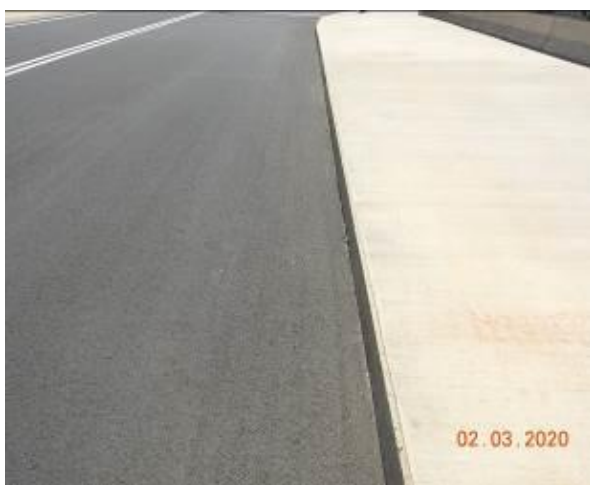
Figure 63 – General Condition of kerb

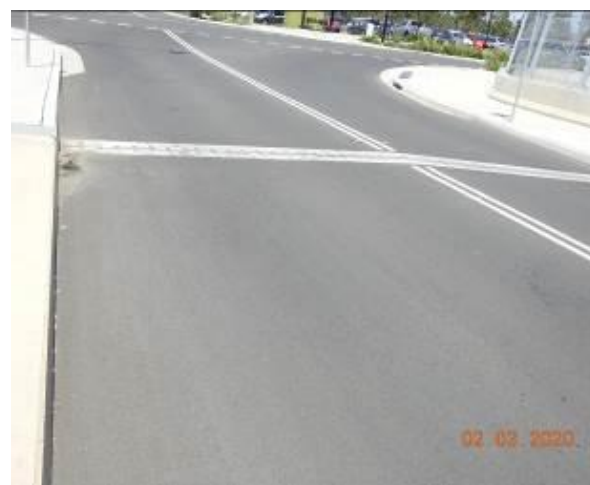
Figure 64 – General Condition of road surface

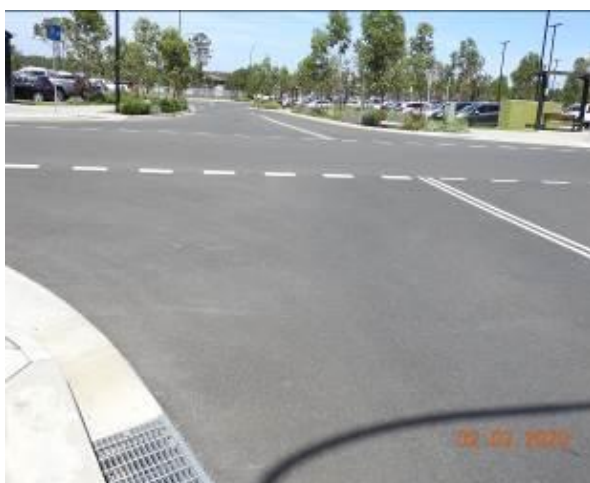
Figure 65 – General Condition of road surface

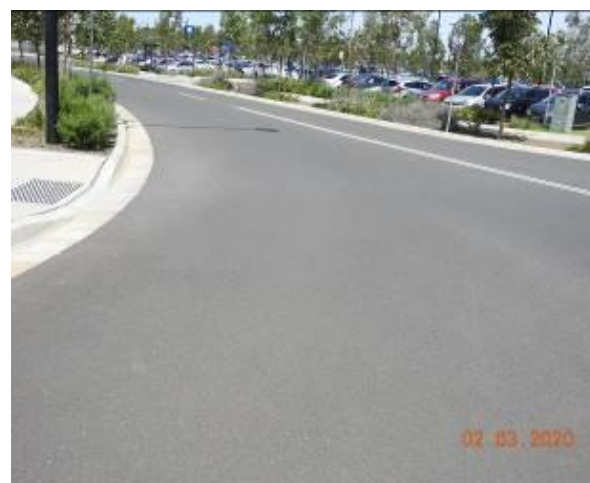
Figure 66 – General Condition of road surface

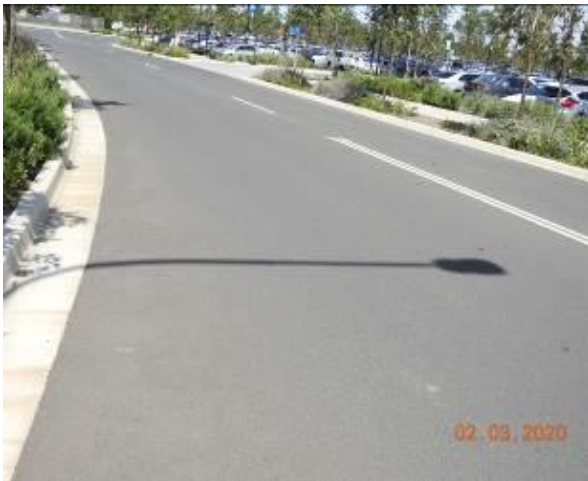
Figure 67 – General Condition of road surface

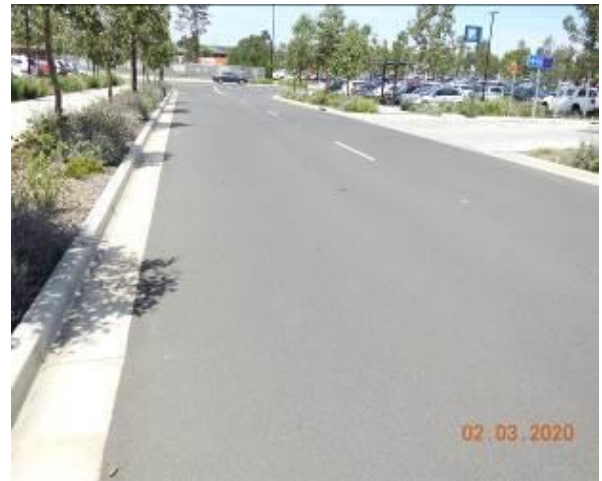
Figure 68 – General Condition of road surface

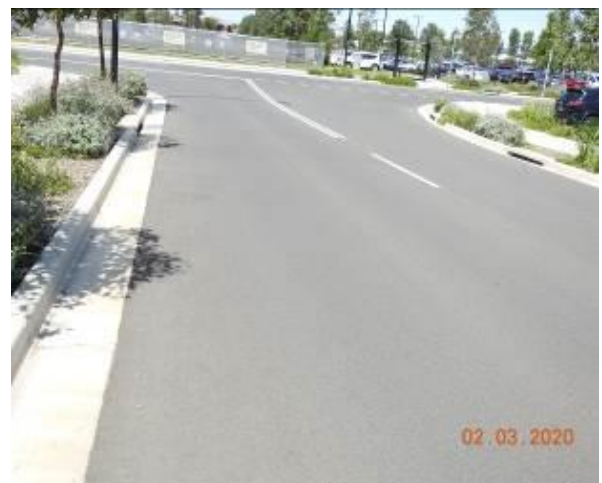
Figure 70 – General Condition of road surface

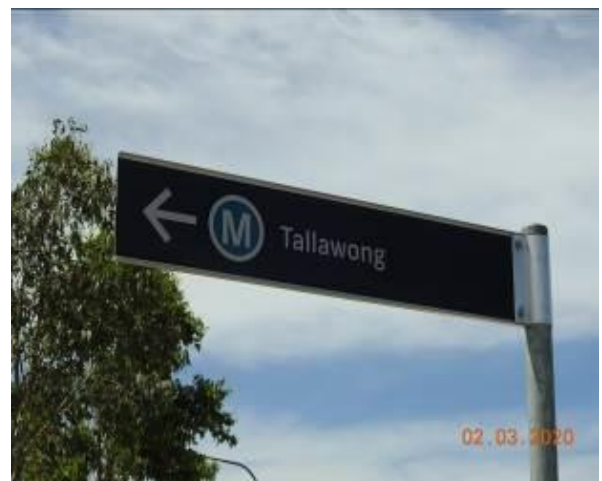
Figure 72 – General Condition of street sign

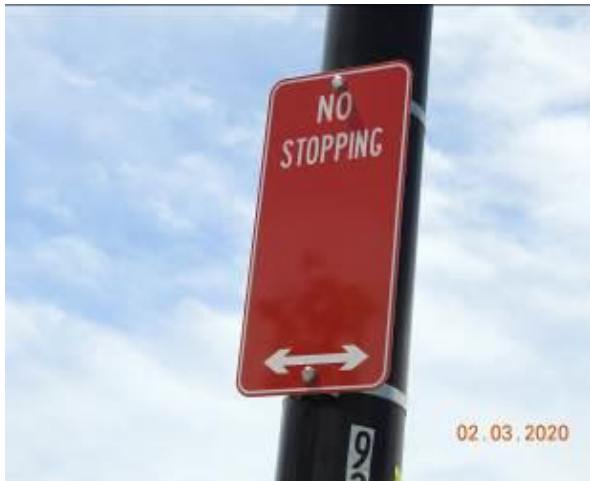
Figure 73 – General Condition of street sign

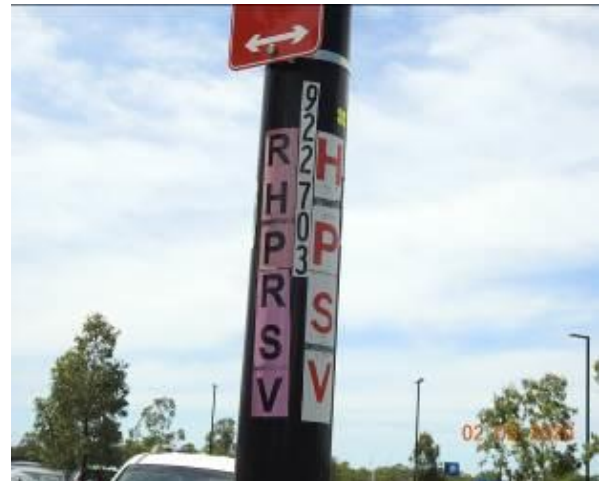
Figure 74 – General Condition of lamp post
Identification No.922703

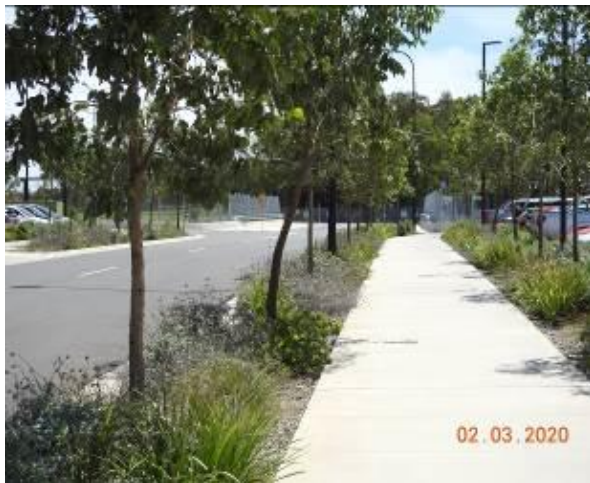
Figure 75 – General Condition of plantation

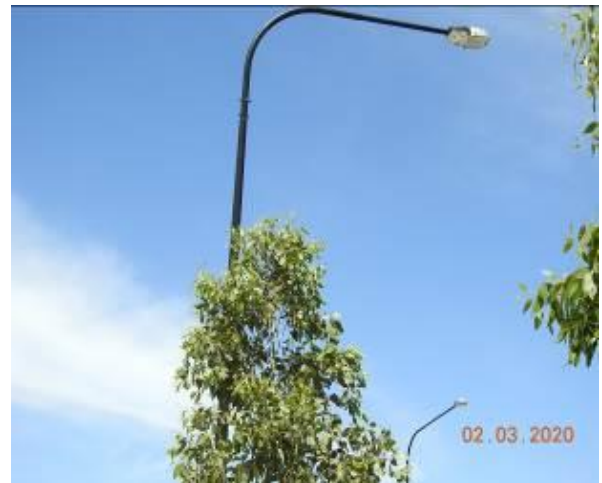
Figure 76 – General Condition of lamp post

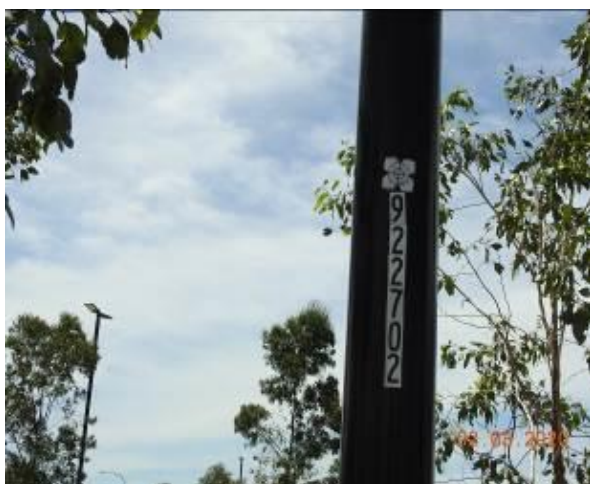
Figure 77 – General Condition of lamp post
Identification No.922702

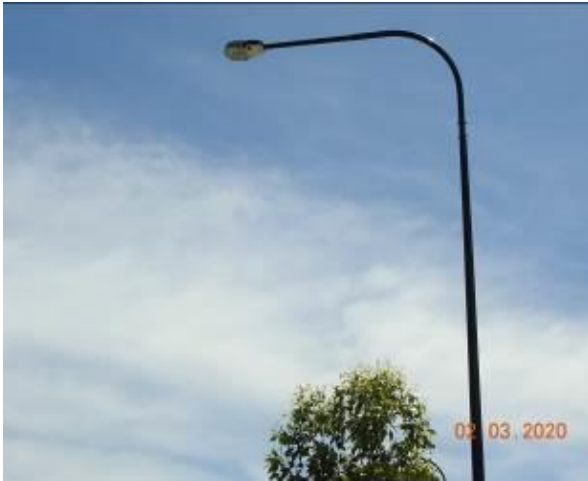
Figure 79 – General Condition of lamp post

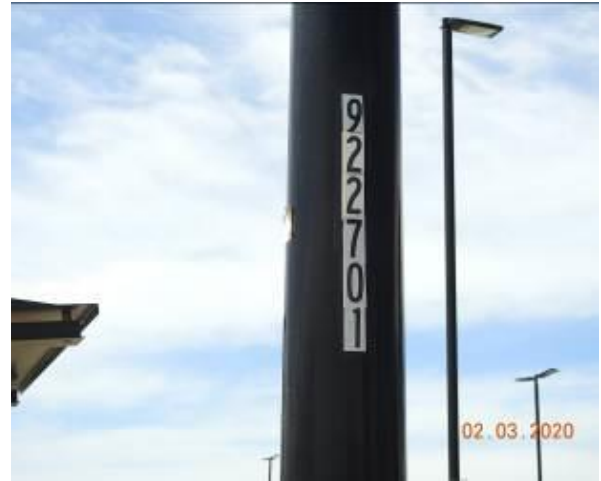
Figure 80 – General Condition of lamp post
Identification No.922701

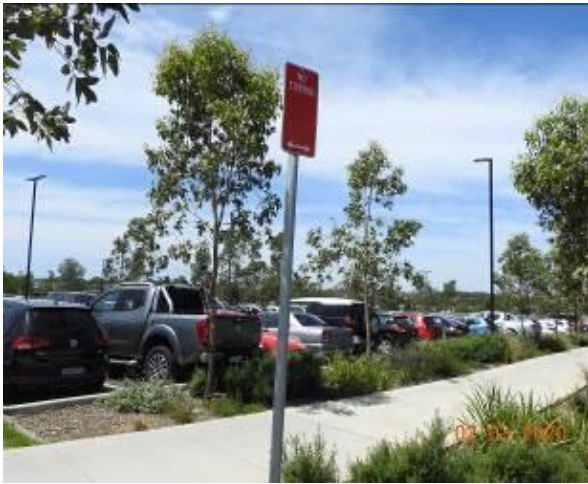
Figure 81 – General Condition of street sign

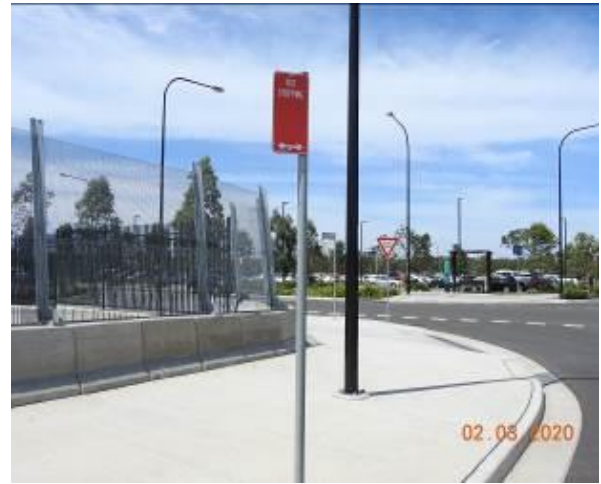
Figure 82 – General Condition of street sign

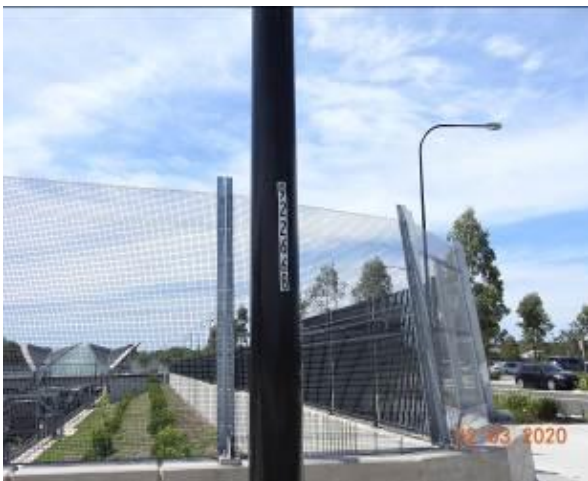
Figure 83 – General Condition of lamp post
Identification No.922668

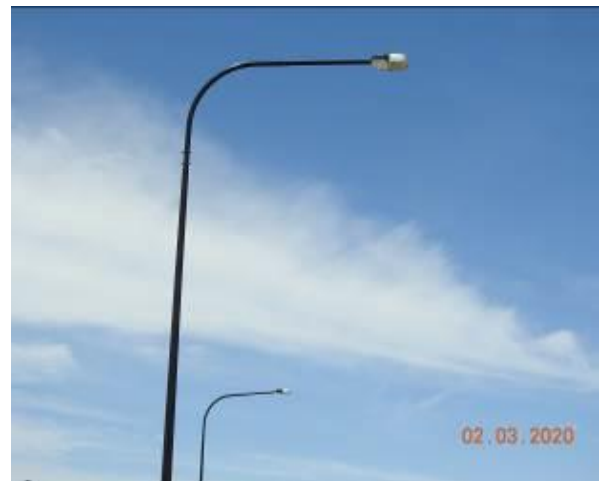
Figure 84 – General Condition of lamp post

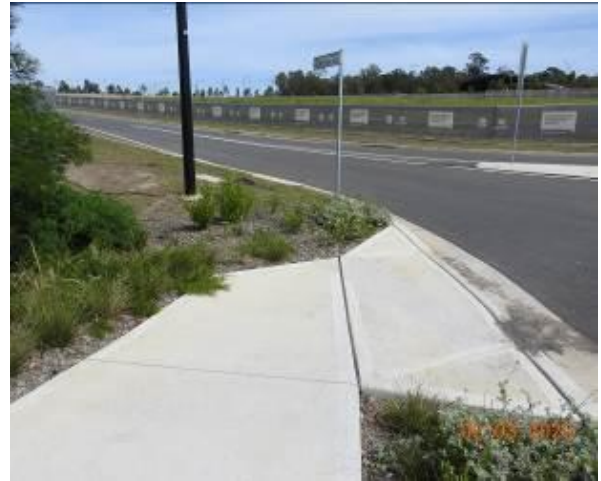
Figure 86 – General Condition of footpath pavement

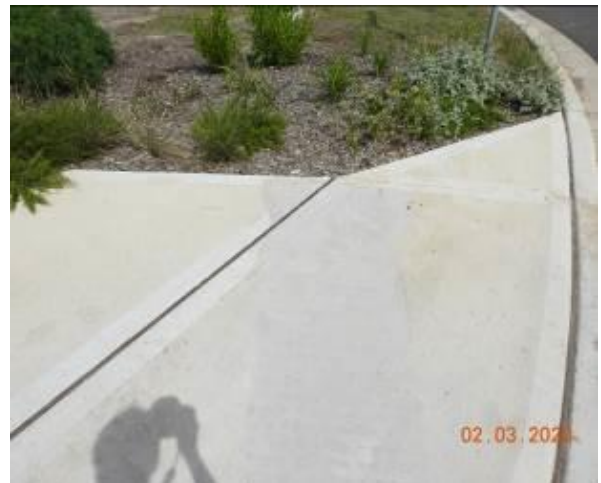
Figure 88 – General Condition of footpath pavement

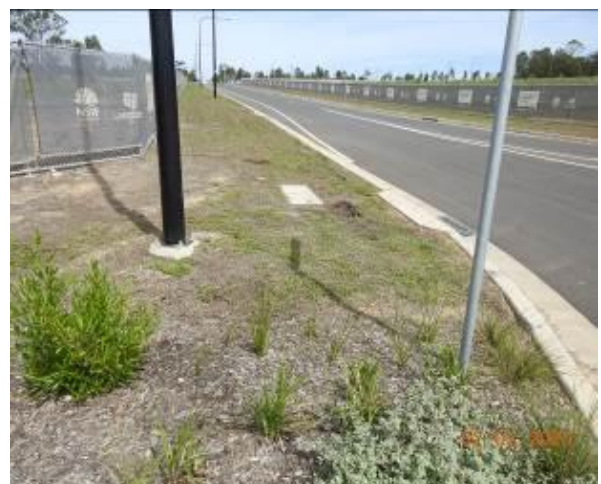
Figure 90 – General Condition of grass area

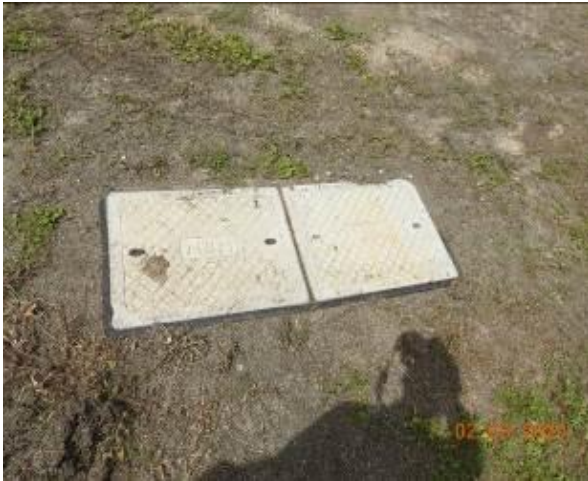
Figure 91 – General Condition of service pit

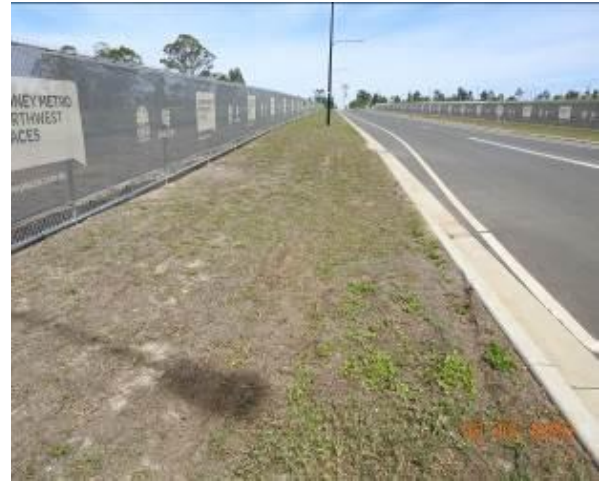
Figure 92 – General Condition of gras area

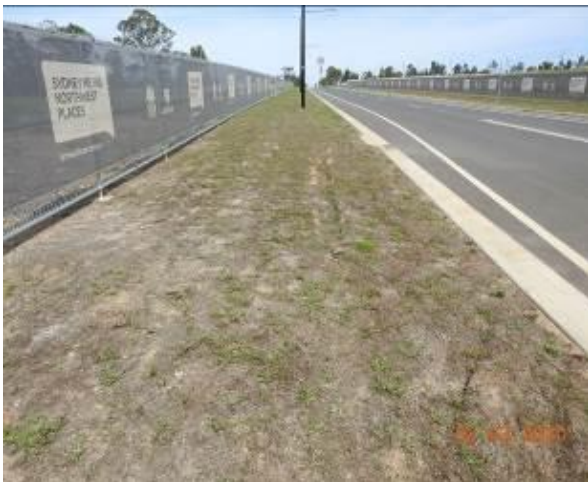
Figure 93 – General Condition of gras area

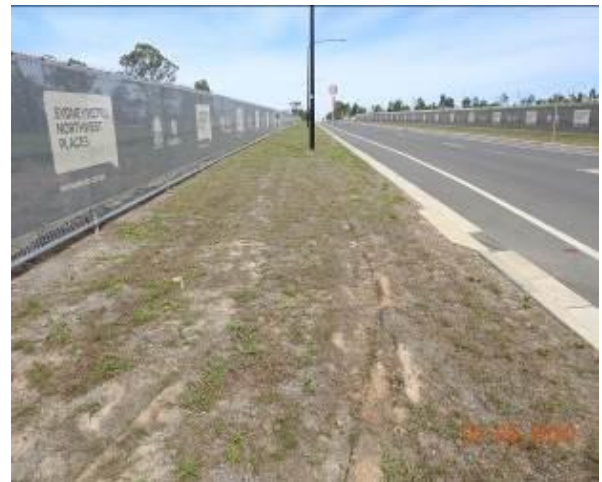
Figure 94 – General Condition of gras area
