**1-15 AND 2-12 CONFERTA AVENUE,
ROUSE HILL NSW 2155
TALLAWONG STATION PRECINCT SOUTH
PRE-DILAPIDATION REPORT**

**DEICORP PROJECTS
(TALLAWONG STATION) PTY LTD**

Job No. 191294.0
24/03/2020

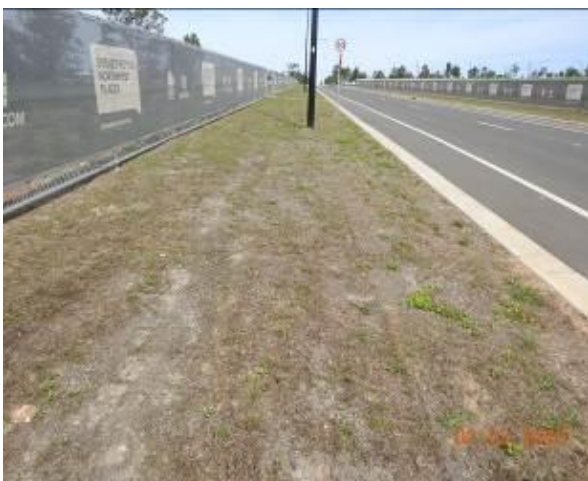
Figure 95 – General Condition of gras area

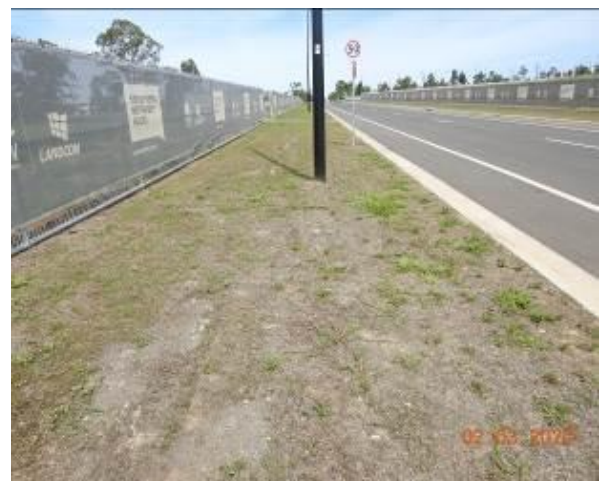
Figure 96 – General Condition of gras area

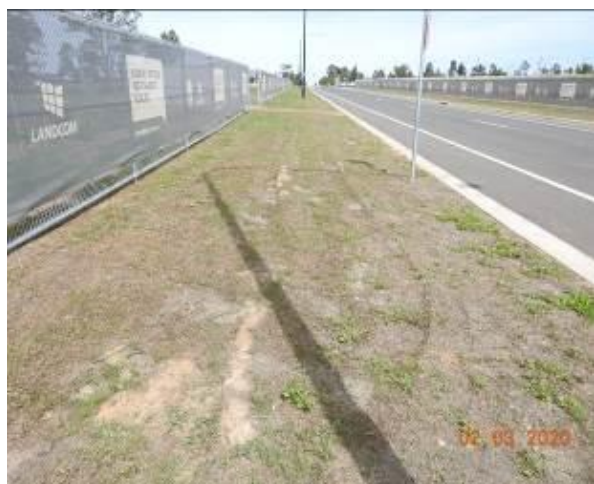
Figure 97 – General Condition of gras area

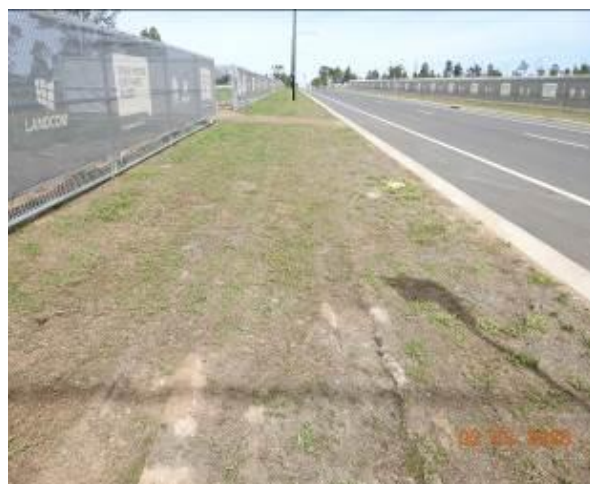
Figure 98 – General Condition of gras area

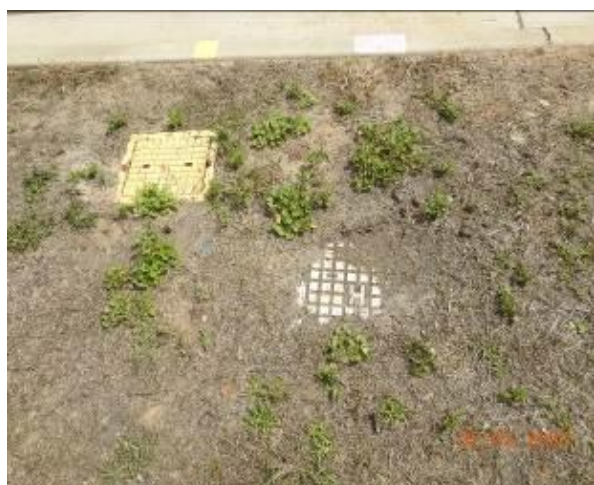
Figure 99 – General Condition of service pit

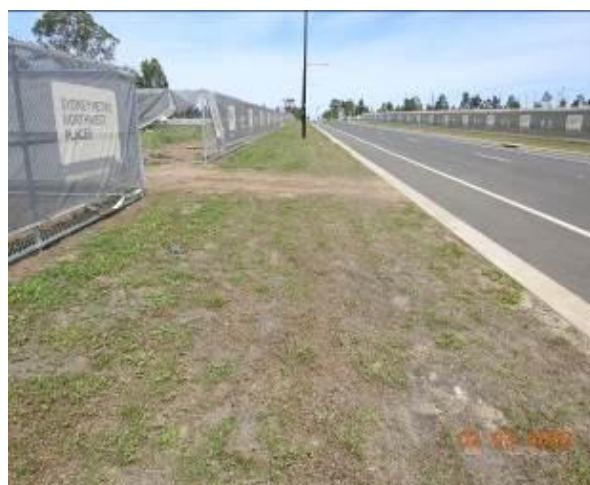
Figure 100 – General Condition of gras area

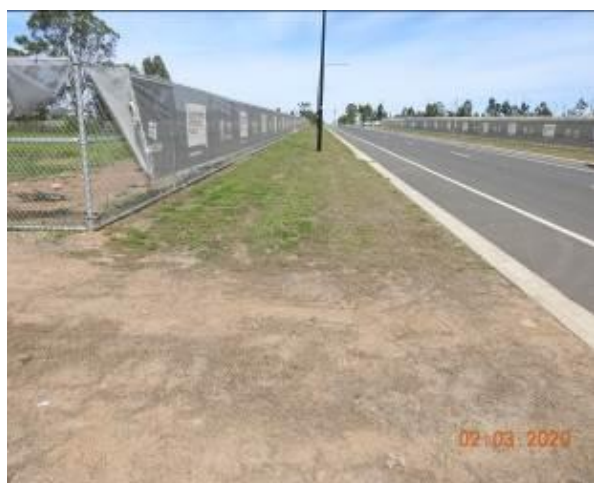
Figure 101 – General Condition of gras area

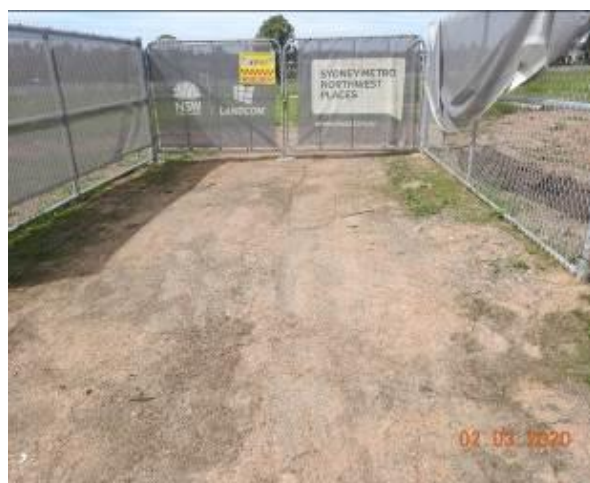
Figure 102 – General Condition of gras area

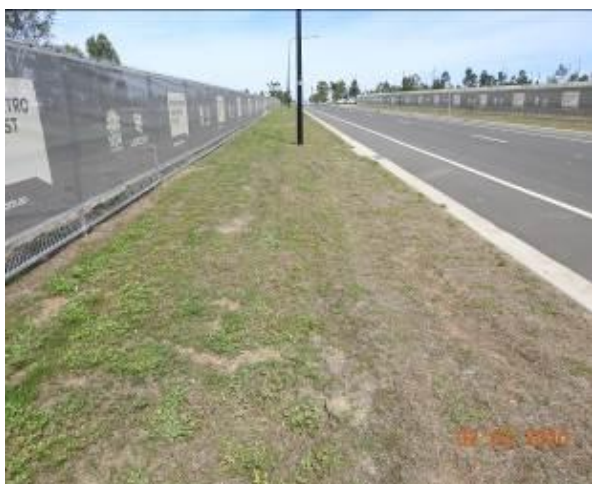
Figure 103 – General Condition of gras area

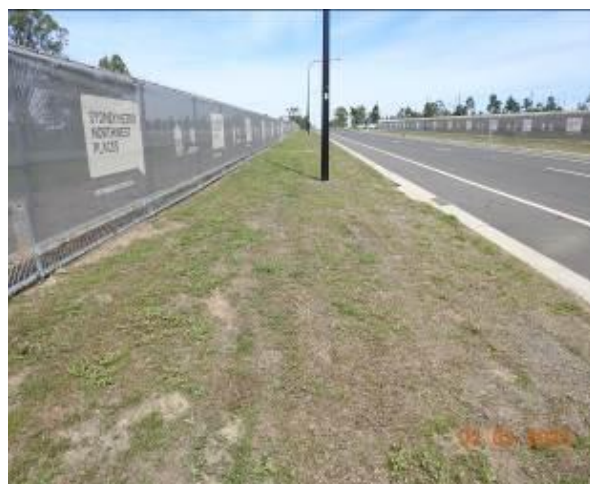
Figure 104 – General Condition of gras area

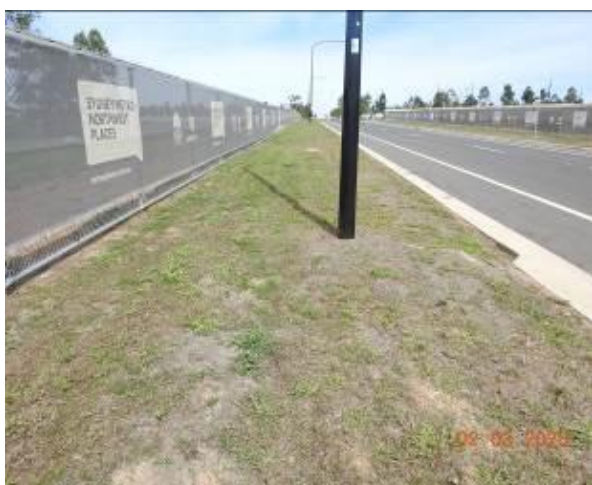
Figure 105 – General Condition of gras area

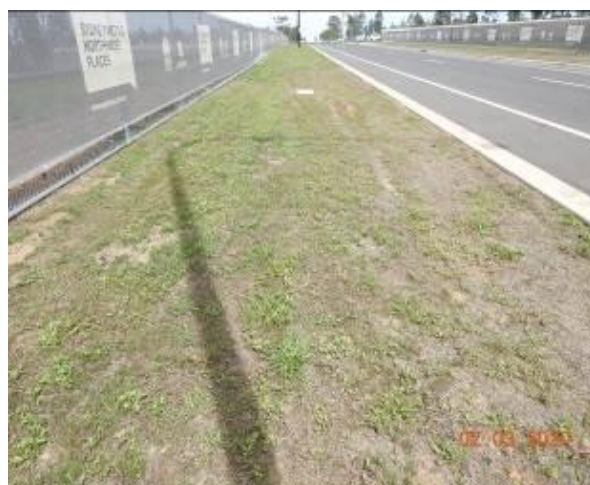
Figure 106 – General Condition of gras area

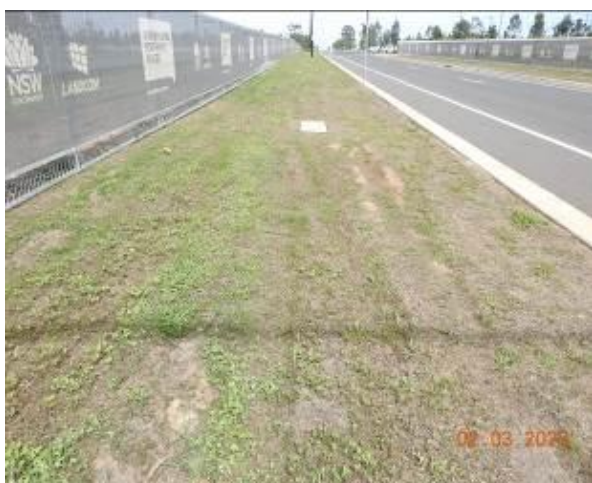
Figure 107 – General Condition of gras area

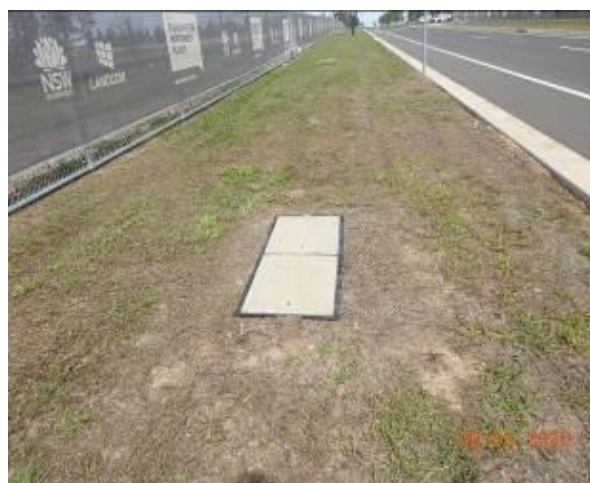
Figure 108 – General Condition of gras area

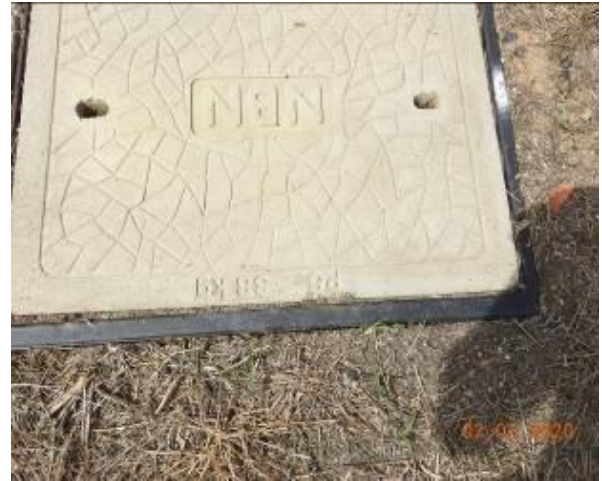
Figure 110 – Loss of material through service pit

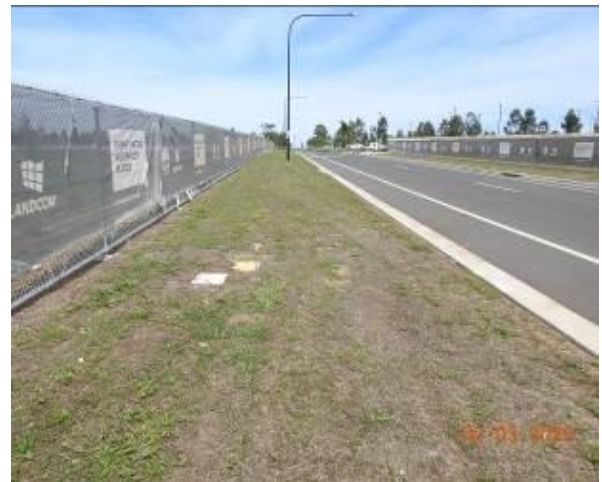
Figure 112 – General Condition of gras area

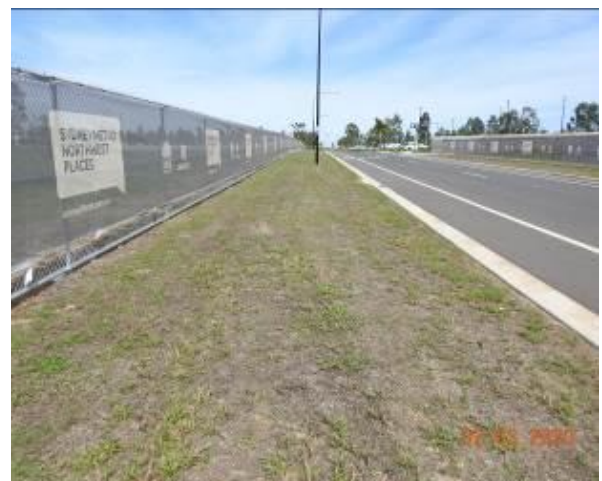
Figure 114 – General Condition of gras area

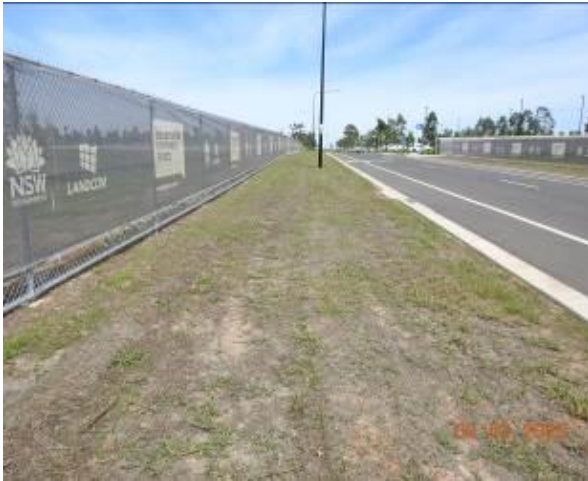
Figure 115 – General Condition of gras area

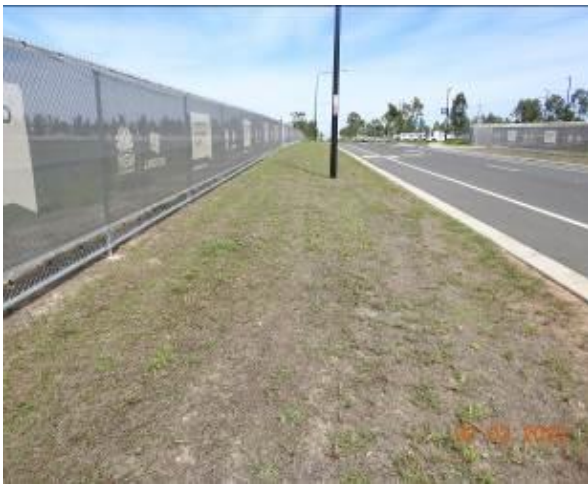
Figure 117 – General Condition of gras area

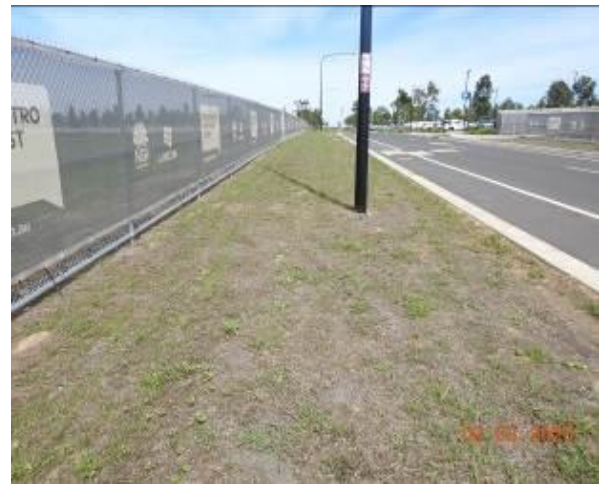
Figure 118 – General Condition of gras area

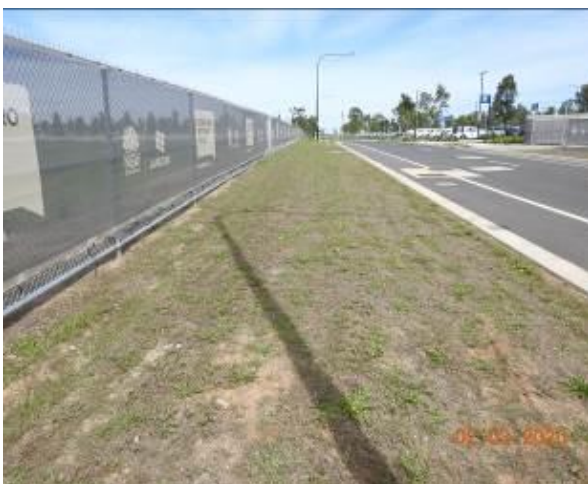
Figure 119 – General Condition of gras area

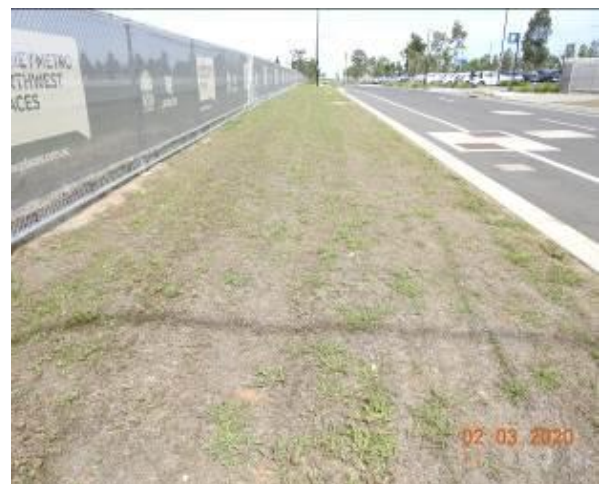
Figure 120 – General Condition of gras area

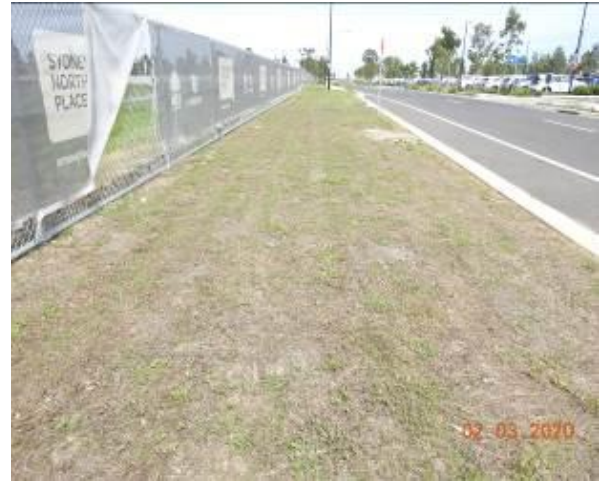
Figure 122 – General Condition of gras area

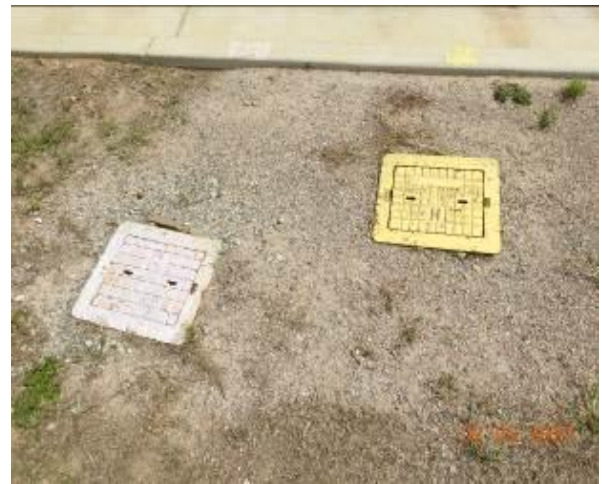
Figure 123 – General Condition of gras area

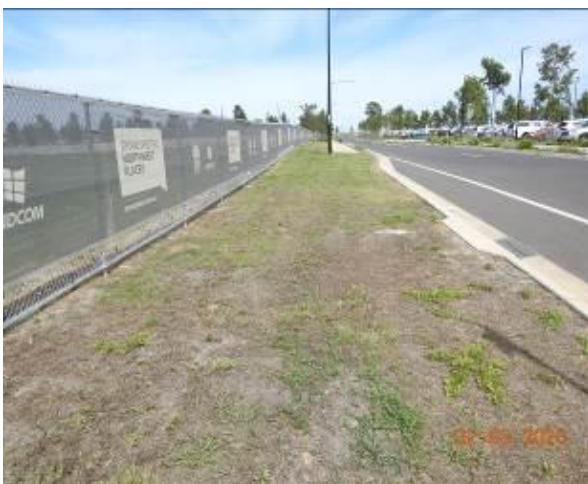
Figure 124 – General Condition of service pit

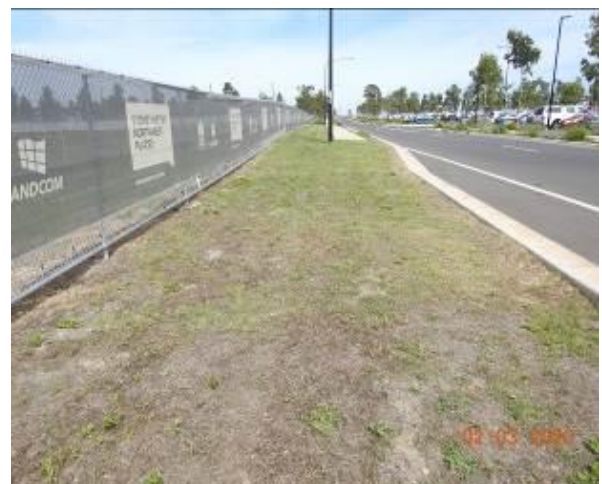
Figure 125 – General Condition of gras area

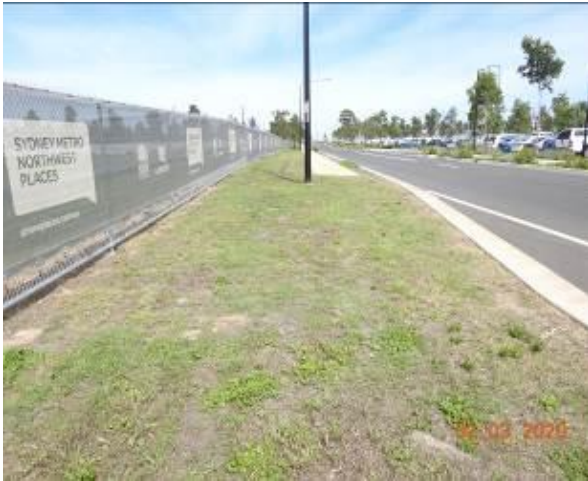
Figure 126 – General Condition of gras area

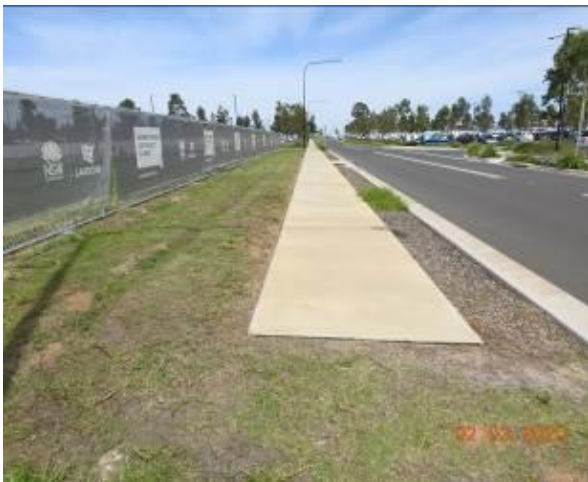
Figure 128 – General Condition of gras area

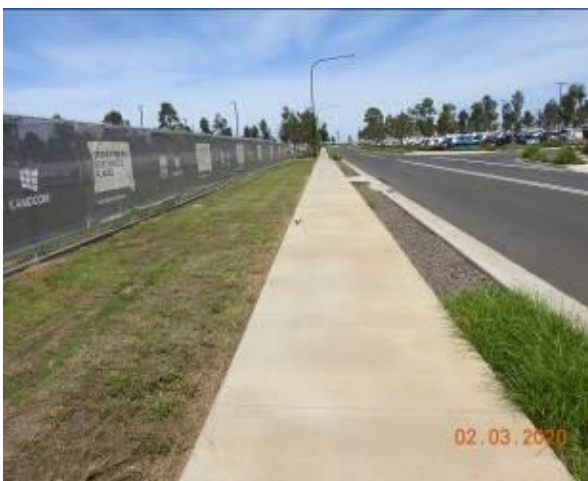
Figure 130 – General Condition of footpath pavement

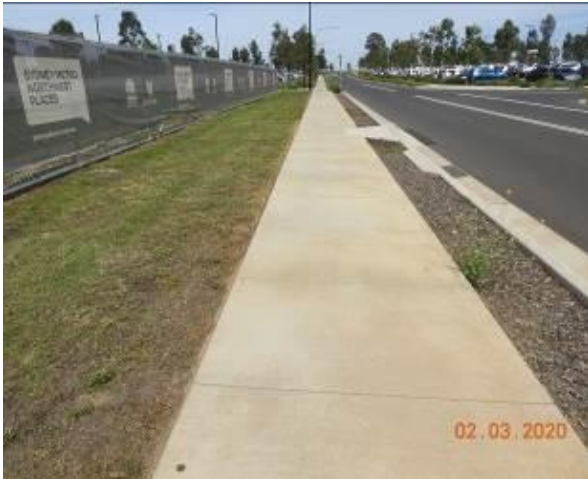
Figure 132 – General Condition of footpath pavement

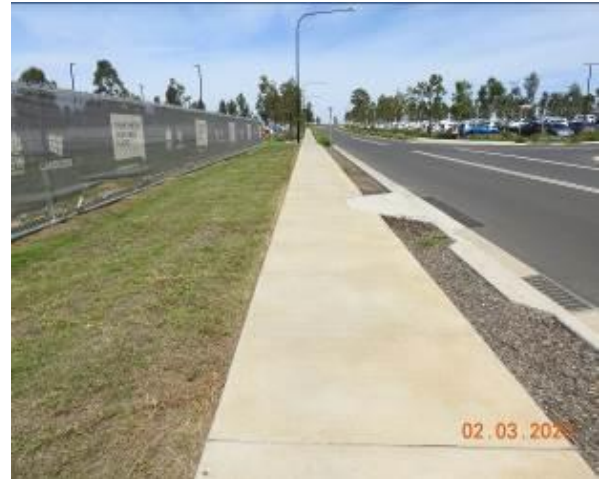
Figure 133 – General Condition of footpath pavement

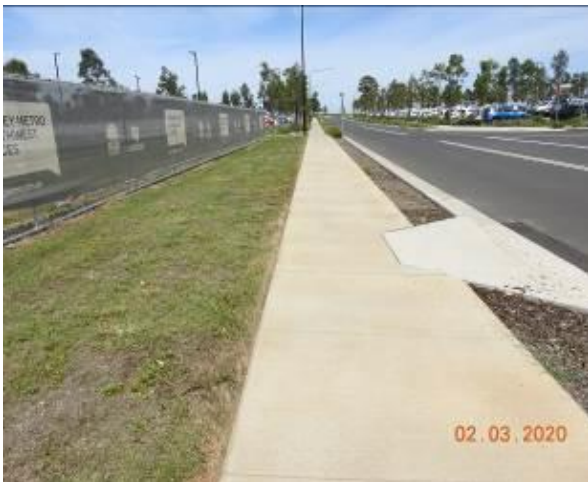
Figure 134 – General Condition of footpath pavement

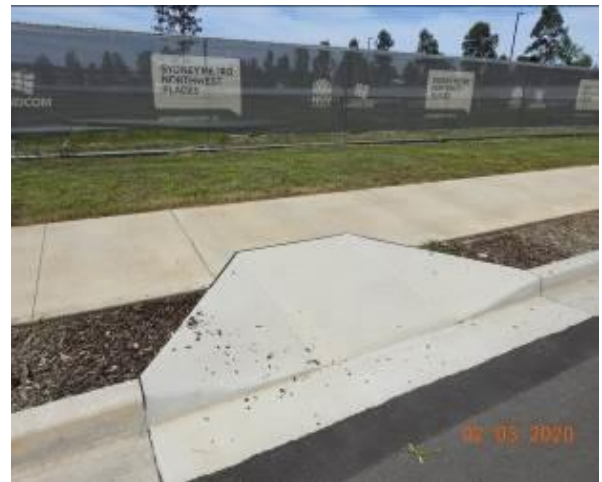
Figure 135 – General Condition of footpath pavement

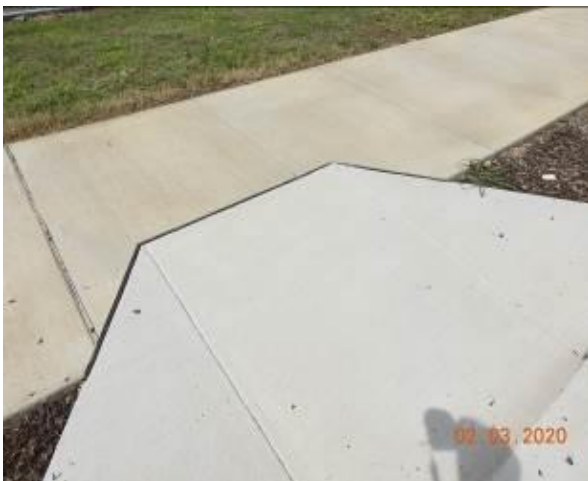
Figure 136 – General Condition of footpath pavement ramp

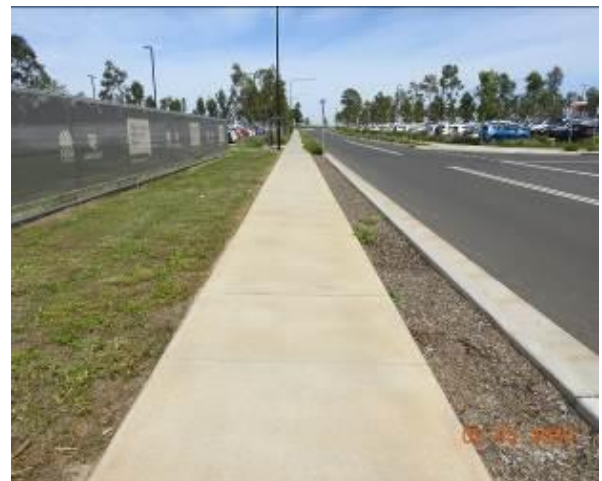
Figure 137 – General Condition of footpath pavement ramp

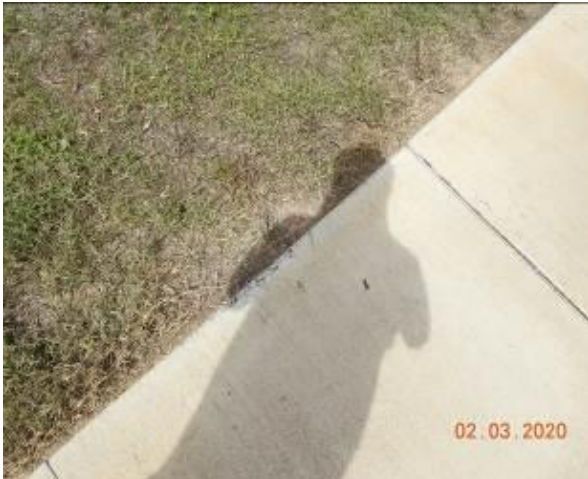
Figure 144 – General Condition of footpath pavement

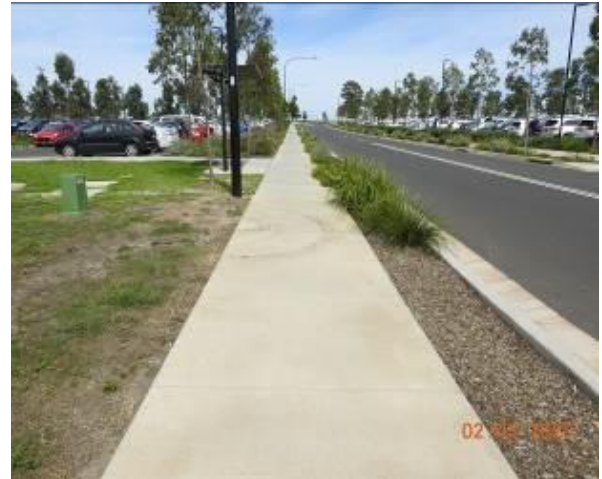
Figure 145 – Loss of material through footpath pavement

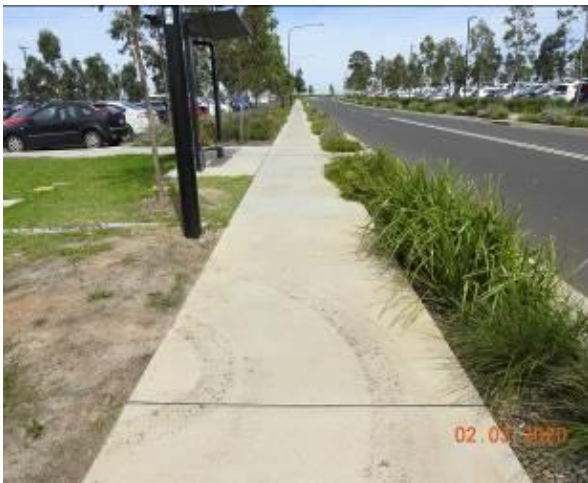
Figure 146 – General Condition of footpath pavement

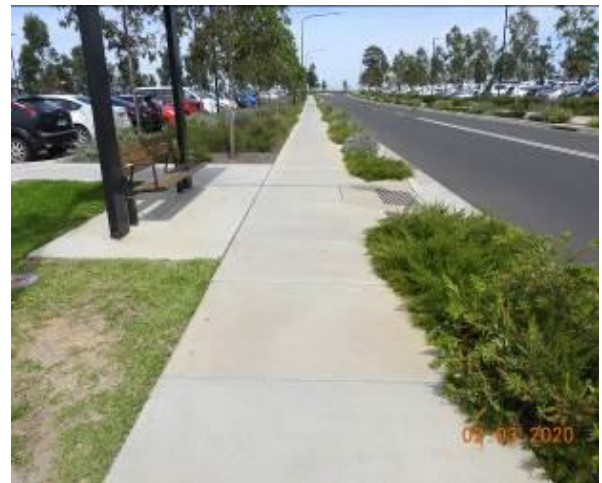
Figure 147 – General Condition of footpath pavement

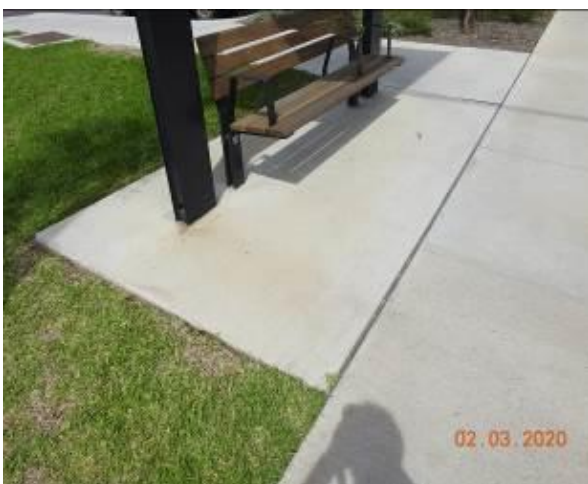
Figure 148 – General Condition of footpath pavement

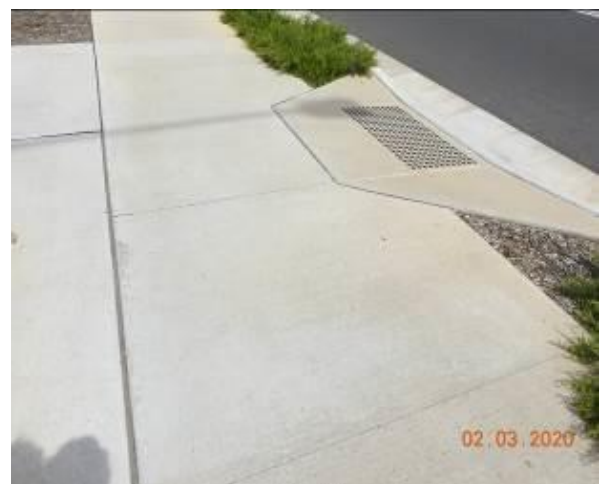
Figure 149 – General Condition of footpath pavement

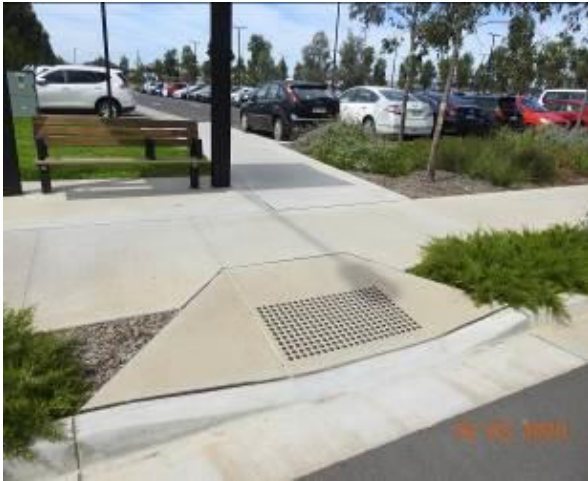
Figure 150 – General Condition of footpath pavement

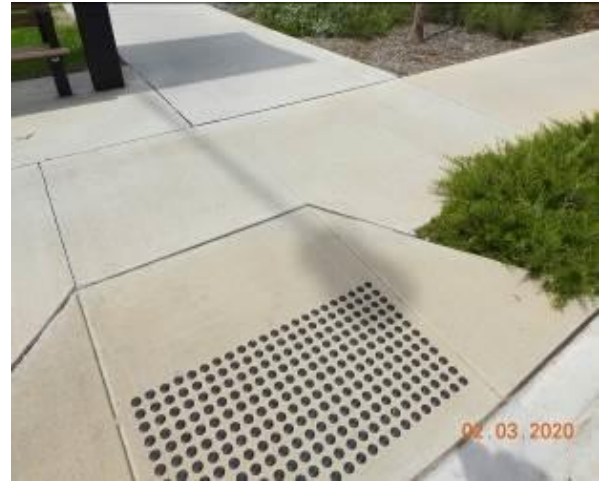
Figure 151 – General Condition of footpath pavement

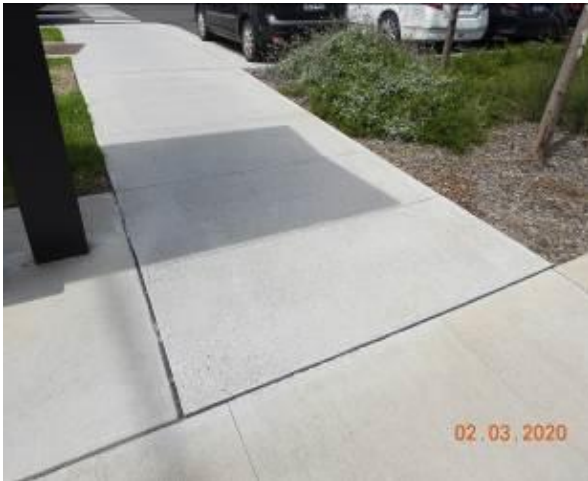
Figure 152 – General Condition of footpath pavement ramp

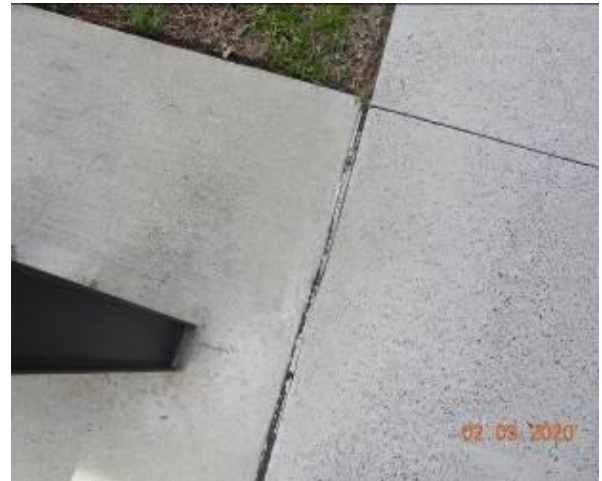
Figure 153 – General Condition of footpath pavement

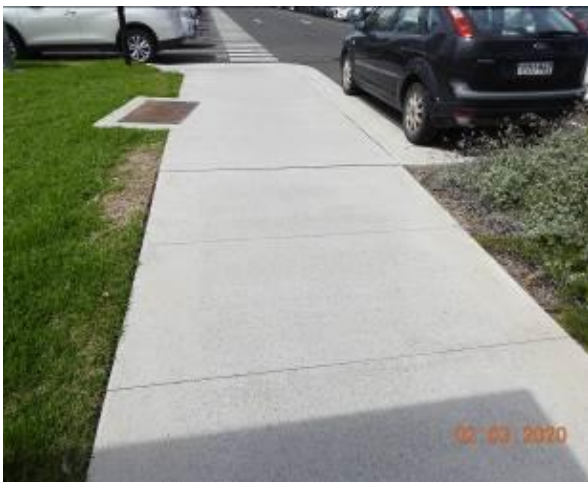
Figure 154 – Crack propagation through footpath pavement

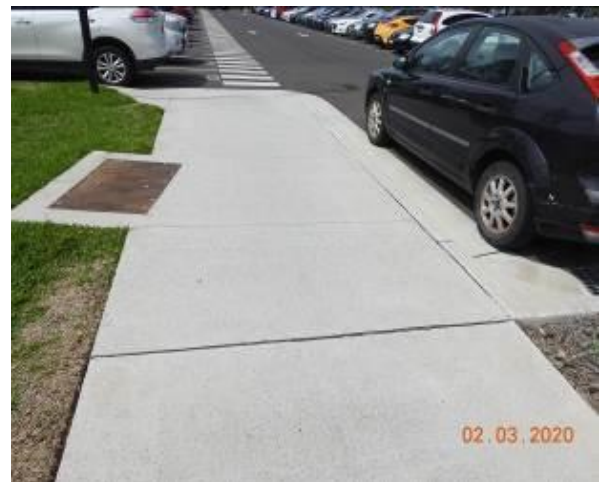
Figure 155 – General Condition of footpath pavement

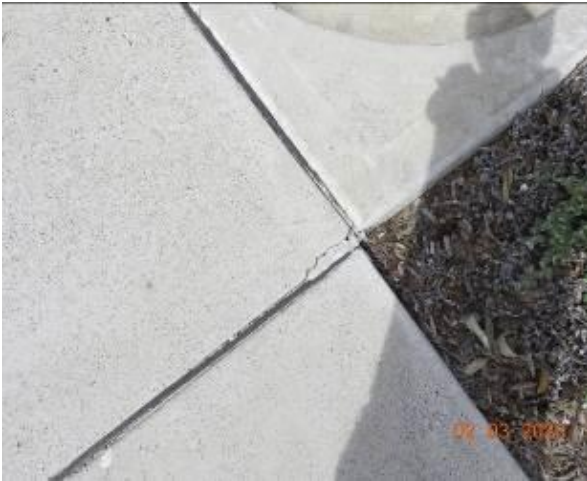
Figure 156 – General Condition of footpath pavement

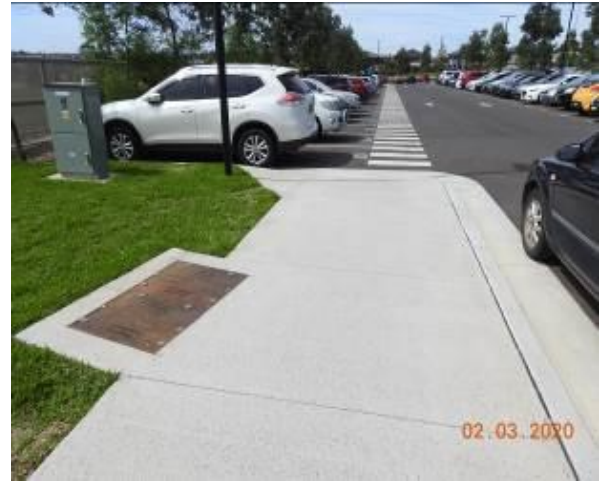
Figure 157 – Crack propagation through footpath pavement

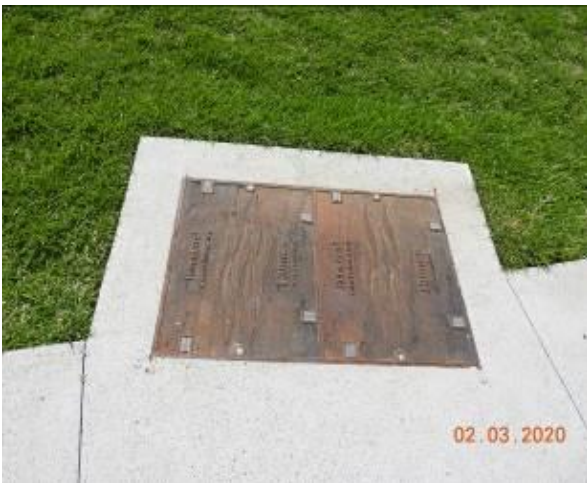
Figure 158 – General Condition of footpath pavement

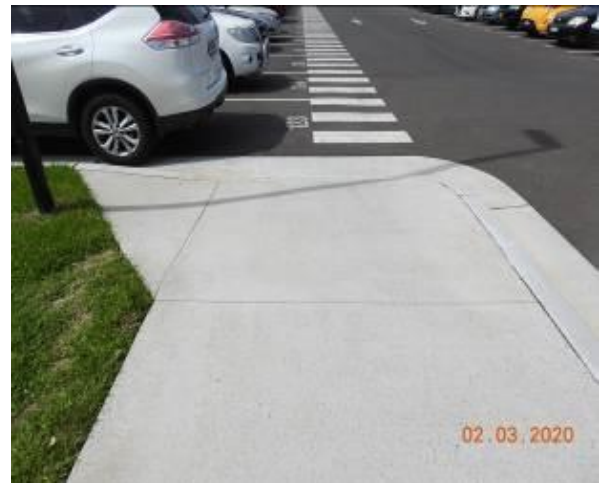
Figure 159 – General Condition of service pit

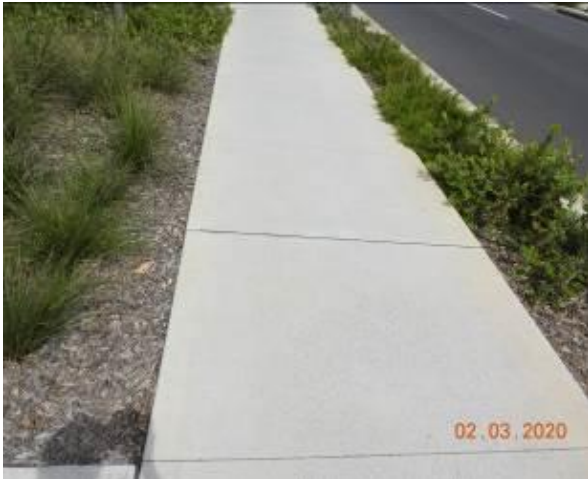
Figure 169 – General Condition of footpath pavement

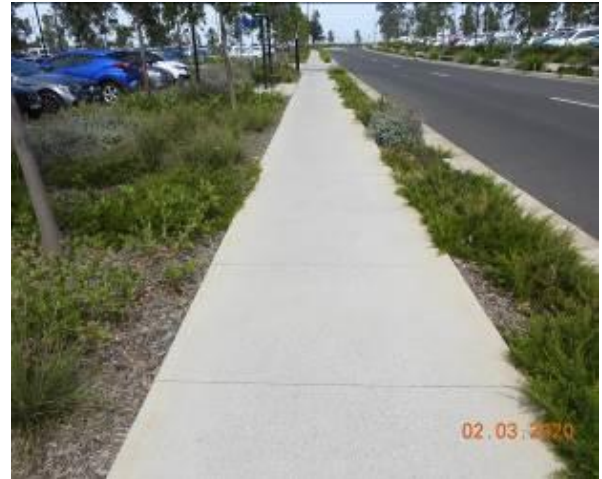
Figure 170 – General Condition of footpath pavement

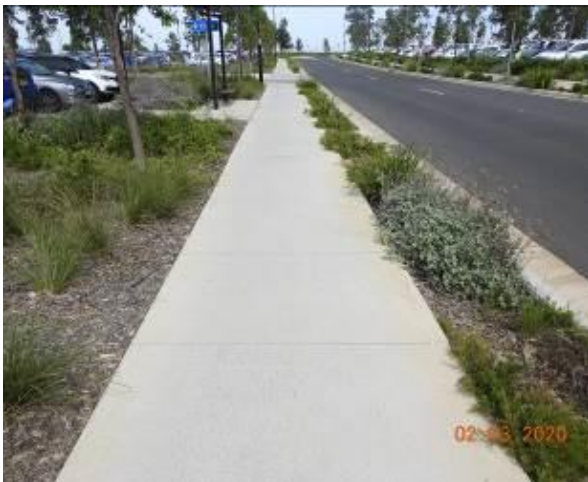
Figure 171 – General Condition of footpath pavement

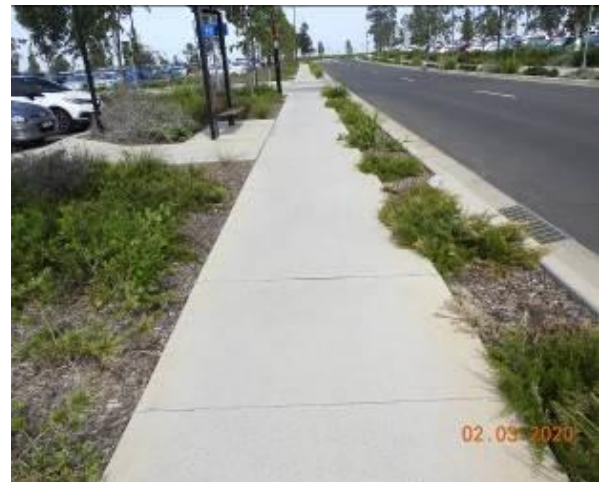
Figure 172 – General Condition of footpath pavement

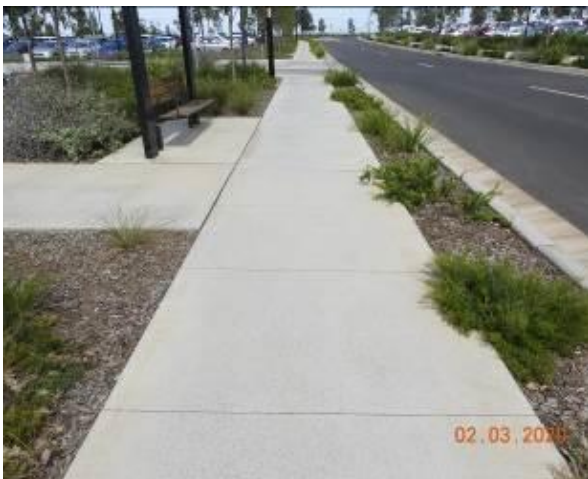
Figure 173 – General Condition of footpath pavement

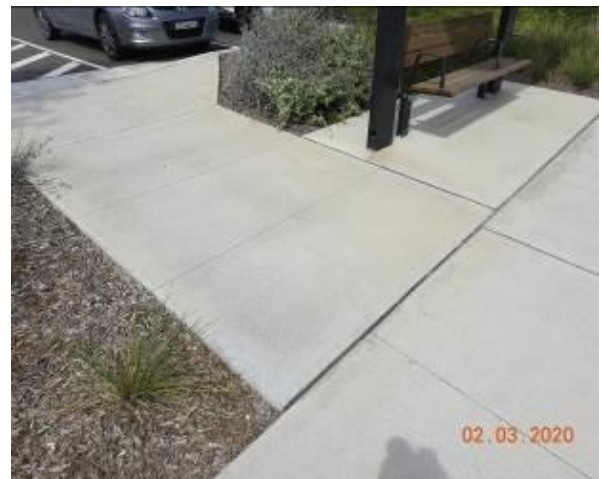
Figure 174 – General Condition of footpath pavement

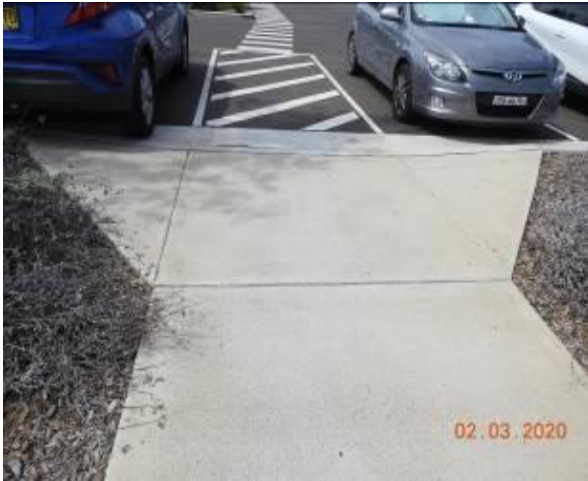
Figure 175 – General Condition of footpath pavement

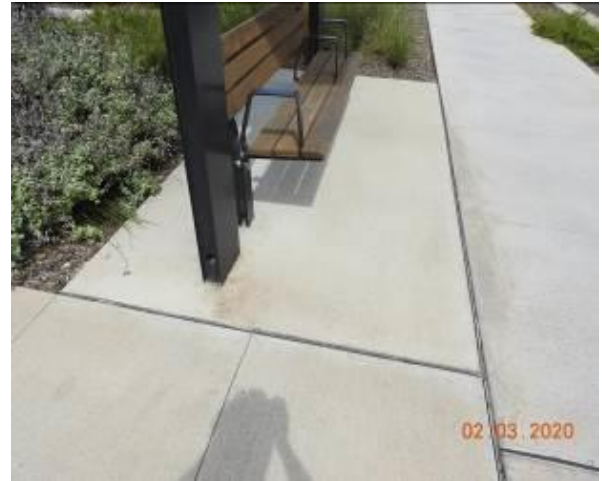
Figure 176 – General Condition of public bench

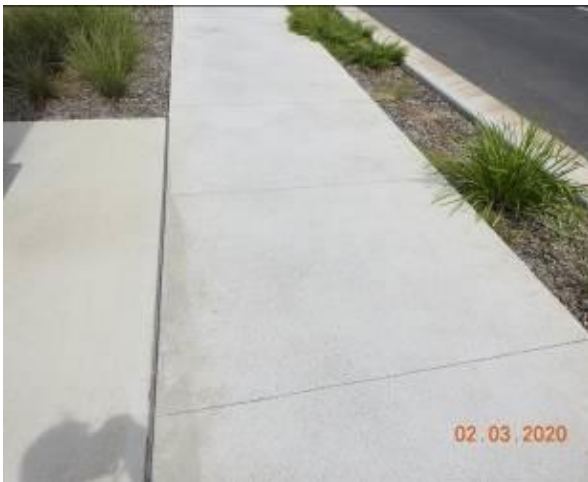
Figure 177 – General Condition of footpath pavement

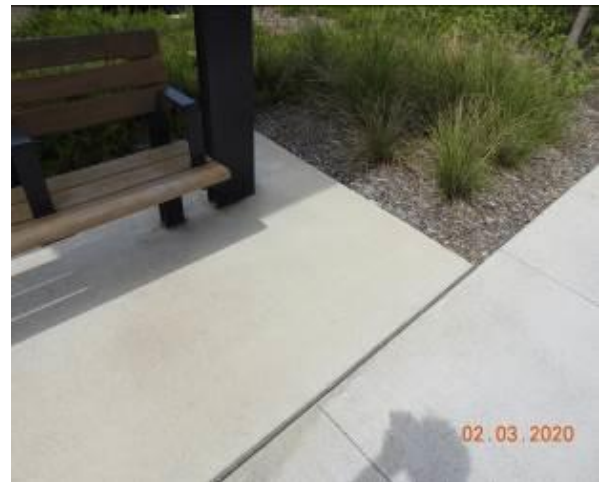
Figure 178 – General Condition of public bench

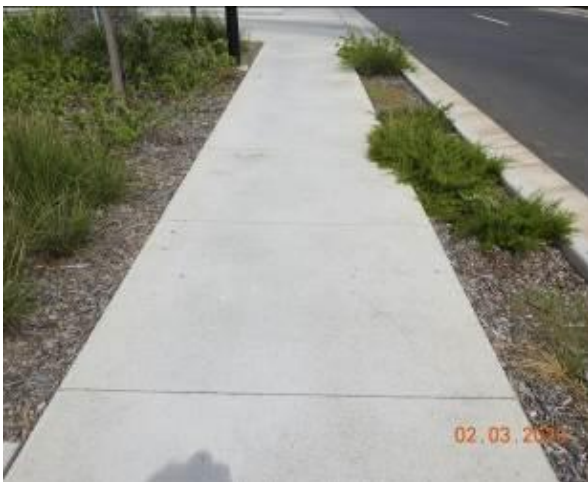
Figure 179 – General Condition of footpath pavement

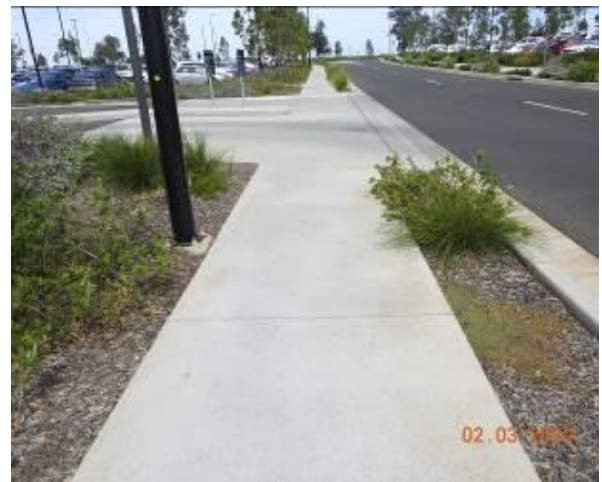
Figure 180 – General Condition of footpath pavement

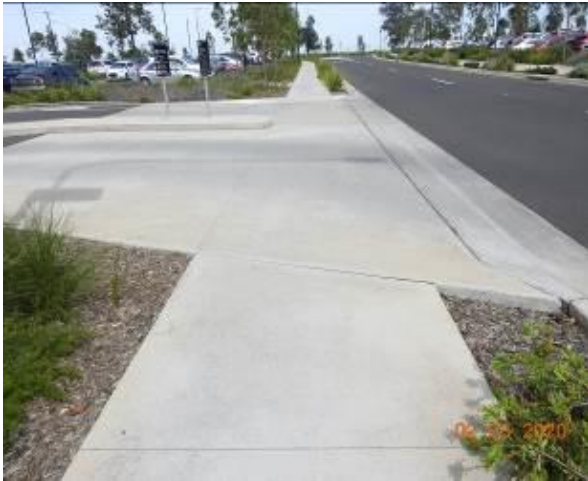
Figure 181 – General Condition of footpath pavement

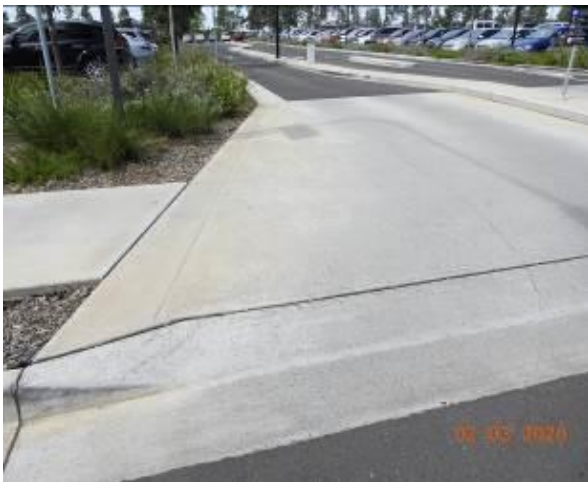
Figure 183 – General Condition of driveway pavement

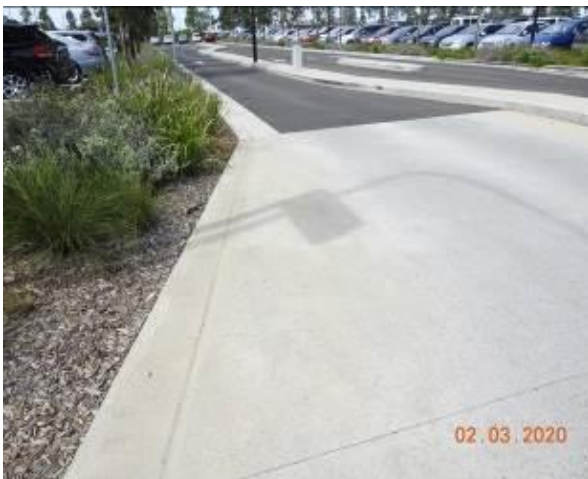
Figure 185 – General Condition of driveway pavement

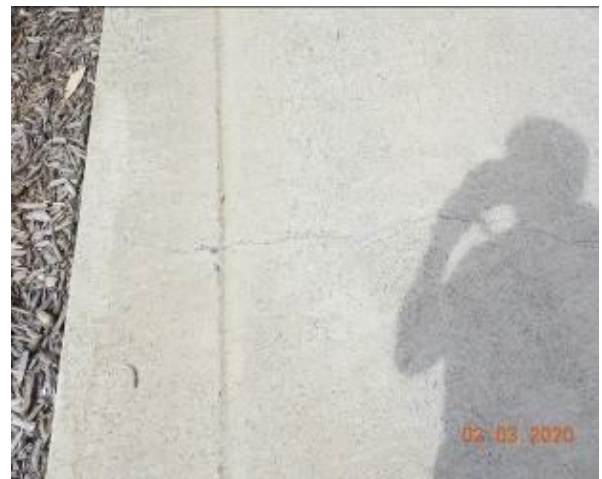
Figure 186 – Crack propagation through driveway pavement

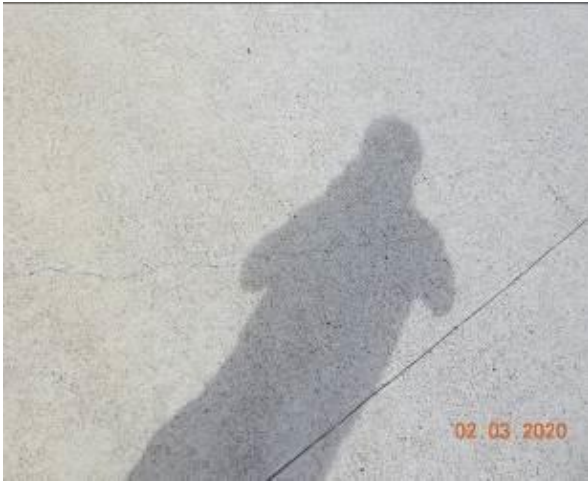
Figure 187 – Crack propagation through driveway pavement

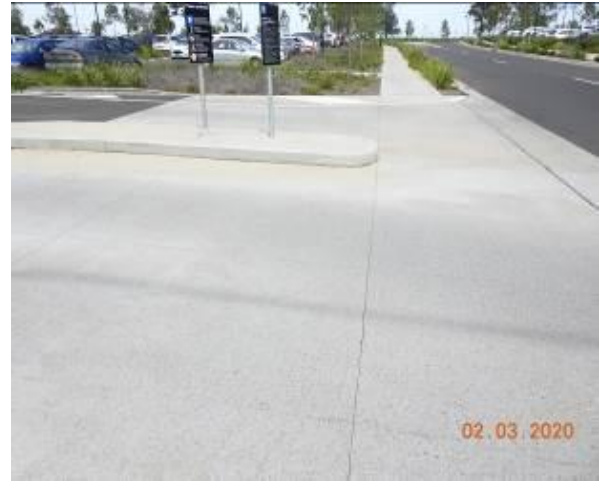
Figure 188 – General Condition of driveway pavement

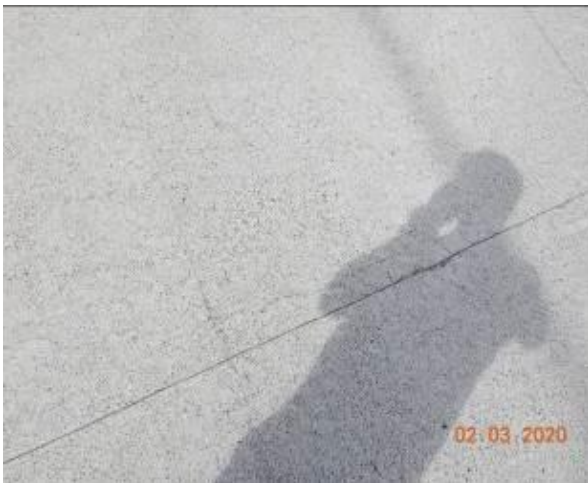
Figure 189 – Crack propagation through driveway pavement

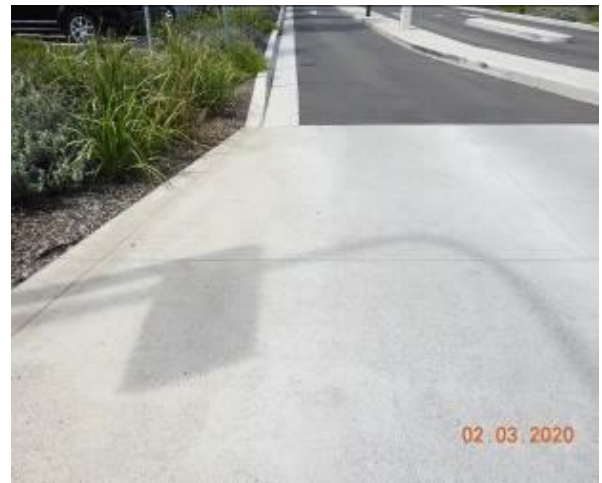
Figure 190 – General Condition of driveway pavement

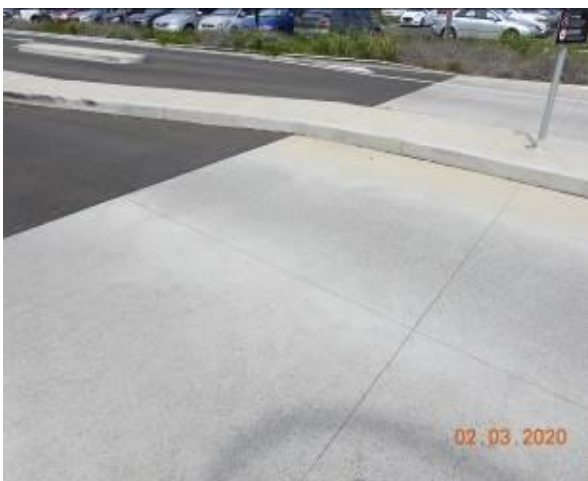
Figure 191 – General Condition of driveway pavement

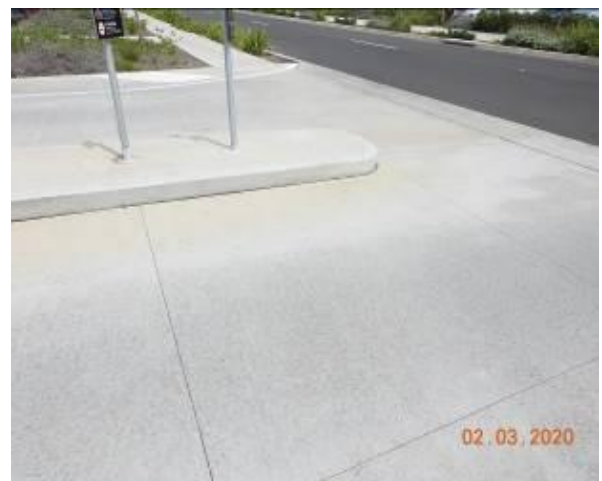
Figure 192 – General Condition of driveway pavement

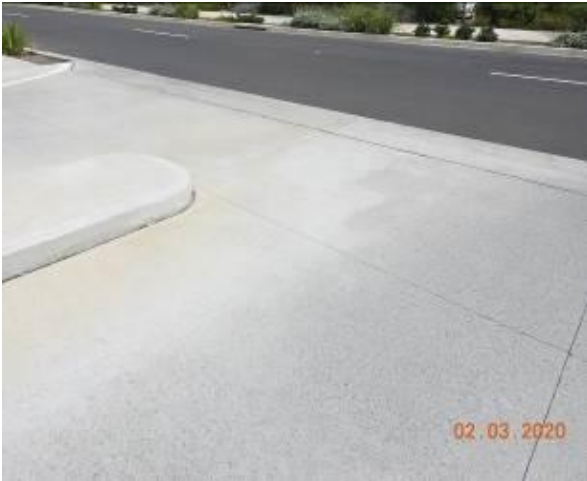
Figure 193 – General Condition of driveway pavement

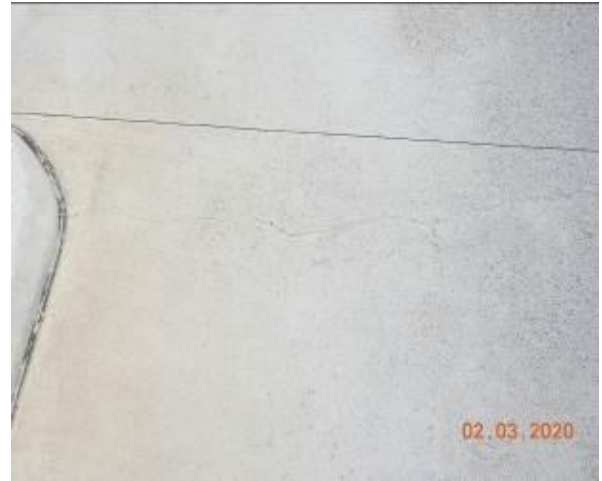
Figure 194 – Crack propagation through driveway pavement

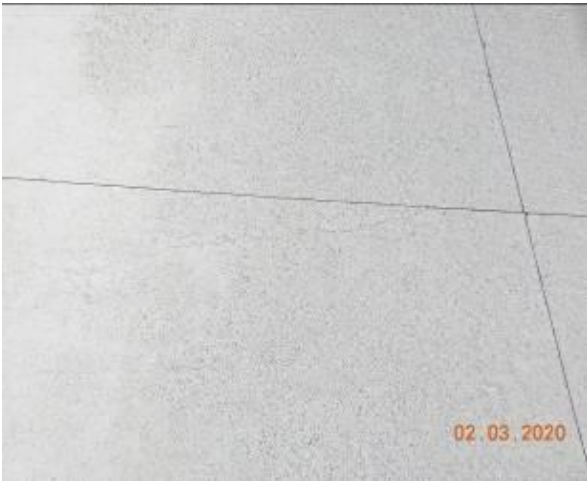
Figure 195 – Crack propagation through driveway pavement

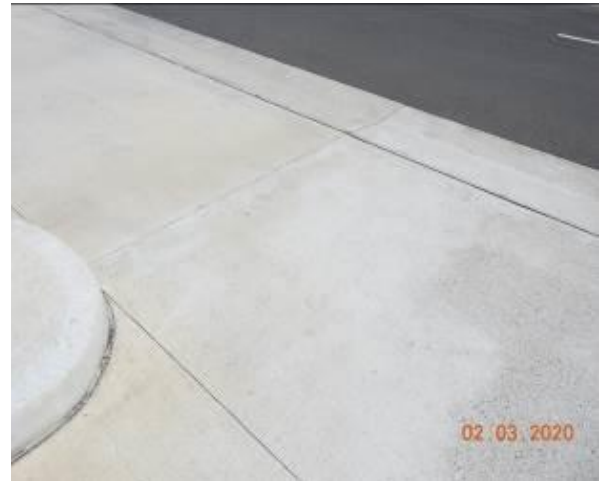
Figure 196 – General Condition of driveway pavement
