**1-15 AND 2-12 CONFERTA AVENUE,
ROUSE HILL NSW 2155
TALLAWONG STATION PRECINCT SOUTH
PRE-DILAPIDATION REPORT**

**DEICORP PROJECTS
(TALLAWONG STATION) PTY LTD**

Job No. 191294.0
24/03/2020

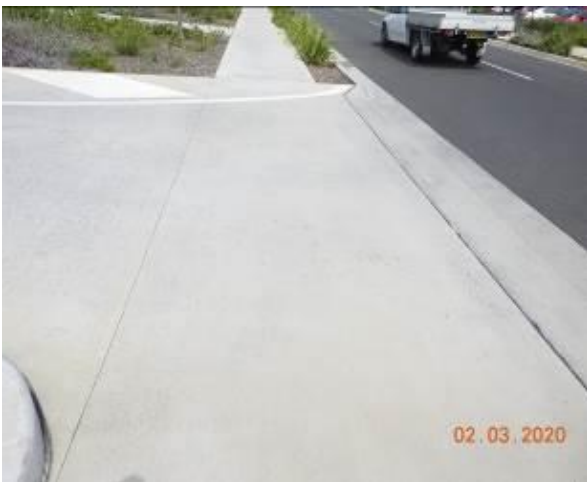
Figure 197 – General Condition of driveway pavement

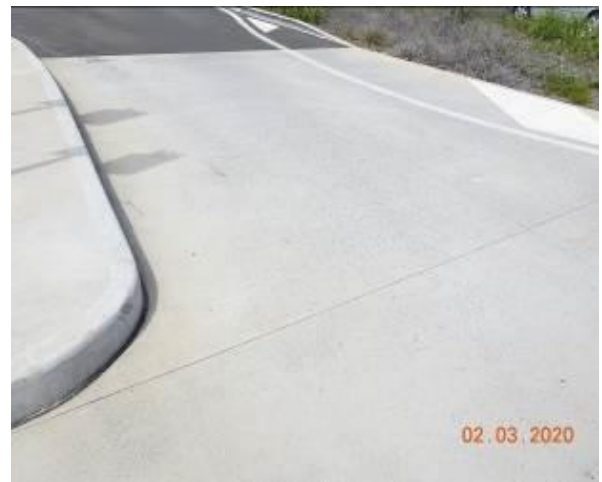
Figure 198 – General Condition of driveway pavement

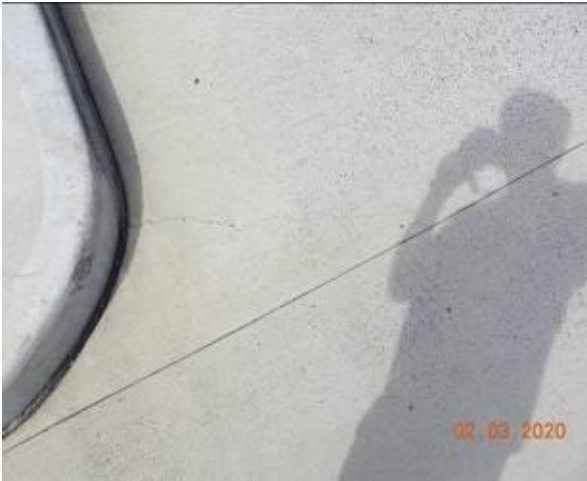
Figure 199 – Crack propagation through driveway pavement

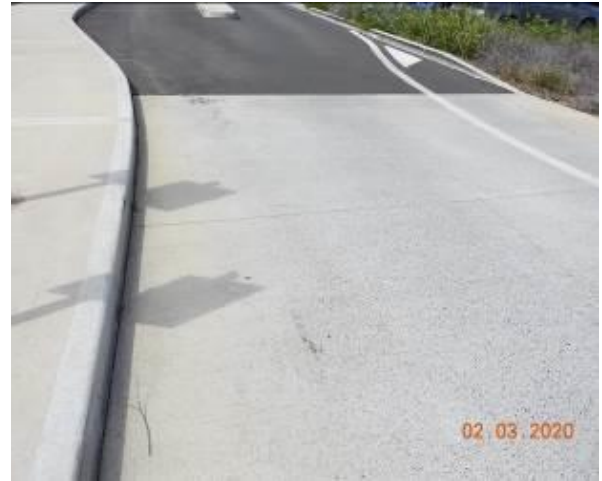
Figure 200 – General Condition of driveway pavement

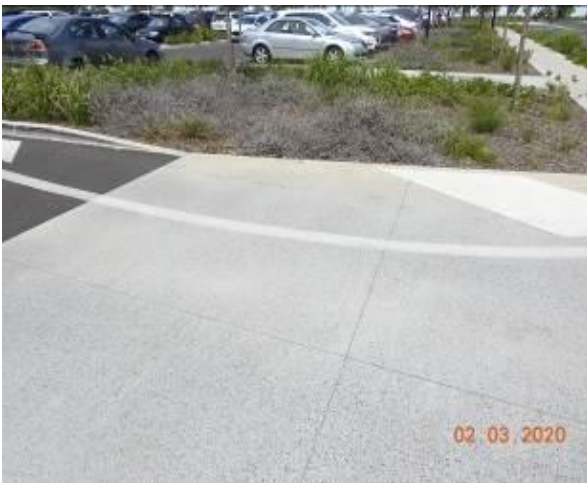
Figure 201 – General Condition of driveway pavement

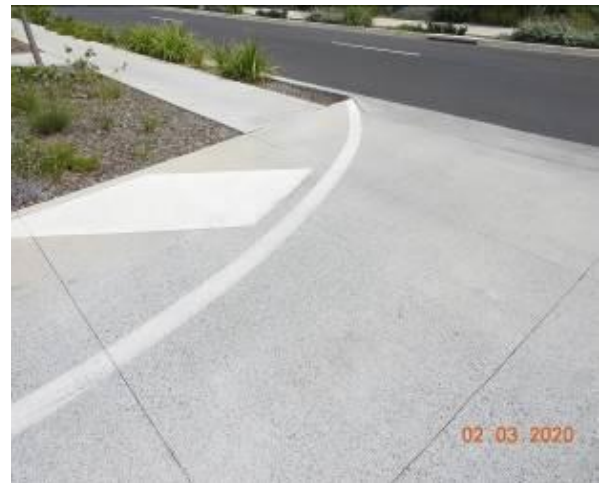
Figure 202 – General Condition of driveway pavement

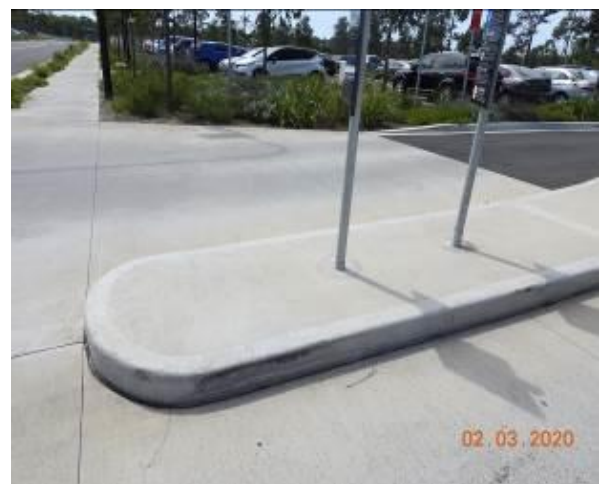
Figure 203 – General Condition of driveway pavement

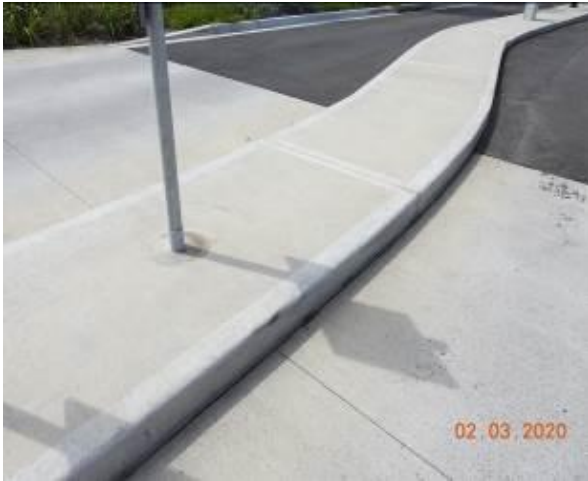
Figure 204 – General Condition of driveway pavement

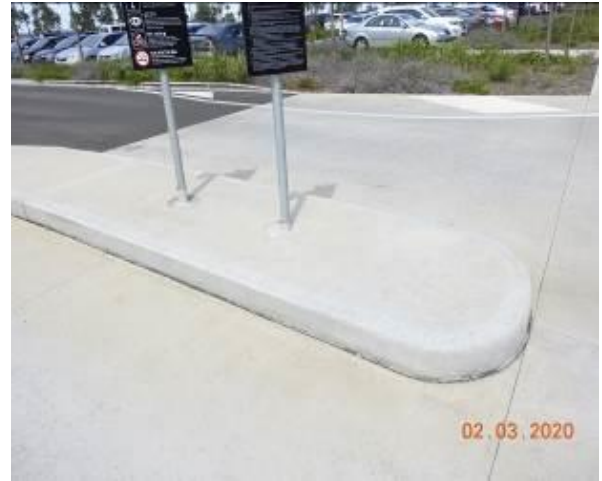
Figure 205 – General Condition of traffic island

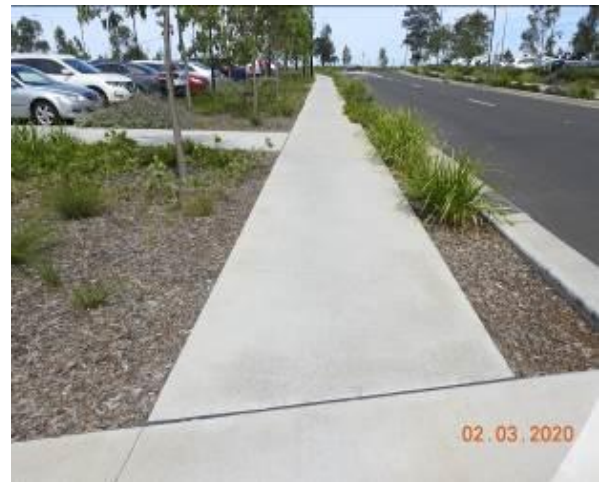
Figure 207 – General Condition of traffic island

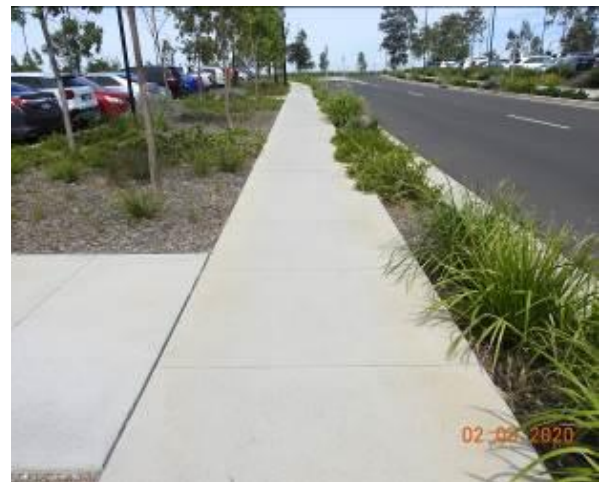
Figure 209 – General Condition of footpath pavement

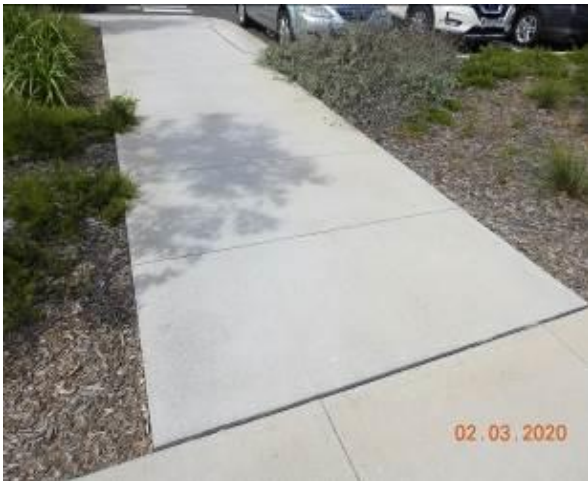
Figure 210 – General Condition of footpath pavement

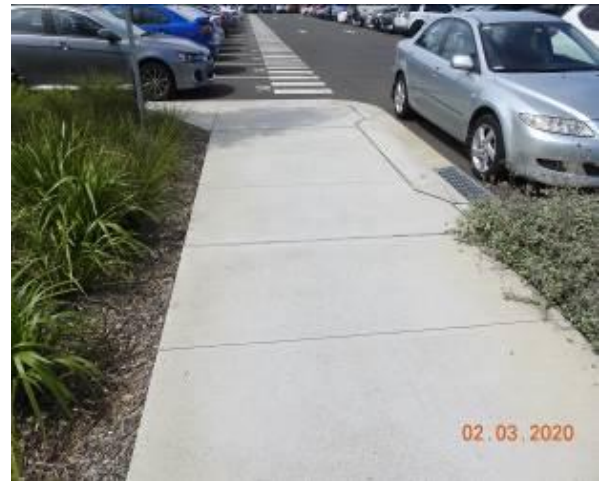
Figure 211 – General Condition of footpath pavement

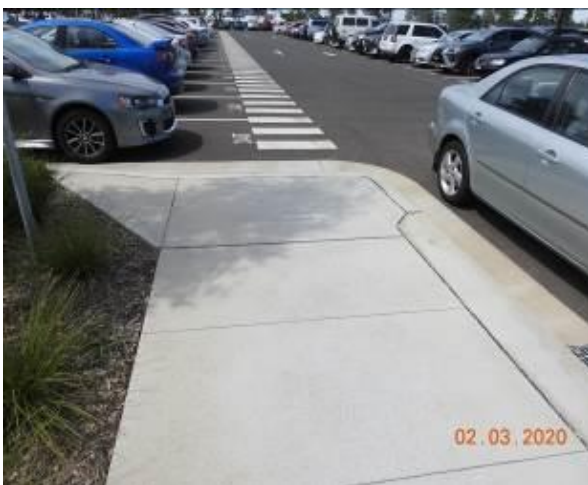
Figure 212 – General Condition of footpath pavement

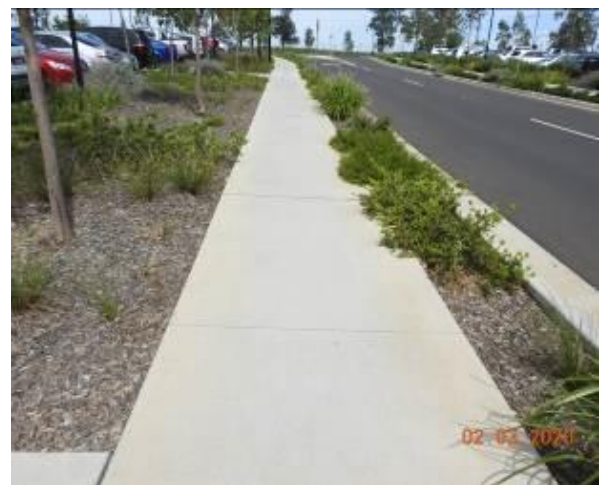
Figure 213 – General Condition of footpath pavement

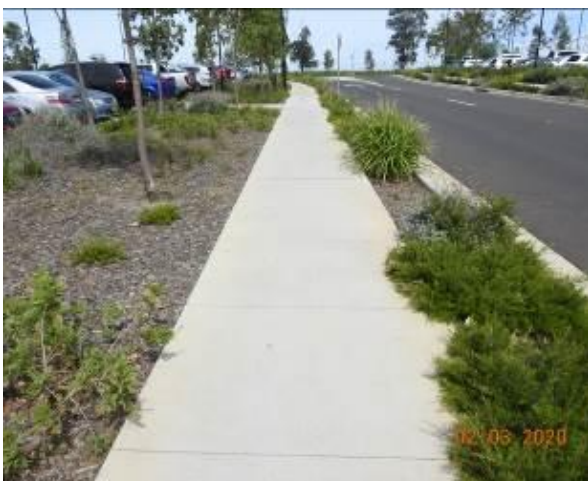
Figure 214 – General Condition of footpath pavement

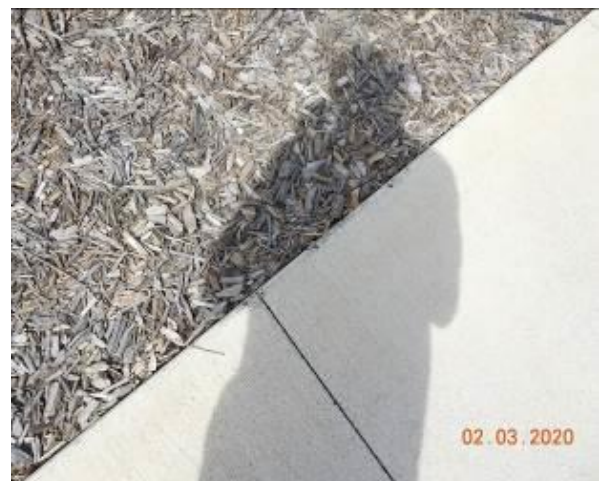
Figure 215 – General Condition of footpath pavement

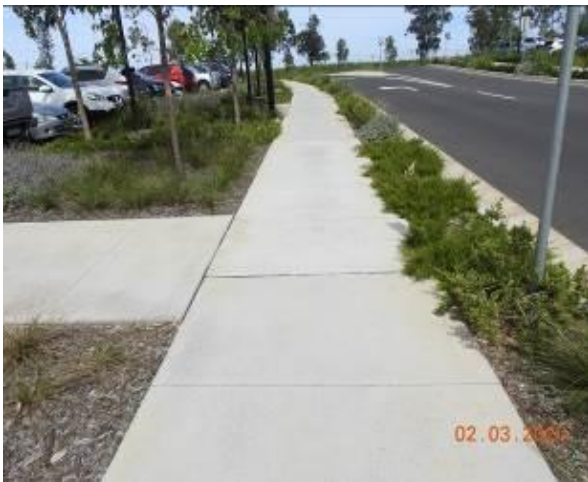
Figure 218 – General Condition of footpath pavement

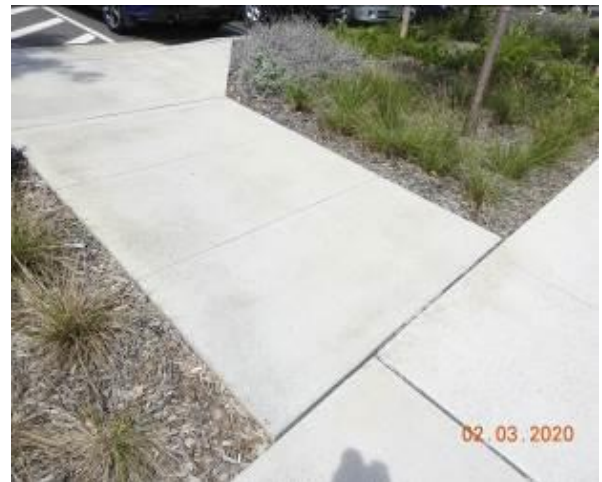
Figure 219 – General Condition of footpath pavement

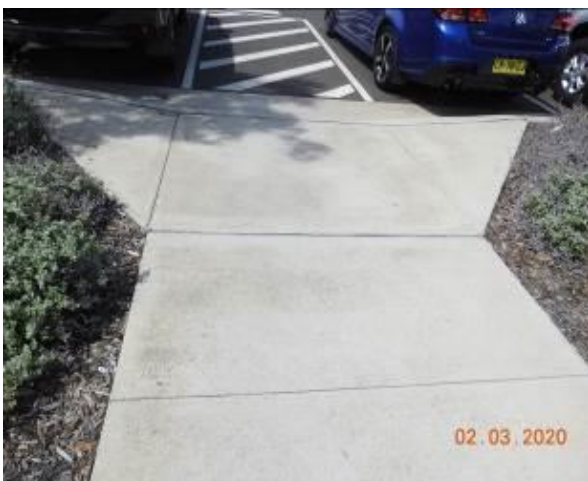
Figure 220 – General Condition of footpath pavement

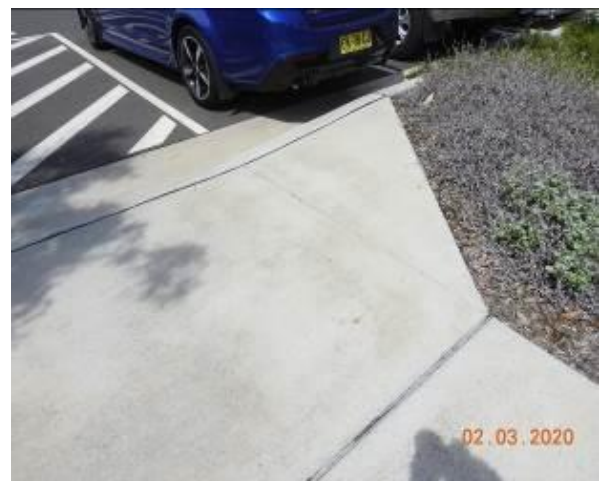
Figure 221 – General Condition of footpath pavement

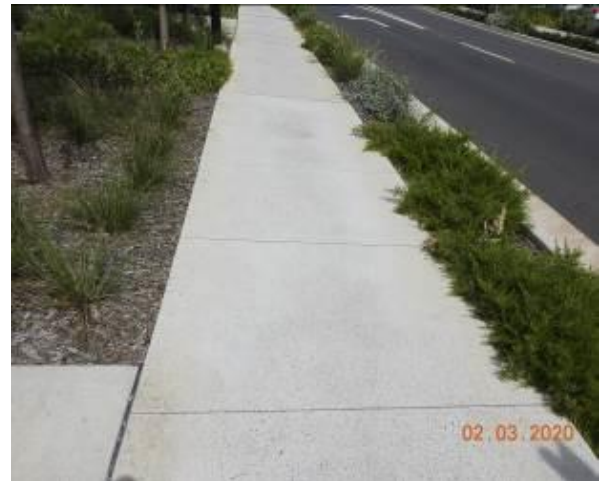
Figure 223 – General Condition of footpath pavement

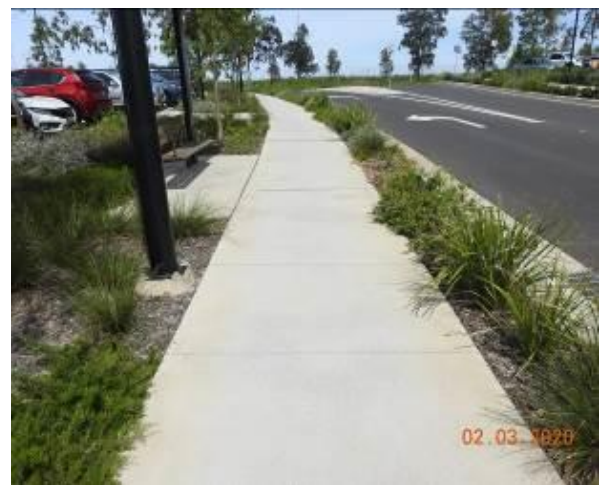
Figure 225 – General Condition of footpath pavement

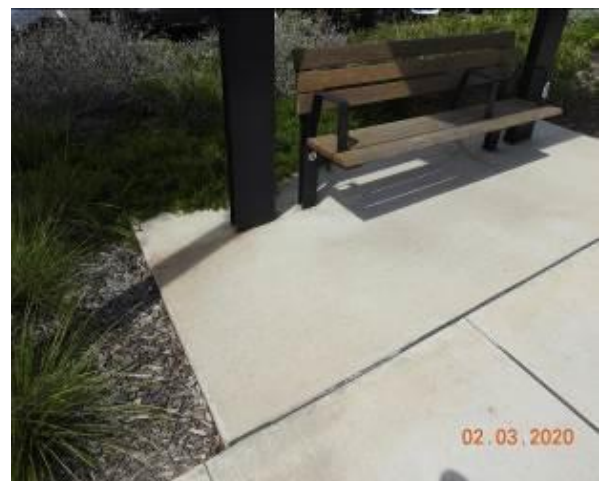
Figure 227 – General Condition of footpath pavement

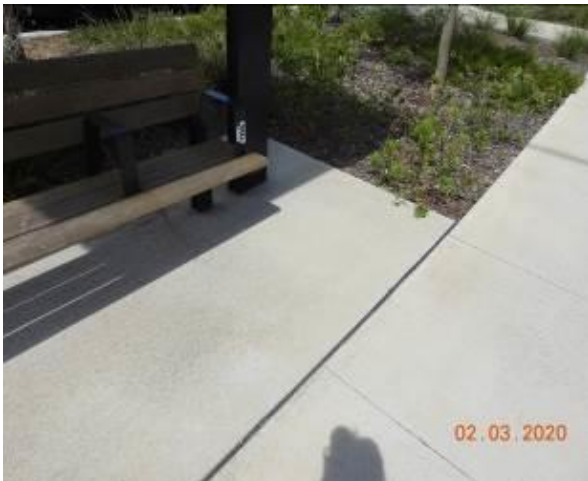
Figure 228 – General Condition of public bench

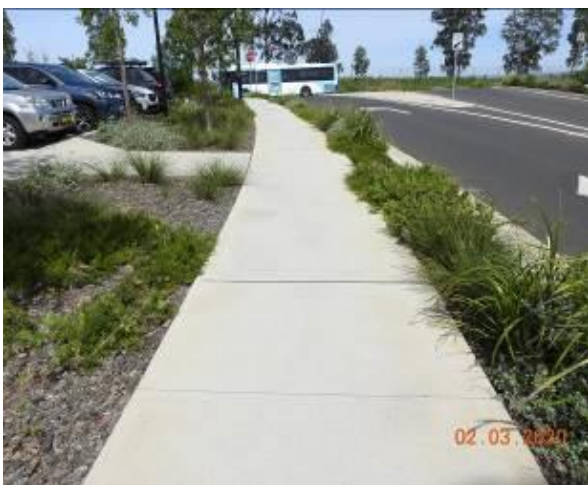
Figure 230 – General Condition of footpath pavement

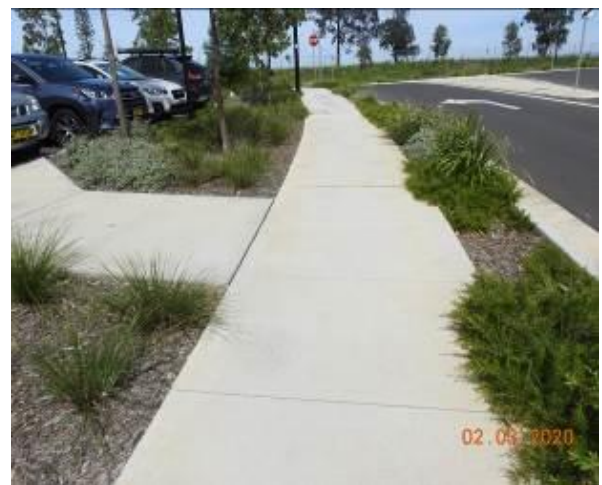
Figure 231 – General Condition of footpath pavement

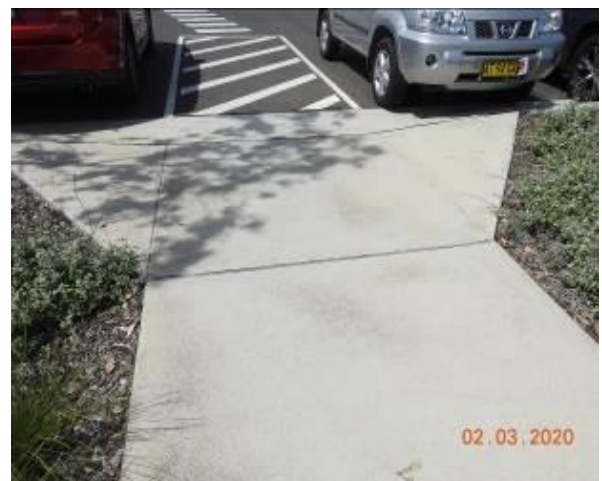
Figure 233 – General Condition of footpath pavement

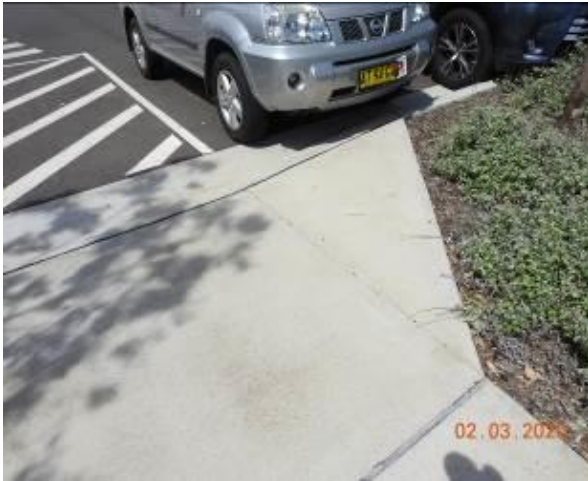
Figure 234 – General Condition of footpath pavement

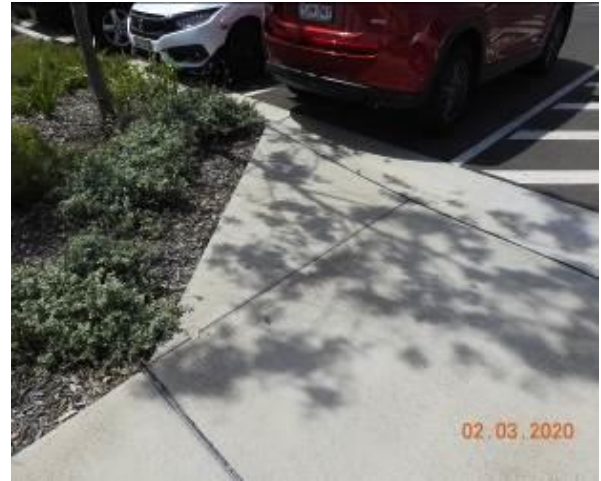
Figure 235 – General Condition of footpath pavement

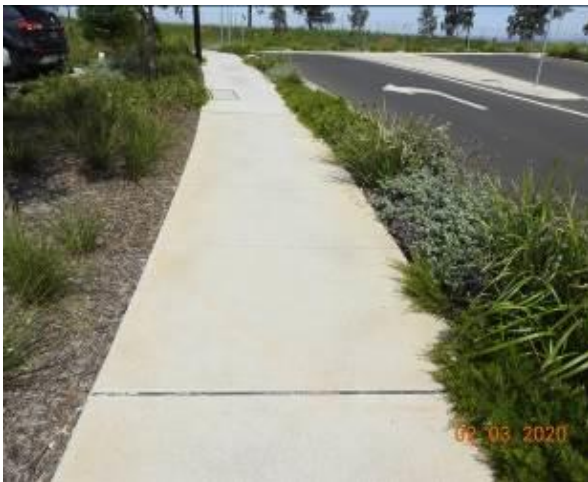
Figure 236 – General Condition of footpath pavement

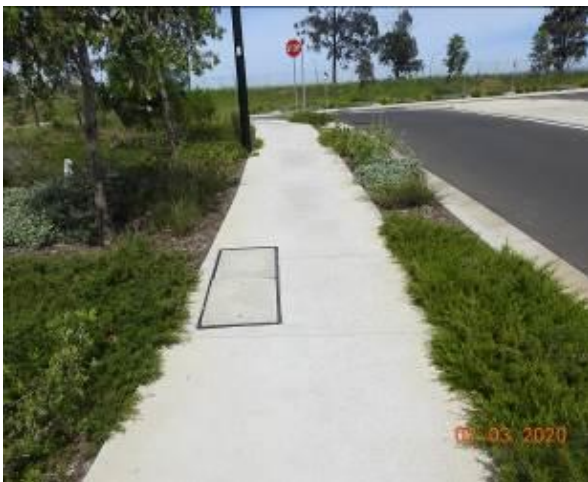
Figure 238 – General Condition of footpath pavement

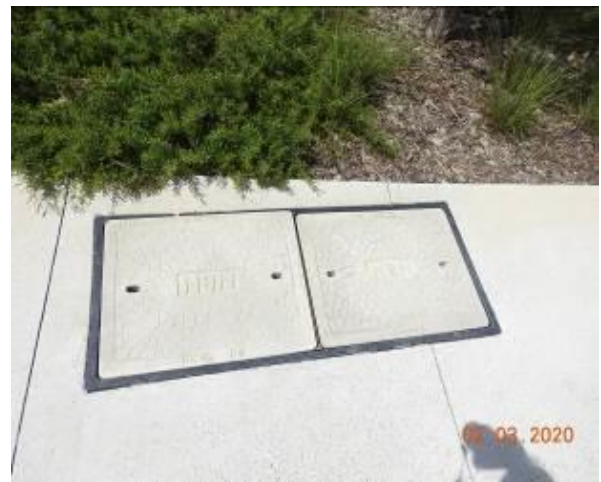
Figure 239 – General Condition of footpath pavement

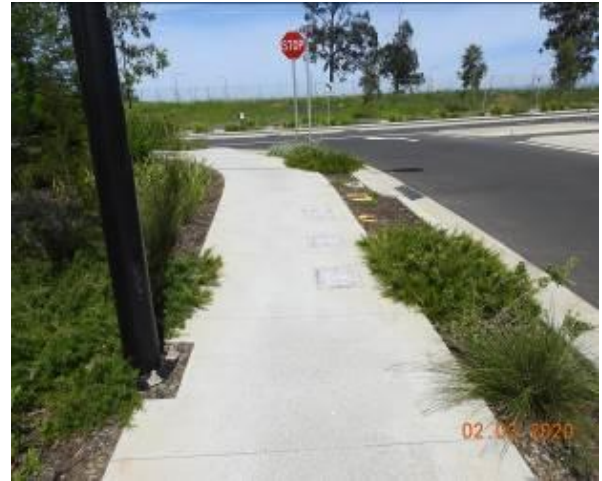
Figure 241 – General Condition of footpath pavement

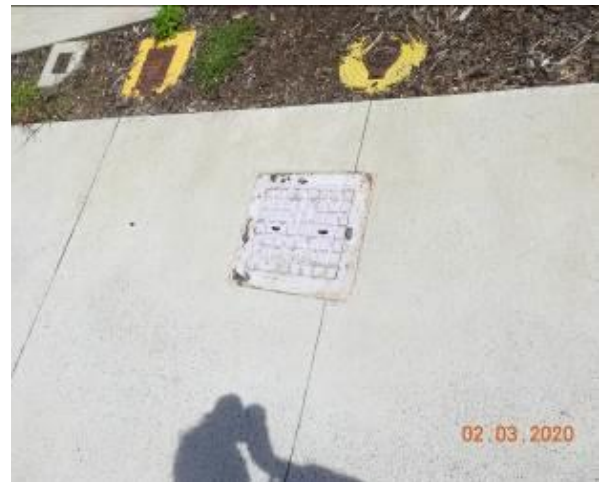
Figure 244 – General Condition of service pit

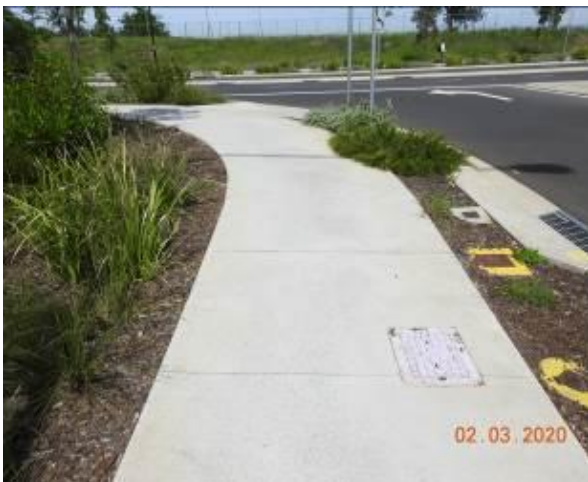
Figure 245 – General Condition of footpath pavement

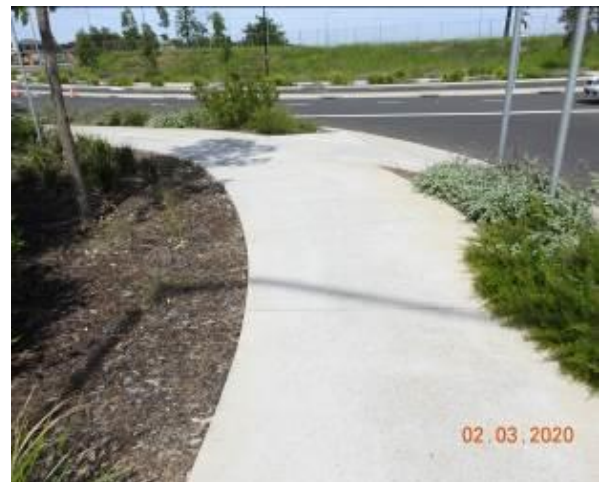
Figure 246 – General Condition of footpath pavement

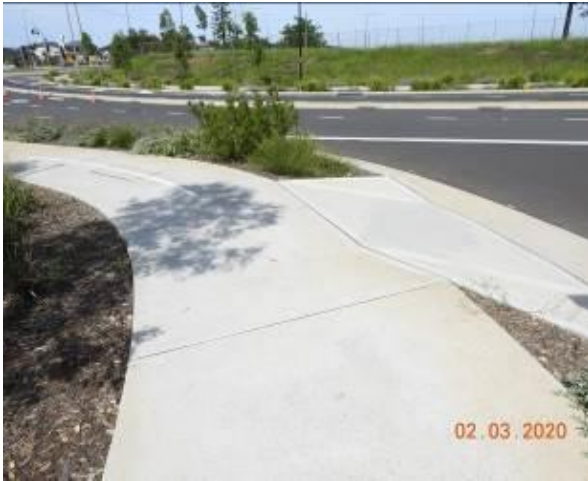
Figure 247 – General Condition of footpath pavement

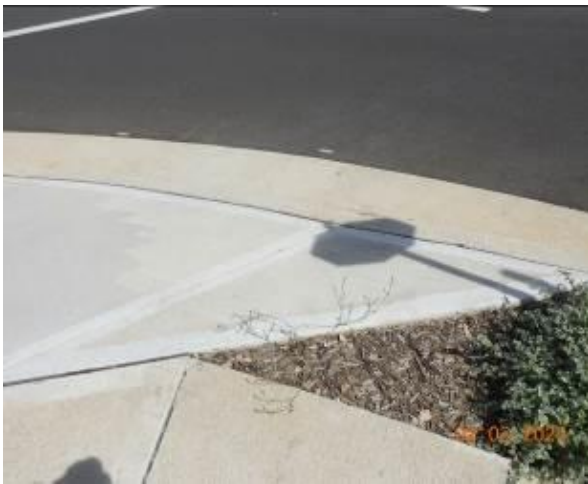
Figure 249 – General Condition of footpath pavement

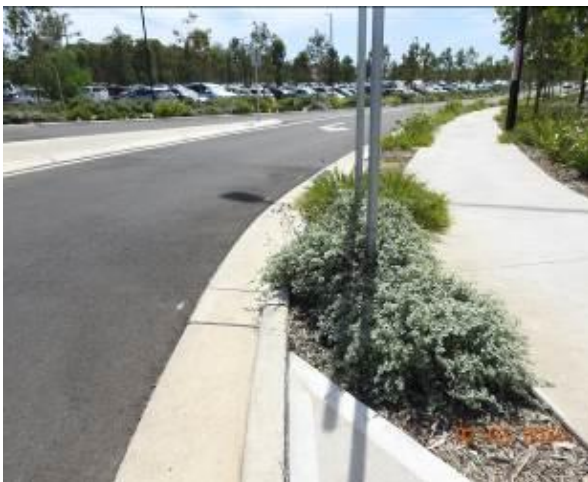
Figure 251 – General Condition of kerb and gutter

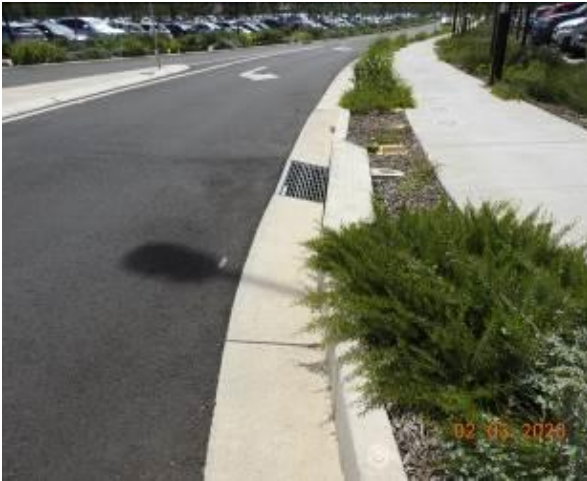
Figure 253 – General Condition of kerb and gutter

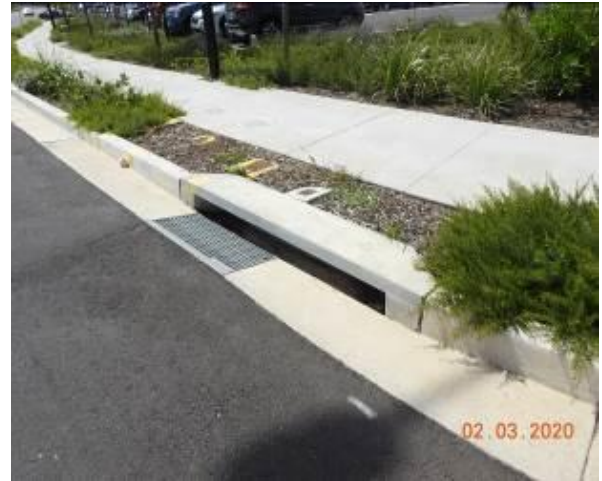
Figure 254 – General Condition of stormwater inlet pit

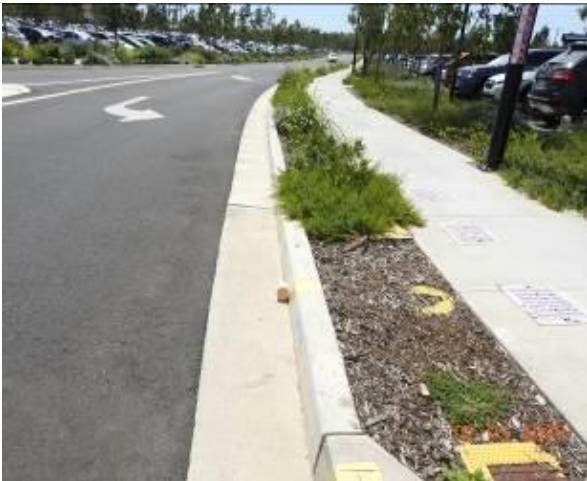
Figure 255 – General Condition of kerb and gutter

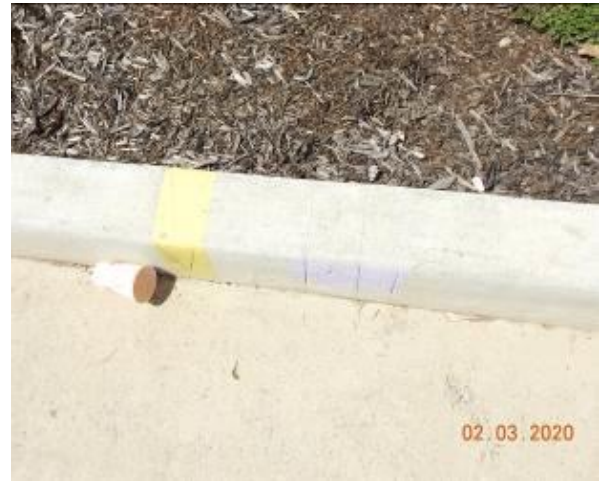
Figure 256 – General Condition of kerb and gutter

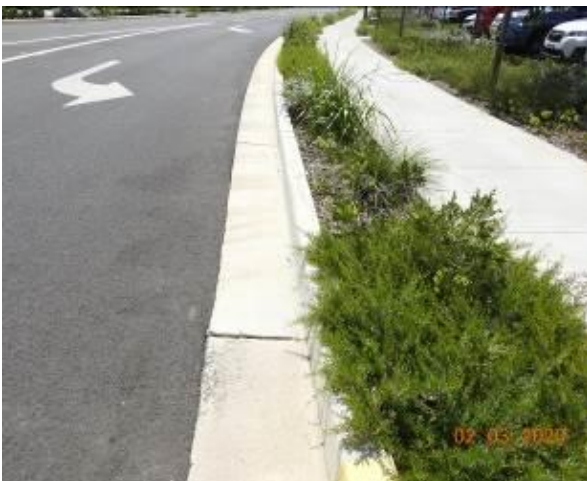
Figure 257 – General Condition of kerb and gutter

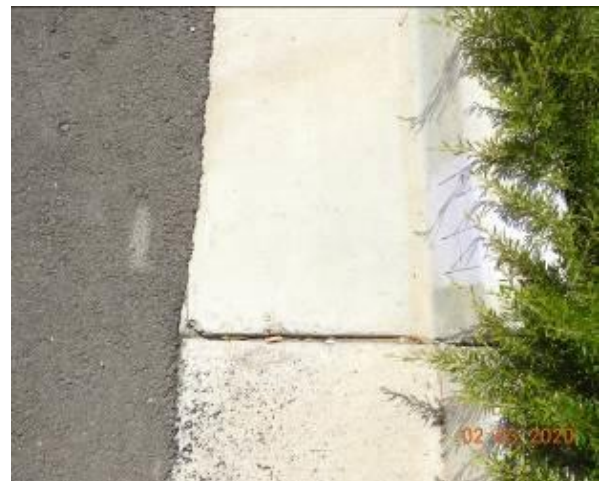
Figure 258 – Crack propagation through kerb and gutter

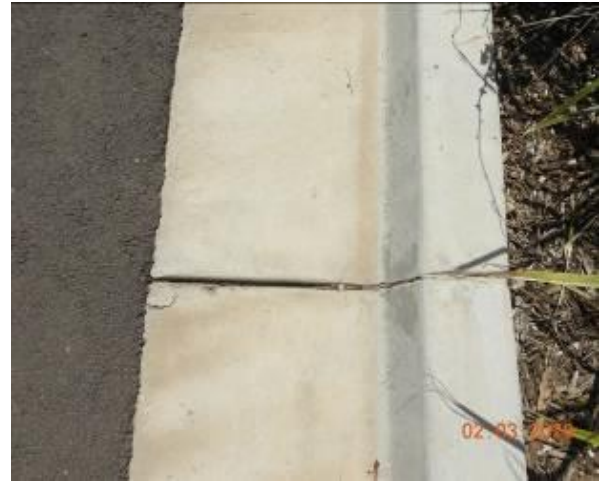
Figure 260 – Crack propagation through kerb and gutter

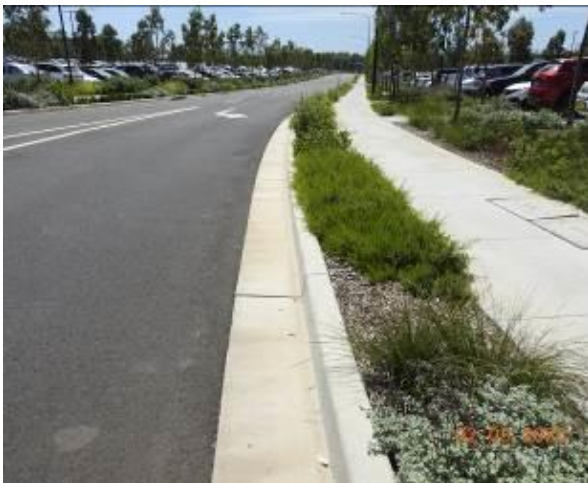
Figure 261 – General Condition of kerb and gutter

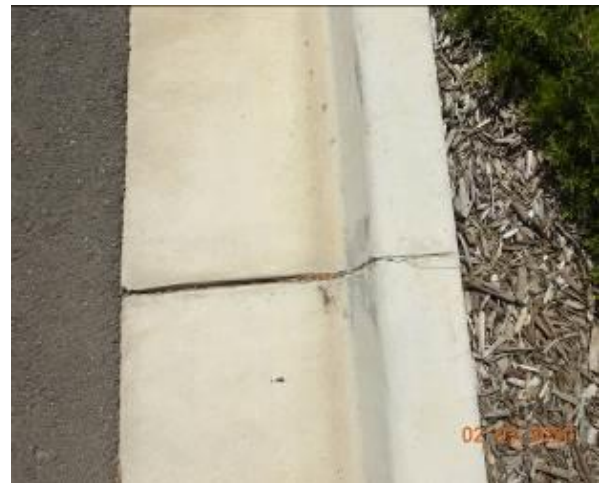
Figure 262 – Crack propagation through kerb and gutter

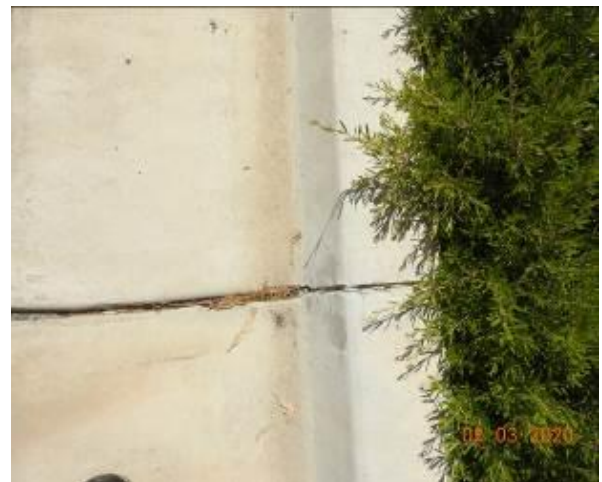
Figure 264 – Crack propagation through kerb and gutter

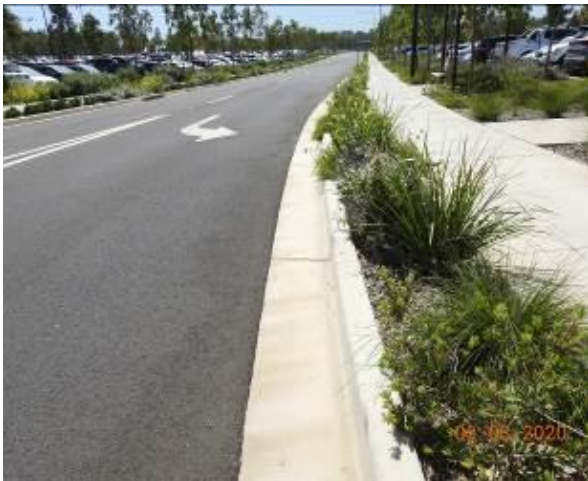
Figure 265 – General Condition of kerb and gutter

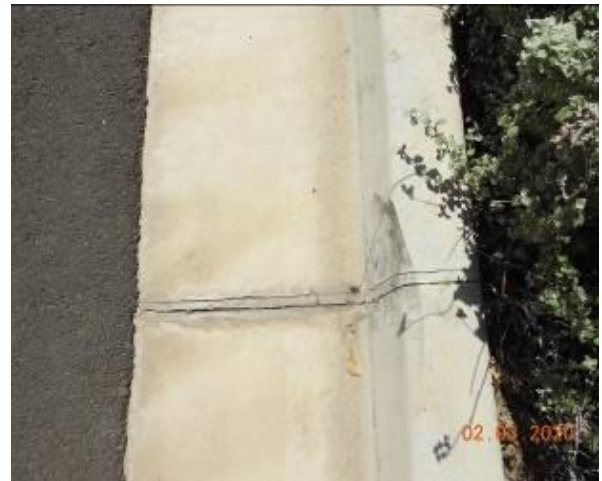
Figure 266 – Crack propagation through kerb and gutter

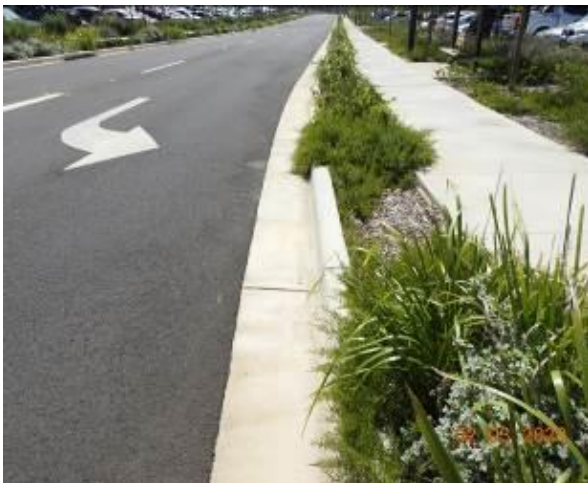
Figure 267 – General Condition of kerb and gutter

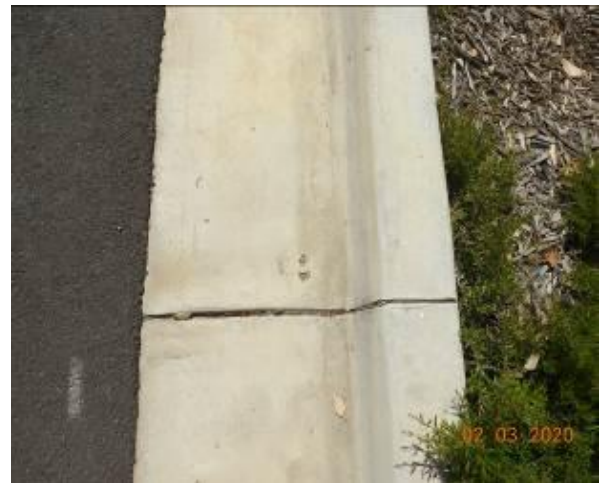
Figure 268 – Crack propagation through kerb and gutter

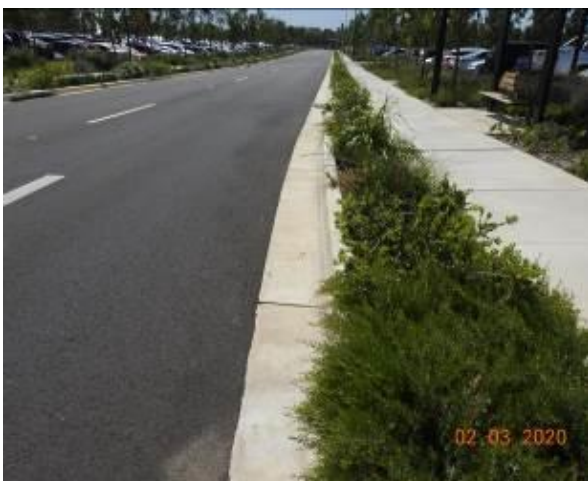
Figure 269 – General Condition of kerb and gutter

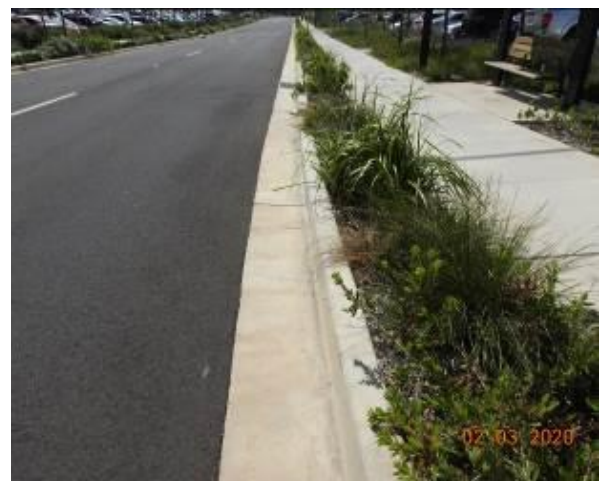
Figure 270 – General Condition of kerb and gutter

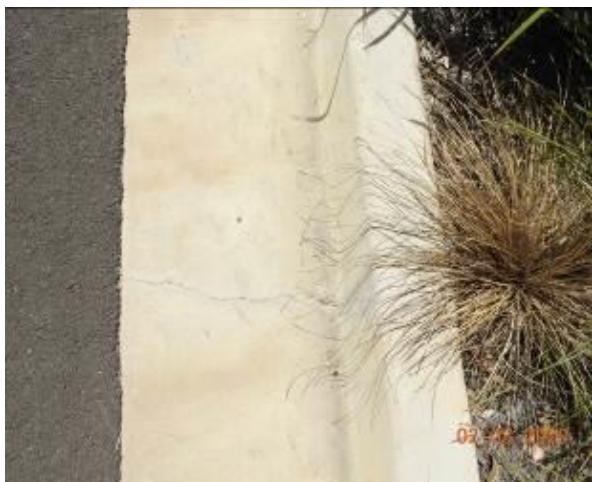
Figure 271 – Crack propagation through kerb and gutter

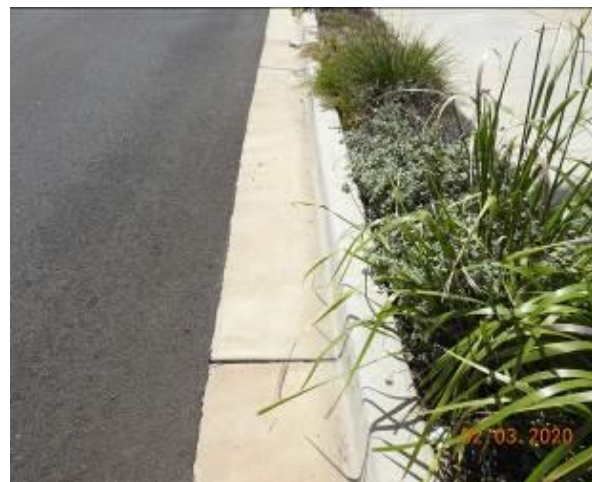
Figure 272 – General Condition of kerb and gutter

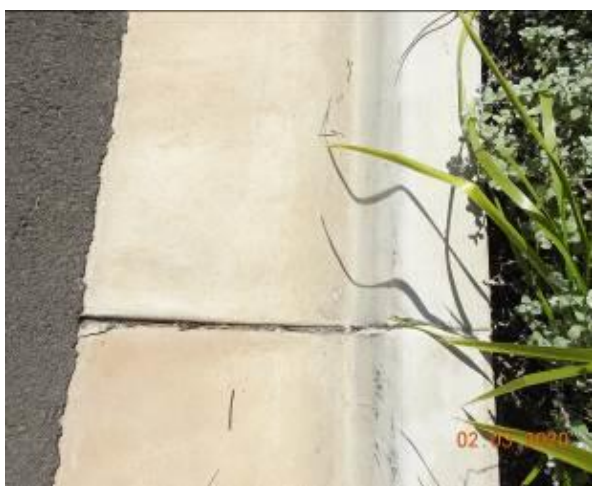
Figure 273 – Crack propagation through kerb and gutter

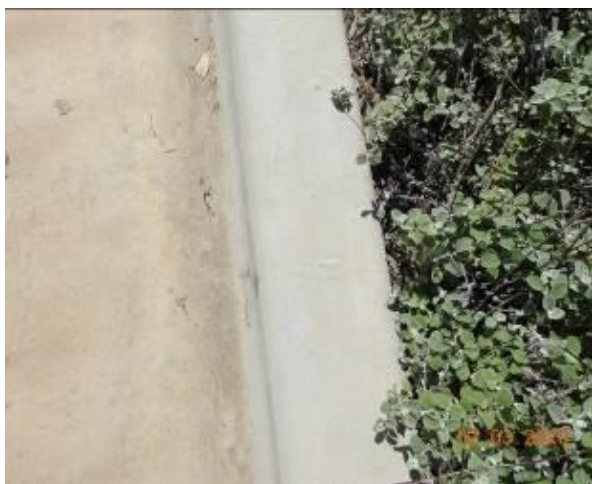
Figure 275 – General Condition of kerb

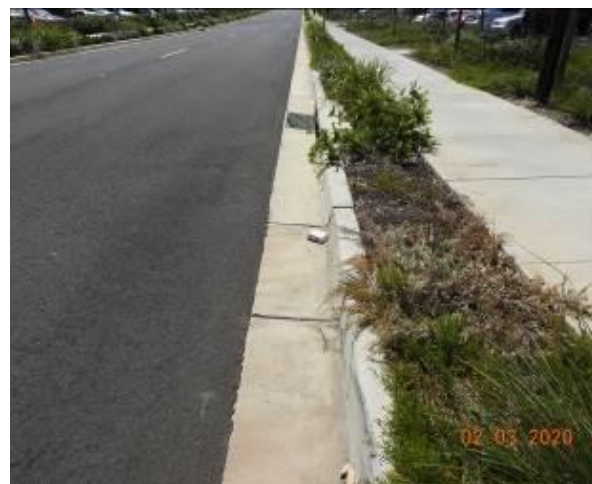
Figure 276 – General Condition of kerb and gutter

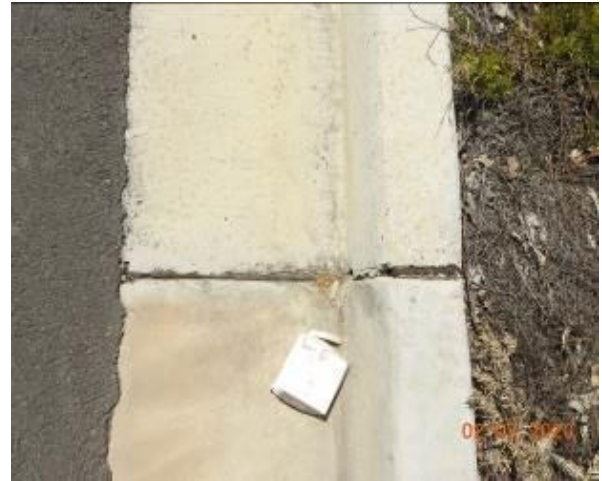
Figure 278 – Crack propagation through kerb and gutter

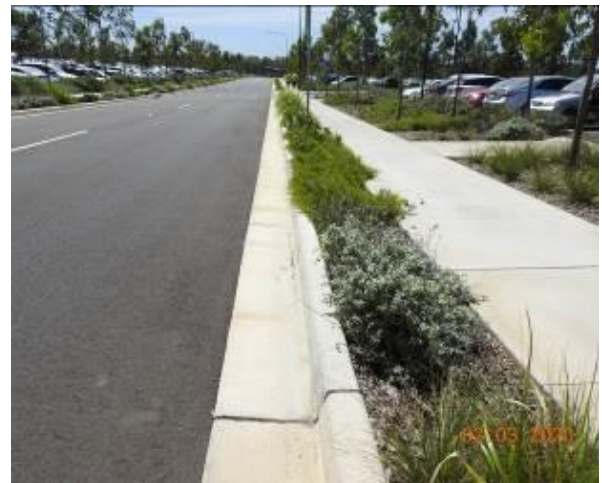
Figure 280 – General Condition of kerb and gutter

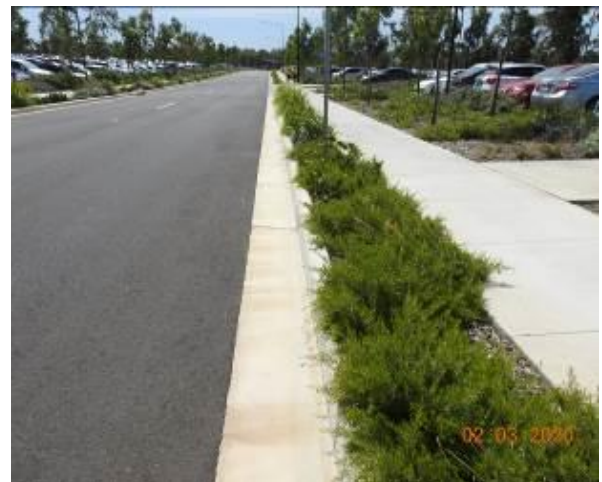
Figure 282 – General Condition of kerb and gutter

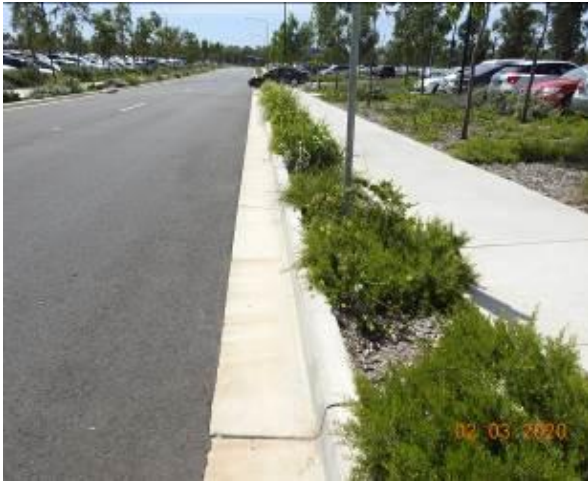
Figure 283 – General Condition of kerb and gutter

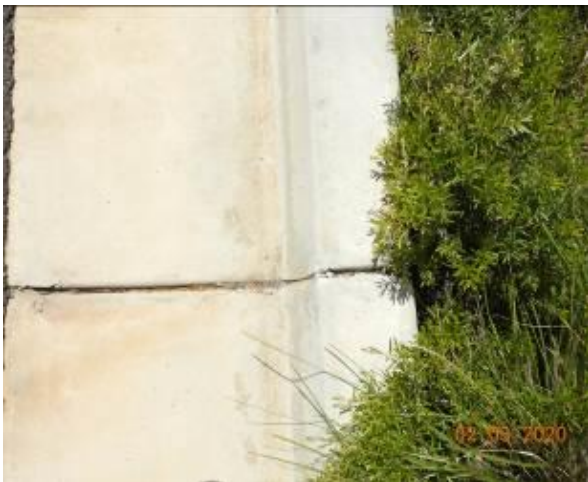
Figure 285 – Crack propagation through kerb and gutter

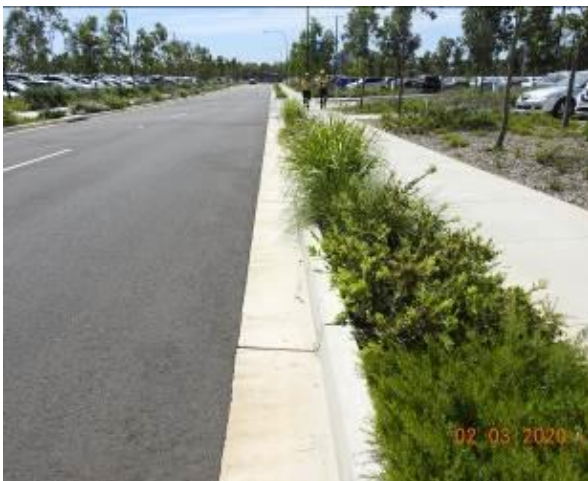
Figure 287 – General Condition of kerb and gutter

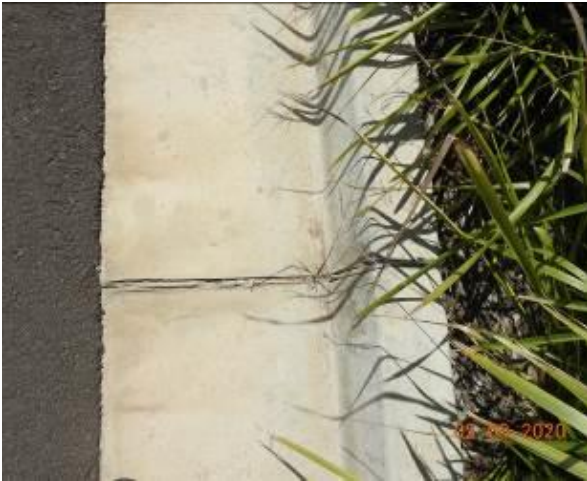
Figure 289 – Crack propagation through kerb and gutter

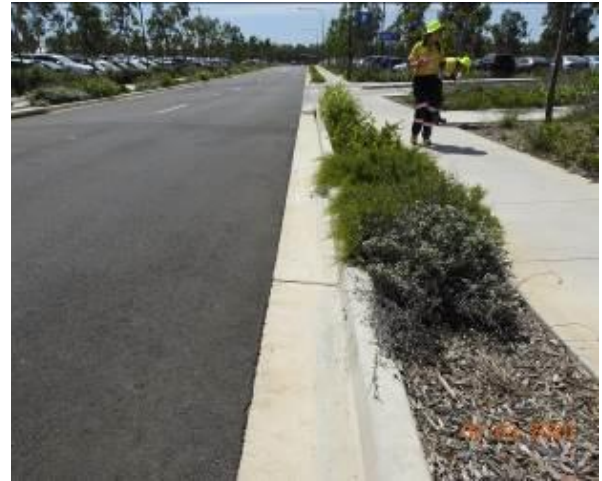
Figure 290 – General Condition of kerb and gutter

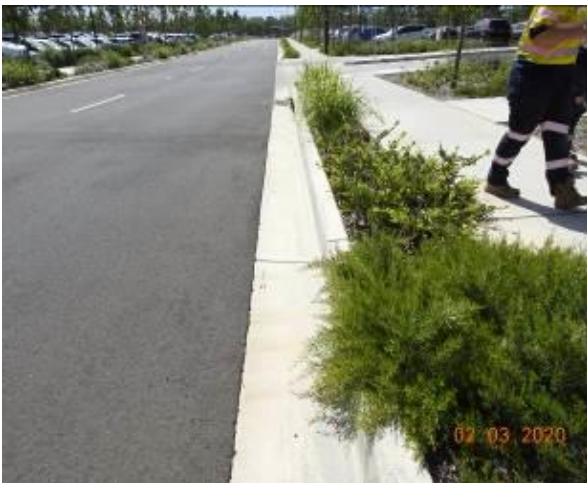
Figure 291 – General Condition of kerb and gutter

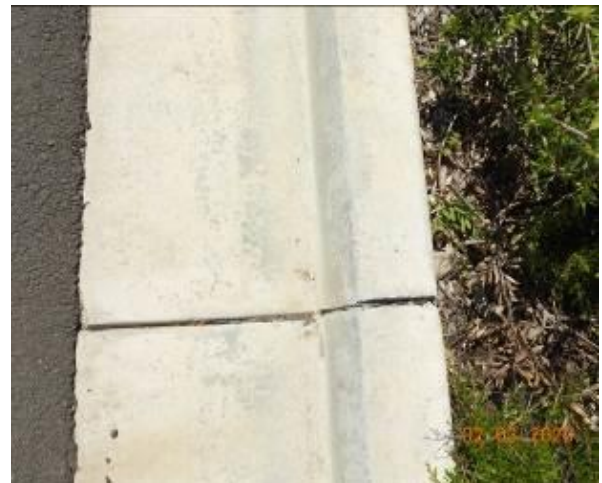
Figure 292 – Crack propagation through kerb and gutter

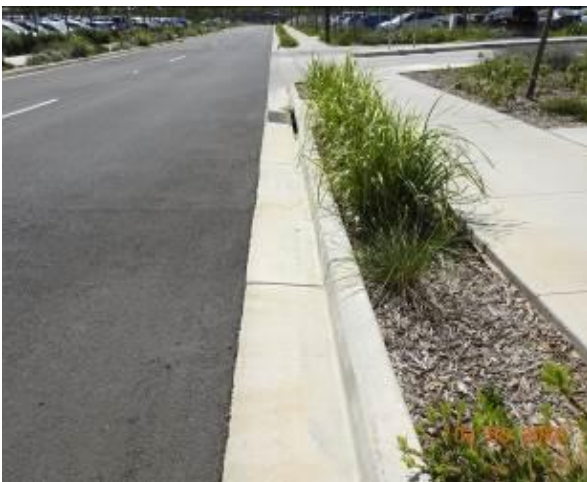
Figure 293 – General Condition of kerb and gutter

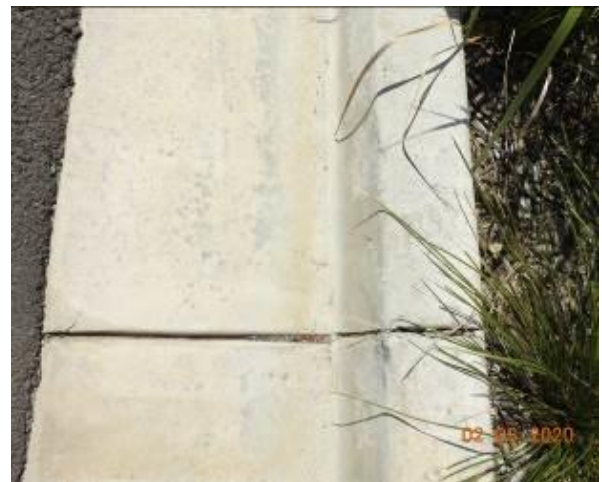
Figure 294 – Crack propagation through kerb and gutter

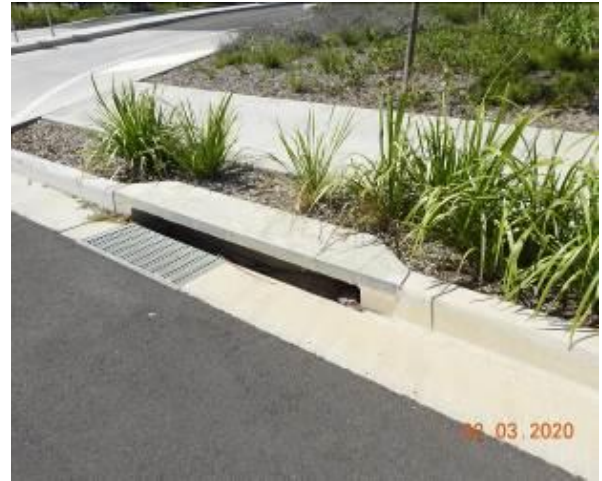
Figure 296 – General Condition of stormwater inlet pit

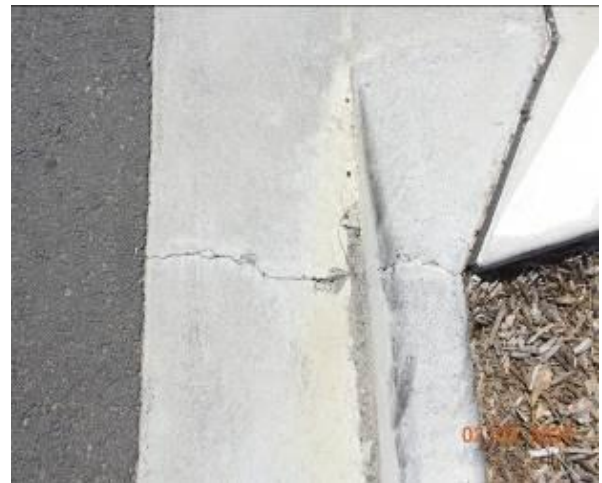
Figure 298 – Crack propagation through kerb and gutter

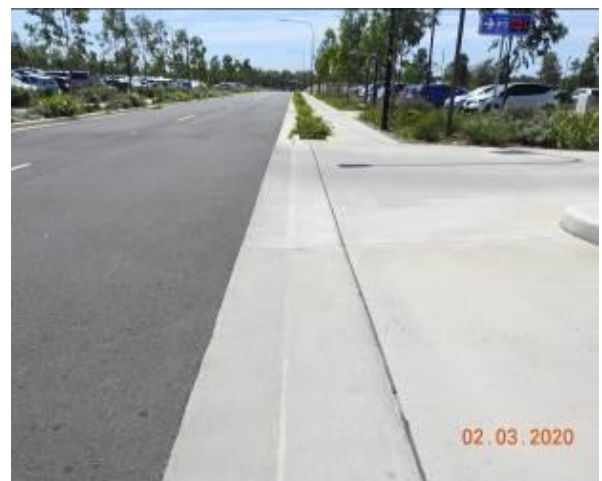
Figure 300 – General Condition of gutter

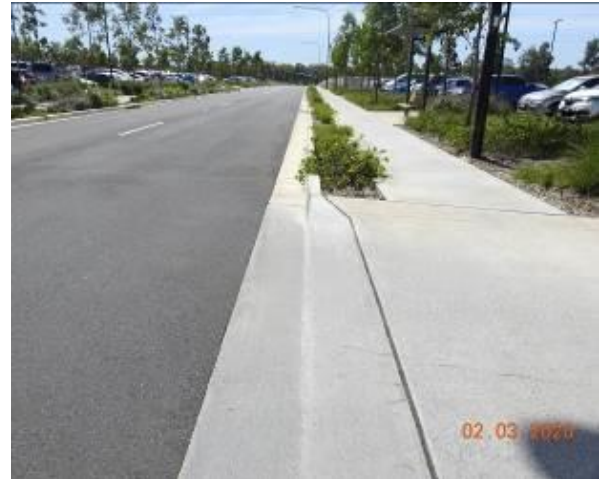
Figure 302 – General Condition of gutter
