**1-15 AND 2-12 CONFERTA AVENUE,
ROUSE HILL NSW 2155
TALLAWONG STATION PRECINCT SOUTH
PRE-DILAPIDATION REPORT**

**DEICORP PROJECTS
(TALLAWONG STATION) PTY LTD**

Job No. 191294.0
24/03/2020

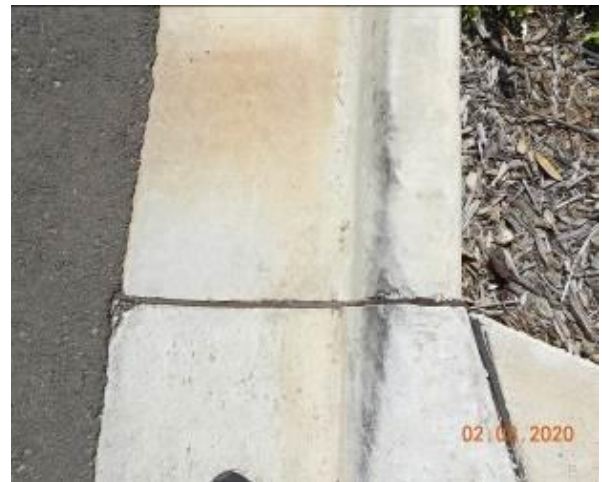
Figure 304 – Crack propagation through kerb and gutter

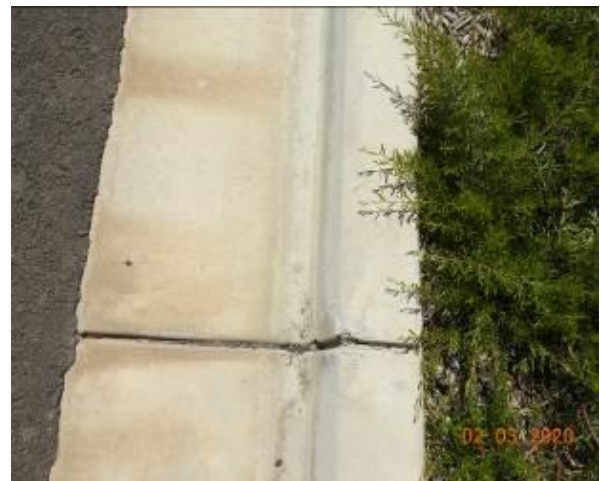
Figure 306 – Crack propagation through kerb and gutter

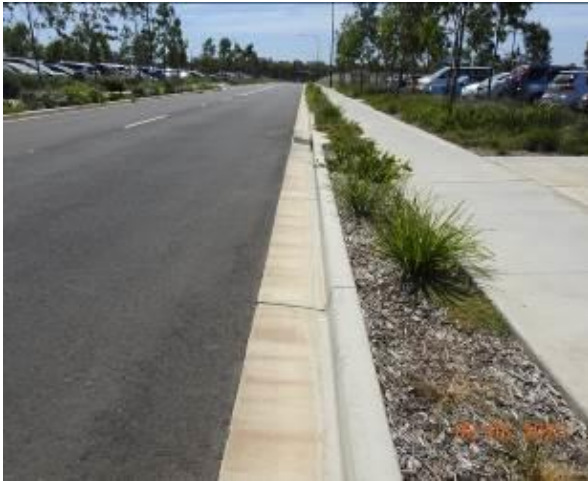
Figure 307 – General Condition of kerb and gutter

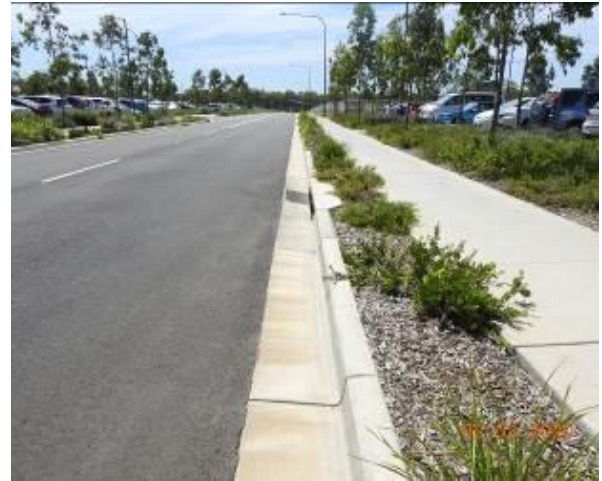
Figure 308 – General Condition of kerb and gutter

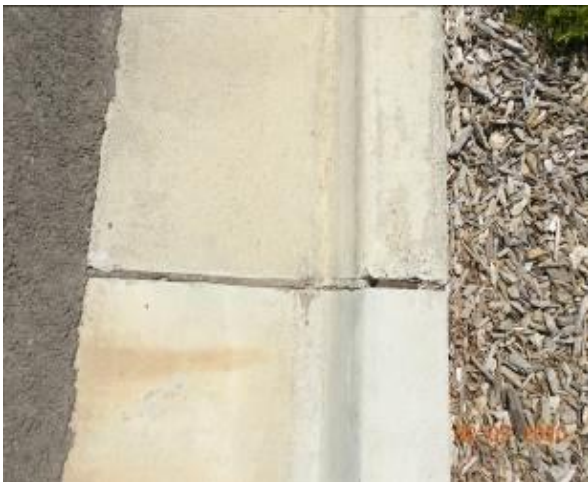
Figure 309 – Crack propagation through kerb and gutter

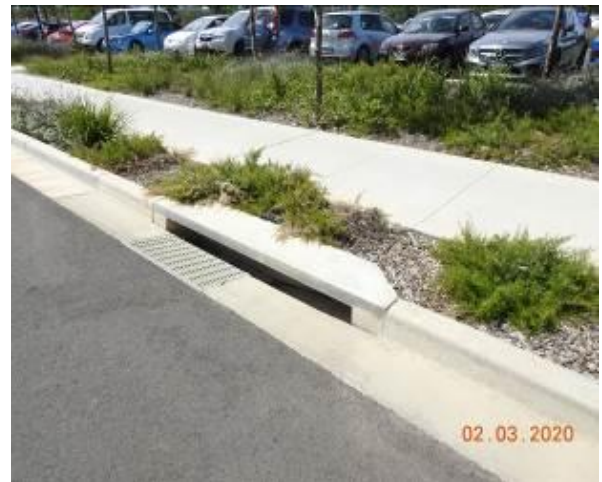
Figure 310 – General Condition of stormwater inlet pit

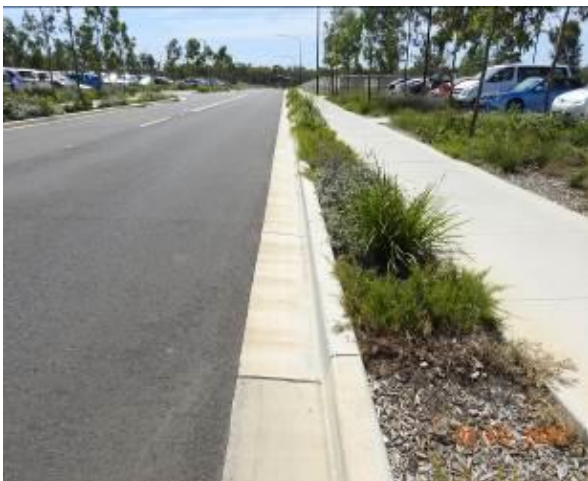
Figure 311 – General Condition of kerb and gutter

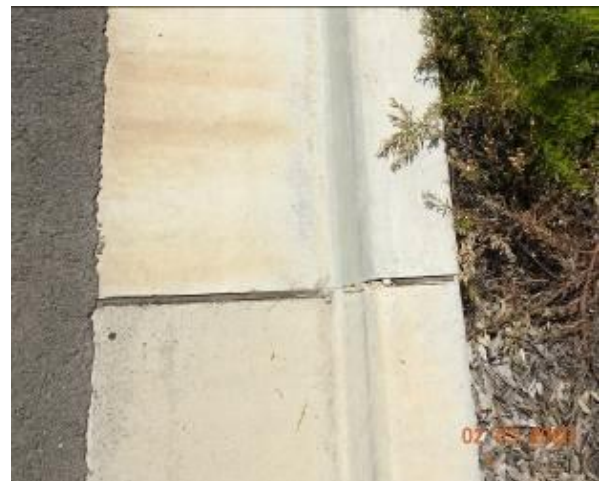
Figure 312 – Crack propagation through kerb and gutter

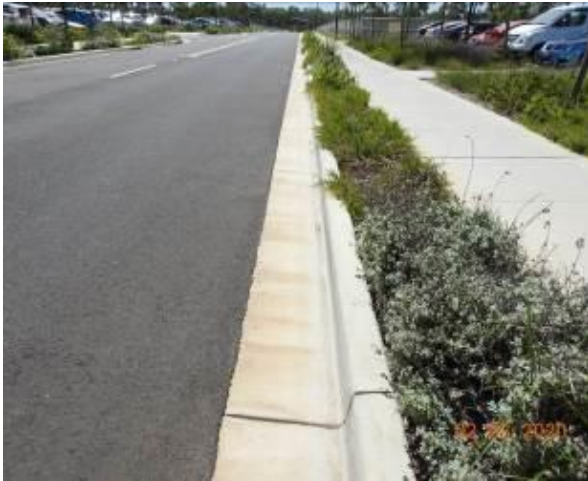
Figure 313 – General Condition of kerb and gutter

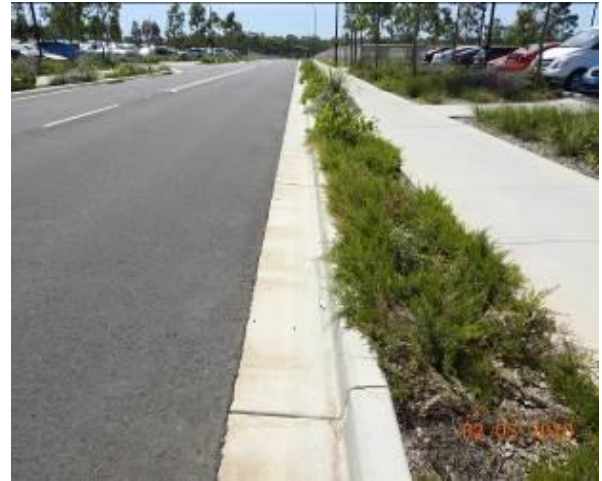
Figure 314 – General Condition of kerb and gutter

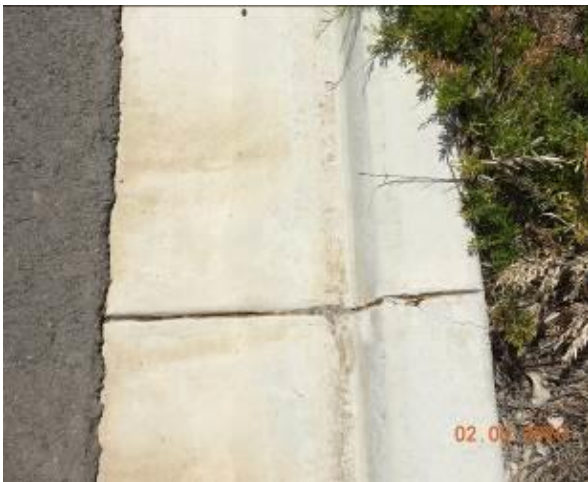
Figure 315 – Crack propagation through kerb and gutter

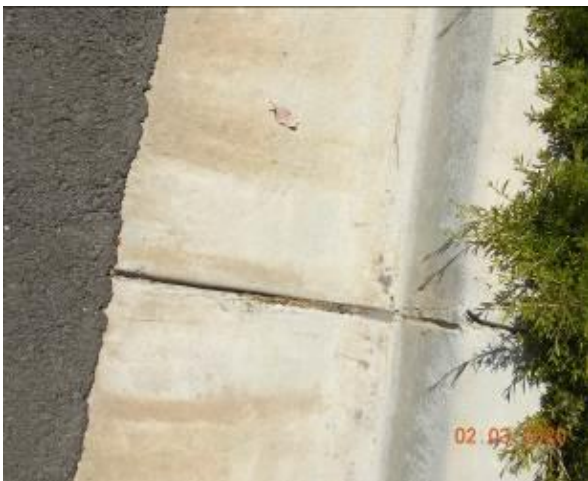
Figure 317 – Crack propagation through kerb and gutter

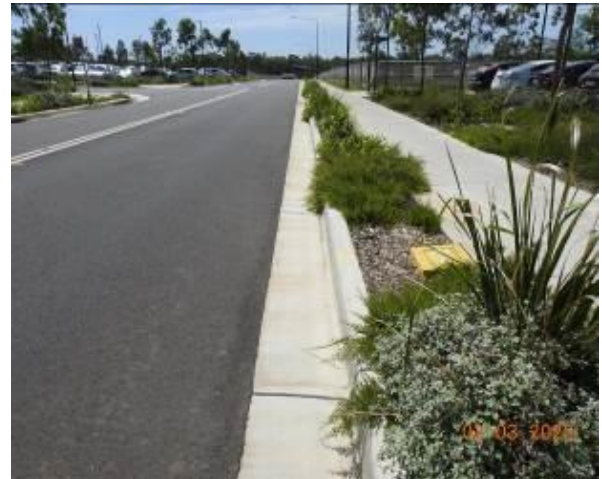
Figure 320 – General Condition of kerb and gutter

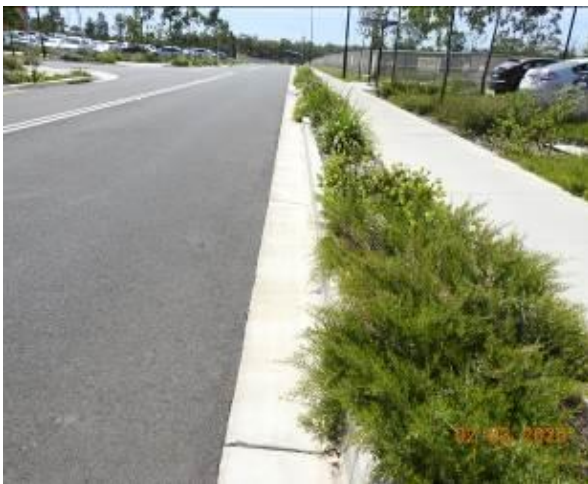
Figure 321 – General Condition of kerb and gutter

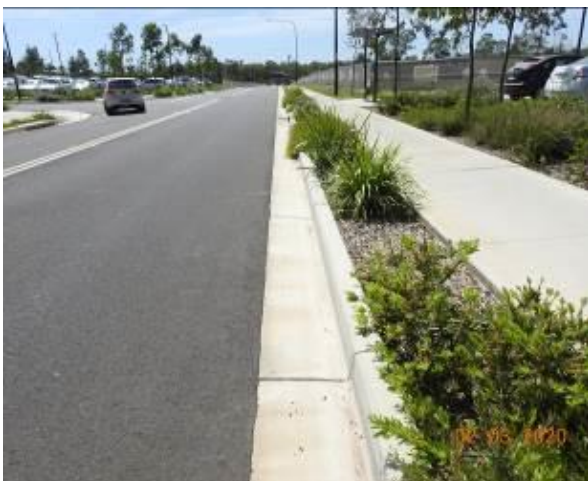
Figure 323 – General Condition of kerb and gutter

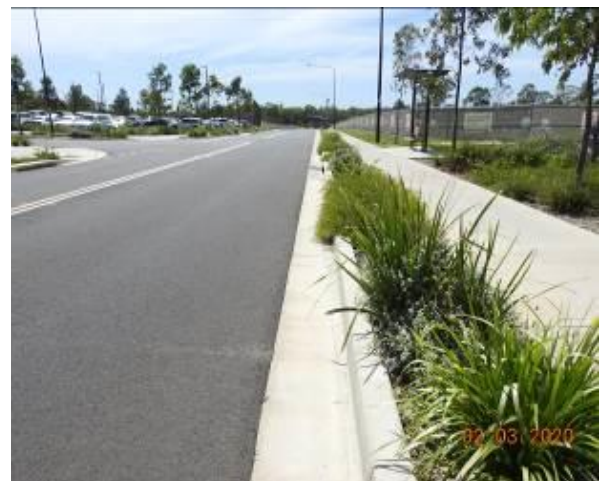
Figure 324 – General Condition of kerb and gutter

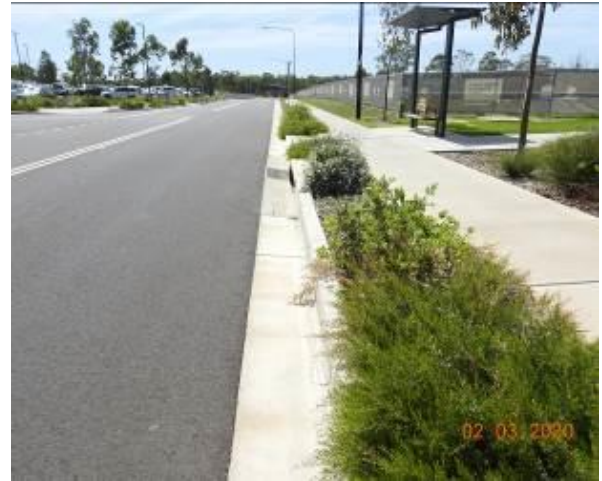
Figure 326 – General Condition of kerb and gutter

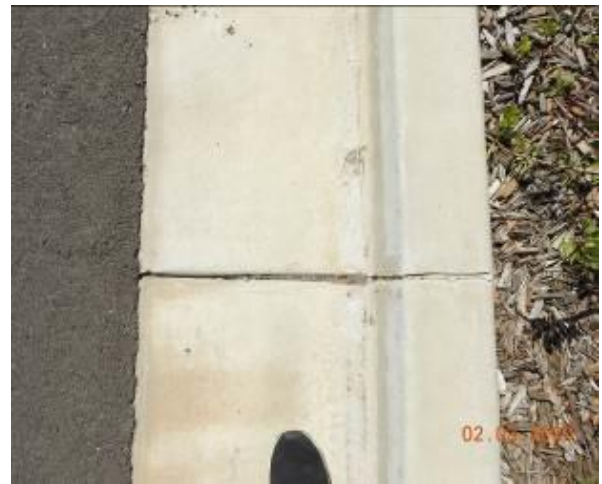
Figure 328 – Crack propagation through kerb and gutter

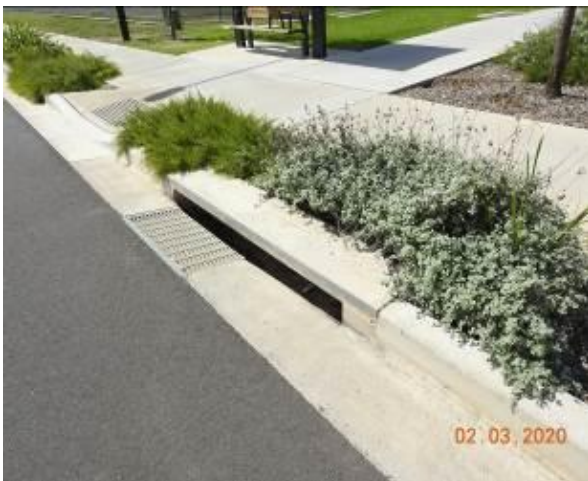
Figure 329 – General Condition of stormwater inlet pit

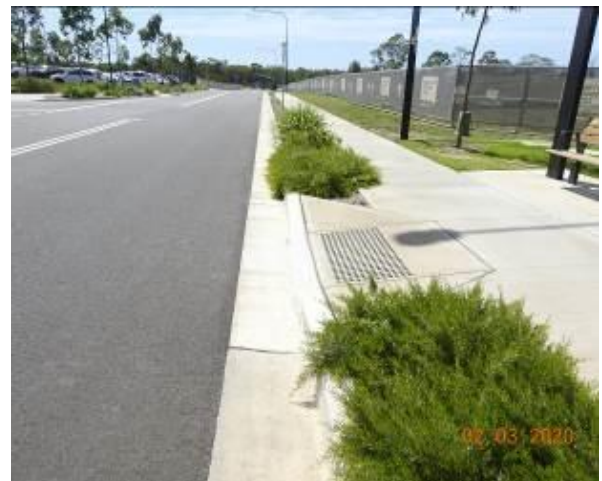
Figure 330 – General Condition of kerb and gutter

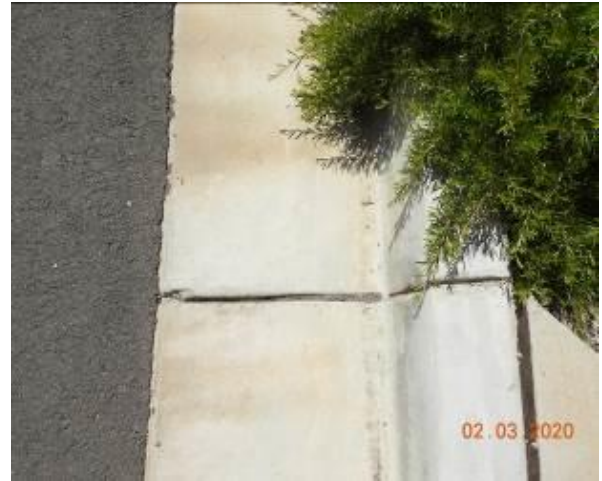
Figure 332 – Loss of material through kerb and gutter

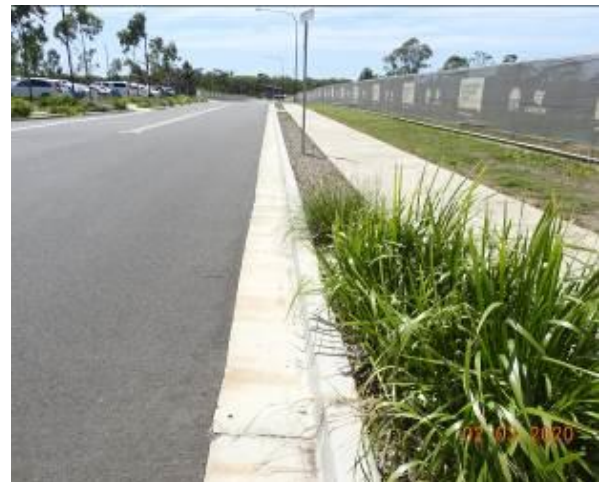
Figure 334 – General Condition of kerb and gutter

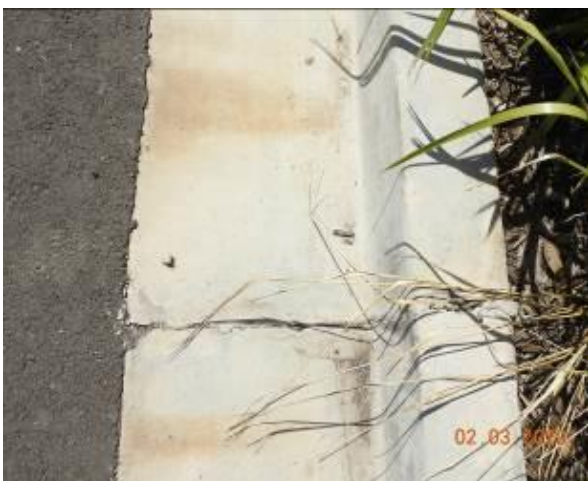
Figure 335 – Crack propagation and loss of material through kerb and gutter

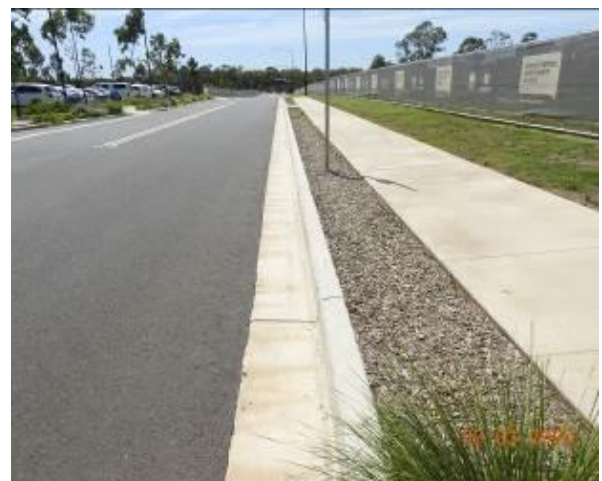
Figure 336 – General Condition of kerb and gutter

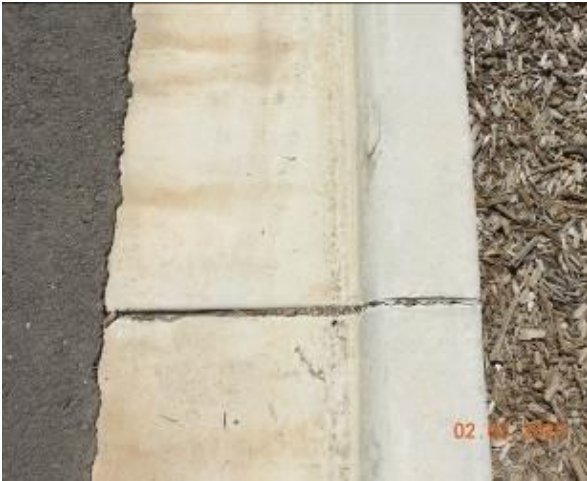
Figure 337 – Crack propagation through kerb and gutter

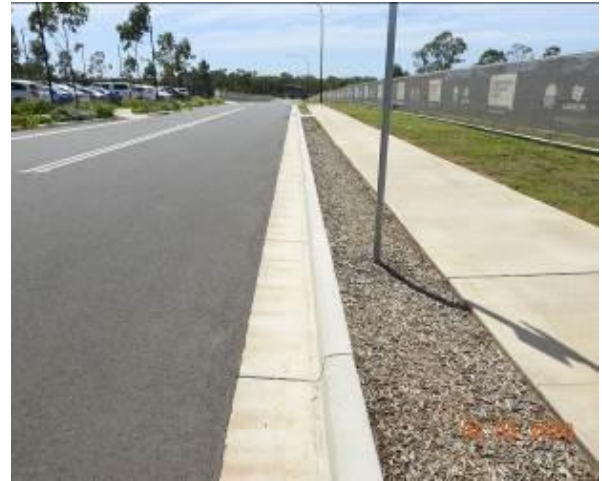
Figure 338 – General Condition of kerb and gutter

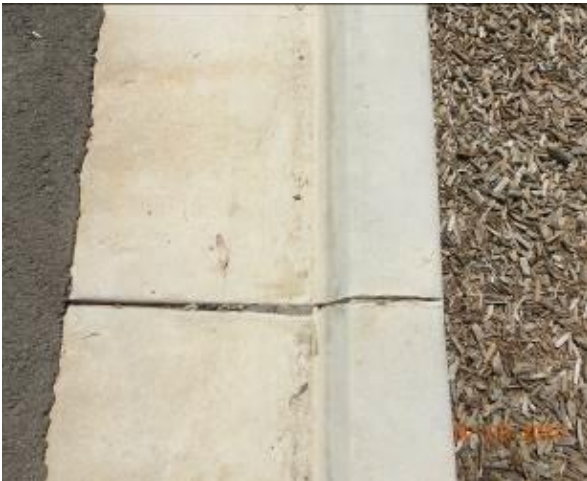
Figure 339 – Crack propagation through kerb and gutter

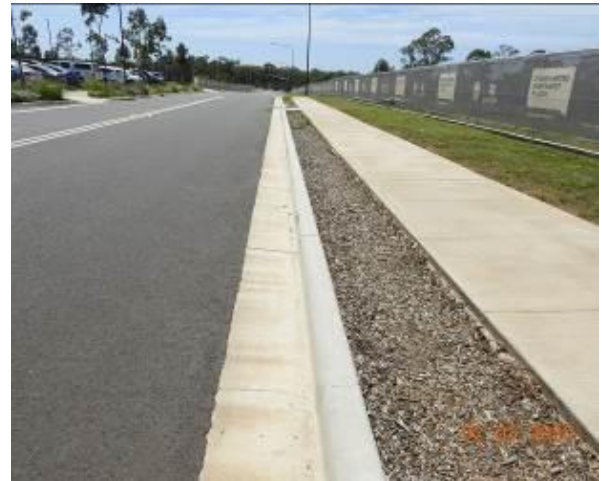
Figure 340 – General Condition of kerb and gutter

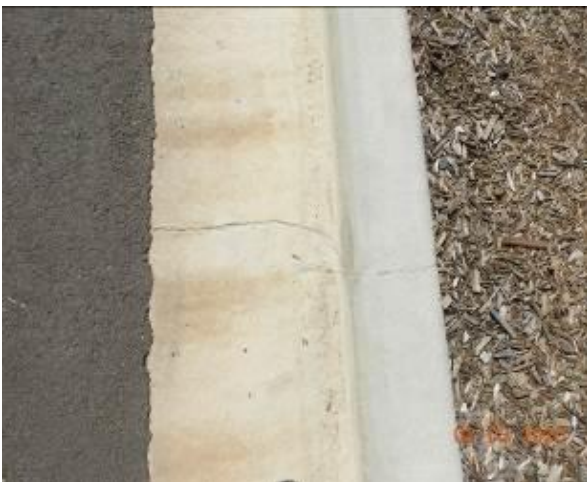
Figure 341 – Crack propagation through kerb and gutter

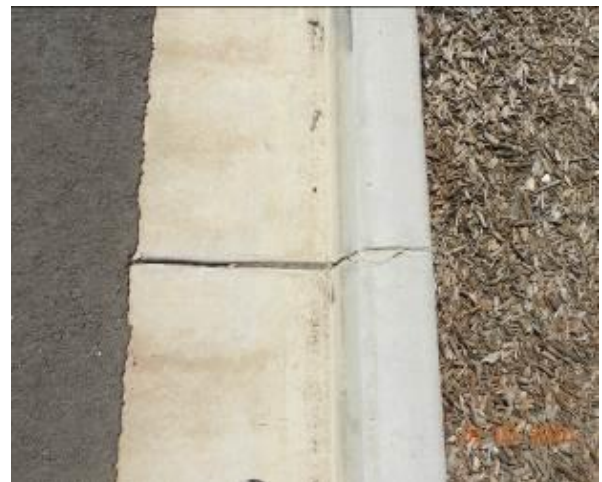
Figure 342 – Crack propagation through kerb and gutter

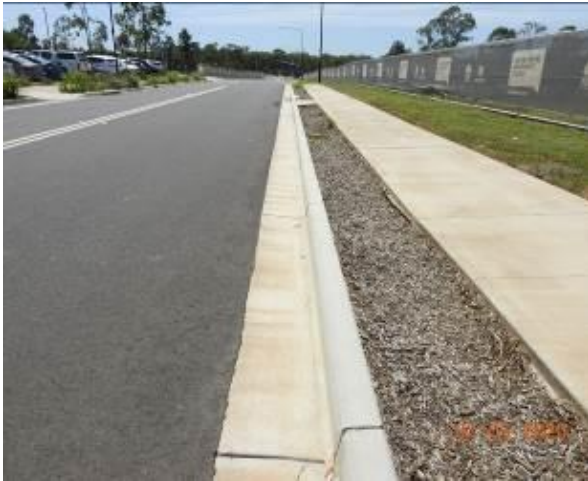
Figure 343 – General Condition of kerb and gutter

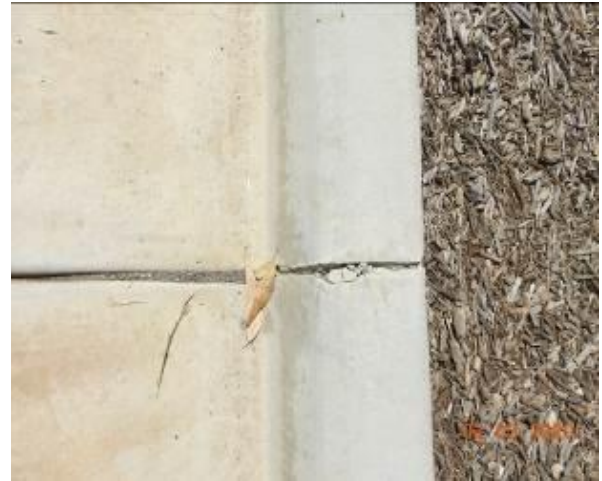
Figure 344 – Crack propagation through kerb and gutter

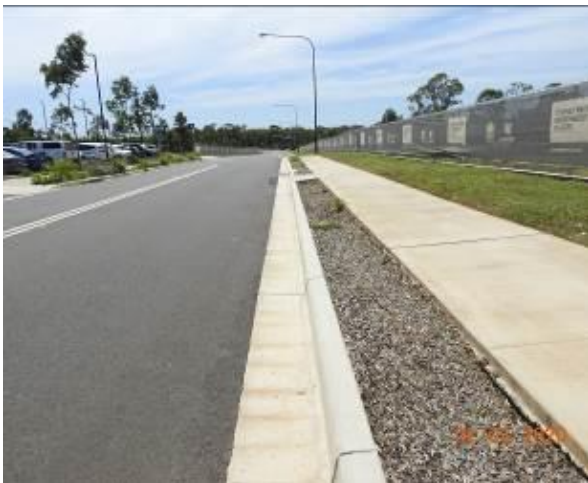
Figure 345 – General Condition of kerb and gutter

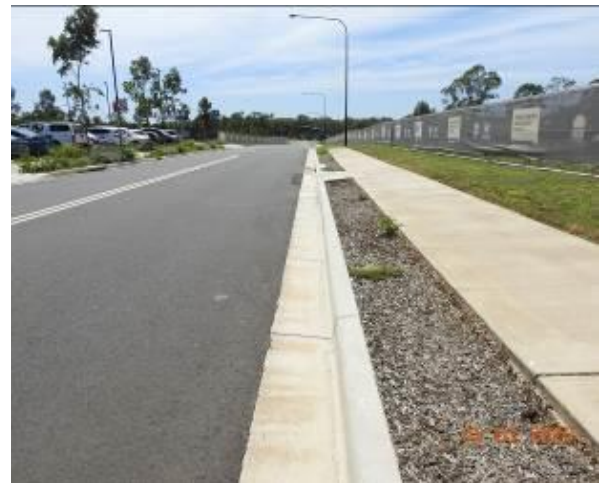
Figure 346 – General Condition of kerb and gutter

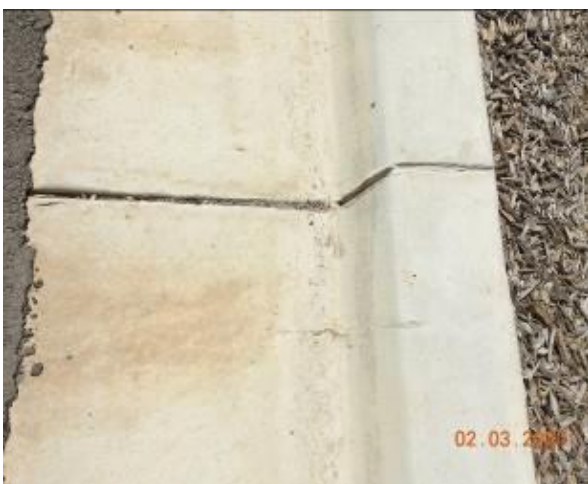
Figure 347 – Crack propagation through kerb and gutter

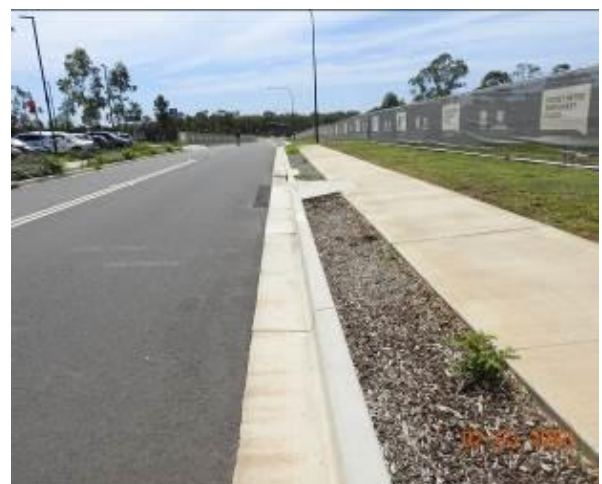
Figure 348 – General Condition of kerb and gutter

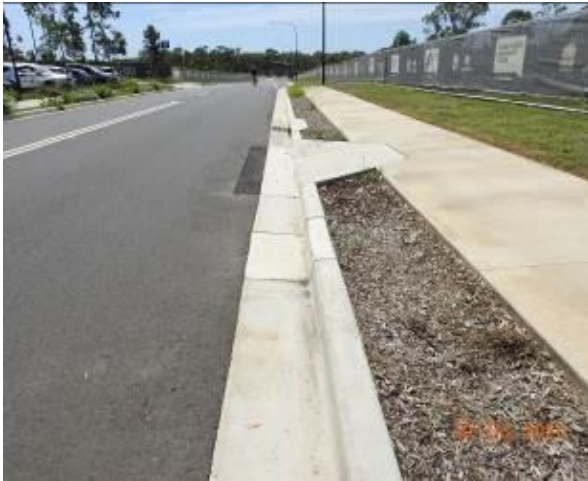
Figure 349 – General Condition of kerb and gutter

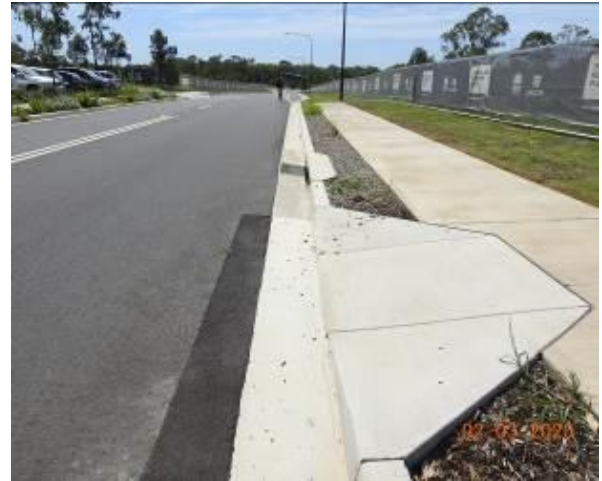
Figure 350 – General Condition of layback and gutter

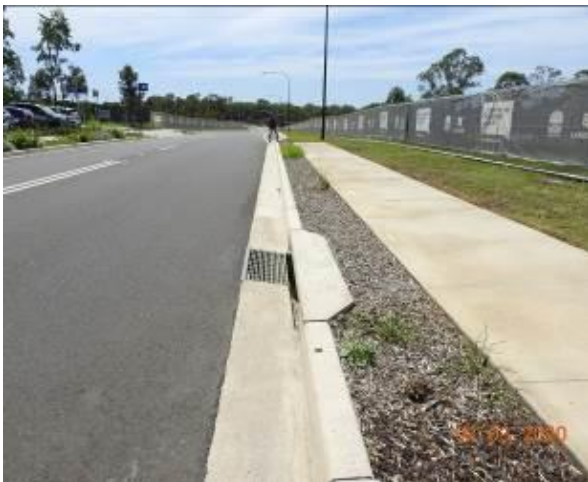
Figure 351 – General Condition of kerb and gutter

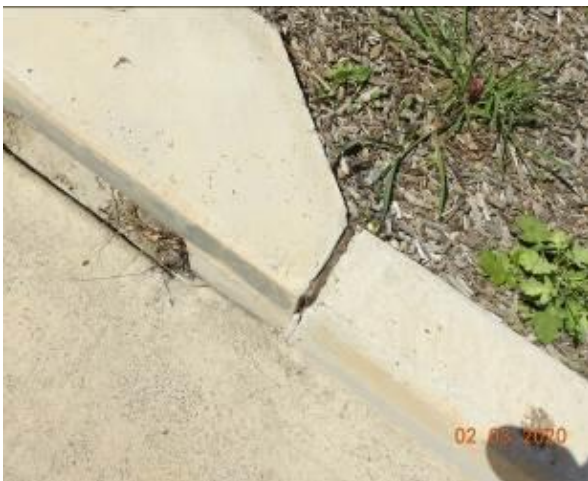
Figure 353 – Crack propagation through kerb and gutter

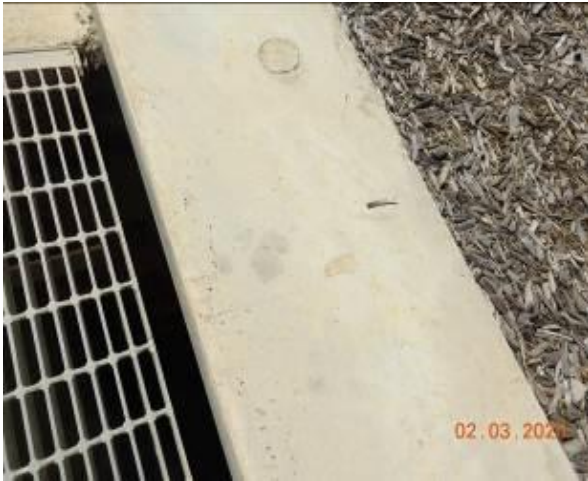
Figure 355 – Crack propagation through stormwater inlet pit

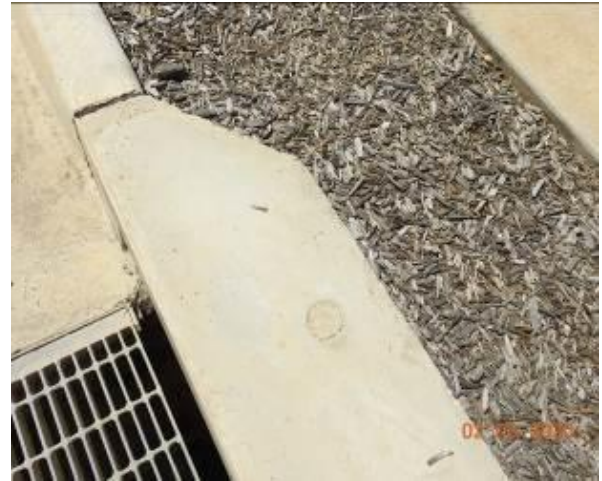
Figure 356 – Crack propagation through stormwater inlet pit

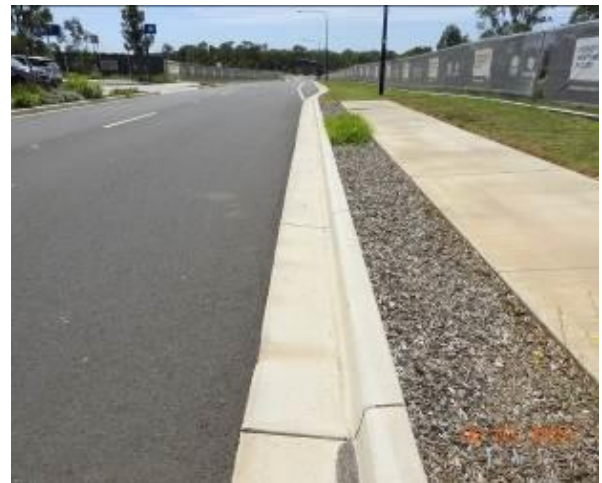
Figure 358 – General Condition of kerb and gutter

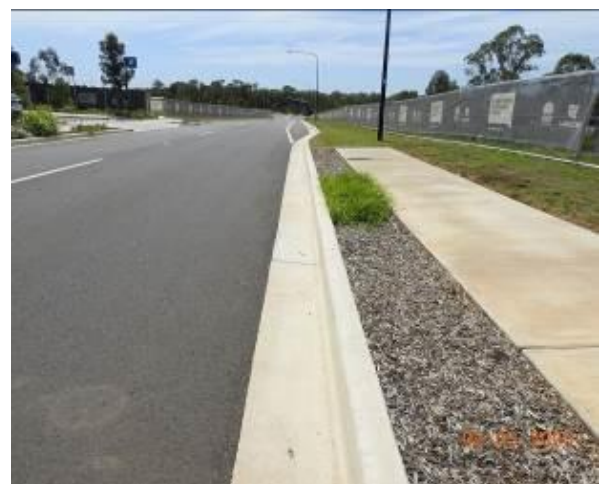
Figure 360 – General Condition of kerb and gutter

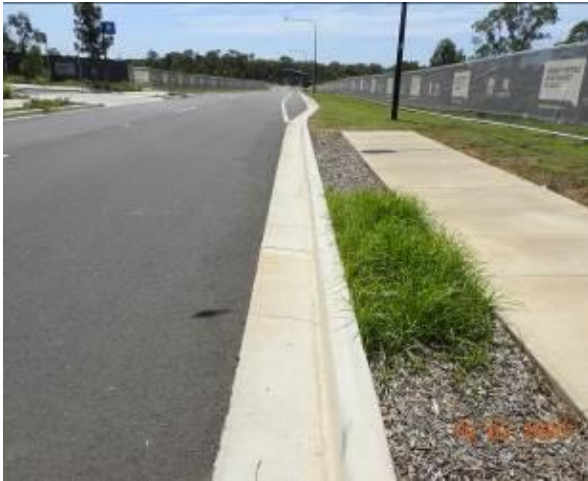
Figure 361 – General Condition of kerb and gutter

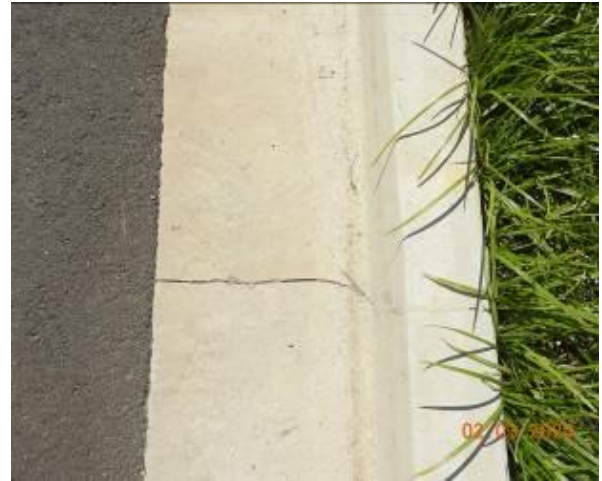
Figure 362 – Crack propagation through kerb and gutter

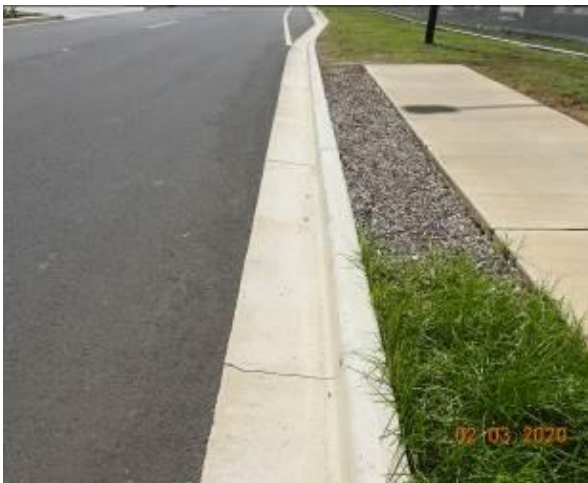
Figure 363 – General Condition of kerb and gutter

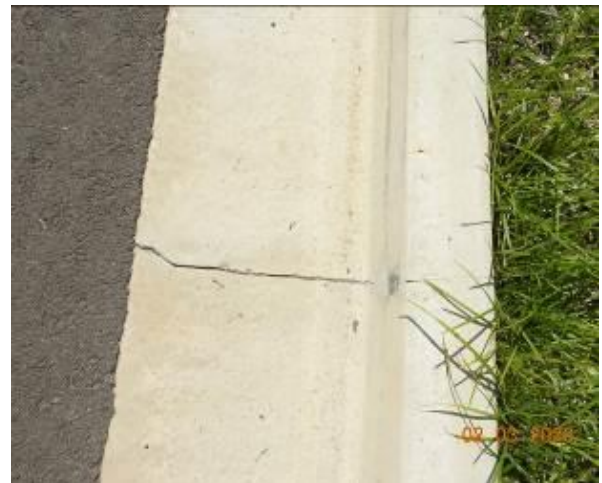
Figure 364 – Crack propagation through kerb and gutter

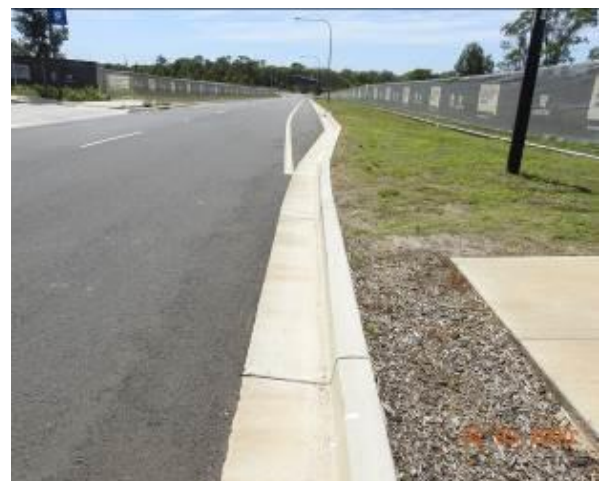
Figure 365 – General Condition of kerb and gutter

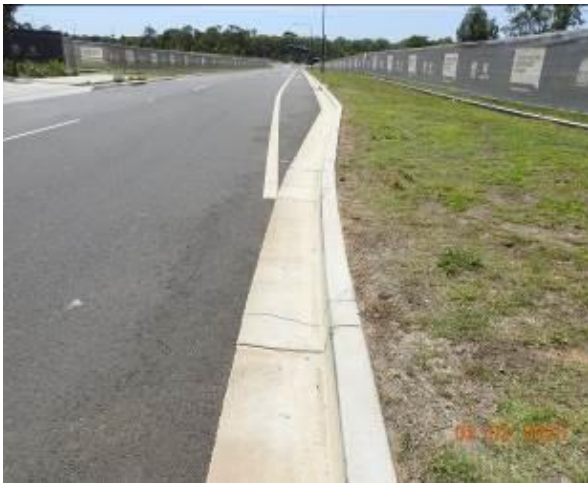
Figure 366 – General Condition of kerb and gutter

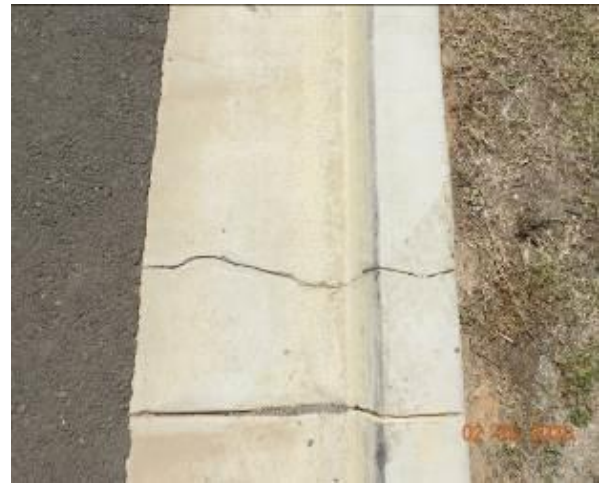
Figure 367 – General condition of kerb and gutter

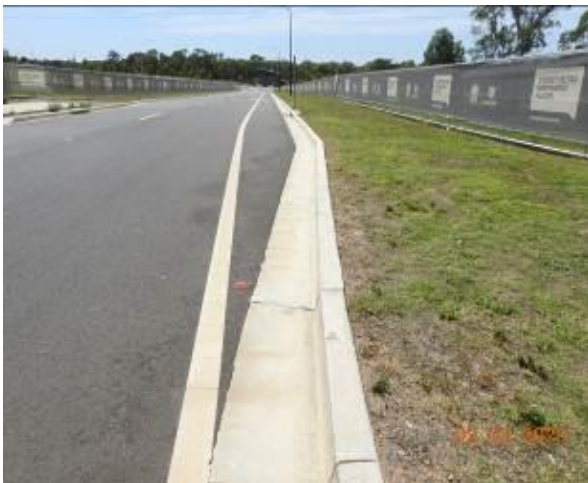
Figure 368 – Crack propagation through kerb and gutter

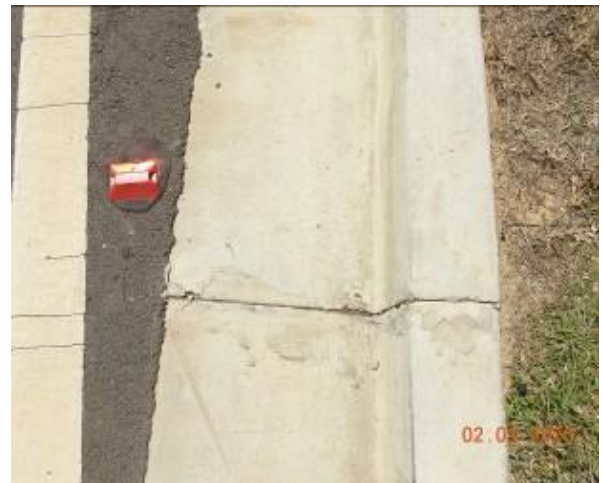
Figure 369 – General Condition of kerb and gutter

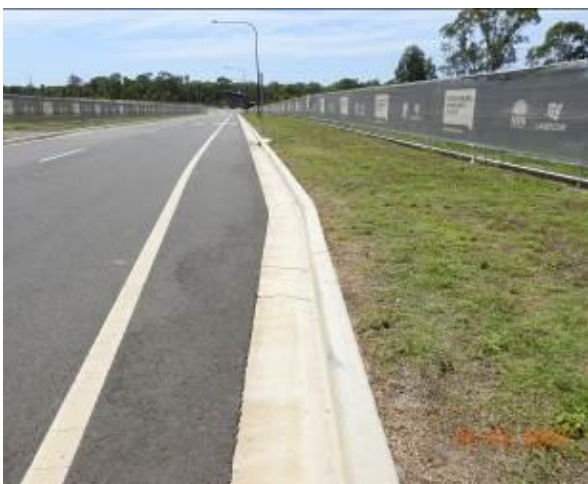
Figure 370 – Loss of material and Evidence of patchwork through kerb and gutter

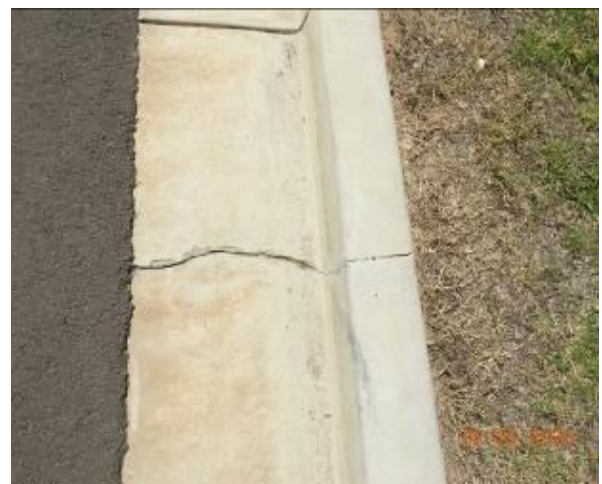
Figure 371 – General Condition of kerb and gutter

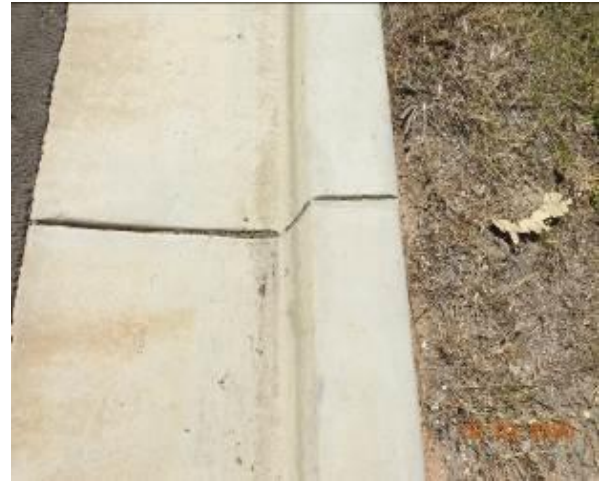
Figure 373 – General Condition of kerb and gutter

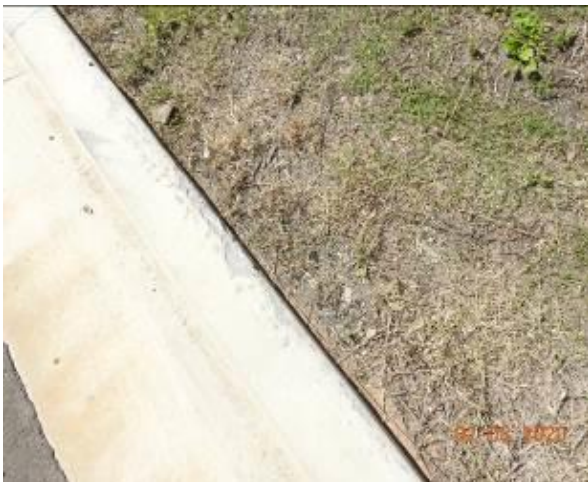
Figure 374 – Crack propagation through kerb

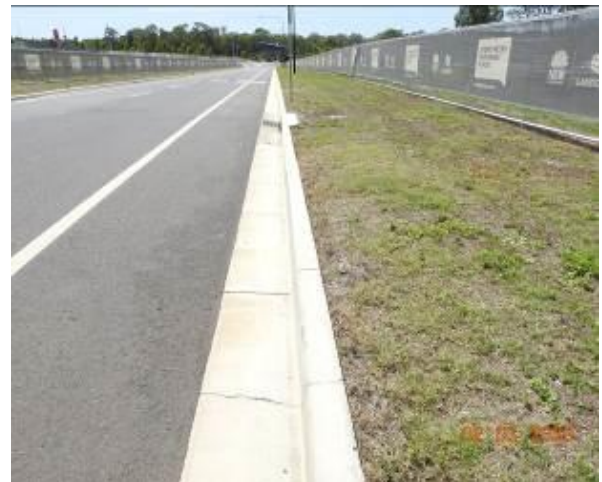
Figure 375 – Loss of material through kerb

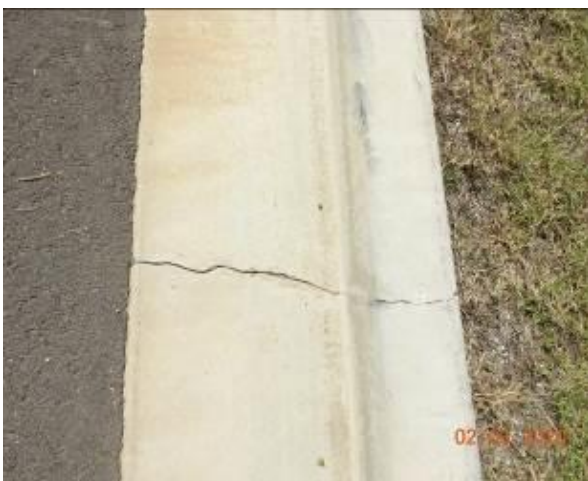
Figure 376 – General Condition of kerb and gutter

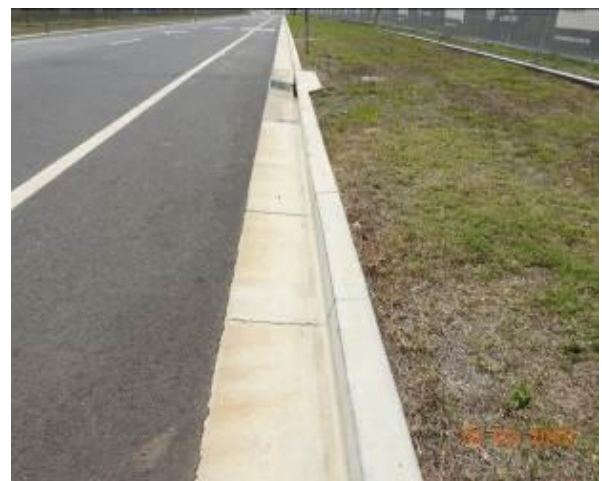
Figure 377 – Crack propagation through kerb and gutter

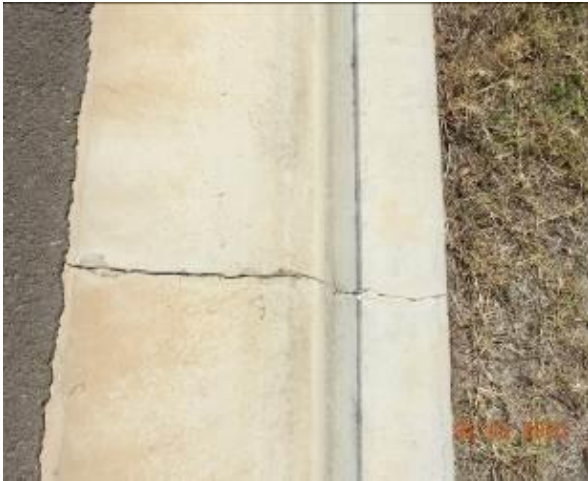
Figure 378 – General Condition of kerb and gutter

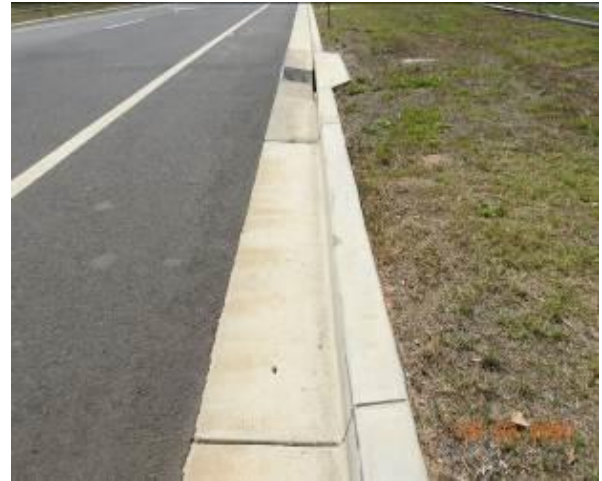
Figure 379 – Crack propagation through kerb and gutter

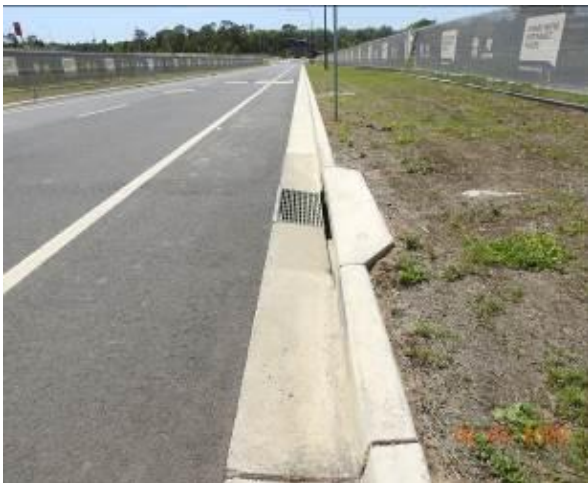
Figure 380 – General Condition of kerb and gutter

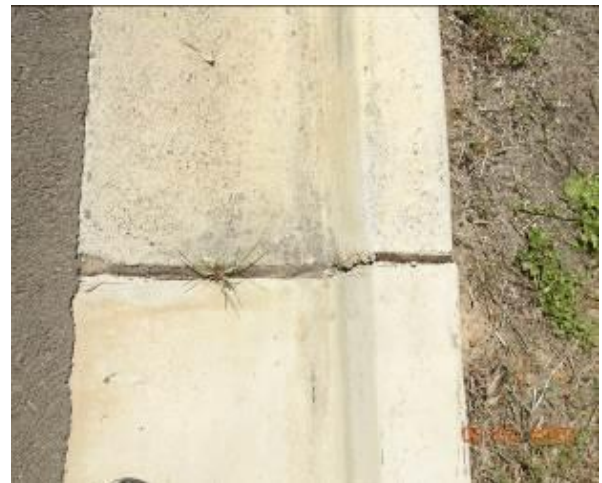
Figure 381 – General Condition of kerb and gutter

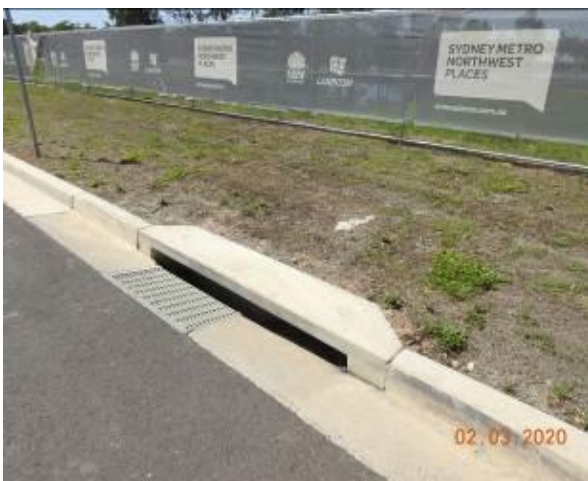
Figure 382 – Crack propagation through kerb and gutter

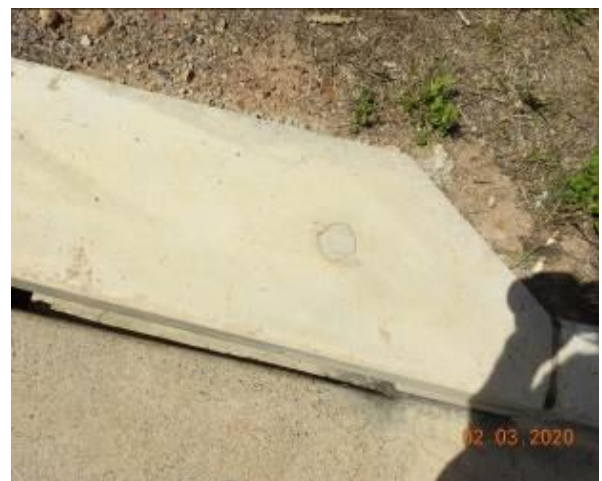
Figure 383 – General Condition of stormwater inlet pit

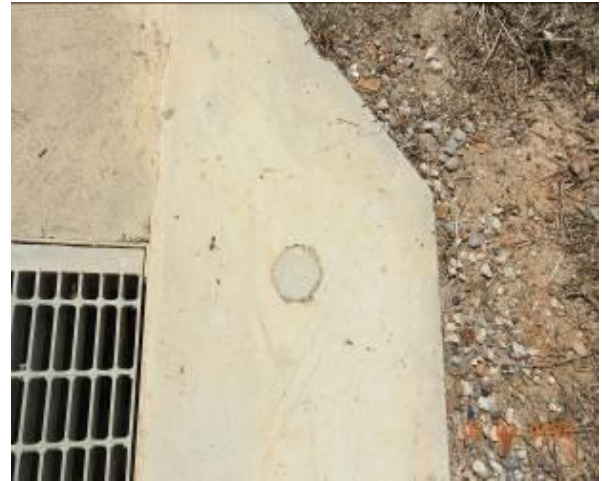
Figure 385 – Crack propagation through stormwater inlet pit

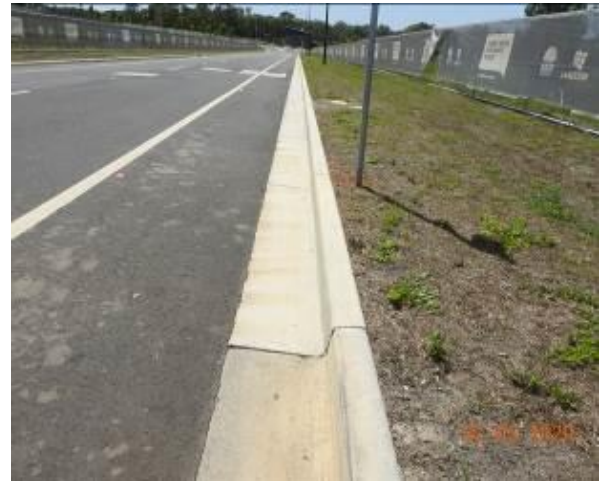
Figure 387 – Crack propagation through stormwater inlet pit

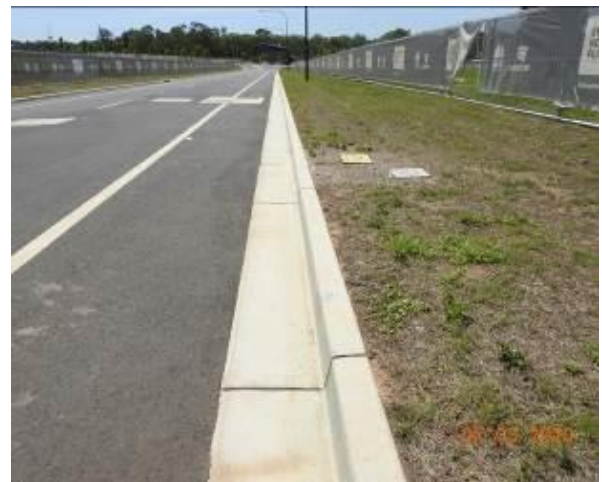
Figure 389 – General Condition of kerb and gutter

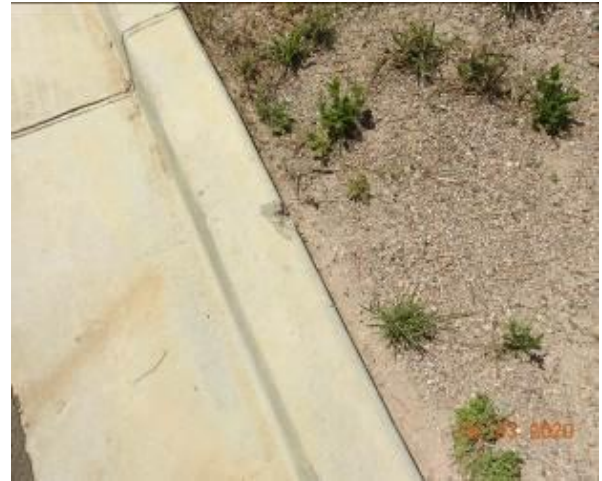
Figure 391 – General Condition of kerb and gutter

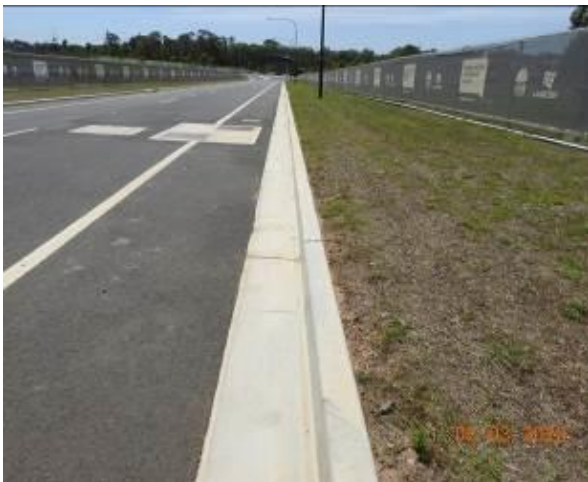
Figure 392 – Loss of material through kerb

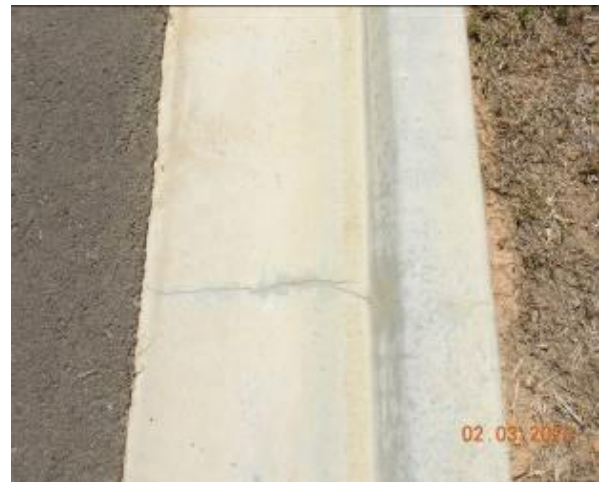
Figure 393 – General Condition of kerb and gutter

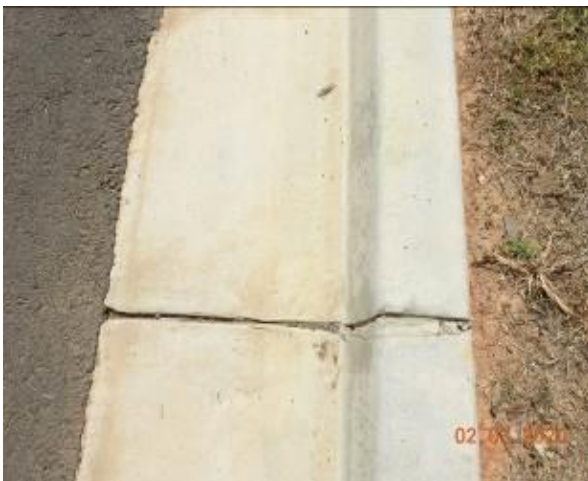
Figure 394 – Crack propagation through kerb and gutter

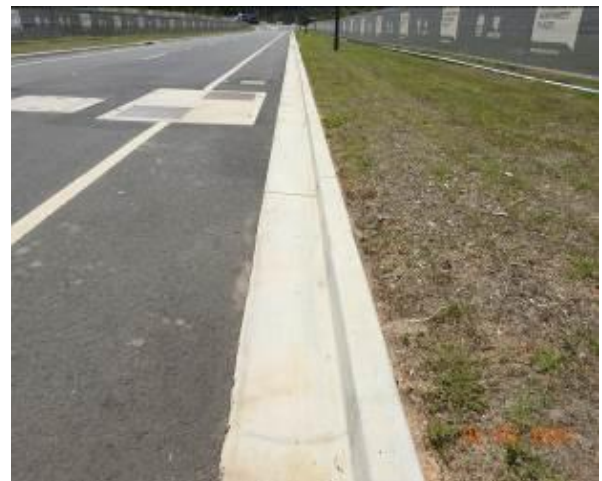
Figure 395 – Crack propagation through kerb and gutter

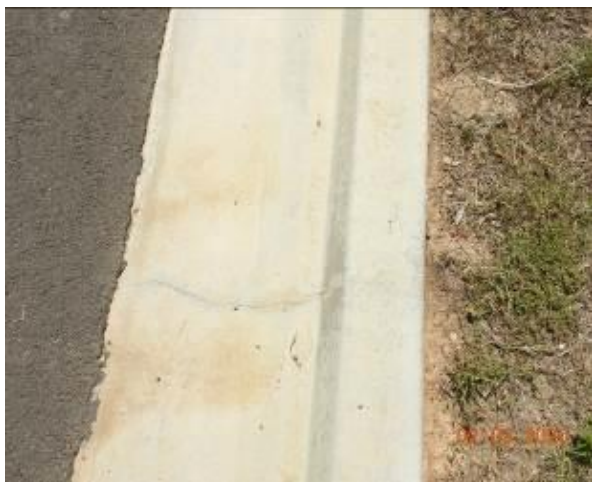
Figure 396 – General Condition of kerb and gutter

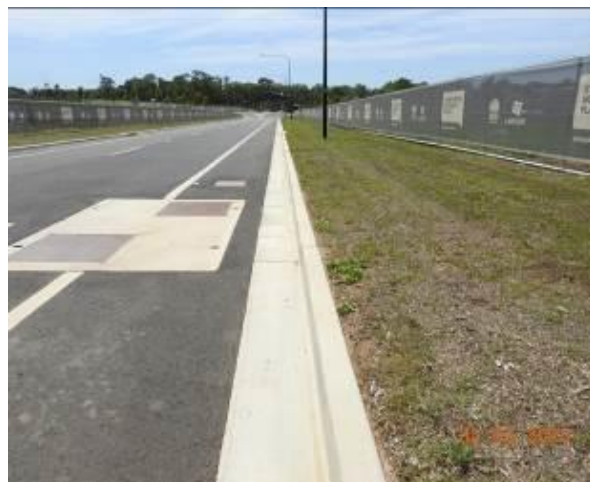
Figure 397 – Crack propagation through kerb and gutter

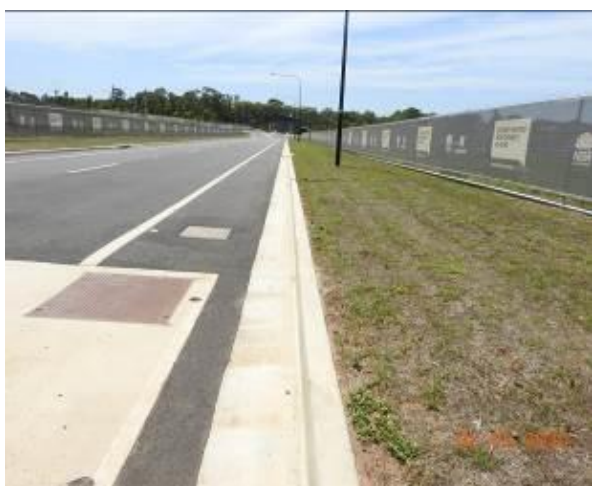
Figure 398 – General Condition of kerb and gutter
