**1-15 AND 2-12 CONFERTA AVENUE,
ROUSE HILL NSW 2155
TALLAWONG STATION PRECINCT SOUTH
PRE-DILAPIDATION REPORT**

**DEICORP PROJECTS
(TALLAWONG STATION) PTY LTD**

Job No. 191294.0
24/03/2020

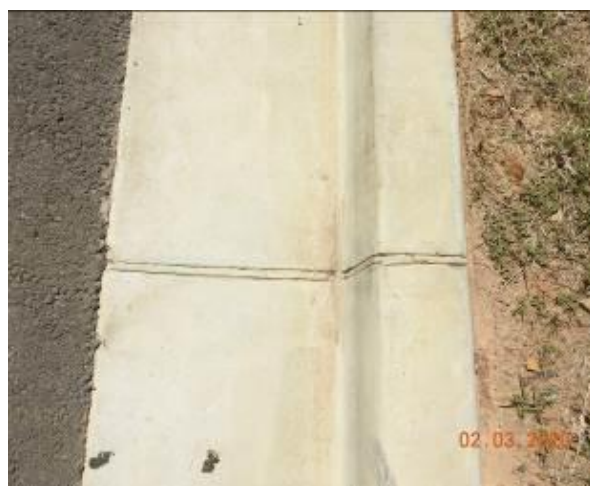
Figure 399 – General Condition of kerb and gutter

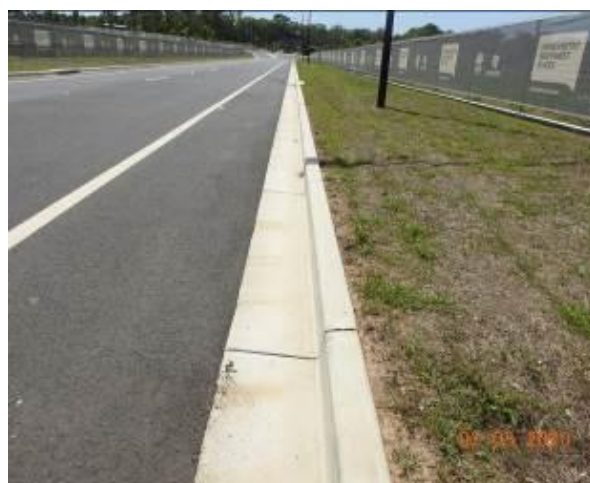
Figure 401 – Crack propagation through kerb and gutter

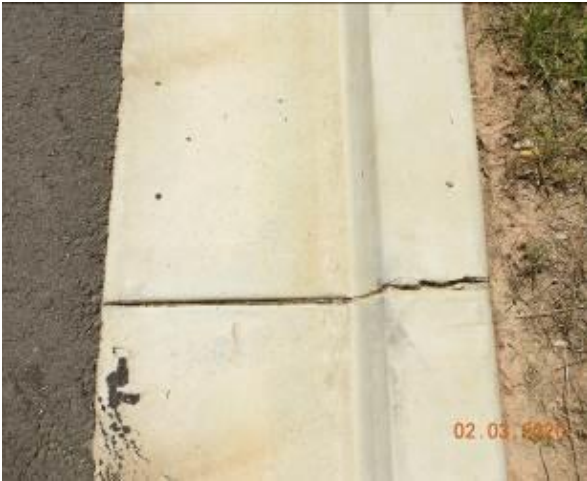
Figure 402 – General Condition of kerb and gutter

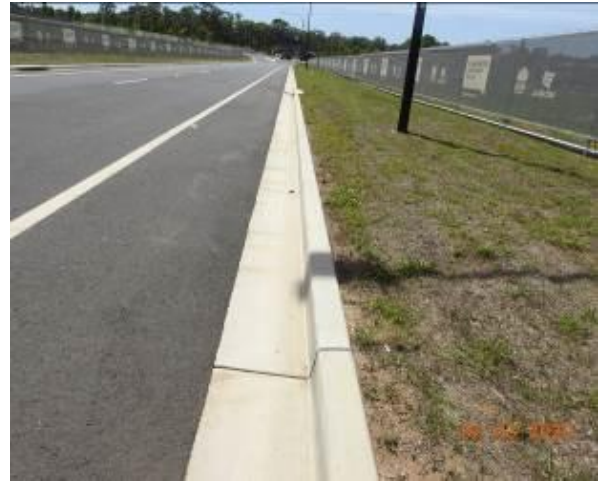
Figure 403 – Crack propagation through kerb and gutter

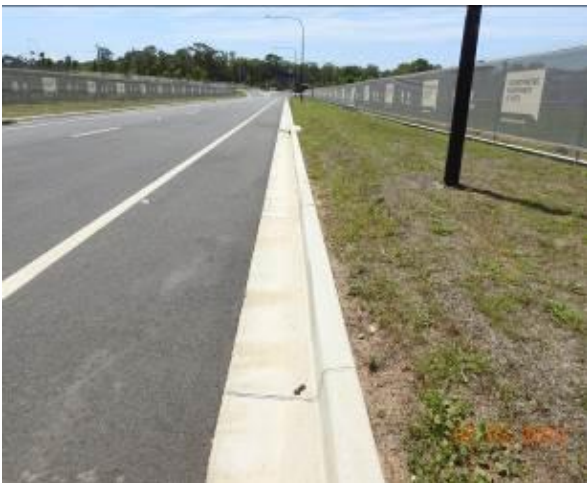
Figure 405 – General Condition of kerb and gutter

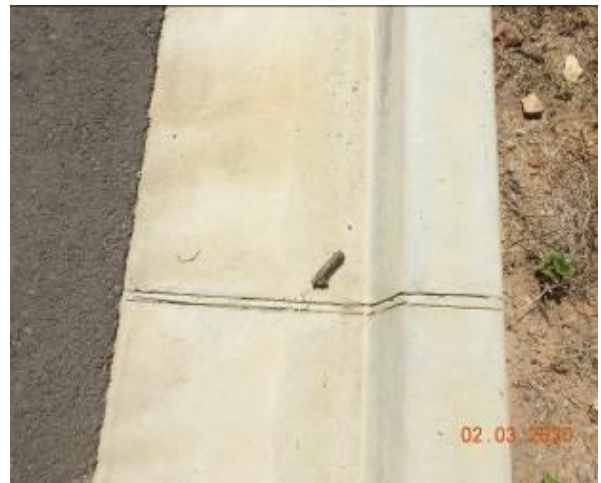
Figure 406 – Crack propagation through kerb and gutter

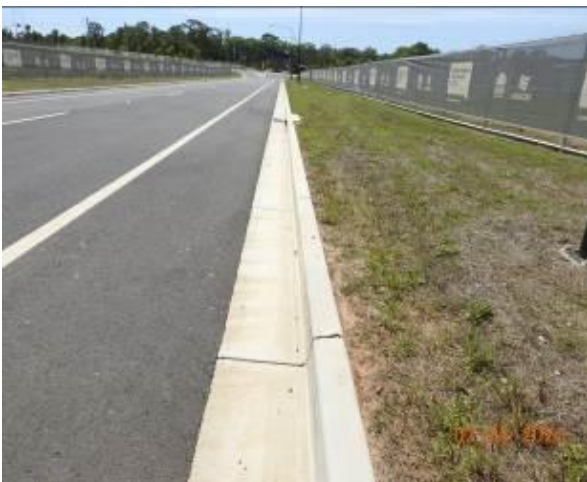
Figure 407 – General Condition of kerb and gutter

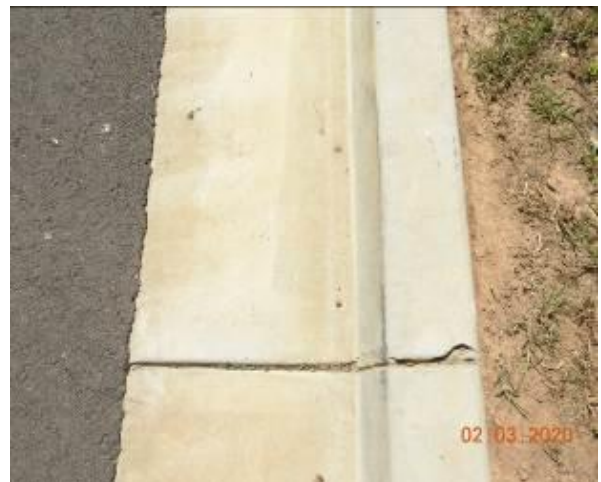
Figure 408 – Crack propagation through kerb and gutter

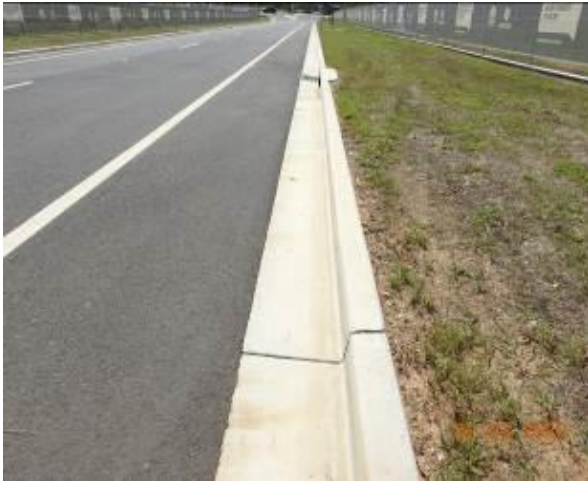
Figure 409 – General Condition of kerb and gutter

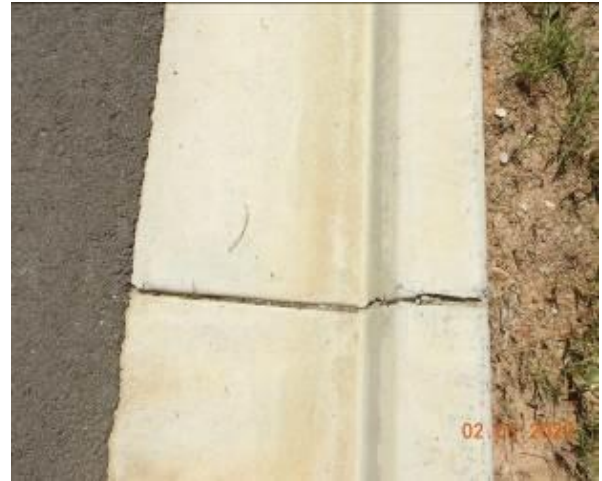
Figure 410 – Crack propagation through kerb and gutter

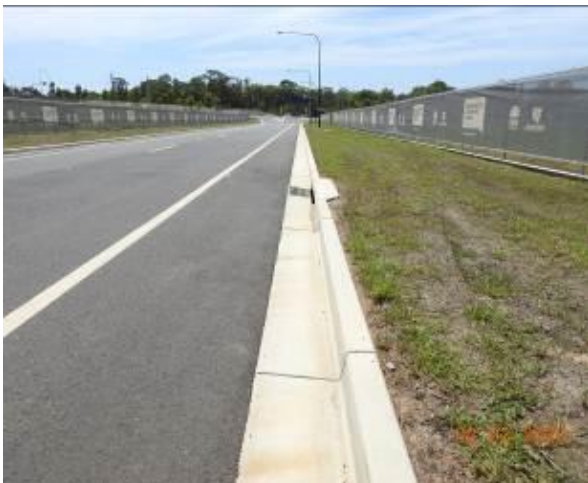
Figure 411 – General Condition of kerb and gutter

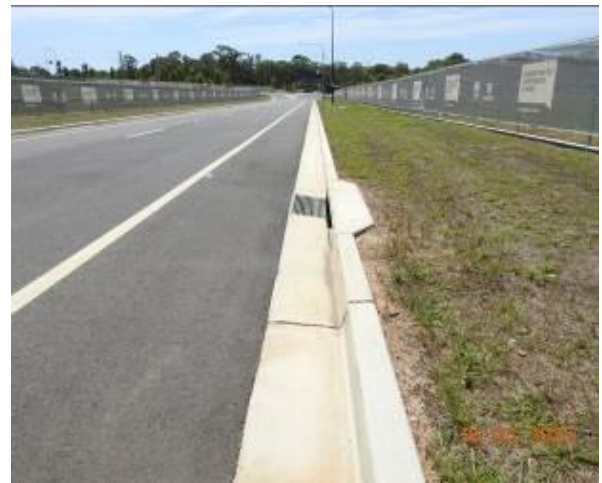
Figure 412 – General Condition of kerb and gutter

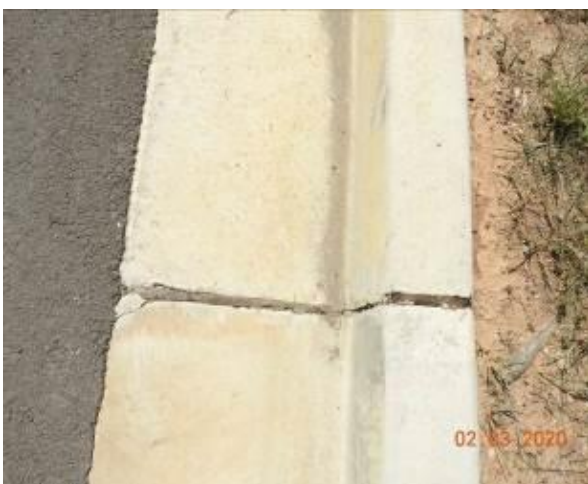
Figure 413 – Crack propagation through kerb and gutter

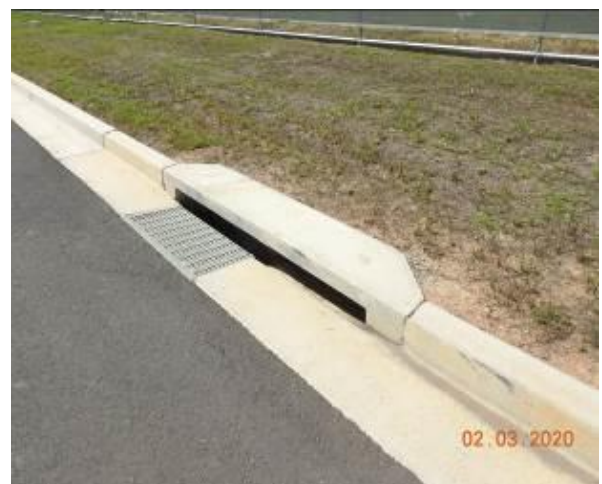
Figure 414 – General Condition of stormwater inlet pit

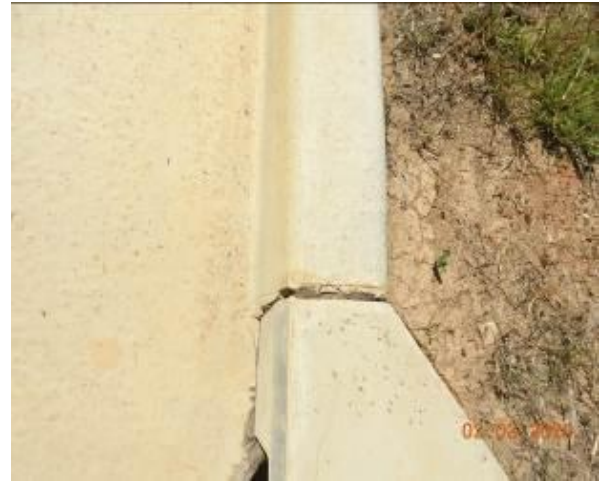
Figure 416 – Crack propagation through kerb and gutter

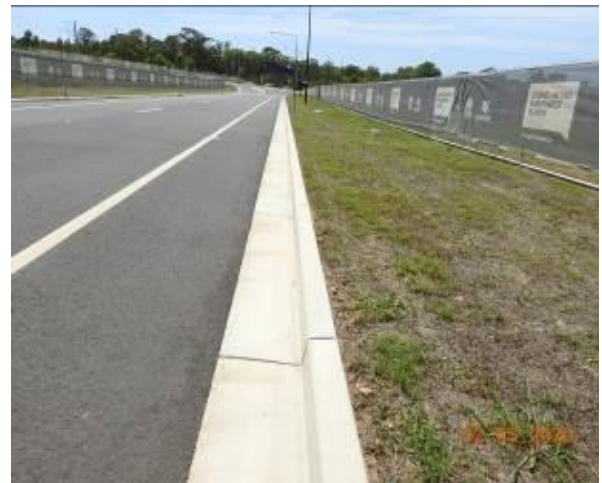
Figure 418 – General Condition of kerb and gutter

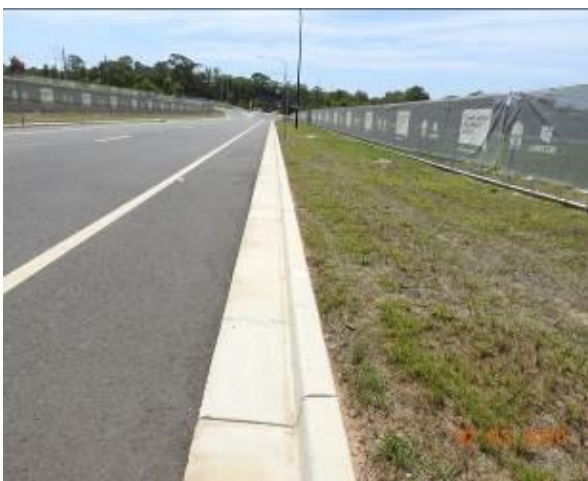
Figure 419 – General Condition of kerb and gutter

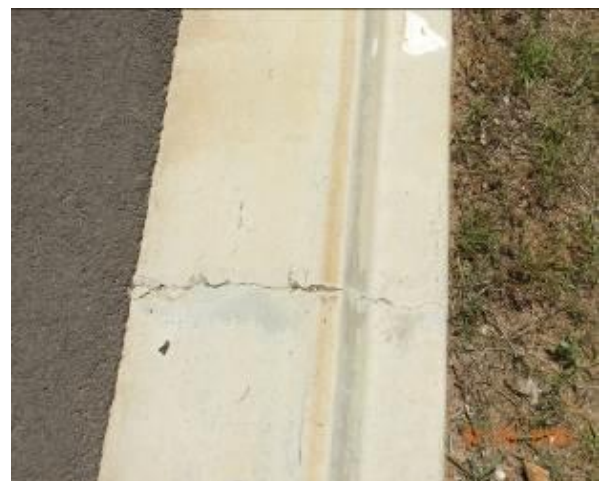
Figure 420 – Crack propagation through kerb and gutter

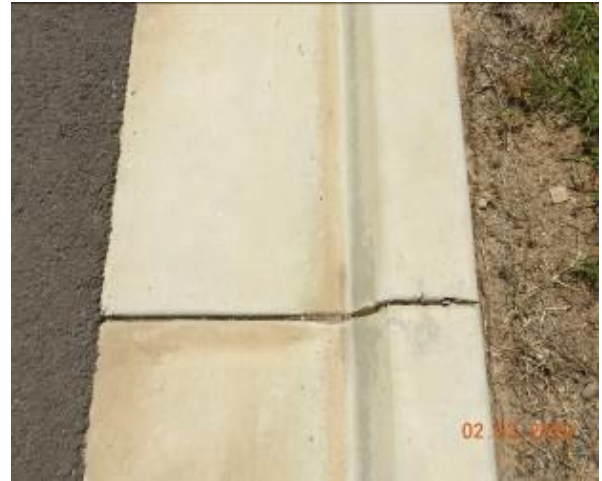
Figure 422 – Crack propagation through kerb and gutter

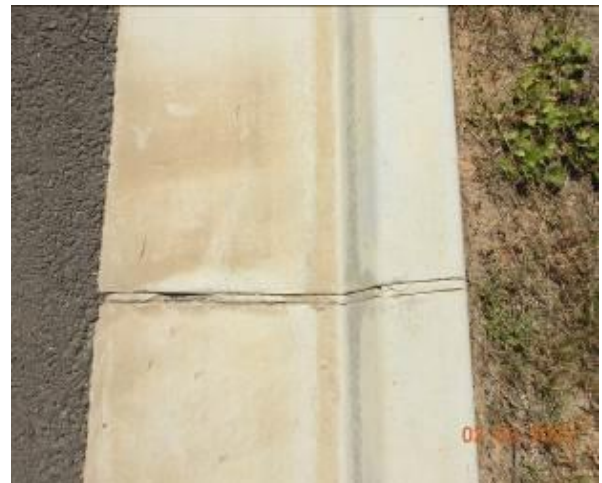
Figure 424 – Crack propagation through kerb and gutter

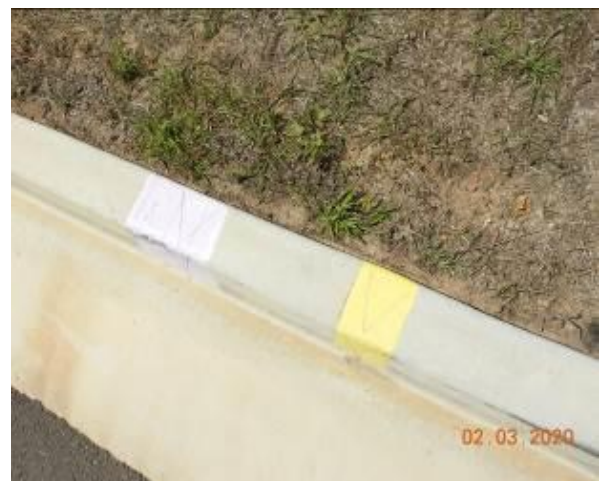
Figure 426 – General Condition of kerb and gutter

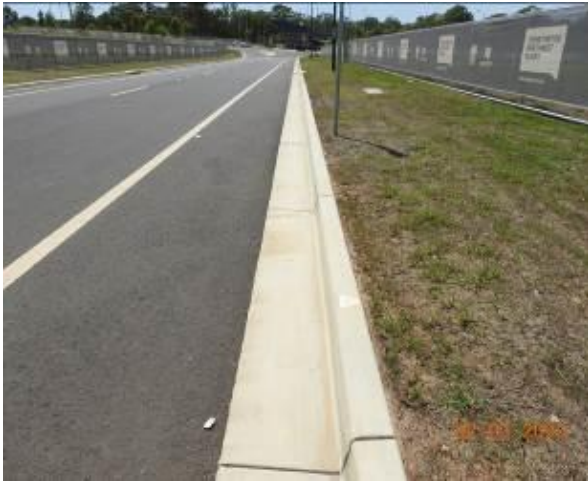
Figure 427 – General Condition of kerb and gutter

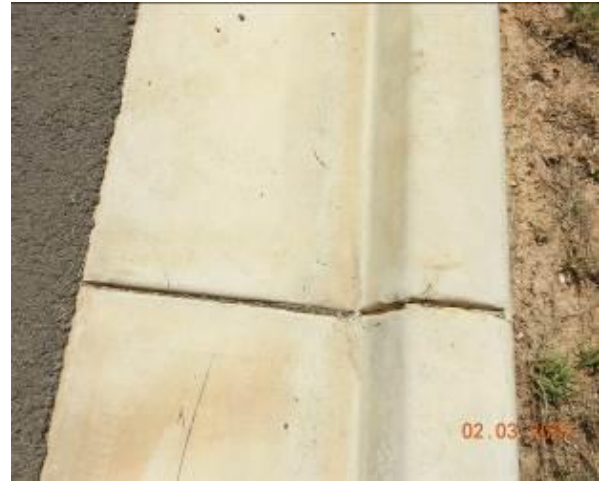
Figure 428 – Loss of material through kerb and gutter

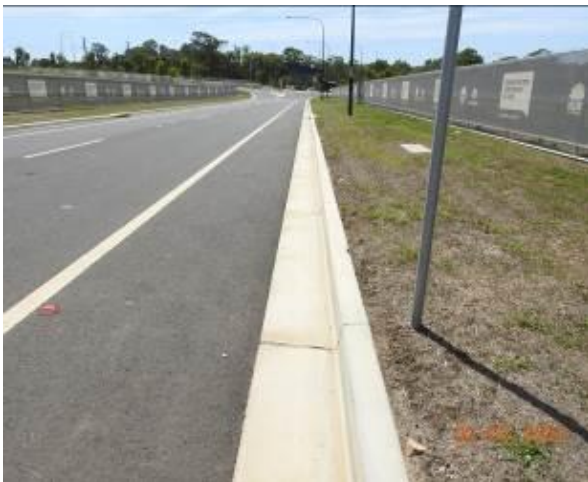
Figure 429 – General Condition of kerb and gutter

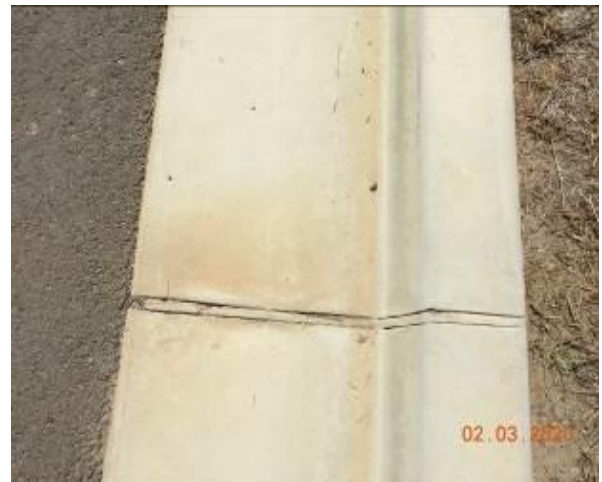
Figure 430 – Crack propagation through kerb and gutter

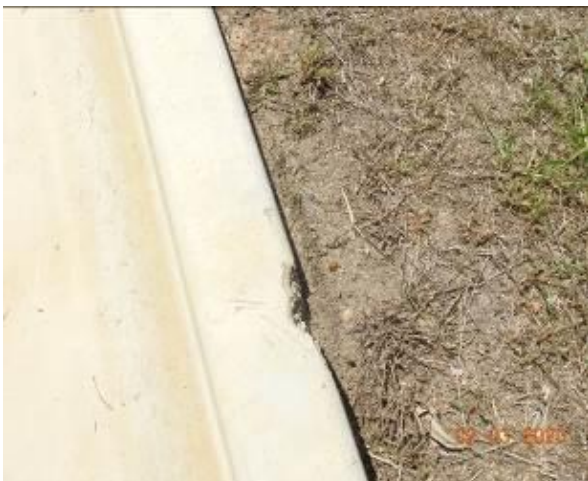
Figure 431 – Loss of material through kerb

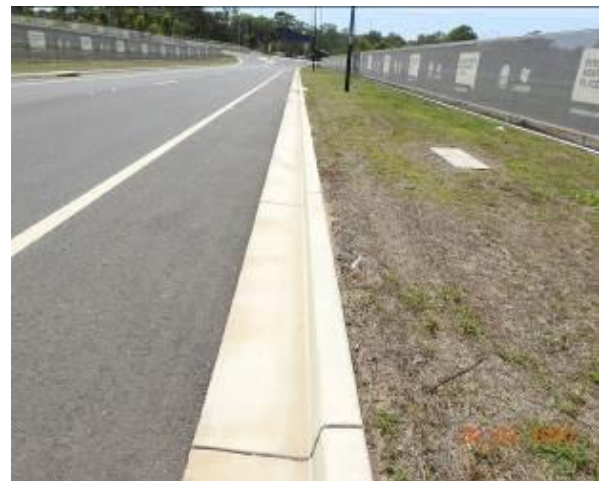
Figure 432 – General Condition of kerb and gutter

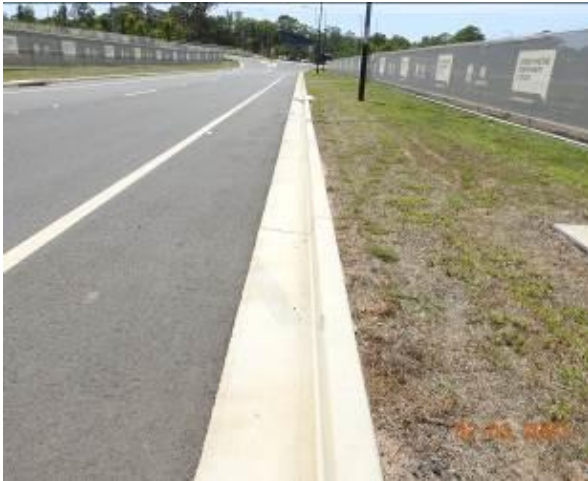
Figure 433 – General Condition of kerb and gutter

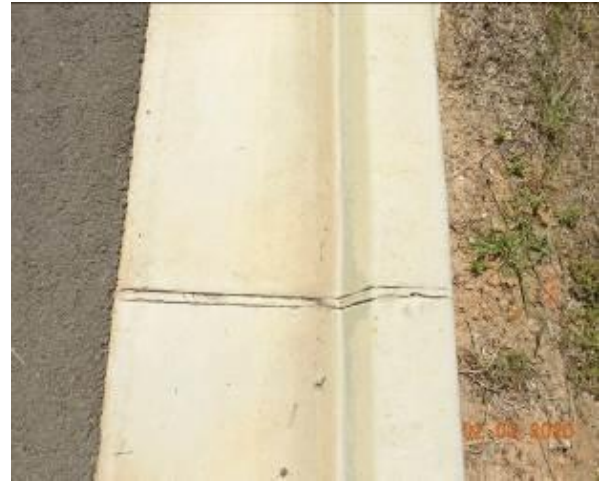
Figure 434 – Crack propagation through kerb and gutter

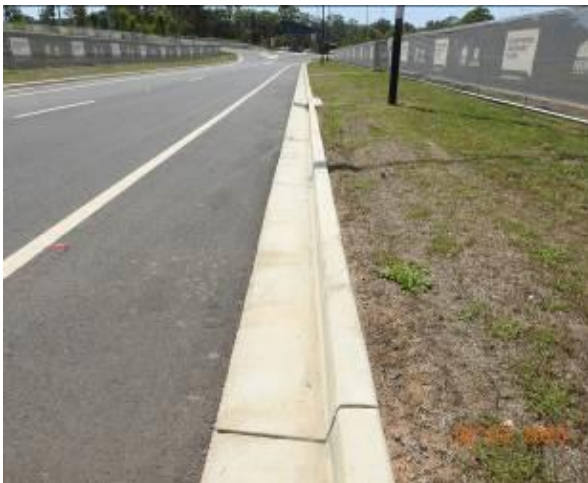
Figure 435 – General Condition of kerb and gutter

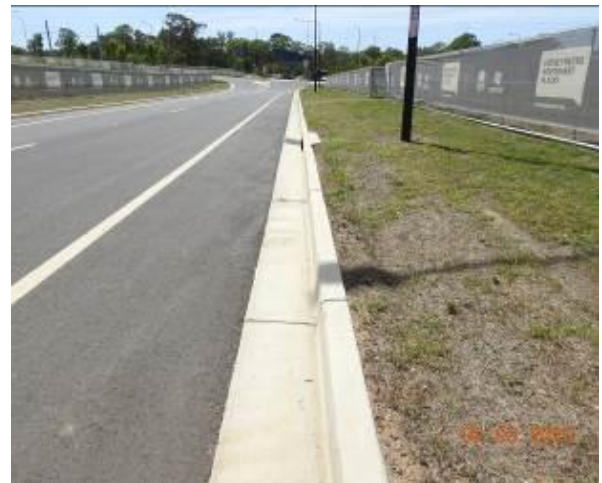
Figure 436 – General Condition of kerb and gutter

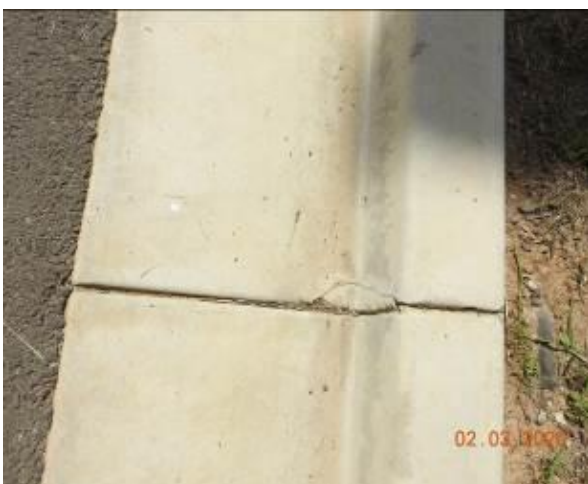
Figure 437 – Crack propagation through kerb and gutter

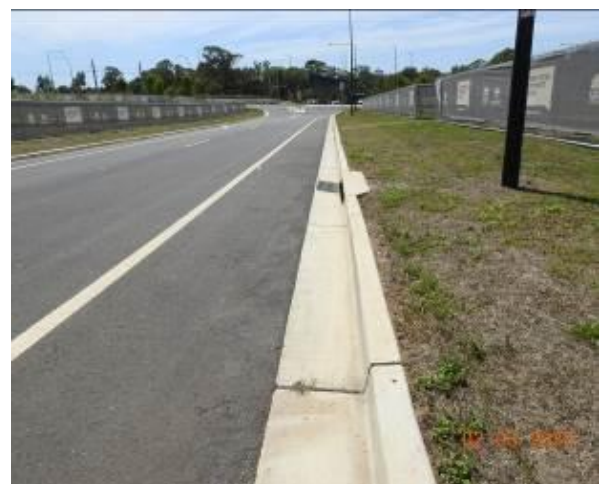
Figure 438 – General Condition of kerb and gutter

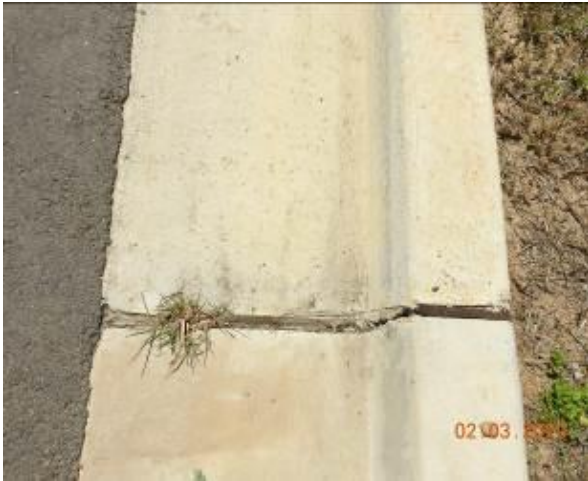
Figure 439 – Crack propagation through kerb and gutter

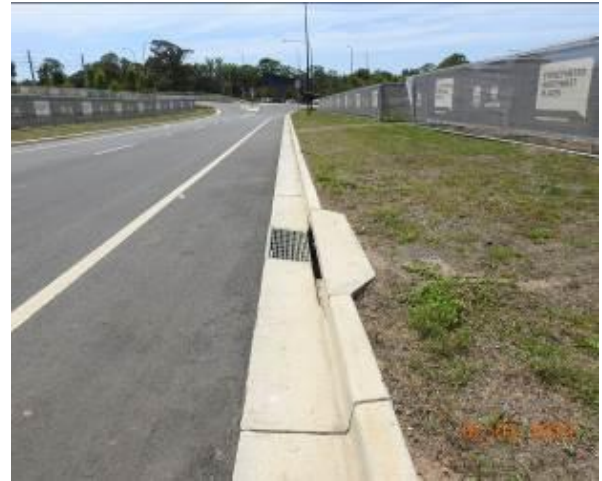
Figure 440 – General Condition of kerb and gutter

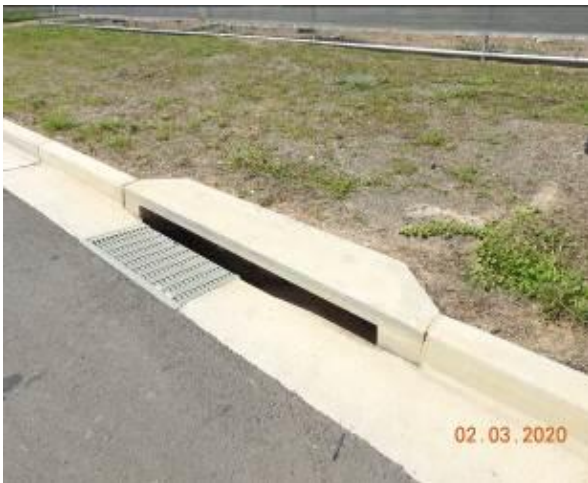
Figure 441 – General Condition of stormwater inlet pit

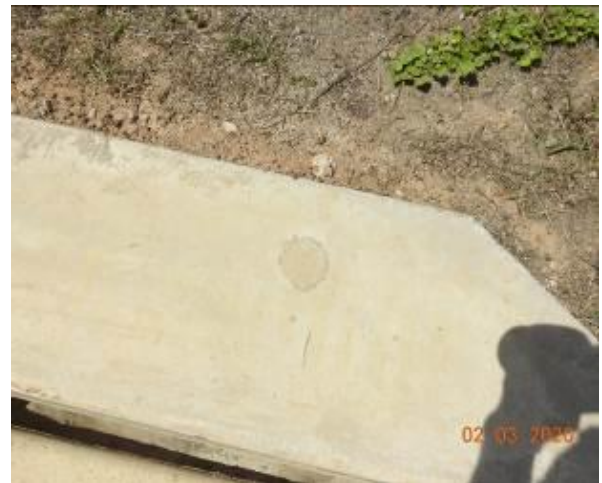
Figure 442 – Crack propagation through stormwater inlet pit

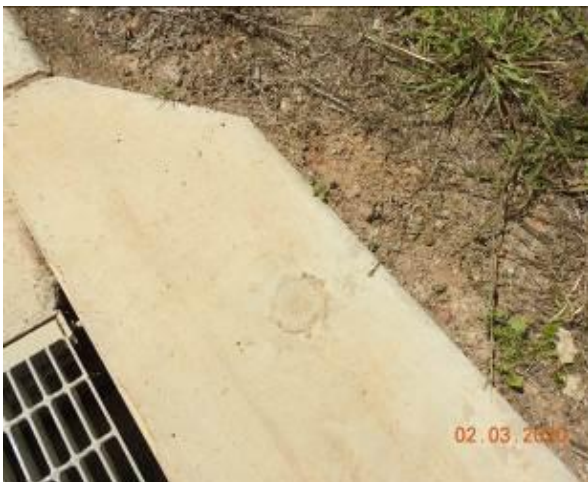
Figure 443 – Crack propagation through stormwater inlet pit

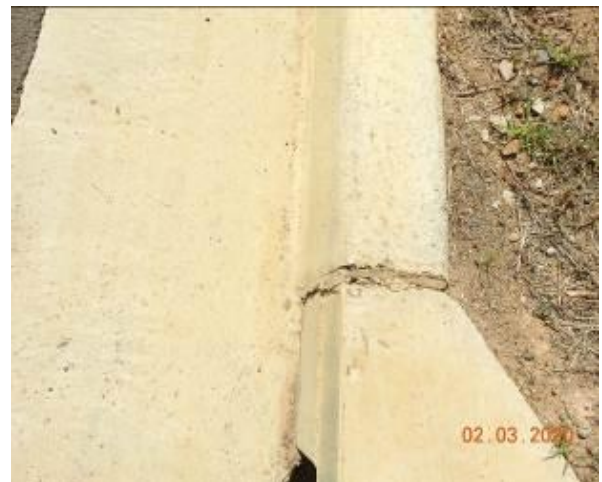
Figure 444 – Crack propagation through stormwater inlet pit

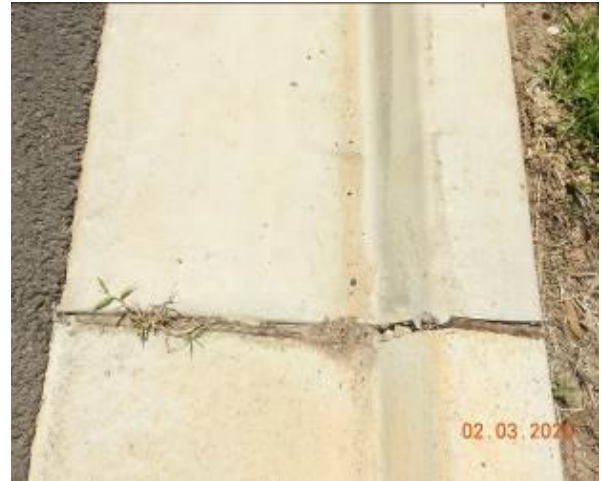
Figure 445 – General Condition of kerb and gutter

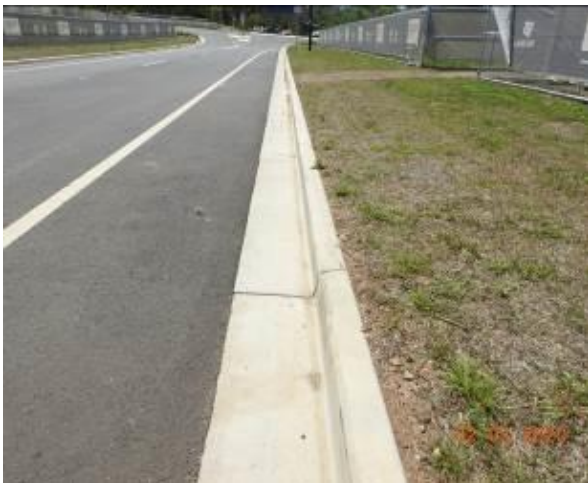
Figure 446 – Crack propagation through kerb and gutter

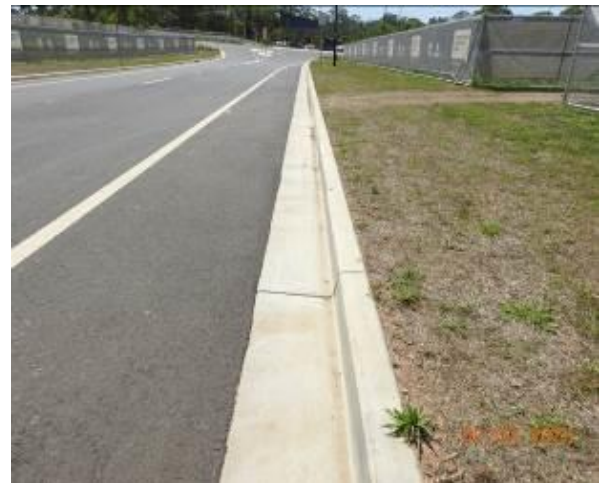
Figure 447 – General Condition of kerb and gutter

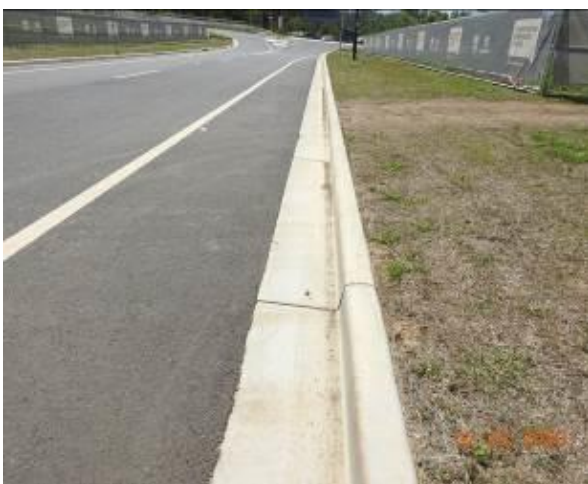
Figure 448 – General Condition of kerb and gutter

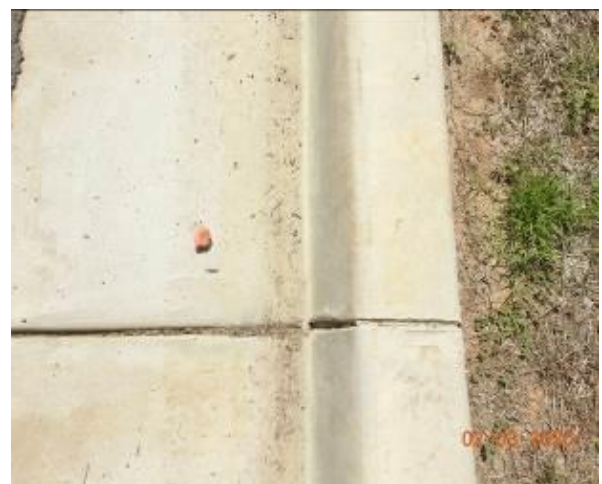
Figure 449 – General Condition of kerb and gutter

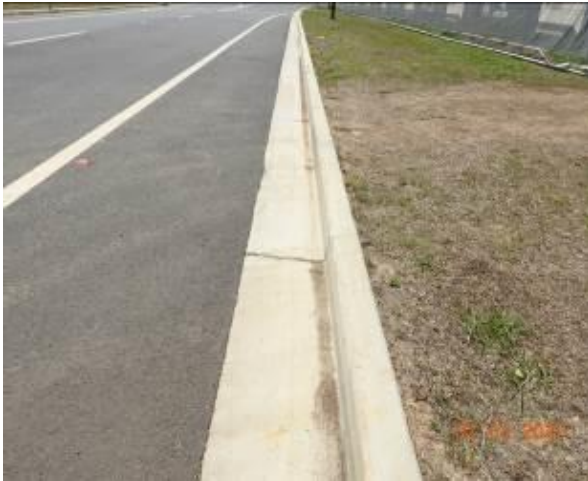
Figure 450 – Crack propagation through kerb and gutter

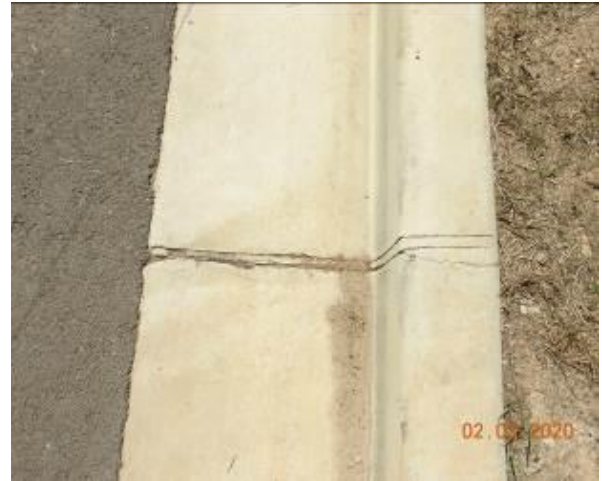
Figure 451 – General Condition of kerb and gutter

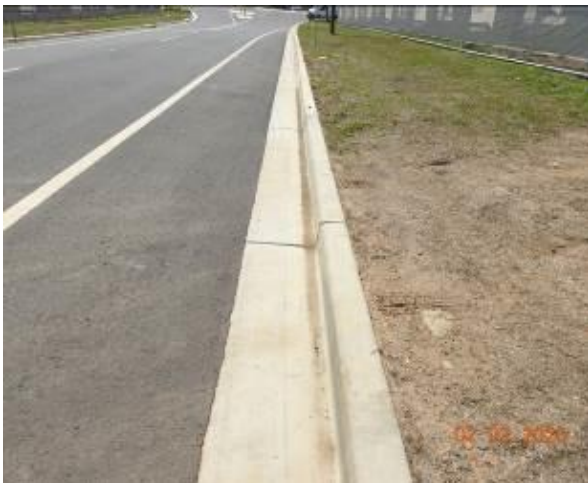
Figure 452 – Crack propagation through kerb and gutter

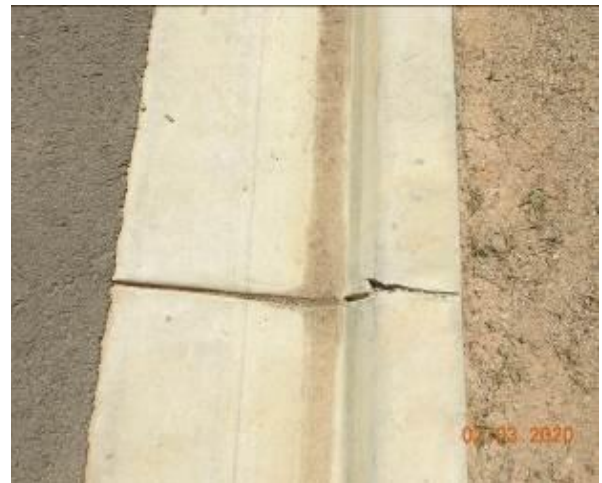
Figure 453 – General Condition of kerb and gutter

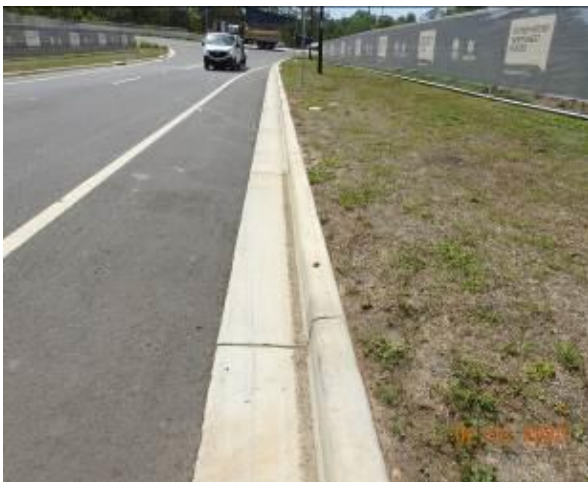
Figure 454 – Crack propagation through kerb and gutter

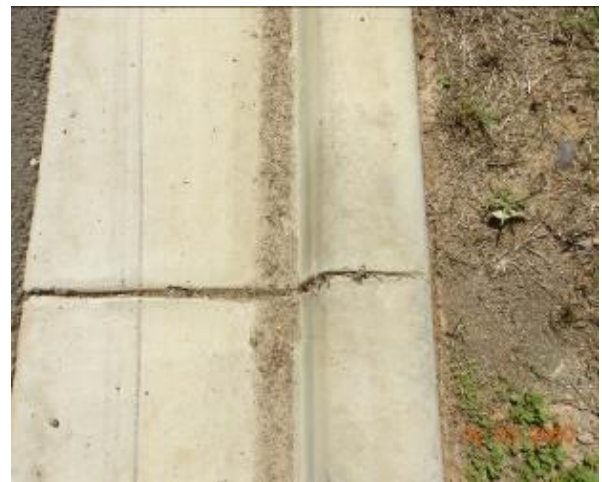
Figure 455 – General Condition of kerb and gutter

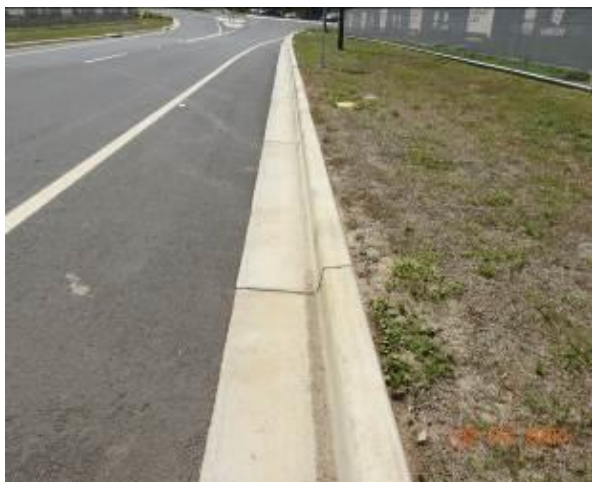
Figure 456 – Crack propagation through kerb and gutter

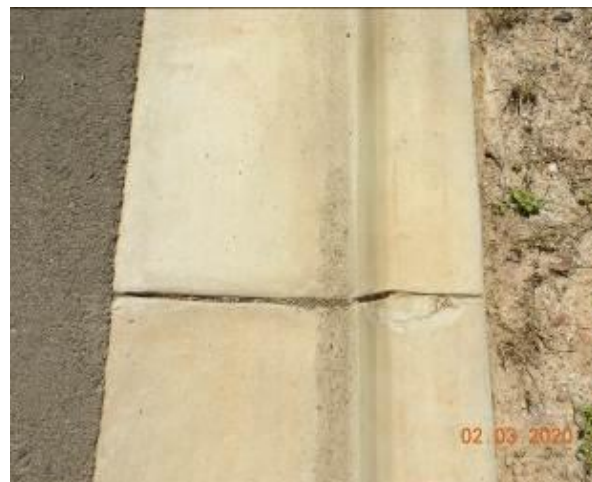
Figure 457 – General Condition of kerb and gutter

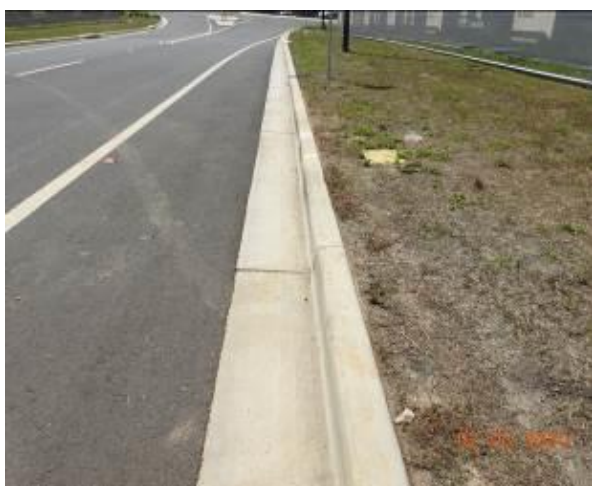
Figure 458 – Crack propagation through kerb and gutter

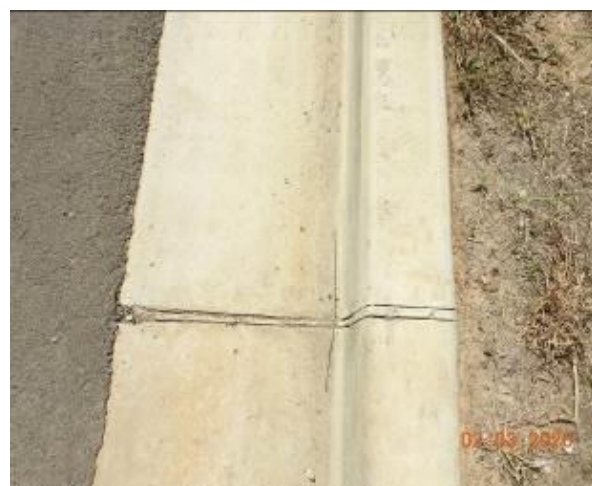
Figure 459 – General Condition of kerb and gutter

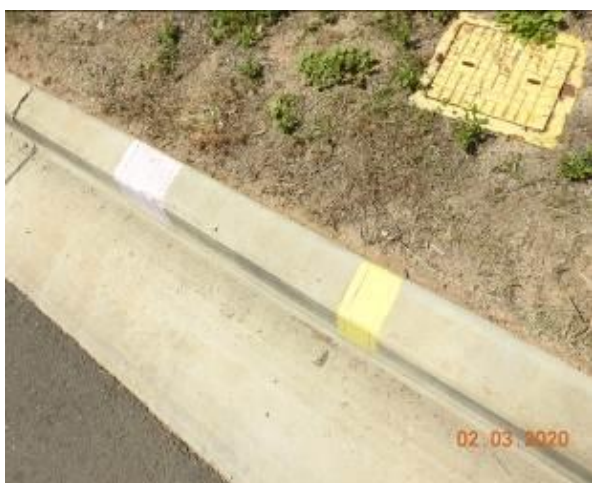
Figure 460 – Crack propagation through kerb and gutter

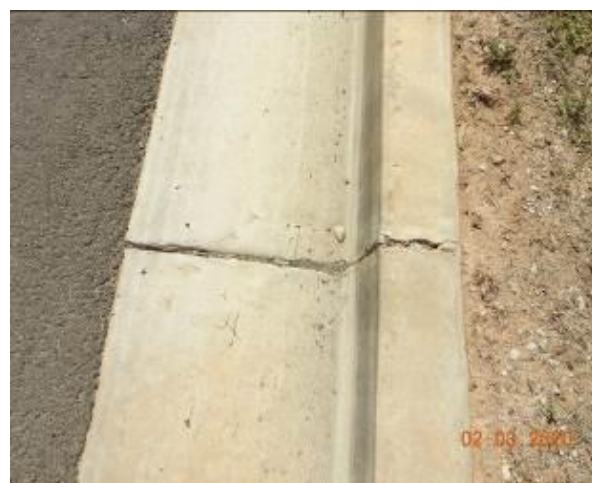
Figure 461 – General Condition of kerb and gutter

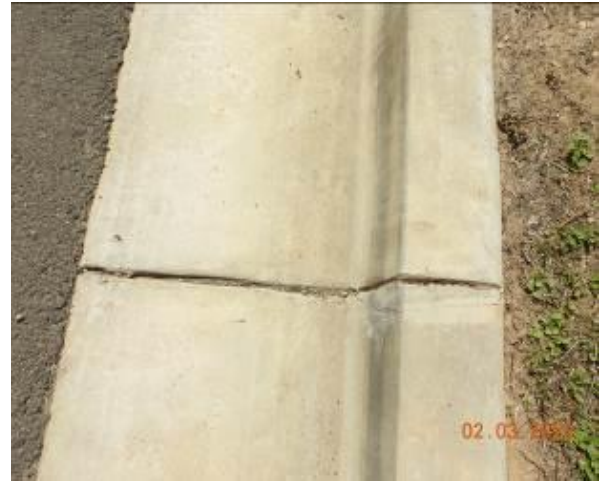
Figure 463 – General Condition of kerb and gutter

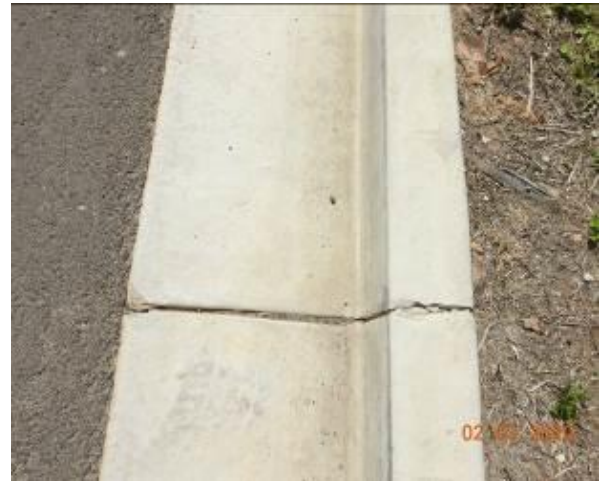
Figure 465 – General Condition of kerb and gutter

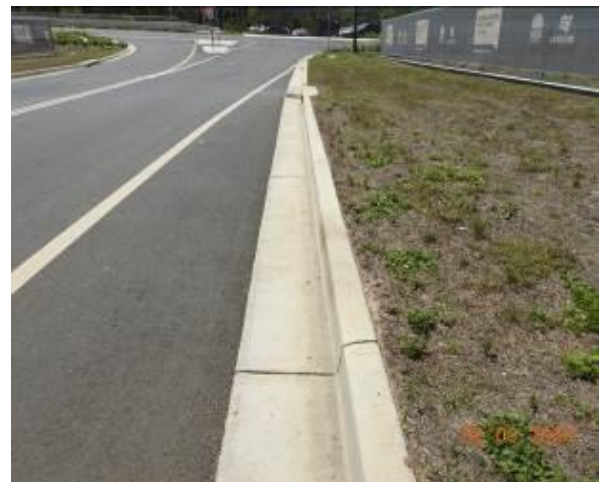
Figure 467 – Crack propagation through kerb and gutter

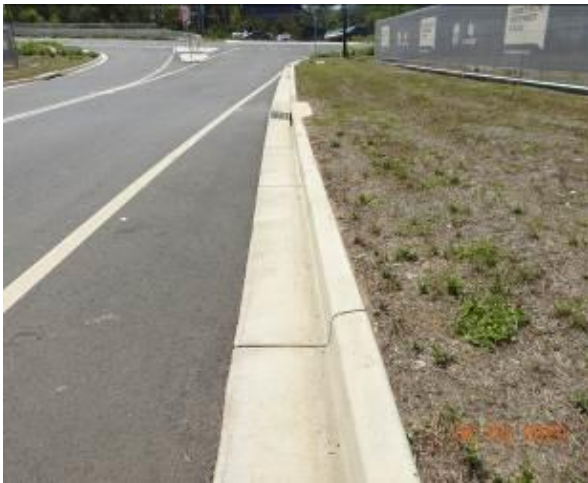
Figure 468 – General Condition of kerb and gutter

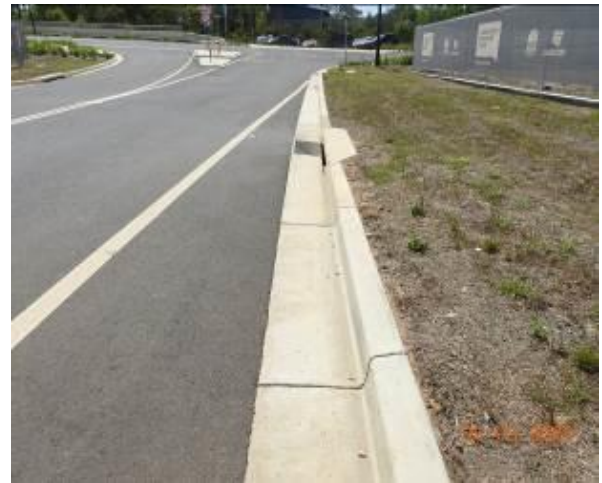
Figure 469 – General Condition of kerb and gutter

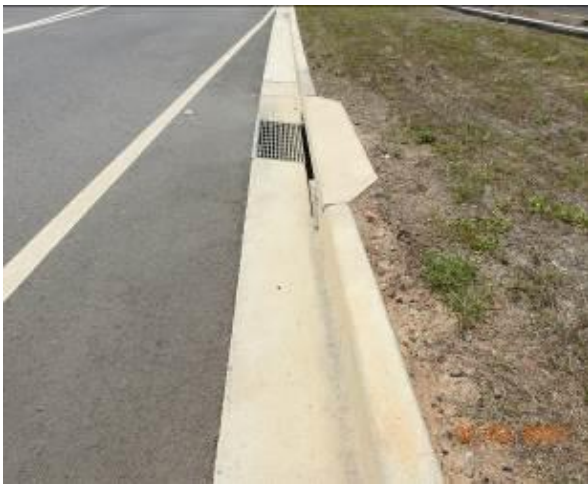
Figure 470 – General Condition of kerb and gutter

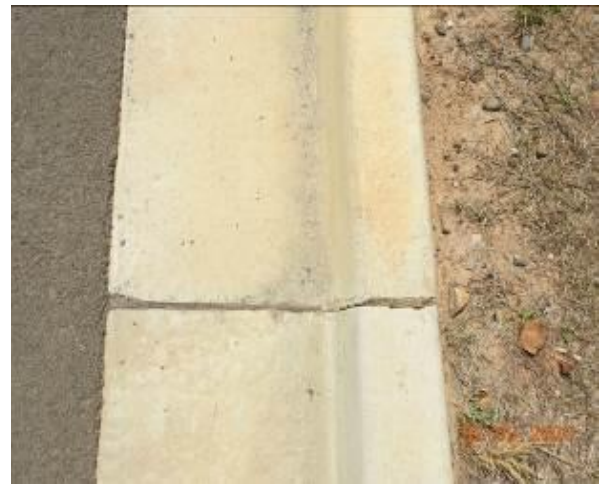
Figure 471 – General Condition of kerb and gutter

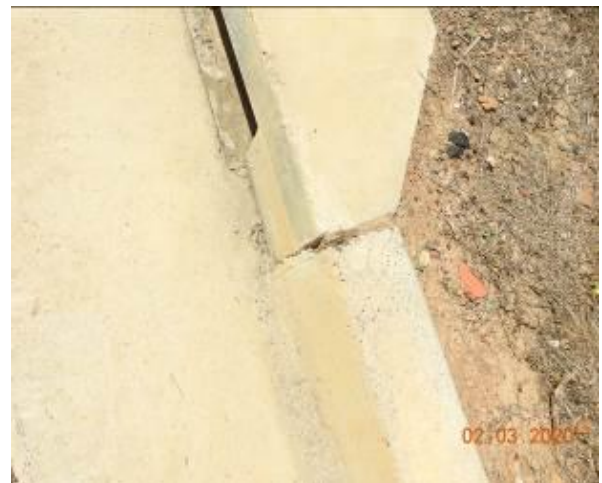
Figure 473 – General Condition of stormwater inlet pit

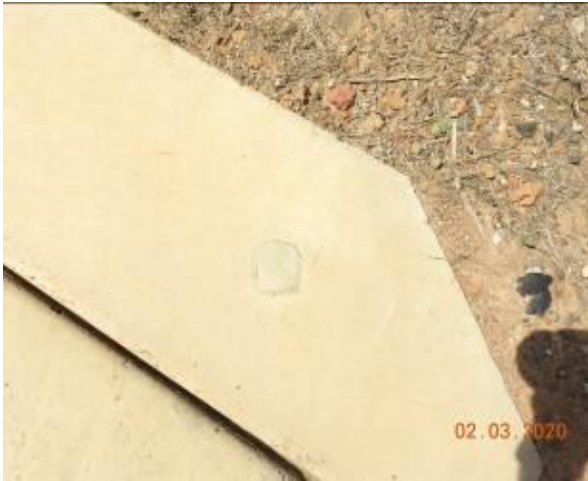
Figure 474 – Crack propagation through stormwater inlet pit

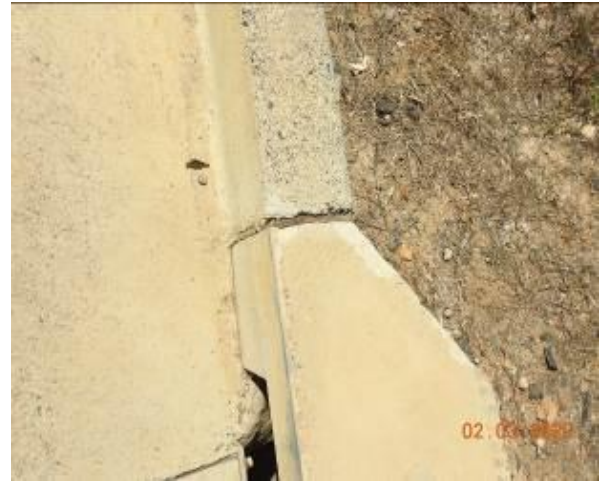
Figure 475 – Crack propagation through stormwater inlet pit

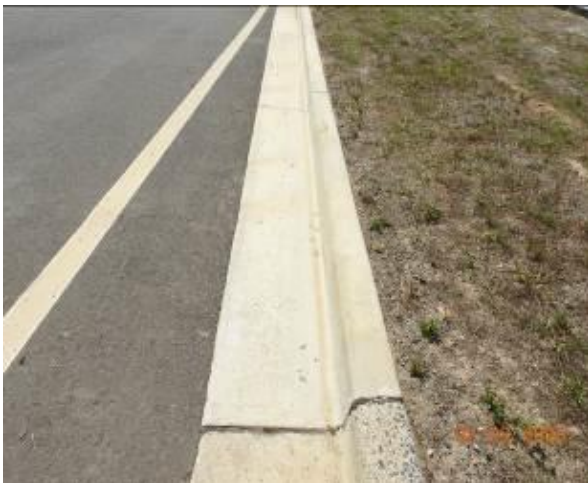
Figure 476 – Crack propagation through stormwater inlet pit

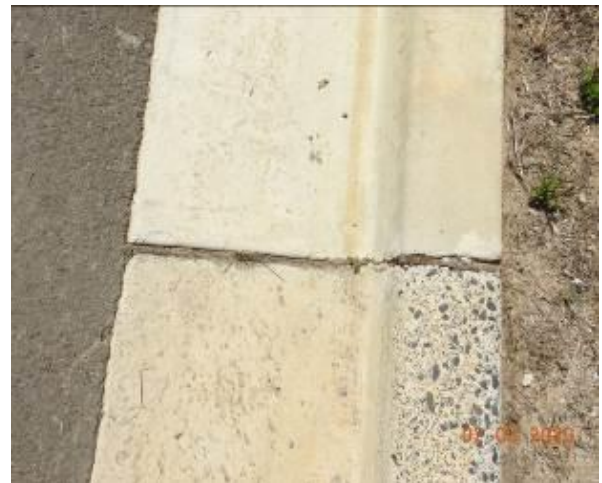
Figure 477 – General Condition of kerb and gutter

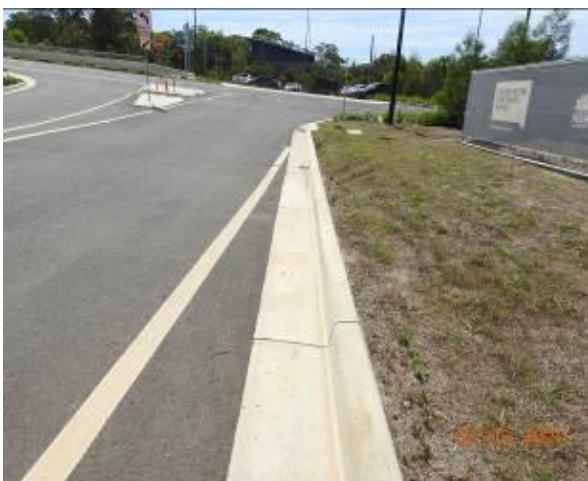
Figure 478 – Crack propagation through kerb and gutter

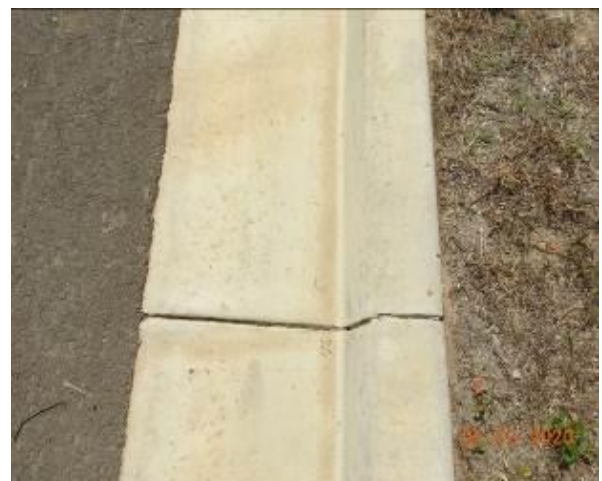
Figure 479 – General Condition of kerb and gutter

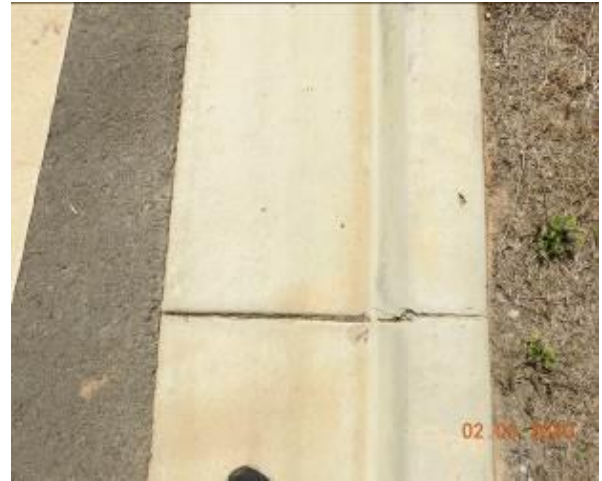
Figure 485 – General Condition of kerb and gutter

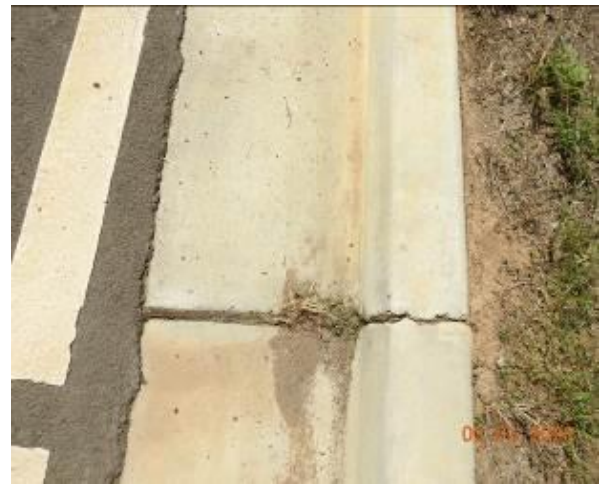
Figure 482 – General Condition of kerb and gutter

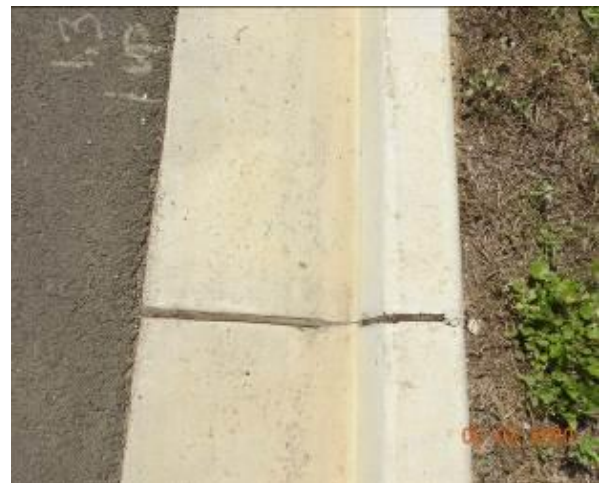
Figure 484 – Crack propagation through kerb and gutter

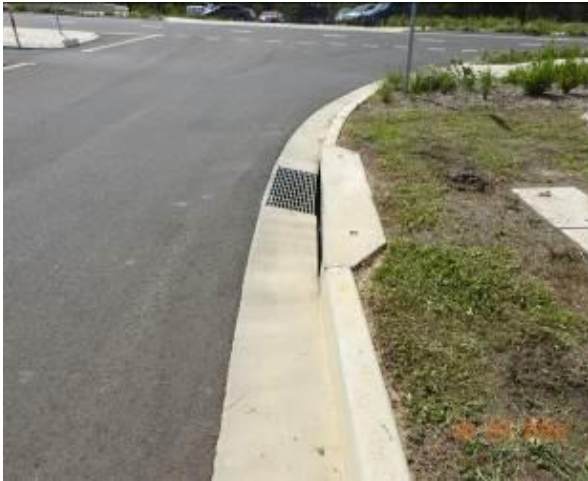
Figure 486 – Crack propagation through kerb and gutter

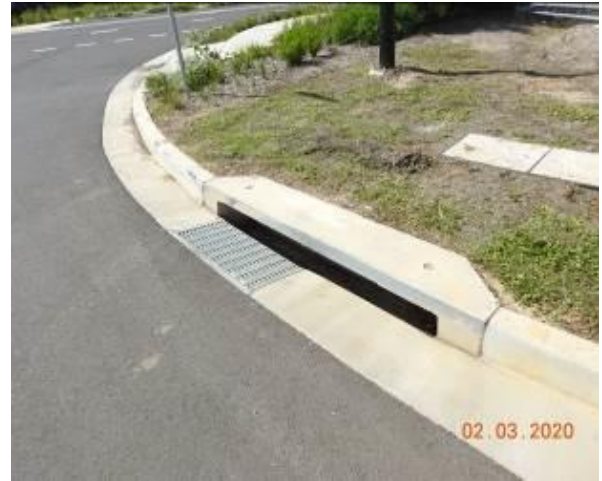
Figure 487 – General Condition of kerb and gutter

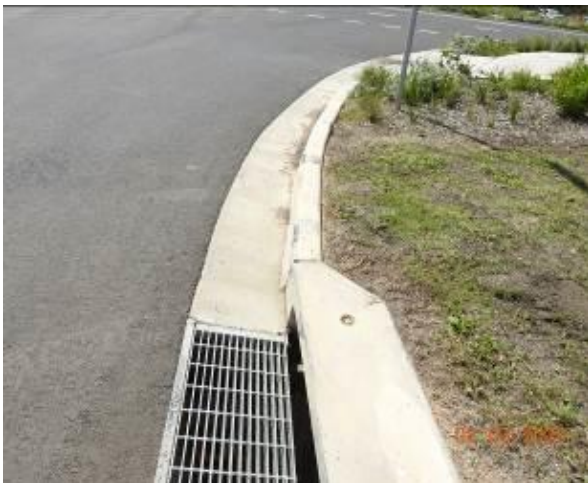
Figure 488 – General Condition of stormwater inlet pit

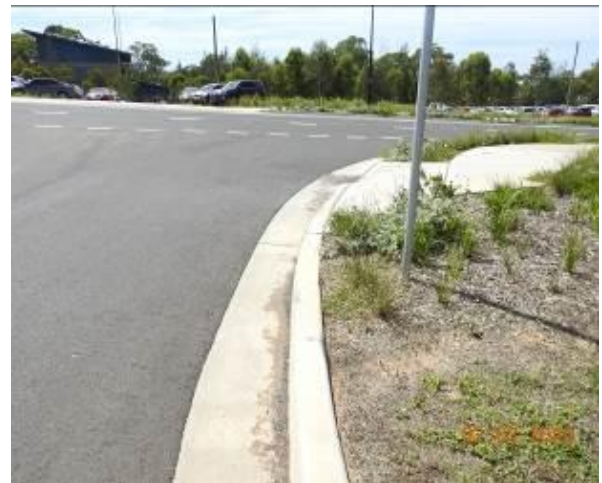
Figure 489 – General Condition of stormwater inlet pit
