**1-15 AND 2-12 CONFERTA AVENUE,
ROUSE HILL NSW 2155
TALLAWONG STATION PRECINCT SOUTH
PRE-DILAPIDATION REPORT**

**DEICORP PROJECTS
(TALLAWONG STATION) PTY LTD**

Job No. 191294.0
24/03/2020

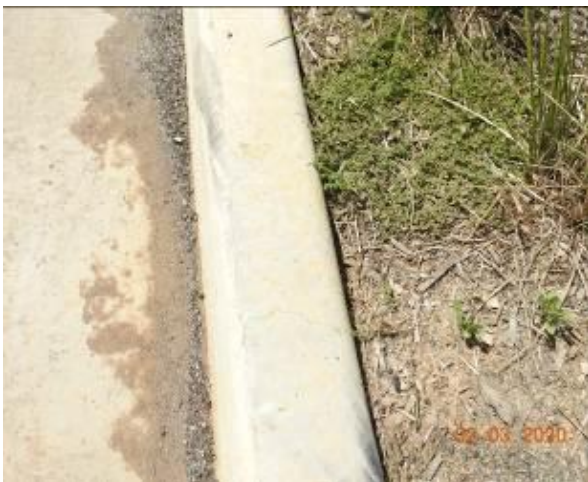
Figure 490 – General Condition of kerb and gutter

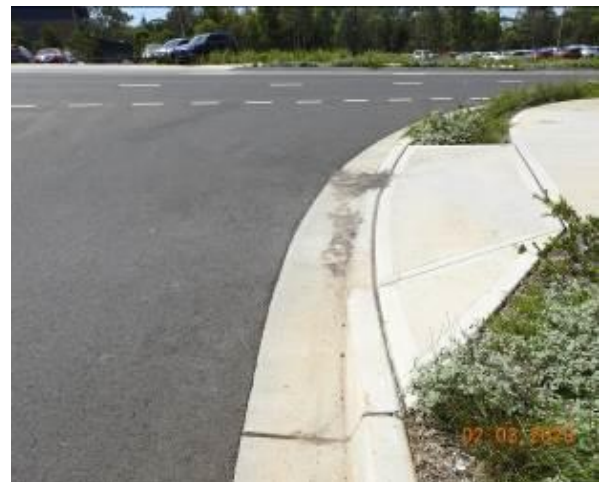
Figure 491 – Crack propagation through kerb

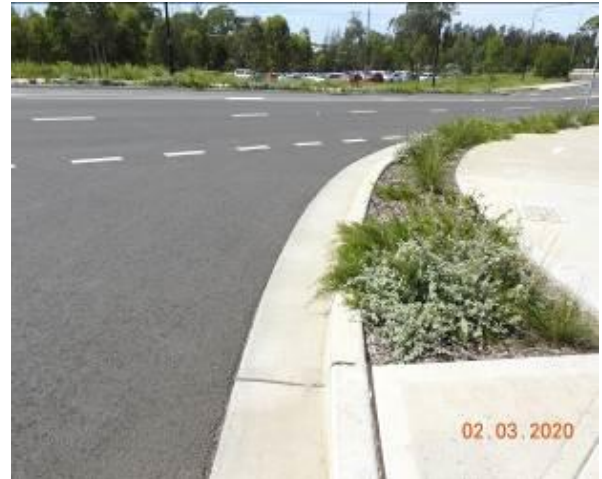
Figure 493 – General Condition of layback and gutter

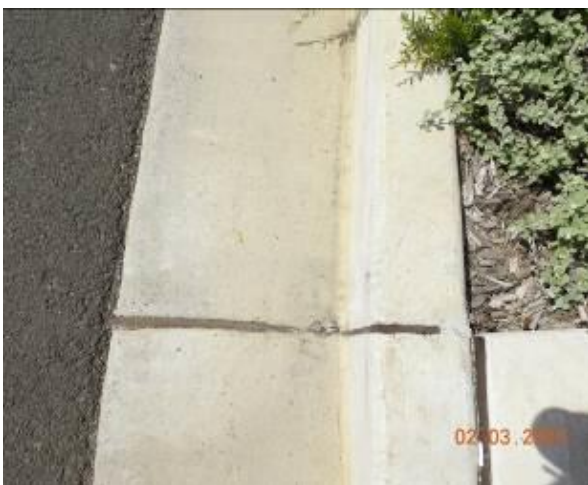
Figure 494 – General Condition of kerb and gutter

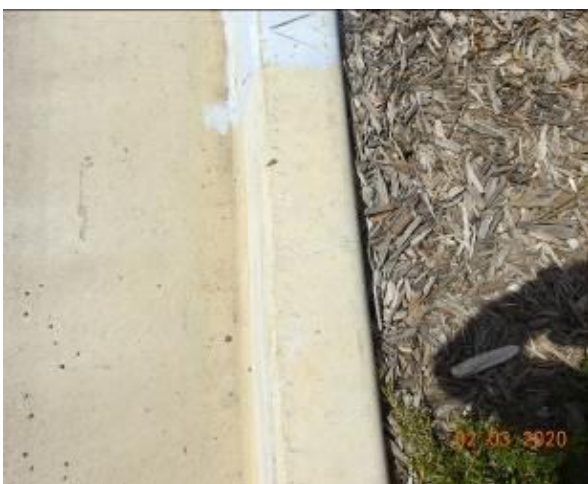
Figure 496 – General Condition of kerb and gutter

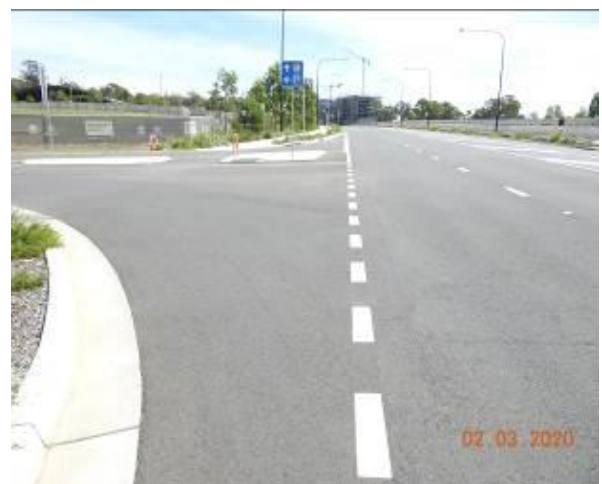
Figure 497 – Crack propagation through kerb and gutter

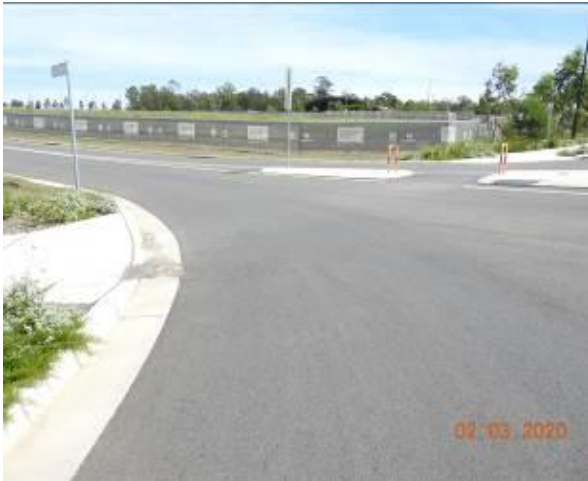
Figure 498 – General Condition of road surface

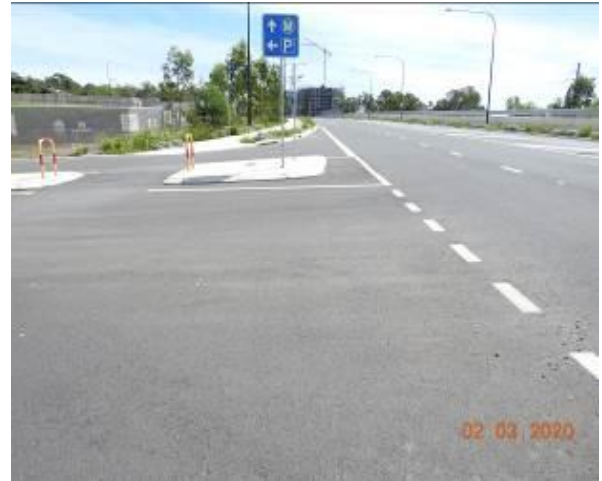
Figure 499 – General Condition of road surface

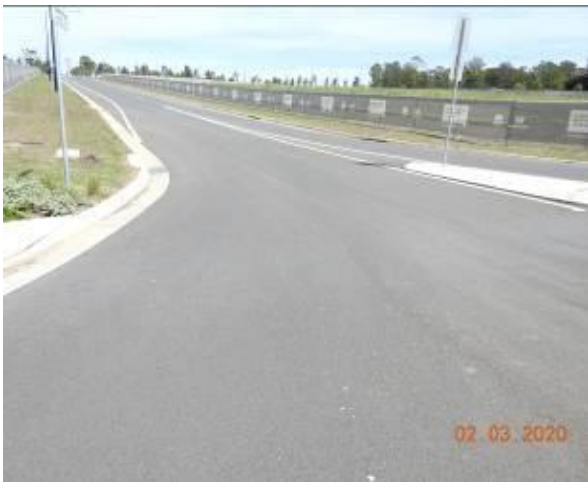
Figure 500 – General Condition of road surface

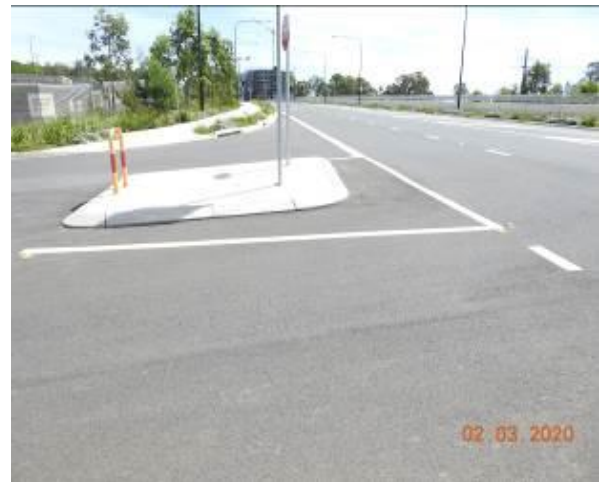
Figure 501 – General Condition of road surface

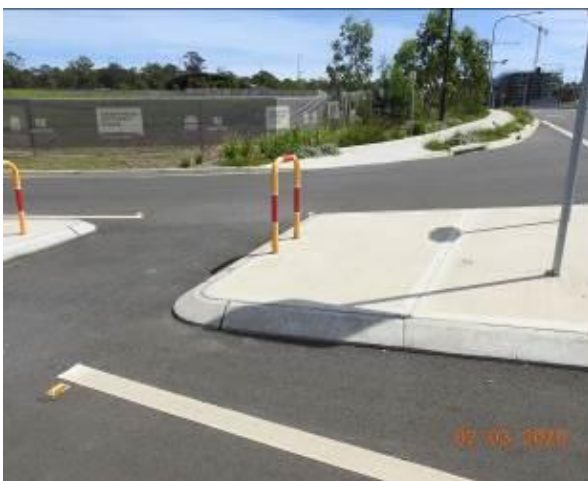
Figure 502 – General Condition of traffic island

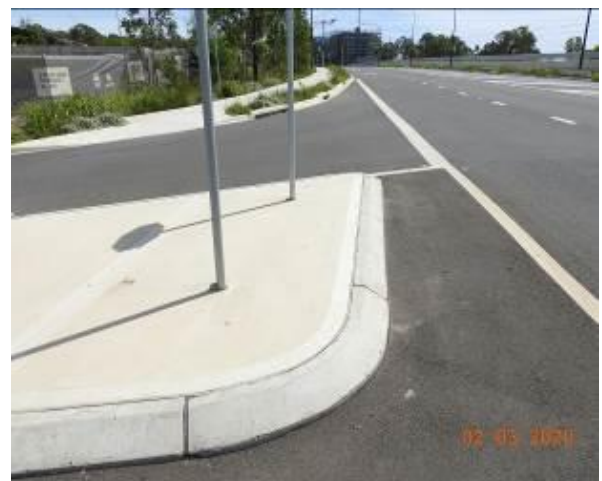
Figure 503 – General Condition of traffic island

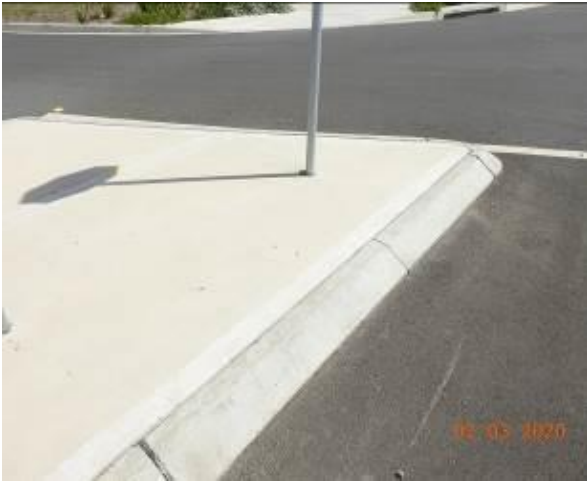
Figure 504 – General Condition of traffic island

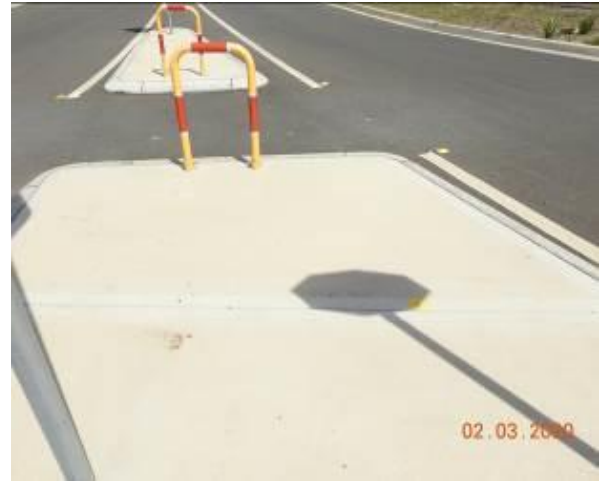
Figure 505 – General Condition of traffic island

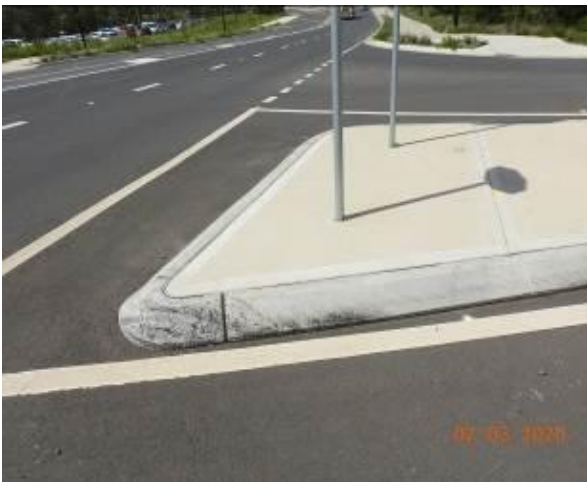
Figure 506 – General Condition of traffic island

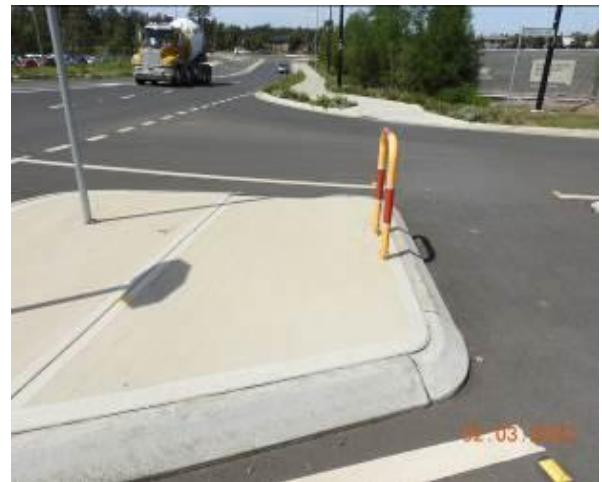
Figure 507 – General Condition of traffic island

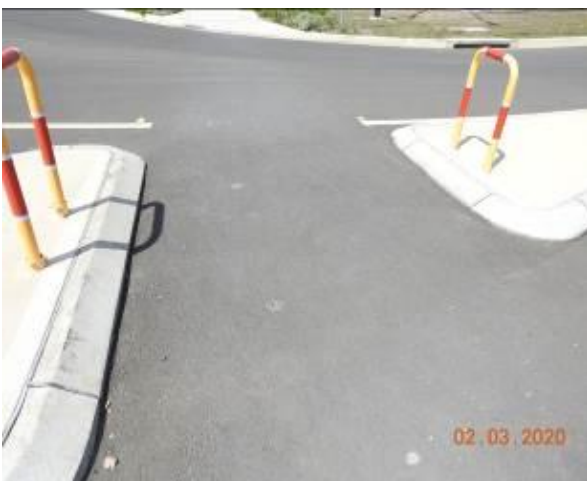
Figure 508 – General Condition of traffic island

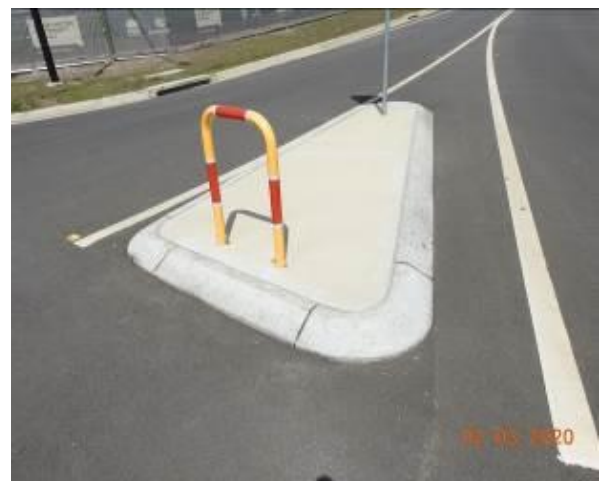
Figure 509 – General Condition of traffic island

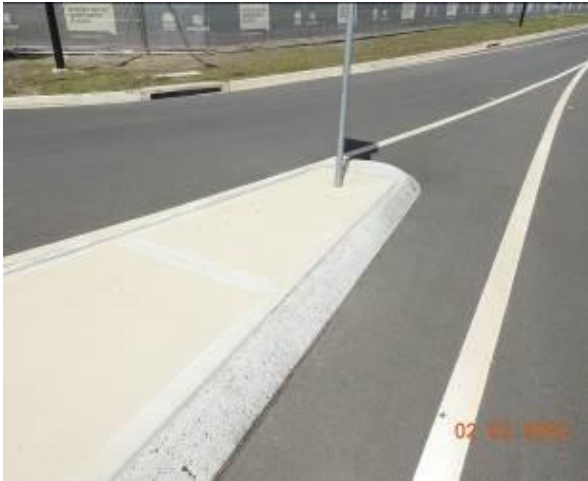
Figure 510 – General Condition of traffic island

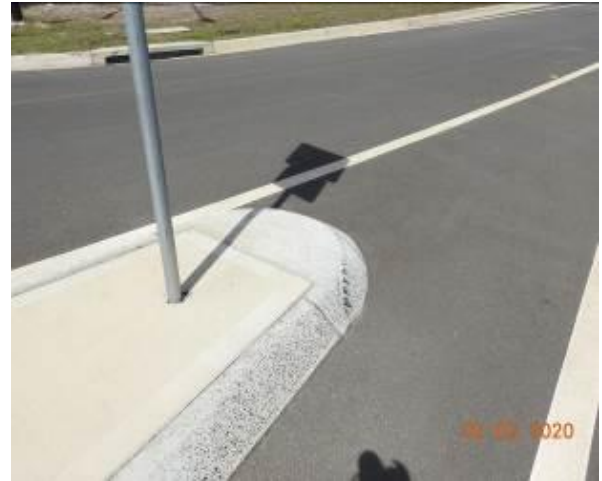
Figure 511 – General Condition of traffic island

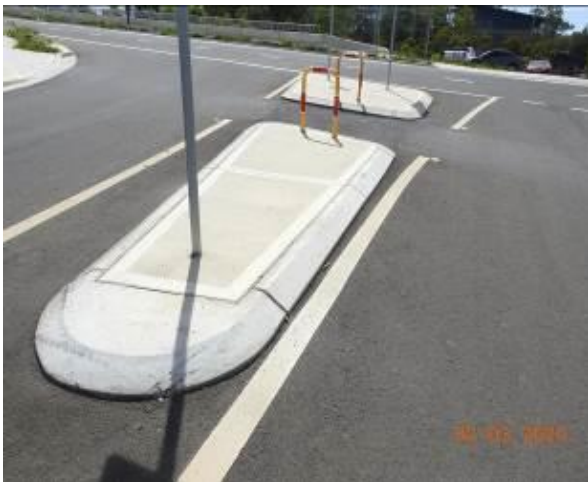
Figure 512 – General Condition of traffic island

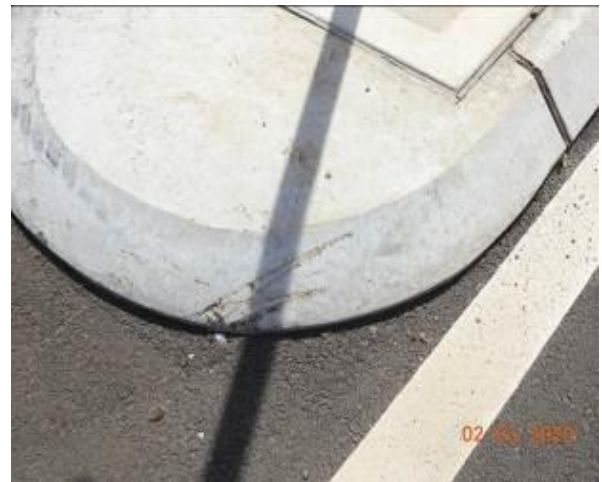
Figure 513 – General Condition of traffic island

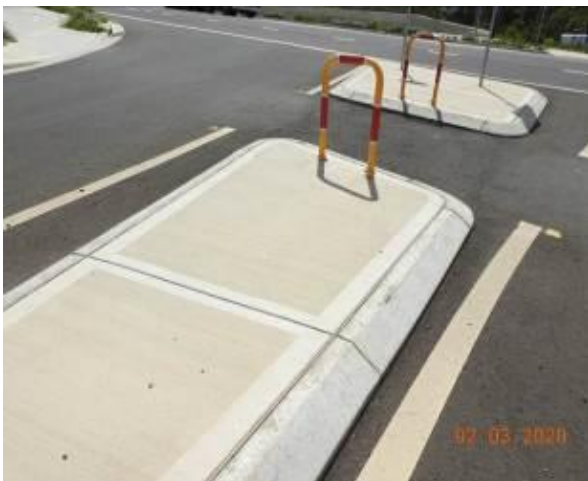
Figure 514 – Crack propagation through traffic island kerb

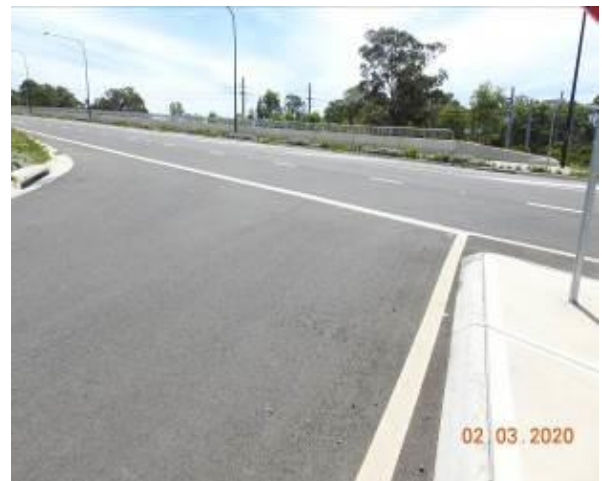
Figure 515 – General Condition of traffic island

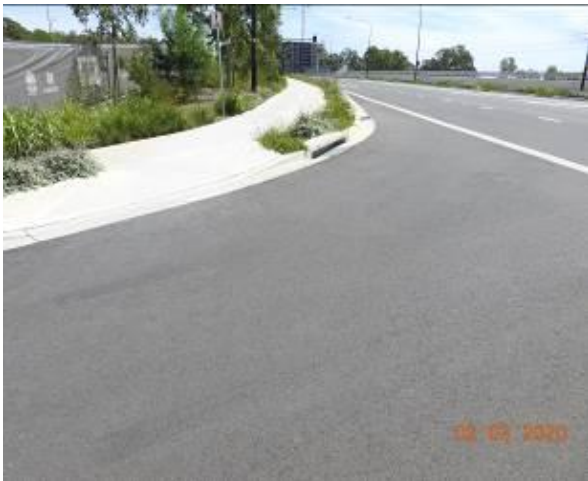
Figure 516 – General Condition of road surface

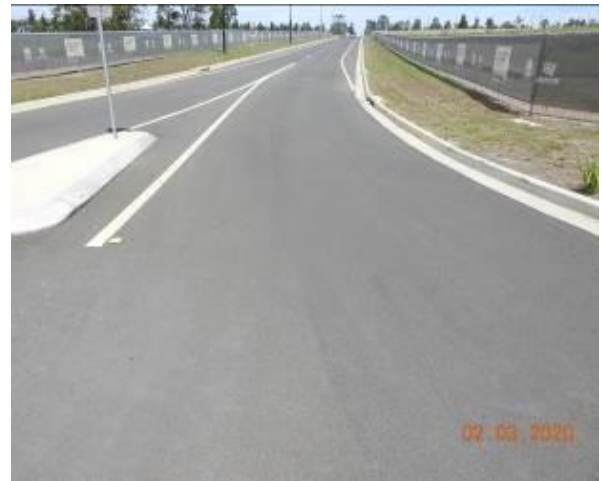
Figure 517 – General Condition of road surface

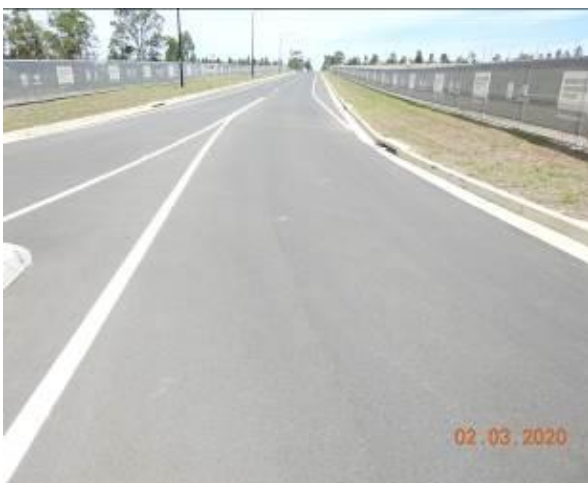
Figure 518 – General Condition of road surface

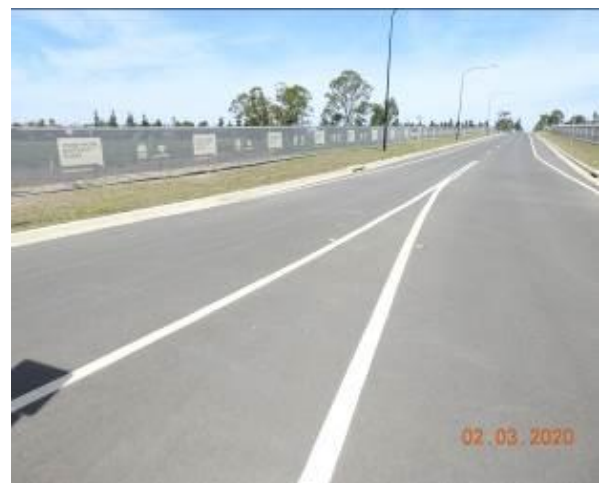
Figure 519 – General Condition of road surface

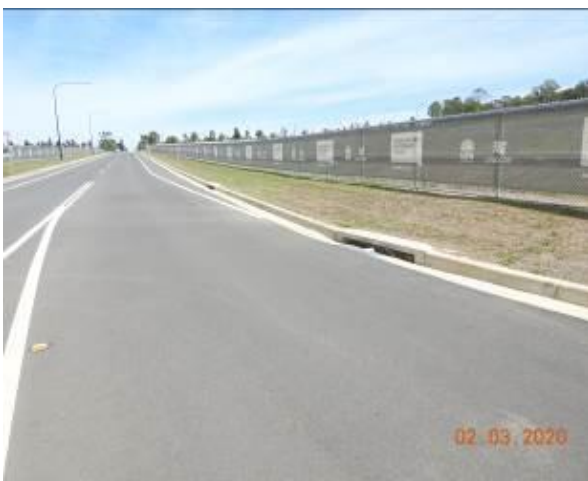
Figure 520 – General Condition of road surface

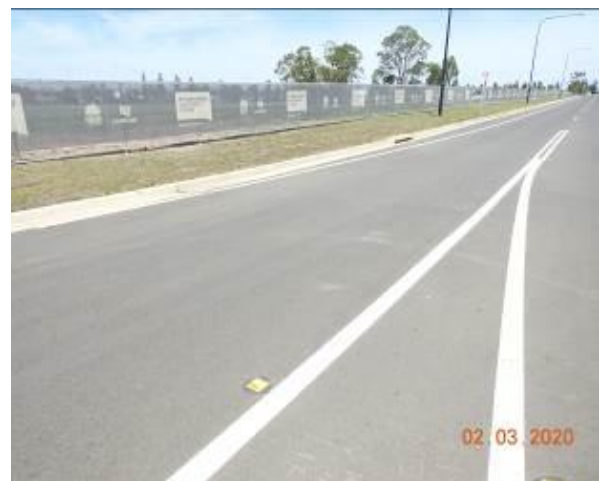
Figure 521 – General Condition of road surface

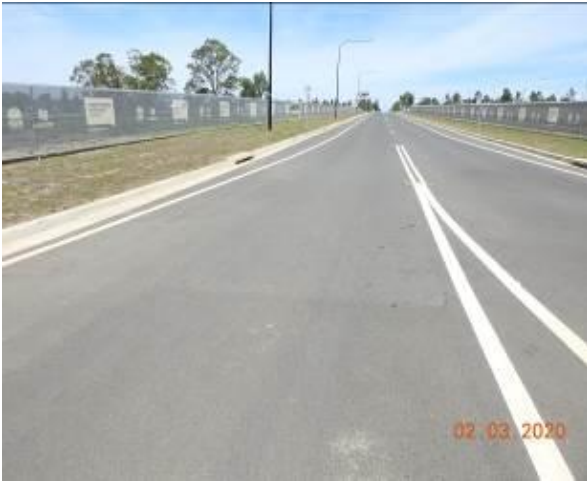
Figure 522 – General Condition of road surface

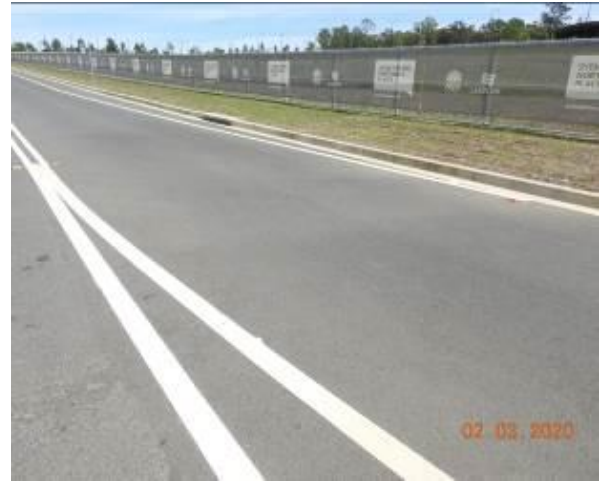
Figure 523 – General Condition of road surface

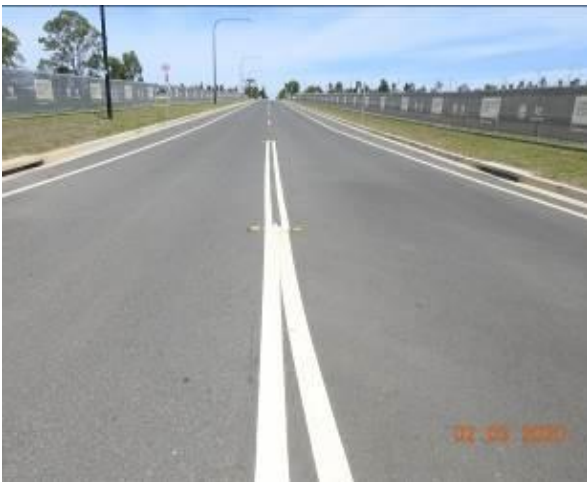
Figure 524 – General Condition of road surface

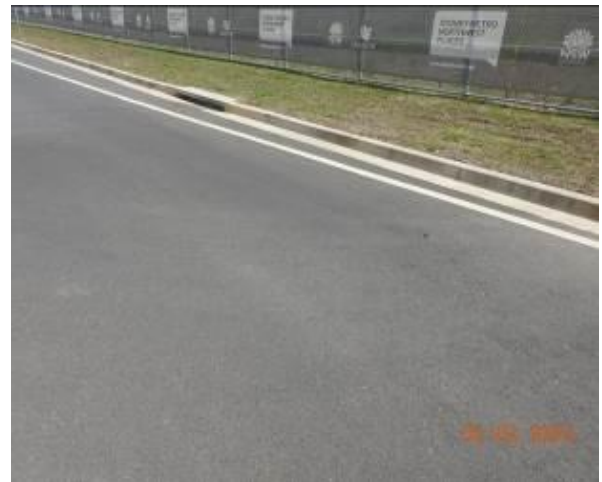
Figure 526 – General Condition of road surface

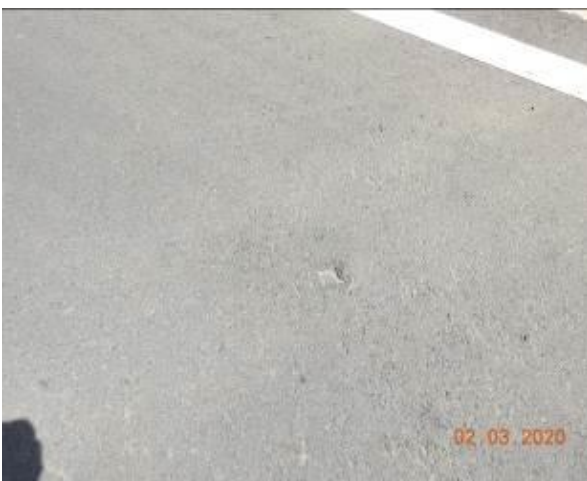
Figure 527 – Loss of material through road surface

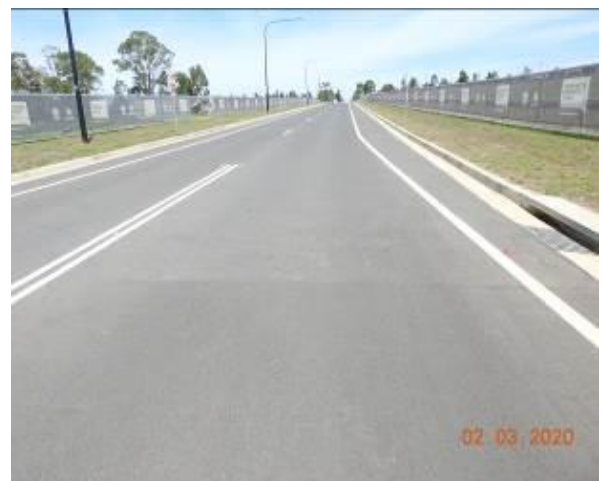
Figure 528 – General Condition of road surface

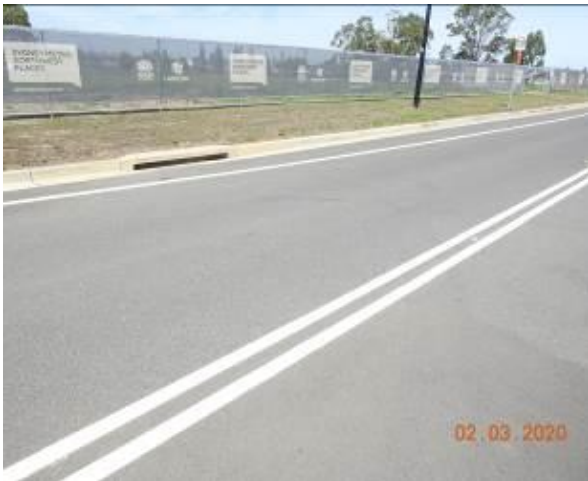
Figure 529 – General Condition of road surface

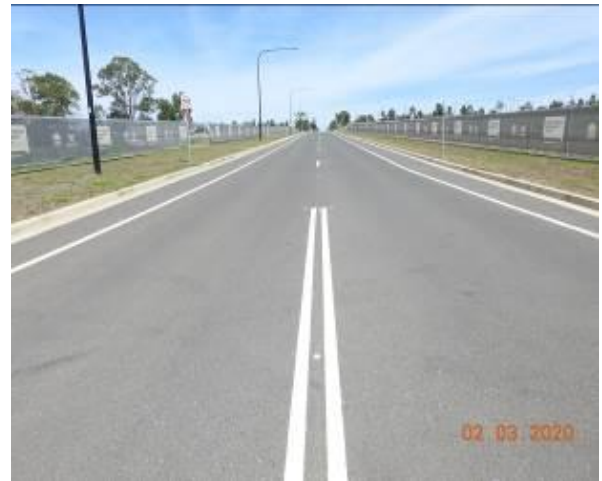
Figure 530 – General Condition of road surface

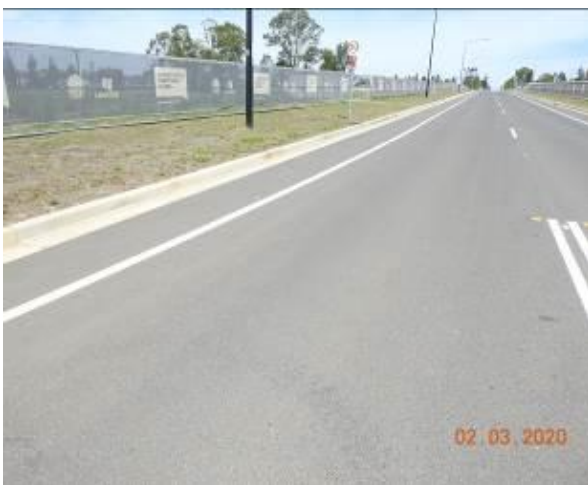
Figure 531 – General Condition of road surface

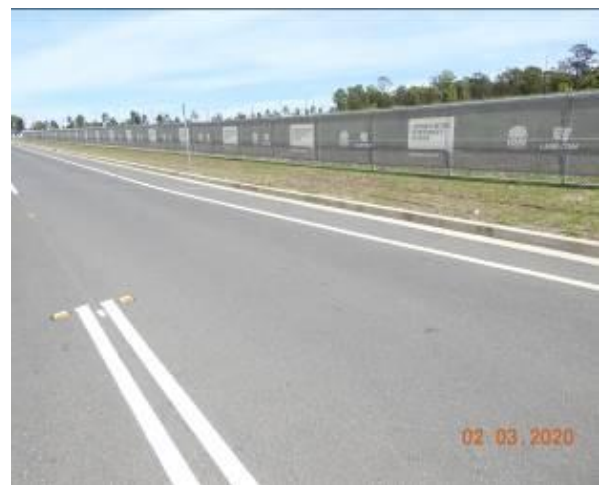
Figure 532 – General Condition of road surface

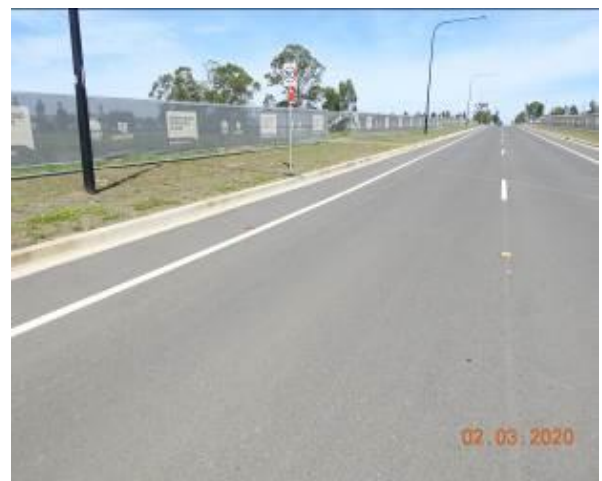
Figure 534 – General Condition of road surface

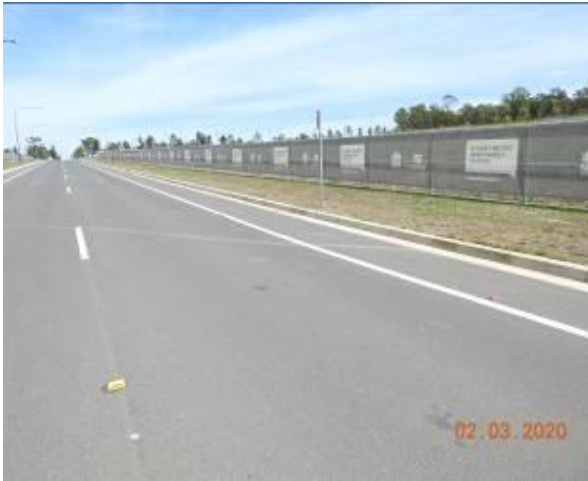
Figure 535 – General Condition of road surface

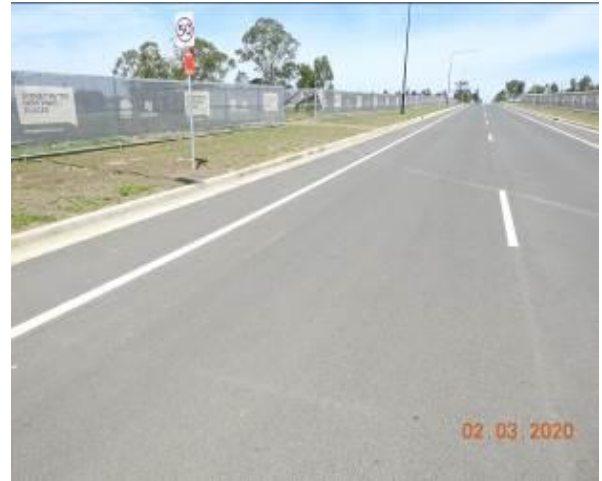
Figure 536 – General Condition of road surface

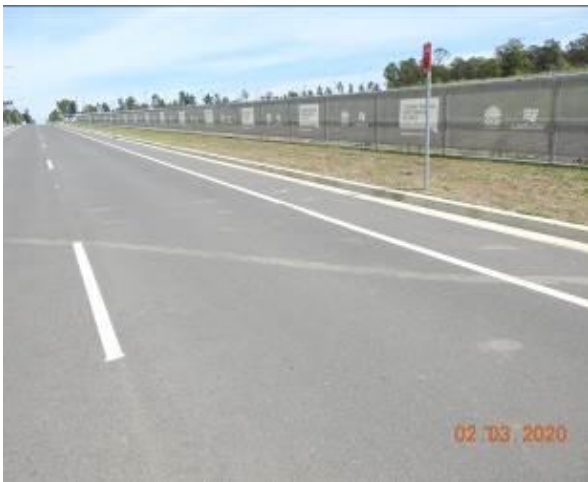
Figure 537 – General Condition of road surface

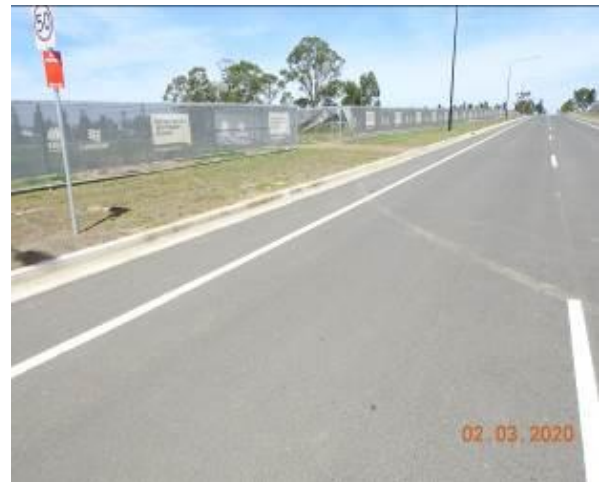
Figure 538 – General Condition of road surface

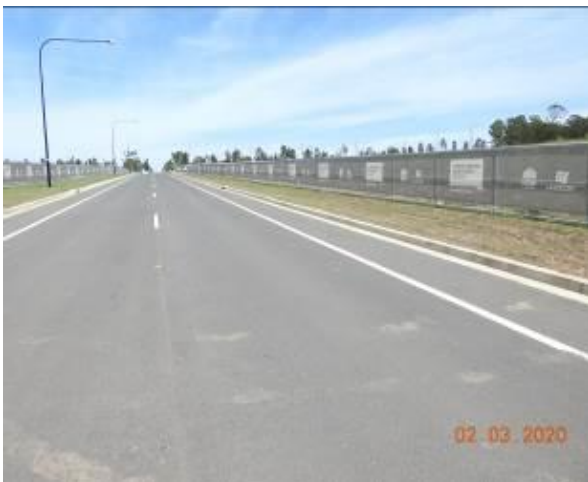
Figure 539 – General Condition of road surface

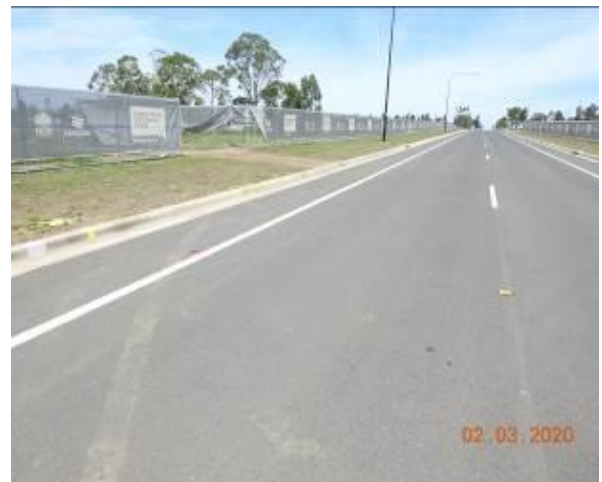
Figure 540 – General Condition of road surface

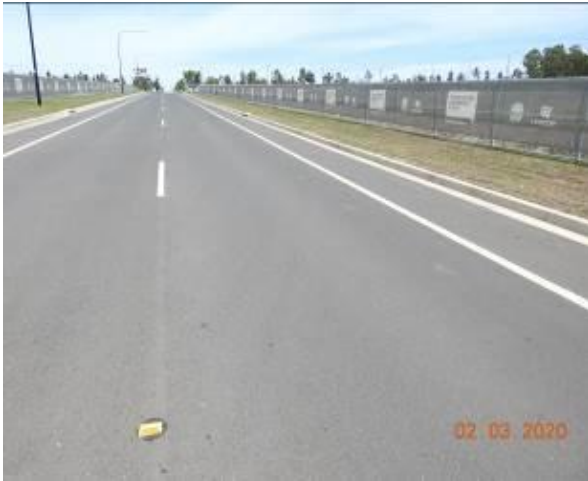
Figure 541 – General Condition of road surface

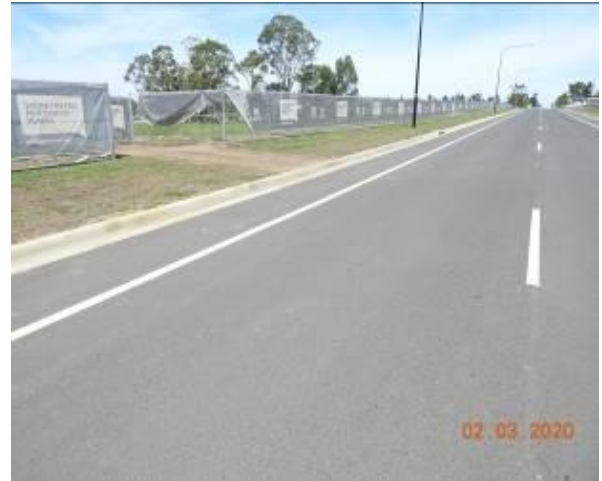
Figure 542 – General Condition of road surface

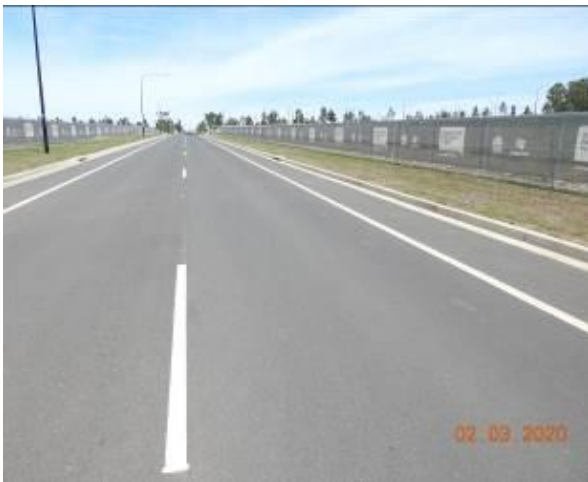
Figure 543 – General Condition of road surface

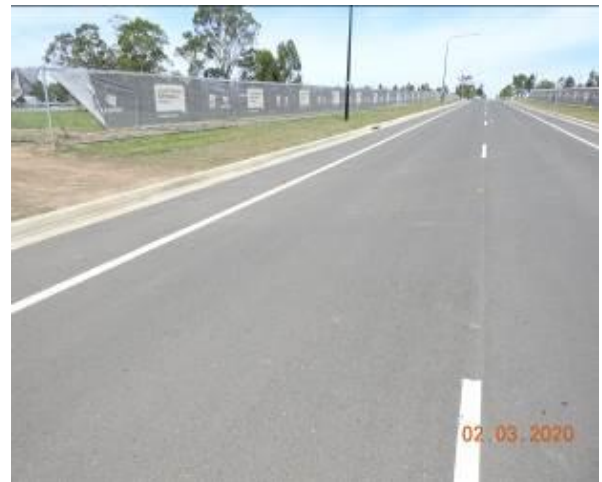
Figure 544 – General Condition of road surface

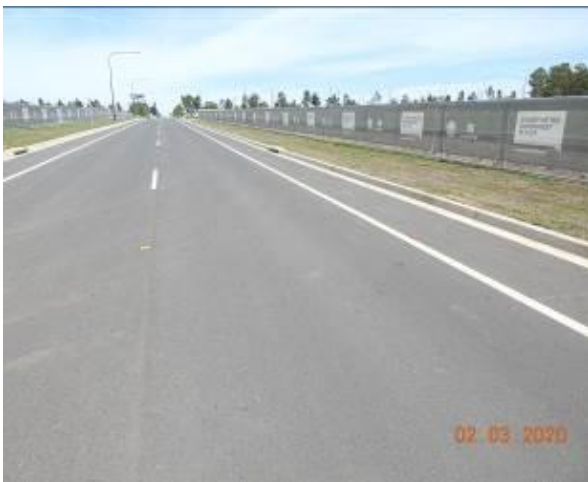
Figure 545 – General Condition of road surface

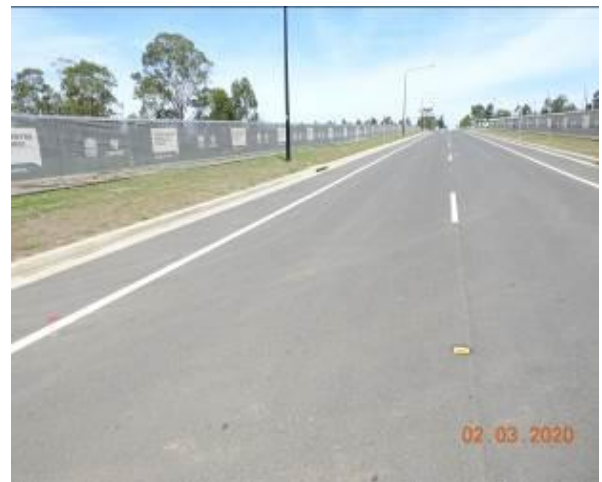
Figure 546 – General Condition of road surface

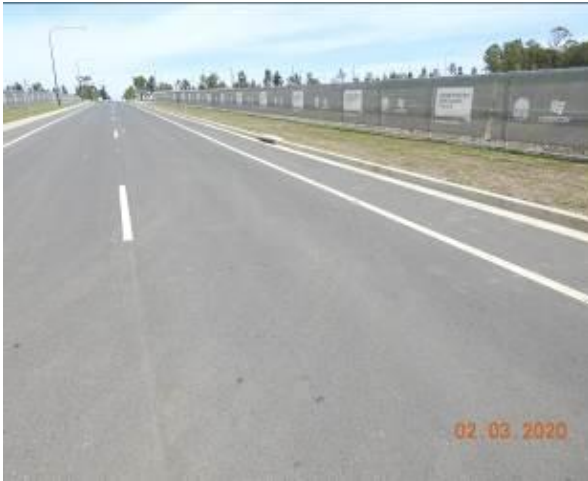
Figure 547 – General Condition of road surface

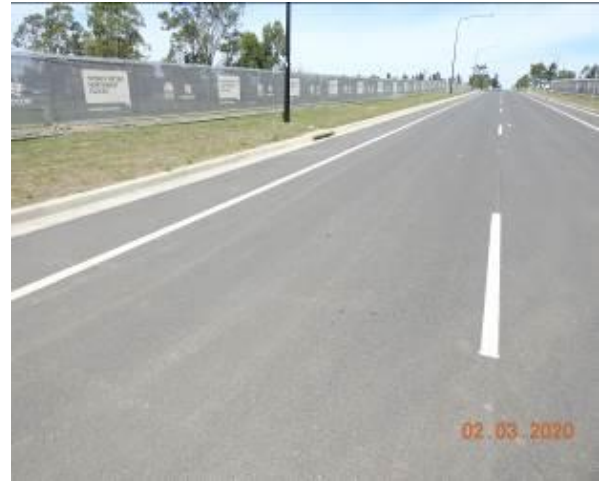
Figure 548 – General Condition of road surface

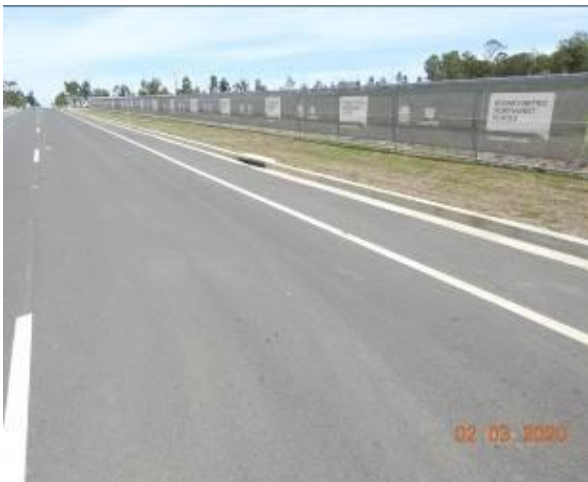
Figure 549 – General Condition of road surface

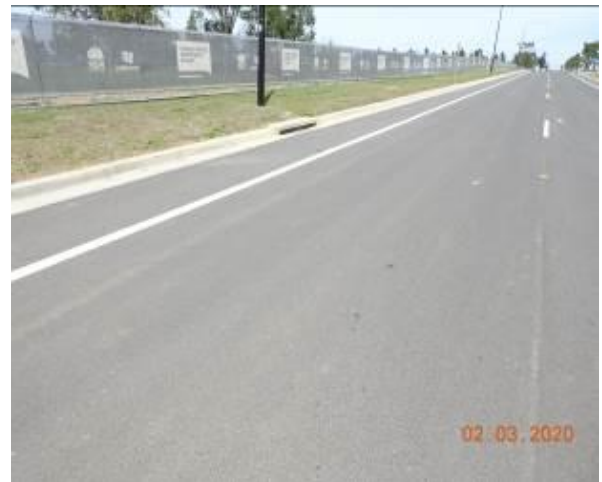
Figure 550 – General Condition of road surface

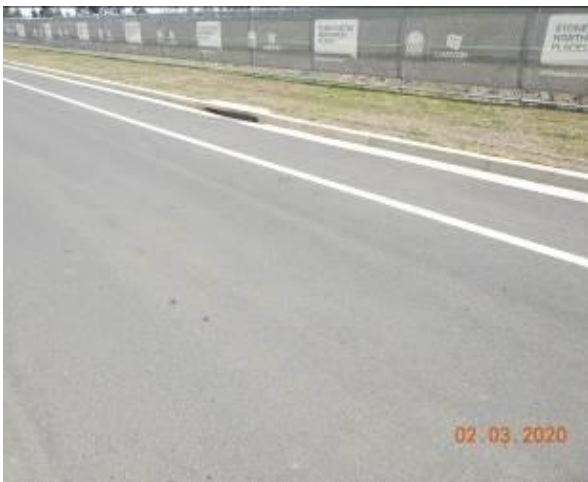
Figure 551 – General Condition of road surface

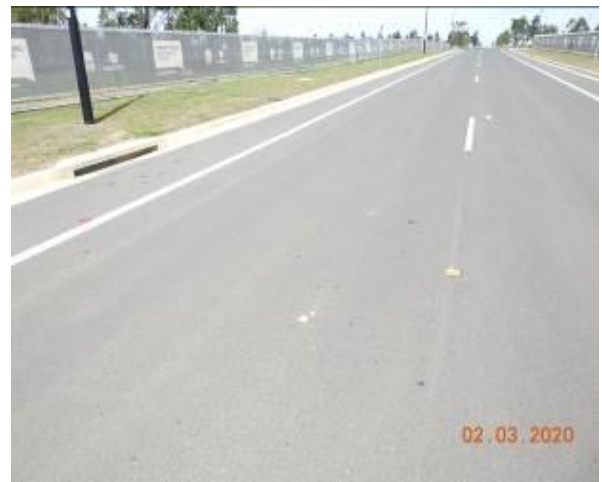
Figure 552 – General Condition of road surface

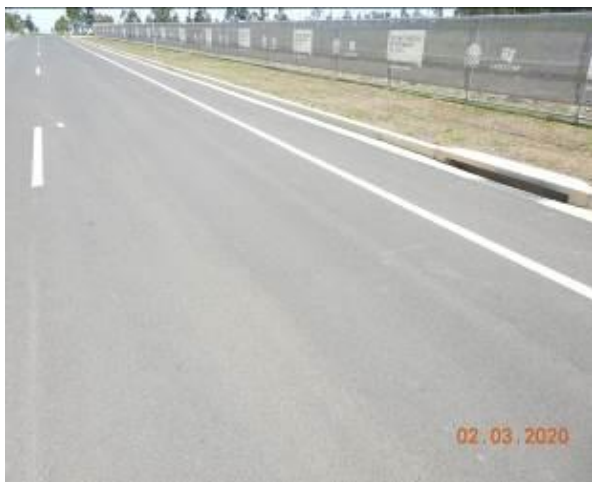
Figure 553 – General Condition of road surface

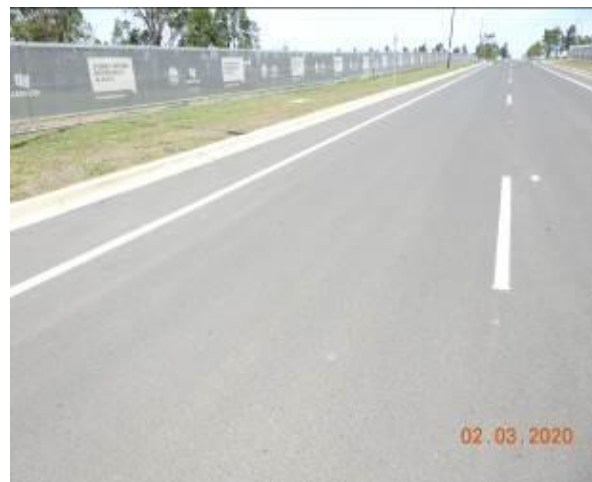
Figure 554 – General Condition of road surface

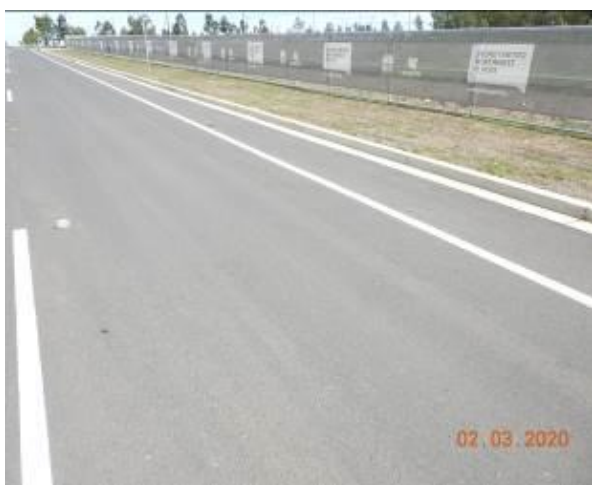
Figure 555 – General Condition of road surface

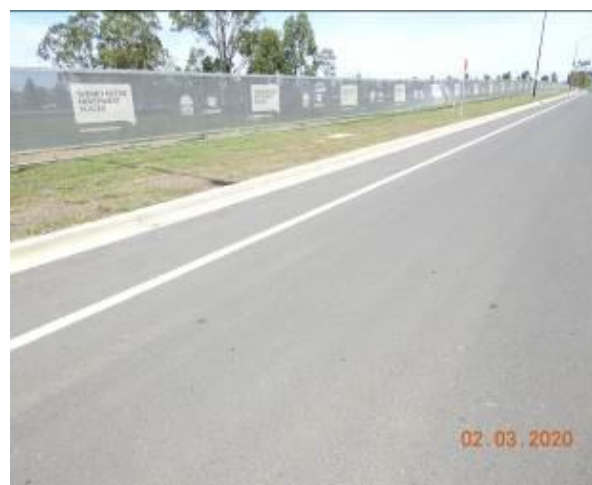
Figure 556 – General Condition of road surface

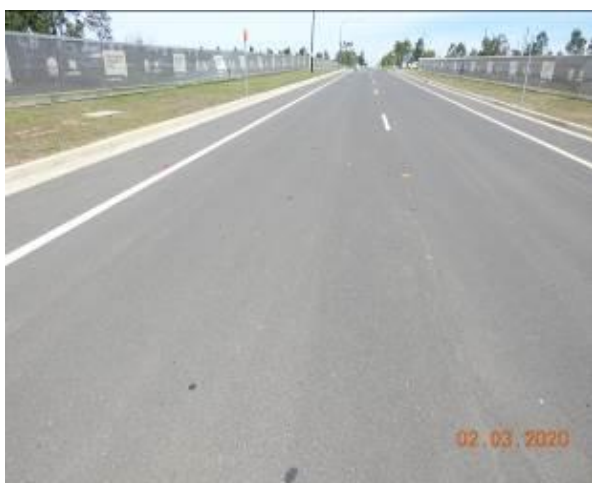
Figure 557 – General Condition of road surface

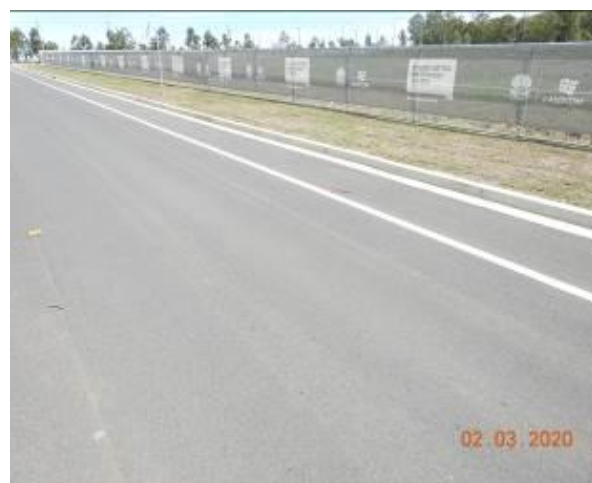
Figure 558 – General Condition of road surface

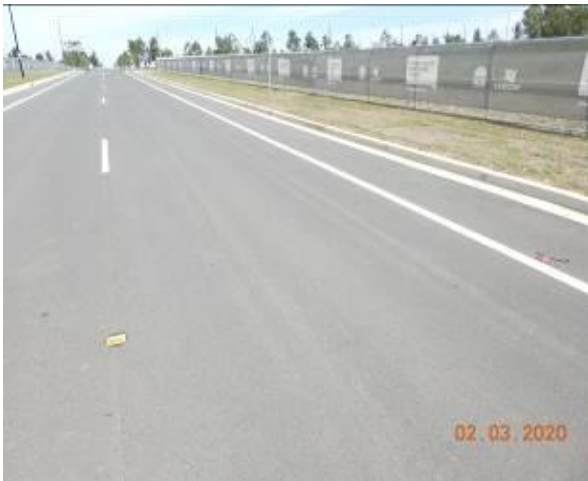
Figure 559 – General Condition of road surface

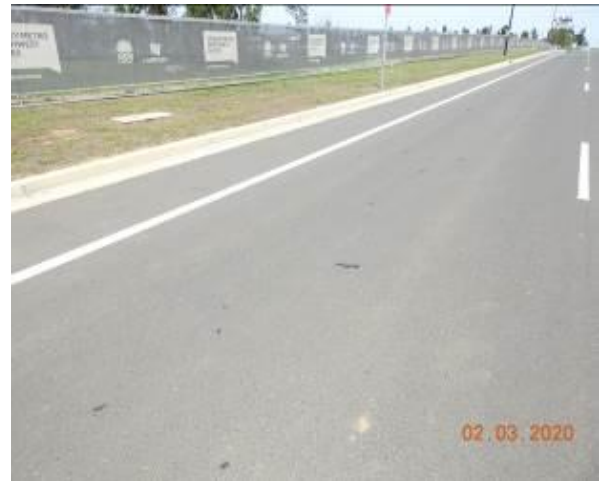
Figure 560 – General Condition of road surface

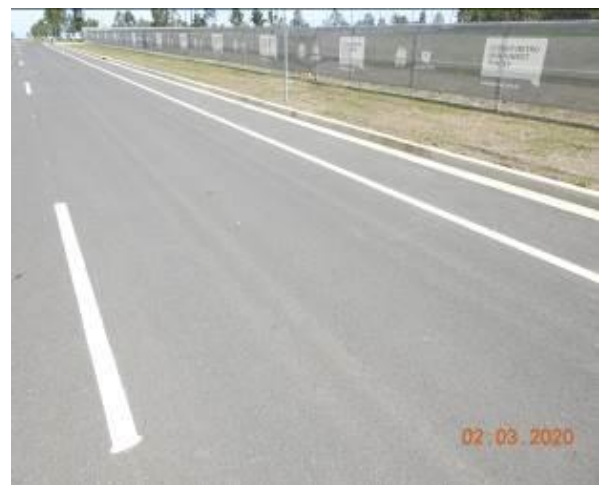
Figure 562 – General Condition of road surface

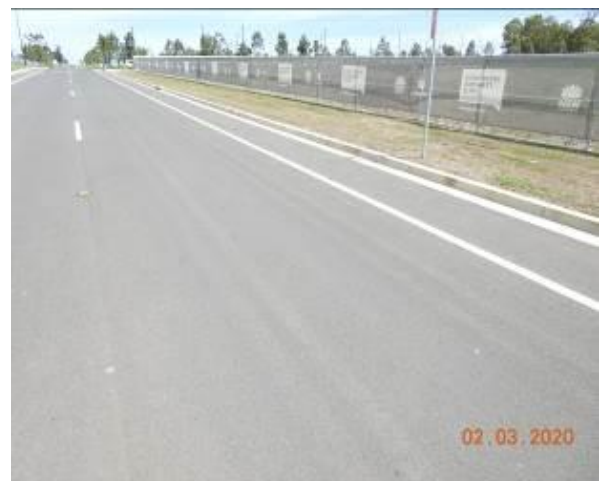
Figure 564 – General Condition of road surface

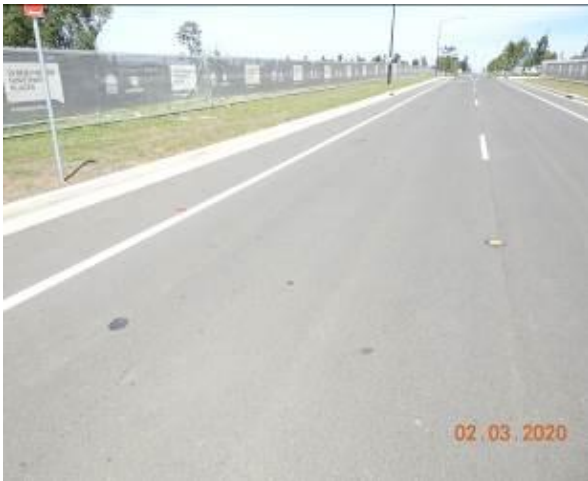
Figure 565 – General Condition of road surface

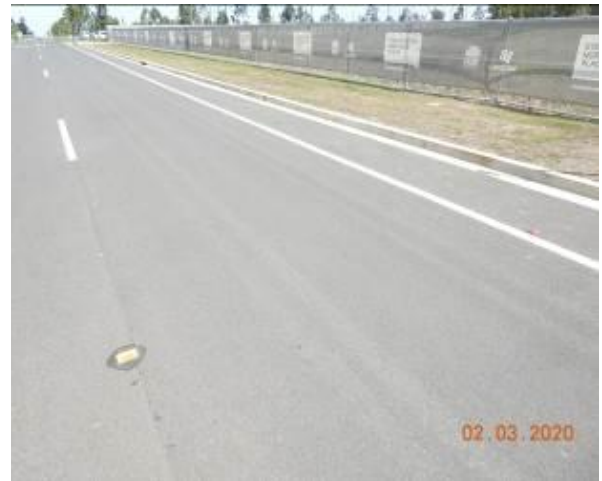
Figure 566 – General Condition of road surface

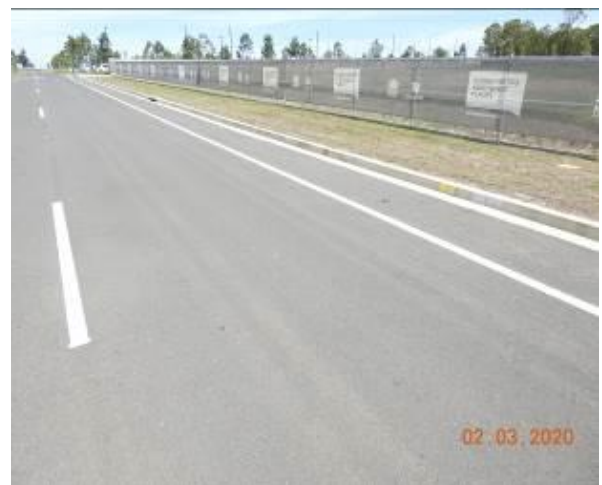
Figure 568 – General Condition of road surface

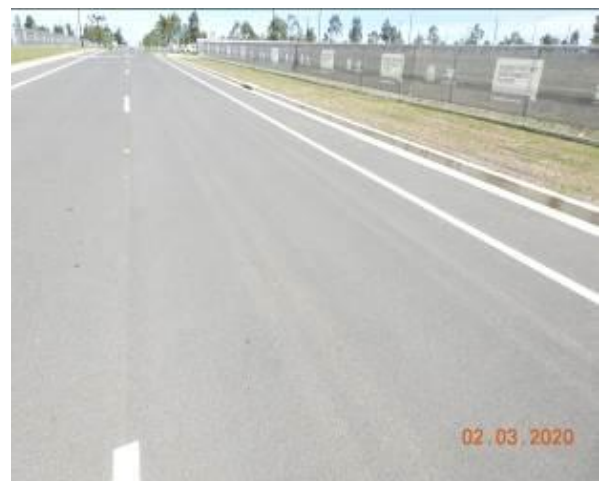
Figure 570 – General Condition of road surface

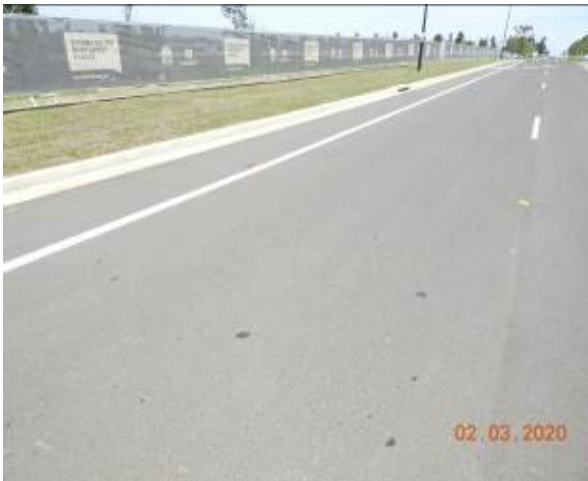
Figure 571 – General Condition of road surface

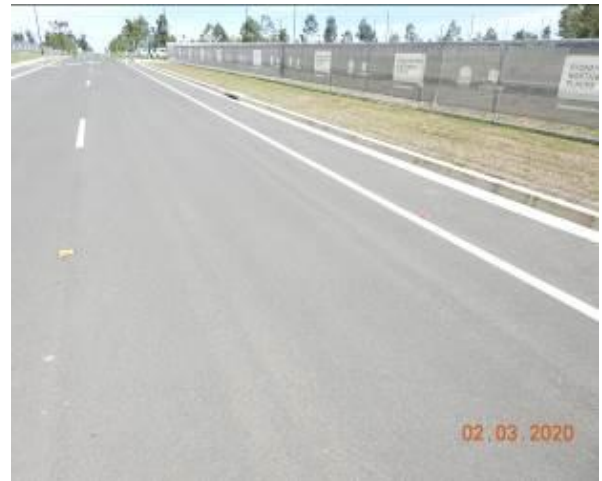
Figure 572 – General Condition of road surface

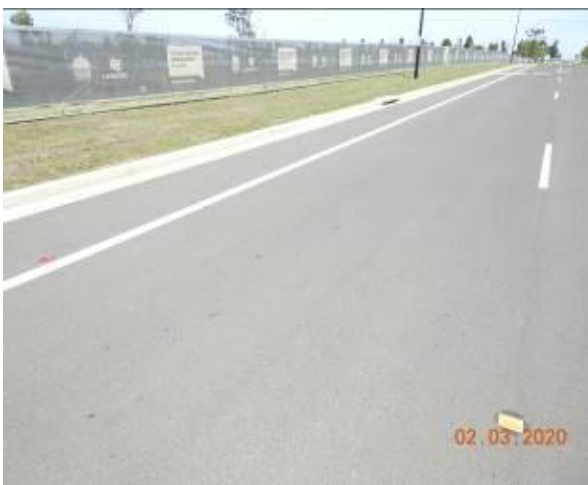
Figure 573 – General Condition of road surface

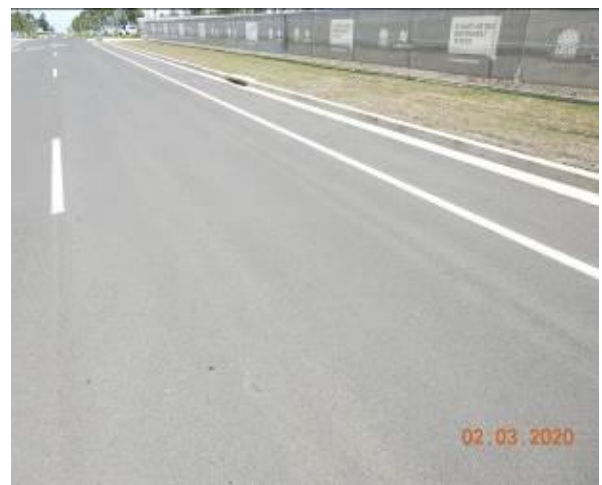
Figure 574 – General Condition of road surface
