**1-15 AND 2-12 CONFERTA AVENUE,
ROUSE HILL NSW 2155
TALLAWONG STATION PRECINCT SOUTH
PRE-DILAPIDATION REPORT**

**DEICORP PROJECTS
(TALLAWONG STATION) PTY LTD**

Job No. 191294.0
24/03/2020

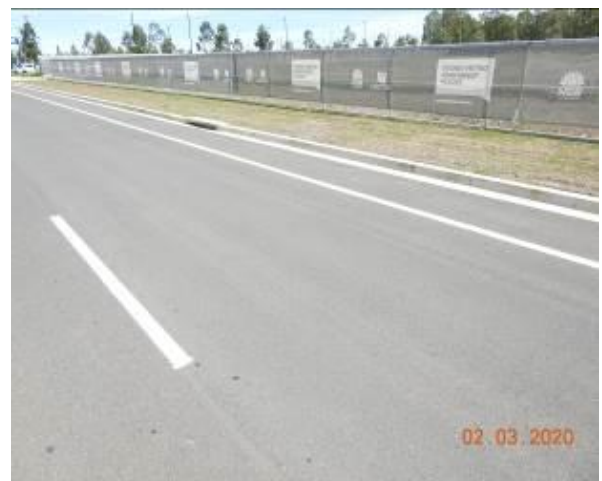
Figure 576 – General Condition of road surface

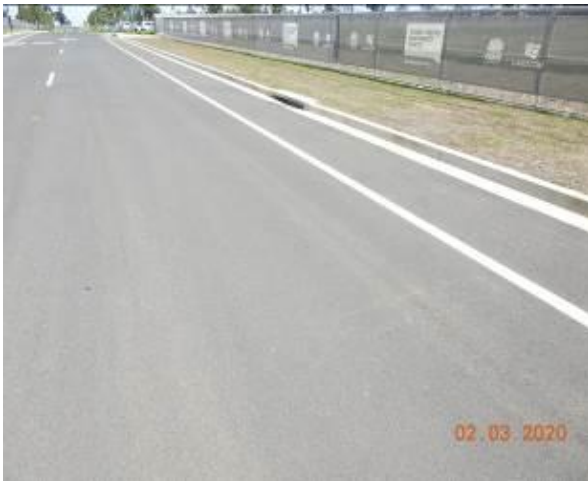
Figure 577 – General Condition of road surface

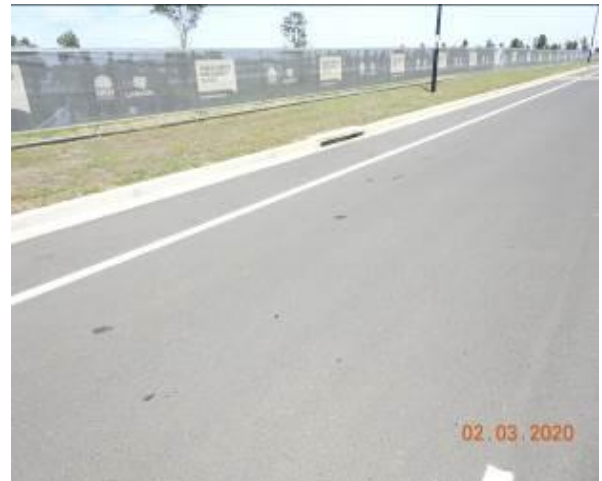
Figure 578 – General Condition of road surface

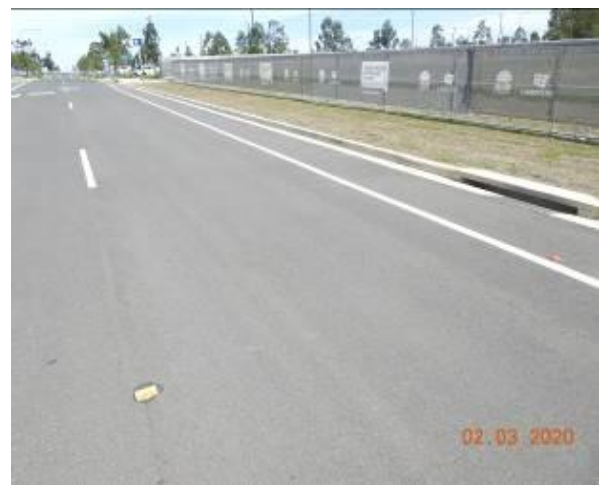
Figure 580 – General Condition of road surface

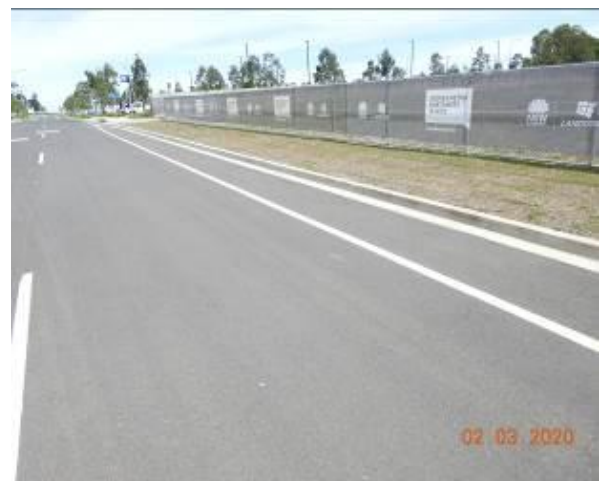
Figure 582 – General Condition of road surface

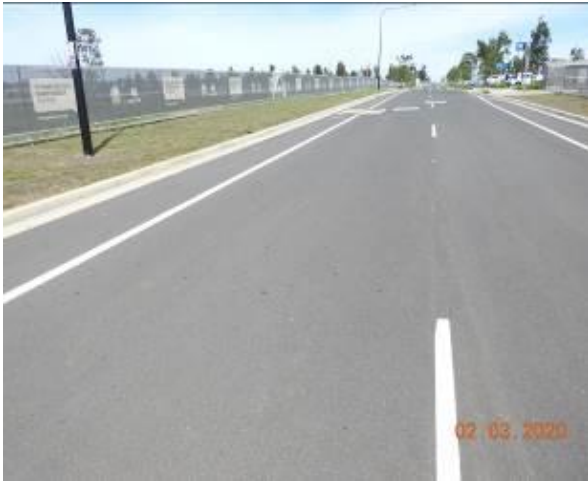
Figure 583 – General Condition of road surface

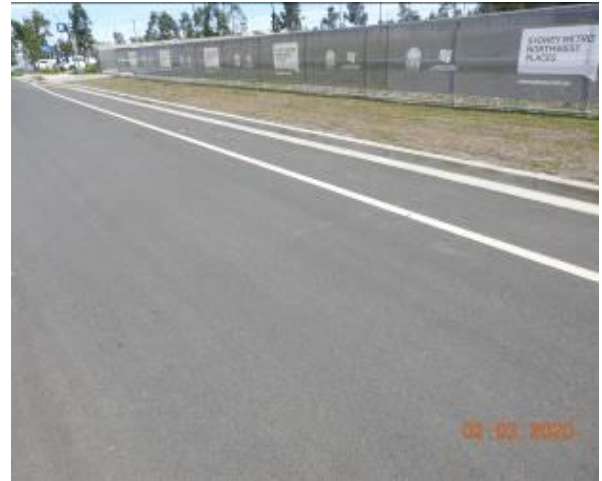
Figure 584 – General Condition of road surface

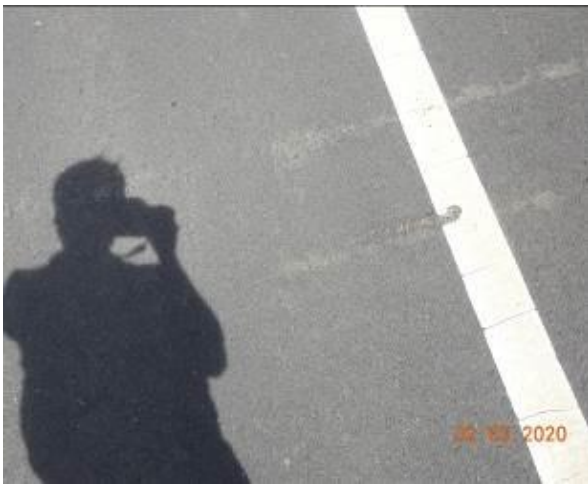
Figure 585 – Loss of material through road surface

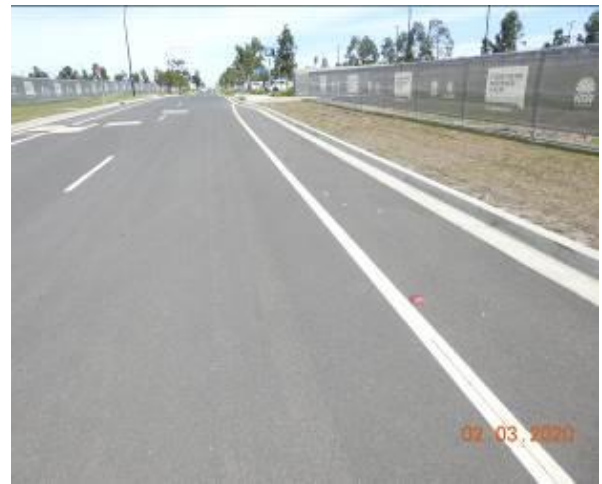
Figure 586 – General Condition of road surface

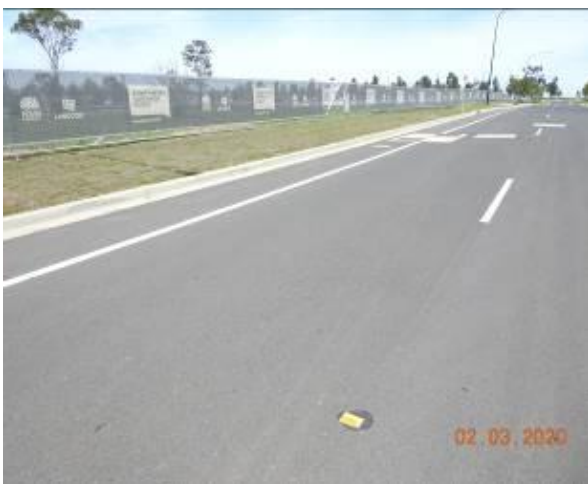
Figure 587 – General Condition of road surface

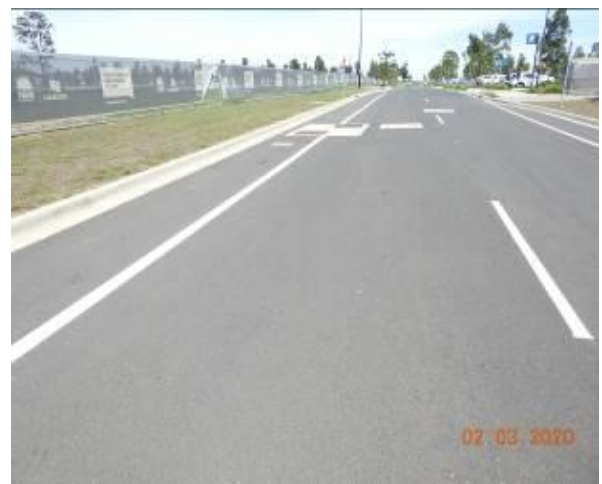
Figure 588 – General Condition of road surface

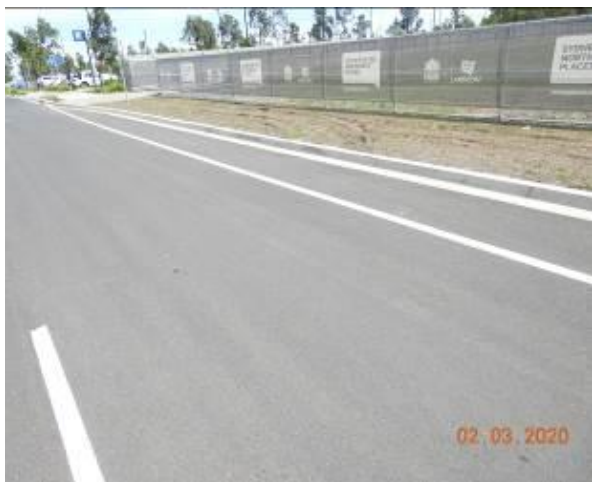
Figure 589 – General Condition of road surface

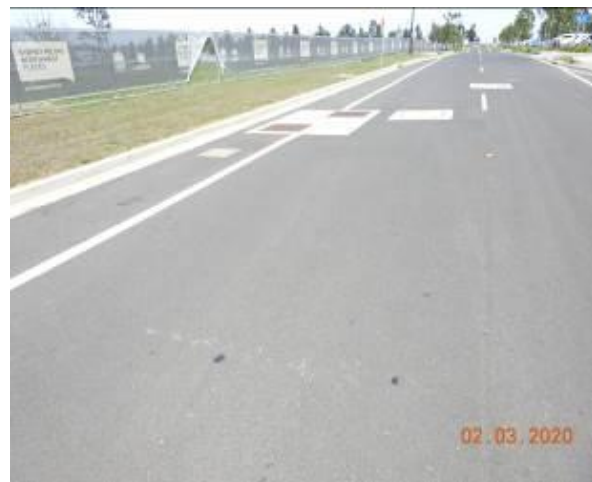
Figure 590 – General Condition of road surface

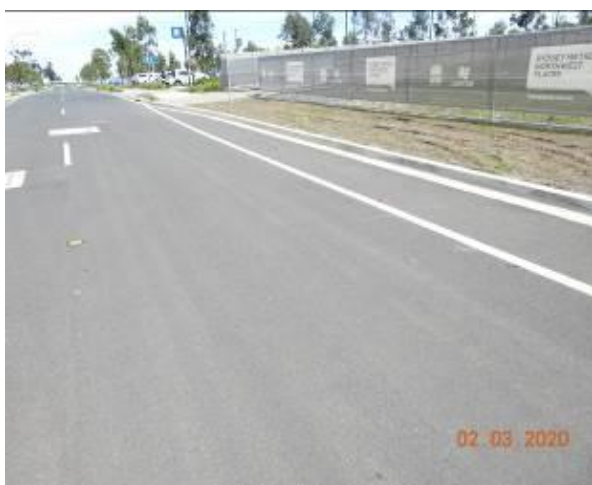
Figure 591 – General Condition of road surface

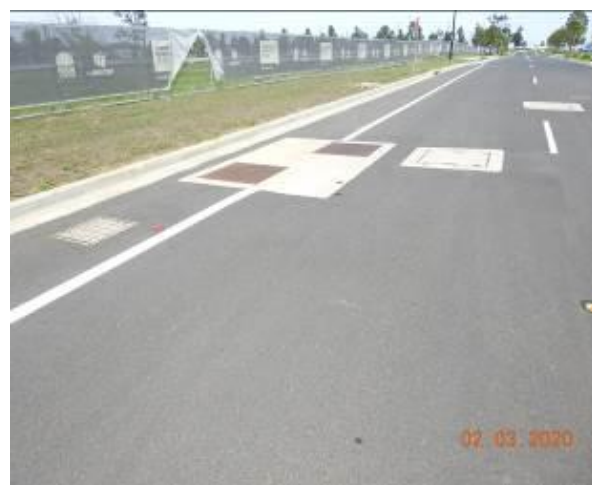
Figure 592 – General Condition of road surface

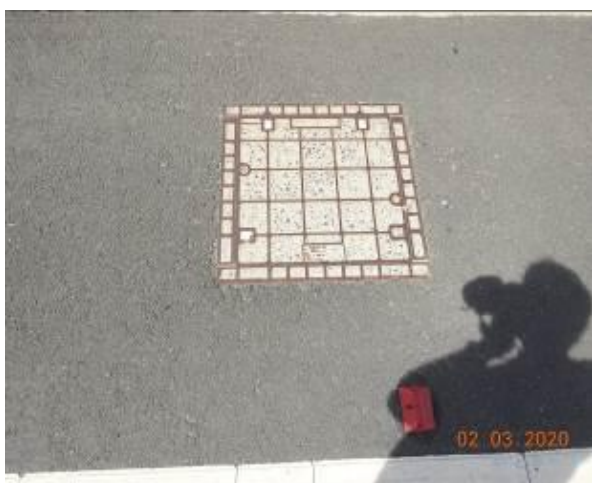
Figure 593 – General Condition of service pit

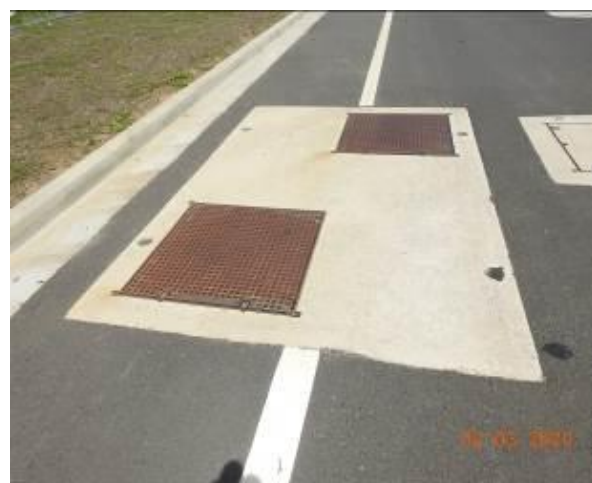
Figure 594 – General Condition of service pit

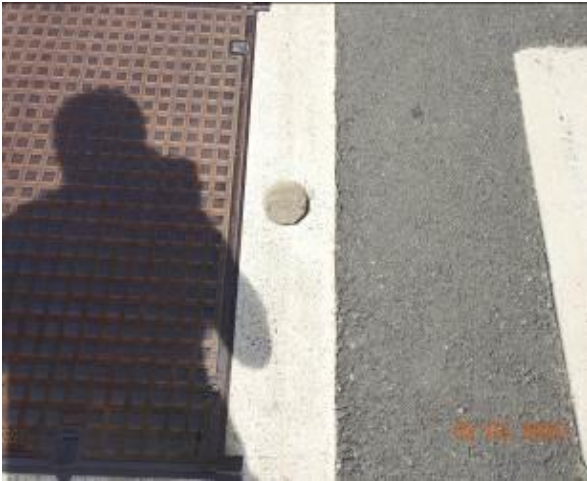
Figure 595 – Loss of material through service pit

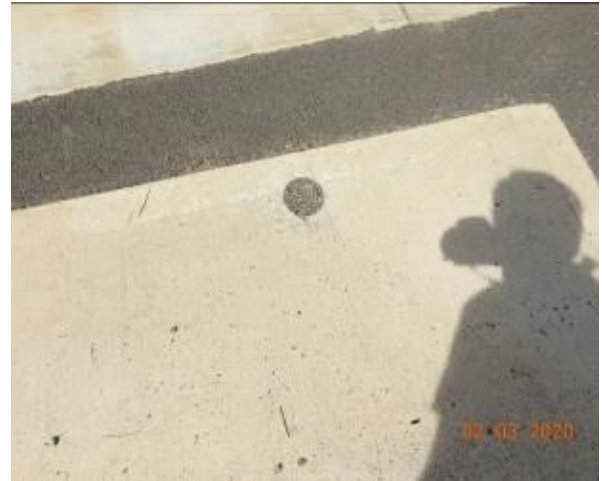
Figure 596 – Loss of material through service pit

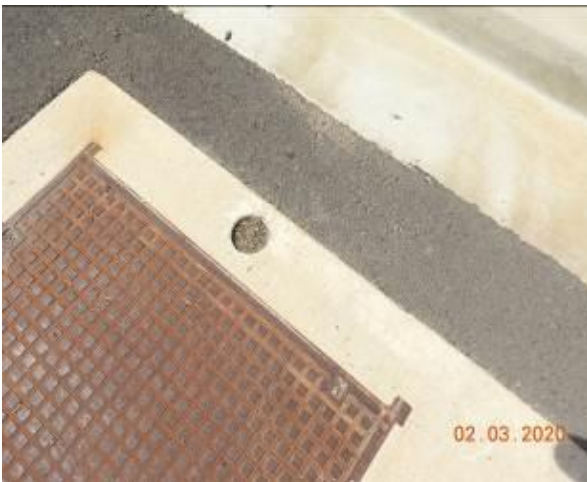
Figure 597 – Loss of material through service pit

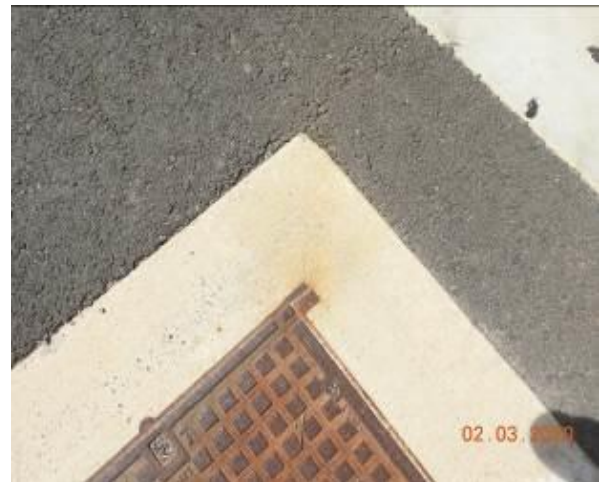
Figure 598 – Crack propagation through service pit

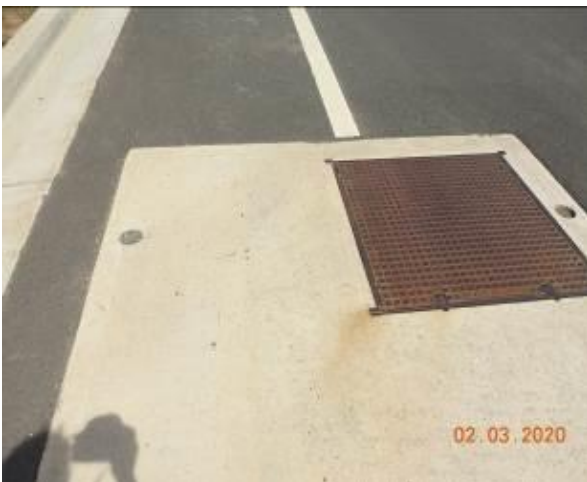
Figure 599 – General Condition of service pit

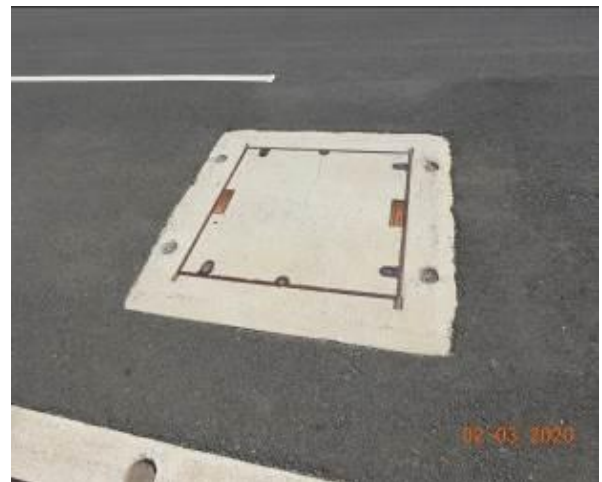
Figure 600 – General Condition of service pit

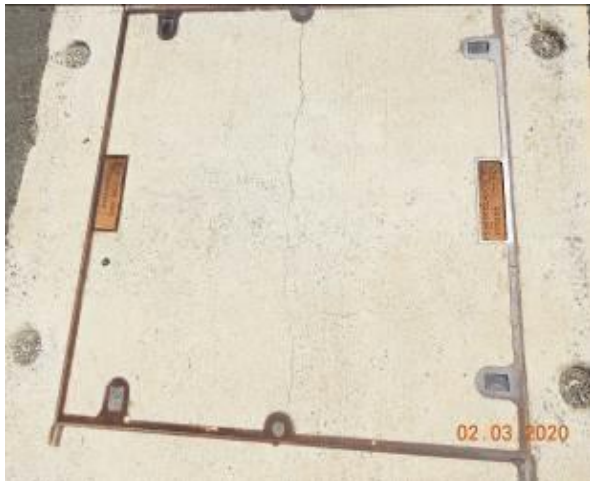
Figure 601 – Crack propagation through service pit

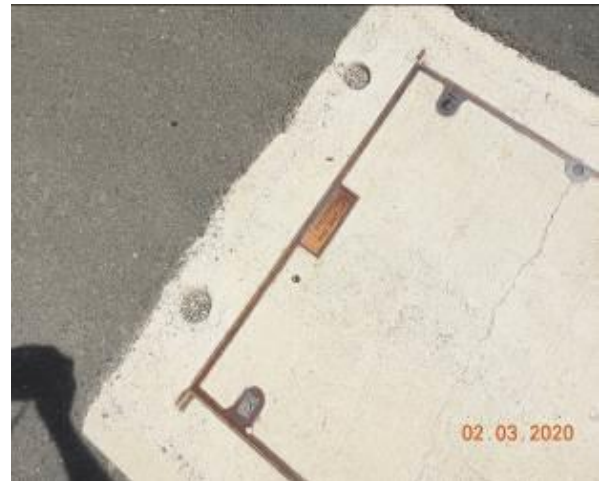
Figure 602 – Loss of material through service pit

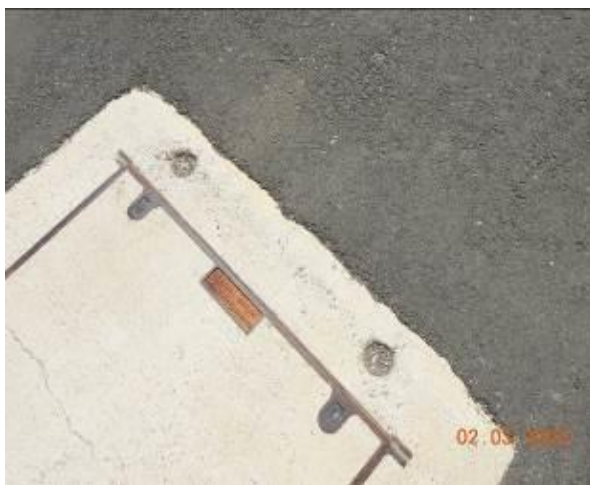
Figure 603 – Loss of material through service pit

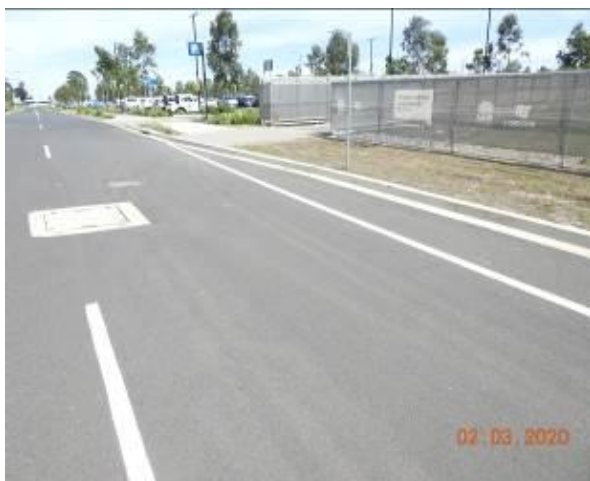
Figure 605 – General Condition of road surface

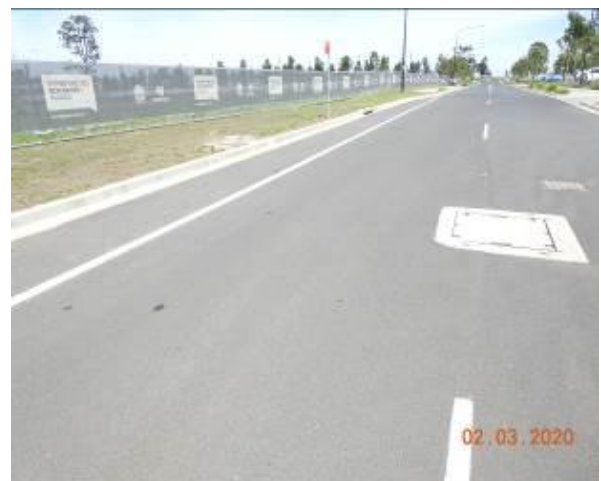
Figure 606 – General Condition of road surface

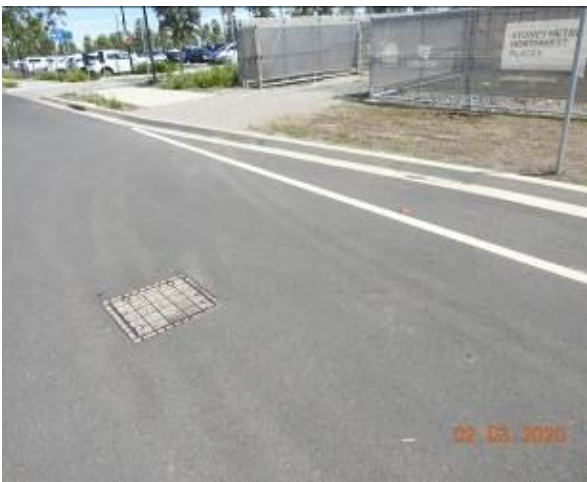
Figure 611 – General Condition of service pit

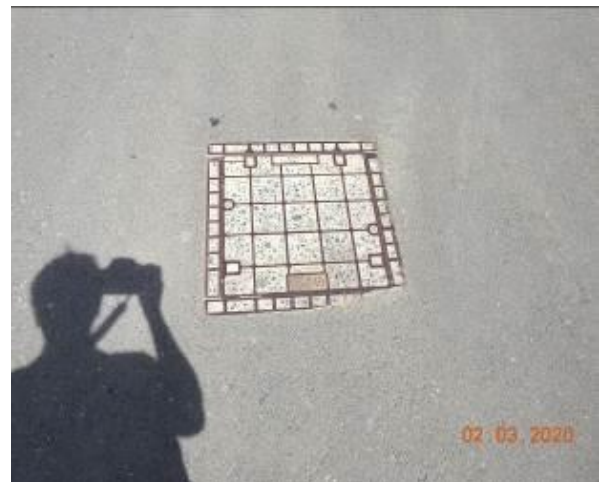
Figure 612 – General Condition of service pit

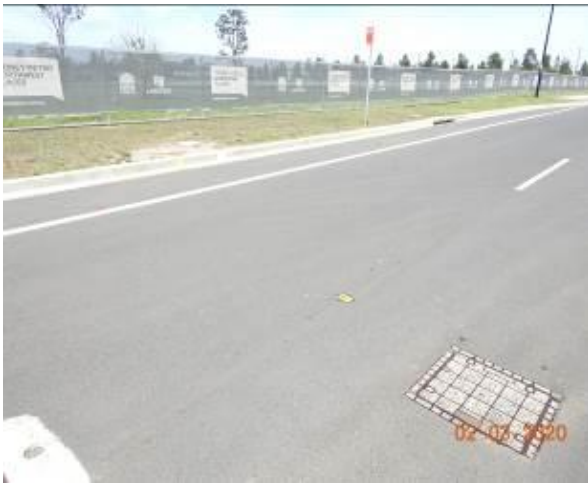
Figure 613 – General Condition of road surface

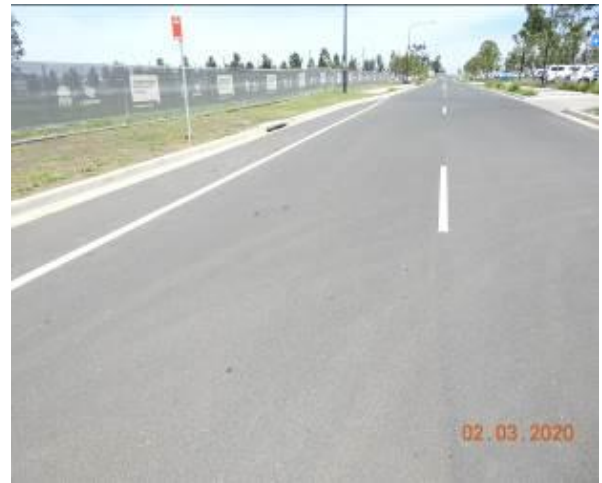
Figure 614 – General Condition of road surface

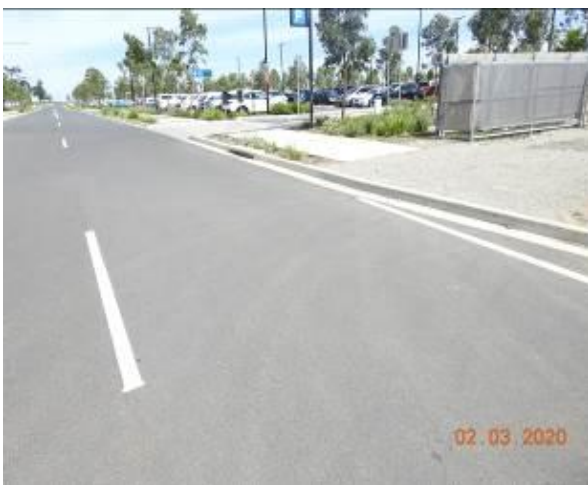
Figure 615 – General Condition of road surface

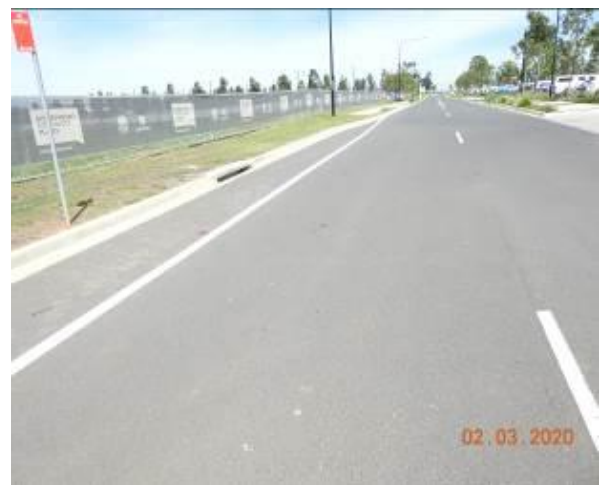
Figure 616 – General Condition of road surface

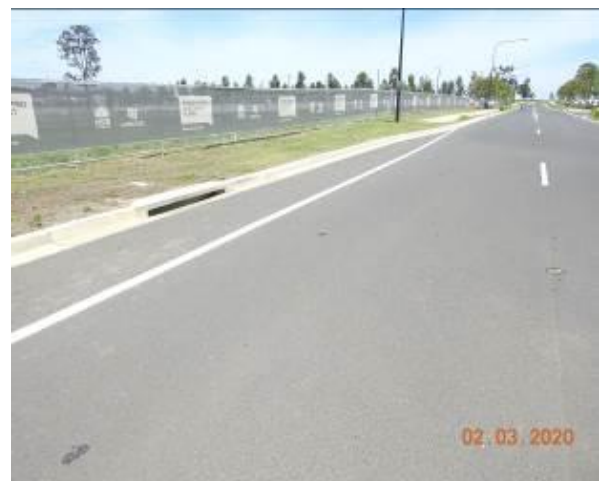
Figure 618 – General Condition of road surface

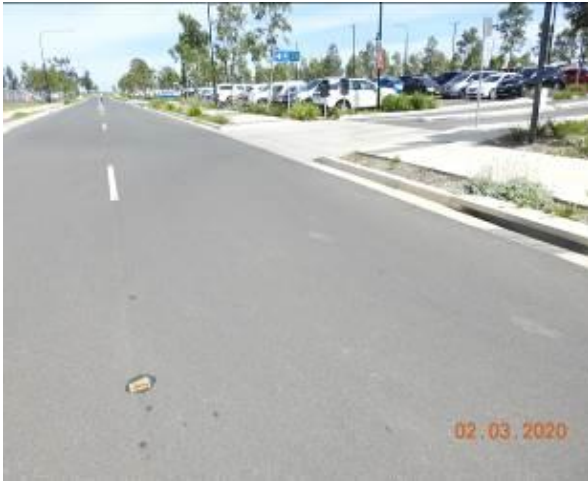
Figure 619 – General Condition of road surface

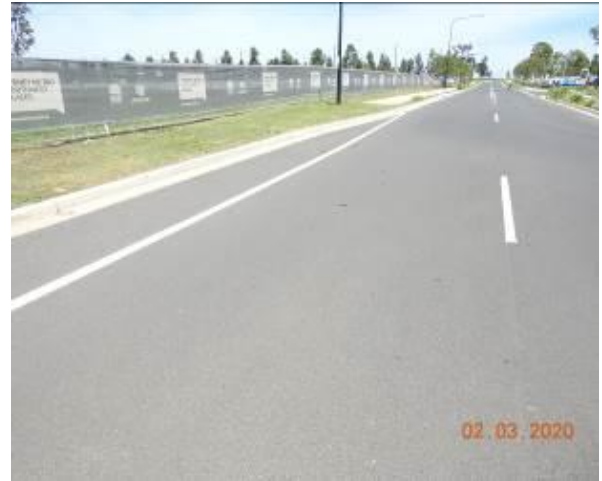
Figure 620 – General Condition of road surface

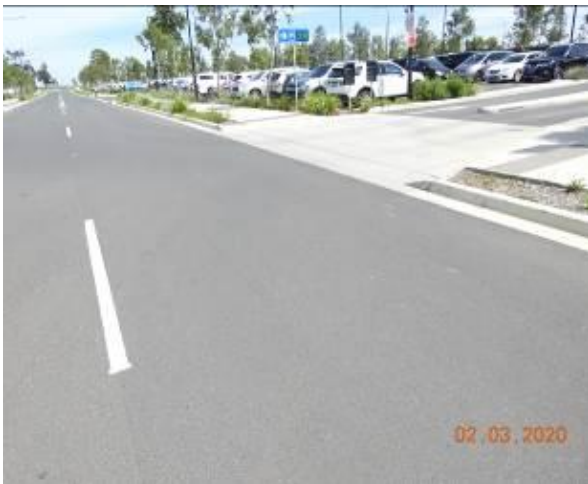
Figure 621 – General Condition of road surface

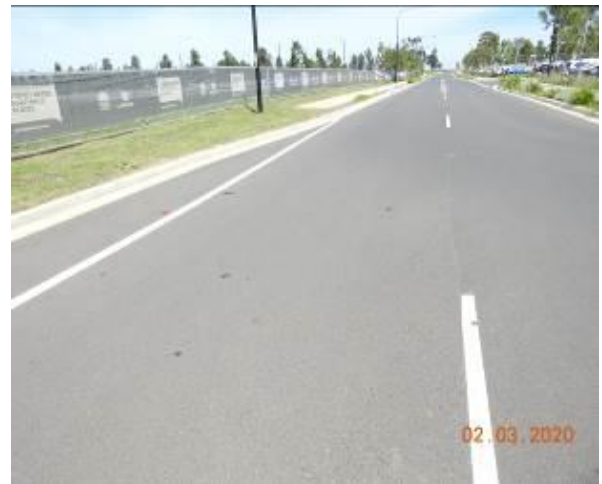
Figure 622 – General Condition of road surface

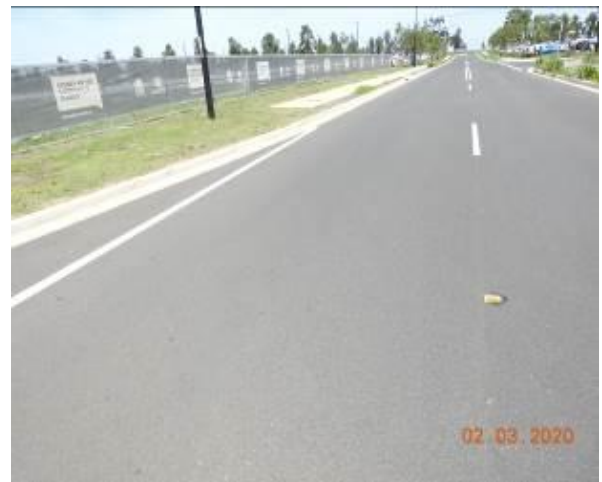
Figure 624 – General Condition of road surface

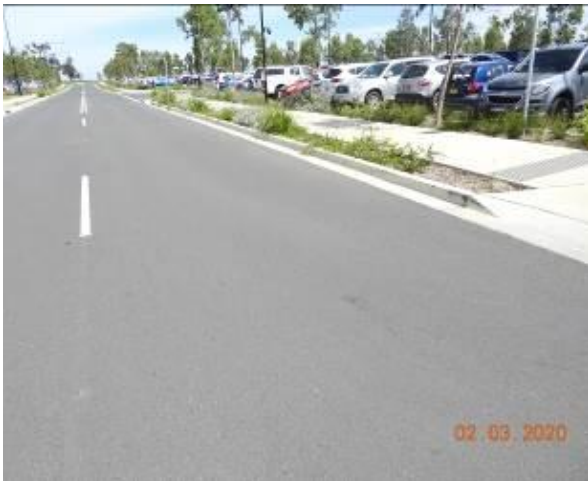
Figure 625 – General Condition of road surface

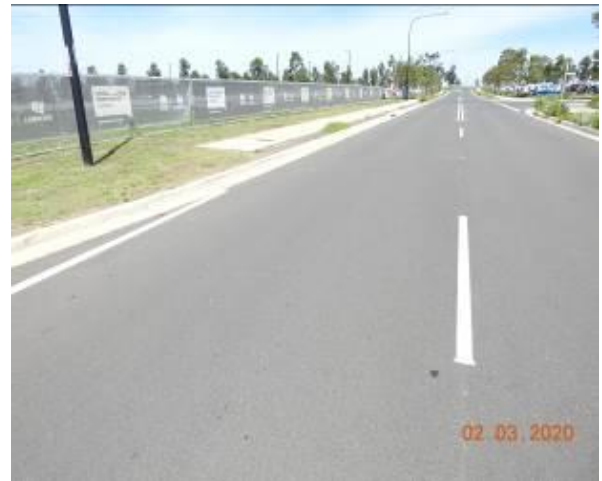
Figure 626 – General Condition of road surface

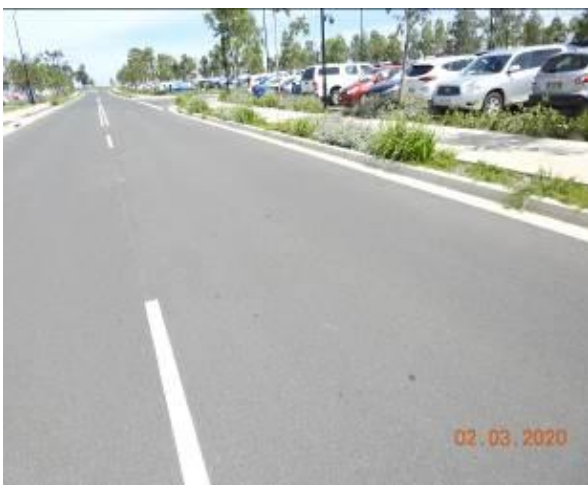
Figure 627 – General Condition of road surface

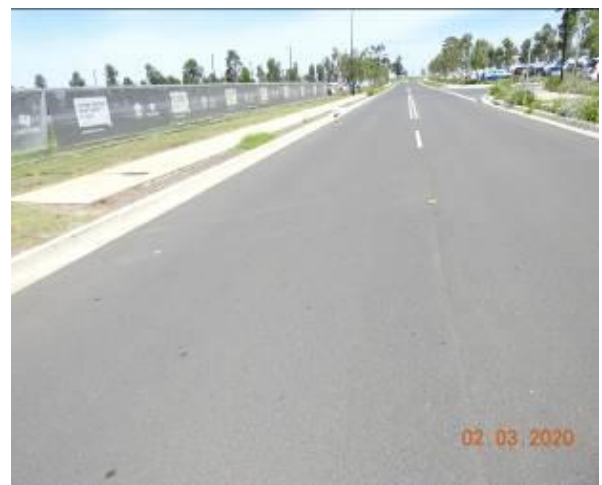
Figure 628 – General Condition of road surface

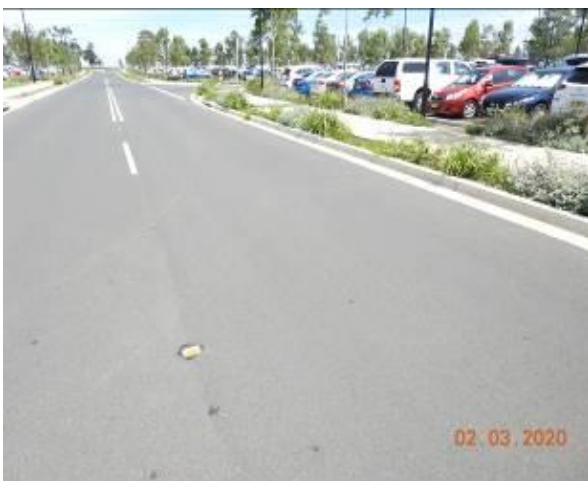
Figure 629 – General Condition of road surface

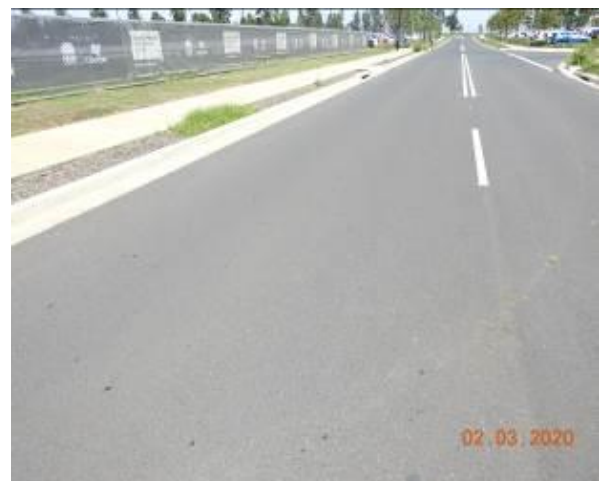
Figure 630 – General Condition of road surface

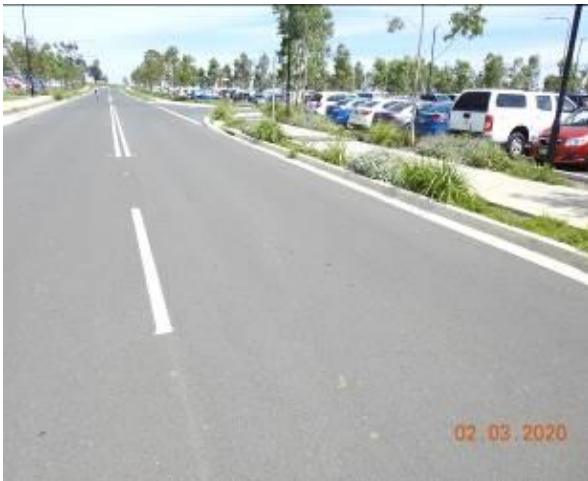
Figure 631 – General Condition of road surface

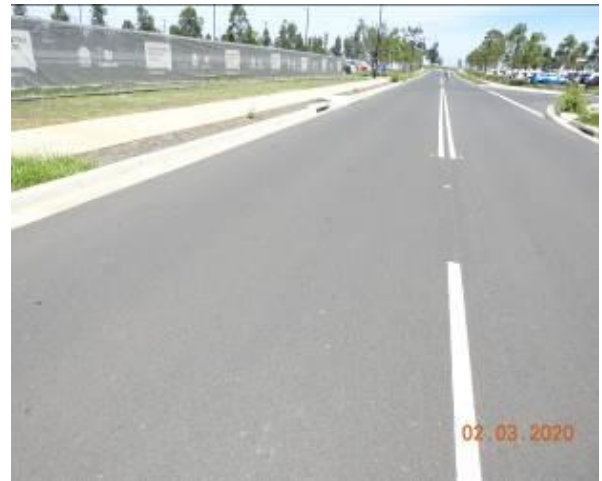
Figure 632 – General Condition of road surface

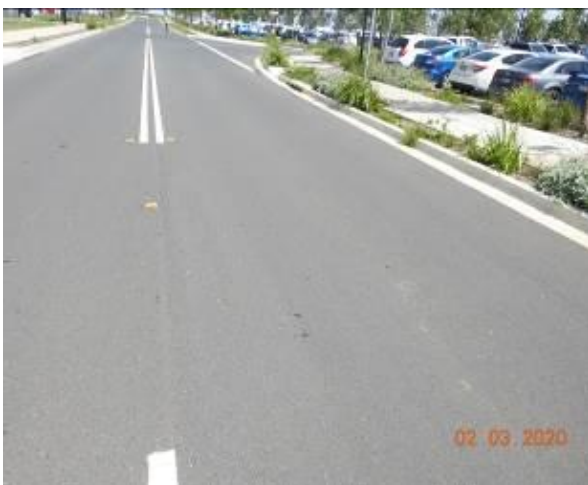
Figure 633 – General Condition of road surface

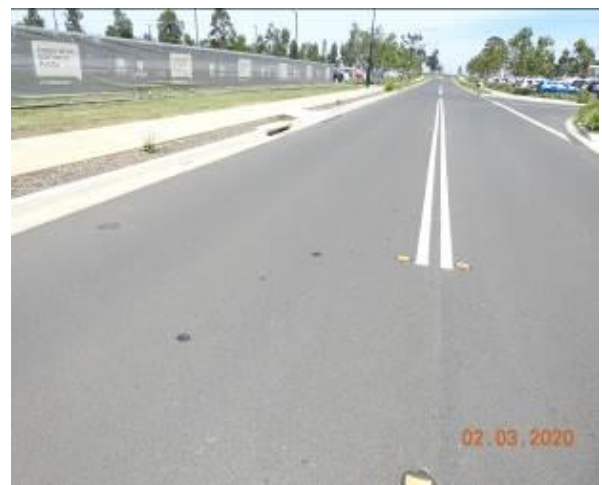
Figure 634 – General Condition of road surface

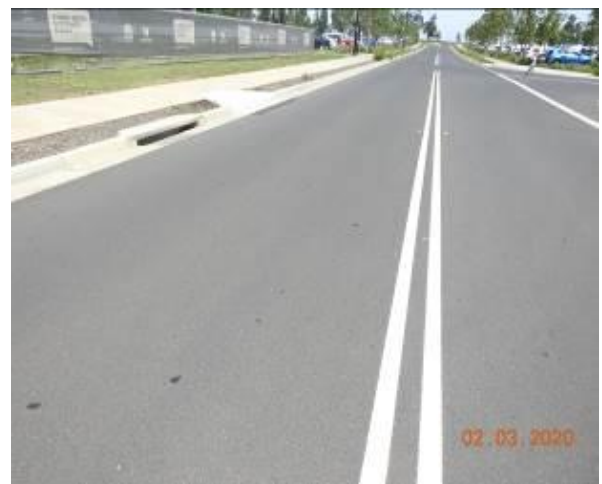
Figure 636 – General Condition of road surface

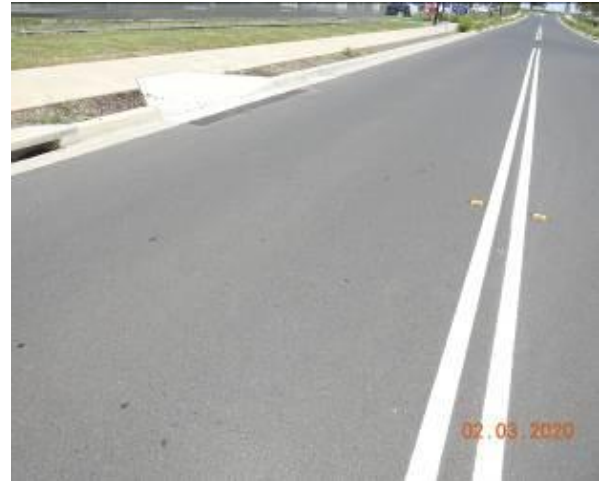
Figure 638 – General Condition of road surface

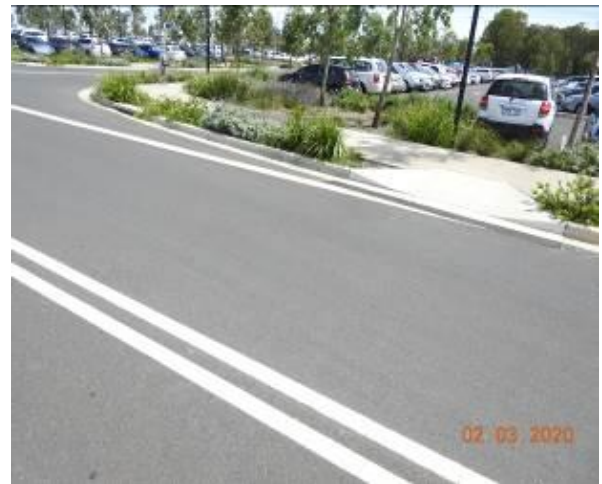
Figure 640 – General Condition of road surface

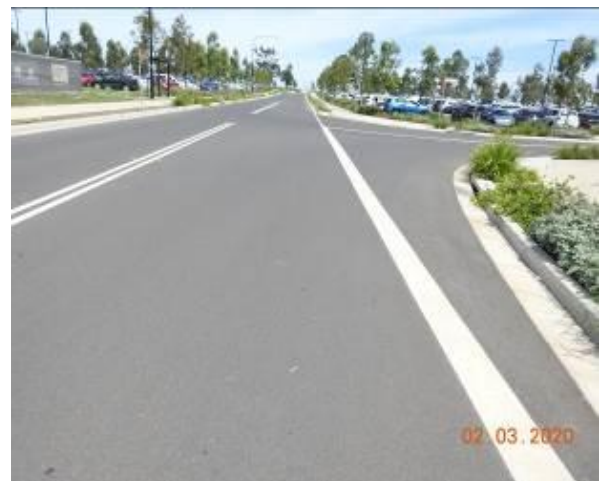
Figure 642 – General Condition of road surface

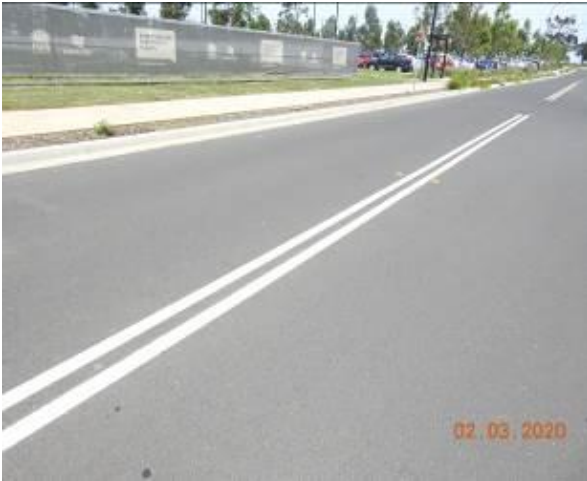
Figure 643 – General Condition of road surface

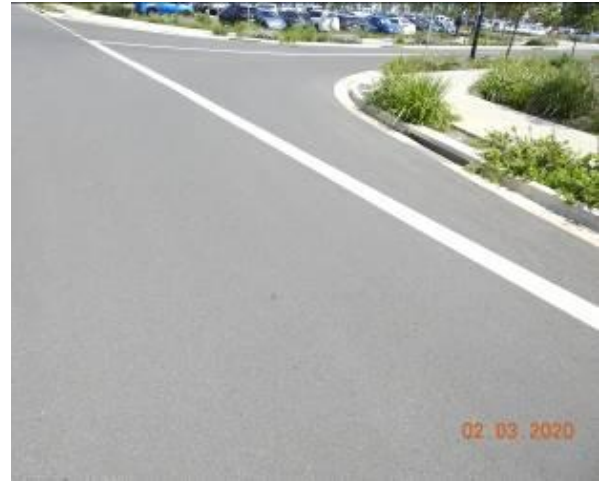
Figure 644 – General Condition of road surface

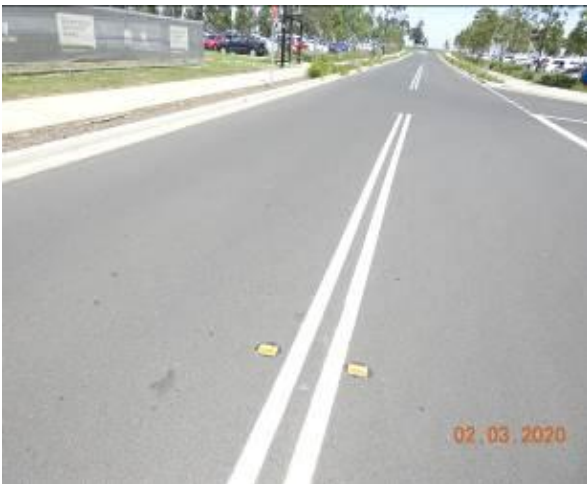
Figure 645 – General Condition of road surface

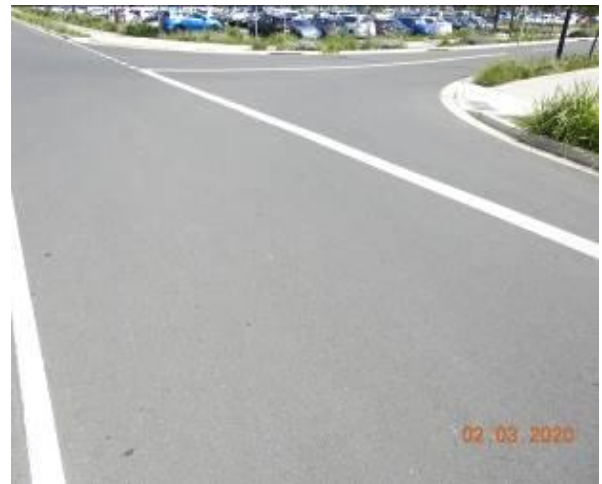
Figure 646 – General Condition of road surface

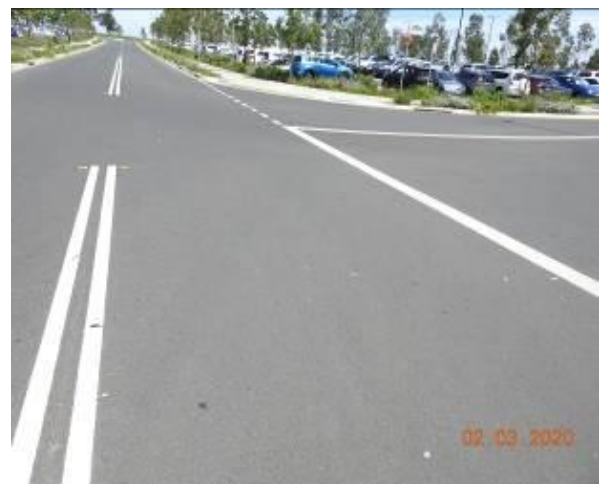
Figure 647 – General Condition of road surface

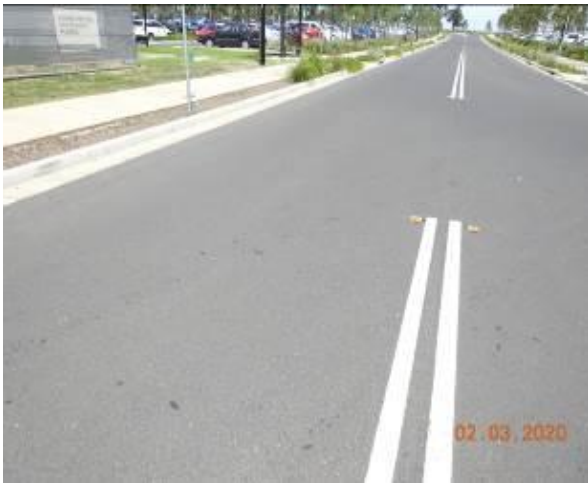
Figure 648 – General Condition of road surface

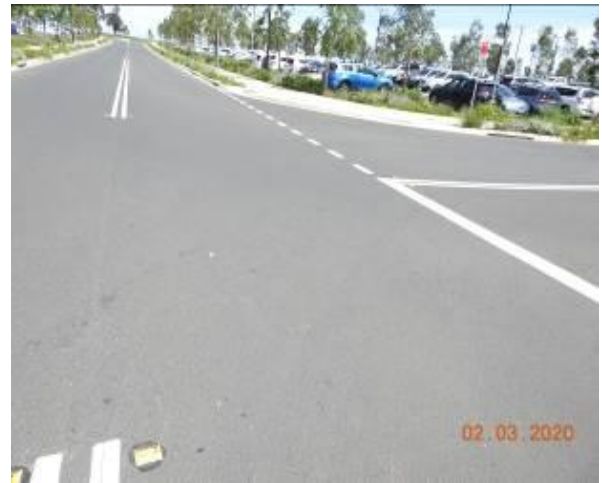
Figure 649 – General Condition of road surface

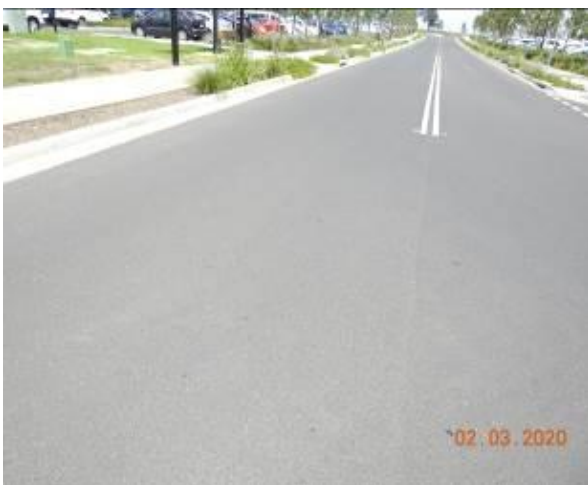
Figure 650 – General Condition of road surface

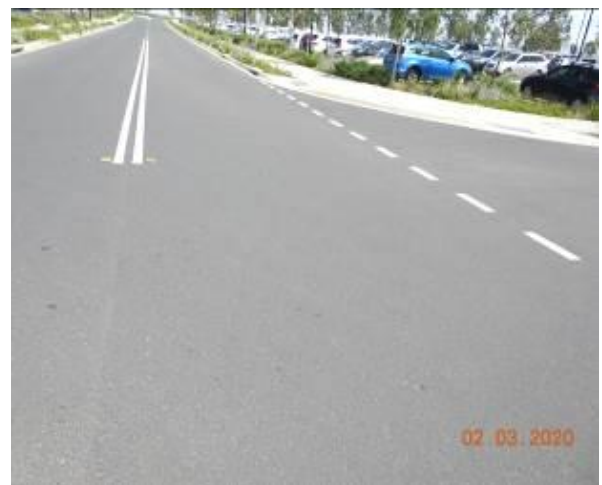
Figure 651 – General Condition of road surface

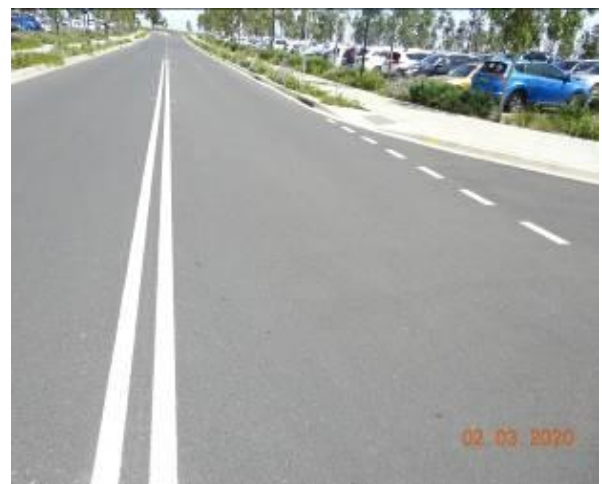
Figure 653 – General Condition of road surface

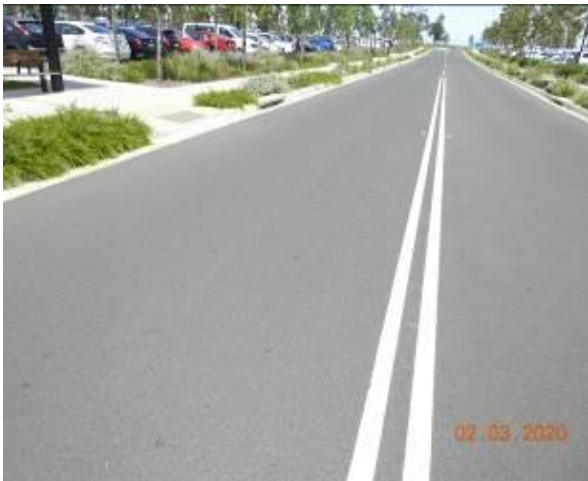
Figure 654 – General Condition of road surface

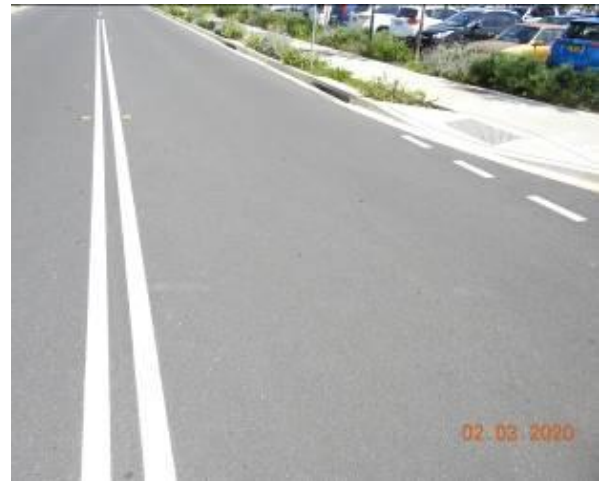
Figure 655 – General Condition of road surface

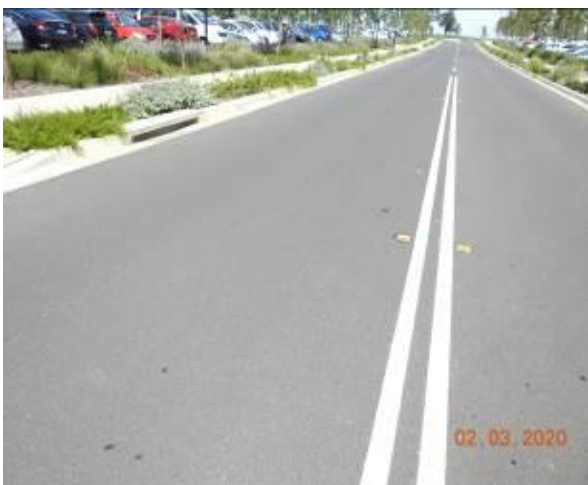
Figure 656 – General Condition of road surface

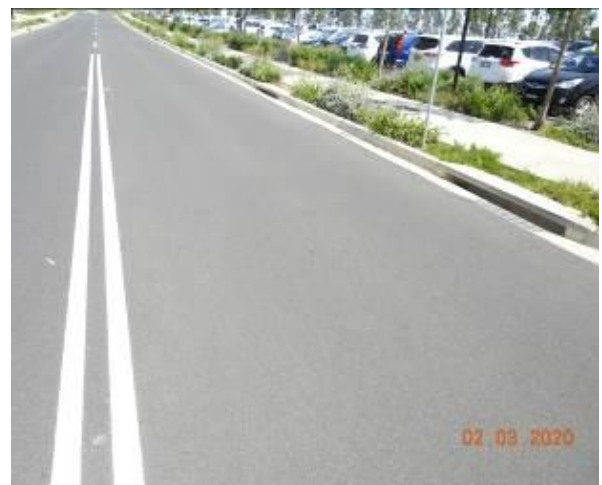
Figure 657 – General Condition of road surface

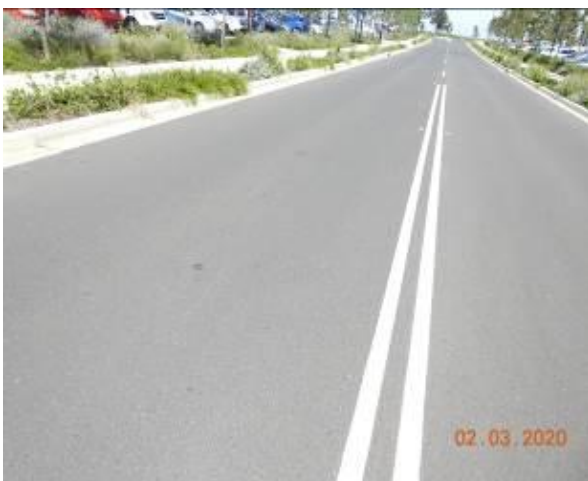
Figure 658 – General Condition of road surface

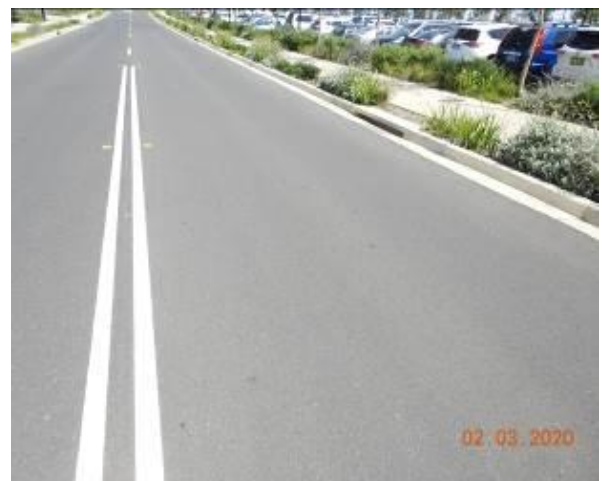
Figure 659 – General Condition of road surface

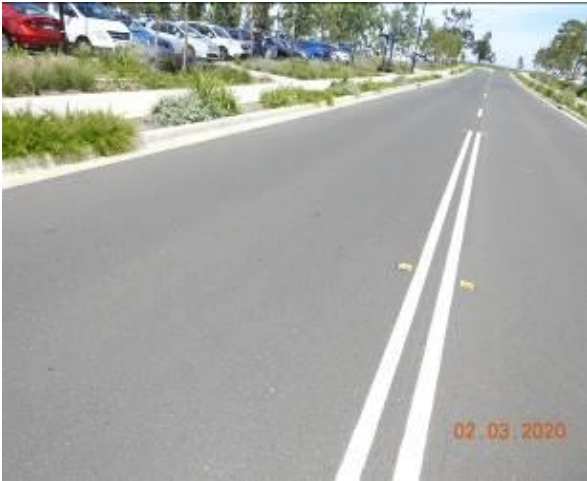
Figure 660 – General Condition of road surface

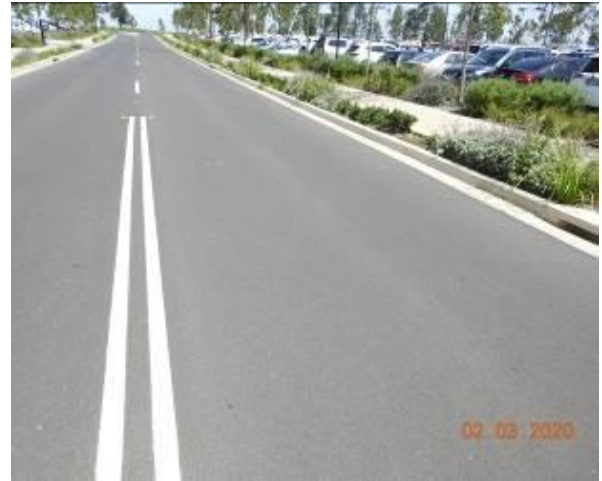
Figure 661 – General Condition of road surface

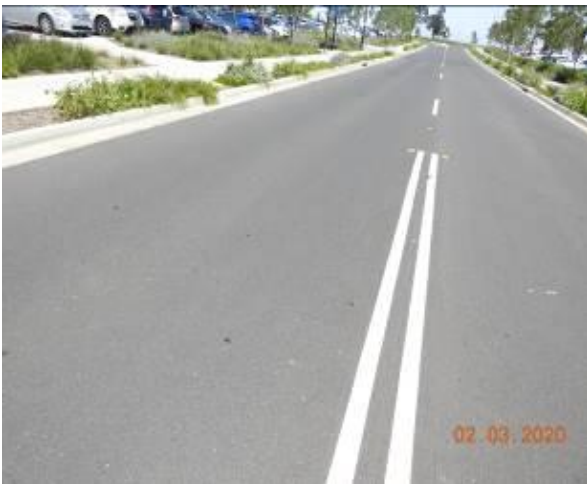
Figure 662 – General Condition of road surface

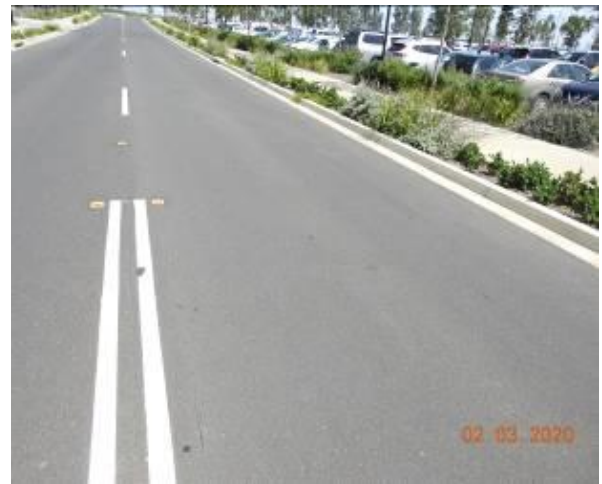
Figure 663 – General Condition of road surface

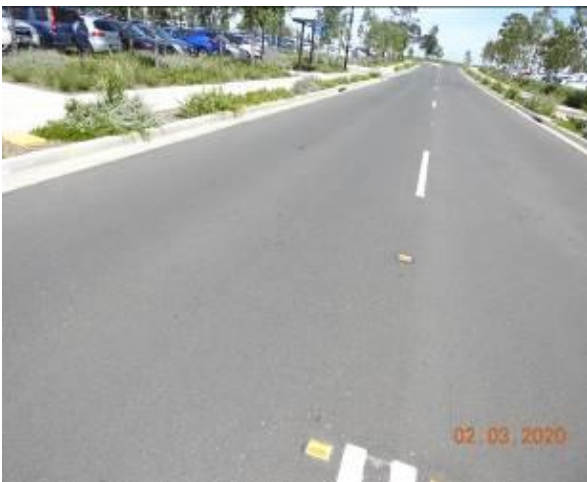
Figure 664 – General Condition of road surface

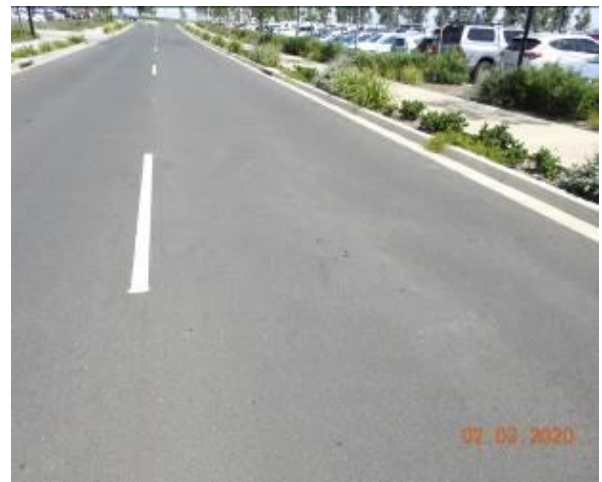
Figure 665 – General Condition of road surface

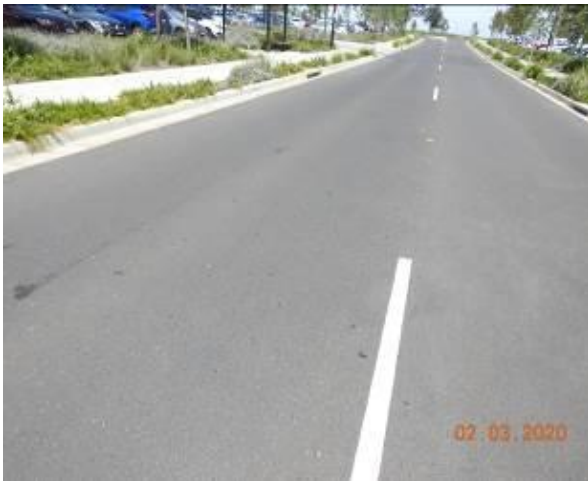
Figure 666 – General Condition of road surface
