**1-15 AND 2-12 CONFERTA AVENUE,
ROUSE HILL NSW 2155
TALLAWONG STATION PRECINCT SOUTH
PRE-DILAPIDATION REPORT**

**DEICORP PROJECTS
(TALLAWONG STATION) PTY LTD**

Job No. 191294.0
24/03/2020

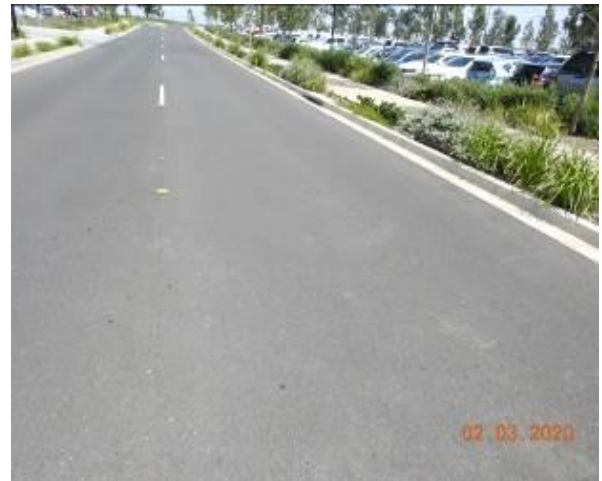
Figure 667 – General Condition of road surface

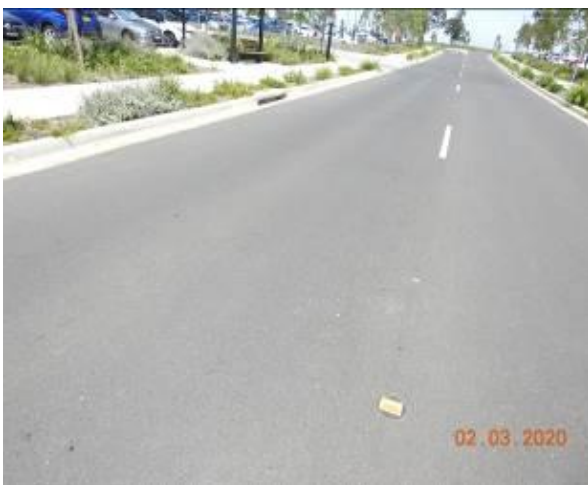
Figure 668 – General Condition of road surface

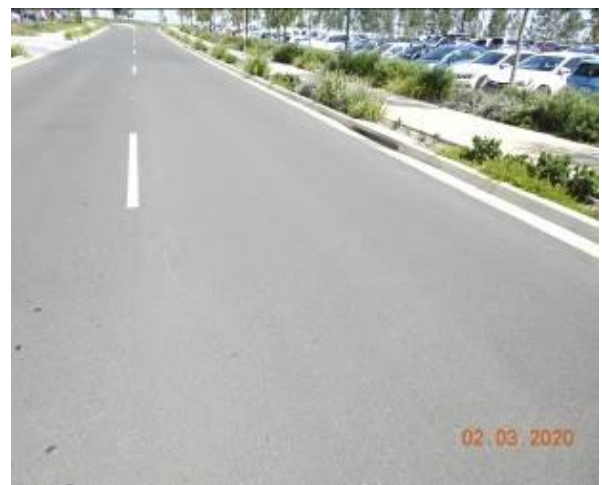
Figure 669 – General Condition of road surface

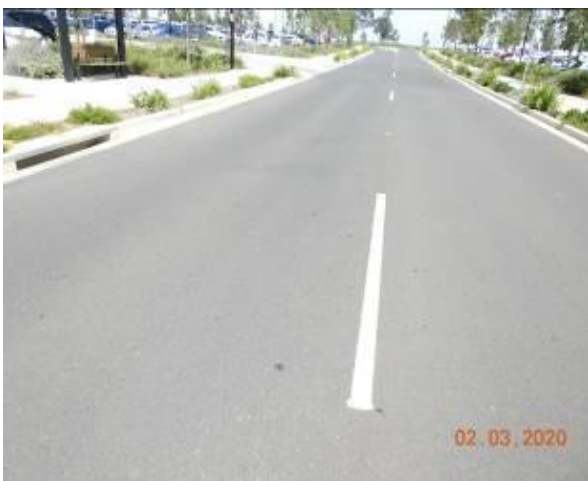
Figure 670 – General Condition of road surface

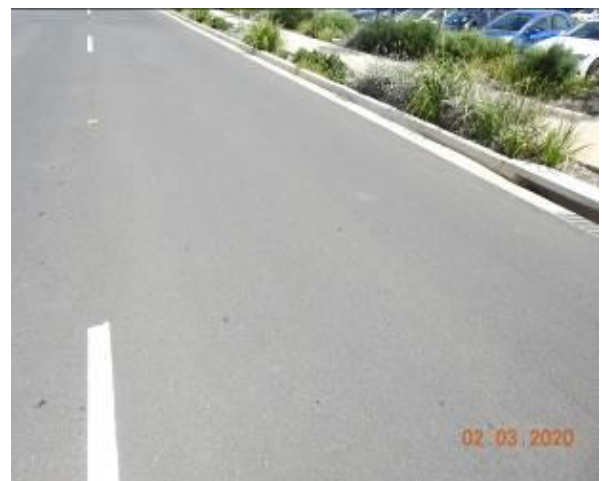
Figure 671 – General Condition of road surface

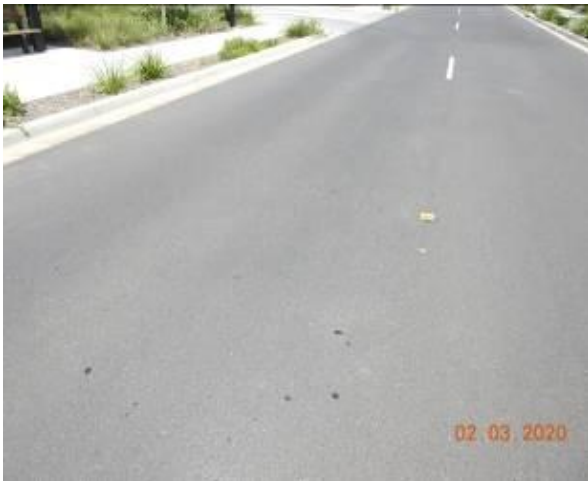
Figure 672 – General Condition of road surface

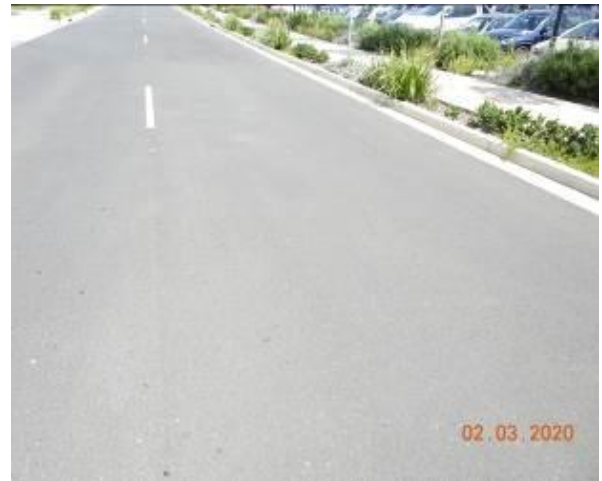
Figure 673 – General Condition of road surface

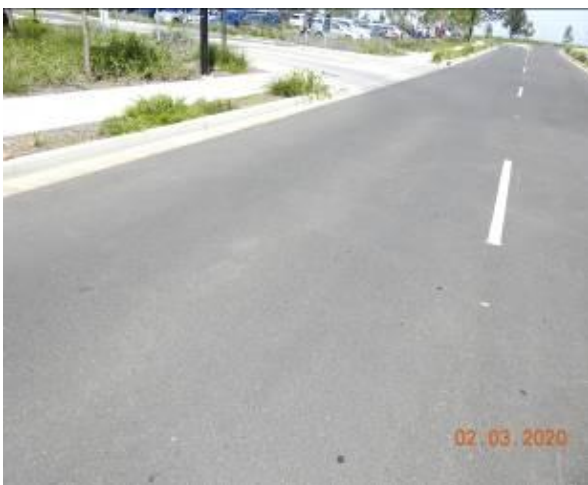
Figure 674 – General Condition of road surface

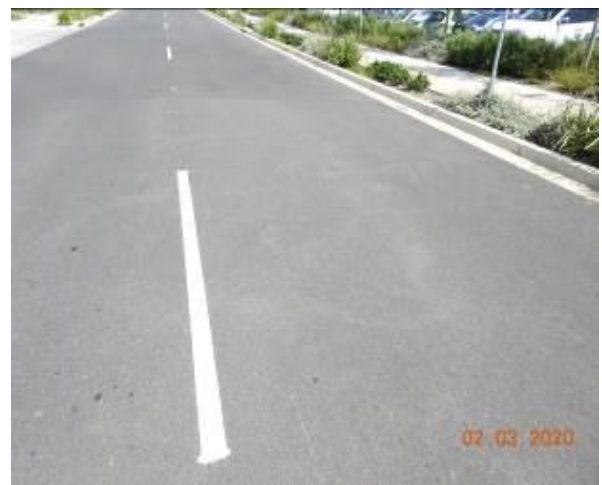
Figure 675 – General Condition of road surface

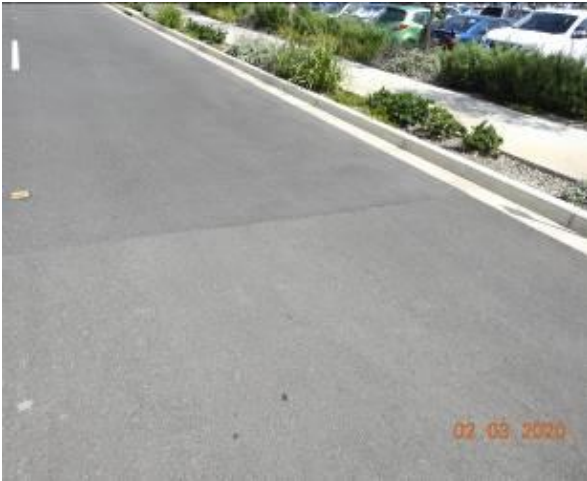
Figure 678 – General Condition of road surface

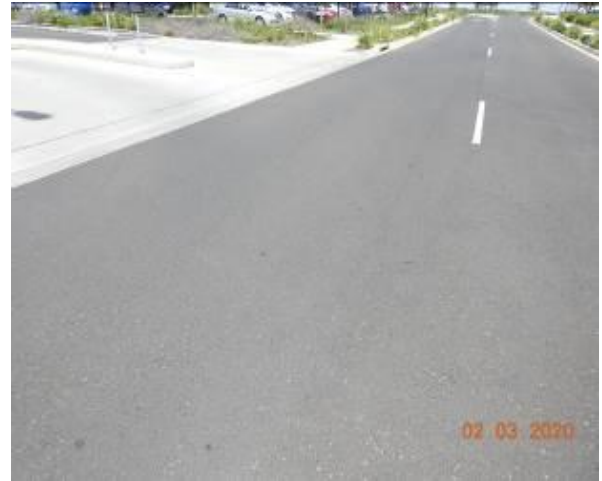
Figure 679 – General Condition of road surface

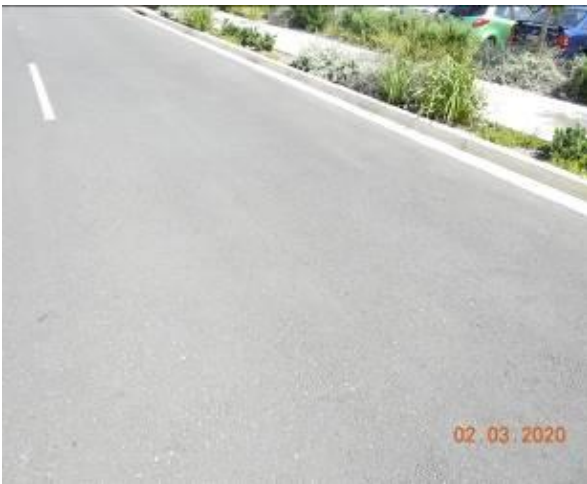
Figure 680 – General Condition of road surface

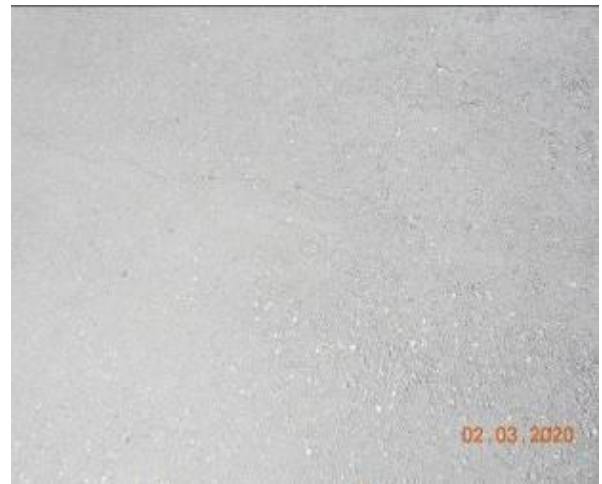
Figure 681 – General Condition of road surface

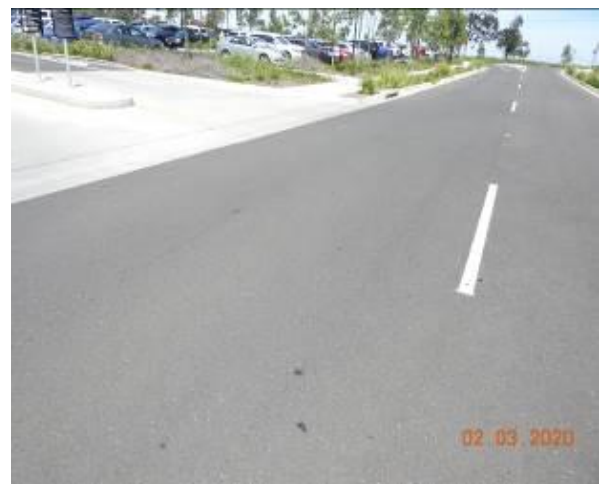
Figure 683 – Crack propagation through road surface

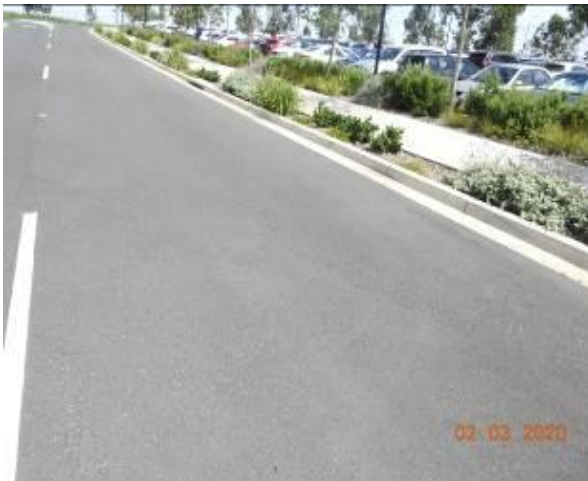
Figure 684 – General Condition of road surface

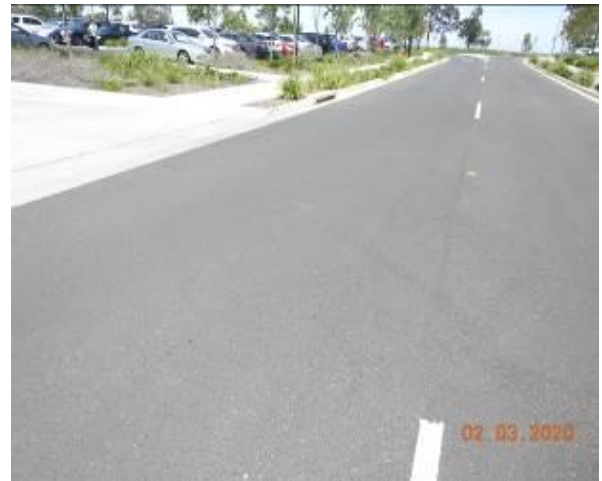
Figure 685 – General Condition of road surface

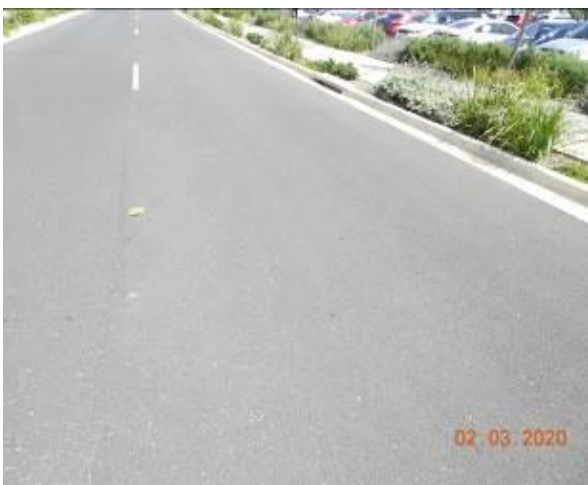
Figure 686 – General Condition of road surface

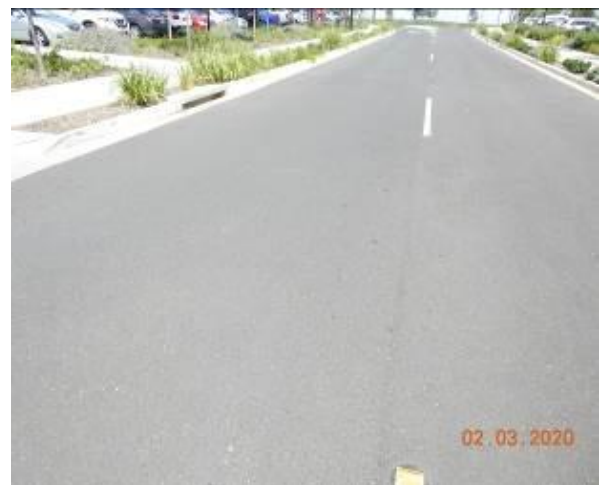
Figure 688 – General Condition of road surface

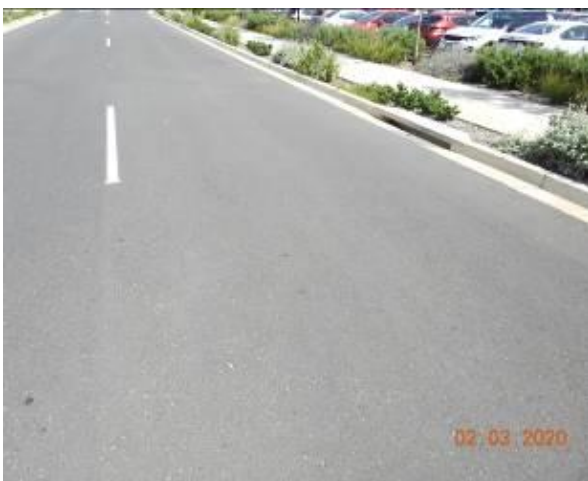
Figure 689 – General Condition of road surface

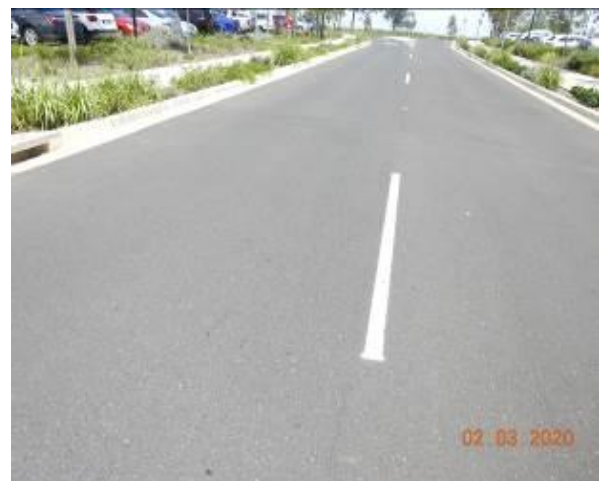
Figure 690 – General Condition of road surface

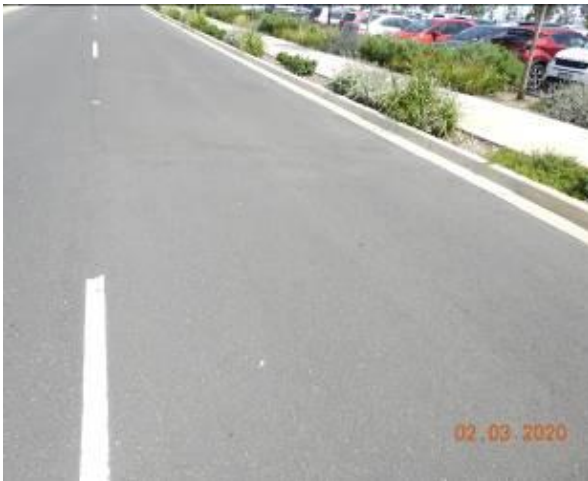
Figure 691 – General Condition of road surface

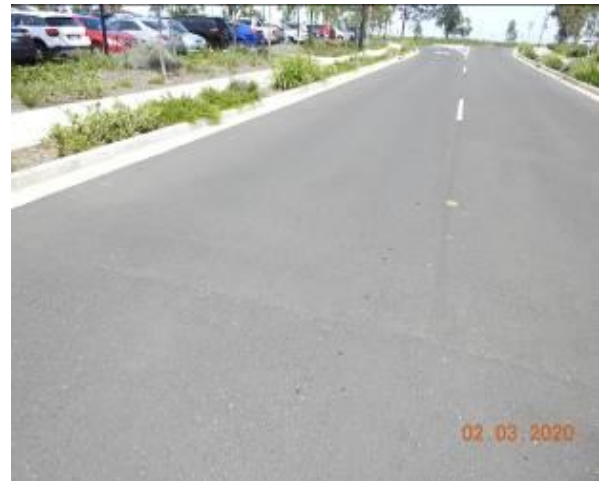
Figure 692 – General Condition of road surface

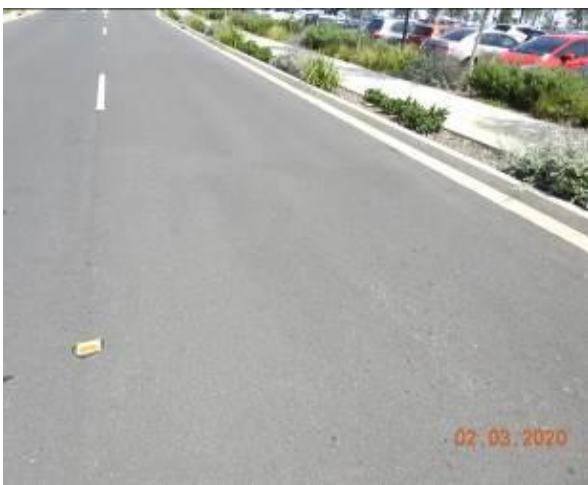
Figure 693 – General Condition of road surface

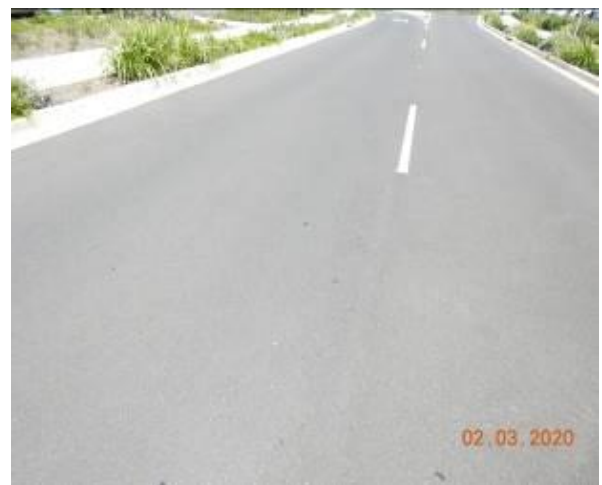
Figure 694 – General Condition of road surface

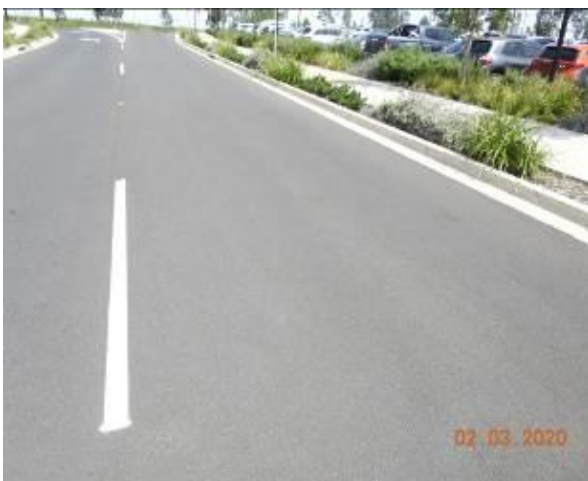
Figure 695 – General Condition of road surface

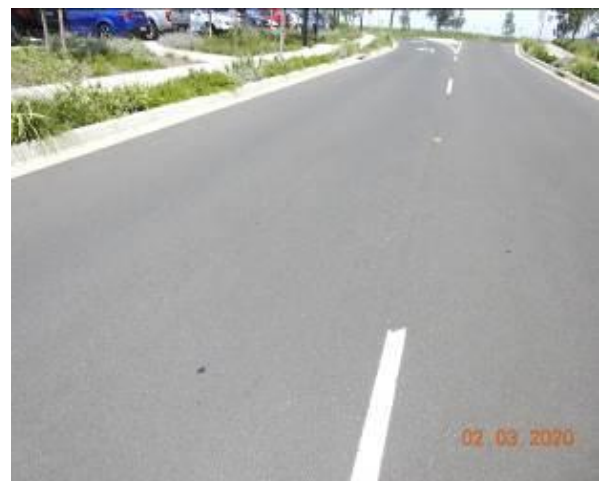
Figure 696 – General Condition of road surface

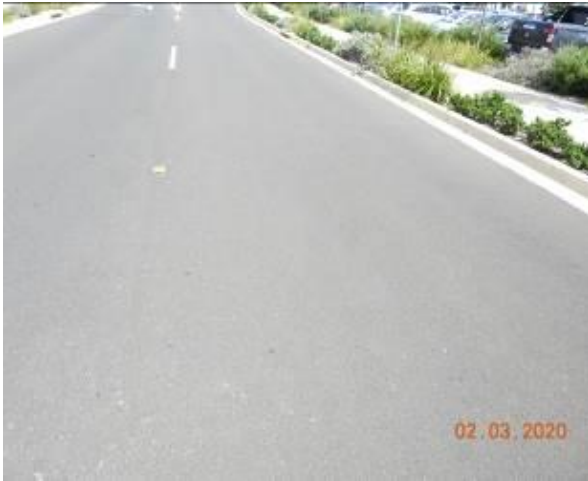
Figure 697 – General Condition of road surface

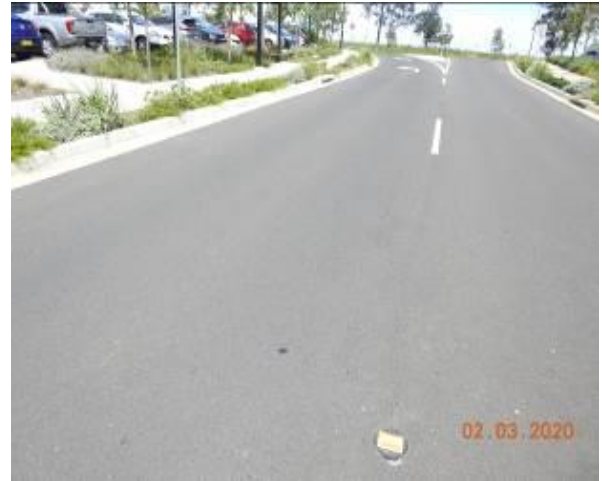
Figure 698 – General Condition of road surface

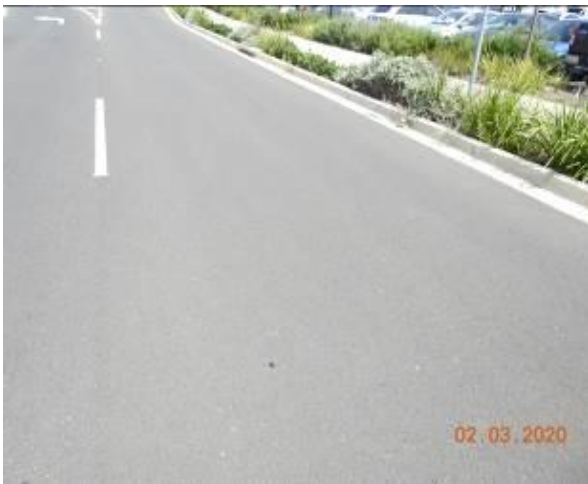
Figure 699 – General Condition of road surface

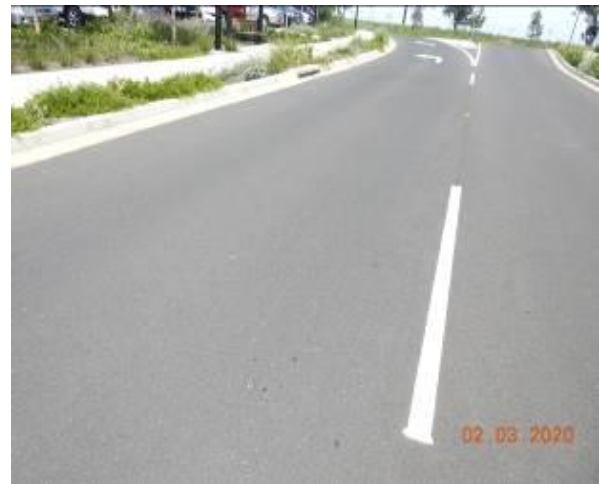
Figure 700 – General Condition of road surface

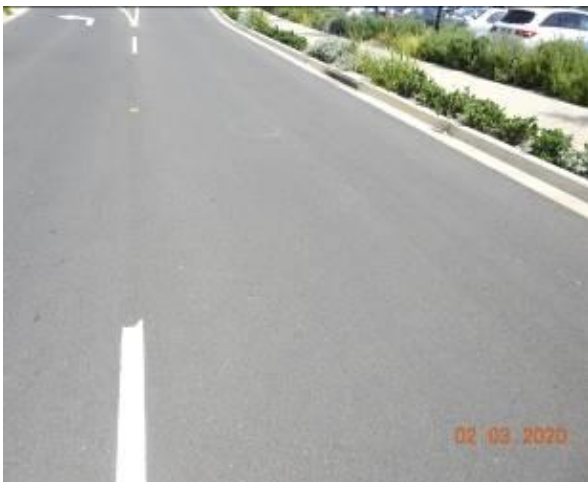
Figure 701 – General Condition of road surface

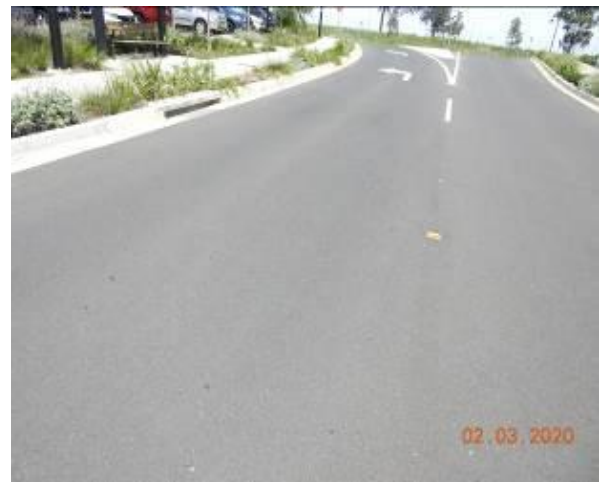
Figure 702 – General Condition of road surface

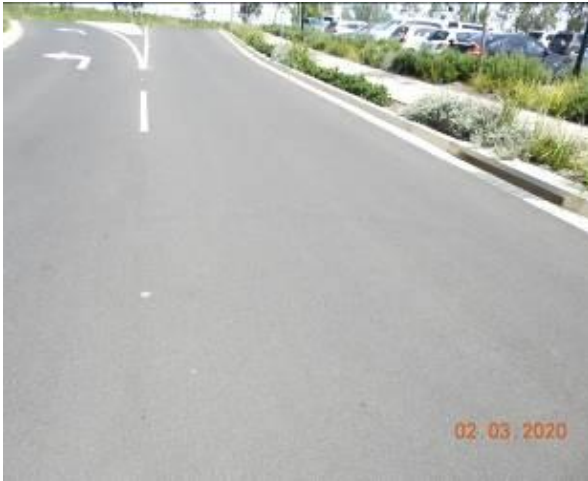
Figure 703 – General Condition of road surface

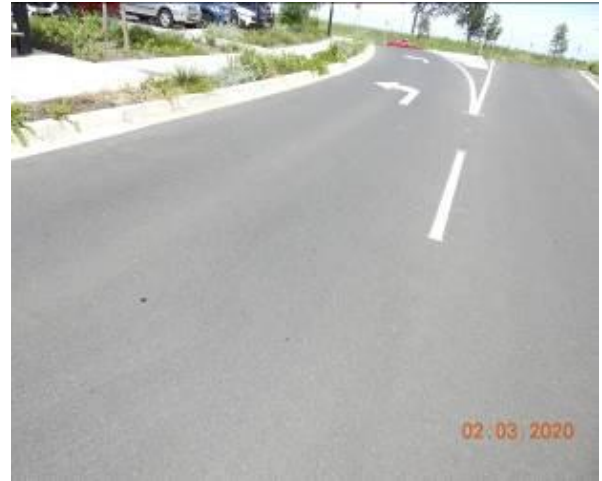
Figure 704 – General Condition of road surface

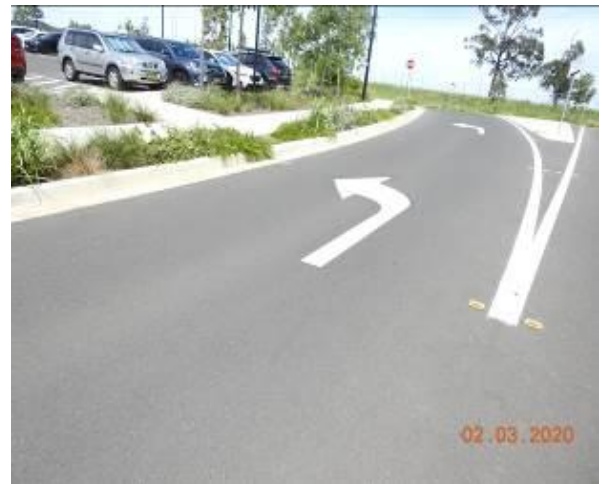
Figure 706 – General Condition of road surface

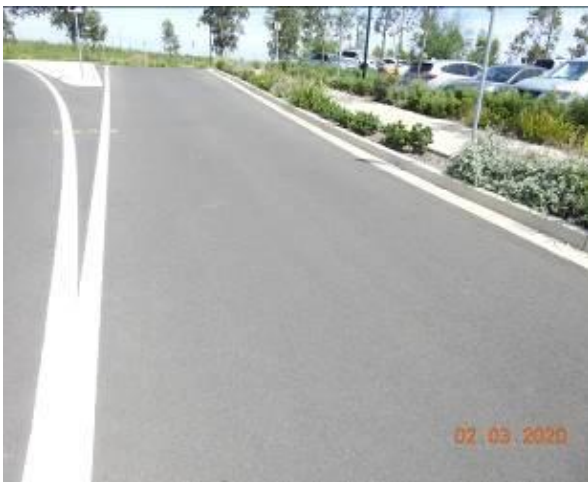
Figure 707 – General Condition of road surface

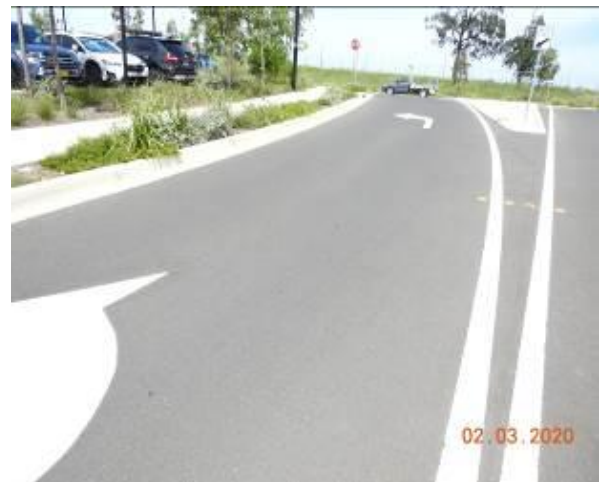
Figure 708 – General Condition of road surface

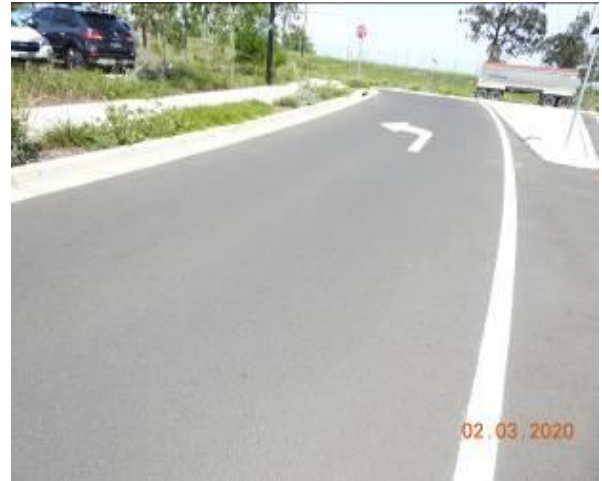
Figure 710 – General Condition of road surface

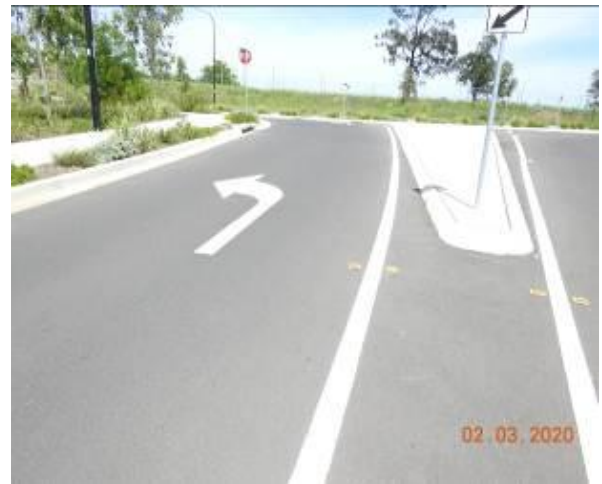
Figure 712 – General Condition of road surface

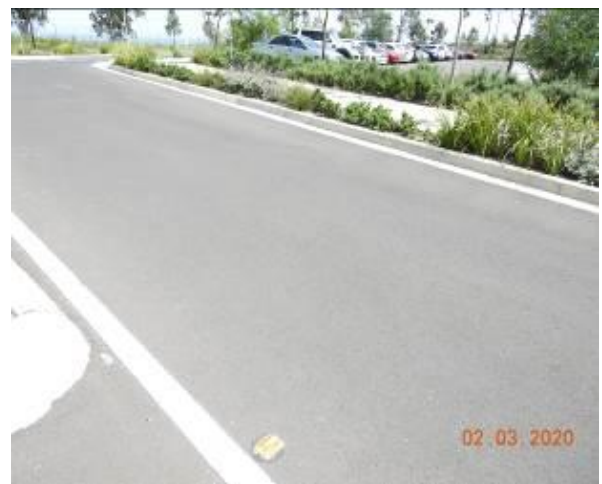
Figure 714 – General Condition of road surface

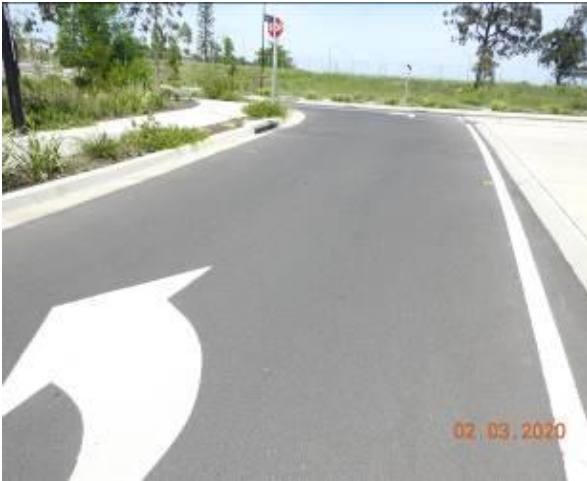
Figure 715 – General Condition of road surface

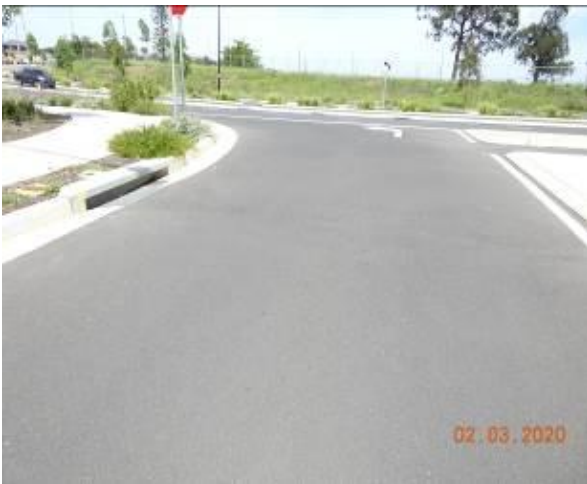
Figure 717 – General Condition of road surface

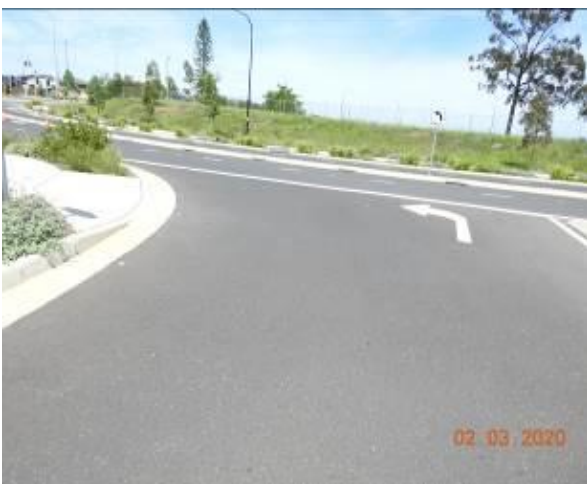
Figure 719 – General Condition of road surface

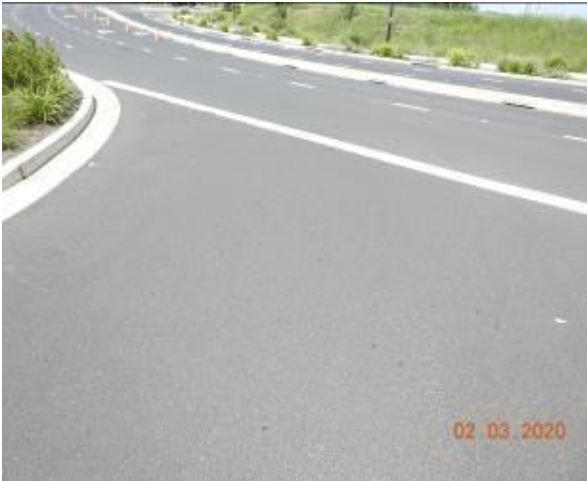
Figure 721 – General Condition of road surface

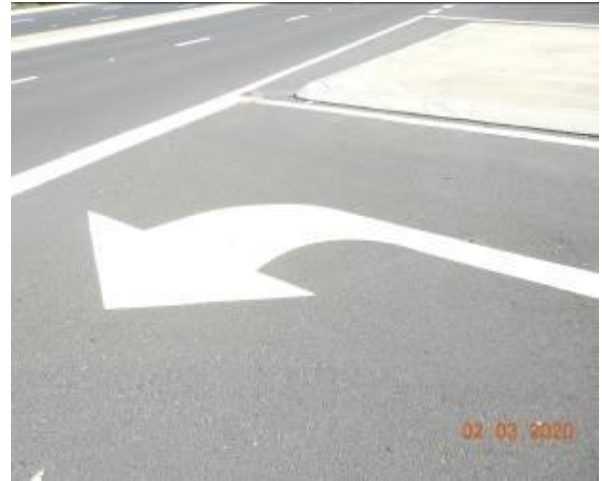
Figure 722 – General Condition of road surface

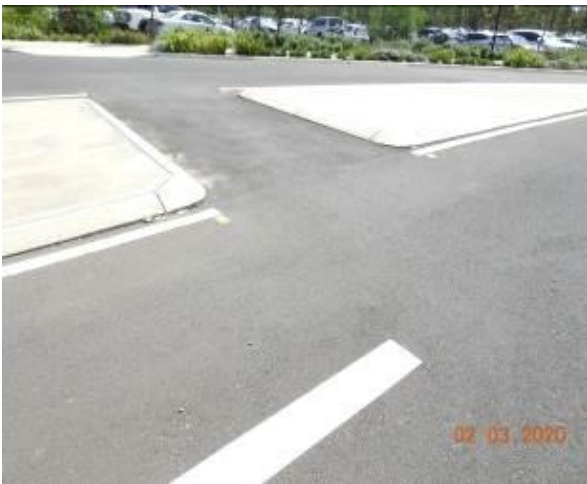
Figure 723 – General Condition of road surface

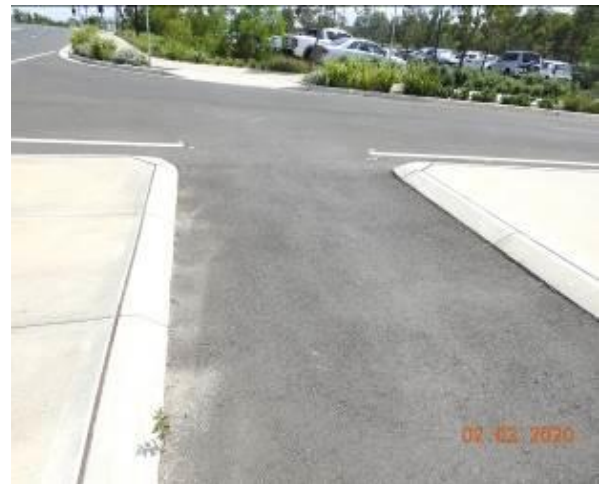
Figure 724 – General Condition of road surface

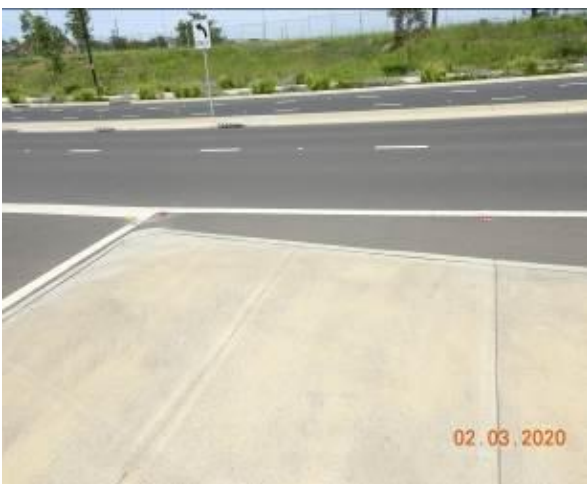
Figure 725 – General Condition of road surface

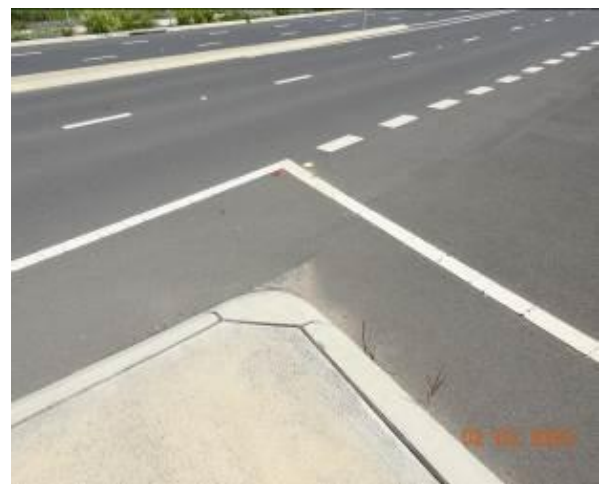
Figure 726 – General Condition of road surface

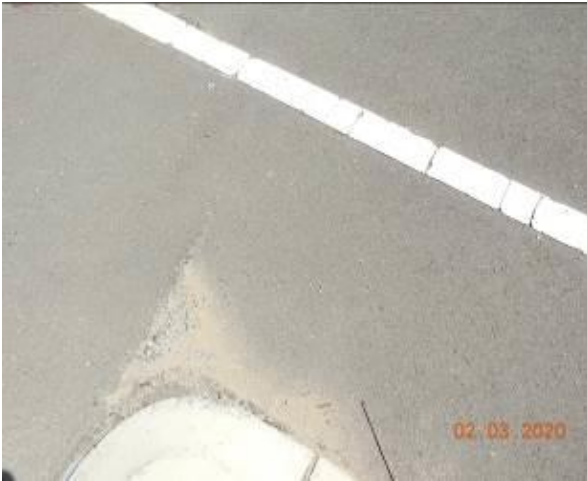
Figure 727 – Crack propagation through road surface

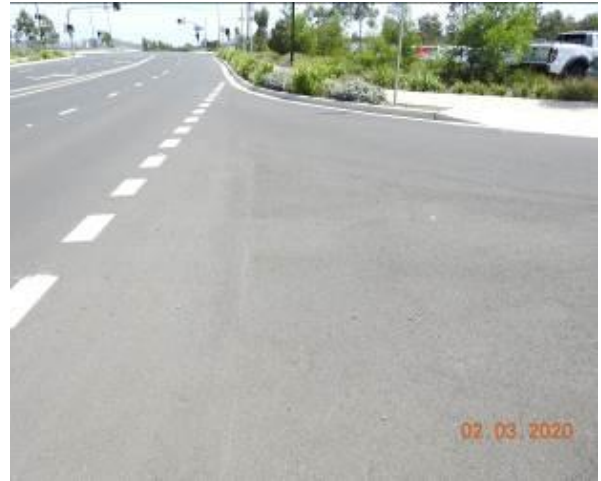
Figure 728 – General Condition of road surface

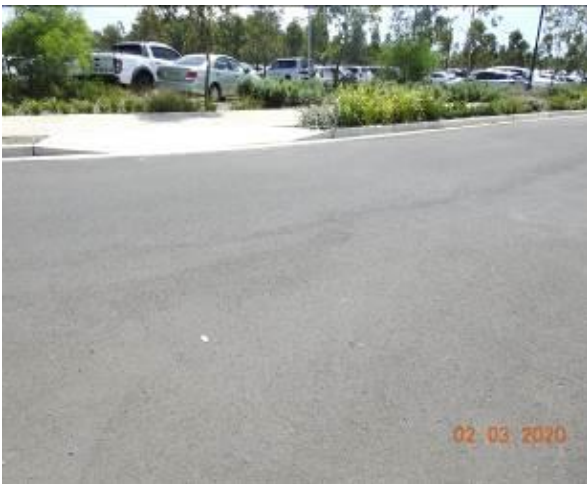
Figure 729 – General Condition of road surface

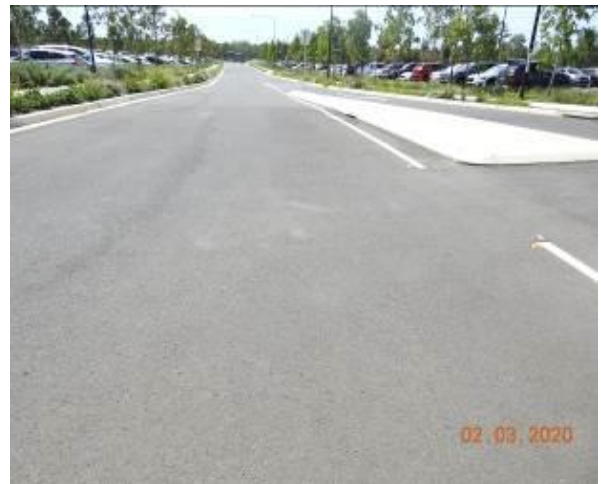
Figure 730 – General Condition of road surface

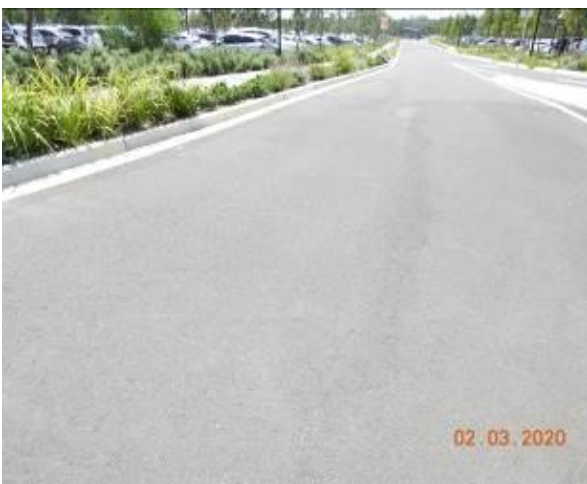
Figure 731 – General Condition of road surface

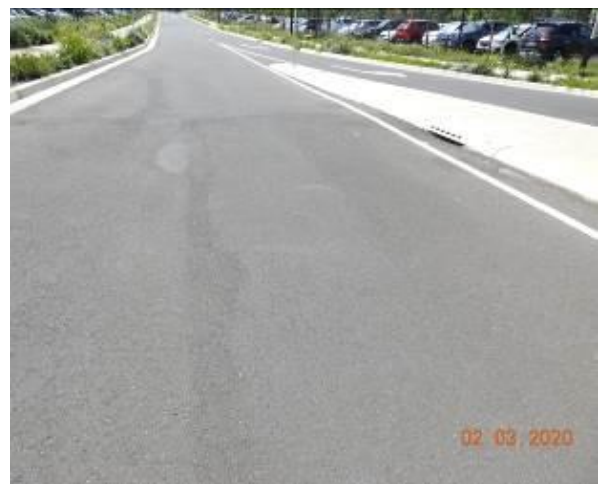
Figure 732 – General Condition of road surface

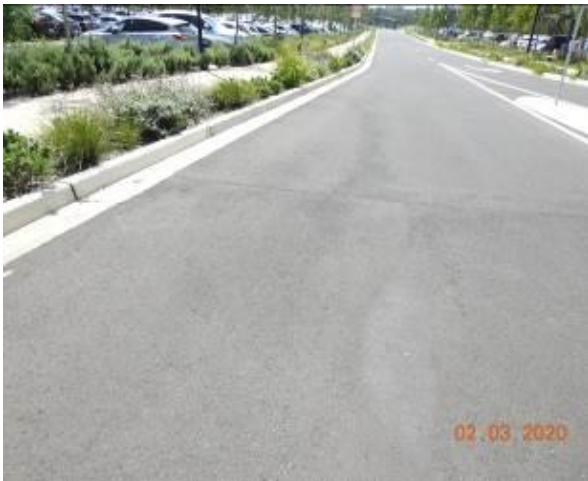
Figure 733 – General Condition of road surface

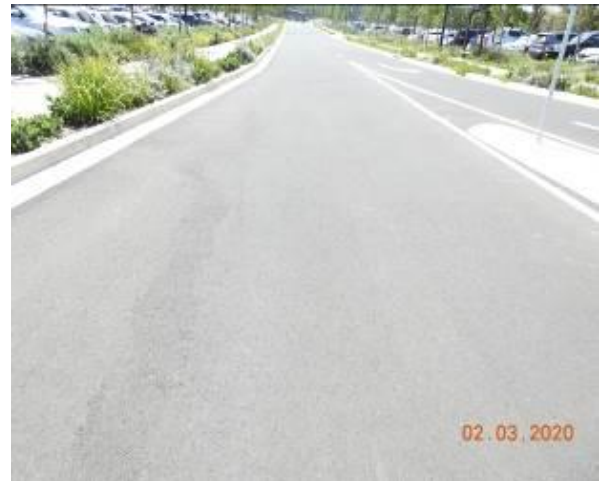
Figure 734 – General Condition of road surface

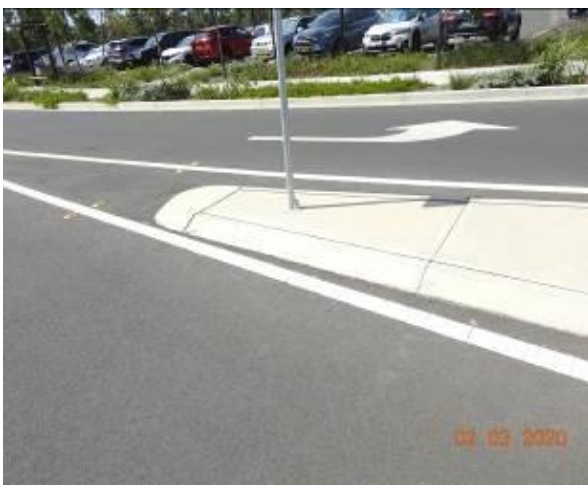
Figure 735 – General Condition of traffic island

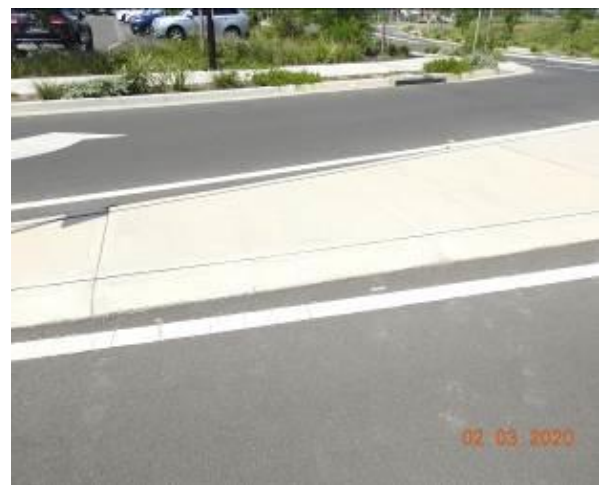
Figure 736 – General Condition of traffic island

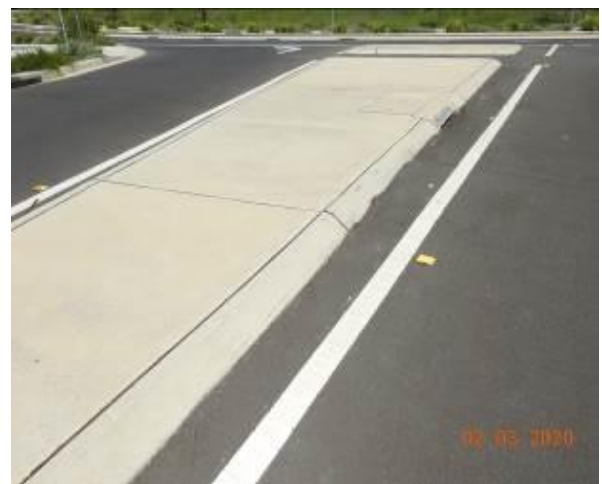
Figure 738 – General Condition of traffic island

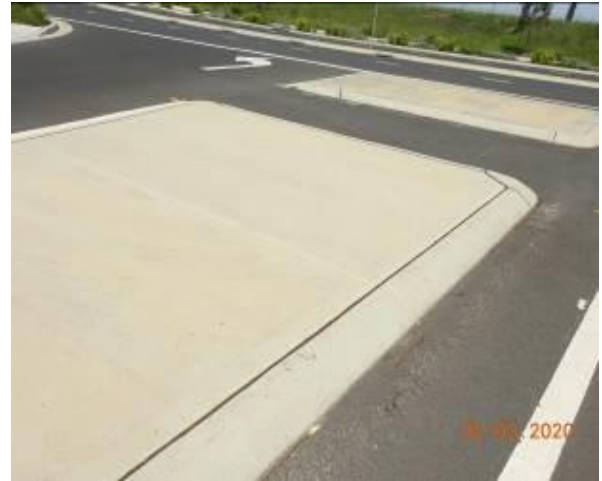
Figure 740 – General Condition of traffic island

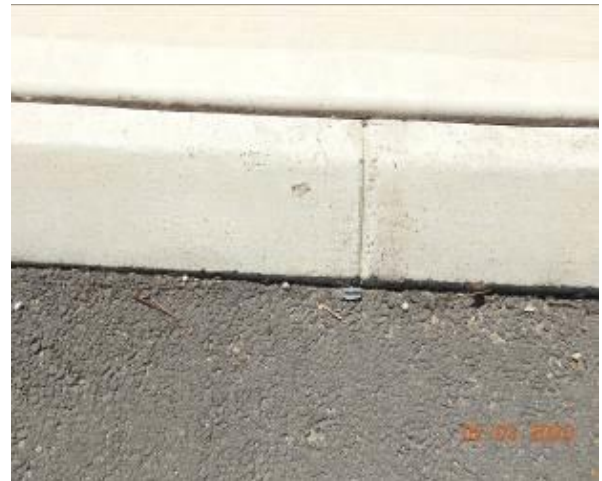
Figure 742 – Crack propagation through traffic island

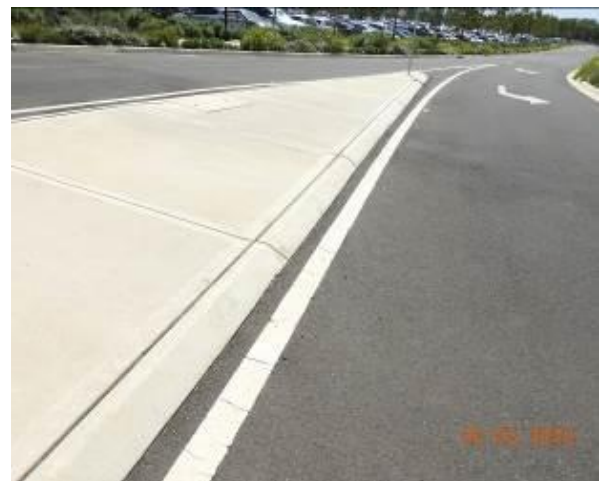
Figure 744 – General Condition of traffic island

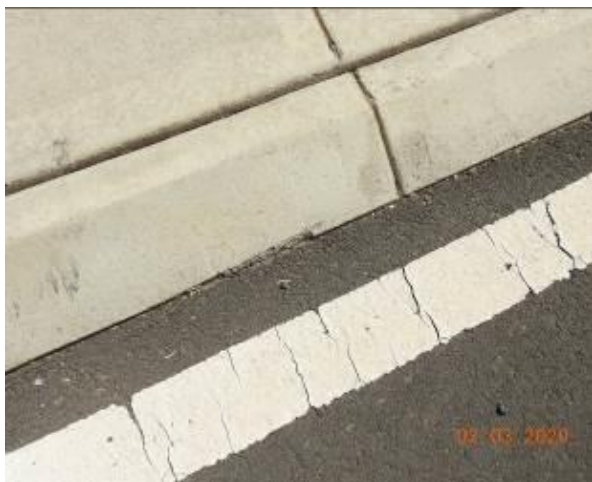
Figure 745 – Loss of material through traffic island kerb

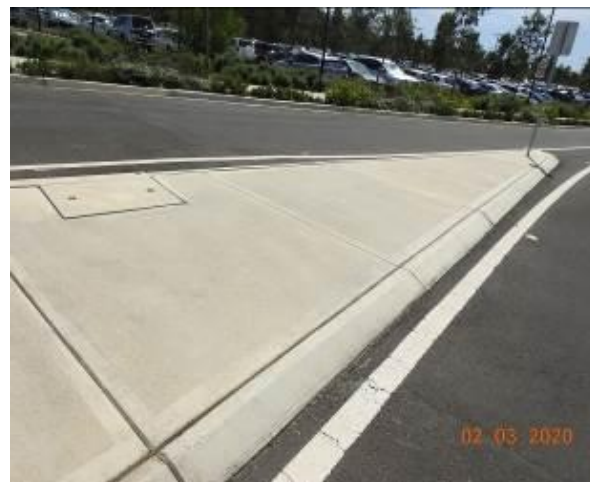
Figure 746 – General Condition of traffic island

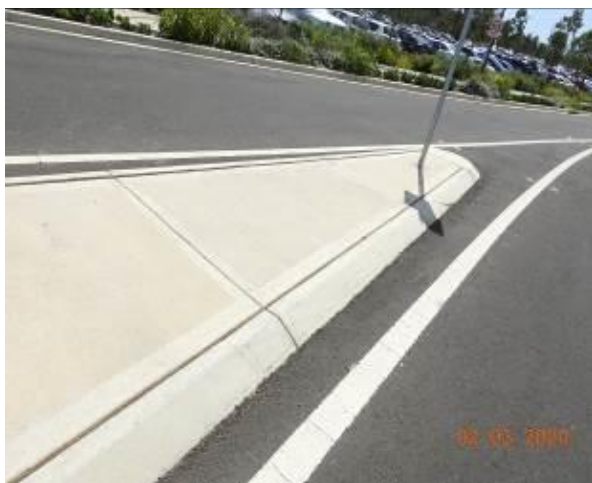
Figure 747 – General Condition of traffic island

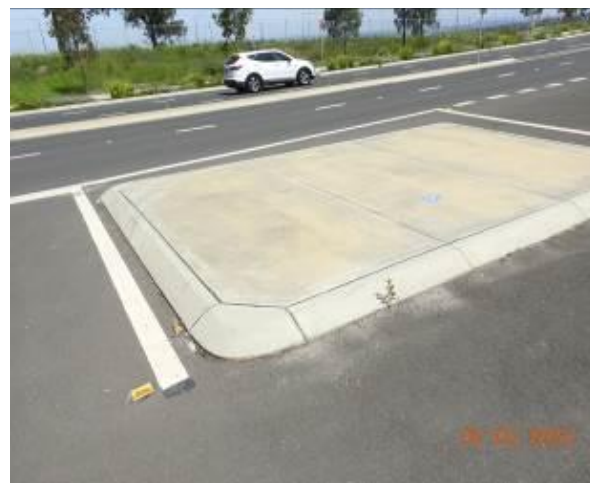
Figure 748 – General Condition of traffic island

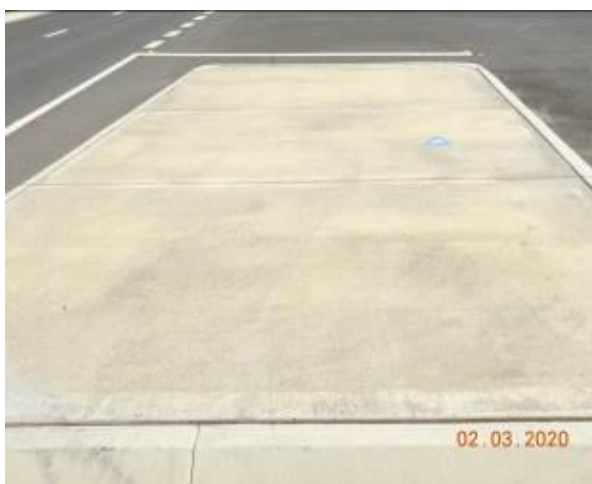
Figure 749 – General Condition of traffic island

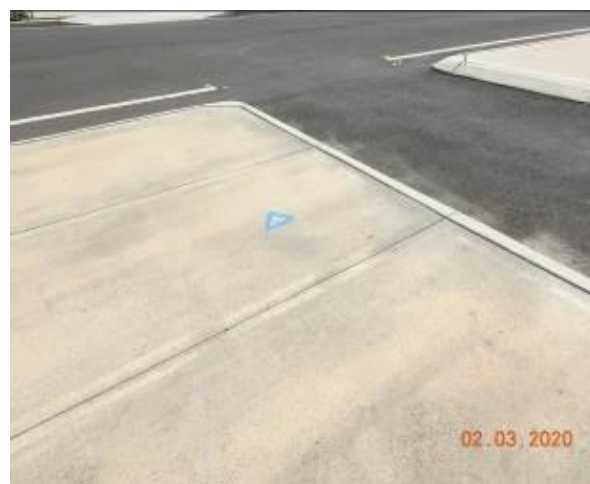
Figure 750 – General Condition of traffic island

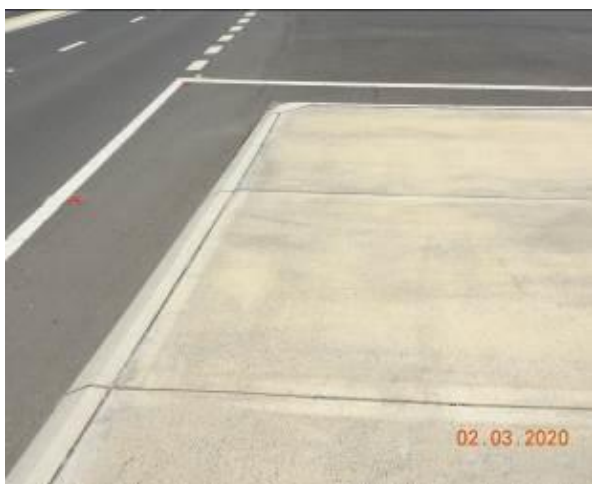
Figure 751 – General Condition of traffic island

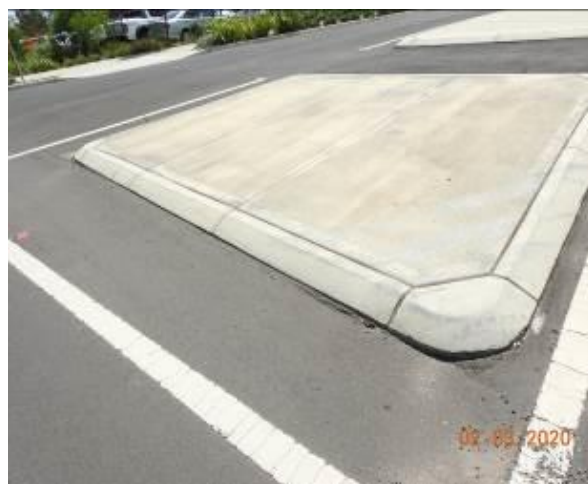
Figure 752 – General Condition of traffic island

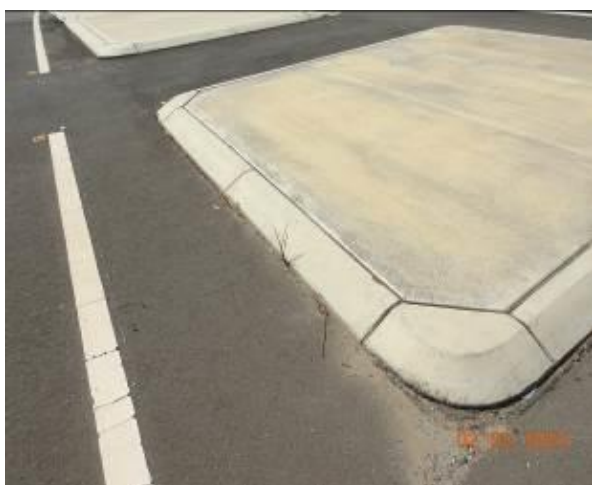
Figure 753 – General Condition of traffic island

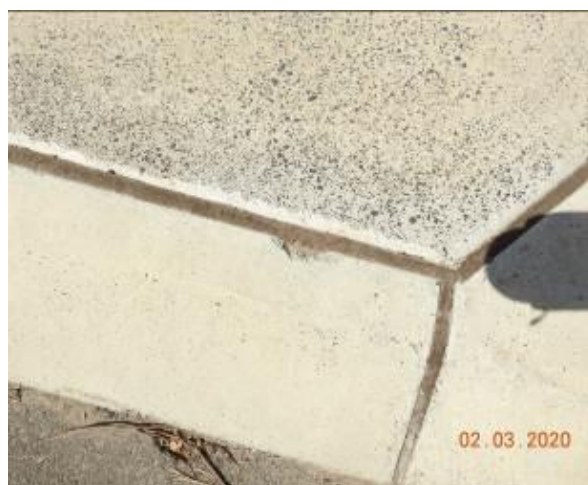
Figure 754 – Loss of material through traffic island kerb

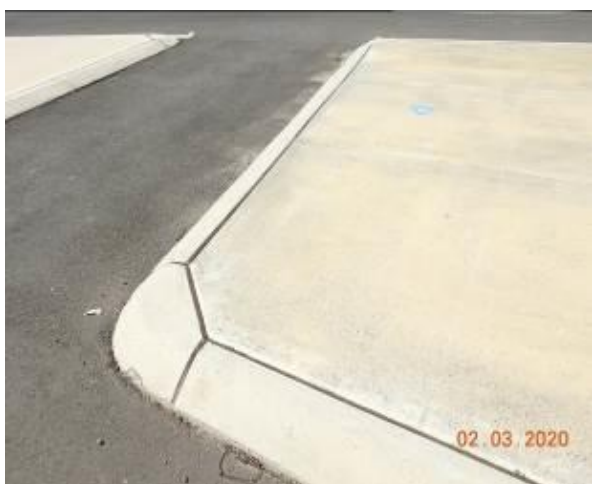
Figure 755 – General Condition of traffic island

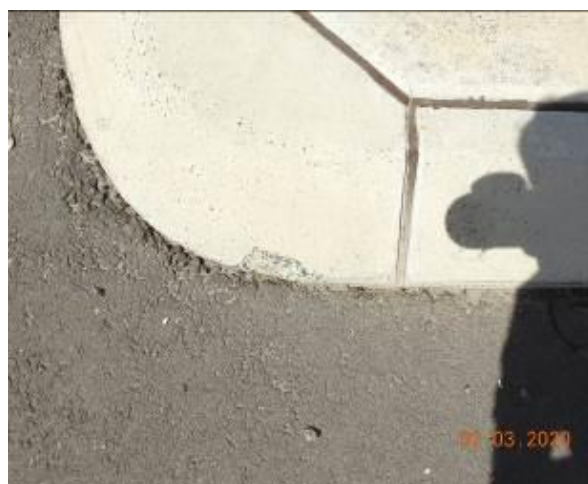
Figure 756 – Loss of material through traffic island

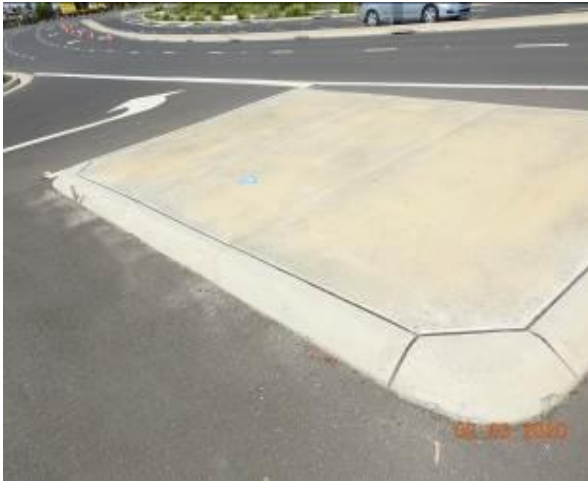
Figure 757 – General Condition of traffic island

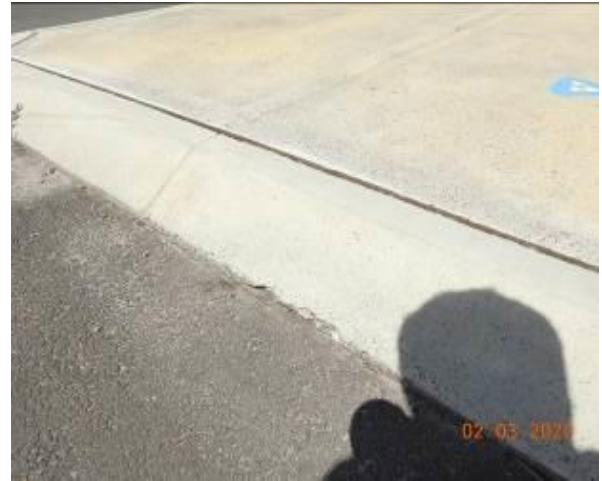
Figure 758 – Loss of material through traffic island
