**1-15 AND 2-12 CONFERTA AVENUE,
ROUSE HILL NSW 2155
TALLAWONG STATION PRECINCT SOUTH
PRE-DILAPIDATION REPORT**

**DEICORP PROJECTS
(TALLAWONG STATION) PTY LTD**

Job No. 191294.0
24/03/2020

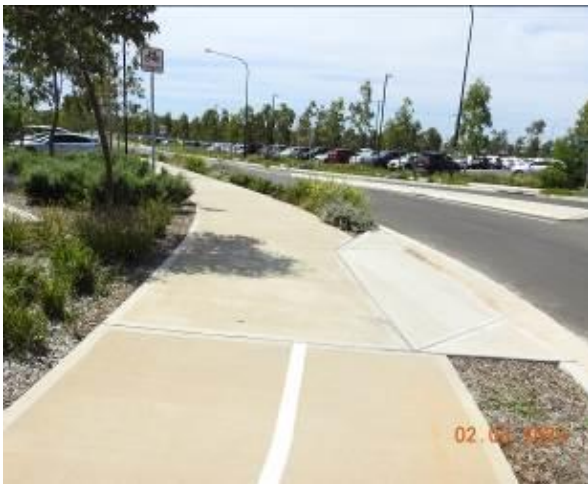
Figure 759 – General Condition of footpath pavement

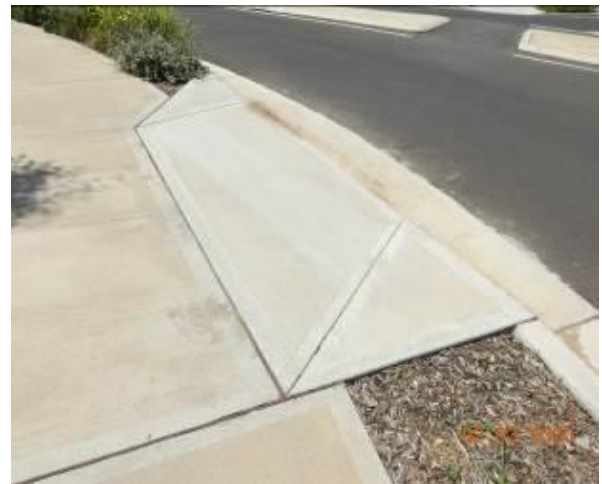
Figure 760 – General Condition of footpath pavement

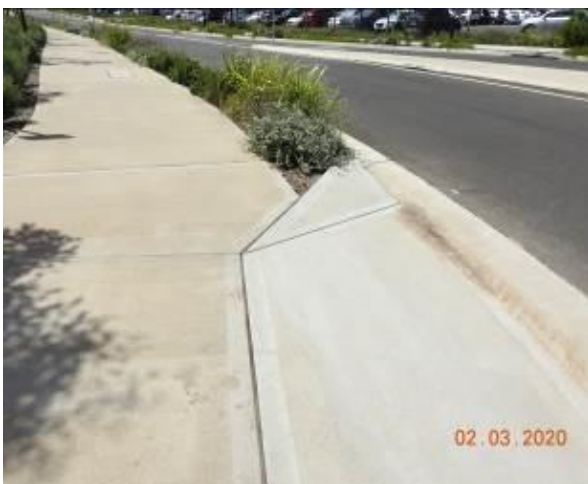
Figure 761 – General Condition of footpath pavement

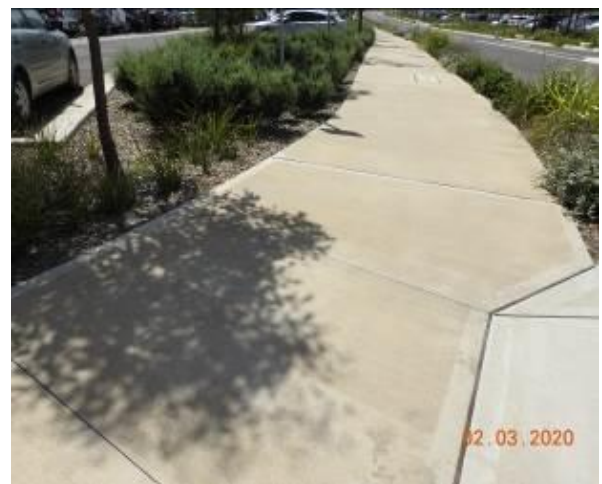
Figure 762 – General Condition of footpath pavement

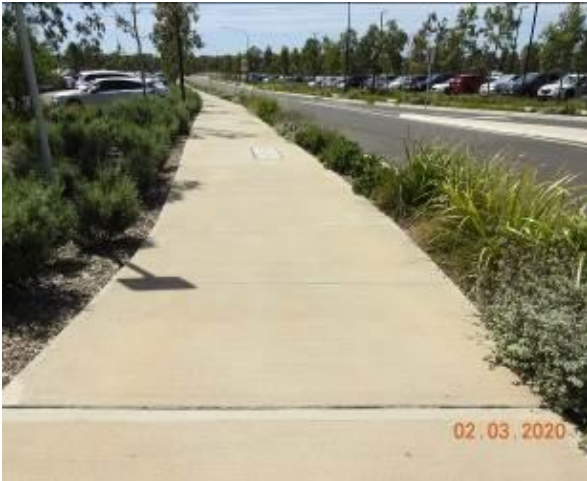
Figure 763 – General Condition of footpath pavement

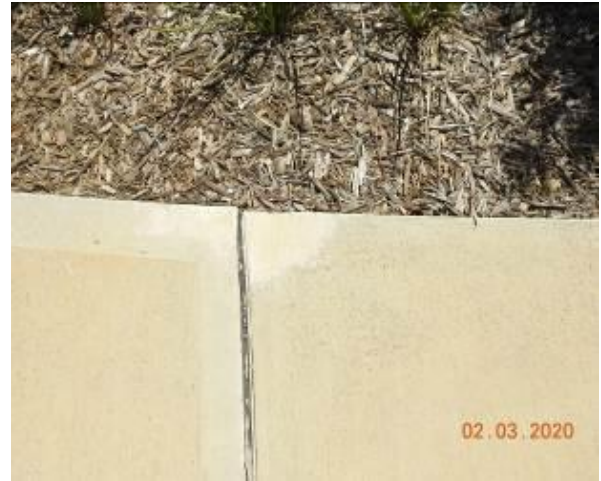
Figure 764 – Crack propagation through footpath pavement

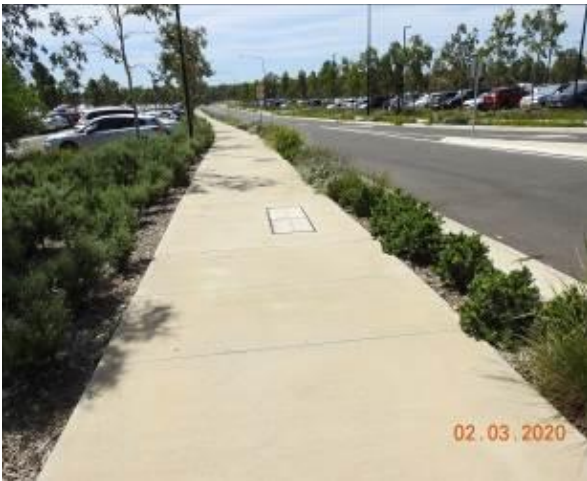
Figure 765 – General Condition of footpath pavement

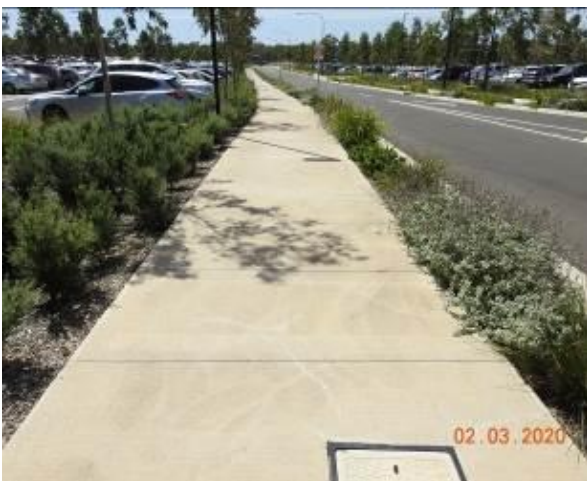
Figure 767 – General Condition of footpath pavement

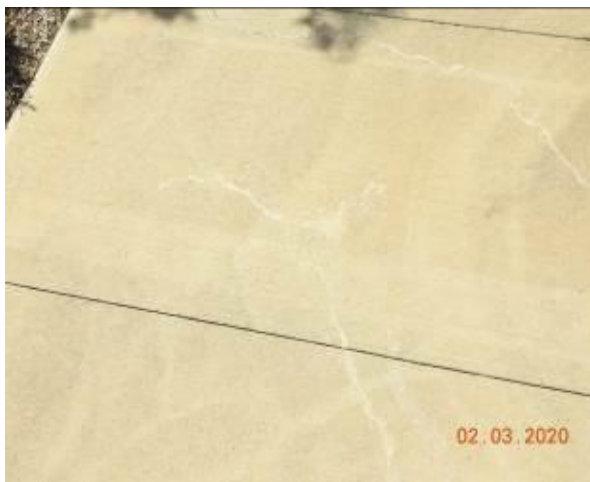
Figure 769 – Crack propagation through footpath pavement

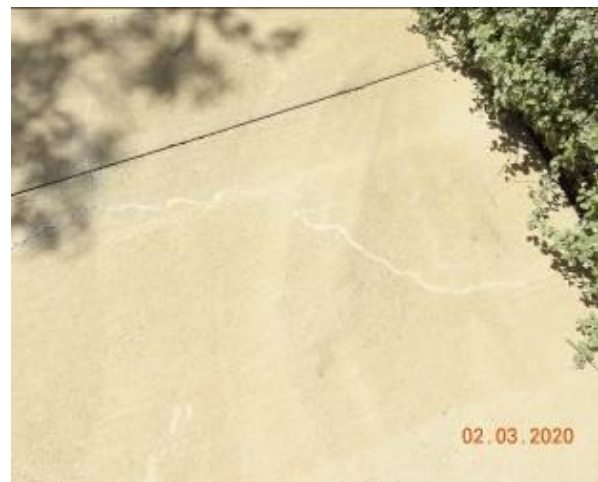
Figure 770 – Crack propagation through footpath pavement

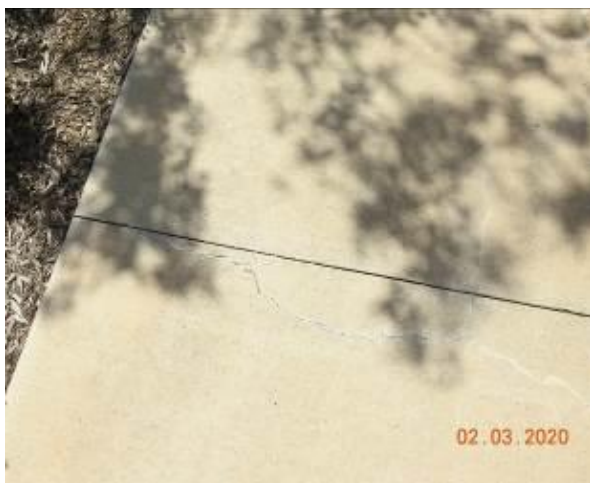
Figure 771 – Crack propagation through footpath pavement

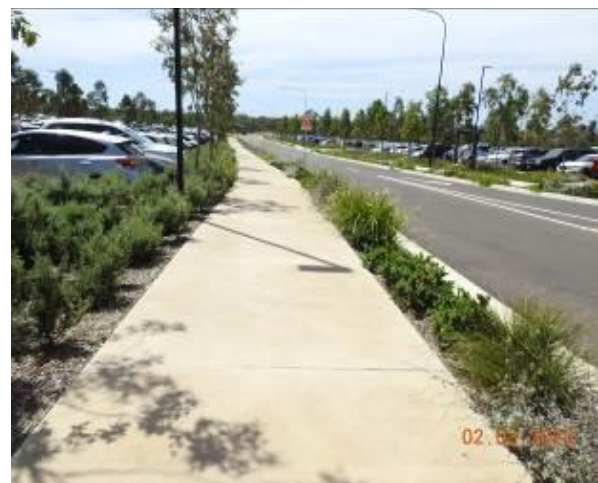
Figure 772 – General Condition of footpath pavement

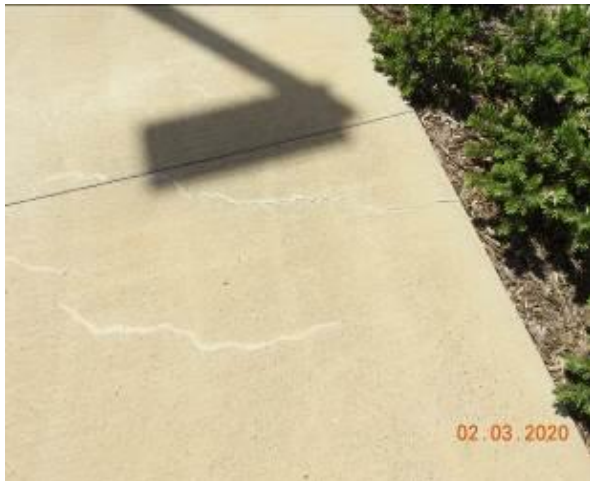
Figure 775 – Crack propagation through footpath pavement

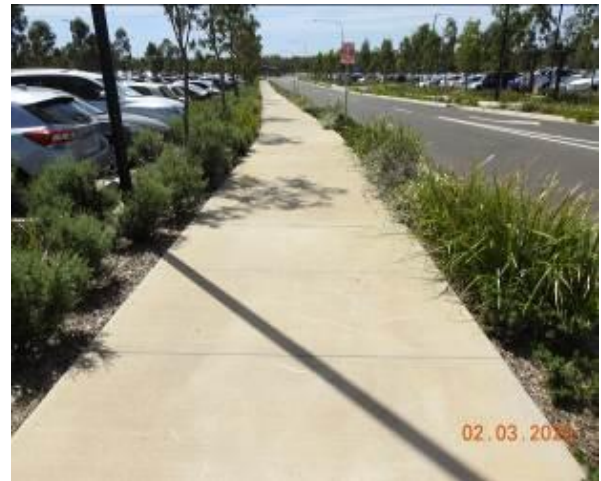
Figure 776 – General Condition of footpath pavement

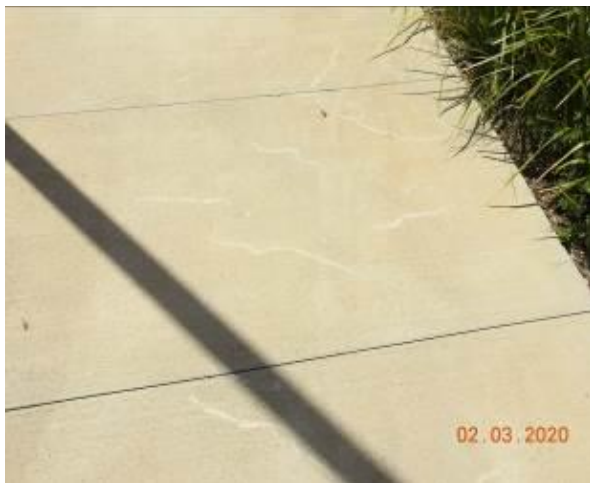
Figure 777 – Crack propagation through footpath pavement

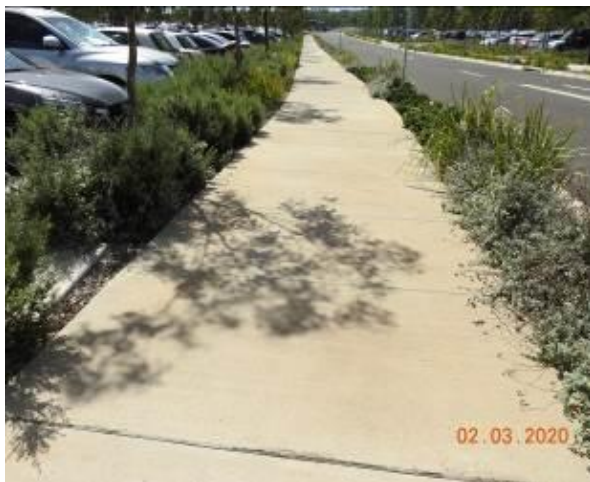
Figure 779 – General Condition of footpath pavement

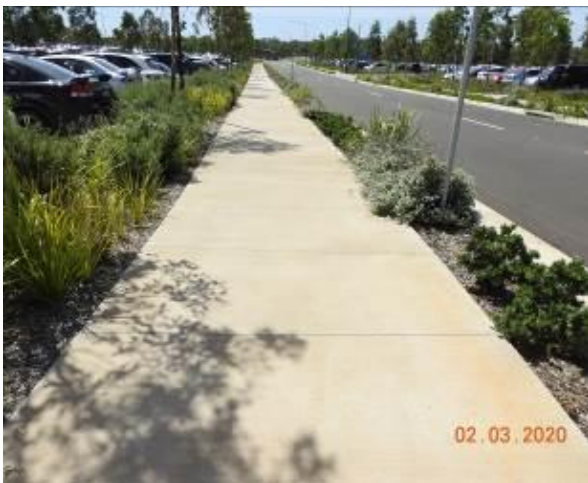
Figure 783 – General Condition of footpath pavement

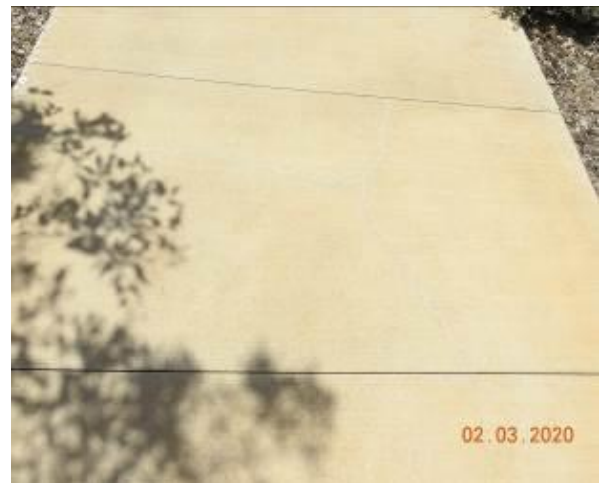
Figure 784 – Crack propagation through footpath pavement

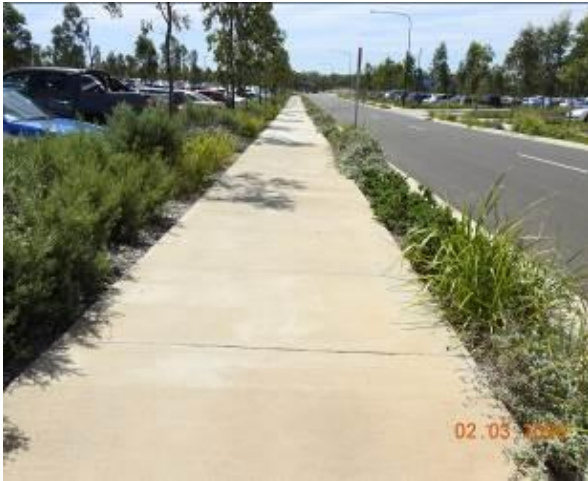
Figure 793 – General Condition of footpath pavement

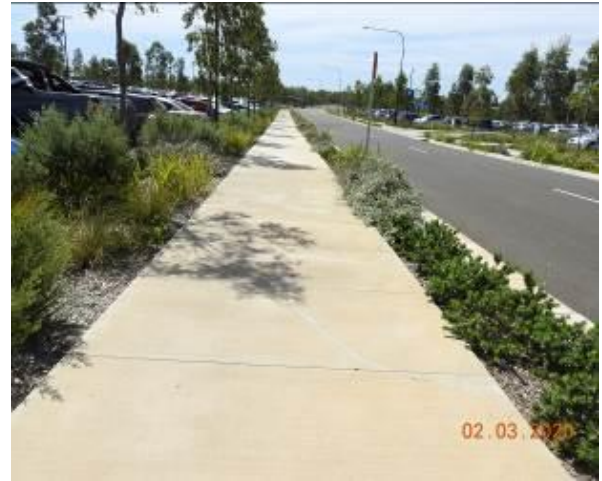
Figure 794 – General Condition of footpath pavement

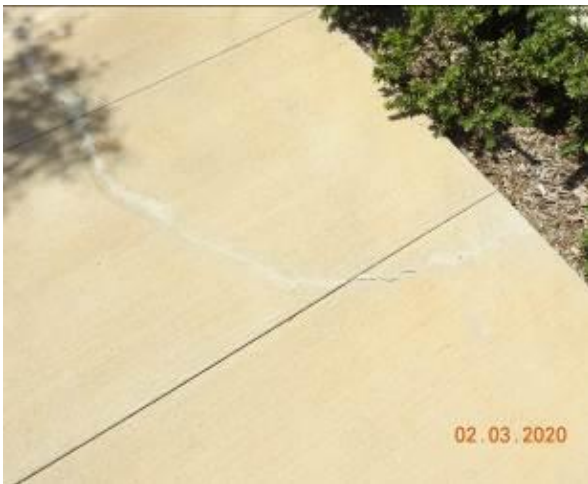
Figure 795 – Crack propagation through footpath pavement

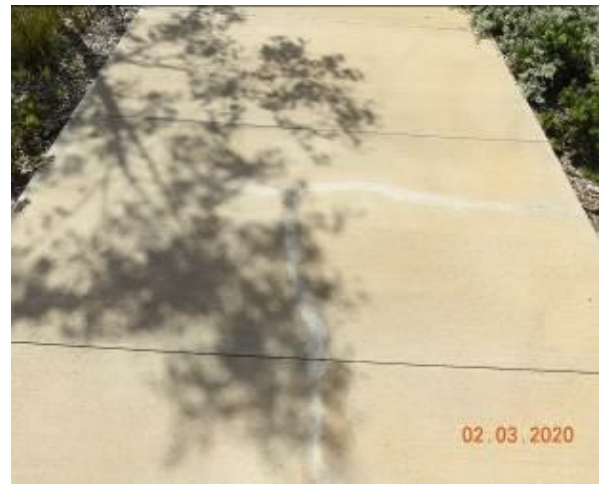
Figure 796 – Crack propagation through footpath pavement

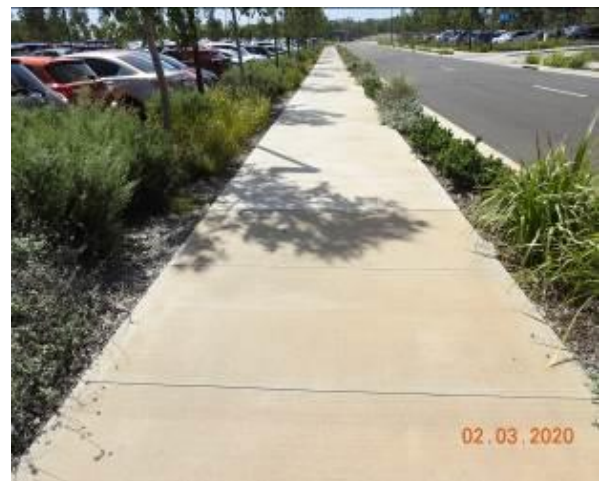
Figure 798 – General Condition of footpath pavement

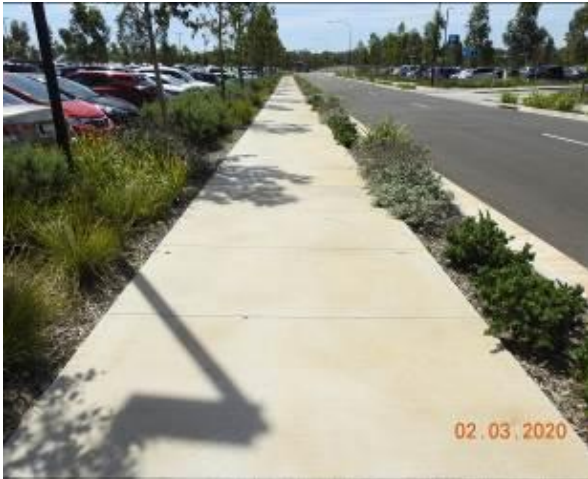
Figure 799 – General Condition of footpath pavement

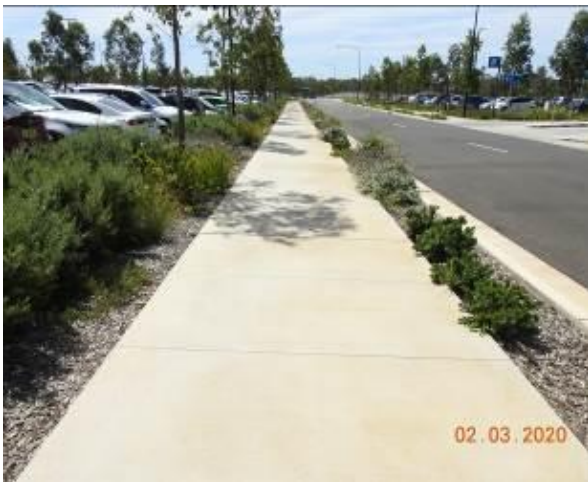
Figure 801 – General Condition of footpath pavement

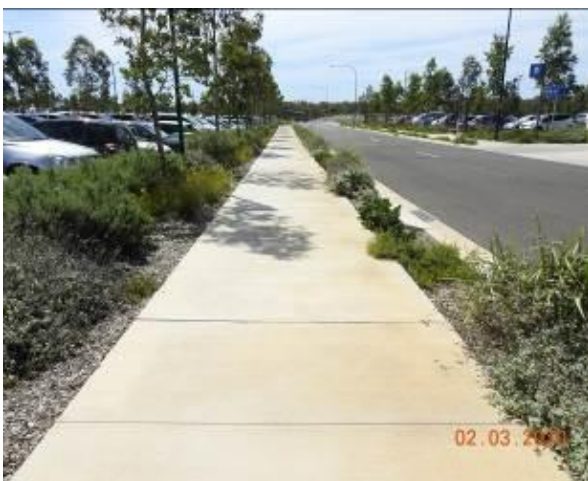
Figure 803 – General Condition of footpath pavement

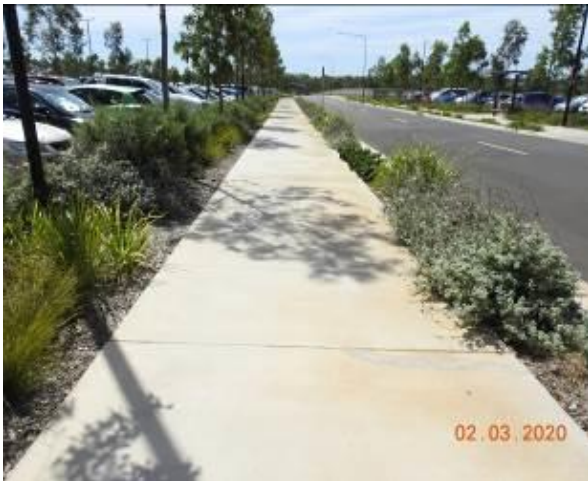
Figure 805 – General Condition of footpath pavement

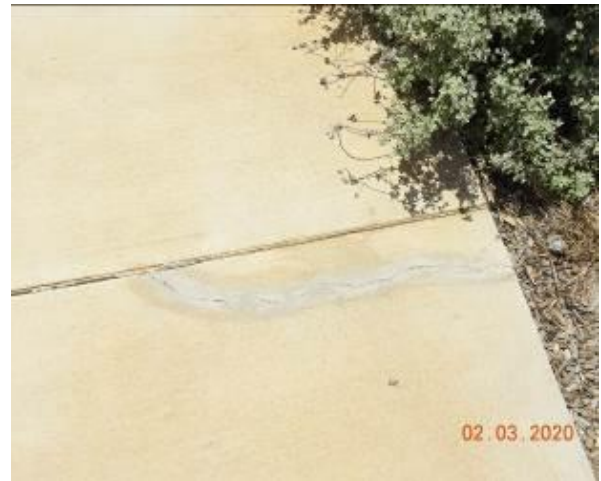
Figure 806 – Crack propagation through footpath pavement

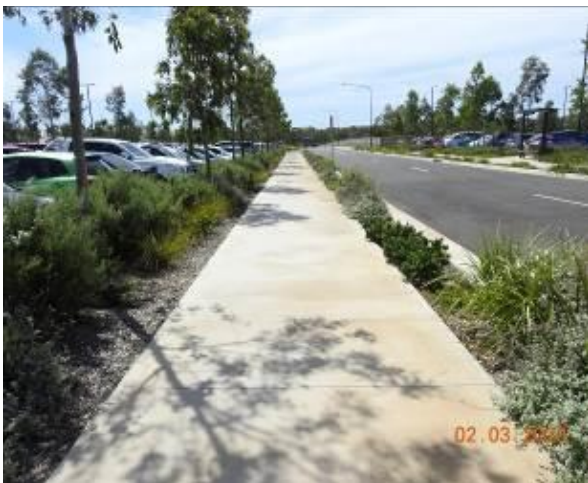
Figure 807 – General Condition of footpath pavement

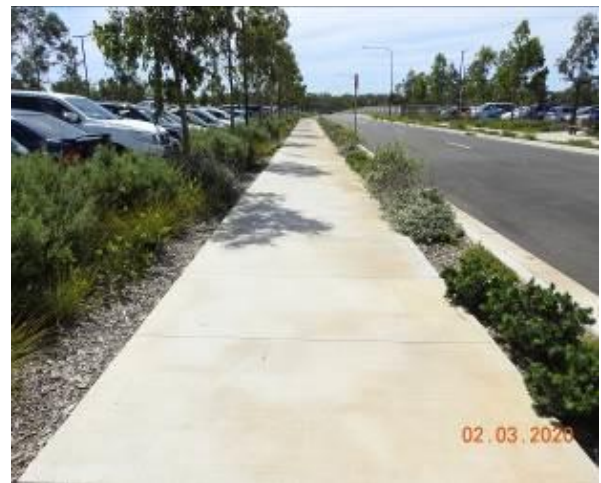
Figure 808 – General Condition of footpath pavement

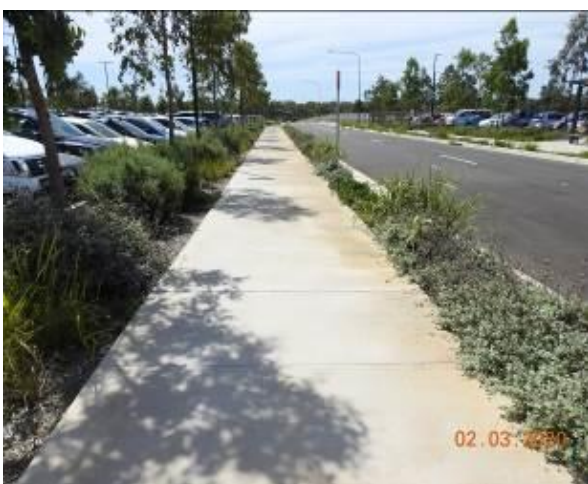
Figure 809 – General Condition of footpath pavement

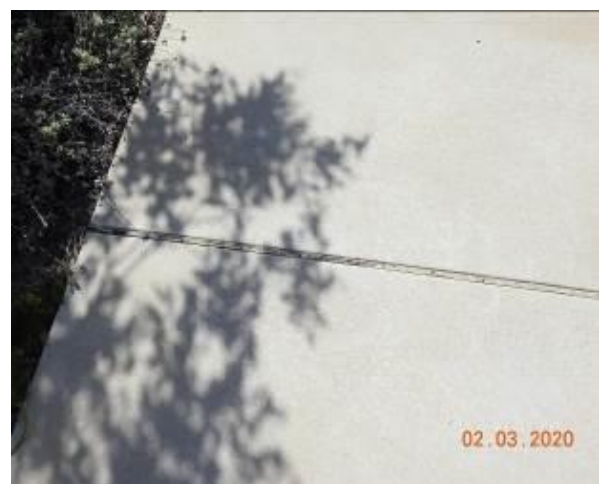
Figure 810 – Crack propagation through footpath pavement

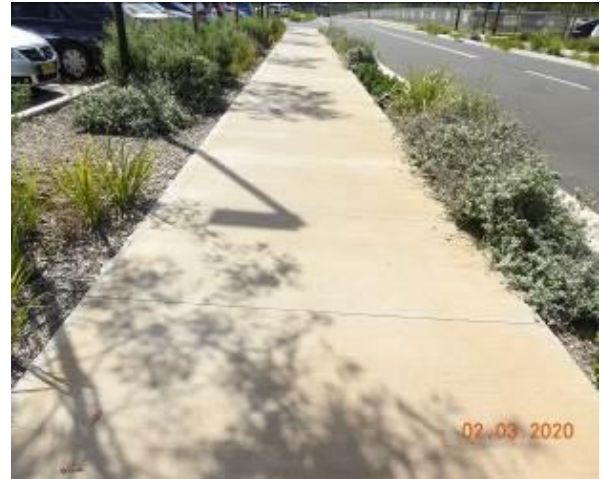
Figure 818 – General Condition of footpath pavement

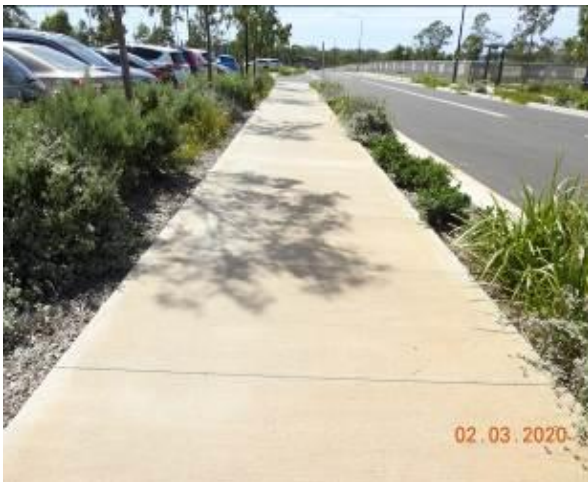
Figure 819 – General Condition of footpath pavement

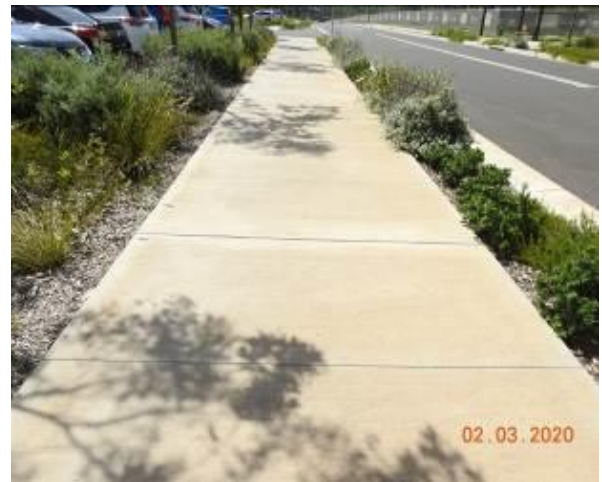
Figure 820 – General Condition of footpath pavement

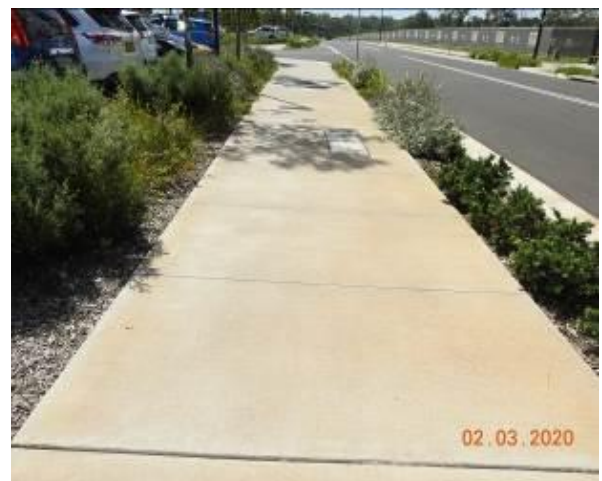
Figure 822 – General Condition of footpath pavement

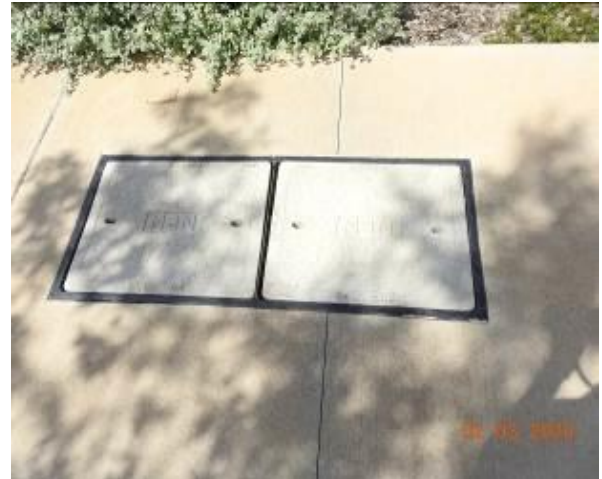
Figure 824 – General Condition of service pit

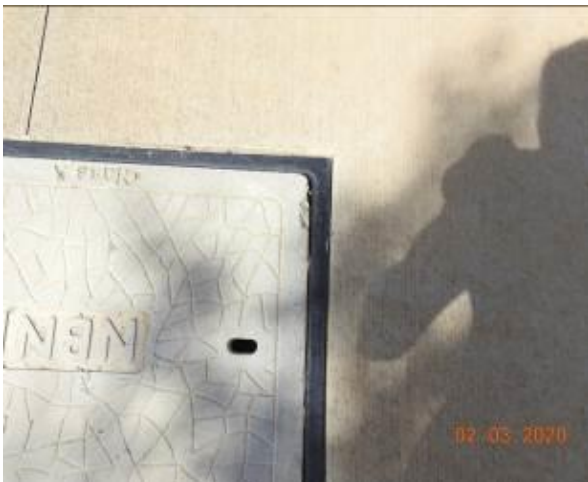
Figure 825 – Loss of material through service pit

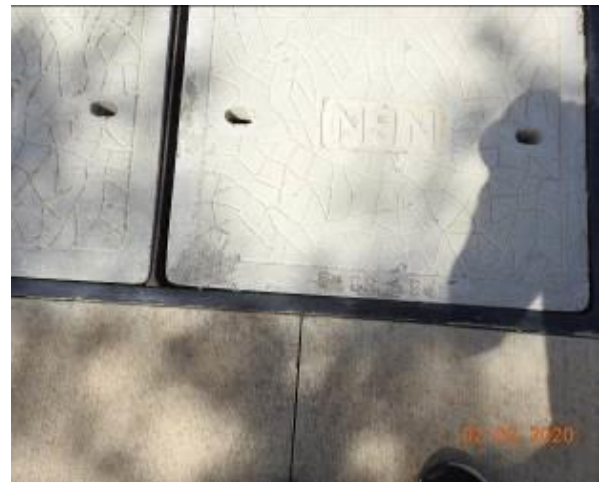
Figure 826 – Crack propagation through service pit

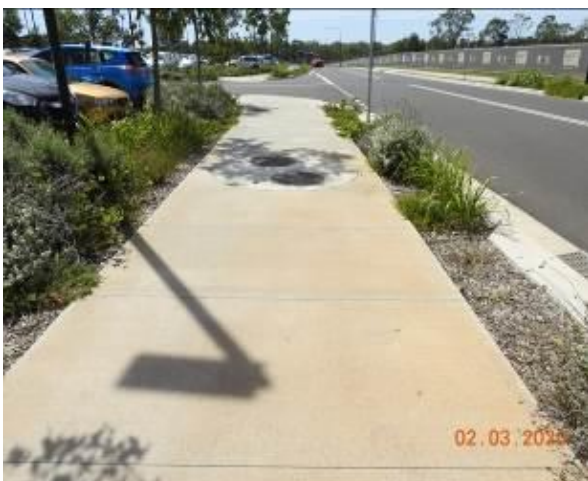
Figure 827 – General Condition of footpath pavement

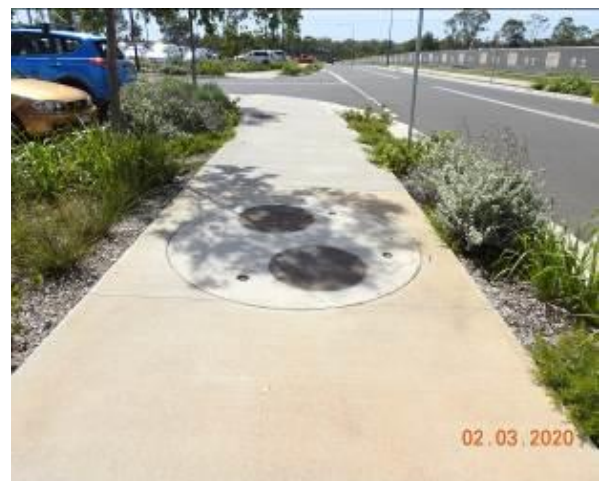
Figure 828 – General Condition of footpath pavement

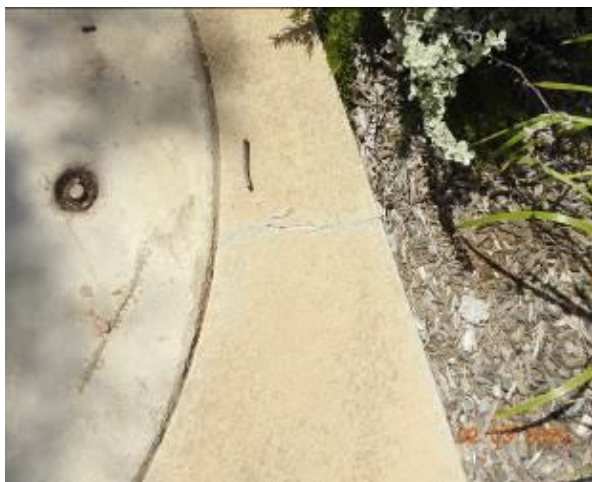
Figure 829 – Crack propagation through footpath pavement

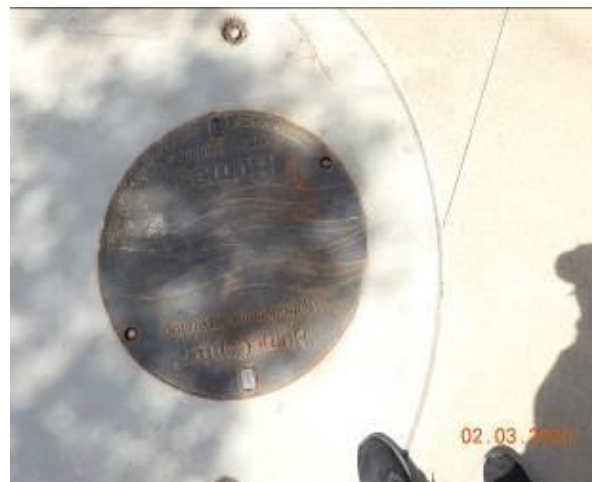
Figure 830 – General Condition of service pit

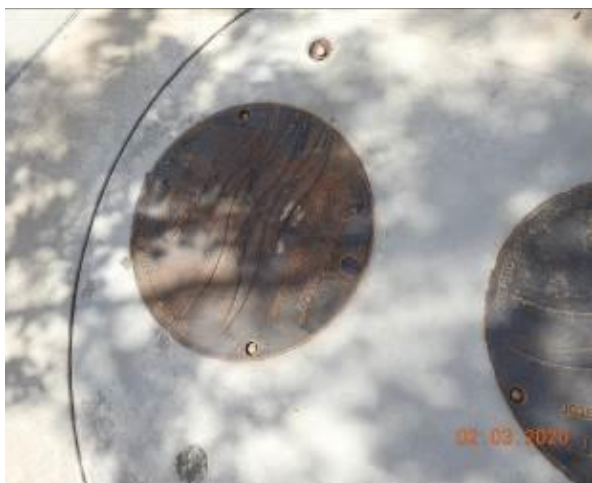
Figure 831 – General Condition of service pit

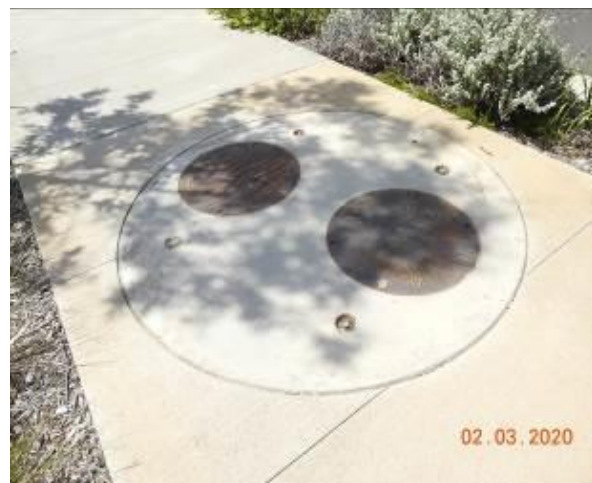
Figure 832 – General Condition of service pit

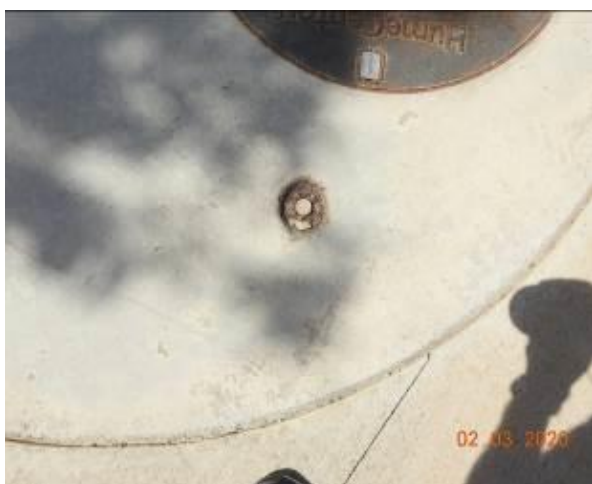
Figure 833 – Loss of material through service pit

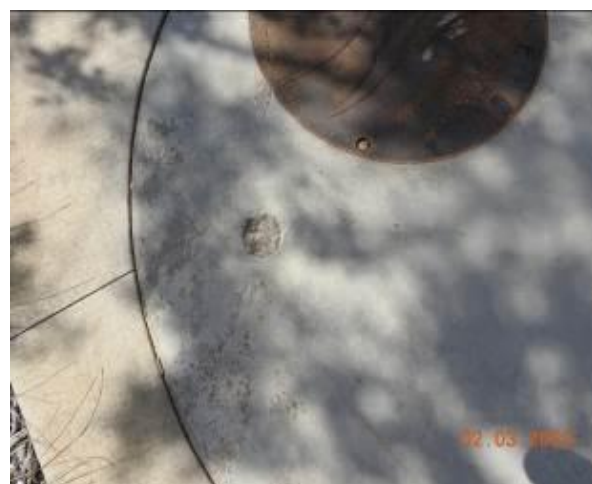
Figure 834 – Loss of material through service pit

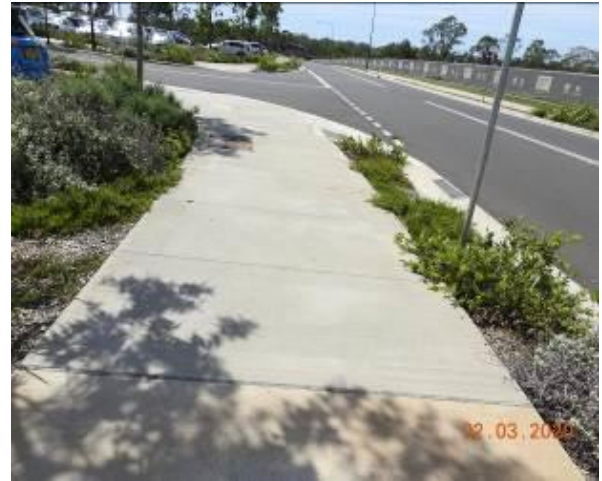
Figure 836 – General Condition of footpath pavement

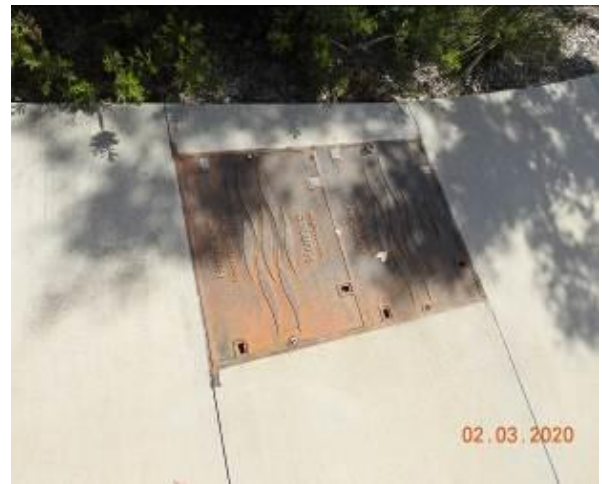
Figure 838 – General Condition of service pit

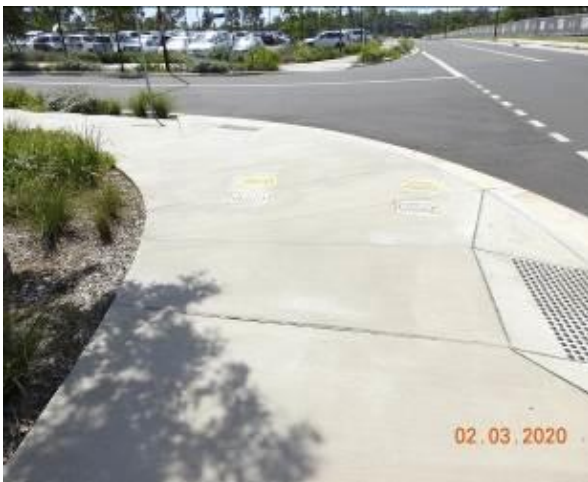
Figure 839 – General Condition of footpath pavement

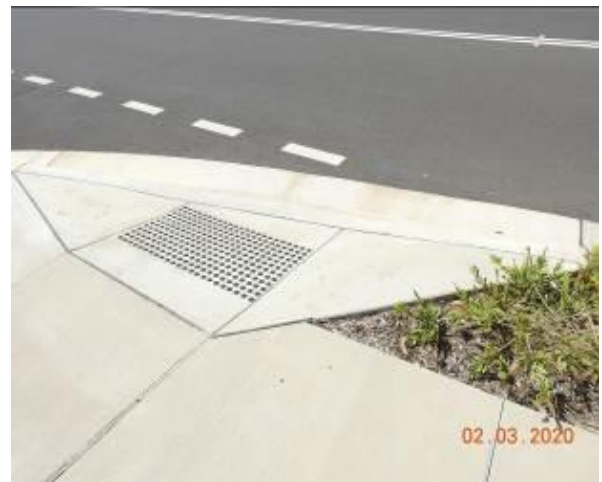
Figure 840 – General Condition of footpath pavement

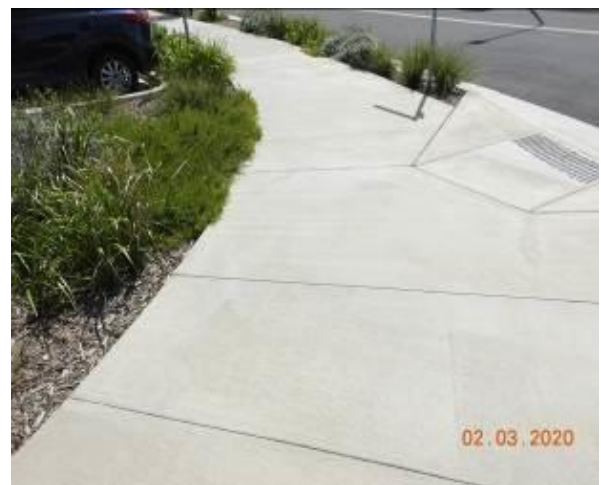
Figure 844 – General Condition of footpath pavement

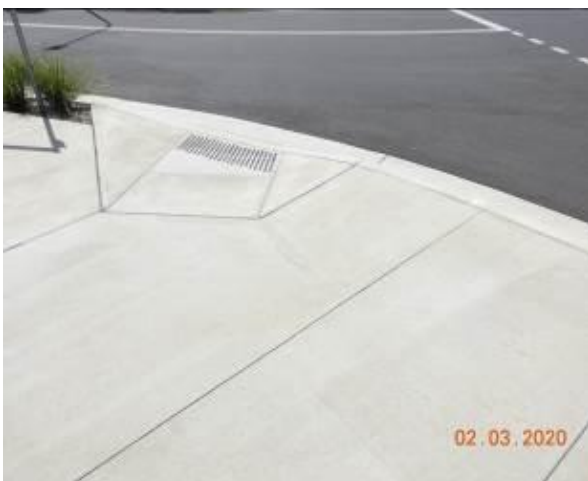
Figure 845 – General Condition of footpath pavement

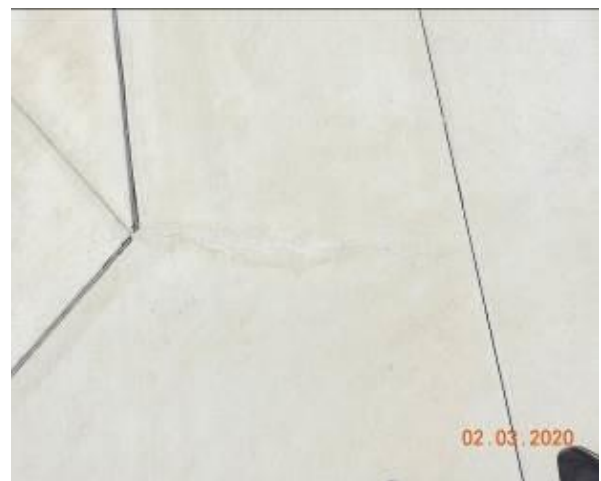
Figure 846 – Crack propagation through footpath pavement

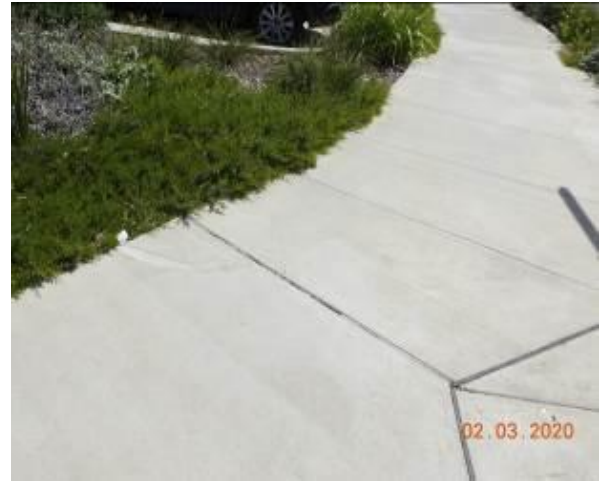
Figure 848 – General Condition of footpath pavement

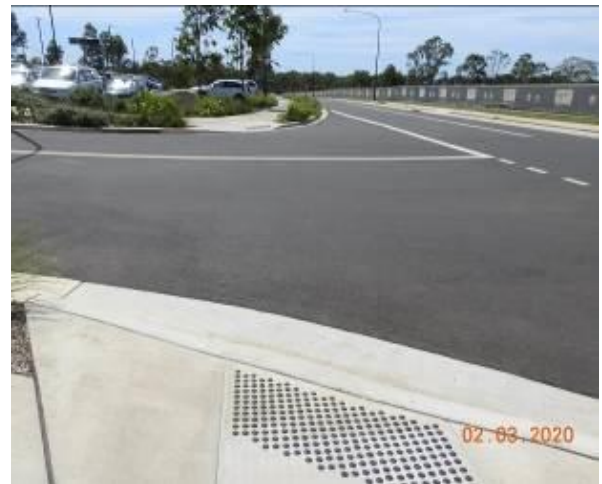
Figure 850 – General Condition of footpath pavement

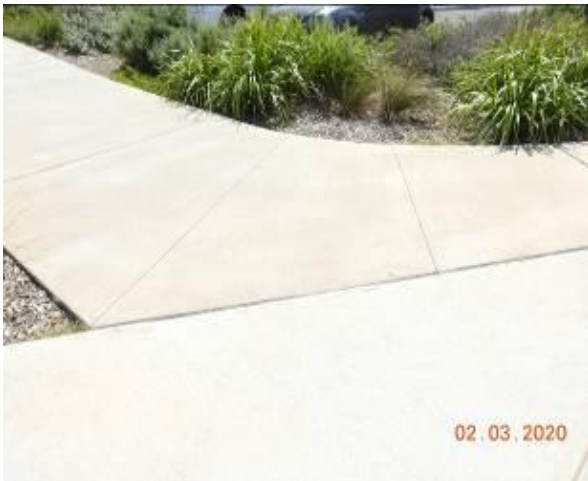
Figure 852 – General Condition of footpath pavement

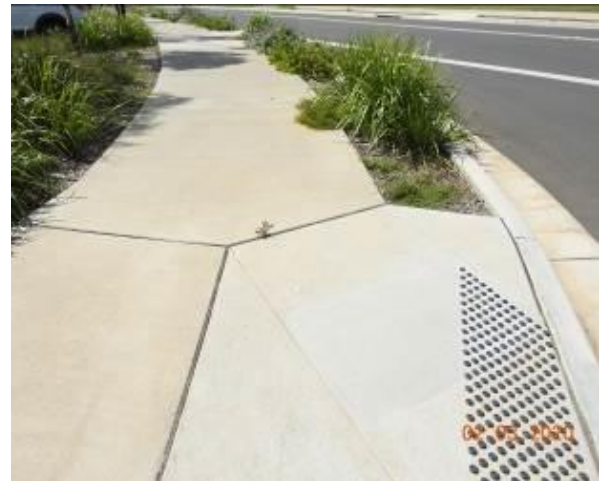
Figure 853 – General Condition of footpath pavement

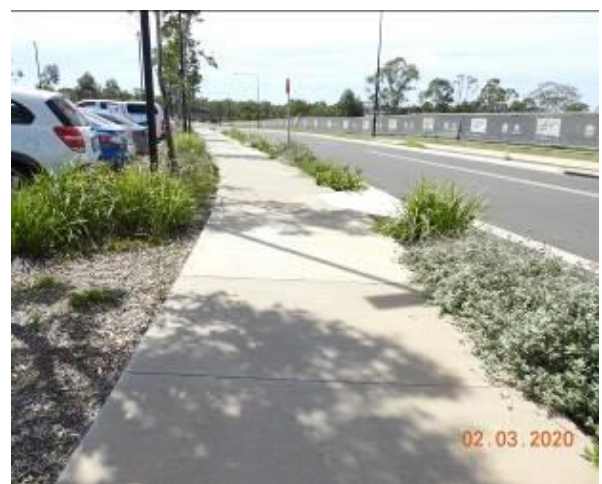
Figure 857 – General Condition of footpath pavement

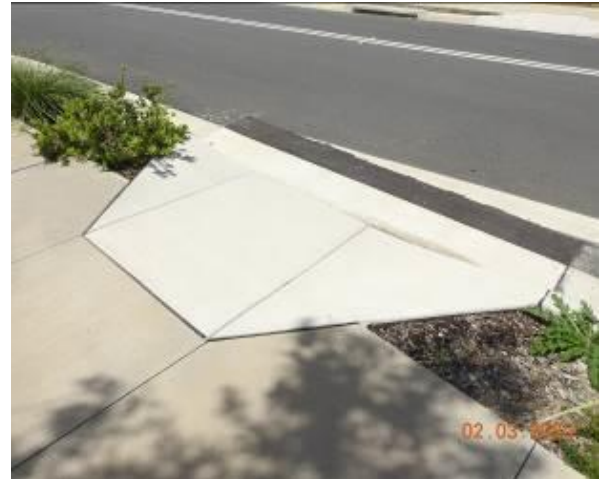
Figure 859 – General Condition of footpath pavement

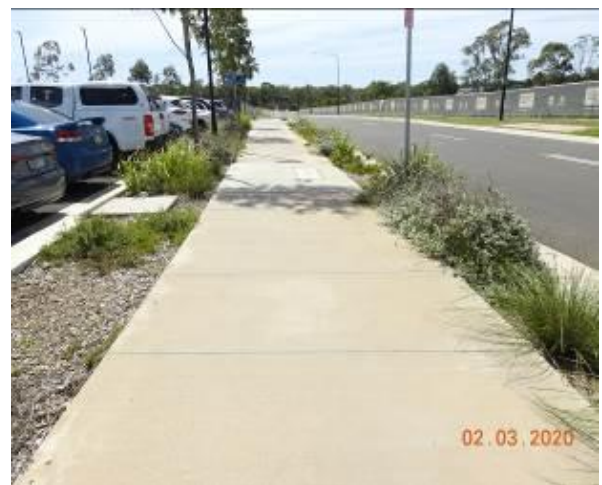
Figure 861 – General Condition of footpath pavement

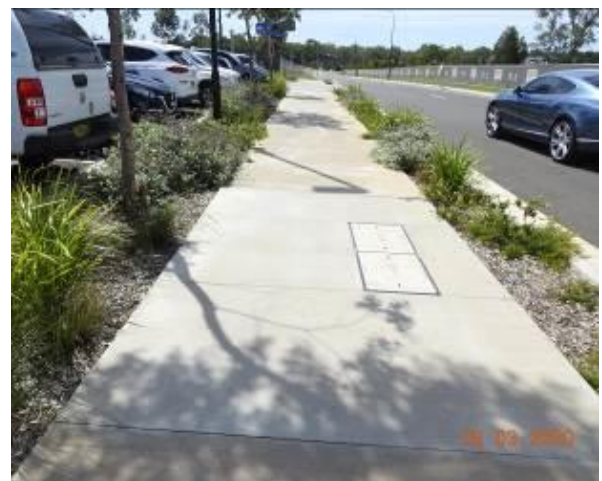
Figure 863 – General Condition of footpath pavement

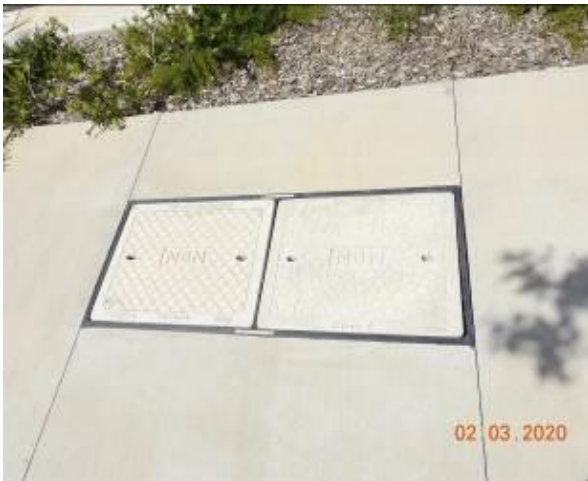
Figure 864 – General Condition of footpath pavement

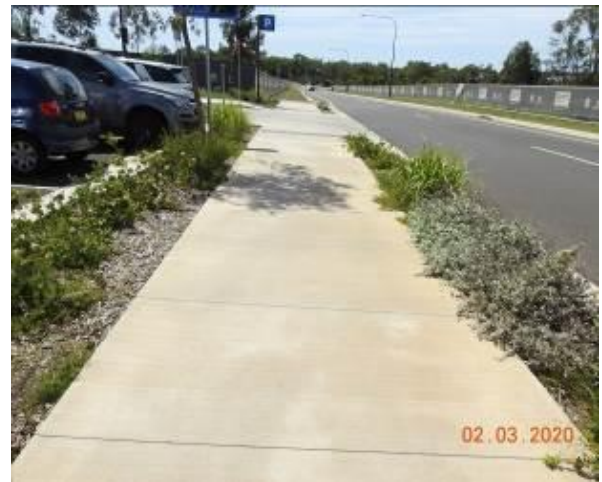
Figure 867 – General Condition of footpath pavement

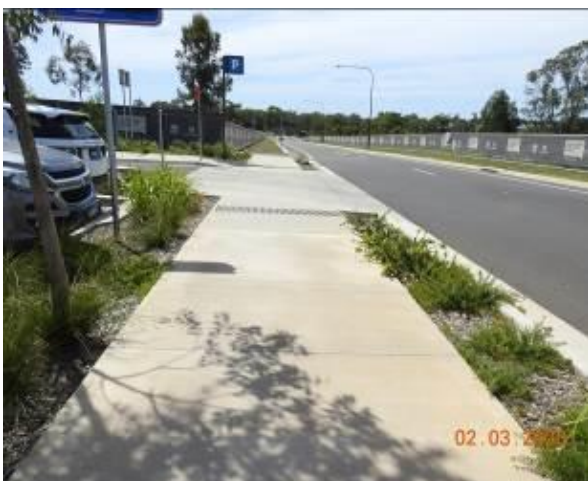
Figure 868 – General Condition of footpath pavement

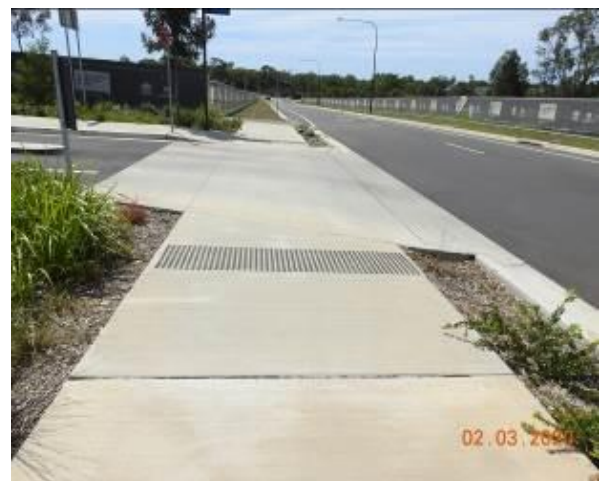
Figure 869 – General Condition of footpath pavement

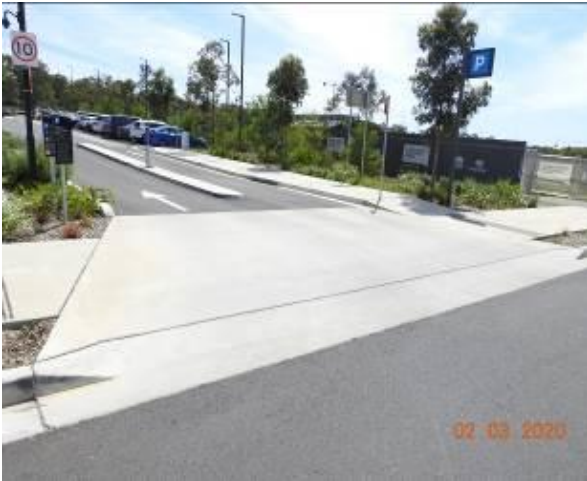
Figure 870 – General Condition of footpath pavement

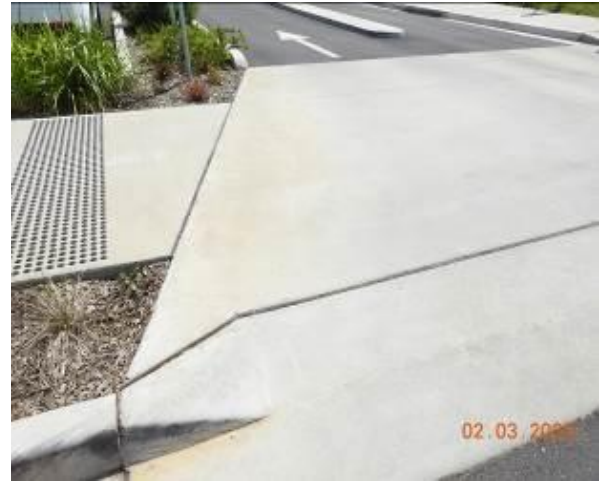
Figure 871 – General Condition of driveway ramp

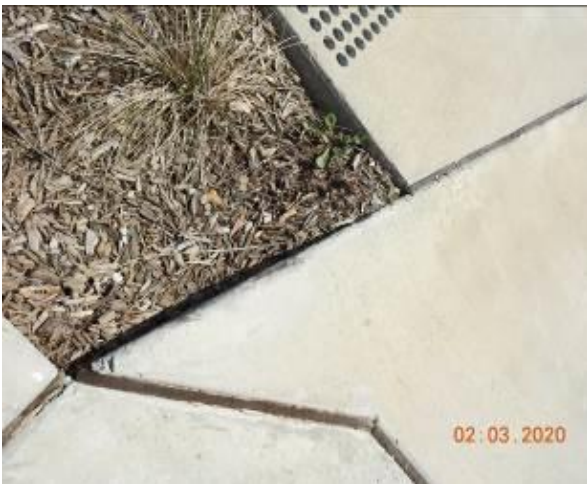
Figure 872 – General Condition of driveway ramp

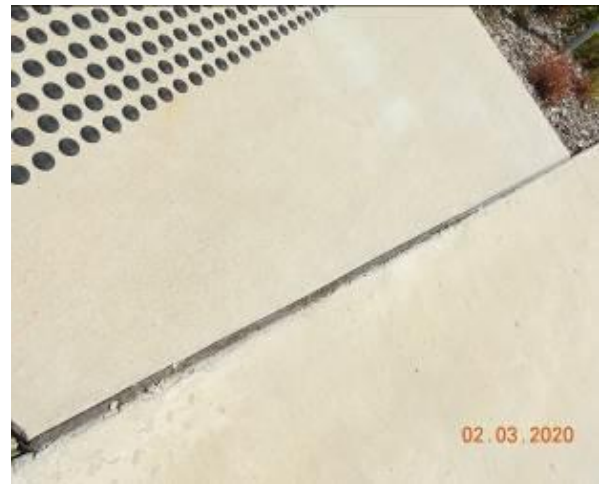
Figure 873 – Crack propagation through driveway ramp

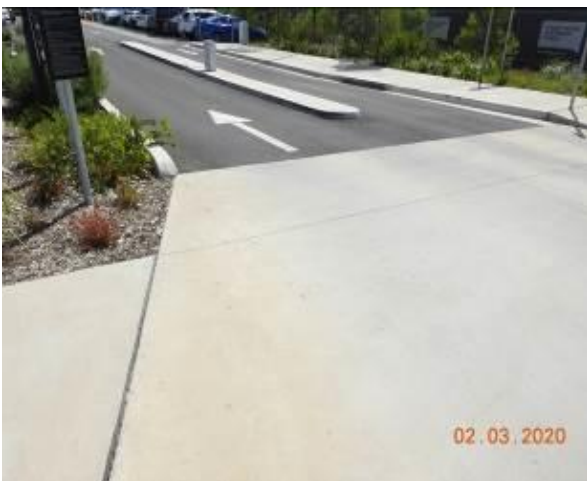
Figure 874 – Crack propagation through driveway ramp

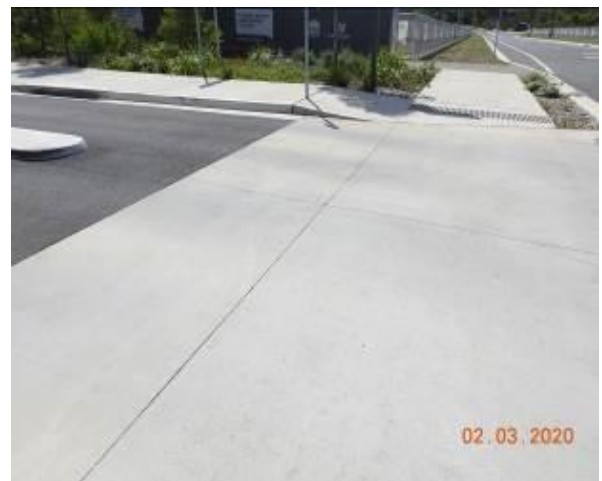
Figure 875 – General Condition of driveway ramp

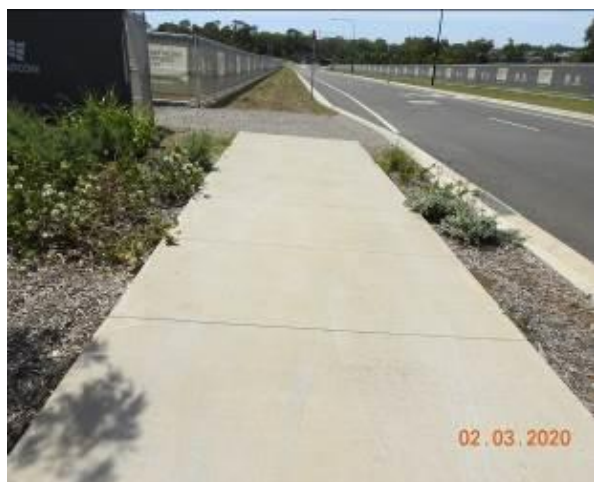
Figure 882 – General Condition of footpath pavement

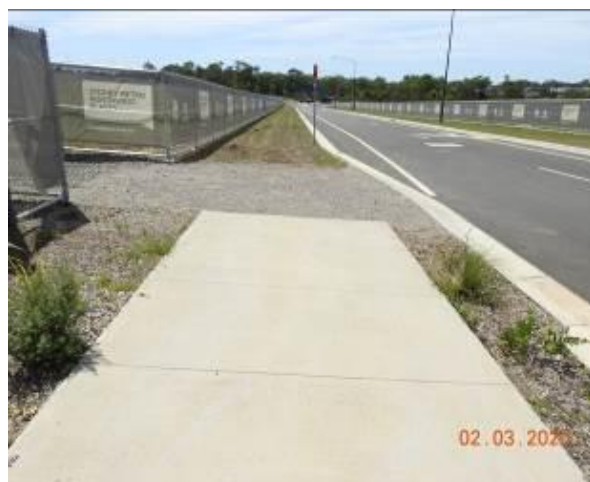
Figure 883 – General Condition of footpath pavement

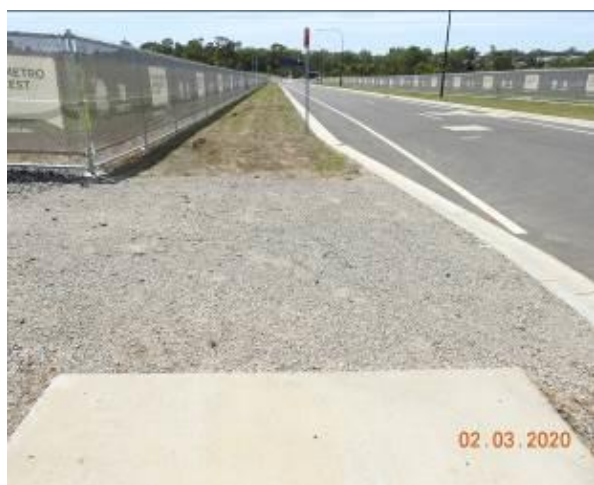
Figure 884 – General Condition of footpath pavement

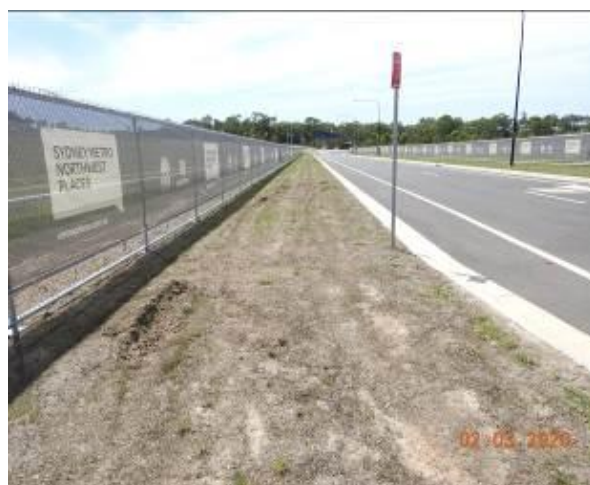
Figure 885 – Loss of material through footpath pavement

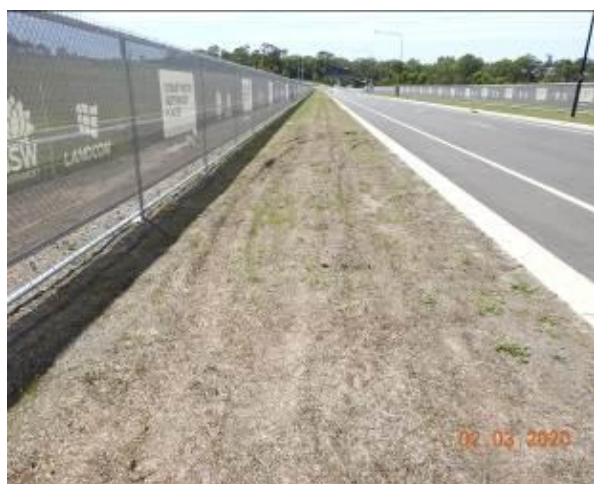
Figure 886 – General Condition of nature strip
