**1-15 AND 2-12 CONFERTA AVENUE,
ROUSE HILL NSW 2155
TALLAWONG STATION PRECINCT SOUTH
PRE-DILAPIDATION REPORT**

**DEICORP PROJECTS
(TALLAWONG STATION) PTY LTD**

Job No. 191294.0
24/03/2020

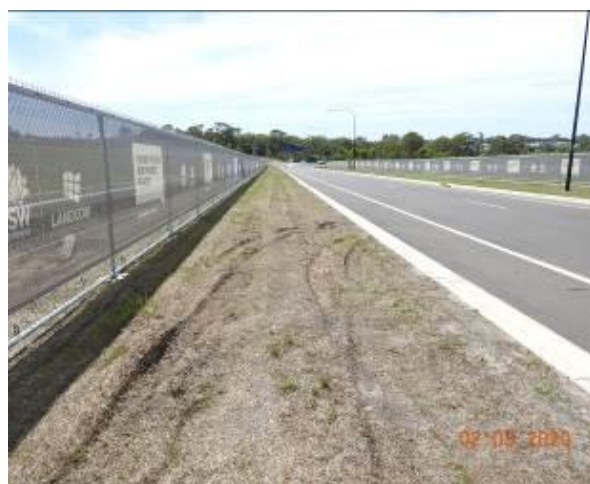
Figure 887 – General Condition of nature strip

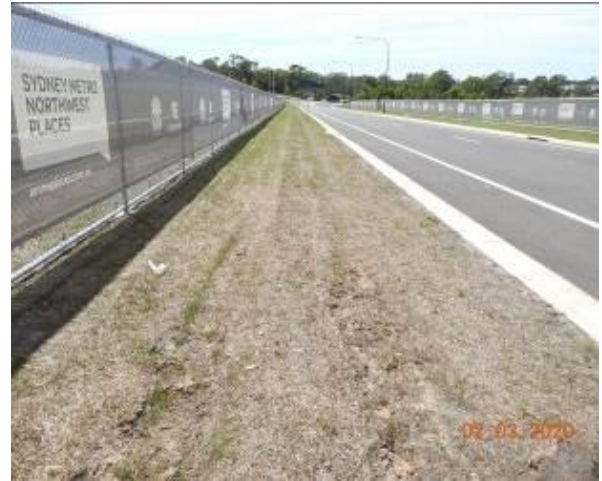
Figure 889 – General Condition of nature strip

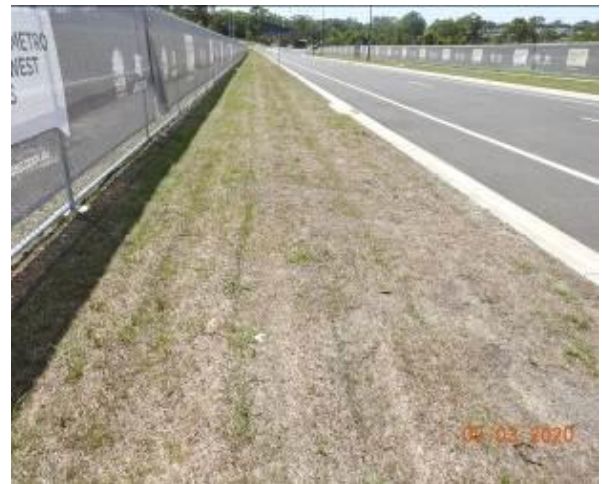
Figure 891 – General Condition of nature strip

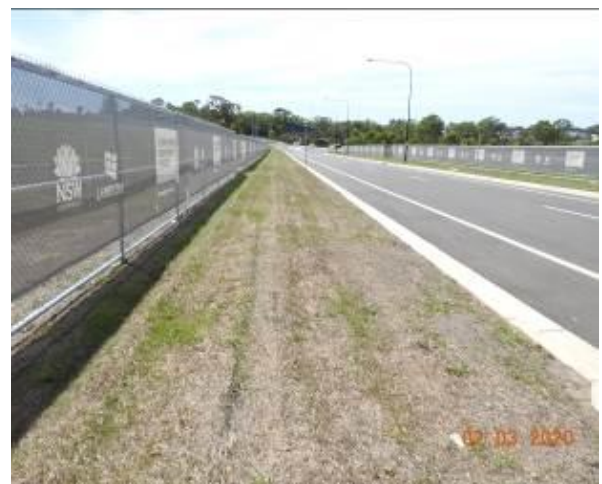
Figure 894 – General Condition of nature strip

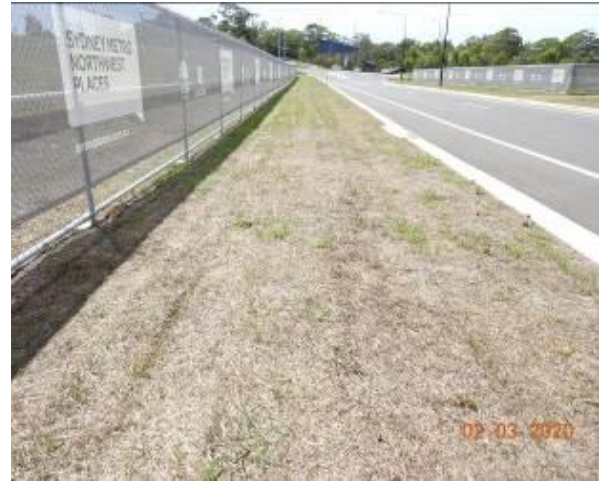
Figure 902 – General Condition of nature strip

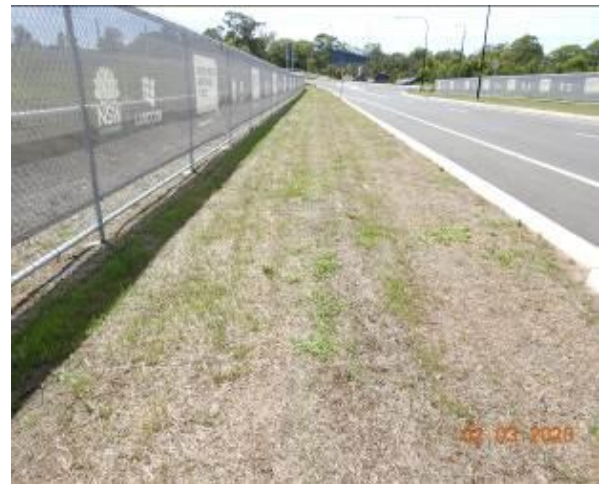
Figure 904 – General Condition of nature strip

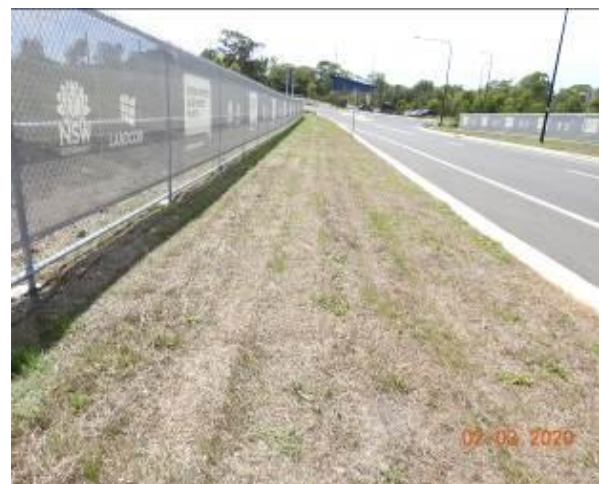
Figure 906 – General Condition of nature strip

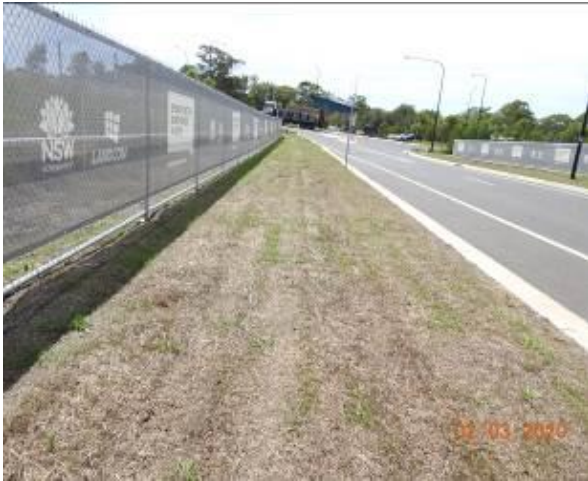
Figure 907 – General Condition of nature strip

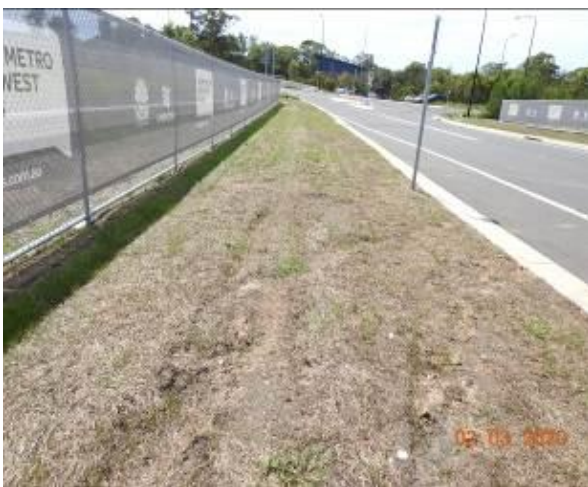
Figure 909 – General Condition of nature strip

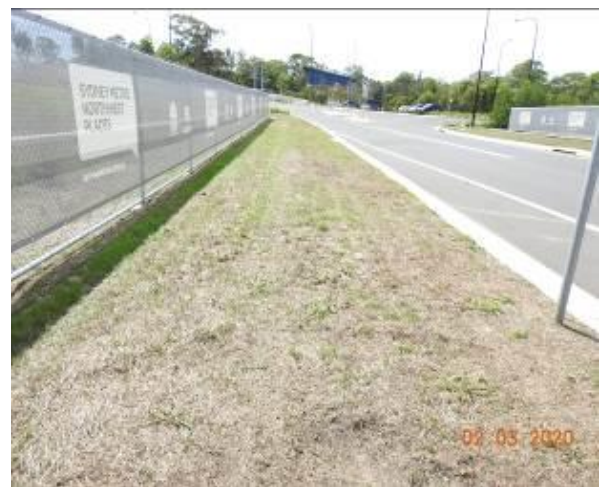
Figure 910 – General Condition of nature strip

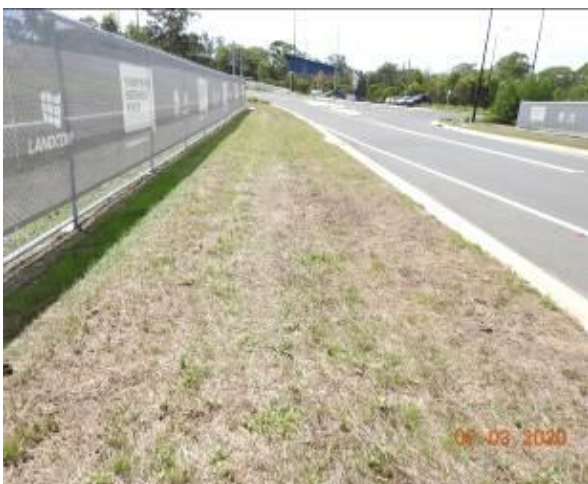
Figure 911 – General Condition of nature strip

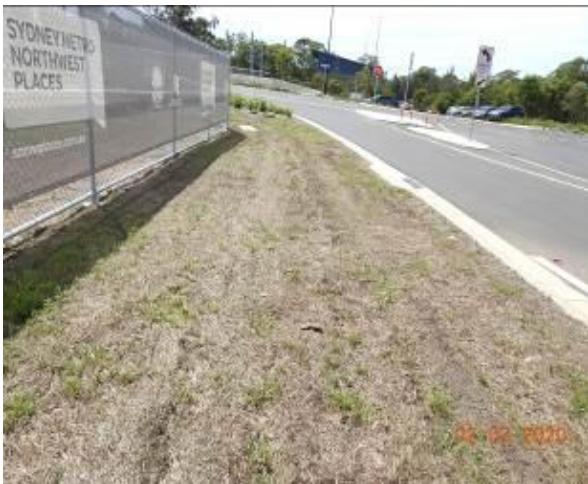
Figure 915 – General Condition of nature strip

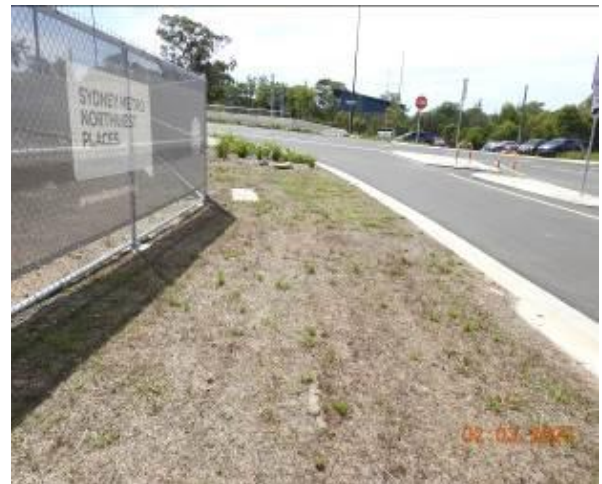
Figure 916 – General Condition of nature strip

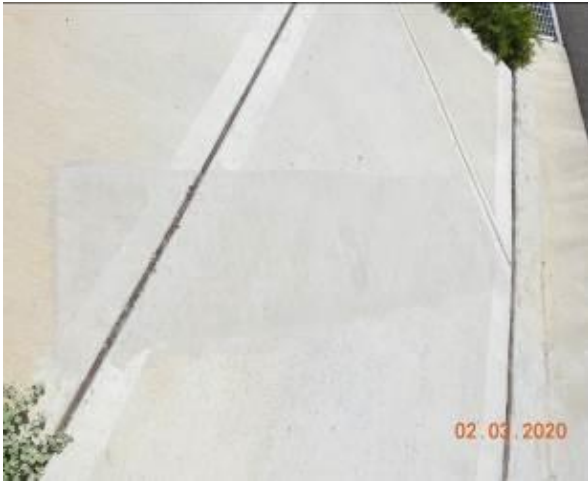
Figure 925 – General Condition of footpath pavement

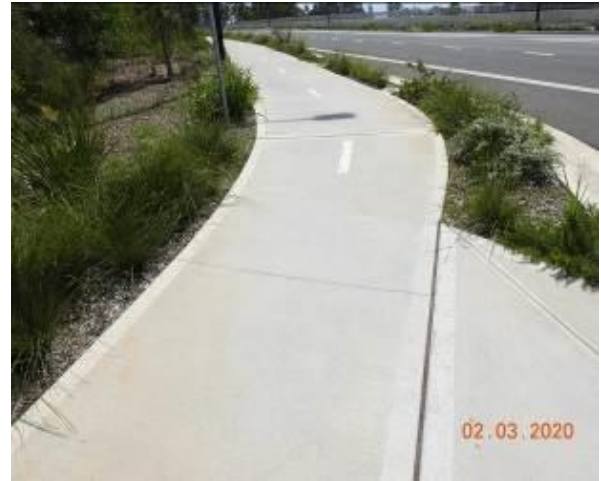
Figure 926 – General Condition of footpath pavement

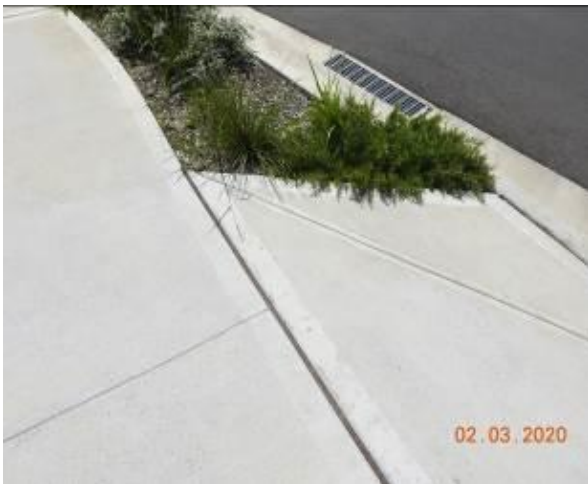
Figure 927 – General Condition of footpath pavement

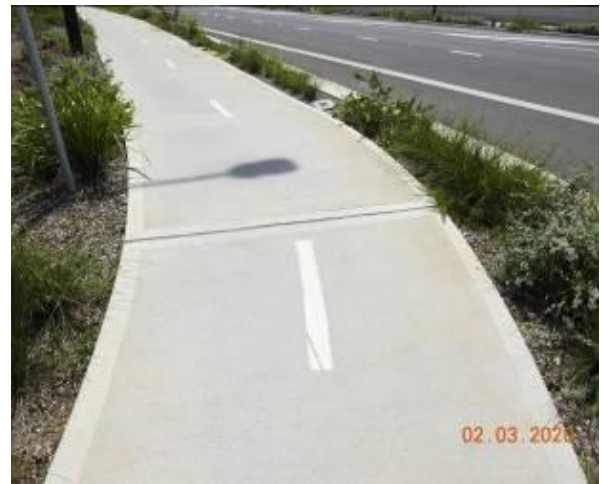
Figure 928 – General Condition of footpath pavement

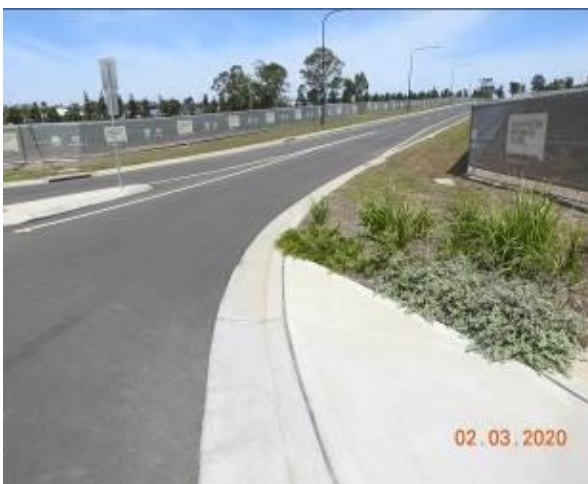
Figure 929 – General Condition of kerb and gutter

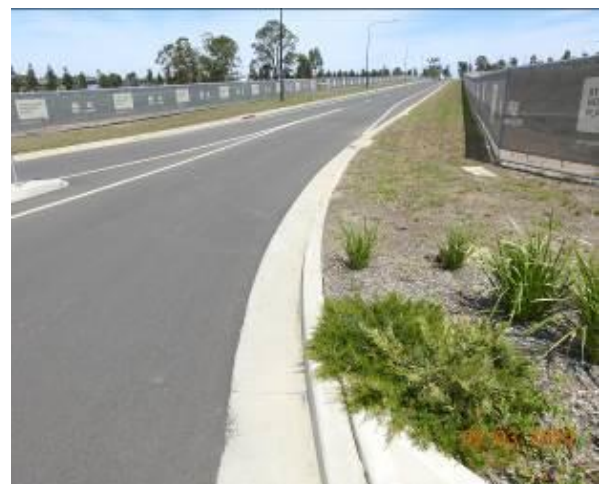
Figure 930 – General Condition of kerb and gutter

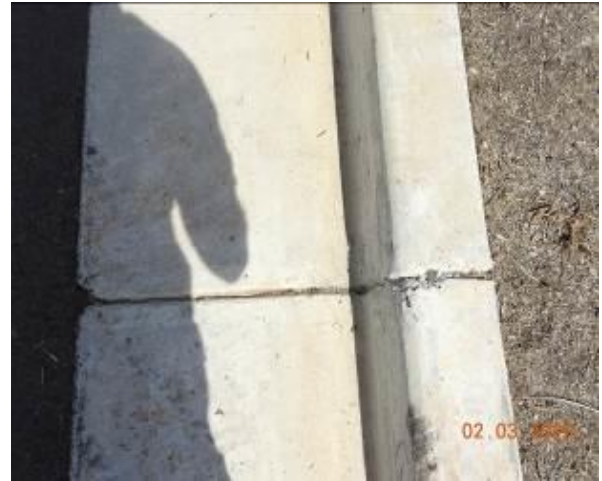
Figure 932 – Crack propagation and loss of material through kerb and gutter

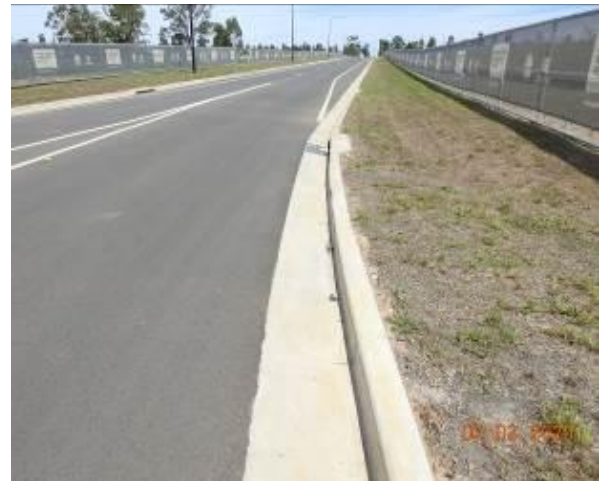
Figure 934 – General Condition of kerb and gutter

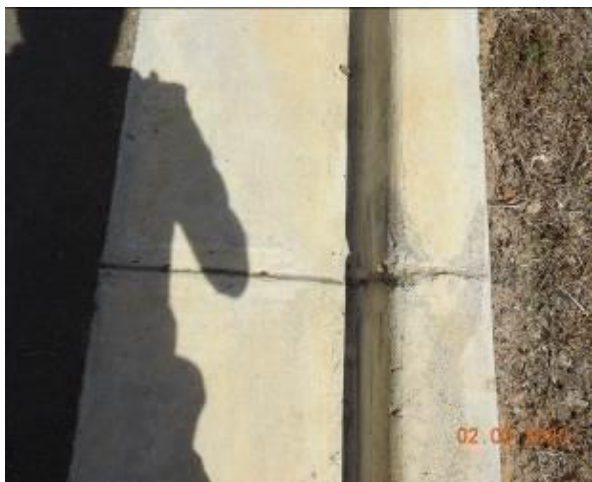
Figure 937 – Loss of material through kerb

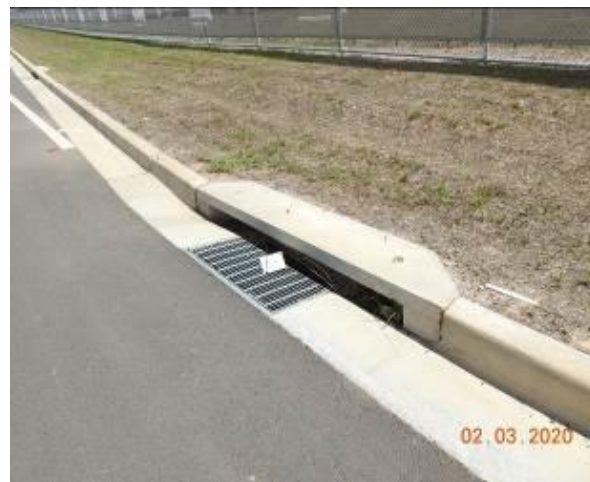
Figure 938 – General Condition of stormwater inlet pit

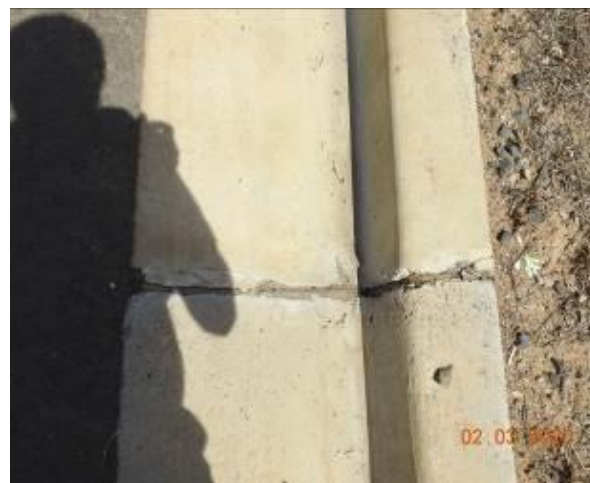
Figure 939 – General Condition of kerb and gutter

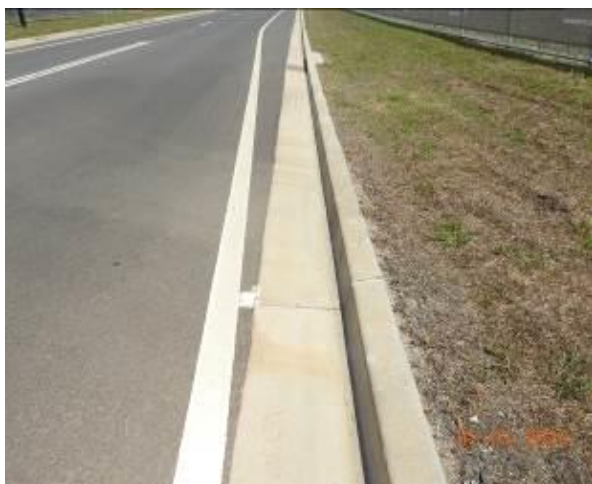
Figure 940 – Crack propagation and loss of material through kerb and gutter

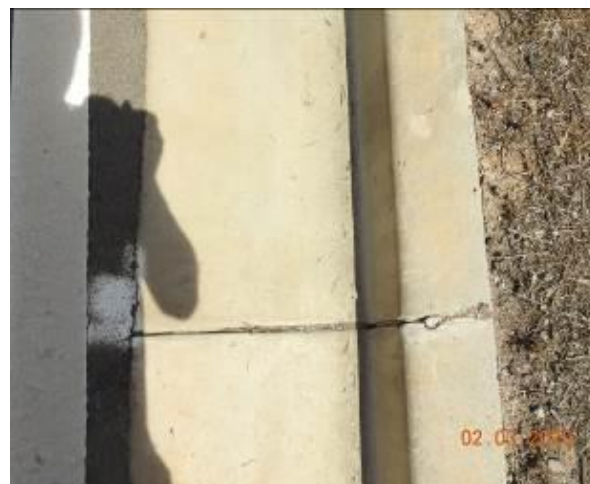
Figure 941 – General Condition of kerb and gutter

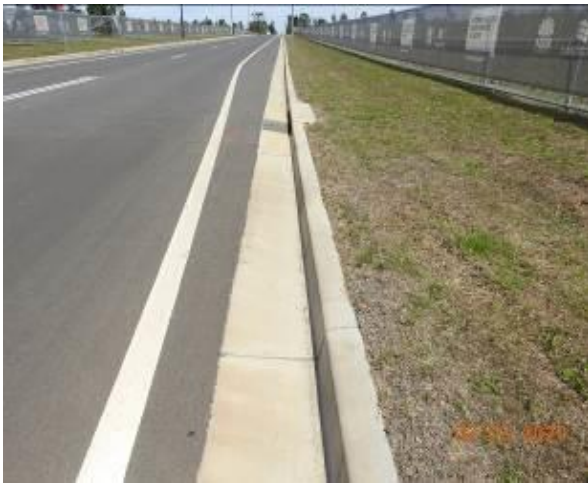
Figure 942 – Crack propagation and loss of material through kerb and gutter

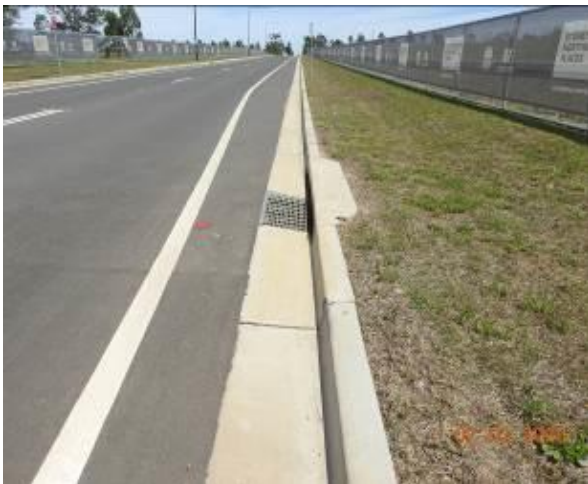
Figure 943 – General Condition of kerb and gutter

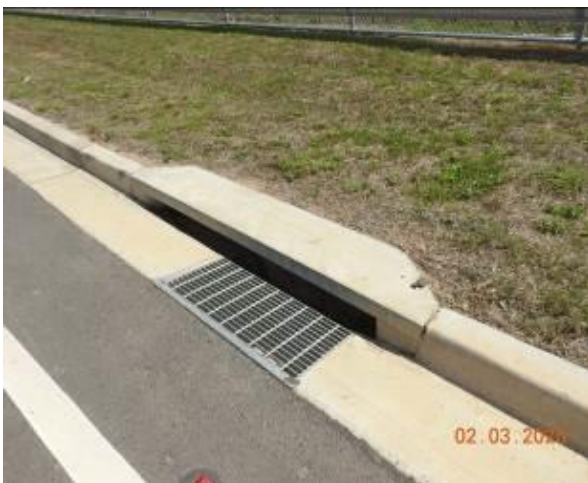
Figure 945 – General Condition of kerb and gutter

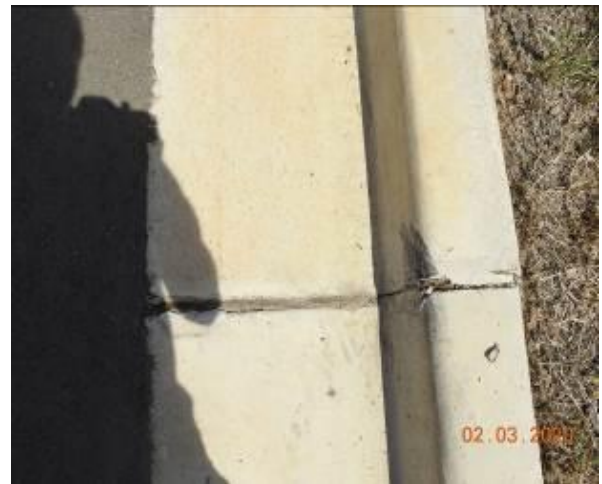
Figure 944 – Loss of material through gutter

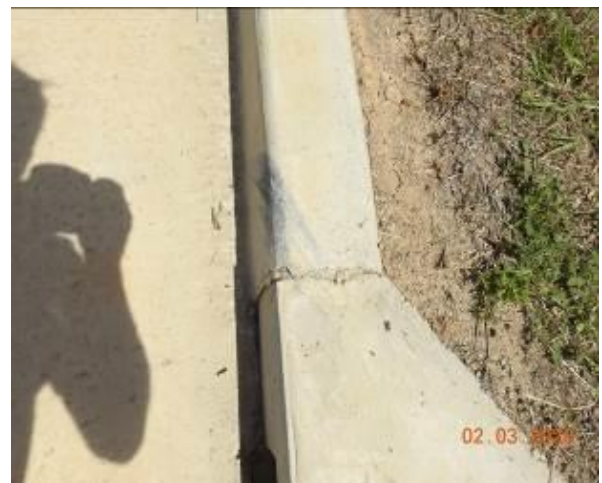
Figure 946 – Crack propagation and loss of material through kerb and gutter

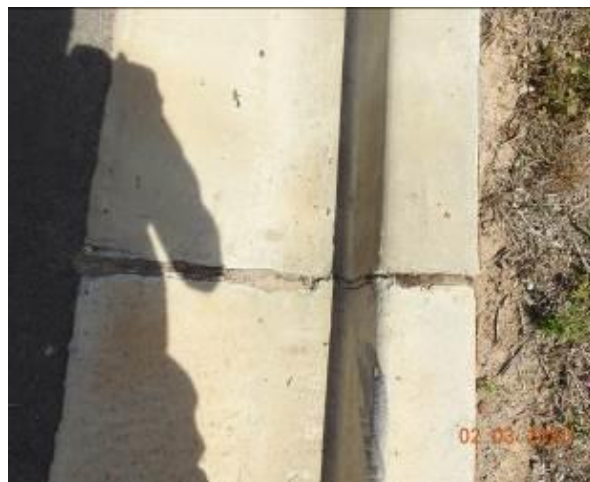
Figure 949 – General Condition of kerb and gutter

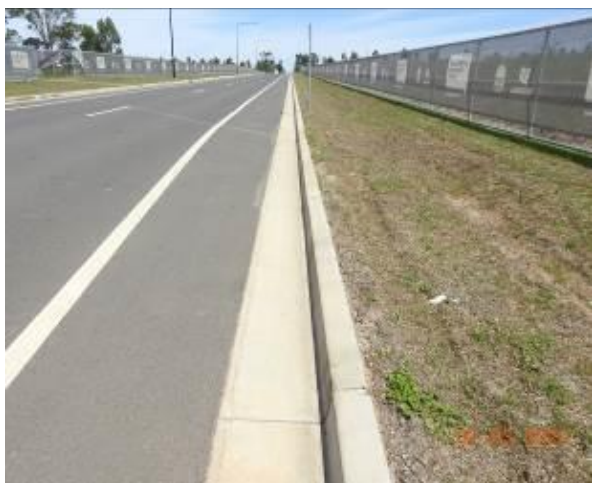
Figure 950 – Crack propagation through kerb and gutter

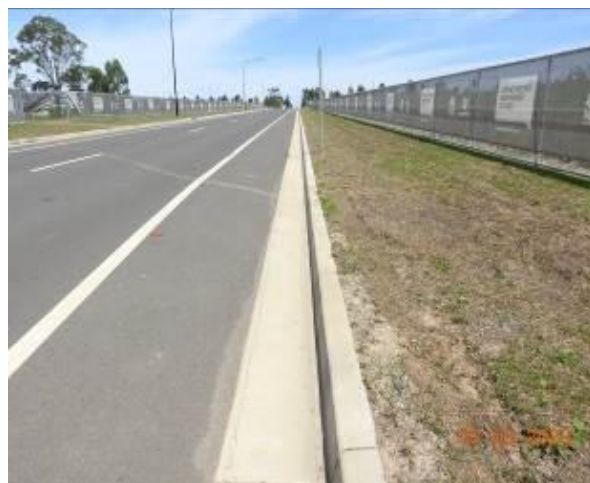
Figure 951 – General Condition of kerb and gutter

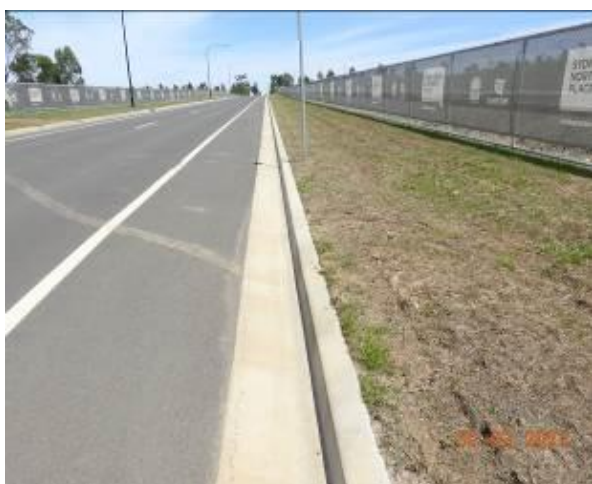
Figure 952 – General Condition of kerb and gutter

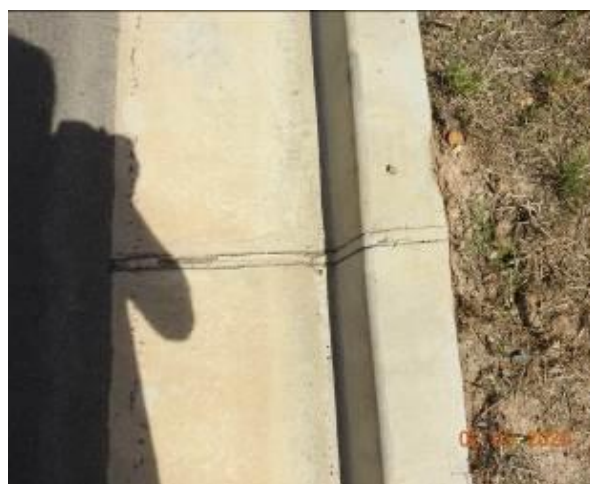
Figure 953 – General Condition of kerb and gutter

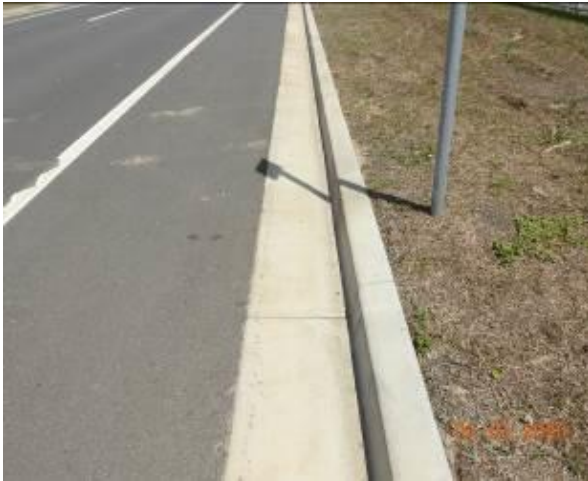
Figure 954 – Crack propagation through kerb and gutter

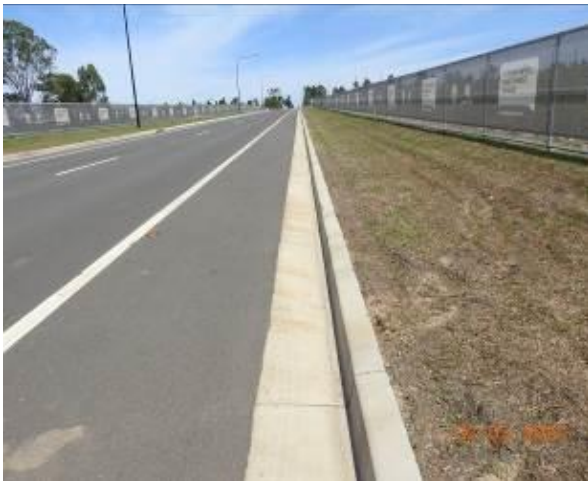
Figure 956 – Crack propagation through kerb and gutter

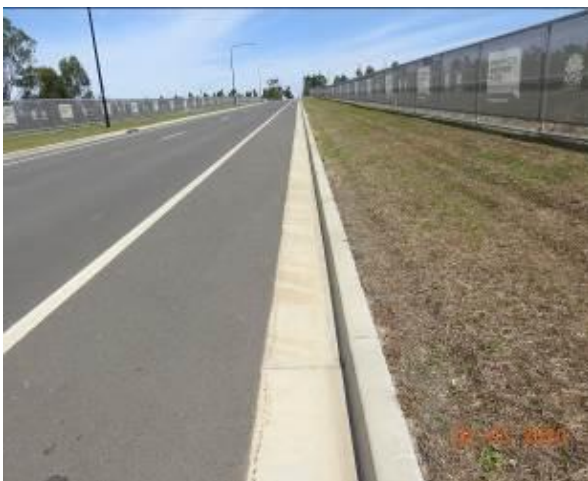
Figure 958 – General Condition of kerb and gutter

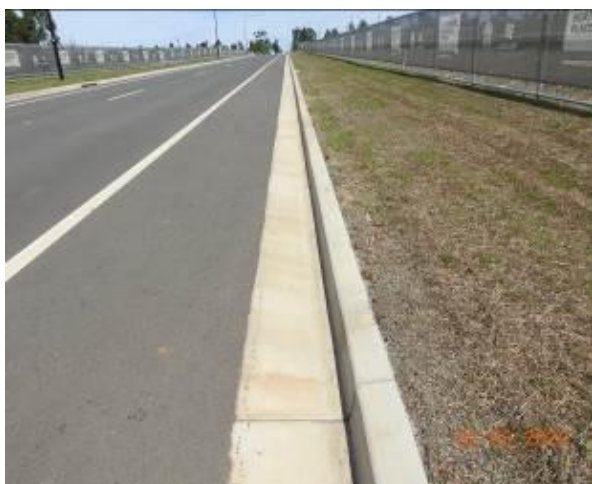
Figure 960 – Crack propagation through kerb and gutter

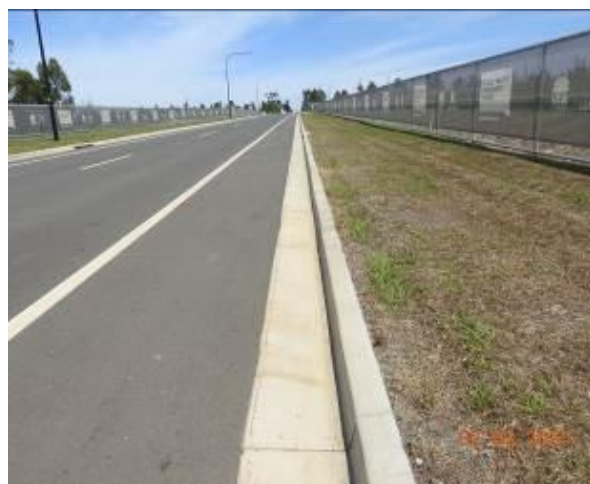
Figure 961 – General Condition of kerb and gutter

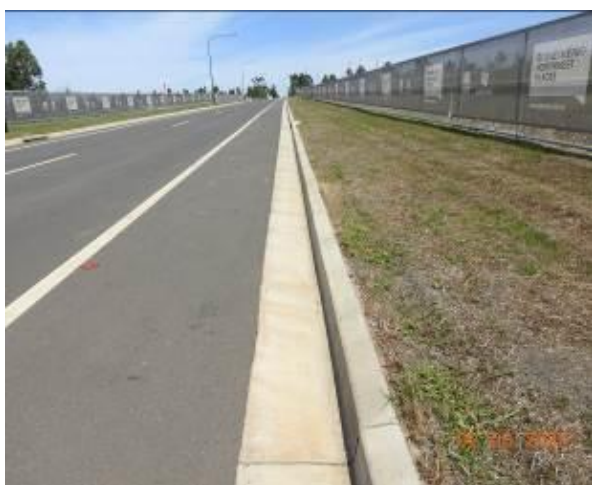
Figure 962 – General Condition of kerb and gutter

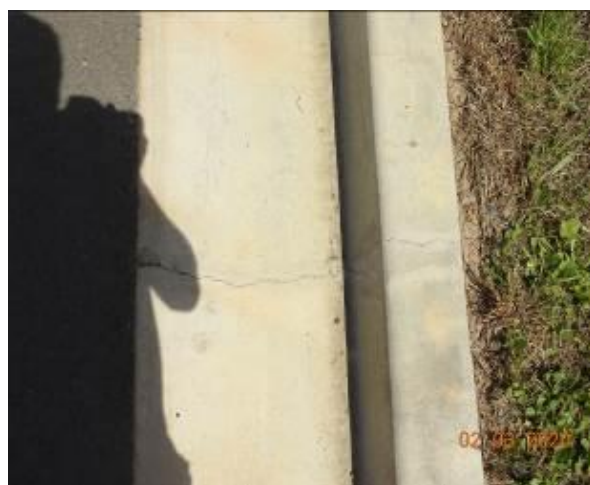
Figure 963 – General Condition of kerb and gutter

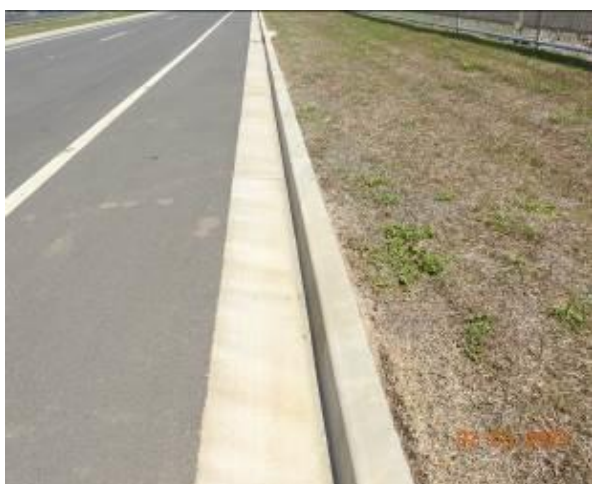
Figure 964 – Crack propagation through kerb and gutter

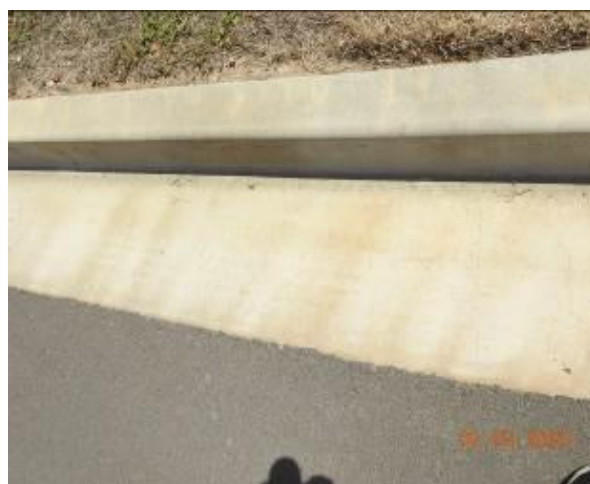
Figure 965 – General Condition of kerb and gutter

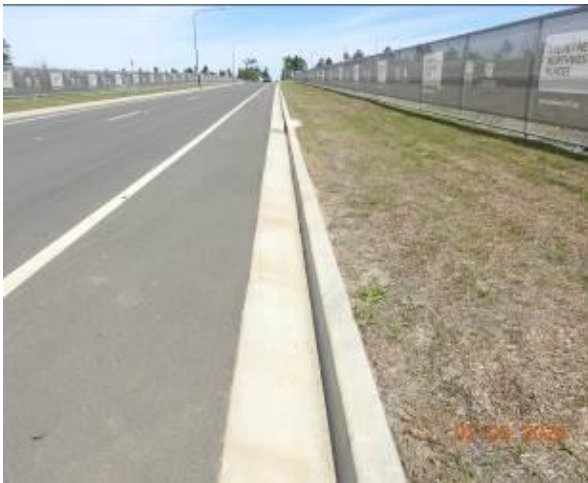
Figure 966 – Crack propagation through gutter

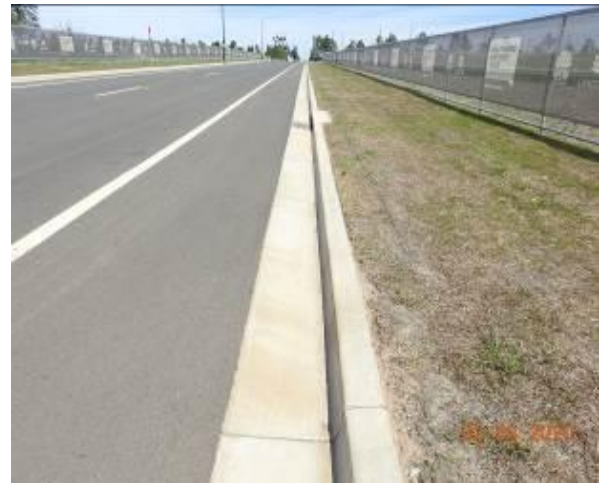
Figure 967 – General Condition of kerb and gutter

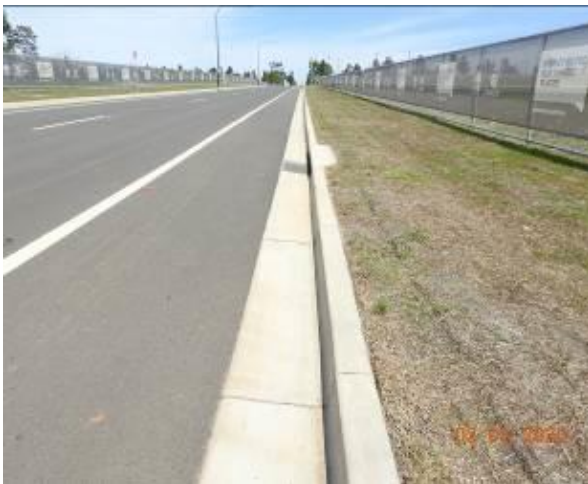
Figure 968 – General Condition of kerb and gutter

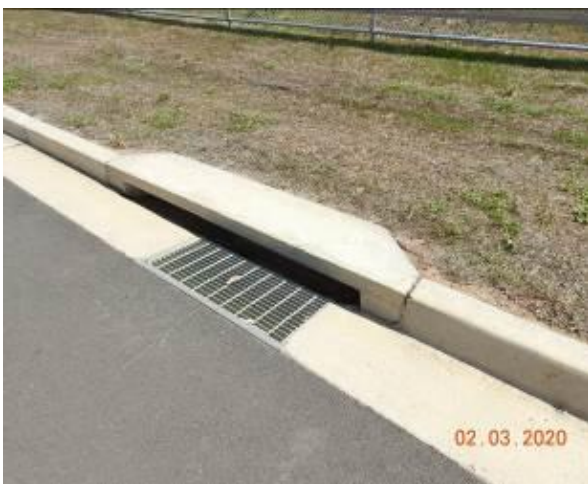
Figure 970 – Loss of material through kerb and gutter

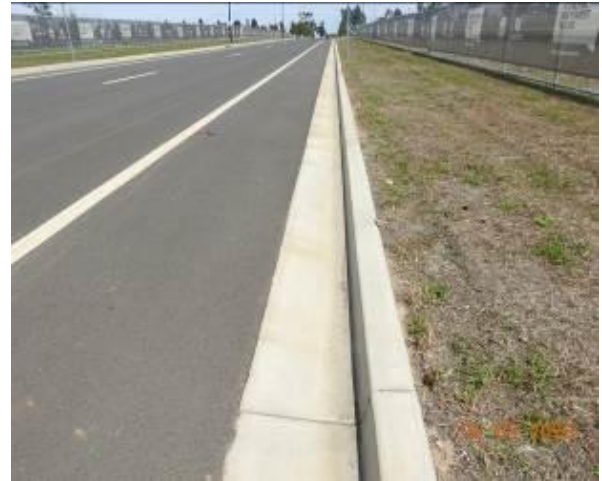
Figure 973 – Crack propagation through kerb and gutter

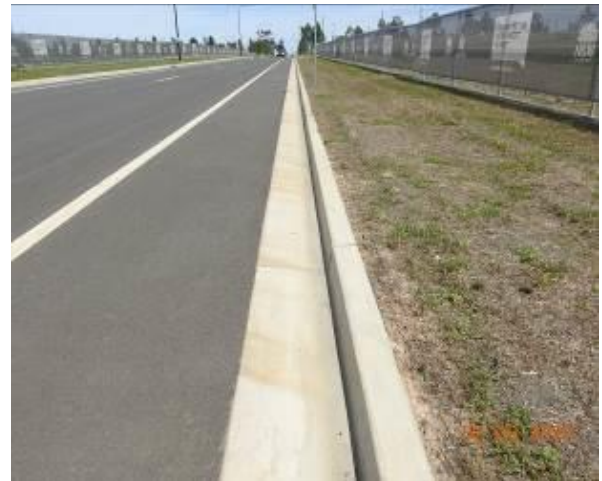
Figure 975 – General Condition of kerb and gutter

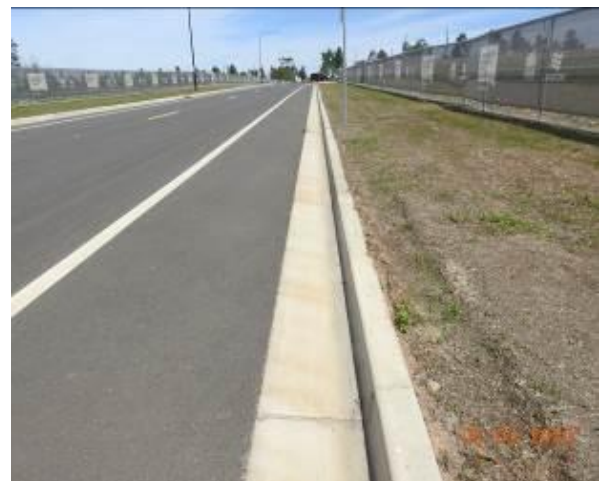
Figure 977 – Crack propagation through kerb and gutter

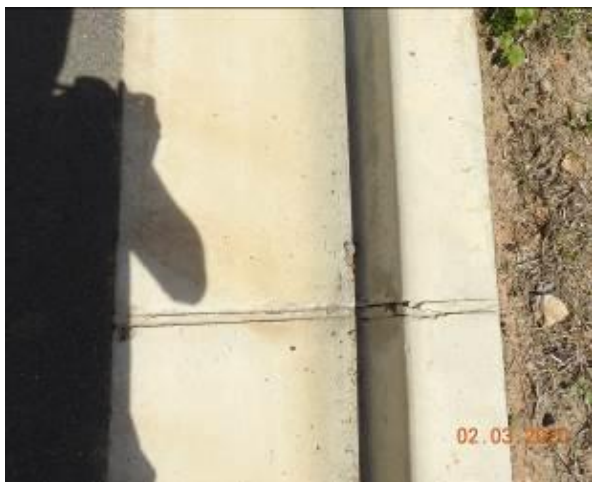
Figure 978 – General Condition of kerb and gutter

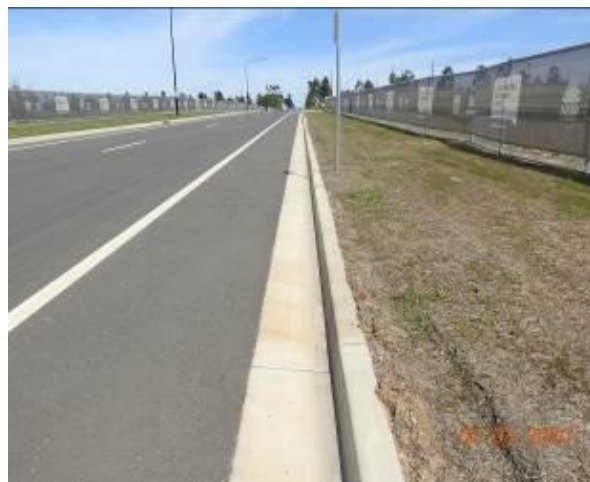
Figure 979 – Crack propagation through kerb and gutter

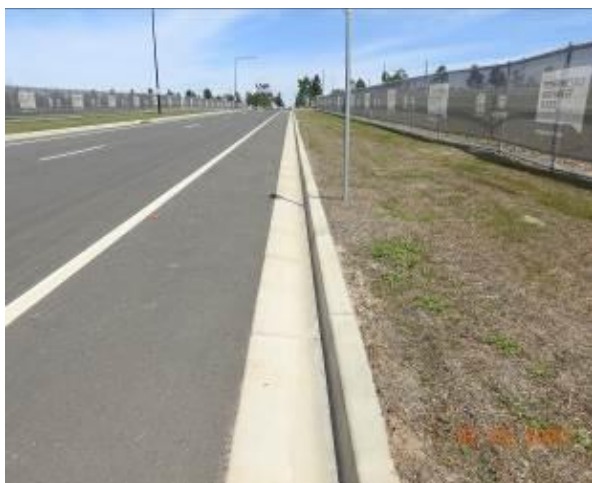
Figure 981 – General Condition of kerb and gutter

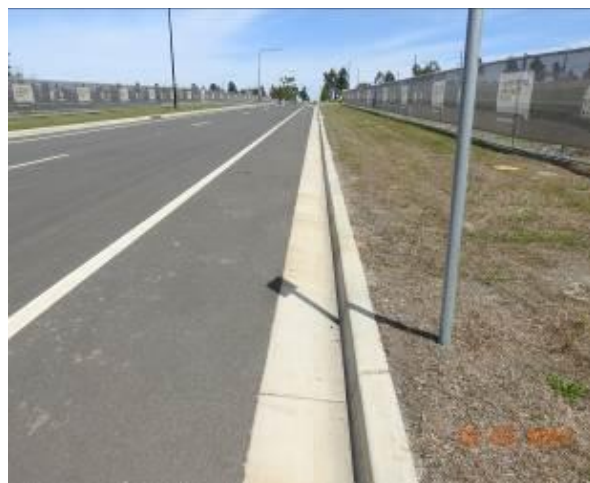
Figure 982 – General Condition of kerb and gutter

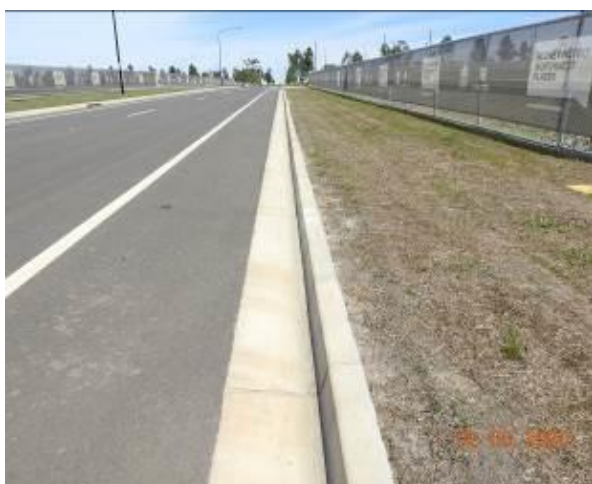
Figure 983 – General Condition of kerb and gutter

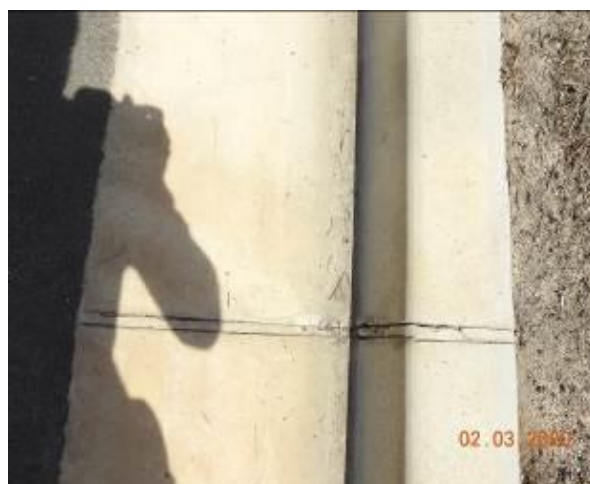
Figure 984 – Crack propagation through kerb and gutter

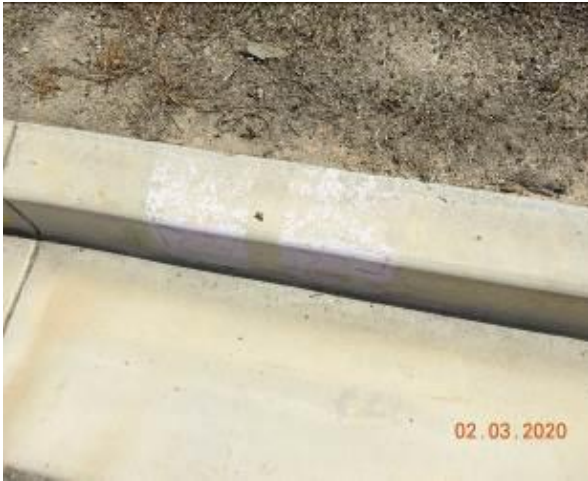
Figure 985 – General Condition of kerb and gutter

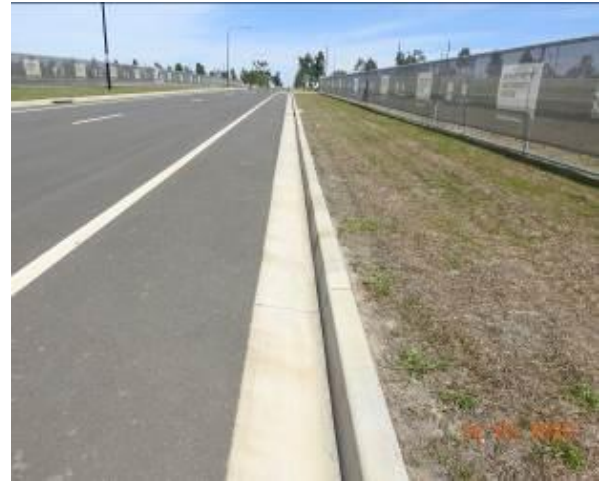
Figure 986 – General Condition of kerb and gutter

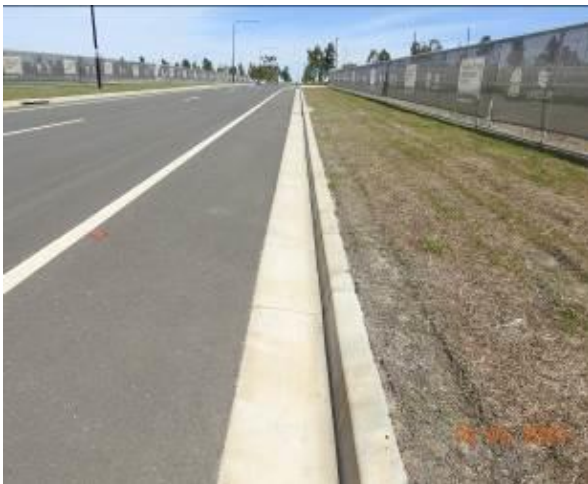
Figure 987 – General Condition of kerb and gutter

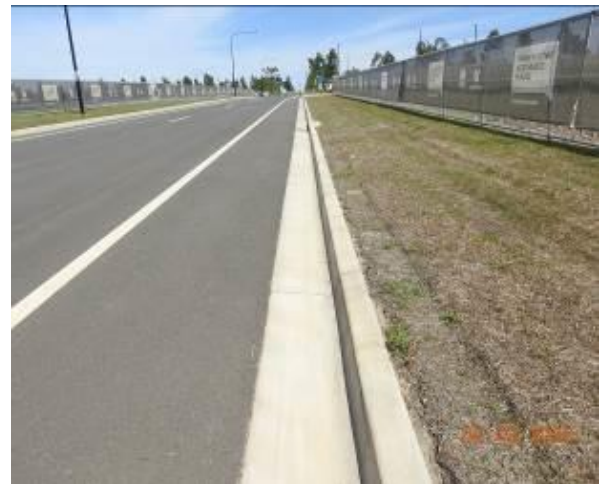
Figure 988 – General Condition of kerb and gutter

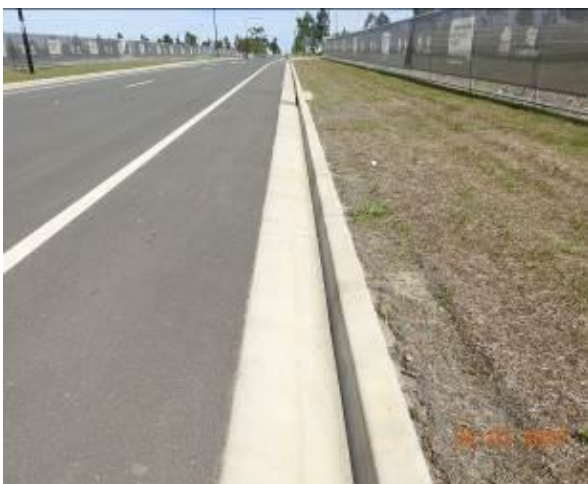
Figure 989 – General Condition of kerb and gutter

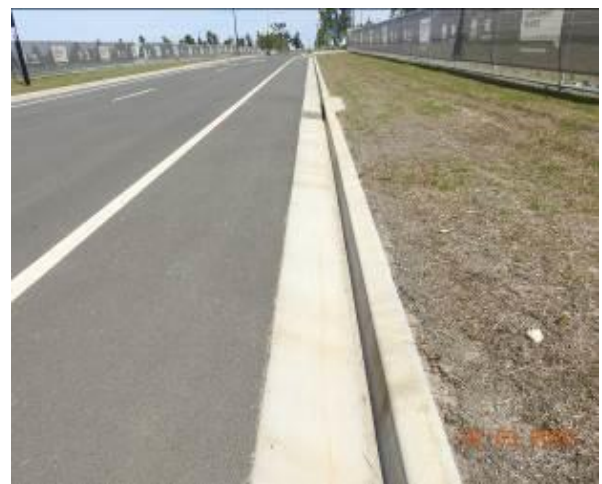
Figure 990 – General Condition of kerb and gutter

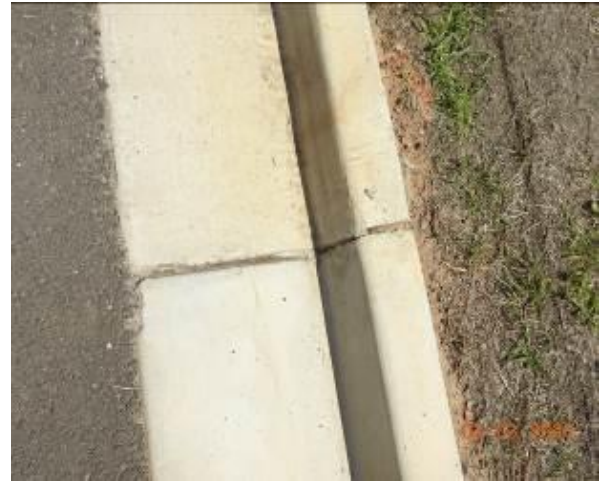
Figure 992 – Crack propagation and loss of material through kerb and gutter

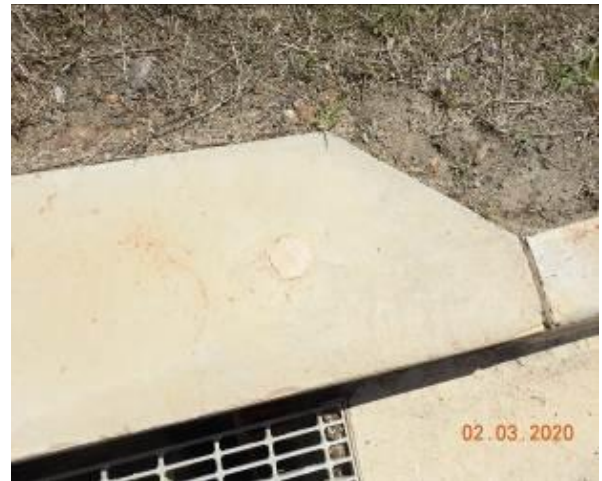
Figure 994 – Crack propagation and Evidence of patchwork through stormwater inlet pit

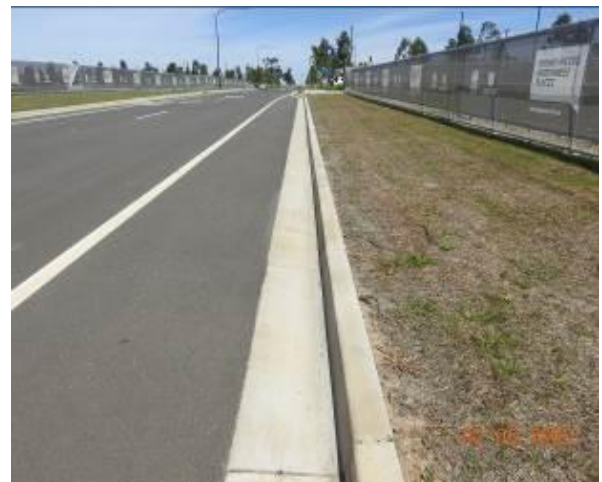
Figure 996 – General Condition of kerb and gutter

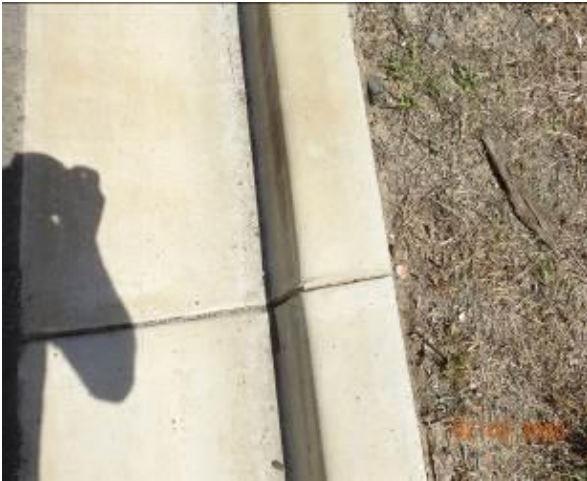
Figure 997 – General Condition of kerb and gutter

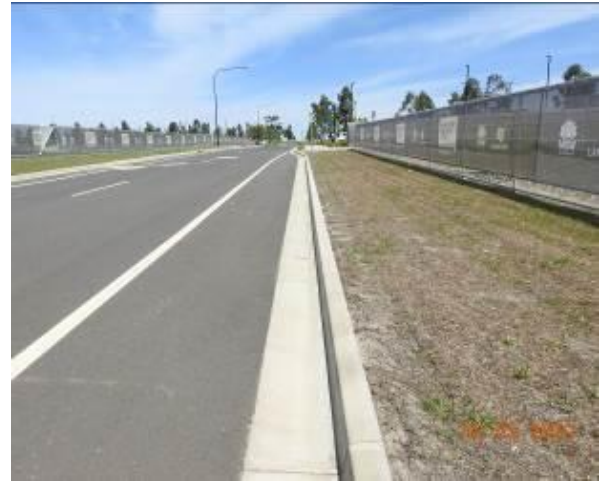
Figure 998 – General Condition of kerb and gutter

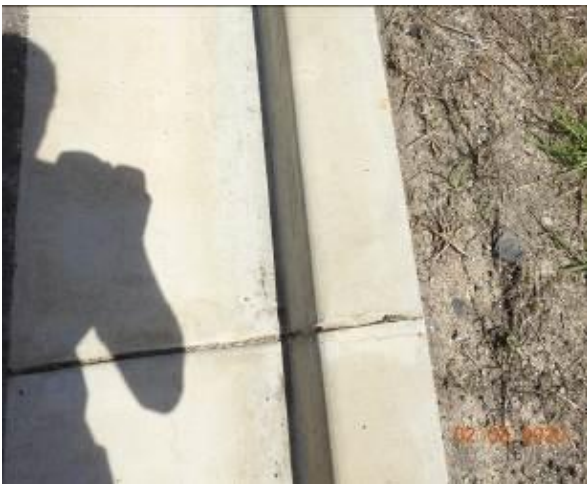
Figure 999 – Crack propagation through kerb and gutter

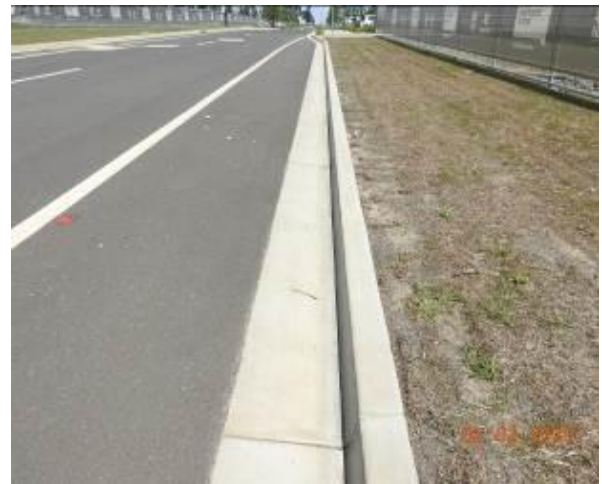
Figure 1000 – General Condition of kerb and gutter

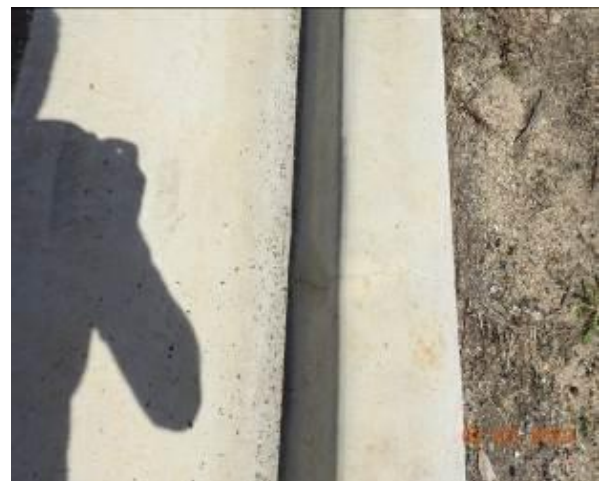
Figure 1002 – Crack propagation through kerb and gutter

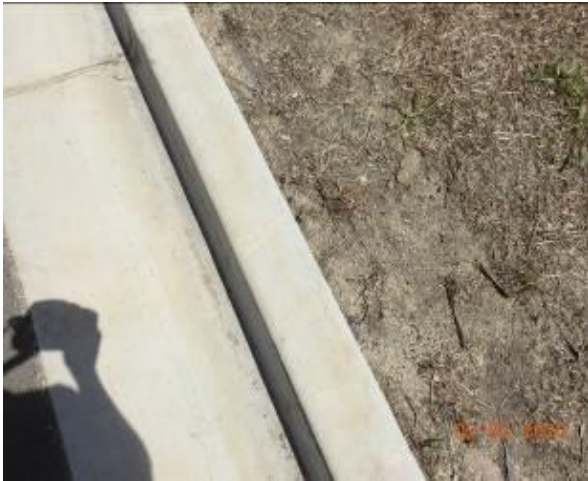
Figure 1003 – General Condition of kerb and gutter

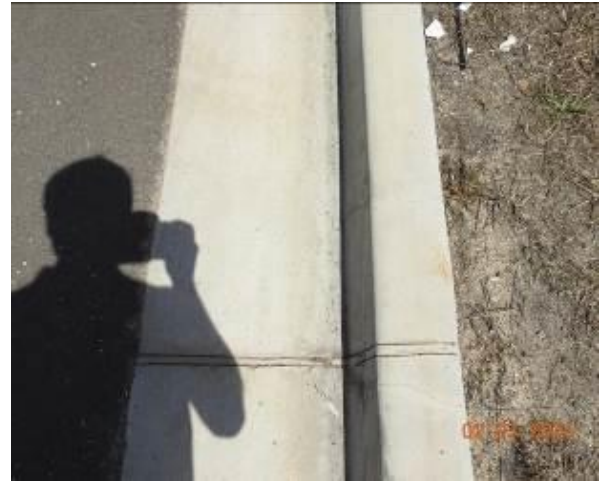
Figure 1004 – Crack propagation through kerb and gutter

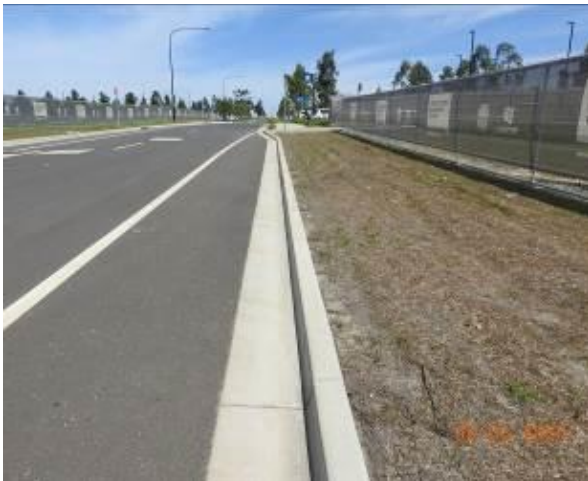
Figure 1005 – General Condition of kerb and gutter

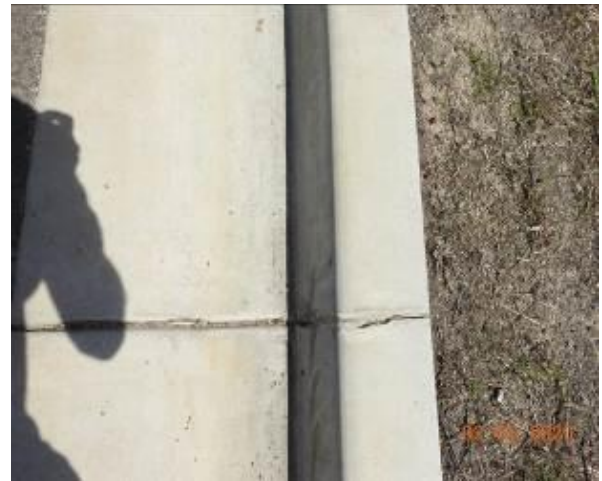
Figure 1006 – Loss of material through kerb

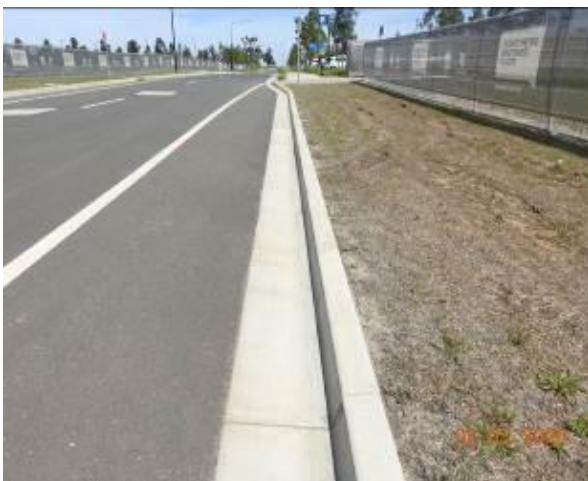
Figure 1007 – General Condition of kerb and gutter
