**1-15 AND 2-12 CONFERTA AVENUE,
ROUSE HILL NSW 2155
TALLAWONG STATION PRECINCT SOUTH
PRE-DILAPIDATION REPORT**

**DEICORP PROJECTS
(TALLAWONG STATION) PTY LTD**

Job No. 191294.0
24/03/2020

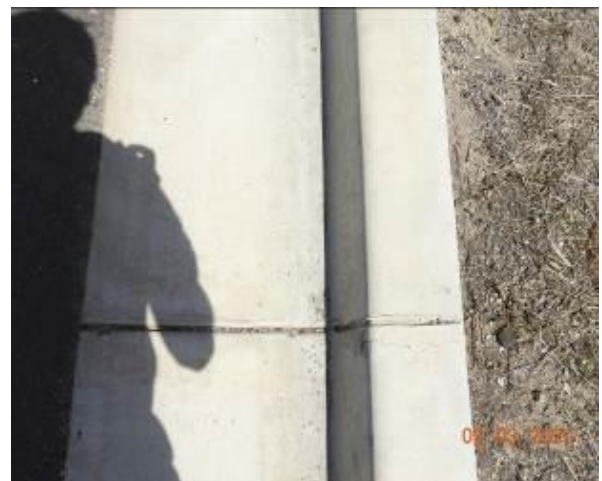
Figure 1008 – Crack propagation through kerb

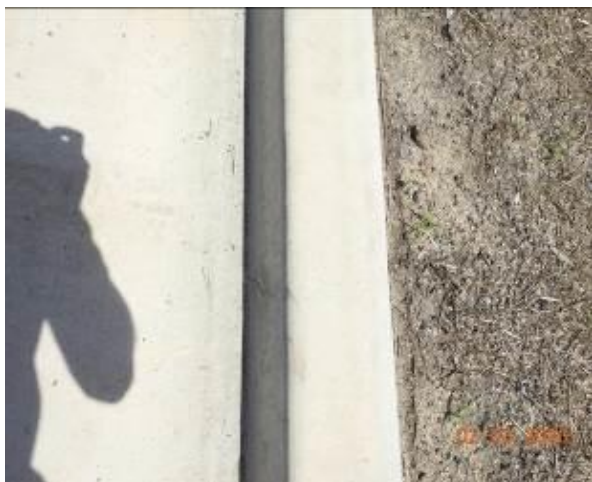
Figure 1009 – Crack propagation through kerb

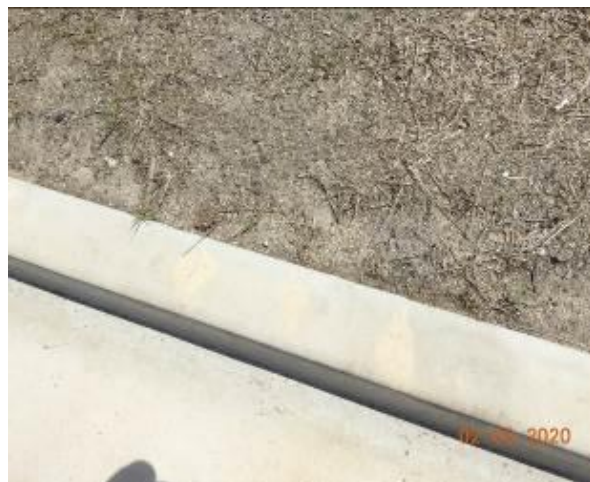
Figure 1010 – Crack propagation through kerb

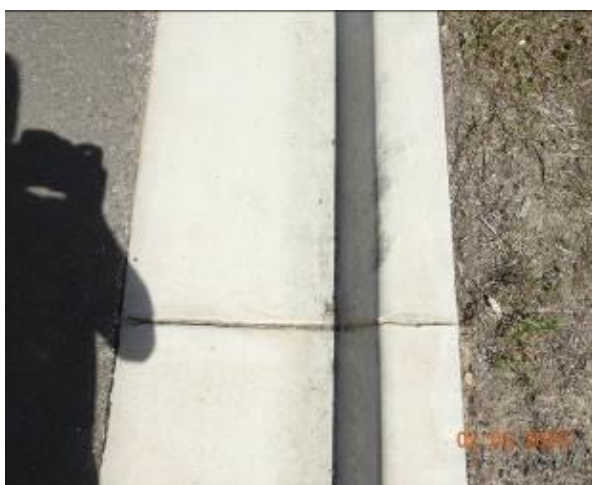
Figure 1011 – Crack propagation through kerb and gutter

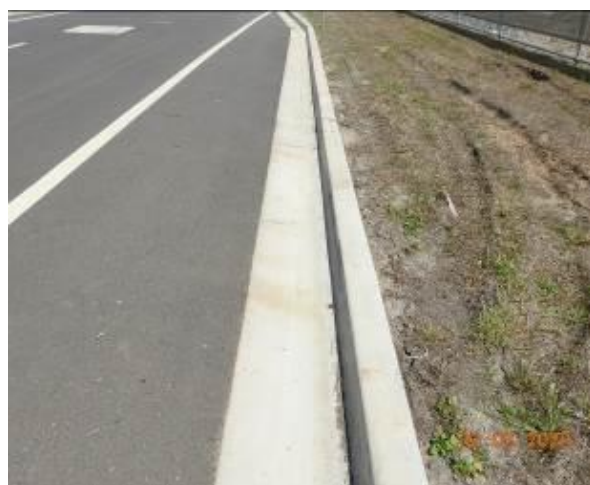
Figure 1012 – General Condition of kerb and gutter

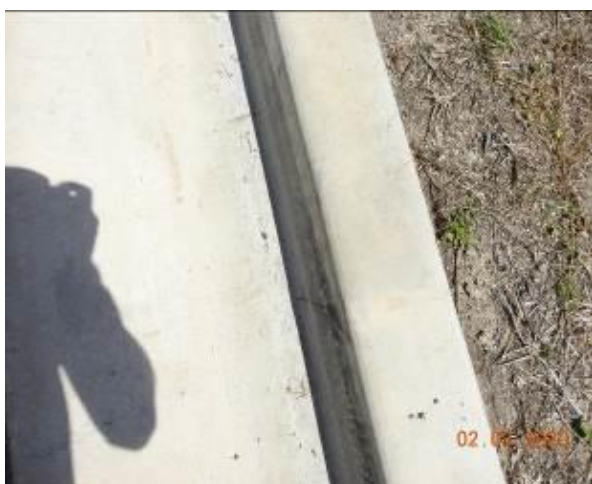
Figure 1013 – Crack propagation through kerb and gutter

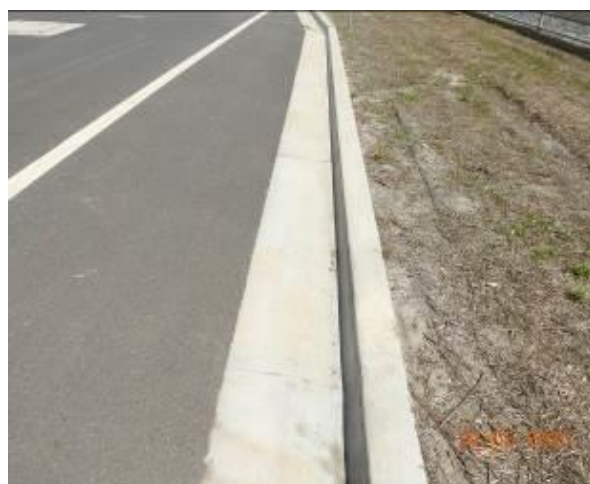
Figure 1014 – General Condition of kerb and gutter

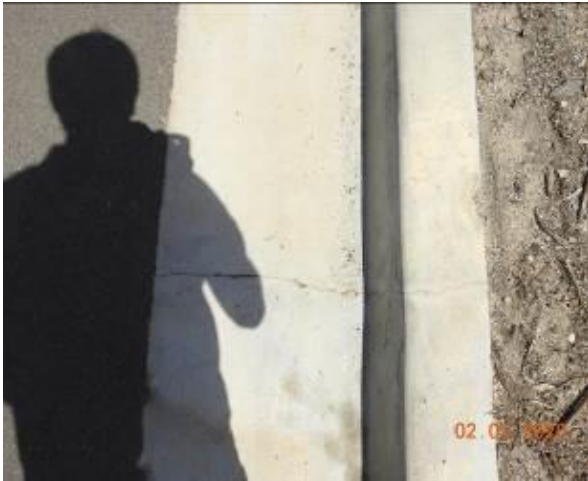
Figure 1015 – Crack propagation through kerb and gutter

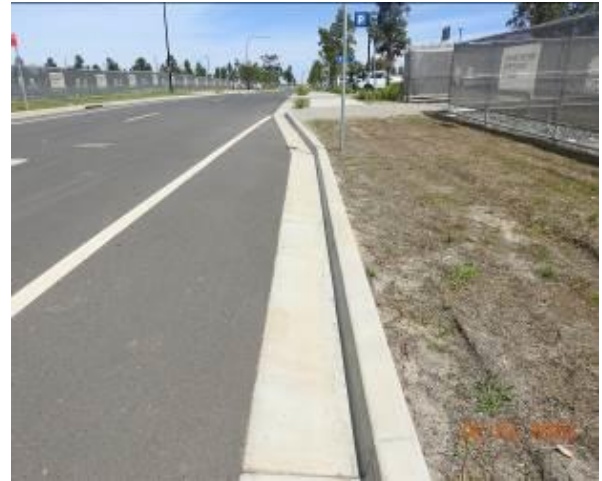
Figure 1016 – General Condition of kerb and gutter

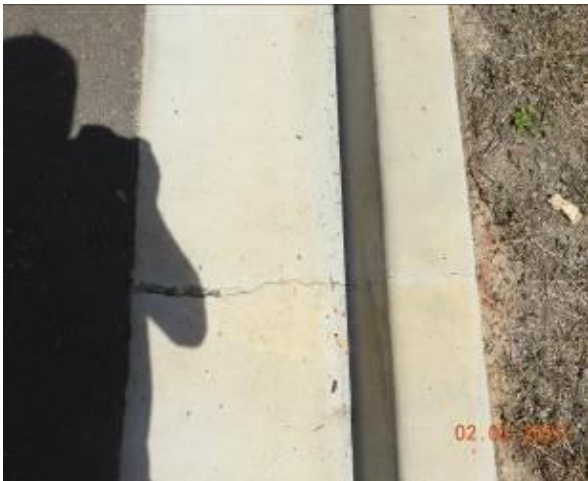
Figure 1017 – Crack propagation through kerb and gutter

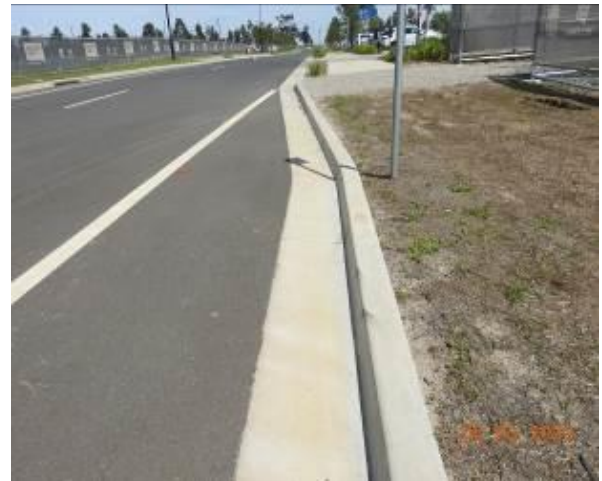
Figure 1018 – General Condition of kerb and gutter

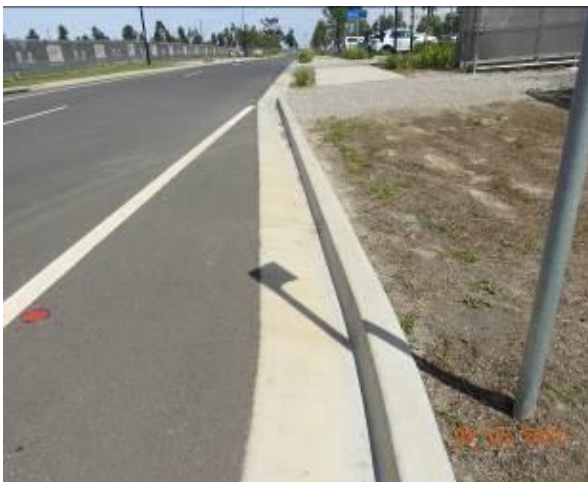
Figure 1019 – General Condition of kerb and gutter

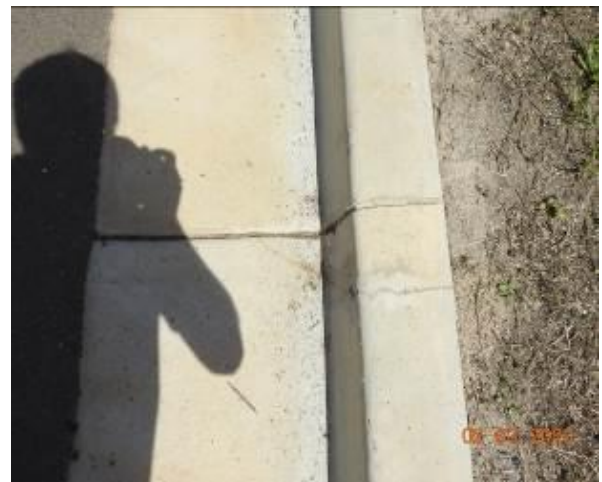
Figure 1020 – Crack propagation through kerb and gutter

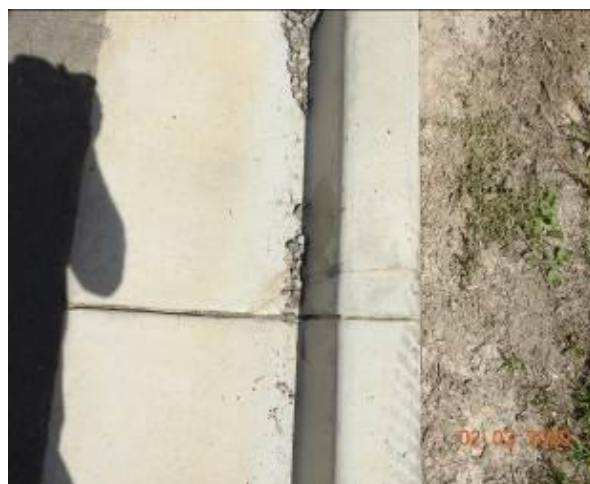
Figure 1021 – General Condition of kerb and gutter

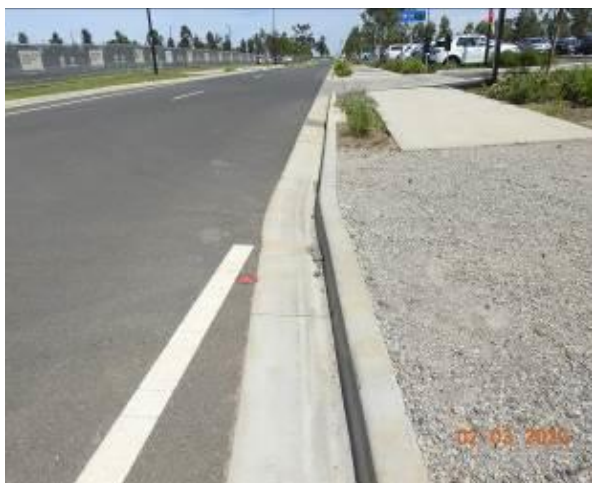
Figure 1022 – Crack propagation through kerb and gutter

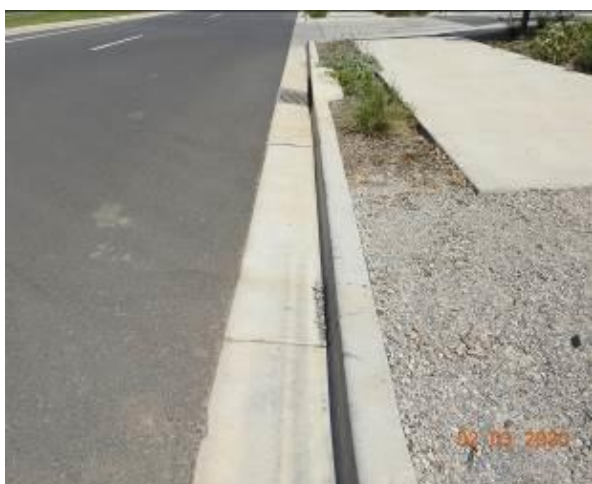
Figure 1024 – Loss of material through kerb

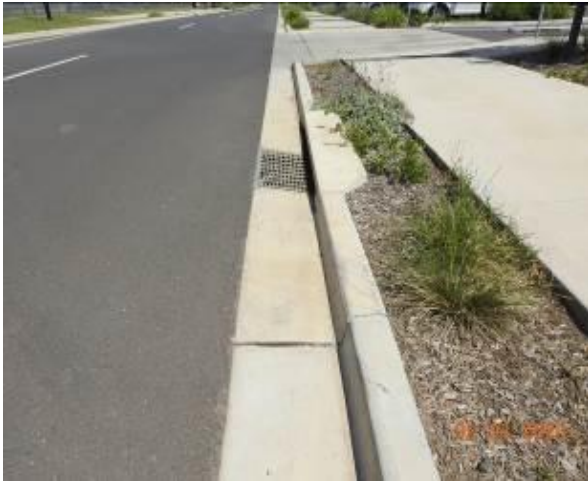
Figure 1026 – Crack propagation through kerb and gutter

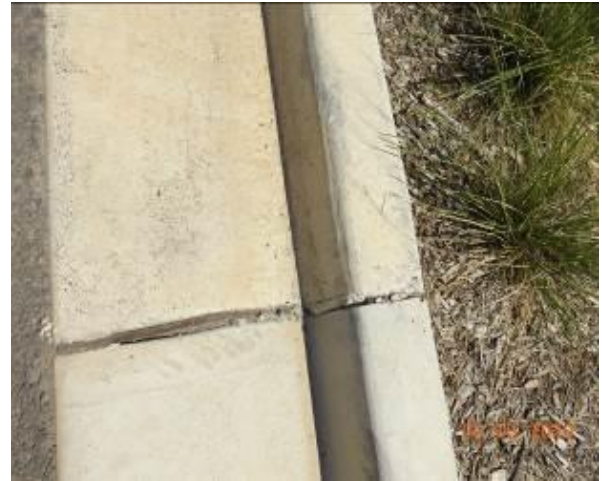
Figure 1027 – General Condition of kerb and gutter

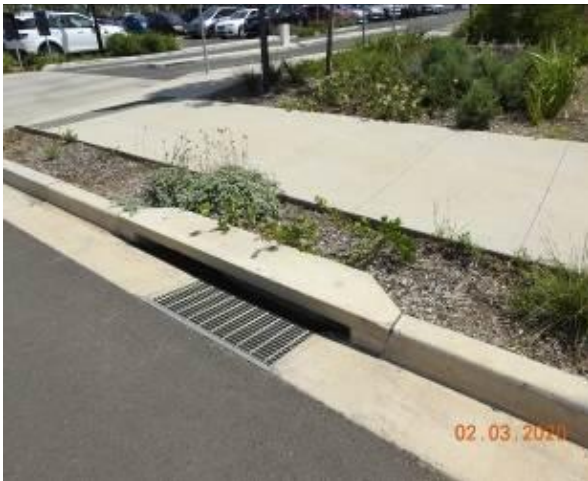
Figure 1028 – Loss of material through kerb and gutter

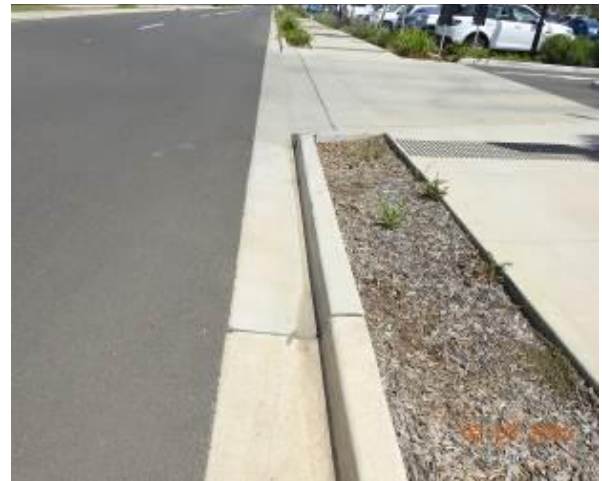
Figure 1029 – General Condition of stormwater inlet pit

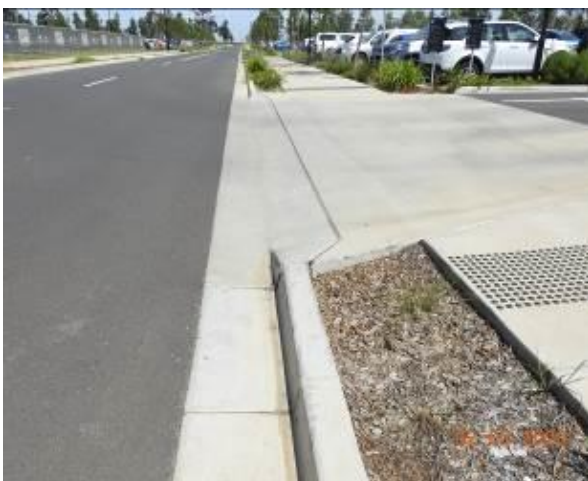
Figure 1030 – General Condition of kerb and gutter

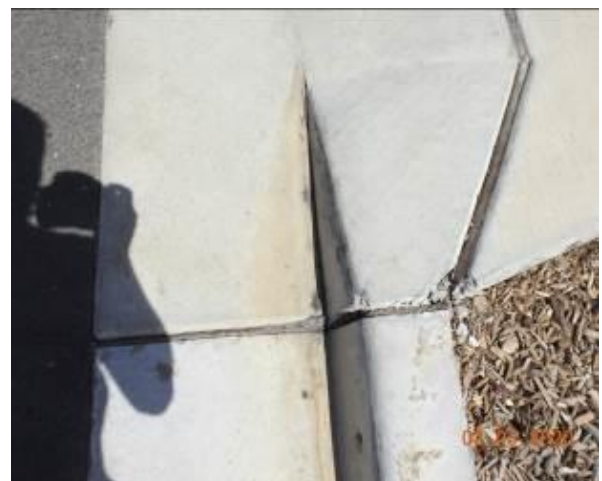
Figure 1031 – General Condition of layback and gutter

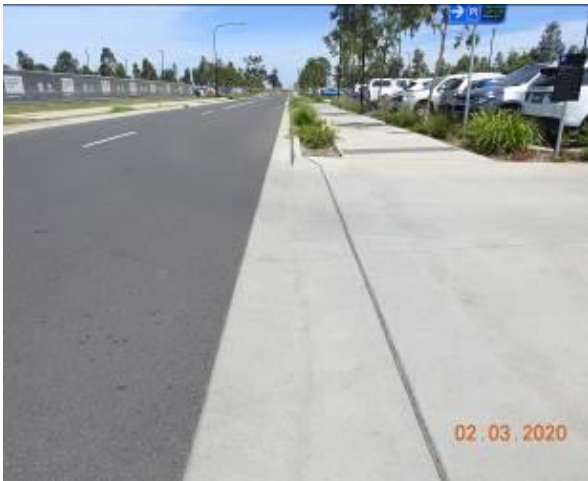
Figure 1032 – Loss of material through kerb and gutter

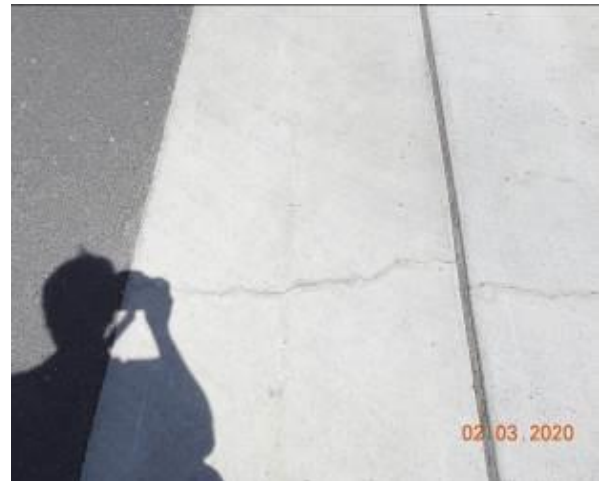
Figure 1033 – General Condition of gutter

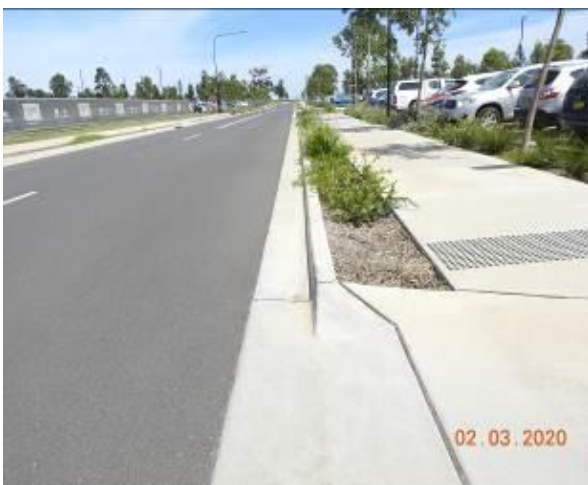
Figure 1034 – Crack propagation through gutter

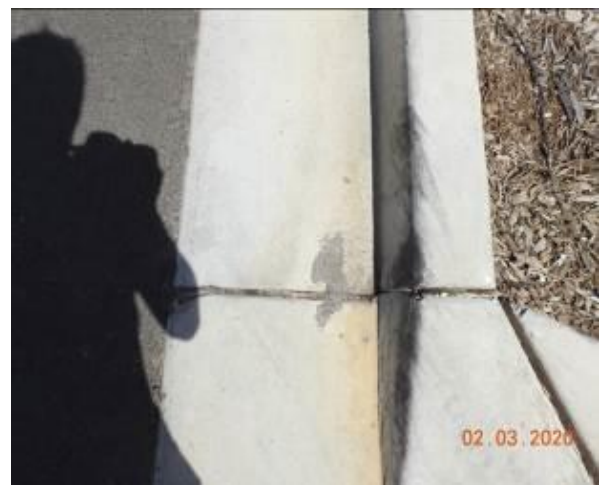
Figure 1035 – General Condition of gutter

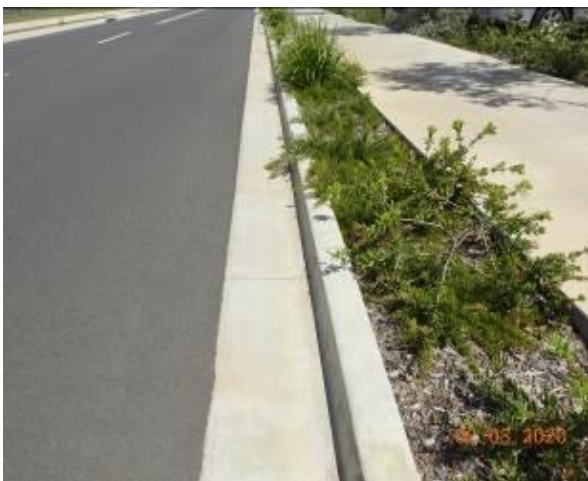
Figure 1036 – Crack propagation through kerb and gutter

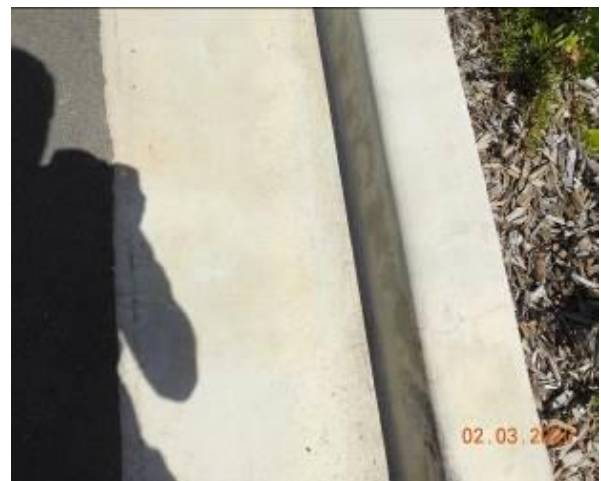
Figure 1037 – General Condition of kerb and gutter

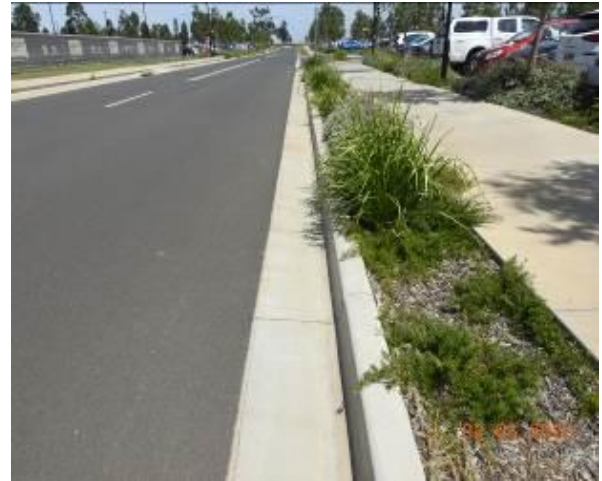
Figure 1039 – Crack propagation through kerb and gutter

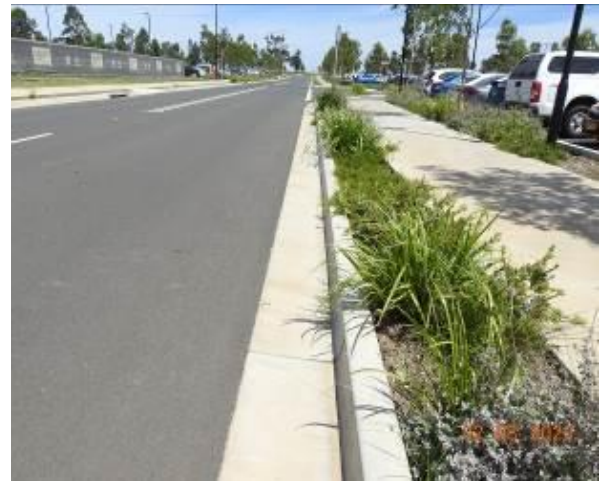
Figure 1041 – General Condition of kerb and gutter

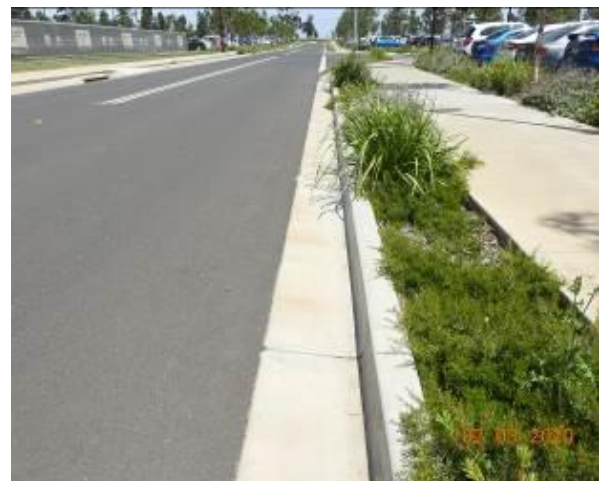
Figure 1043 – Crack propagation through kerb and gutter

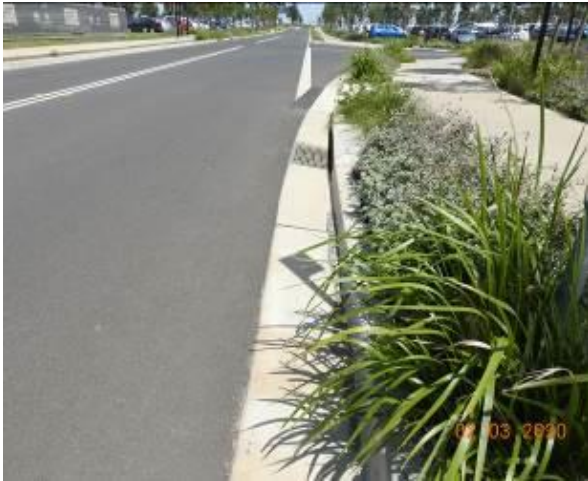
Figure 1050 – Crack propagation and loss of material through kerb and gutter

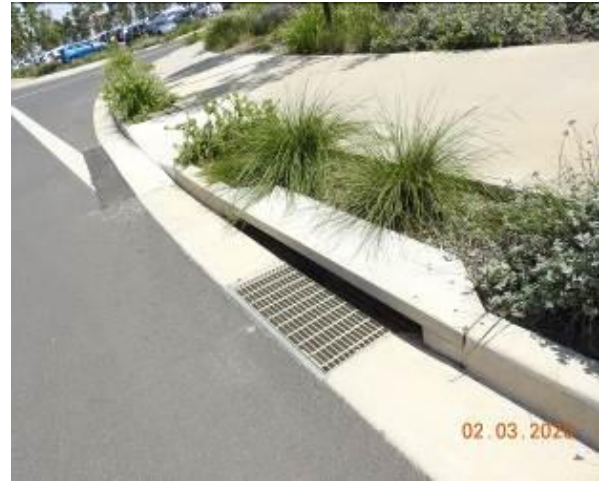
Figure 1051 – General Condition of kerb and gutter

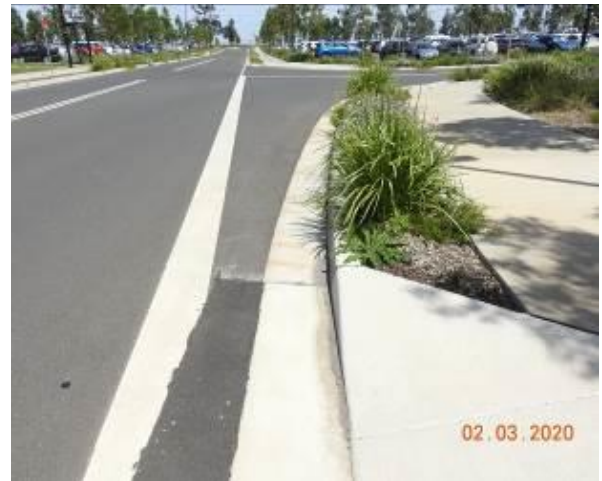
Figure 1053 – General Condition of kerb and gutter

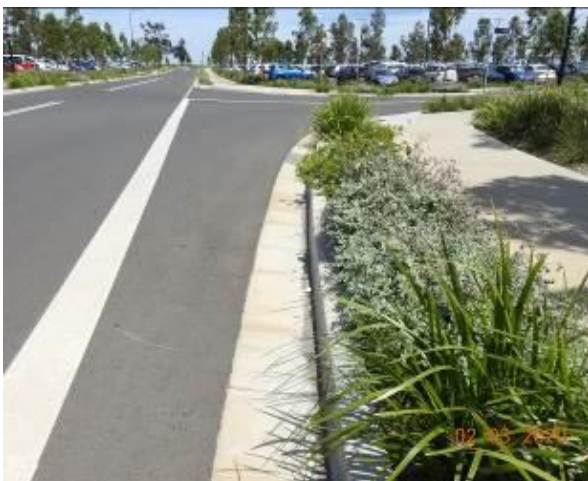
Figure 1054 – General Condition of kerb and gutter

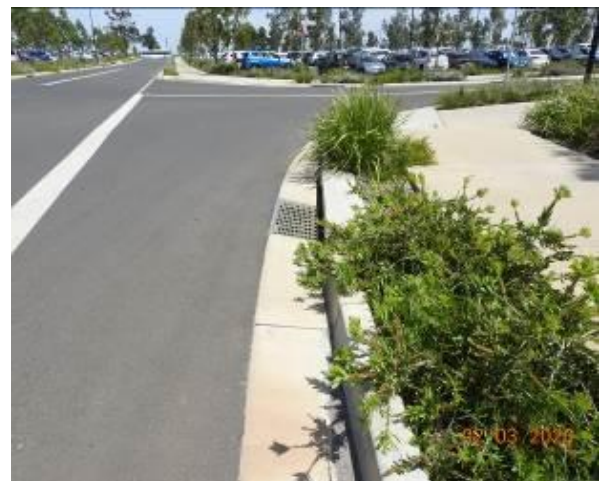
Figure 1055 – General Condition of kerb and gutter

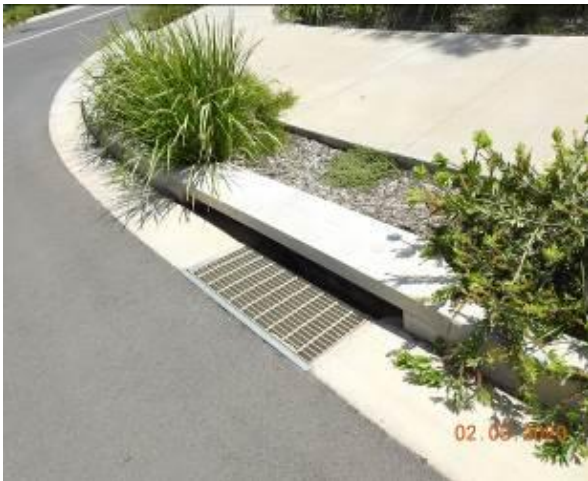
Figure 1056 – General Condition of kerb and gutter

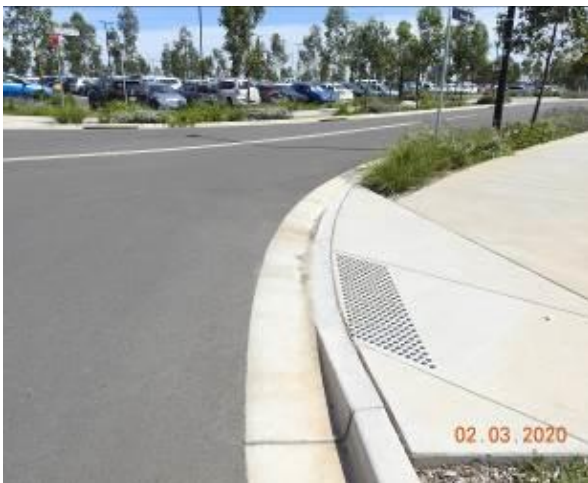
Figure 1058 – General Condition of kerb and gutter

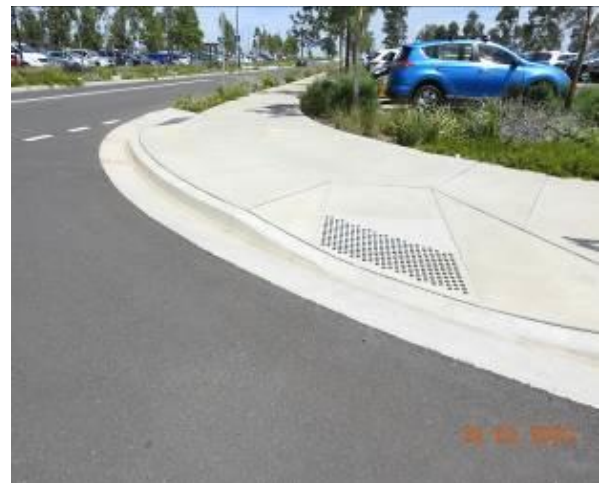
Figure 1059 – General Condition of kerb and gutter

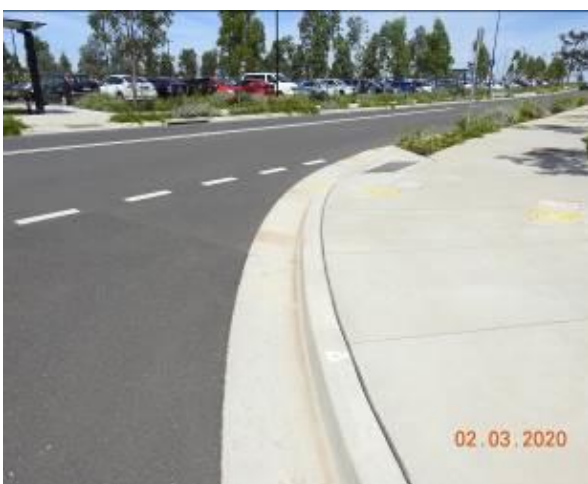
Figure 1061 – General Condition of kerb and gutter

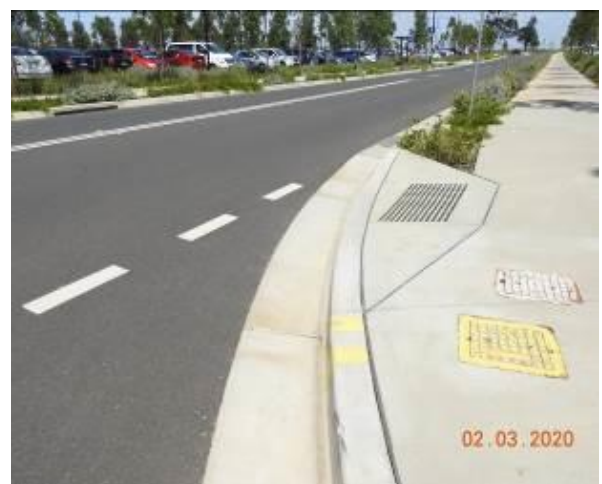
Figure 1062 – General Condition of kerb and gutter

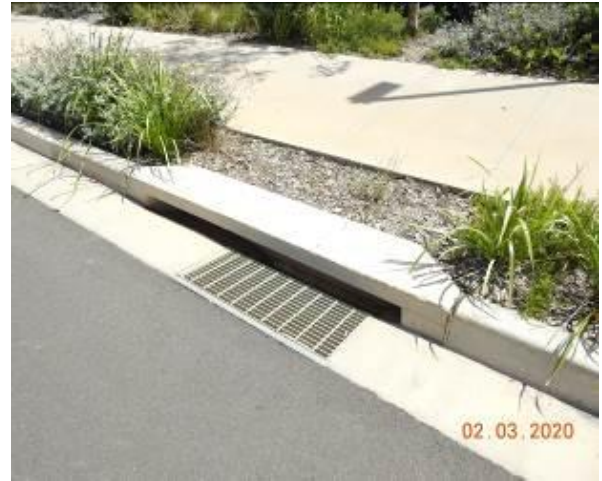
Figure 1070 – General Condition of stormwater inlet pit

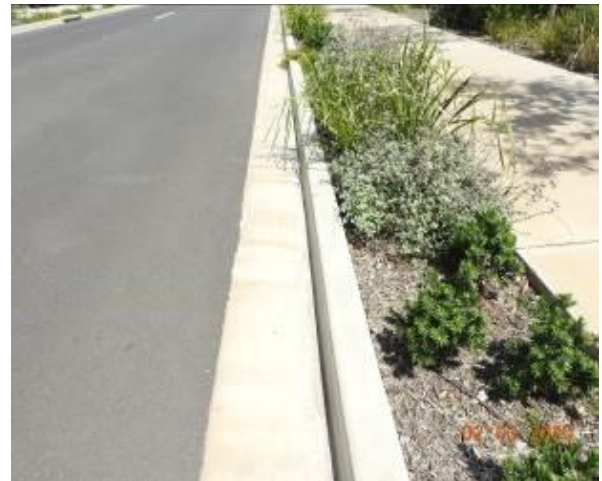
Figure 1072 – General Condition of kerb and gutter

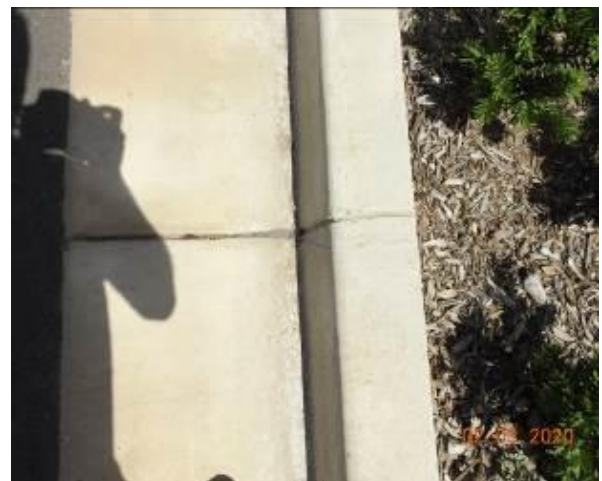
Figure 1074 – Crack propagation through kerb

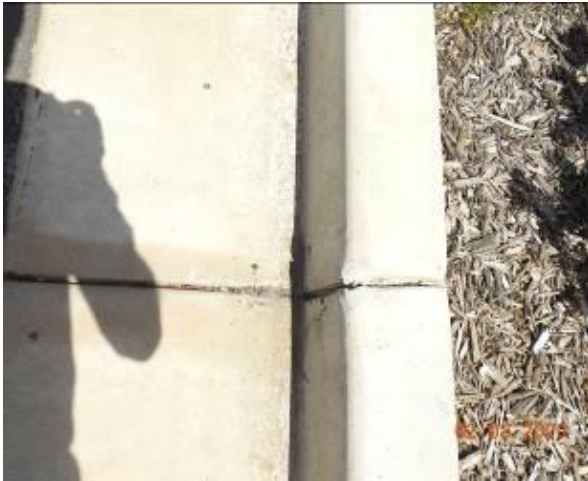
Figure 1087 – Crack propagation through kerb

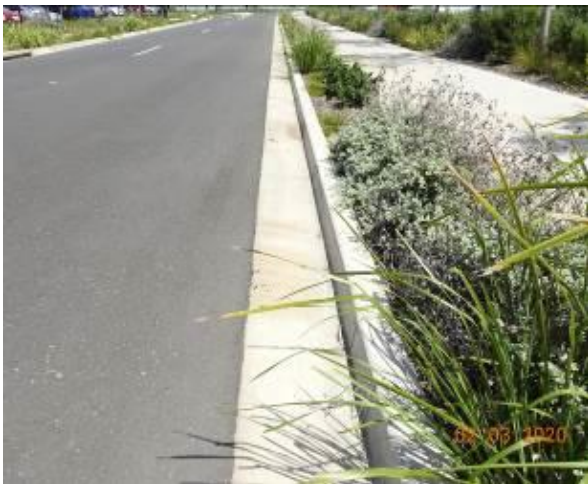
Figure 1089 – General Condition of kerb and gutter

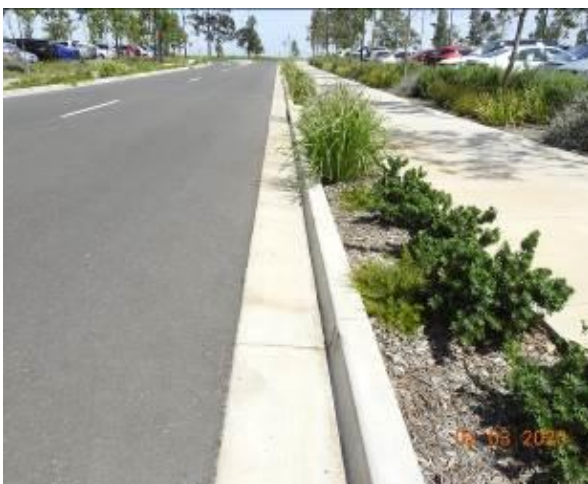
Figure 1091 – General Condition of kerb and gutter

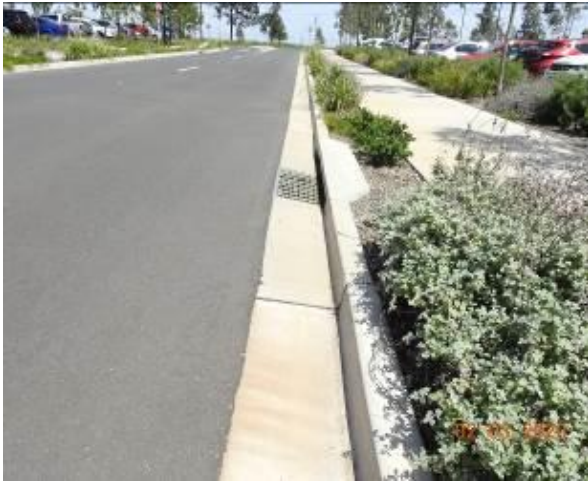
Figure 1093 – General Condition of kerb and gutter

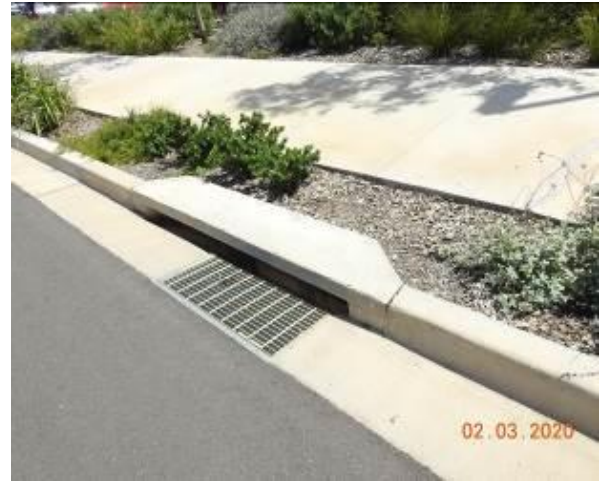
Figure 1094 – General Condition of stormwater inlet pit

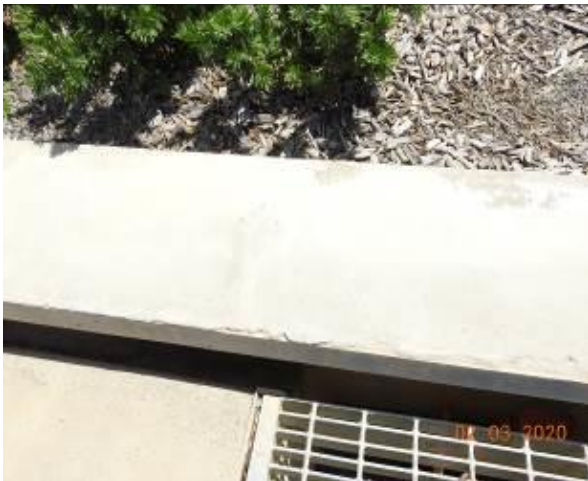
Figure 1095 – Crack propagation through stormwater inlet pit

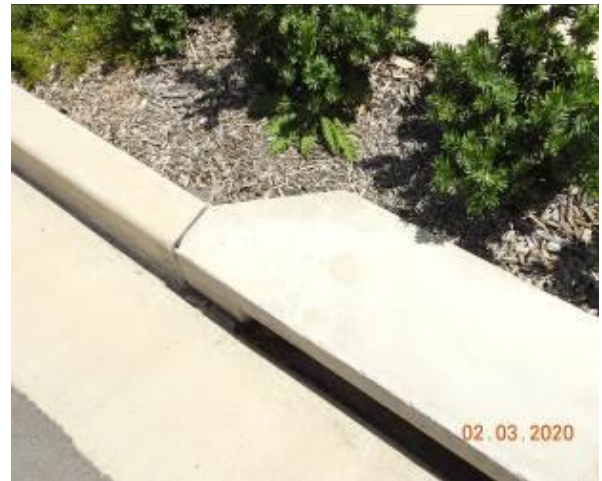
Figure 1096 – Crack propagation through stormwater inlet pit

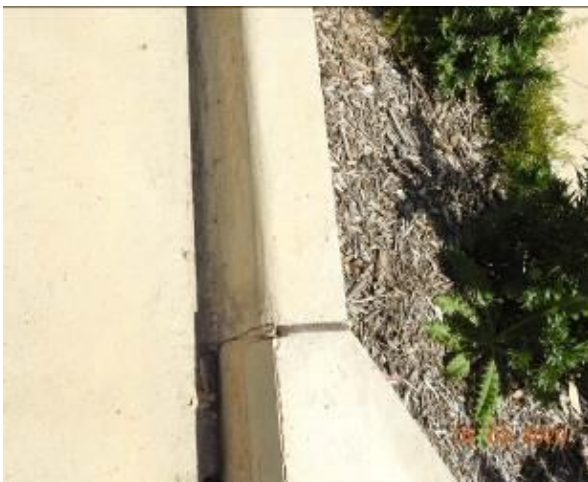
Figure 1097 – Crack propagation through stormwater inlet pit

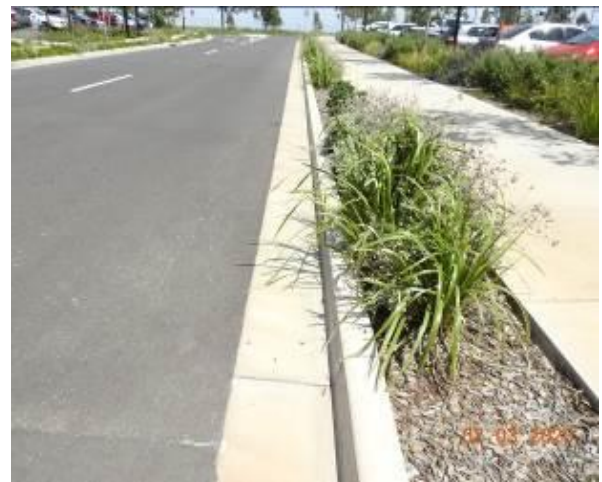
Figure 1098 – General Condition of kerb and gutter

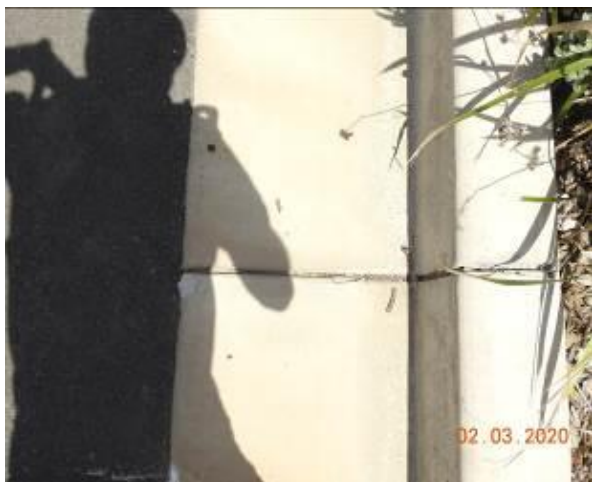
Figure 1099 – Crack propagation through kerb and gutter

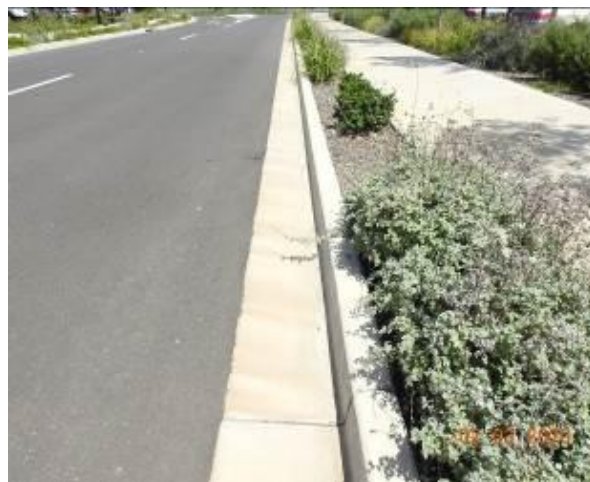
Figure 1100 – General Condition of kerb and gutter

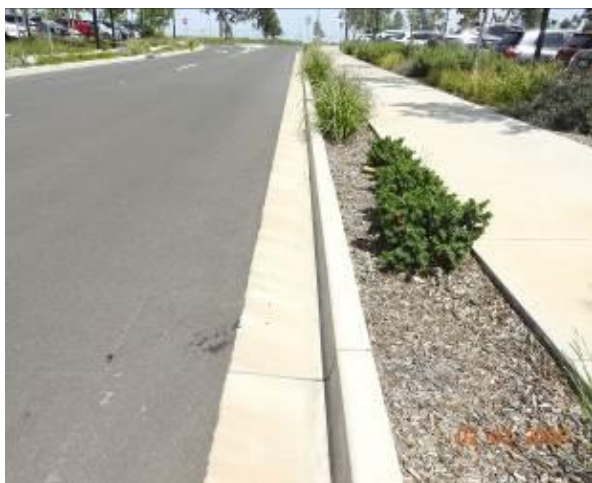
Figure 1101 – General Condition of kerb and gutter

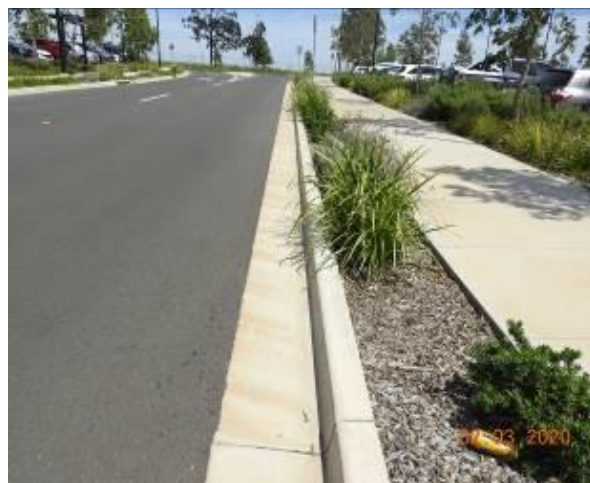
Figure 1102 – General Condition of kerb and gutter

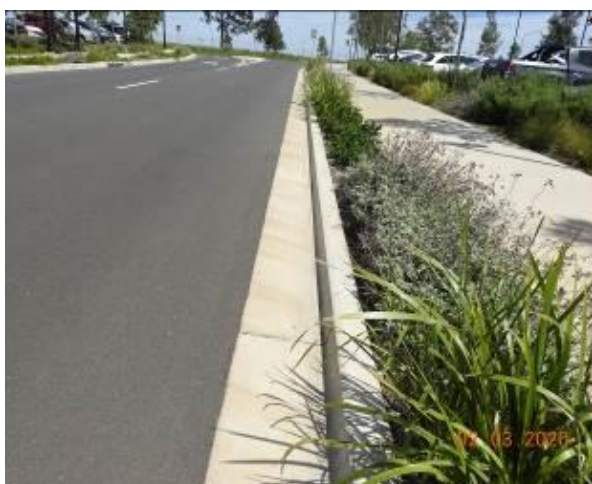
Figure 1103 – General Condition of kerb and gutter

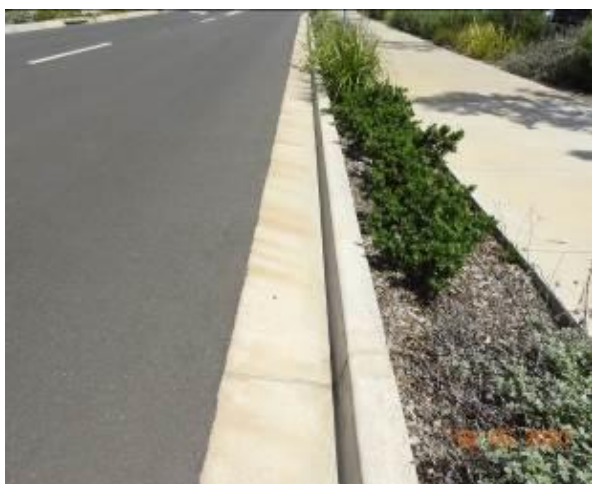
Figure 1105 – General Condition of kerb and gutter

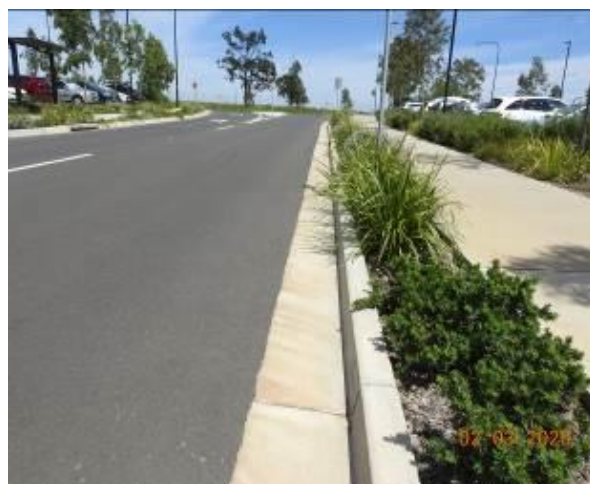
Figure 1106 – General Condition of kerb and gutter

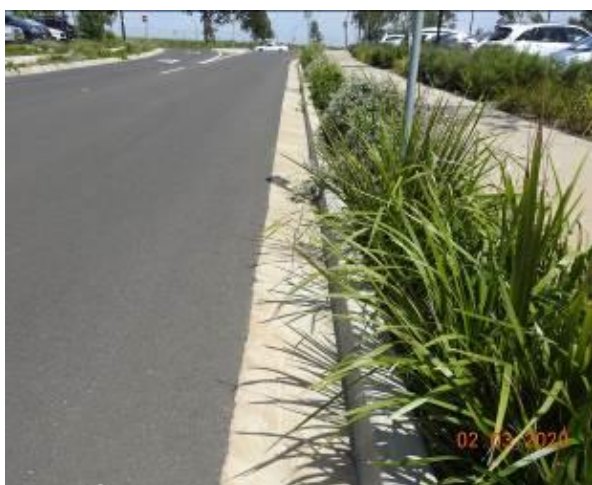
Figure 1107 – General Condition of kerb and gutter

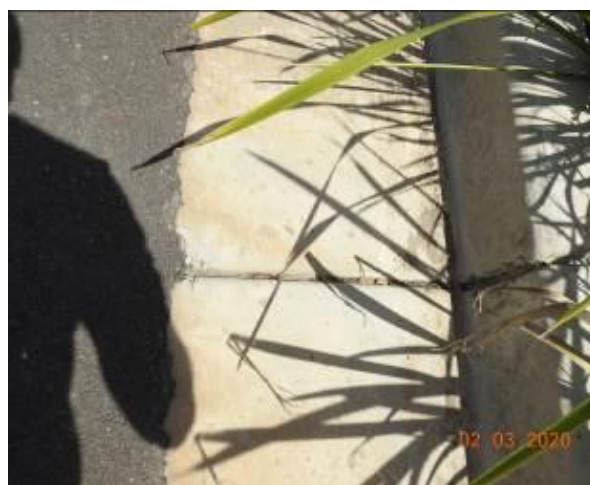
Figure 1108 – Crack propagation through kerb and gutter

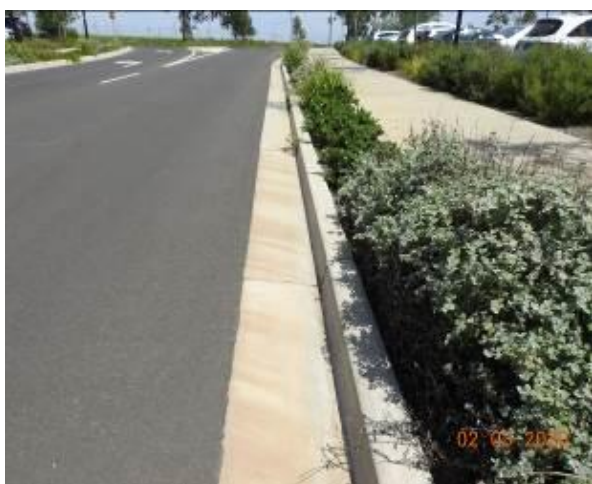
Figure 1109 – General Condition of kerb and gutter

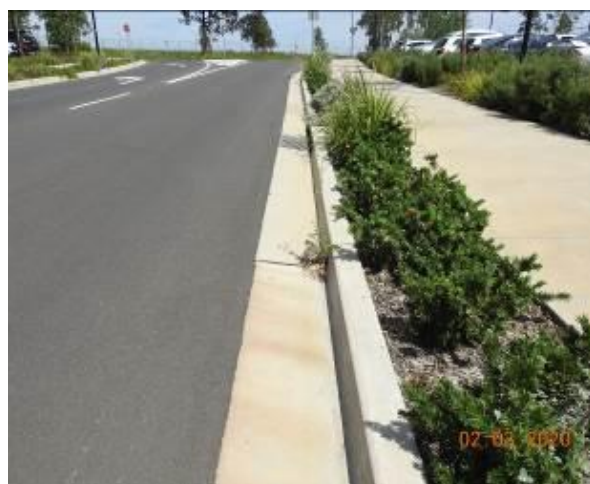
Figure 1110 – General Condition of kerb and gutter

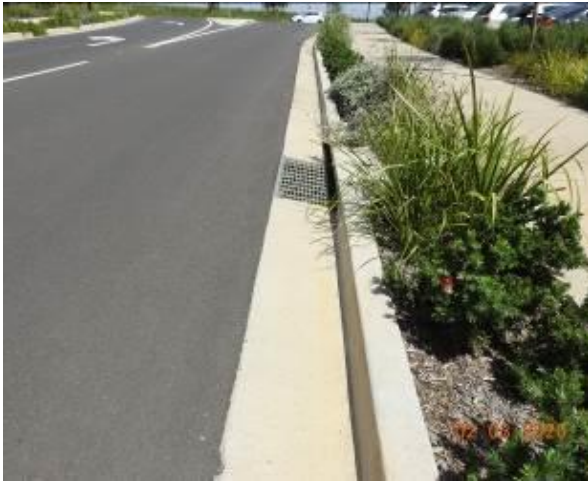
Figure 1111 – General Condition of kerb and gutter

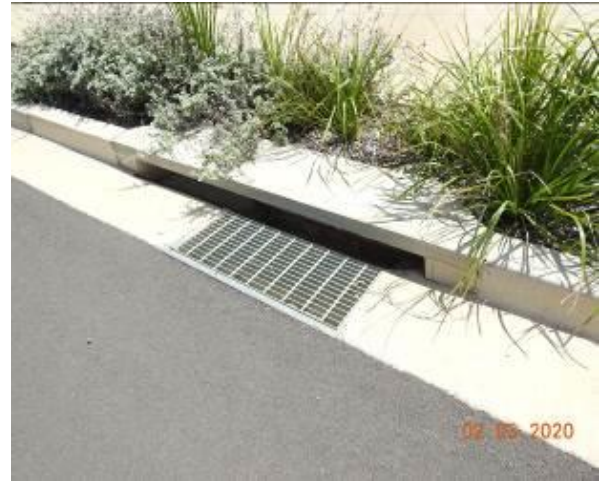
Figure 1112 – General Condition of stormwater inlet pit

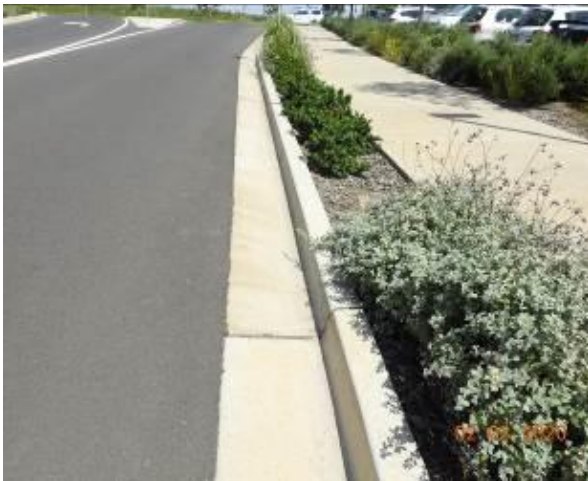
Figure 1113 – General Condition of kerb and gutter

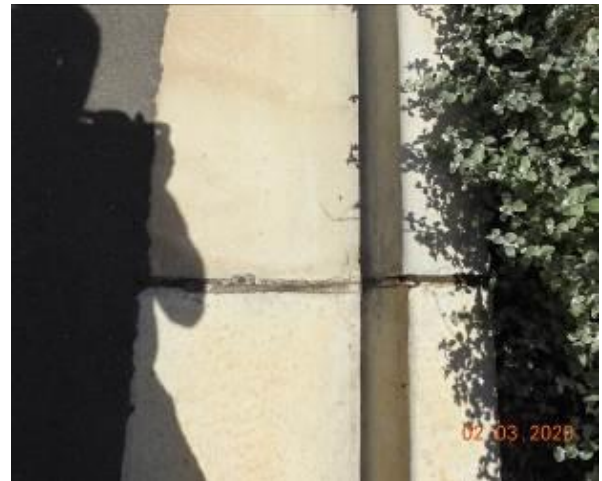
Figure 1114 – Crack propagation through kerb and gutter

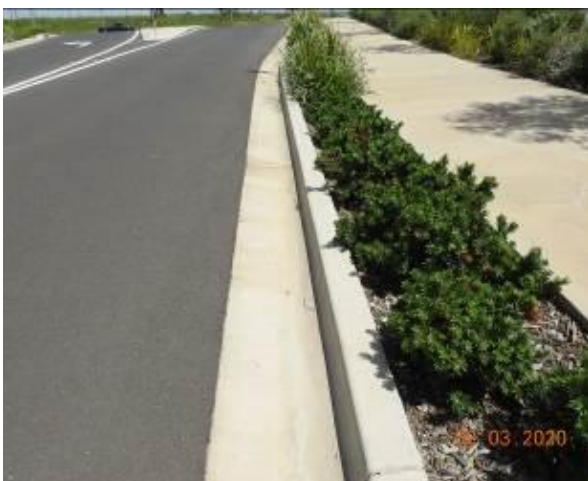
Figure 1115 – General Condition of kerb and gutter

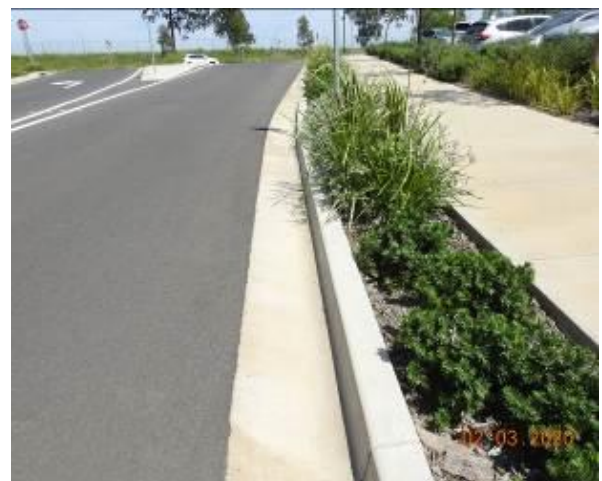
Figure 1116 – General Condition of kerb and gutter

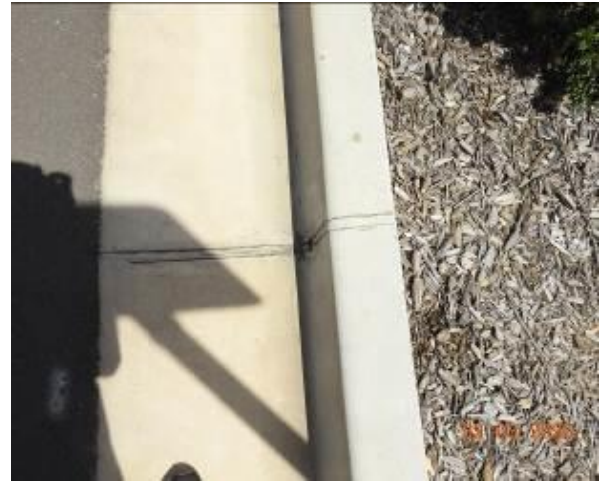
Figure 1118 – Crack propagation through kerb and gutter

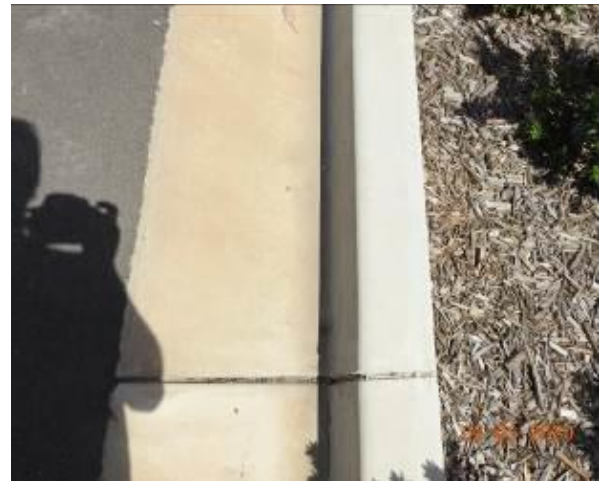
Figure 1120 – Crack propagation through kerb and gutter

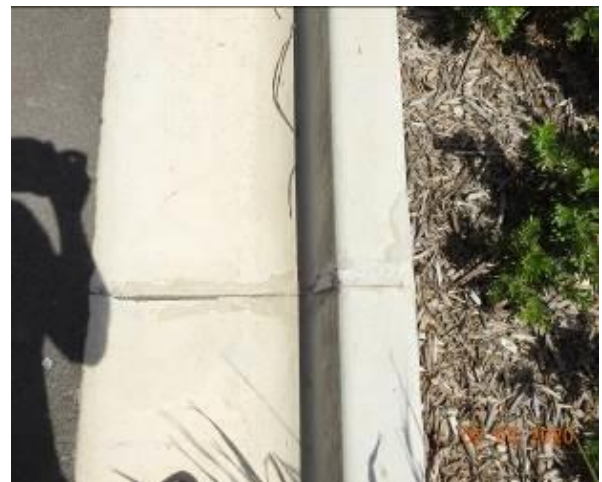
Figure 1122 – Crack propagation and loss of material through kerb and gutter

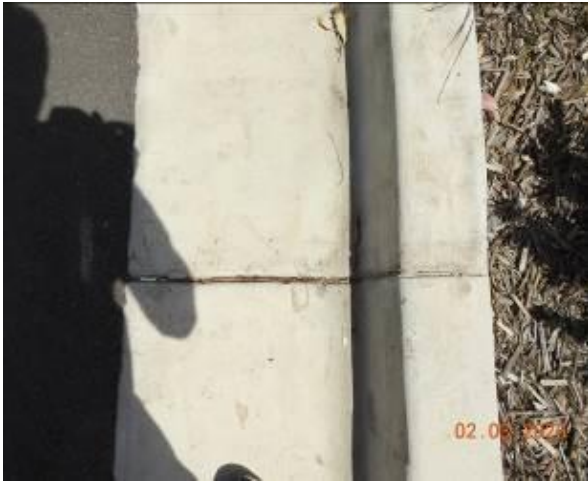
Figure 1123 – Crack propagation through kerb and gutter

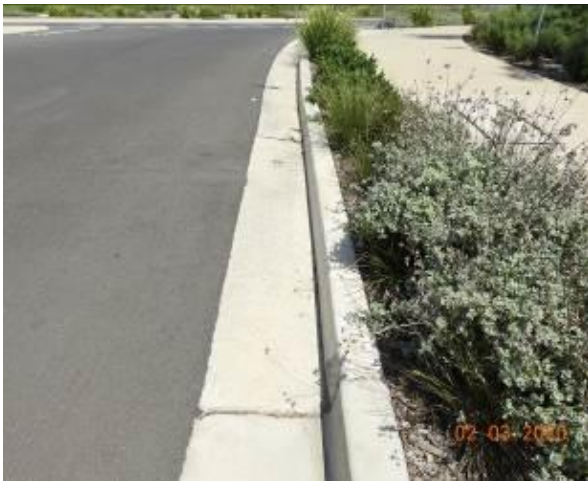
Figure 1125 – General Condition of kerb and gutter

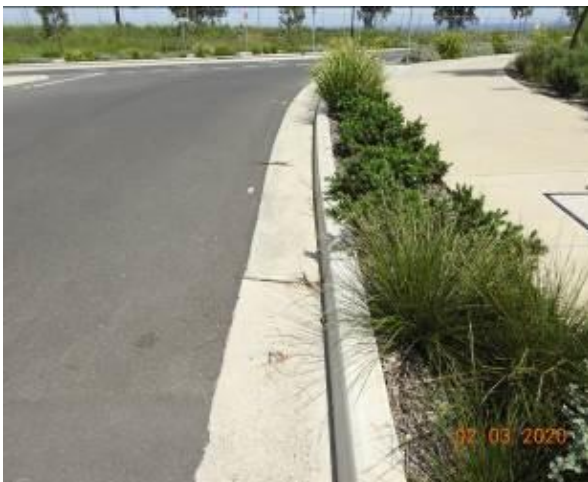
Figure 1127 – General Condition of kerb and gutter

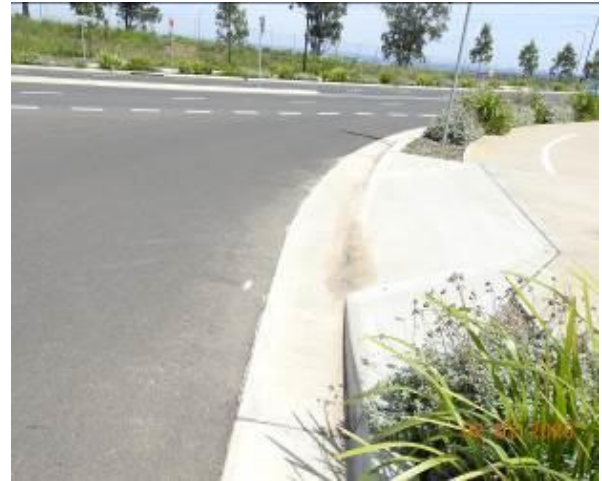
Figure 1130 – General Condition of kerb and gutter
