**1-15 AND 2-12 CONFERTA AVENUE,
ROUSE HILL NSW 2155
TALLAWONG STATION PRECINCT SOUTH
PRE-DILAPIDATION REPORT**

**DEICORP PROJECTS
(TALLAWONG STATION) PTY LTD**

Job No. 191294.0
24/03/2020

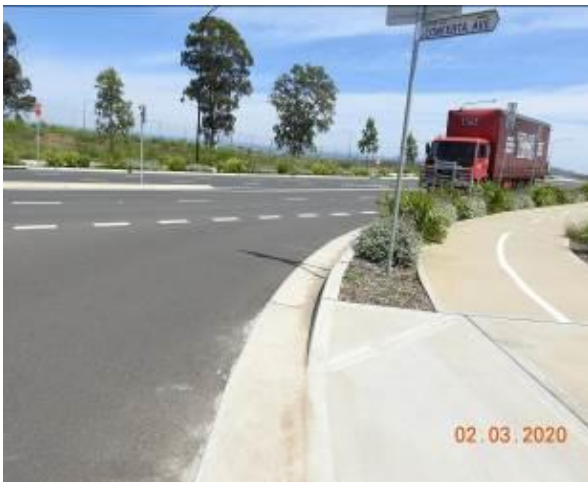
Figure 1131 – General Condition of kerb and gutter

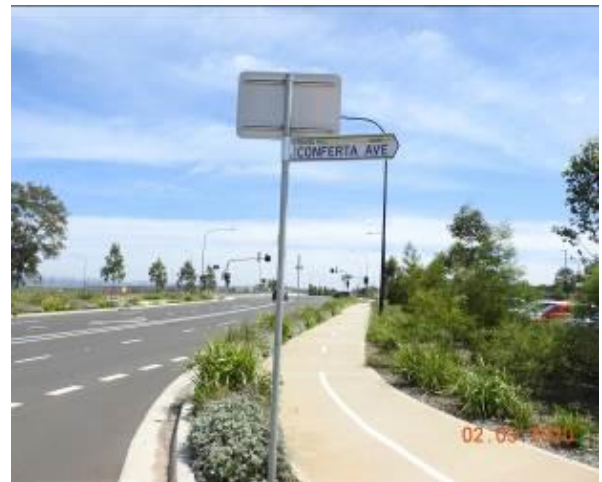
Figure 1132 – General Condition of street sign

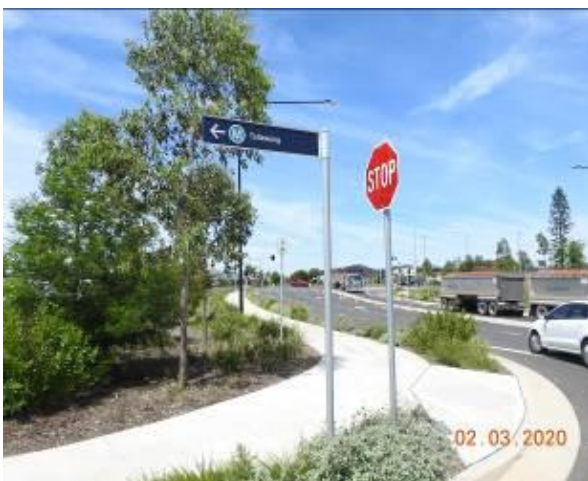
Figure 1133 – General Condition of street sign

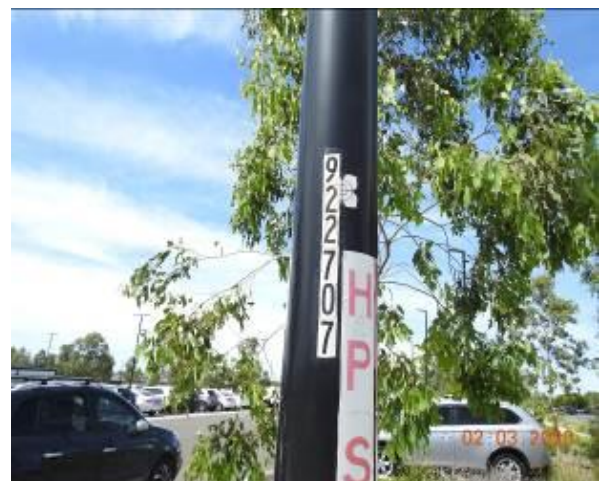
Figure 1134 – General Condition of lamp post
Identification N.922707

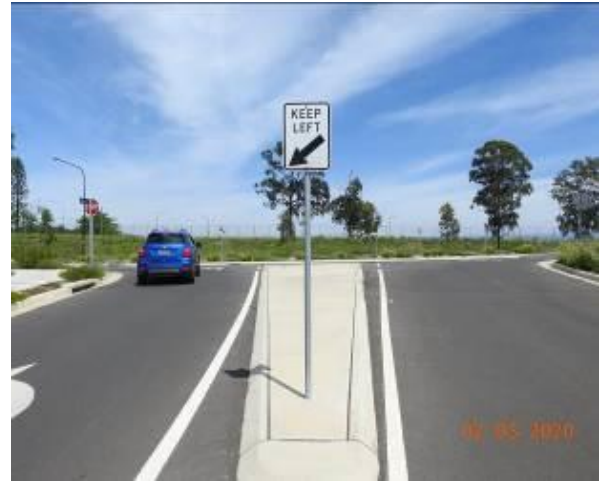
Figure 1136 – General Condition of street sign

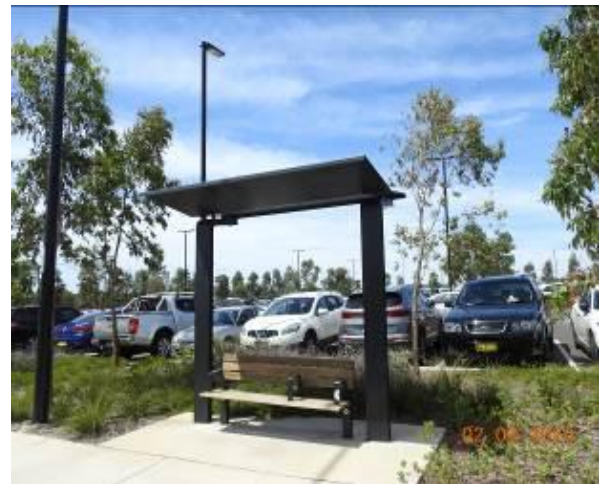
Figure 1138 – General Condition of public bench

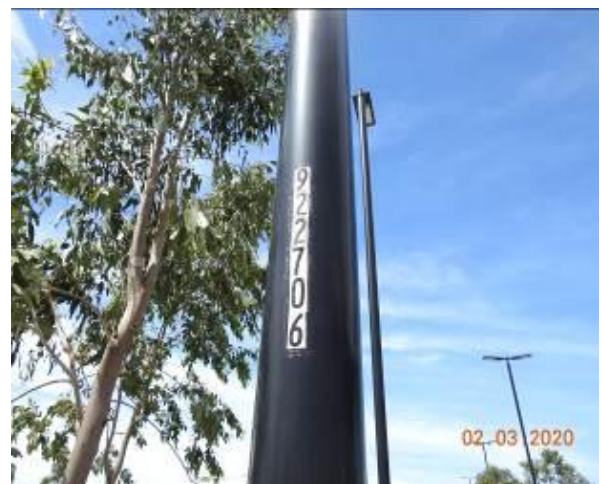
Figure 1140 – General Condition of lamp post
Identification N.922706

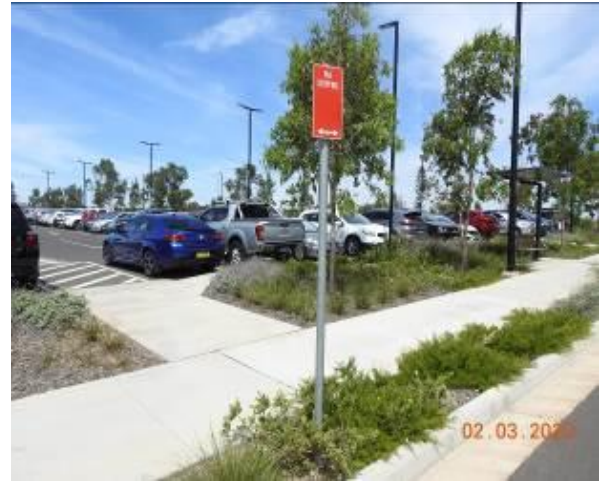
Figure 1142 – General Condition of street sign

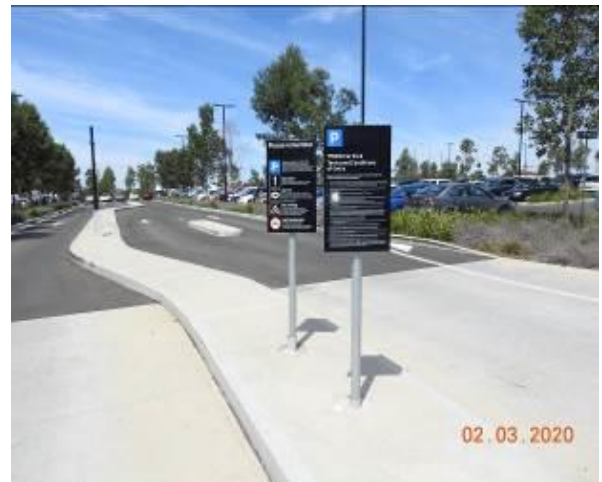
Figure 1144 – General Condition of street sign

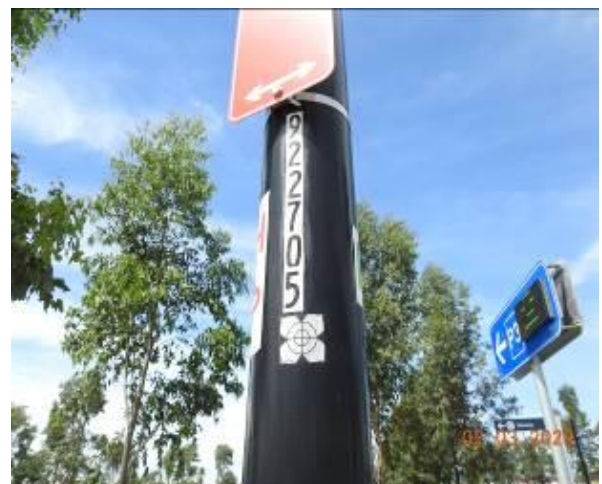
Figure 1146 – General Condition of lamp post
Identification N.922705

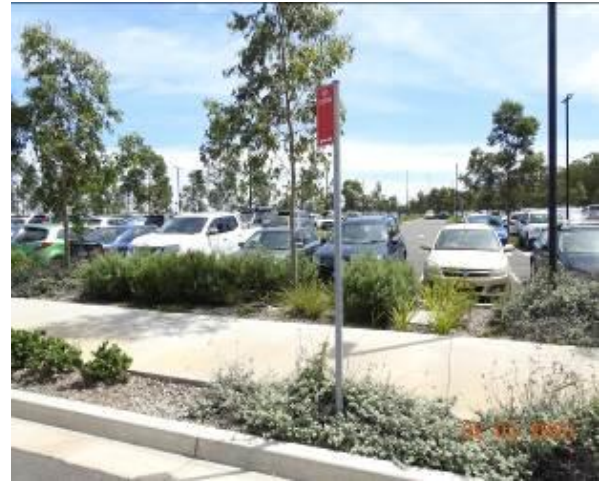
Figure 1148 – General Condition of street sign

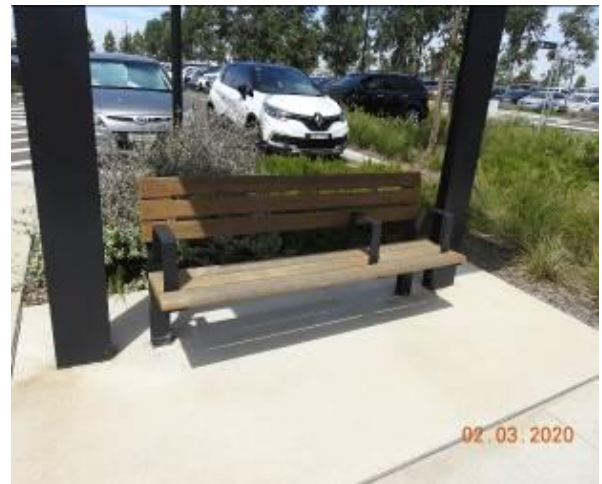
Figure 1150 – General Condition of public bench

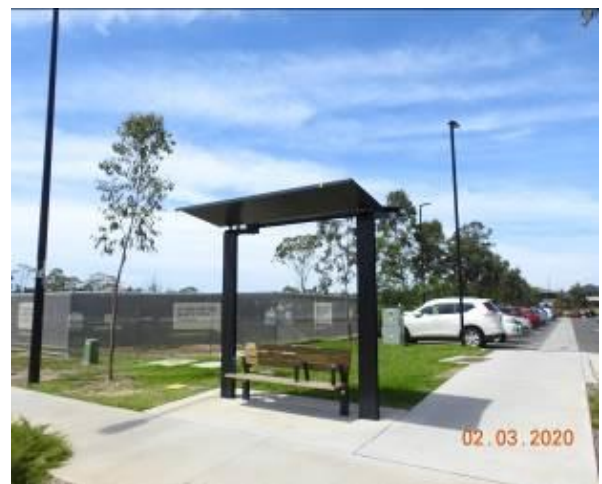
Figure 1152 – General Condition of public bench

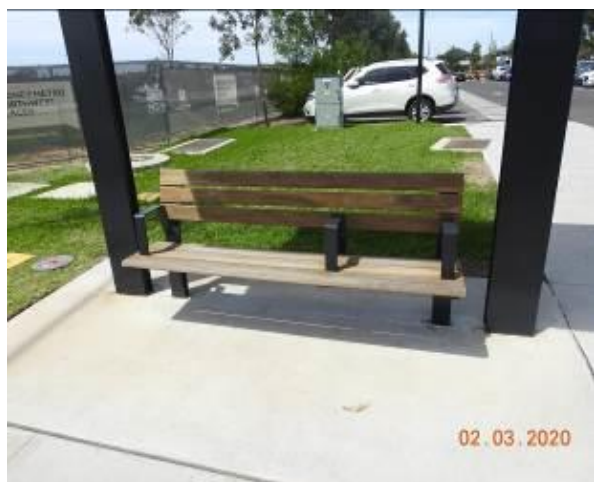
Figure 1153 – General Condition of public bench

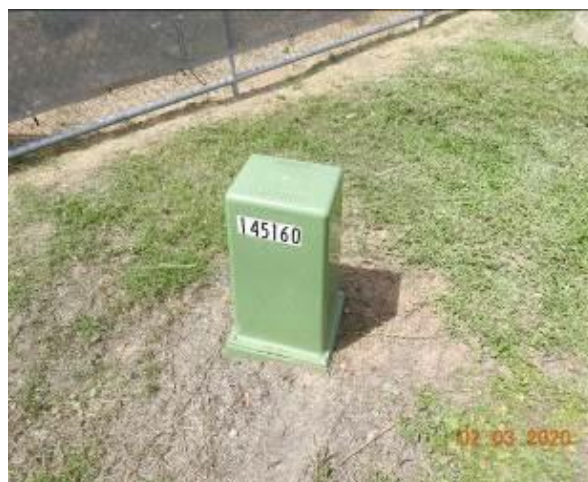
Figure 1154 – General Condition of electricity box

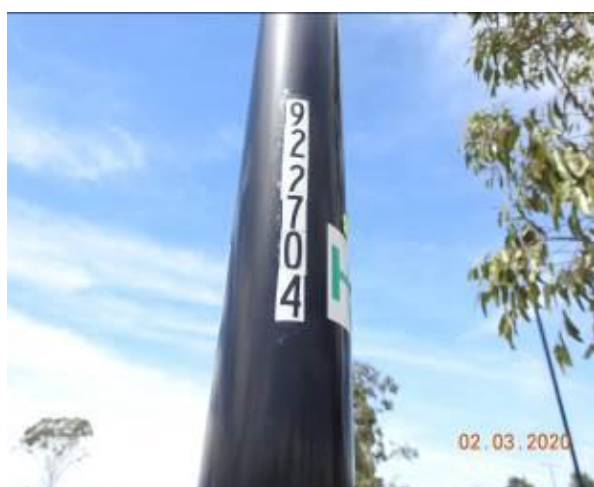
Figure 1155 – General Condition of lamp post
Identification N.922704

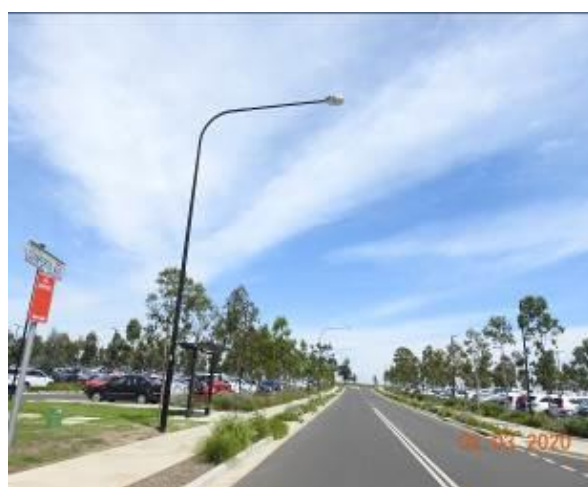
Figure 1156 – General Condition of lamp post

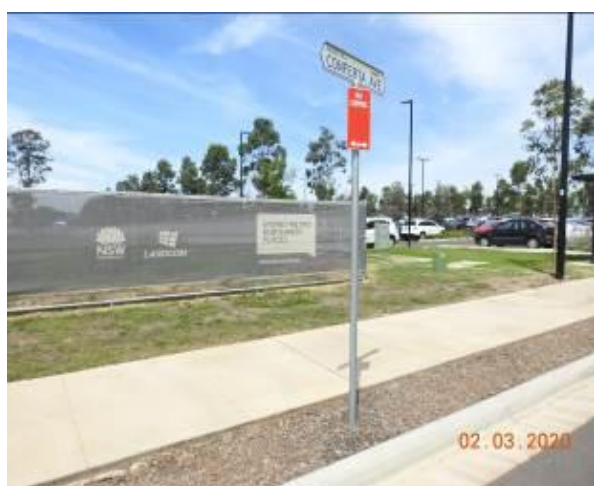
Figure 1157 – General Condition of street sign

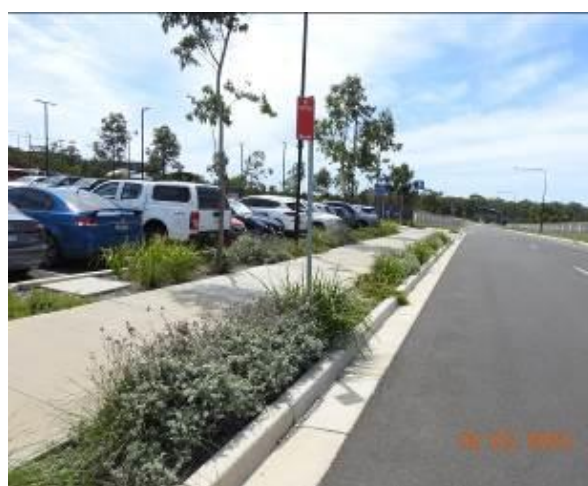
Figure 1158 – General Condition of street sign

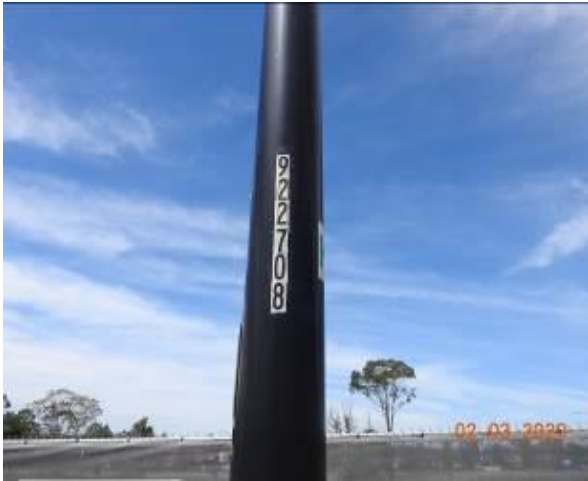
Figure 1159 – General Condition of lamp post
Identification N.922708

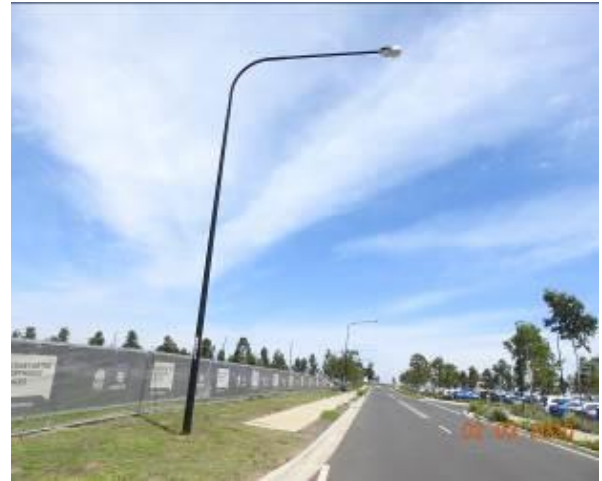
Figure 1160 – General Condition of lamp post

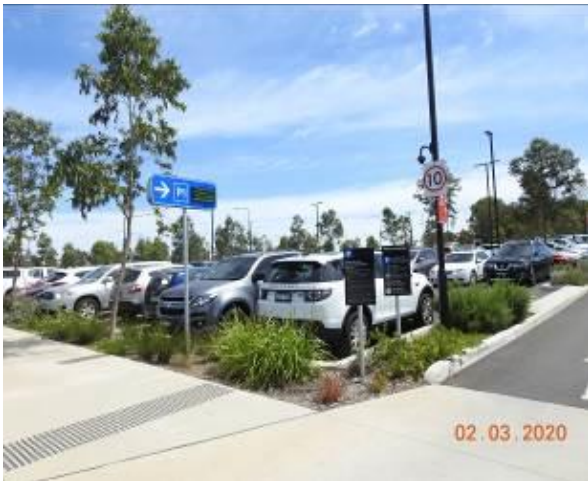
Figure 1161 – General Condition of street sign

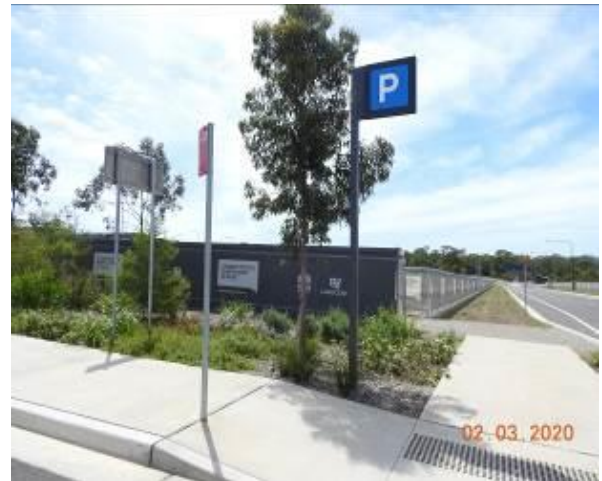
Figure 1162 – General Condition of street sign

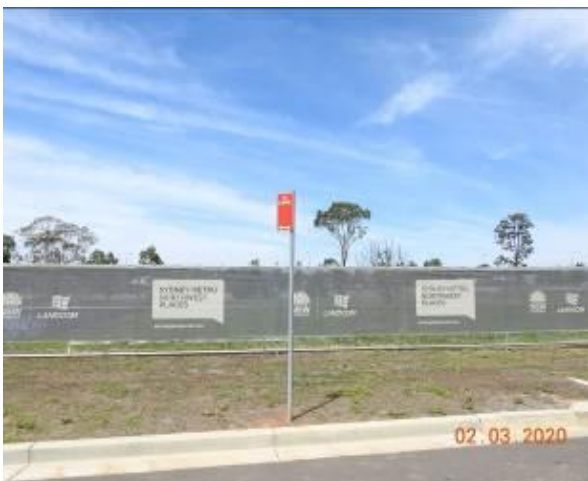
Figure 1163 – General Condition of street sign

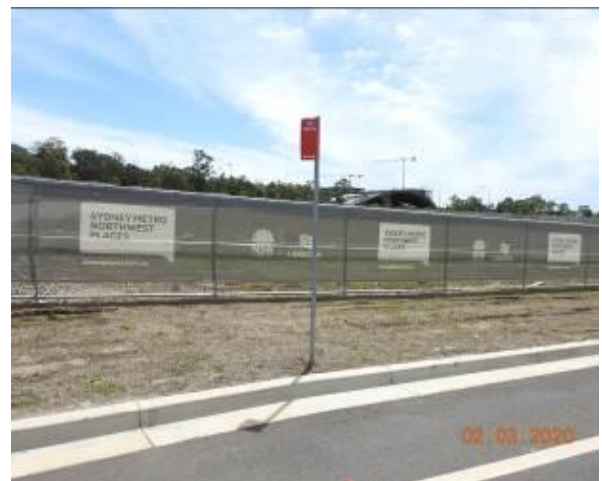
Figure 1164 – General Condition of street sign

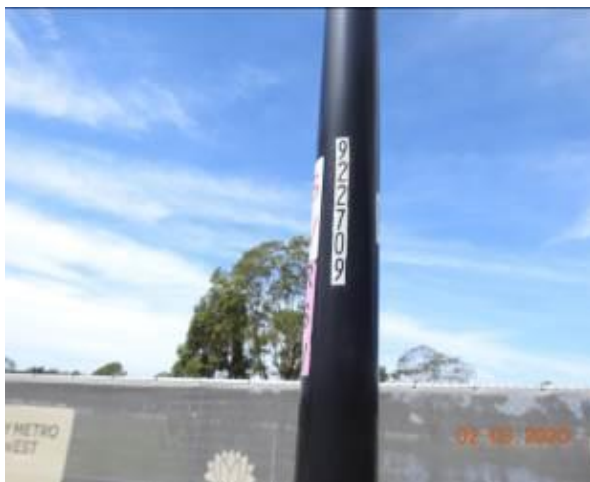
Figure 1165 – General Condition of lamp post
Identification N.922709

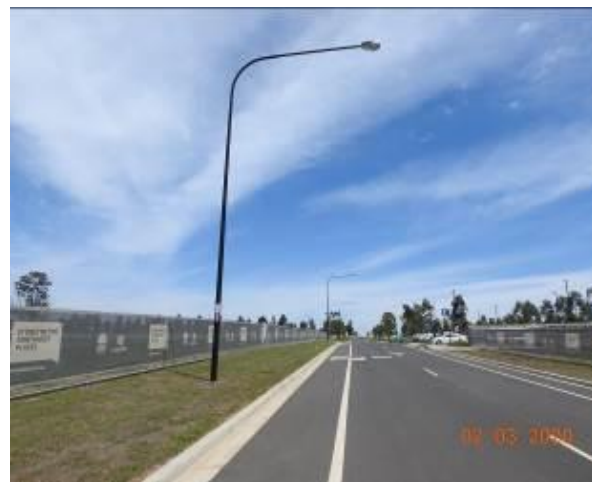
Figure 1166 – General Condition of lamp post

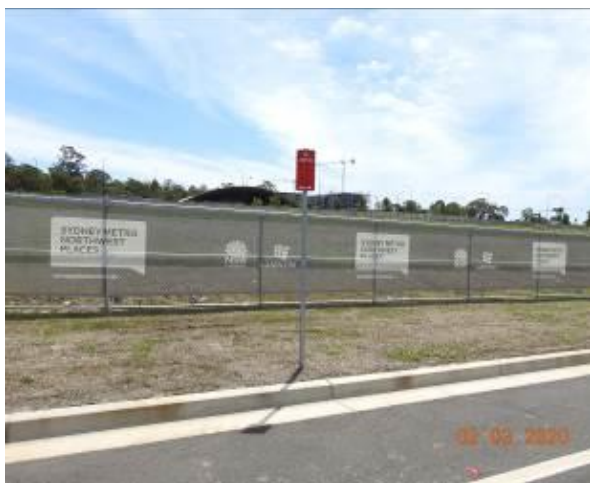
Figure 1167 – General Condition of street sign

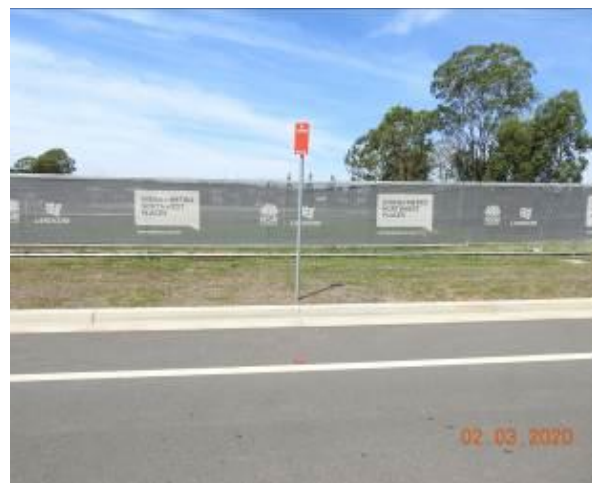
Figure 1168 – General Condition of street sign

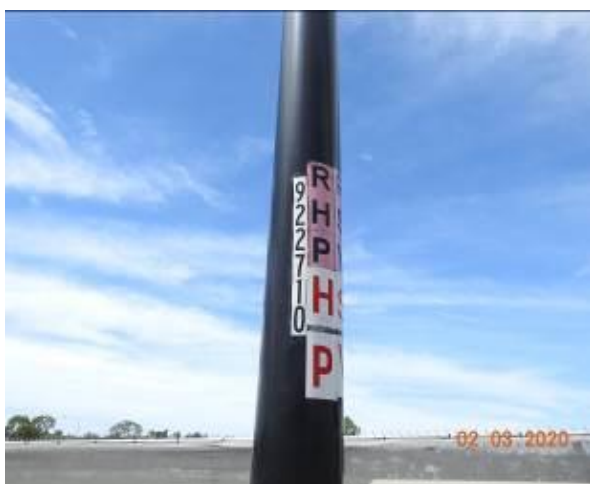
Figure 1169 – General Condition of lamp post
Identification N.922710

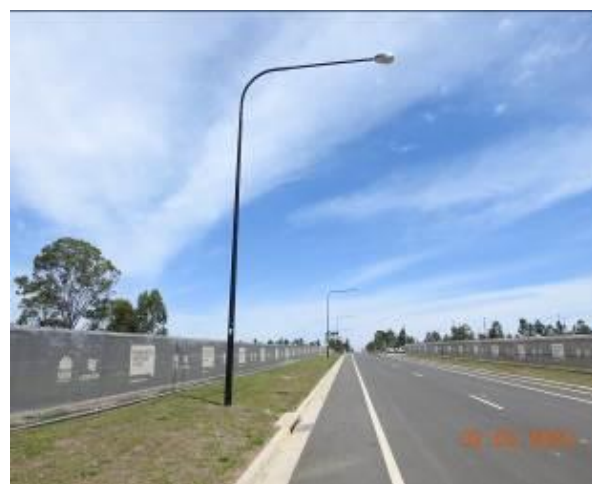
Figure 1170 – General Condition of lamp post

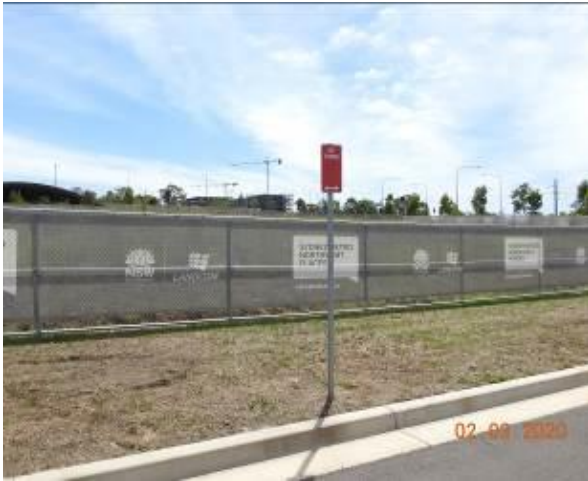
Figure 1171 – General Condition of street sign

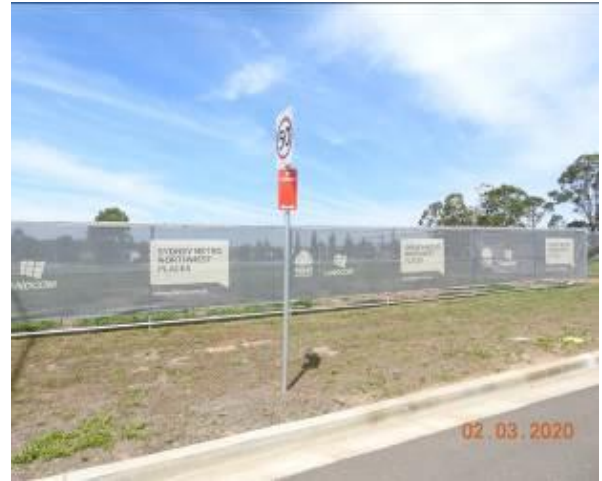
Figure 1172 – General Condition of street sign

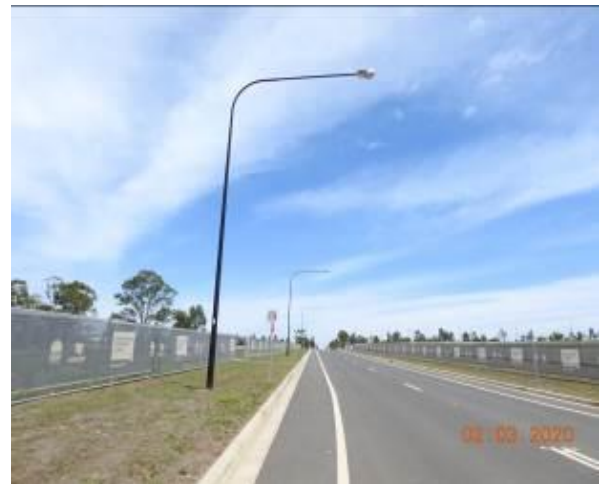
Figure 1174 – General Condition of lamp post

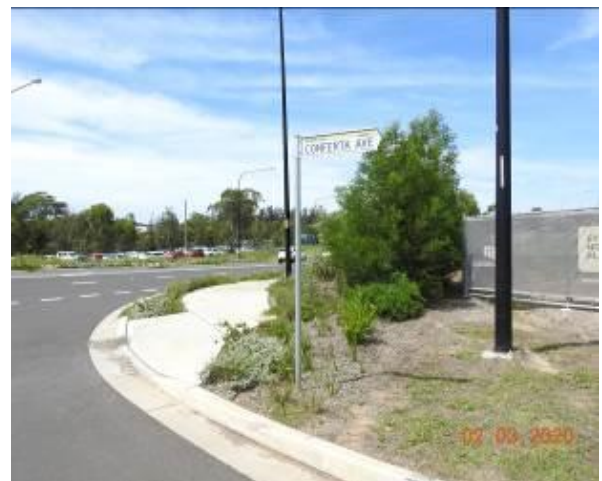
Figure 1176 – General Condition of street sign

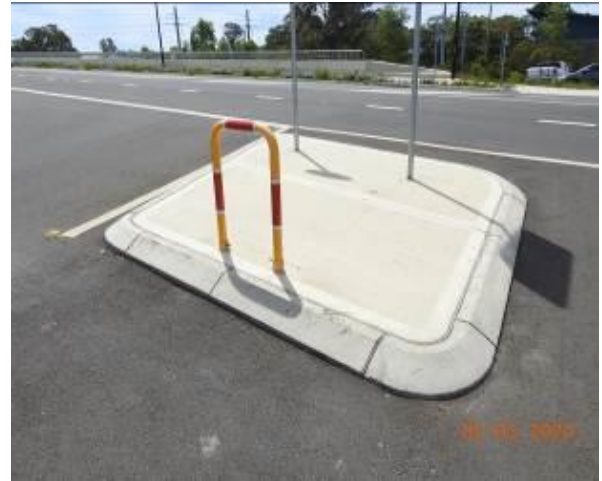
Figure 1178 – General Condition of traffic island bollard

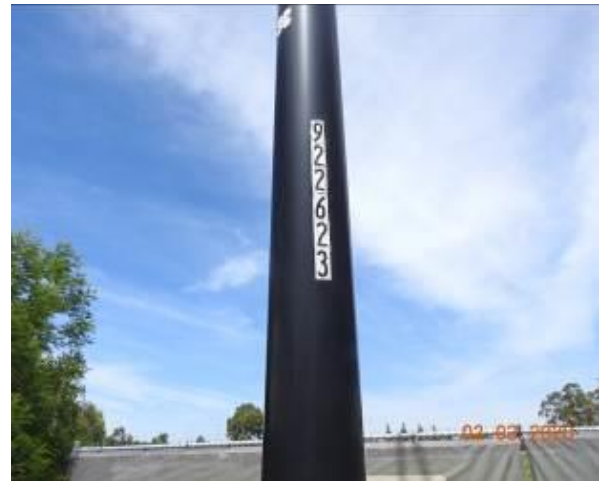
Figure 1180 – General Condition of lamp post Identification N.922623

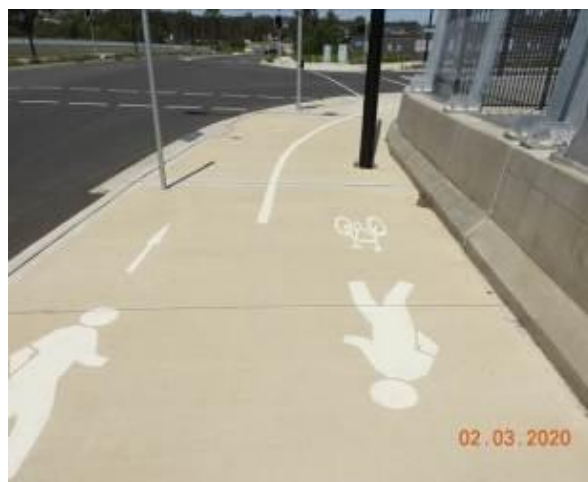
Figure 1183 – General Condition of footpath pavement

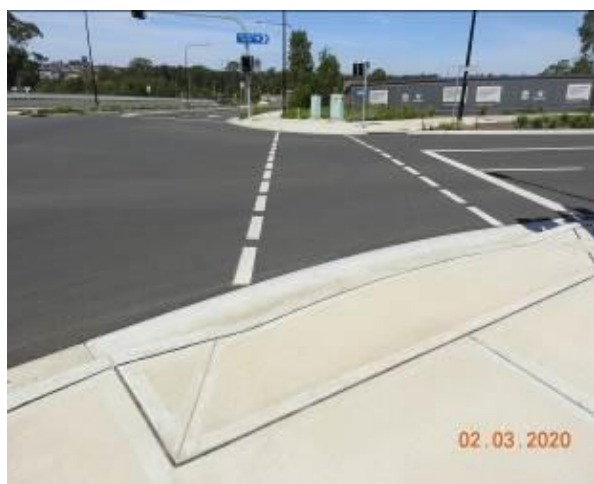
Figure 1184 – General Condition of footpath pavement

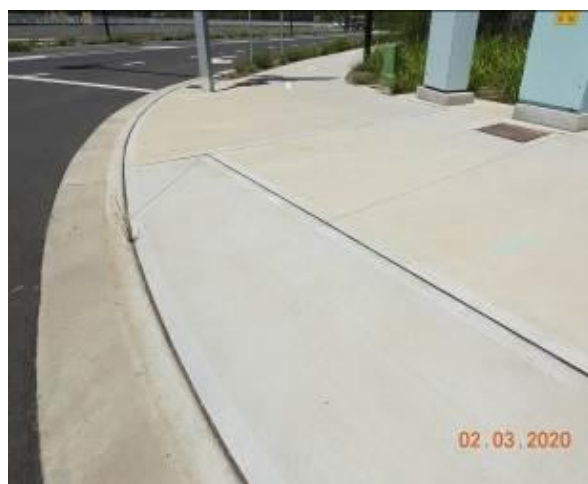
Figure 1185 – General Condition of footpath pavement

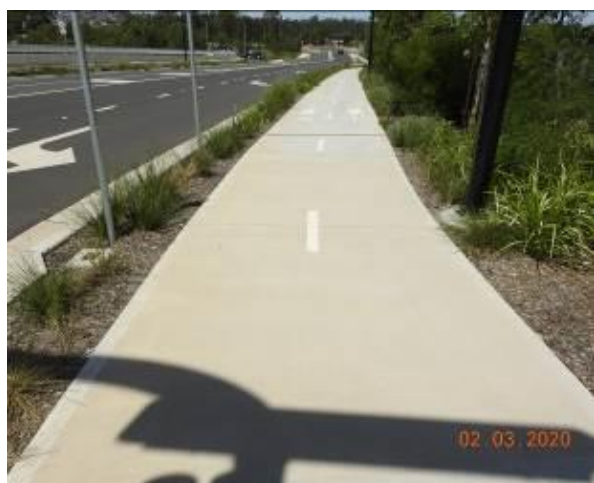
Figure 1186 – General Condition of footpath pavement

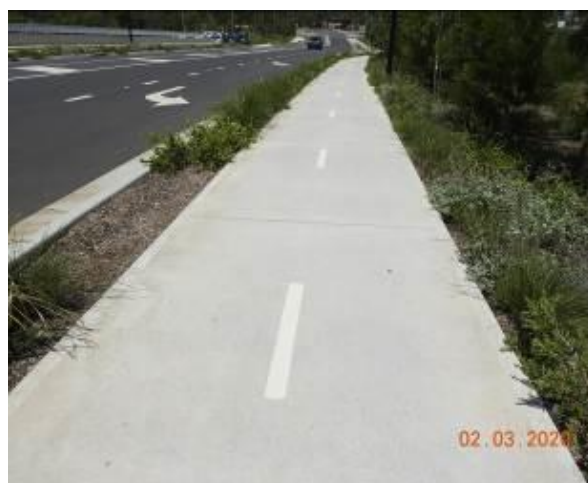
Figure 1187 – General Condition of footpath pavement

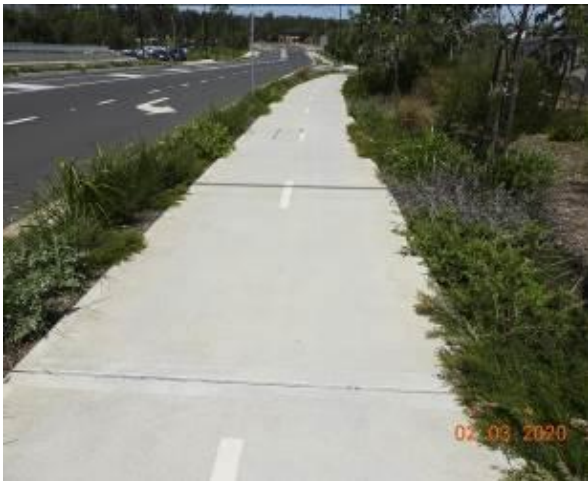
Figure 1188 – General Condition of footpath pavement

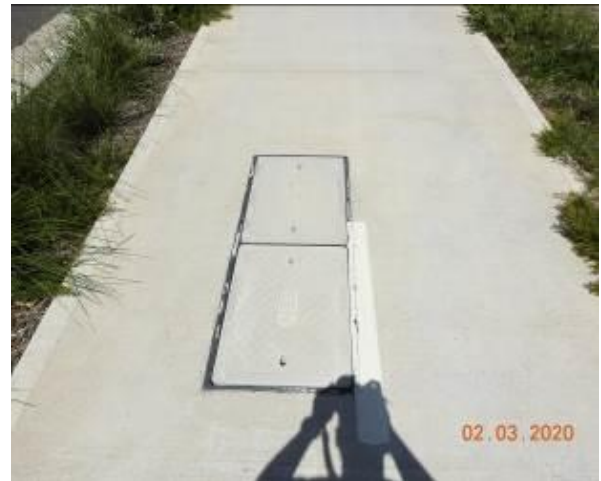
Figure 1189 – General Condition of service pit

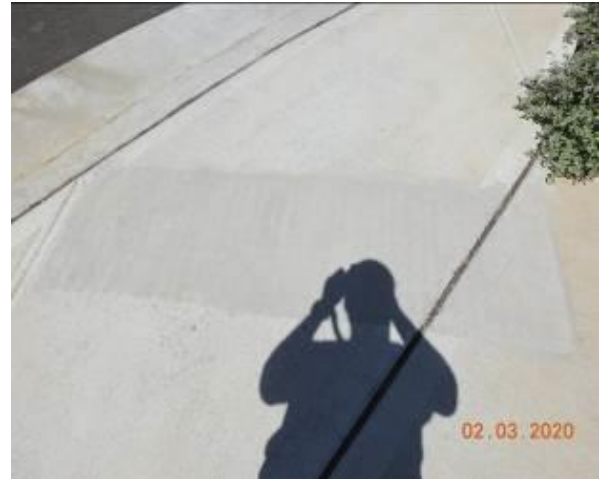
Figure 1195 – General Condition of footpath pavement

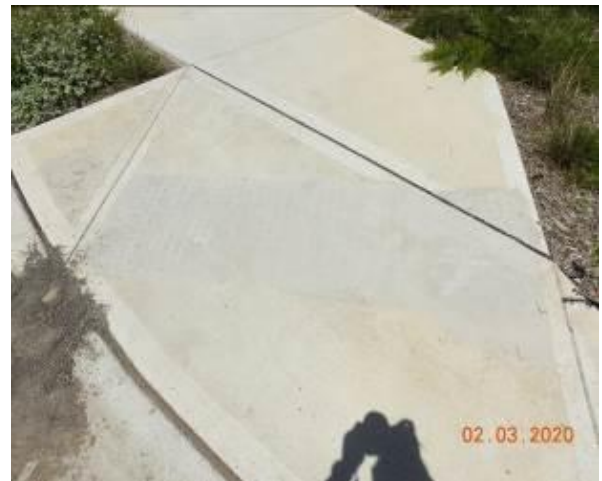
Figure 1197 – General Condition of footpath pavement

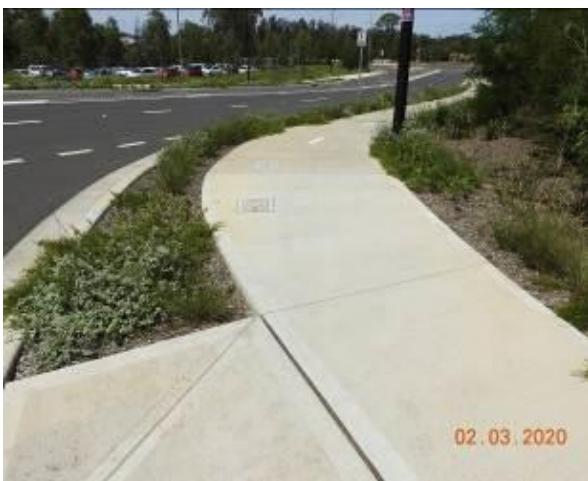
Figure 1198 – General Condition of footpath pavement

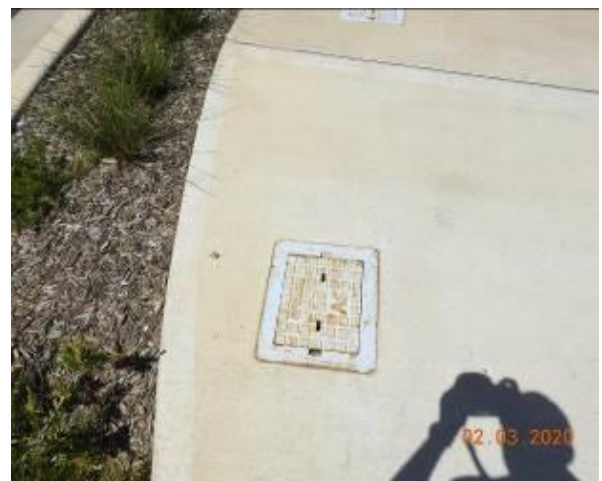
Figure 1199 – General Condition of service pit

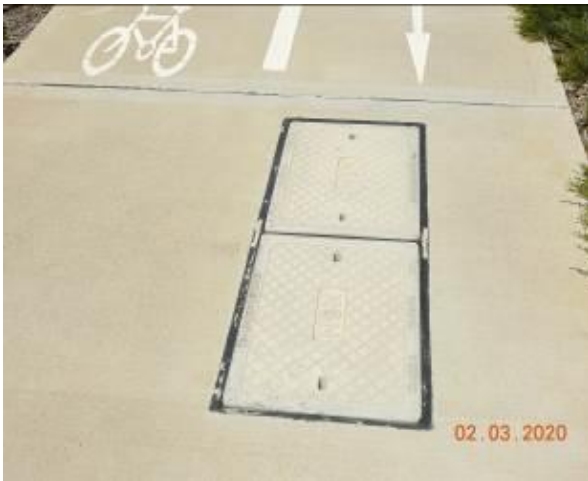
Figure 1206 – General Condition of service pit

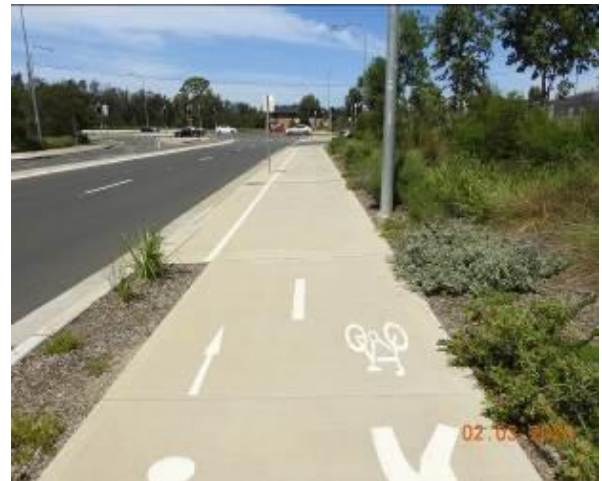
Figure 1207 – General Condition of footpath pavement

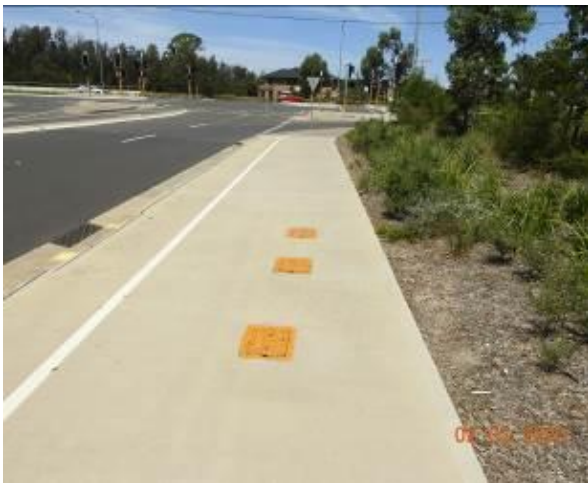
Figure 1208 – General Condition of footpath pavement

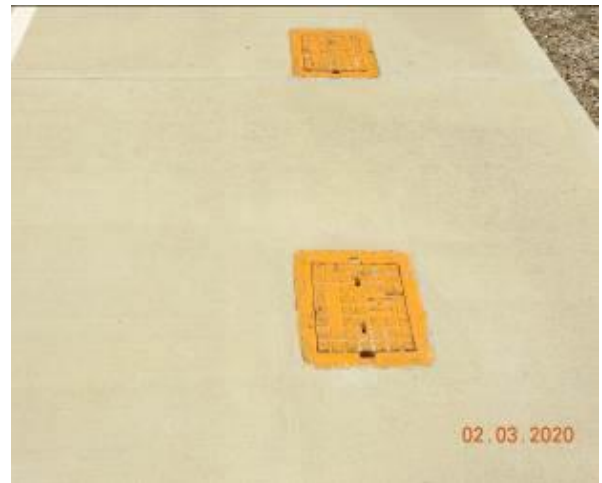
Figure 1209 – General Condition of service pit

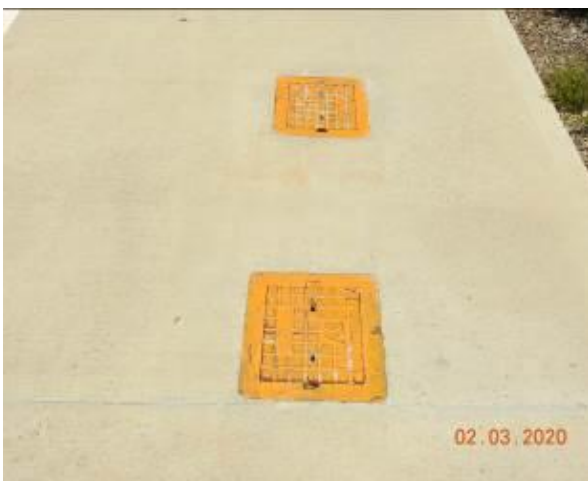
Figure 1210 – General Condition of service pit

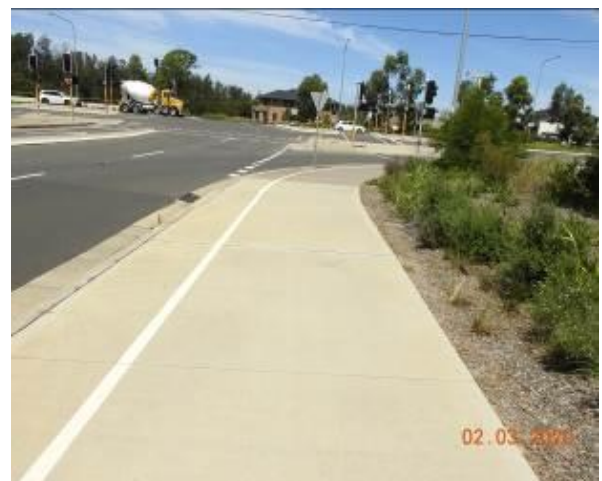
Figure 1211 – General Condition of footpath pavement

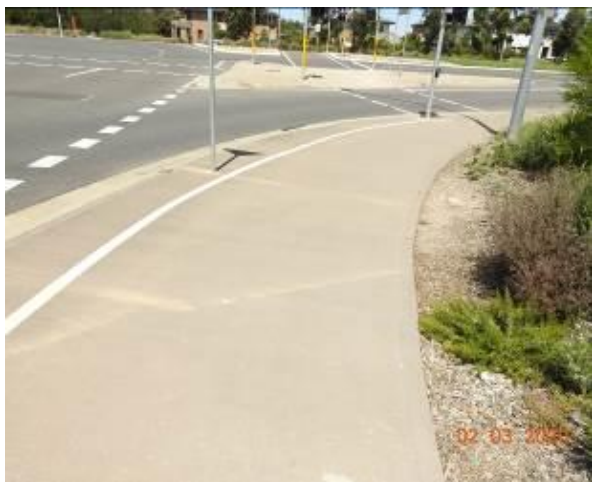
Figure 1212 – General Condition of footpath pavement

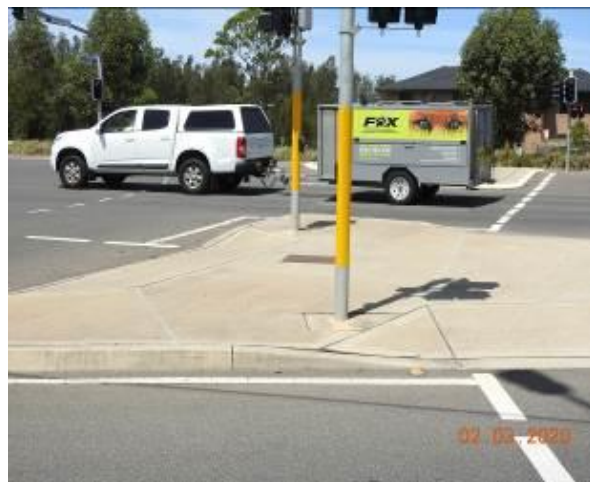
Figure 1213 – General Condition of footpath pavement

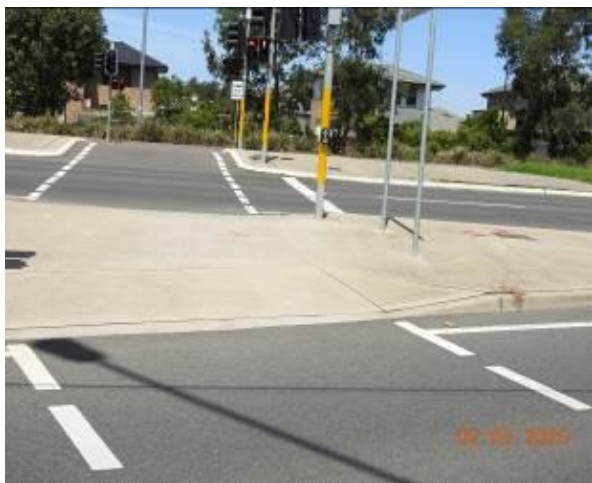
Figure 1214 – General Condition of footpath pavement

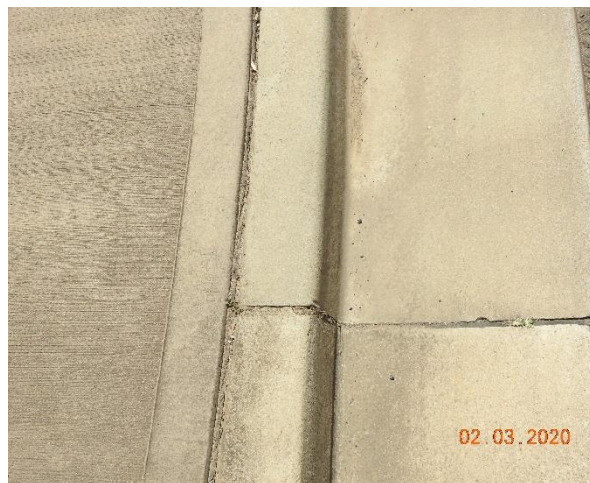
Figure 1215 – General Condition of kerb and gutter

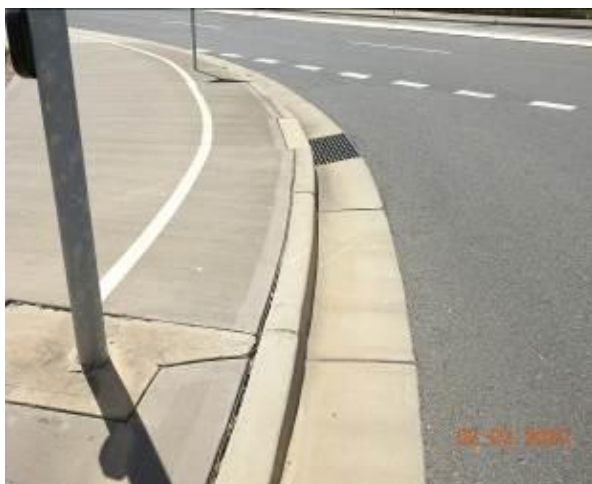
Figure 1216 – General Condition of kerb and gutter

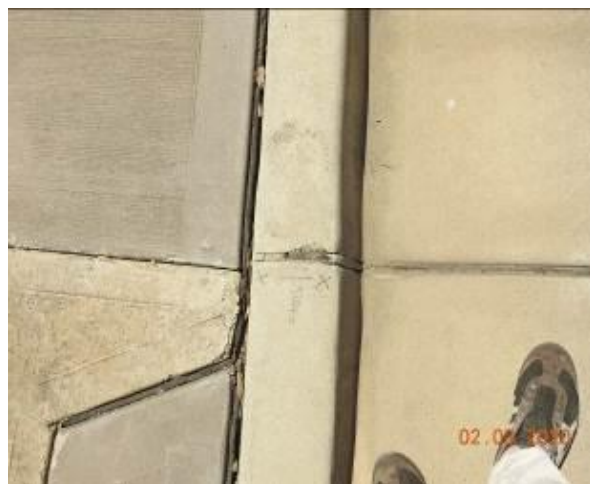
Figure 1217 – Loss of material through kerb and gutter

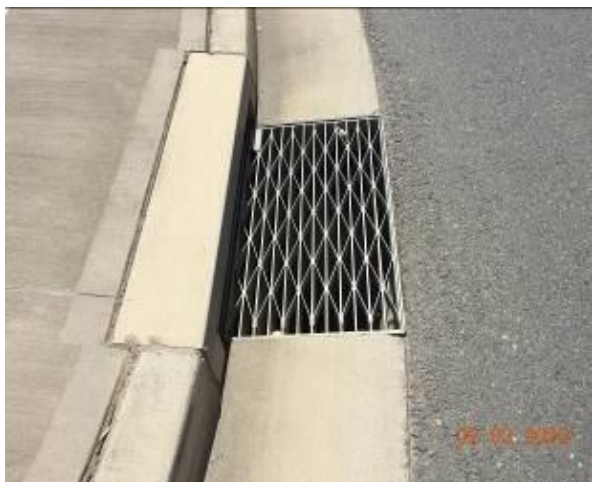
Figure 1218 – General Condition of stormwater inlet pit

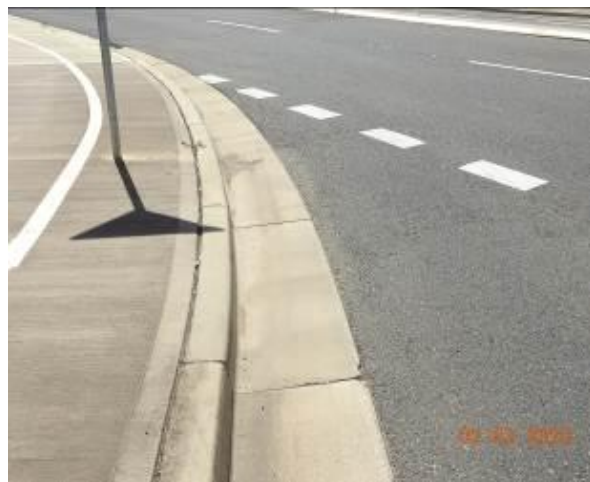
Figure 1219 – General Condition of kerb and gutter

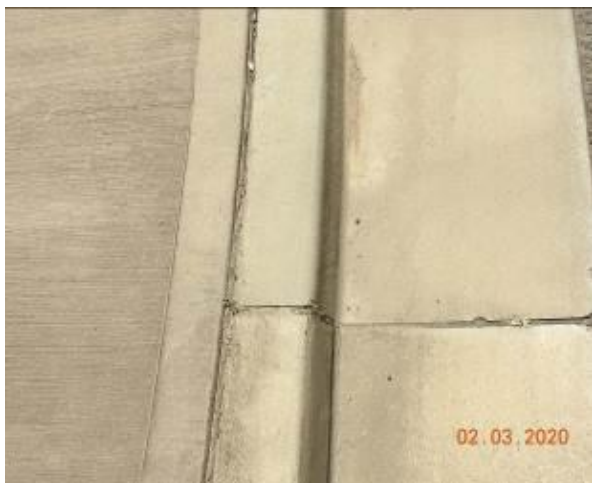
Figure 1220 – Loss of material through kerb and gutter

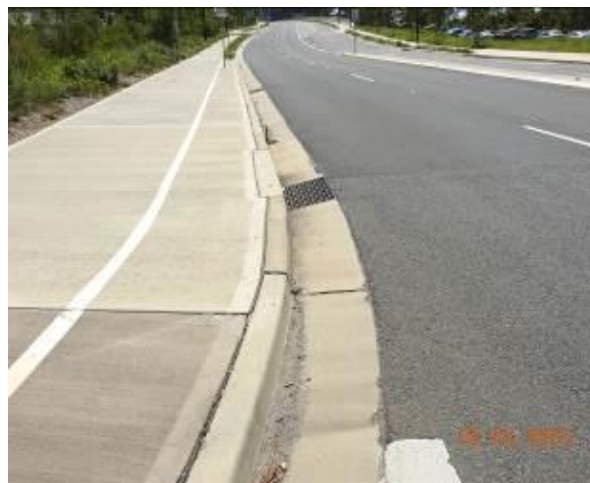
Figure 1221 – General Condition of kerb and gutter

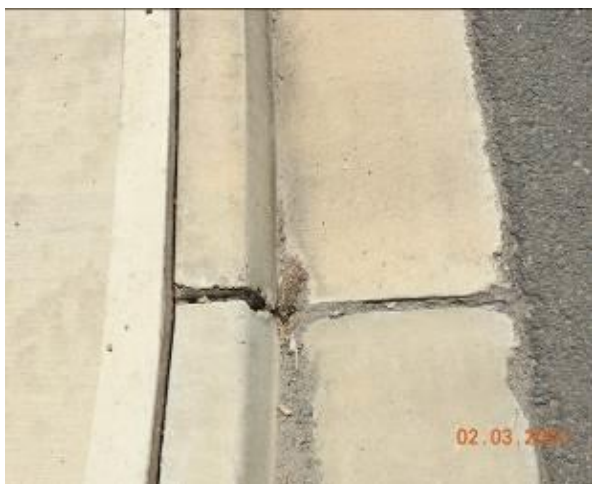
Figure 1222 – Loss of material through kerb and gutter

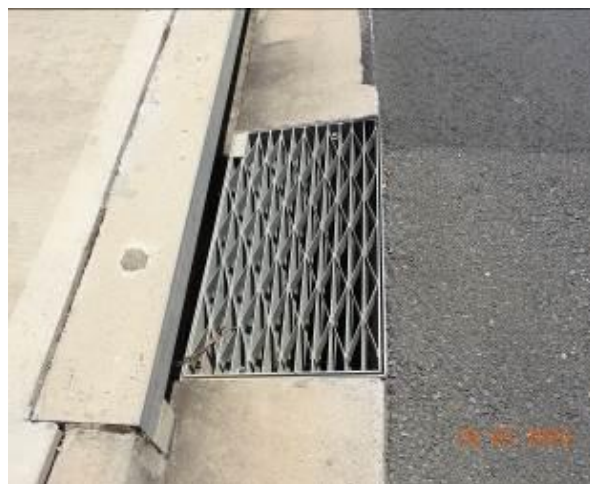
Figure 1223 – General Condition of stormwater inlet pit

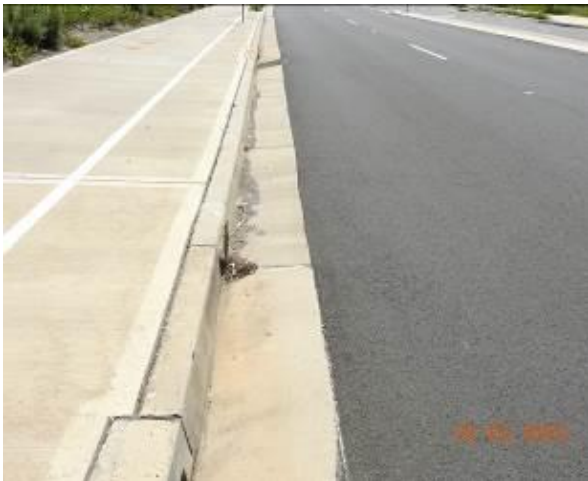
Figure 1224 – General Condition of kerb and gutter

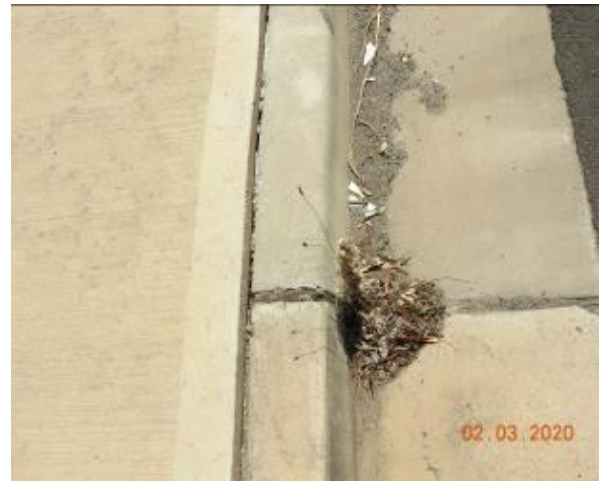
Figure 1225 – Crack propagation through kerb and gutter

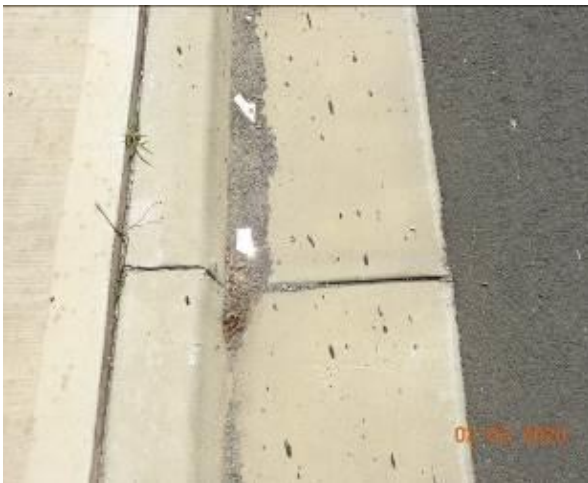
Figure 1226 – Crack propagation through kerb and gutter

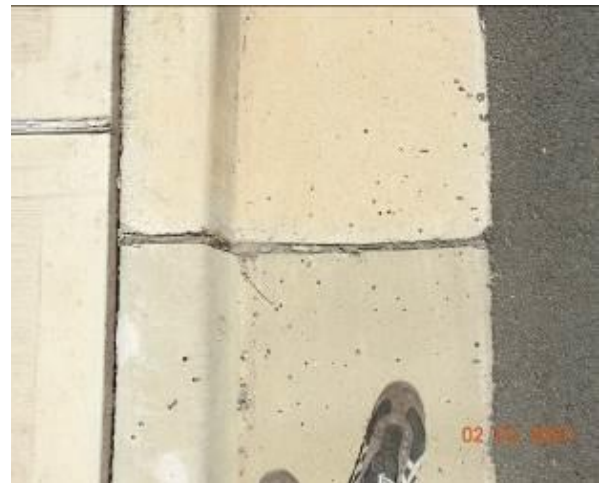
Figure 1227 – Crack propagation through kerb and gutter

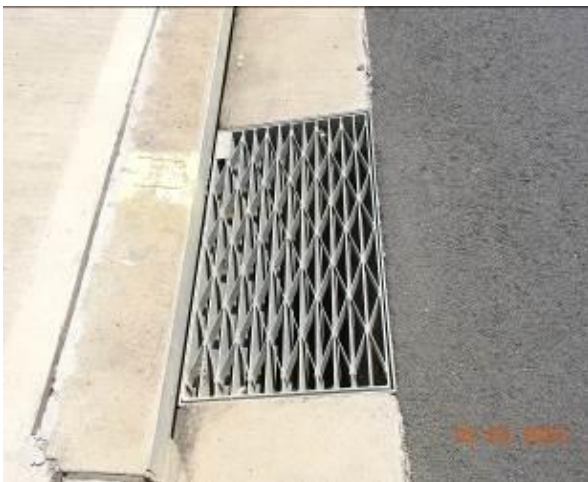
Figure 1228 – General Condition of stormwater inlet pit

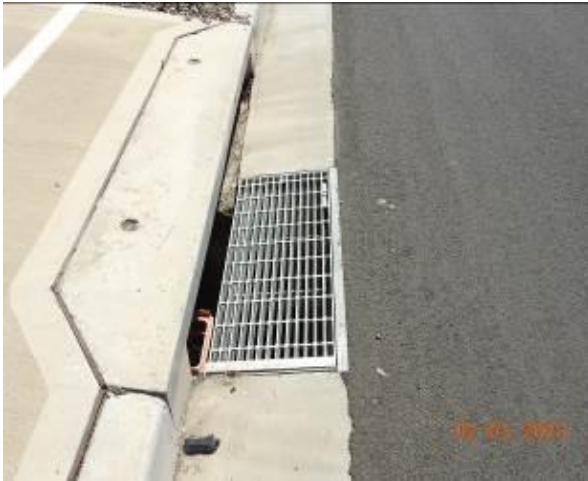
Figure 1236 – General Condition of stormwater inlet pit

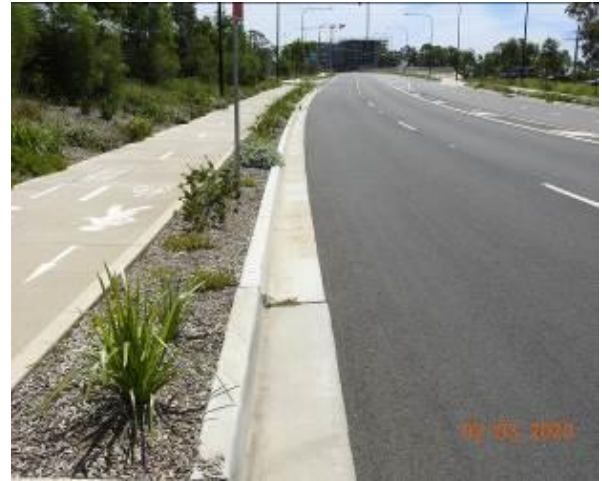
Figure 1237 – General Condition of kerb and gutter

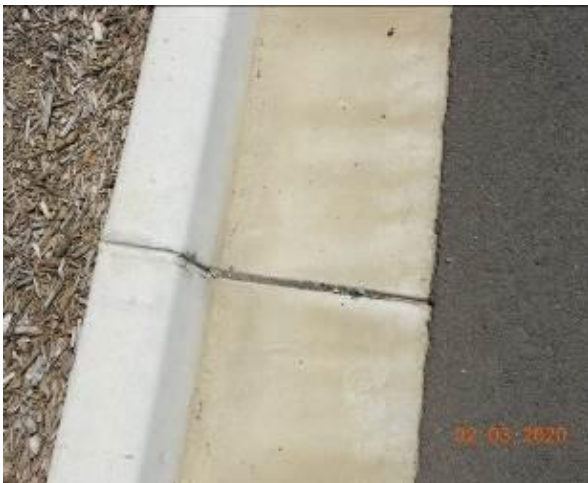
Figure 1238 – Crack propagation through kerb and gutter

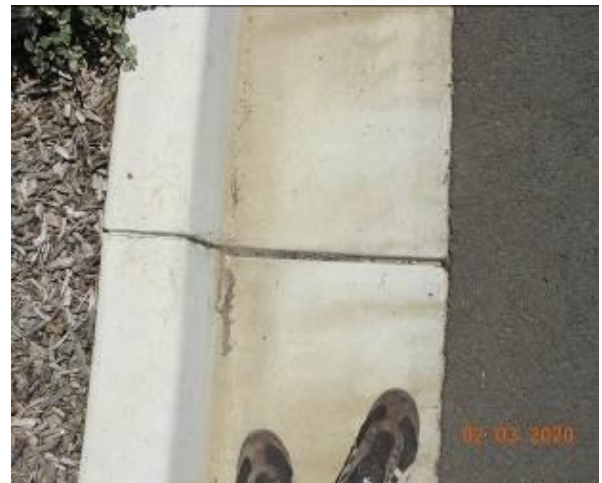
Figure 1239 – Crack propagation through kerb and gutter

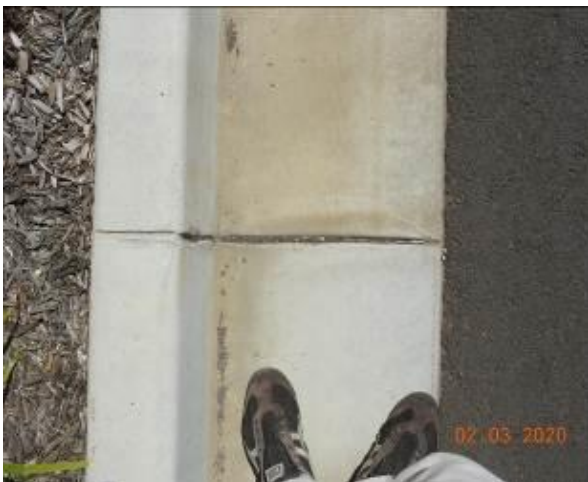
Figure 1240 – Crack propagation through kerb and gutter

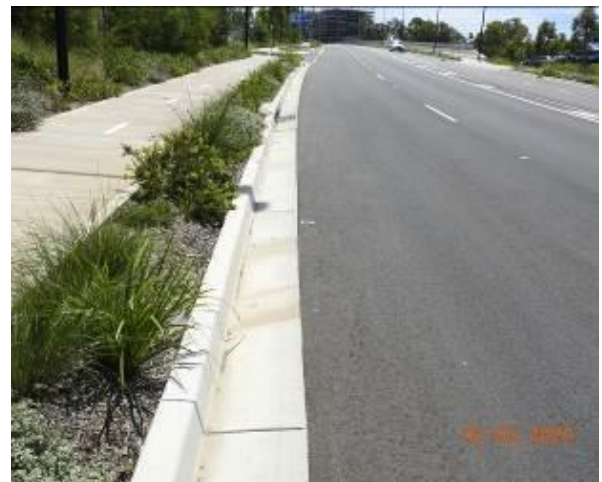
Figure 1241 – General Condition of kerb and gutter
