**1-15 AND 2-12 CONFERTA AVENUE,
ROUSE HILL NSW 2155
TALLAWONG STATION PRECINCT SOUTH
PRE-DILAPIDATION REPORT**

**DEICORP PROJECTS
(TALLAWONG STATION) PTY LTD**

Job No. 191294.0
24/03/2020

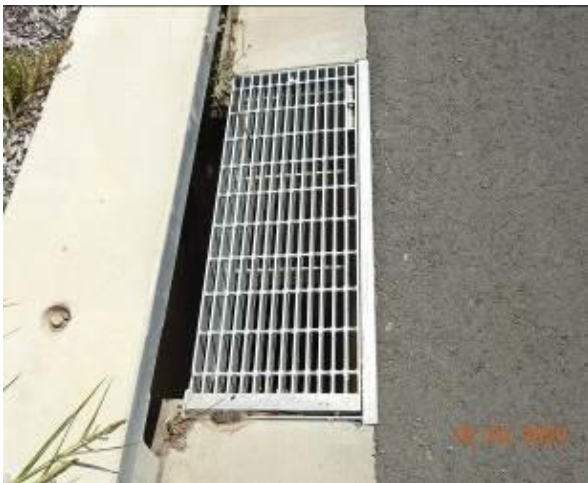
Figure 1244 – General Condition of stormwater inlet pit

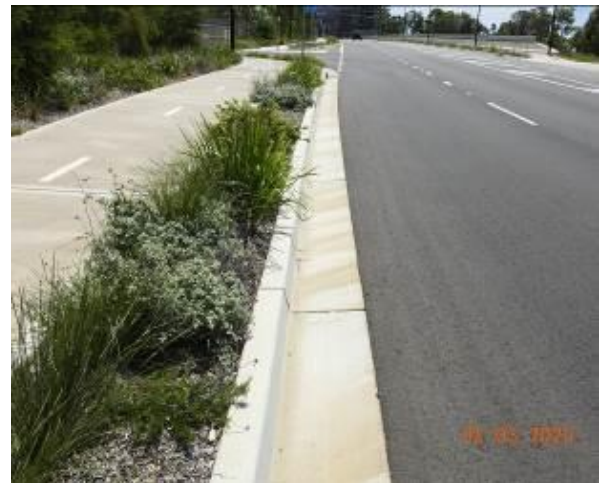
Figure 1245 – General Condition of kerb and gutter

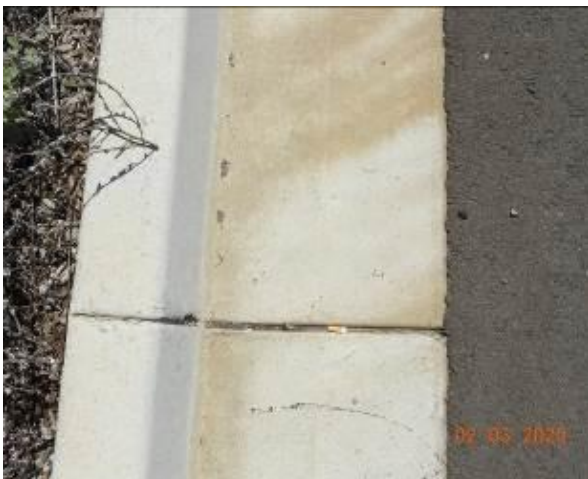
Figure 1246 – Crack propagation through kerb

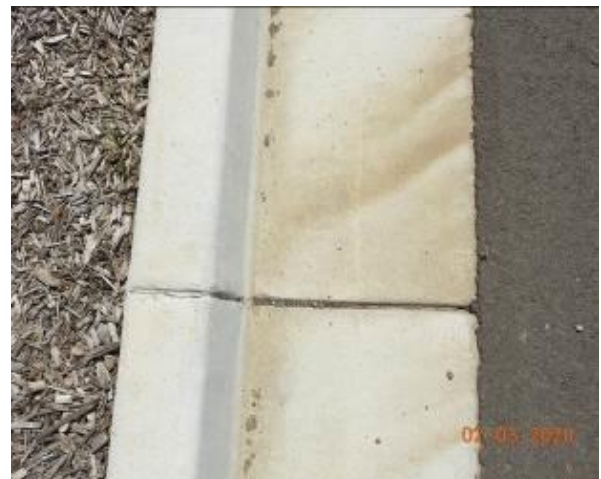
Figure 1247 – Crack propagation through kerb

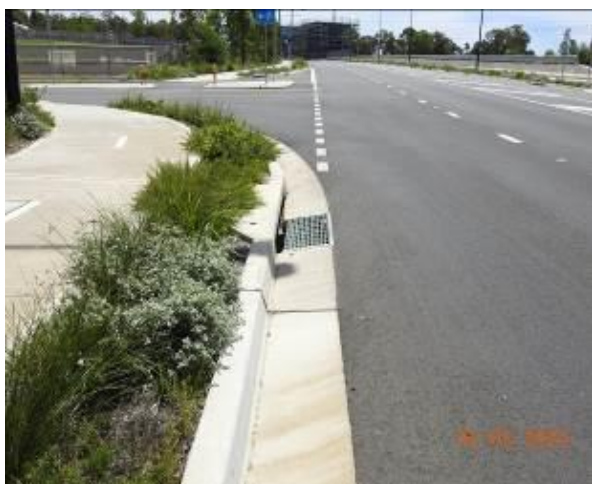
Figure 1248 – General Condition of kerb and gutter

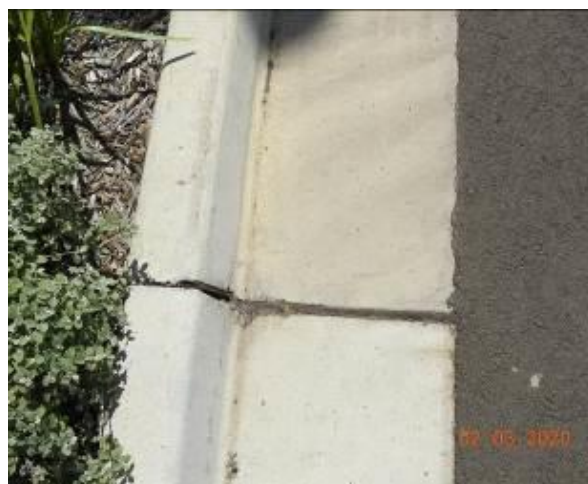
Figure 1249 – Loss of material through kerb

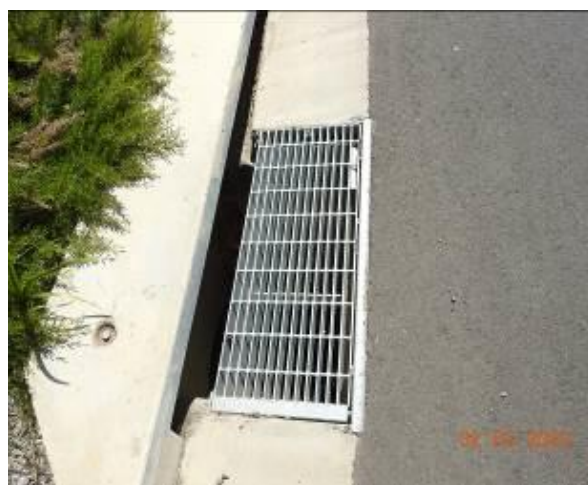
Figure 1251 – General Condition of stormwater inlet pit

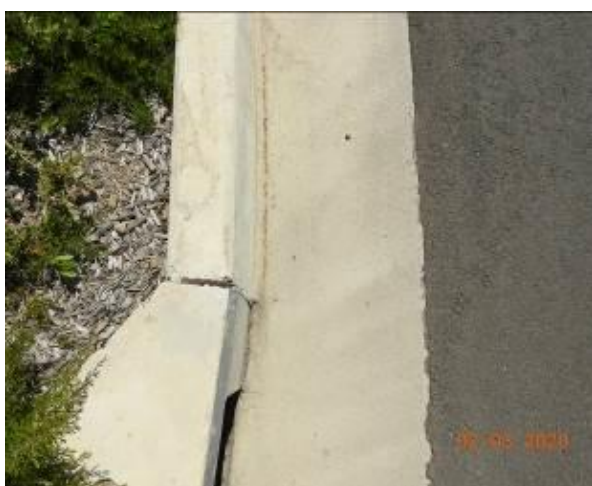
Figure 1252 – Crack propagation through kerb

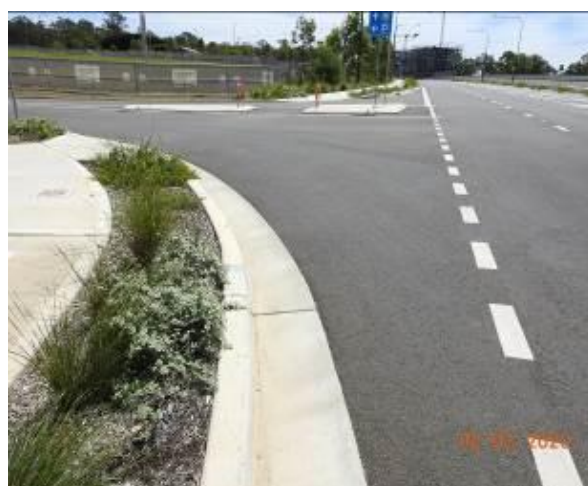
Figure 1253 – General Condition of kerb and gutter

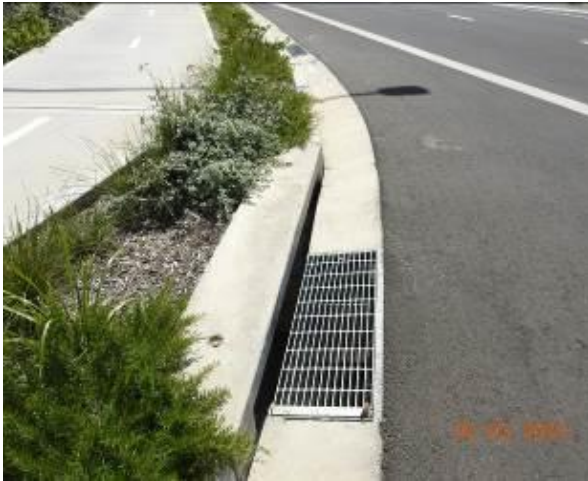
Figure 1254 – General Condition of stormwater inlet pit

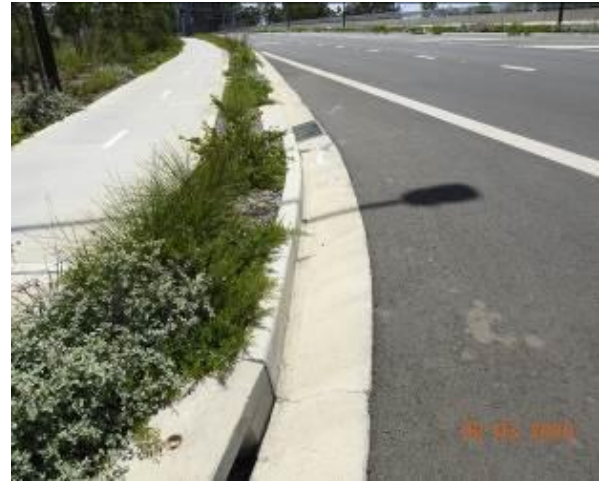
Figure 1255 – General Condition of kerb and gutter

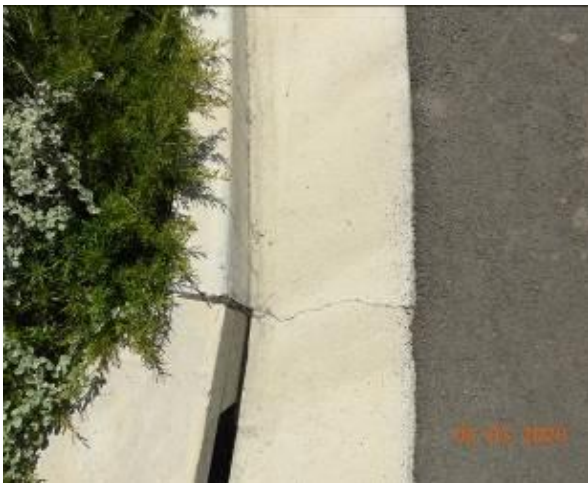
Figure 1256 – Crack propagation through kerb and gutter

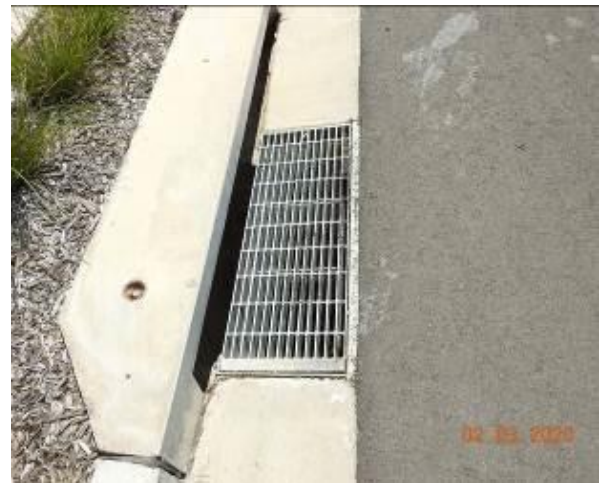
Figure 1257 – General Condition of stormwater inlet pit

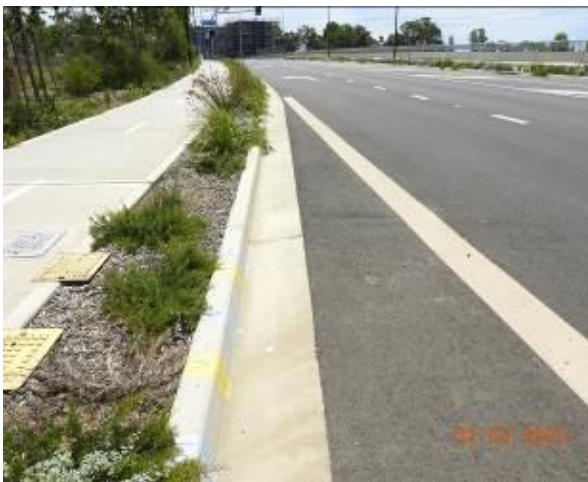
Figure 1258 – General Condition of kerb and gutter

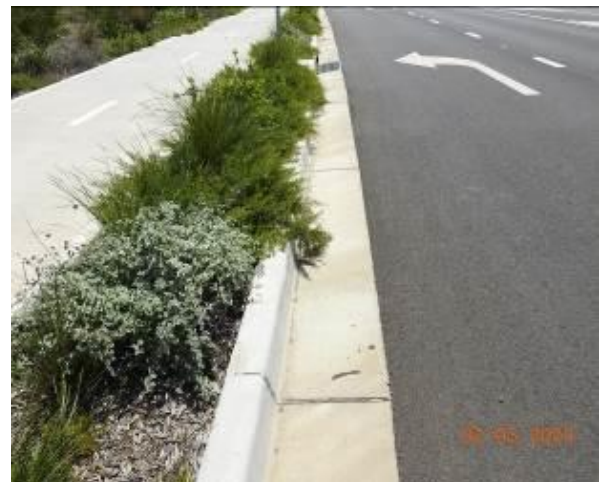
Figure 1259 – General Condition of kerb and gutter

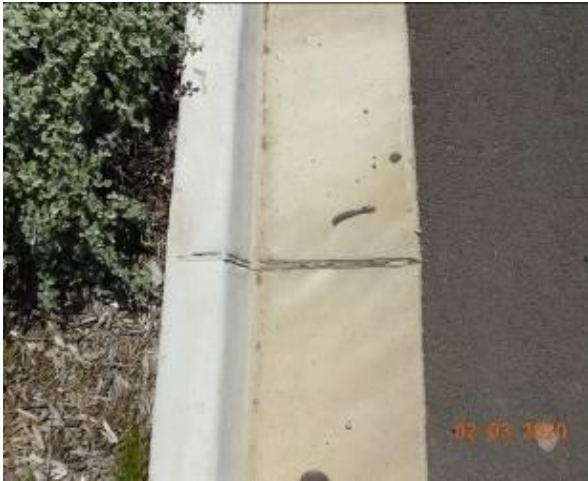
Figure 1260 – Crack propagation through kerb and gutter

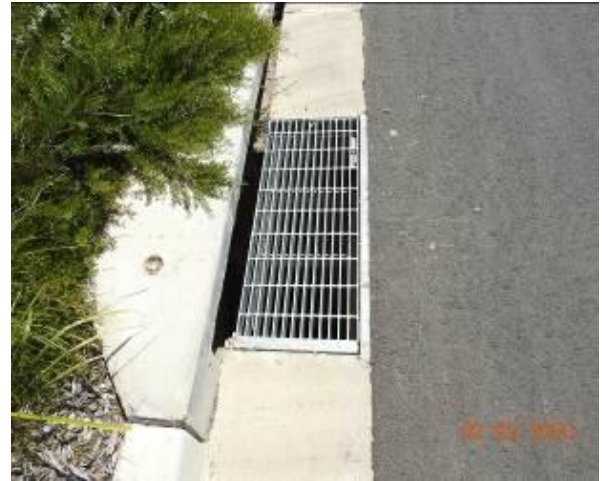
Figure 1261 – General Condition of stormwater inlet pit

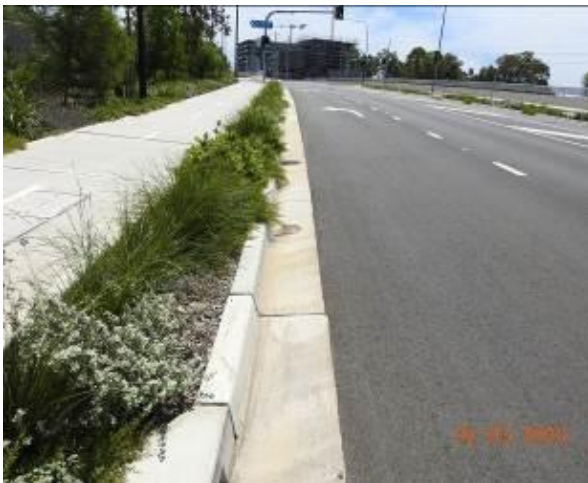
Figure 1262 – General Condition of kerb and gutter

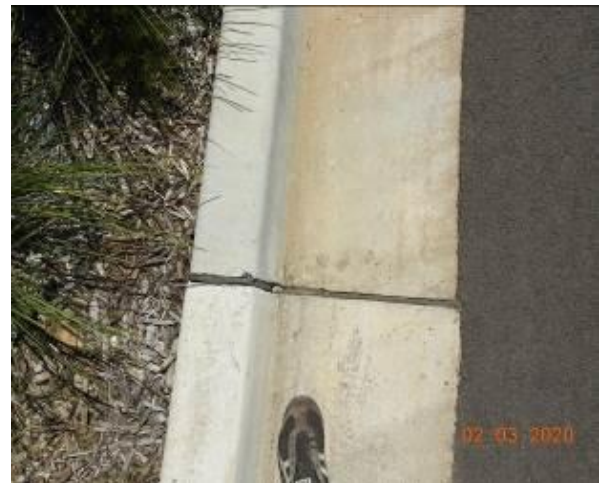
Figure 1263 – Crack propagation through kerb and gutter

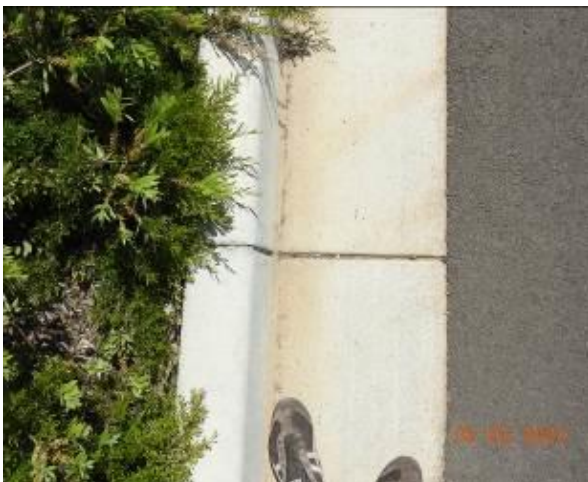
Figure 1264 – Crack propagation through kerb and gutter

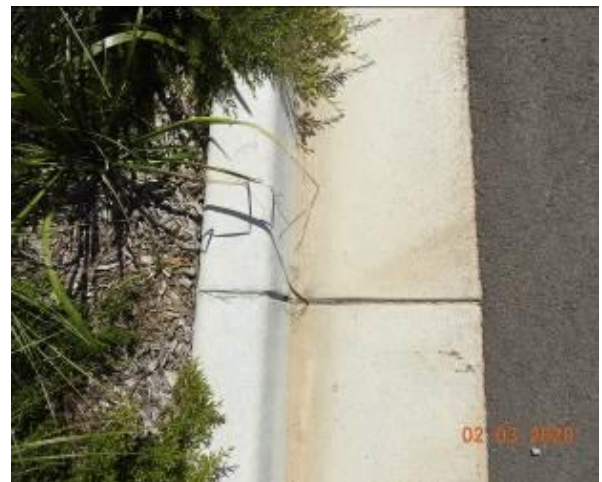
Figure 1265 – Crack propagation through kerb and gutter

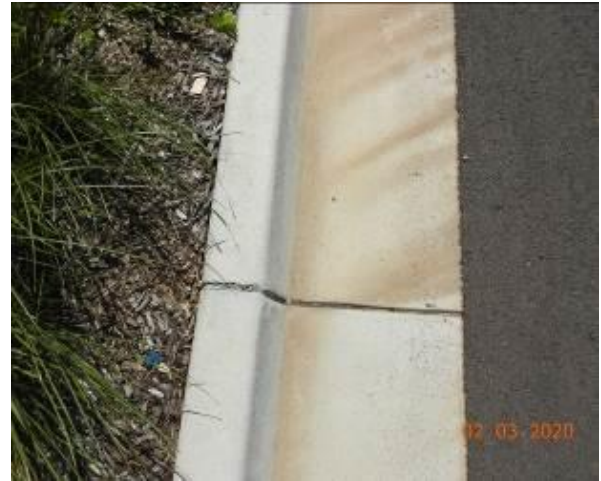
Figure 1266 – General Condition of kerb and gutter

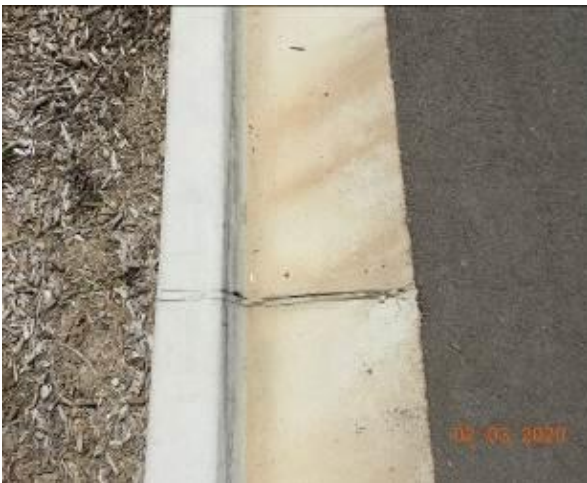
Figure 1267 – Crack propagation through kerb and gutter

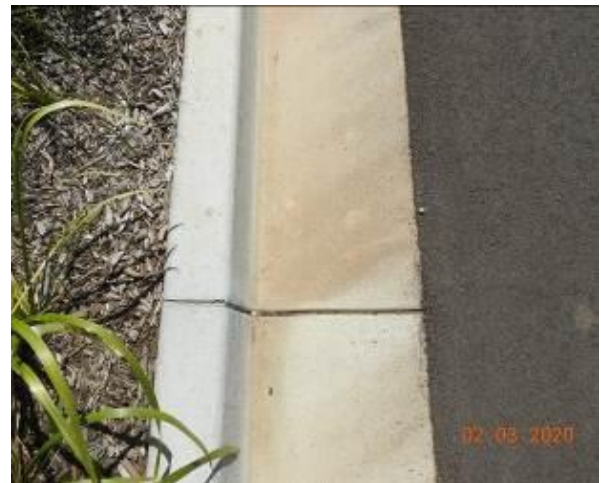
Figure 1268 – Crack propagation through kerb and gutter

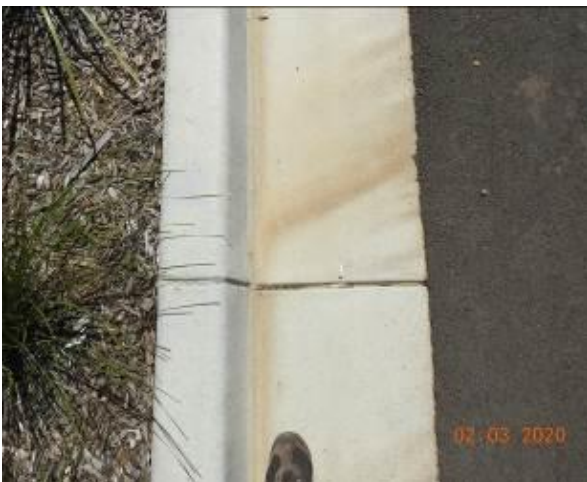
Figure 1269 – Crack propagation through kerb and gutter

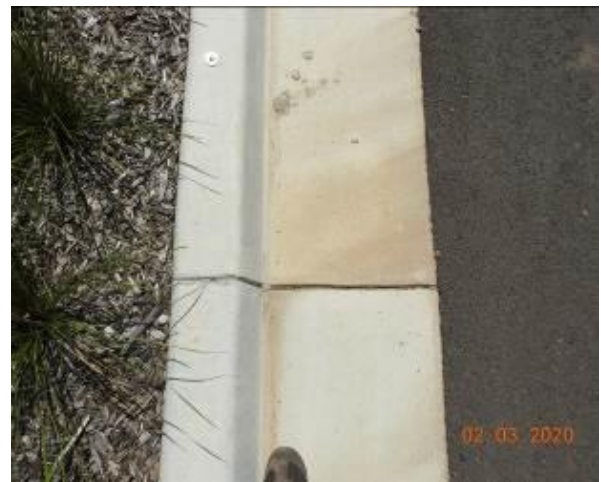
Figure 1270 – Crack propagation through kerb and gutter

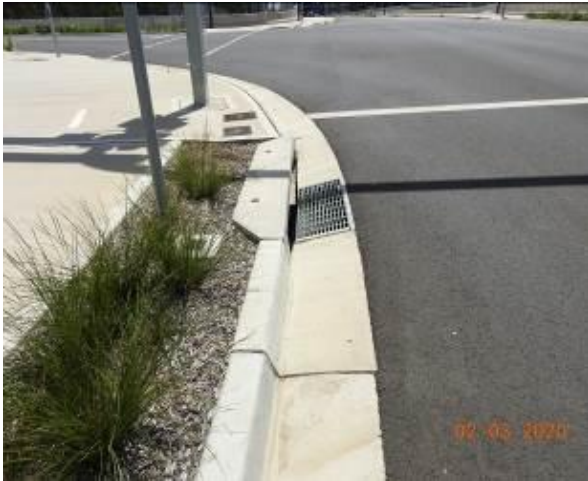
Figure 1271 – Crack propagation through kerb and gutter

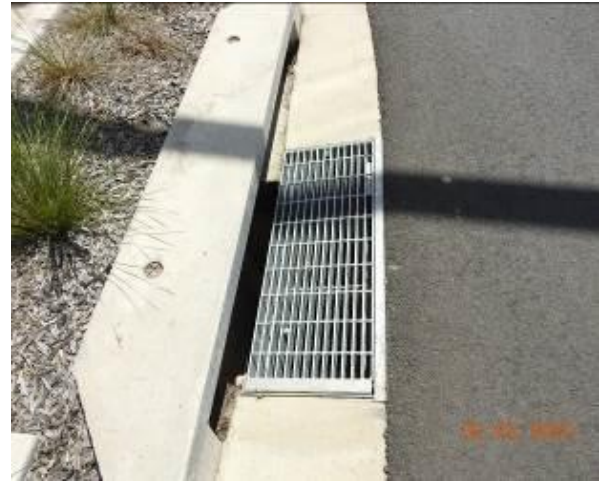
Figure 1272 – General Condition of kerb and gutter

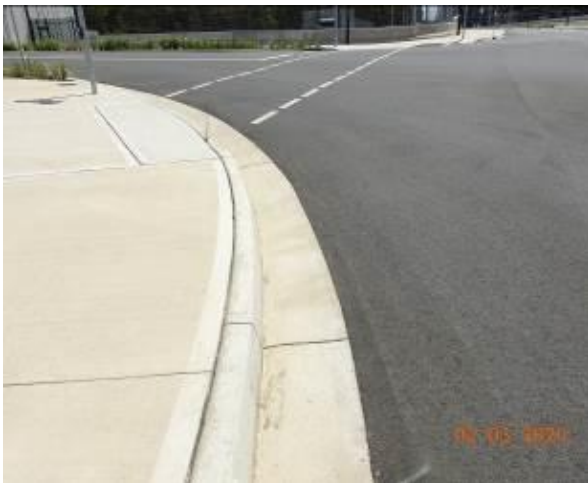
Figure 1273 – General Condition of stormwater inlet pit

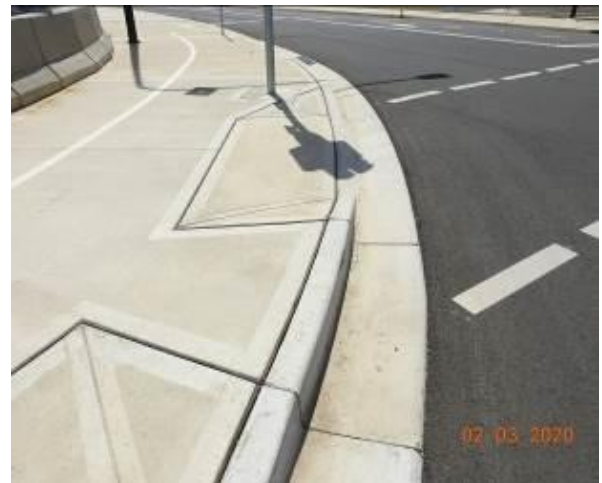
Figure 1274 – General Condition of kerb and gutter

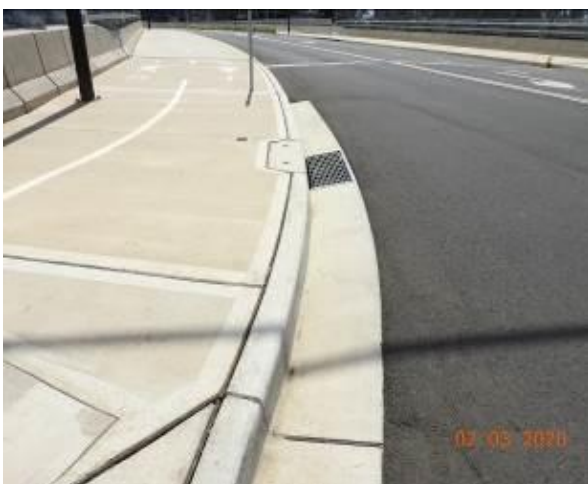
Figure 1275 – General Condition of kerb and gutter

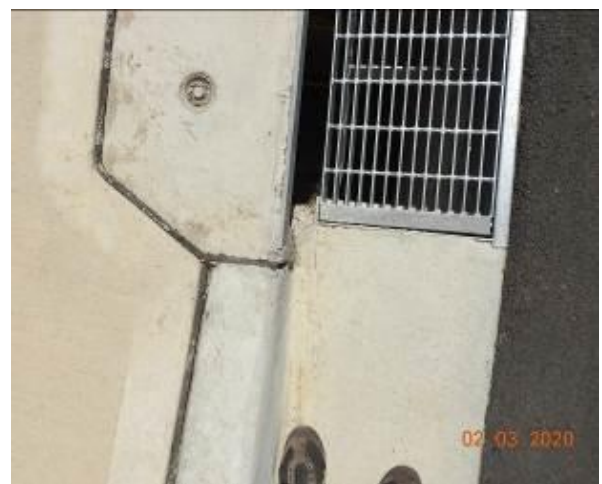
Figure 1276 – General Condition of kerb and gutter

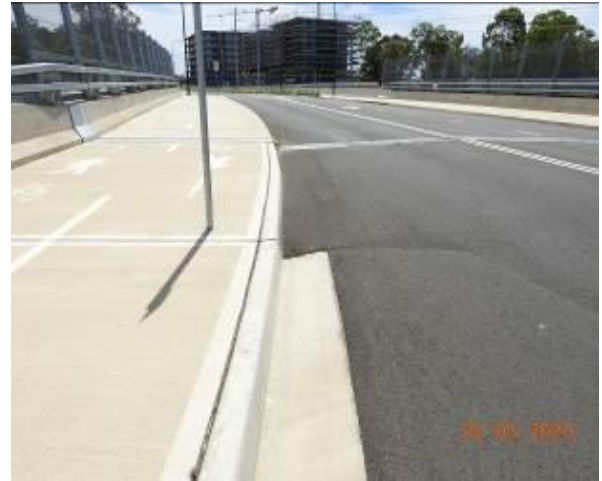
Figure 1278 – General Condition of stormwater inlet pit

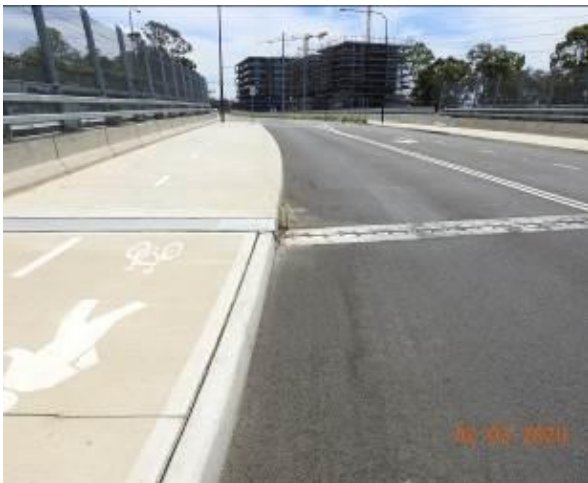
Figure 1279 – General Condition of kerb and gutter

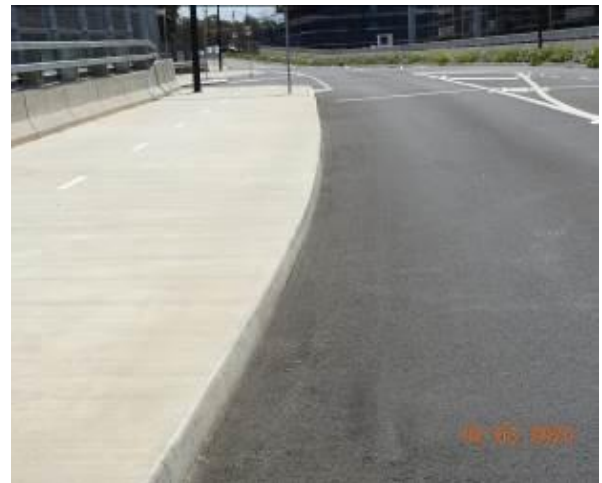
Figure 1280 – General Condition of kerb and gutter

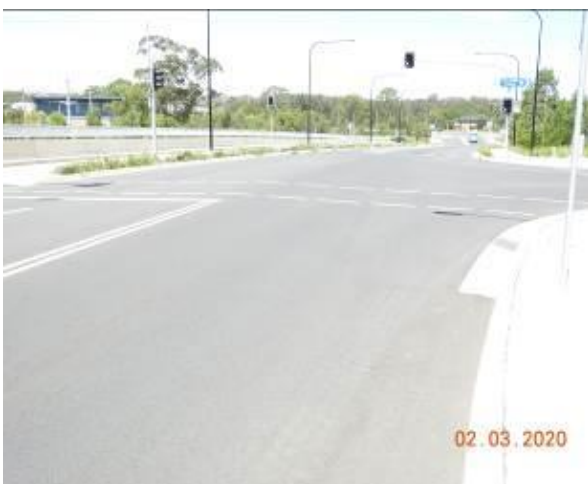
Figure 1281 – General Condition of kerb and gutter

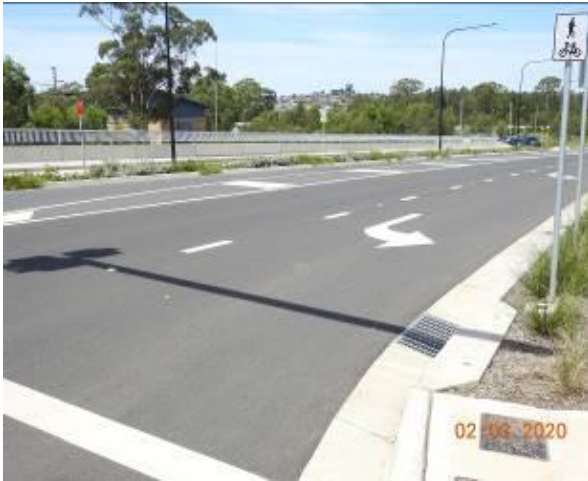
Figure 1283 – General Condition of road surface

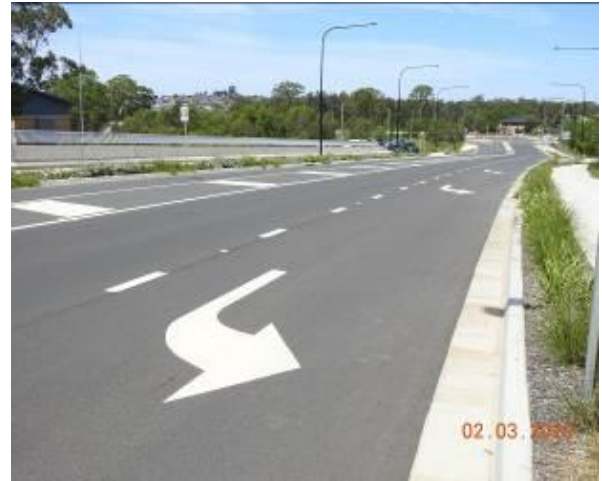
Figure 1284 – General Condition of road surface

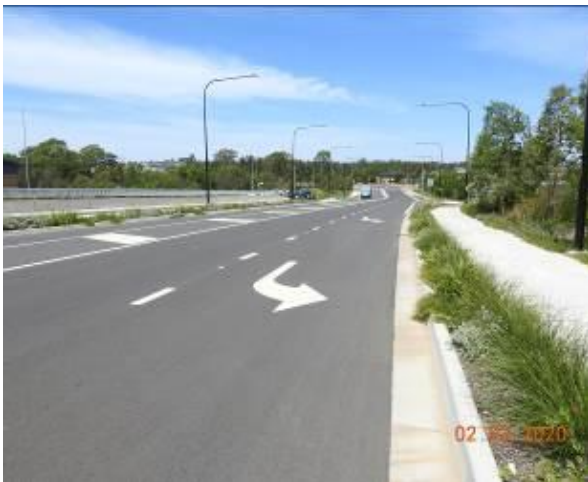
Figure 1285 – General Condition of road surface

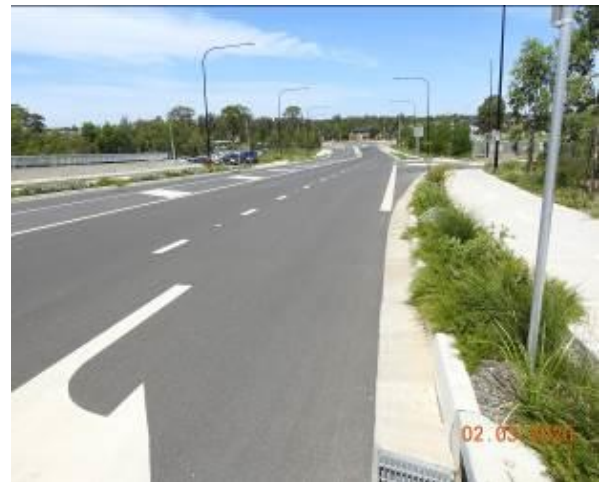
Figure 1286 – General Condition of road surface

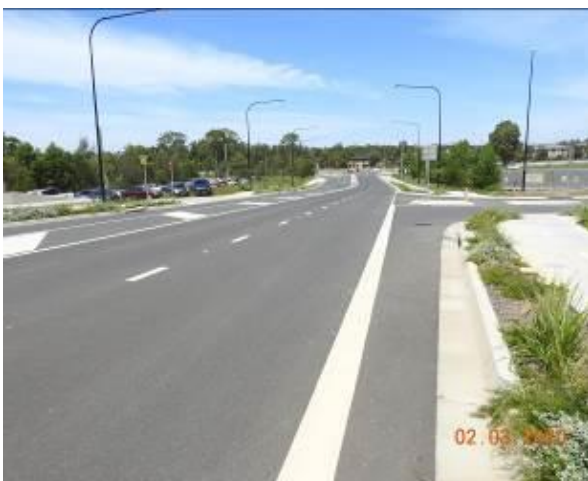
Figure 1287 – General Condition of road surface

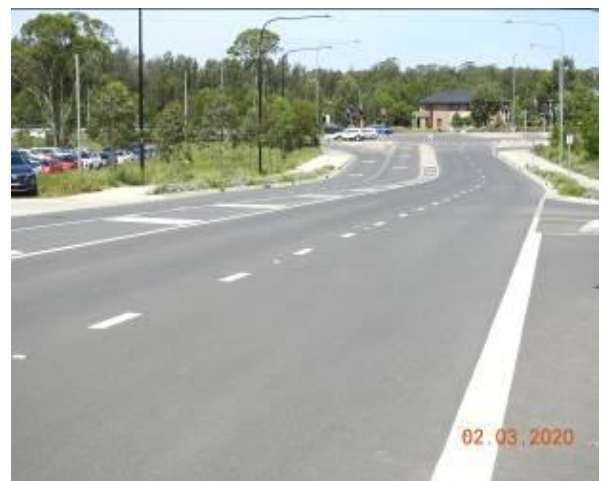
Figure 1288 – General Condition of road surface

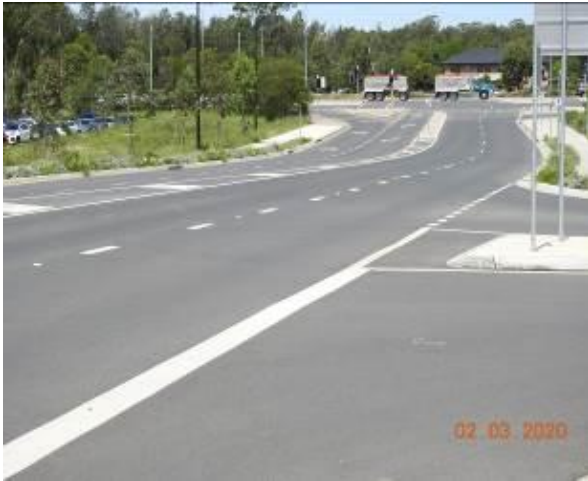
Figure 1289 – General Condition of road surface

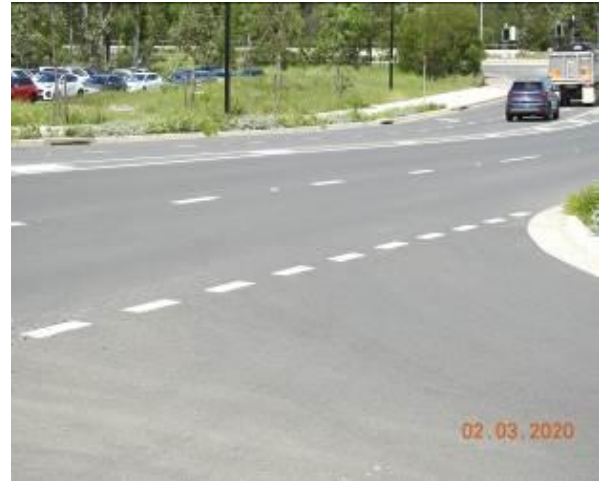
Figure 1290 – General Condition of road surface

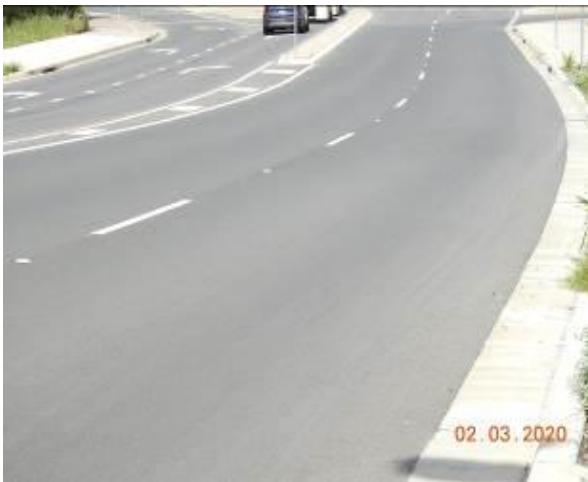
Figure 1291 – General Condition of road surface

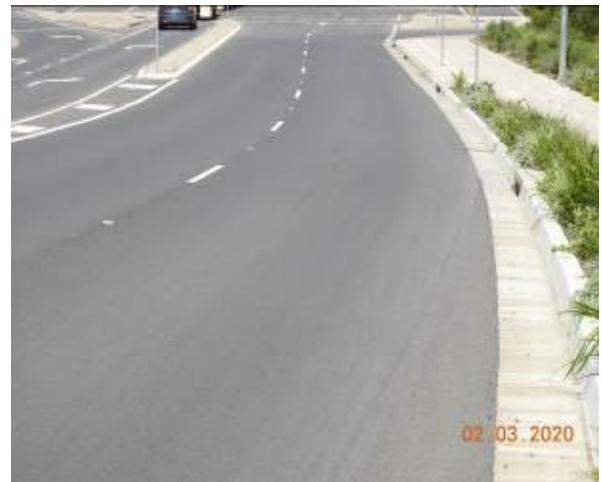
Figure 1292 – General Condition of road surface

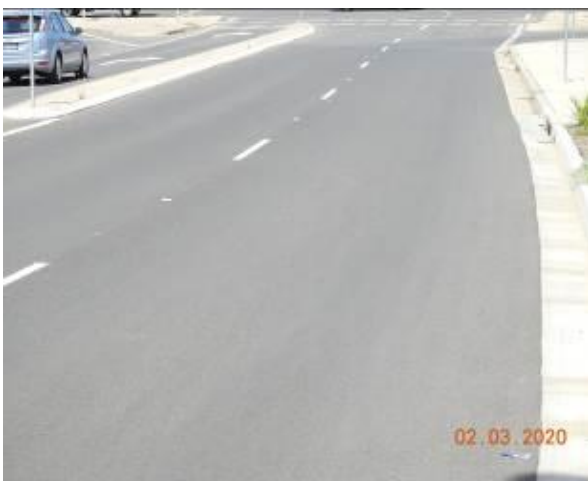
Figure 1293 – General Condition of road surface

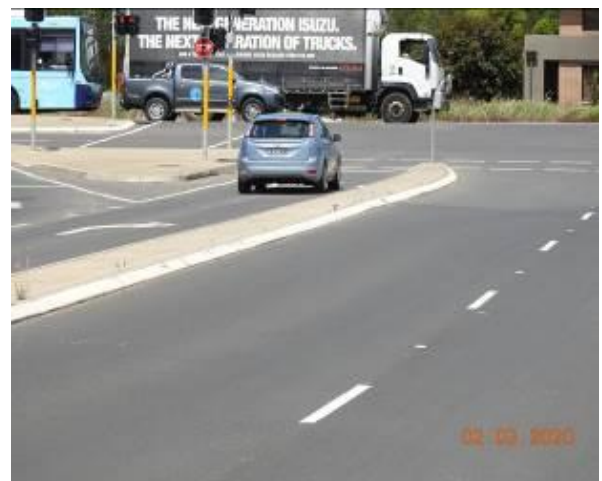
Figure 1294 – General Condition of road surface

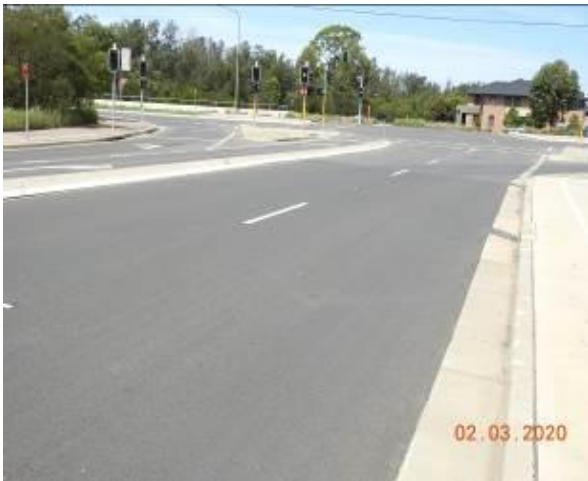
Figure 1295 – General Condition of road surface

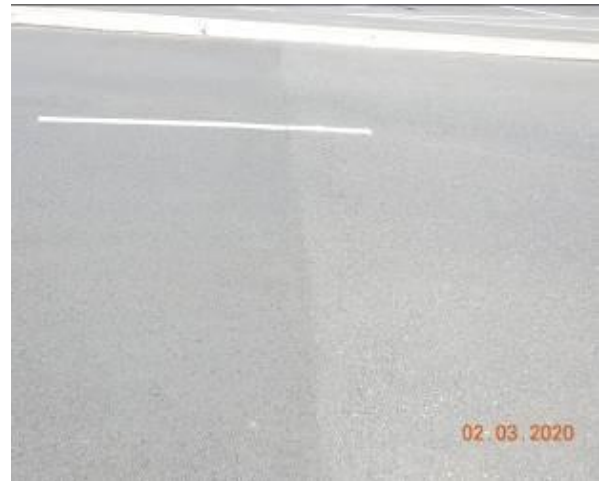
Figure 1296 – General Condition of road surface

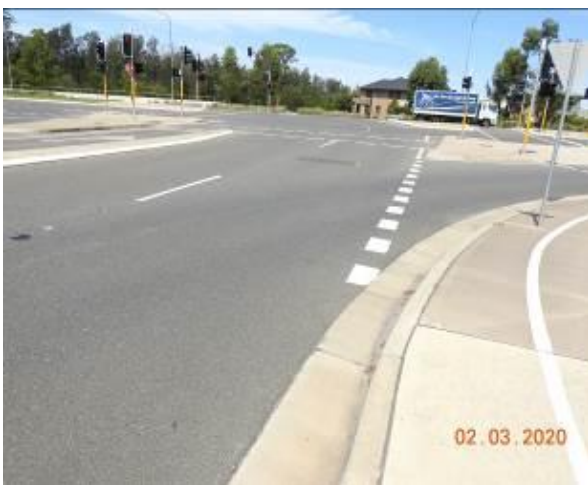
Figure 1297 – General Condition of road surface

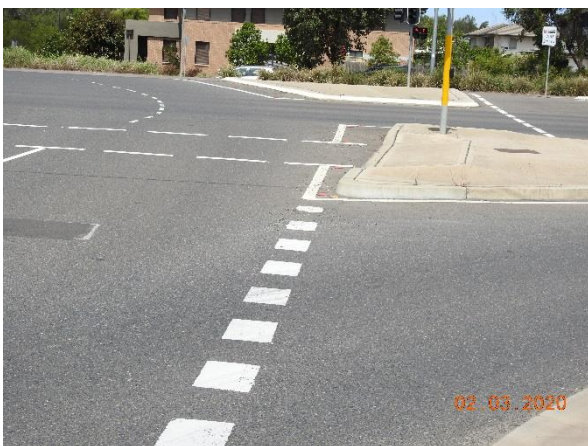
Figure 1299 – General Condition of road surface

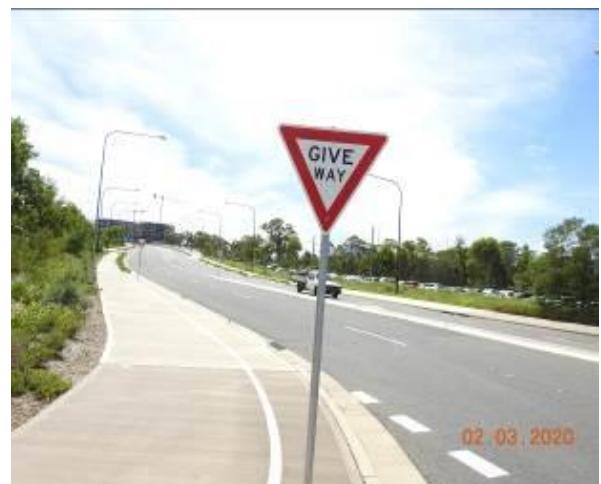
Figure 1300 – General Condition of road surface

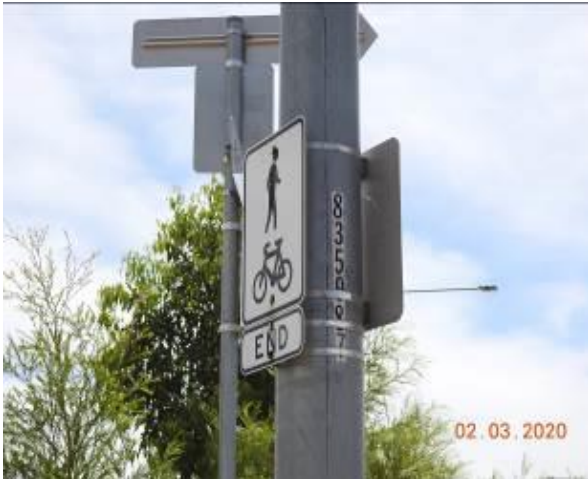
Figure 1301 – General Condition of street sign

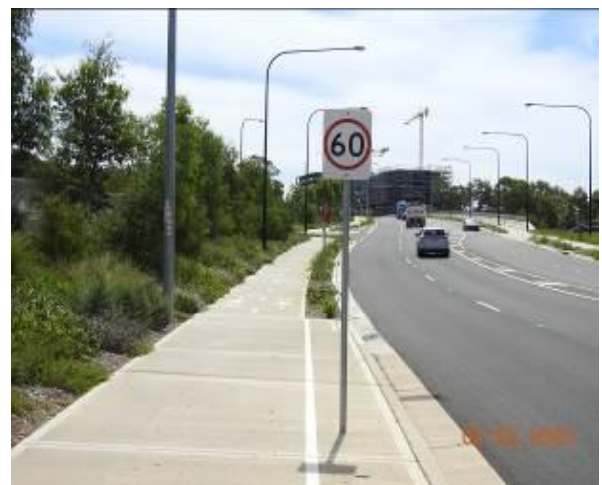
Figure 1304 – General Condition of street sign

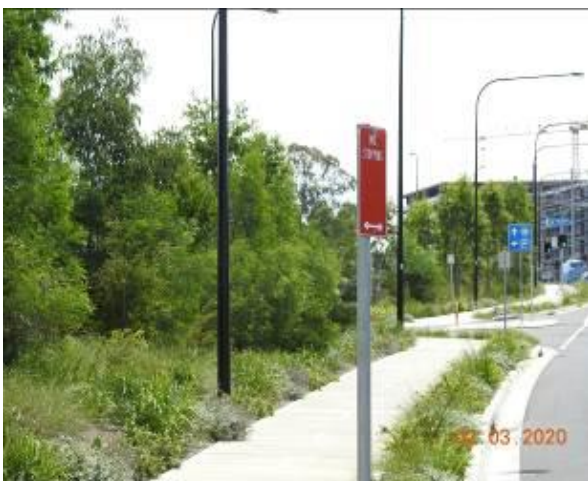
Figure 1305 – General Condition of street sign

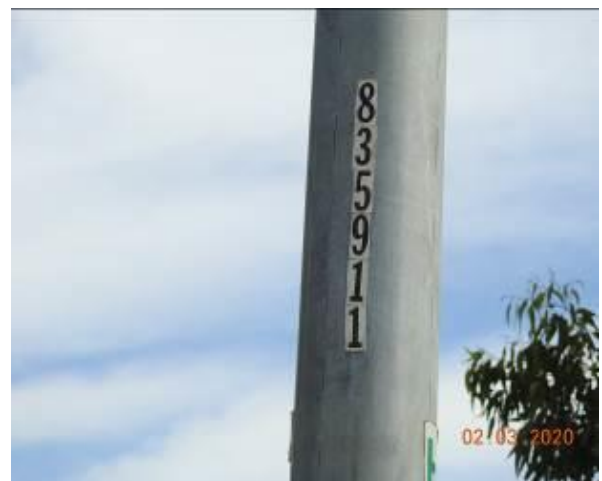
Figure 1306 – General Condition of street sign

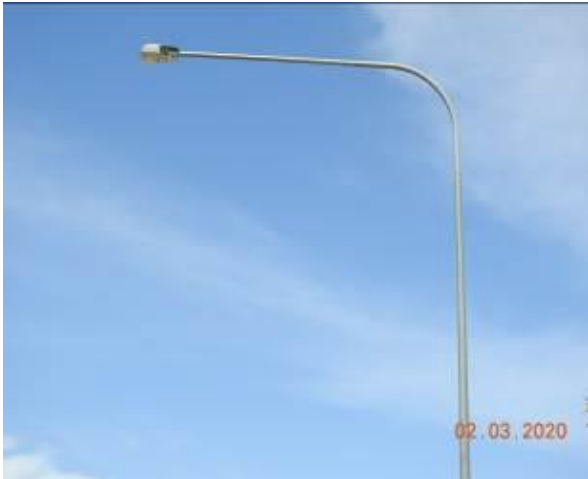
Figure 1308 – General Condition of lamp post

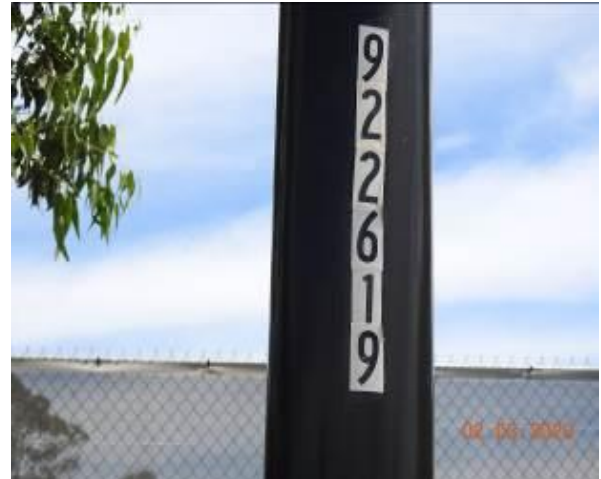
Figure 1309 – General Condition of lamp post
Identification No.922619

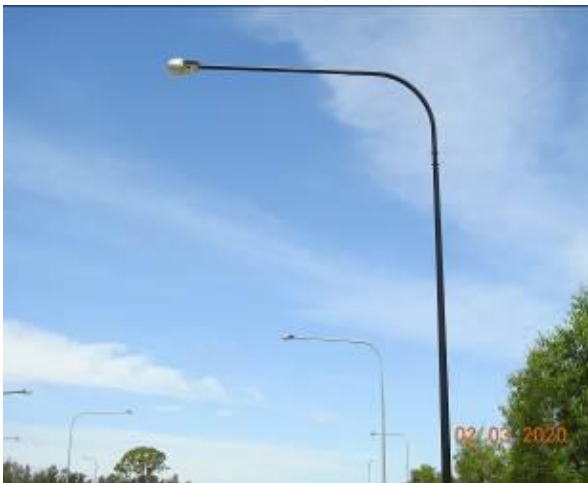
Figure 1310 – General Condition of lamp post

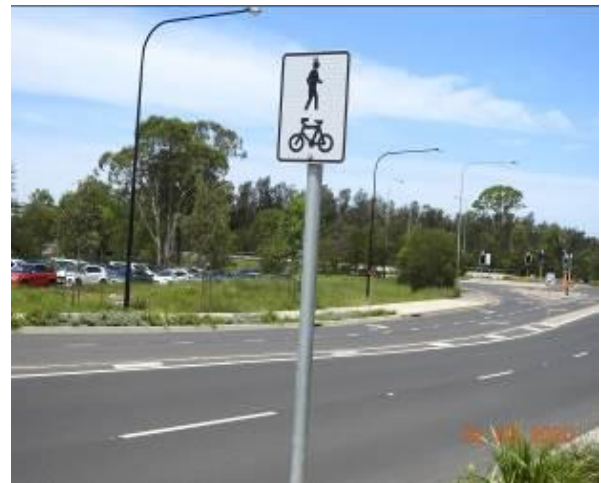
Figure 1311 – General Condition of street sign

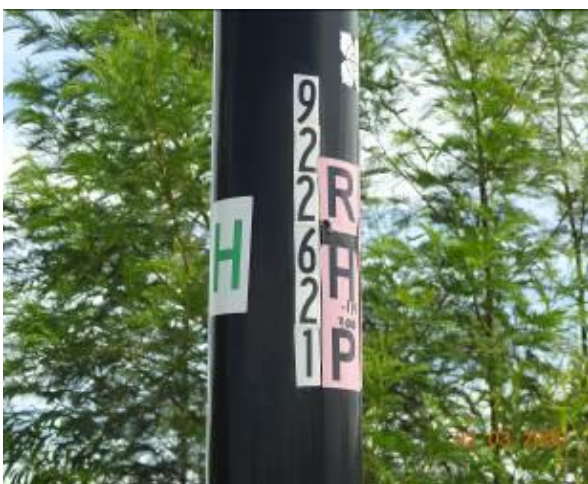
Figure 1312 – General Condition of lamp post
Identification No.922621

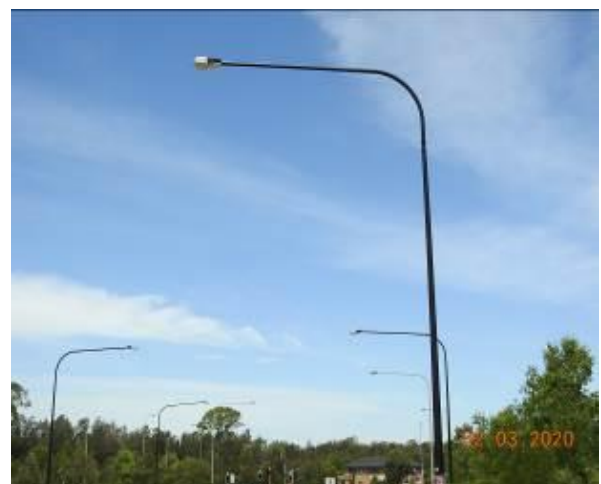
Figure 1313 – General Condition of lamp post

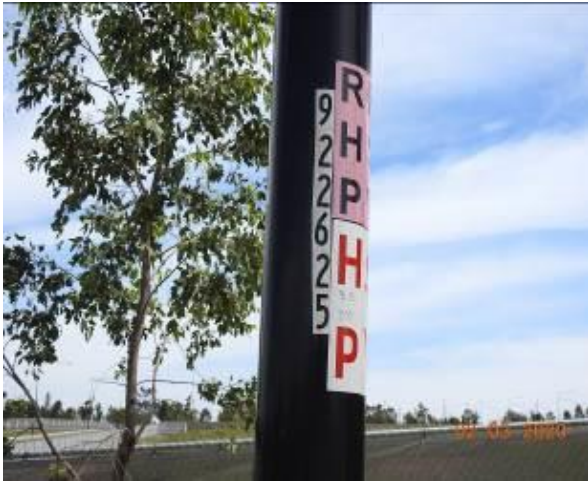
Figure 1314 – General Condition of lamp post
Identification No.922625

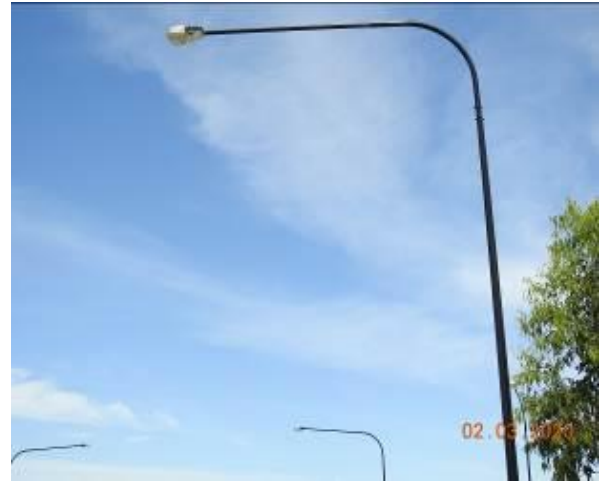
Figure 1315 – General Condition of lamp post

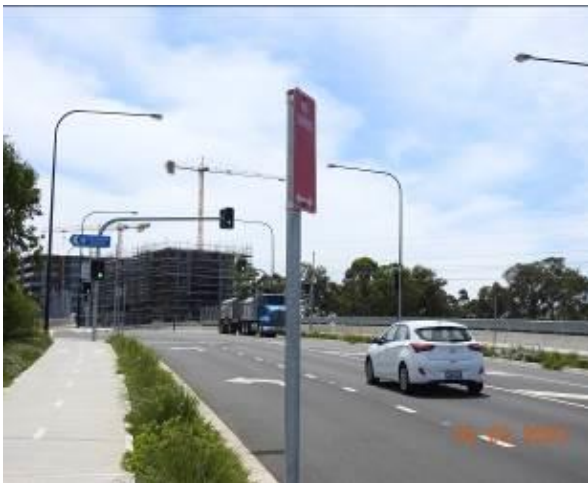
Figure 1316 – General Condition of street sign

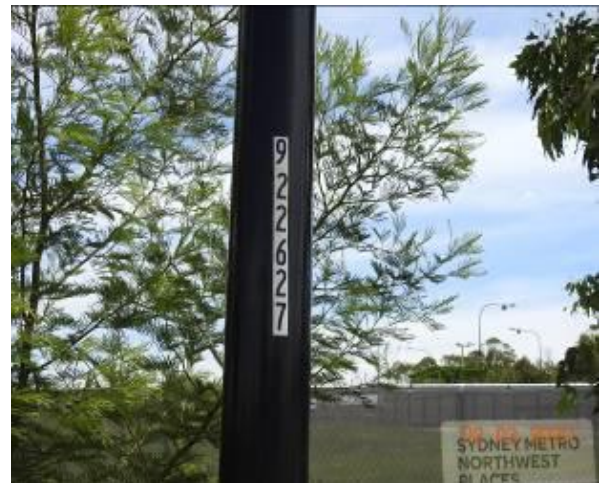
Figure 1317 – General Condition of lamp post
Identification No.922627

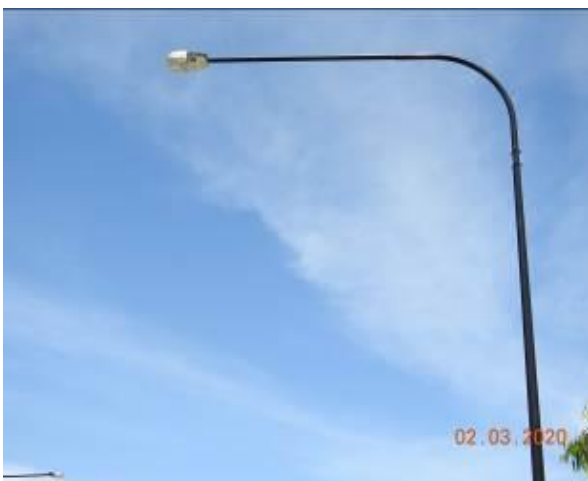
Figure 1318 – General Condition of lamp post

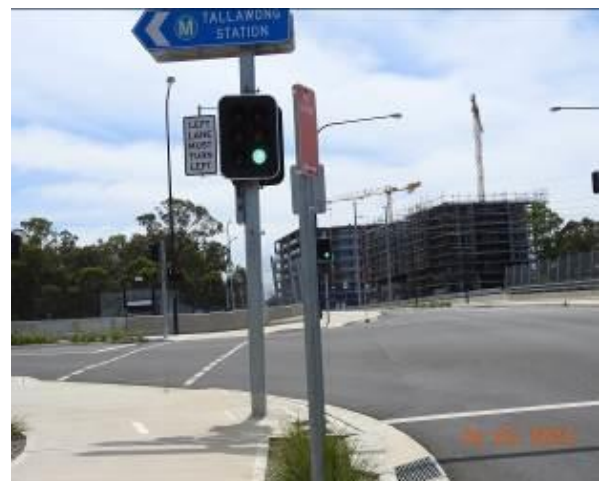
Figure 1319 – General Condition of traffic light /
street sign

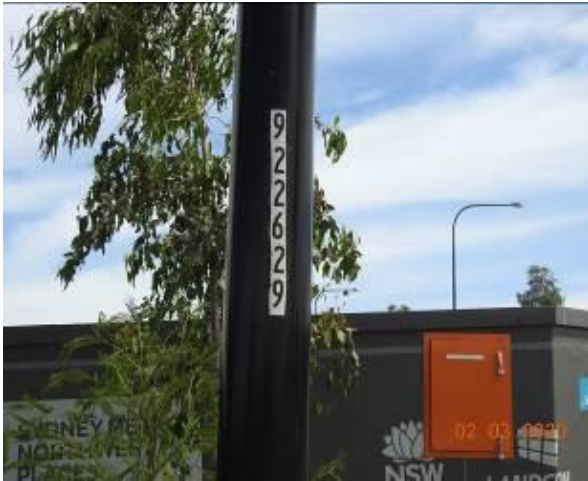
Figure 1320 – General Condition of lamp post
Identification No.922629

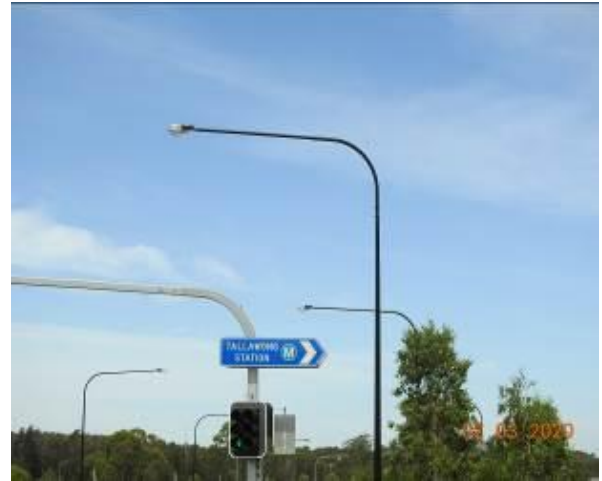
Figure 1321 – General Condition of lamp post

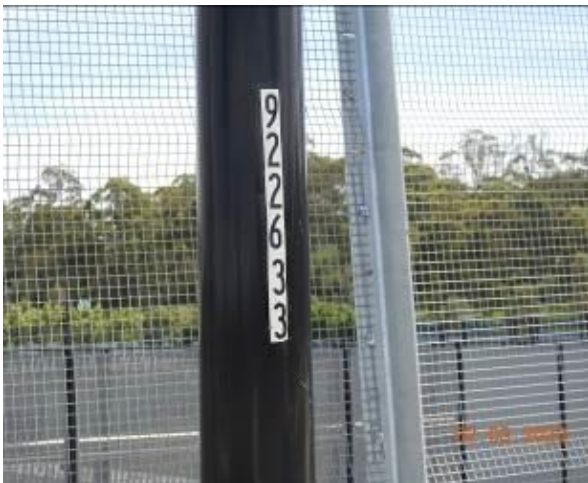
Figure 1322 – General Condition of lamp post
Identification No.922633

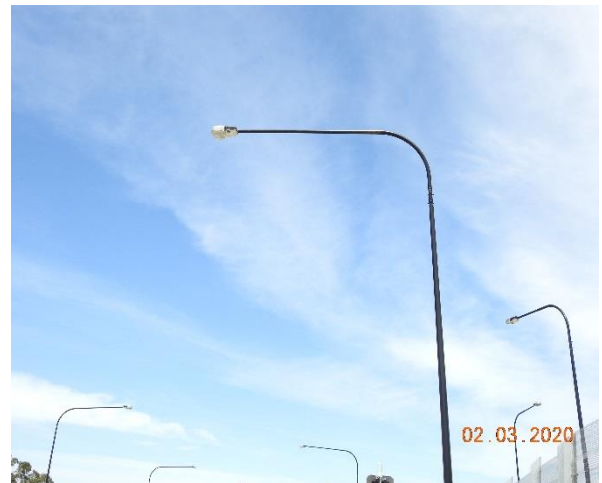
Figure 1323 – General Condition of lamp post

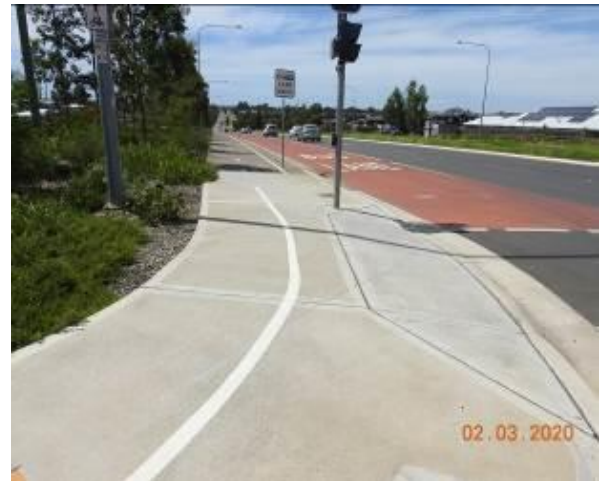
Figure 1325 – General Condition of footpath pavement

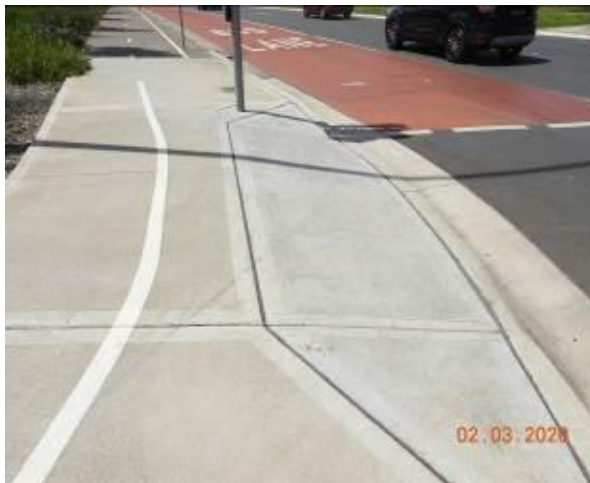
Figure 1326 – General Condition of footpath pavement

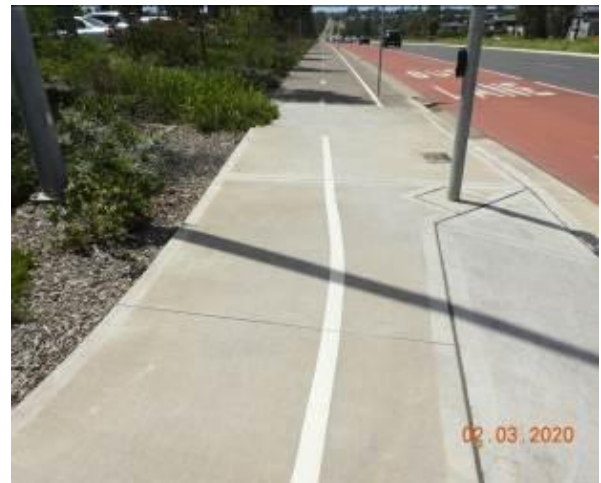
Figure 1327 – General Condition of footpath pavement

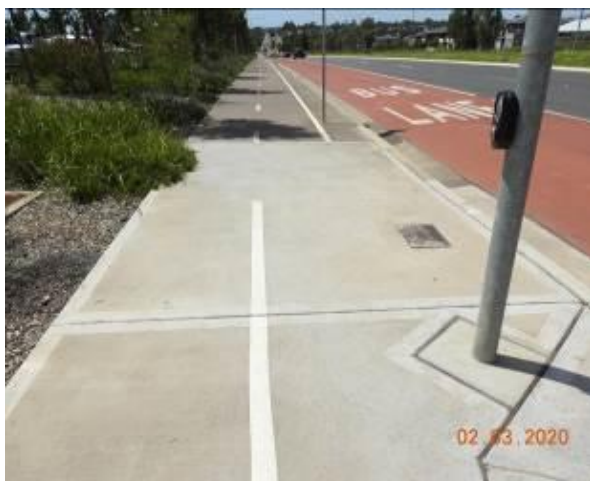
Figure 1328 – General Condition of footpath pavement
