**1-15 AND 2-12 CONFERTA AVENUE,
ROUSE HILL NSW 2155
TALLAWONG STATION PRECINCT SOUTH
PRE-DILAPIDATION REPORT**

**DEICORP PROJECTS
(TALLAWONG STATION) PTY LTD**

Job No. 191294.0
24/03/2020

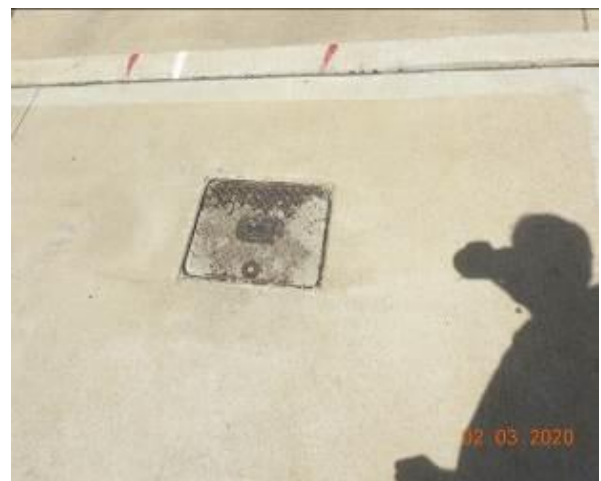
Figure 1329 – General Condition of service pit

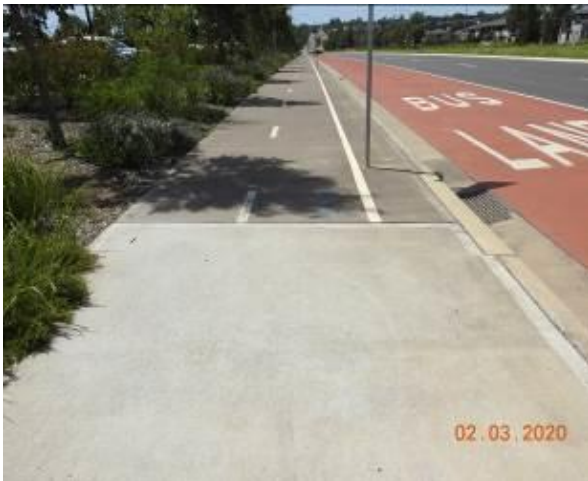
Figure 1330 – General Condition of footpath pavement

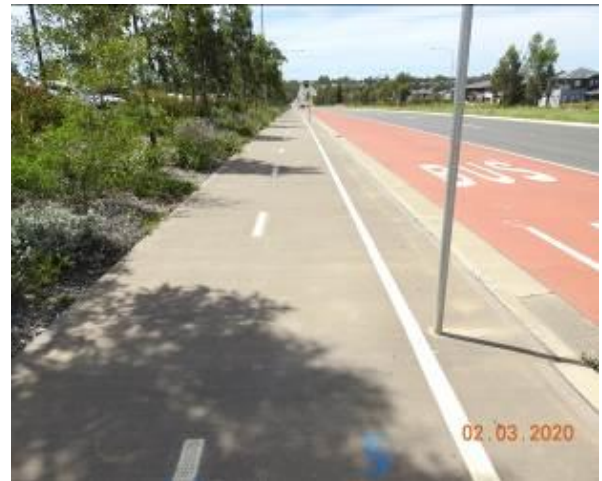
Figure 1331 – General Condition of footpath pavement

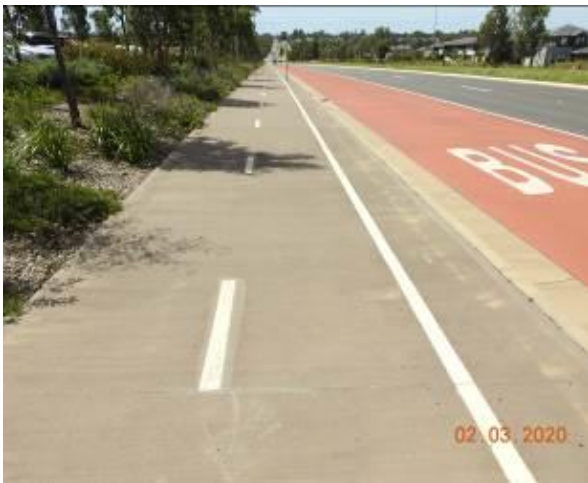
Figure 1332 – General Condition of footpath pavement

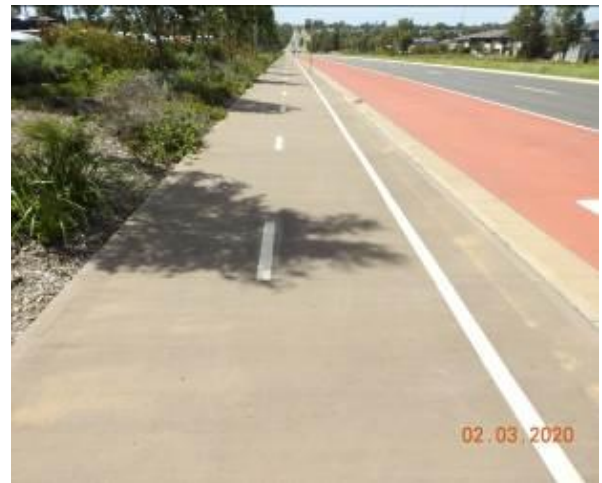
Figure 1333 – General Condition of footpath pavement

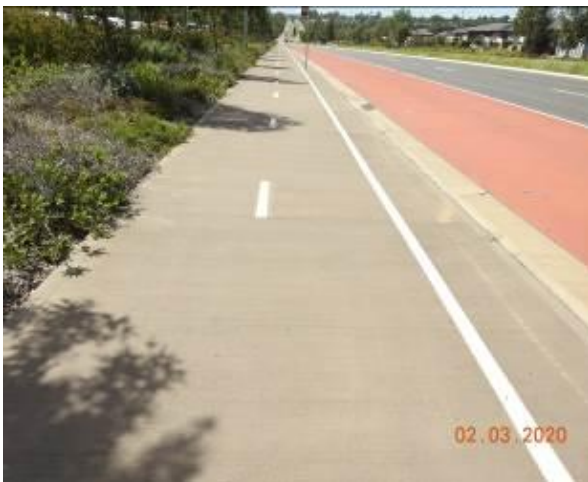
Figure 1334 – General Condition of footpath pavement

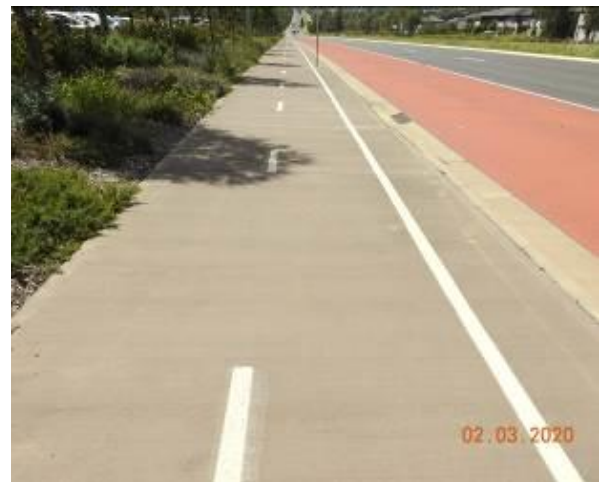
Figure 1335 – General Condition of footpath pavement

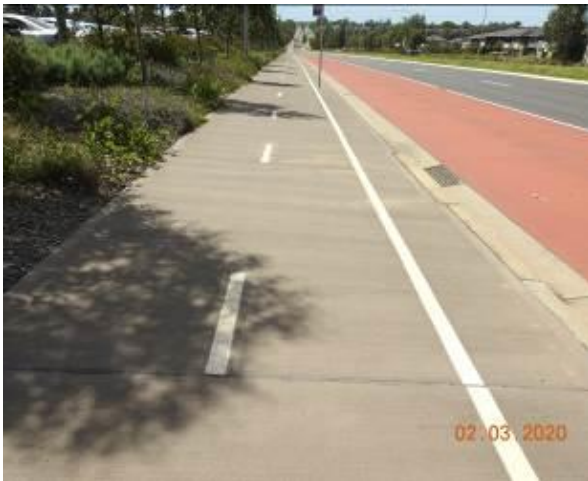
Figure 1336 – General Condition of footpath pavement

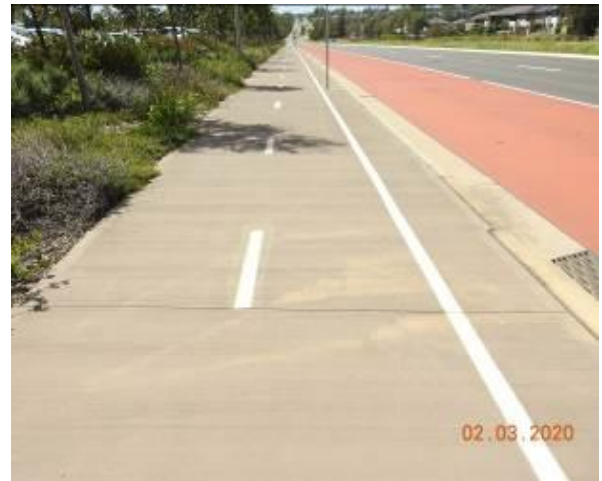
Figure 1337 – General Condition of footpath pavement

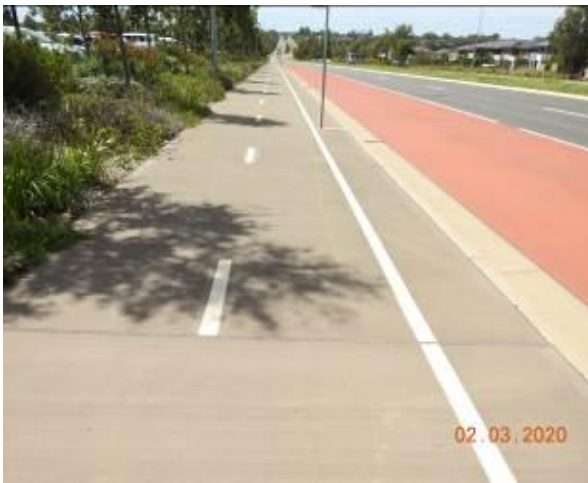
Figure 1338 – General Condition of footpath pavement

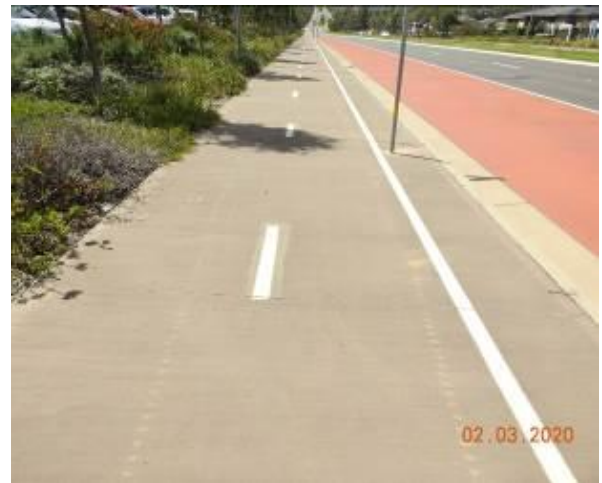
Figure 1339 – General Condition of footpath pavement

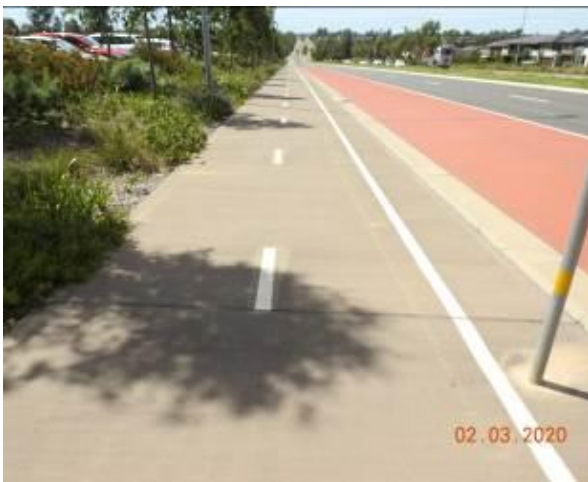
Figure 1340 – General Condition of footpath pavement

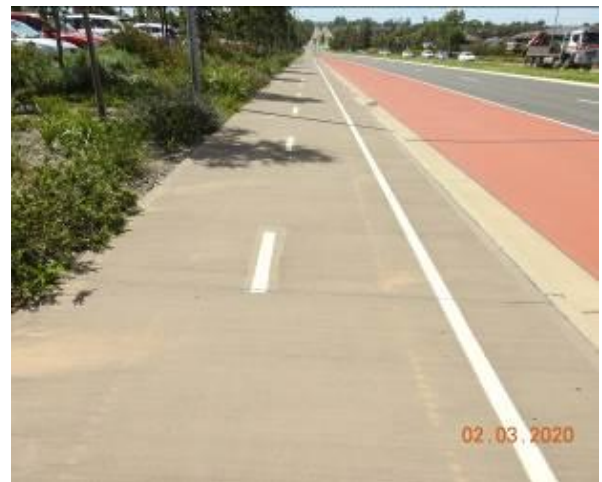
Figure 1341 – General Condition of footpath pavement

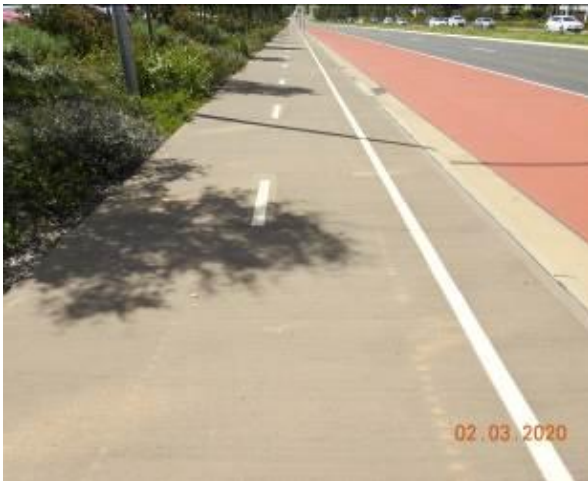
Figure 1342 – General Condition of footpath pavement

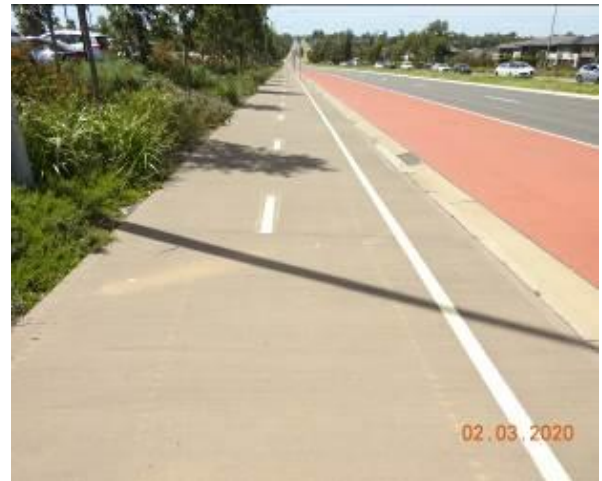
Figure 1343 – General Condition of footpath pavement

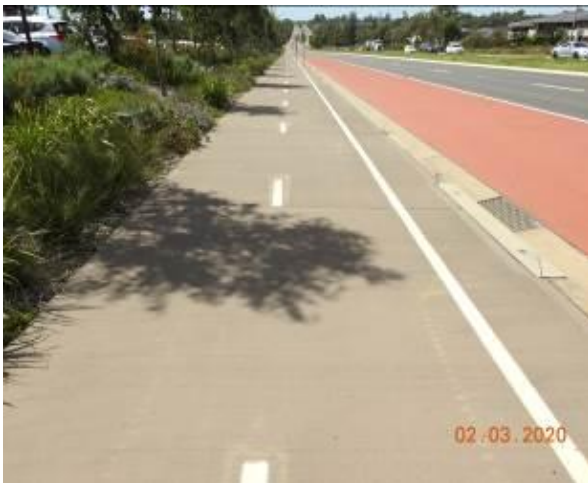
Figure 1344 – General Condition of footpath pavement

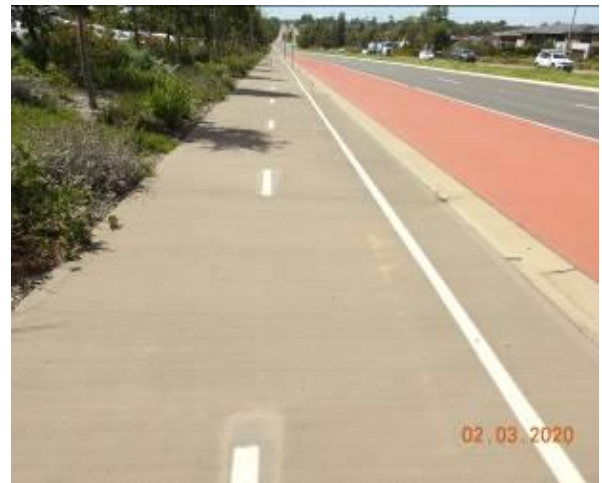
Figure 1345 – General Condition of footpath pavement

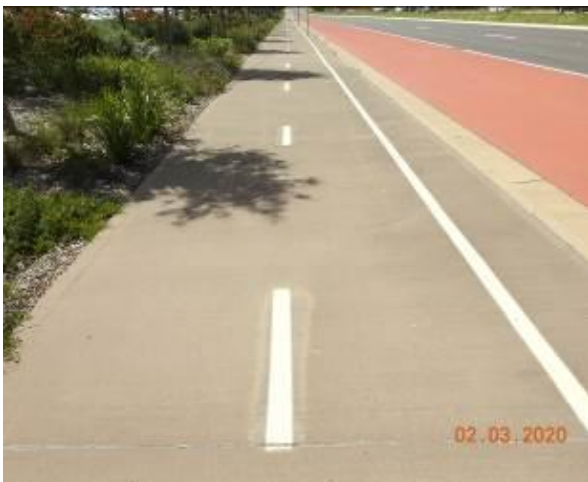
Figure 1346 – General Condition of footpath pavement

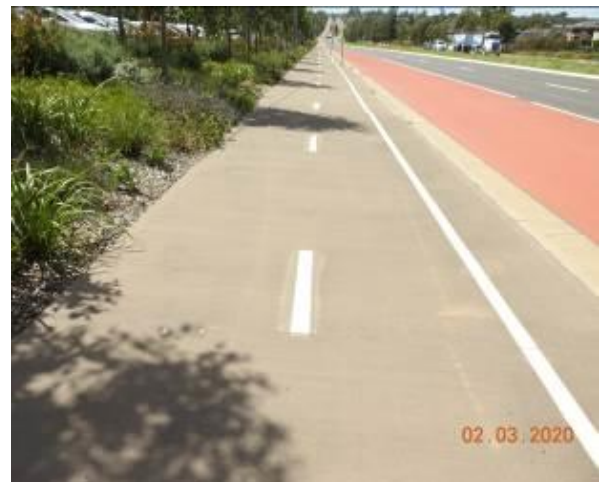
Figure 1347 – General Condition of footpath pavement

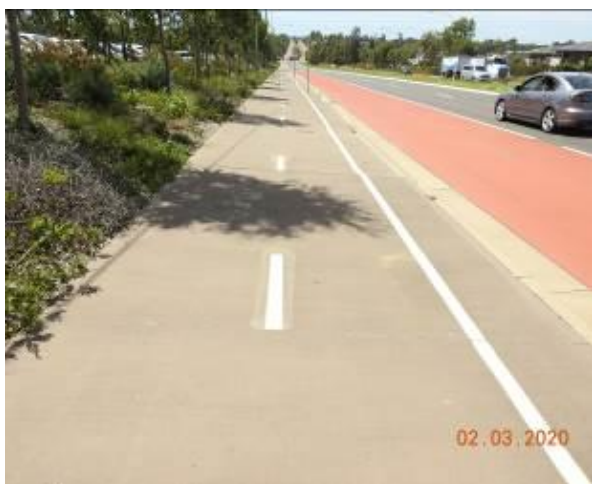
Figure 1348 – General Condition of footpath pavement

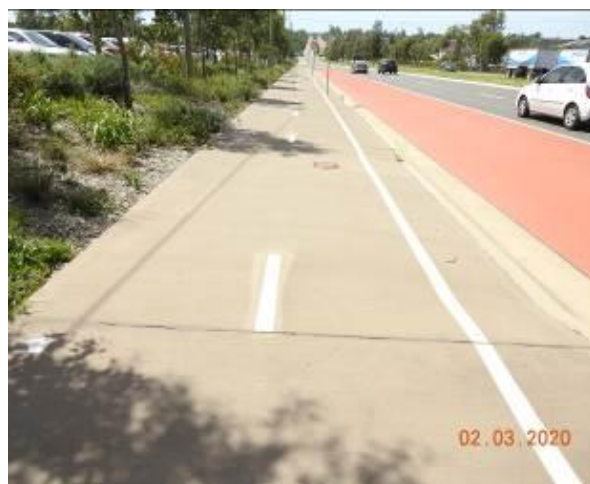
Figure 1349 – General Condition of footpath pavement

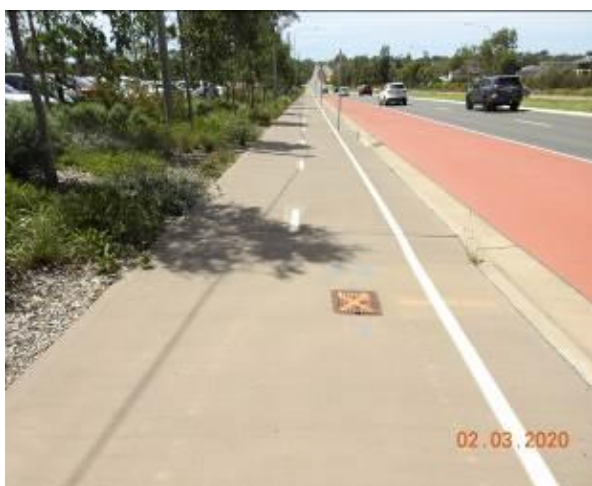
Figure 1350 – General Condition of footpath pavement

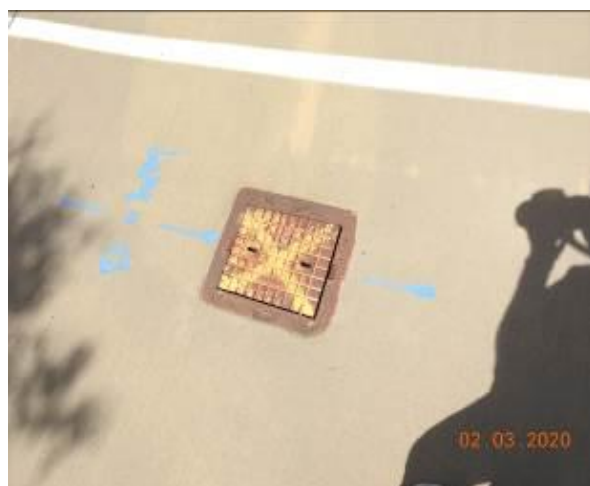
Figure 1351 – General Condition of service pit

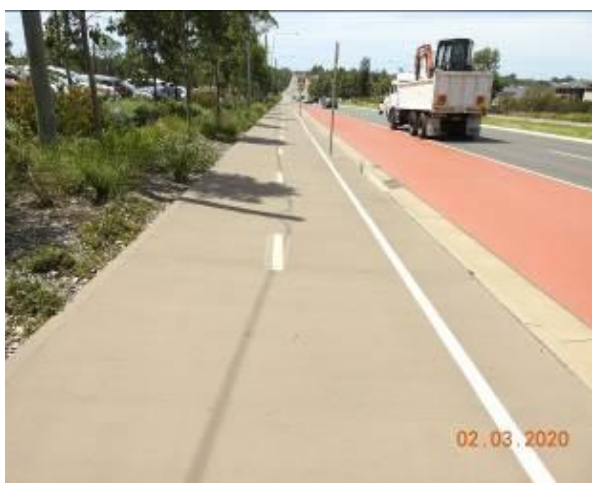
Figure 1352 – General Condition of footpath pavement

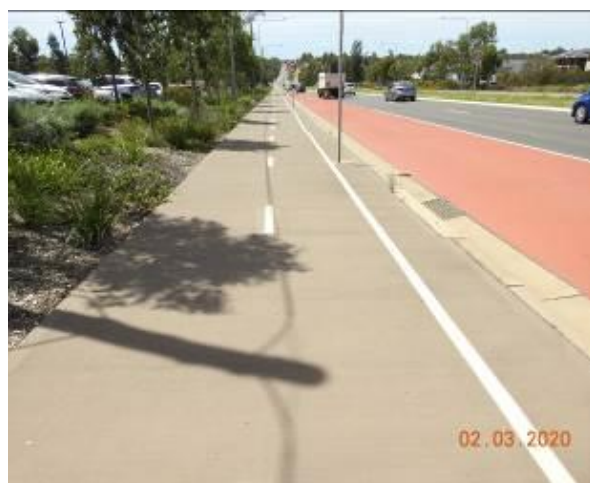
Figure 1353 – General Condition of footpath pavement

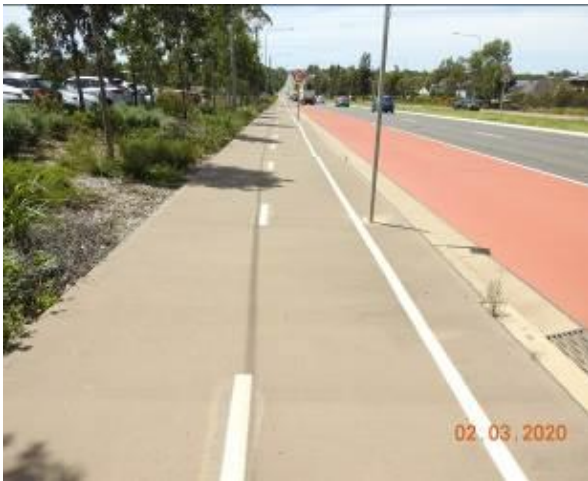
Figure 1354 – General Condition of footpath pavement

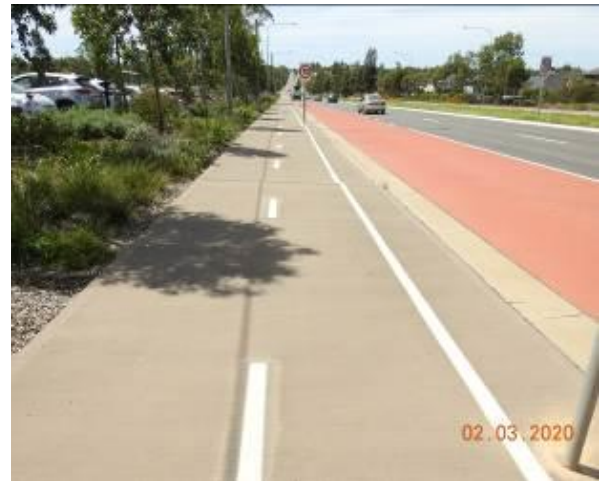
Figure 1355 – General Condition of footpath pavement

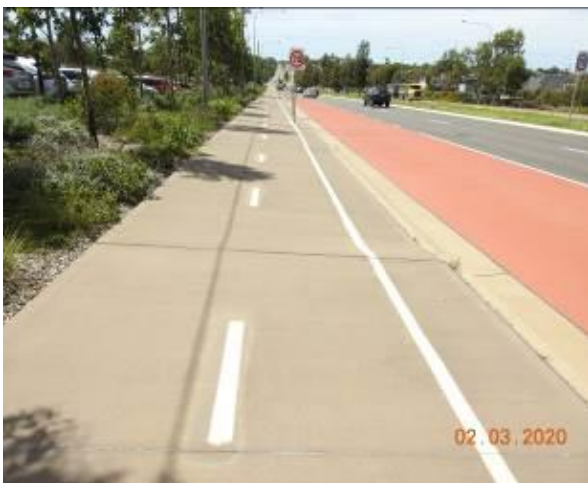
Figure 1356 – General Condition of footpath pavement

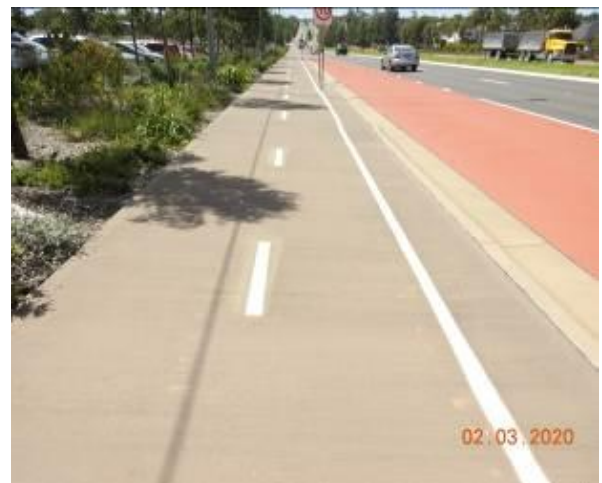
Figure 1357 – General Condition of footpath pavement

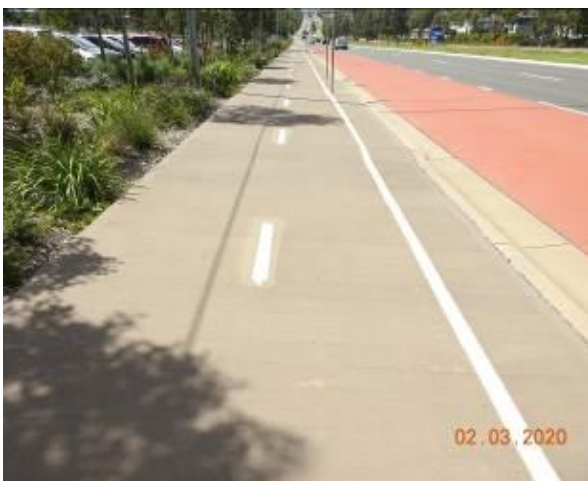
Figure 1358 – General Condition of footpath pavement

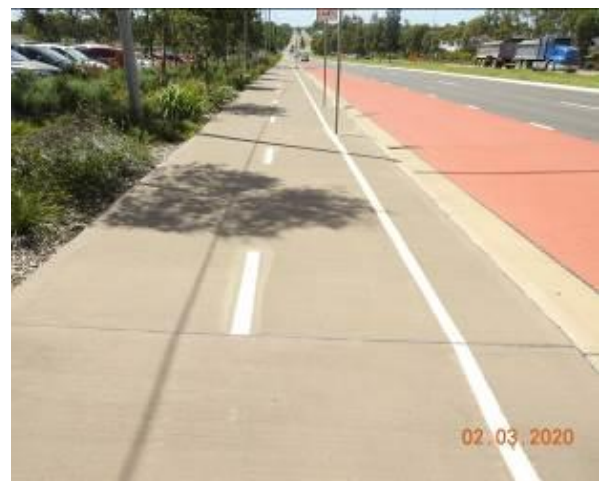
Figure 1359 – General Condition of footpath pavement

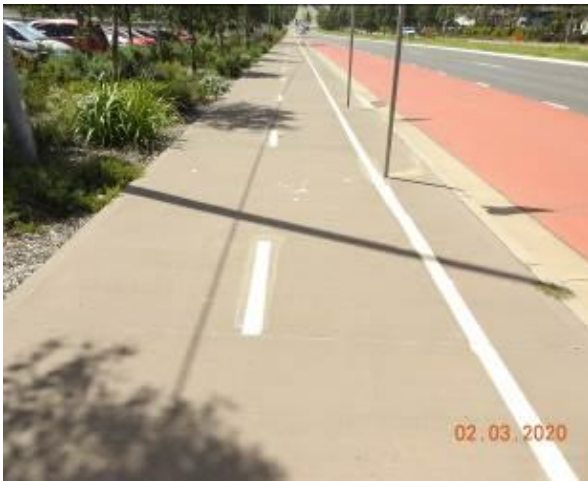
Figure 1360 – General Condition of footpath pavement

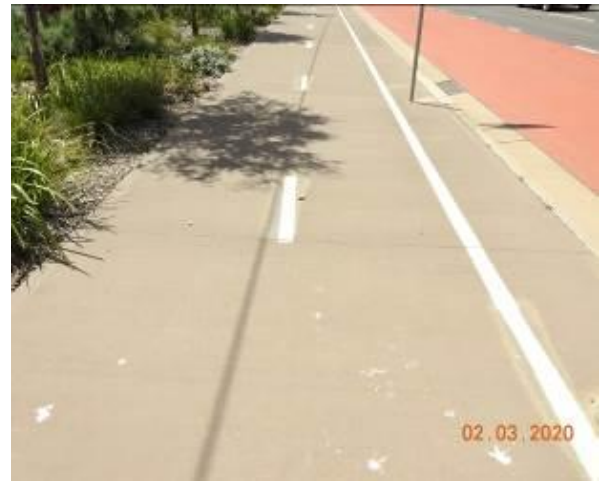
Figure 1361 – General Condition of footpath pavement

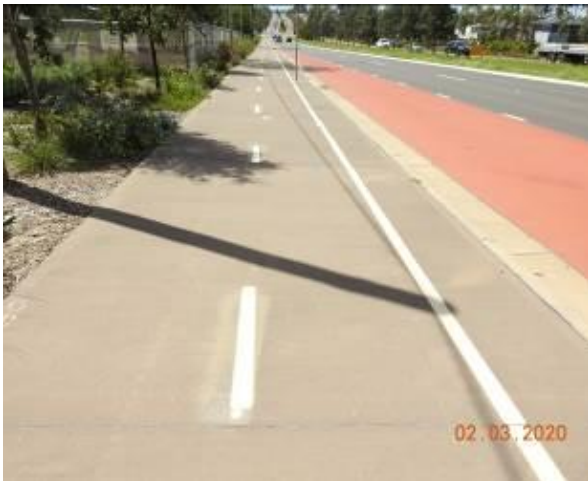
Figure 1366 – General Condition of footpath pavement

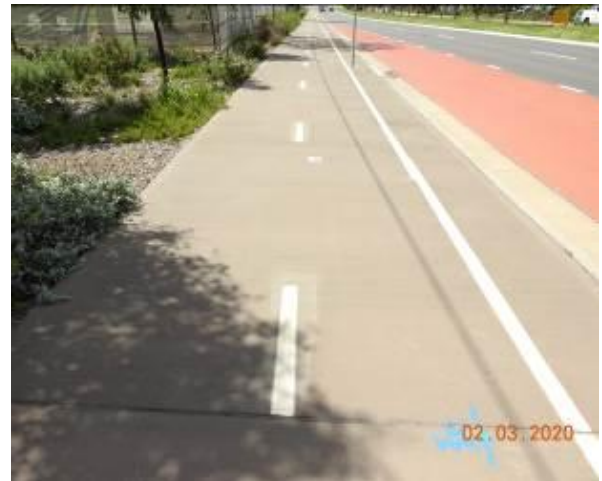
Figure 1367 – General Condition of footpath pavement

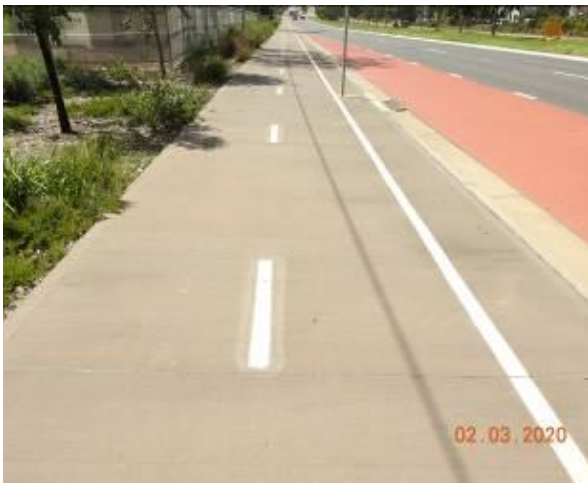
Figure 1368 – General Condition of footpath pavement

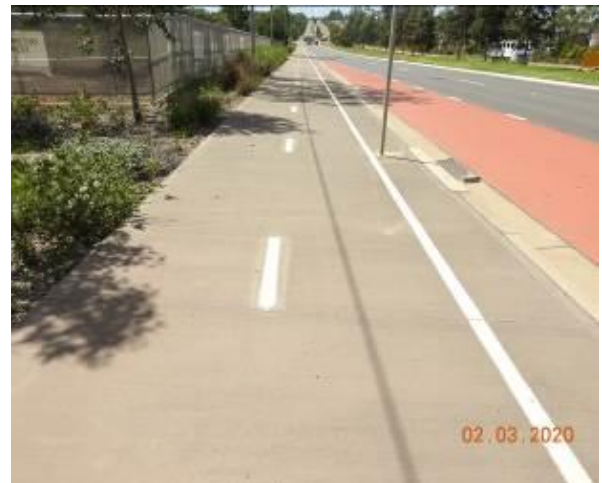
Figure 1369 – General Condition of footpath pavement

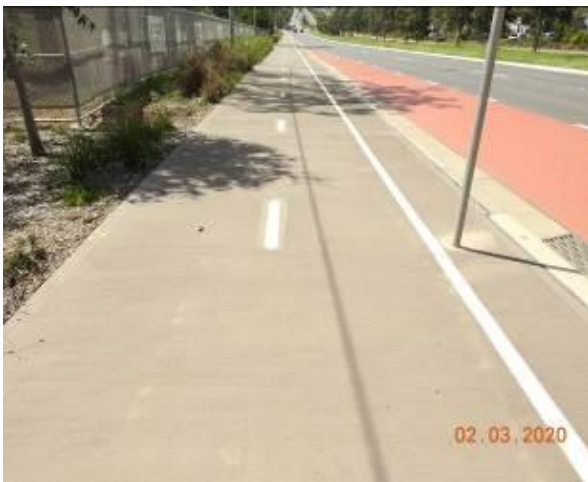
Figure 1370 – General Condition of footpath pavement

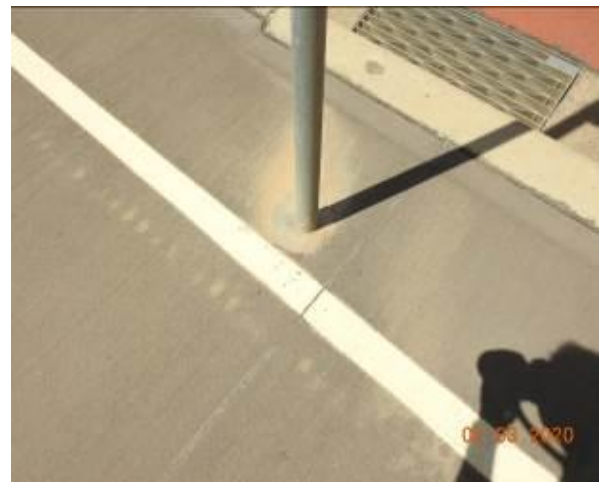
Figure 1371 – Evidence of patchwork through footpath pavement

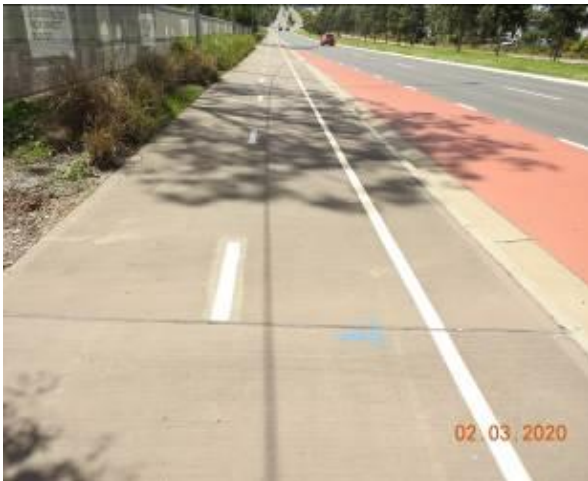
Figure 1372 – General Condition of footpath pavement

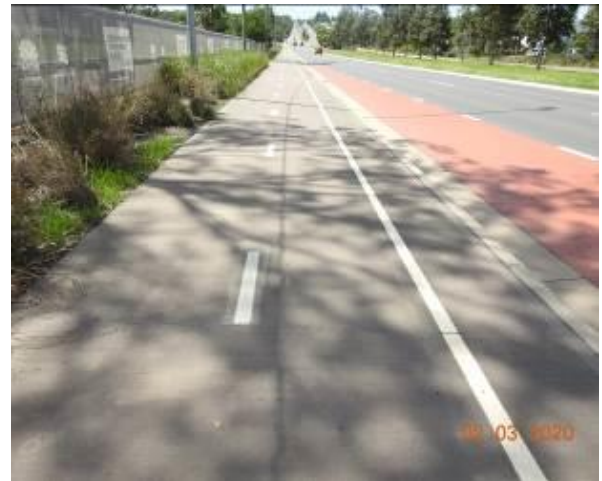
Figure 1373 – General Condition of footpath pavement

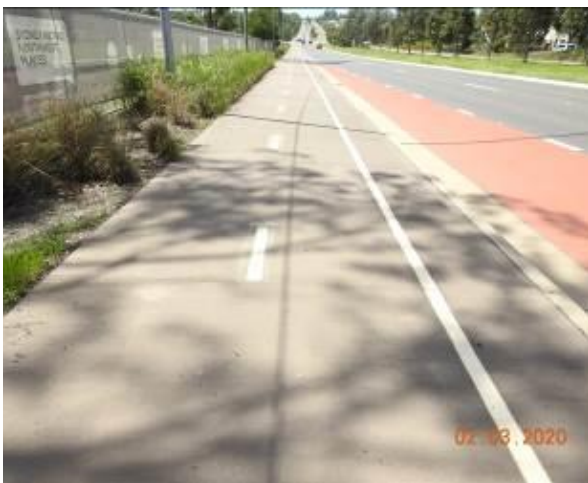
Figure 1374 – General Condition of footpath pavement

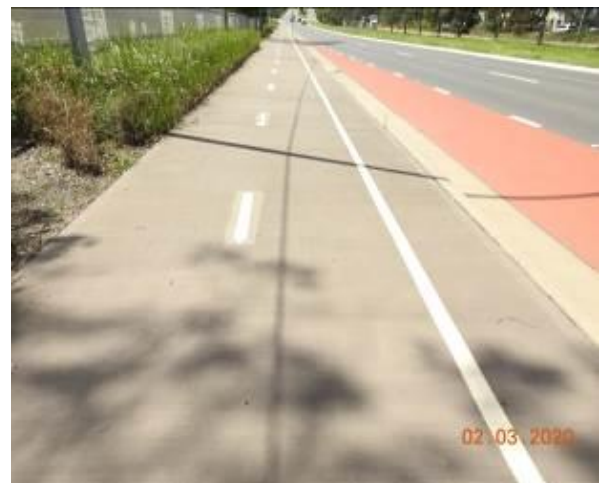
Figure 1375 – General Condition of footpath pavement

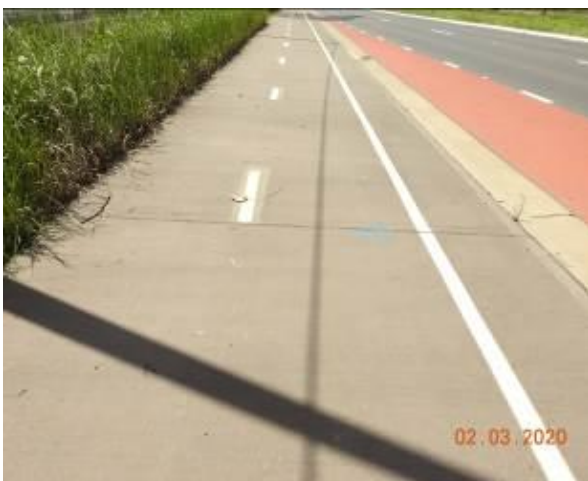
Figure 1376 – General Condition of footpath pavement

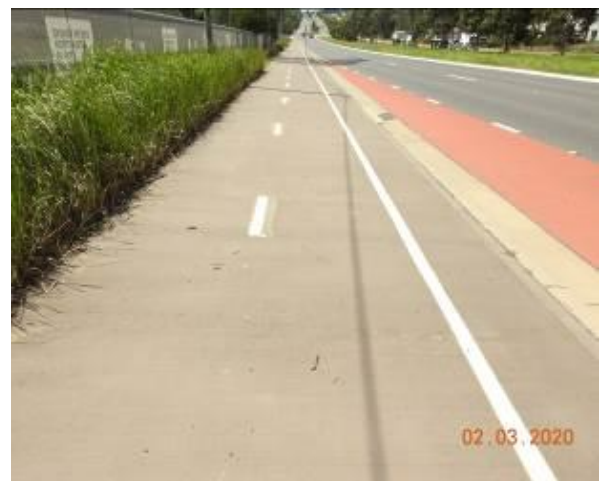
Figure 1377 – General Condition of footpath pavement

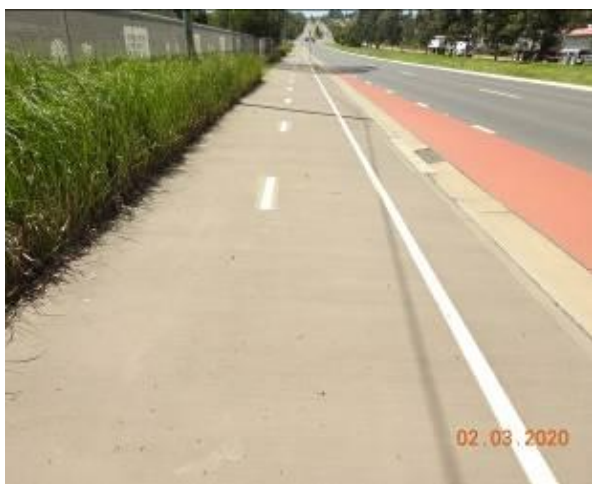
Figure 1378 – General Condition of footpath pavement

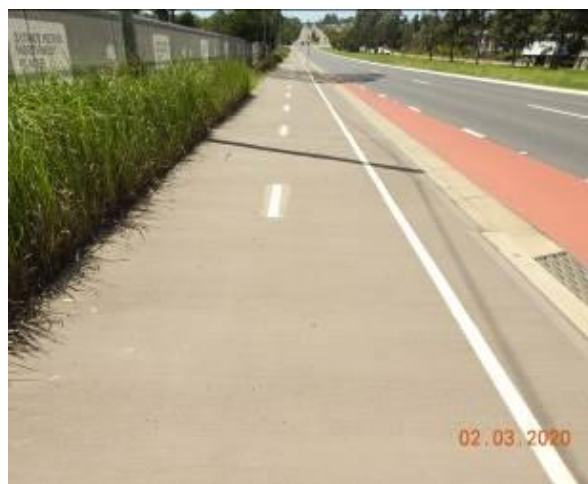
Figure 1379 – General Condition of footpath pavement

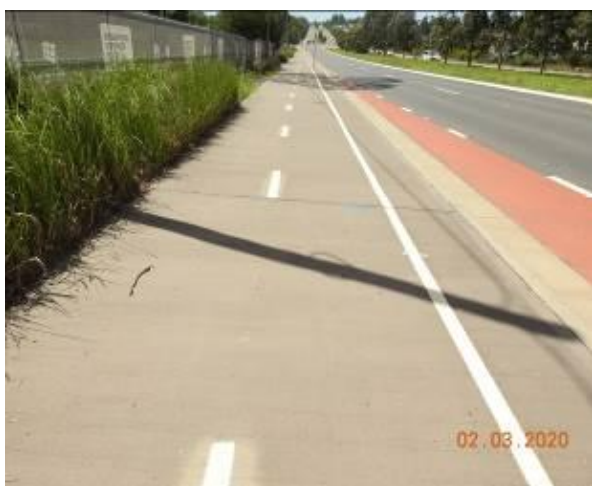
Figure 1380 – General Condition of footpath pavement

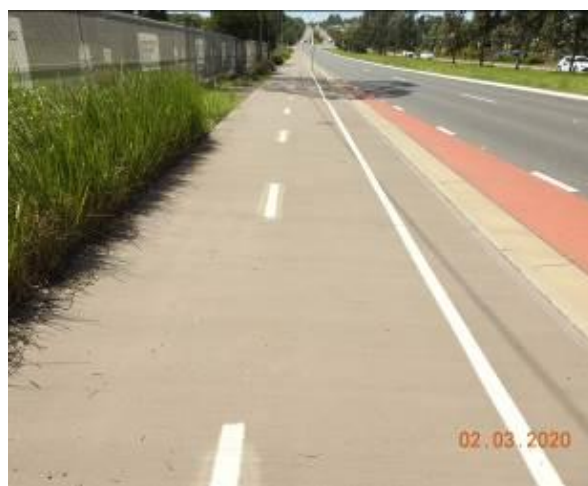
Figure 1381 – General Condition of footpath pavement

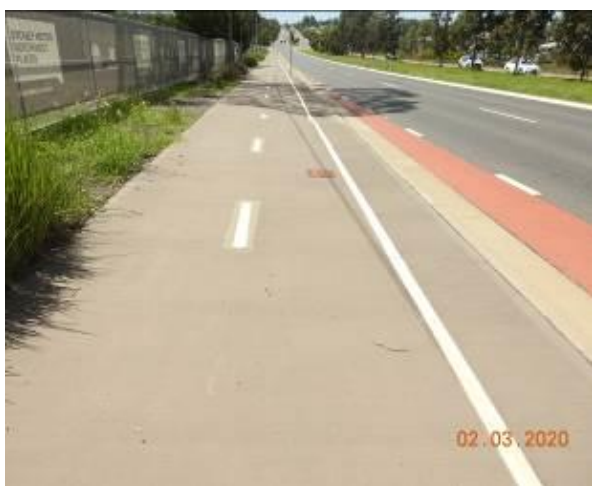
Figure 1382 – General Condition of footpath pavement

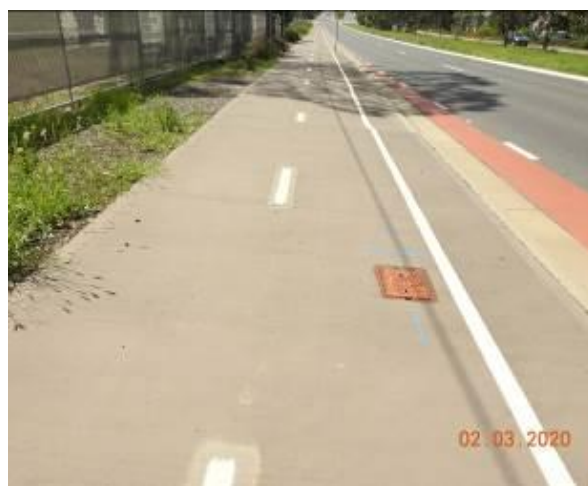
Figure 1383 – General Condition of footpath pavement

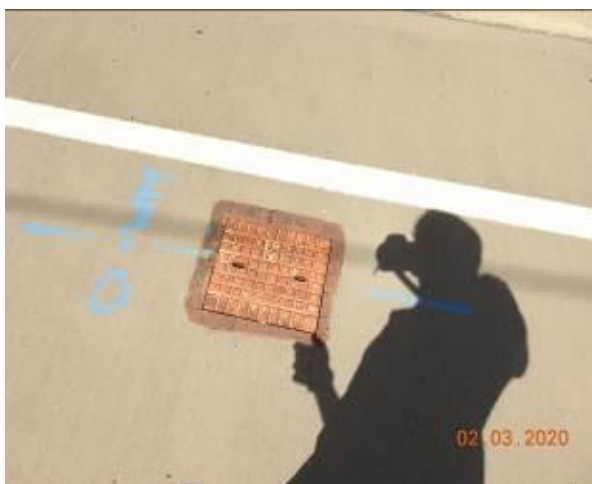
Figure 1384 – General Condition of service pit

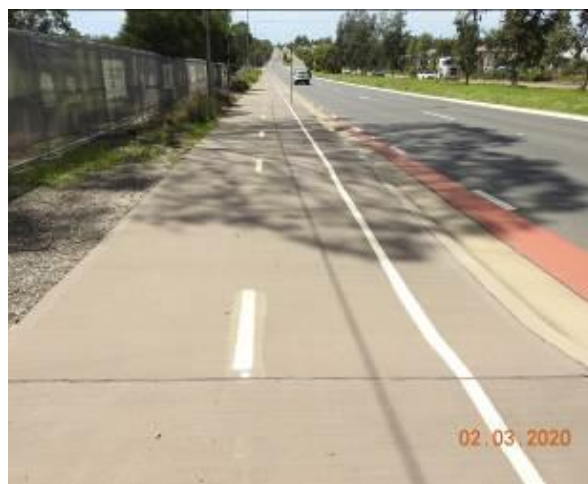
Figure 1385 – General Condition of footpath pavement

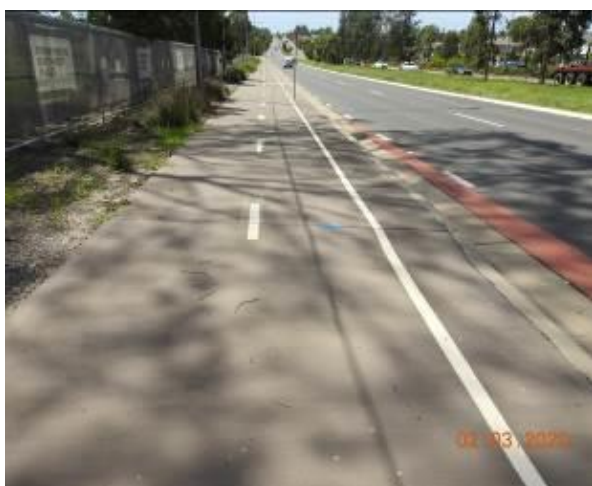
Figure 1386 – General Condition of footpath pavement

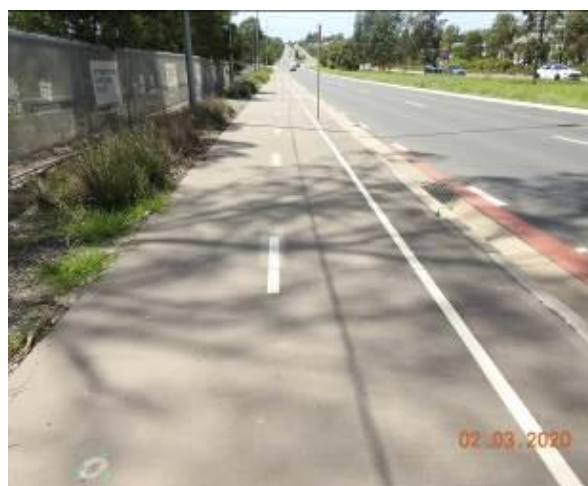
Figure 1387 – General Condition of footpath pavement

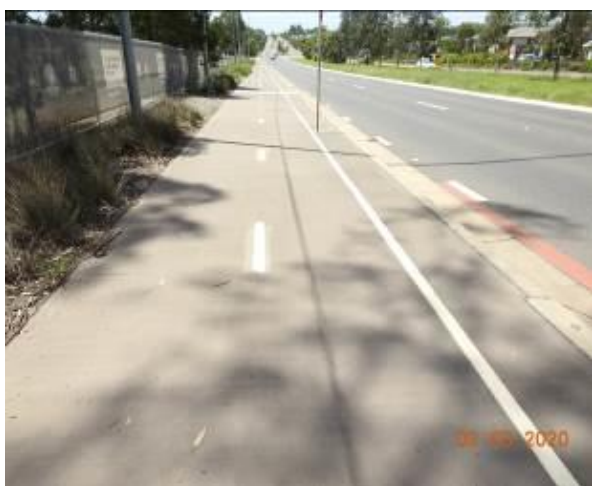
Figure 1388 – General Condition of footpath pavement

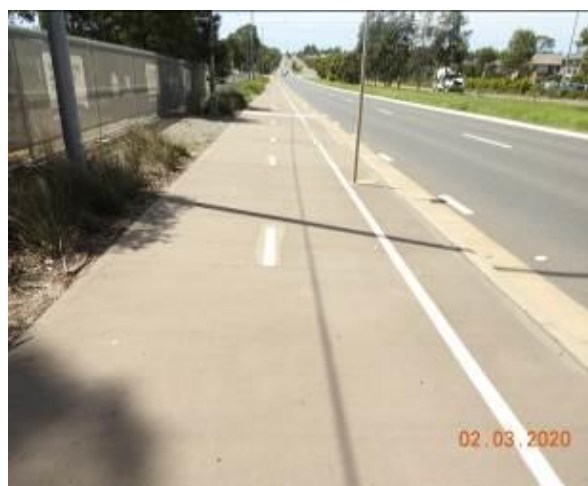
Figure 1389 – General Condition of footpath pavement

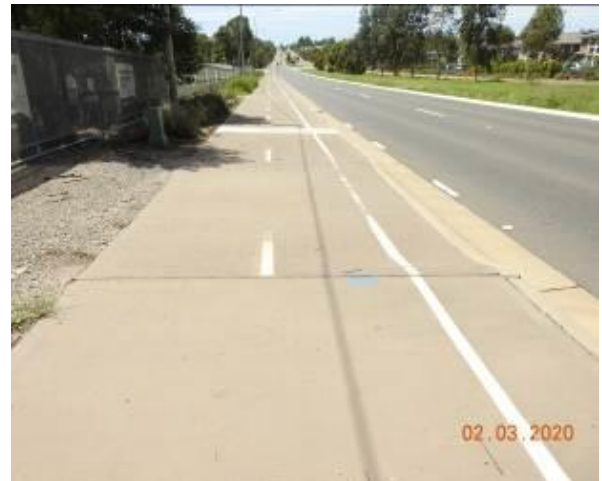
Figure 1391 – General Condition of footpath pavement

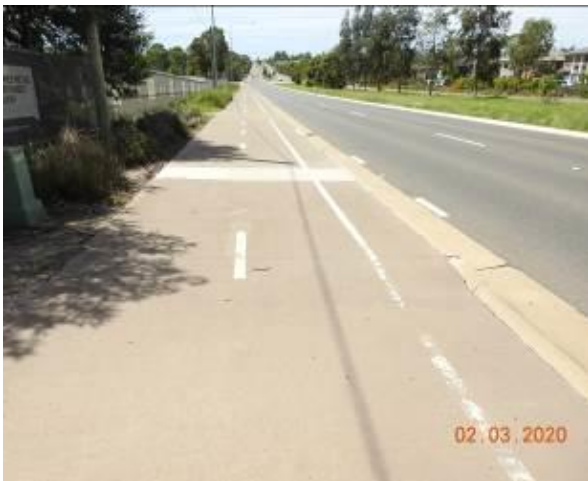
Figure 1392 – General Condition of footpath pavement

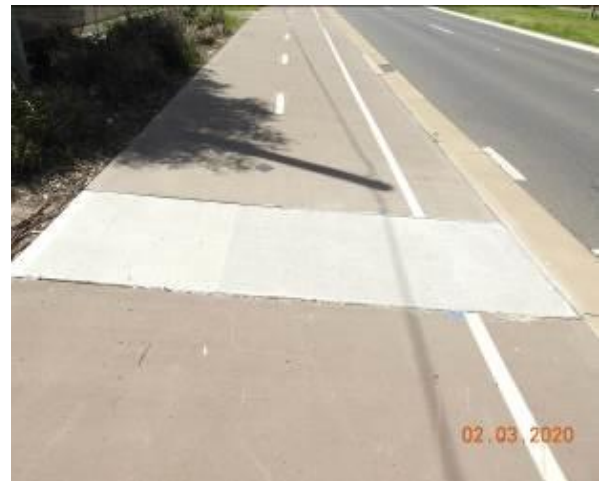
Figure 1393 – Evidence of patchwork through footpath pavement

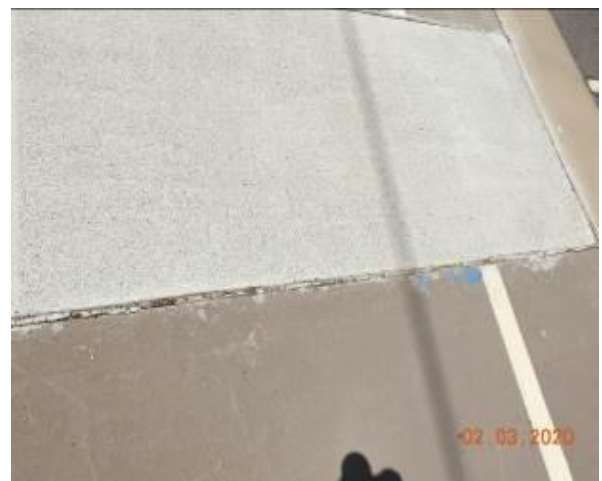
Figure 1395 – Crack propagation through footpath pavement

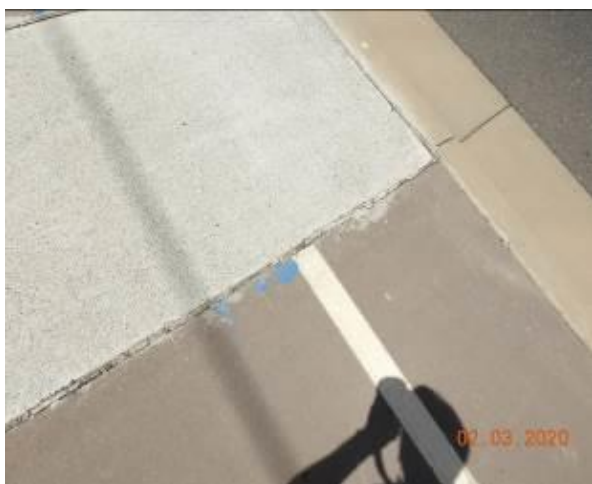
Figure 1396 – Crack propagation through footpath pavement

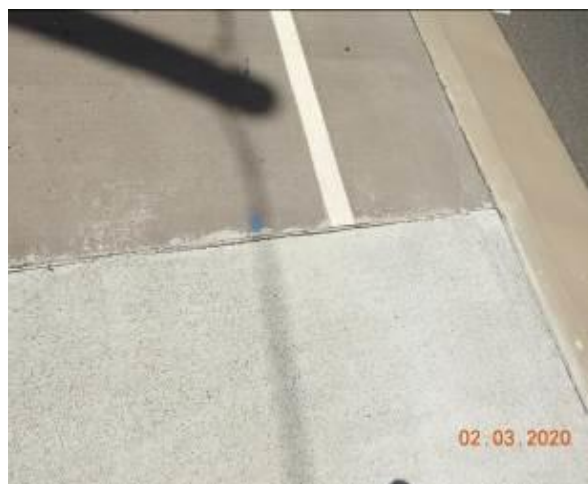
Figure 1397 – Crack propagation through footpath pavement

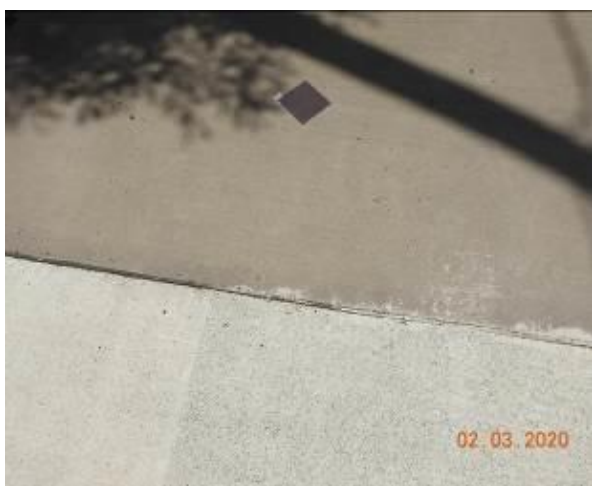
Figure 1398 – Crack propagation through footpath pavement

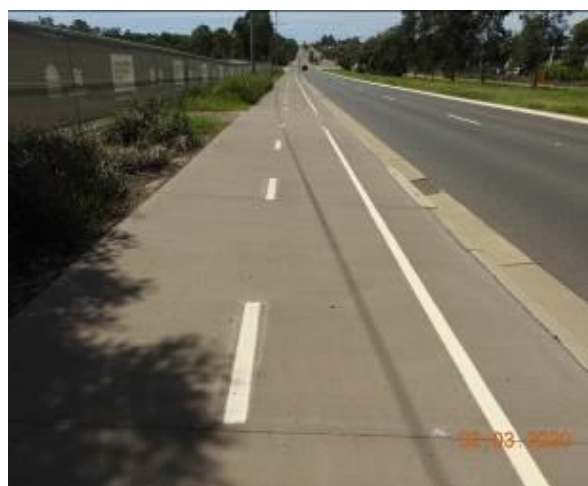
Figure 1399 – General Condition of footpath pavement

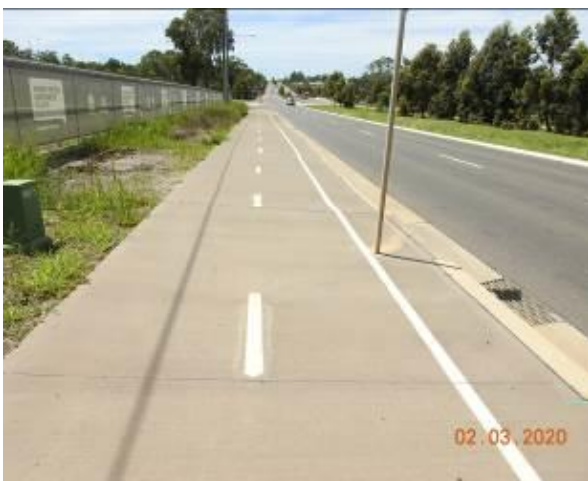
Figure 1413 – Evidence of patchwork through footpath pavement

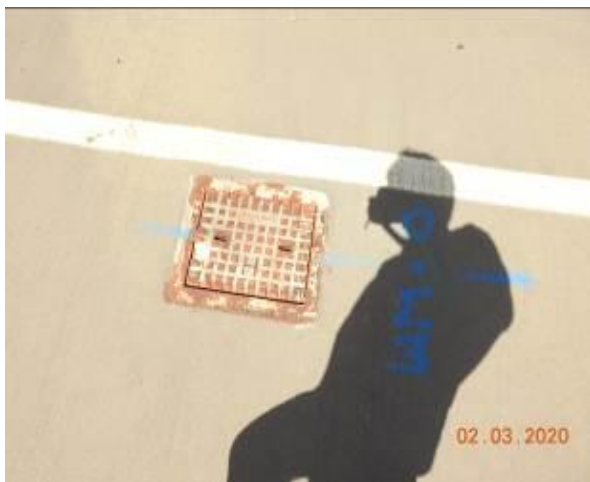
Figure 1420 – General Condition of service pit

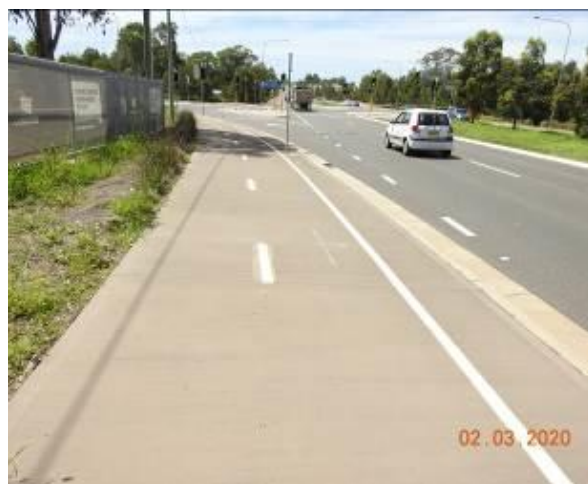
Figure 1426 – General Condition of footpath pavement

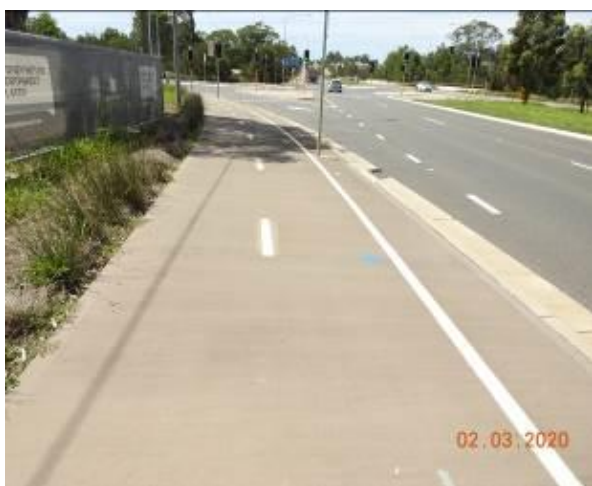
Figure 1427 – General Condition of footpath pavement

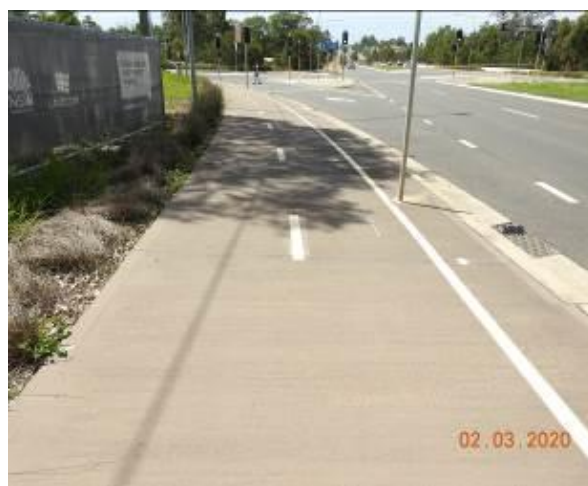
Figure 1428 – General Condition of footpath pavement

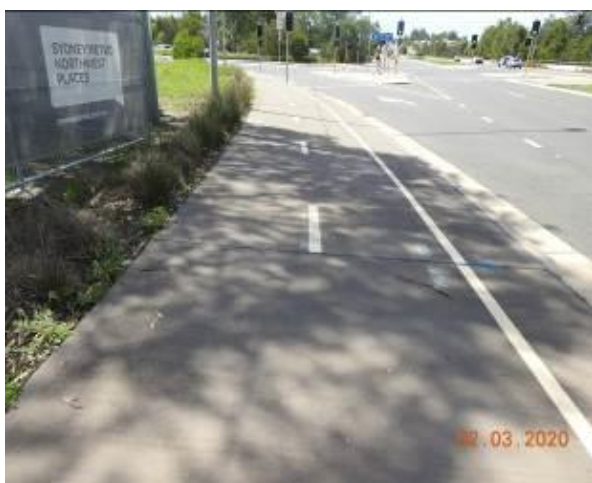
Figure 1429 – General Condition of footpath pavement

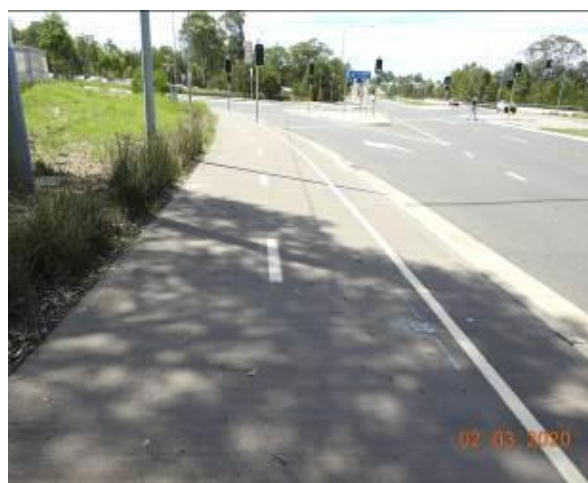
Figure 1430 – General Condition of footpath pavement

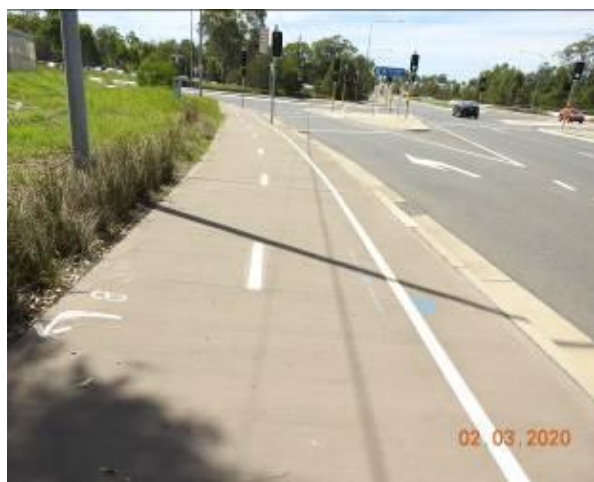
Figure 1431 – General Condition of footpath pavement

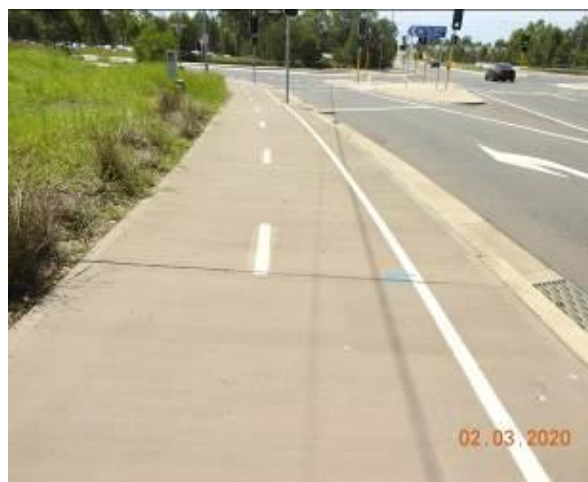
Figure 1432 – General Condition of footpath pavement

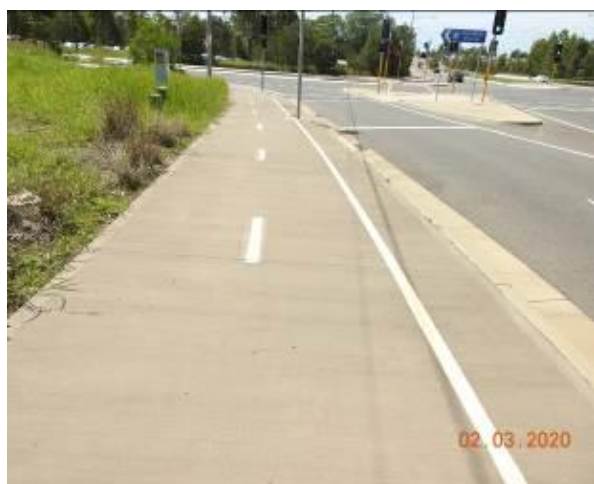
Figure 1433 – General Condition of footpath pavement

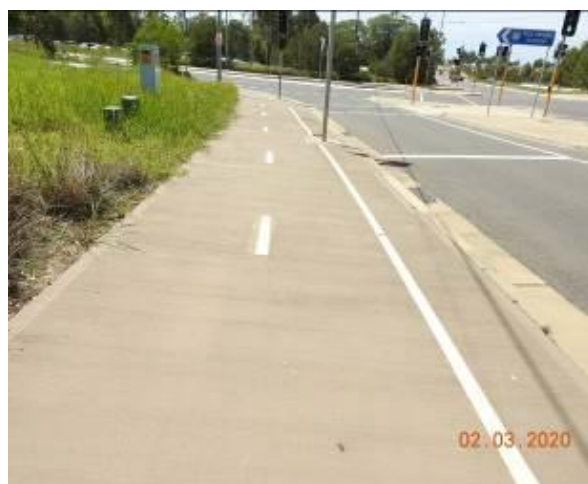
Figure 1434 – General Condition of footpath pavement

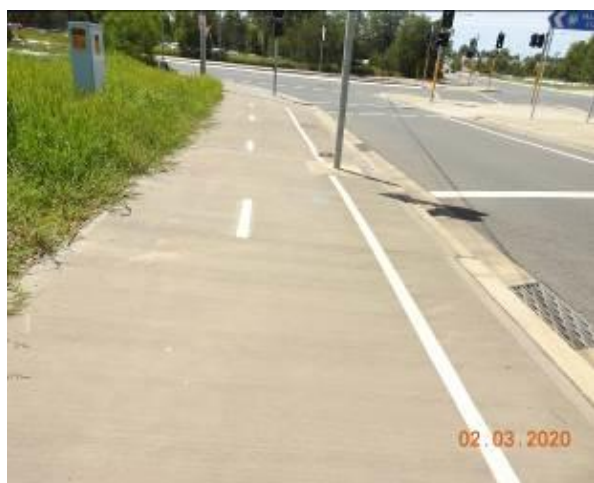
Figure 1435 – General Condition of footpath pavement
